CEDAR LAKE DAM INSPECTION REPORT

Dam Identification No.: 1101

City: Alcona County, MI

DATE OF REPORT: OCTOBER 16, 2024

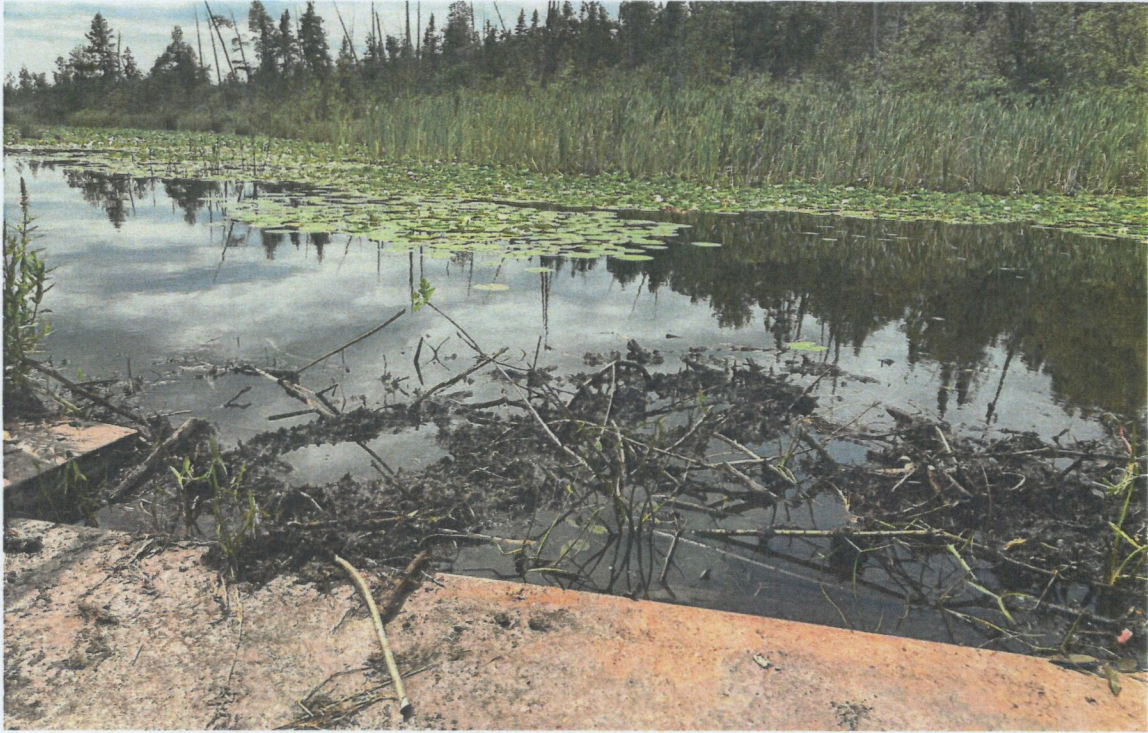
Some debris upstream of the fixed crest wier, not obstructing flow

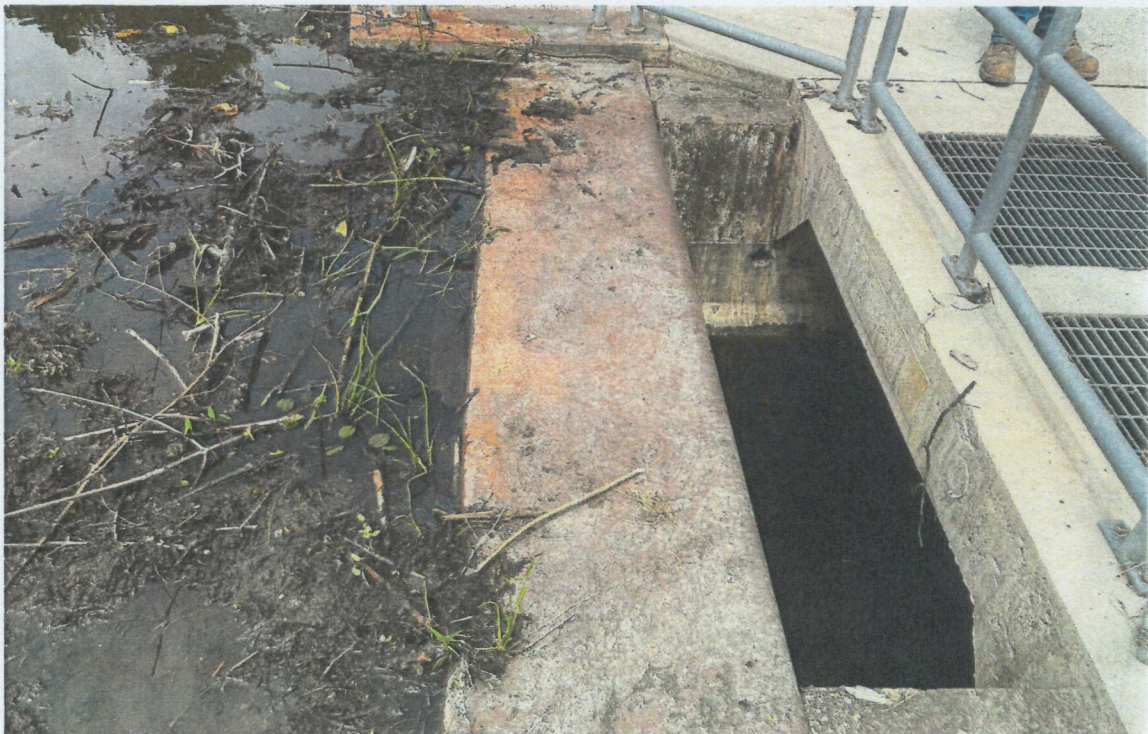
SSP fixed crest wier

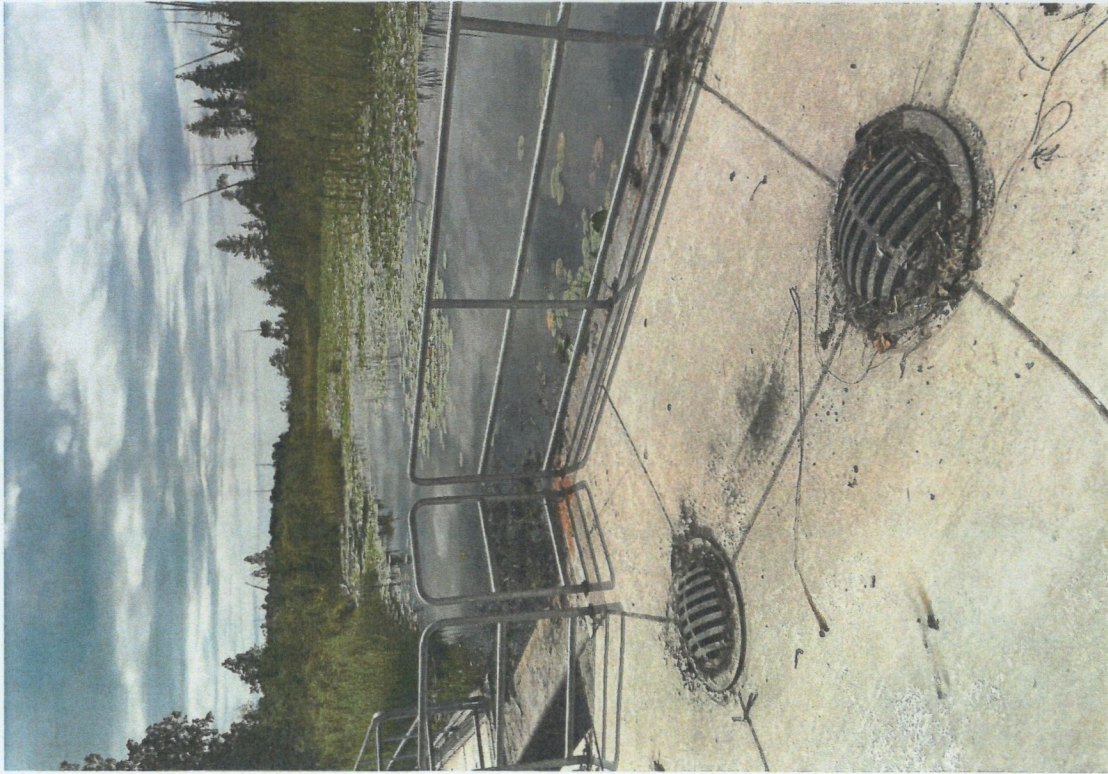
Overflow catchbasin on left side of structure

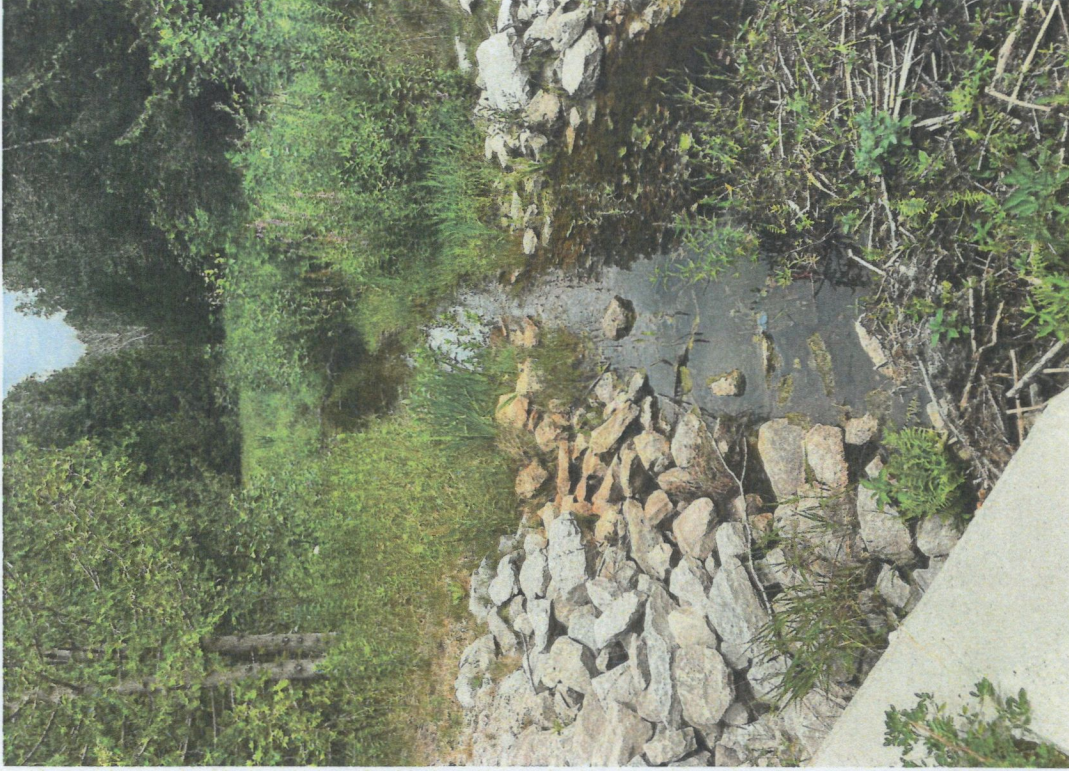
Downstream channel - some brush and mud in flow channel

- Remove debris downstream of outlet (This is already scheduled to be completed.)
- Remove brush and vegetation growing on downstream wing walls.

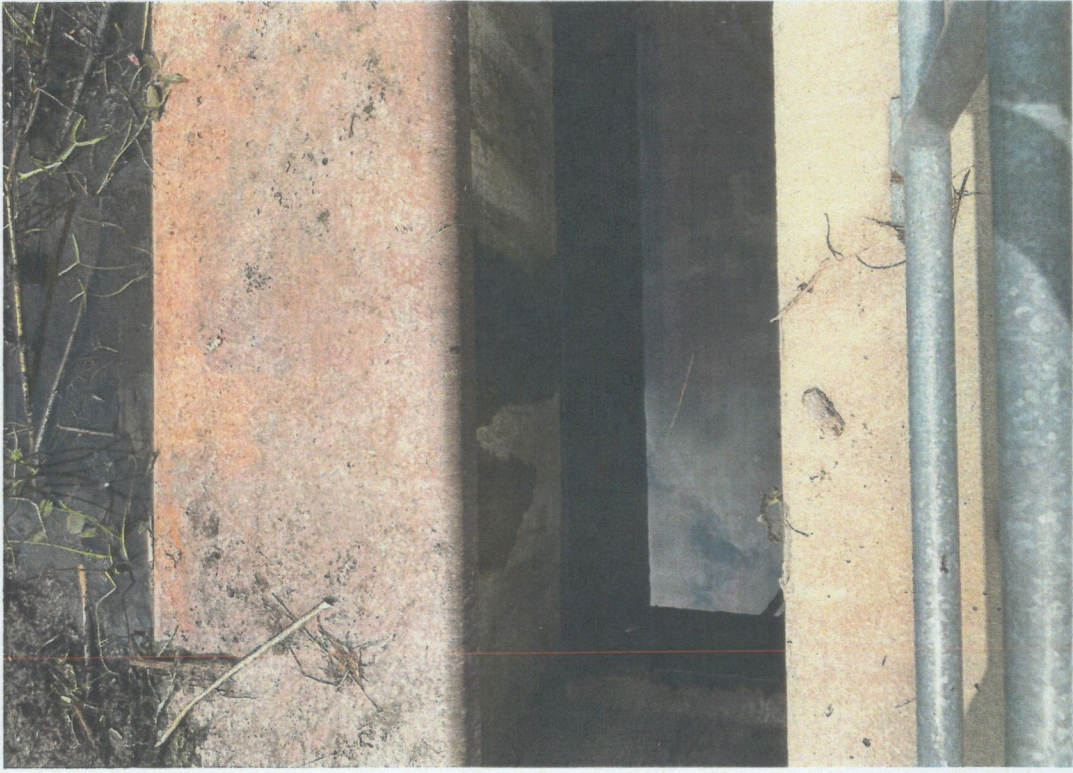
Some seepage observed on downstream side of SSP cap,
minor
