# CEDAR LAKE DAM INSPECTION REPORT

**Dam Identification No.: 1101**

**City: Alcona County, MI**

DATE OF REPORT: OCTOBER 16, 2024

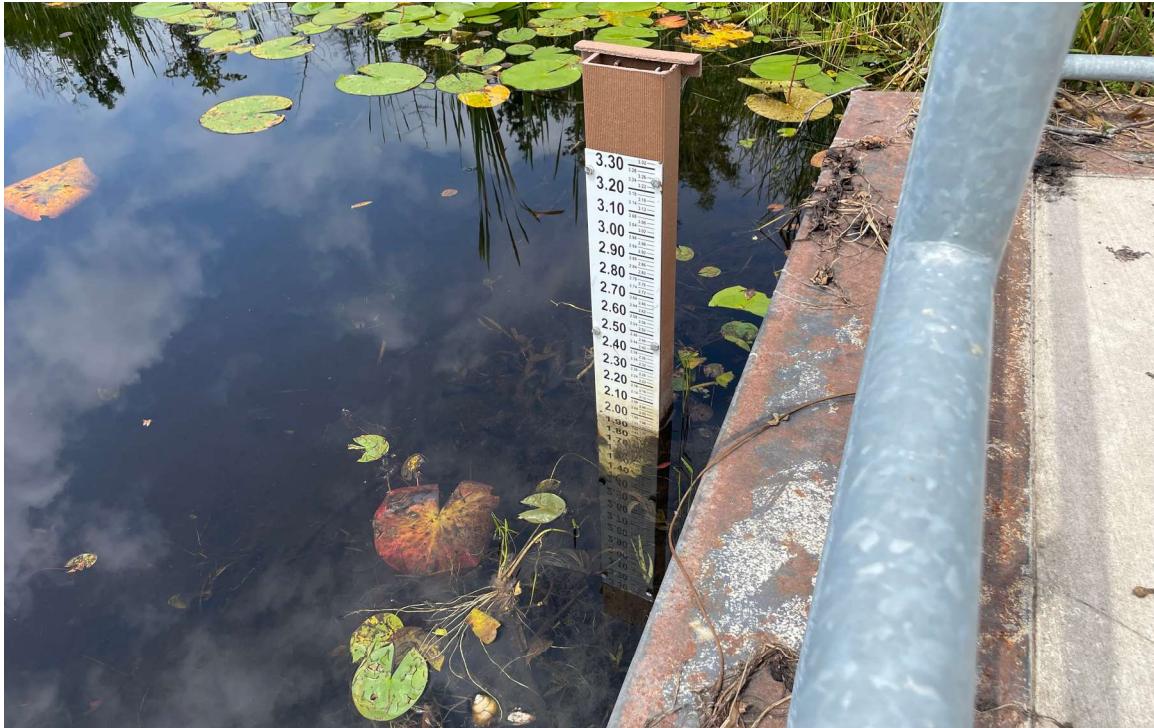
Staff gauge at time of inspection

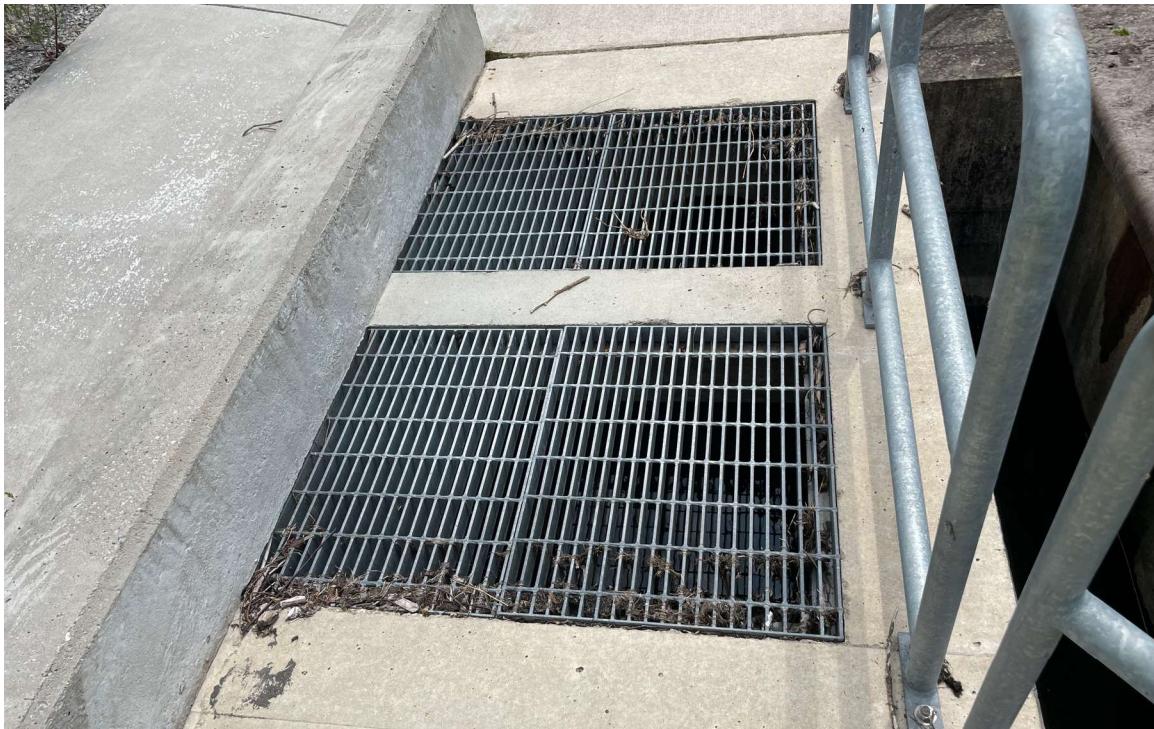
Overflow grates on top of structure

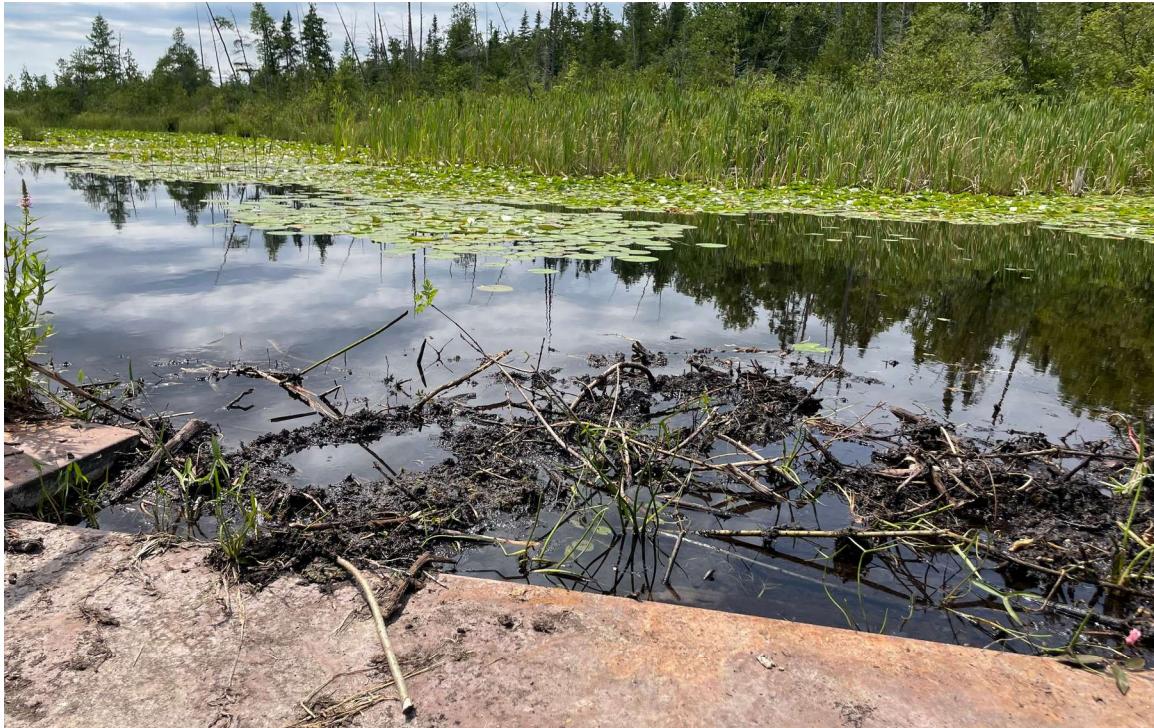
Some debris upstream of the fixed crest wier, not obstructing flow

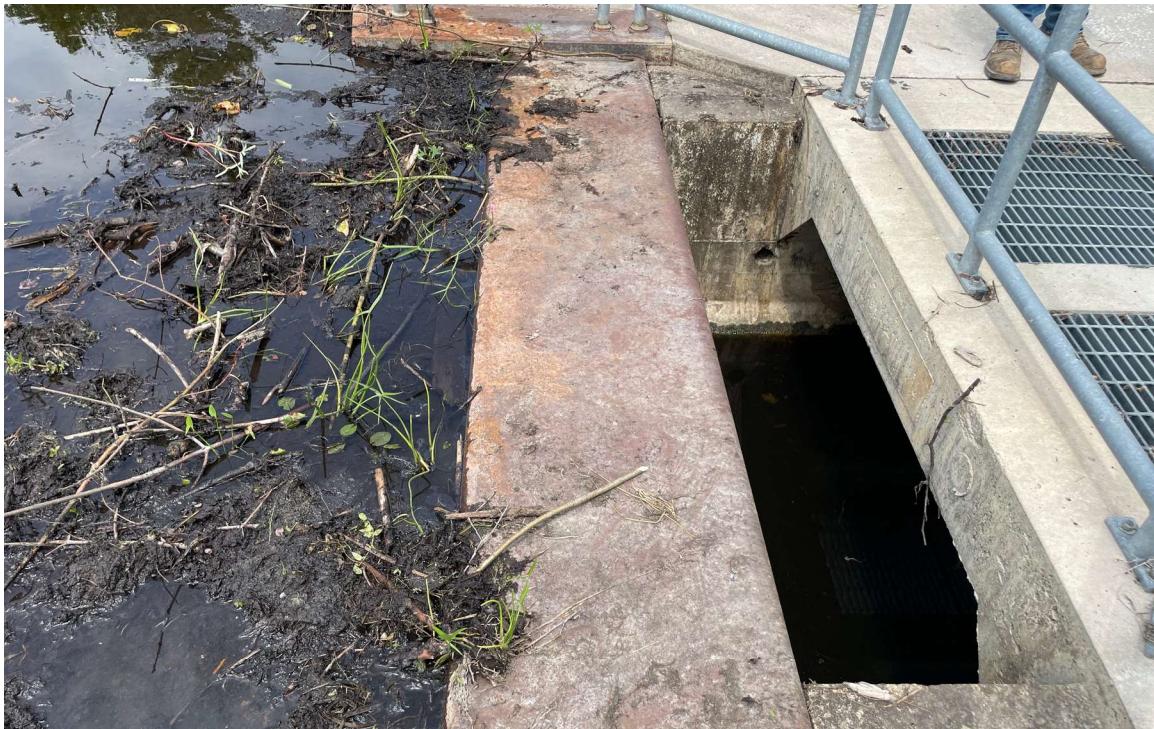
SSP fixed crest wier

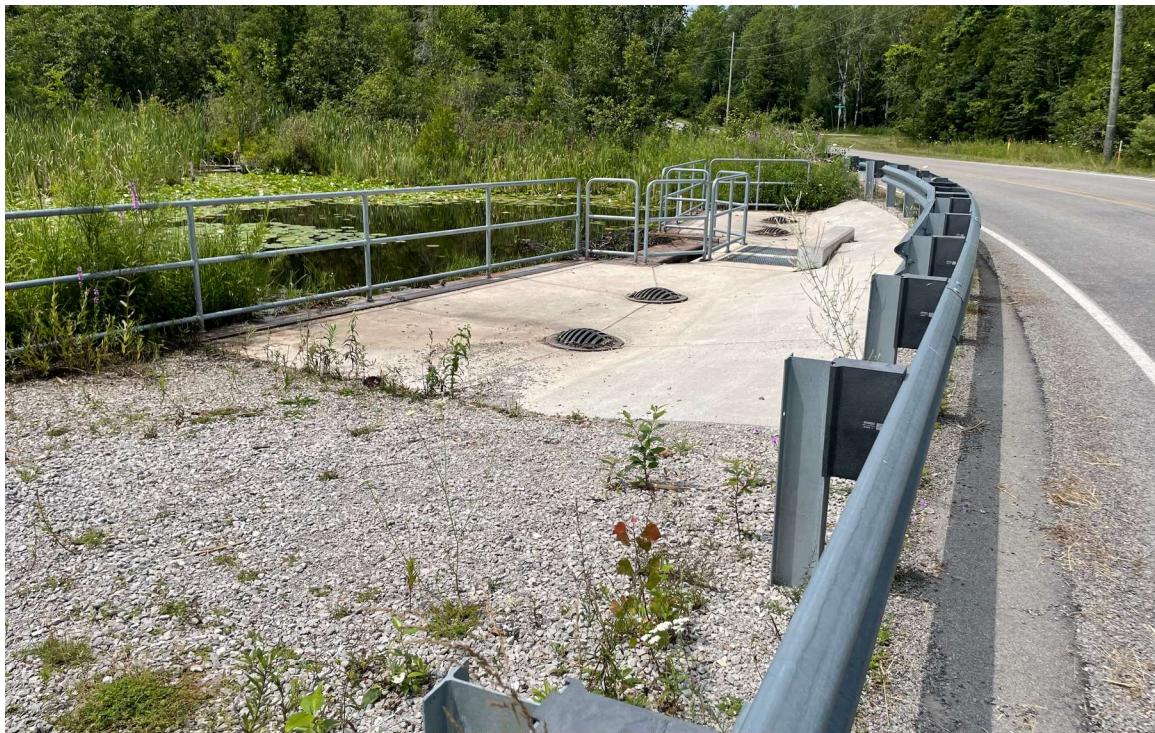
New lake level control structure, constructed in 2020

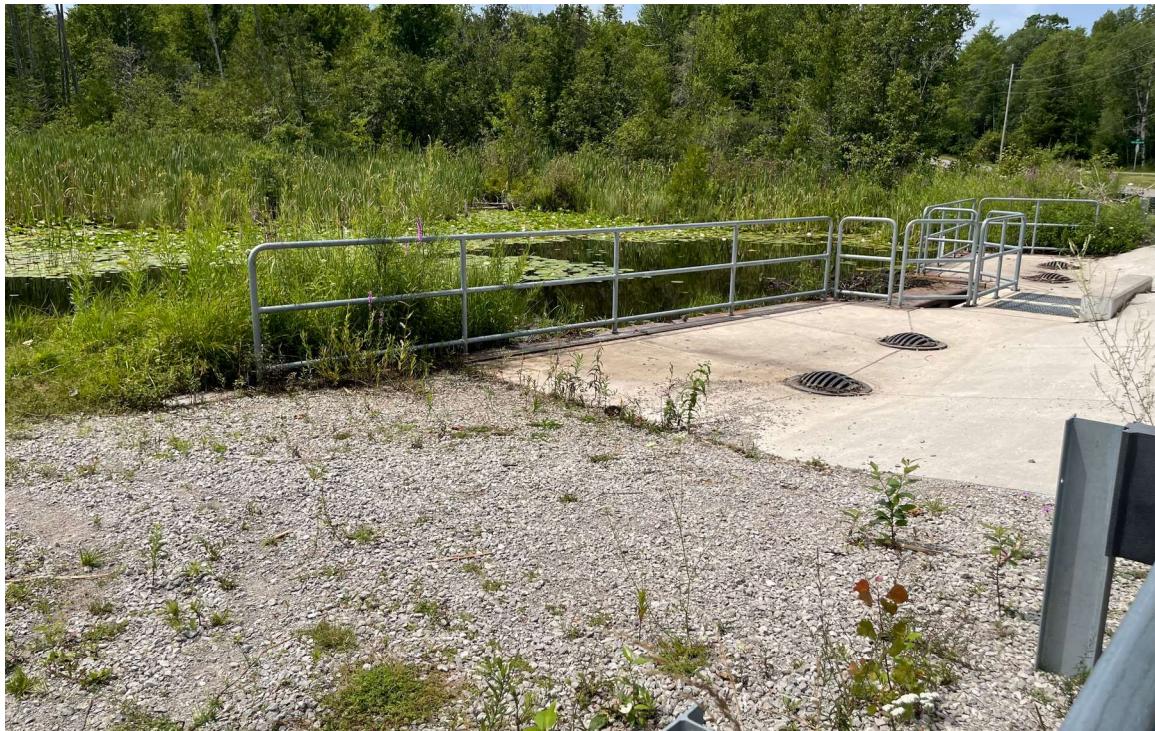
Gravel parking area on right side of dam, new handrail on upstream side of structure

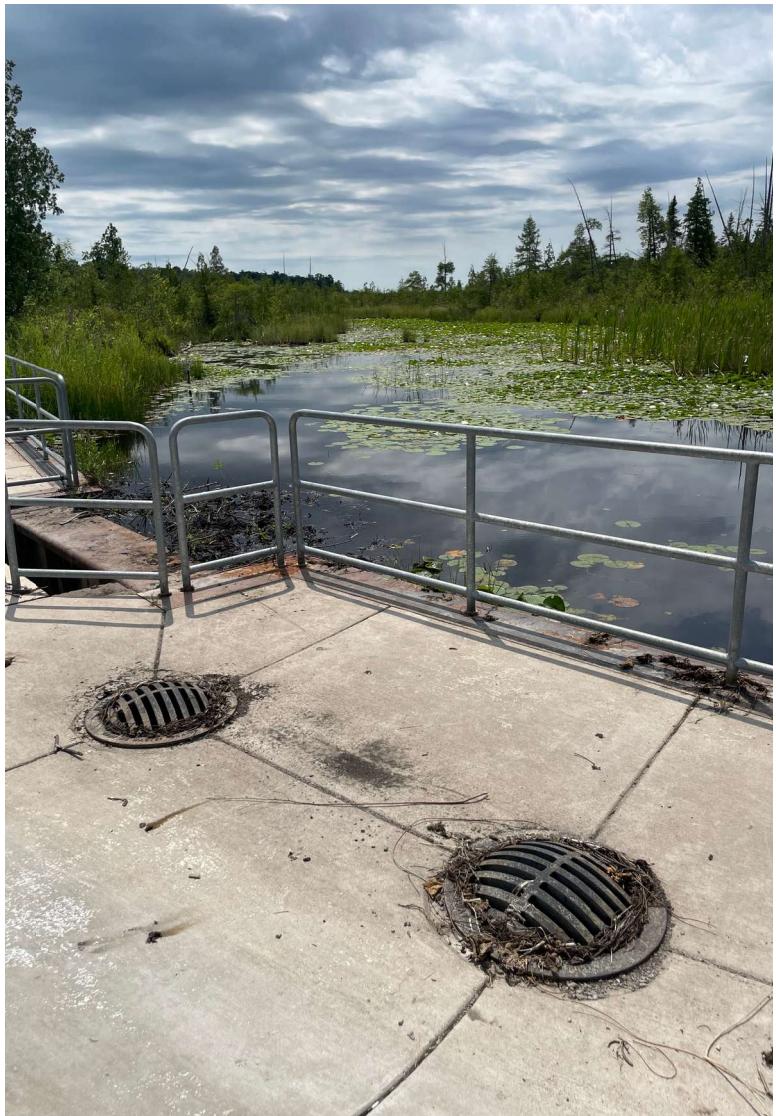
Overflow catchbasin on left side of structure

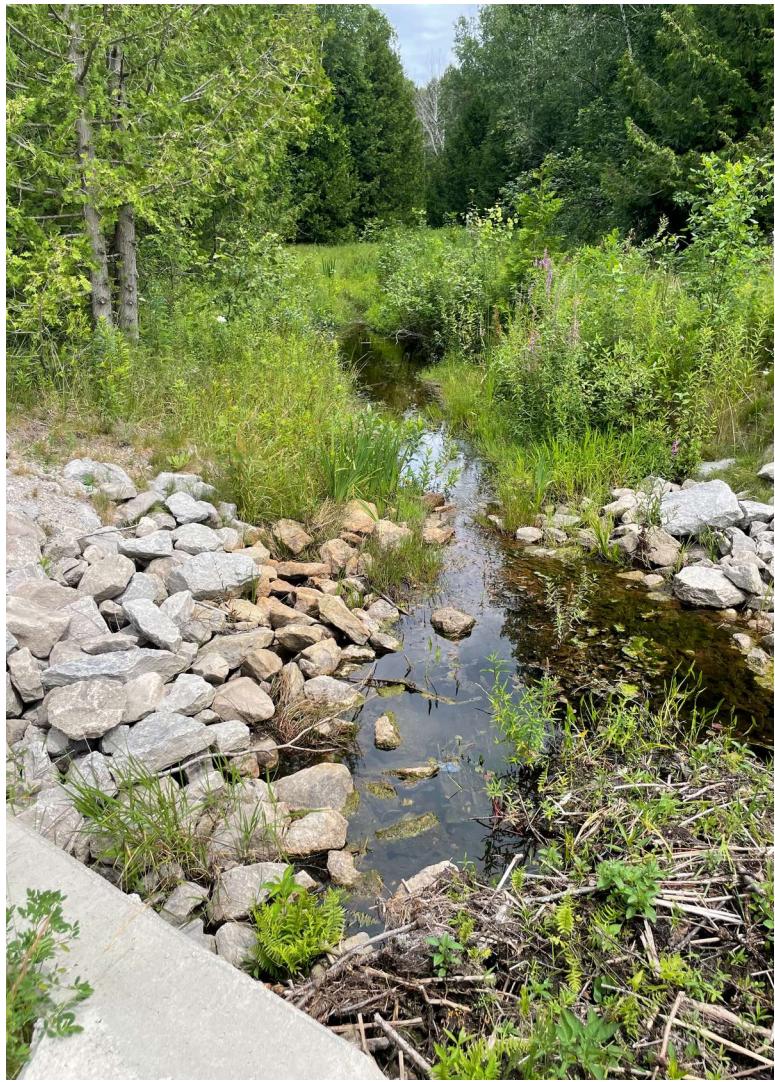
Downstream channel - some brush and mud in flow channel

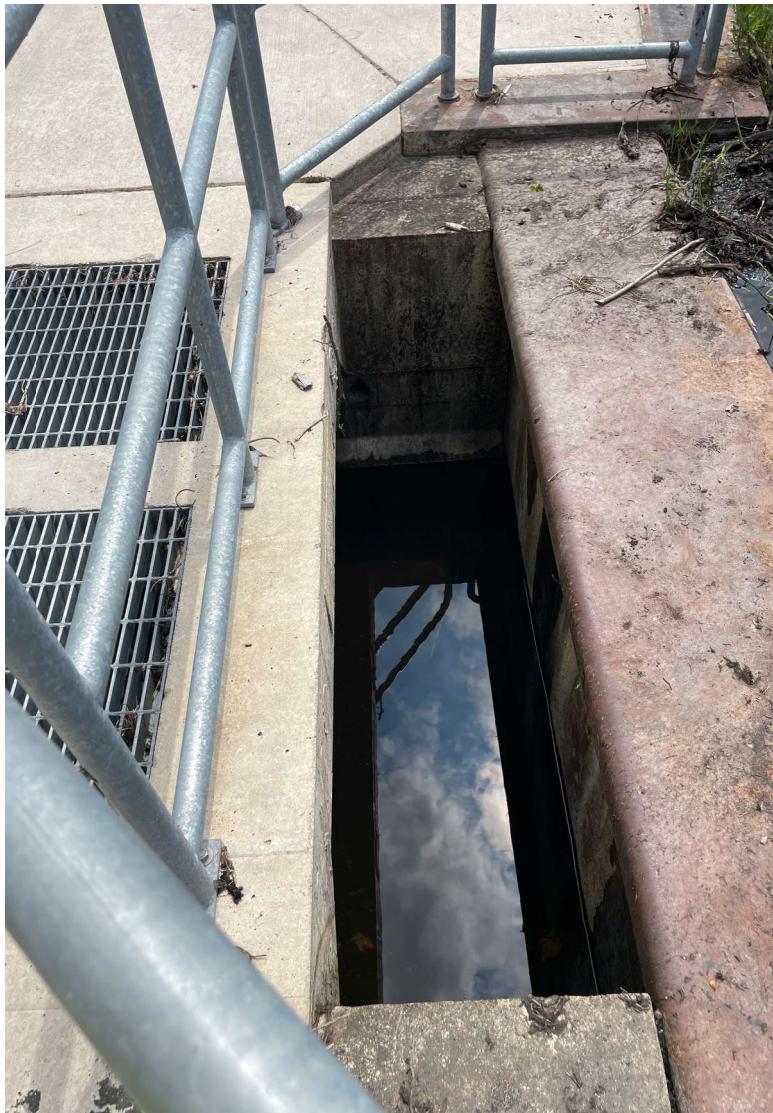
Primary fixed crest wier

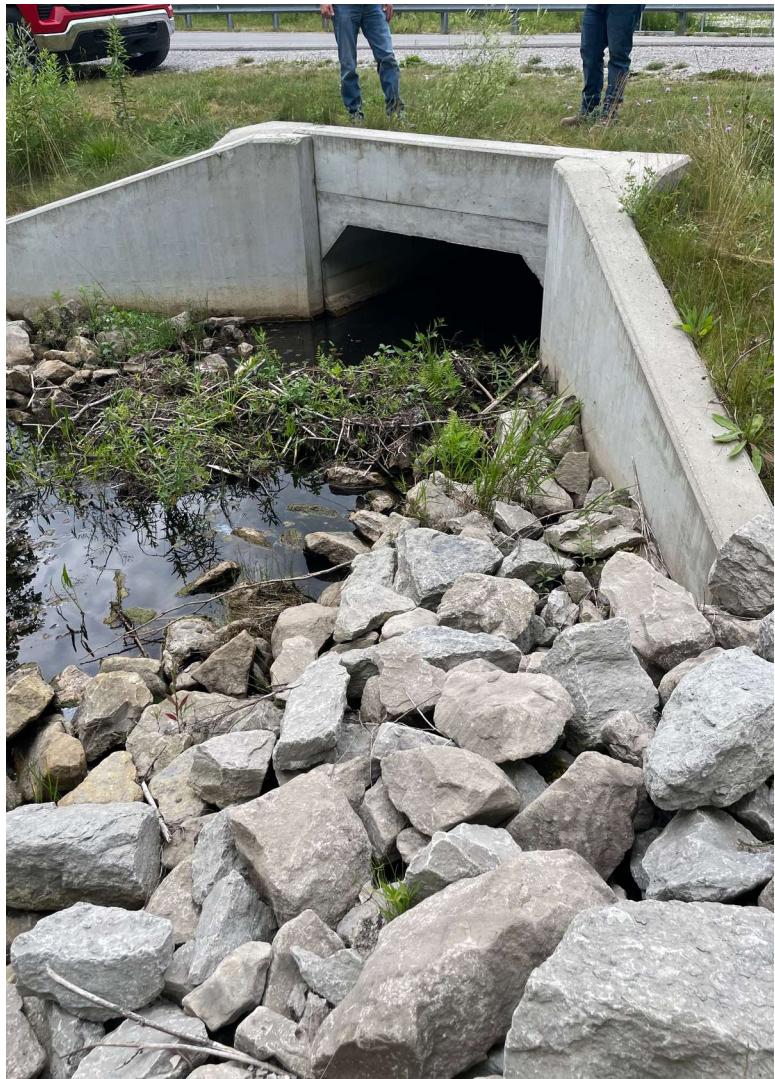
Downstream wing wall, some vegetation on right side wing wall

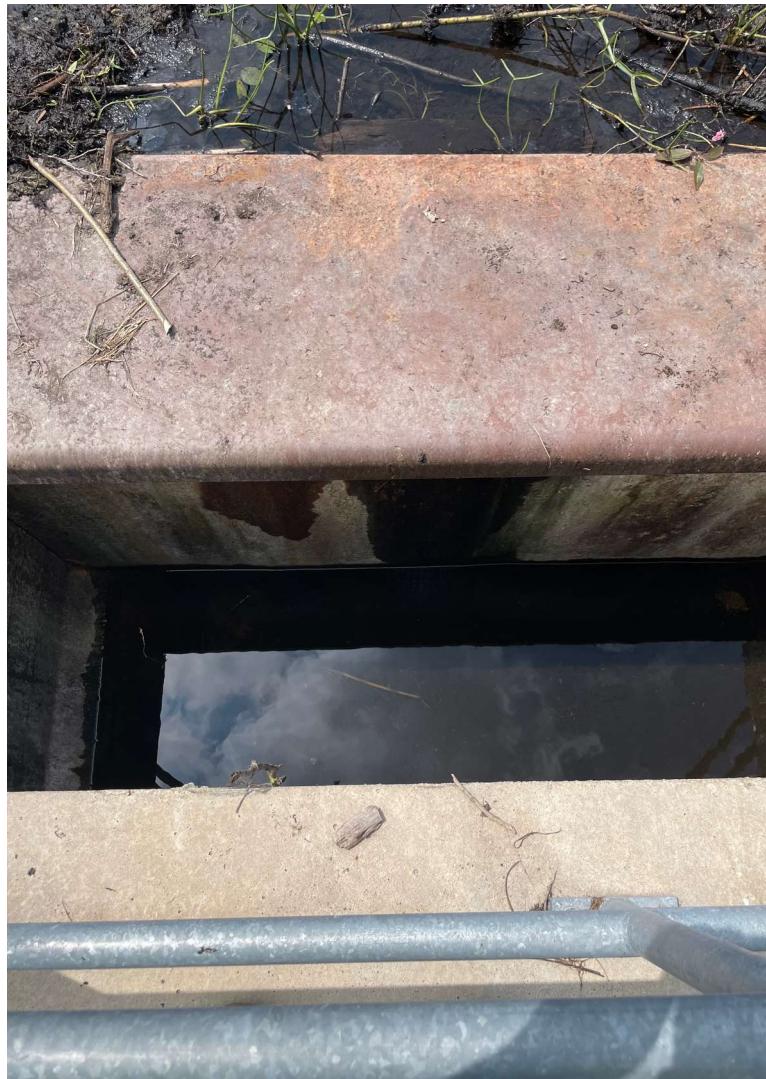
Some seepage observed on downstream side of SSP cap,  
minor
