HELPMYTHMYPOLICY.com

August 10, 2025 • 18 Photos

4709 Brenda Street NE, Albuquerque, NM 87109

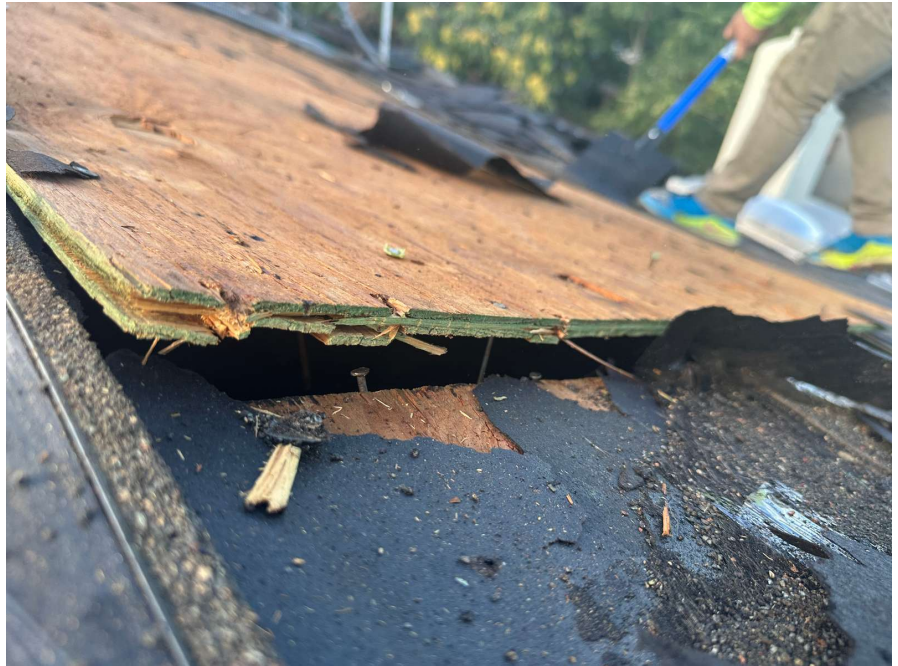
Photo 1: Roof

"Decking exposed during roof opening revealed immediately undersized OSB—visibly thinner than code-compliant minimums. This material fails to meet structural standards and triggers coverage under Section I – Dwelling Protection, which includes 'materials and supplies...used to construct, alter, or repair the dwelling.' The discovery supports full replacement due to systemic defect and compromised load-bearing capacity."

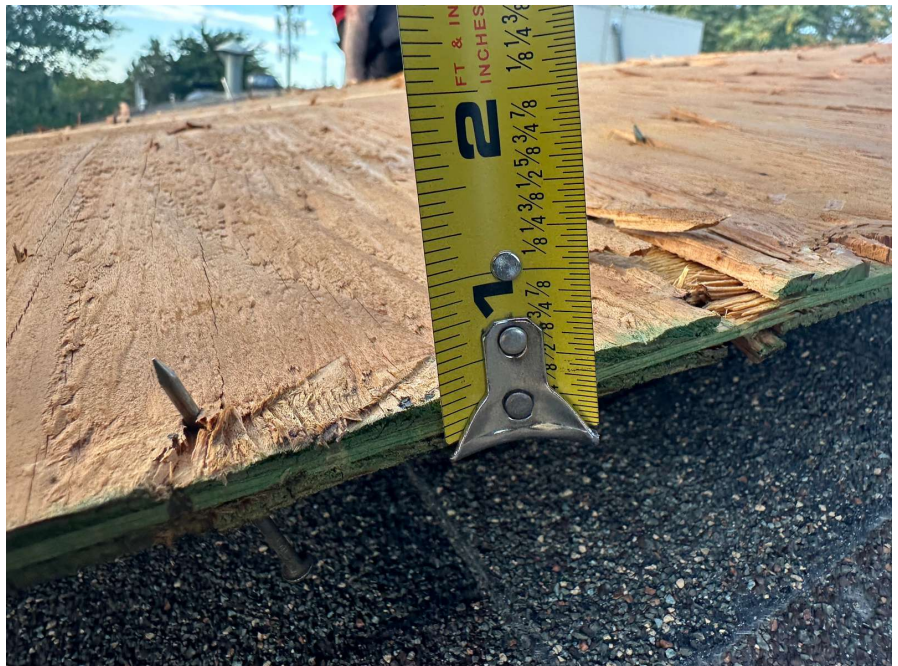
Photo 2: Roof

"OSB board shown with tape measure—barely meets the 3/8" threshold, if at all. Material quality is visibly substandard, raising concerns about structural integrity and compliance. Under Section I – Property We Cover, Coverage A includes 'materials and supplies...used to construct, alter, or repair the dwelling,' which must meet minimum standards to prevent latent defect exclusions."

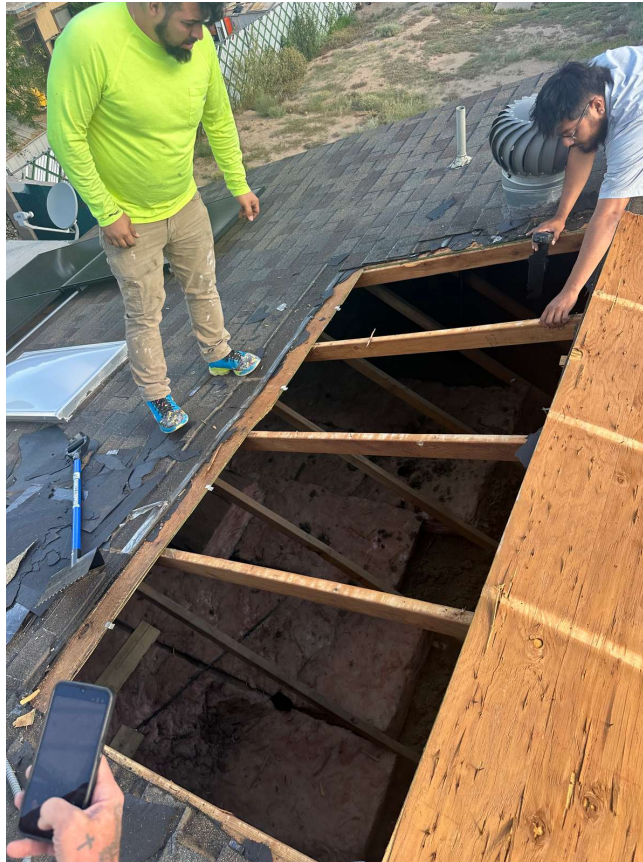
Photo 3: Roof

"Roof opening performed by the roofer to expose interior slope conditions—insulation visibly darkened and compromised from moisture intrusion. This inspection was necessary to document covered damage and aligns with Section I, Condition 2.g.(1), which requires the insured to 'show the damaged property.' The degraded insulation no longer meets thermal performance standards and must be replaced under Coverage A – Dwelling Protection."

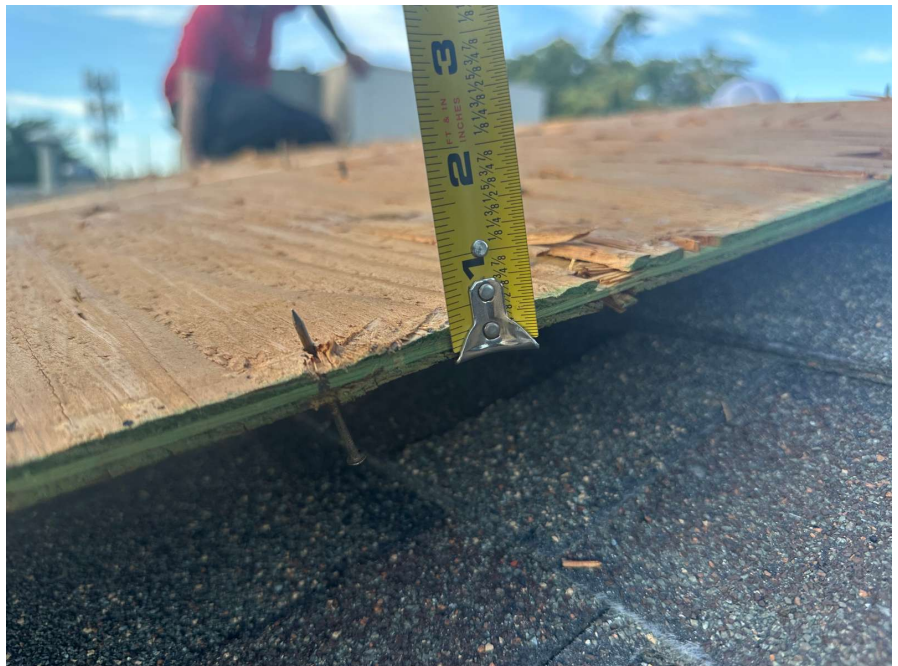
Photo 4: Roof

"The entire roofing system is constructed with substandard 3/8" OSB decking, which fails to meet current code and manufacturer specifications for wind-rated assemblies. This systemic deficiency compromises structural integrity and constitutes a covered peril under collapse provisions and code upgrade endorsements. Full replacement is required to restore the roofing system to compliant condition, as partial repairs would leave latent hazards and violate minimum safety standards."

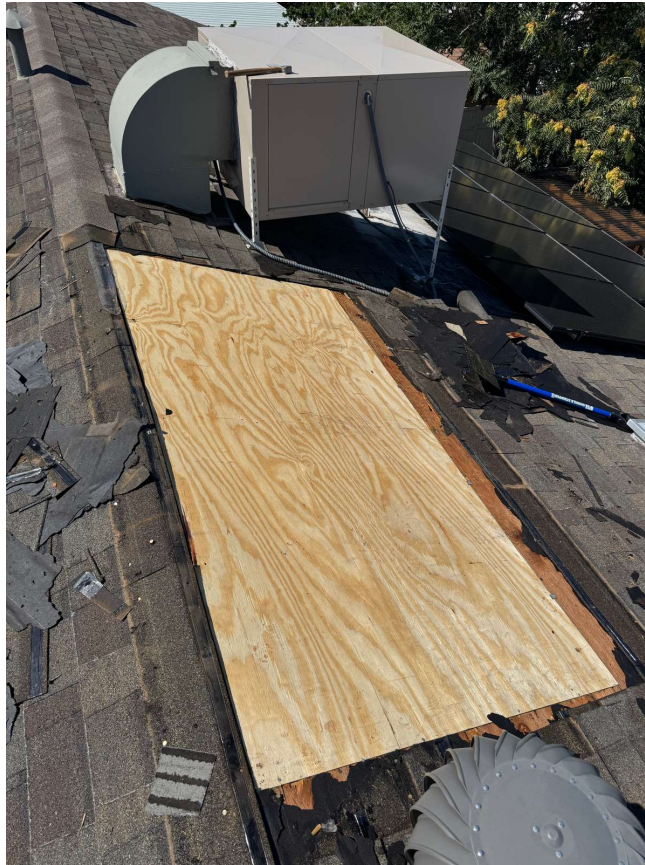
Photo 5: Roof

"New 5/8" OSB installed as part of reasonable repairs after the original 3/8" OSB was found to be noncompliant and structurally deficient. This upgrade was necessary to prevent further damage and fulfill the insured's obligation under Section I, Condition 2.d.(1) to 'protect the property from further damage.'"

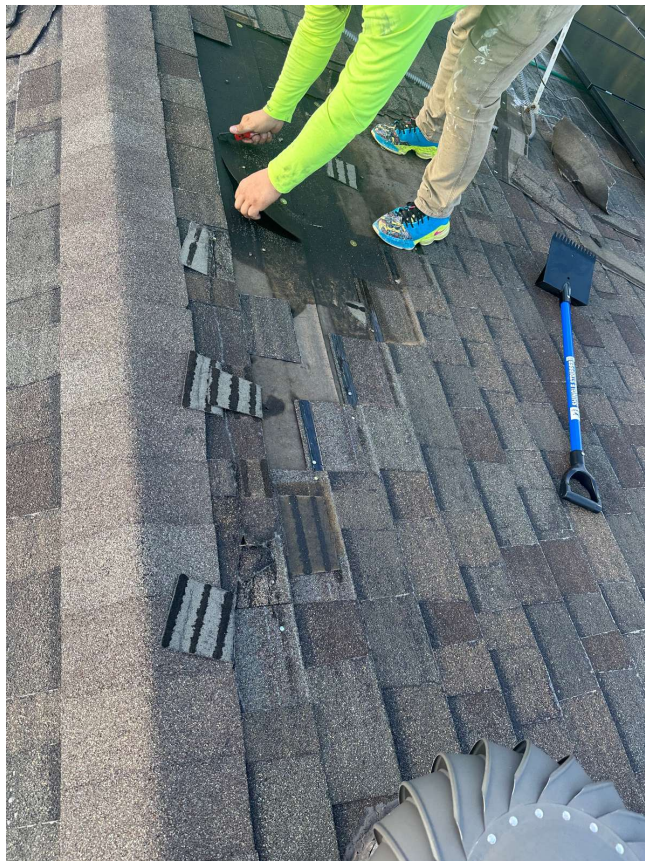
Photo 6: Roof

"Roofer performed targeted blading of a rectangular area to locate decking seams—softness between trusses made identification straightforward. The exposed OSB revealed advanced deterioration and undersizing, consistent with systemic deck failure. This condition supports full replacement under Dwelling Protection and may trigger code upgrade provisions due to noncompliant fastening and structural insufficiency."

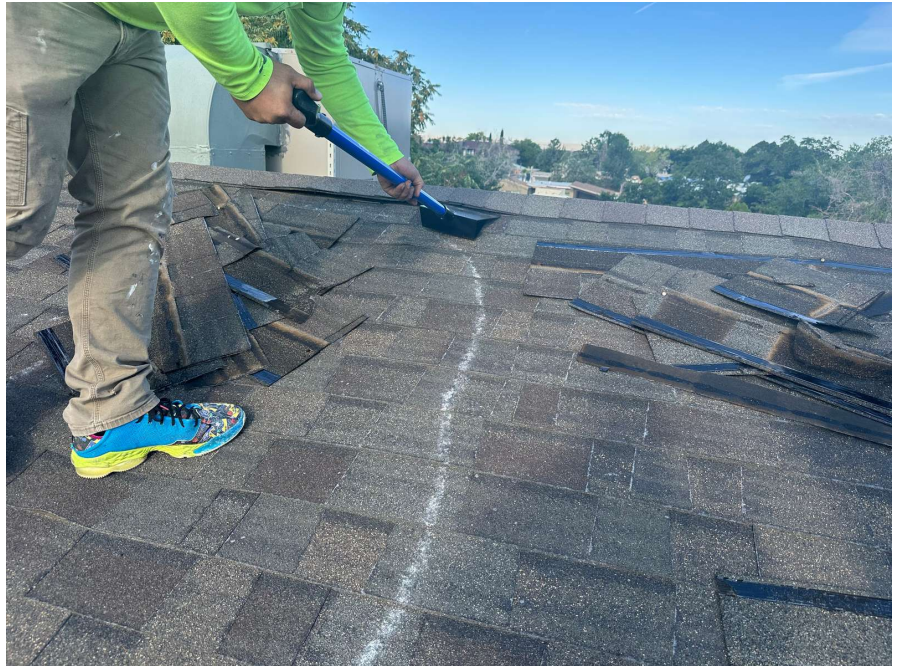
Photo 7: Roof

"Roof asset prior to opening. Carrier was invited to attend at 8:00 AM; opening began at 9:30 AM. No carrier adjuster appeared. Public Adjuster was present and documented the inspection. Carrier had already issued payment for wind-related damages prior to this opening—confirming coverage but declining to participate in further investigation. Their absence undermines collaborative scope validation and violates reasonable inspection duties under Section I, Condition 2.e."

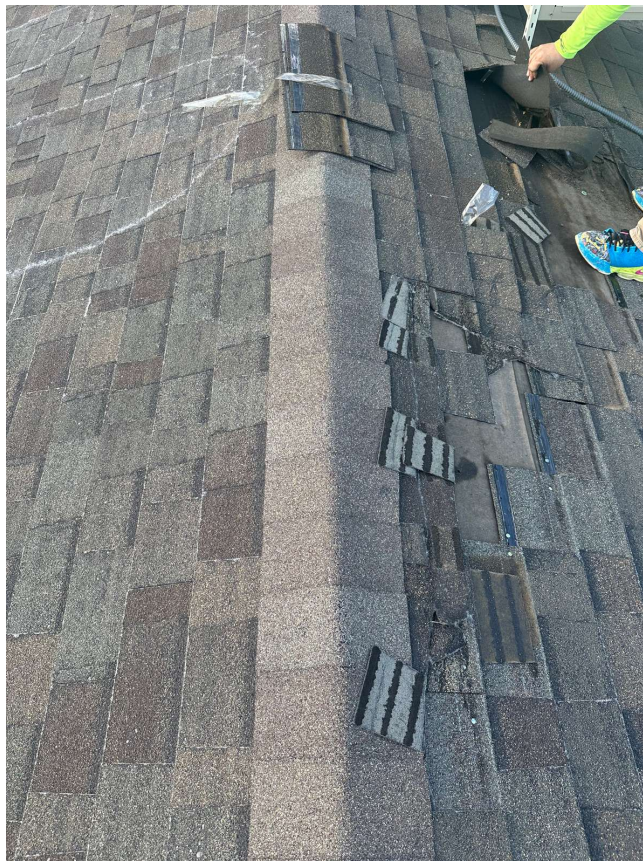
Photo 8: Roof

"Roofer performed targeted blading of a rectangular area to locate decking seams—softness between trusses made identification straightforward. The exposed OSB revealed advanced deterioration and undersizing, consistent with systemic deck failure. This condition supports full replacement under Dwelling Protection and may trigger code upgrade provisions due to noncompliant fastening and structural insufficiency."

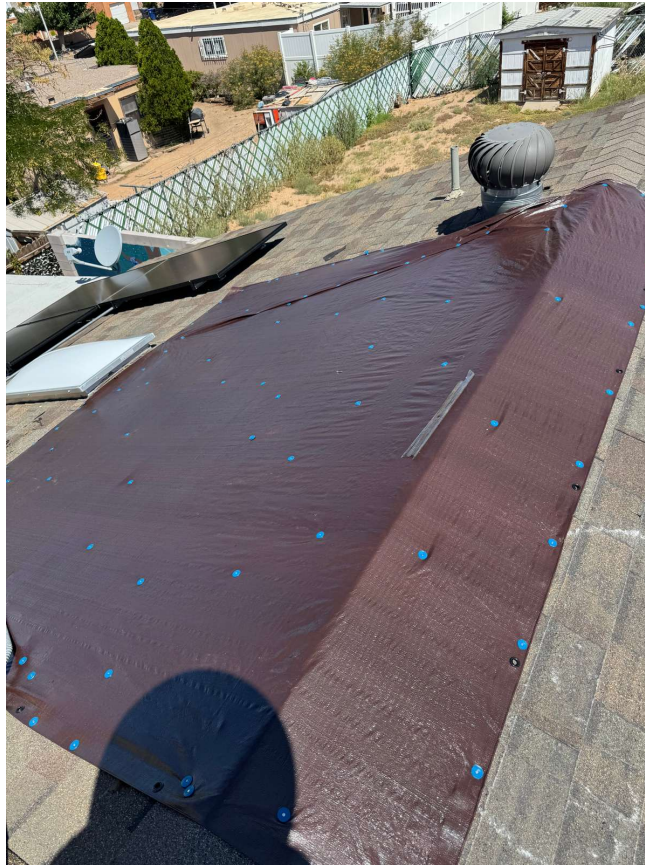
Photo 9: Roof

"Tarped area over newly installed 5/8" OSB—opened for carrier investigation per procedural cooperation. Despite multiple requests, carrier refused to inspect or schedule an appointment, violating Section I, Condition 2.e., which requires the insured to 'cooperate' and the carrier to reciprocate in good faith."

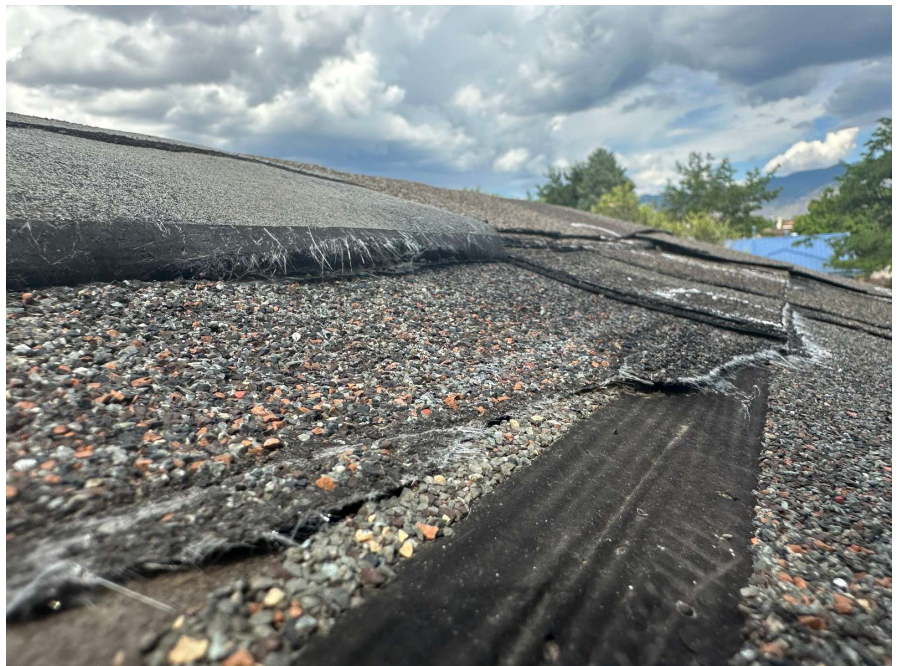
Photo 10: Roof

"South-facing slope shows partial shingle displacement—section torn and lifting, leaving the fastener exposed and the water barrier breached. This is a textbook example of wind damage under Section I – Windstorm peril, with compromised adhesion and incomplete coverage. The condition supports slope-wide replacement under Dwelling Protection due to structural failure and loss of weatherproofing."

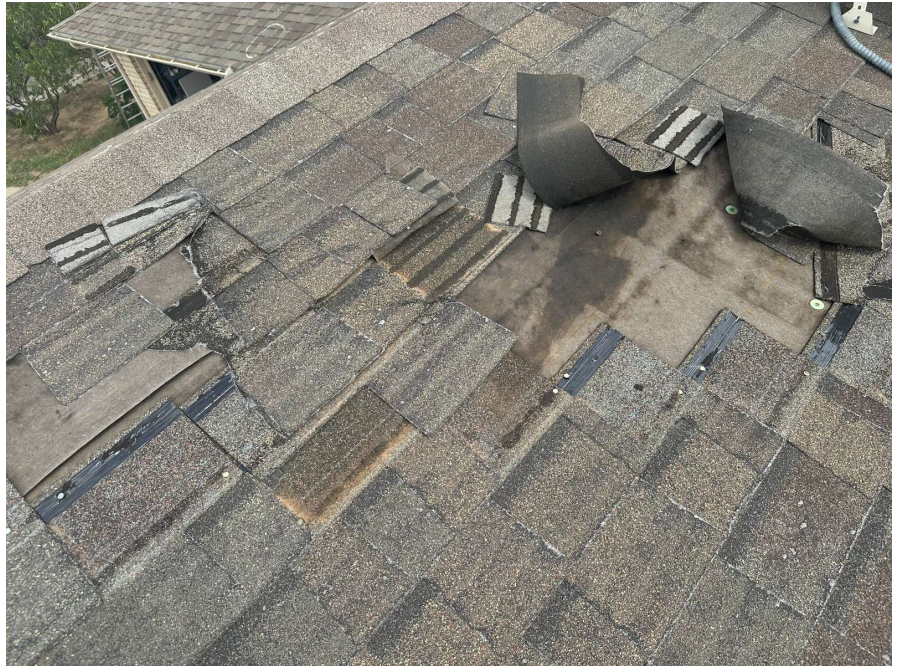
Photo 11: Roof

"Roof shown prior to tear-out—wind and hail have visibly compromised the surface with lifted shingles, fractured sealant lines, and impact bruising. These conditions fall squarely under Section I – Windstorm and Hail perils, triggering coverage for full-slope replacement. The damage precedes any repair activity and confirms the need for structural remediation under Dwelling Protection."

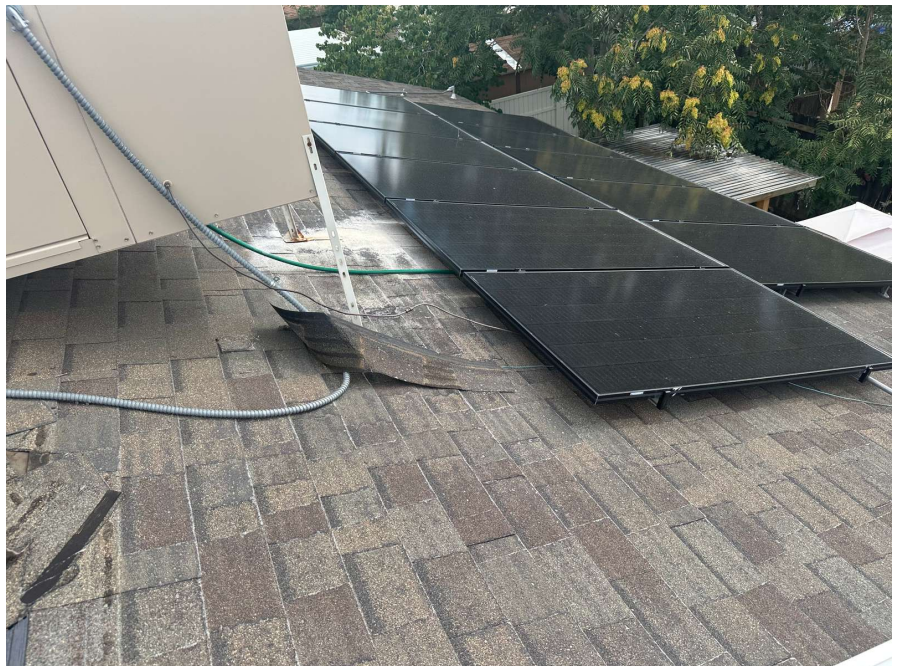
Photo 12: Roof

"Wind-blown shingle near the air conditioner and solar panel confirms active displacement and slope failure—both units must be removed to replace decking, underlayment, and roofing materials. Permits will be required for reinstallation, and framing beneath must be evaluated due to visible water staining and compromised support. This triggers coverage under Dwelling Protection and Additional Coverages, including Reasonable Repairs and Building Ordinance or Law, as structural integrity and code compliance must be restored."

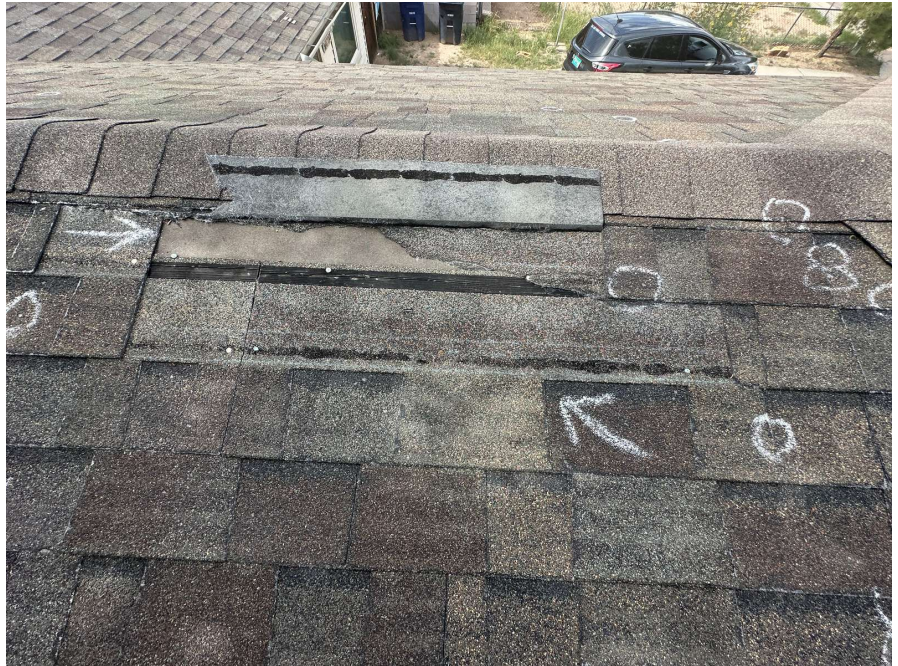
Photo 13: Roof

"Carrier-documented wind damage is visible on the south-facing slope, with photo #15 noting 'two wind-damaged shingles' on the left slope. Yet in photo #18, the same slope is mislabeled as the 'right slope with zero wind damage,' despite visible shingle displacement. This contradiction confirms covered loss under Windstorm peril and supports full-slope replacement due to procedural inconsistency and scope misidentification."

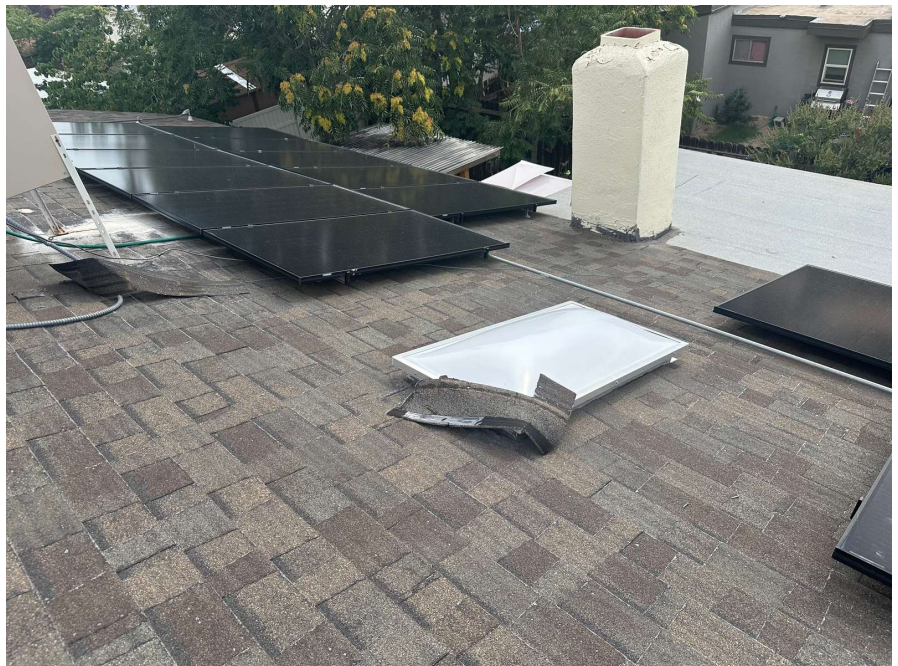
Photo 14: Roof

"Wind-blown shingle resting on the skylight confirms active displacement from the roof system—evidence of uplift and seal failure consistent with Windstorm peril. This debris poses a risk to the skylight and indicates compromised adhesion on the slope above. Coverage is triggered under Section I – Dwelling Protection, and full-slope replacement is warranted to restore structural and weatherproof integrity."

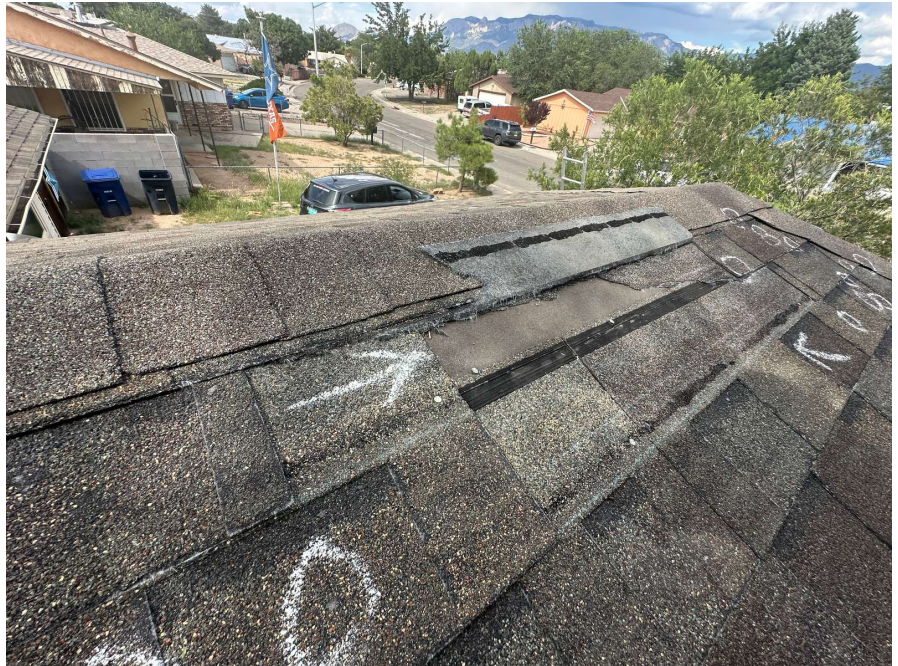
Photo 15: Roof

"Carrier photos taken 6/3/2025 by Lee Johnson show wind damage on the south-facing slope, with photo #15 clearly notating 'two wind-damaged shingles' on the left slope. Photo #18 captures the same area but is mislabeled as the 'right slope with zero wind damage,' creating a material contradiction in the carrier's own documentation. This inconsistency undermines scope accuracy and supports slope-specific replacement under Windstorm peril coverage and Dwelling Protection."

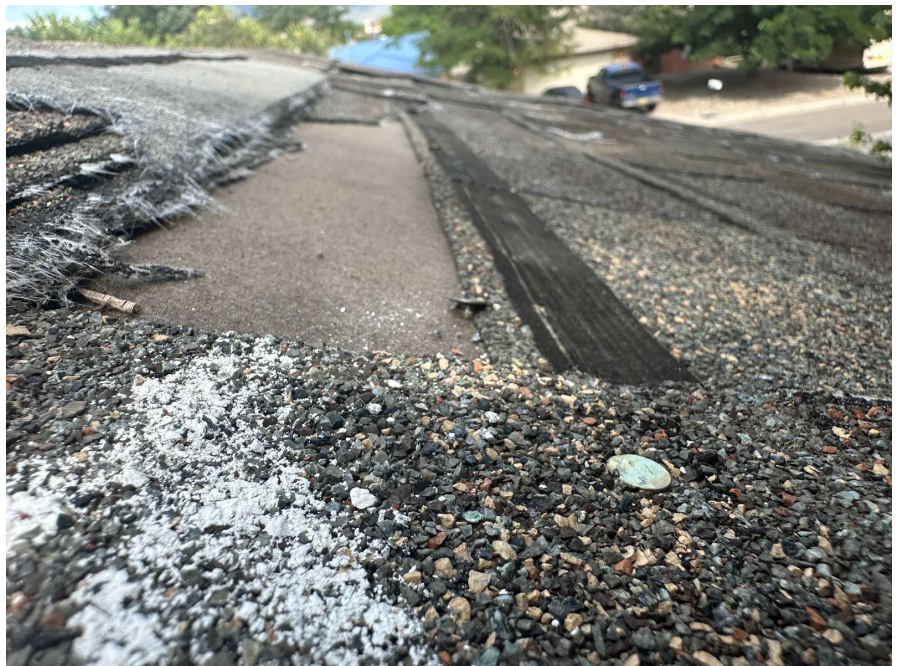
Photo 16: Roof

"Shingle on the south-facing slope shows clear uplift with the fastener visibly disengaged—indicative of wind-driven displacement and sealant failure. This type of damage breaches the roof's water barrier and qualifies as a covered peril under Windstorm, triggering replacement under Dwelling Protection. The slope has been previously documented by the carrier, and this image further substantiates structural compromise requiring full-scope remediation."

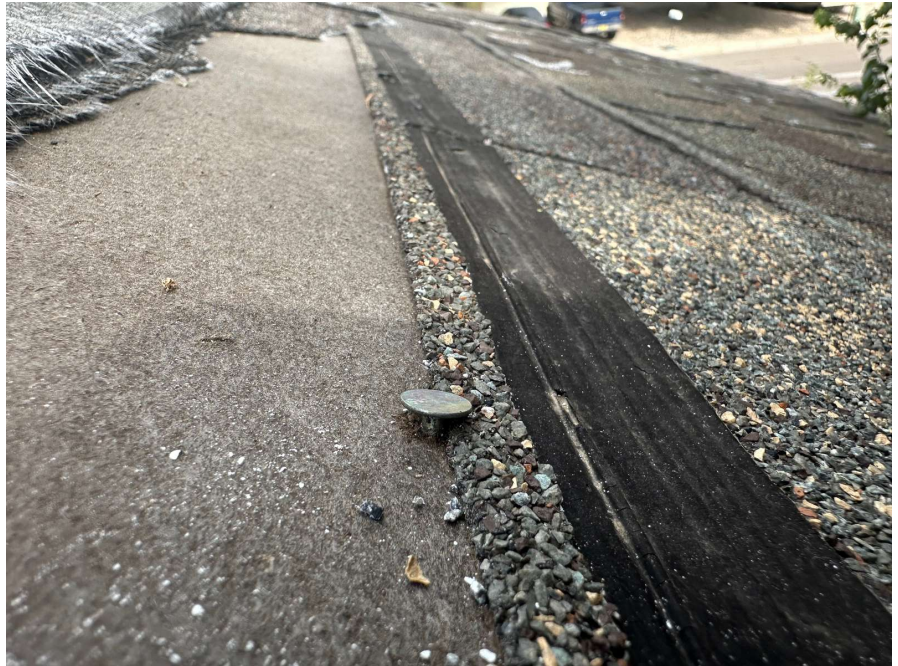
Photo 17: Roof

"Exposed nail on the south-facing slope reveals a direct path for water intrusion—sealant failure and uplift have compromised the shingle's protective function. This condition constitutes covered wind damage under Section I – Windstorm peril and triggers replacement under Dwelling Protection. The vulnerability to moisture intrusion demands full-slope remediation to restore water integrity and prevent further loss."

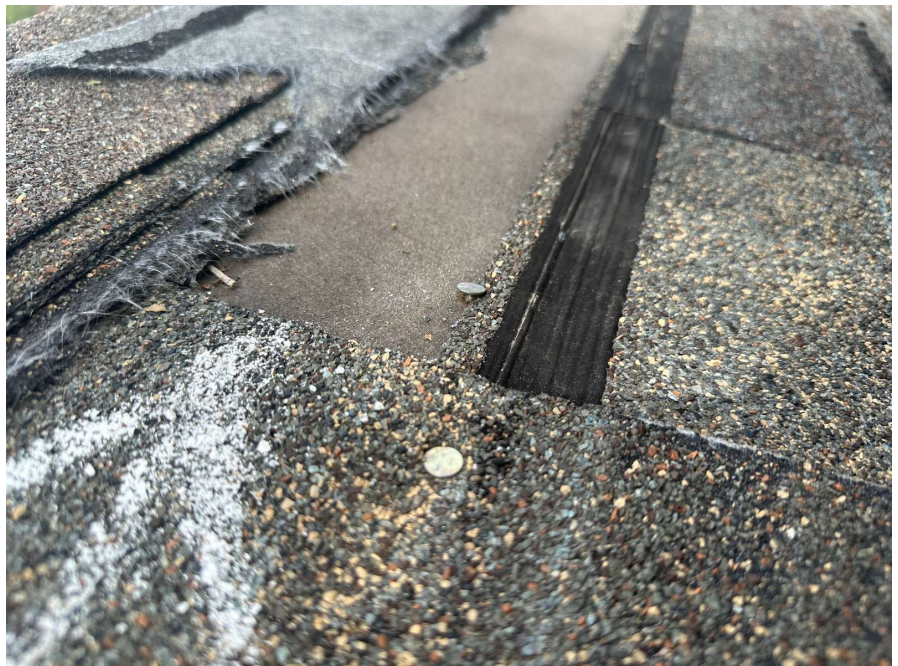
Photo 18: Roof

"Close-up of the south-facing slope shows a lifted shingle with the nail partially exposed—classic wind damage consistent with uplift and seal failure. This condition compromises water integrity and confirms covered loss under Windstorm peril, as defined in Section I – Losses We Cover. The slope has already been acknowledged in carrier documentation, and this image reinforces the need for full-slope replacement due to compromised fastening and material displacement."
