Photographic Documentation – Wind Damage Evidence

Property Address: 4709 Brenda St. NE, Albuquerque, NM 87109

Policyholders: Mr. Paul Williams & Mrs. Patricia Willems

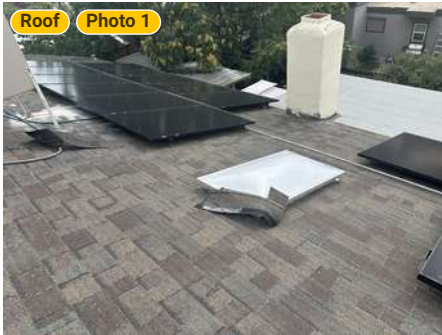
"Wind-blown shingle resting on the skylight confirms active displacement from the roof system—evidence of uplift and seal failu...

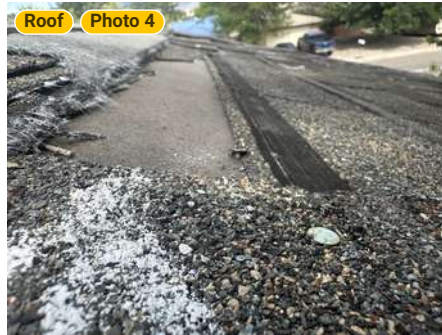
"Shingle on the south-facing slope shows clear uplift with the fastener visibly disengaged—indicative of wind-driven displaceme...

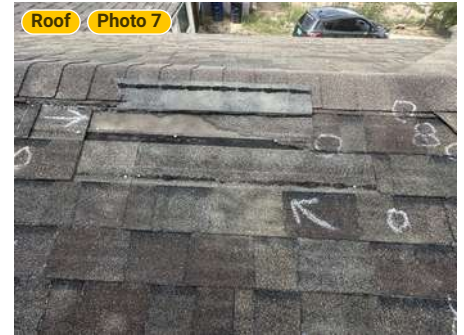
"Carrier-documented wind damage is visible on the south-facing slope, with photo #15 noting 'two wind-damaged shingles' on the ...

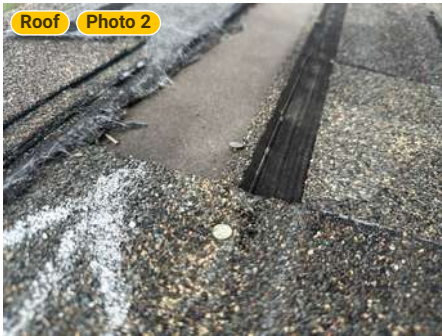
"Close-up of the south-facing slope shows a lifted shingle with the nail partially exposed—classic wind damage consistent with ...

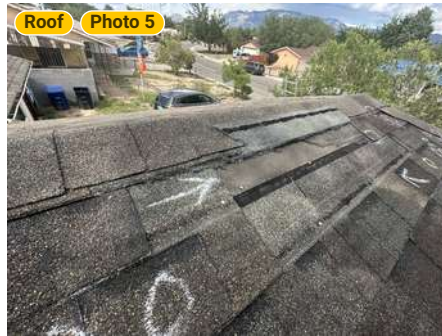
"Carrier photos taken 6/3/2025 by Lee Johnson show wind damage on the south-facing slope, with photo #15 clearly notating 'two ...

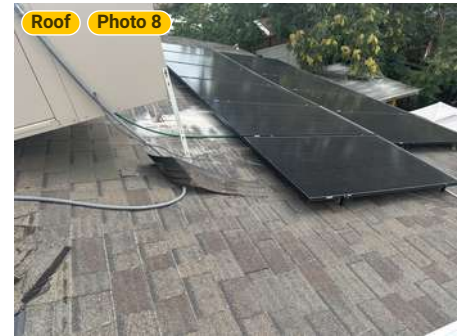
"Wind-blown shingle near the air conditioner and solar panel confirms active displacement and slope failure—both units must be ...

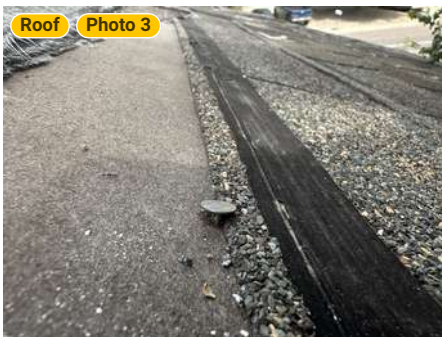
"Exposed nail on the south-facing slope reveals a direct path for water intrusion—sealant failure and uplift have compromised t...

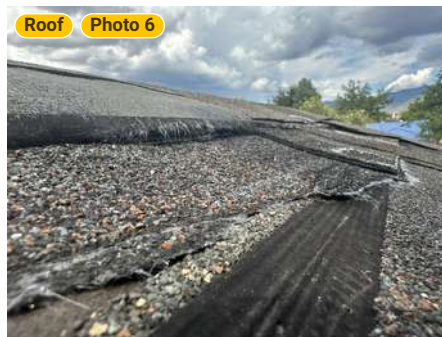
"South-facing slope shows partial shingle displacement—section torn and lifting, leaving the fastener exposed and the water bar...

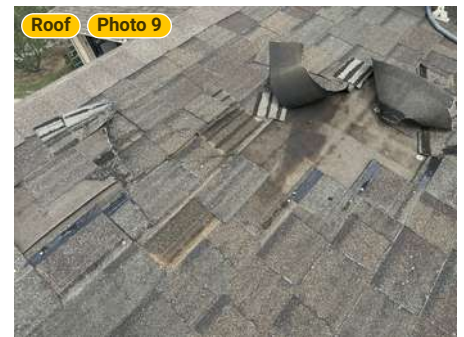
"Roof shown prior to tear-out—wind and hail have visibly compromised the surface with lifted shingles, fractured sealant lines,...

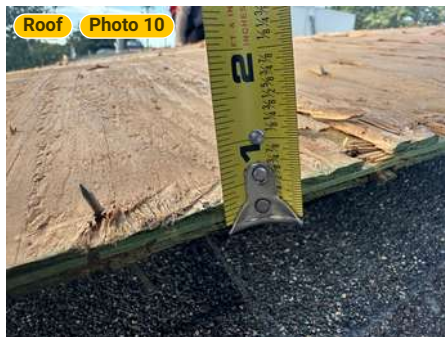
"OSB board shown with tape measure —barely meets the 3/8" threshold, if at all. Material quality is visibly substandard, raising...

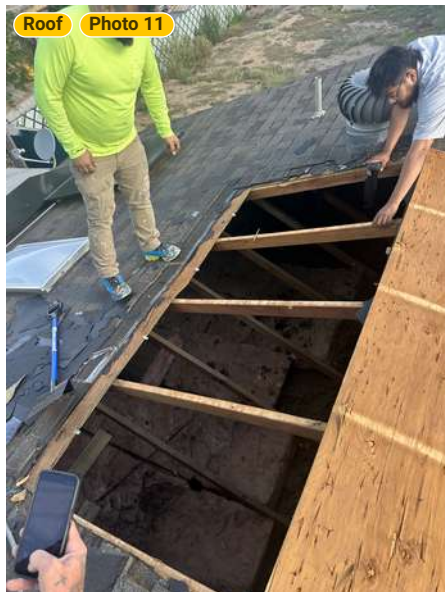
"Roof opening performed by the roofer to expose interior slope conditions—insulation visibly darkened and compromised from mois...

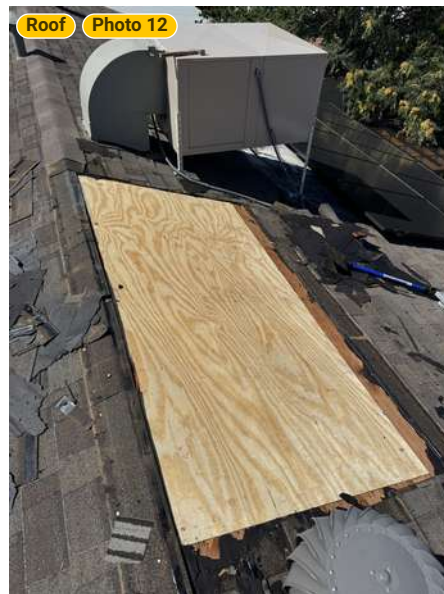
"New 5/8" OSB installed as part of reasonable repairs after the original 3/8" OSB was found to be noncompliant and structurally...

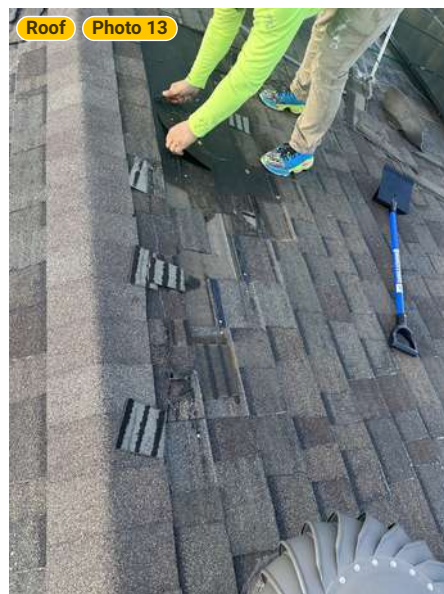
"Roofer performed targeted blading of a rectangular area to locate decking seams—softness between trusses made identification s...

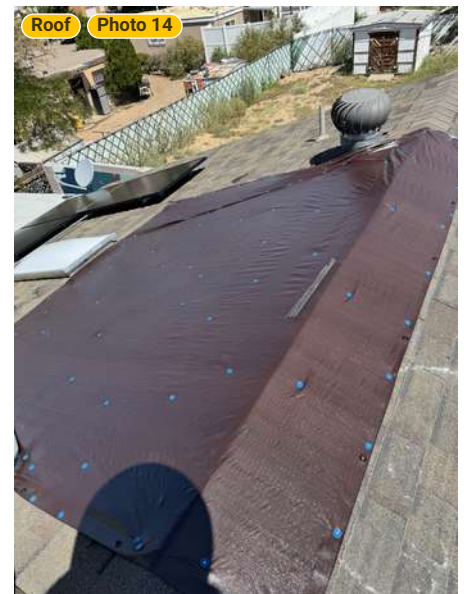
"Tarped area over newly installed 5/8" OSB—opened for carrier investigation per procedural cooperation. Despite multiple reqes...

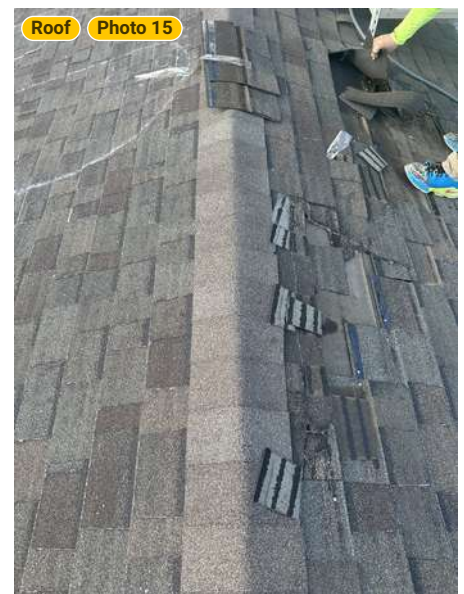
"Roofer performed targeted blading of a rectangular area to locate decking seams—softness between trusses made identification s...

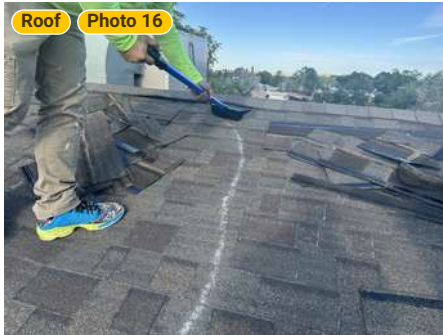
"Roof asset prior to opening. Carrier was invited to attend at 8:00 AM; opening began at 9:30 AM. No carrier adjuster appeared....

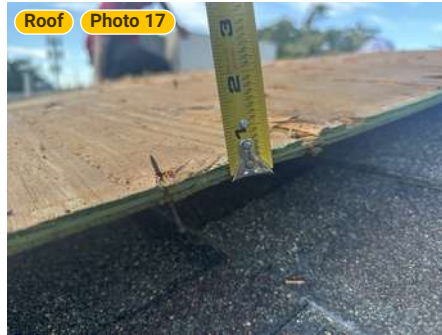
"The entire roofing system is constructed with substandard 3/8" OSB decking, which fails to meet current code and manufacturer ...

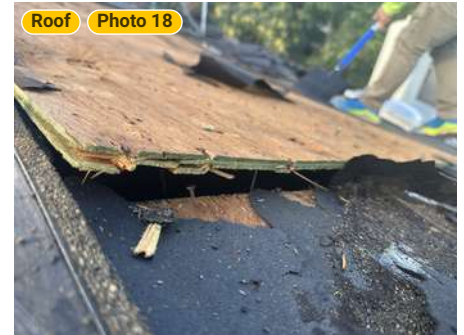
"Decking exposed during roof opening revealed immediately undersized OSB —visibly thinner than code-compliant minimums. This mat...
