Property Inspection Report

Prepared for: Bob Client
10/24/2019

123 Somewhere Street
Yourtown, US 12345

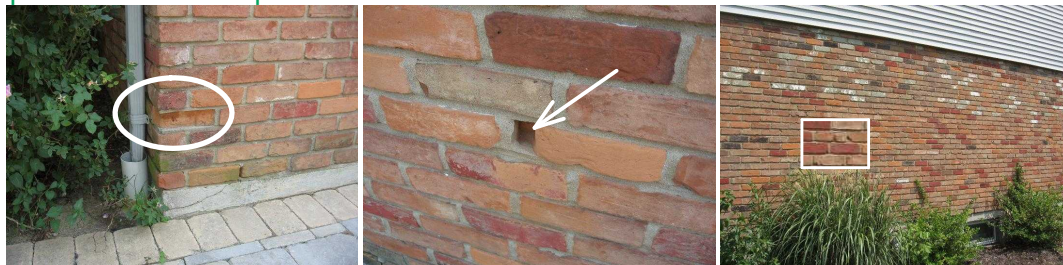
- 2. 1st Floor Exterior Surface Type:** Brick veneer - Some damaged bricks, Recommend sealing brick with penetration sealer products

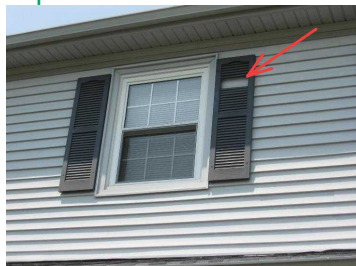
- 3. 2nd Floor Exterior Surface Type:** Vinyl siding - Damaged front shutter, Chalking noted due to age, One panel needs to be repositioned at rear elevation

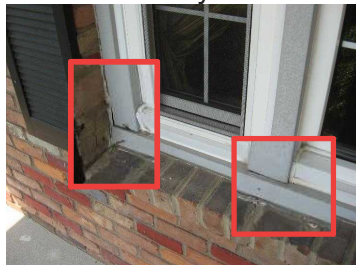
- 4. Trim:** Aluminum - Chalking noted due to age, Loose nails in areas
- 5. Soffits:** Vinyl - Loose/sagging at front porch
- 6. Patio Door:** Vinyl sliding - Resecure loose handle hardware, Screen damage noted
- 7. Windows:** Vinyl insulated - Reseal caulking at window perimeters at brick window openings

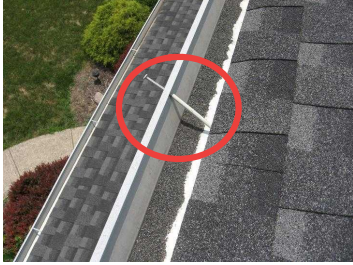
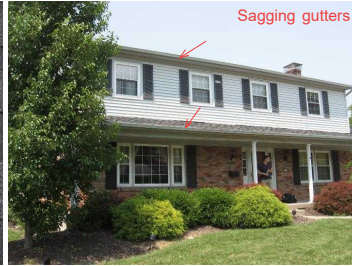
- 9. Gutters:** Aluminum - Loose nails, Sagging gutters at front and rear

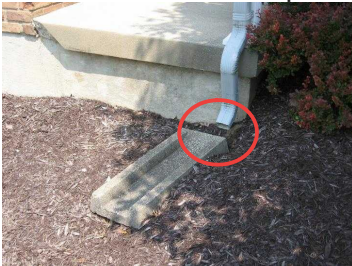
10. **Leader/Extension:** Splash blocks - **Splash block(s) not properly installed**

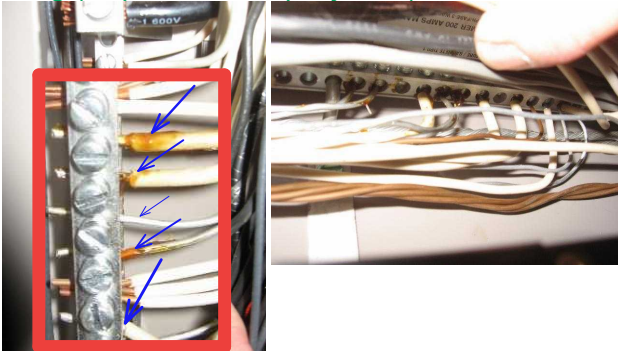
- 14. **120 VAC Branch Circuits:** Copper and aluminum - **Evaluation by a licensed electrician is recommended, See aluminum wiring notes below**
- 15. **Aluminum Wiring:** Present at several circuits - **Aluminum branch wiring has had a history of problems relating to poor connections due to galvanic corrosion, dissimilar metals, brittle conductors and type of aluminum alloy used during the time period of 1965 through 1972. These problems create unsatisfactory conditions at connections and splice locations and therefore create potential fire hazards. Recommend wiring update for aluminum wiring by a licensed electrician, Circuits are recommended to be upgraded with special compression type connectors at splices and branch circuits to reduce the potential risks of aluminum branch wiring.(Cop-Alum Crimp System)**

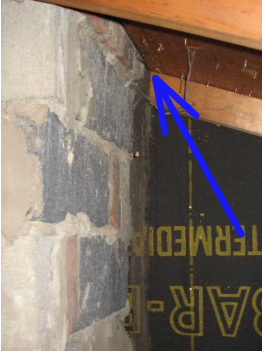
16. **Attached Garage Attic Roof Framing:** 2x3/4 Truss - Wood blocking components missing at chimney perimeter

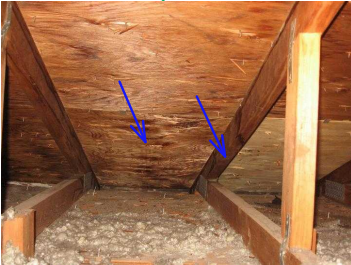
17. **Attached Garage Attic Sheathing:** Plywood - Water stains and slight damage present, Areas of sheathing have been repaired

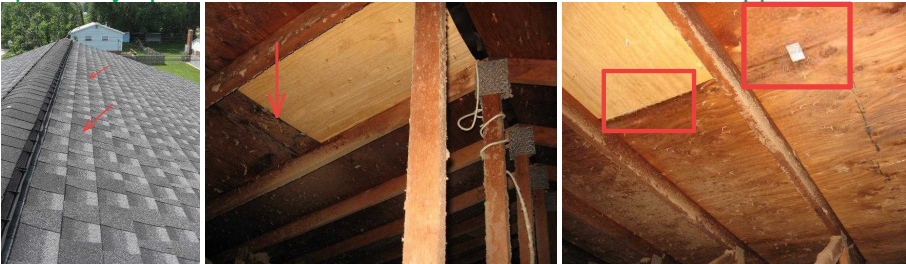
18. **Main Attic Sheathing:** Plywood - Poor repair at 2 areas near ridge at rear slope - No H clips installed and repair only spanned one truss - Recommend additional support be installed

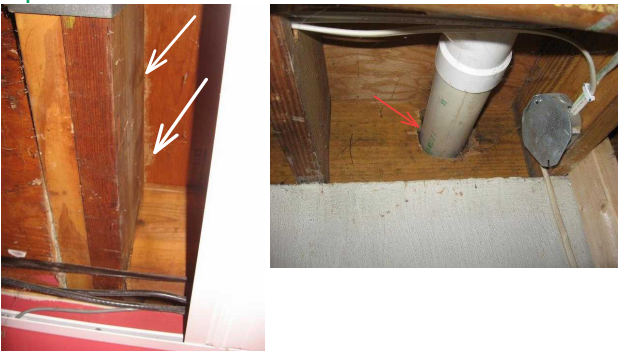
19. **Joists/Trusses:** 2x10 - Areas not visible due to ceiling finishes or other obstructions, Framing joist near fireplace chimney shows evidence of previous termite infestation - No repairs required, Seal penetration as required

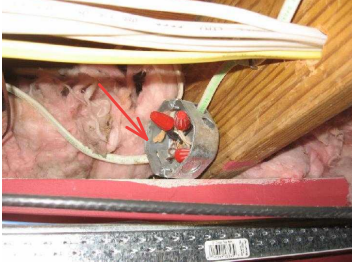
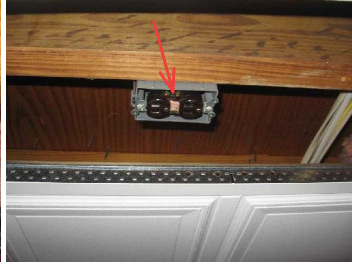
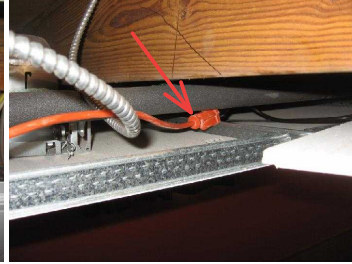
- 20. Main Basement Floor: Carpet - Carpet stains noted
- 21. Main Basement Electrical: 110 VAC - Loose junction boxes, missing and mis-sized covers, extension cord wiring to projector

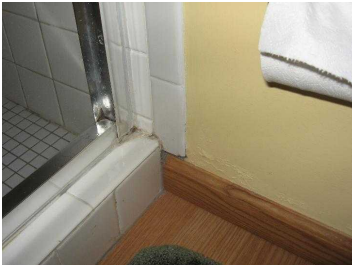
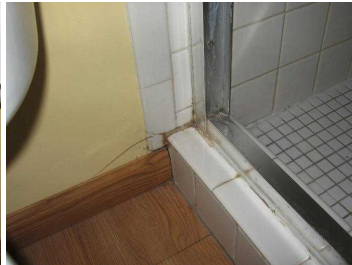
- 22. Master Bathroom Floor: Laminated flooring - Gapping noted in planks
- 23. Master Bathroom Shower/Surround: Ceramic tile - Leaking at corner of door frame

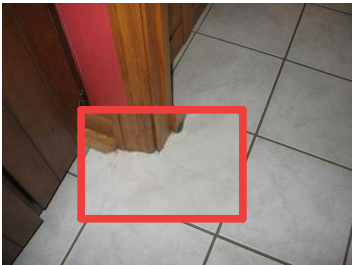
- 24. 2nd Floor Hall Bathroom Closet: Large - Alignment needed at closet doors
- 25. 2nd Floor Hall Bathroom Floor: Laminated flooring - Gapping noted in planks
- 26. 1st Floor Hall Half Bathroom Floor: Ceramic tile - Cracked tile noted

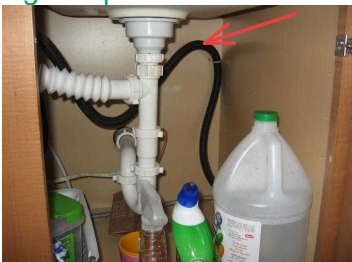
- 27. 1st Floor Kitchen Dishwasher: Maytag - Properly secure the dishwasher discharge hose so that it creates a "high loop" above the basin drain to minimize food or water backup under dishwasher

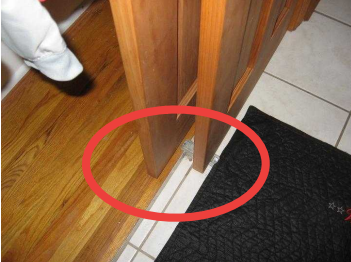
29. 1st Floor Living Space Closet: Various - Missing door glides at bypass closet door in Foyer

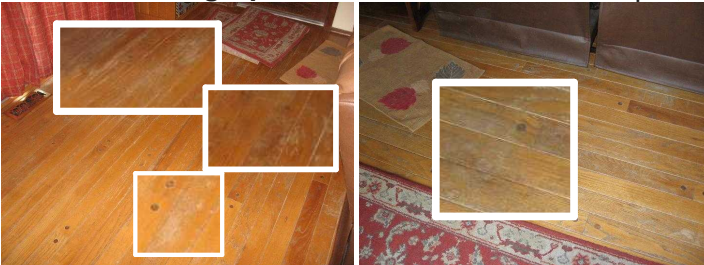
30. 1st Floor Living Space Floor: Ceramic tile, Carpet, Hardwood - Worn wood finish in Family room

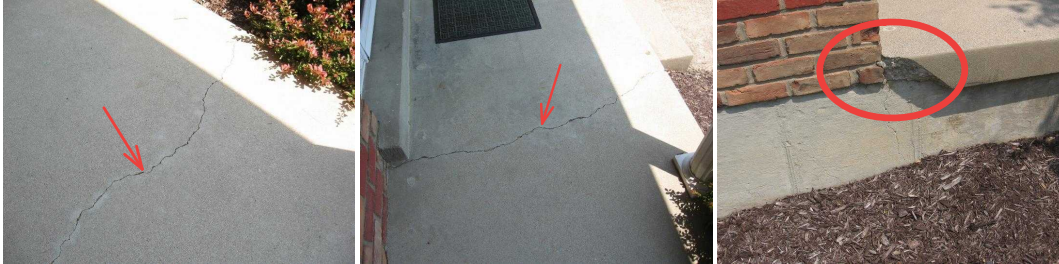
1. **Porch: Concrete** - Settling away from foundation with surface cracks noted

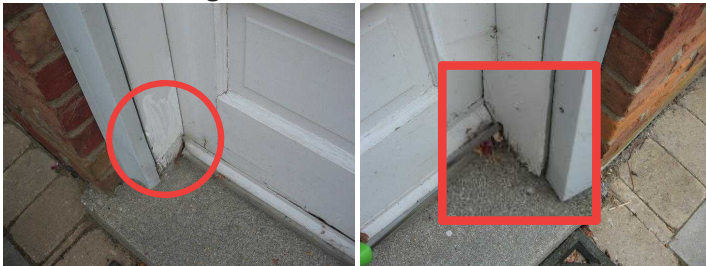
2. **Attached Garage Service Doors: Wood** - Wood rot at bottom of door and frame

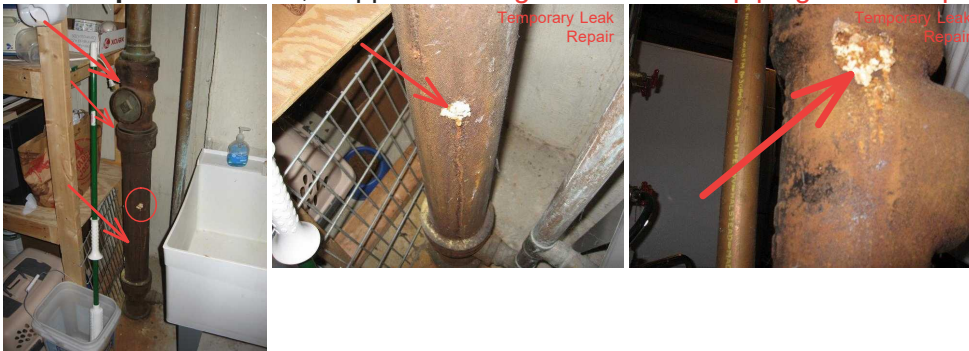
4. **Drain Pipes: Cast iron, Copper** - Pitting cast iron drain piping stack - replace affected sections where required

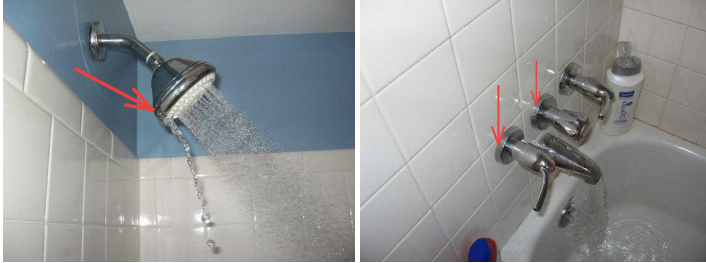
5. **2nd Floor Hall Bathroom Faucets/Traps: Delta fixtures with a metal trap** - Leaking shower head, Loose trim rings

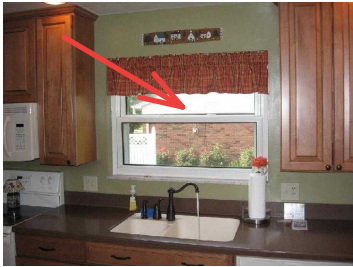
6. 1st Floor Kitchen Windows: Vinyl Insulated - Insulated glass unit seal failure

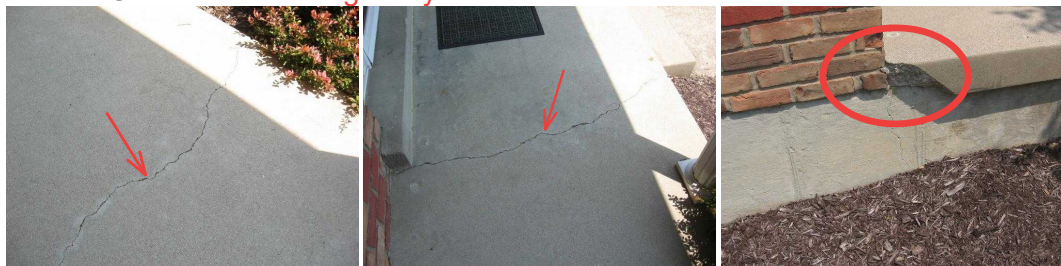
Porch: Concrete - Settling away from foundation with surface cracks noted

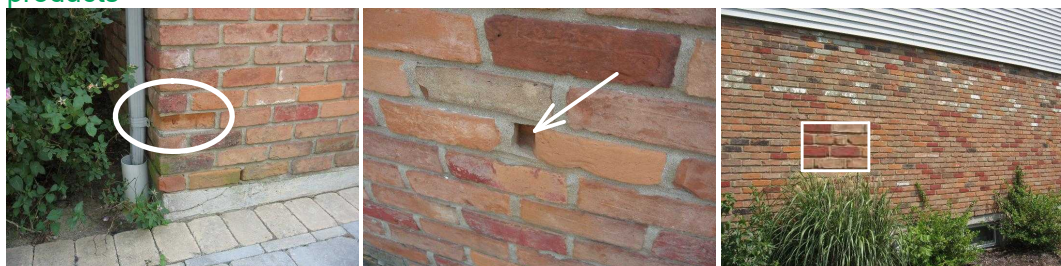
Type: Brick veneer - Some damaged bricks, Recommend sealing brick with penetration sealer products

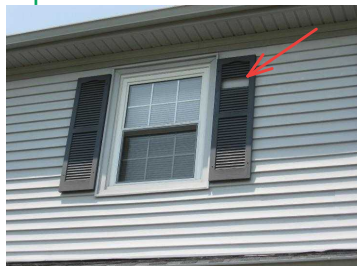
Type: Vinyl siding - Damaged front shutter, Chalking noted due to age, One panel needs to be repositioned at rear elevation

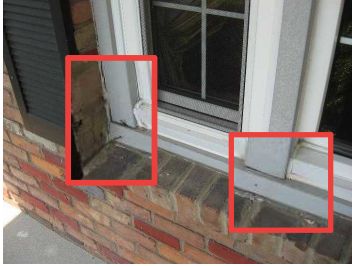
Windows: Vinyl insulated - Reseal caulking at window perimeters at brick window openings

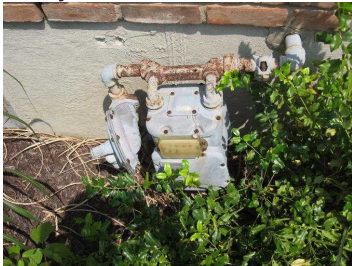
Gas Meter: Exterior surface mount at side of home - Rust present, Keep bushes and shrubs away from meter

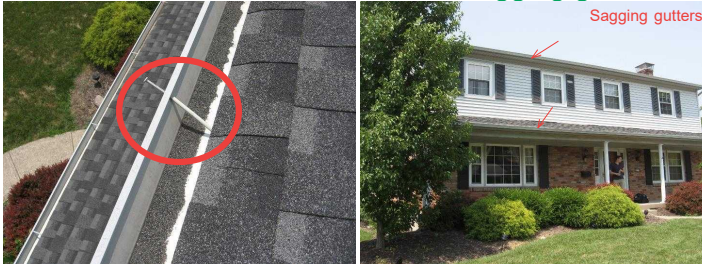
Gutters: Aluminum - Loose nails, Sagging gutters at front and rear

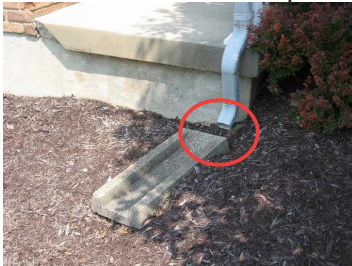
Leader/Extension: Splash blocks - Splash block(s) not properly installed

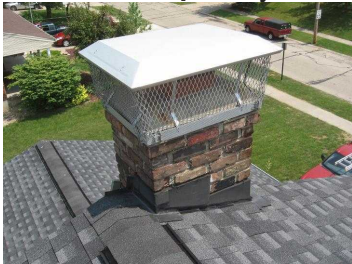
Flue/Flue Cap: Clay tile - Weather cap obstructed view of flue

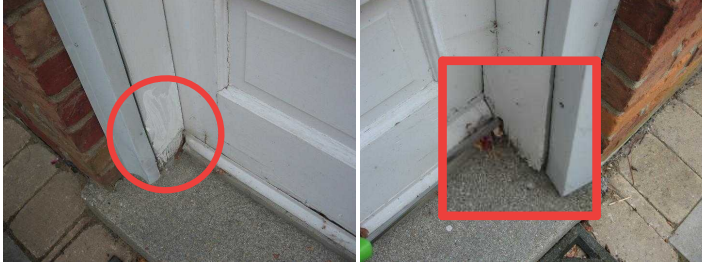
Service Doors: Wood - Wood rot at bottom of door and frame

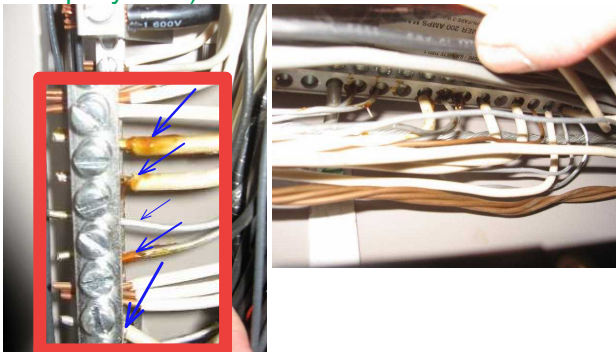
5. Marginal **Aluminum Wiring:** Present at several circuits - **Aluminum branch wiring has had a history of problems relating to poor connections due to galvanic corrosion, dissimilar metals, brittle conductors and type of aluminum alloy used during the time period of 1965 through 1972. These problems create unsatisfactory conditions at connections and splice locations and therefore create potential fire hazards. Recommend wiring update for aluminum wiring by a licensed electrician, Circuits are recommended to be upgraded with special compression type connectors at splices and branch circuits to reduce the potential risks of aluminum branch wiring.(Cop-Alum Crimp System)**

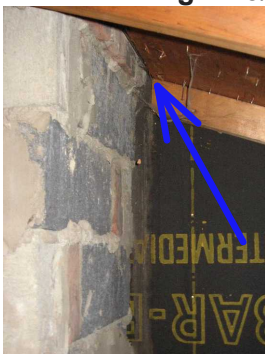
1. **Method of Inspection:** In the attic
2. Acceptable **Unable to Inspect:** 15% - Safety and footing
3. Marginal **Roof Framing:** 2x3/4 Truss - Wood blocking components missing at chimney perimeter

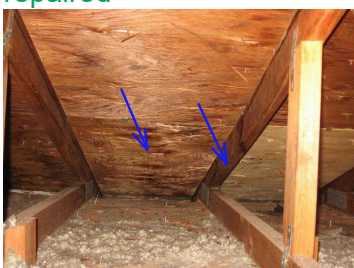
4. Marginal **Sheathing:** Plywood - Water stains and slight damage present, Areas of sheathing have been repaired

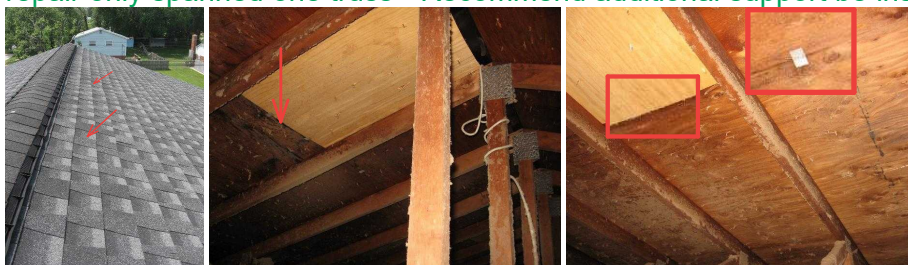
- 9. Method of Inspection:** In the attic
- 10. Acceptable** **Unable to Inspect:** 10% - Safety and footing
- 11. Acceptable** **Roof Framing:** 2x3/4 Truss
- 12. Marginal** **Sheathing:** Plywood - Poor repair at 2 areas near ridge at rear slope - No H clips installed and repair only spanned one truss - Recommend additional support be installed

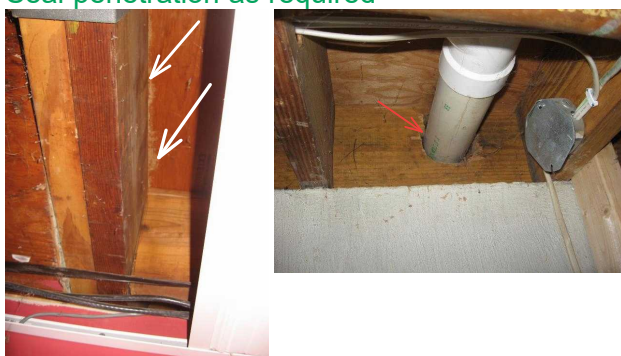
- 1. Acceptable** **Structure Type:** Wood frame
- 2. Acceptable** **Foundation:** Poured concrete
- 3. Acceptable** **Differential Movement:** Slight settlement present - Minor settlement at front porch, Cracks will require monitoring
- 4. Acceptable** **Beams:** Steel I-Beam
- 5. Acceptable** **Bearing Walls:** Wood frame
- 6. Marginal** **Joists/Trusses:** 2x10 - Areas not visible due to ceiling finishes or other obstructions, Framing joist near fireplace chimney shows evidence of previous termite infestation - No repairs required, Seal penetration as required

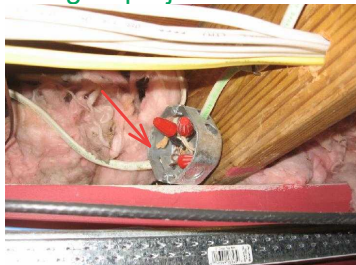
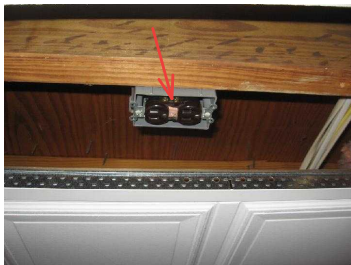
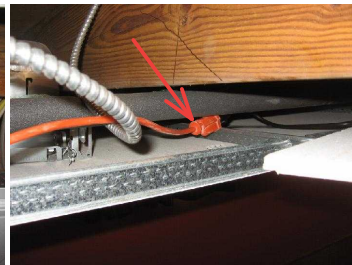
Electrical: 110 VAC - **Loose junction boxes, missing and mis-sized covers, extension cord wiring to projector**

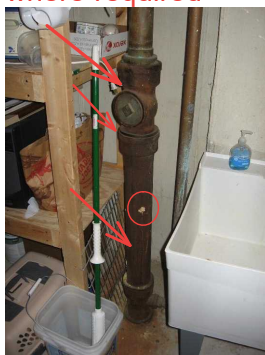
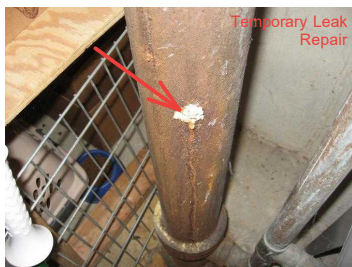
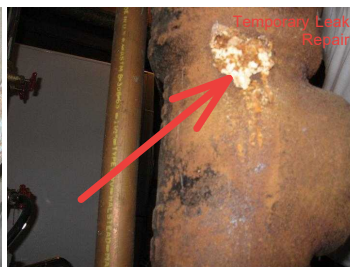
1. Acceptable **Service Line:** Copper
2. Acceptable **Main Water Shutoff:** Basement
3. Acceptable **Water Lines:** Copper
4. Defective **Drain Pipes:** Cast iron, Copper - **Pitting cast iron drain piping stack - replace affected sections where required**

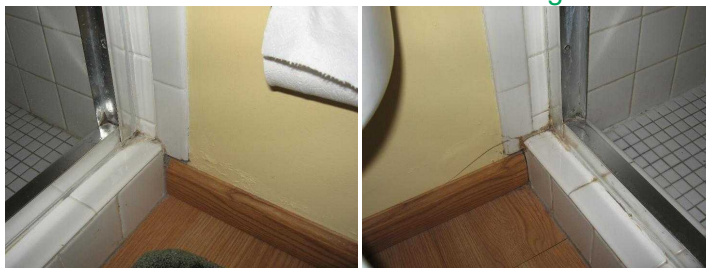
Shower/Surround: Ceramic tile - Leaking at corner of door frame

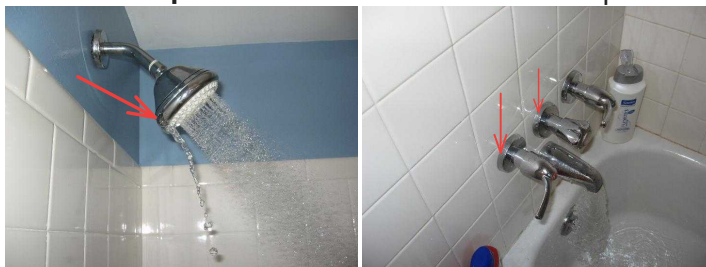
Faucets/Traps: Delta fixtures with a metal trap - Leaking shower head, Loose trim rings

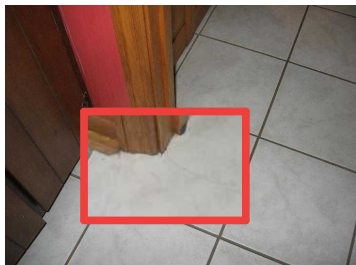
Floor: Ceramic tile - Cracked tile noted

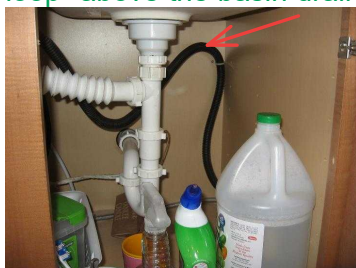
- 1. Acceptable **Cooking Appliances:** Frigidaire
- 2. Acceptable **Disposal:** General Electric
- 3. Marginal **Dishwasher:** Maytag - Properly secure the dishwasher discharge hose so that it creates a "high loop" above the basin drain to minimize food or water backup under dishwasher

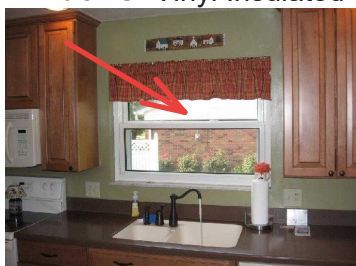
- 4. Air Gap Present? No
- 5. Acceptable **Refrigerator:** Amana
- 6. Acceptable **Microwave:** General Electric
- 7. Marginal **Sink:** Stainless Steel - Chipping at drain
- 8. Acceptable **Electrical:** 110 VAC GFCI
- 9. Acceptable **Plumbing/Fixtures:** Stainless Steel
- 10. Acceptable **Counter Tops:** Solid Surface
- 11. Acceptable **Cabinets:** Wood - Loose cabinet door hinges
- 12. Acceptable **Pantry:** Large
- 13. Acceptable **Ceiling:** Drywall
- 14. Acceptable **Walls:** Drywall
- 15. Acceptable **Floor:** Ceramic tile
- 16. Acceptable **Doors:** Hollow wood
- 17. Defective **Windows:** Vinyl Insulated - Insulated glass unit seal failure

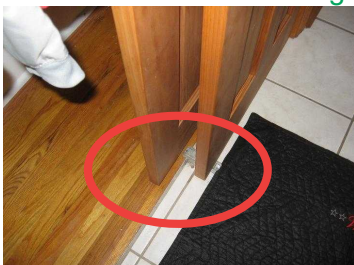
Closet: Various - Missing door glides at bypass closet door in Foyer

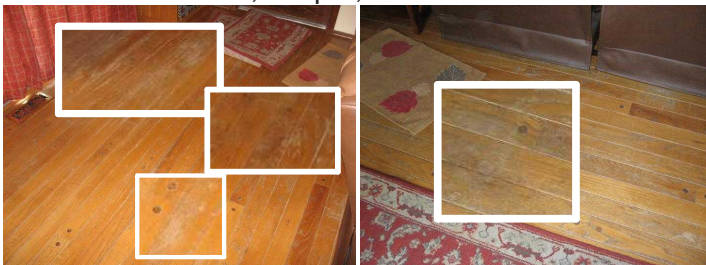
Floor: Ceramic tile, Carpet, Hardwood - Worn wood finish in Family room

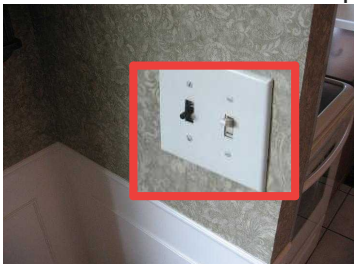
Electrical: 110 VAC - Replace missing dimmer switch in Dining room
