# Home Inspection Report

123 Main St  
Anytown, GA

# Premier Home Inspections

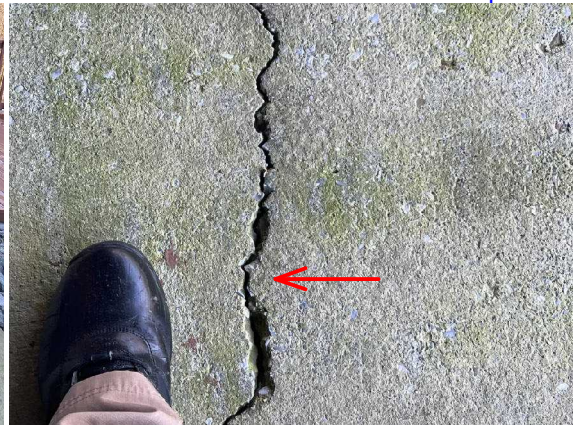
1. ☒ ☐ ☐ ☐ ☐ Driveway: Gravel
2. ☒ ☐ ☐ ☐ ☐ Steps/Stoops: Wood
3. ☒ ☐ ☒ ☐ ☐ Porch: Wood - Due to the low height of the front porch, some of the joists were not visible
4. ☐ ☐ ☐ ☒ ☐ Patio: Concrete - There has been some settlement at the patio. This settlement has resulted in a crack of about 1/4 inch with some slight displacement. This is likely resulted in some minor settlement of the deck support post. It is unknown if this patio will continue to settle. Recommend sealing crack and monitoring. Should condition continue to worsen then recommend consultation with a qualified contractor for further evaluation and repair.

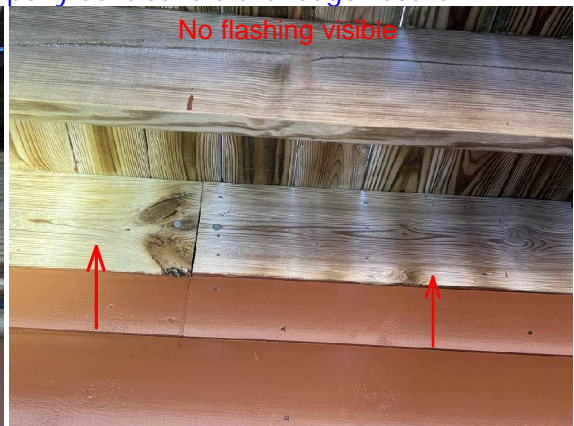
5. ☒ ☐ ☐ ☐ ☐ Deck: Wood - Inspector unable to verify flashing at the deck, ledger boards. Flashing helps prevent water from penetrating behind the ledger board which could lead to deterioration. While it is possible there could be flashing behind the ledger board and not visible to inspector, flashing is usually visible when installed properly as it covers the ledger board.

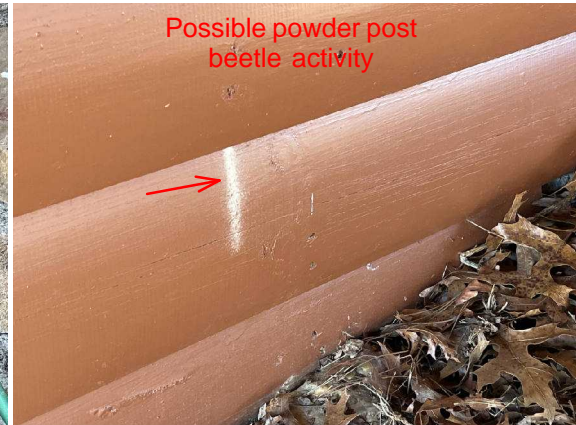
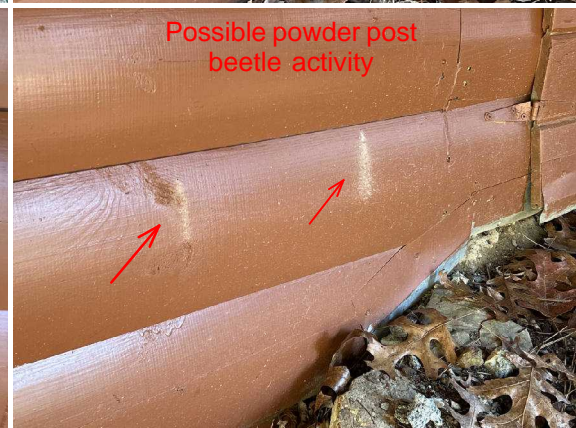
1. ☒ ☐ ☐ ☒ ☐ Type: Wood - There is some deterioration to the siding near the rear right retaining wall. It is possible this was the result of wood destroying organisms. Recommend consultation with a pest control company for further evaluation. Recommend any deteriorating siding be replaced.

There is also evidence of suspected powder post beetles in the siding near the entrance to the crawlspace area and at front porch. Recommend consultation with a pest control company for further evaluation and treatment.

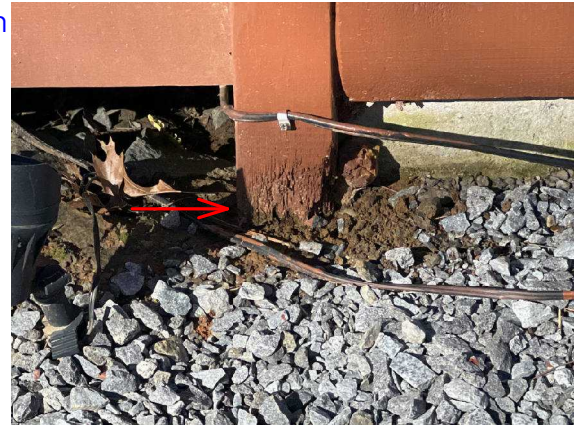
2. ☒ ☐ ☐ ☒ ☐ Trim: Wood - There is some deterioration to the trim near ground left to the left of chimney. Recommend repair.

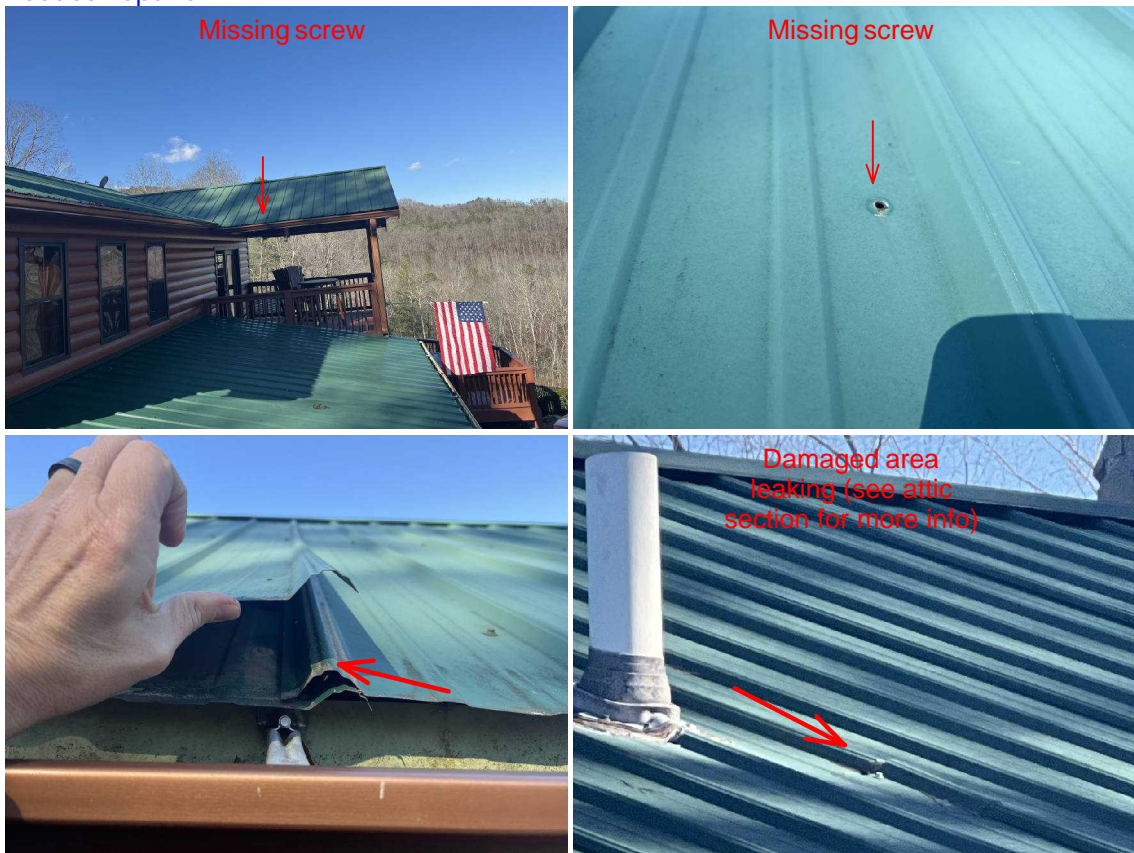
1. Method of Inspection: On roof
2. ☒ ☐ ☐ ☒ ☐ Material: Metal - There is a missing screw at the metal roof panel near the upper floor deck.  
The edge of this panel can easily be lifted by hand.

There is also a damaged area of metal roofing near the PVC event that is leaking. It appears this has been repaired with sealant, which will only be a temporary repair.

Recommend consultation with a roofer for further evaluation of the roof and to make any needed repairs.

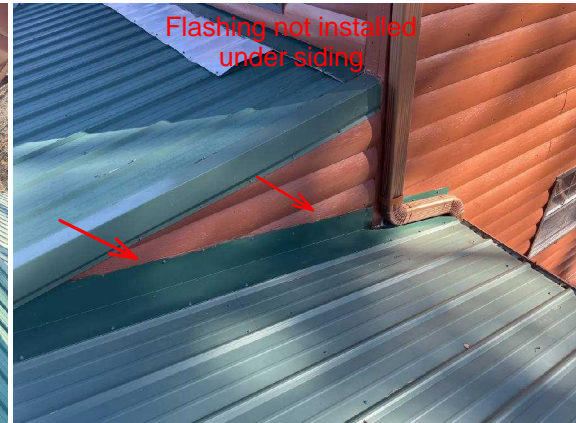
5. ☒ ☐ ☐ ☐ ☐ Flashing: Metal - There is an unusually large piece of flashing on the side roof. Reason for such a large piece of flashing is unknown. Recommend asking sellers about this repair.

The flashing for the covered porch addition was not installed under the siding. Flashing should be installed under the siding to help prevent water from penetrating behind the flashing. If this flashing is not properly repaired by a roofer, then the top of the flashing will at least have to be kept sealed to help prevent moisture intrusion although this will have to be maintained over time so proper installation is suggested.

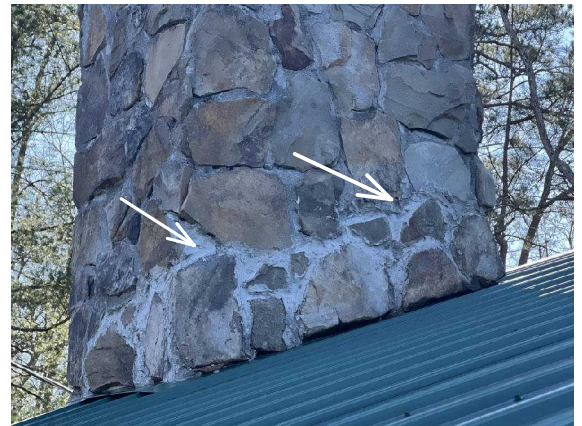
11. ☒☐☐☐☐ Chimney: Stone covered - There appears to have been some repairs to the mortar of the chimney. Recommend asking sellers about any repairs that may have been completed.

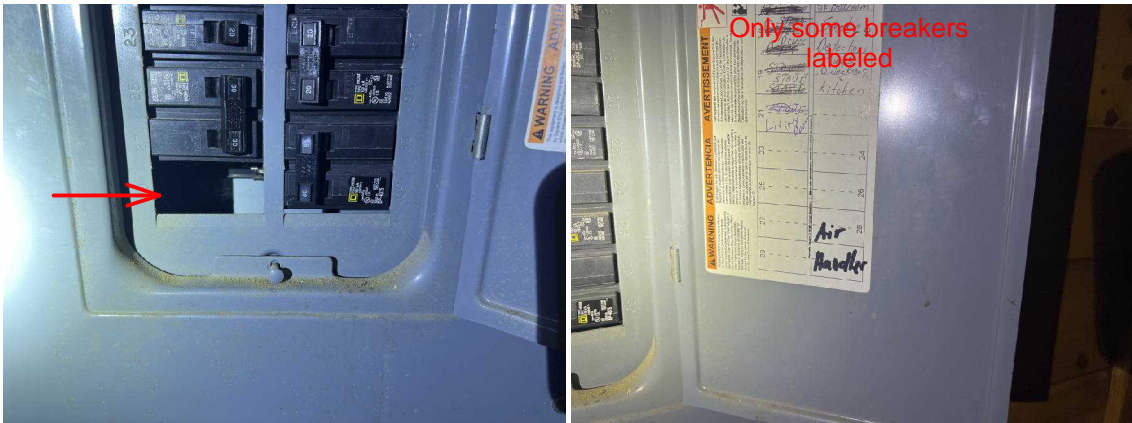
11. ☒☐☐☒☐ Breakers: Copper - Recommend the open breaker slot be covered with a filler plate. Also recommend all breakers be labeled. At the time of inspection only some of the breaker were labeled.

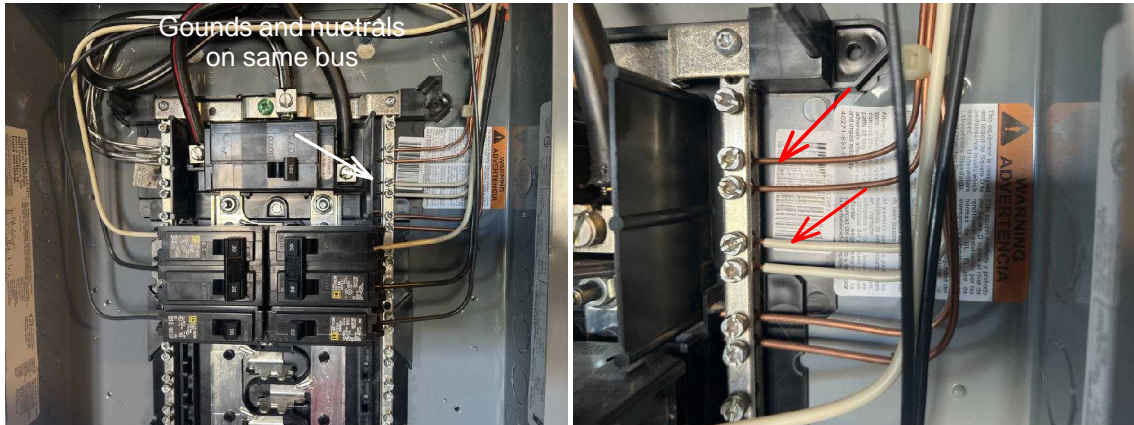
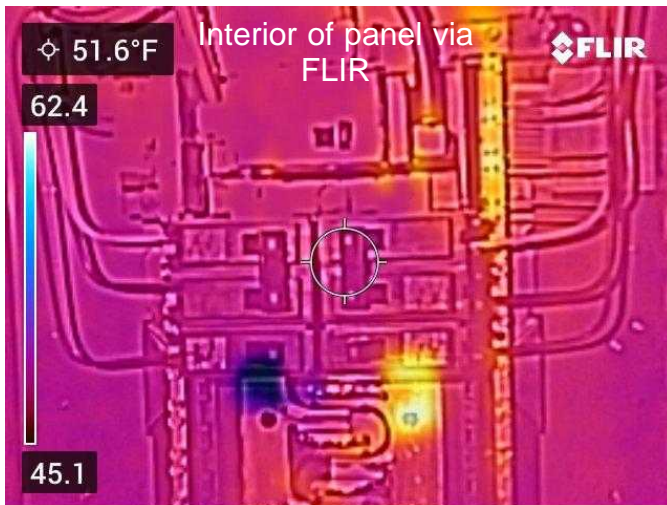
13. ☒☐☐☒☐ Manufacturer: Square D - The grounds and neutrals should be separated in a sub panel. They are not separated in this sub panel. Recommend consultation with electrician for further evaluation.

FLIR infrared indicates no elevated heat levels.

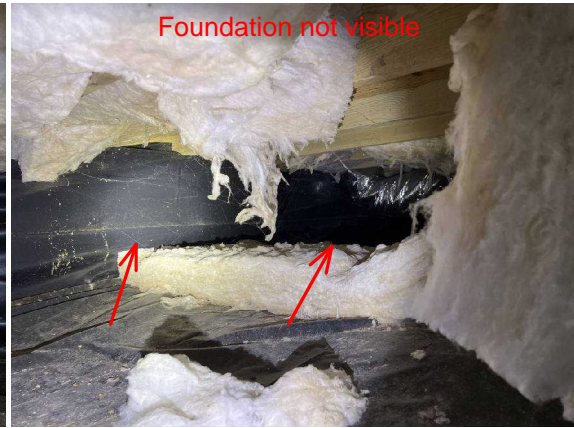
1. ☒ ☐ ☐ ☐ ☐ Structure Type: Wood frame
2. ☒ ☐ ☒ ☒ ☐ Foundation: Block - A large section of the foundation wall is not visible as inspectors view was blocked by a vapor barrier that is covering the wall. Consequently, this wall could not be observed.

However, there was a hole knocked in the foundation wall for the package HVAC unit ductwork. This is not uncommon. However, this is the same area that supports one of the support beams. Recommend consultation with a qualified contractor for further evaluation and to install additional support.

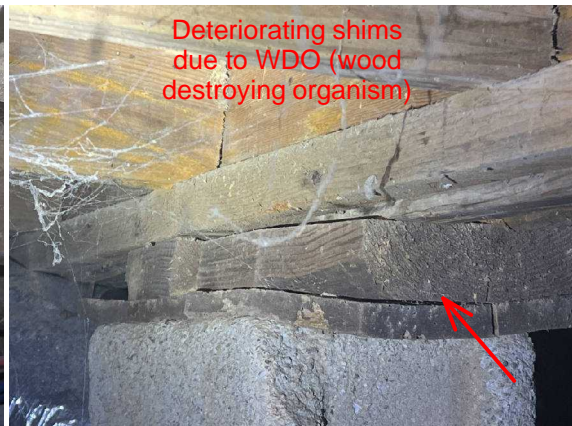
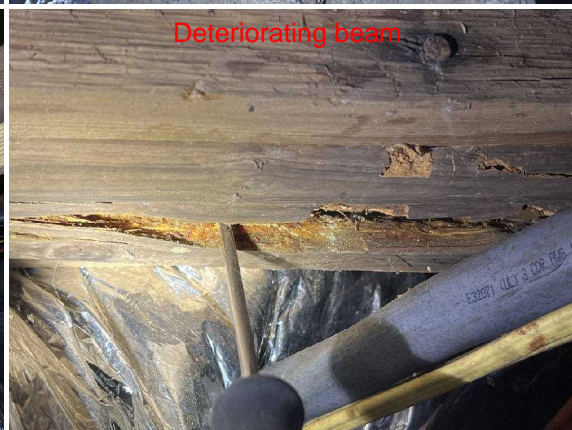
3. ☐ ☐ ☐ ☒ Beams: Solid wood - There is damage to several support beams under the laundry and bedroom areas of the main floor. This damage appears to be from moisture and also possible wood destroying organisms. There is also deterioration to the pieces of wood on top of block support posts that support the beam.

There has been a package heating and air unit installed, and a large hole was cut in the foundation wall. This is not unusual, however, a main support beam rest on the wall that was removed.

There has been a significant amount of repair work done in the crawlspace, however, some of these newer joists were attached to a beam that appears to be deteriorating.

This damage is possibly the cause of the sloping floors mentioned later in the report.

Recommend consultation with a qualified contractor for further evaluation and for repair recommendations and cost.

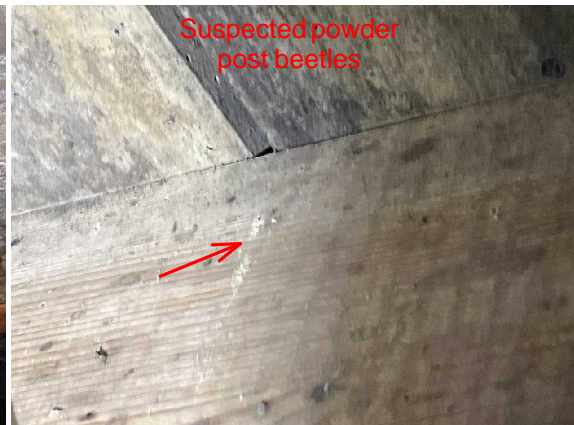
There is a cracked joist under the laundry room area that will need to be repaired.

Some of the newer joists have been attached the a deteriorating beam (see photos above).

Recommend further evaluation and repair by a qualified contractor. Also recommend consultation with a pest control company for treatment options.

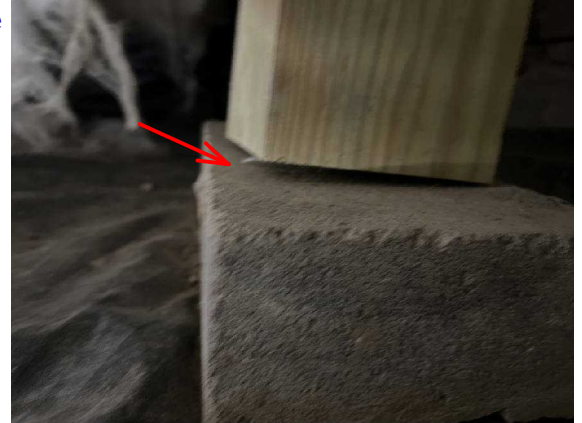
5. ☒☐☐☒☐ Piers/Posts: Wood - The wood support post near the fireplace area is no longer touching the footer. Recommend repair.

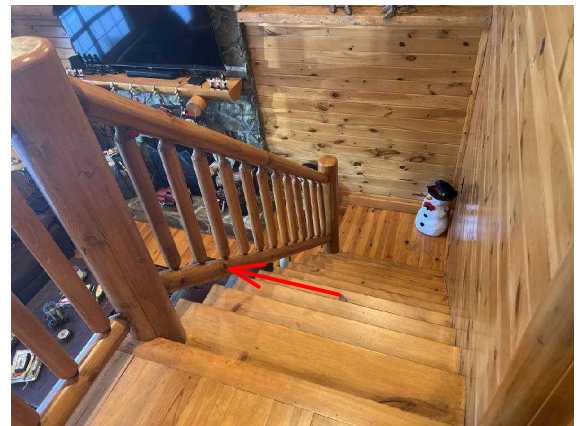
6. ☒☐☐☒☐ Stairs/Handrails: Wood stairs with wood handrails - The handrail on the steps leading to the upper floor is loose. Recommend tightening.

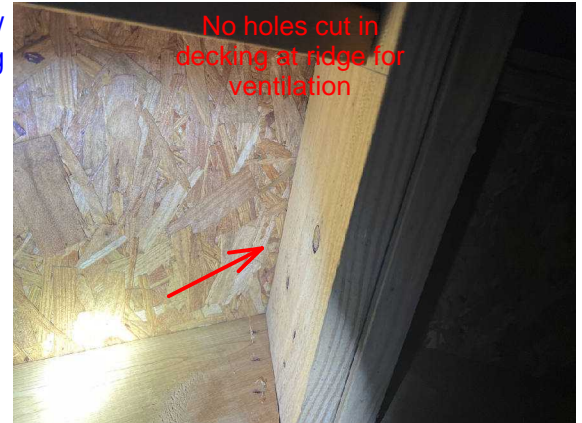
4. ☐ ☒ ☐ ☒ ☐ Ventilation: There was no ventilation in the attic. Any soffit vents are blocked by insulation and the decking for the ridge vent was not properly cut to allow for air to escape. Recommend consultation with the roofer for further evaluation and to install proper ventilation.

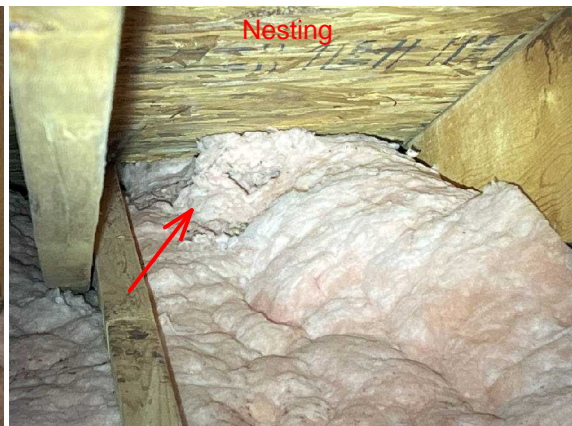
5. ☒ ☐ ☐ ☒ ☐ Insulation: Fiberglass - There were some signs of rodents in the attic. That was tunneling in the insulation and evidence of rodent traffic around the condensate line. It is unknown if this is a current problem or occurred in the past. Expanding foam insulation has been installed in an apparent attempt to keep the rodents out of the attic. However, rodents can chewed through foam insulation. Recommend consultation with a pest control company for further evaluation and recommendations (there may already be a contract on the house as there are commercial rodent bait stations on exterior-recommend asking seller).

There are also a few areas of missing insulation. Energy efficiency can be increased if additional insulation is installed.

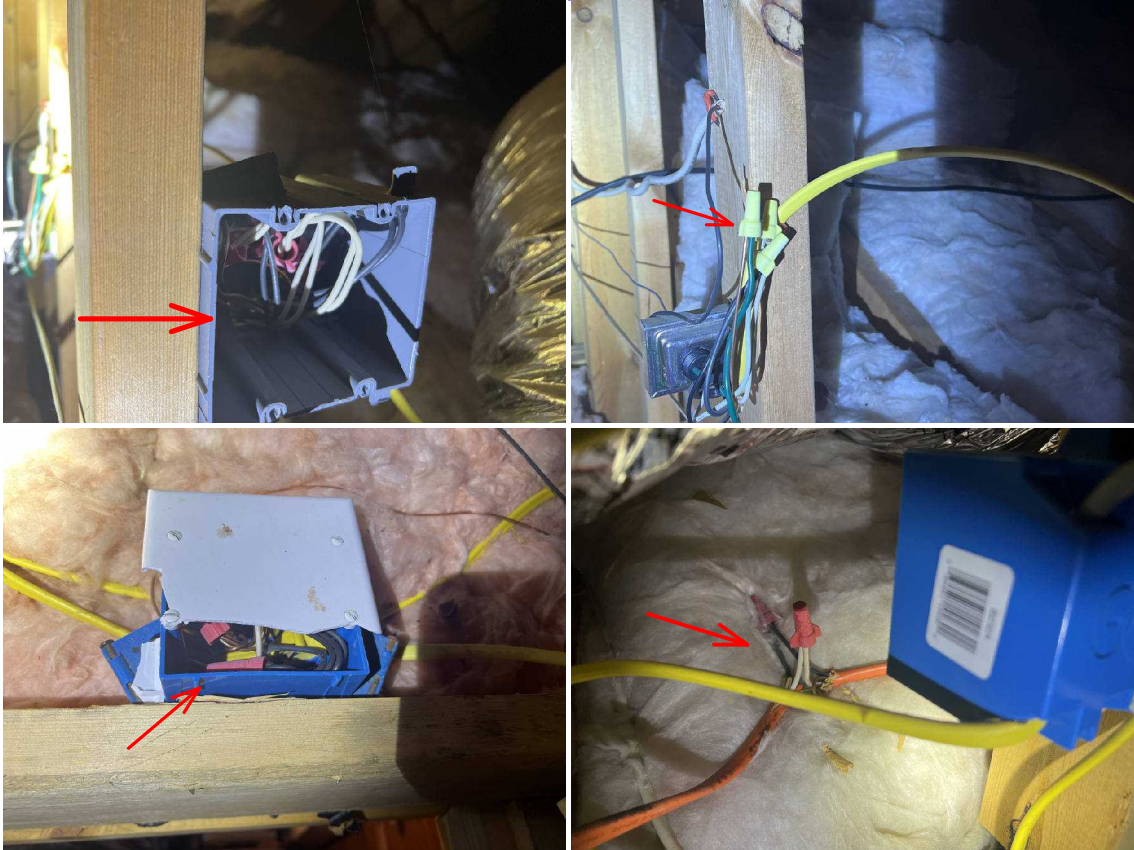
6. ☐☐☐☒ Wiring/Lighting: 110 VAC - Recommend all junction boxes have covers installed. Also, recommend the electrical splices near the opening to the attic be protected it a junction box.

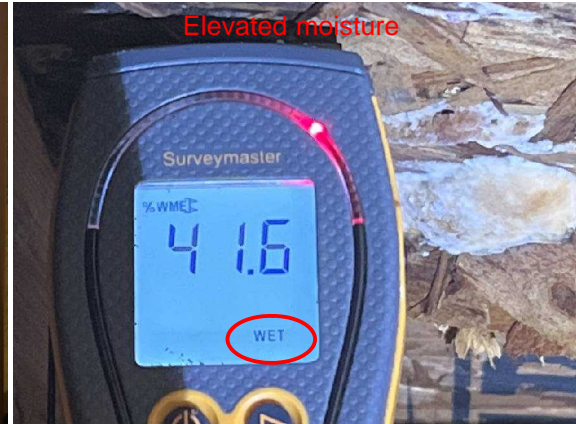
Moisture Penetration: (continued)

7. ☐☐☐☒ Moisture Penetration: Ongoing water penetration noted - There is an active roof leak above the second floor bathroom area. This area tested with elevated moisture levels per moisture meter and is likely the result of the staining in the ceiling in that bathroom mentioned later in the report. There is also some staining near the soffit. However, inspector is unable to reach this area due to lack of access to check to see if it is active per moisture meter.

Recommend consultation with a roofer for further evaluation of the roof and to make any needed repairs.

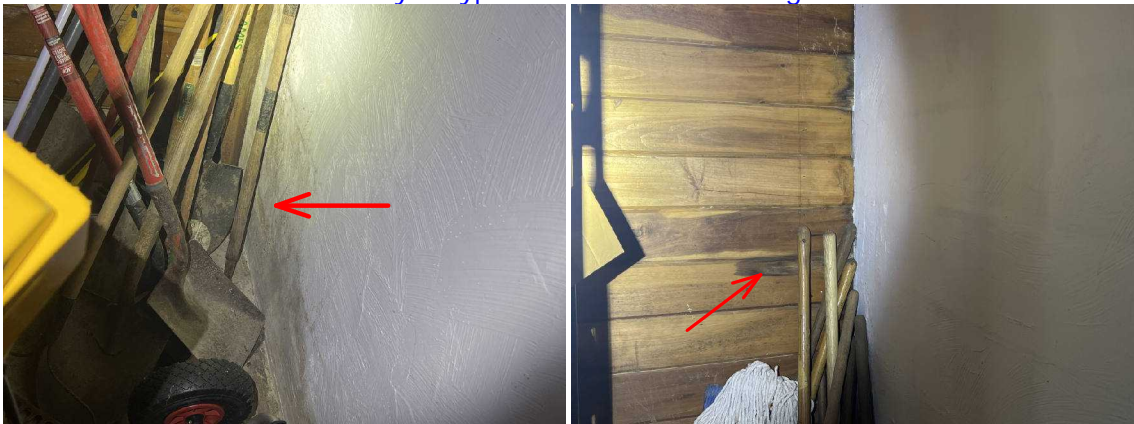
2. ☒ ☐ ☐ ☐ ☐ Walls: Concrete, Wood
3. ☒ ☐ ☐ ☐ ☐ Floor: Poured
4. ☒ ☐ ☐ ☐ ☐ Doors: Metal
5. ☒ ☐ ☐ ☐ ☐ Windows: Metal frame insulated
6. ☒ ☐ ☐ ☐ ☐ Electrical: 110 VAC outlets and lighting circuits
7. ☐ ☒ ☐ ☐ ☐ Smoke Detector:
8. ☒ ☐ ☐ ☐ ☐ HVAC Source: Heating and Cooling system register
9. ☒ ☐ ☐ ☐ ☐ Ventilation: Windows
10. ☒ ☐ ☐ ☒ ☐ Moisture Location: At foundation - There are some signs of moisture intrusion in the corner of the basement area.

This area test is slightly elevated with moisture contact. No obvious reasons noted, but possibly caused by clogged gutters (mentioned earlier in the report) causing water to overflow and fall at base of foundation. This is only a hypothesis and cannot be guaranteed.

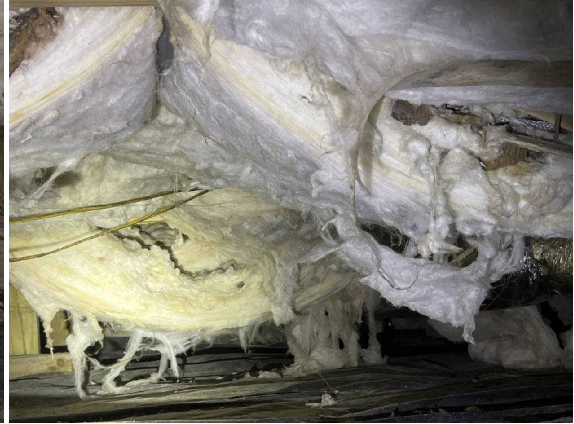
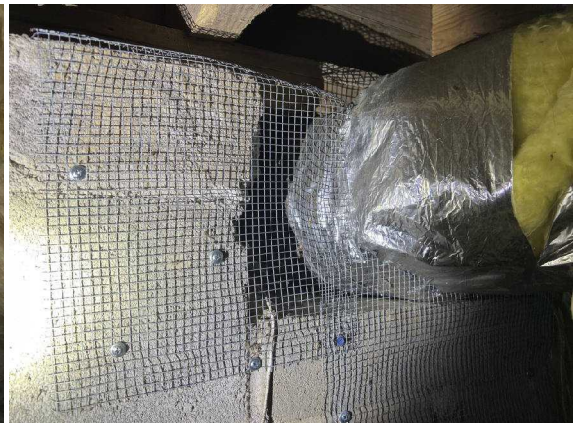
Insulation: (continued)

1. Method of Inspection: In the crawl space
2. ☒ ☐ ☐ ☐ ☐ Access: Door
3. ☐ ☒ ☐ ☐ ☐ Moisture Penetration:
4. ☐ ☒ ☐ ☐ ☐ Ventilation:
5. ☐ ☒ ☐ ☒ ☐ Insulation: Fiberglass - There is no insulation under the bedrooms and laundry room on the main floor.

However, there is insulation in the other (repaired areas with newer wood) areas of the crawlspace. However, this insulation is falling in numerous areas due to rodent activity.

There is evidence of rodent bait stations as well as hardware cloth that has been installed to help keep rodents away. It is unknown if this is a current problem or occurred in the past. Recommend asking seller about any rodent control they have in place and if a professional pest control company is servicing this house.

Recommend any falling insulation be replaced. The falling insulation did block view of some areas of crawlspace.

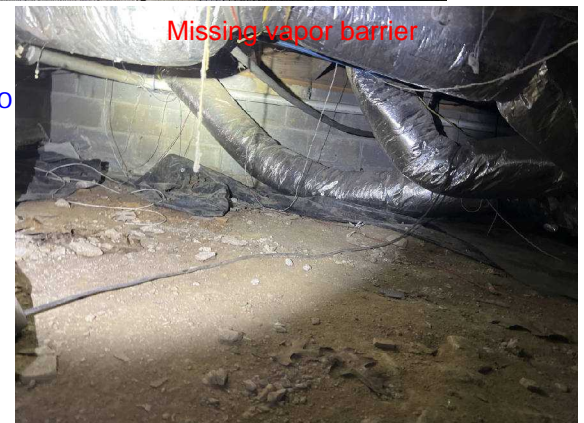
6. ☒ ☐ ☐ ☐ ☐ Vapor Barrier: Partial - There is only a partial vapor barrier in the crawlspace. Recommend a vapor barrier be installed over the entire crawlspace floor to help keep humidity levels down.

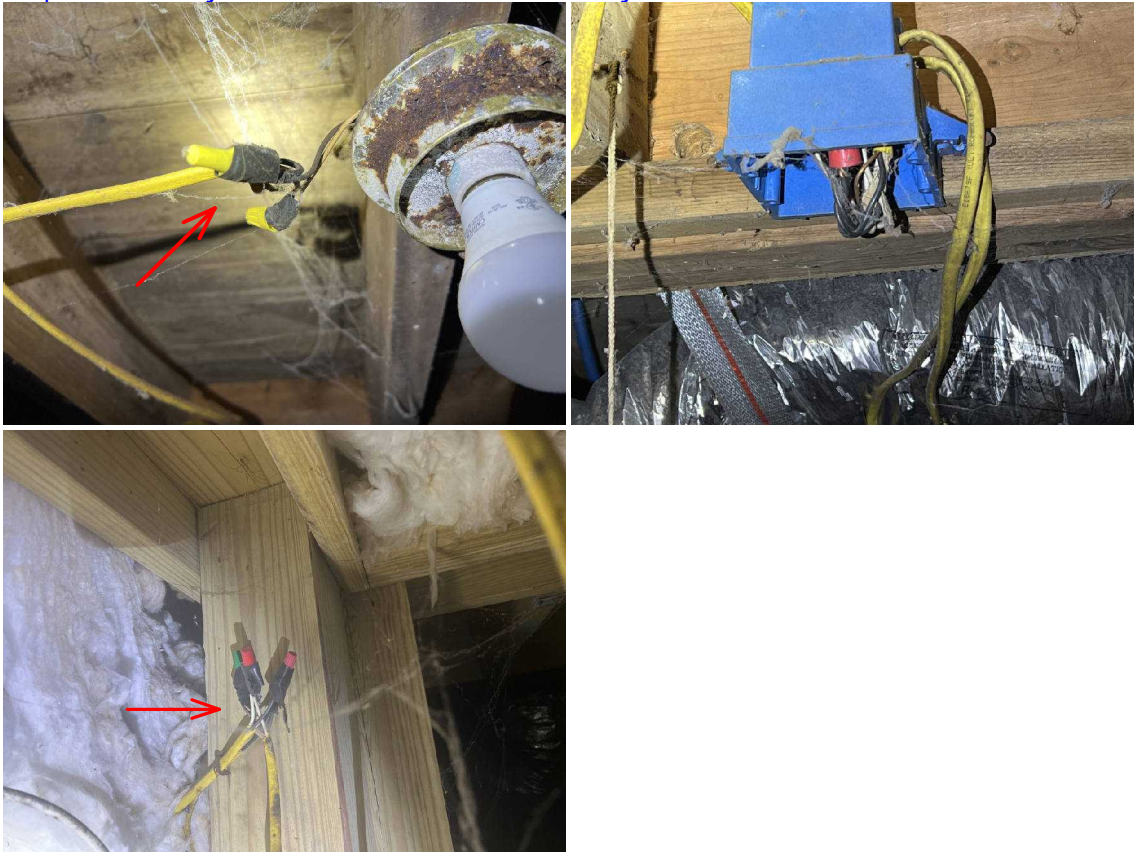
7. ☐☐☐☒☐ Electrical: 110 VAC/220 VAC - There are several electrical splices in the crawlspace that need to be protected in junction boxes. Recommend all junction boxes have covers installed

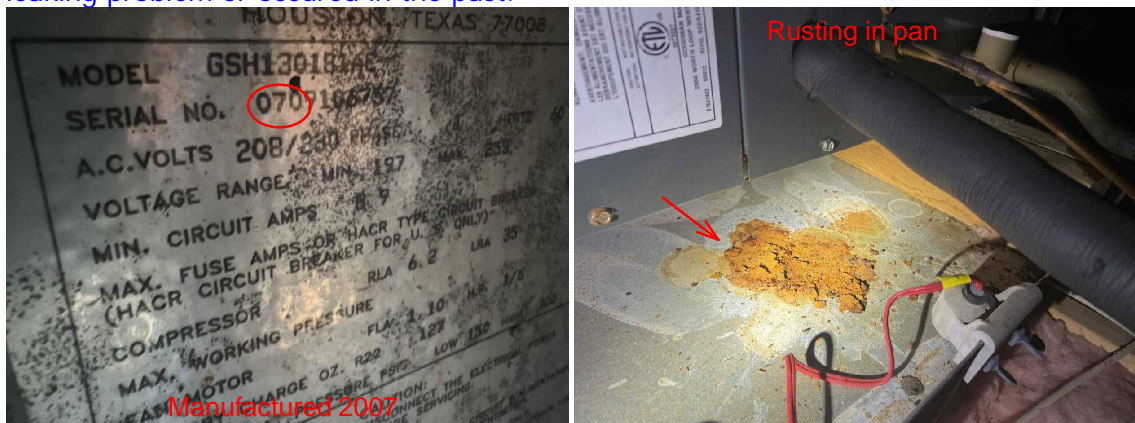
10. ☒☐☐☒☐ A/C System Operation: Not inspected - Due to an exterior temperature below 60 degrees, and to avoid damage to the unit, the AC could not be operated. However, this AC system is 15 years old and nearing end of expected life.

Due to the age, and the rusting on the drip pan in the attic at the condensate line, recommend service by an HVAC company. Since AC could not be operated it is unknown if this is a current leaking problem or occurred in the past.

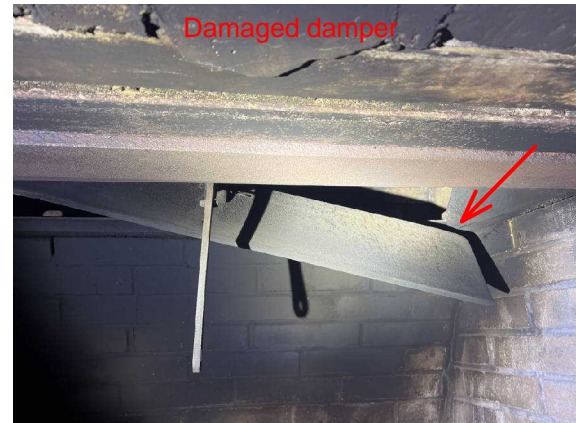
- 4. ☐☐☐☒☐ Damper: Metal - The damper is no longer properly attached. Recommend consultation with a qualified contractor for repair so that the damper works properly.

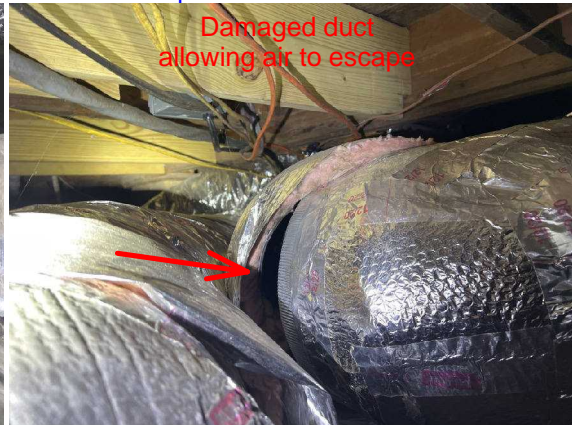
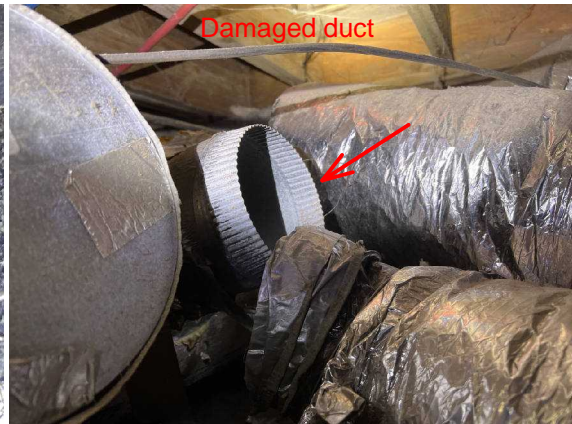
8. ☐☐☐☒☐ Distribution: Insulflex duct - There is some damage to the supply line duct in a few areas the crawlspace, allowing heated air to be vented into the crawlspace. There is also some damage to the ductwork likely caused by workers in the crawlspace. This duct has been flattened.

Recommend consultation with an HVAC contractor for repair.

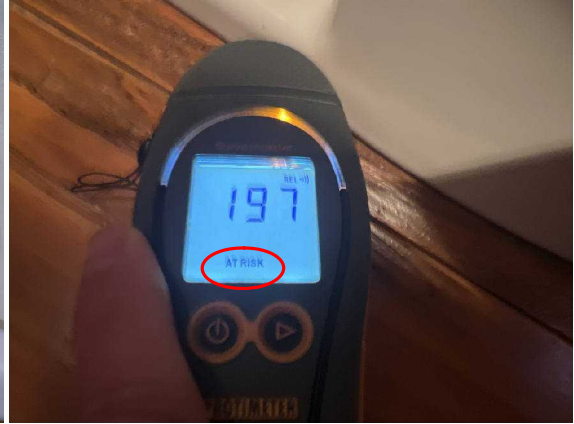
Floor: (continued)

- 1. ☒ ☐ ☐ ☐ ☐ Closet:
- 2. ☒ ☐ ☐ ☐ ☐ Ceiling: Wood
- 3. ☒ ☐ ☐ ☐ ☐ Walls: Wood
- 4. ☒ ☐ ☐ ☒ ☐ Floor: Wood - There is some minor damage to the floor around the toilet. This area tested slightly elevated with moisture. This toilet is loose and this may be resulting in some minor leak. Recommend this toilet have a new wax ring installed and the toilet reset and properly secured.

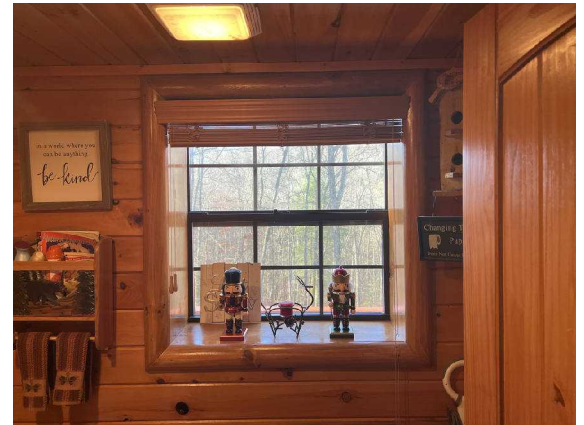
5. ☒ ☐ ☐ ☐ ☐ Doors: Wood
6. ☒ ☐ ☐ ☒ ☐ Windows: Metal frame insulated - This window will not open with normal pressure. Inspector does not force windows for fear of breaking them. Recommend window be made to be operable.

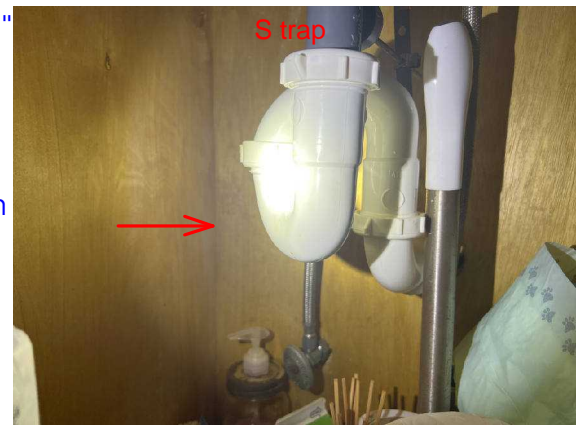
7. ☒ ☐ ☐ ☐ ☐ Electrical: 110 VAC outlets and lighting circuits, 110 VAC GFCI
8. ☒ ☐ ☐ ☐ ☐ Counter/Cabinet: Tile and wood
9. ☒ ☐ ☐ ☒ ☐ Sink/Basin: Molded single bowl - This sink has an "S" trap. These types of traps are no longer used in new construction due to problems with siphoning. Recommend either replacing with P traps, or being diligent in making sure S traps are not dry and there is always water in the trap to stop sewer gasses from entering the home.

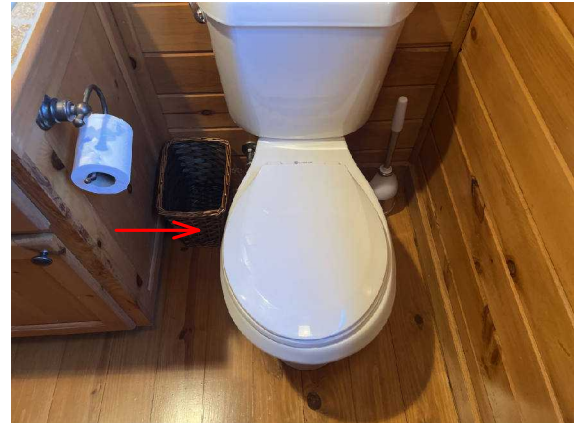
10. ☒☐☐☒☐ Toilets: Glacier Bay - The toilet is loose and possibly leaking slightly. Recommend a new wax ring be installed and the toilet properly secured

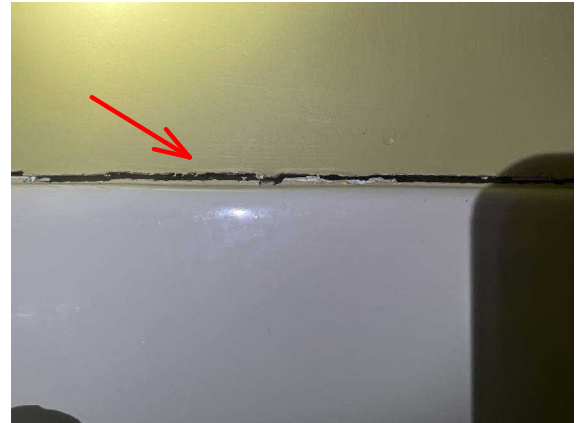
43. ☒☐☐☒☐ Walls: Painted drywall - Recommend caulking the crack at the drywall at the top of the shower. This will help prevent water intrusion. This possibly the result of some settlement due to structural issues mentioned earlier in the report.

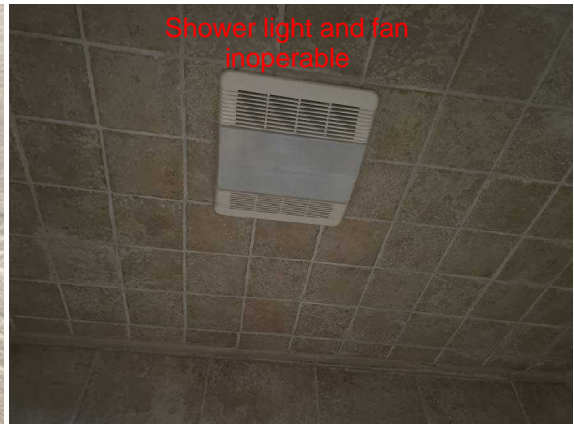
61. ☒ ☐ ☐ ☒ ☐ Electrical: 110 VAC outlets and lighting circuits, 110 VAC GFCI - The GFCI receptacle in the master bathroom is tripped and will not reset. This is likely the reason that the lights in the shower also do not work. Recommend repair.

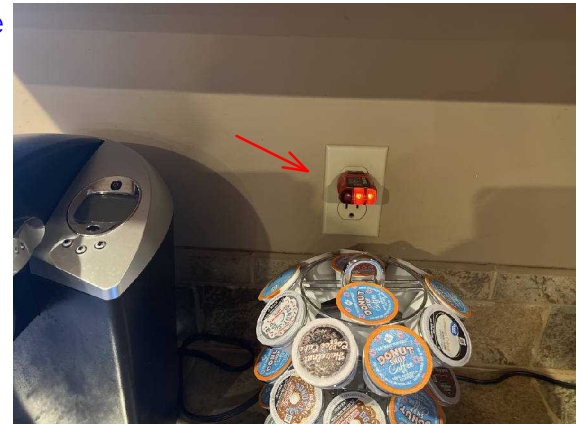
7. ☒ ☐ ☐ ☐ ☐ Microwave: Whirlpool
8. ☒ ☐ ☐ ☐ ☐ Sink: Stainless Steel
9. ☒ ☐ ☐ ☒ ☐ Electrical: 110 VAC outlets and lighting circuits - The receptacles are non-GFCI protected. Although this was not a requirement when this home was constructed, installation of GFCI protected receptacles can increase safety and this is recommended.

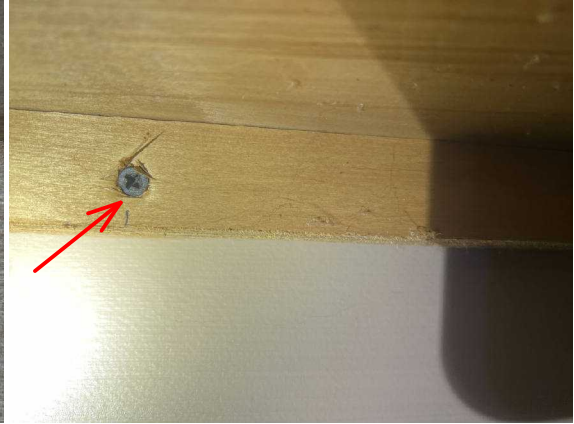
Cabinets: (continued)

10. ☒ ☐ ☐ ☐ ☐ Counter Tops: Tile
11. ☒ ☐ ☐ ☐ ☐ Cabinets: Wood - It appears that the cabinets may have been installed using drywall screws. While it is sometimes difficult to determine the exact type of screws use after they have been installed, drywall screws are not designed to hold the weight a cabinet can sometimes experience. Installation of screws designed for cabinet use would be an easy way to ensure these cabinets can hold a substantial amount of weight.

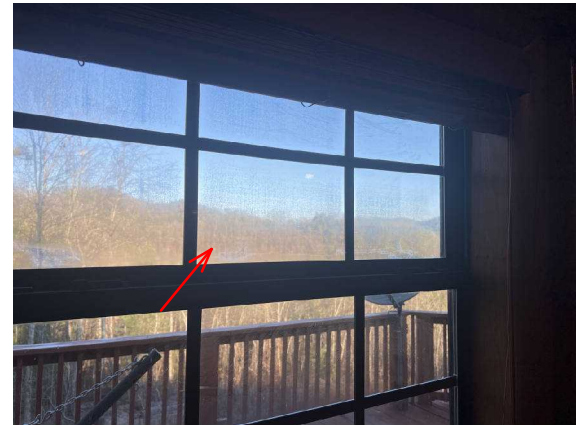
12. ☐ ☒ ☐ ☐ ☐ Pantry:  
13. ☒ ☐ ☐ ☐ ☐ Ceiling: Wood  
14. ☒ ☐ ☐ ☐ ☐ Walls: Painted drywall  
15. ☒ ☐ ☐ ☐ ☐ Floor: Wood  
16. ☒ ☐ ☐ ☐ ☐ Doors: Metal  
17. ☒ ☐ ☐ ☒ ☐ Windows: Metal frame insulated - Fogging between panes of glass likely the result of a failing seal. Not uncommon over time in insulated windows

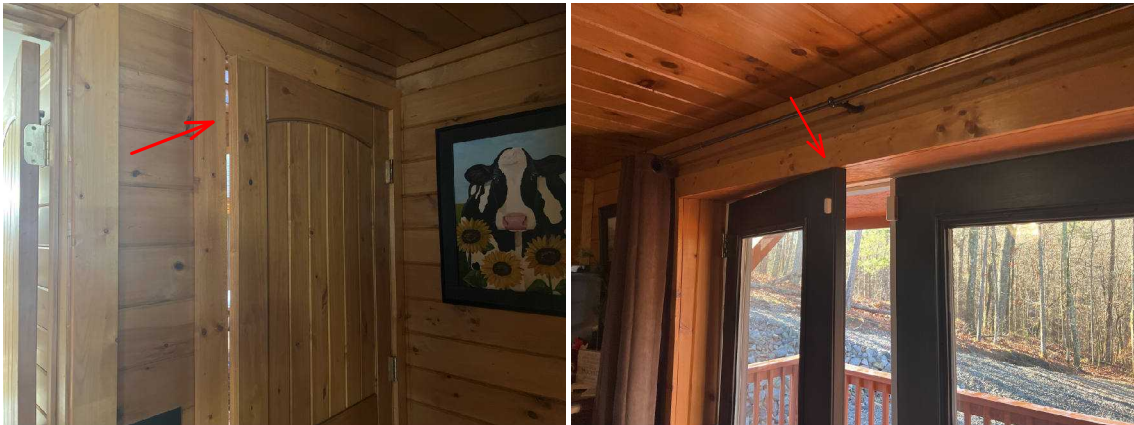
The door leading to the exterior rubs the door frame opening one operated. Recommend door be adjusted.

These issues may be the result of the structural issues mentioned earlier in the report.

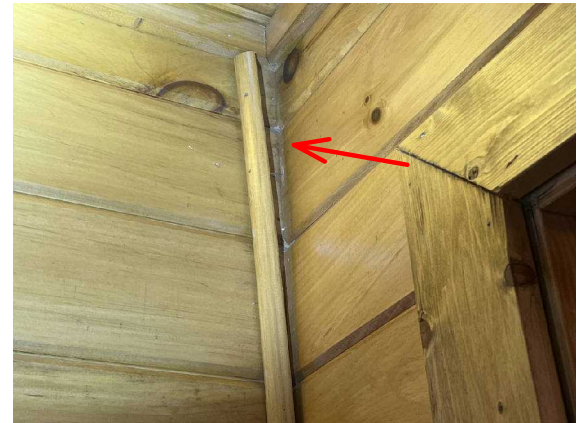
19. ☒☐☐☐☐ Closet: Single  
20. ☒☐☐☐☐ Ceiling: Wood  
21. ☒☐☐☒☐ Walls: Wood - The corner trim is no longer properly secured. This is possibly the result of some minor settlement. Recommend is trim piece be adjusted and reinstalled.

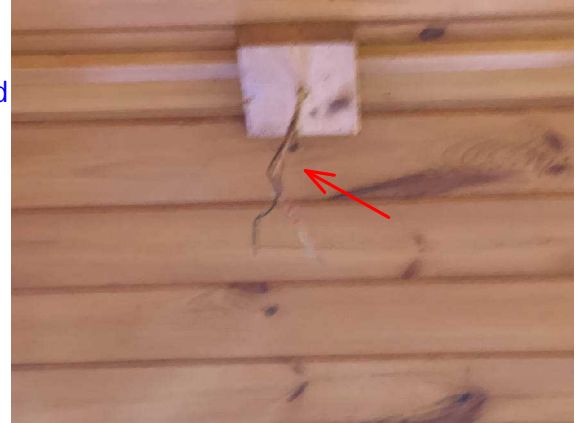
34. ☐☐☐☒☐ Electrical: 110 VAC outlets and lighting circuits -  
Recommend either a light fixture be installed or the  
exposed electrical conductor be capped and protected  
inside a junction box.

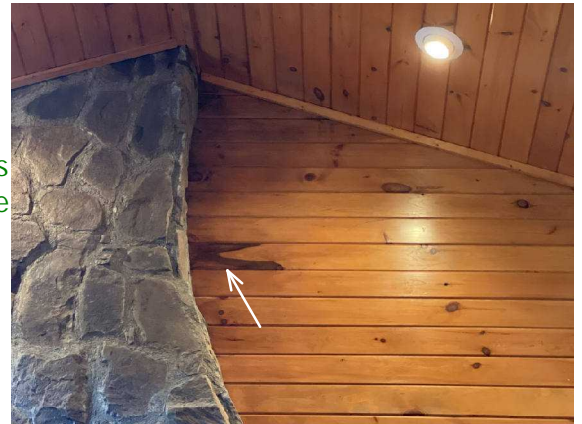
1. ☐☒☐☐☐ Closet:  
2. ☒☐☐☐☐ Ceiling: Wood  
3. ☒☐☐☐☐ Walls: Wood, Painted drywall - there is some  
darkening on one piece of the tongue and groove  
wall near the chimney. However, infrared  
photography does not indicate any abnormalities. It  
is possible based on the location of this stain that it is  
actually the wood color. A chimney penetration is one  
of the number one areas where leaking will occur so  
it is recommended this area be periodically  
monitored.

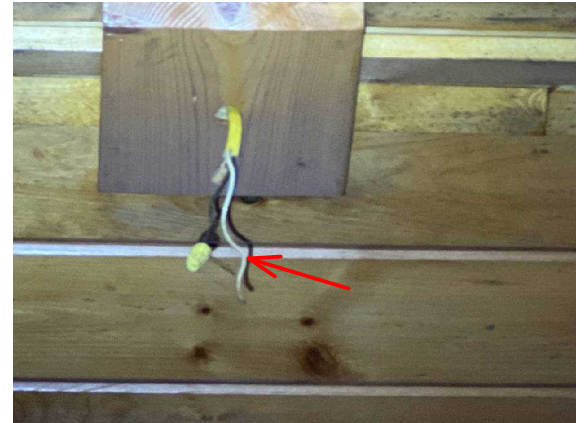
7. ☒ ☐ ☐ ☒ ☐ Electrical: 110 VAC outlets and lighting circuits -  
Recommend either a light fixture be installed in the  
living room ceiling or this conductor capped and  
protected inside a junction box.

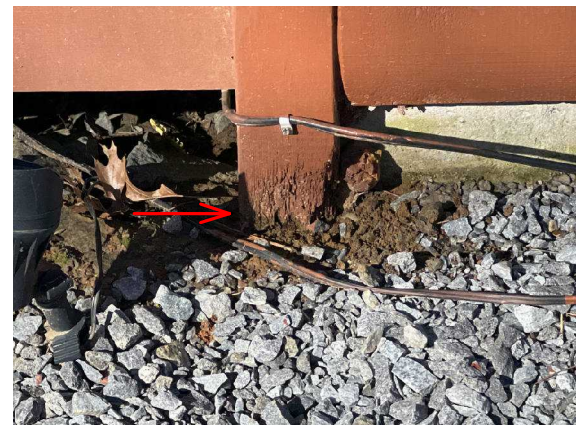
3. Trim: Wood - There is some deterioration to the trim near ground left to the left of chimney. Recommend repair.

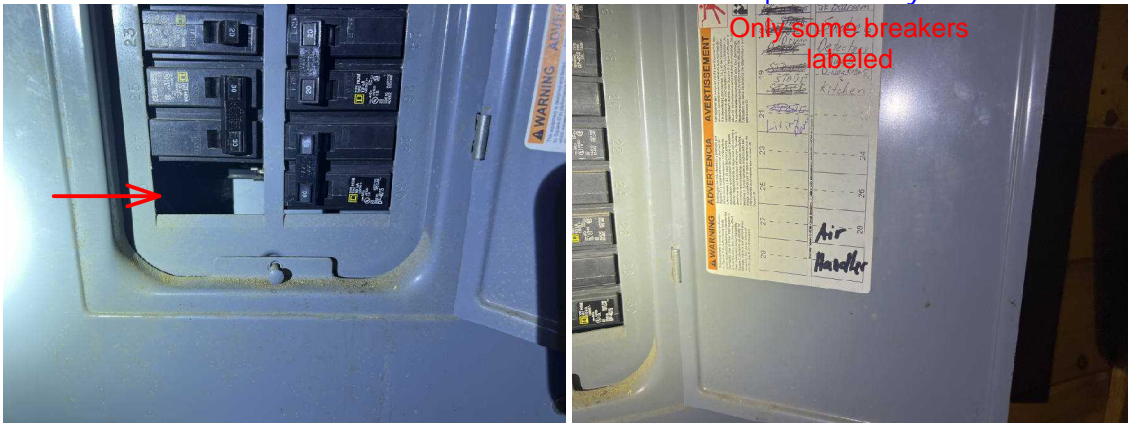
7. Bedroom Electric Panel Breakers: Copper - Recommend the open breaker slot be covered with a filler plate. Also recommend all breakers be labeled. At the time of inspection only some of the breaker were labeled.

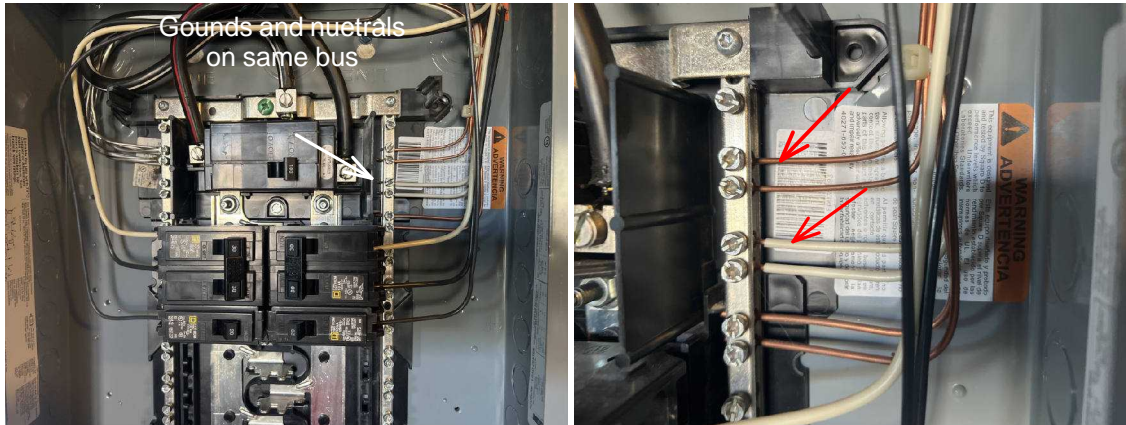
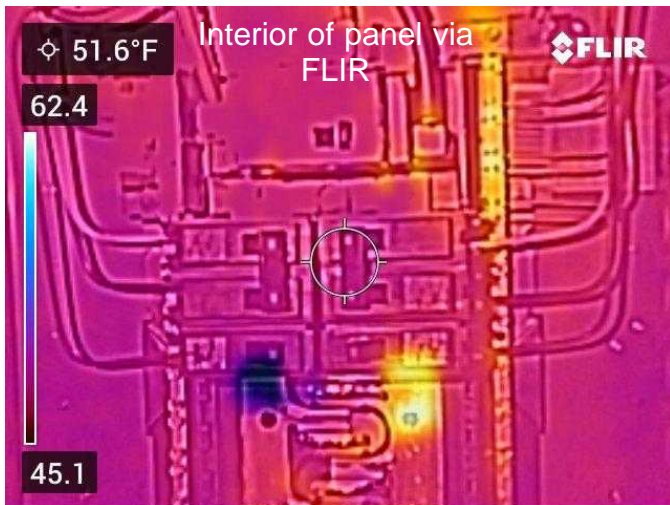
8. Basement sub panel Electric Panel Manufacturer: Square D - The grounds and neutrals should be separated in a sub panel. They are not separated in this sub panel. Recommend consultation with electrician for further evaluation.

FLIR infrared indicates no elevated heat levels.

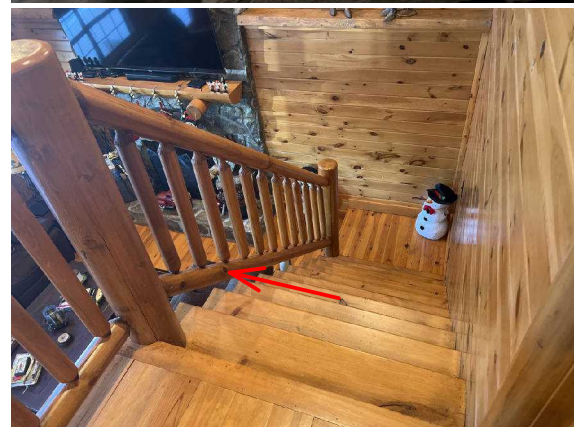
12. Stairs/Handrails: Wood stairs with wood handrails - The handrail on the steps leading to the upper floor is loose. Recommend tightening.

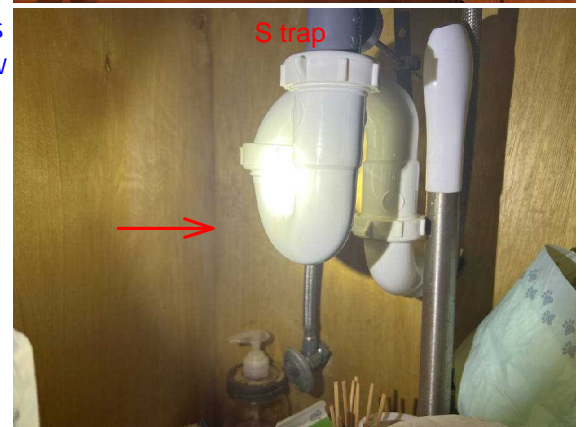
28. 1st floor half bath Bathroom Sink/Basin: Molded single bowl - This sink has an "S" trap. These types of traps are no longer used in new construction due to problems with siphoning. Recommend either replacing with P traps, or being diligent in making sure S traps are not dry and there is always water in the trap to stop sewer gasses from entering the home.

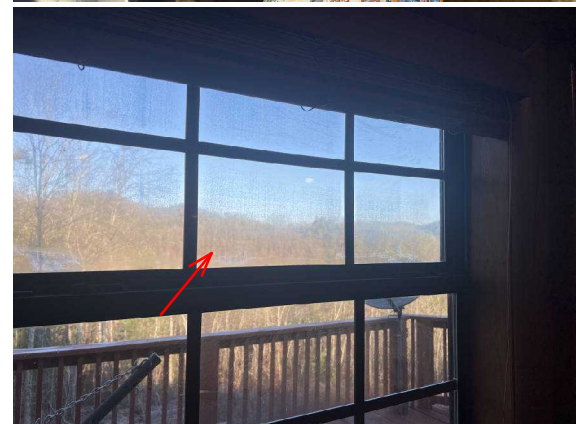
36. 1st Floor Kitchen Windows: Metal frame insulated - Fogging between panes of glass likely the result of a failing seal. Not uncommon over time in insulated windows

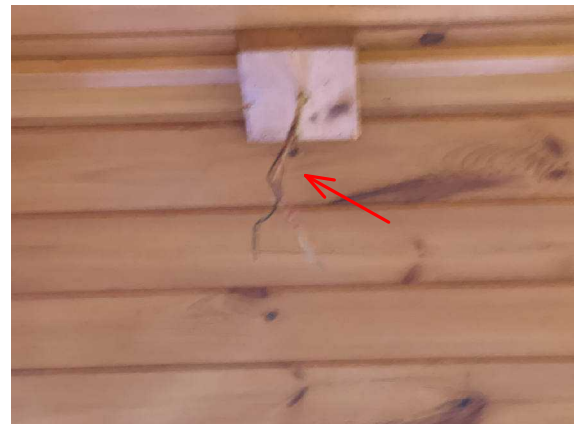
40. 2nd Floor Master Bedroom Electrical: 110 VAC outlets and lighting circuits - Recommend either a light fixture be installed or the exposed electrical conductor be capped and protected inside a junction box.

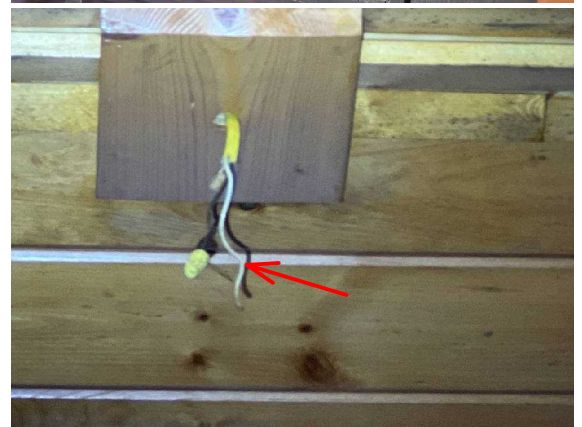
43. Living Room Living Space Electrical: 110 VAC outlets and lighting circuits - Recommend either a light fixture be installed in the living room ceiling or this conductor capped and protected inside a junction box.
