Premier Home Inspections  
519 Old Hwy 5 N  
Elijay, GA 30540

# Home Inspection Report

90 Camber Ct  
Elijay, Georgia 30540

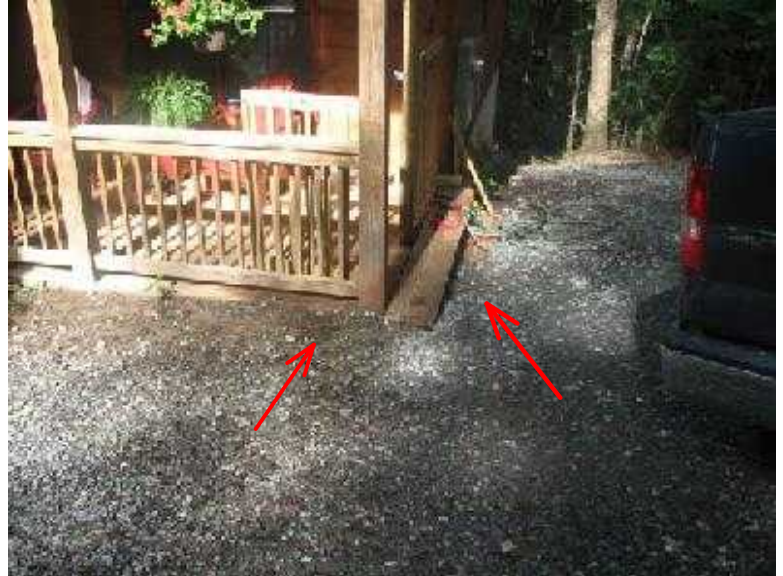
1.       **Driveway:** Gravel Gravel and dirt washing down driveway and accumulating at porch steps and is almost to the point of washing onto front porch.

2.       **Steps/Stoops:** Wood Driveway gravel and dirt levels are at or above stair level. This is being caused by gravel and dirt washing down driveway and accumulating at base of porch. If this continues, gravel and dirt will eventually start to wash over porch areas. Wood to earth contact also prematurely deteriorates wood.

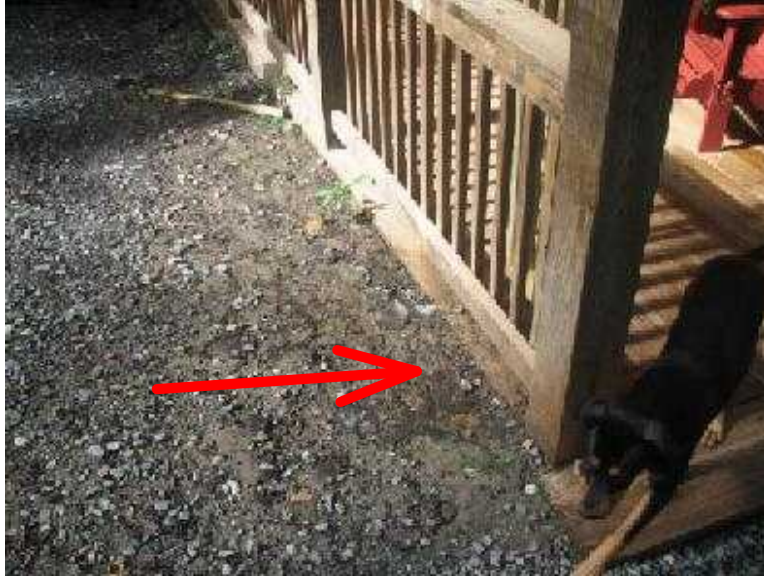
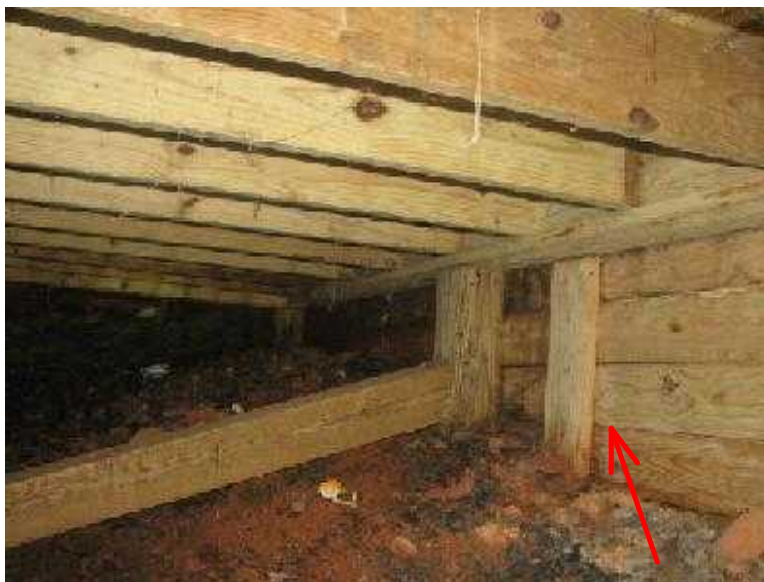
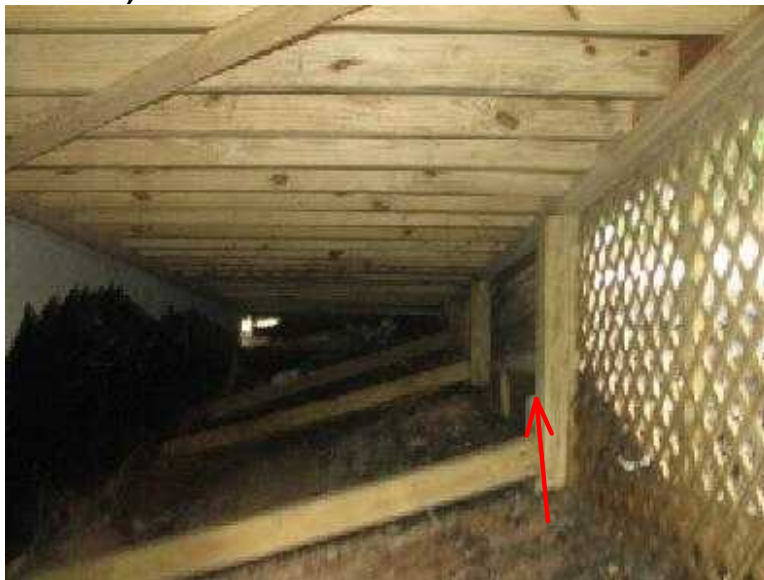
6.       **Retaining Walls:** Wood A retaining wall has been constructed beneath the front porch using treated 2x6 lumber. This wall is holding back the bottom portion of the driveway, as well as the additional dirt and gravel washing down the driveway accumulating near the front porch floor. Wooden retaining walls are usually made from 4x4 material or railroad ties. A 2x6 type of wall exposed to this type of pressure and moisture will most likely fail a significant amount of time before a comparable 4x4 or cross tie wall. The 2x6s are already bowing in slightly in a few places. Wood to earth contact prematurely rots wood. Some of the wood's face on the foundation side of the retaining wall near the steps of the front porch is visibly wet from the runoff from driveway. It is recommended that a grading contractor being contacted about the best course of action for this area.

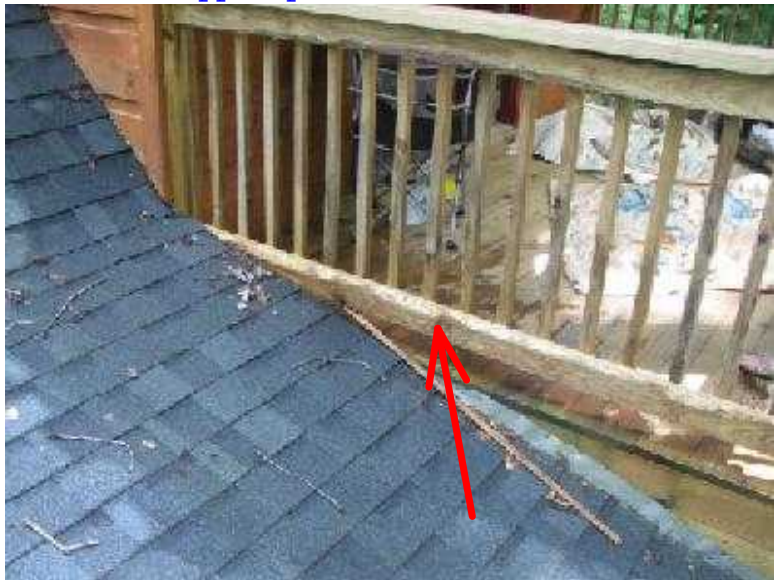
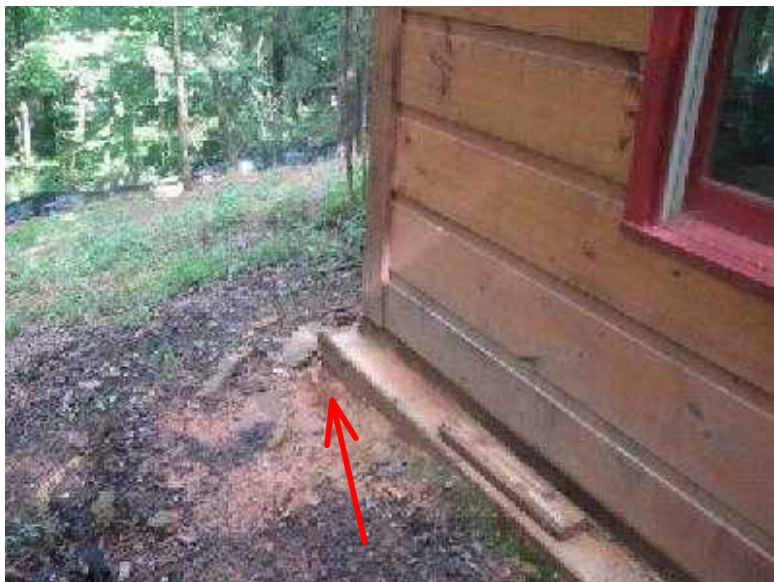
- 1. **Method of Inspection:** On roof
- 2.       **Material:** Asphalt shingle
- 3. **Type:** Intersecting Gable
- 4. **Approximate Age:** 2 Years
- 5.       **Flashing:** Aluminum
- 6.       **Plumbing Vents:** PVC
- 7.       **Electrical Mast:** Underground utilities
- 8.       **Gutters:** None Recommend installation of gutters to prevent erosion of area around foundation. Also will prevent water from running off roof onto upper porch area and then down to lower front porch area.

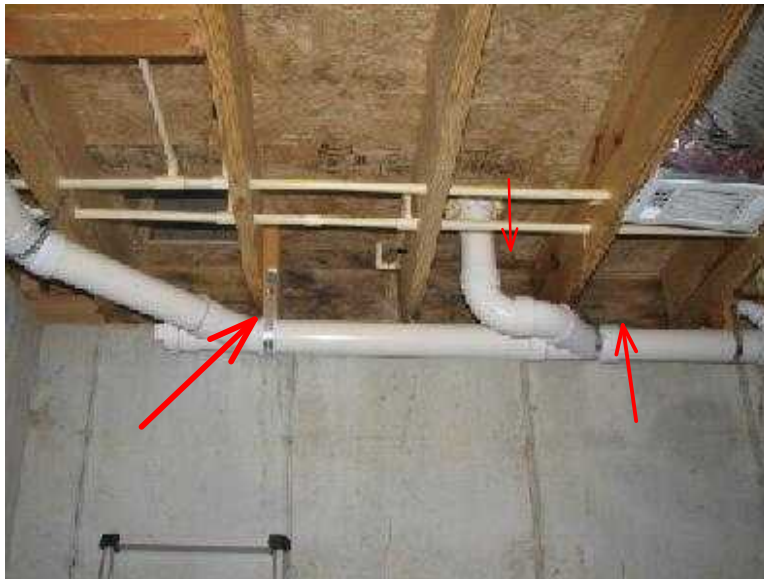
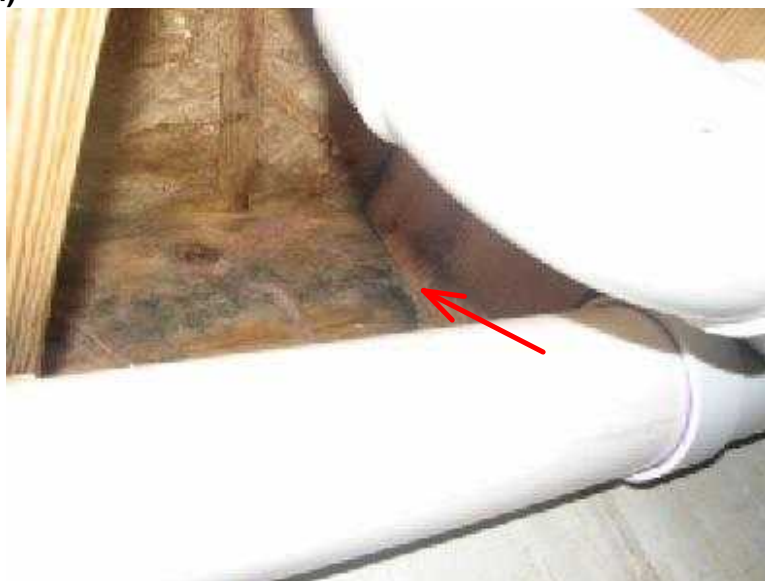
1.       **Ceiling:** Exposed framing Part of sub floor and rim joist under first floor bathroom has mold growth. Recommend area be treated by mold remediation company when mold problems in walls of bathroom are treated.

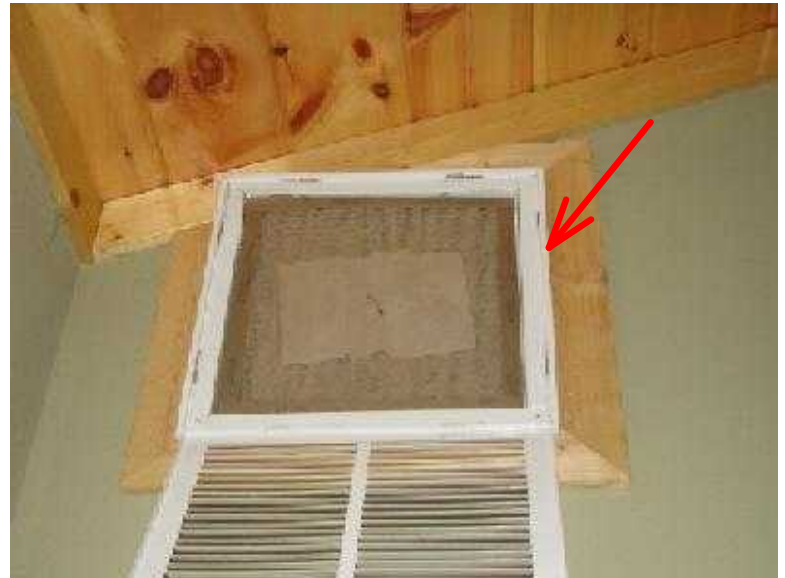
1.       **Heating System Operation:** Adequate
2. **Manufacturer:** Goodman
3. **Model Number:** ARUF303026AA **Serial Number:** 0708743000
4. **Type:** Heat Pump **Capacity:** Not available
5. **Area Served:** Whole house **Approximate Age:** 2 Years
6. **Fuel Type:** Electric
7.       **Blower Fan/Filter:** Direct drive with disposable filter HVAC filters need to be replaced-Dirty

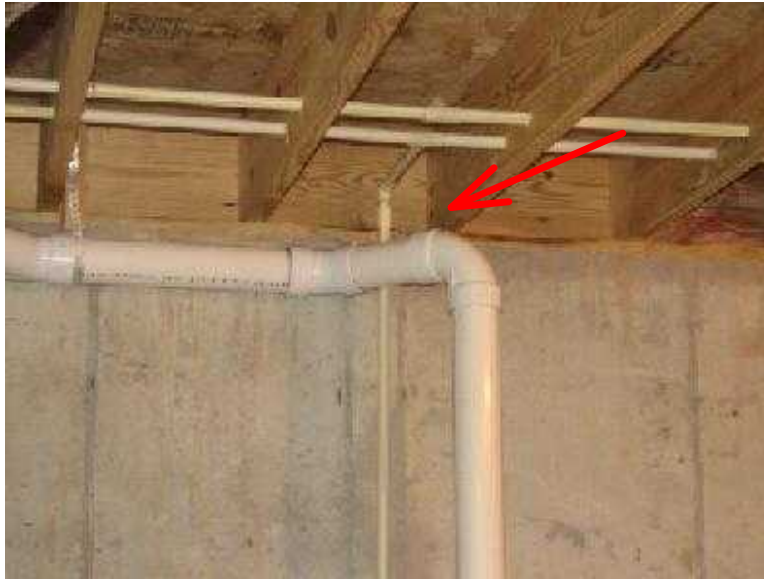
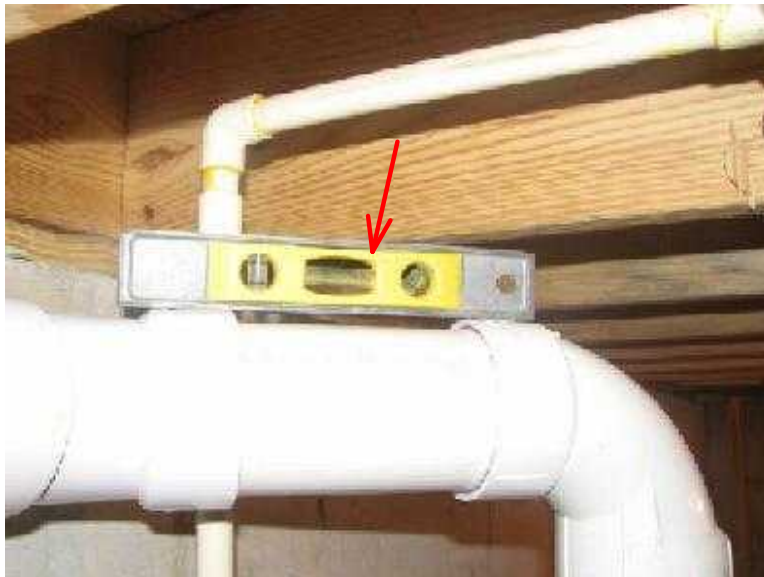
**Drain Pipes:** PVC Homeowner reported overflow in the first flow bathroom from waste in tub backing up. Also reported the waste line had been snaked and a clog pushed on through the line. Main waste line does not slope properly at the top of the run where waste line enters slab in basement. Small run of pipe at 90 degree bend appears to be about 1/2" higher than the next run of pipe, creating an uphill run. All waste piping needs to maintain a downward slope.

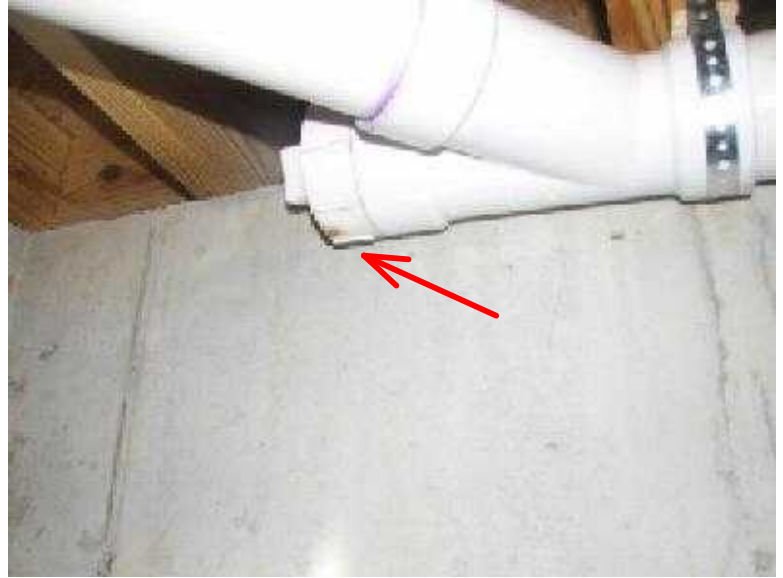
5.       **Service Caps:** Accessible  
 Minor leak at clean out service cap under first floor bathroom.

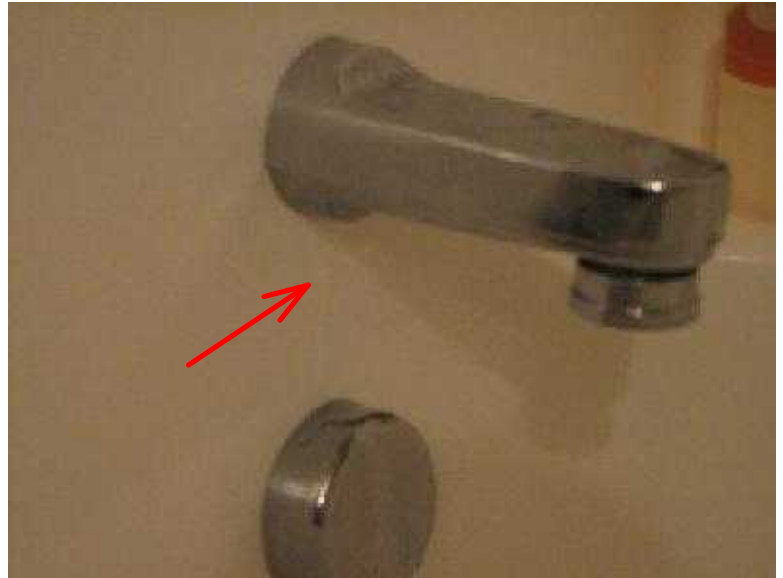
- 10.       **Tub/Surround:** Fiberglass tub and fiberglass surround Tub faucet leaking around shower wall area. If water is allowed to enter wall cavity, drywall can be damaged over time.

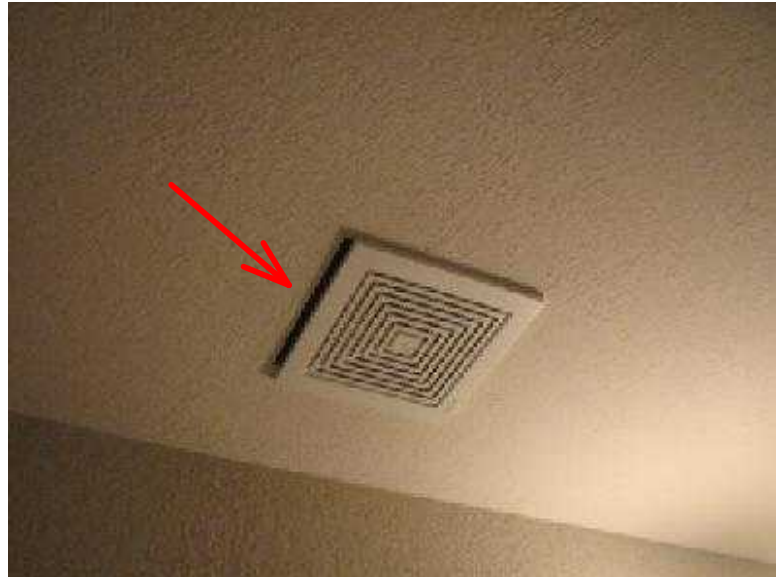
- 11.       **Shower/Surround:** Fiberglass pan and fiberglass surround
- 12.       **Toilets:** Mansfield
- 13.       **HVAC Source:** Heating & cooling system register
- 14.       **Ventilation:** Electric ventilation fan Fan cover does not completely cover hole in ceiling

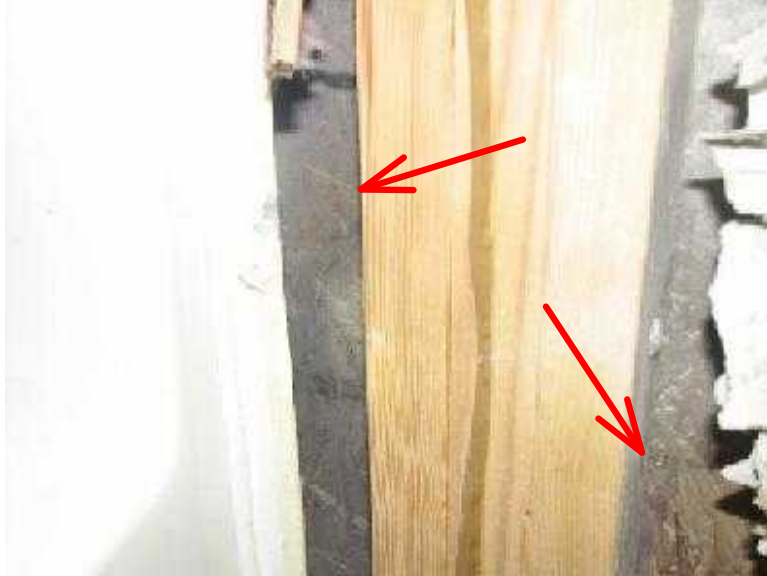
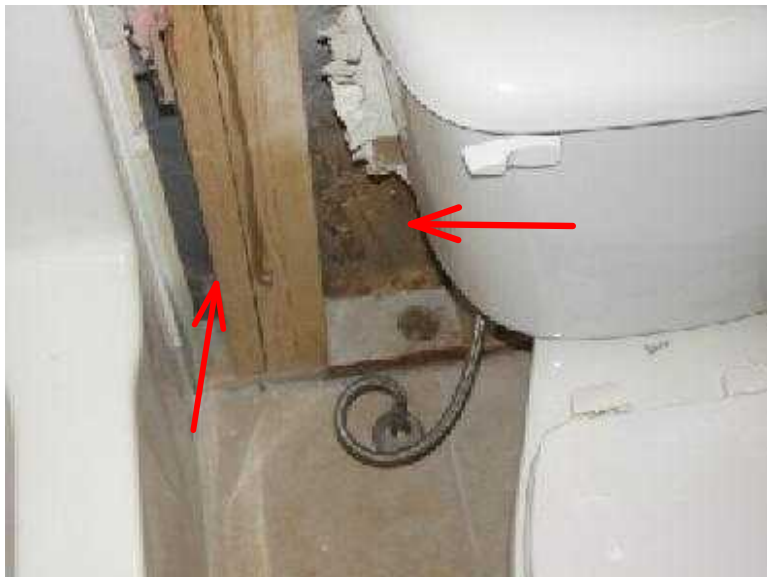
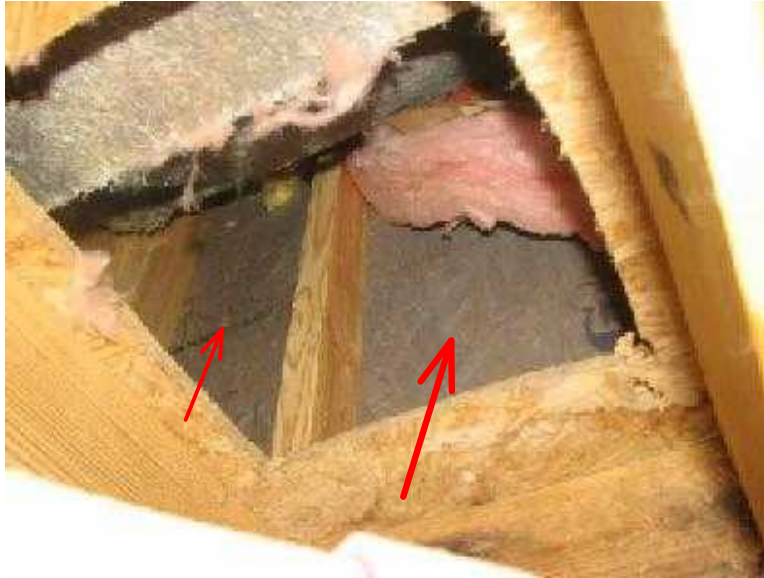
17.      **Walls:** Painted drywall Drywall near the toilet has been removed so the interior of the wall could be accessed to check for mold due to a reported overflow of waste water out of the tub. This water overflow has caused mold growth on the interior of the wall cavity. It is recommended that a mold remediation company be consulted to treat and/or remove the mold. Removal and replacement of drywall and tile should be done at the direction of the remediation company. Mold was also found behind the tub/shower unit.

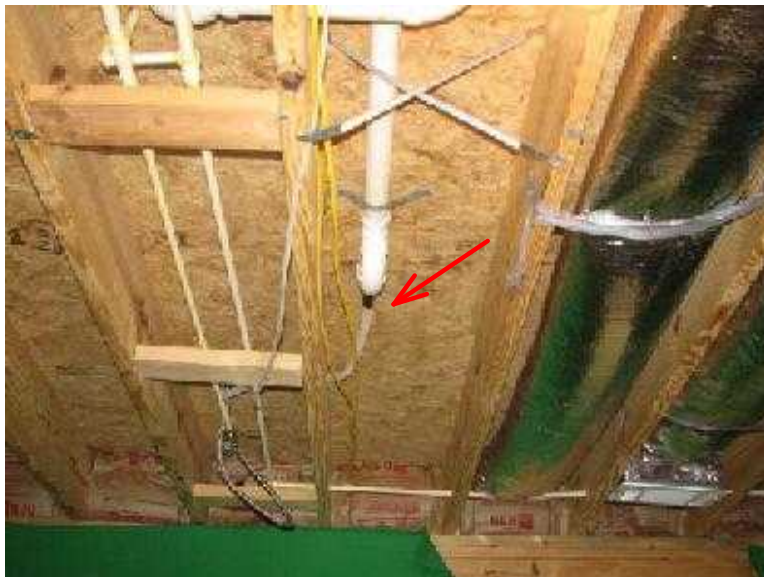
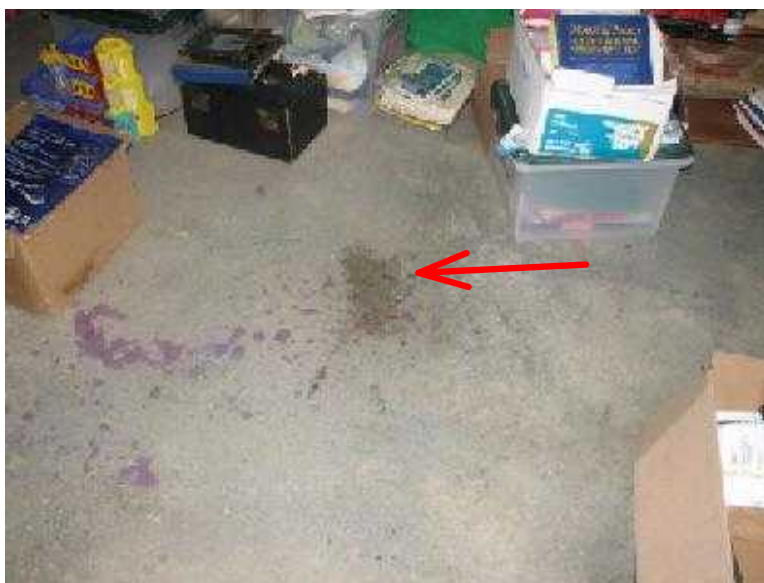
4.       **Dishwasher:** Frigidaire Dishwasher drain line is leaking onto basement floor.

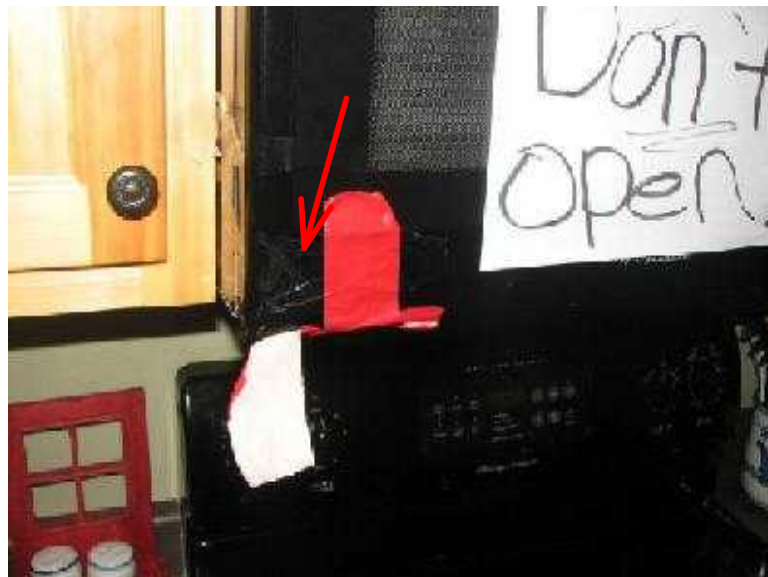
8.       **Microwave:** Frigidaire  
Microwave door broken

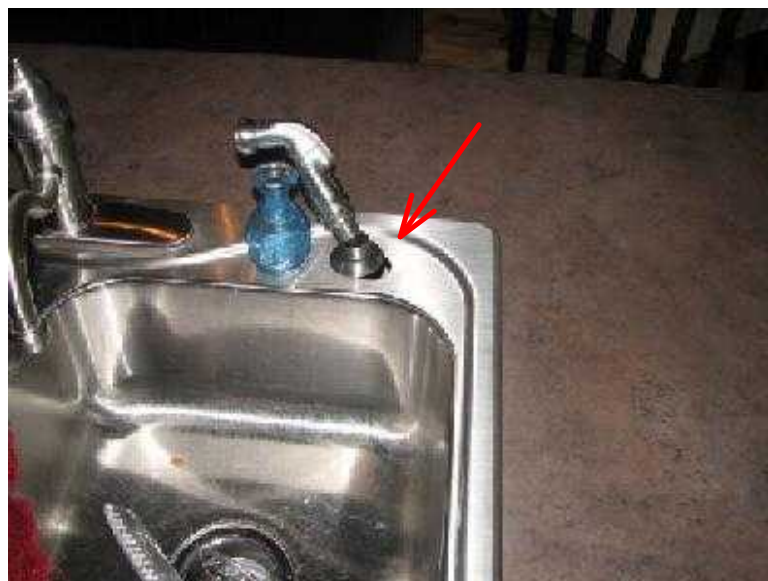
9.       **Sink:** Stainless Steel  
Vegetable sprayer flange loose

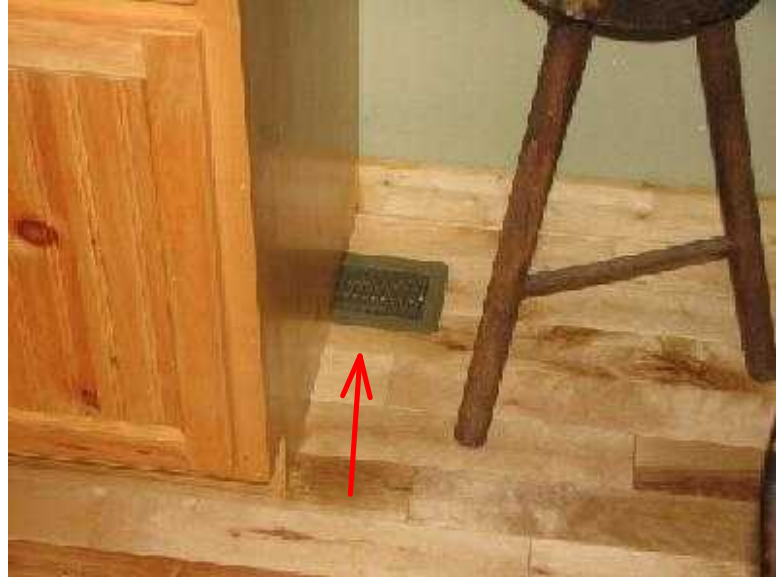
20.       **HVAC Source:** Heating & cooling system register  
 Kitchen HVAC register is partially covered by cabinet unit. This can cause condensation on the bottom of the cabinet unit

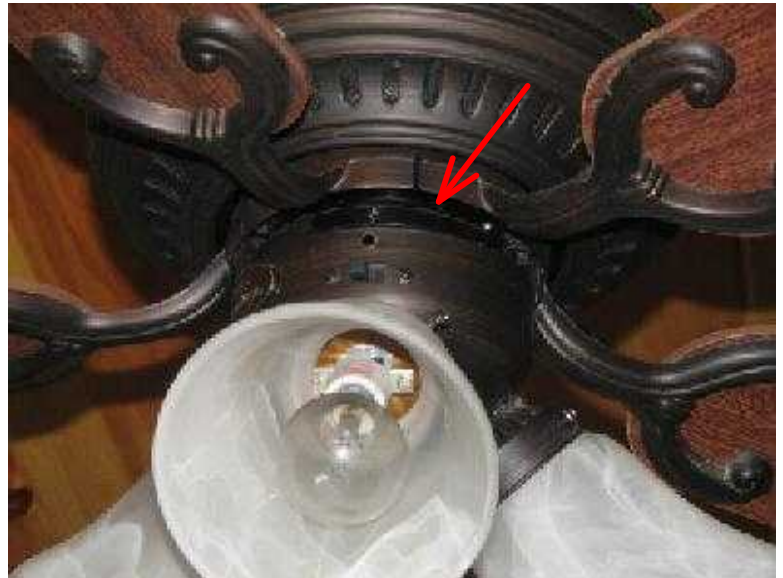
Ceiling fan light is inoperable. It appears the light housing part of the fan is not properly attached to the main body of fan, possibly causing wiring inside to pull loose.

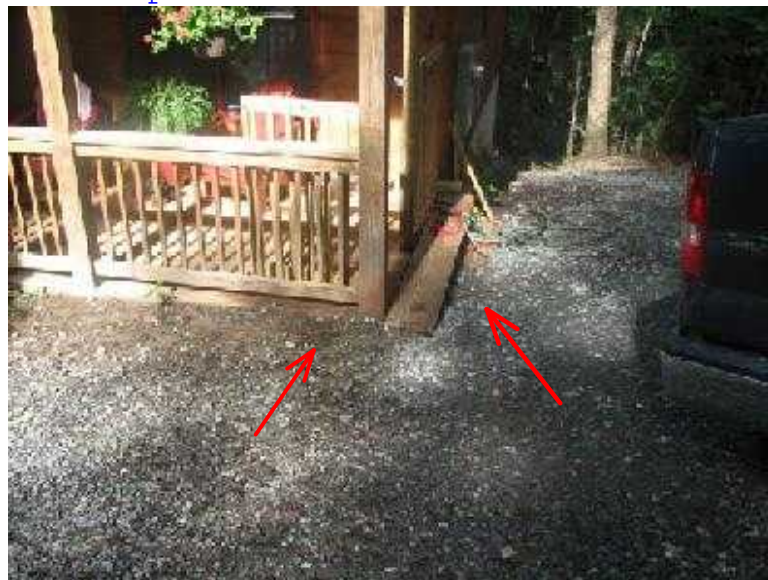
1. **Driveway:** Gravel Gravel and dirt washing down driveway and accumulating at porch steps and is almost to the point of washing onto front porch.

2. **Steps/Stoops:** Wood Driveway gravel and dirt levels are at or above stair level. This is being caused by gravel and dirt washing down driveway and accumulating at base of porch. If this continues, gravel and dirt will eventually start to wash over porch areas. Wood to earth contact also prematurely deteriorates wood.

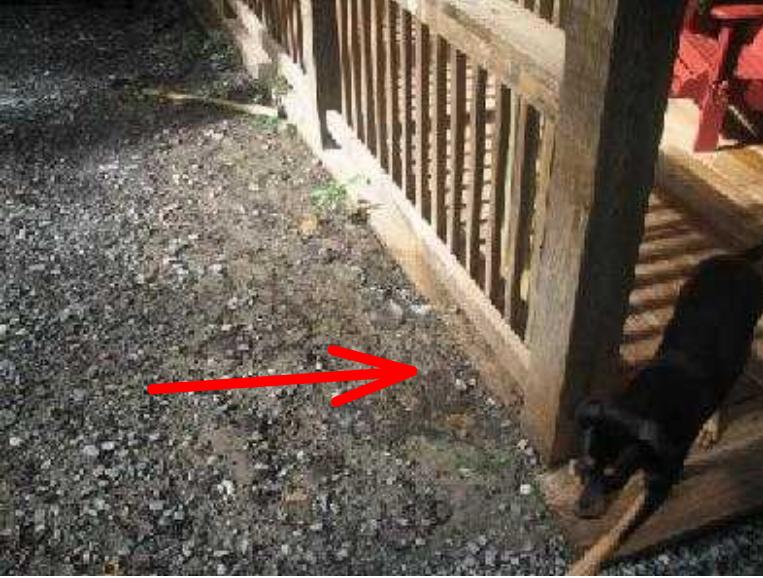
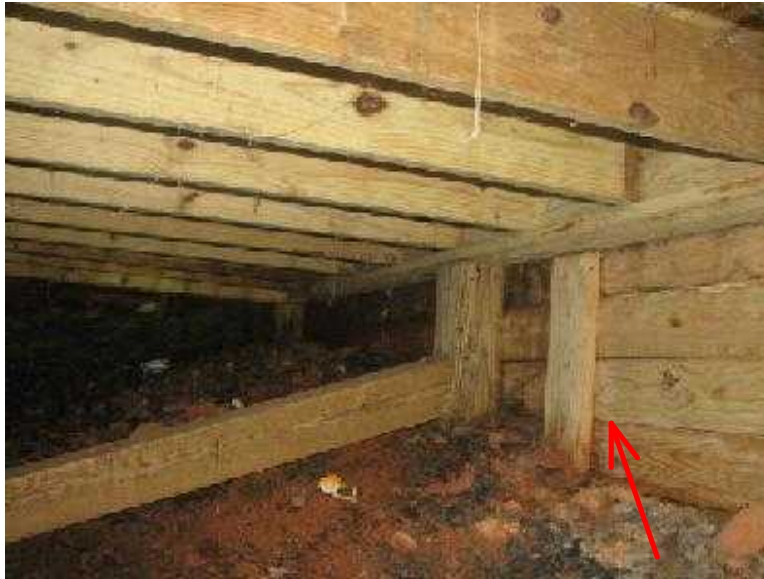
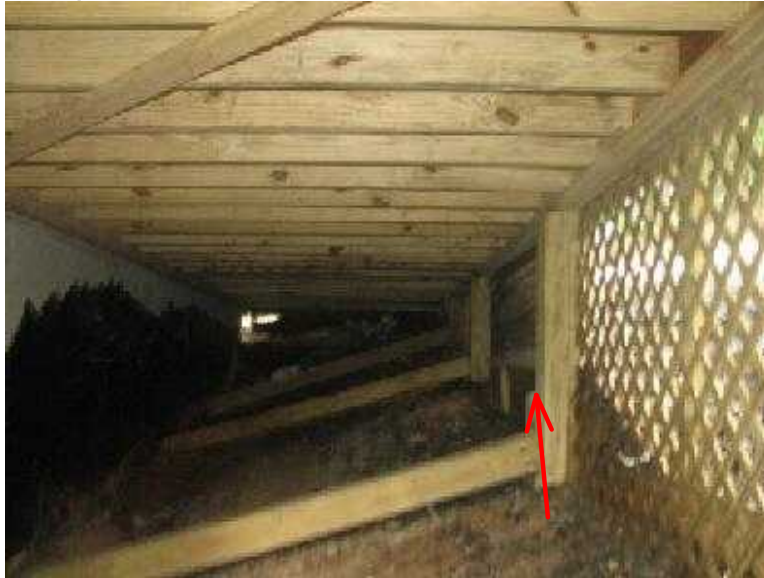
3. **Retaining Walls:** Wood A retaining wall has been constructed beneath the front porch using treated 2x6 lumber. This wall is holding back the bottom portion of the driveway, as well as the additional dirt and gravel washing down the driveway accumulating near the front porch floor. Wooden retaining walls are usually made from 4x4 material or railroad ties. A 2x6 type of wall exposed to this type of pressure and moisture will most likely fail a significant amount of time before a comparable 4x4 or cross tie wall. The 2x6s are already bowing in slightly in a few places. Wood to earth contact prematurely rots wood. Some of the wood's face on the foundation side of the retaining wall near the steps of the front porch is visibly wet from the runoff from driveway. It is recommended that a grading contractor being contacted about the best course of action for this area.

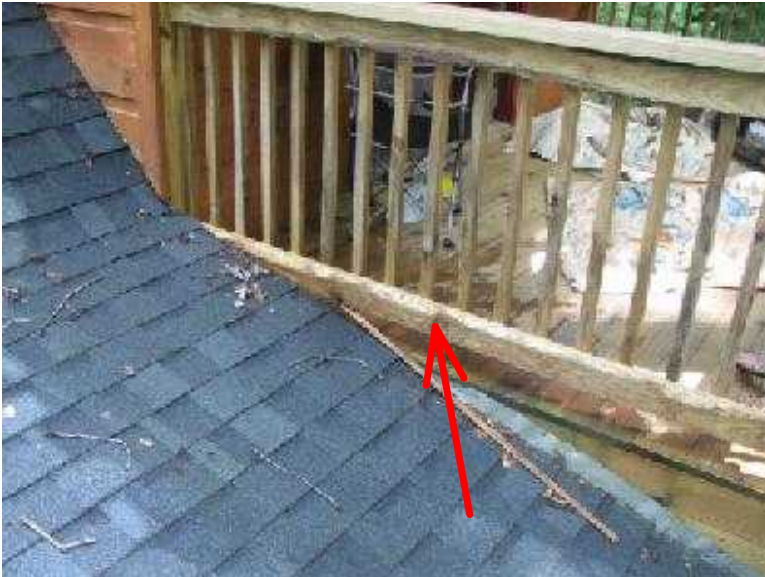
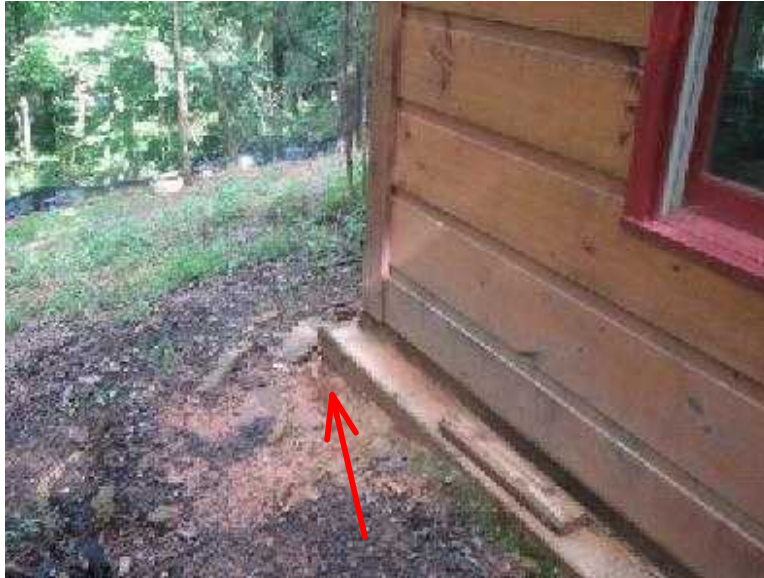
4. **Gutters:** None Recommend installation of gutters to prevent erosion of area around foundation. Also will prevent water from running off roof onto upper porch area and then down to lower front porch area.

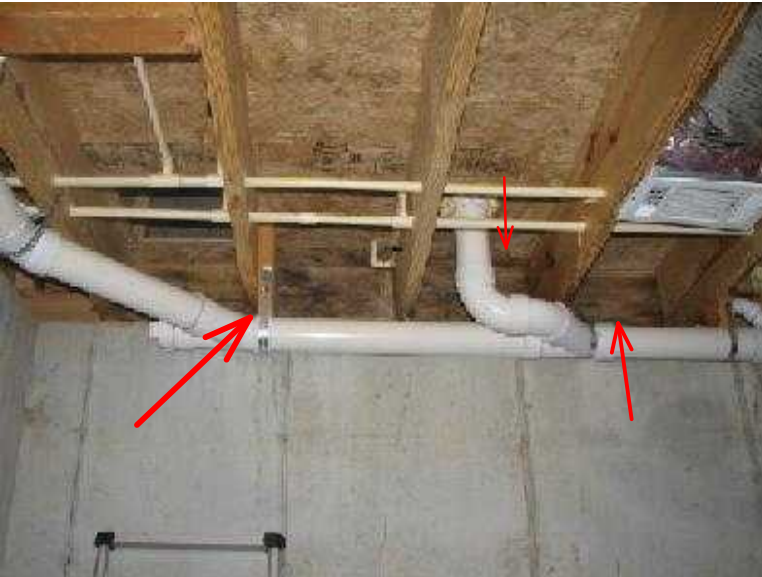
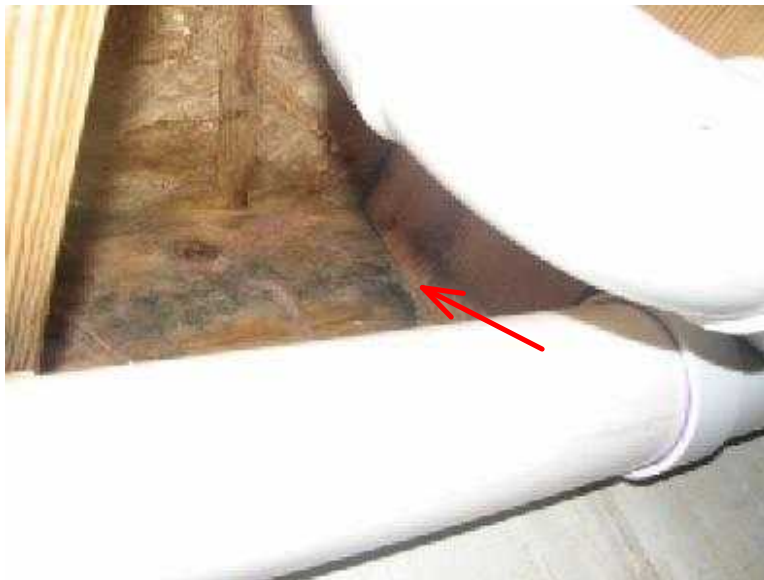
5. **Main Basement Ceiling:** Exposed framing Part of sub floor and rim joist under first floor bathroom has mold growth. Recommend area be treated by mold remediation company when mold problems in walls of bathroom are treated.

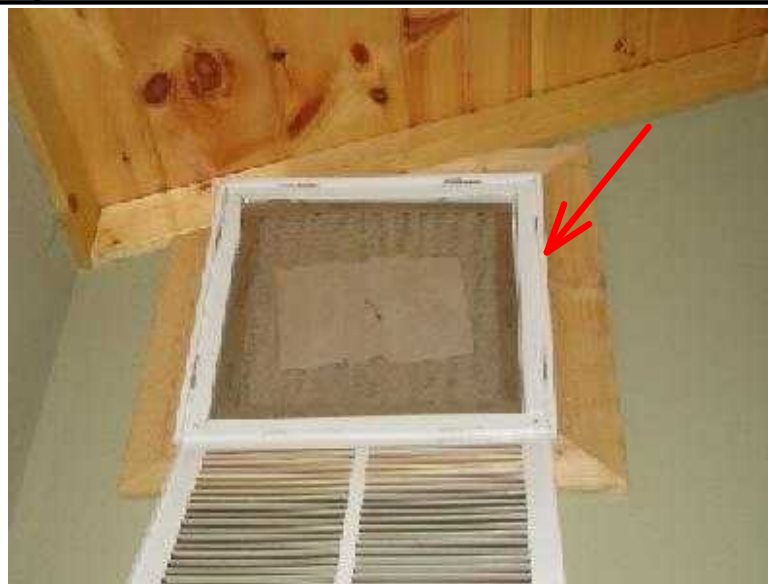
7. **Basement Heating System Blower Fan/Filter:** Direct drive with disposable filter HVAC filters need to be replaced-Dirty

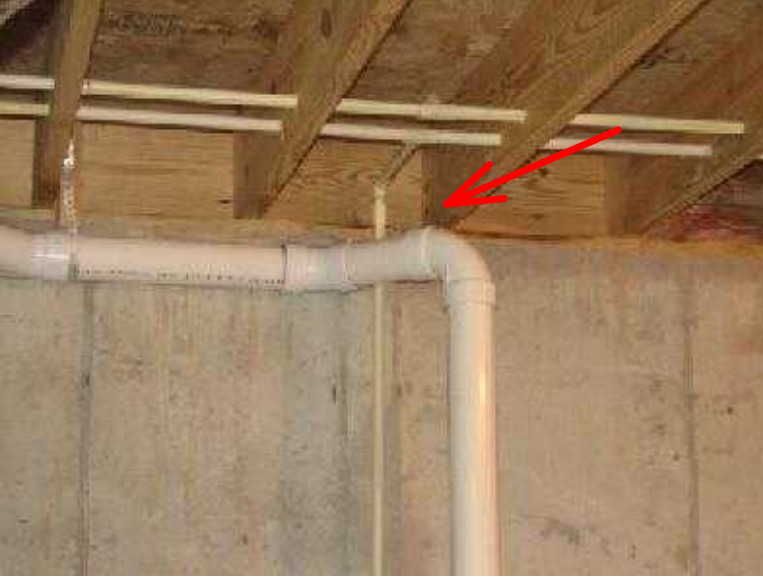
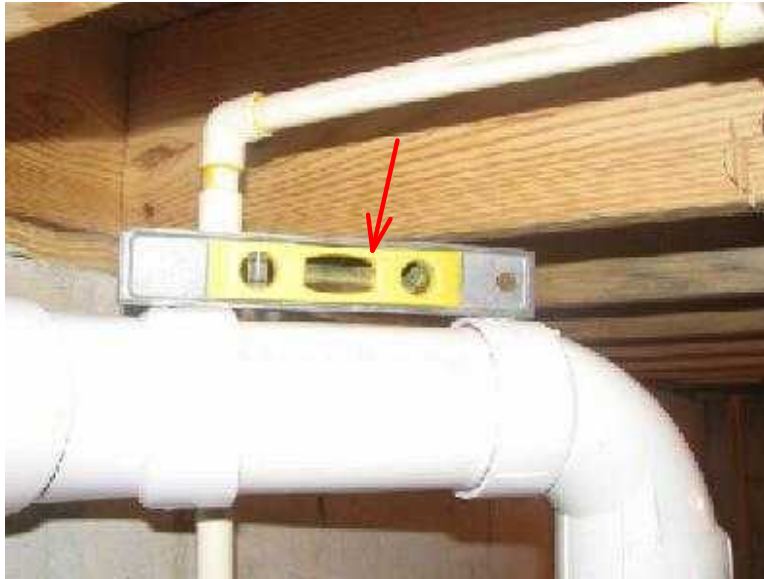
8. **Drain Pipes:** PVC Homeowner reported overflow in the first floor bathroom from waste in tub backing up. Also reported the waste line had been snaked and a clog pushed on through the line. Main waste line does not slope properly at the top of the run where waste line enters slab in basement. Small run of pipe at 90 degree bend appears to be about 1/2" higher than the next run of pipe, creating an uphill run. All waste piping needs to maintain a downward slope.

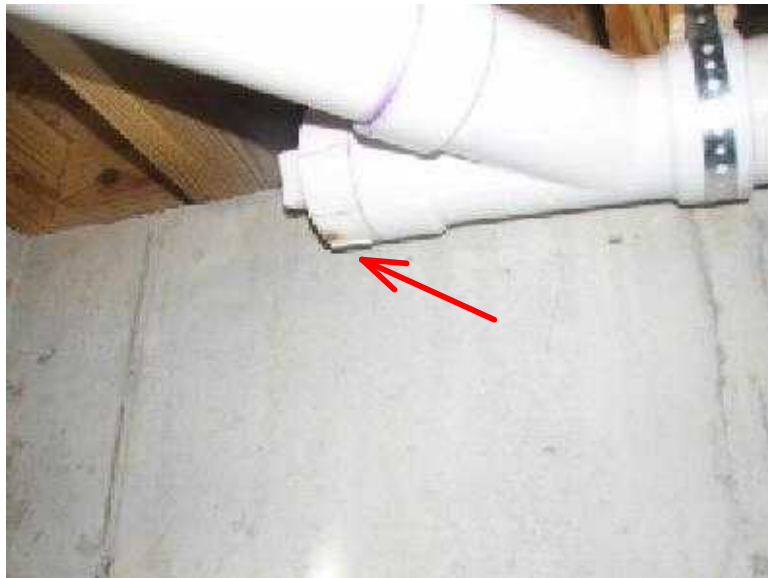
9. **Service Caps:** Accessible [Minor leak at clean out service cap under first floor bathroom.](#)

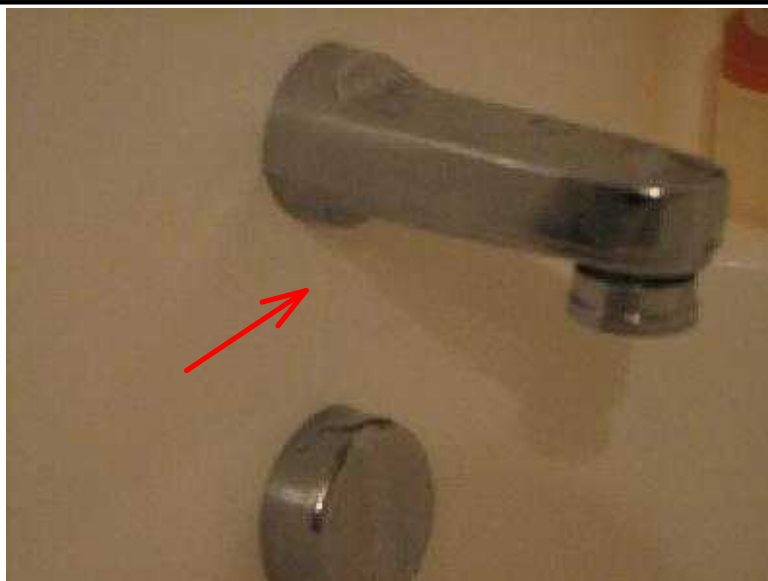
10. **2nd floor main Bathroom Tub/Surround:**  
Fiberglass tub and fiberglass surround  
Tub faucet leaking around shower wall  
area. If water is allowed to enter wall  
cavity, drywall can be damaged over  
time.

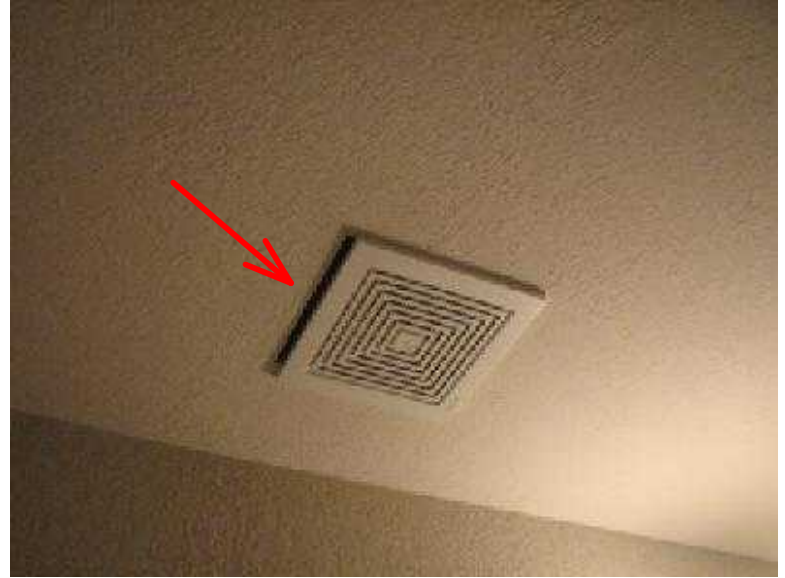
11. 2nd floor main Bathroom Ventilation: Electric ventilation fan Fan cover does not completely cover hole in ceiling

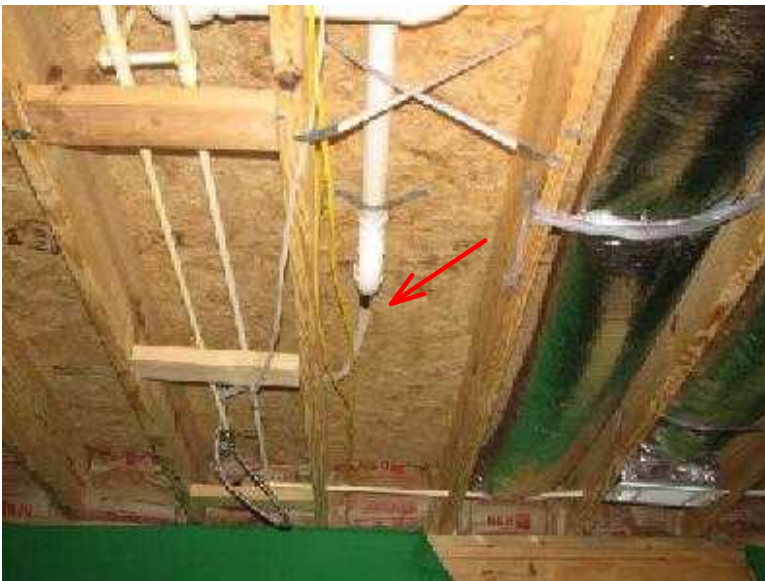
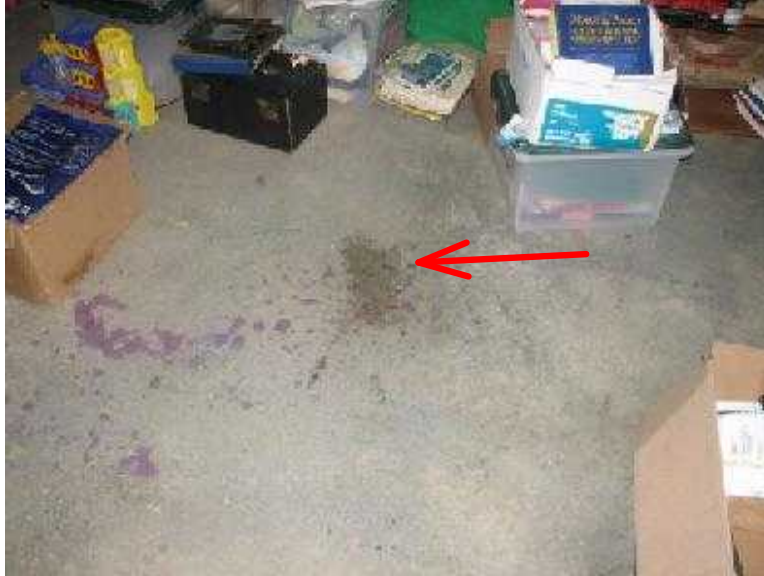
12. 1st Floor Kitchen Dishwasher: Frigidaire Dishwasher drain line is leaking onto basement floor.

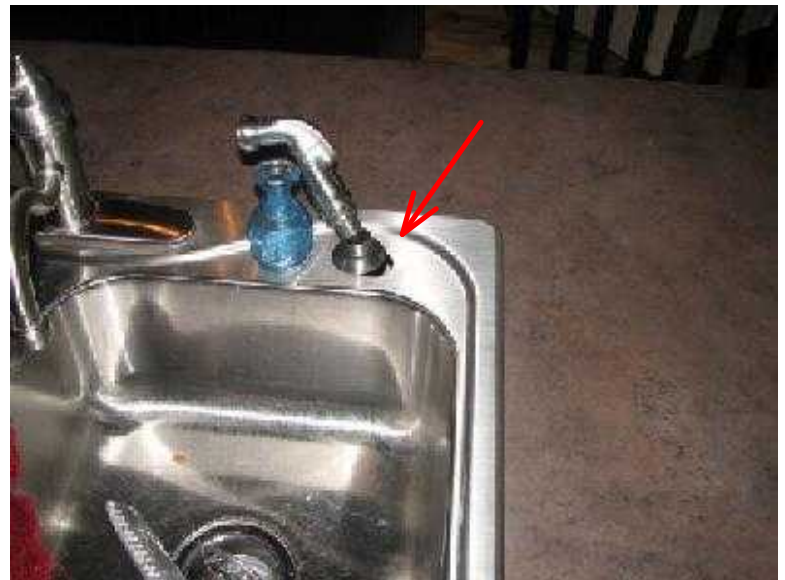
13. 1st Floor Kitchen Sink: Stainless Steel  
Vegetable sprayer flange loose

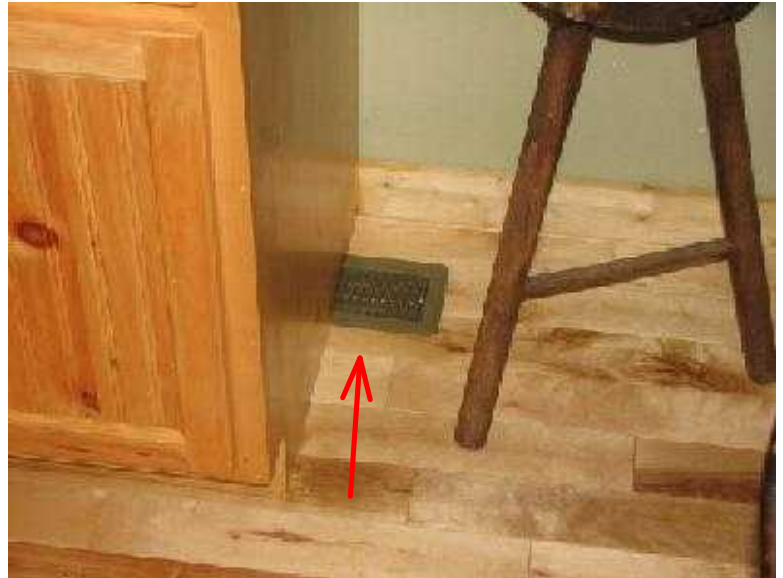
14. **1st Floor Kitchen HVAC Source:** Heating & cooling system register **Kitchen HVAC register is partially covered by cabinet unit.** This can cause condensation on the bottom of the cabinet unit

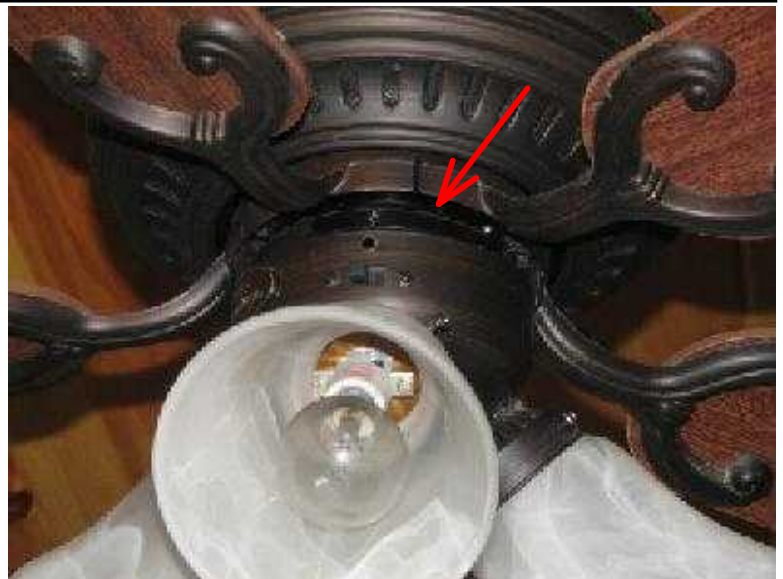
15. **Upstairs loft Living Space Electrical:** 110 VAC outlets and lighting circuits **Ceiling fan light is inoperable.** It appears the light housing part of the fan is not properly attached to the main body of fan, possibly causing wiring inside to pull loose.

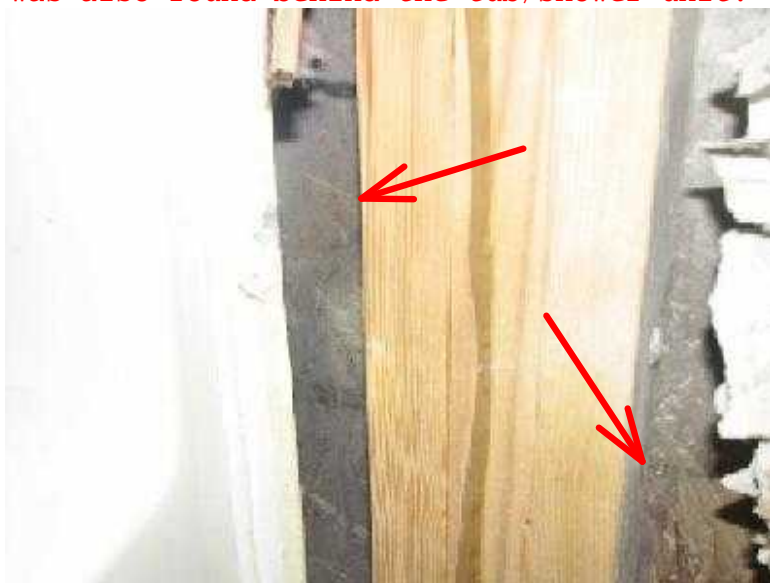
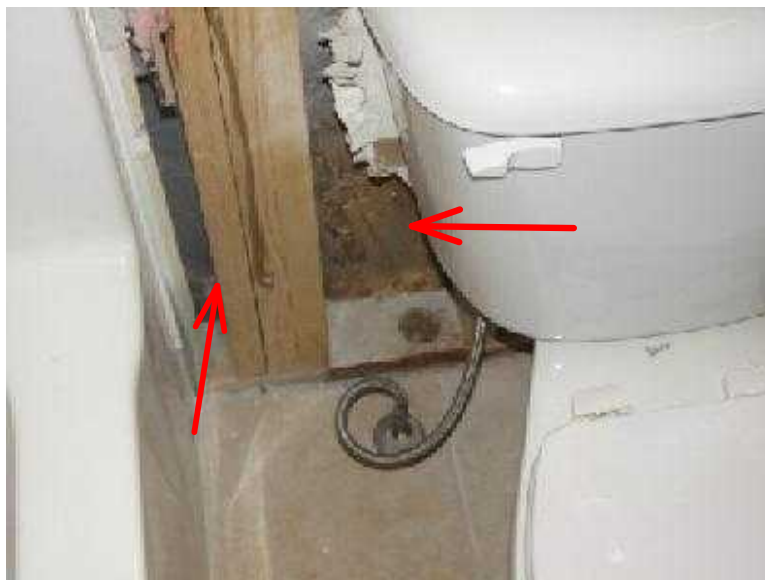
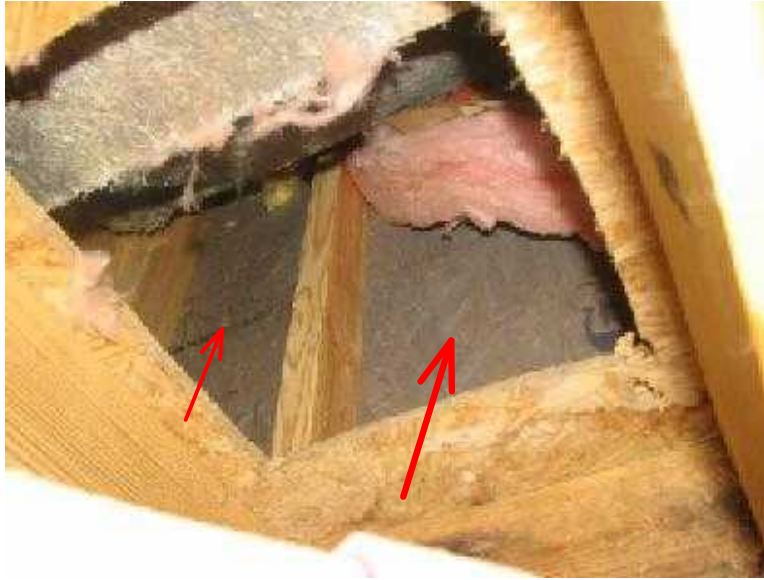
- 1st floor main Bathroom Walls:** Painted drywall Drywall near the toilet has been removed so the interior of the wall could be accessed to check for mold due to a reported overflow of waste water out of the tub. This water overflow has caused mold growth on the interior of the wall cavity. It is recommended that a mold remediation company be consulted to treat and/or remove the mold. Removal and replacement of drywall and tile should be done at the direction of the remediation company. Mold was also found behind the tub/shower unit.

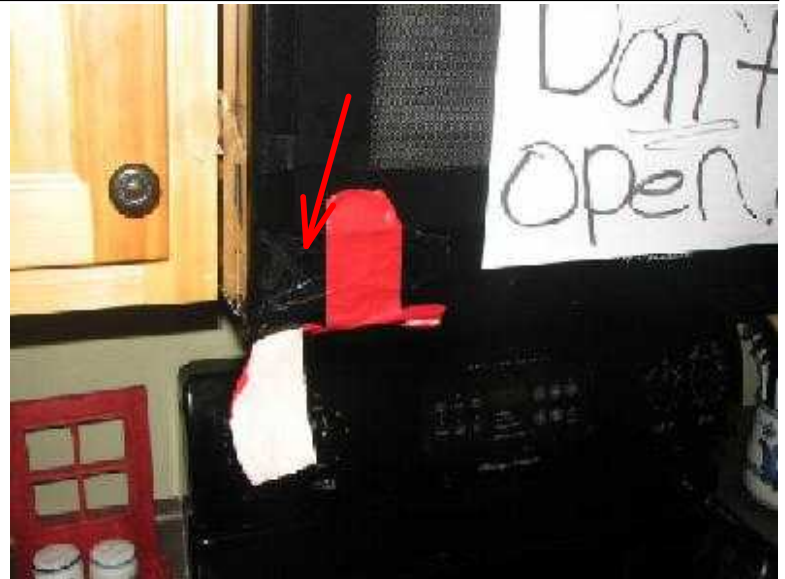
2. 1st Floor Kitchen Microwave: Frigidaire  
Microwave door broken
