WAPATO DIVERSION UPDATE:

SHORT-TERM REPAIRS COMPLETE

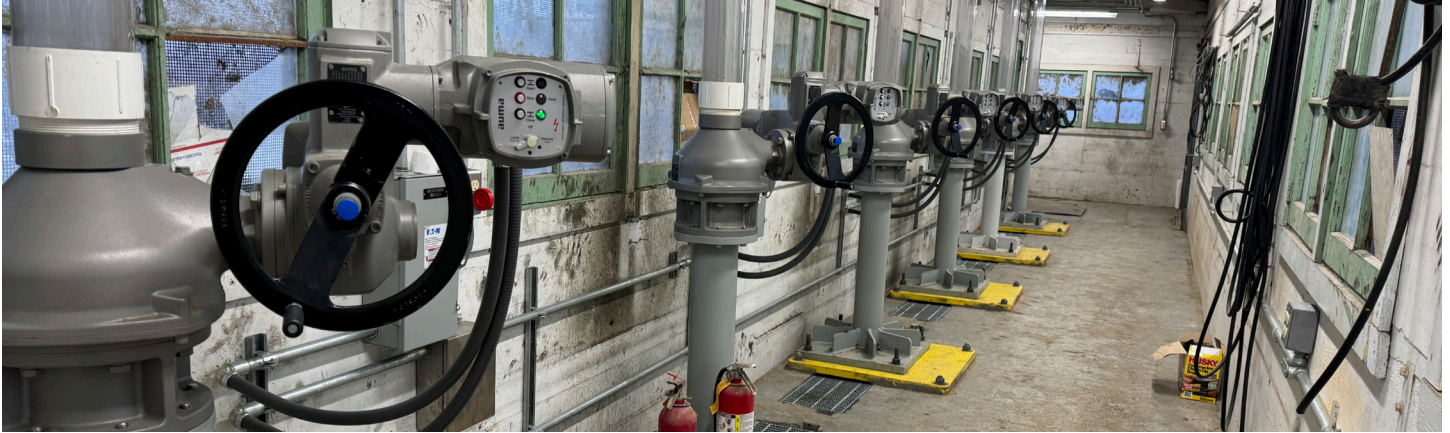
The existing electrical system was operating well beyond its service life and did not meet safety requirements. Several of the components had failed and were not operational.

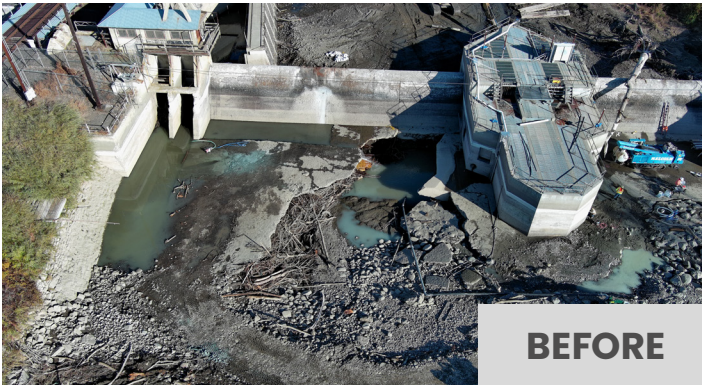
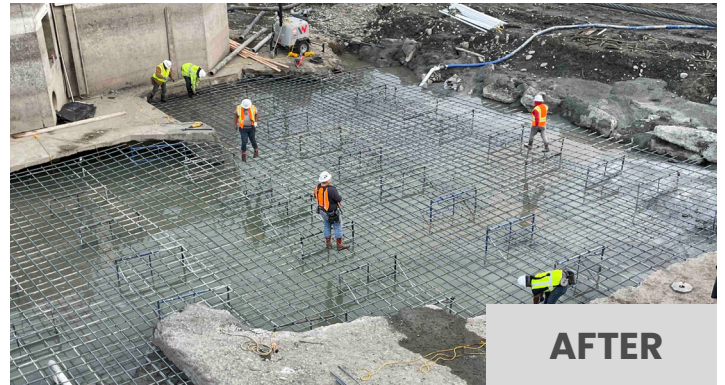
While the short-term rehabilitation project was underway, an extensive scour hole was discovered downstream of the west diversion dam. The scour exposed the diversion foundation and undermined the concrete apron and fish ladder. An emergency repair plan was developed and executed to repair this scour hole, consisting of a mass concrete placement of approximately 1,350 cubic yards of concrete.

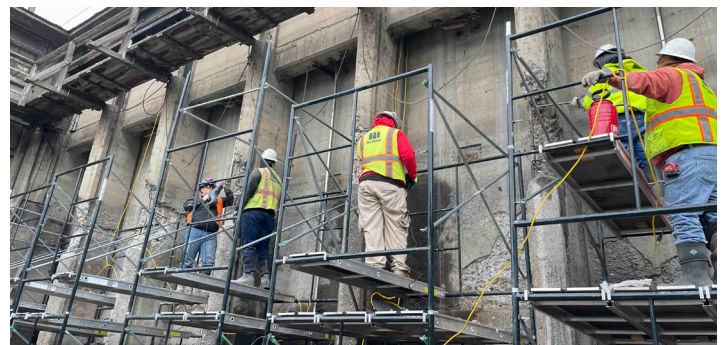
The headworks concrete is severely damaged. BIA completed localized repairs to extend the service life of these structural elements while a more permanent solution is developed.
