# INSPECTION REPORT

For the Property at:  
**631 HUDSON AVE**  
ALBANY, NY

Prepared for: JOHN DOE  
Inspection Date: Monday, June 10, 2019  
Prepared by: Kevin Freiburger

RE: Report No. 1001  
631 Hudson Ave  
Albany, NY

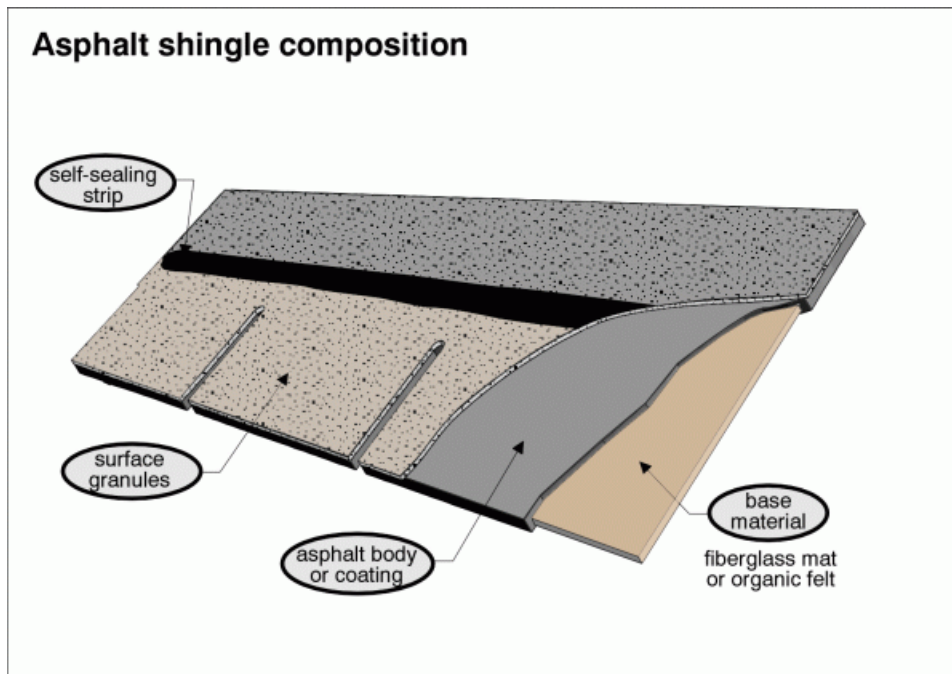
### SLOPED ROOFING \ Asphalt shingles

Condition: • Granule loss

Implication(s): Chance of water damage to contents, finishes and/or structure

Location: South

Task: Replace

Time: Less than 1 year

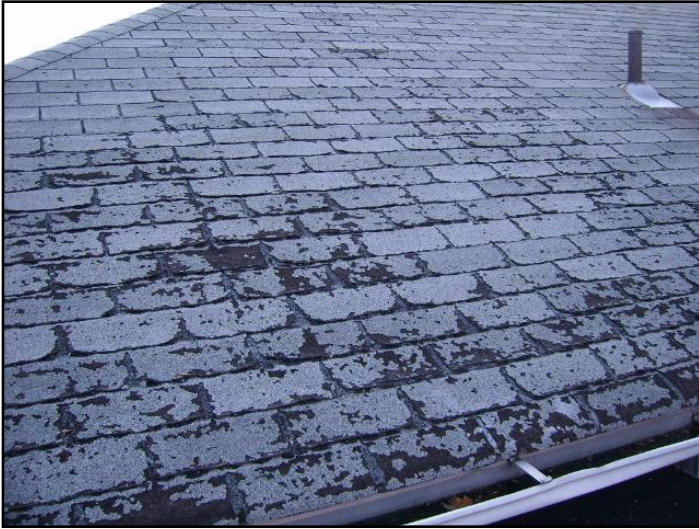
*Granule loss*

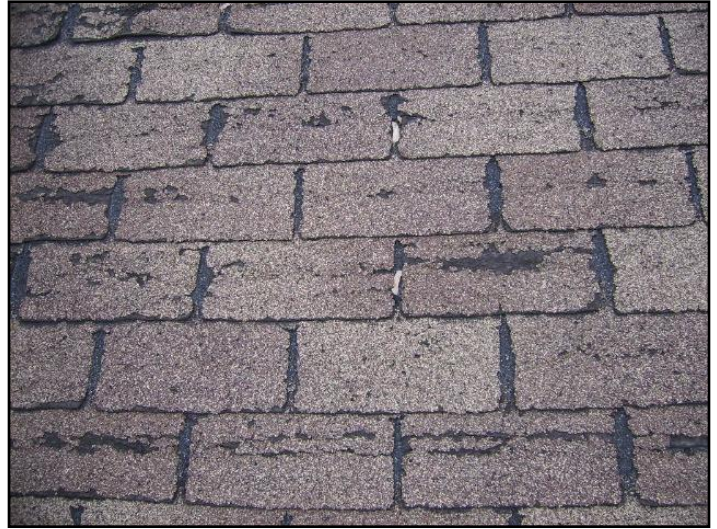
*Granule loss*

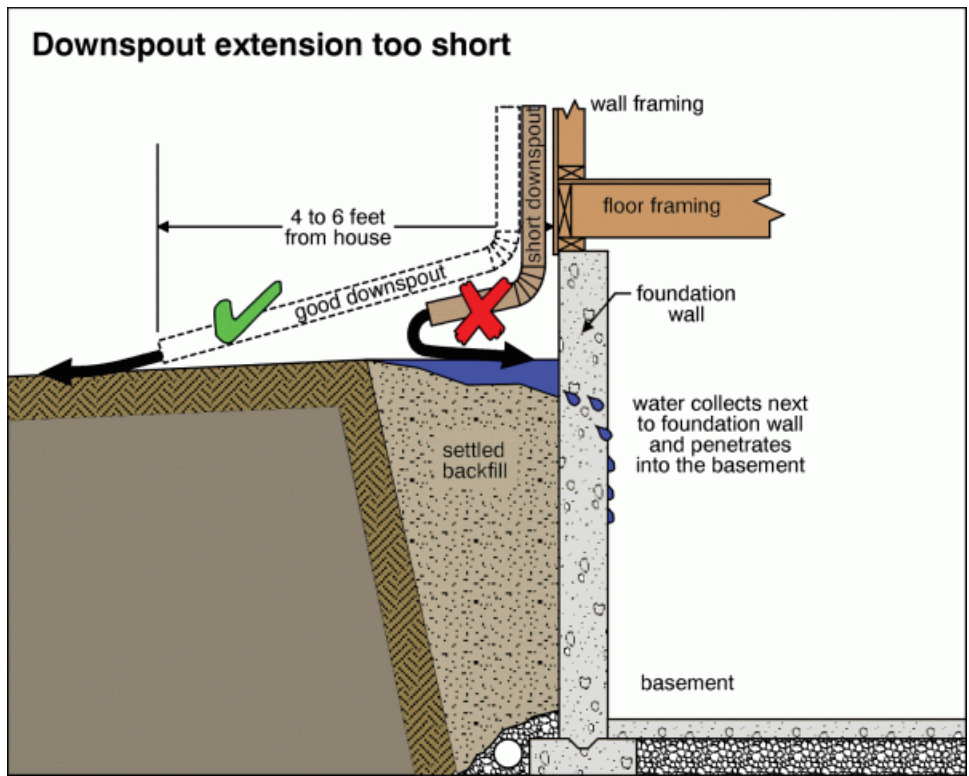
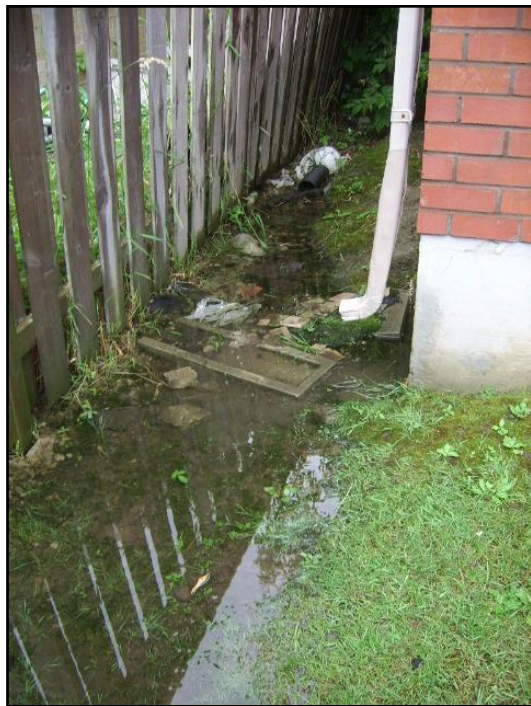
**Condition:** • Discharge too close to building

**Implication(s):** Chance of water damage to contents, finishes and/or structure

**Location:** Rear Left

*Downspouts end too close to building*

**Task:** Improve

**Time:** Immediate

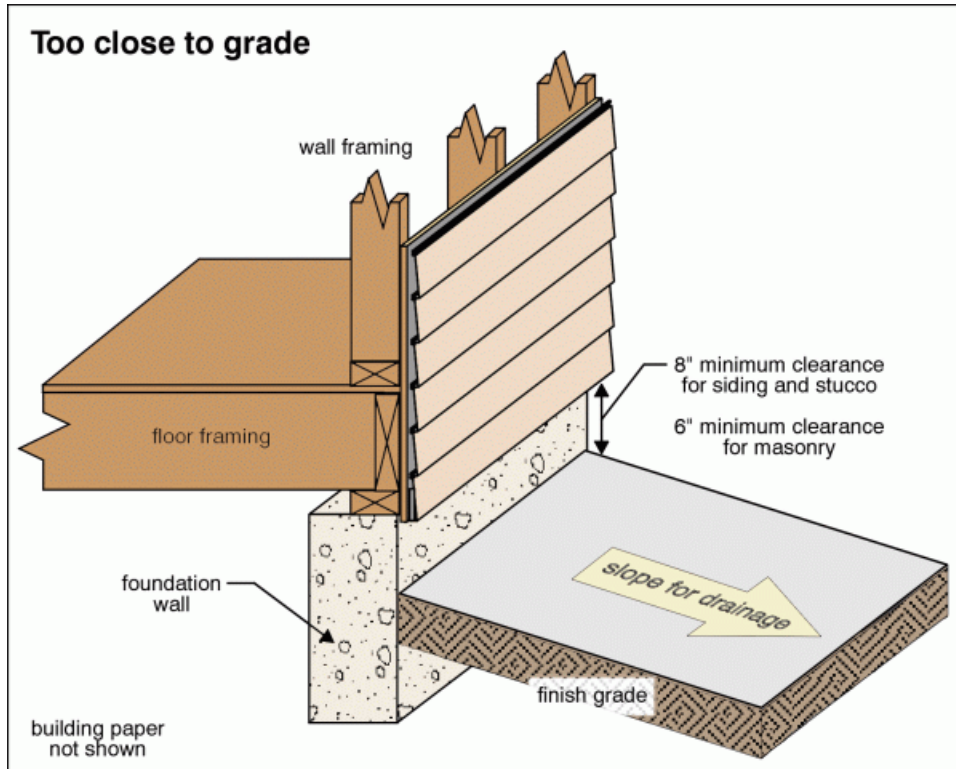
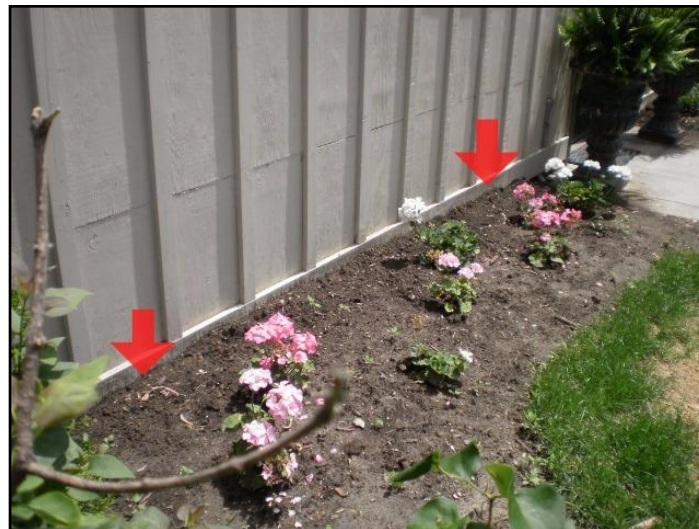
**Condition:** • Too close to grade

**Implication(s):** Chance of water damage to contents, finishes and/or structure | Material deterioration | Rot | Insect damage

**Location:** West Exterior

*Too close to grade*

**Task:** Correct

**Time:** Less than 1 year

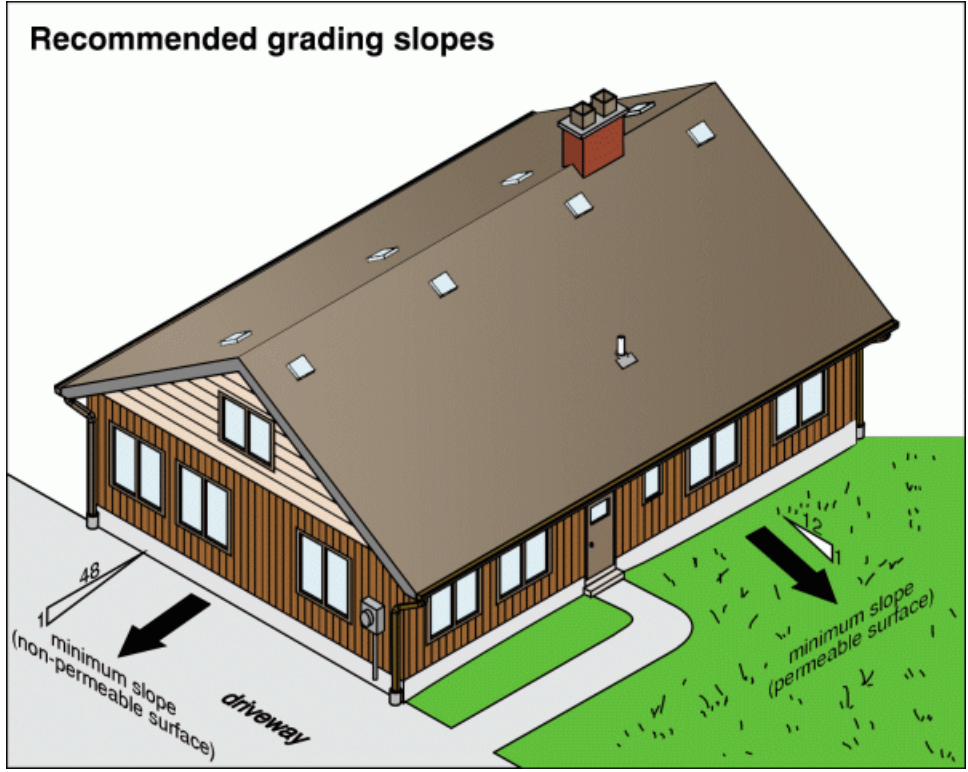
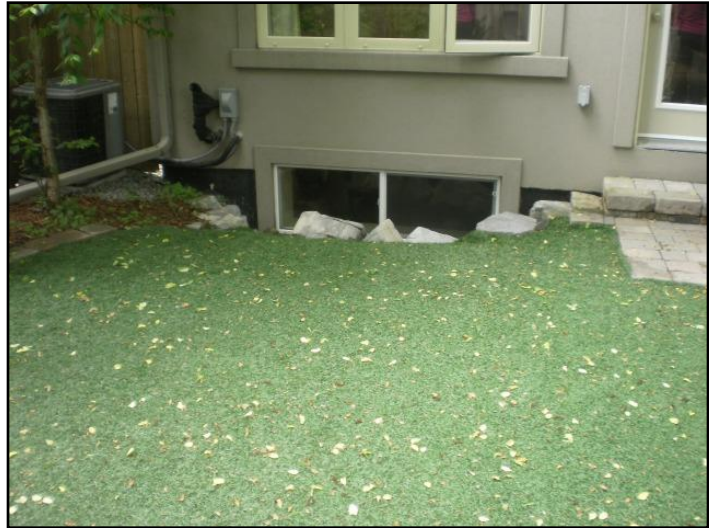
**Condition:** • Improper slope or drainage

**Implication(s):** Chance of water damage to contents, finishes and/or structure

**Location:** Front

*Improper slope*

**Task:** Improve

Time: If necessary
