Armed Forces Adjusting Services, LLC

- 1 SKETCH1/Main Level - 1-
Address
Date Taken: 8/20/2023
Taken By: Hesley Valemburn
Verification

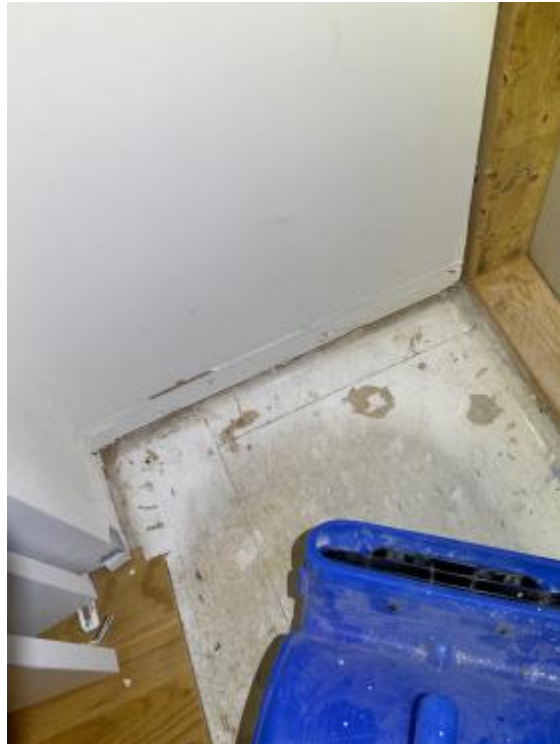
- 56 SKETCH1/Level 2/Office closet -
56-Office Closet
Date Taken: 8/20/2023
Taken By: Hesley Valemburn

Replace baseboard and 1/4 round

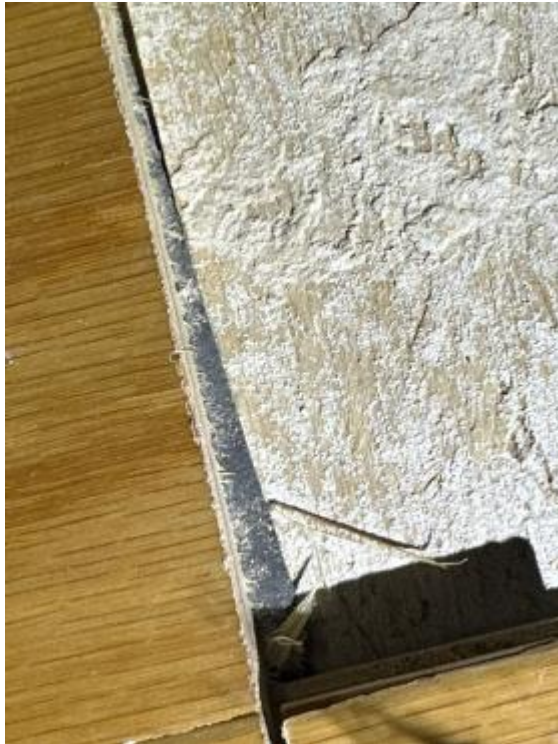
- 58 SKETCH1/Level 2/Office closet -
58-Office Closet
Date Taken: 8/20/2023
Taken By: Hesley Valemburn
Evidence of underlayment

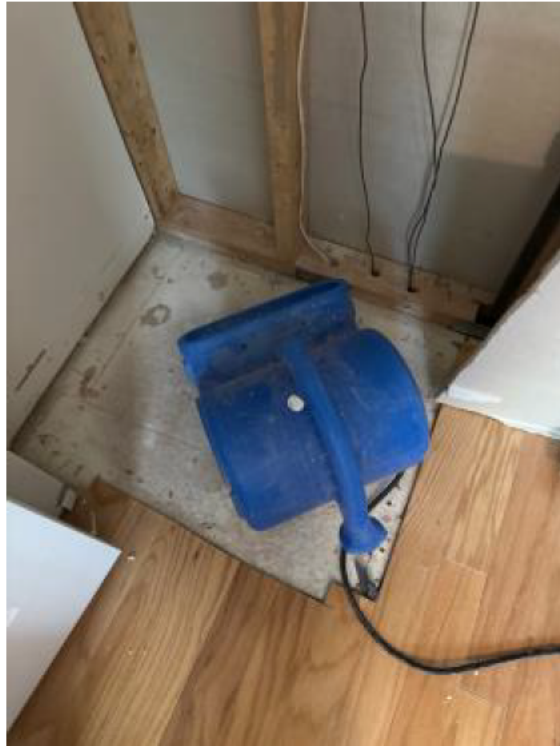
61 SKETCH1/Level 2/Office closet -
61-Office Closet

Mitigation Company removed approx
3 Sq Ft of engineer wood flooring
