SUMMARY

This Summary outlines potentially significant issues from a cost or safety standpoint. This section is provided as a courtesy and cannot be considered a substitute for reading the entire report. Please read the complete document.

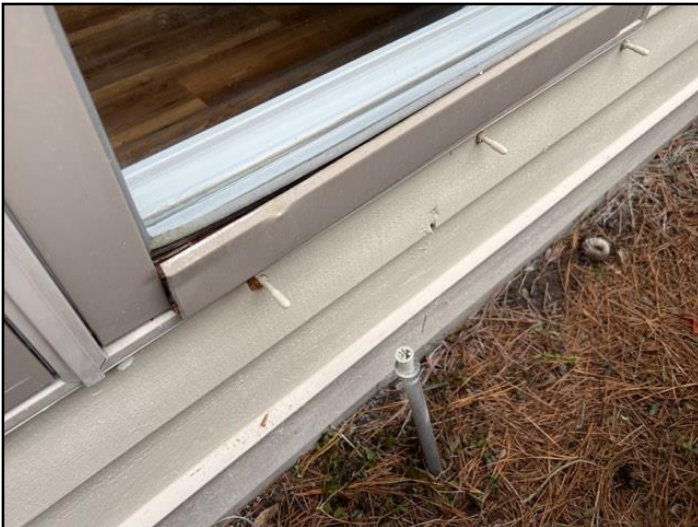
Observed deteriorated wood behind the lower metal sash on front right side bedroom window. Observed wood deteriorated at the lower rail at window sash on the interior side of window. Mid levels of moisture present when tested. Recommend further evaluation and repair.

1. Loose metal trim at window

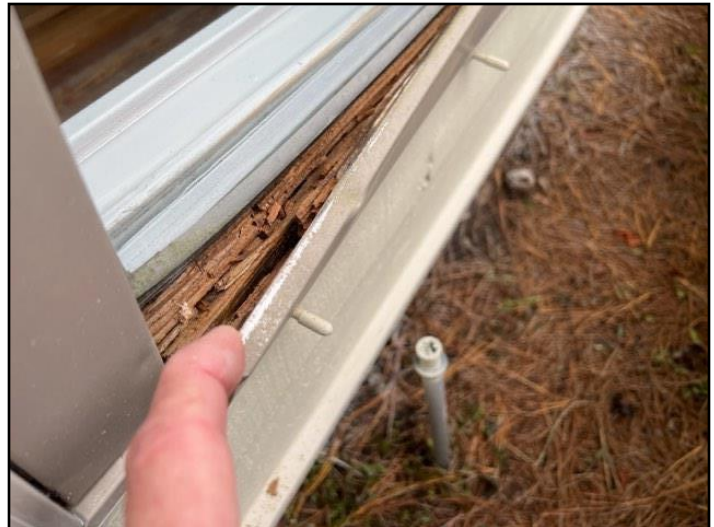
2. Wood deteriorated behind metal trim

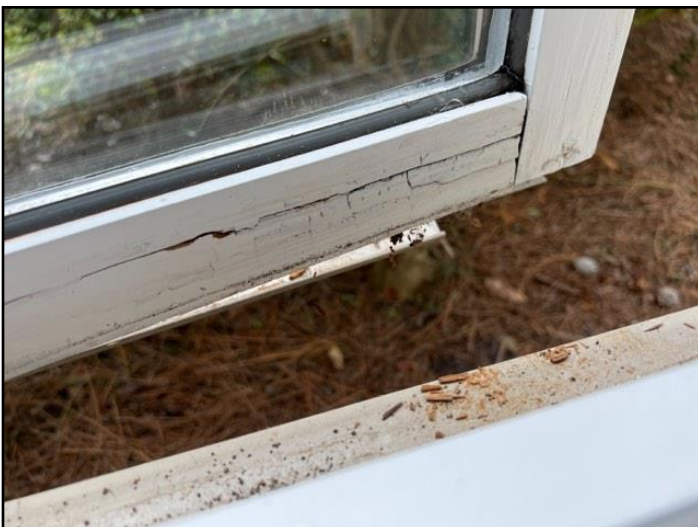
3. Interior lower rail damaged

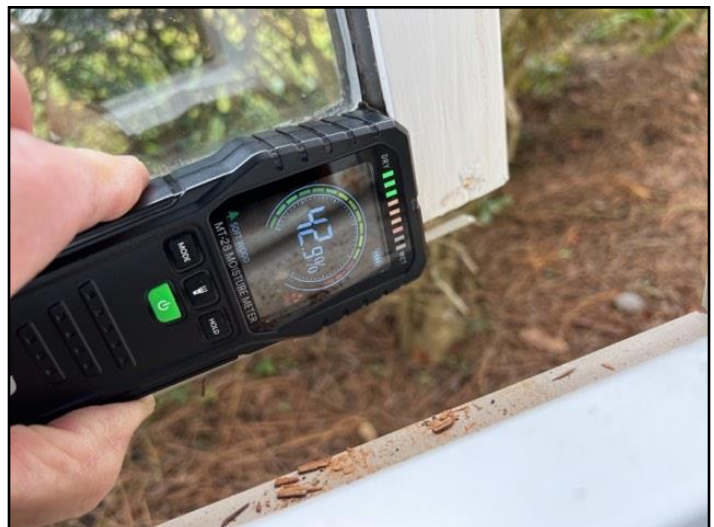
4. Moisture present at window

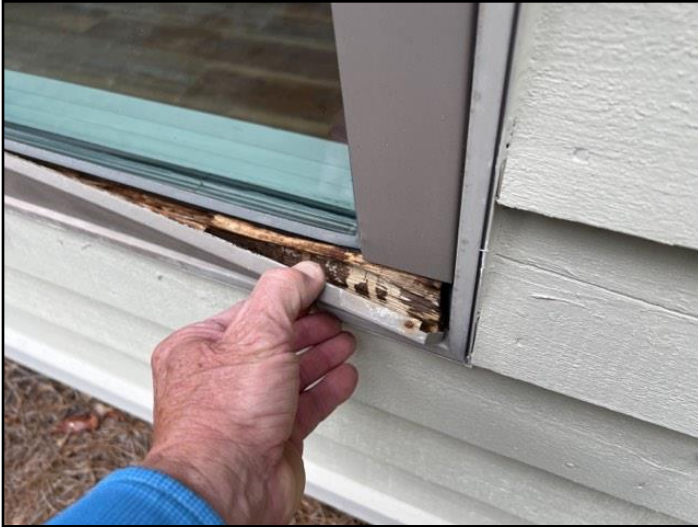
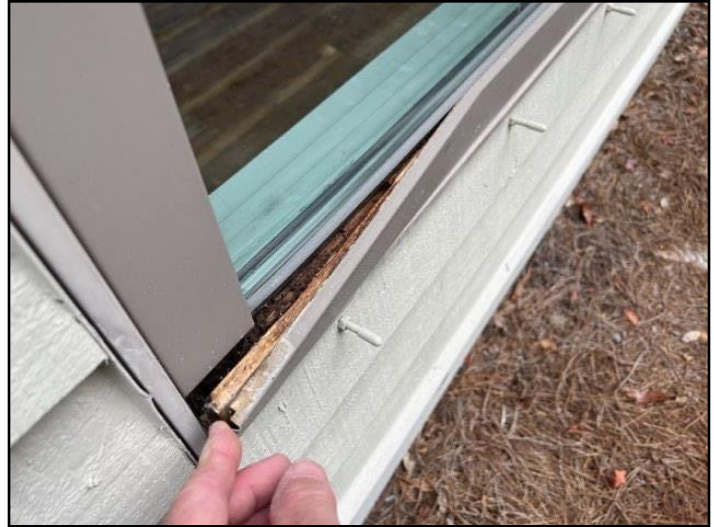
Observed loose metal trim on rear glass window. Observed wood deteriorated behind metal trim on both sides of window. Observed no moisture on the interior side of window. Recommend further evaluation repair.

5. Wood deteriorated behind metal frame

6. Wood deteriorated behind metal frame

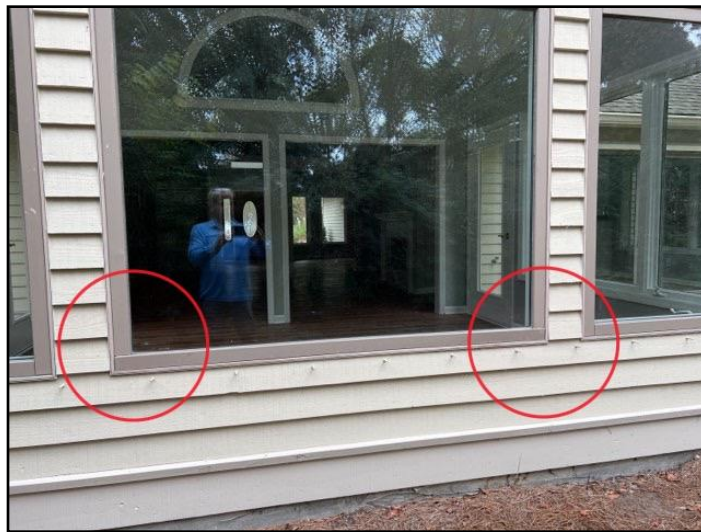
7. Rear window at sunroom

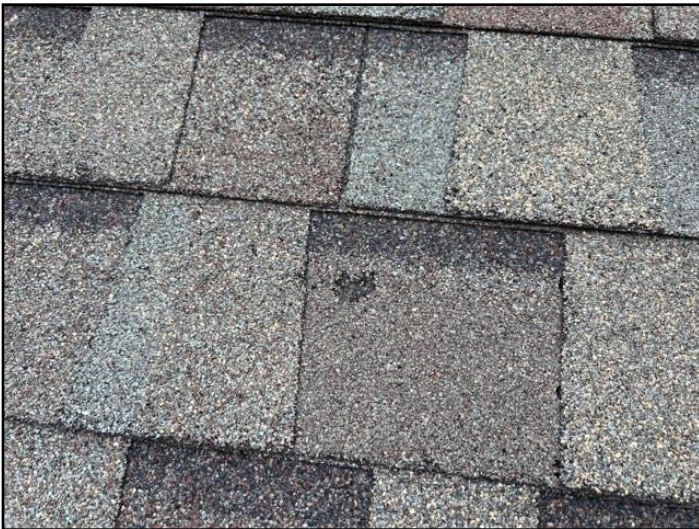
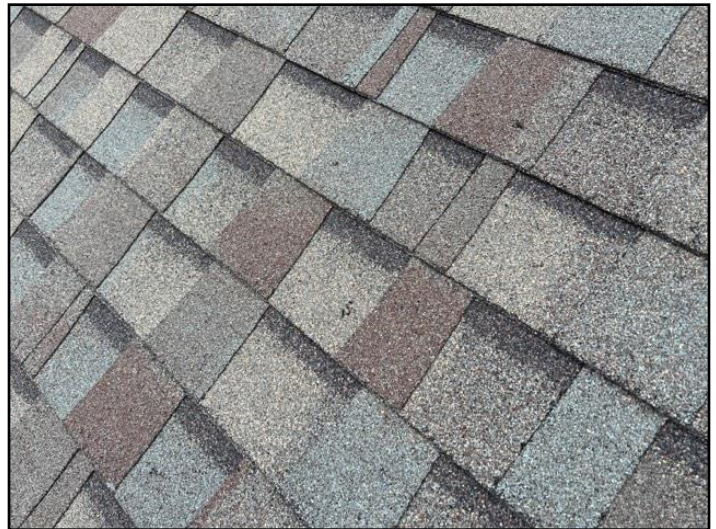
Observed minor impact damage at various areas of roof. Recommend monitoring.

14. Minor impact damage

15. Minor impact damage

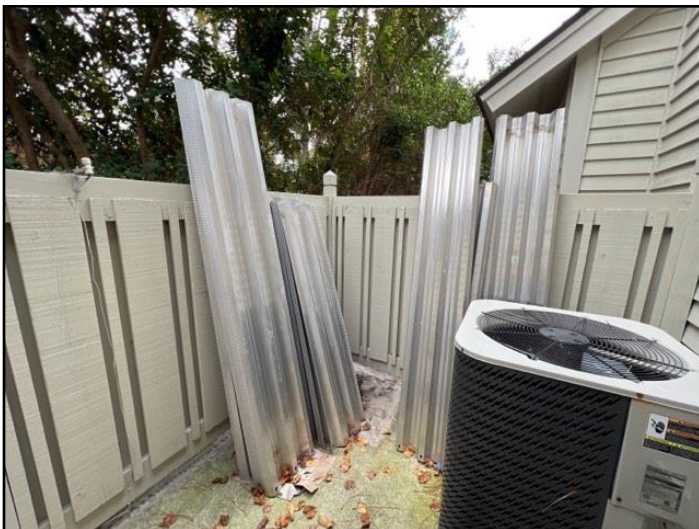
General: • Observed aluminum hurricane panels stored in service area on left side of home.

22. Aluminum panels for windows

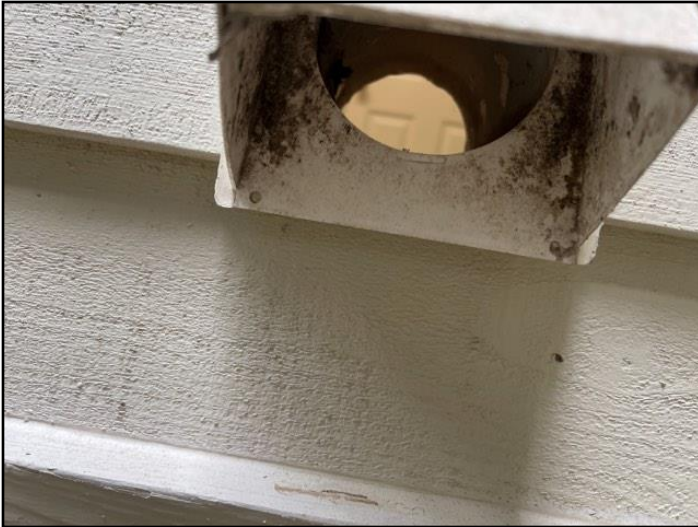
Dryer vent missing flapper on exterior side. You can see through pipe into interior of home. Recommend repairing or replacement.

31. Dryer vent missing flapper

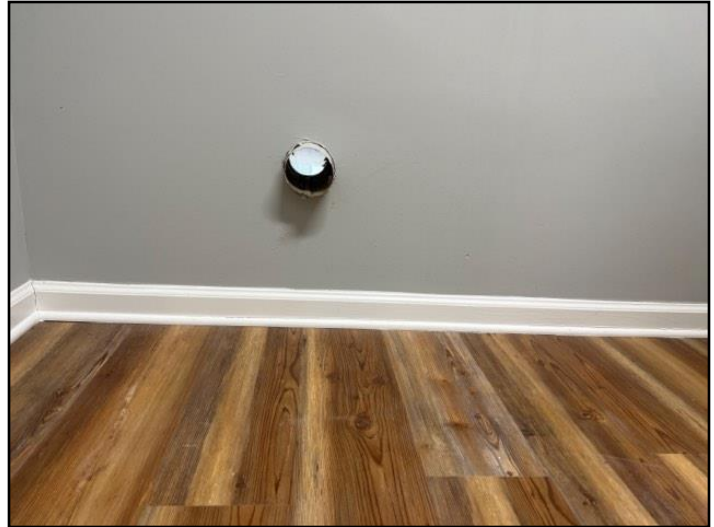
32. Interior side of vent pipe

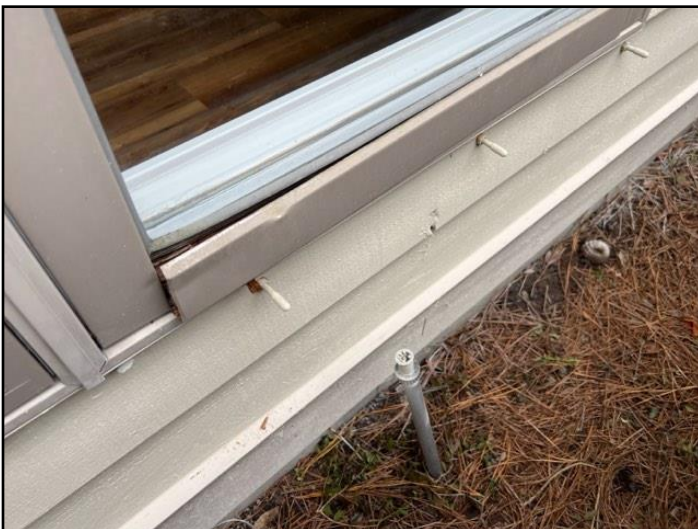
Observed deteriorated wood behind the lower metal sash on front right side bedroom window. Observed wood deteriorated at the lower rail at window sash on the interior side of window. Mid levels of moisture present when tested. Recommend further evaluation and repair.

33. Loose metal trim at window

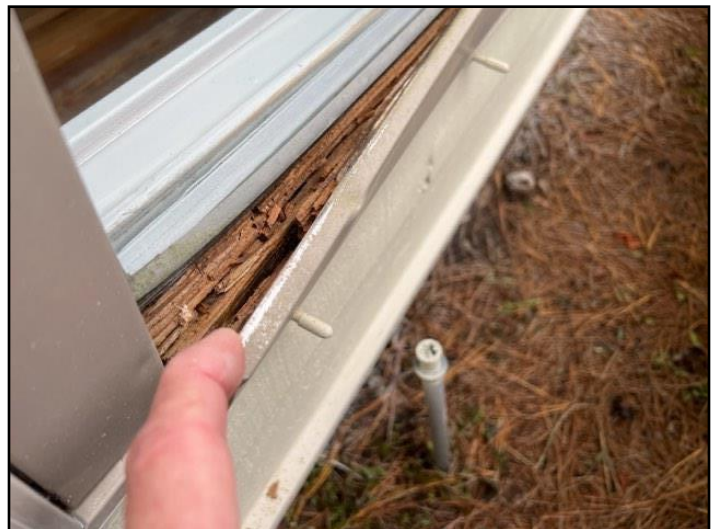
34. Wood deteriorated behind metal trim

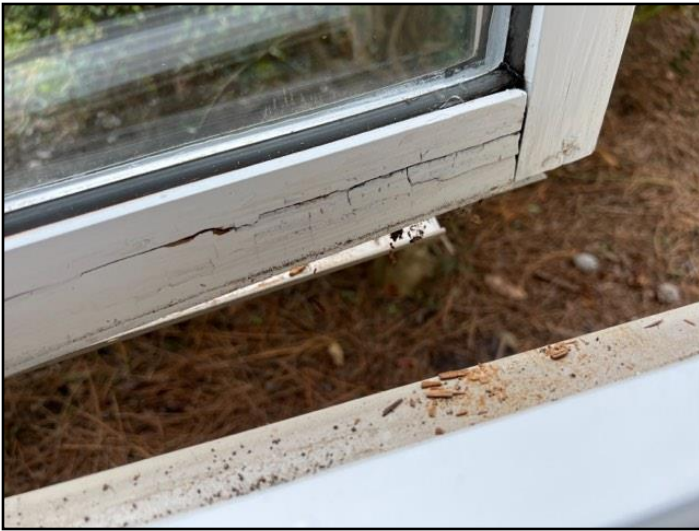
35. Interior lower rail damaged

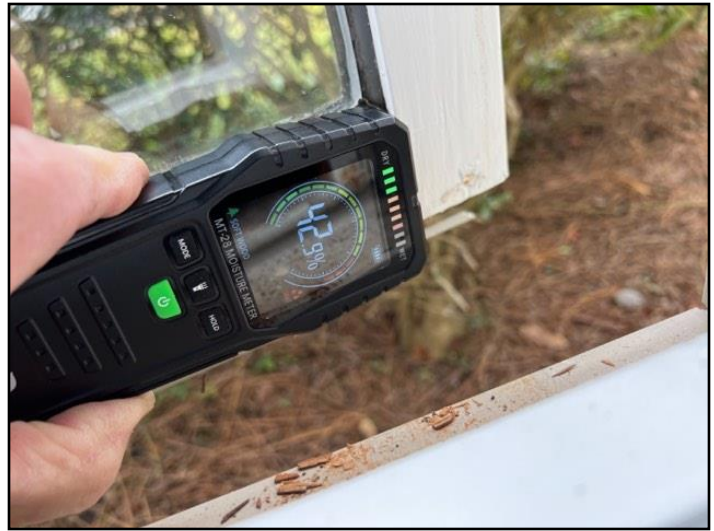
36. Moisture present at window

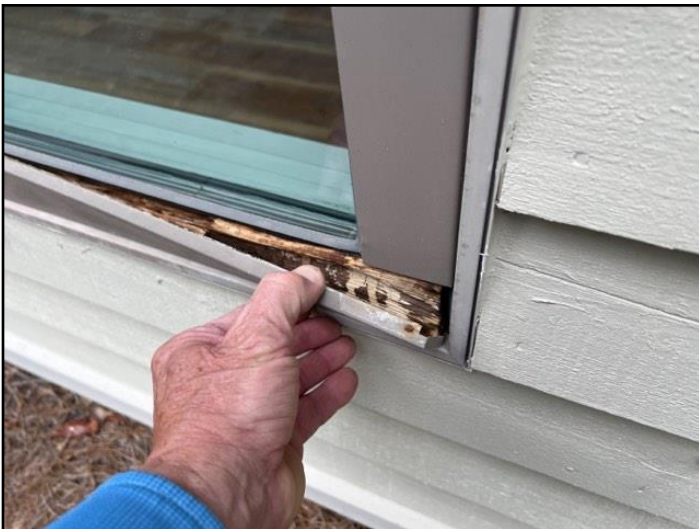
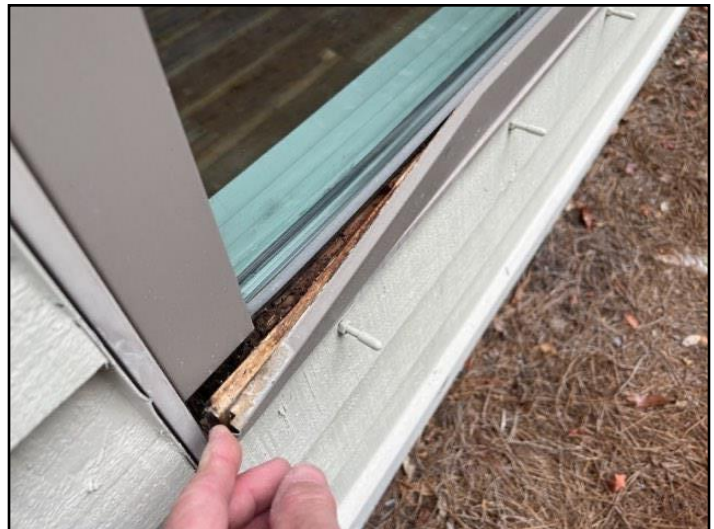
Observed loose metal trim on rear glass window. Observed wood deteriorated behind metal trim on both sides of window. Observed no moisture on the interior side of window. Recommend further evaluation repair.

37. Wood deteriorated behind metal frame

38. Wood deteriorated behind metal frame

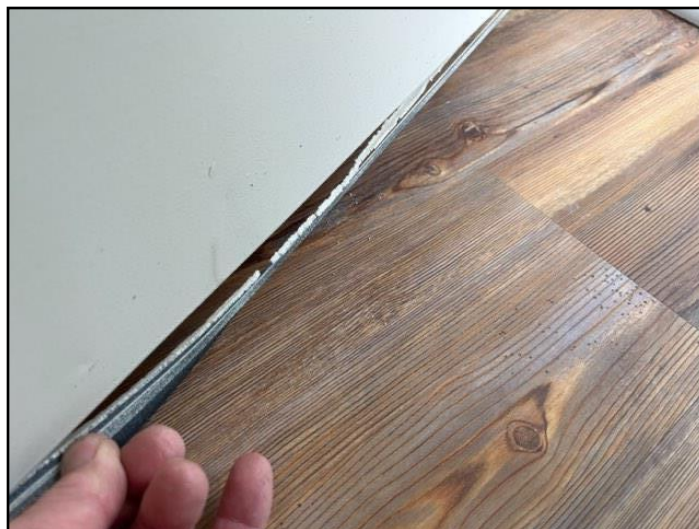
Door sweep loose on the exterior side of left door in rear sunroom. Monitor

40. Loose Weatherstripping

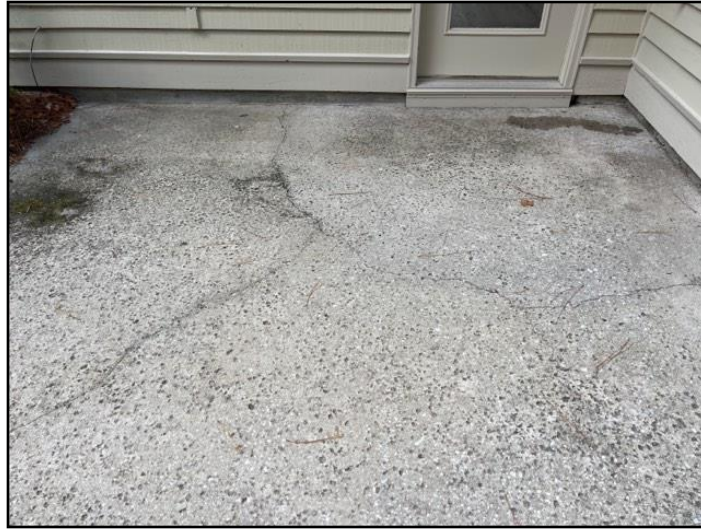
Observed minor cracking of cement patio on rear left side of home. Monitor.

41. Minor Cracking on rear patio

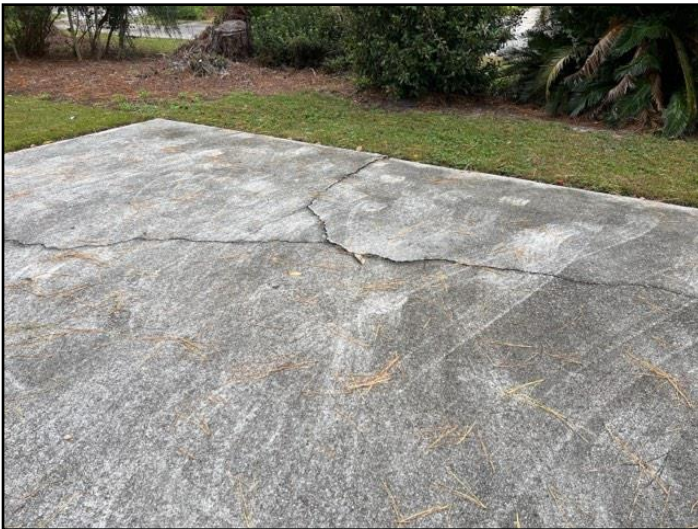
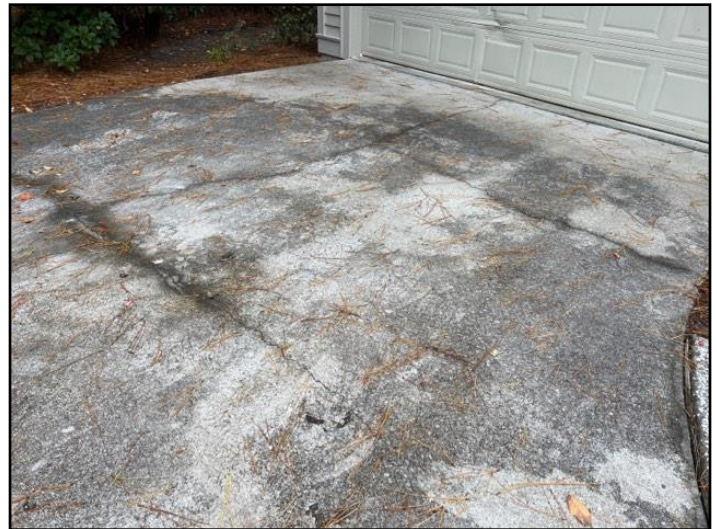
Observed minor cracking on cement driveway. Monitor.

42. Minor cracking on driveway

43. Minor cracking on driveway

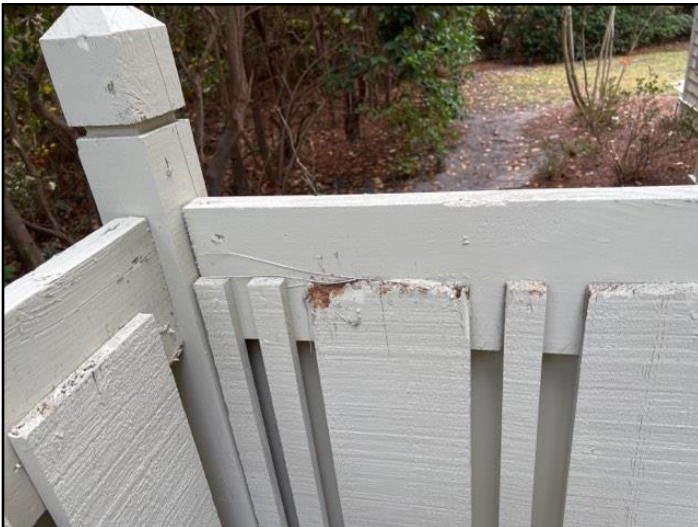
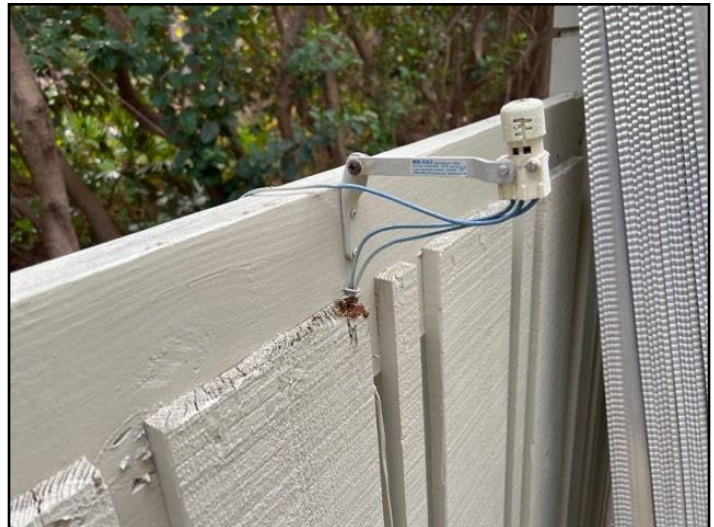
Observed minor deterioration to a couple of the vertical fence boards at service area fencing . Recommend monitoring, improve if condition worsens.

44. Minor deterioration to fence boards

45. Minor deterioration to fence boards

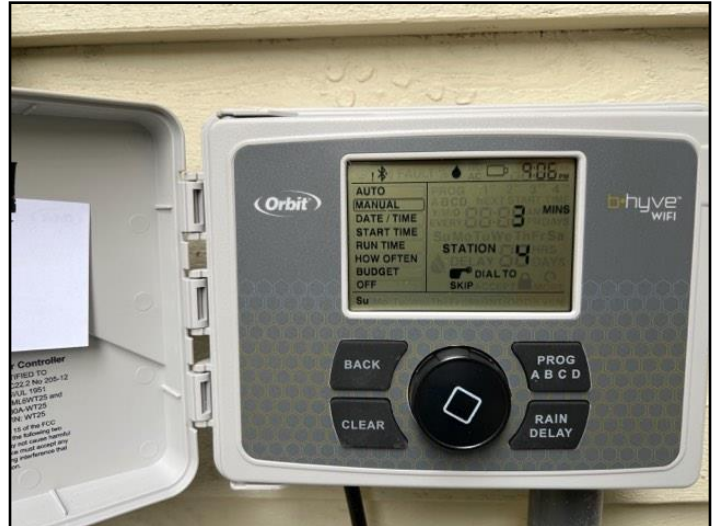
.....Unable to get irrigation System panel to operate. I tried testing panel in manual mode, cycling through the 6 stations. Unable to get sprinkler system on. Display shows each station was operating but observed no water at sprinkler heads throughout property. Recommend further evaluation or disclosure from owner to its specific operation.

49. Panel not operating

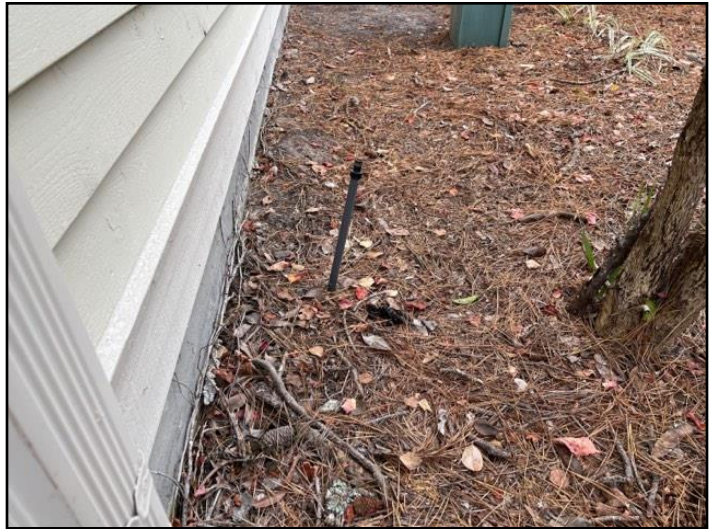
Observed several sprinkler heads that are leaning along the front shrubs and on right side of home. Unable to test system to see if heads are operational.

55. Tilted sprinkler heads

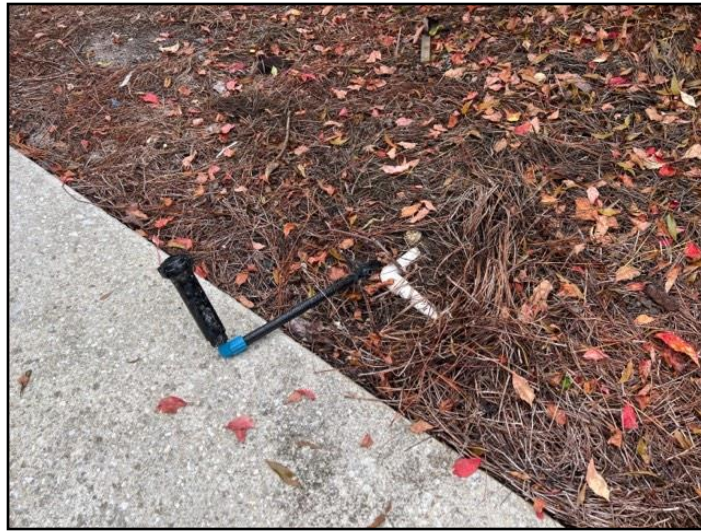
18. **Condition:** • Observed exposed loose sprinkler head and piping at rear patio. Recommend securing.

56. *Exposed piping and loose sprinkler head*

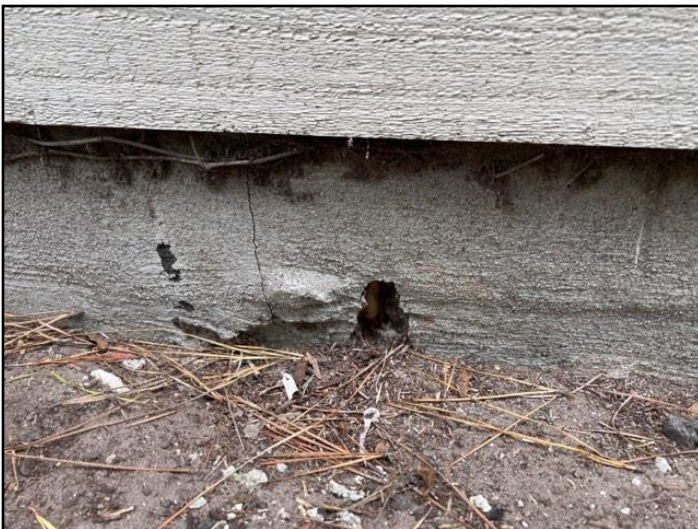
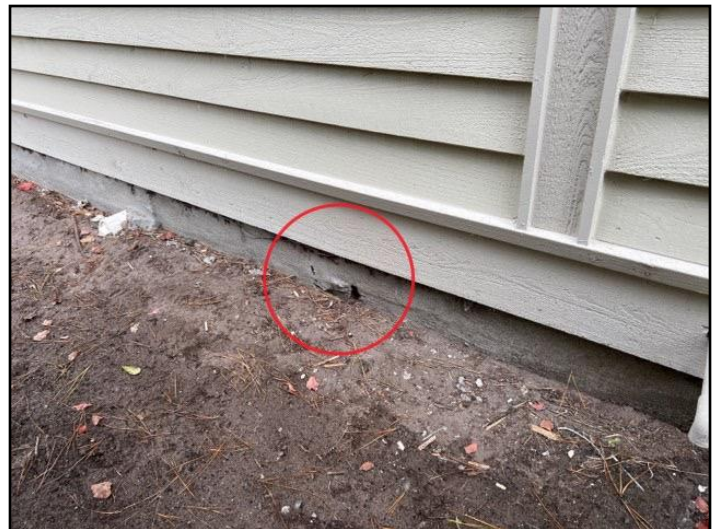
Observed minor cracking & spalling of the cement foundation on middle right side of home. Recommend Monitoring

62. Typical minor cracks at slab

63. Typical minor cracks

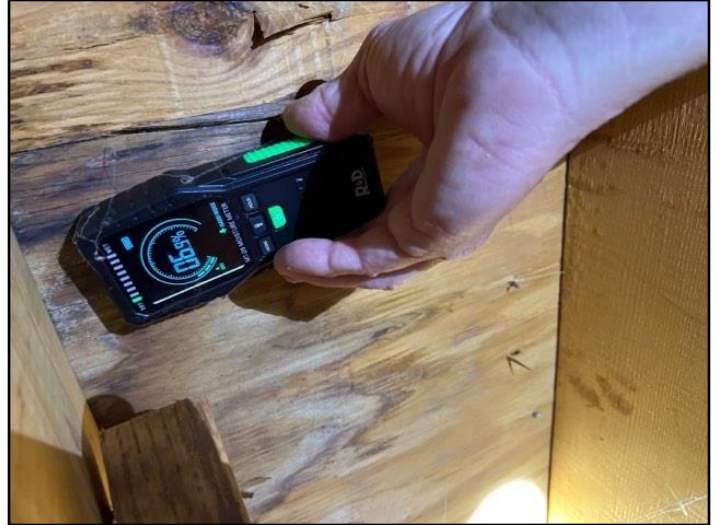
Observed water stains on sheathing on front left side corner of the garage attic. No moisture present when tested.

65. No moisture present

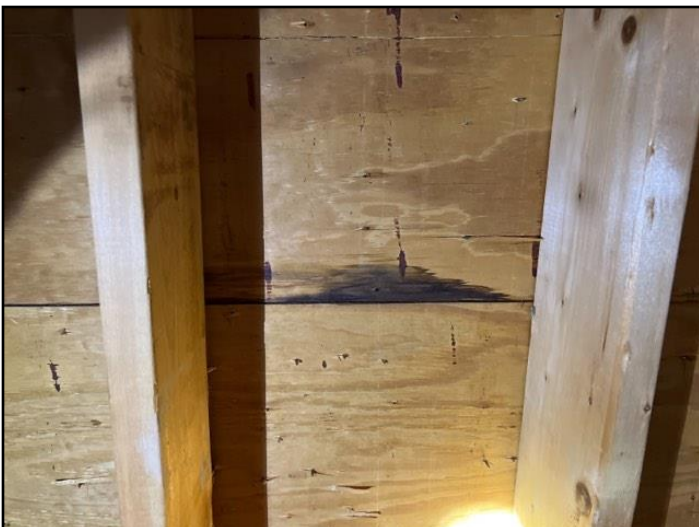
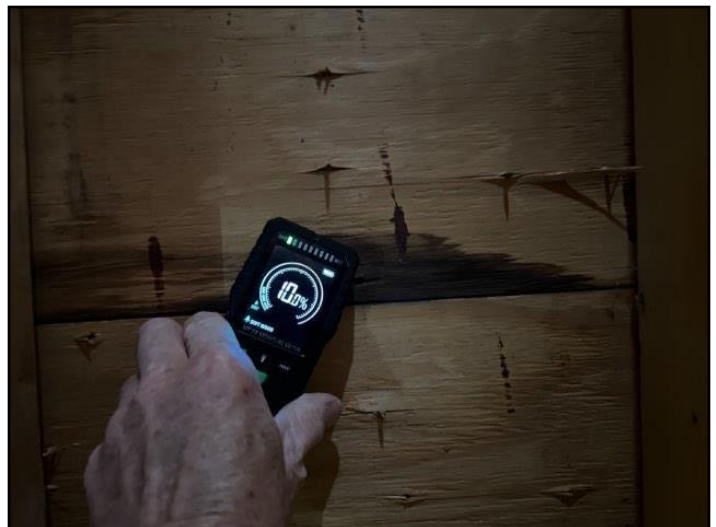
Observed minor water stains at two areas on roof sheathing in main portion of attic. Observed no moisture when tested. Recommend monitoring.

66. Water stains on roof sheathing

67. Low to no moisture detected

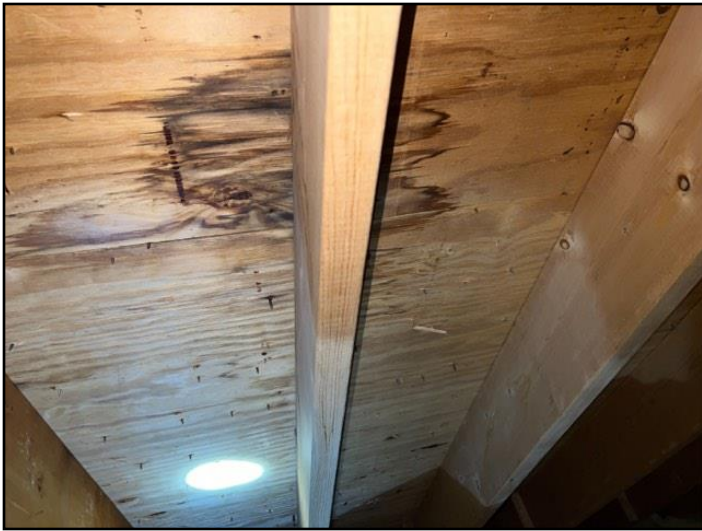
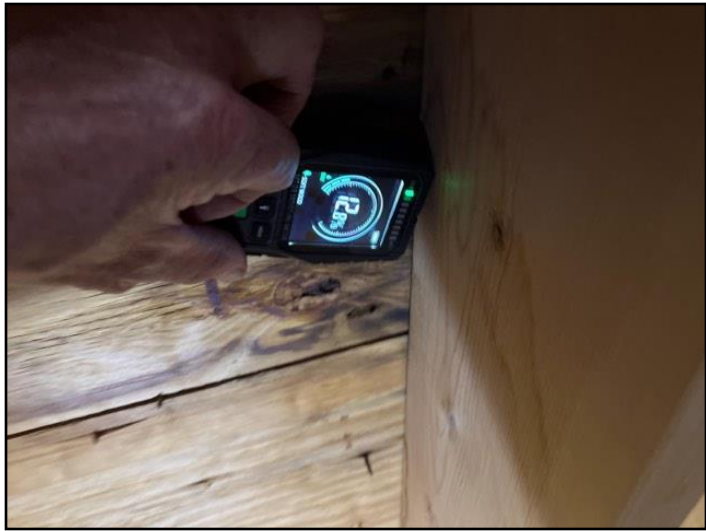
68. Water stains on rear sheathing

69. Low to no moisture present

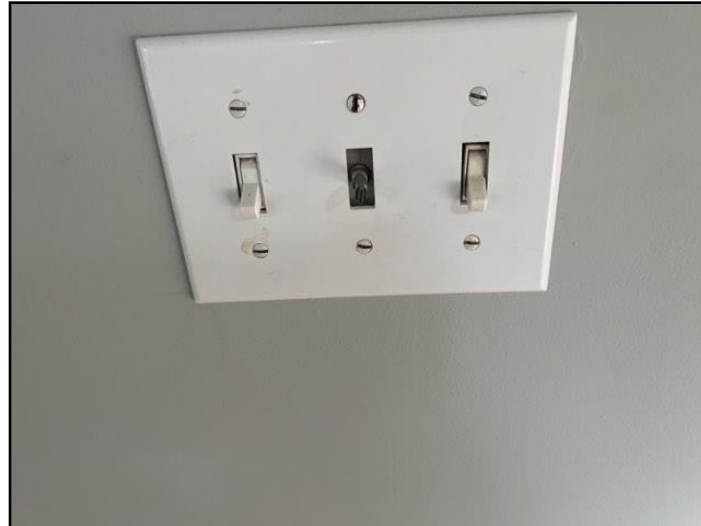
24. Condition: • Rotary knob missing on electrical switch for rear kitchen light. Light is operational. Provide

82. Rotary knob missing at light switch

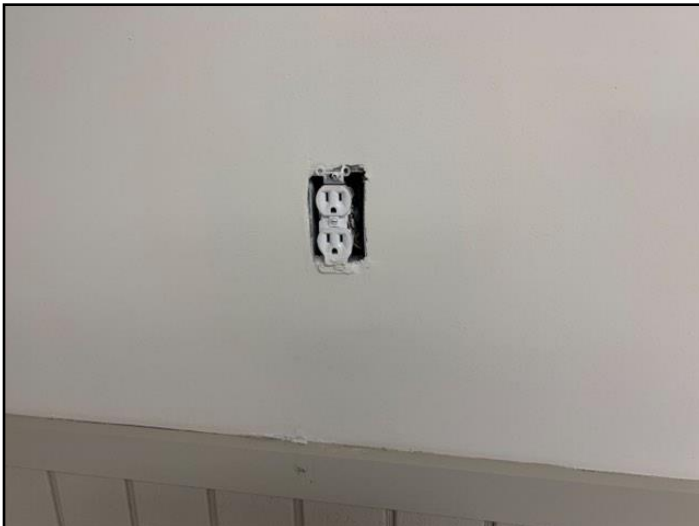
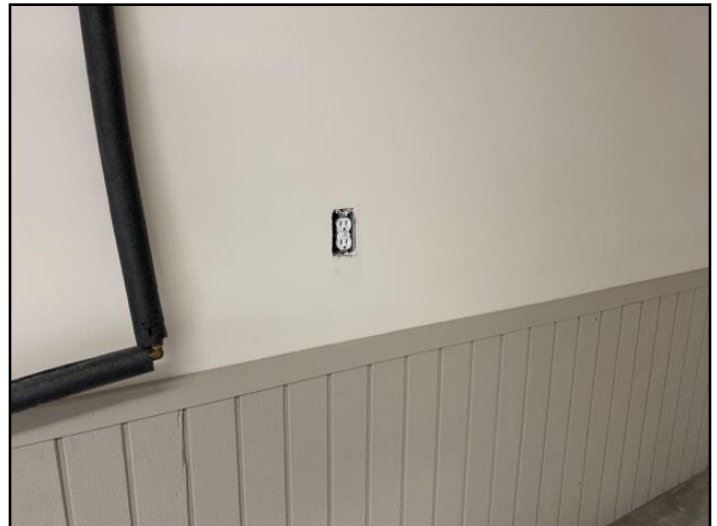
Cover plates missing on two electrical outlets in garage. Provide.

83. Missing cover plate on outlets in garage

84. Missing cover plate at receptacle

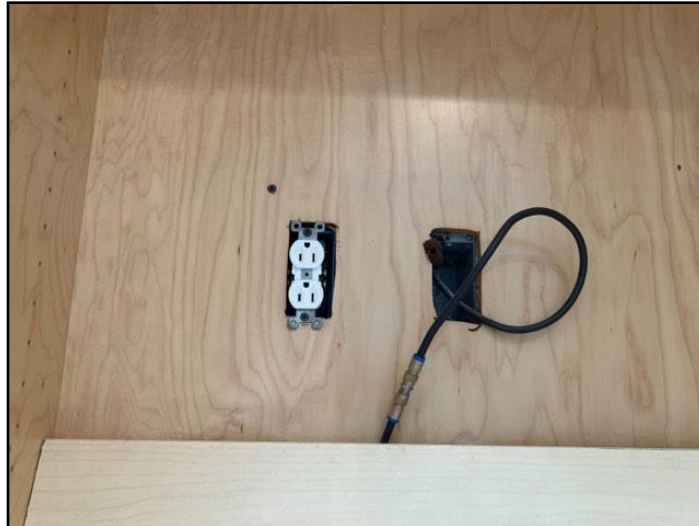
Cover plates missing at electrical outlet and cable junction box in kitchen closet. Provide.

85. *Missing cover plates*

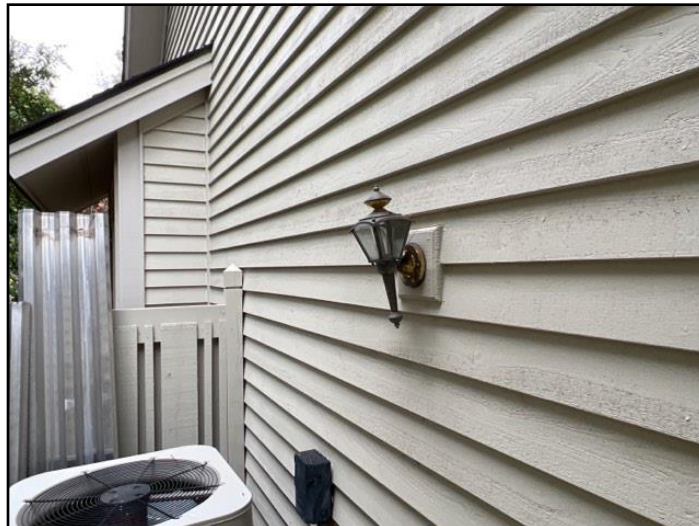
86. *Inoperative light at service area.*

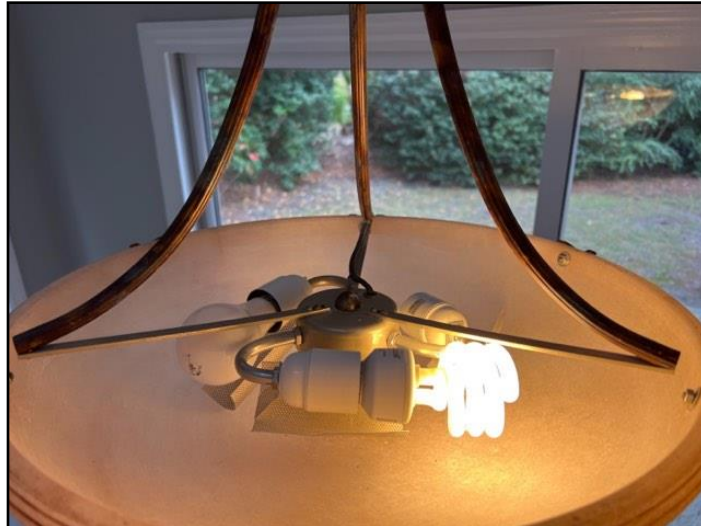
87. *Bulbs out at light in kitchen*

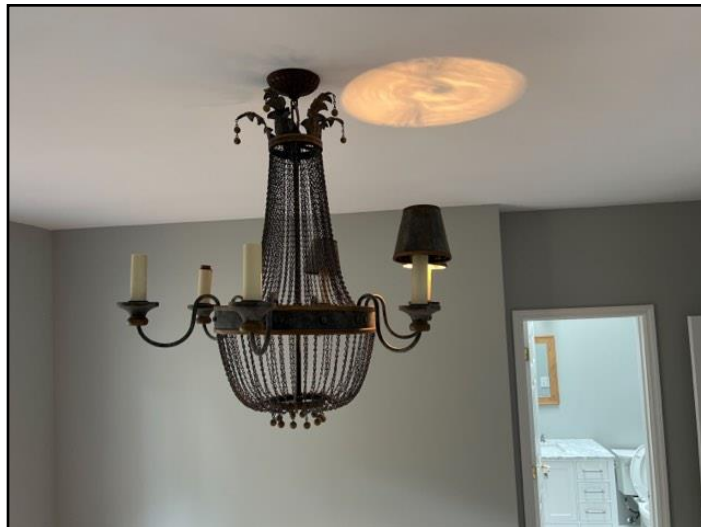
Bulbs missing /inoperative at light fixture in front right bedroom. Recommend providing.

88. *Bulbs missing at light fixture*

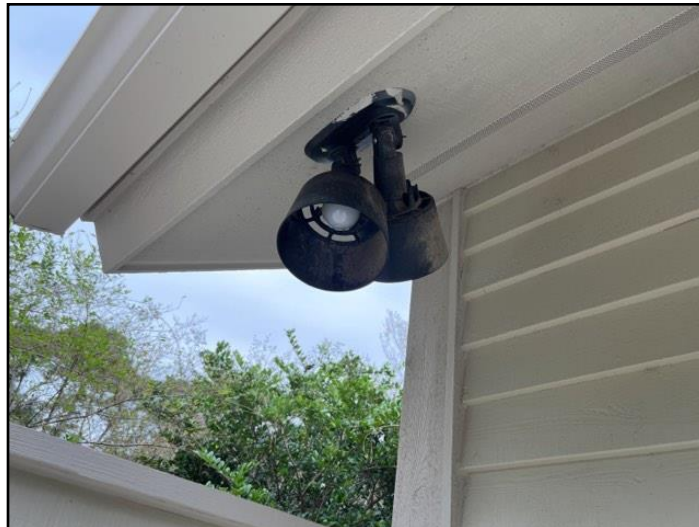
Spotlights off of primary bedroom inoperative. Recommend improving.

89. Inoperative spot light

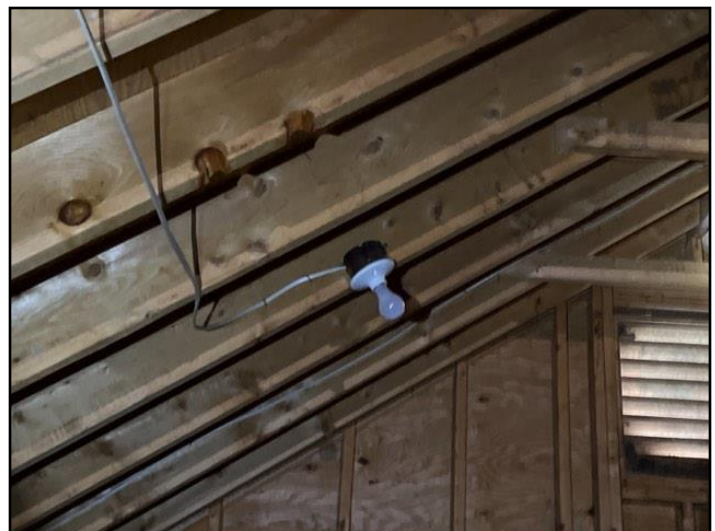
91. Inoperative lights in attic

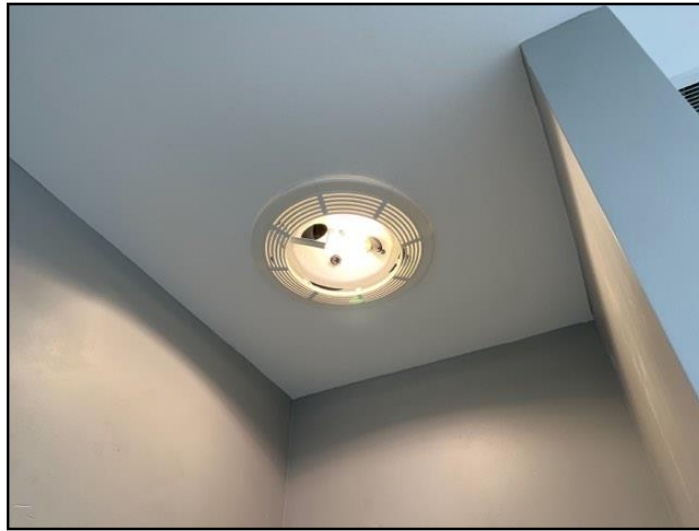
Missing lens cover at vent fan in primary bathroom. Provide.

92. Missing lens cover at light/vent fan

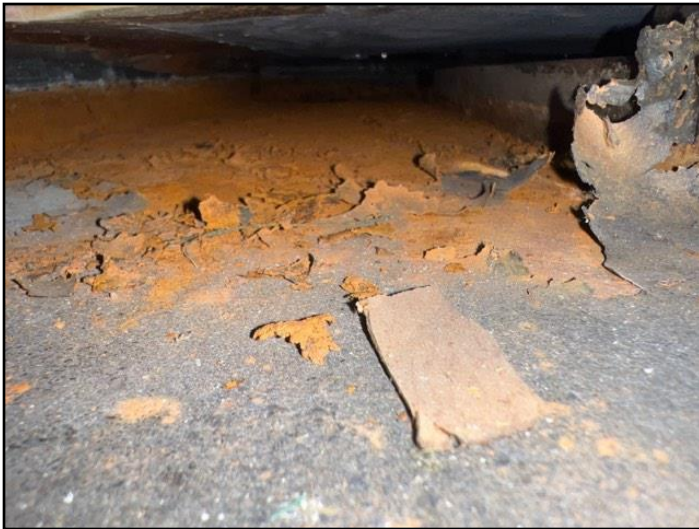
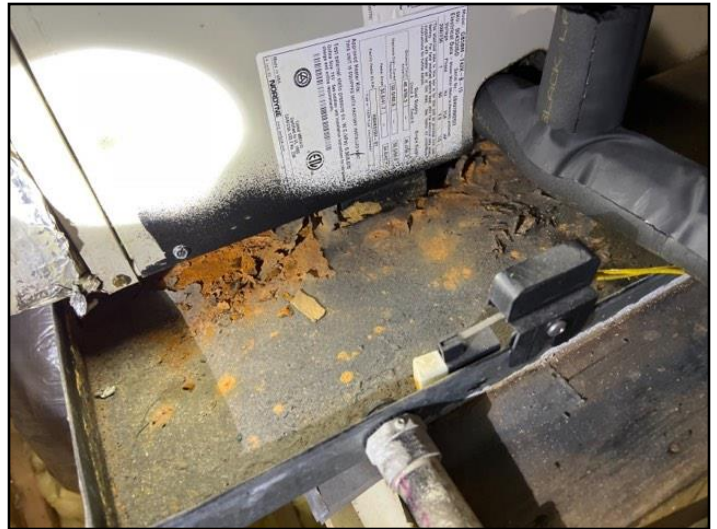
114. *Rust in condensate pan*

115. *Rust in pan*

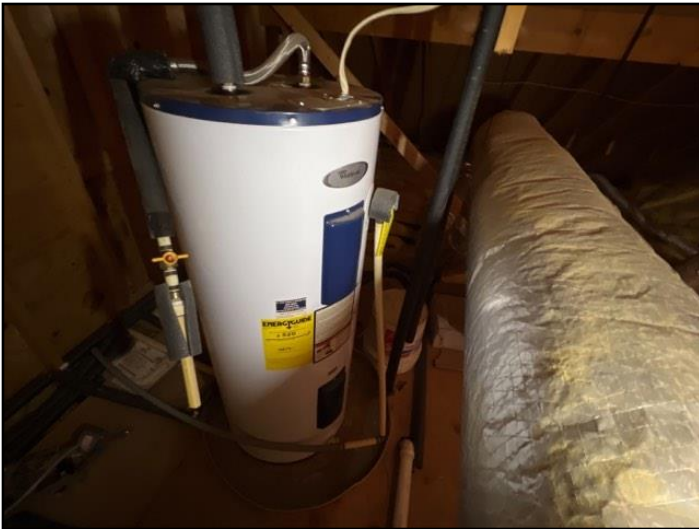
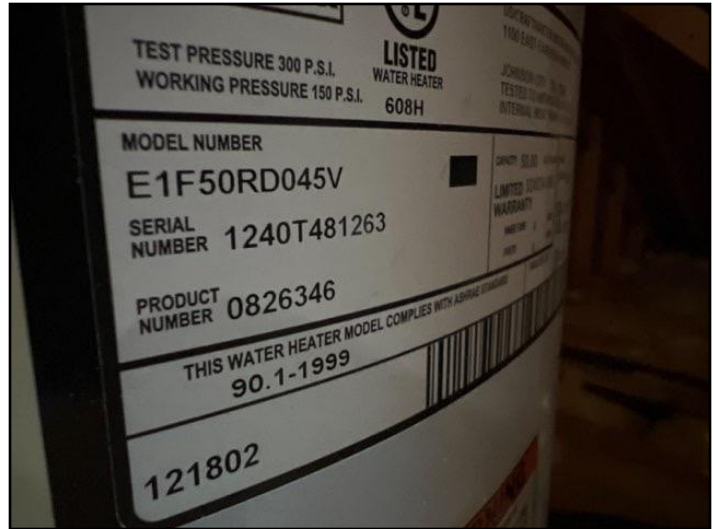
Observed a whirlpool 50 gallon water heater, 2012' on right side of home over bedrooms. Water heater possibly inoperative. No supply lines attached to piping at water heater. Electricity to water heater is live. Request disclosure.

130. Whirlpool Water heater

131. 50 gal, 2012'

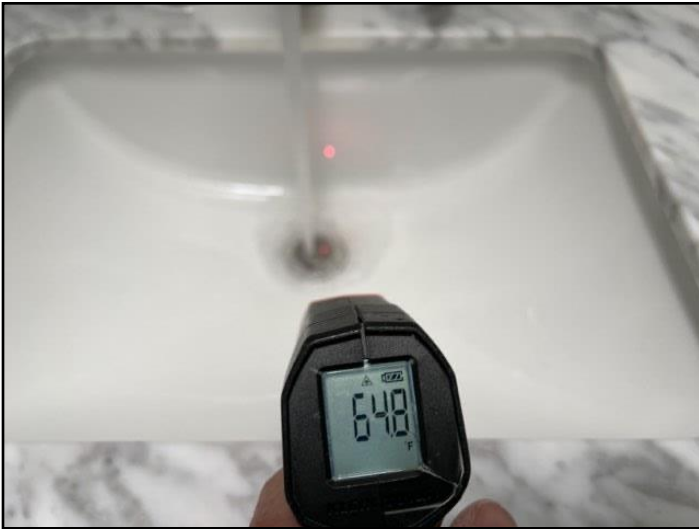
Observed no hot water at all three faucets in bathrooms and at kitchen sink. Water valve turned off at GE water heater.

134. Less than 100° F

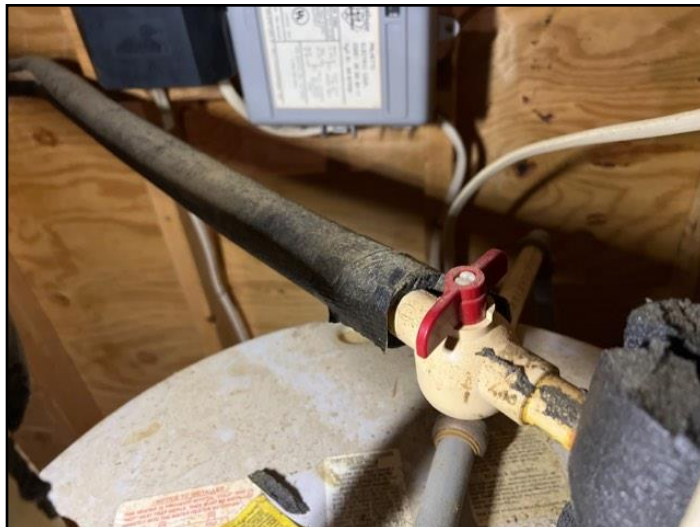
Observed water valve shut off at GE water heater in attic over laundry area. No hot water present.

139. Water supply turned off

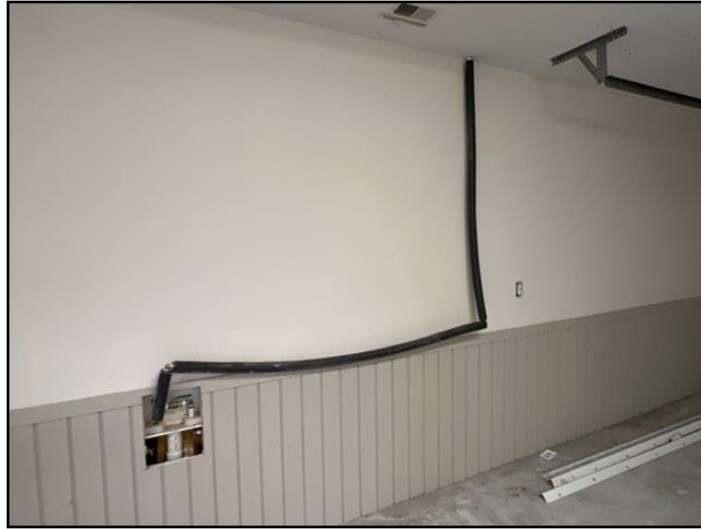
140. Supply piping loose in garage

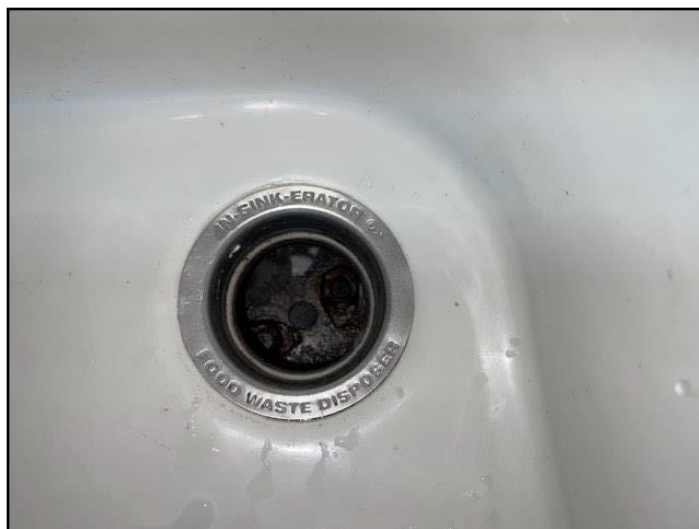
Disposal operational. Rubber splash guard missing in sink. Provide.

166. *Splash guard missing*

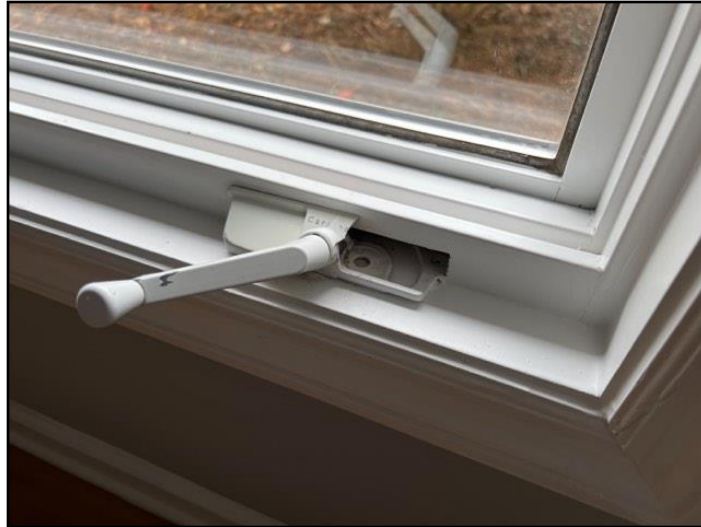
172. Broken cover at hand crank mechanism

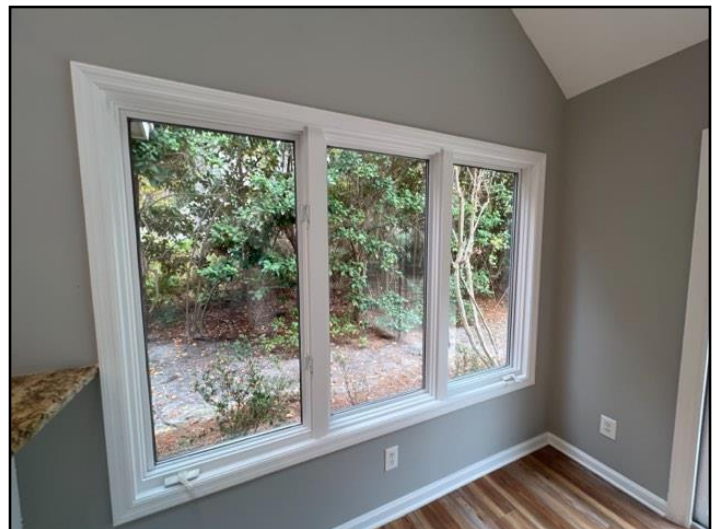
174. Missing screens an windows

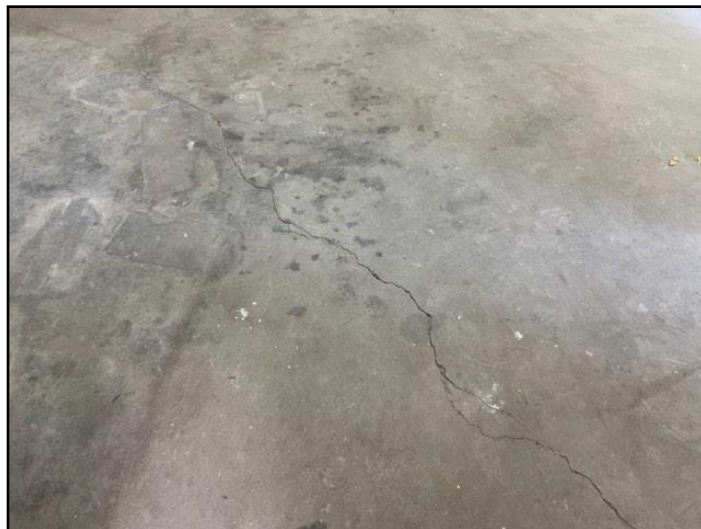
176. Minor crack on garage floor
