40 Sailmaster Com, Hilton Head Island, SC June 26, 2021

Report No. 1011, v.3

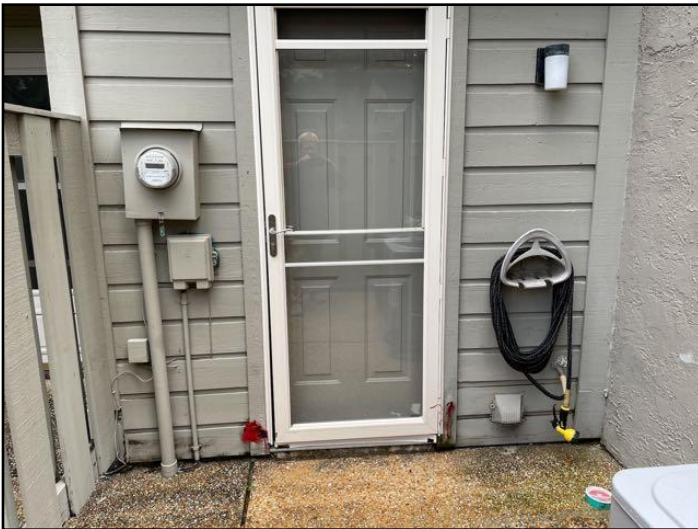
Condition: • [Damaged, cracked or loose](#)

Location: Front First Floor Service Area

8. Damaged, cracked or loose

Task: Repair or replace

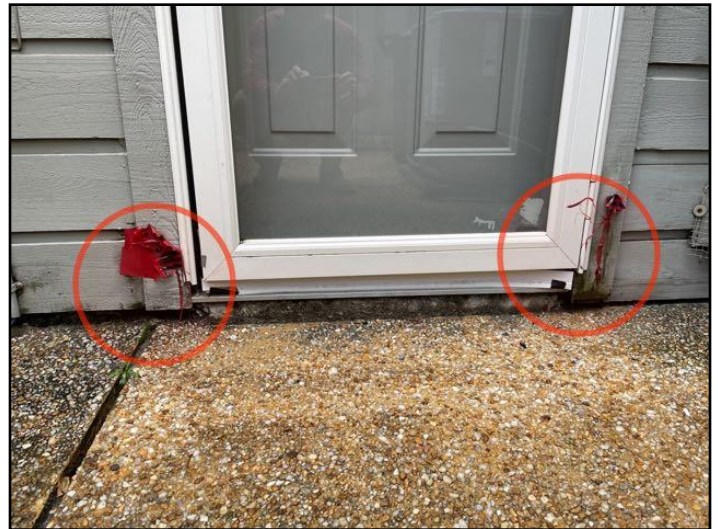
9. Damaged, cracked or loose

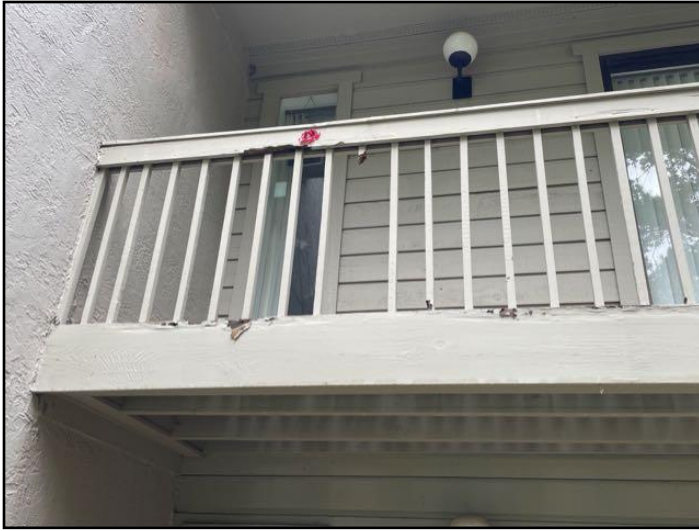
Condition: • [Damage](#)

Deterioration of wood possible Safety issue

10. Damage

Task: Further evaluation

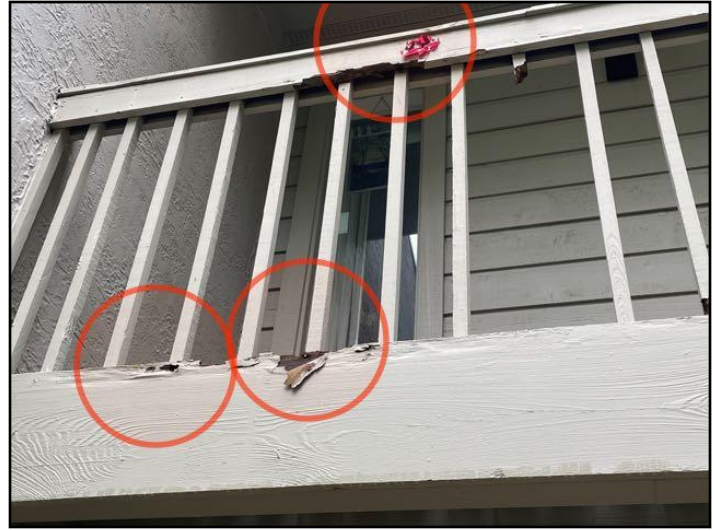
11. Damage

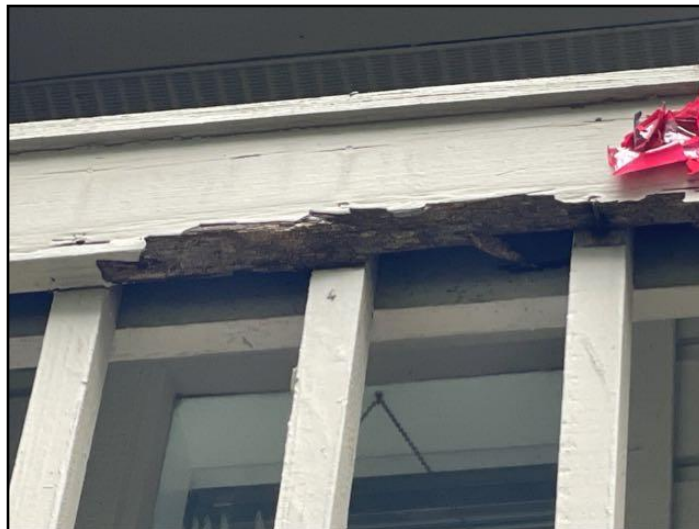
12. Damage

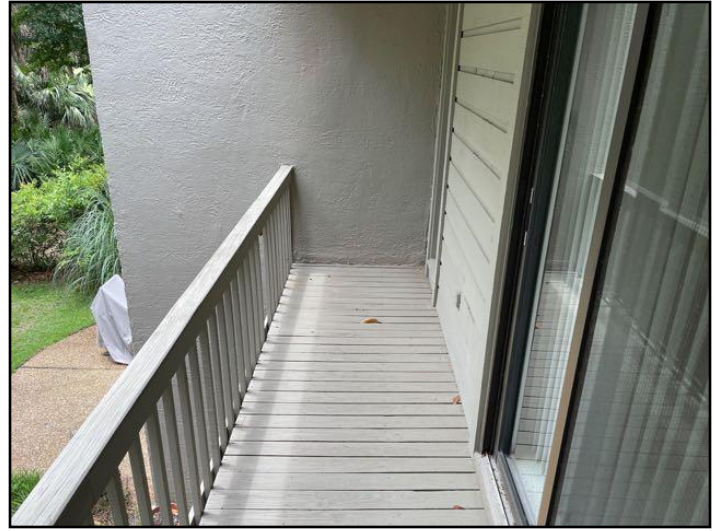
Condition: • [Sag](#)

The deck is sagging downward and away from the building

16. Sag Top of Balcony

Task: Further evaluation

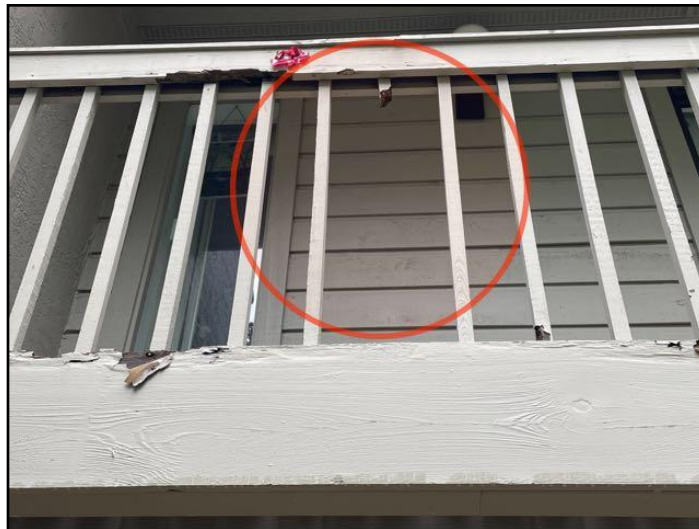
Condition: • [Missing](#)

Missing Balusters

17. Missing Balusters

Task: Improve

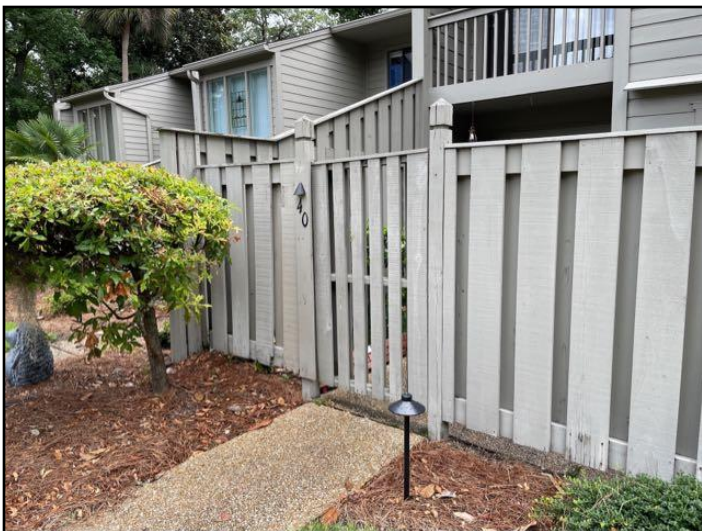
Condition: • Rot

18. Rot fencing

Task: Further evaluation

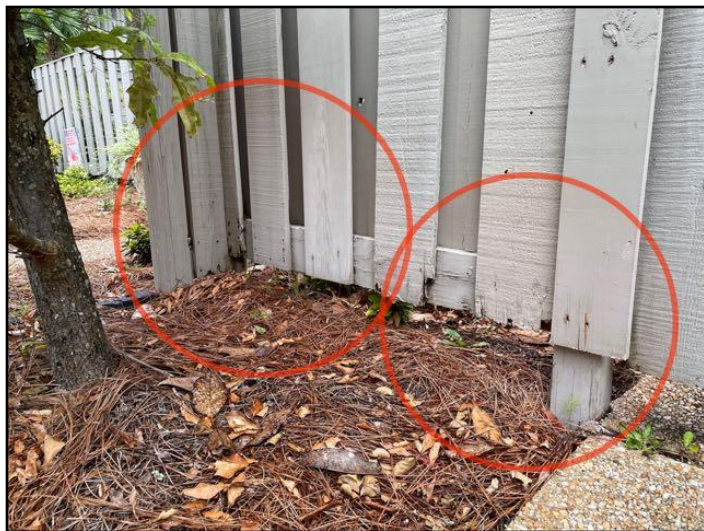
19. Rot fencing

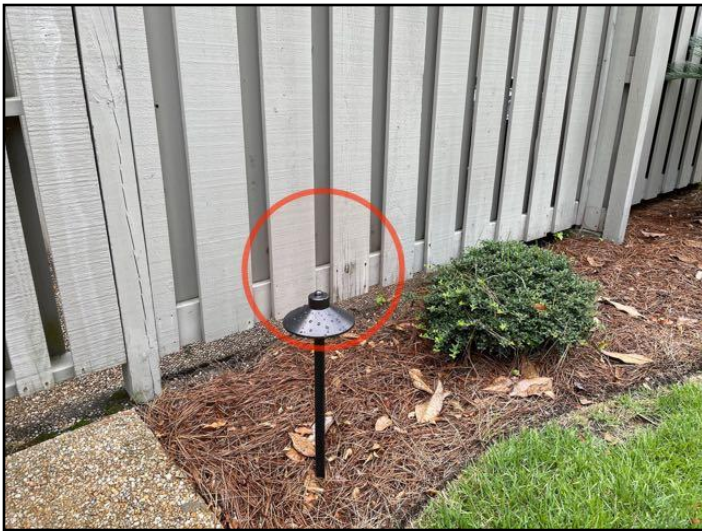
20. Rotfencing

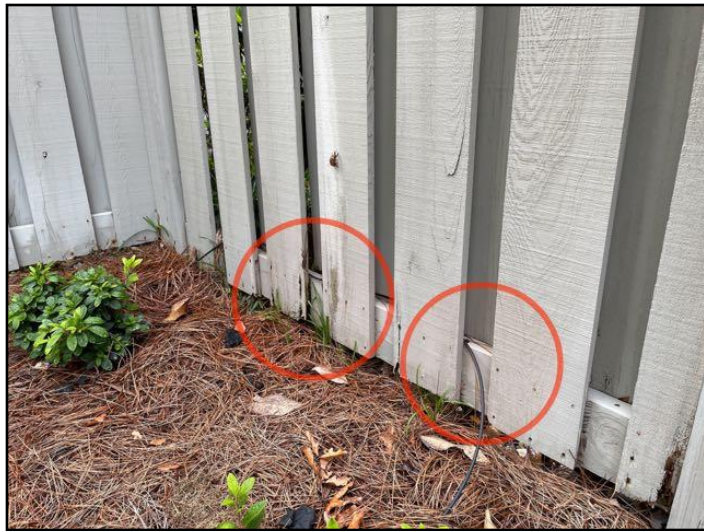
21. Rot fencing

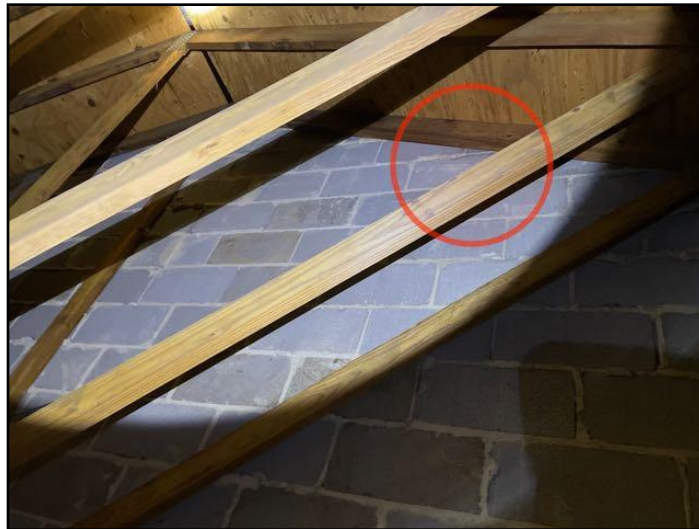
Condition: • Damage

Noticed water stains and possible Environmental Suspect Growth on ridge beam

22. Ridge beam, Possible Water Damage

Task: Further Evaluation

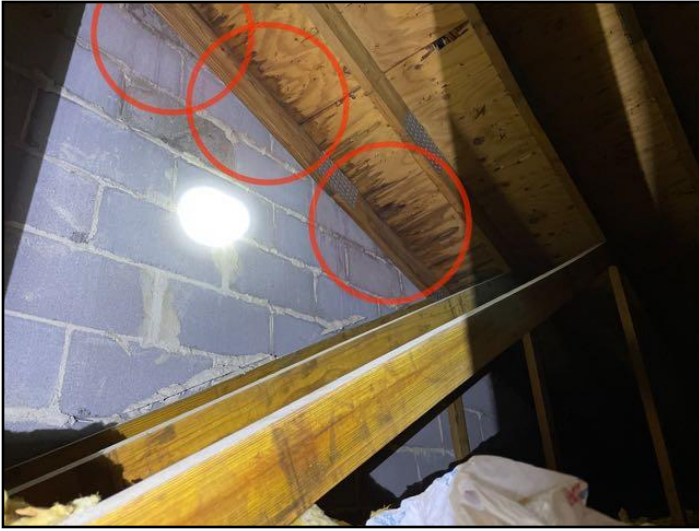
Condition: • Water damage

Water stains on sheathing location where Roof/Wall Flash damage was observed

23. Water damage

Task: Further evaluation

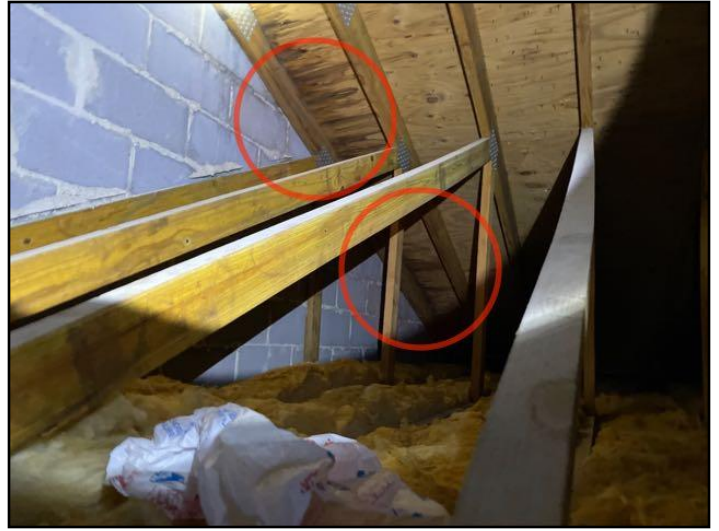
24. Water damage

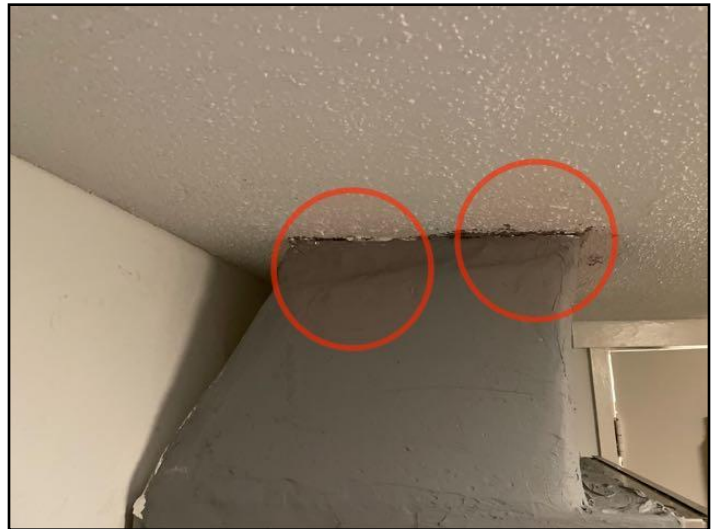
Condition: • Loose/Missing Tape

Reduced efficiency/performance, cross-contamination of ventilation air

30. Loose/Missing Tape

Task: Repair and Improve

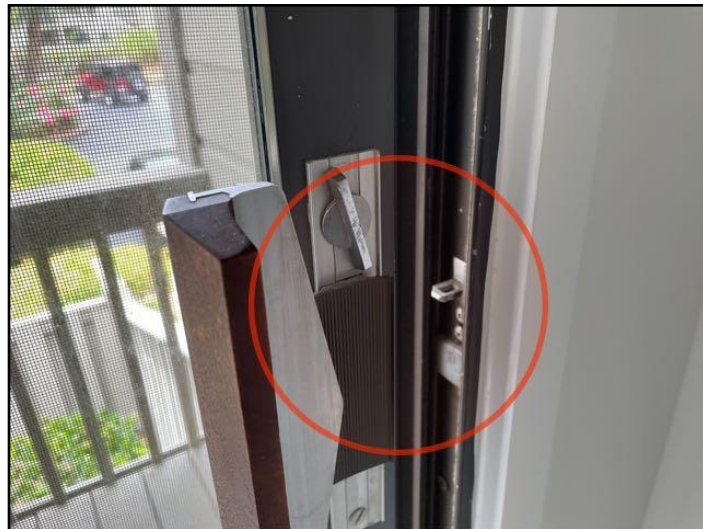
Condition: • [Inoperable](#)

33. Inoperable

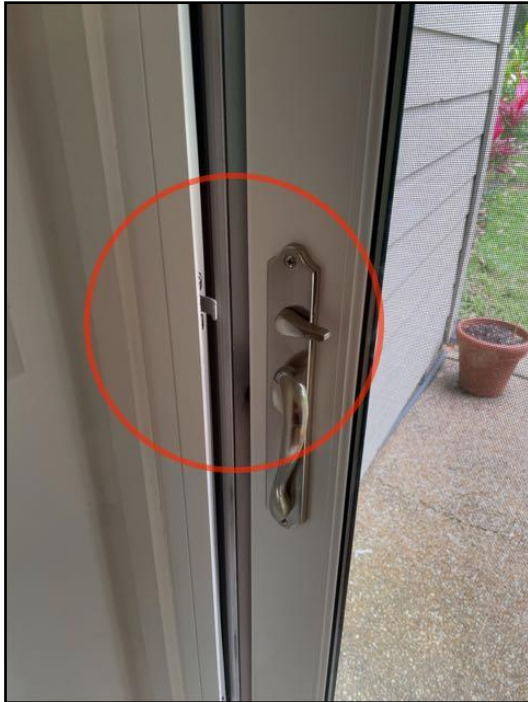
Condition: • Lock not effective on exterior door

Lock on rear slider difficult to operate and lock. Recommend improvement. Safety and Security Issue

34. Lock not effective on exterior door

Task: Improve / repair

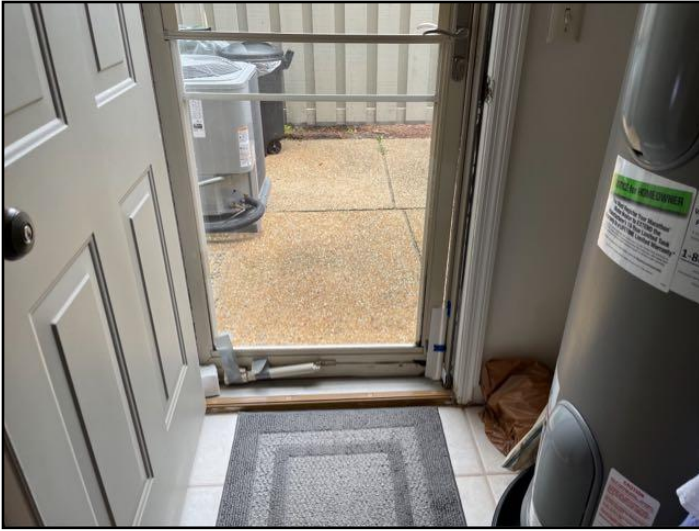
Condition: • [Doorstops missing or ineffective](#)

36. Doorstops missing or ineffective

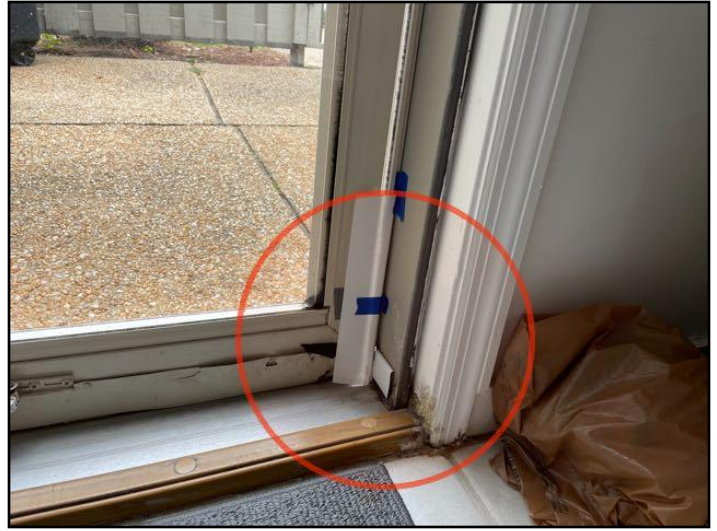
37. Doorstops missing or ineffective

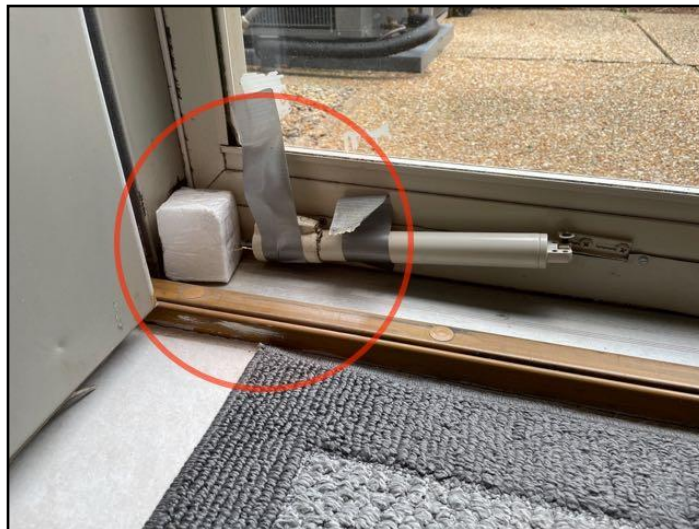
38. Doorstops missing or ineffective

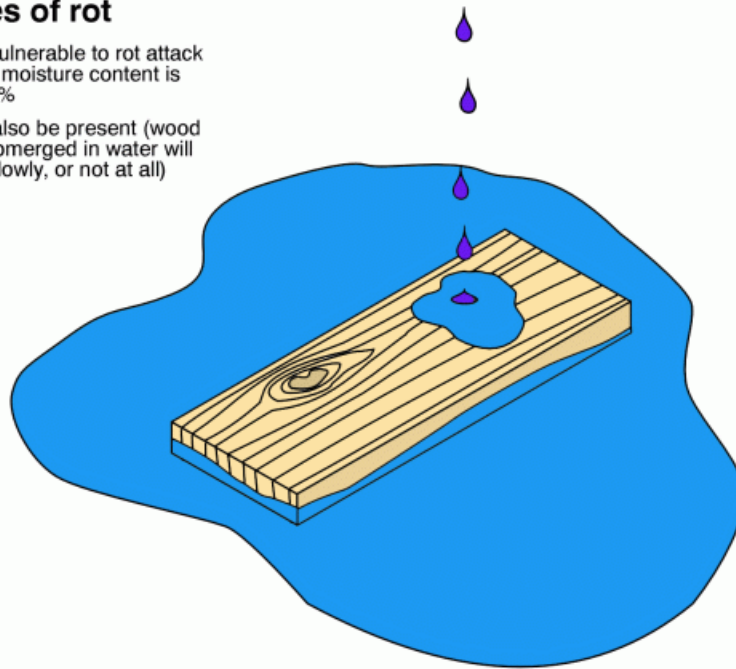
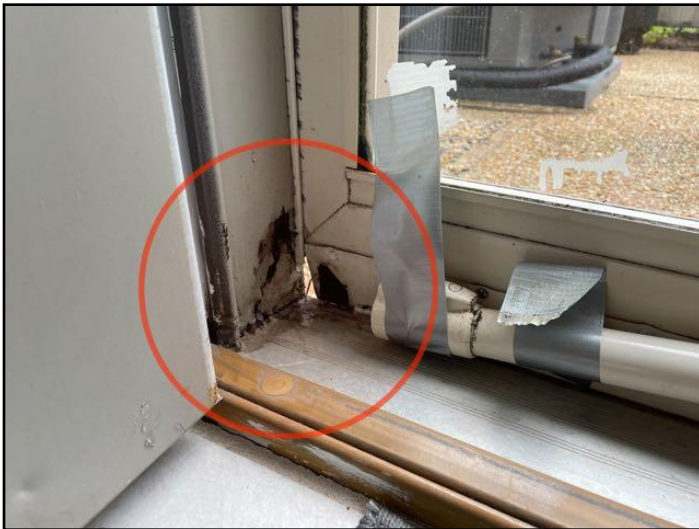
Condition: • [Rot](#)

wood is vulnerable to rot attack when the moisture content is above 20%

39. Rot Door sill

Task: Repair or replace

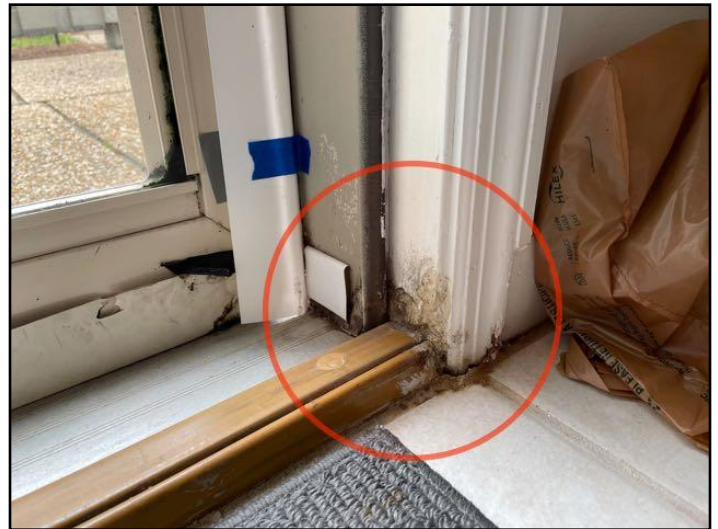
40. Rot Door Sill

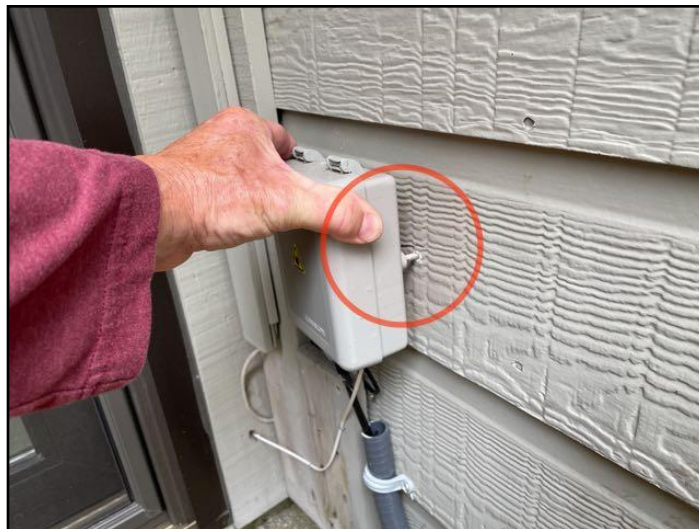
3. Condition: • Auxiliary cable Box Loose/ not secure

50. Cable Box loose on ext. wall

Task: Improve

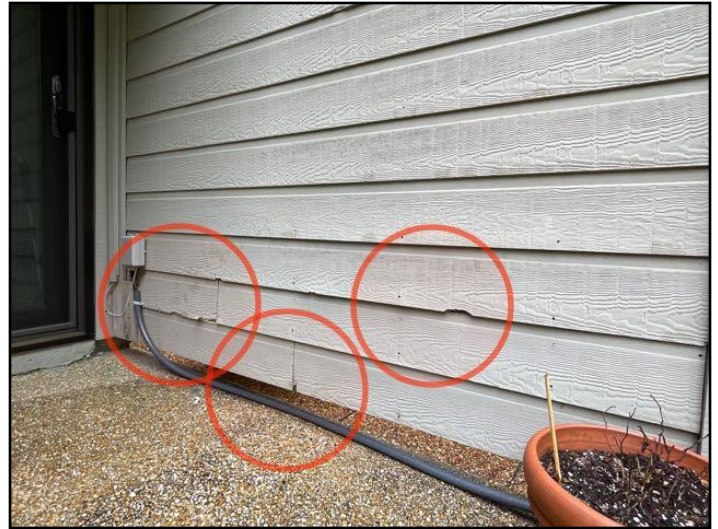
4. Condition: • [Loose or missing pieces](#)

52. Loose or missing pieces

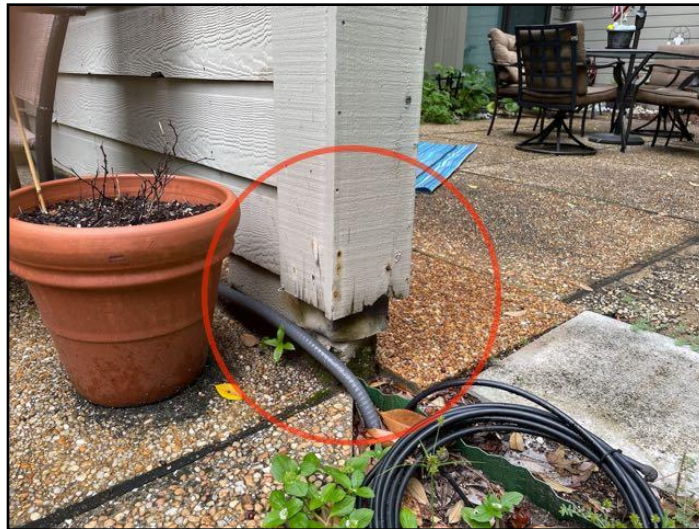
5. Condition: • Damage

53. Rot or insect damage

Task: Further evaluation

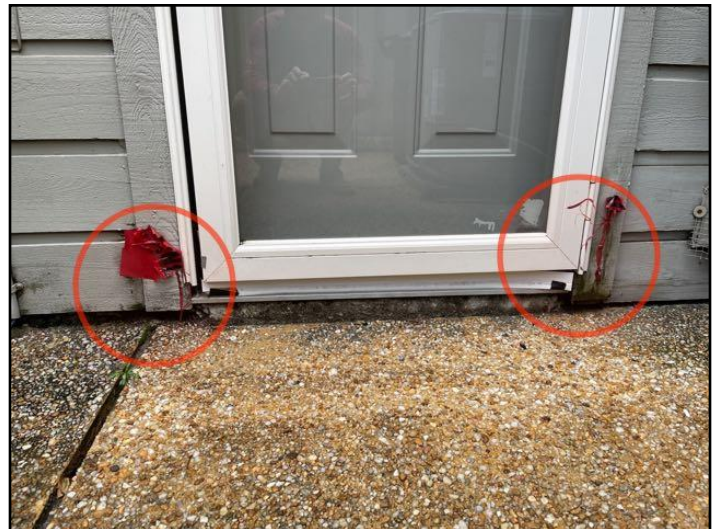
7. Condition: • [Damaged, cracked or loose](#)

56. Damaged, cracked or loose

Task: Repair or replace

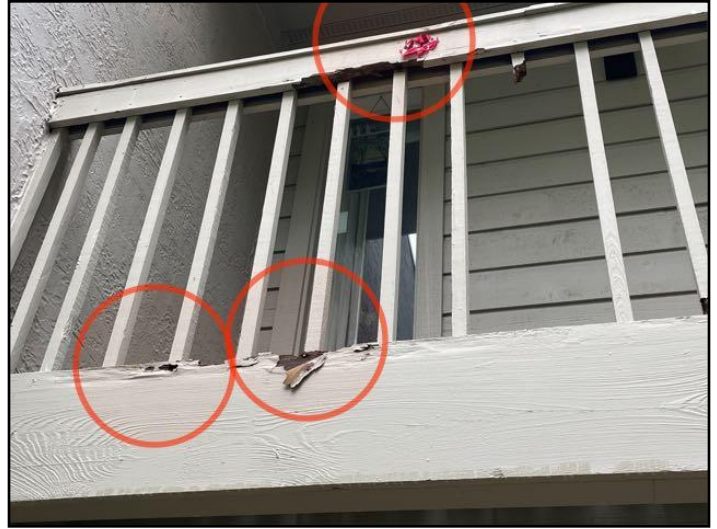
8. Condition: • [Damage](#)

Deterioration of wood possible Safety issue

58. Damage

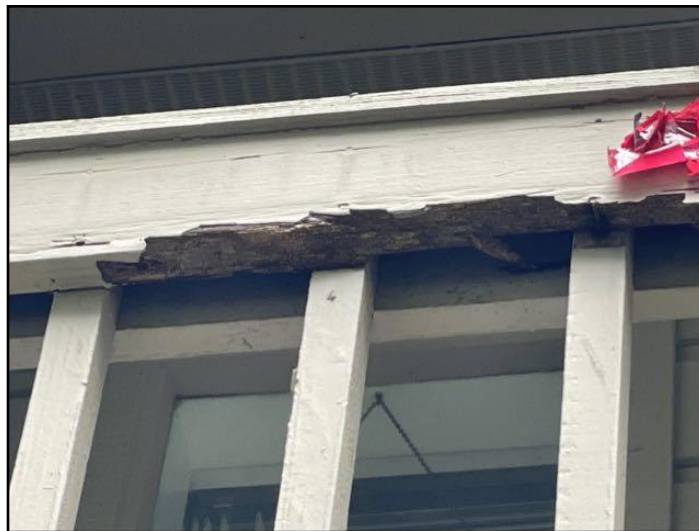
59. Damage

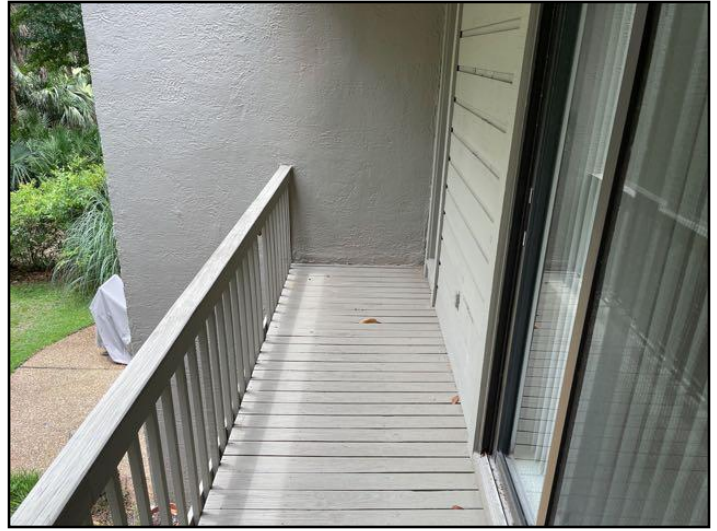
9. Condition: • [Sag](#)

63. Sag Top of Balcony

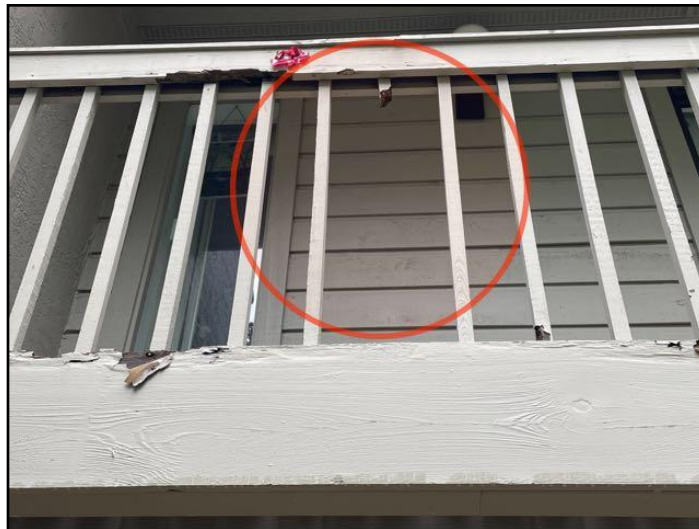
11. Condition: • [Missing](#)

Missing Balusters

64. Missing Balusters

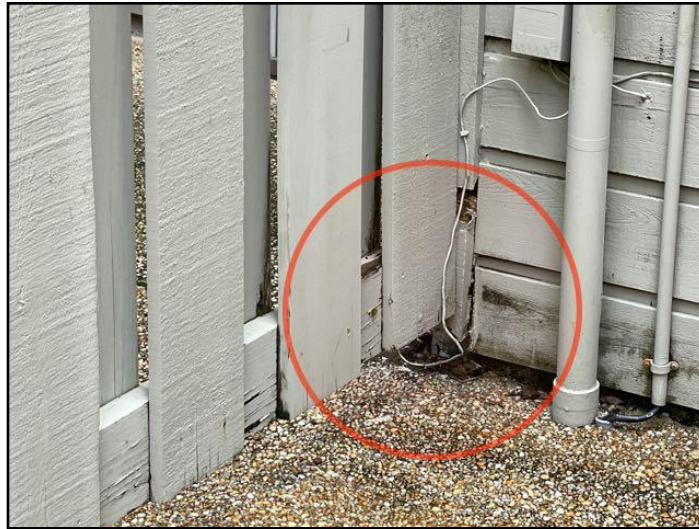
14. Condition: • Damage

67. Damage

Task: Further evaluation

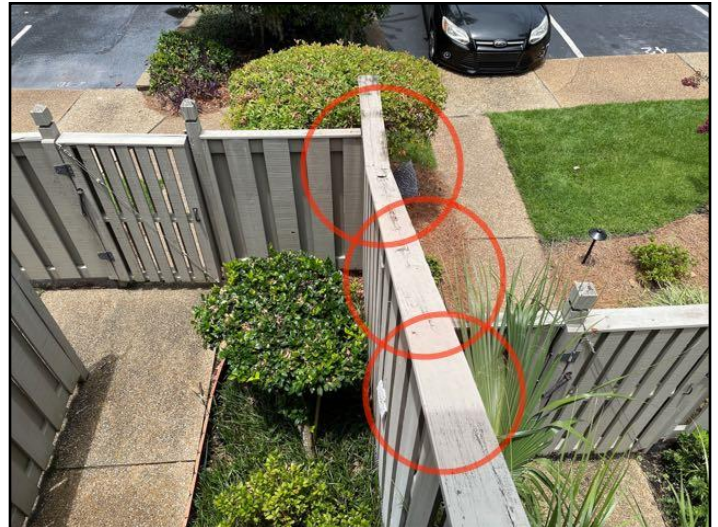
15. Condition: • Deteriorated

Fence cap rotted and deteriorated

69. Deteriorated

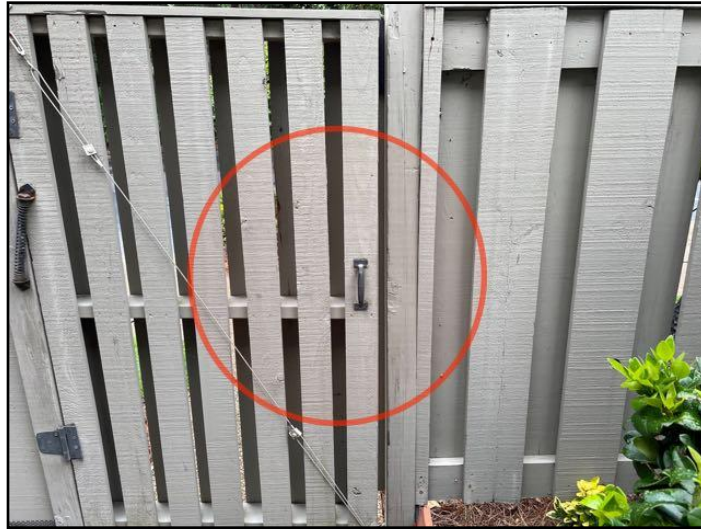
16. Condition: • Gate inoperative

70. Gate inoperative no latch

Task: Repair or replace

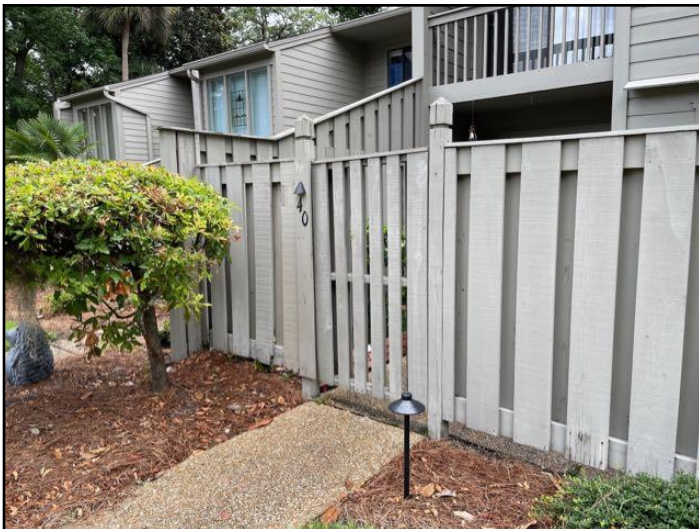
17. **Condition:** • Rot

71. Rot fencing

Task: Further evaluation

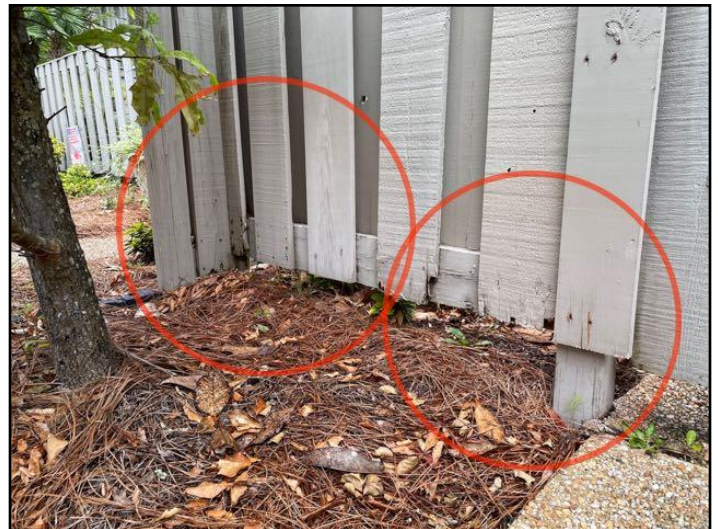
72. Rot fencing

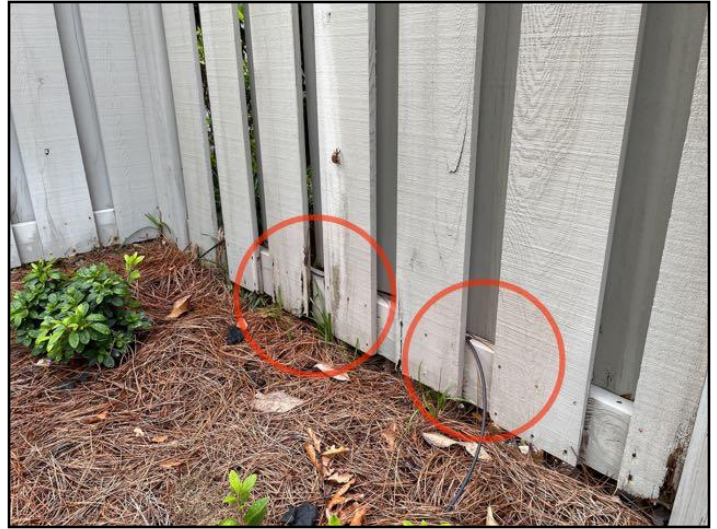
74. Rot fencing

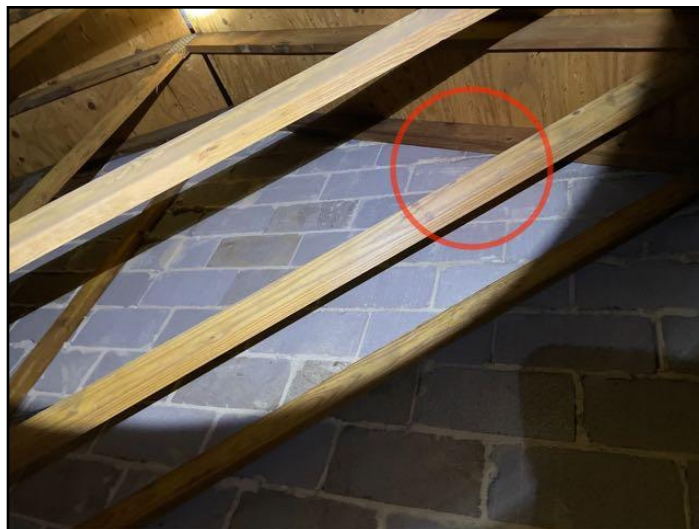
18. Condition: • Damage

Noticed water stains and possible Environmental Suspect Growth on ridge beam

78. Ridge beam, Possible Water Damage

Task: Further Evaluation

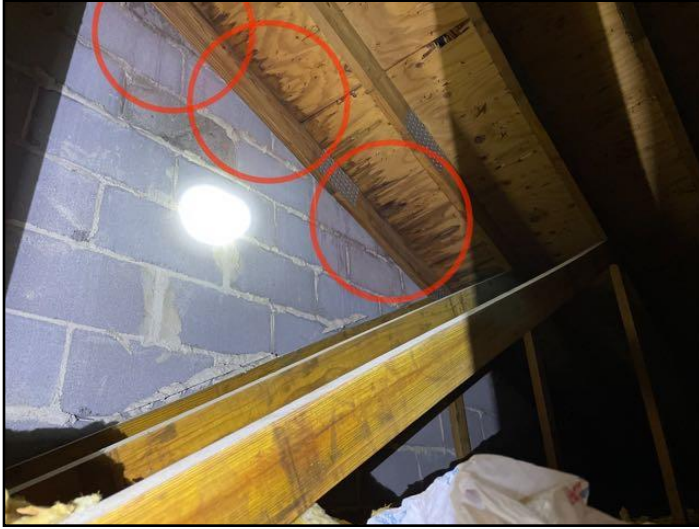
19. Condition: • Water damage

Water stains on sheathing location where Roof/Wall Flash damage was observed

79. Water damage

Task: Further evaluation

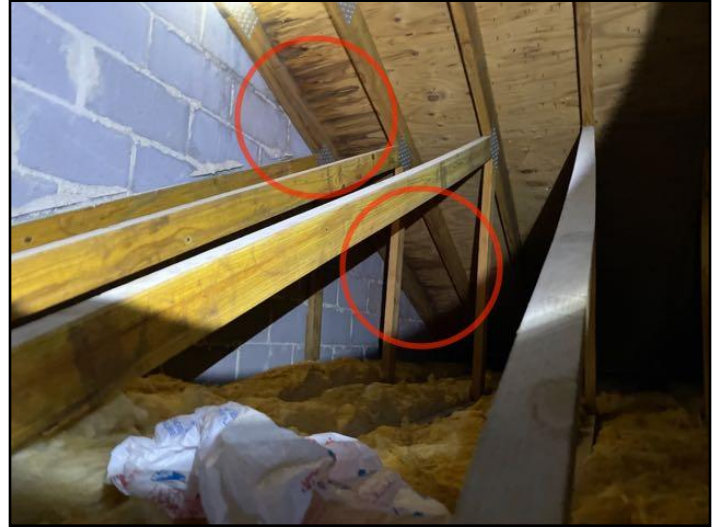
80. Water damage

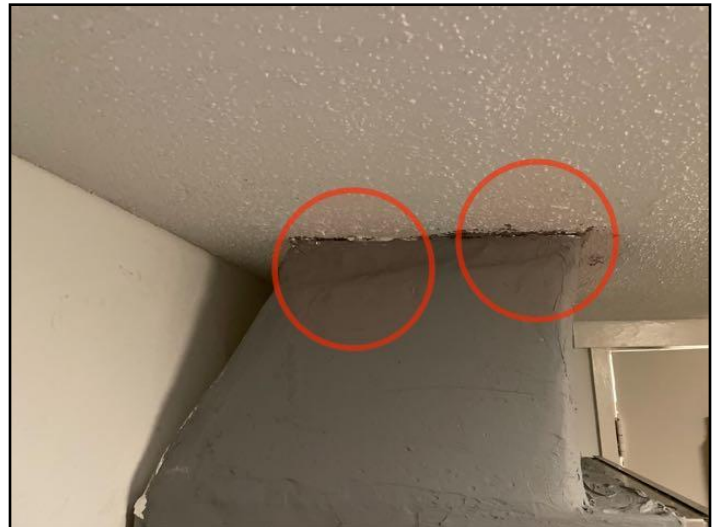
24. Condition: • Loose/Missing Tape

97. Loose/Missing Tape

Task: Repair and Improve

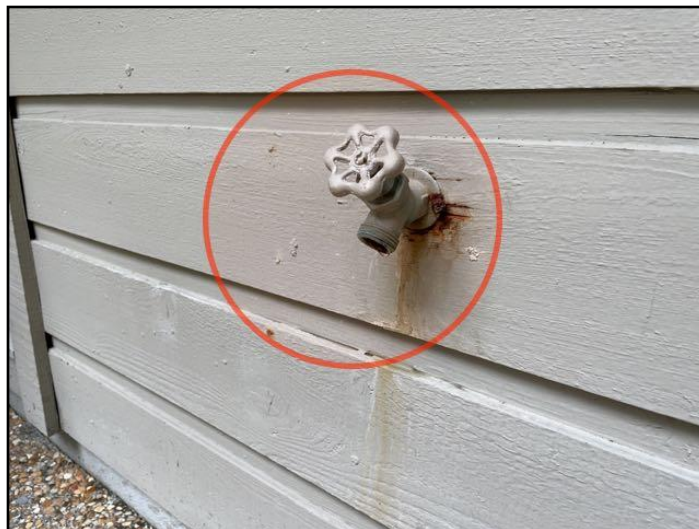
26. Condition: • [Leak or drip](#)

Rust at the base of the hose bib When tested small drip occurred for 3 to 4 minutes

103. Leak or drip

Task: Further evaluation

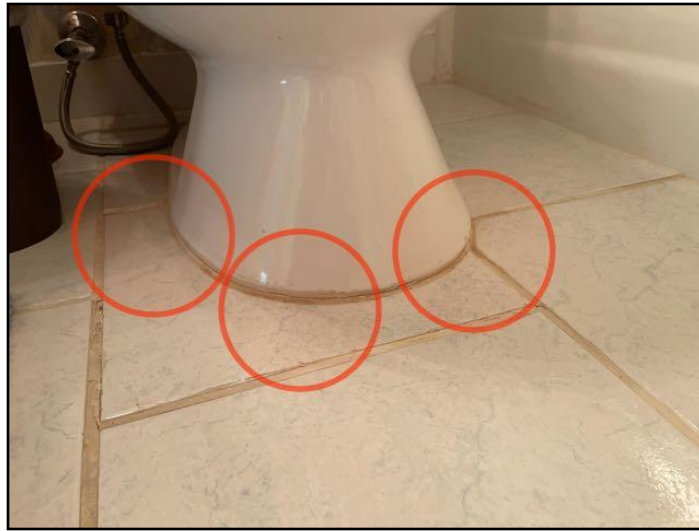
27. Condition: • [Caulking loose, missing or deteriorated](#)

104. Caulking loose, missing or deteriorated

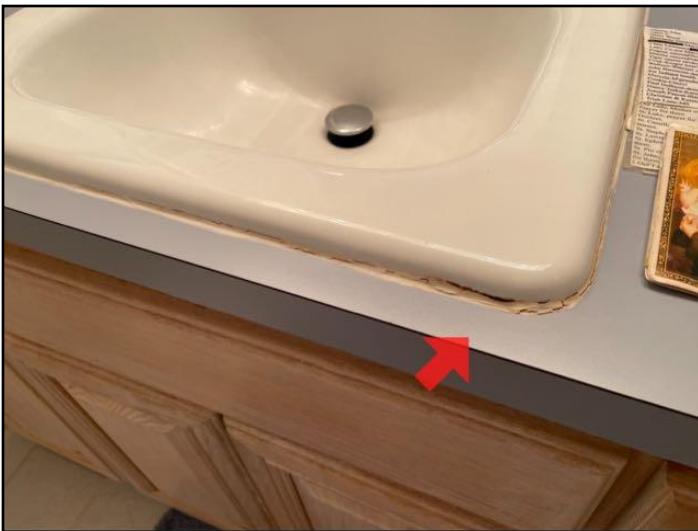
28. Condition: • [Caulking loose, missing or deteriorated](#)

105. Caulking loose, missing or deteriorated

Task: Improve

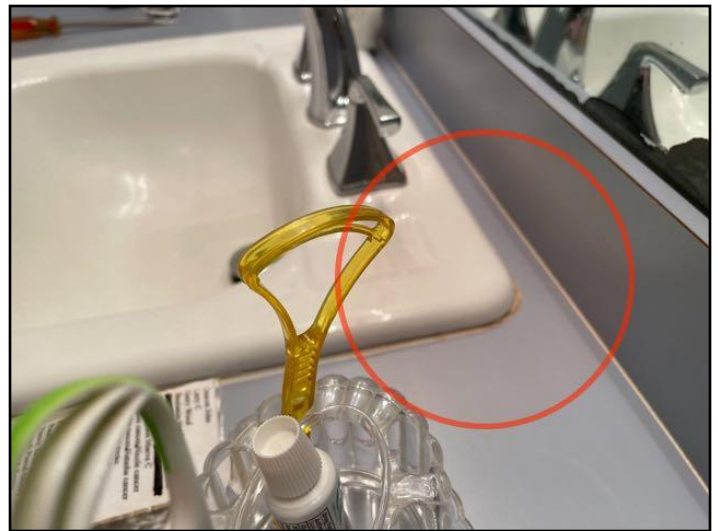
106. Caulking loose, missing or deteriorated

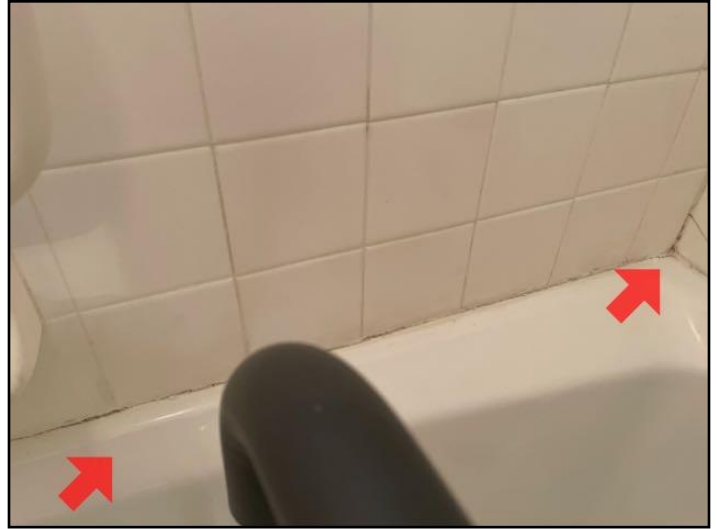
29. Condition: • [Caulking loose, missing or deteriorated](#)

108. Caulking loose, missing or deteriorated

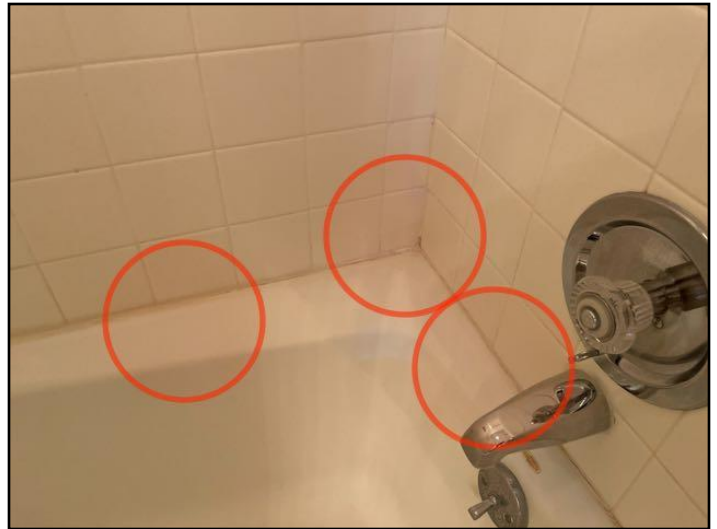
30. Condition: • [Grout loose, missing or deteriorated](#)

Master Bath Grout loose / Missing

110. Grout loose, missing or deteriorated

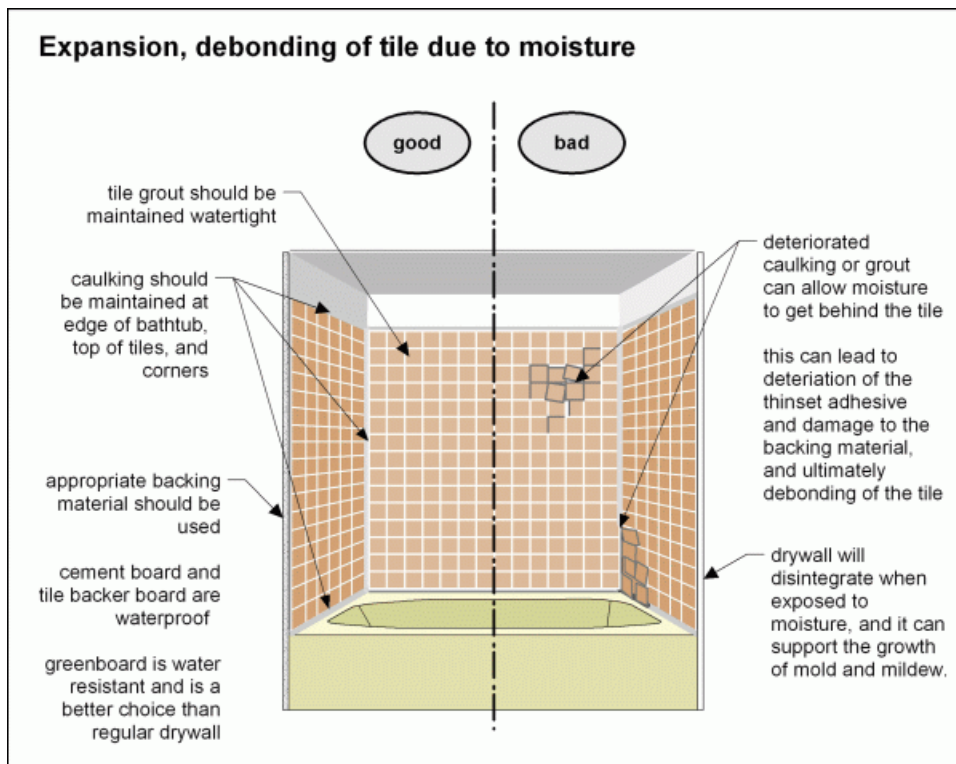
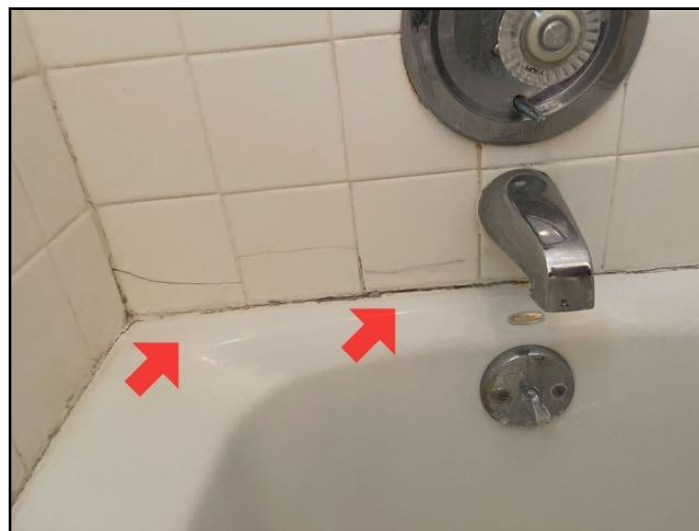
31. Condition: • [Tile loose, broken or missing](#)

111. Tile loose, broken or missing

Task: Monitor

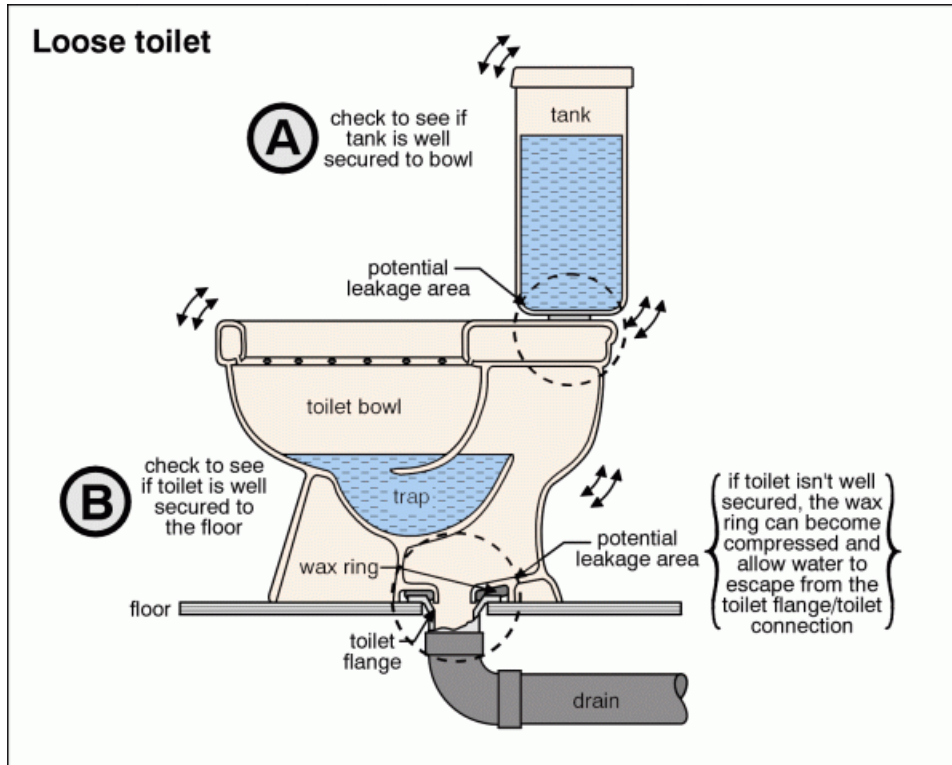
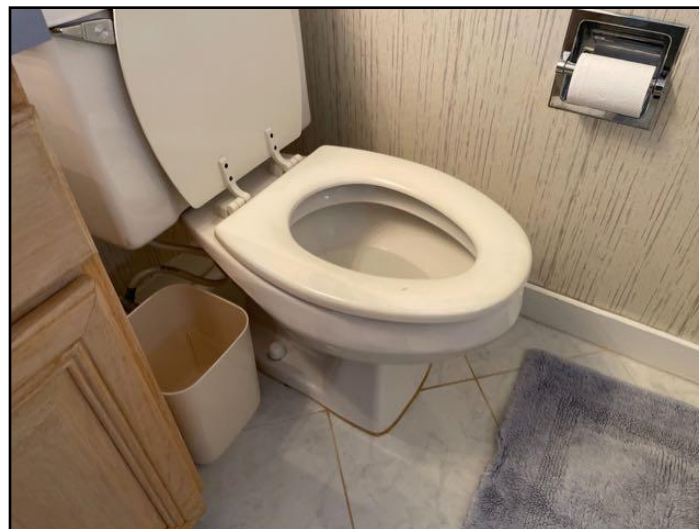
32. Condition: • [Loose](#)

Toilet second floor Bath Loose to floor

112. Loose

Task: Improve

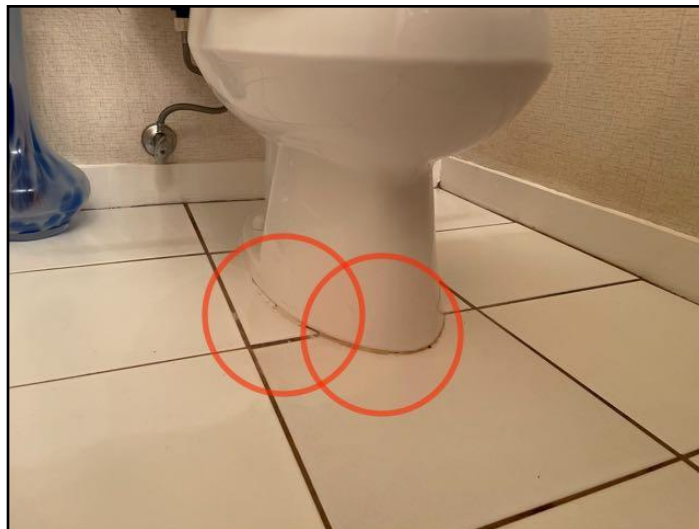
34. Condition: • Loose grout or caulking missing and /or damaged

114. Grout loose, missing or deteriorated

Task: Improve

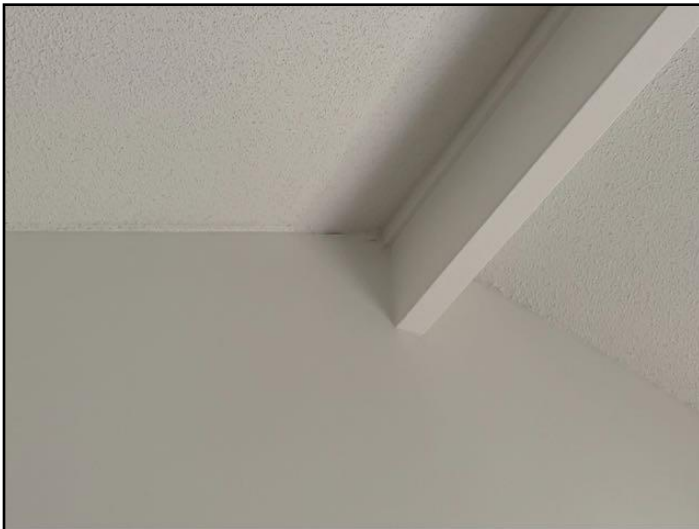
- Drywall/plaster damage
- Second-floor master bedroom

115. Drywall/plaster damage

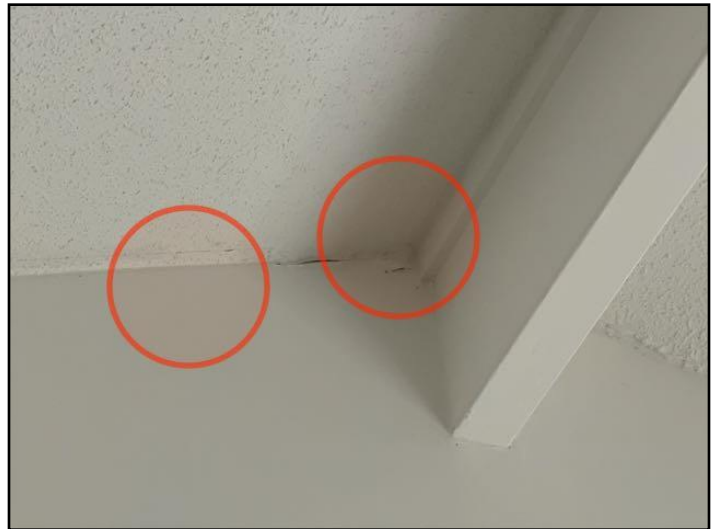
116. Drywall/plaster damage

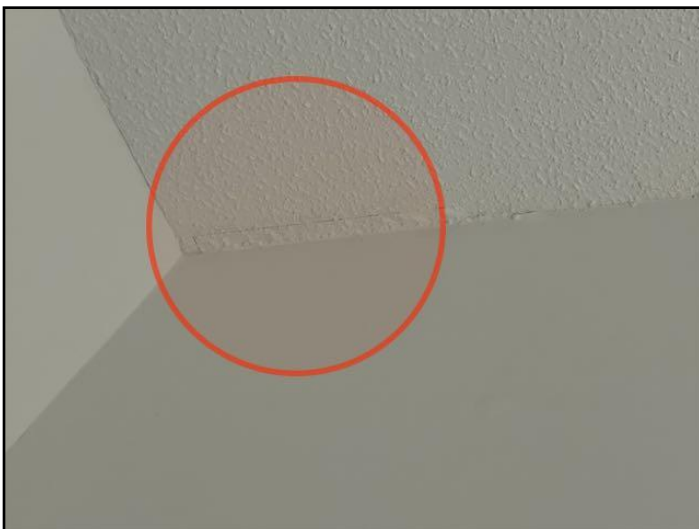
117. Drywall/plaster damage

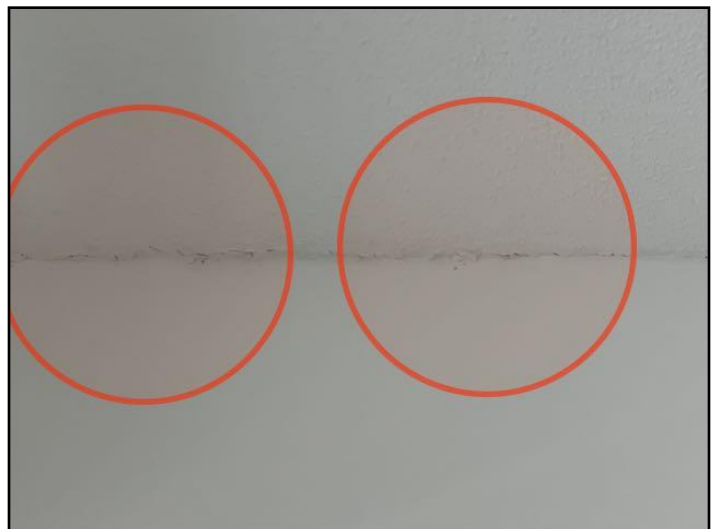
118. Drywall/plaster damage
