40 Sailmaster Com, Hilton Head Island, SC June 26, 2021

Report No. 1011, v.3

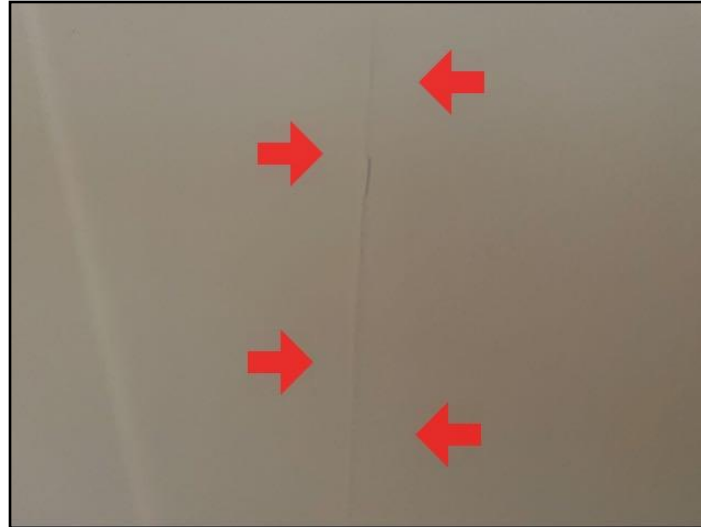
37. Condition: • Cracks

Implication(s): Damage or physical injury due to falling materials | Chance of structural movement

139. Cracks

Task: Monitor

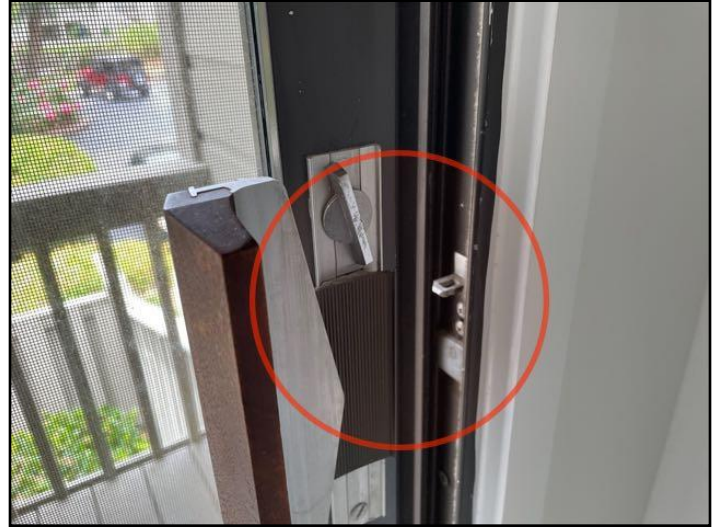
39. Condition: • [Inoperable](#)

143. Inoperable

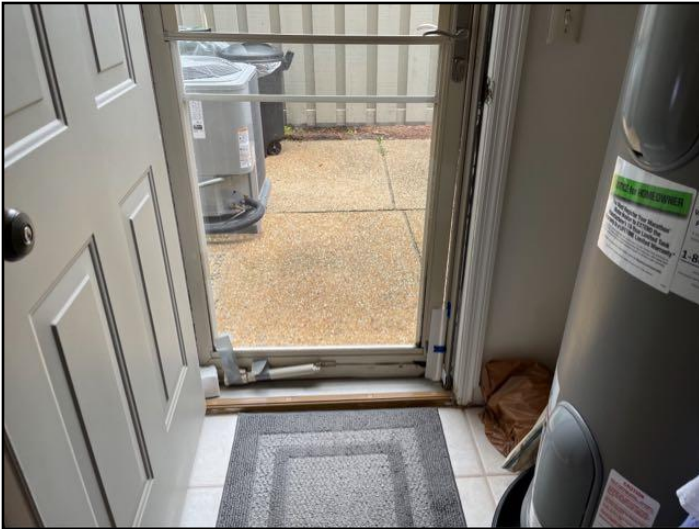
42. Condition: • [Doorstops missing or ineffective](#)

147. Doorstops missing or ineffective

Task: Further evaluation

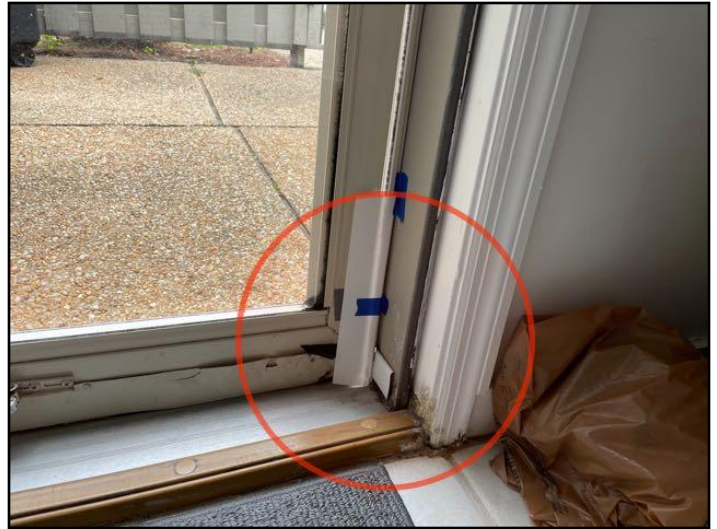
148. Doorstops missing or ineffective

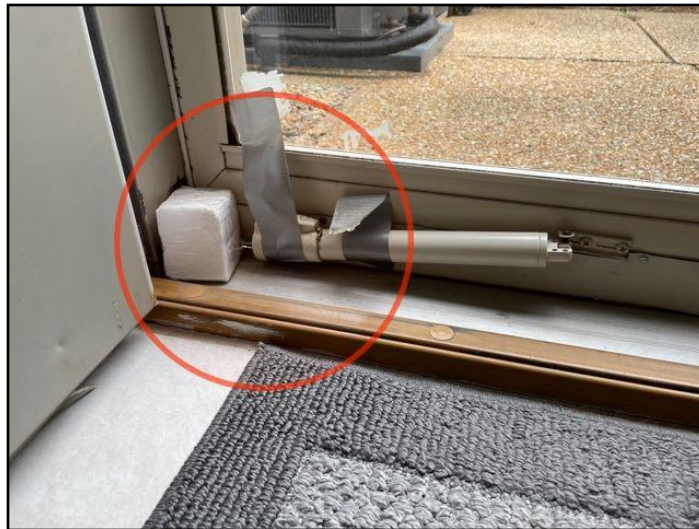
149. Doorstops missing or ineffective

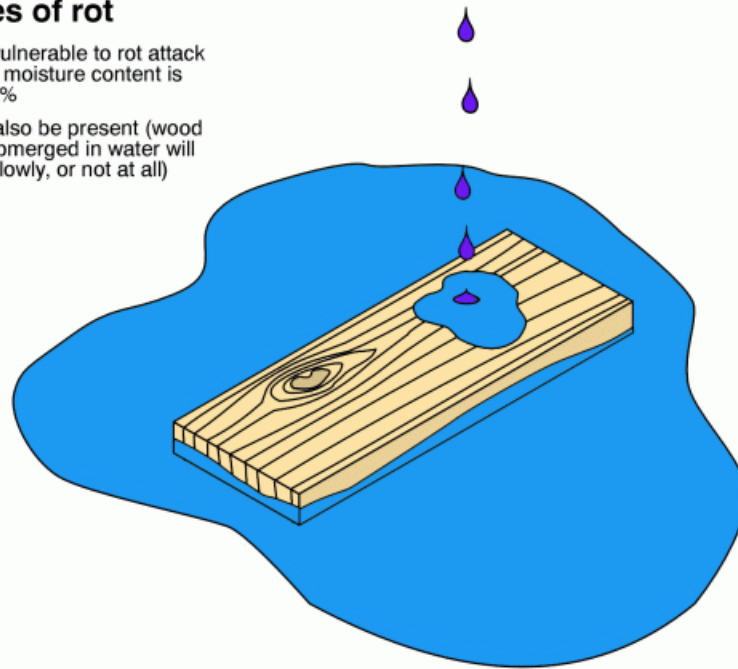
43. Condition: • [Rot](#)

wood is vulnerable to rot attack when the moisture content is above 20%

150. Rot Door sill

Task: Repair or replace

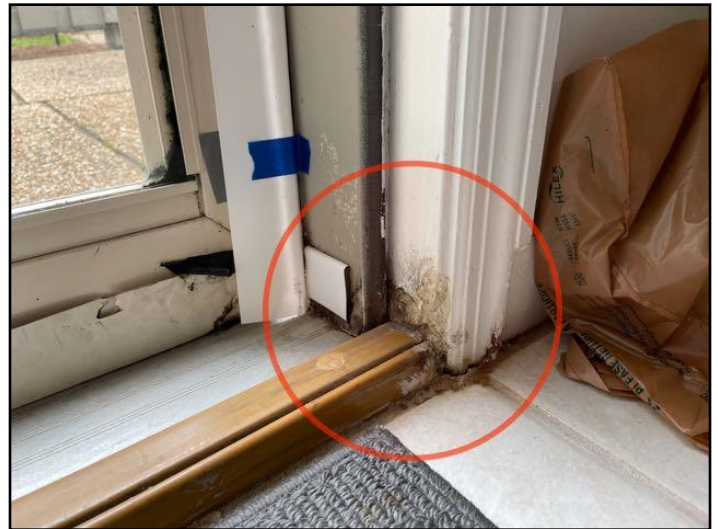
151. Rot Door Sill

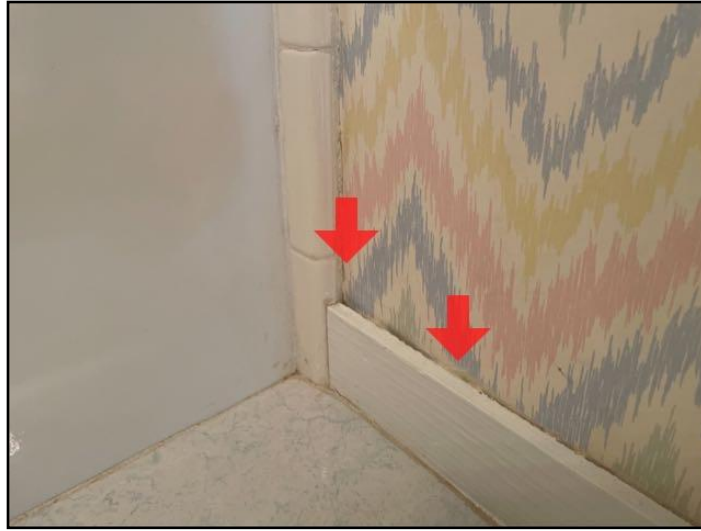
44. Condition: • [Water damage](#)

152. *Possible Water damage*
