FULL RESERVE STUDY

Whittier Towers Apartments Association, Inc.

**Lauderdale By The Sea, Florida
October 11, 2021**

Reference: 211064

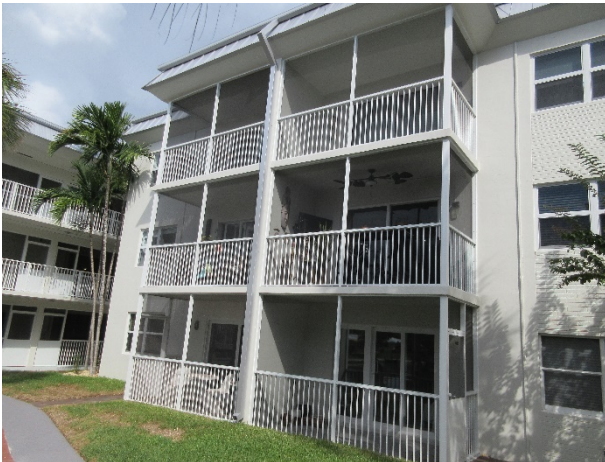
Condition: Good overall

Concrete balconies overview

Useful Life: Capital repairs including a close-up visual inspection, patching of delaminated concrete, routing and filling of cracked concrete, and waterproof coating applications every 8- to 12-years.

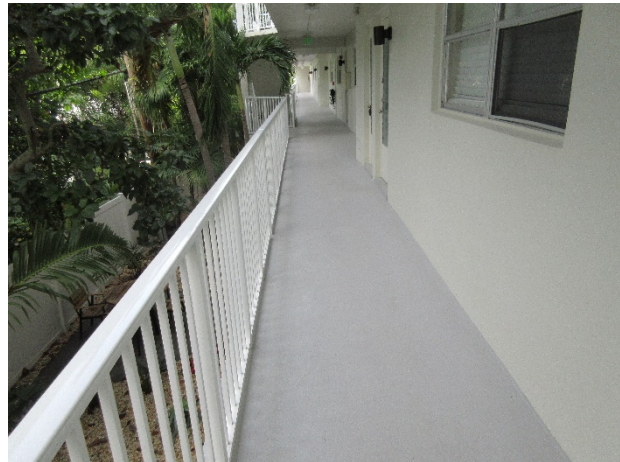
Concrete breezeway overview

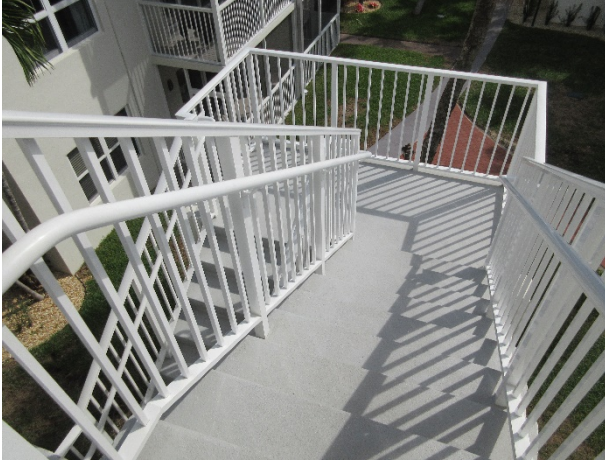
Concrete staircase overview

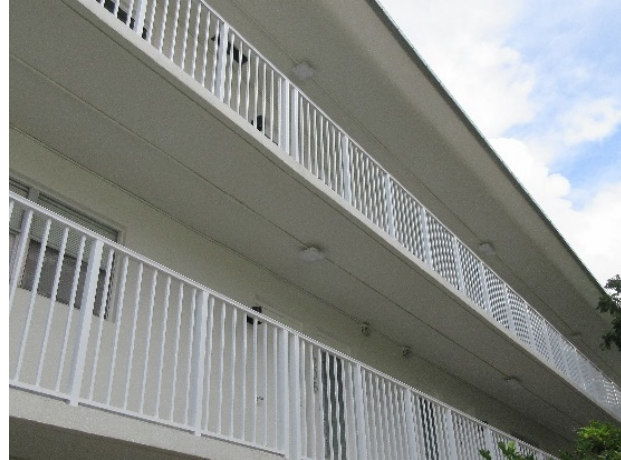
Concrete breezeway underside

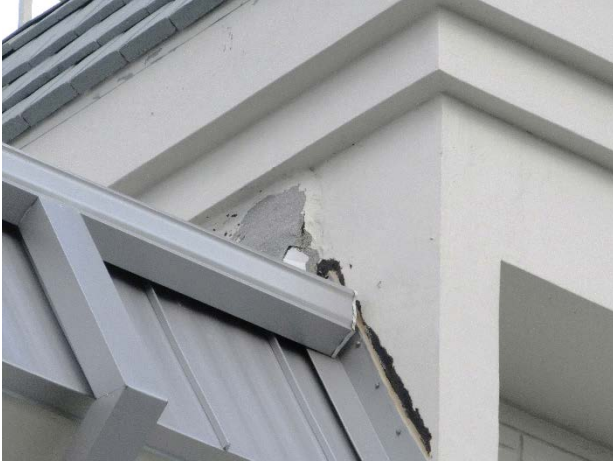
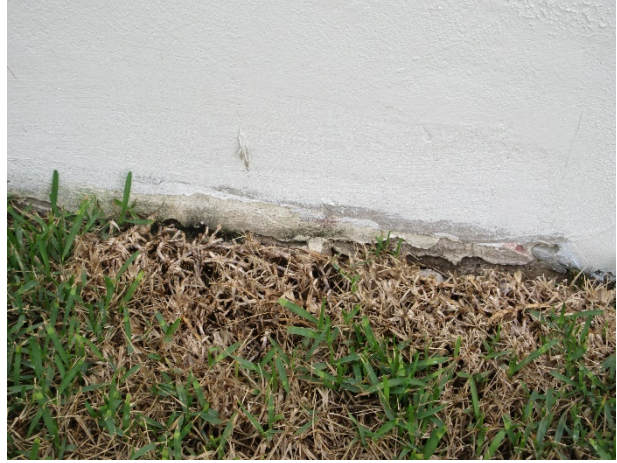
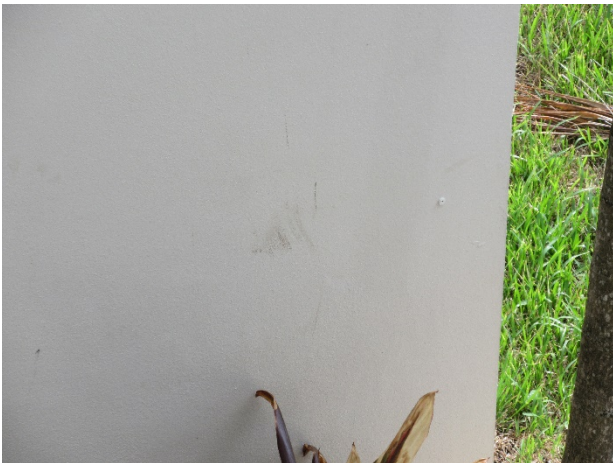
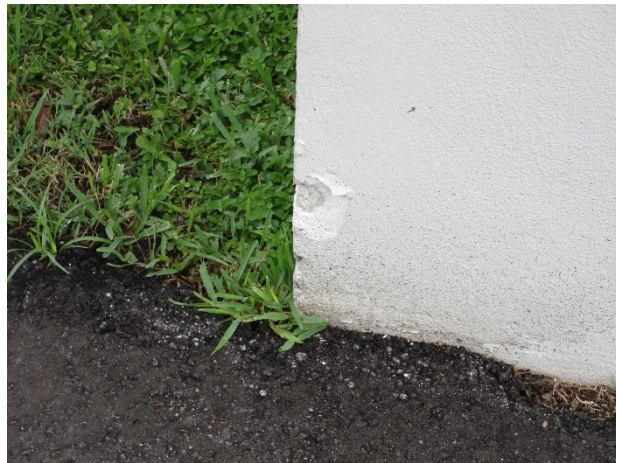
Conditions: The façade and the coating are in good overall condition with isolated coating finish deterioration evident.

Coating finish deterioration

Useful Life: We recommend concrete facade inspections, paint finishes and repairs every five- to seven-years.

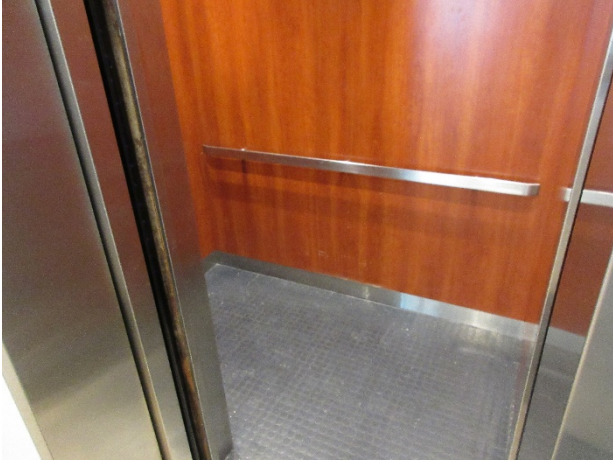
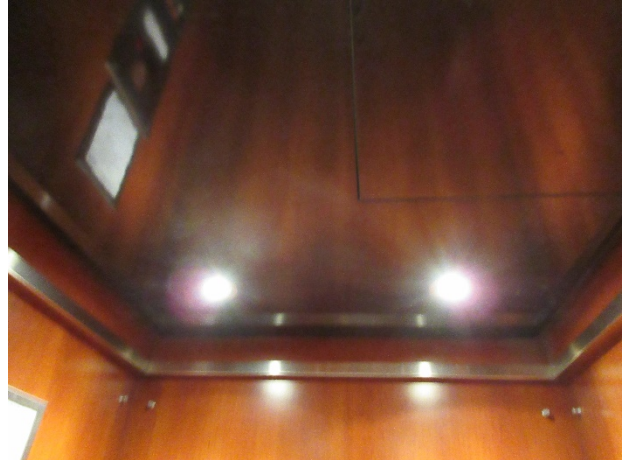
Condition: Good to fair overall

Elevator cab finishes

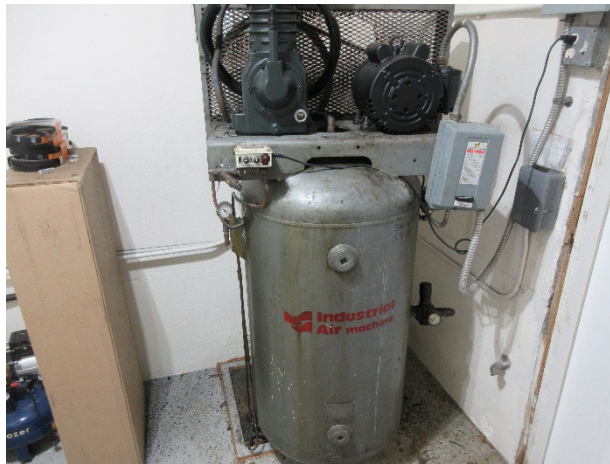
Condition: Reported satisfactory

Compressor overview

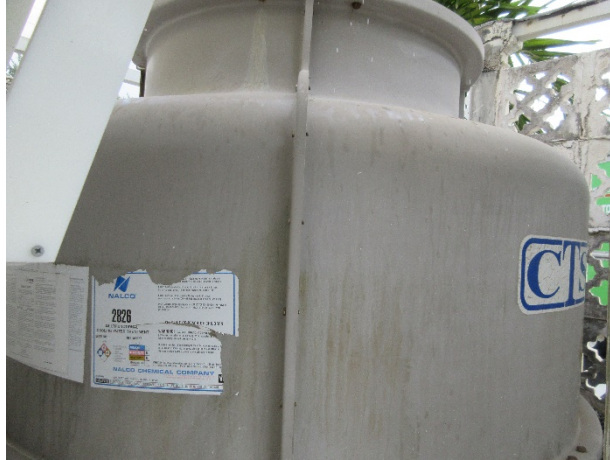
Condition: Reported satisfactory without operational deficiencies

Cooling tower

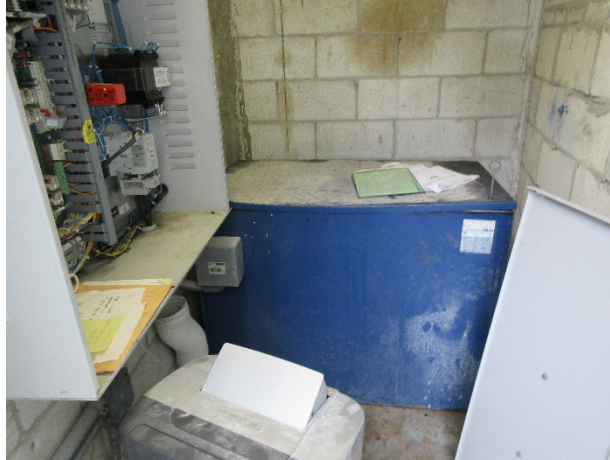
Condition: Reported satisfactory and service interruptions are reportedly infrequent.

Pump housing

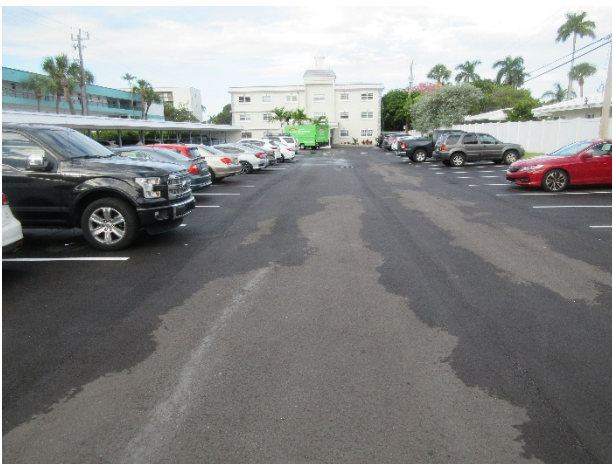
Condition: Good overall with minor areas of standing water evident

Asphalt pavement overview

application of two or more new lifts of asphalt. We recommend mill and overlayment on asphalt pavement that exhibits normal deterioration and wear. We recommend total replacement of asphalt pavement that exhibits severe deterioration, inadequate drainage, pavement that has been overlaid multiple times in the past or where the configuration makes overlayment not possible. Based on the apparent visual condition and configuration of the asphalt pavement, we recommend the mill and overlay method of repaving at Whittier Towers.

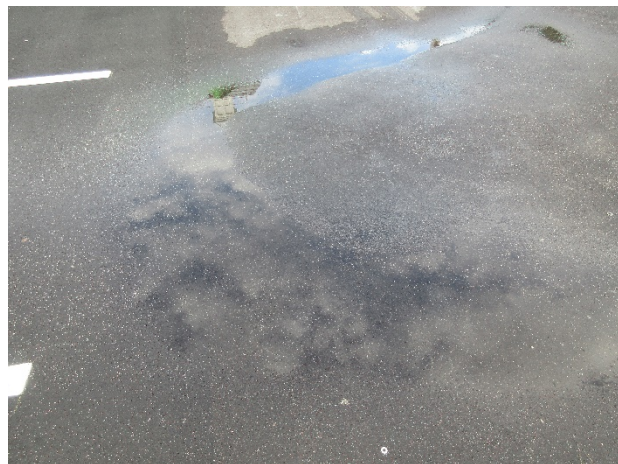
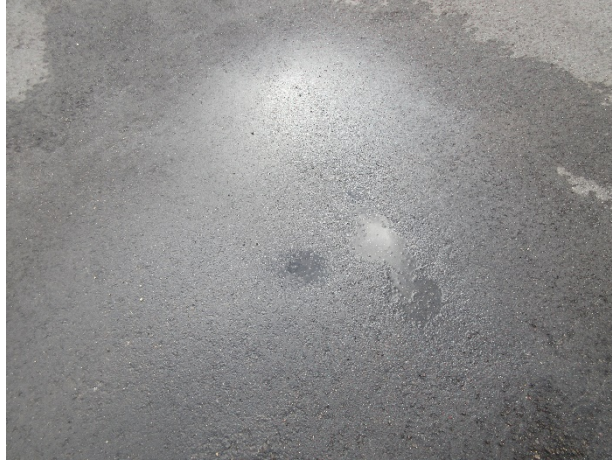
Standing water

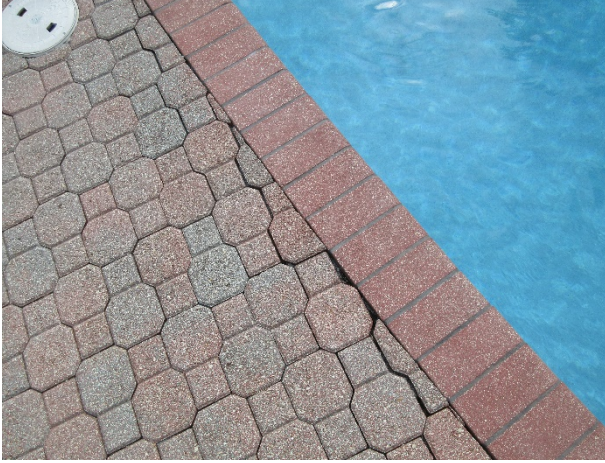
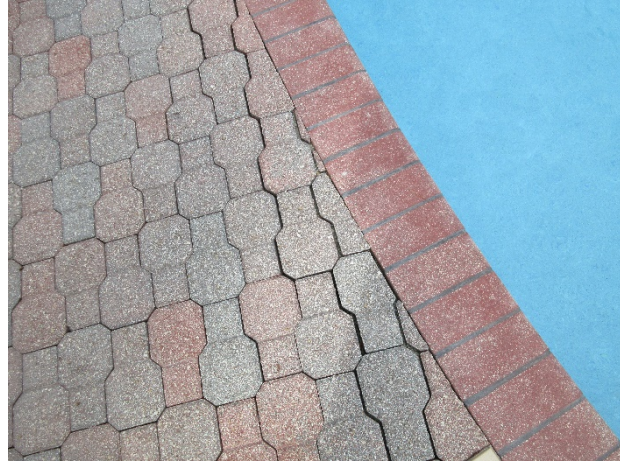
Condition: Good to fair overall with minor paver settlement evident

Paver settlement

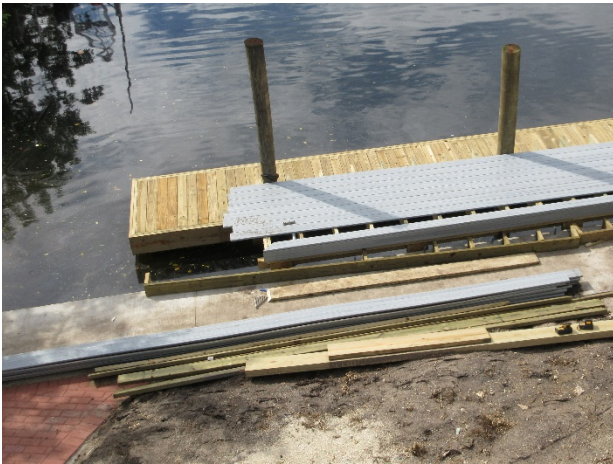
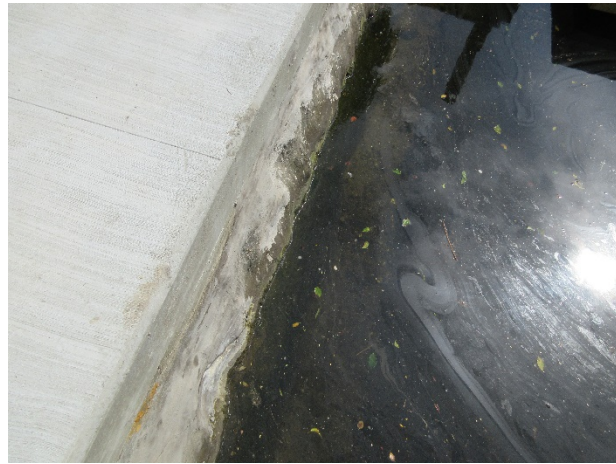
Conditions: Good overall

Concrete bulkhead overview

Useful Life: Inspections and capital repairs 10- to 15-years and replacement up to every 35 years
