PCI Stage Defects Inspection Report

D.C Building Inspectors

Inspection Date: 17 Nov 2023

Practical Completion Inspection

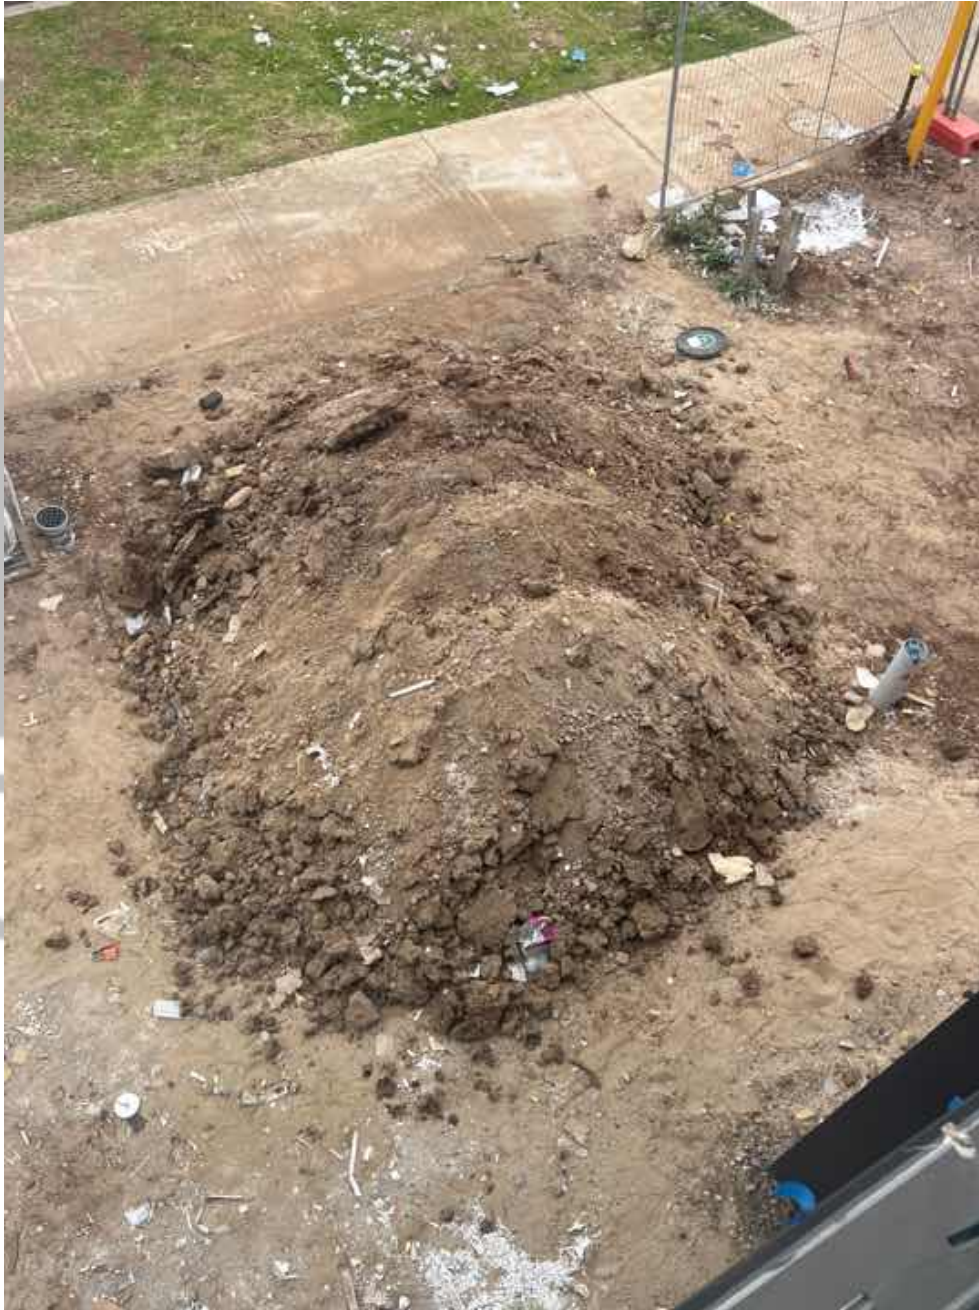
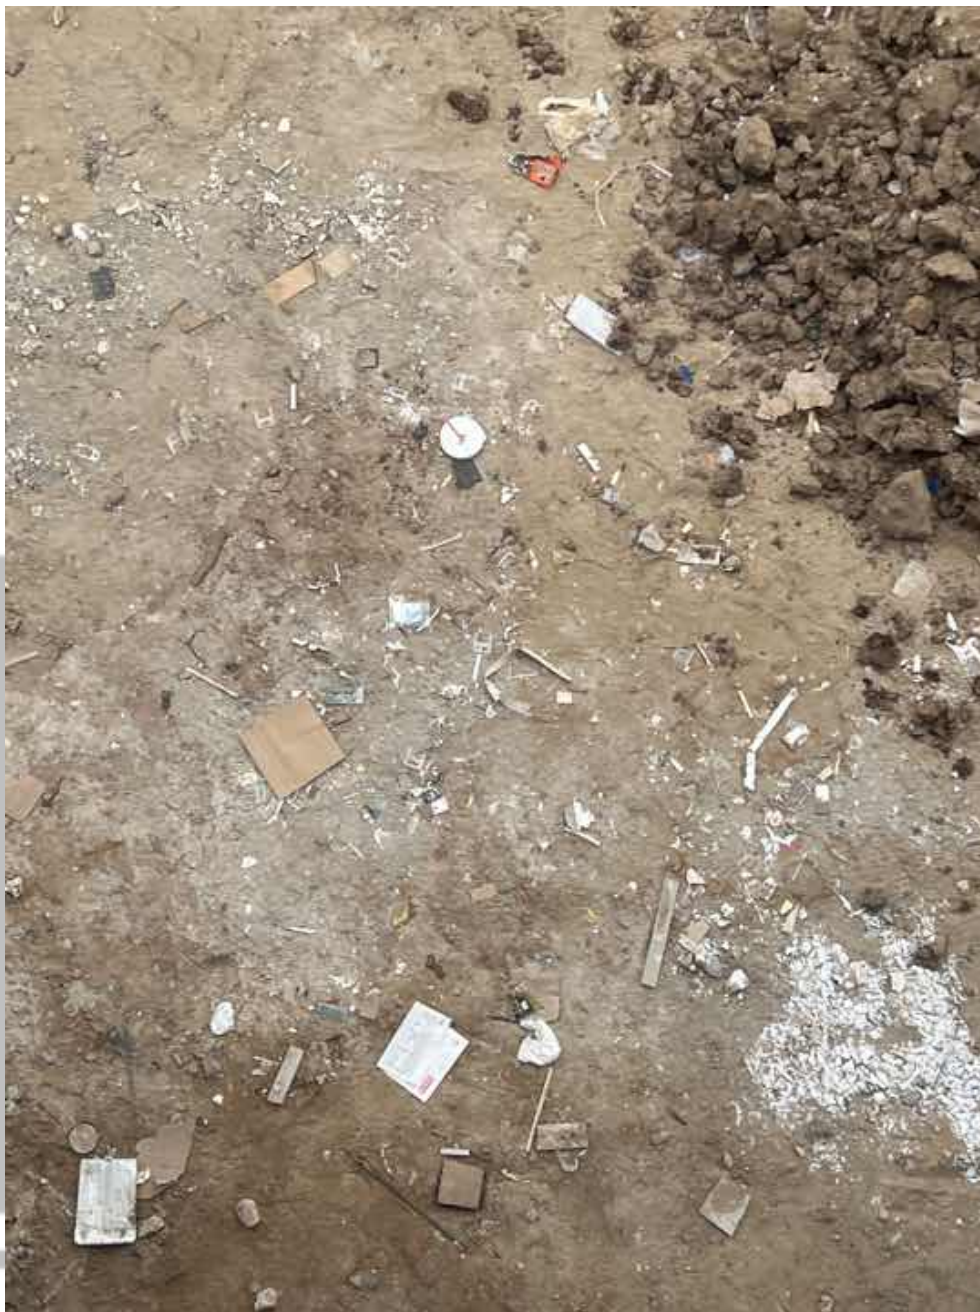
General site clean required.

VBA guide to standards and tolerances 2015: - All areas shall be cleaned prior to handover, in accordance with part 18.08.

This requirement has not been met.
