Sample Report

D.C Building Inspectors

Pest And Building Inspection

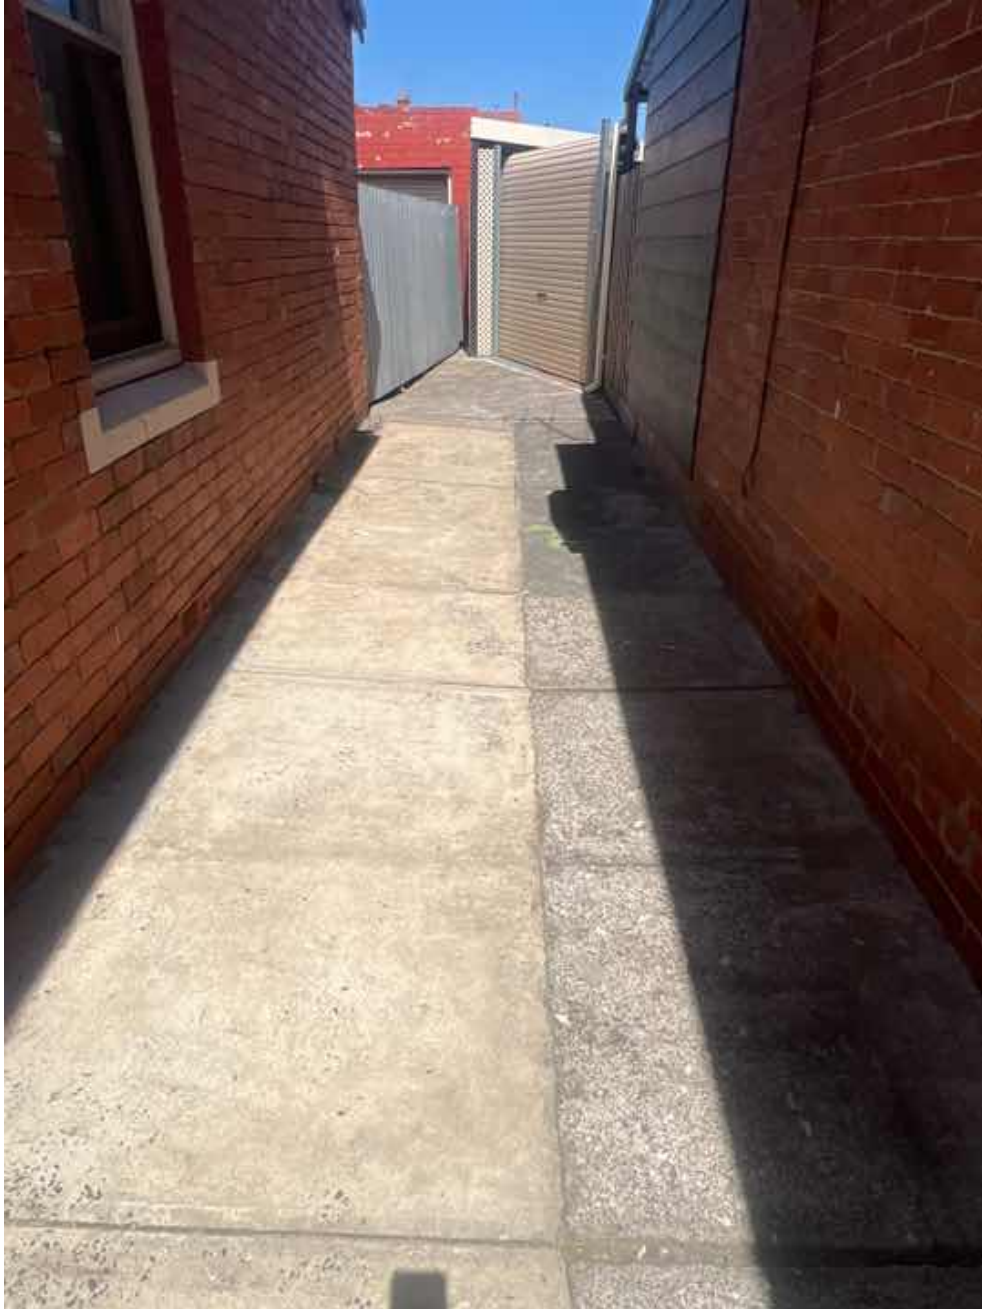
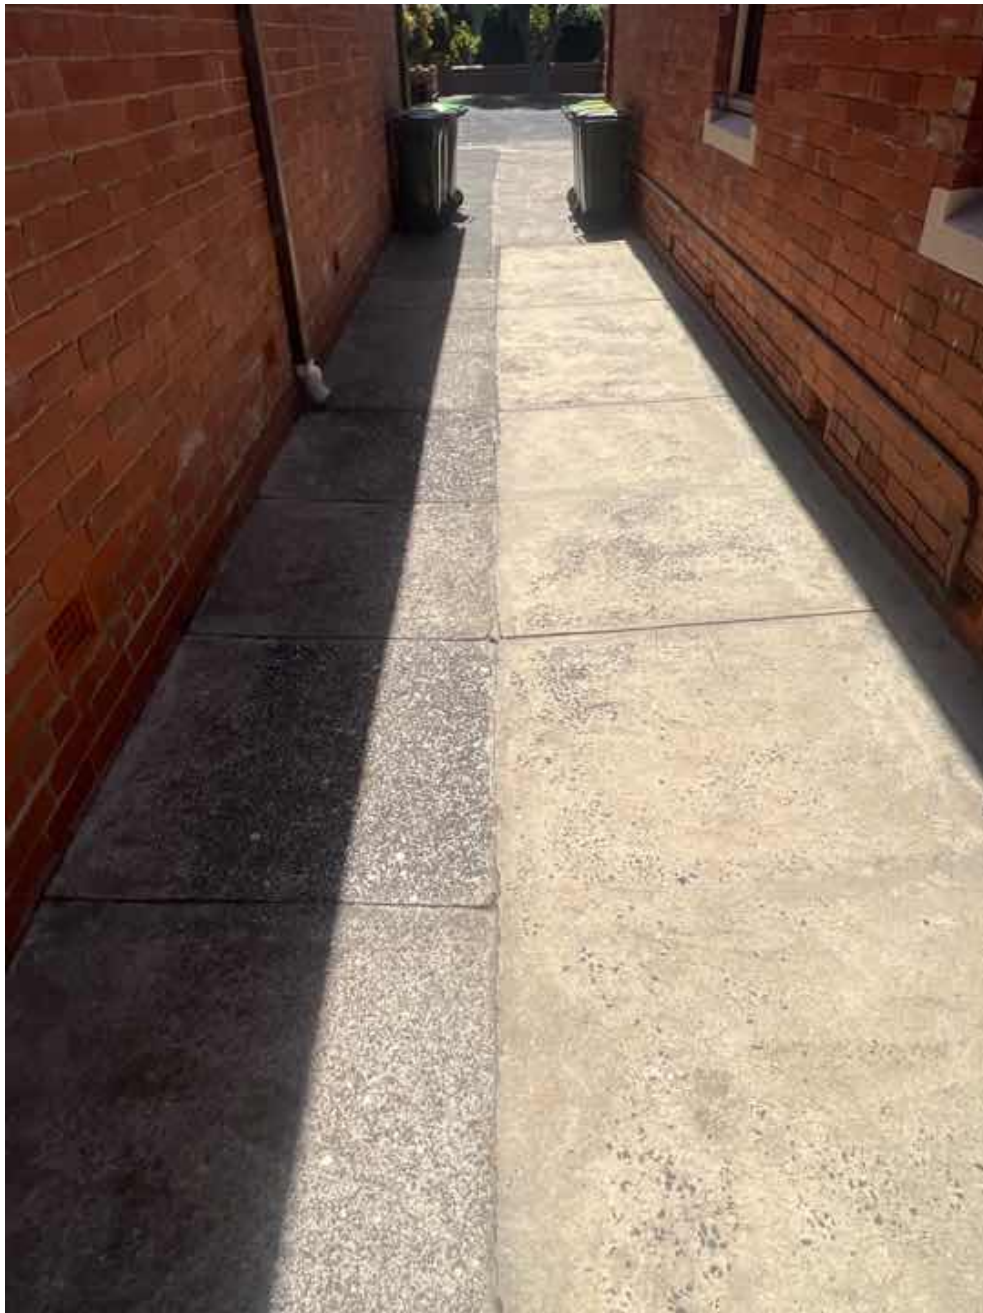
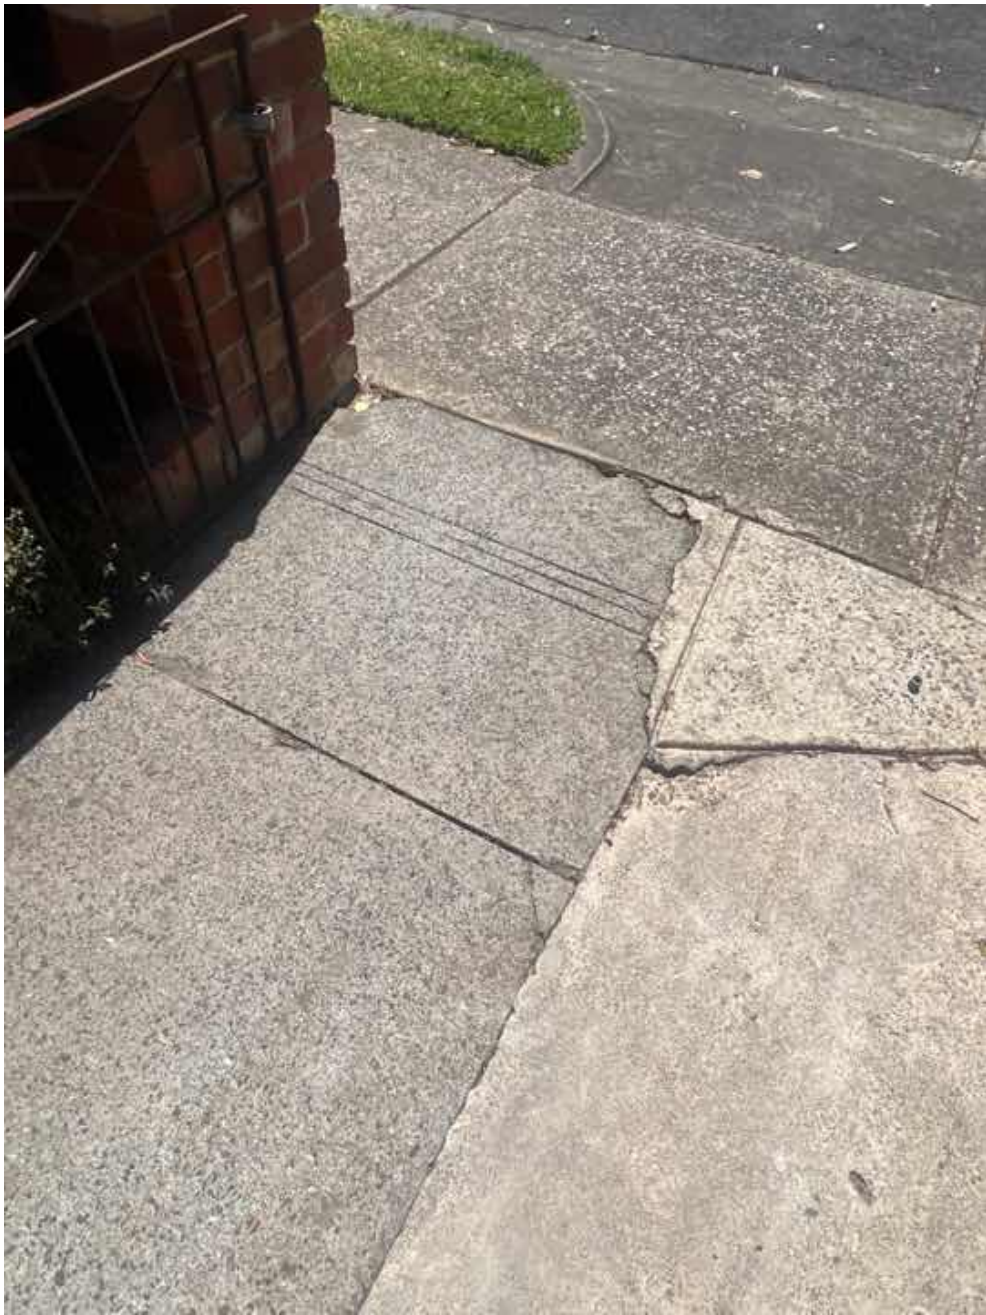
Driveway Condition

The driveway is in poor condition to some areas and replacement is recommended. Contact a qualified concreter for a quotation prior to a decision to purchase.

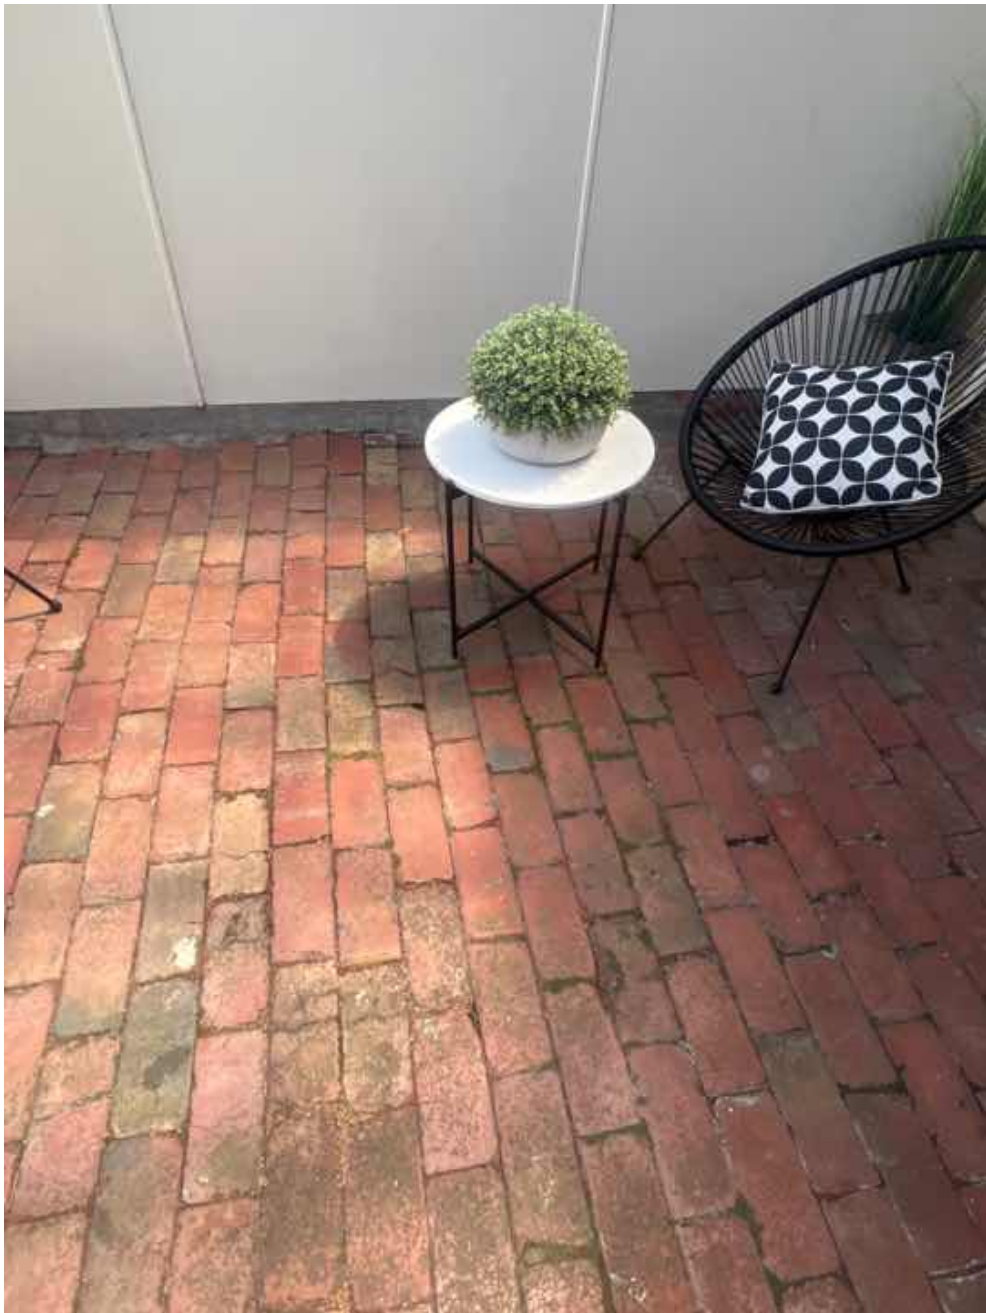
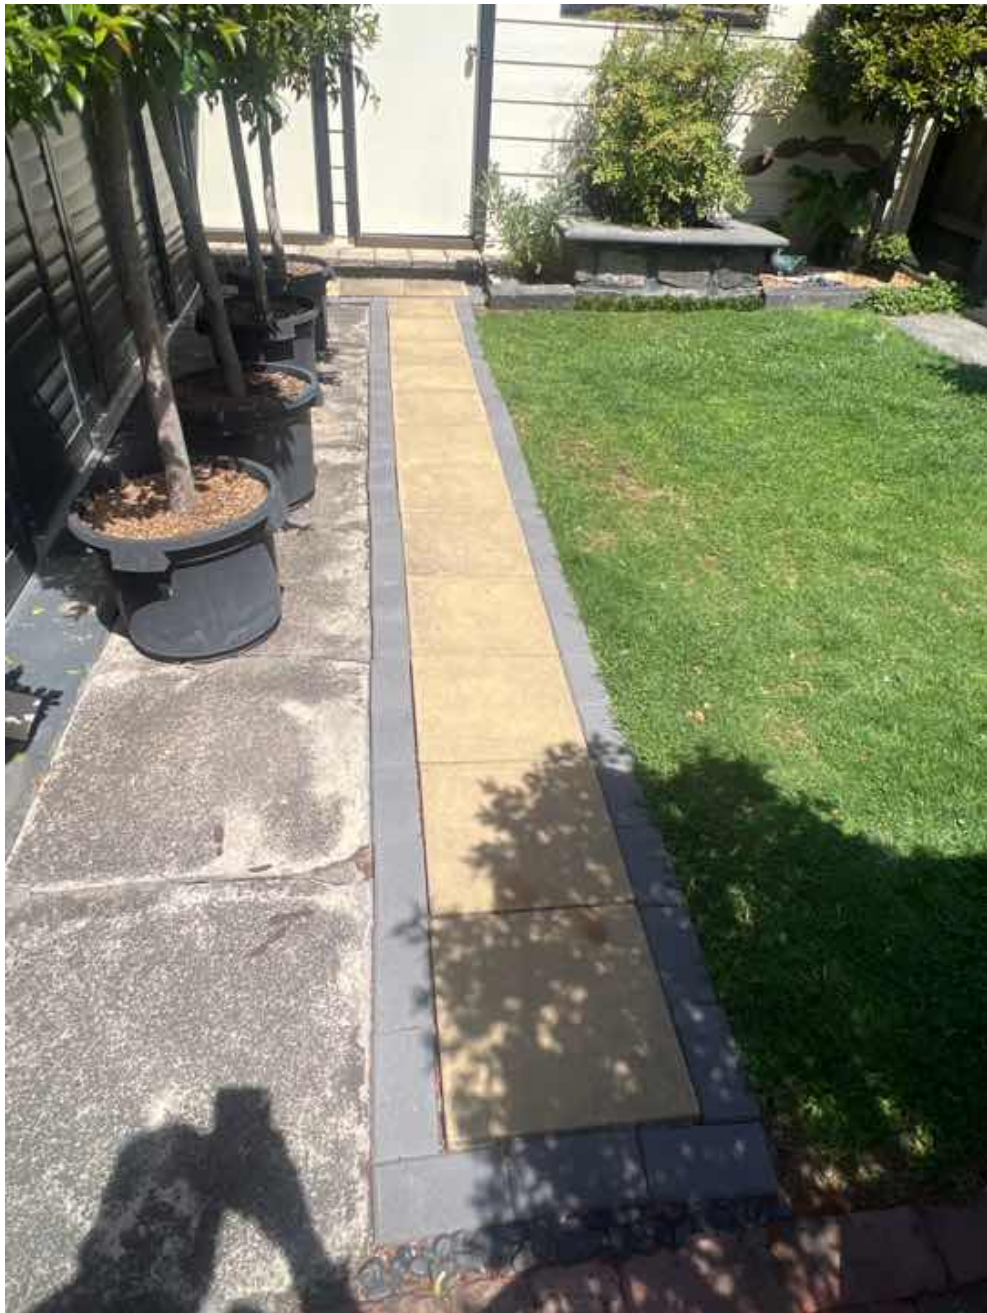
Pathways Condition

Common cracks and settlement were observed on paths. Whilst these cracks appeared to be typical at the time of inspection, we strongly recommend you monitor these cracks and if worsening occurs contact a concreter for further advice.

The concrete path is in poor condition replacement recommended. Contact a qualified concreter for repairs. Surface raised and settled in some areas. This can cause water ponding. Relaying recommended.

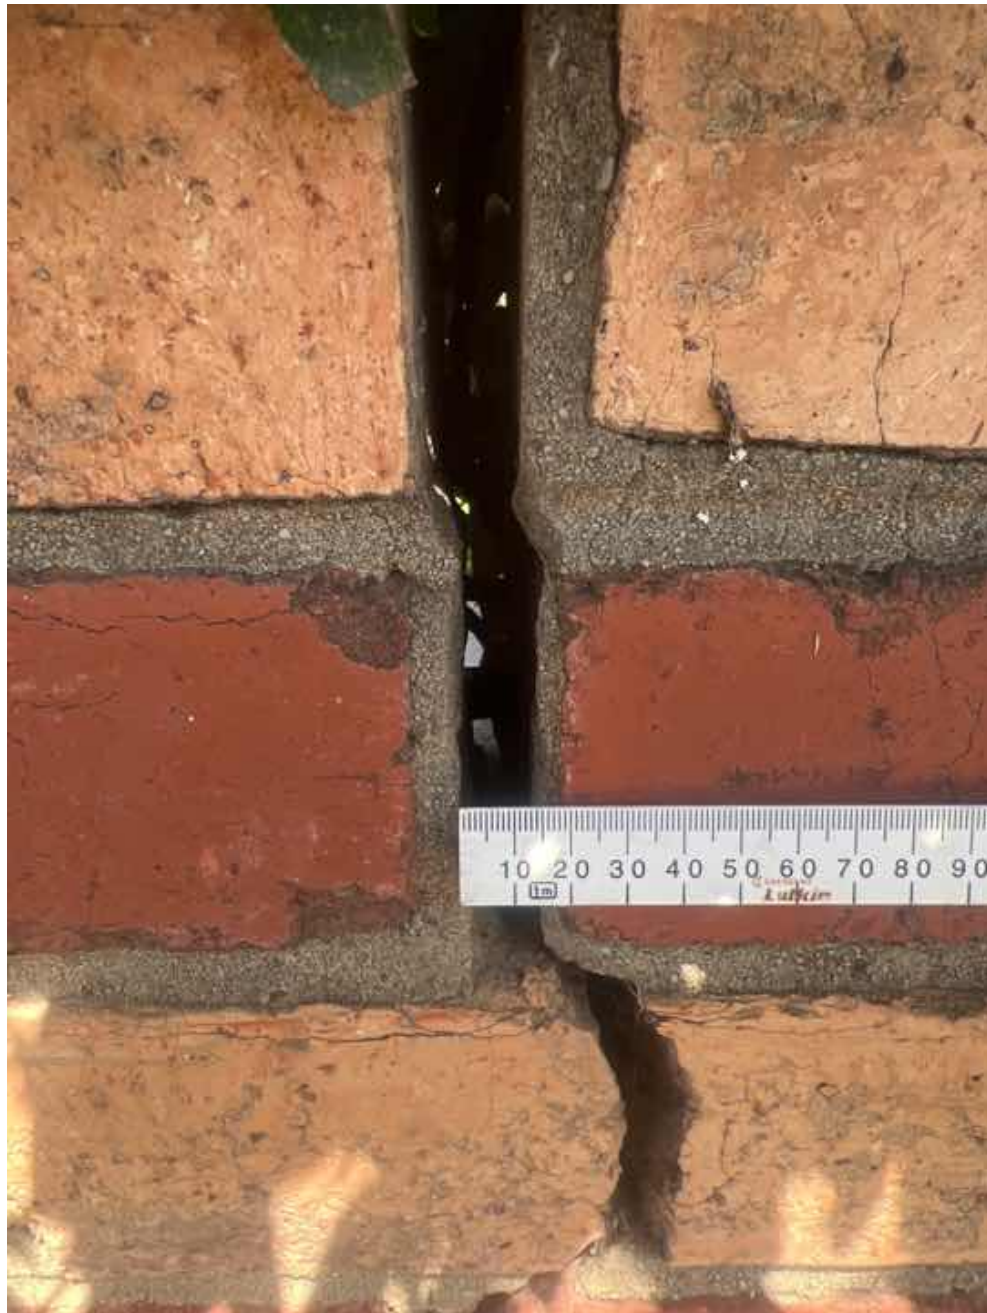
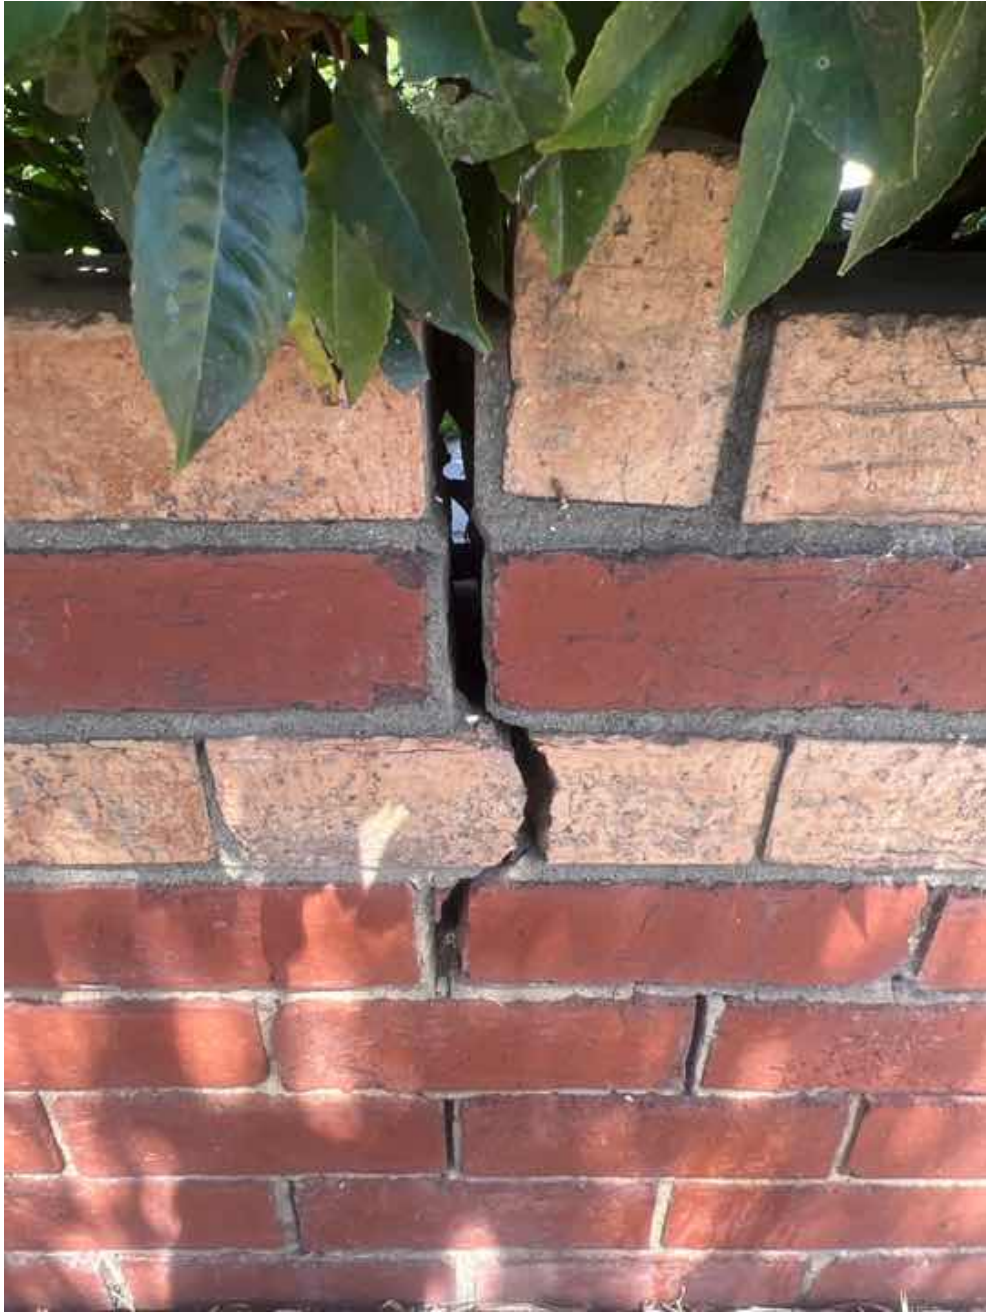
Overall Condition (Front Brick)

The front brick fence has settlement/movement cracks. This may be a potential safety hazard. A qualified brick layer should be engaged for repairs.

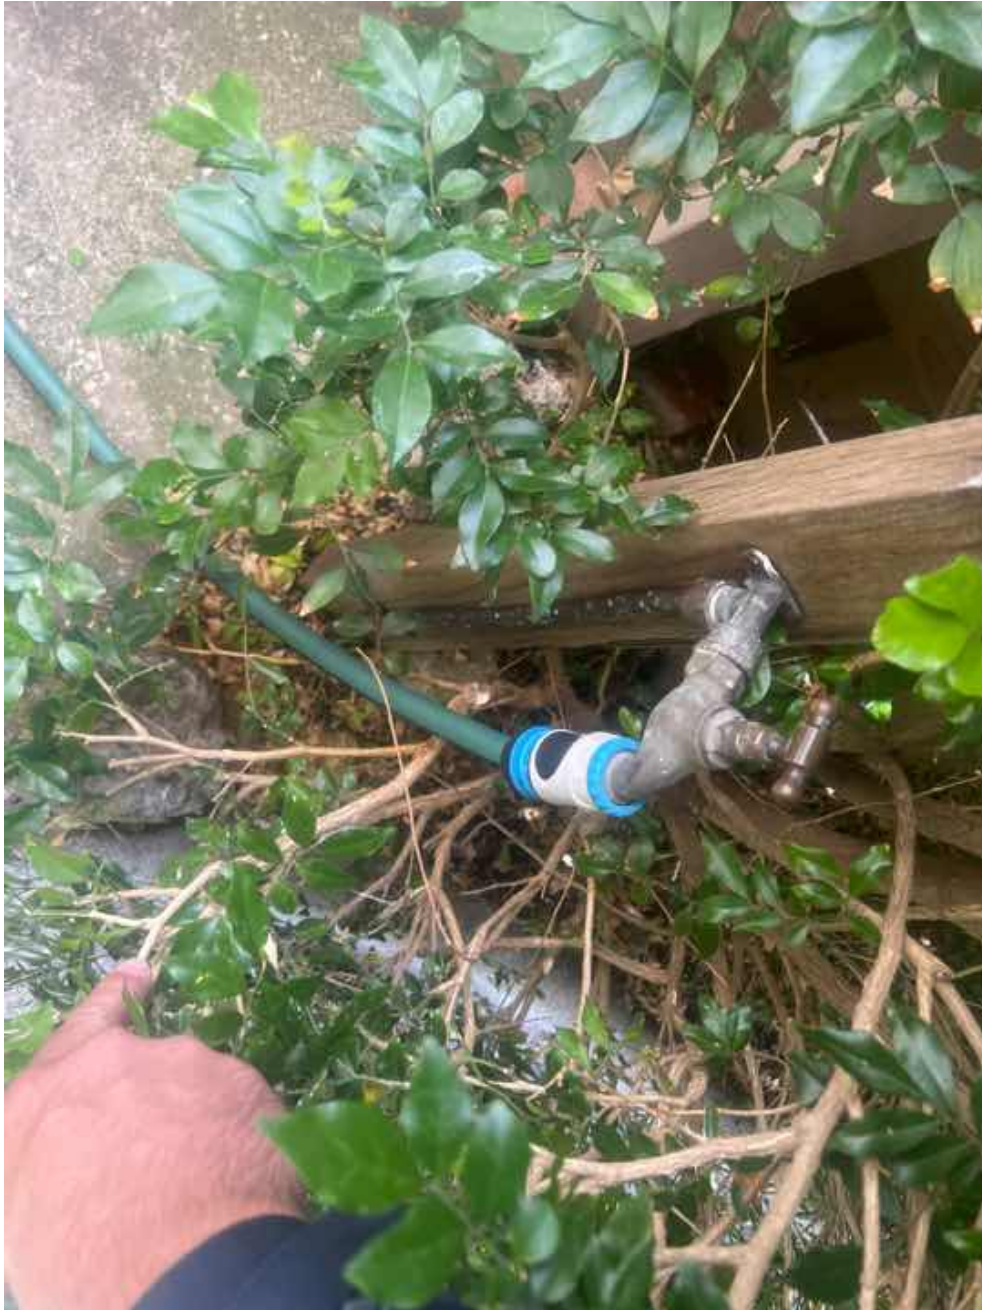
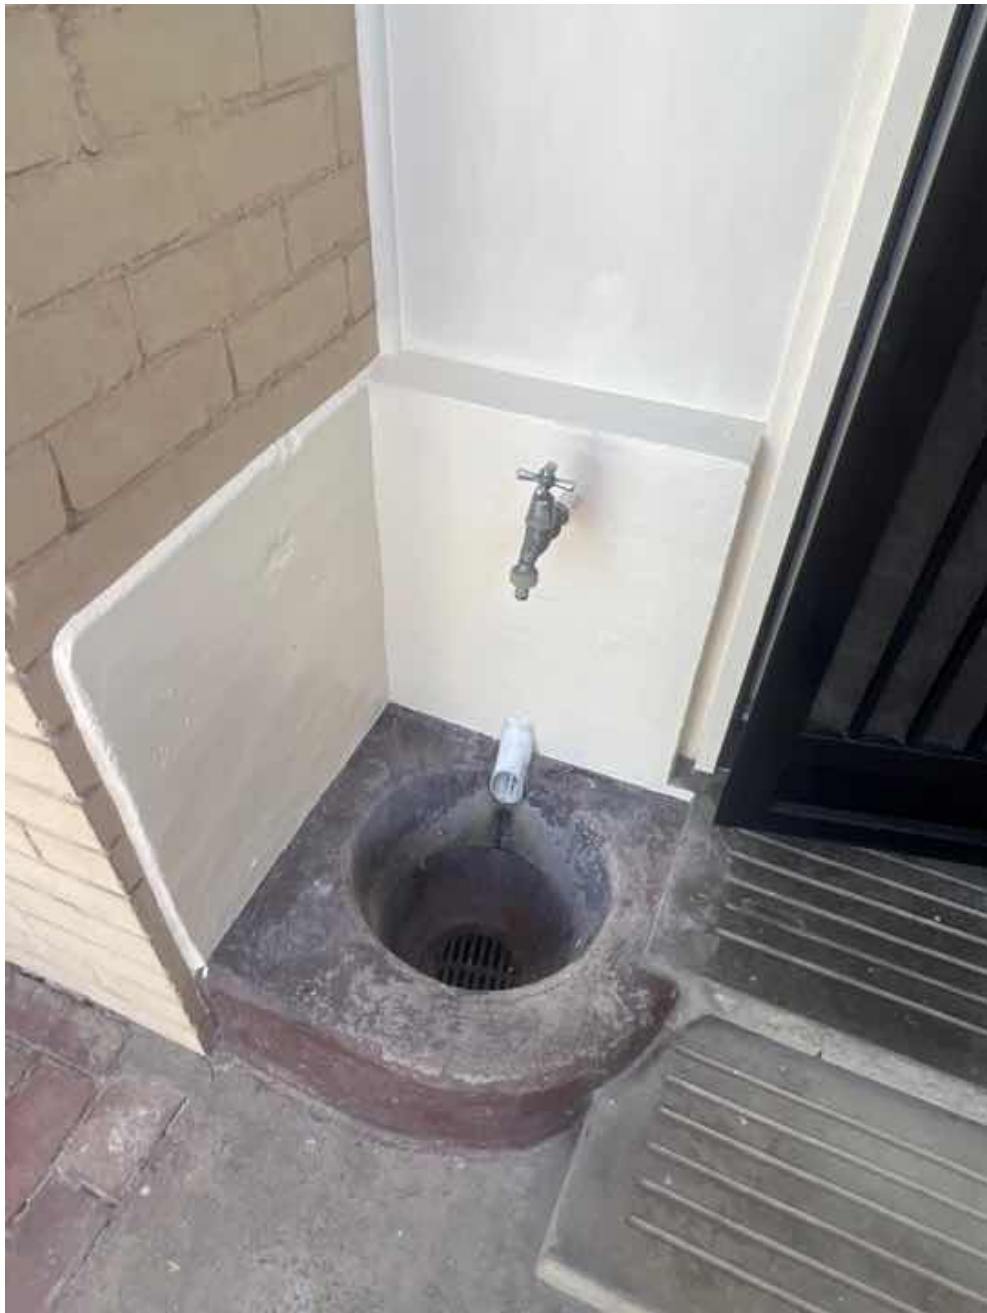
Debris evident in/around drains - Requires cleaning out.

Recommend installing a drainage point under the tap to assist with drainage.

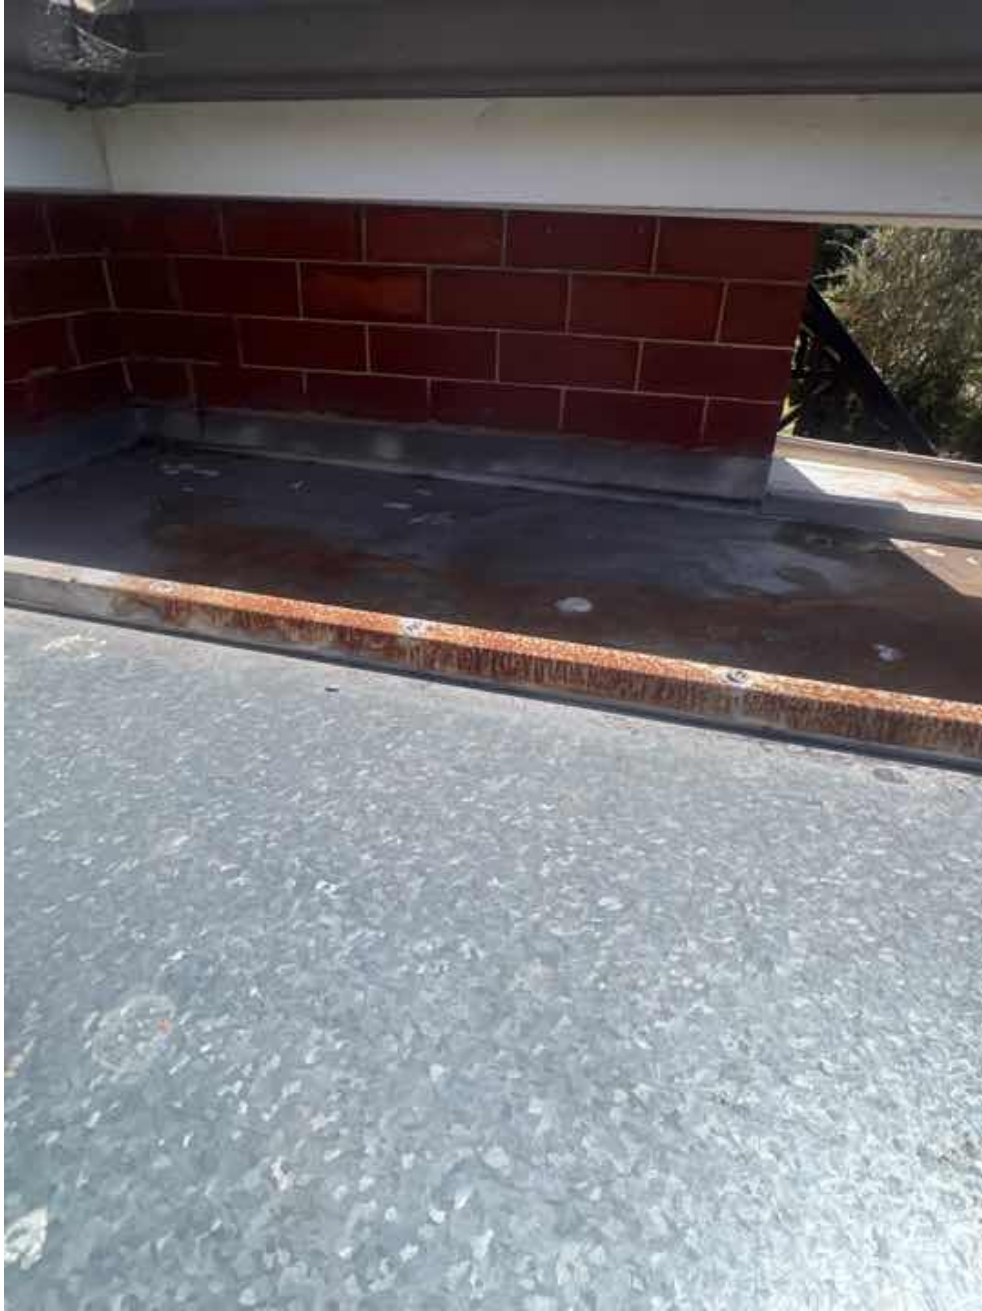
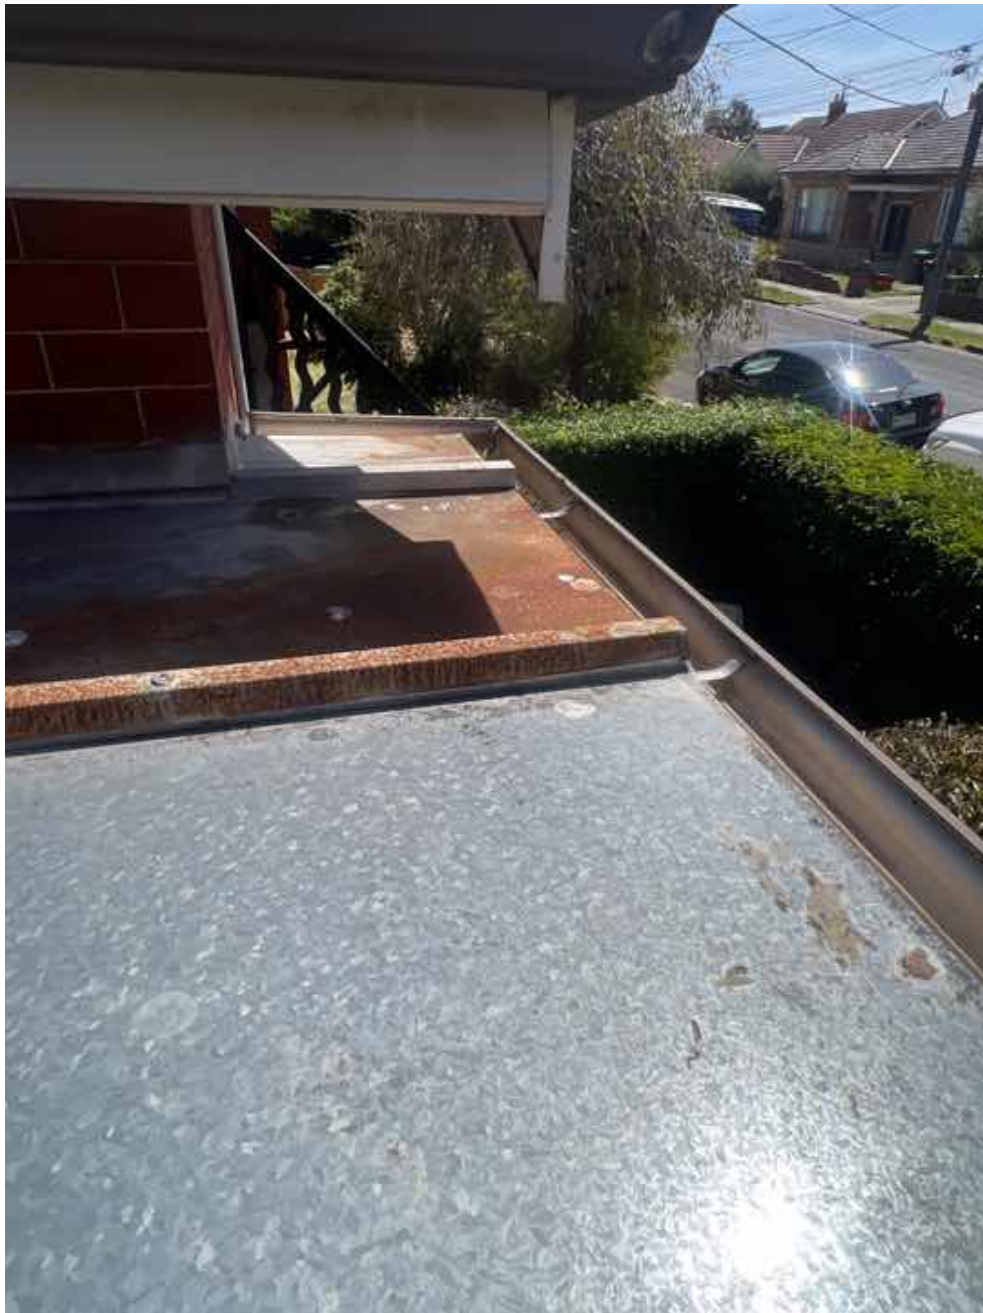
Roof Clad Condition

Metal roof is rusting and requires or replacement as the may lead to water ingress into the roof cavity. Contact a qualified roofing contractor for immediate repairs.

Moss has built up on the tiles over time. It is preferable to have removed / cleaned to prevent deterioration.

Recommendations: A qualified roof restoration contractor should be engaged for advice and recommendations.

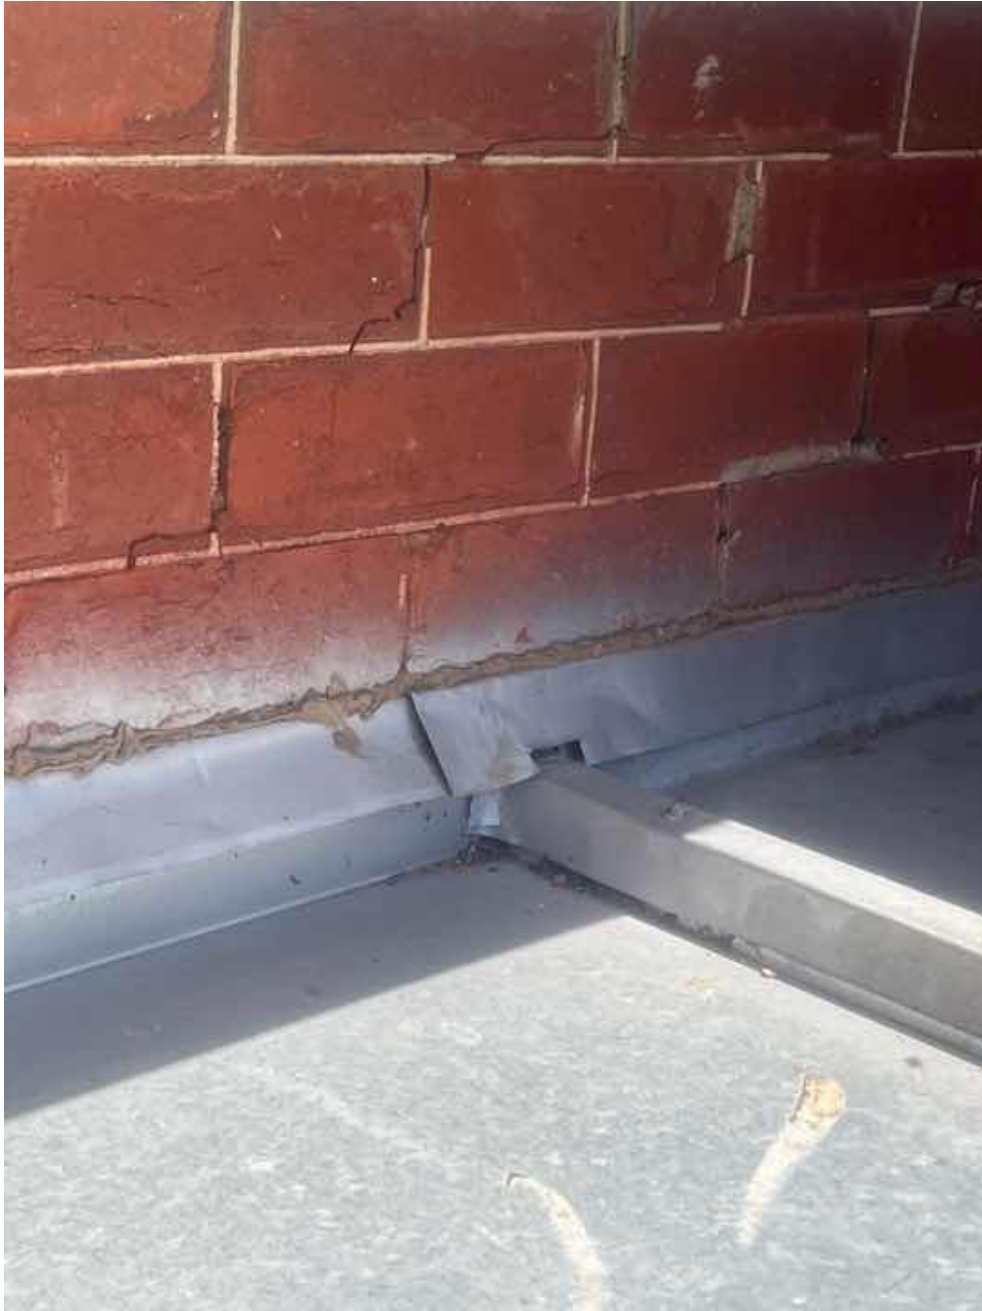
Flashing Conditions

Minor flashing lift/detachment. A qualified roofer should be engaged for repairs and recommendations.

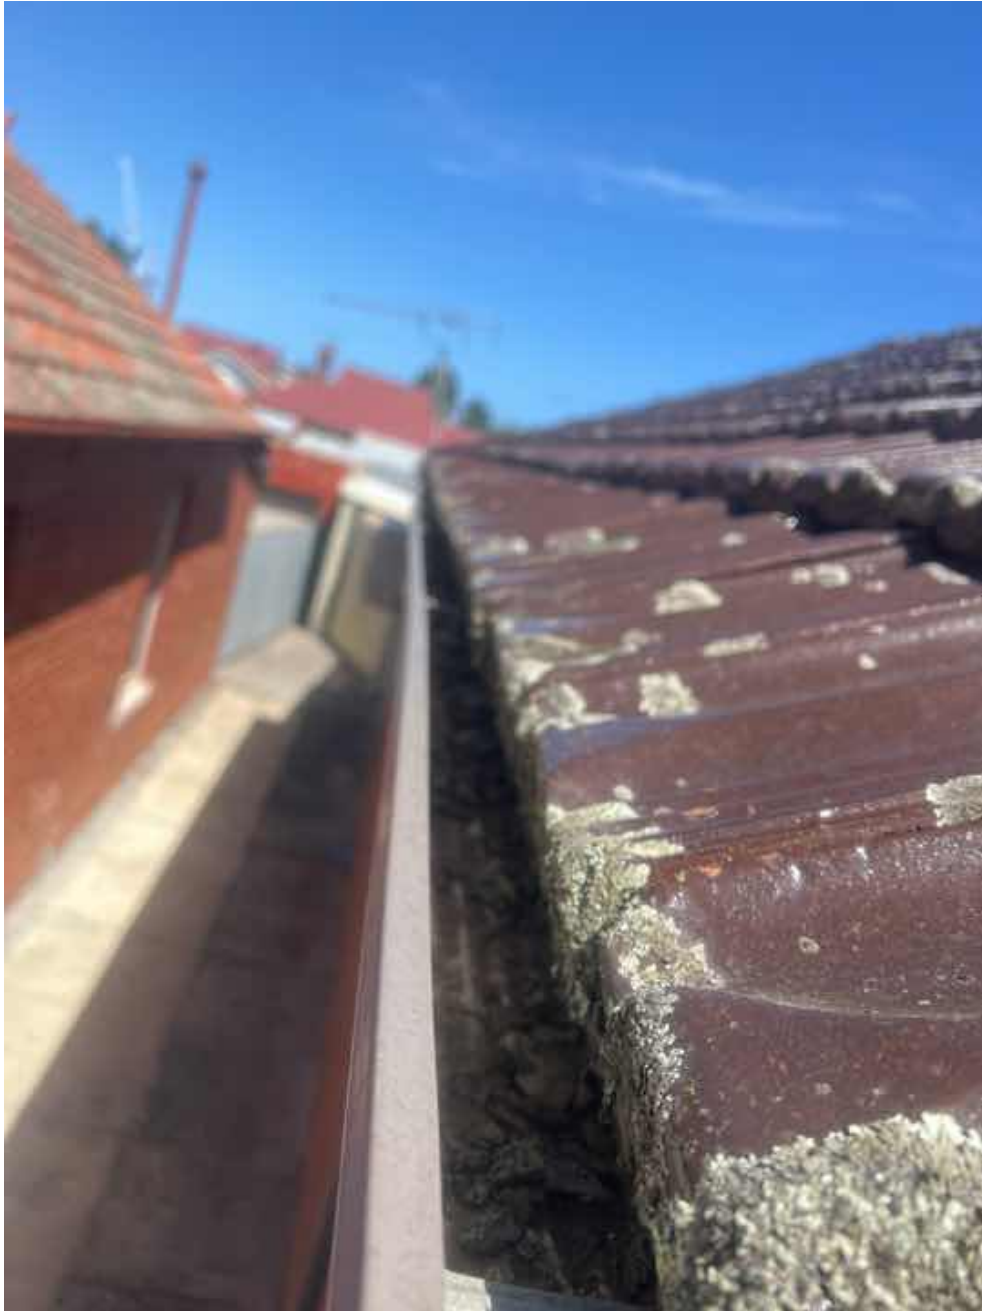
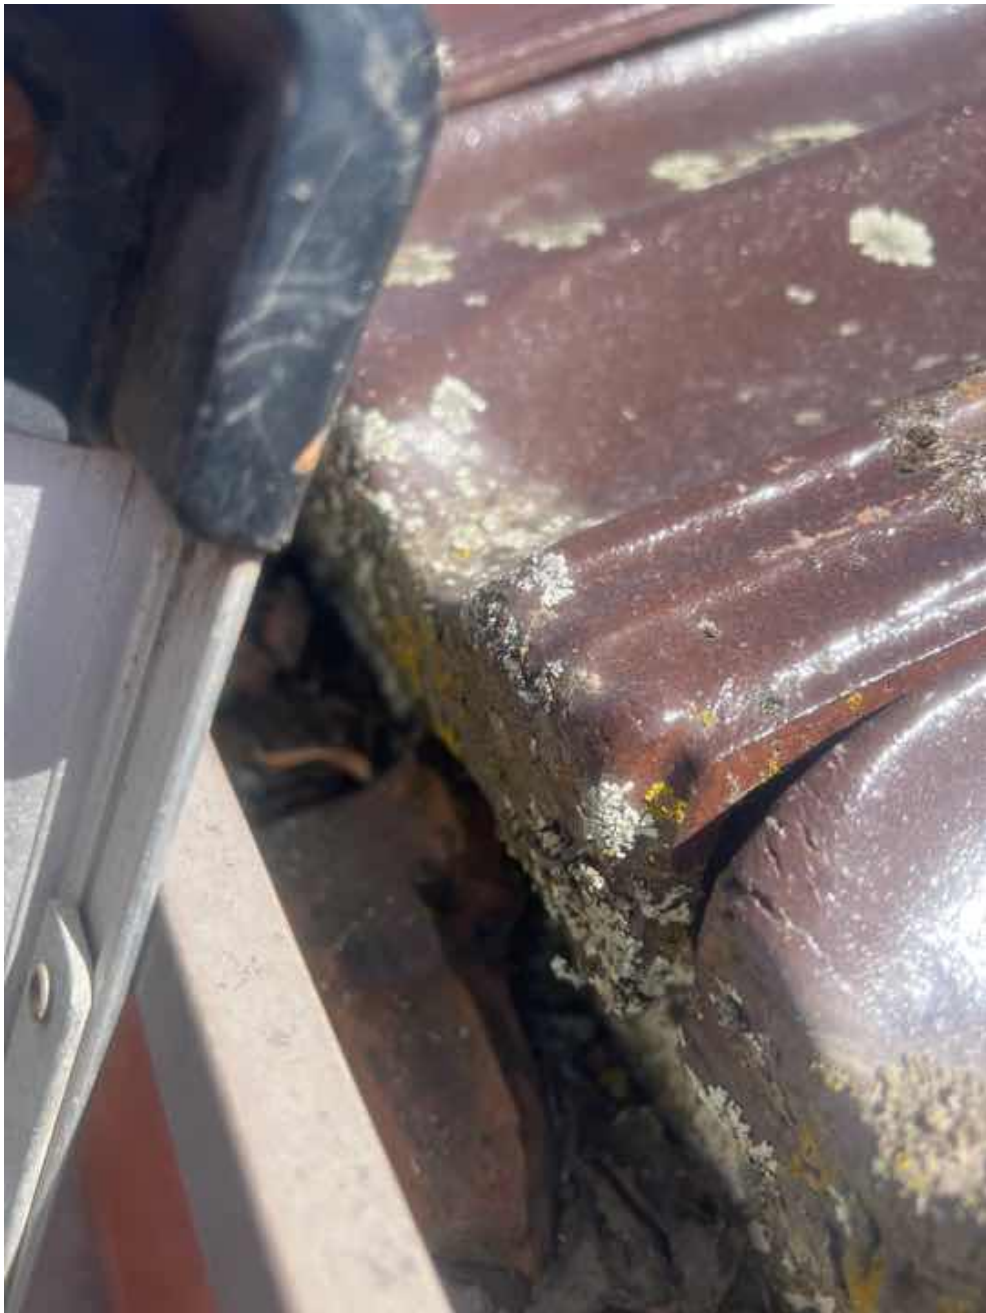
Gutter Findings

Debris in guttering areas- this requires cleaning out to prevent blocking of downpipes and leaking into eaves and fascia. Have gutters cleaned and assessed by a plumber for adequate fall. Regularly clean to prevent ponding. Ponding water will contribute to rust.

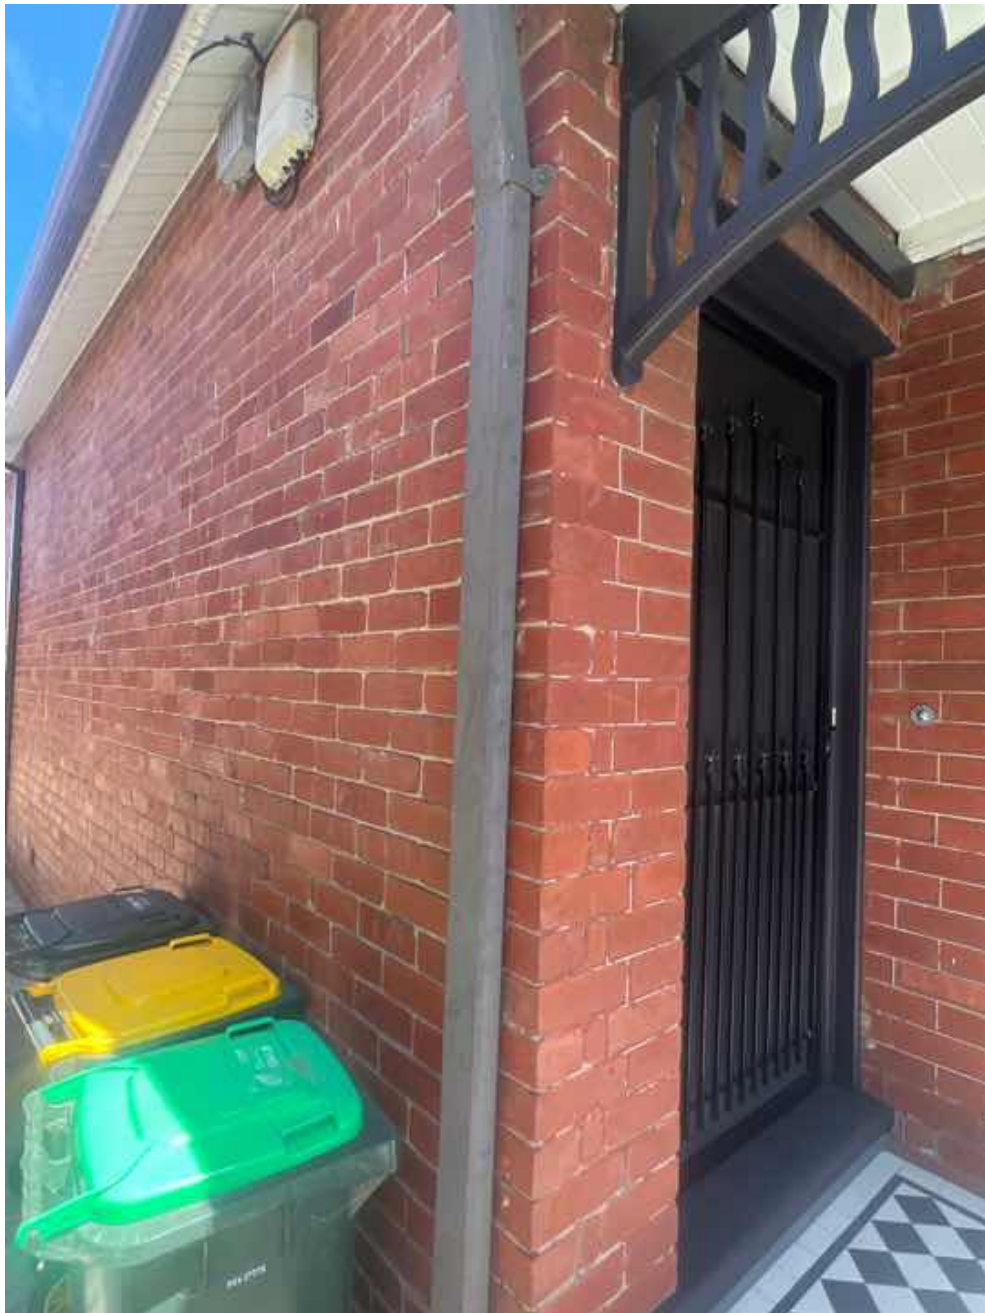
The downpipe/s wall clips is detached or missing. Although minor and easily rectifiable, we recommend a licensed roof plumber be engaged for repairs.

Leaking downpipe joins visible. This can be conducive to termite infestation and cause water damage to cladding over time. A qualified roof plumber should be engaged to repair.

Downpipe/s not connected to storm water discharge - Downpipes not connected to storm water have the potential to cause differential settlement to the footings, cause rising damp and is also conducive to termite infestation. A qualified roof plumber should be engaged for advice and recommendations.
