Sample Report

D.C Building Inspectors

Pest And Building Inspection

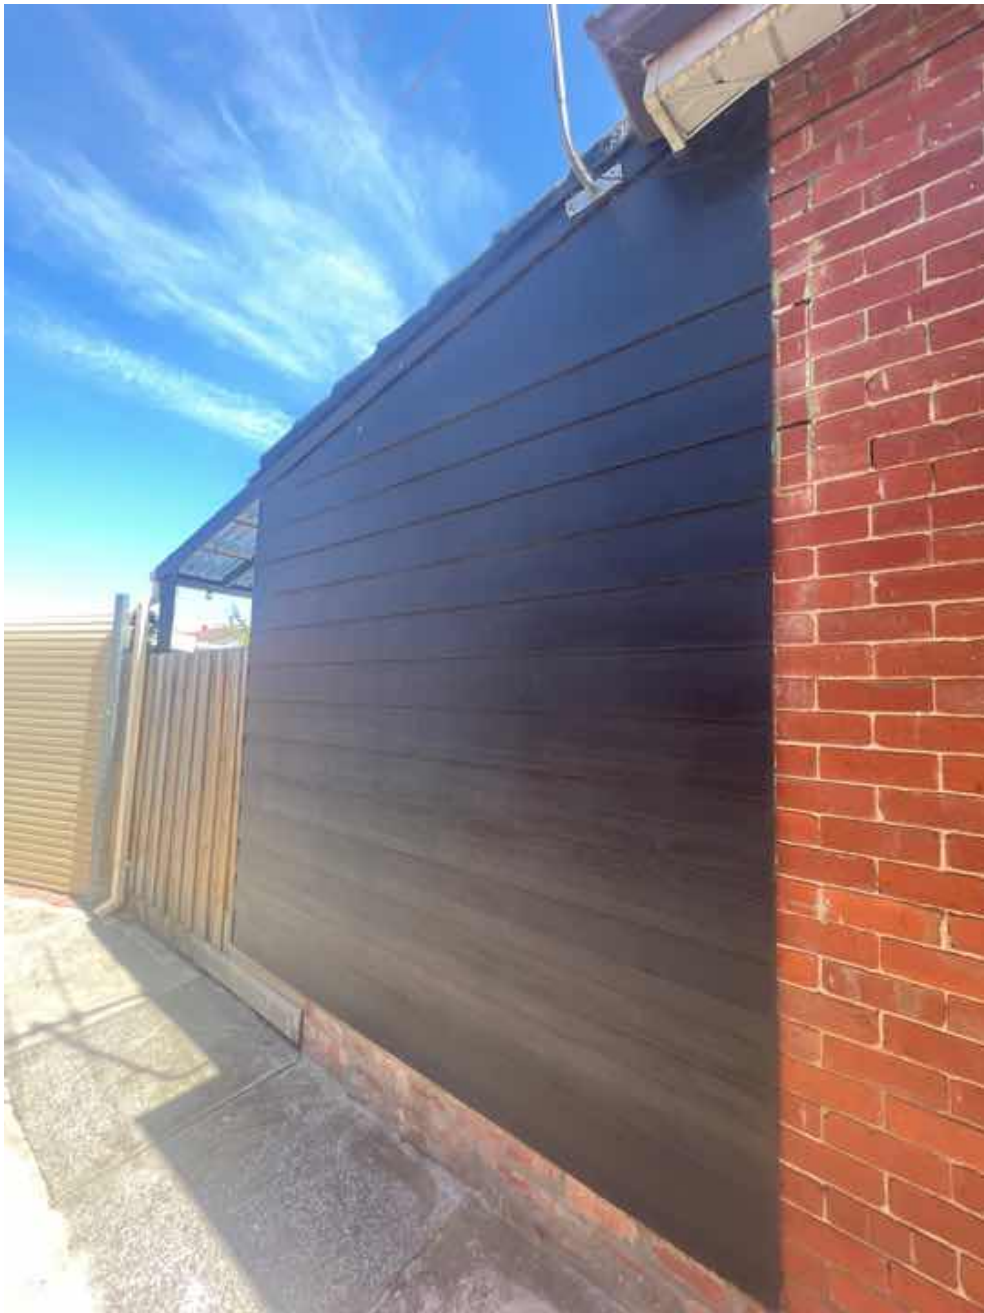
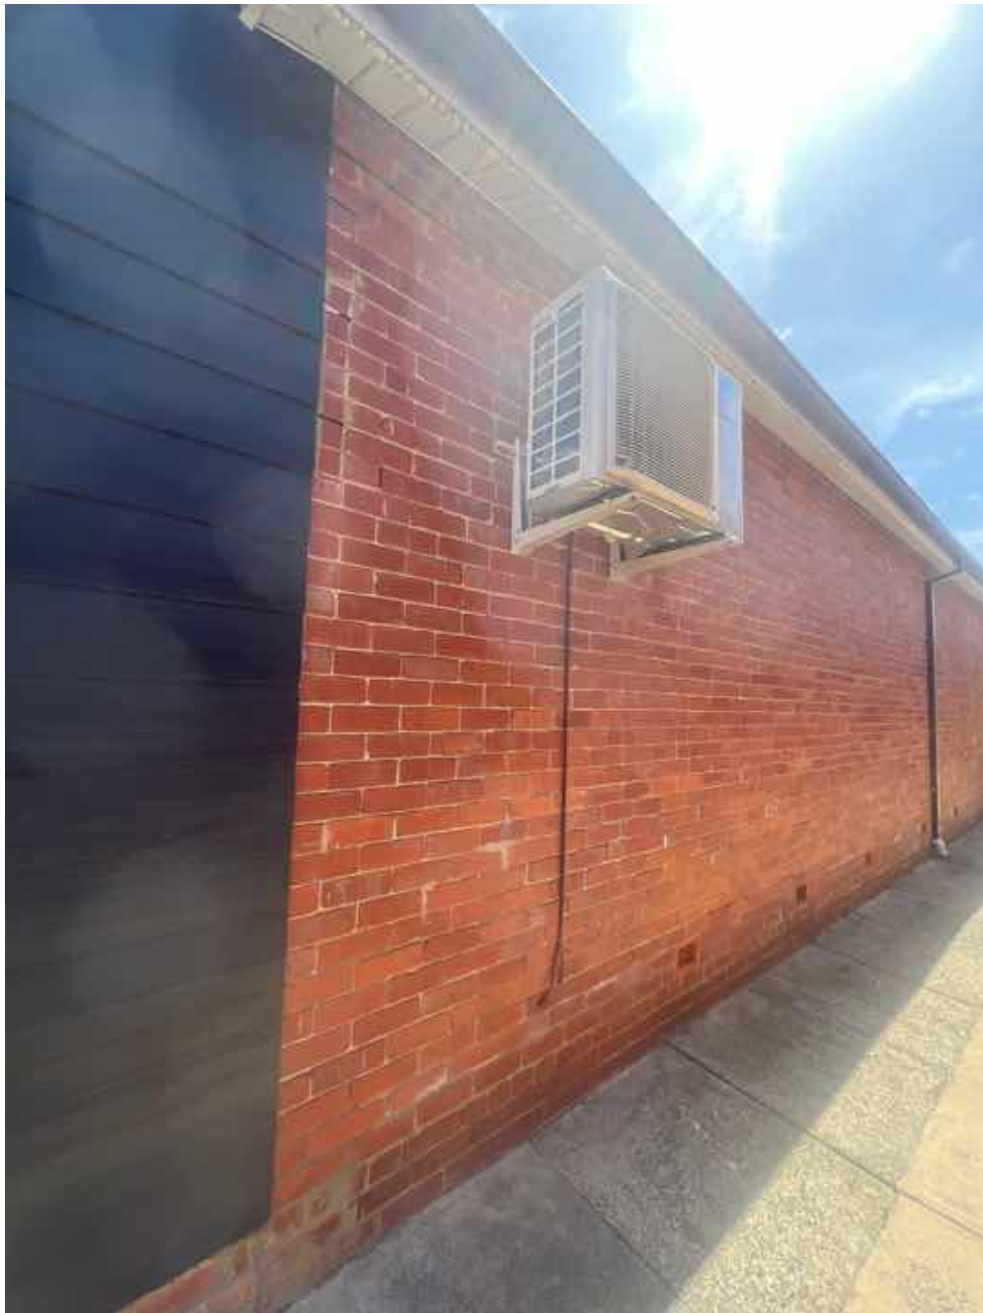
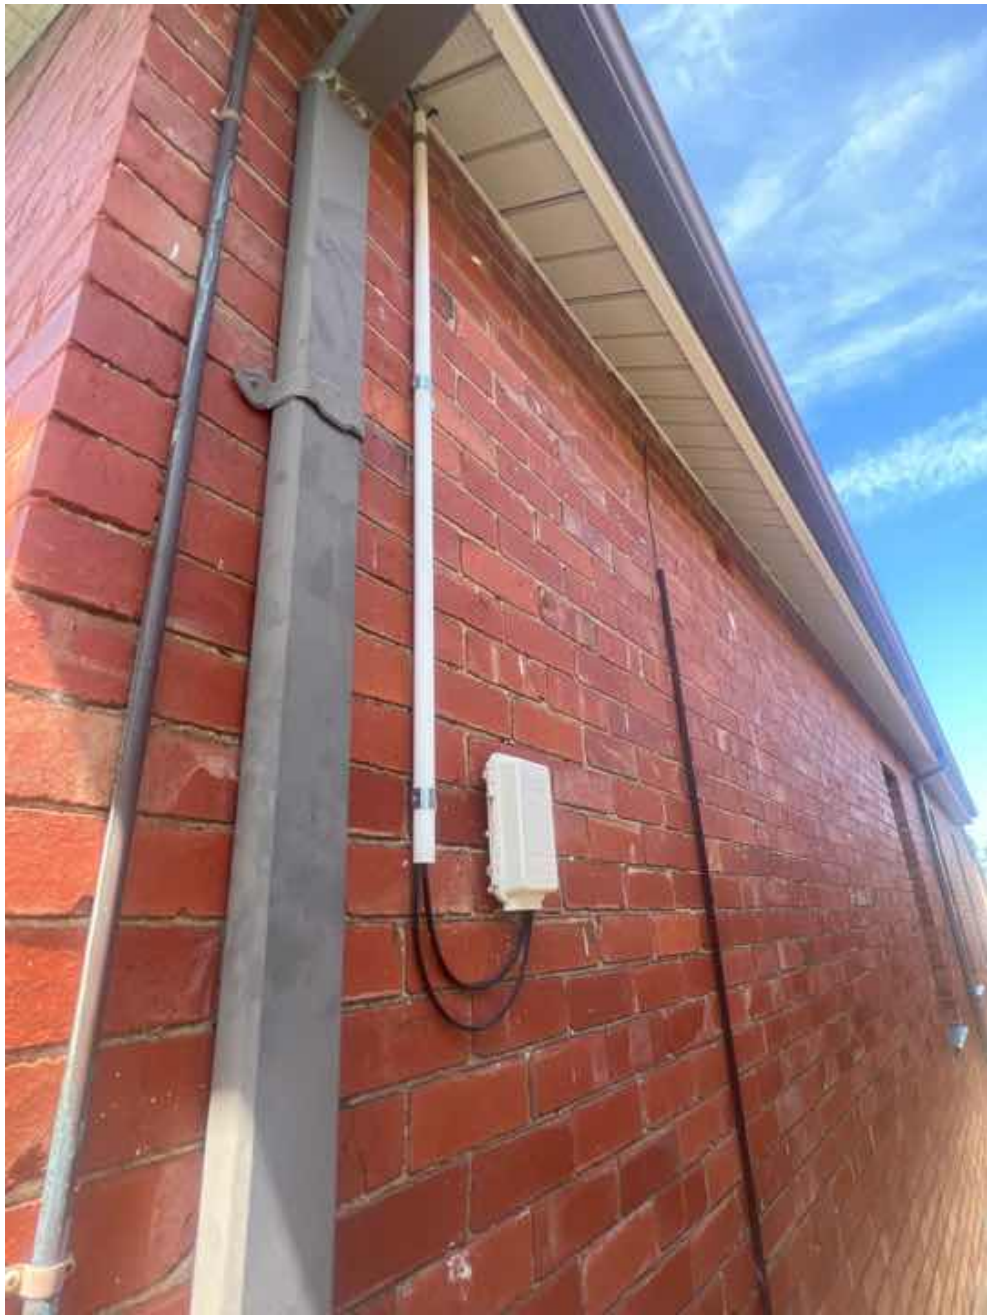
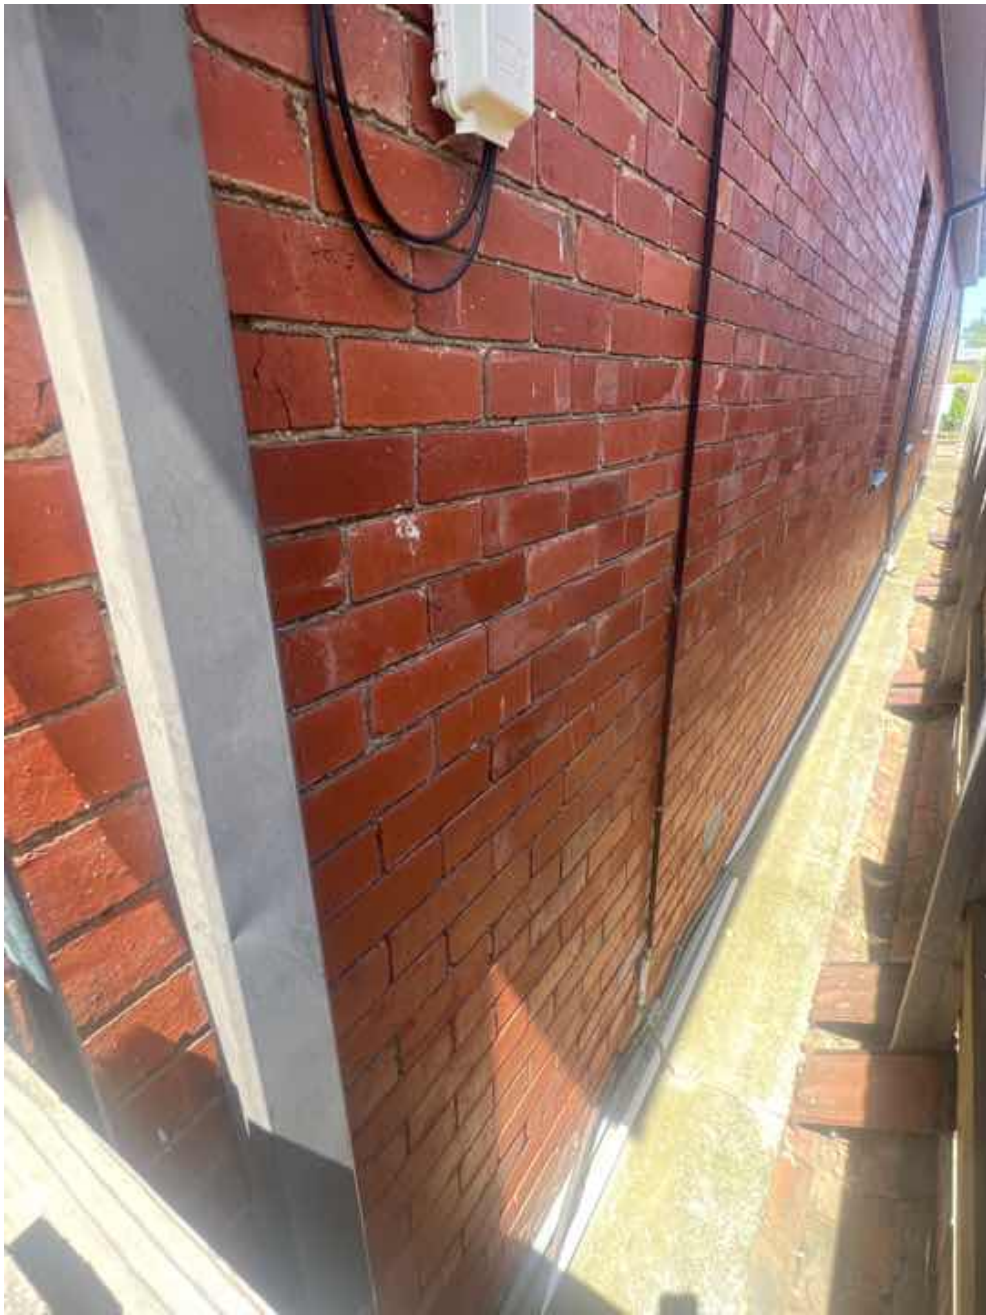
Brick fretting to brickwork observed. Overtime the salts in the uptake of moisture breaks the bricks down to powder form. Contact a qualified bricklayer for repairs.

Cracks noted (Damage Category 3 to 4)

Possible causes may be foundation movement. Support structure deflection. Thermal movement and moisture uptake or loss, failure under external loads. In the inspectors opinion these cracks require further assessment. A structural engineer should be consulted for further evaluation and advice.

Sections of the masonry brick wall/s have been repointed. This is where cracks have developed and mortar inserted into same. Monitoring advised and if further opening occurs engage a qualified structural engineer for advice and recommendations.

Rising damp detected. A qualified damp proof specialist should be engaged for advice and recommendations. Accurate diagnosis of the cause and extent of the damp problem is very important. It is strongly advised that you have this issue assessed prior to purchasing the dwelling as can be quite costly if a damp proof course has to be reinstated.

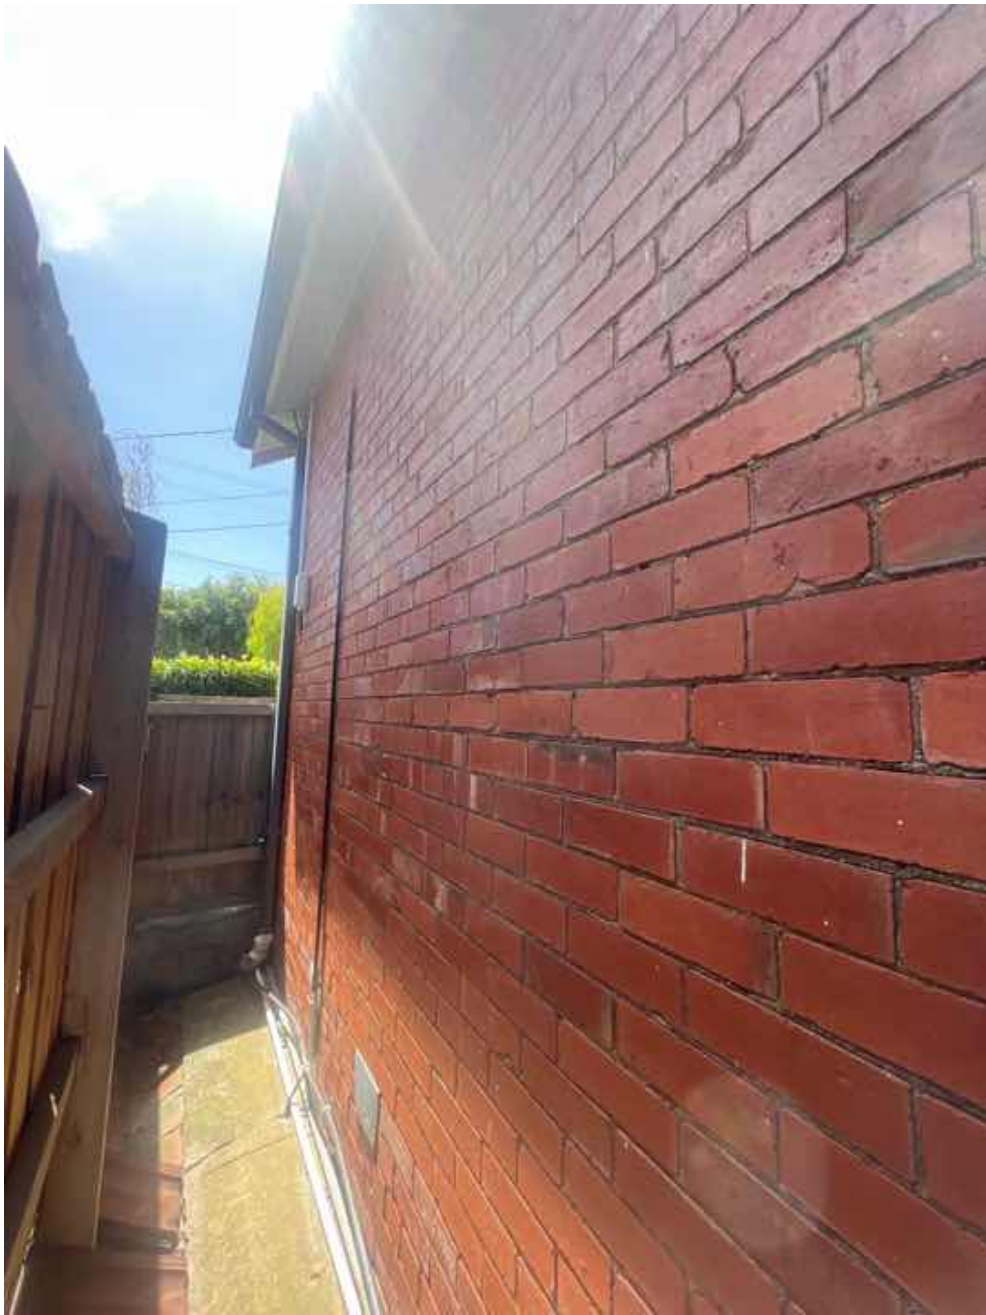
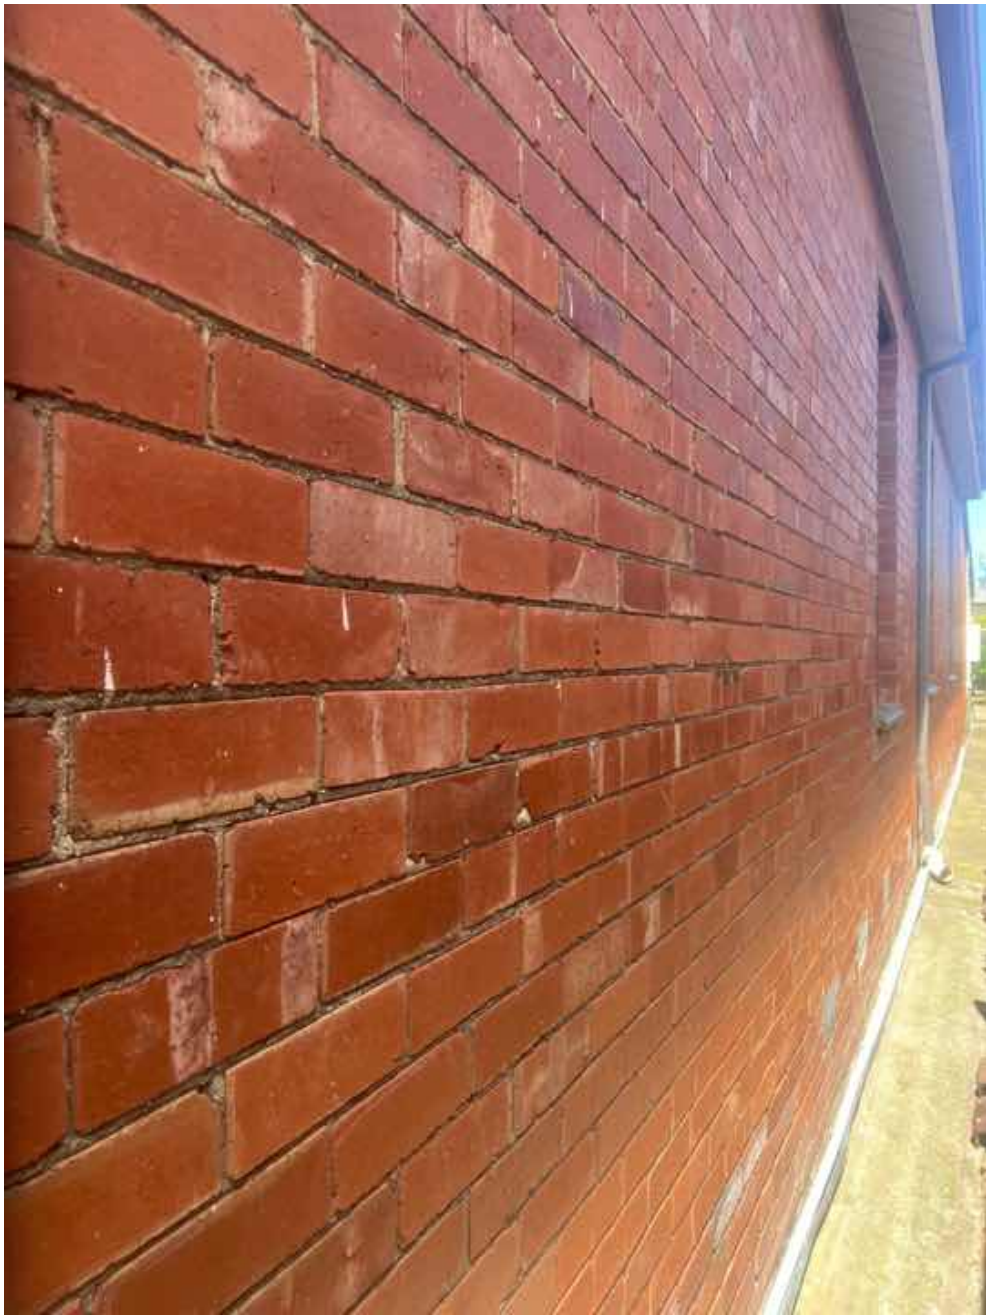
Cracks noted (Damage Category 3 to 4)

Possible causes may be foundation movement. Support structure deflection. Thermal movement and moisture uptake or loss, failure under external loads. In the inspectors opinion these cracks require further assessment. A structural engineer should be consulted for further evaluation and advice.

Mortar erosion between the brickwork is eroded. Contact a qualified bricklayer for repairs.

Minor decay was noted to the external wall lining. We recommend replacement of all affected timbers.

Minor cladding damage observed. This should be repaired so as to avoid moisture ingress and pests entry.

5-6 mm category 3 - major crack

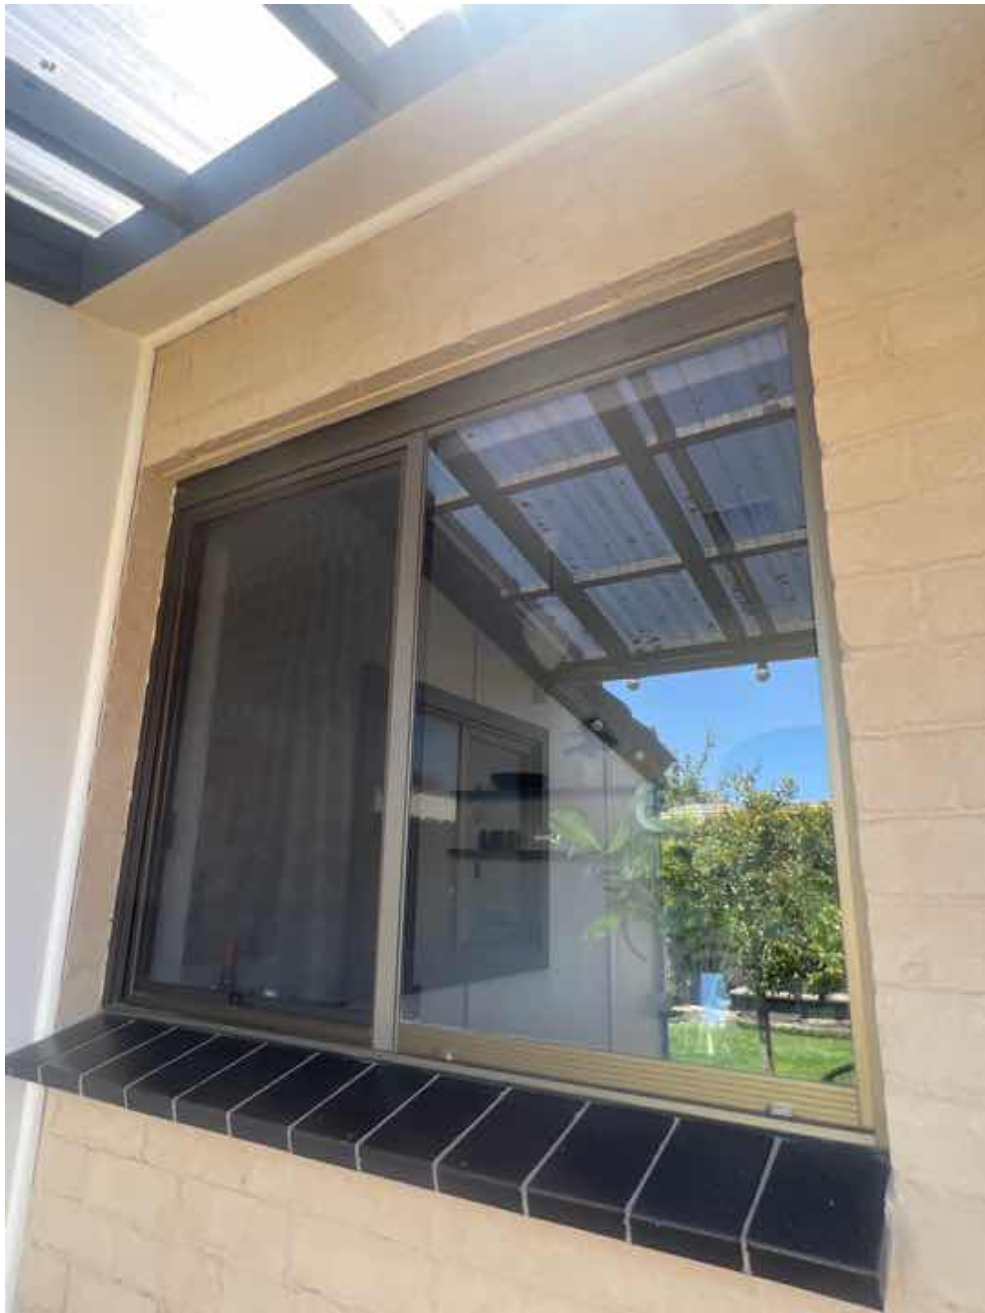
General age/damage has occurred to window components. Recommendations: Restoration work recommended. A qualified carpenter should be engaged for advice and recommendations.

Lintel rust in sections. This may cause cracking in wall linings above the window. A qualified brick layer should be engaged for advice and recommendations.

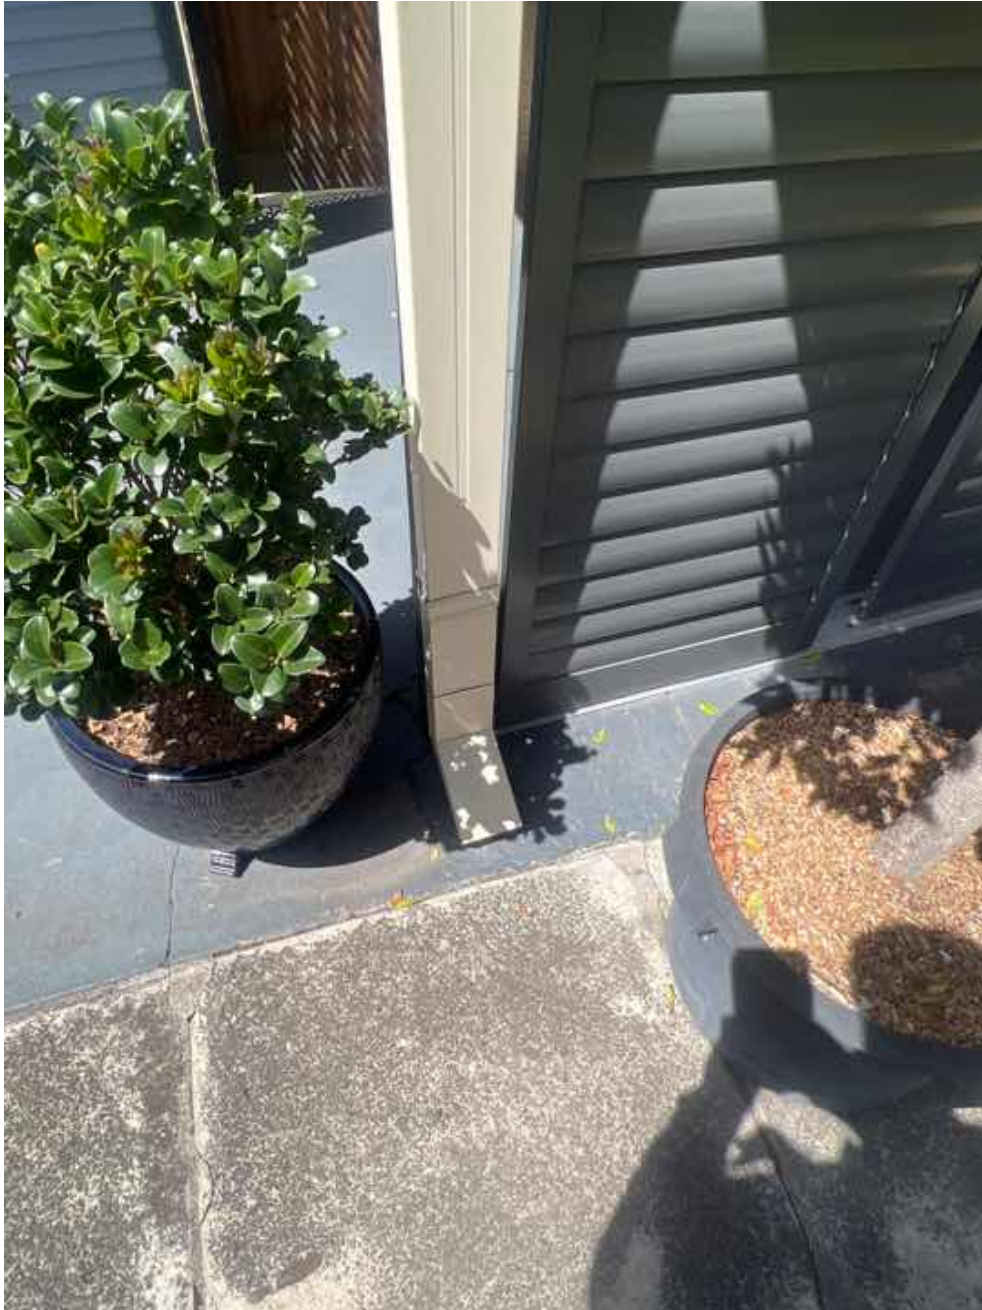
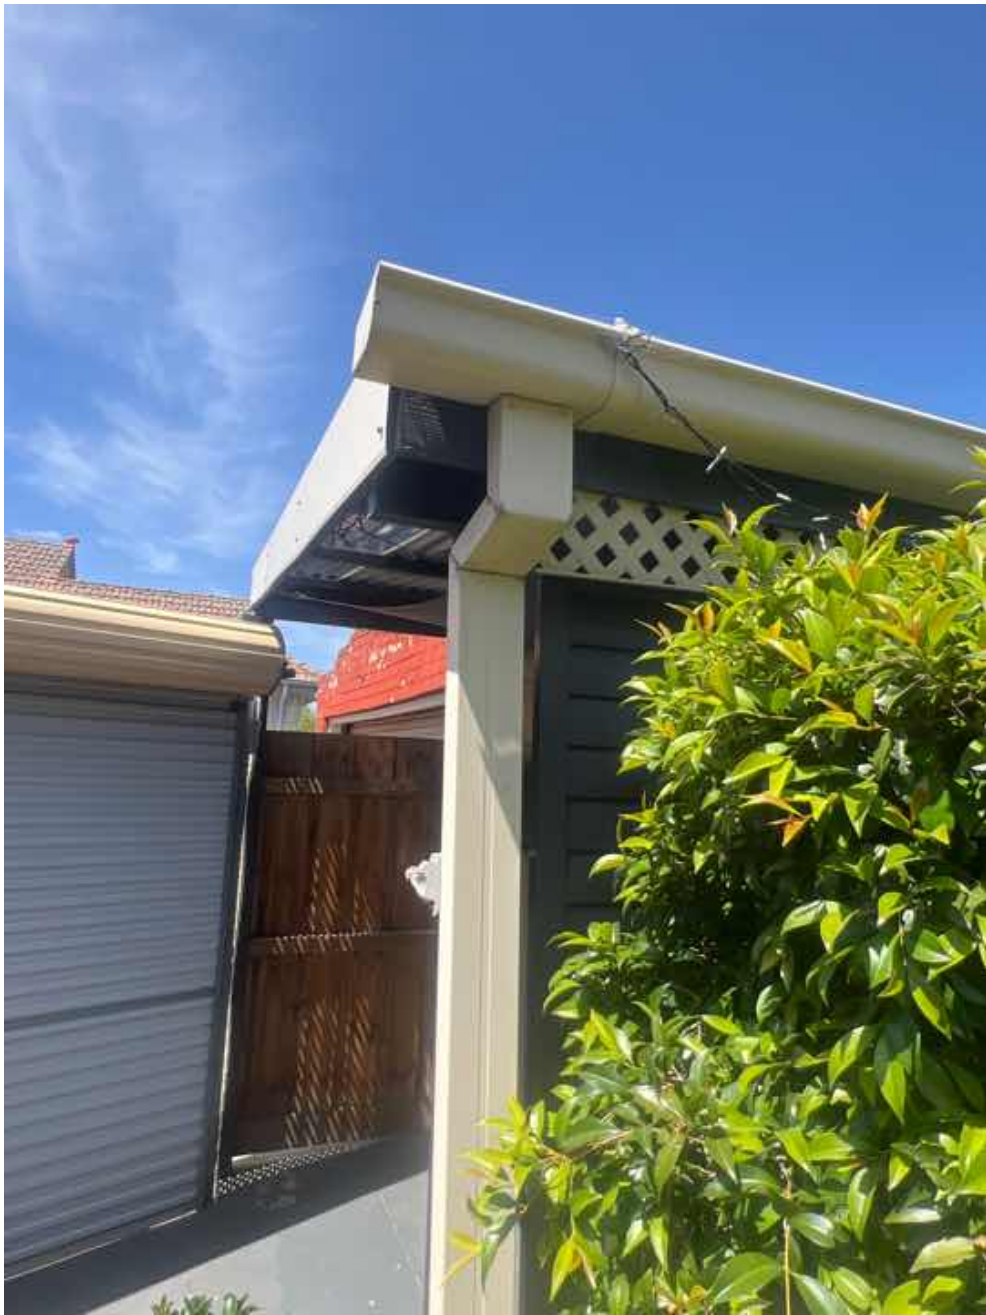
Pergola Roofing

Downpipe/s not connected to storm water discharge. A qualified roof plumber should be engaged for advice and recommendations.

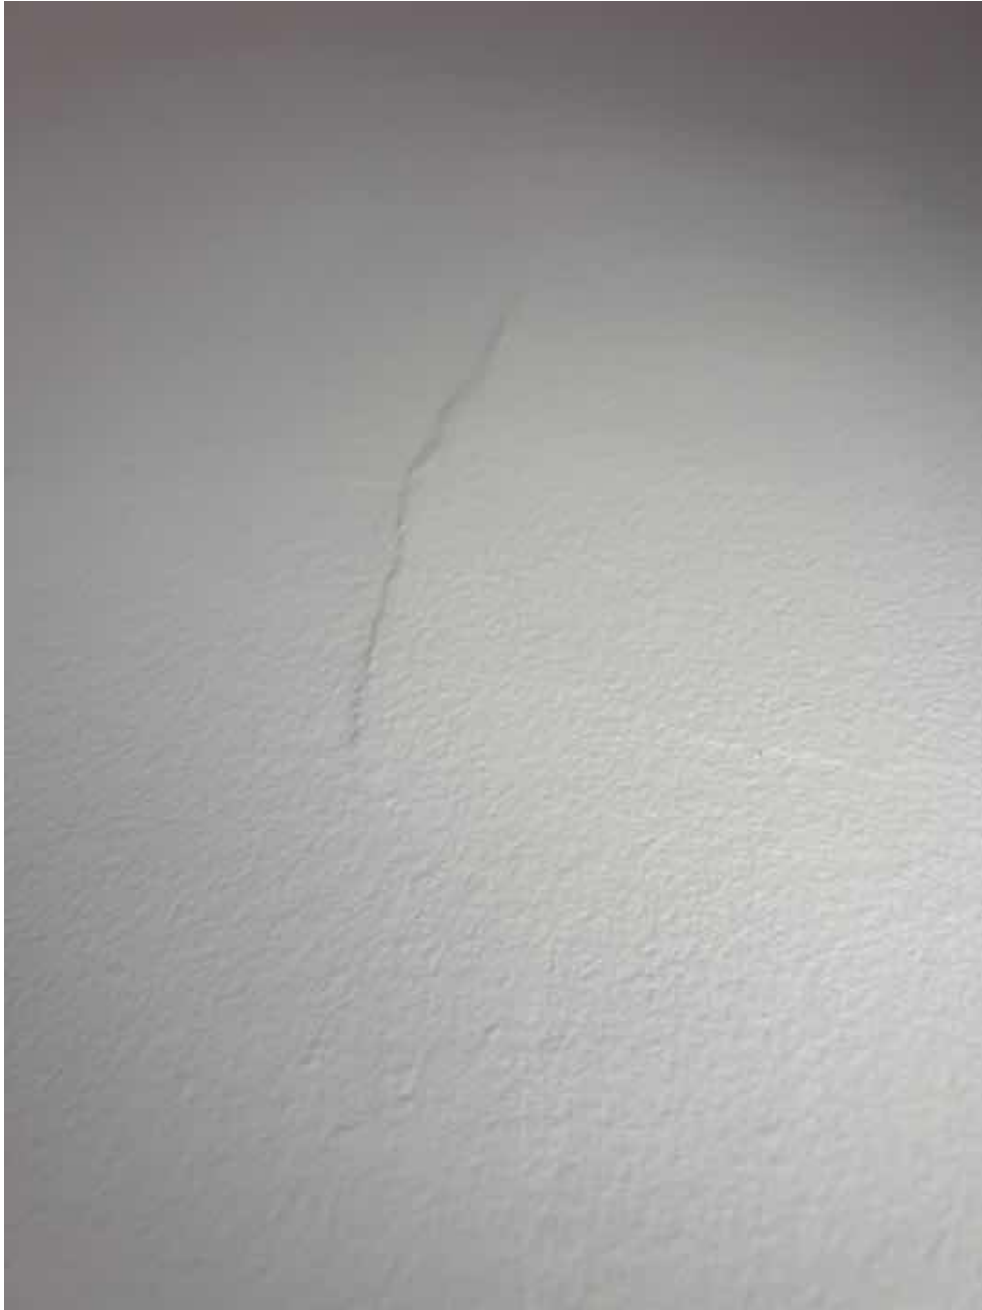
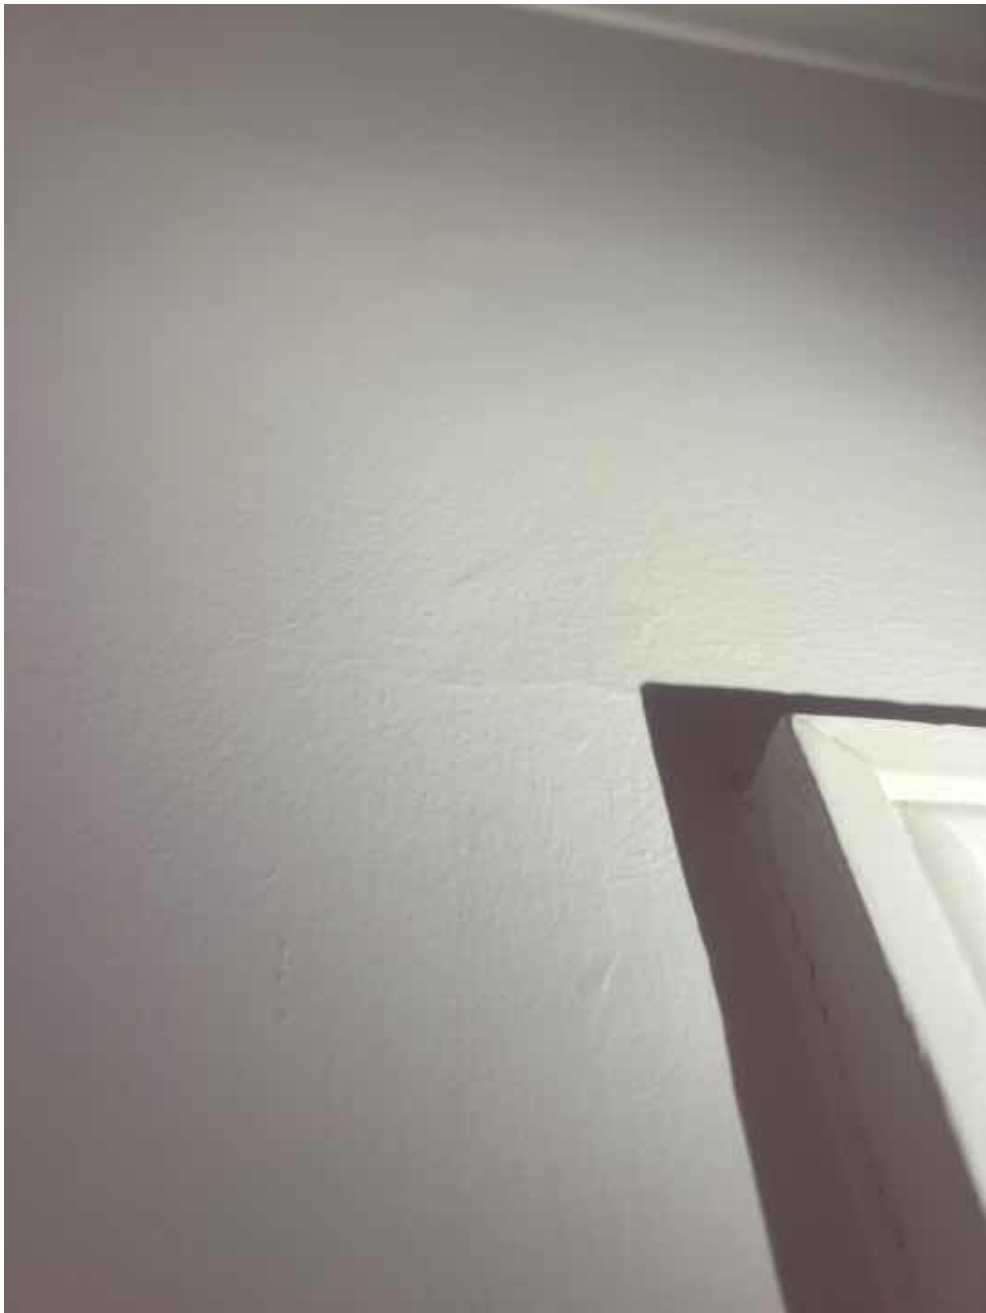
Walls

Patched wall cracks visible - Recommendations: Engage a plasterer to assess for further advice and repairs - I am unable to guarantee that these patched areas will not re-open in the future. If further opening occurs the affected areas may require re-assessment by a suitably qualified contractor.

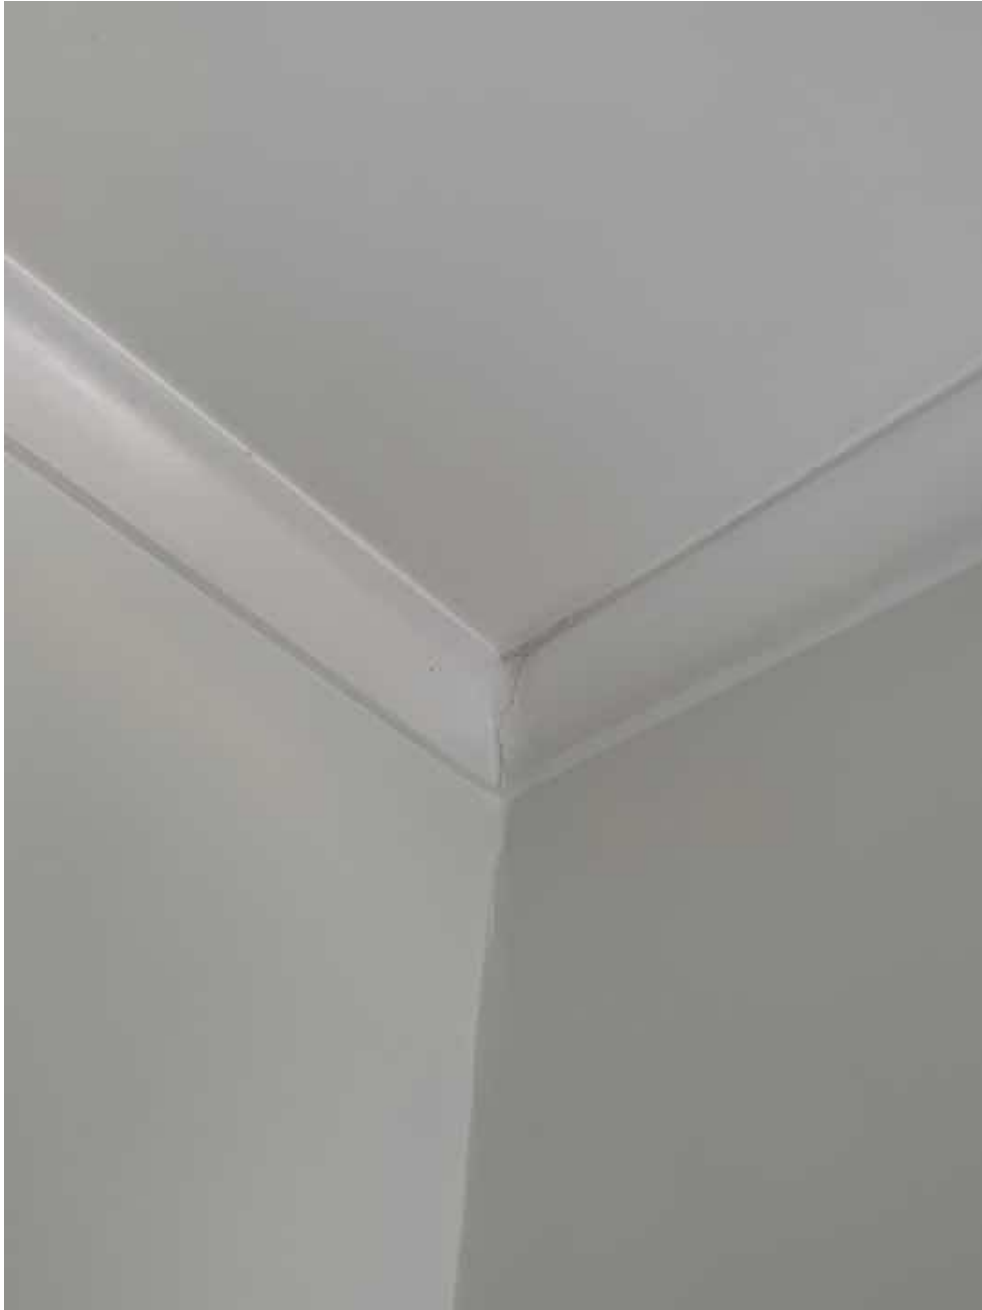
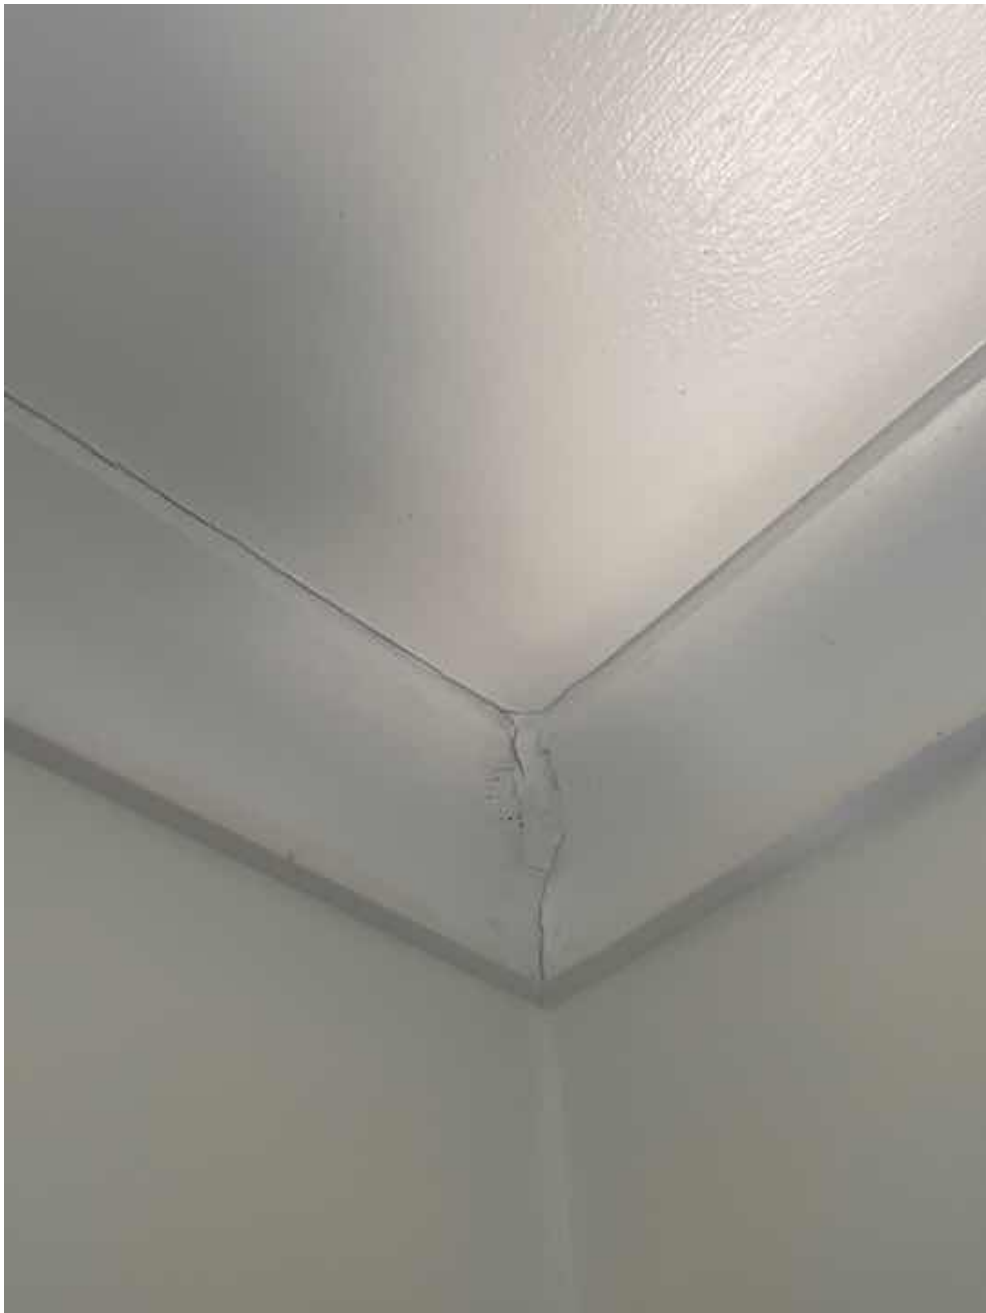
Ceiling

Settlement Cracks Noted. These are typical and generally patch and paint will suffice, however monitoring these cracks is advised for 12 months and if they become worse, further investigation by a suitably qualified professional is advised.

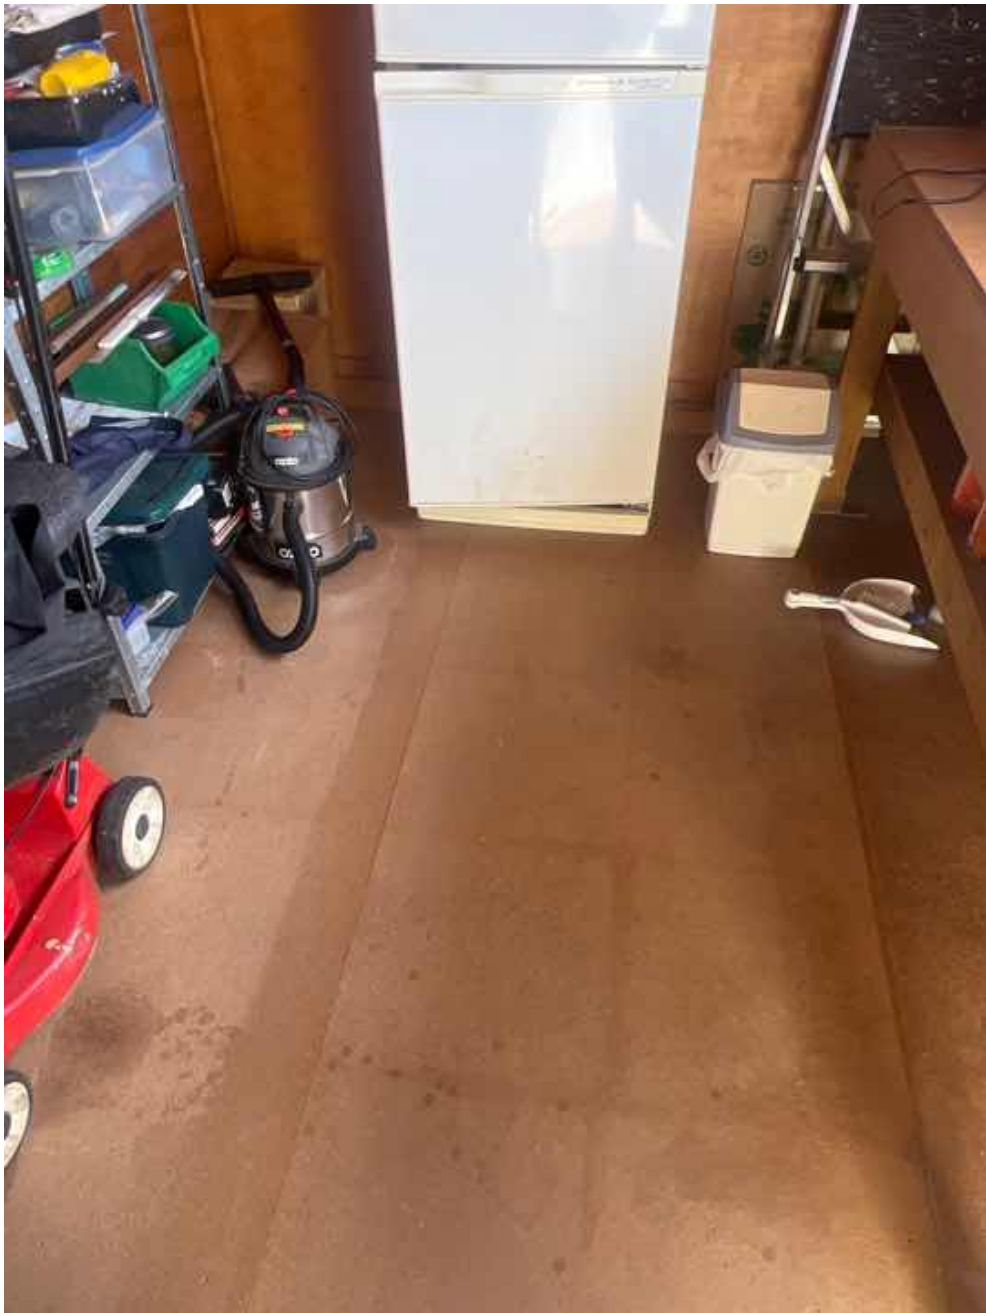
Flooring

Decay noted to the timber floor. It is strongly recommended that all affected timbers be replaced. This presents a Safety Hazard. Contact a qualified carpenter for repairs.

Unevenness visible in floor. Possibly due to poor workmanship or excessive movement/settlement. A qualified carpenter should be engaged for advice and recommendations re levelling.

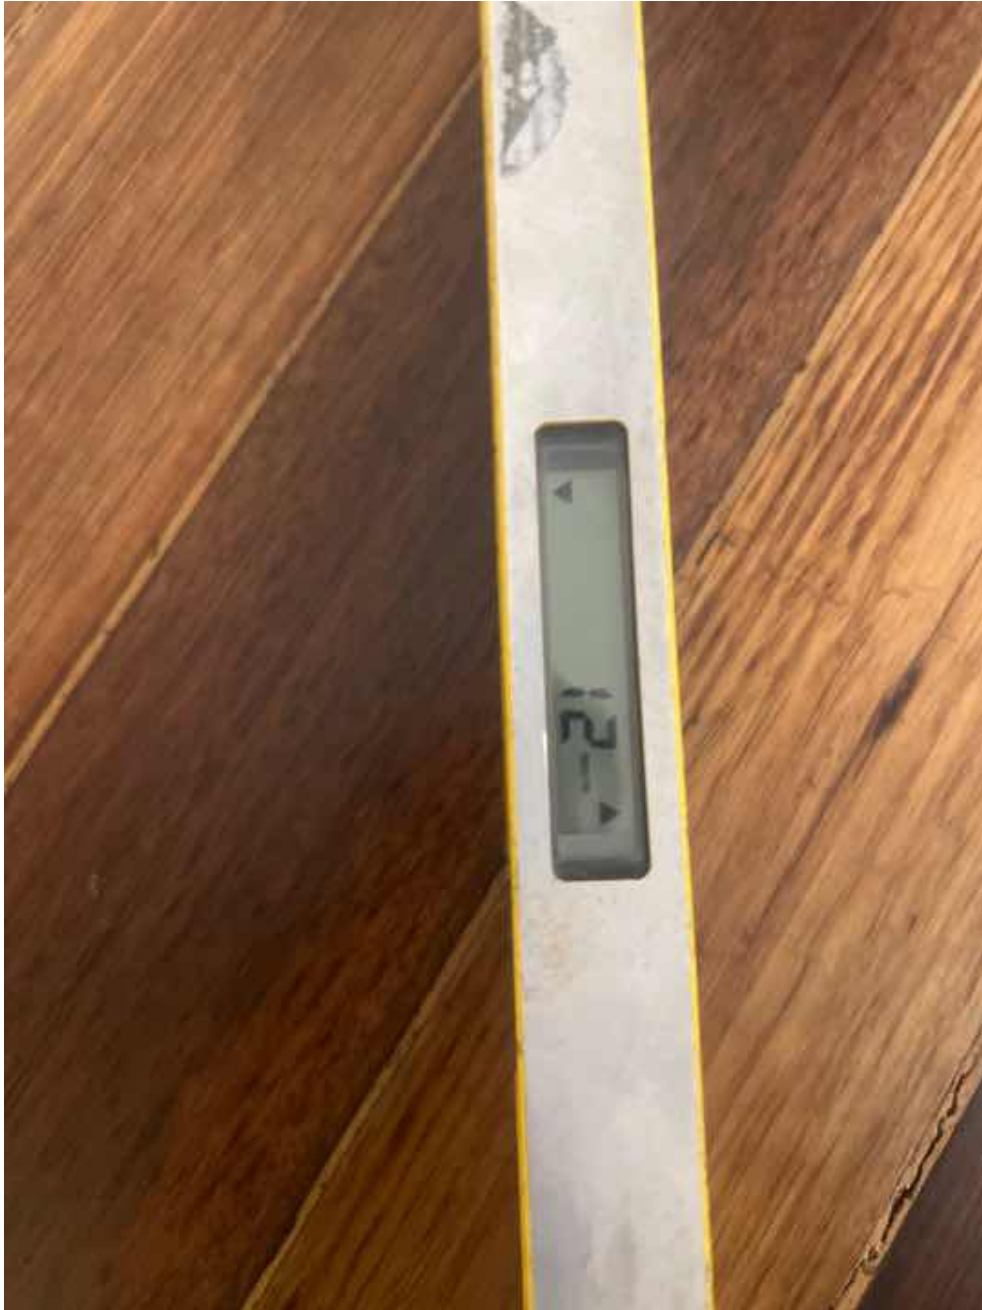
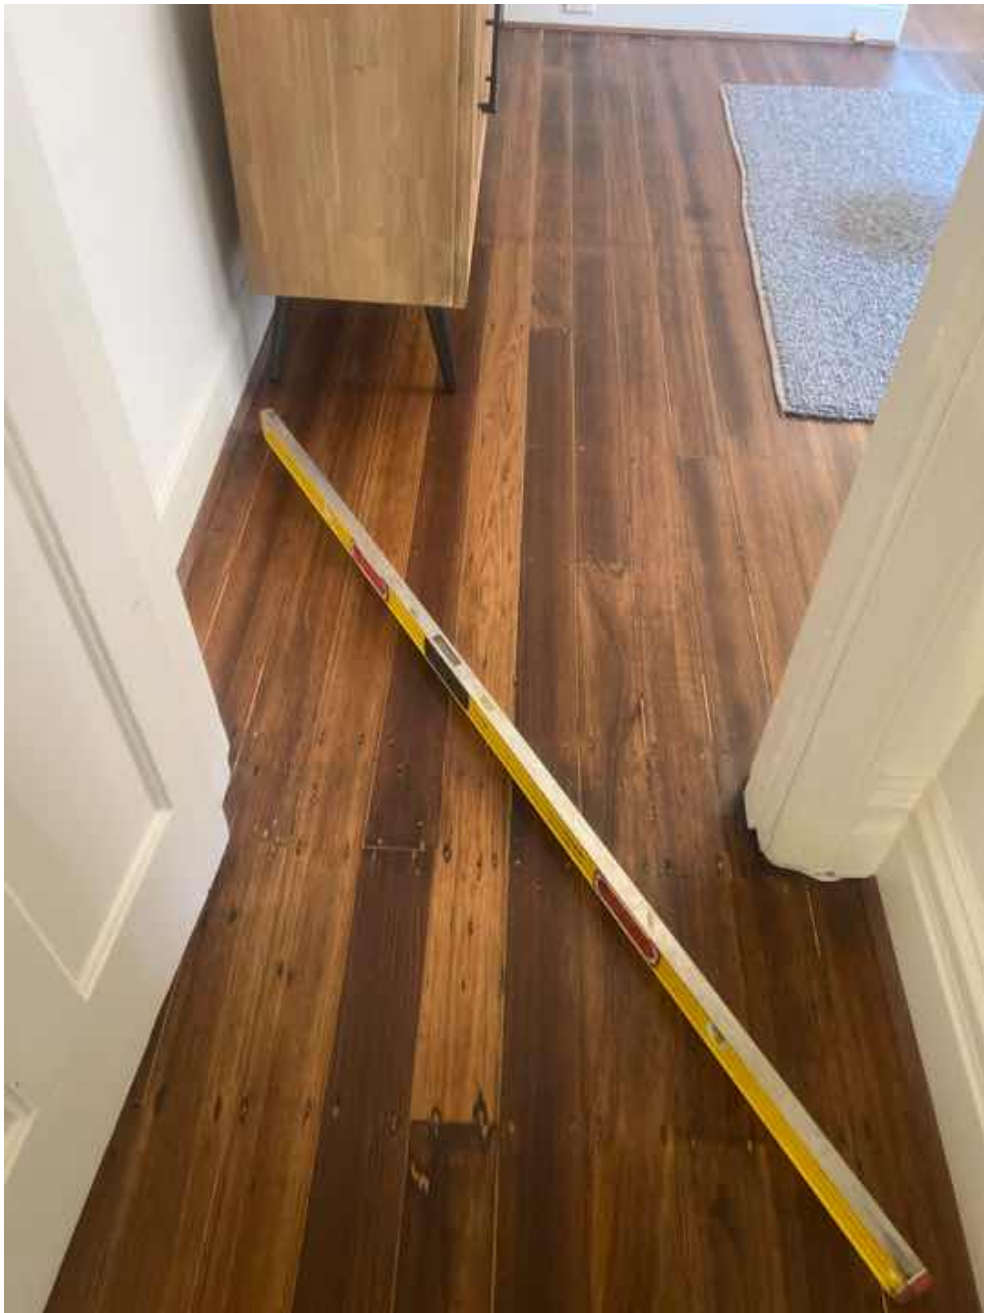
Flooring

Unevenness visible in floor. Possibly due to poor workmanship or excessive movement/settlement. A qualified carpenter should be engaged for advice and recommendations re levelling.
