Sample Report

D.C Building Inspectors

Pest And Building Inspection

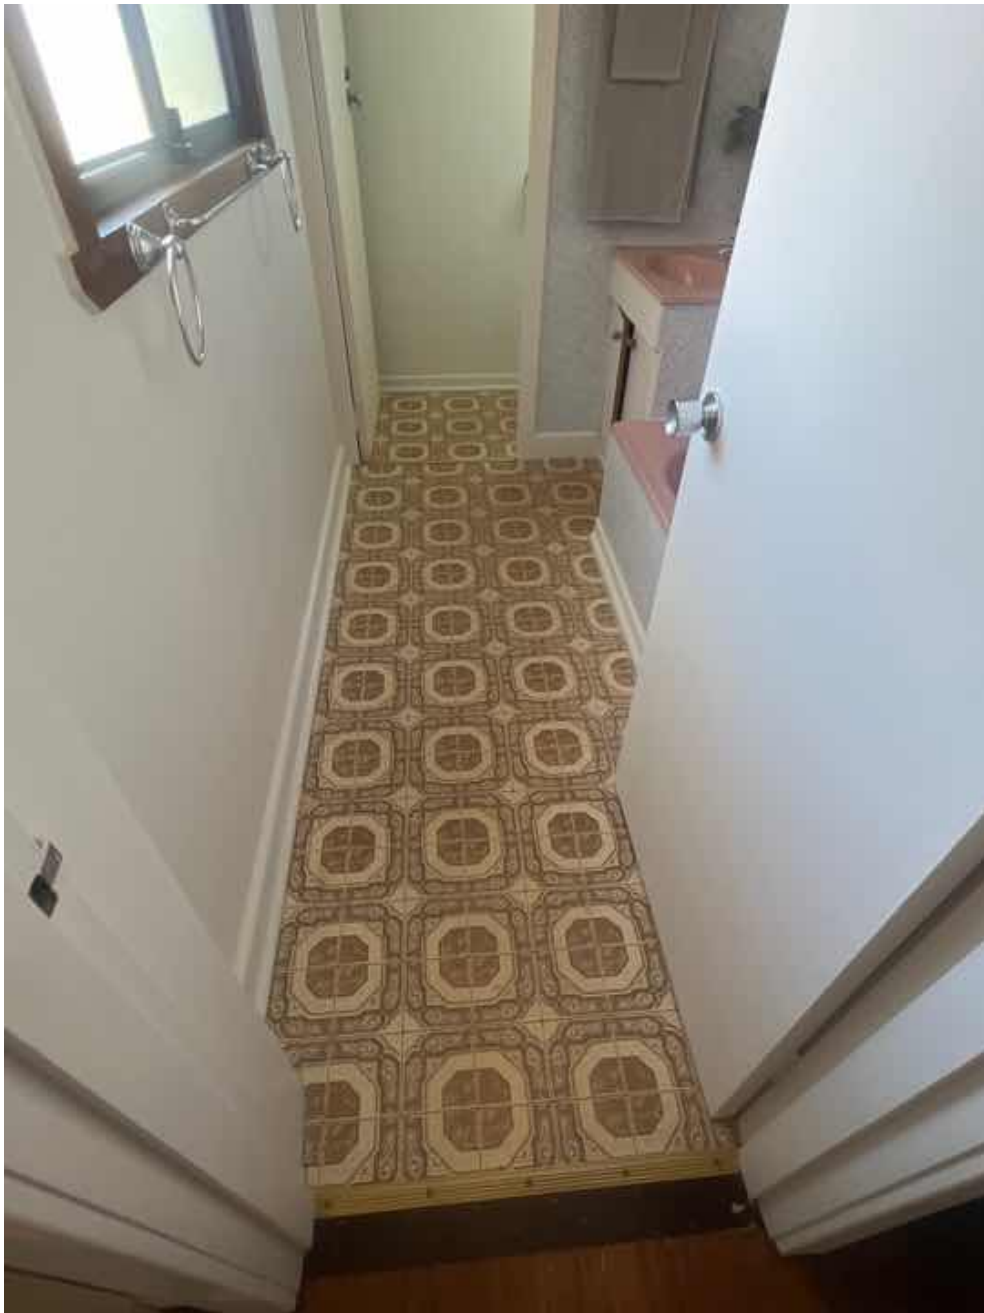
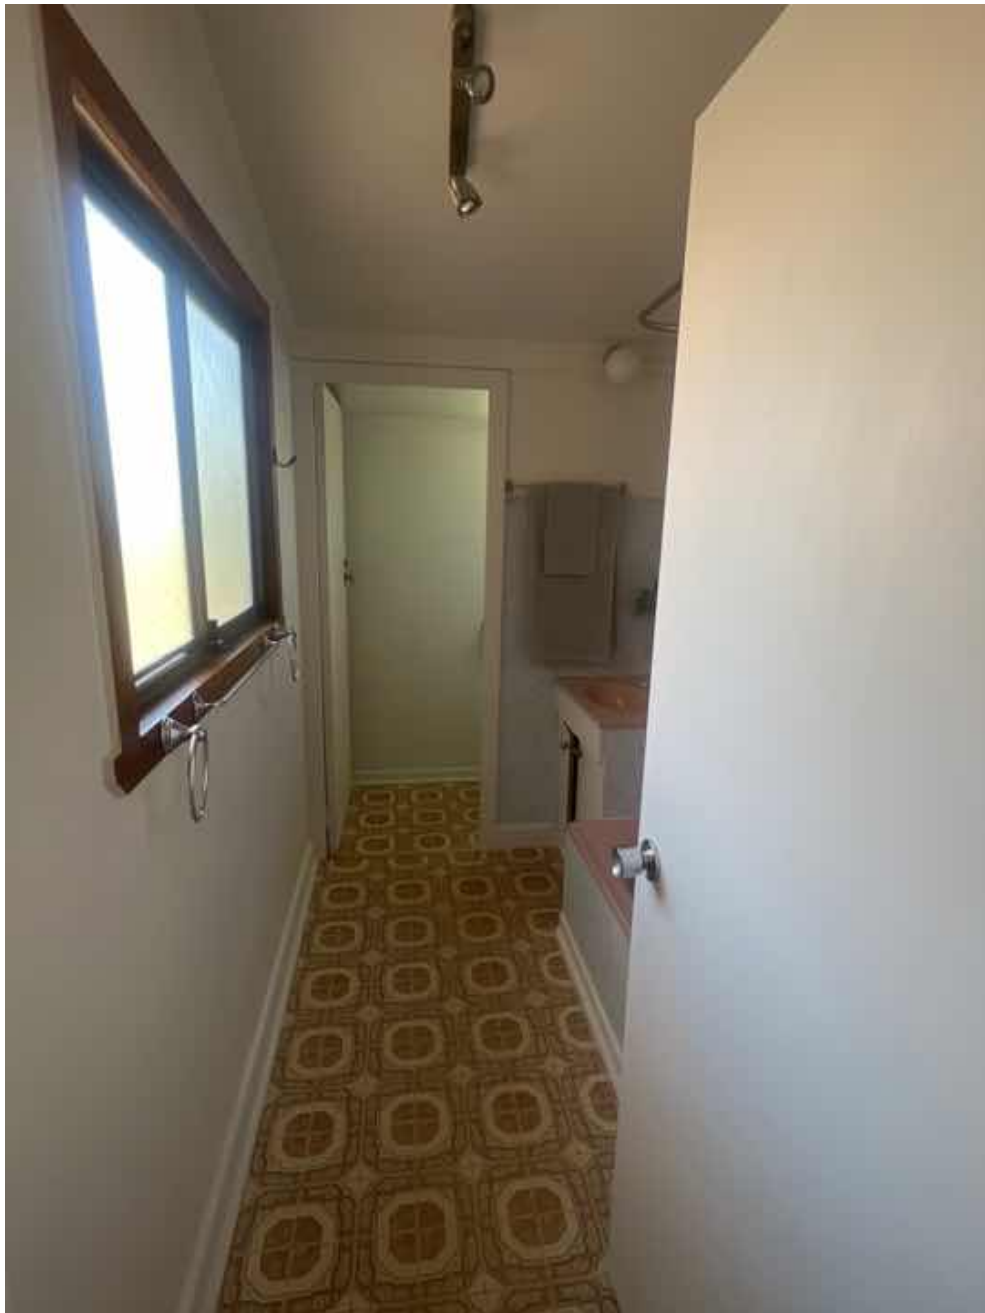
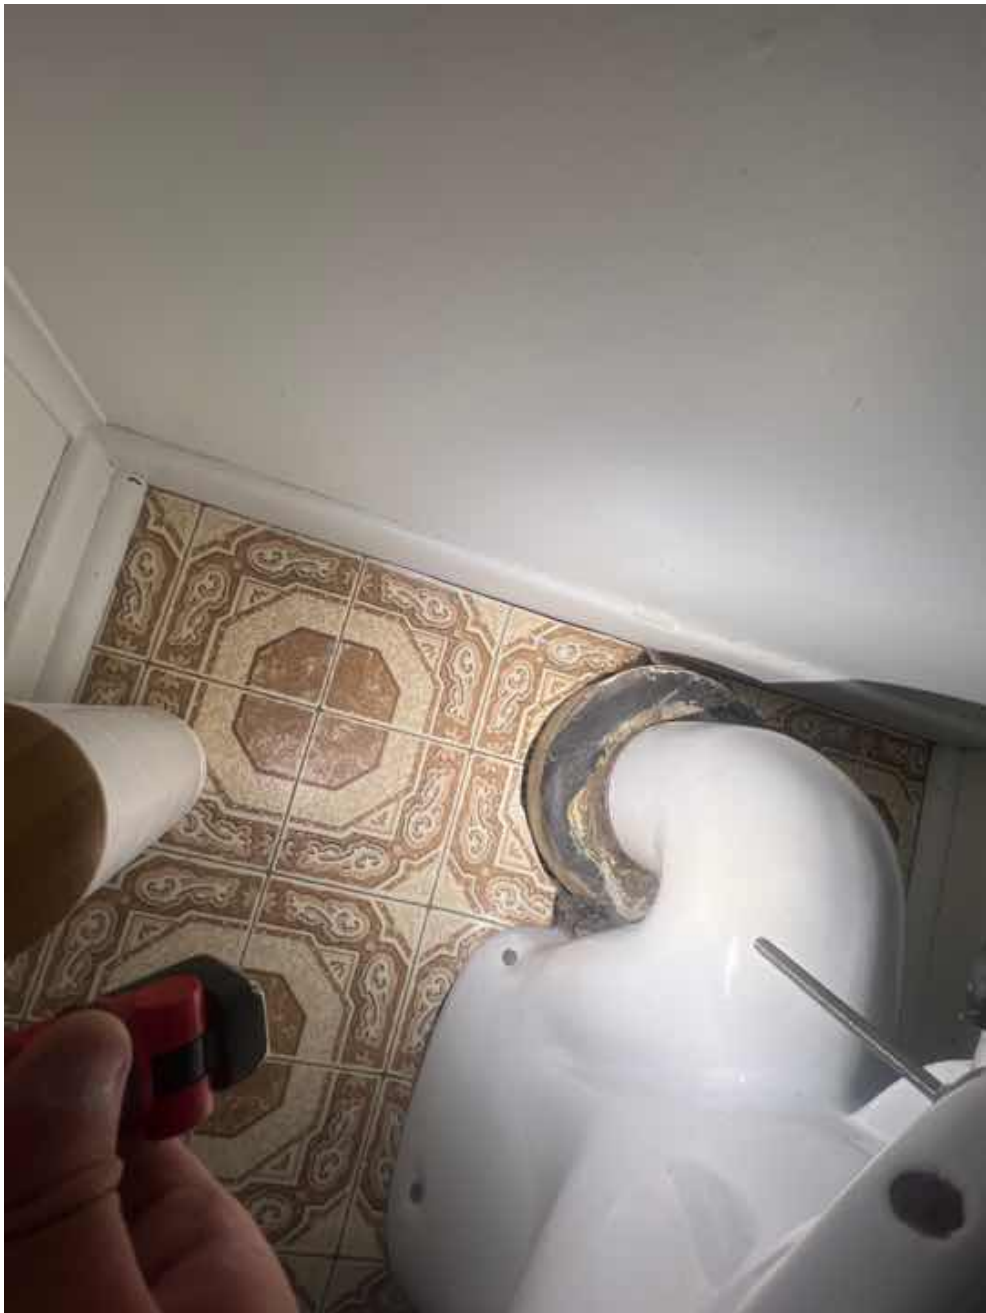
Absence of a waterproof membrane may allow moisture to leak into the subfloor.

General wear and tear was also observed to the bath tub, flooring, vanity and walls were damaged.

We recommend a licensed builder is engaged to provide a scope of work and cost to renovate the bathroom.

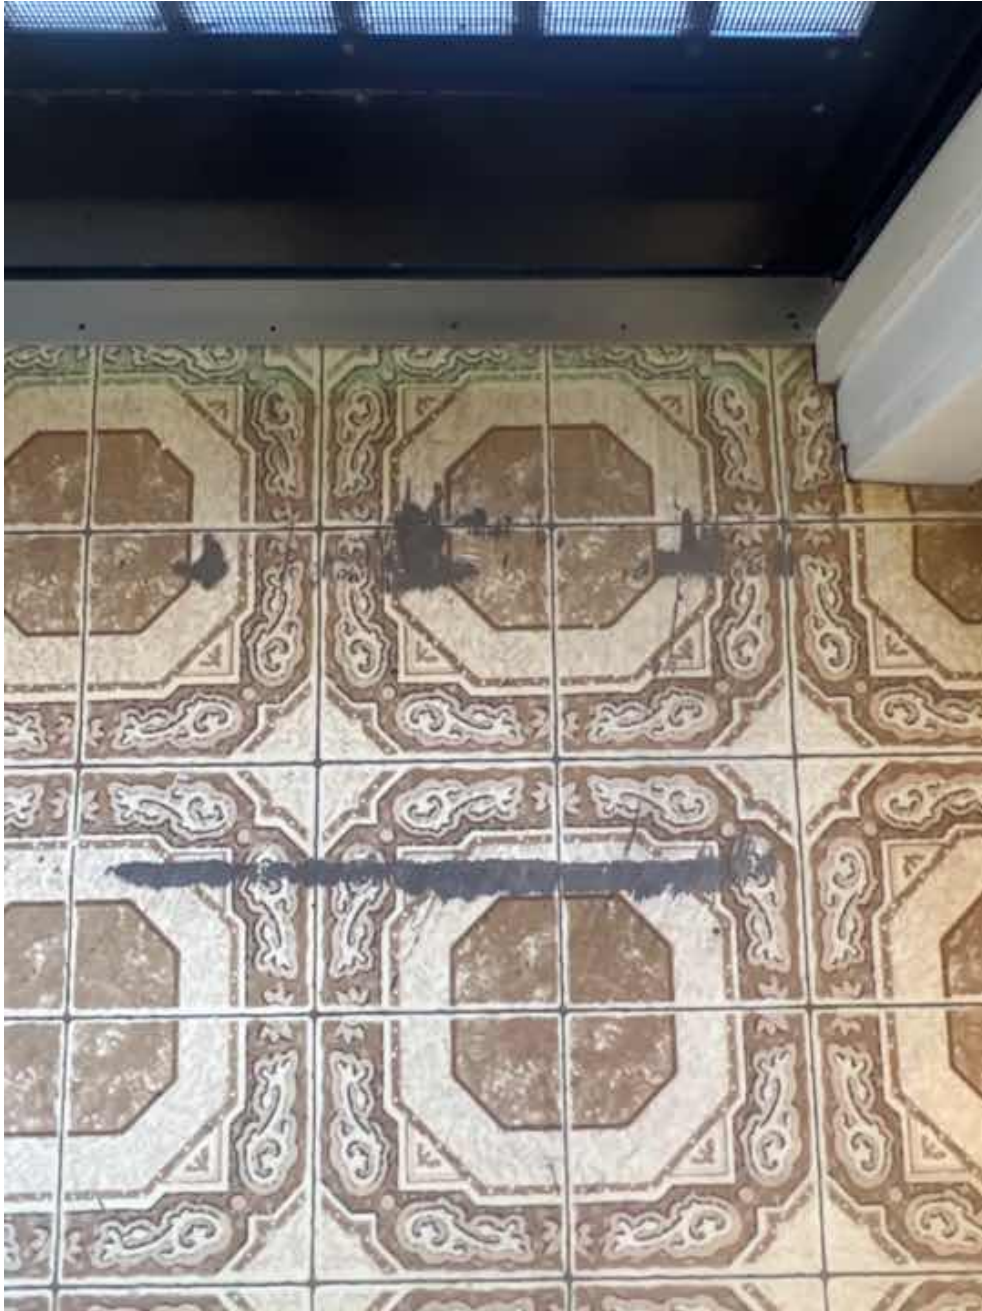
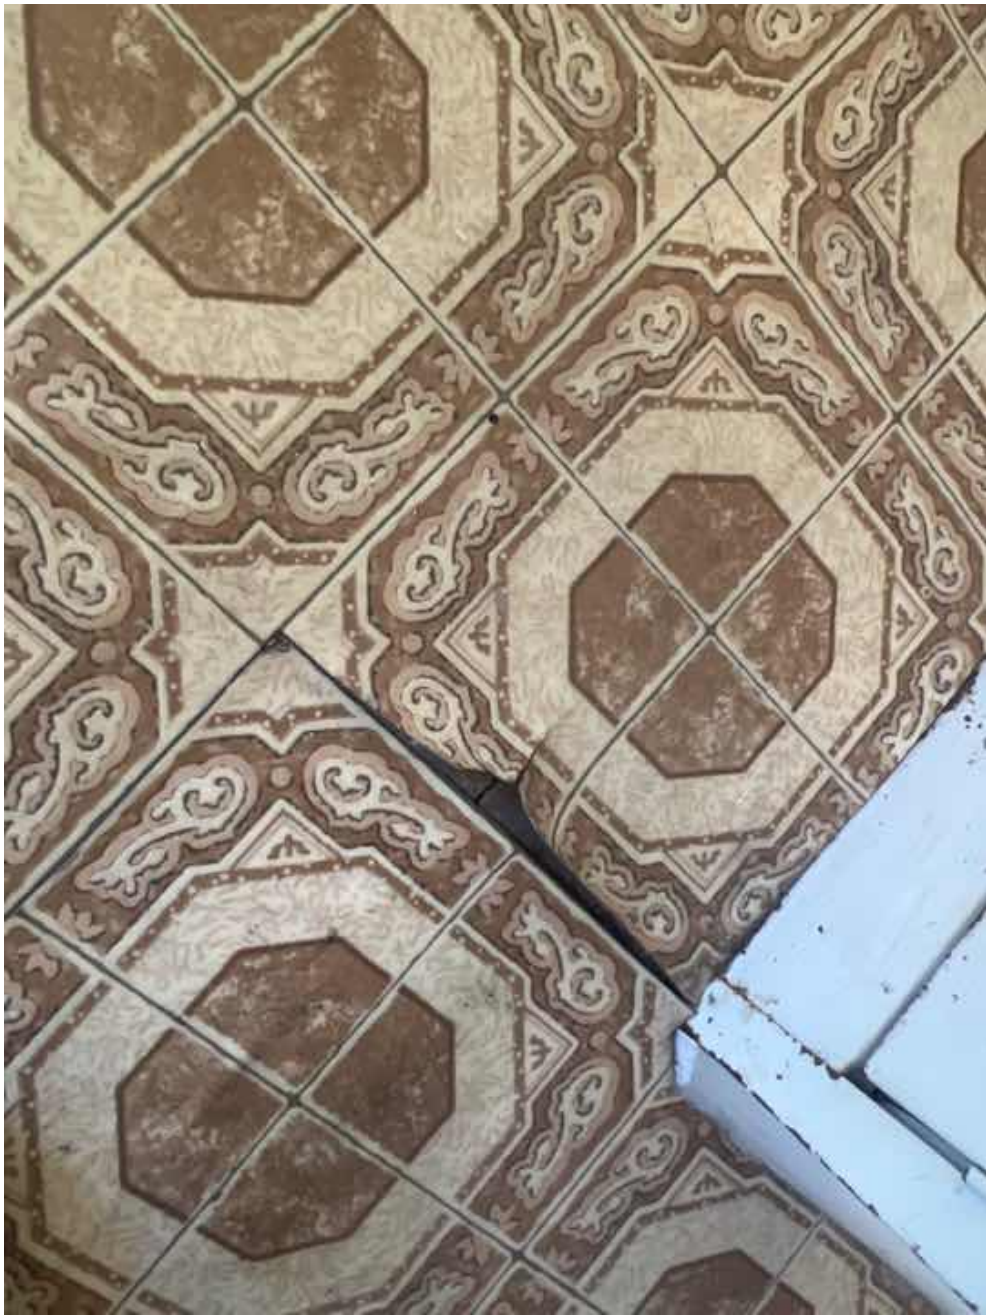
Floor

Damage to linoleum floor observed. Replacement by a qualified tiler is recommended.

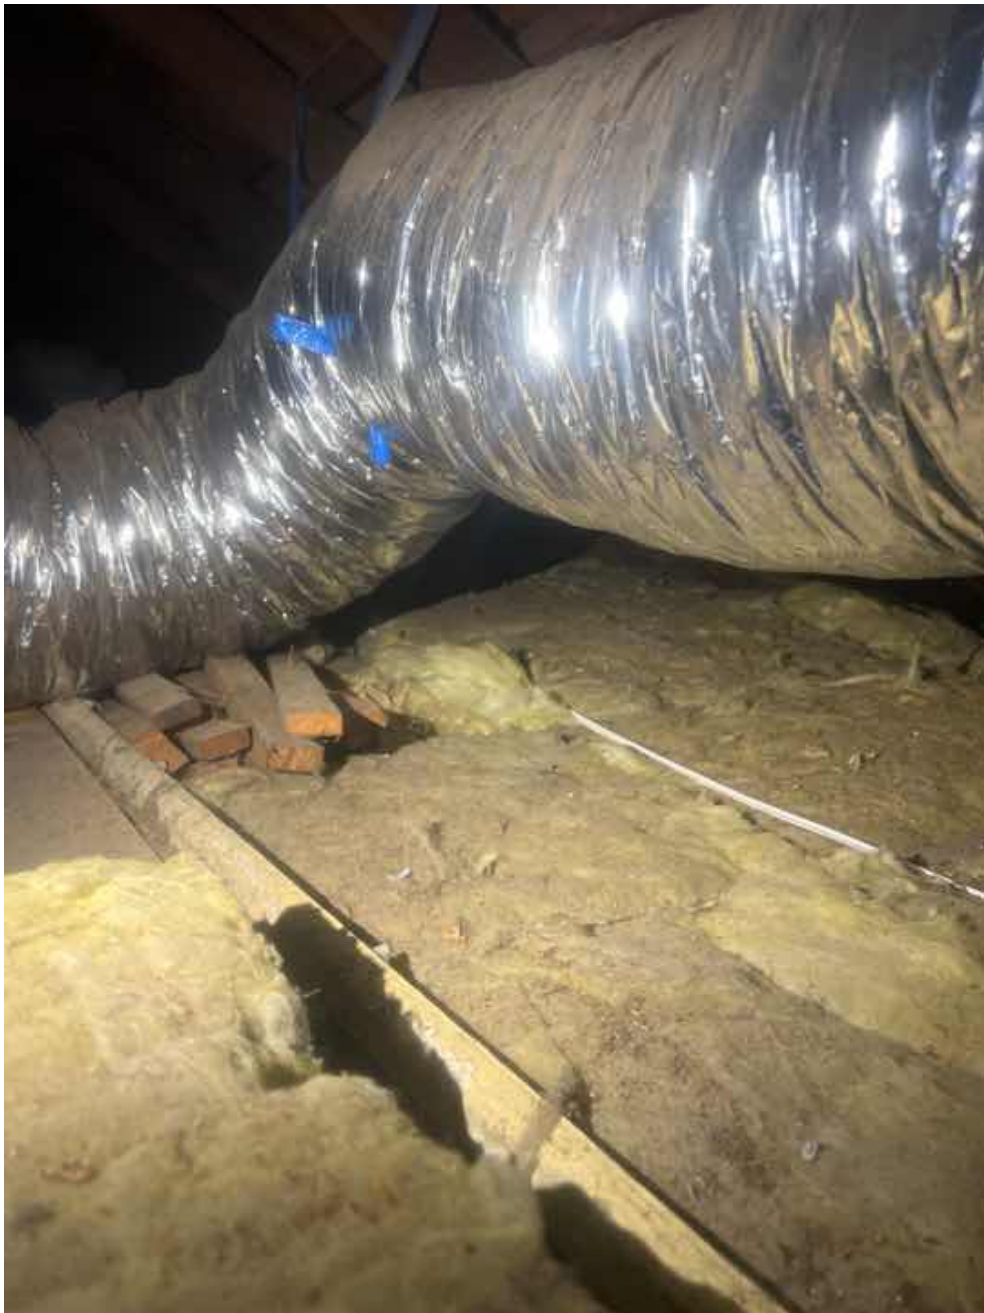
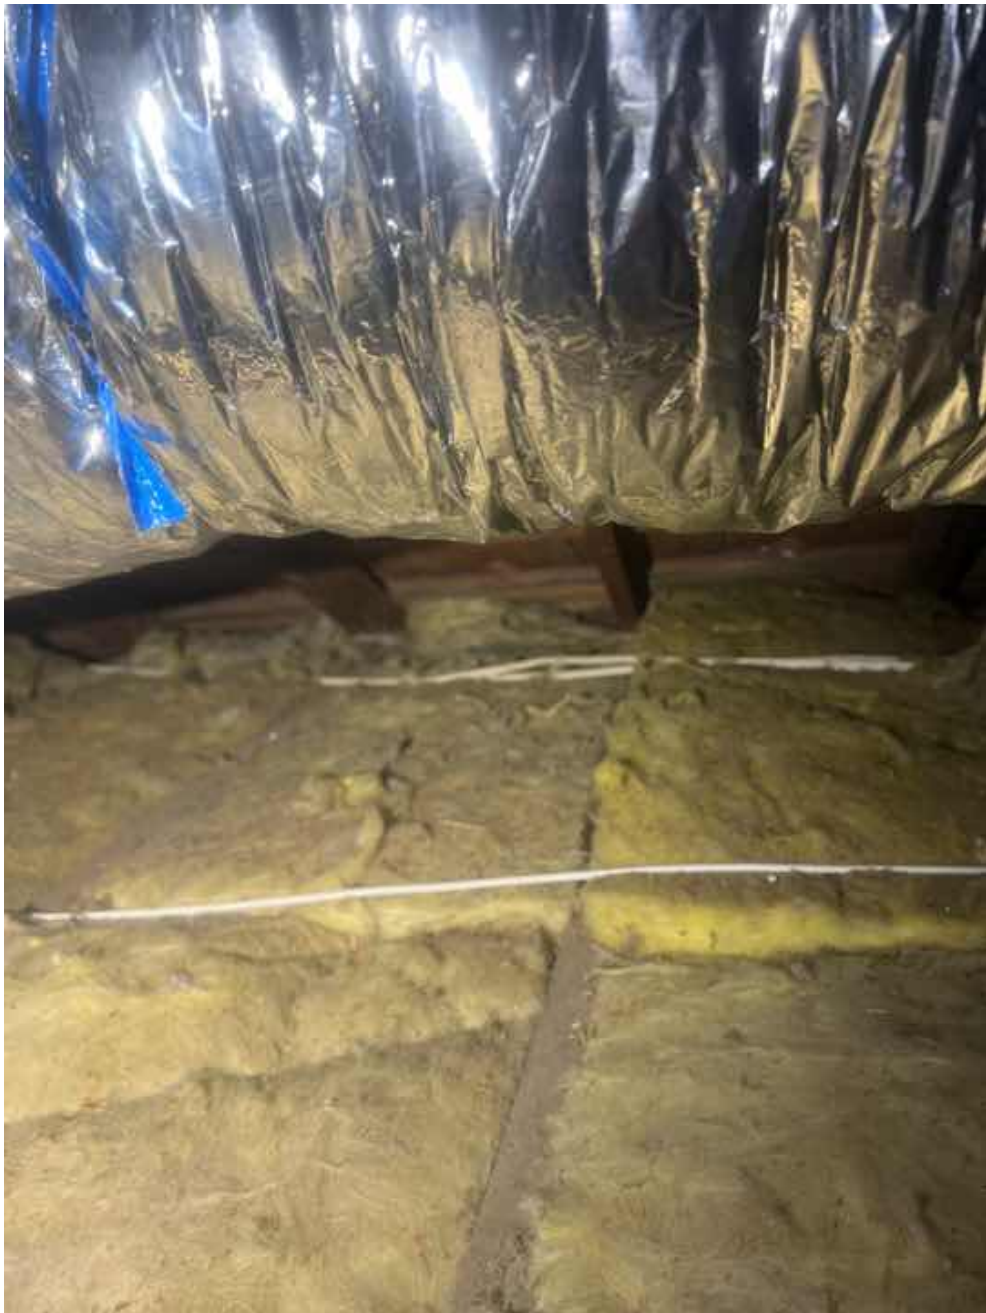
Roof Framing Defects

We note a timber rafter has been cut and appears to have been repaired. We cannot comment on the structural integrity of this repair therefore we recommend a structural engineer is engaged to provide recommendations and advice regarding the adequacy of this repair. This is a potential major structural defect and we recommend further investigation prior to a decision to purchase.

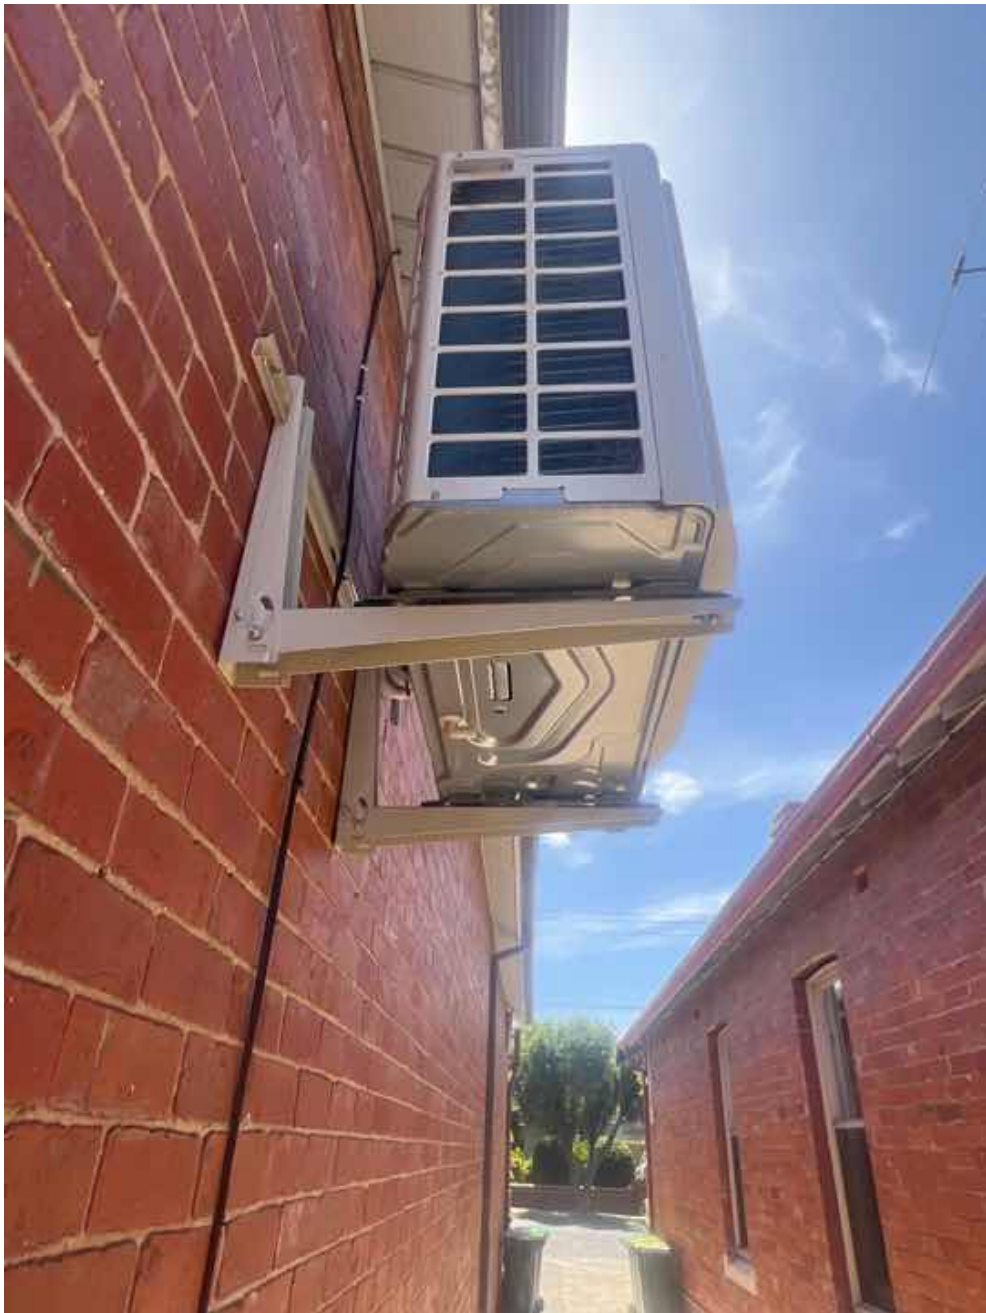
No - Divert A/C overflow away from the building perimeter.
