Darent at Eynsford

An advisory visit carried out by the Wild Trout Trust – October 2013

This report is the output of a Wild Trout Trust Advisory Visit (AV) undertaken on a 1km section of the River Darent at Eynsford in Kent. The beat inspected ran from the Eynsford Castle at National Grid Ref TQ541658 downstream to TQ544666.

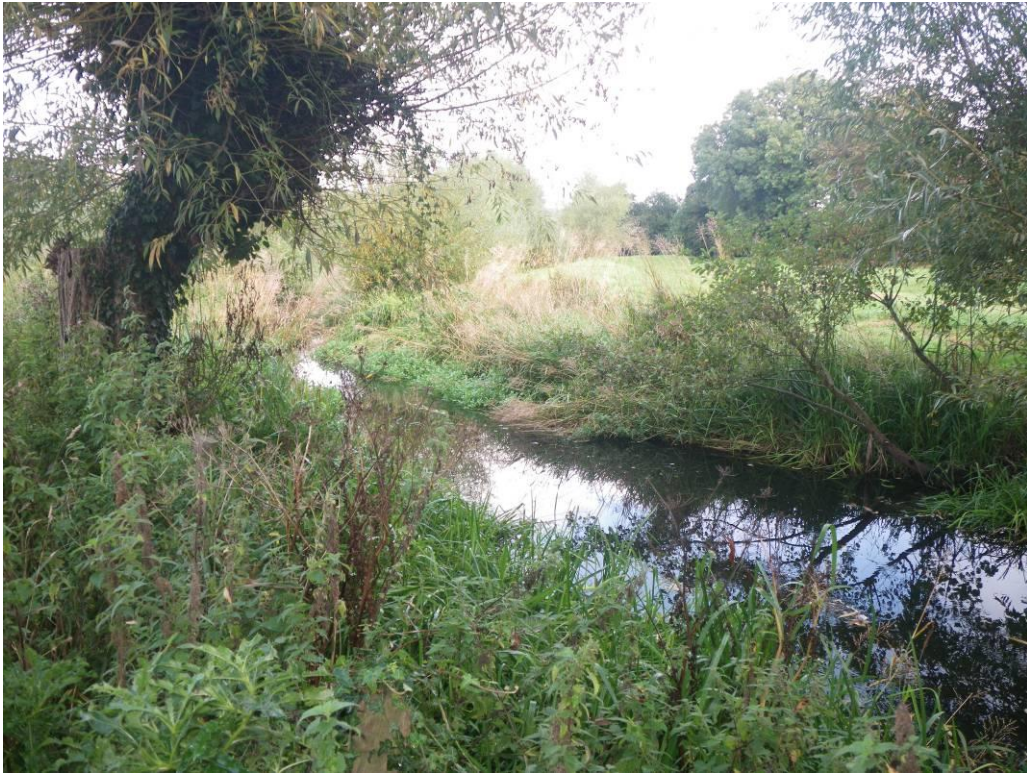
Photo 1. Slow flowing impounded section adjacent to Eynsford Castle

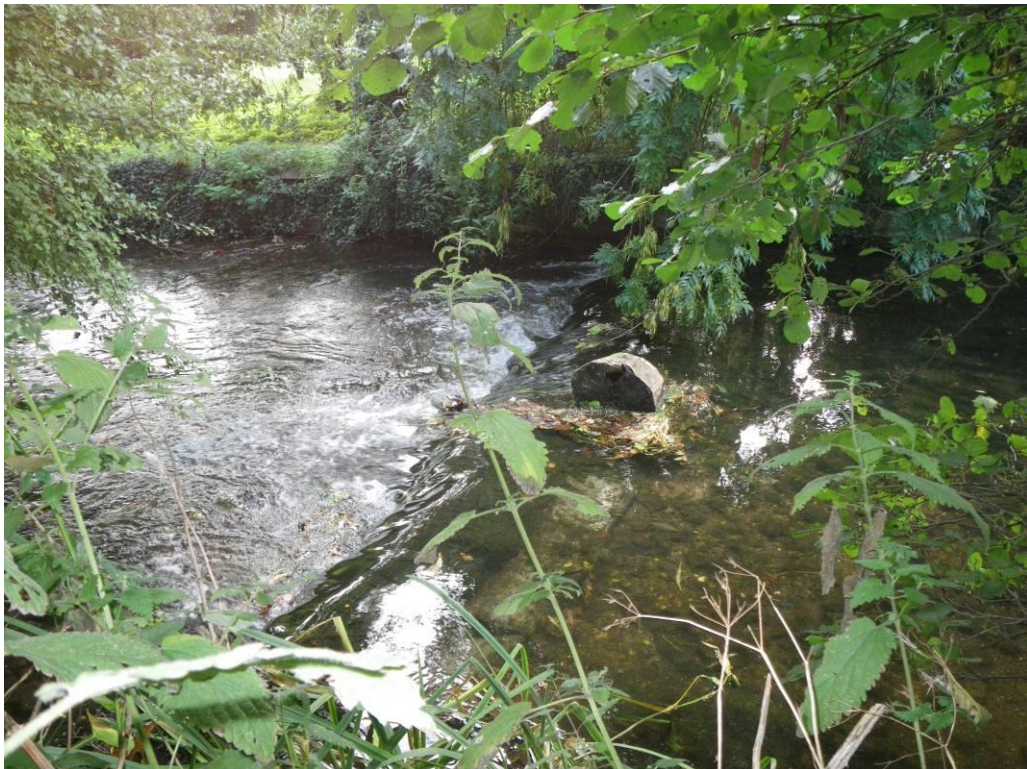
The section of the Darent downstream from Eynsford castle is divided by a series of structures. The upstream section adjacent to the castle is slow glide habitat, with the channel impounded by a weir (photo 2). This structure is not thought to be an impediment to trout migration but it would help to improve upstream habitat if the structure were removed. A good compromise might be to simply notch, or remove a narrow central section to ease migration for small coarse fish and promote the development of improved upstream habitat.

Photo 2. Low weir downstream of Eynsford castle.

In lieu of achieving the desired outcome of a newly constructed bypass channel, some simple measures can be taken to improve fish migration and habitat quality in this top section. The priority action would be to remove at least the central “third” of the stone weir depicted in photo 2. Material taken from the central section can be usefully used to support the stub wings that will be left to form two opposing “dragons teeth”. This should placate those who value the structure but will also maintain a more valuable scour pool below and increase flow velocities upstream by reducing the impoundment. This will hopefully arrest the bed accretion in time and will eventually help to maintain an increased depth in the reach immediately above the structure.

- Liaise with the RB landowners adjacent to the upstream weir with a view to taking out the central section.
- Work with the NWKCP and the EA to remove all obstructions on the reach; however, if this is not achievable, explore options for a new bypass channel around the existing impoundments.
- Undertake a programme of tree planting on the open central section as a method of restricting reed encroachment.
- Undertake sympathetic control of reeds when clumps become established in central channel locations.
- Undertake tree coppicing and pollarding on the lower section to allow more light into the channel.
- Use woody material to construct brushwood cover in shallow, bare margins.
- Use large woody debris to help locally sort and scour river bed gravels.
- Create two or three new holding pools on the bottom section by redistributing the existing river bed material.

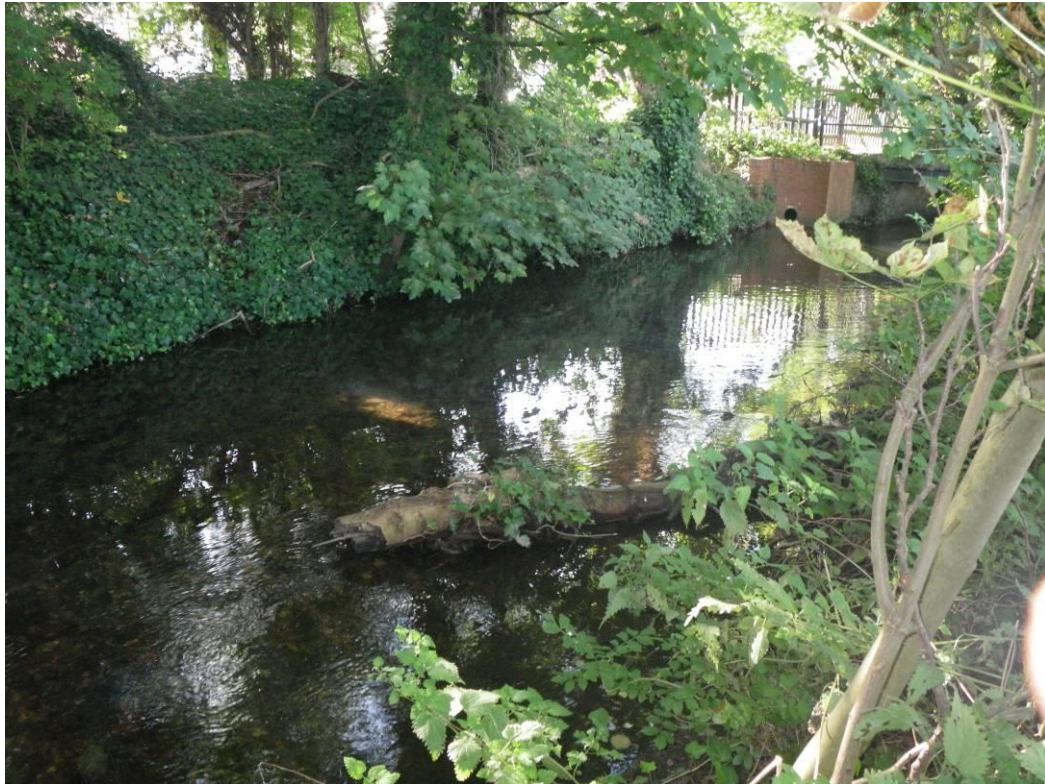
Photo 3. Head of the reach running downstream from the private development.

The next section runs downstream from a private development adjacent to old milling structures (not inspected). This section mainly consists of shallow glide habitat and is quite heavily shaded (photo 3). Further downstream the tree cover is reduced and comparatively long sections are dominated by high stands of emergent reeds and grasses (photo 4). It is highly likely that the channel has been subjected to over-enthusiastic drainage works at some stage in the past, contributing towards the reed dominated deep glide habitat.

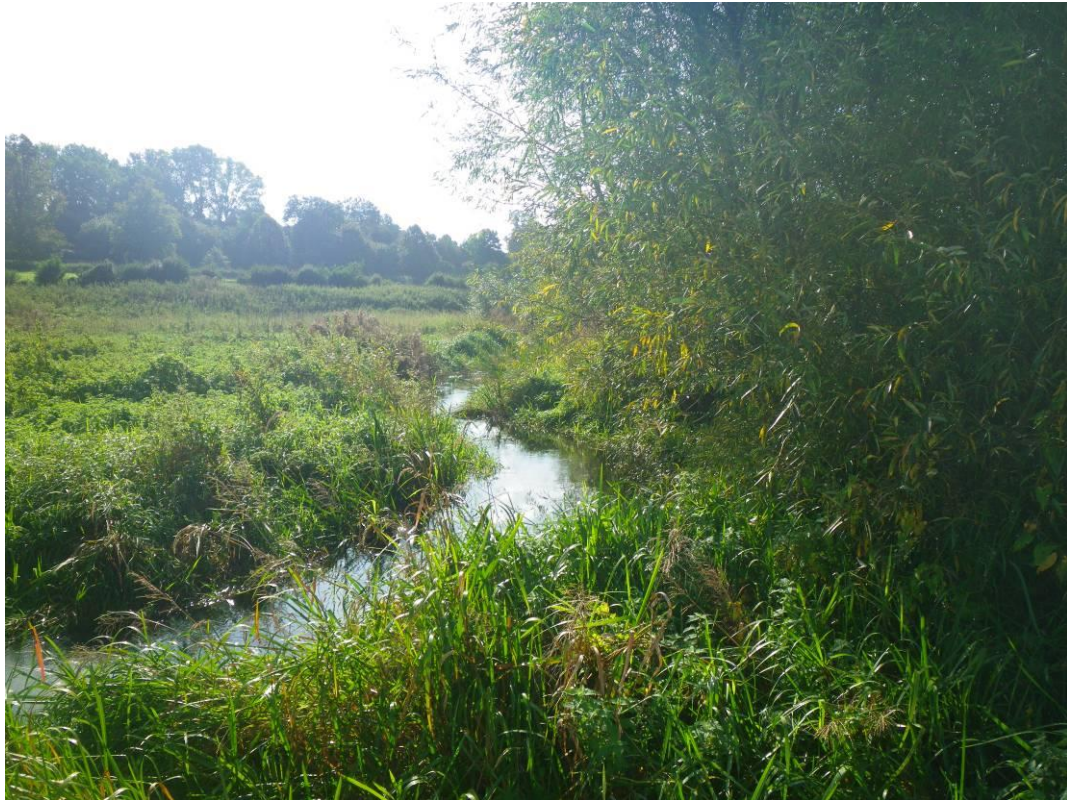
Photo 4. Open section dominated by dense stands of emergent plants.

The central section is challenging. Currently the reach is difficult to maintain due to excessive emergent reed growth. This reach has a valuable meandering planform but would benefit from more localised shading to limit reed growth, especially in central channel locations. Localised tree planting can help to make potential holding pools more attractive for trout and reduce the requirement for weed control. It is also possible to limit emergent reed growth by locally raising the river bed to promote elevated water velocities. This type of work can be very expensive and often relies on the use of imported gravels. If contemplated, great care needs to be taken to avoid any risks of backing up the channel and damaging habitat that is currently in good condition.

Until such time that strategic tree planting provides some controlling shade, the only other option is to continue with sensitive river keeping techniques, either by hand-pulling plants that appear in the middle of the channel, or using the scythe to maintain a pinched but viable channel. It is vital to realise that emergent reeds and grasses are extremely valuable in providing habitat for fish and invertebrates, protection for the bank, as well as being a barometer of long term flow conditions.

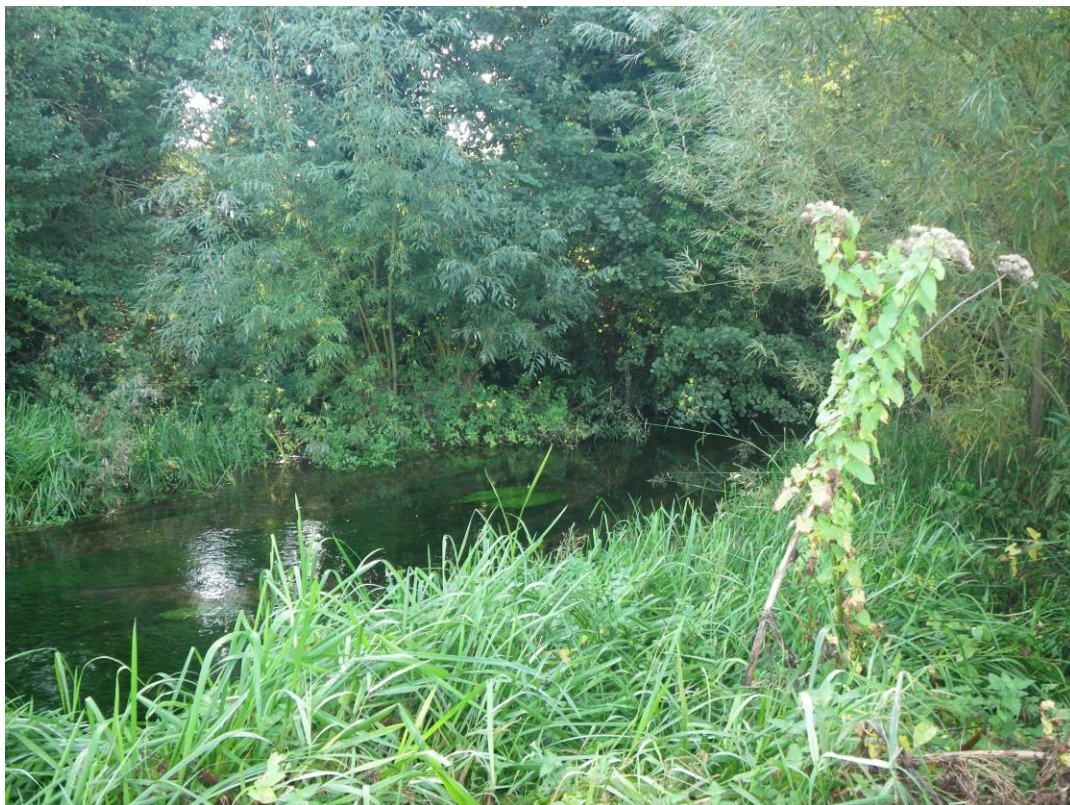
In between these sections there are comparatively short reaches that support an ideal mix of tree cover, emergent plant fringe and submerged water crowfoot and starwort beds, providing high quality habitat for fish and invertebrates (photo 5).

Photo 5. A valuable section of channel underpinned by the balance of light and shade, with a varied and rich habitat: emergent and submerged weed beds and open runs of shallow glide flowing over a mainly clean gravel bed. Good habitat for trout.

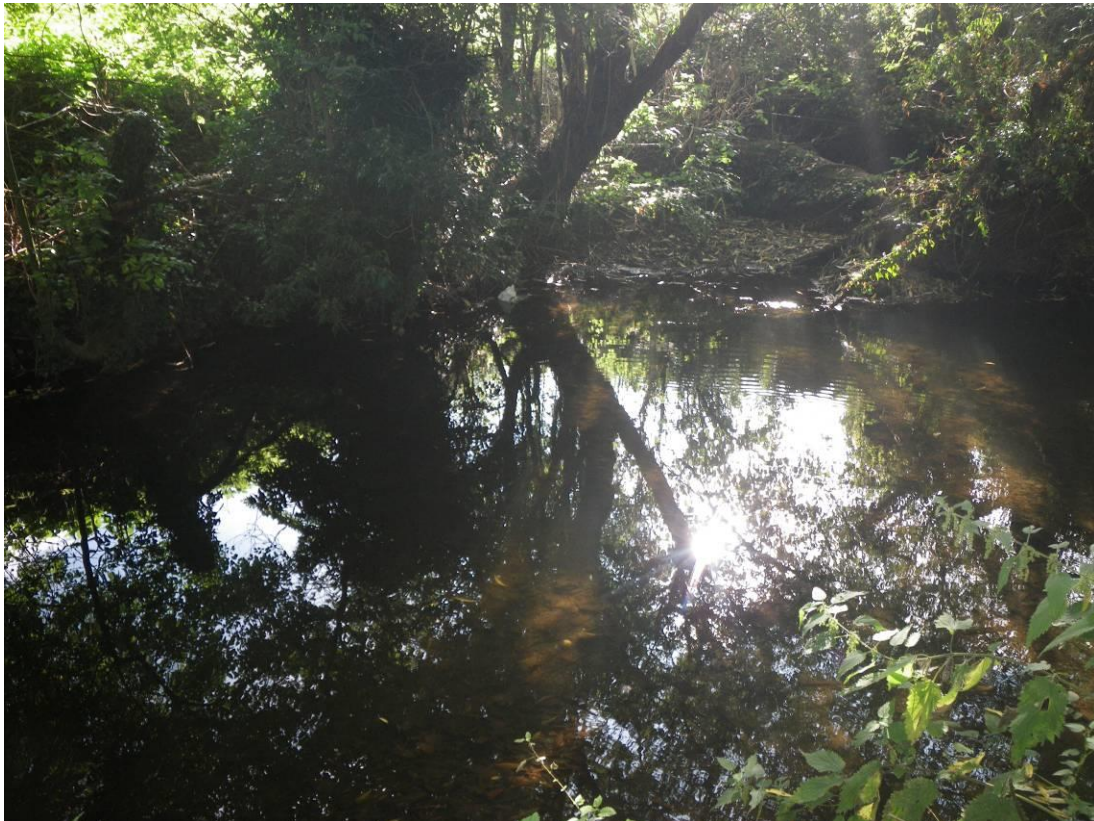
The bottom section of channel is shallow and quite heavily shaded (photo 6), flowing over a predominantly gravel bed (photo 9). The heavy shading limits marginal plant life, resulting in a much wider wetted channel than further upstream where encroaching marginal plants narrow the channel. Very shallow water graduating out from the centre of the channel is valuable in providing good quality habitat for juvenile trout but more diversity in terms of depth and cover is required if this section is to be valuable for wild trout production.

Photo 6. A good holding lie for adult fish in the heavily shaded bottom section

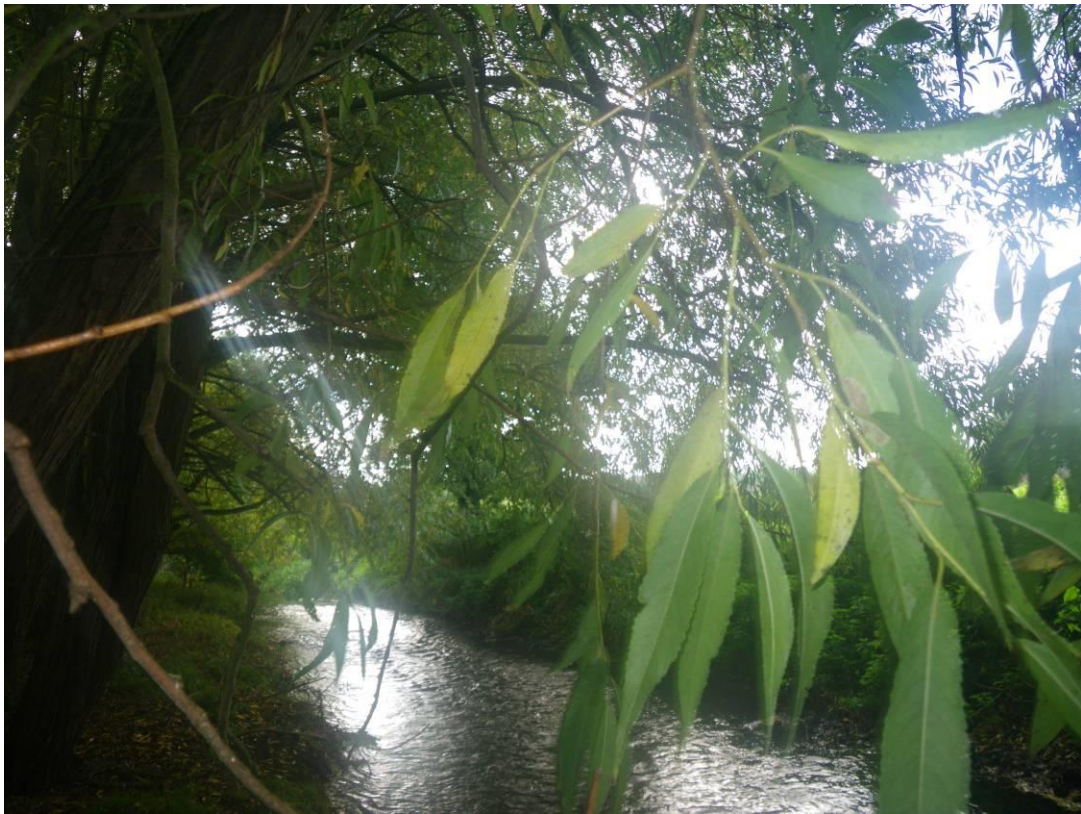
Photo 7. Long shallow riffle, again under heavy shade.

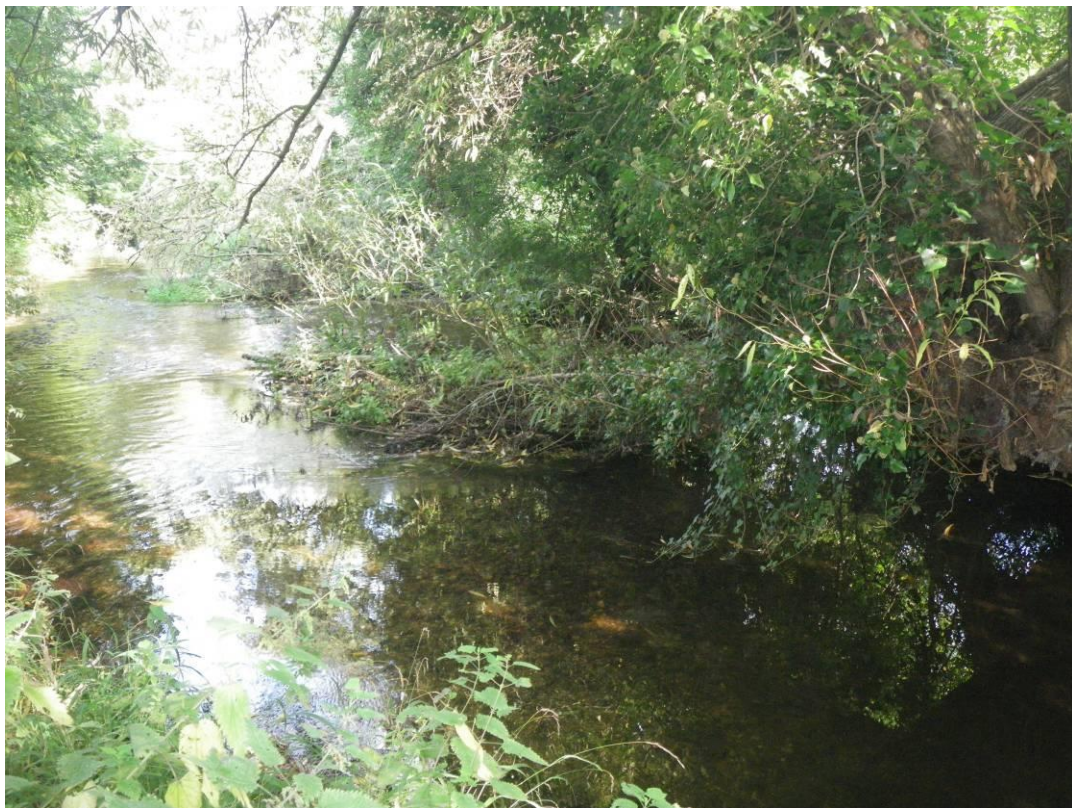
One or two slightly deeper holding glides have been promoted by fallen woody debris (photo 8) but long sections are lacking significant amounts of cover for fish of all life stages.

Photo 8. Woody debris providing valuable cover on the tail of a potential spawning glide.

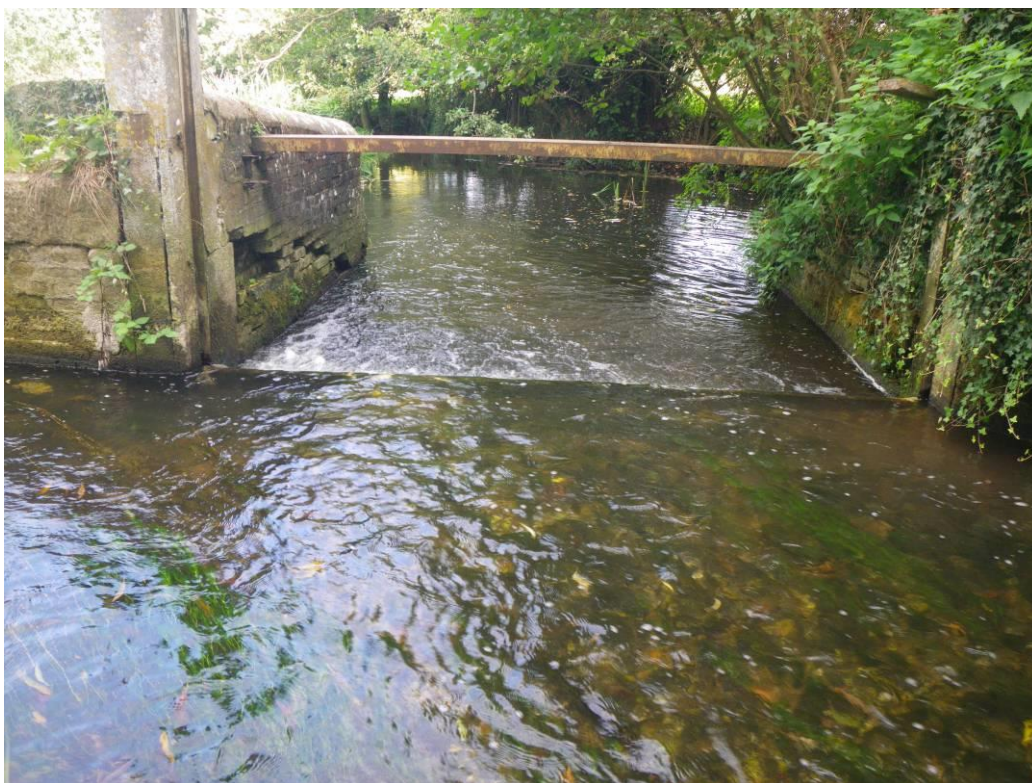
Mean water levels have undoubtedly been reduced in recent times through the lowering of an impoundment located near the bottom boundary (photo 9). The structure looks to form part of an old milling site with a bypass channel.

It is understood that the island created by the main river and bypass channel is soon to be re-developed. It is hoped that the current arrangement remains in place, whereby the numbers of sluice boards is kept to a minimum. At the time of the visit there was still one board in place. The removal of this last board might have serious implications for flow in the bypass channel but improvements could still be made by replacing it with a modified board incorporating a deep notch for improved fish migration.

Currently there is evidence that the river bed upstream of the structure has risen with accreted gravels and the increased flow velocity generated by pulling all of the boards out of the weir has locally increased upstream flow velocities and enabled valuable water crowfoot to become established.

Photo 9. Derelict weir structure located near the bottom boundary.

The management and operation of the structure near the fishery bottom boundary is of paramount importance. The existing structure is derelict and should ideally be removed for the greatest ecological improvements to be realised. Replacement may, however, be essential to maintain flow in both channels. If this is the case then ensuring that the penning level is maintained as low as possible and making provision for improved fish migration are essential requirements for any proposed refurbishment. Achieving these goals may be outside the gift of the fishing club, but any work to the structure will require consent and the club should liaise closely with the Environment Agency to ensure a positive outcome at this site.

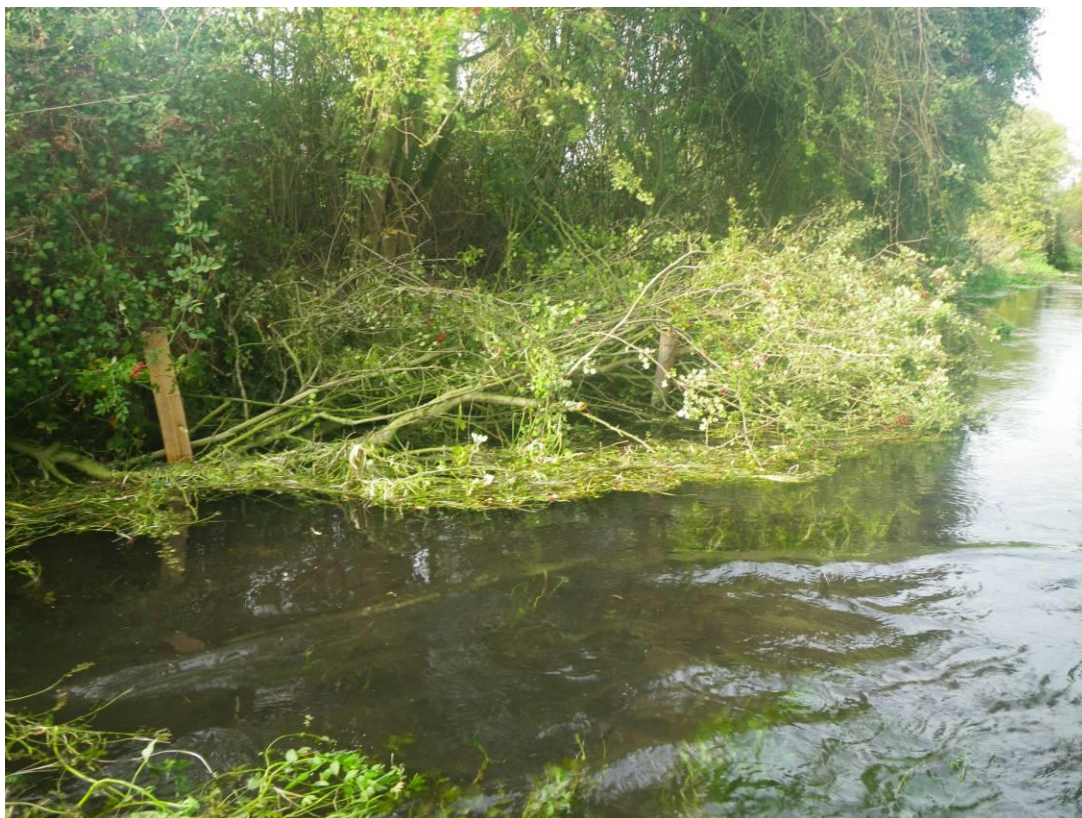
Photo 10. A whole hawthorn laid into a shallow chalkstream margin for improved juvenile trout survival.

The lower section of this beat undoubtedly has the most potential for enhancement. Currently the channel is wide and shallow and lacks diversity in terms of bed topography and channel width. Improved conditions for juvenile trout can be achieved by covering shallow bare margins with pegged in brushwood and brash (photo 10). The gravels are comparatively flat and compacted and the use of large woody debris flow deflectors to help sort river bed gravels will also enhance spawning opportunities.

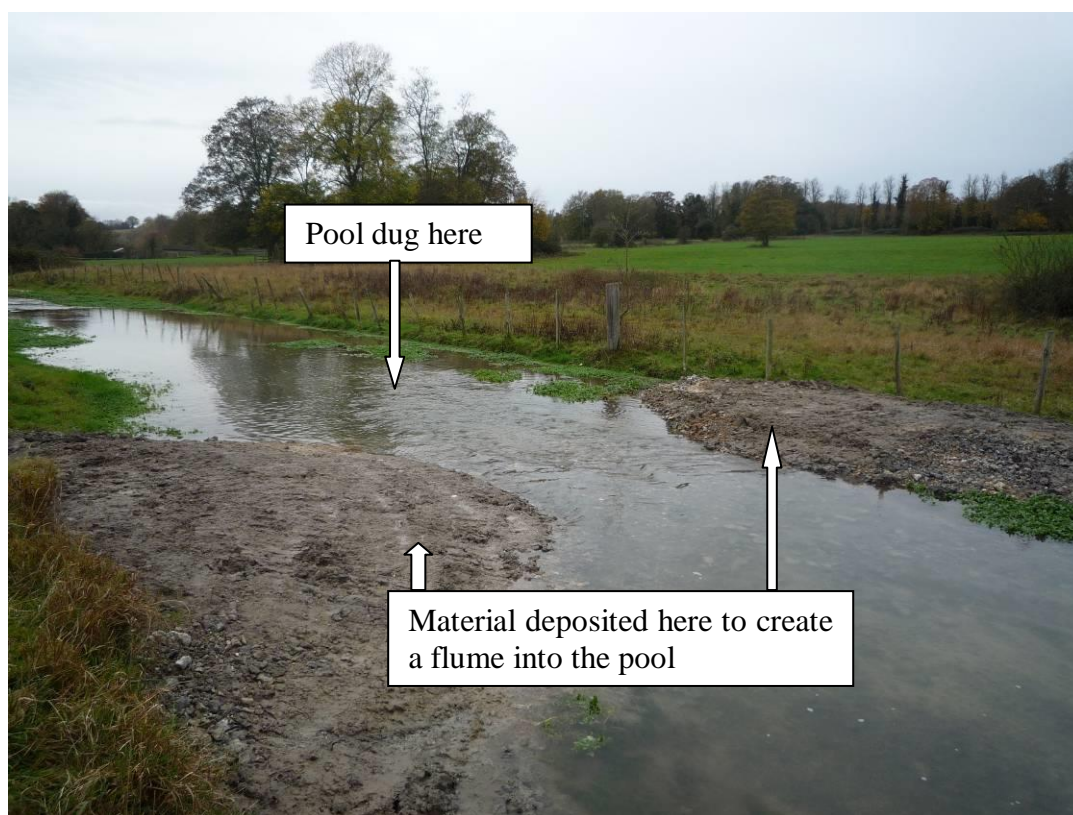
Photo 11. A run and pool created on a section of wide, shallow chalkstream using the "dig and dump" technique

An additional bottleneck is the comparative lack of high quality holding pools for adult trout, both in terms of providing a refuge for pre and post spawning brood stock, but also for fishery performance. Flow deflectors alone may not be successful due to the concreted nature of the river bed. Pools can be created manually with hand tools and LWD flow deflectors installed to keep them swept clean. Another popular technique (photo 11) is to use a tracked excavator to redistribute existing river bed materials. Access is difficult on this site due to the extensive tree cover but it might be possible to track a machine into the reach and create two or three key holding pools. Again, these would require the addition of some kind of flow deflectors (ideally LWD) to locally increase flow velocity and scour that will naturally maintain the pools. An example of combining the creation of a pool with the installation of a flow deflector to sweep it clean is given in this video: <http://www.youtube.com/watch?v=9KIHLcSQ-KY>
