**Oregon Department of Transportation  
Bridge Inspection Report**

| <b>District :</b> | 11 | <b>Structure :</b> | OREGON<br>WATER<br>WONDERLAND,<br>WOOD DUCK<br>COURT | <b>Bridge ID :</b> | 20783 |

**Oregon Department of Transportation**  
**Highway Division**  
Bridge Operations Section  
Local Agency Bridge Photos

Bridge No. 20783  
Deschutes County  
Date: July 2022

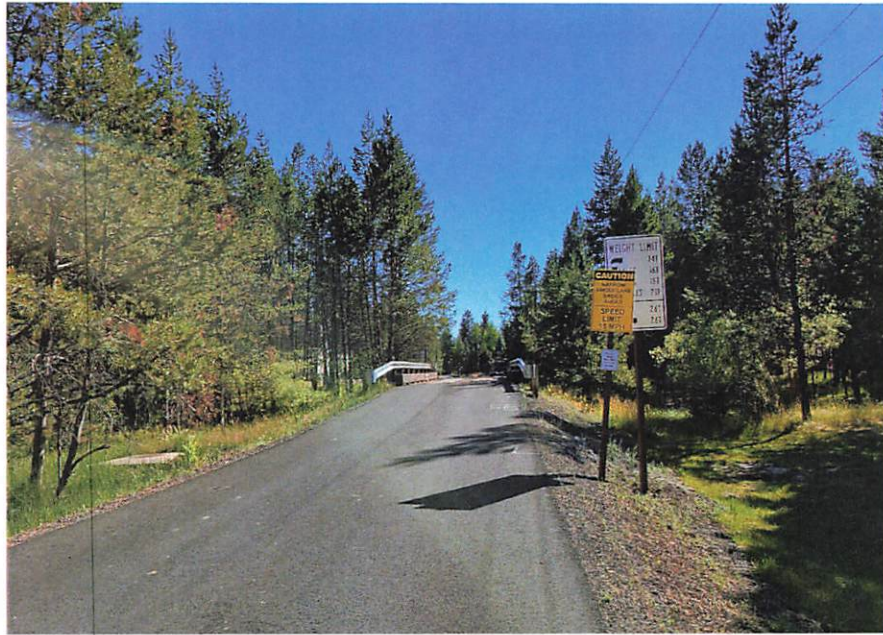
**Load Posting Viewing South**

Narrow Bridge Sign obstructs the load posting sign.
