Case Report

Peculiar reaction of oxidized zirconium from a total knee arthroplasty prosthesis: A case report

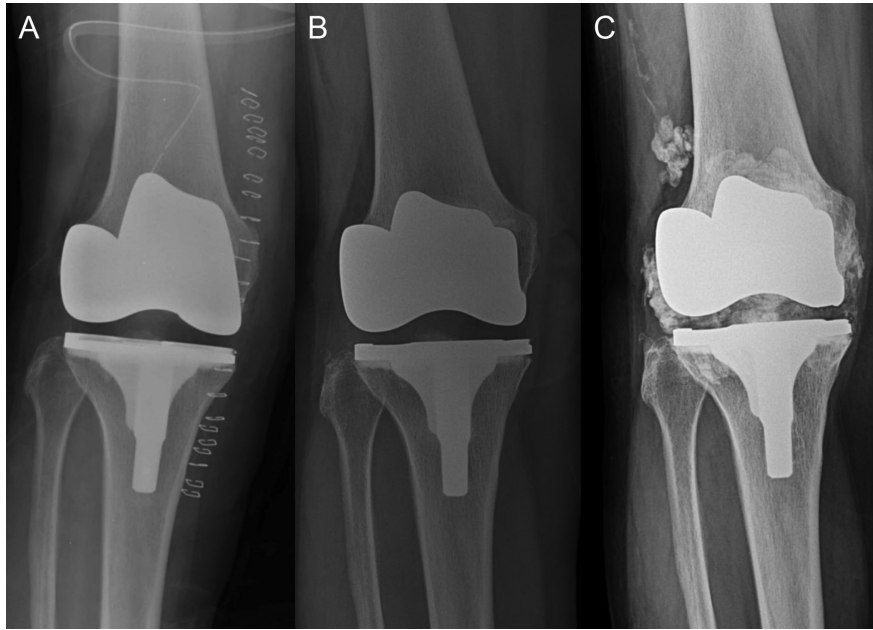
Figure 1. Serial postoperative anteroposterior radiographs (A) immediately, (B) at 5 years, and (C) 10 years following primary oxidized zirconium total knee arthroplasty.

In the present case, there were no abnormal findings of implant failure until 5 years after index surgery. However, at 10 years after primary TKA, radiographs demonstrated a TKA with obliteration of the PE space on the medial space with apparent grooving of the medial femoral condyle. The resultant severe metallosis was caused by friction between the femoral and tibial prosthetic metal surfaces due to catastrophic wear of the tibial PE. Then, zirconium deposits in the synovium gave an appearance similar to that of an arthrogram. These were derived from the wear and grooving of the Oxinium femoral component against the titanium tibial base plate. “Oxinium Arthrogram” of the surrounding prosthetic joint tissue, which is a sign of oxidized Zirconium implant failure, had grown and worsened further at 12 years after TKA. Early identification of PE wear and prompt revision could have avoided the rapid progression of the subsequent metallosis and catastrophic implant failure.

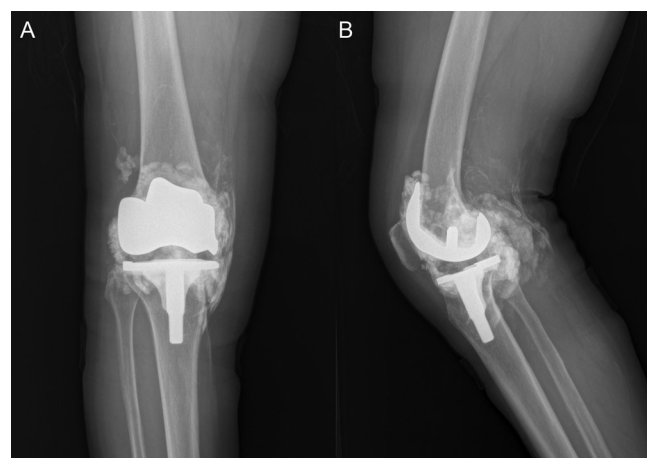
Anteroposterior and lateral radiographs revealed a cemented TKA with obliteration of the polyethylene (PE) space on the medial side. There was also apparent grooving of the medial femoral condyle (Figure 2). The radiographs also revealed lobulated, bubble-shaped opacities following the outline of the joint capsule, extending from the suprapatellar pouch to the popliteal area of the knee. Bone scintigraphy and single-photon emission computed tomography/computed tomography revealed focally increased methylene diphosphonate uptake in the right femoral condyle, possibly due to osteolysis (Figure 3). This patient was diagnosed with wear of the PE and subsequent catastrophic failure of the femoral component.

Figure 2. Postoperative anteroposterior (A) and lateral (B) radiographs of a failed oxidized zirconium total knee arthroplasty 12 years after index surgery with the grooving of the medial femoral condyle and the large metal arthrogram.

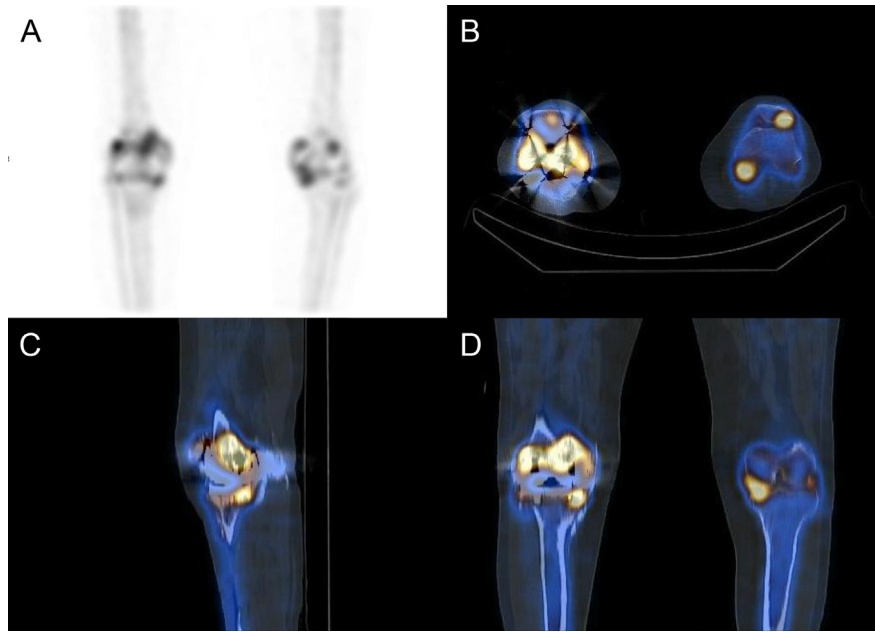
Figure 3. Bone scintigraphy and single-photon emission computerized tomography/computerized tomography A) coronal maximum intensity projection image; B) transaxial image; C) sagittal image; D) coronal image] of a failed oxidized zirconium total knee arthroplasty showed focally methylene diphosphonate uptake in the right femoral condyle, which was possibly due to osteolysis.

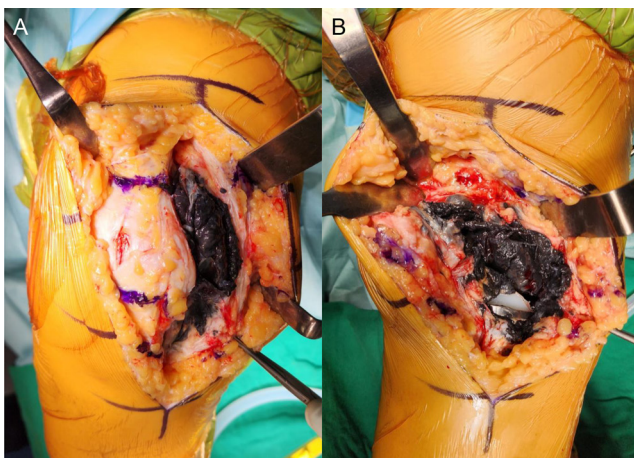
One-stage revision surgery was performed using a standard medial parapatellar approach. Severe black metallosis was found

intraoperatively within the lining of the joint, suggesting the release of metallic debris from the prosthesis (Figure 4). The medial side of the PE had completely worn off, resulting in the erosion of the femoral component from contact with the tibial tray, as evidenced by grooving with exposure of the underlying silver layers without black appearance. Moreover, the tibial component showed black staining from the metallic debris and groove along the posteromedial aspect of the titanium tibial component and thinning of the peripheral locking mechanism (Figure 5). Metallic debris was also noted within the cut surface of the femur and tibia, indicative of the osteolysis that had occurred, leading up to the failure of the implants. All the components were removed, and synovectomy was done as much as possible; however, complete resection of debris was impossible due to the potential risk of neurovascular injury. Revision TKA was performed using the semi-constrained Constrained condylar Knee (CCK) (LCCK [Legacy Constrained Condylar Knee]; Zimmer, Warsaw, Ind, USA) (Figure 6). Metal augmentation was used on the distal and posterior condyles of the femur to fill the bone defect. She

Figure 4. (A-B) Intraoperative photographs with severe black metallosis within the knee joint's synovial lining suggest implant failure due to extensive wear.

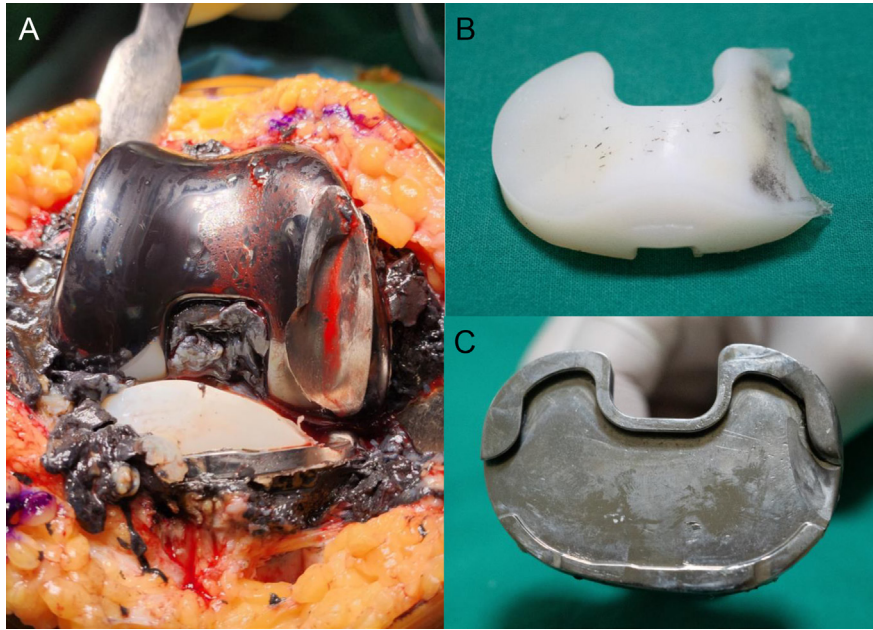
Figure 5. (A) Intraoperative photographs with extensive wear and significant grooving of the femoral component with exposure to the underlying zirconium substrate and (B) the complete wear of the medial side of polyethylene. (C) Explanted total knee arthroplasty tibial component with black staining from the oxidized zirconium debris and groove along the posteromedial aspect of the titanium tibial component.

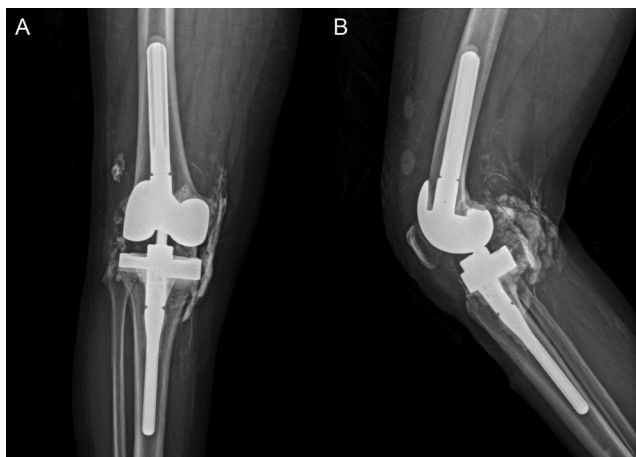
had no postoperative complications and demonstrated an improvement in clinical outcomes with good alignment and no evidence of osteolysis or loosening 2 years after the revision surgery.

Figure 6. Postoperative anteroposterior radiograph (A) and lateral radiographs (B) after synovectomy and revision total knee arthroplasty. Metal augmentation was used on the distal and posterior condyles of the femur to fill the bone defect.

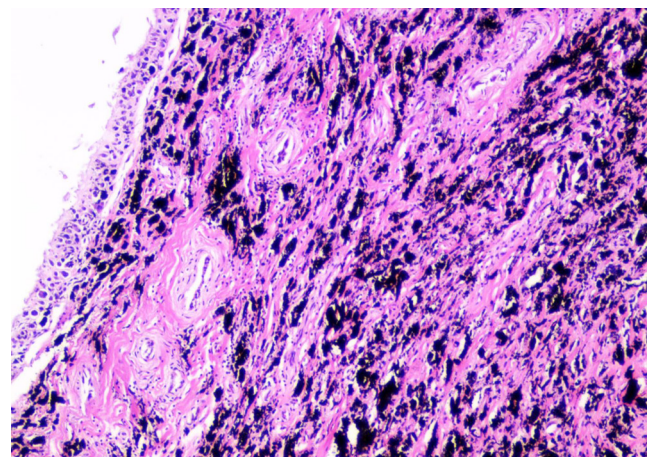
Histopathological examination demonstrated widespread deposition of black-pigmented metal particles in periprosthetic synovial tissue (Figure 7). The synovium was reactive and chronically inflamed, apparently due to extensive deposits of fine black metal fragments. Infiltration of histiocytes and the formation of giant cells, a response to foreign substances, were observed in addition to phagocytosis of the black-pigmented metal (Figure 8).

Figure 7. Representative photomicrograph of the histopathologic examination showing periprosthetic metallosis and metal-induced synovitis. The synovium is reactive and appears loaded with fine black metallic debris (hematoxylin and eosin, ×100).

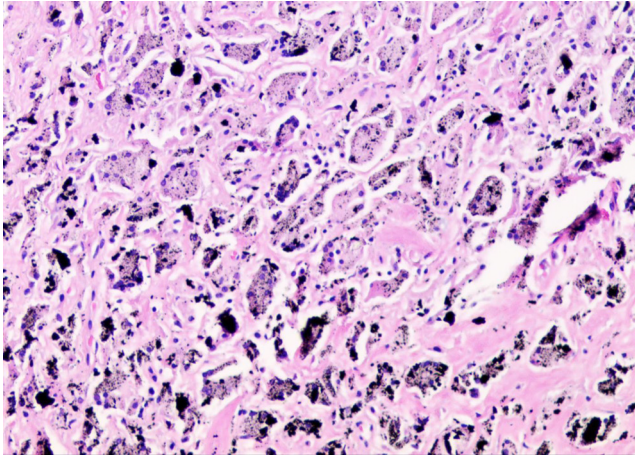
Figure 8. High-power magnification showed the presence of black metallic debris within multinucleated giant cells in the synovial lining (Congo red, 200×).
