Gotham City Home Inspections, Inc.

123 Anywhere St, NYC, NY 10449
Inspection prepared for: Sample Report
Date of Inspection: 6/8/2019 Time: 10:00 AM
Age of Home: Built pp. 1930 Size: 900
Weather: Sunny
Order ID: 6892

Inspector: Anthony (Tony) Castoro
License # 16000054820
355 Wilson Avenue, Staten Island, NY 10312
Phone: (718)360-1868
Email: tonyc@abrooklynhomeinspection.com
www.gothamcityhomeinspections.com

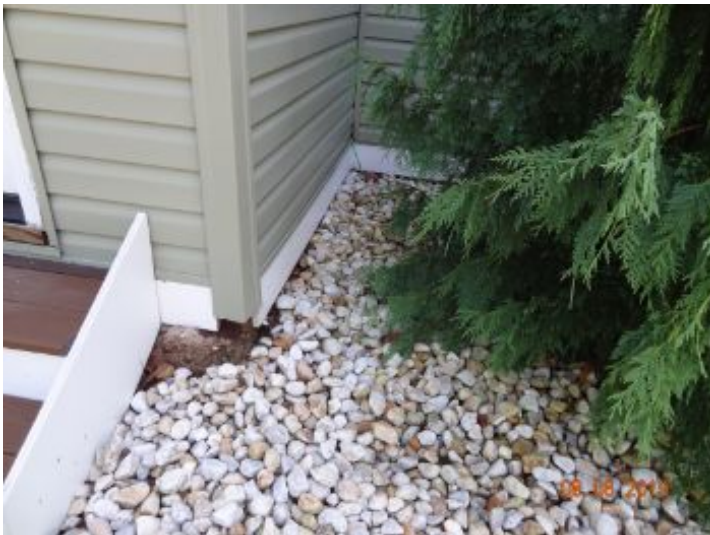
Observations: The vinyl siding is installed to grade level at the perimeter of the front entry of the house. Typically at least 6-8 inches of exposed foundation should be visible. This condition is prone to moisture and insect/termite issues. I cannot determine the conditions of underlying materials

Siding installed to grade at front entry

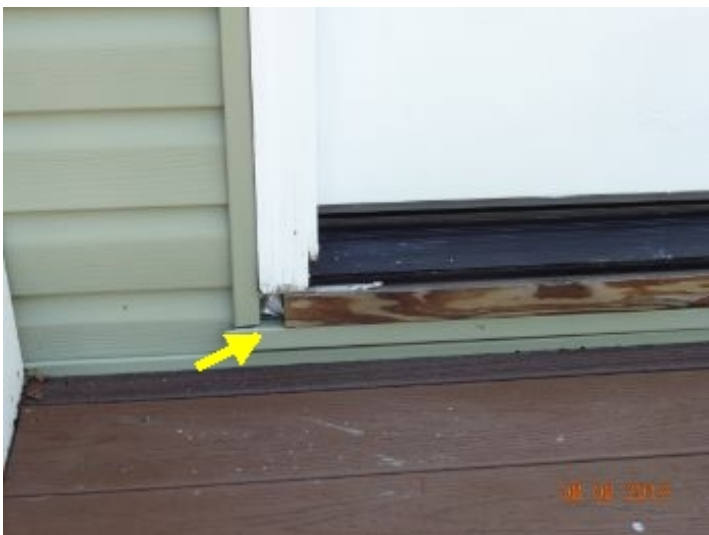
Observations: Two small openings observed below the front entry doorway where water can penetrate to interior structures.

small openings at base of front entry doorway

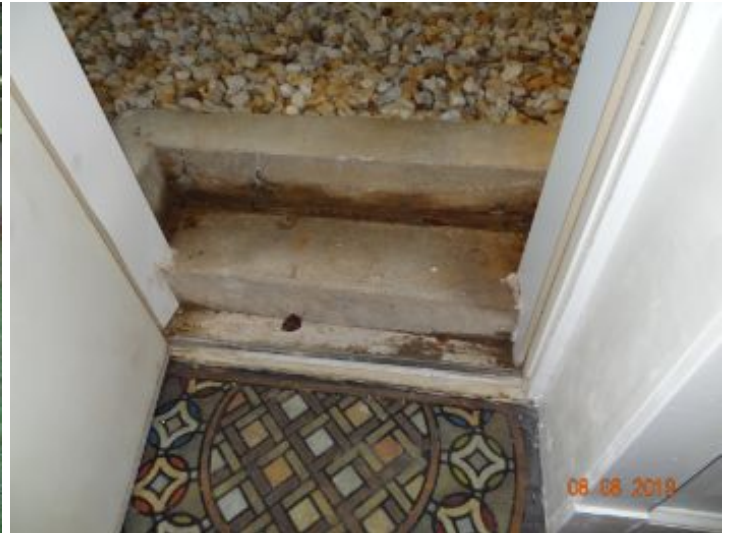
- The floor drain at the rear basement door is irregularly located at the interior side of the door rather than at the exterior, evidence of ponding water and water damage was observed at the base of the door and frame. Some low spots were observed at the grade along the perimeter of the house where soil is sloped toward the foundation walls, water may pond against the foundation walls. Several cracks were noted at the foundation walls.

no floor drain at exterior of rear basement door

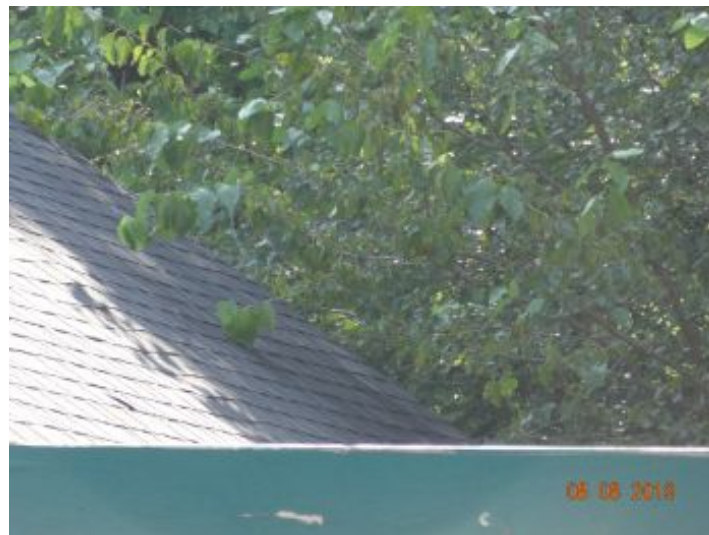
- Tree branches overhanging/contacting House structure at the right side, trim/prune/remove as needed.

tree branches overhanging the roof.

Page 9 Item: 12	Vegetation Affecting Structure	<ul style="list-style-type: none"> Tree branches overhanging/contacting House structure at the right side, trim/prune/remove as needed.

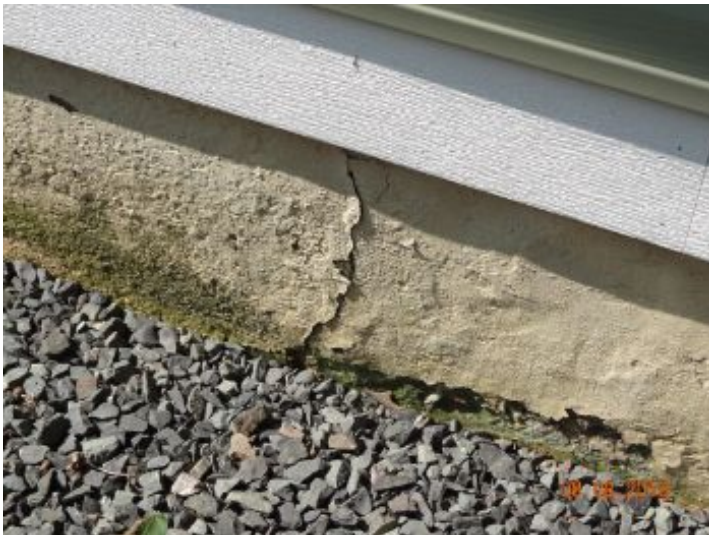
Page 12 Item: 2	Foundation Walls	<ul style="list-style-type: none"> A crack was observed at the left side foundation wall where the extension foundation meets the older foundation, an opening is present where water may penetrate. A low spot at the grade is present that this area will water will pond. Surface deterioration observed at the concrete foundation wall at the left side of the house, at the older section. Repaired cracks noted at left and right side foundation walls. Two unrepaired cracks noted at the right side foundation wall. A low spot is present at grade at one of the cracks at the right side foundation wall where water may pond at the crack An extension has been added to this home, I recommend checking with NYC DOB for permits and approvals for work done to this building.
Page 13 Item: 4	Under Floor Crawlspaces(s)	<ul style="list-style-type: none"> There was no access below the front crawlspace, all structures within were not inspected. There is no means of ventilation in the crawlspace below the front of the house. The inspector could not determine presence of underfloor insulation in the crawlspace due to no access.

- A crack was observed at the left side foundation wall where the extension foundation meets the older foundation, an opening is present where water may penetrate. A low spot at the grade is present that this area will water will pond. Surface deterioration observed at the concrete foundation wall at the left side of the house, at the older section. Repaired cracks noted at left and right side foundation walls. Two unrepaired cracks noted at the right side foundation wall. A low spot is present at grade at one of the cracks at the right side foundation wall where water may pond at the crack
- An extension has been added to this home, I recommend checking with NYC DOB for permits and approvals for work done to this building.

crack at left side foundation wall.

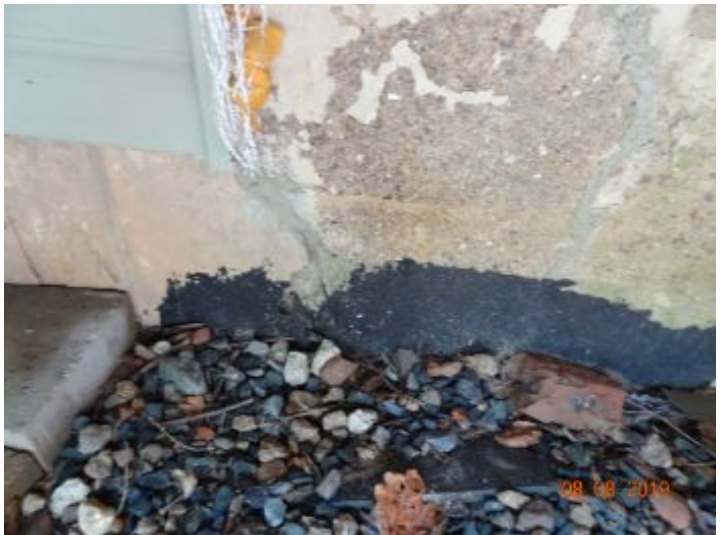
opening at base of foundation wall between new and old foundation walls/low spot at grade

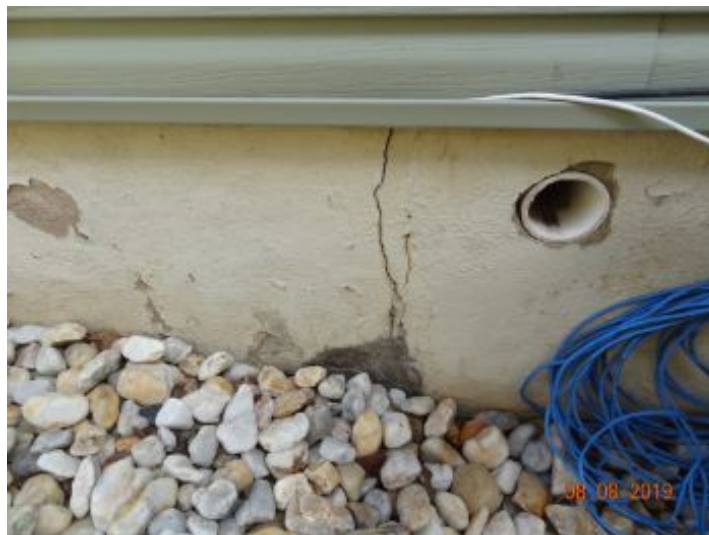
crack at right side foundation wall.

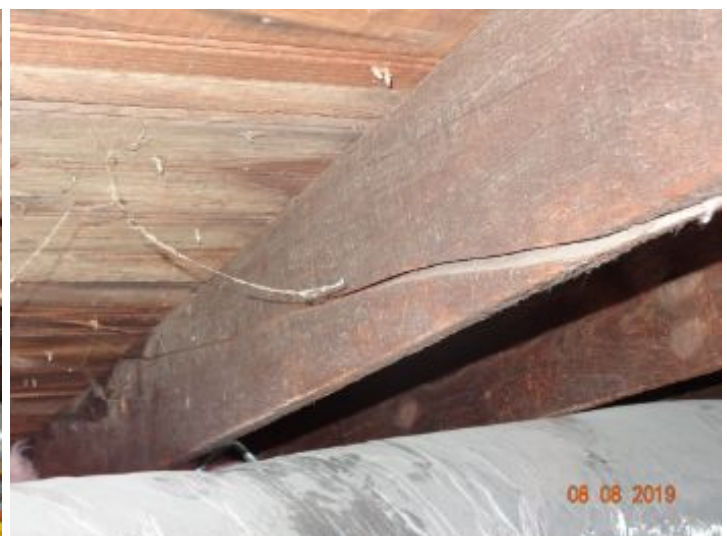
Page 13 Item: 8	Ceiling, Roof Structure	<ul style="list-style-type: none"> One cracked rafter and one damage rafter observed at the left side of the roof structure. FYI: Roof rafters have been reduced in size from 2 x 6 to 2 x 4 at the rear section of the attic.

- Limited review of roof structure due to vaulted ceilings at the extension. Limited review of ceiling structure do refinishing materials.
- One cracked rafter and one damage rafter observed at the left side of the roof structure.
- FYI: Roof rafters have been reduced in size from 2 x 6 to 2 x 4 at the rear section of the attic.

cracked rafter

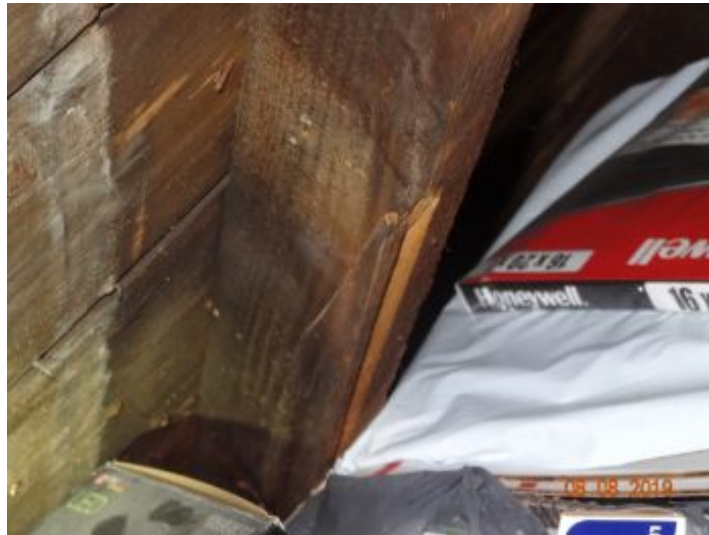
damaged rafter

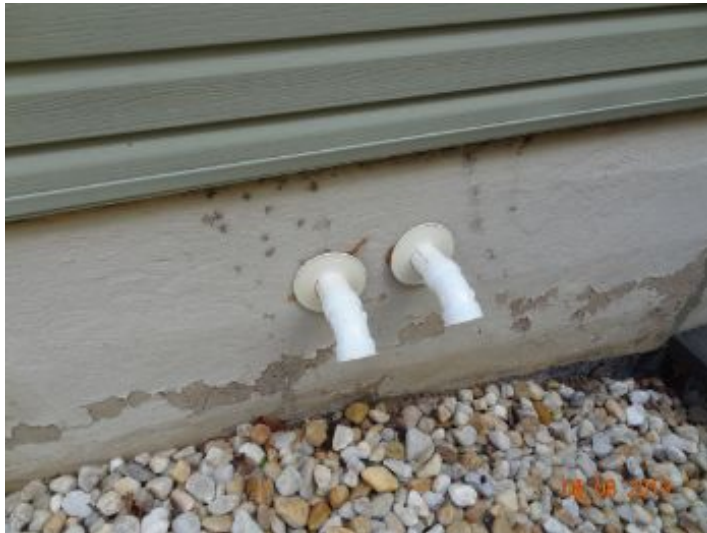
- The visible portions of the flue pipe are functional.
- FYI: The boiler's PVC direct vents may get covered in a heavy snow, recommend keeping this area clear in heavy snow.

tankless boiler direct vents

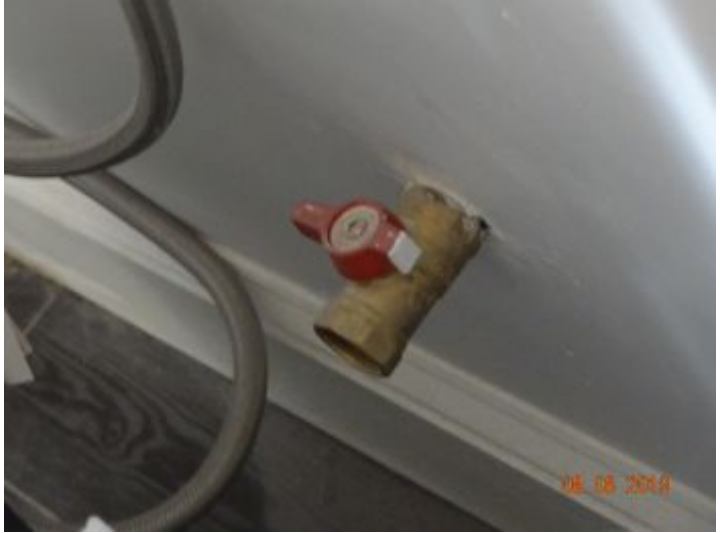
- SAFETY: Un-capped gas piping observed at behind the washer/dryer area in the basement.

uncapped gas pipe

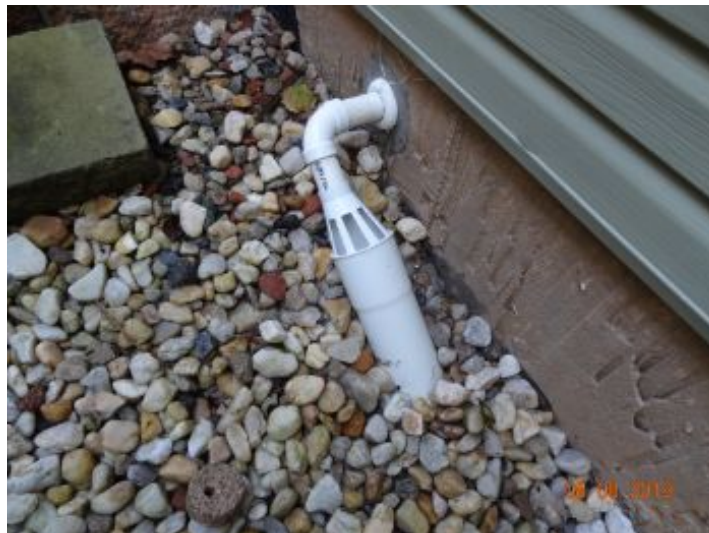
- A PVC pipe was observed at the right side exterior that penetrates the foundation wall and is routed into the soil. A sump pump may be present but was not visible at the interior. I recommend asking the seller for further information.

unknown pipe penetrating foundation wall/possible sump pump

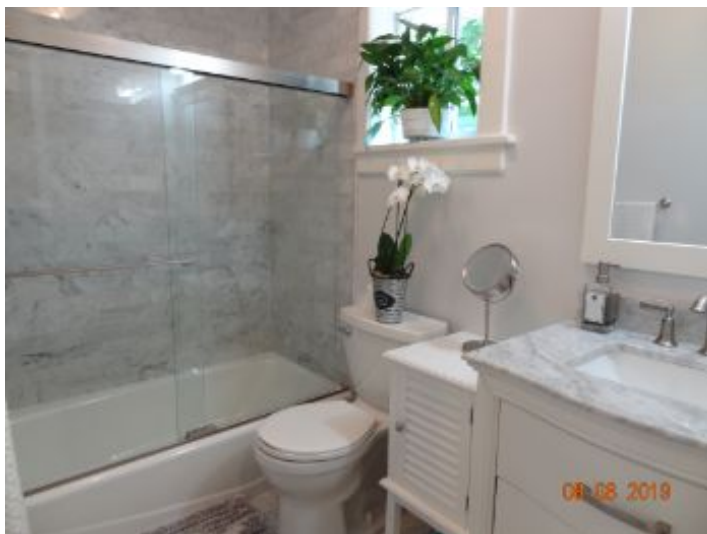
Bathroom .

Page 24 Item: 1	Tub(s)	• The bathtub drain stopper does not function. cracked grout noted at one wall corner at the bathtub enclosure, recommend caulk.
-----------------	--------	--

- Functional at time of inspection.
- The bathtub drain stopper does not function. cracked grout noted at one wall corner at the bathtub enclosure, recommend caulk.

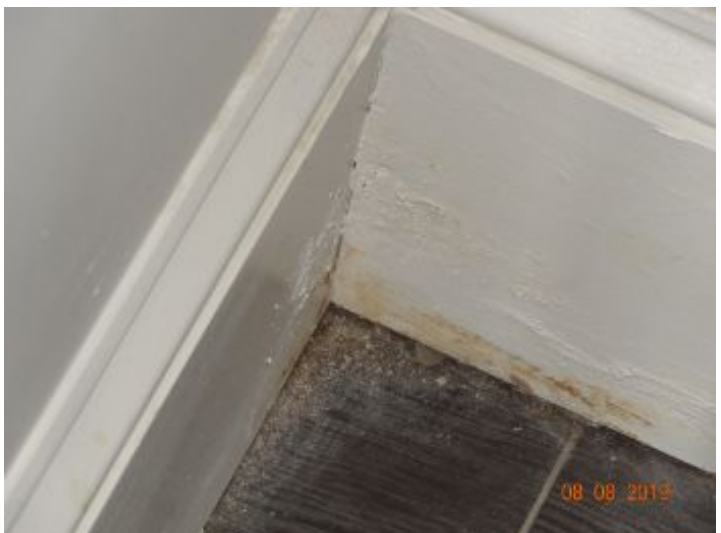
Page 25 Item: 2	Wall and Ceiling Finishes	• A small water stain was observed at the base trim at the bottom of the wall next to the washing machine, possible water penetration from the exterior or other issue present.
Page 26 Item: 6	Stairways, Steps, Railings	• No handrail present at the basement stairway, a narrow stairway is present.
Page 26 Item: 8	Cabinets, Vanities	One drawer in the kitchen contacts the stove handle and only opens partially.

- General conditions of the walls and ceilings appeared satisfactory, except where noted.
- A small water stain was observed at the base trim at the bottom of the wall next to the washing machine, possible water penetration from the exterior or other issue present.

Water stain at base trim behind washing machine

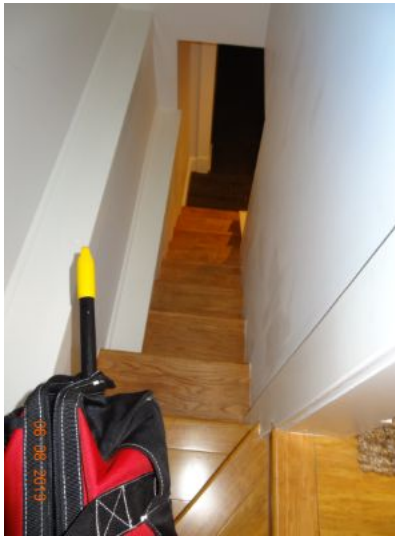
- No handrail present at the basement stairway, a narrow stairway is present.

no handrail

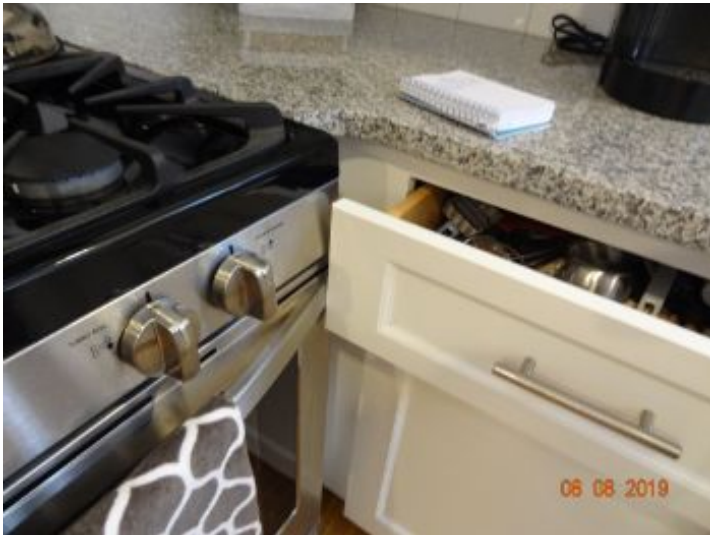
Observations: One drawer in the kitchen contacts the stove handle and only opens partially.

drawer contacts stove handle
