Home Inspection Report

123 Brick Rd
Sample, IL 12345

Inspected By: Erich Rohloff IL License
450.011661 Expires 11/30/2026

Brick by Brick Inspections Inc.
(708) 261-4467
brickbybrickinspections.com

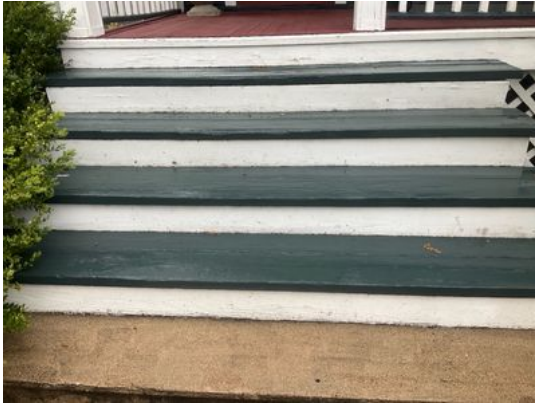
Comment 3

Older peeling paint noted on the entryway steps. Recommend scraping and painting the staircase.

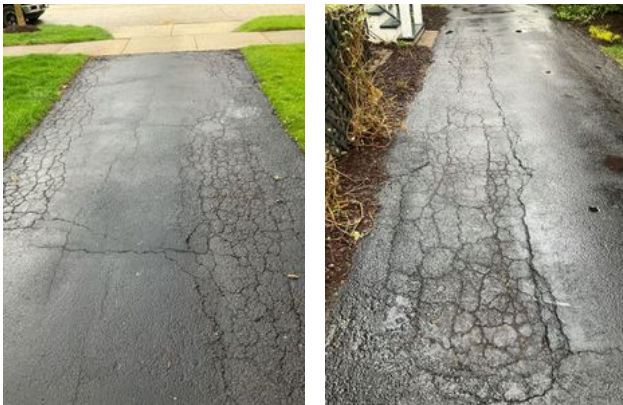
Comment 4

Cracking noted in the asphalt driveway. Recommend keeping the driveway sealed to prevent further deterioration of the driveway. The driveway will require patching and repairs in the next few years.

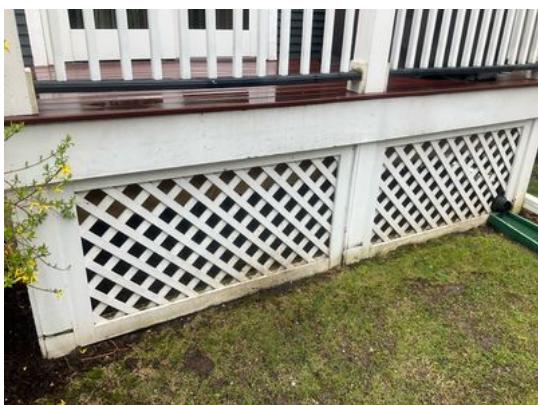
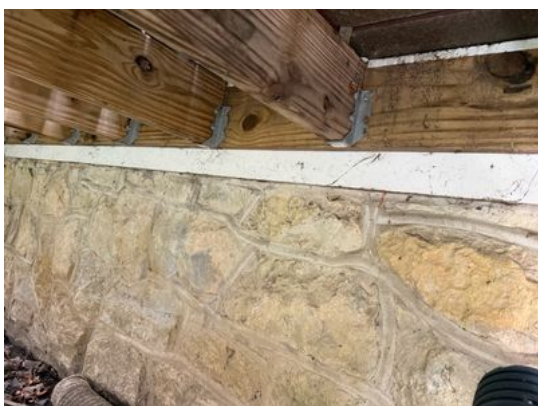
Comment 8

The supporting post on the rear deck are set slightly below grade. This can allow for the wood posts to slowly deteriorate, causing settlement of the deck.

The ledger board is not bolted to the homes exterior but appears to be nailed. The supporting board should be bolted it the homes exterior. Recommend monitor for movement or settlement of the deck. Future repairs should be made by a licensed contractor.

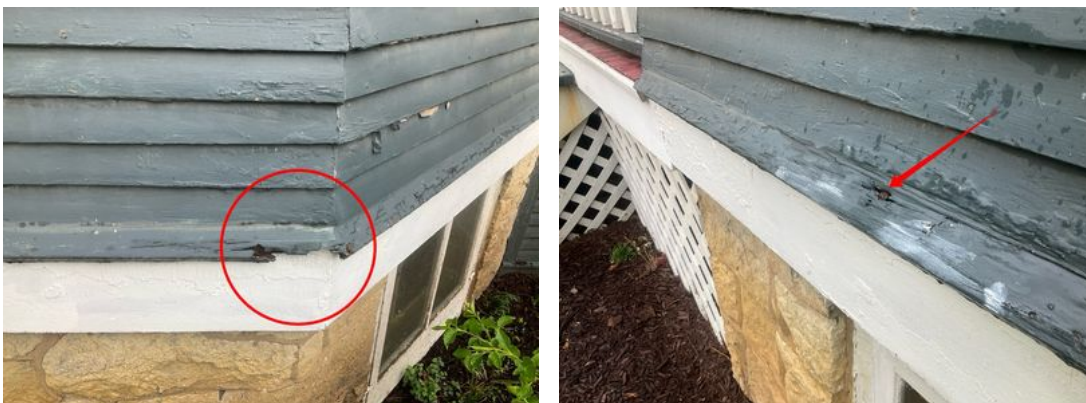
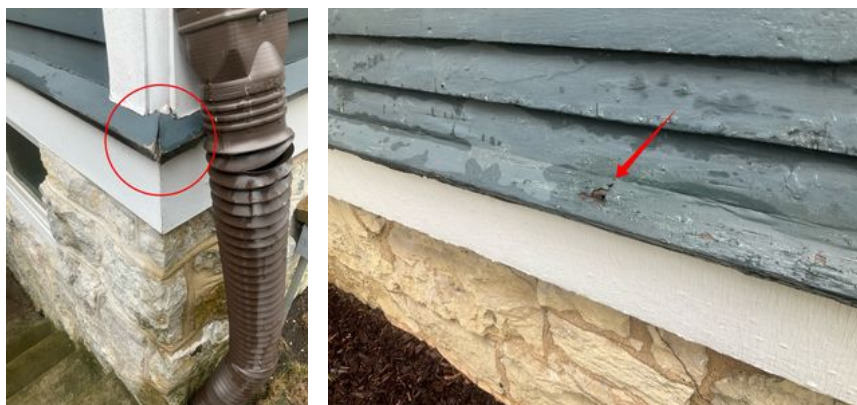
Comment 11

The kick out trim at the base of the homes wood exterior is deteriorating in several areas around the home. The deteriorating wood should be repaired or replaced. The corners of the newer section of the home have separated and should be sealed and repaired. Recommend repair by a licensed contractor or qualified painter.

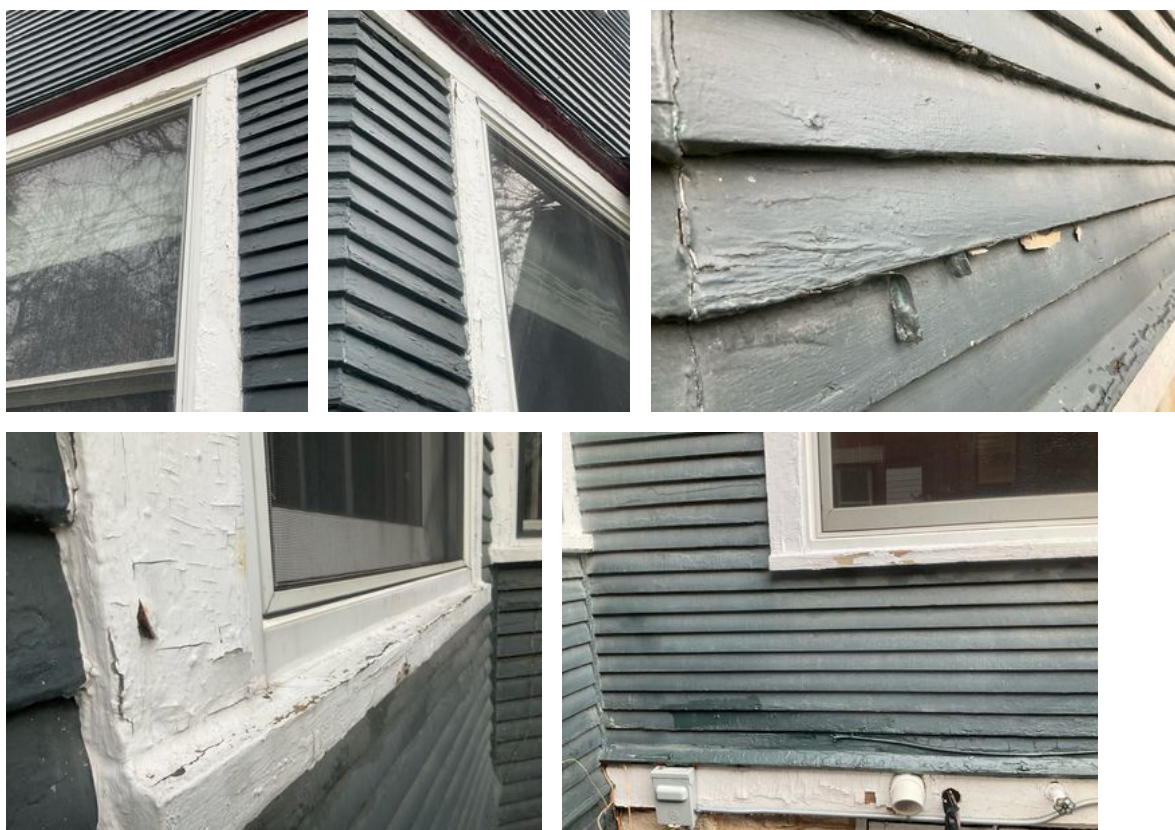
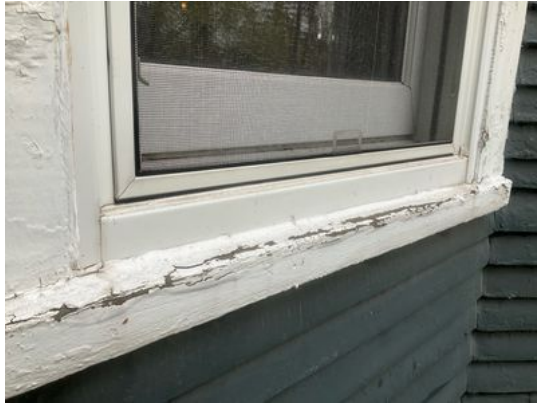
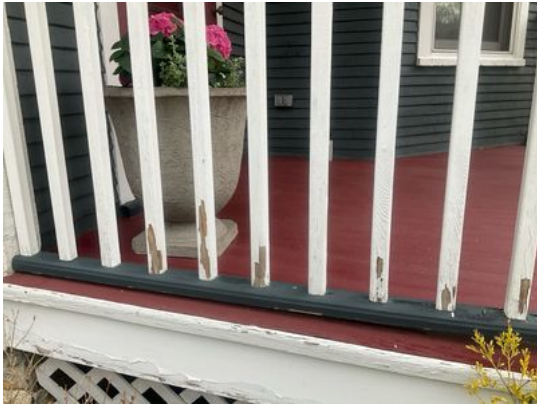
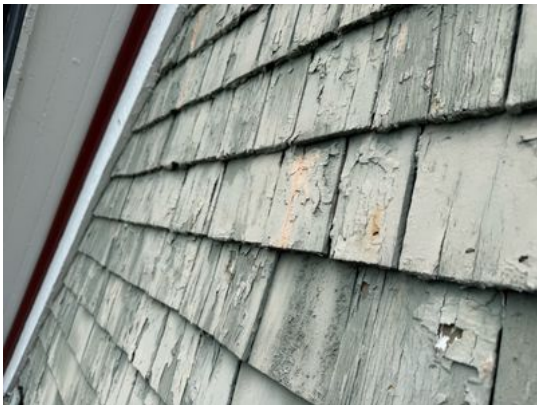
Comment 12

Peeling paint noted along the home exterior wood siding, trim, and railings. Multiple layers of paint over the original sections of the house. It is recommended that a professional painter further evaluate and make recommendations for painting the home exterior.

Continued moisture exposure to the exterior wood siding and trim can begin to cause deterioration of the wood. It is recommended that the exterior be repaired and painted in the near future.

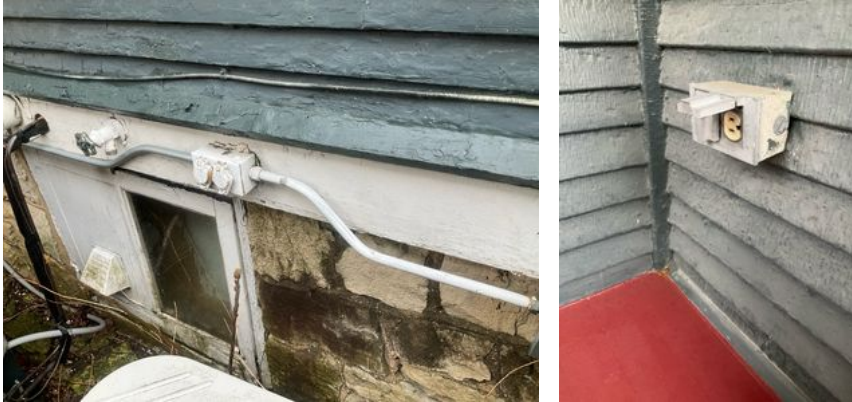
Comment 13

Recommend installing GFCI outlets in outdoor or wet areas. Recommend replacement of the 2 exterior outlets with GFCI protected outlets.

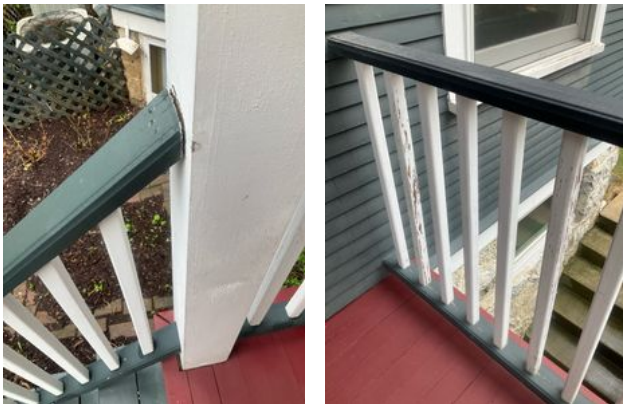
Comment 14

The railing is coming loose along the side entry staircase. The railing and balusters have loose or peeling paint. Recommend securing the railing and scraping and painting the railing and balusters.

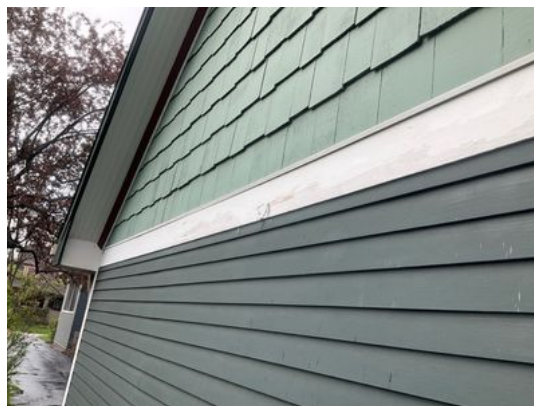
Comment 16
Information

Peeling paint noted around the garage is wood trim, and door casings. Recommend repairing any damaged or deteriorated wood and repainting the wood exterior trim.

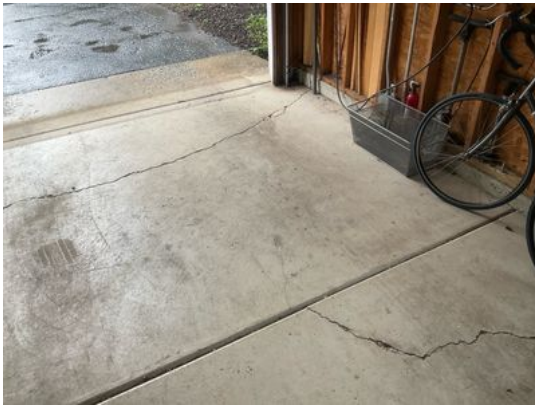
Comment 17
Information

Cracking noted in the garage floor. Concrete cracking is normal but should be monitored. If the floor begins to heave upward or the cracks continue to expand a licensed concrete contractor should be consulted.

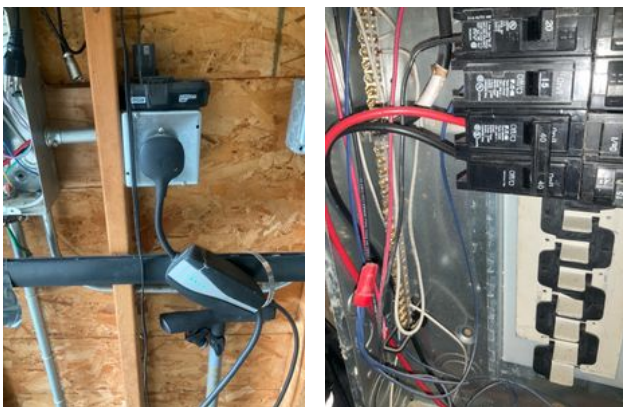
Comment 18
Deficiency

The car charger located in the garage appears to be connected to the 240 V 40 amp breaker located inside the main electrical service panel.

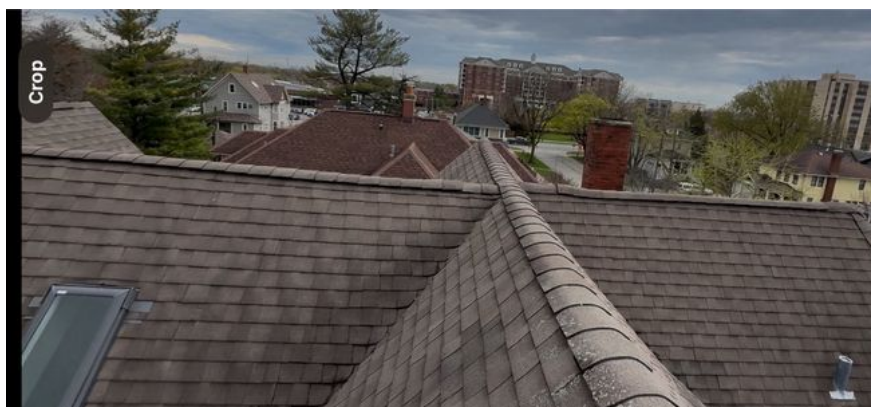
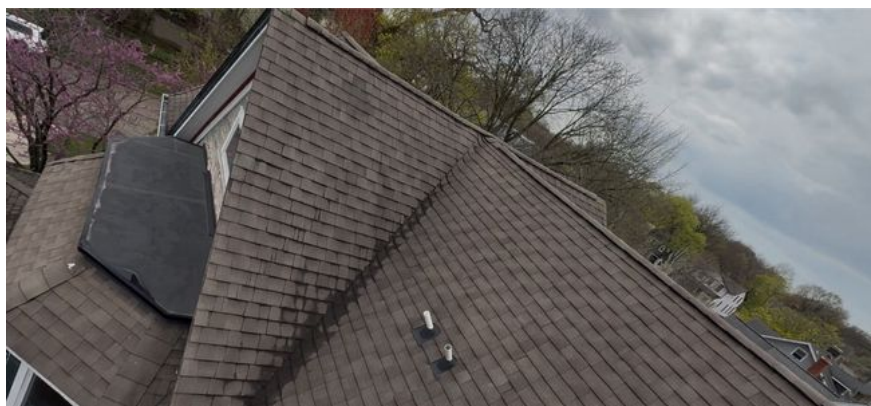
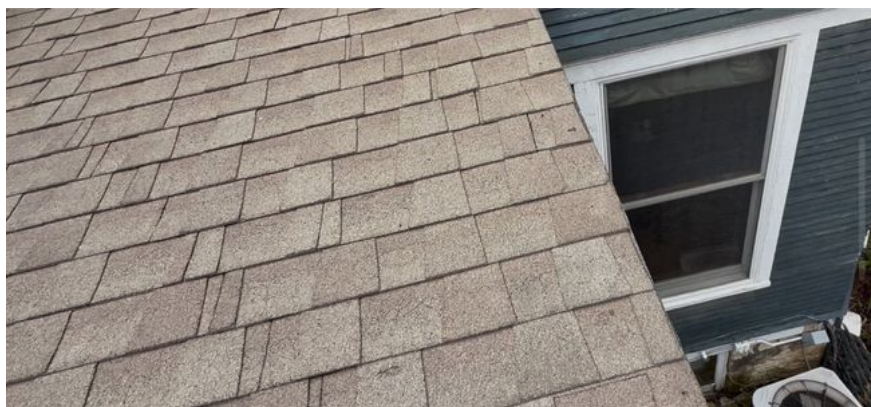
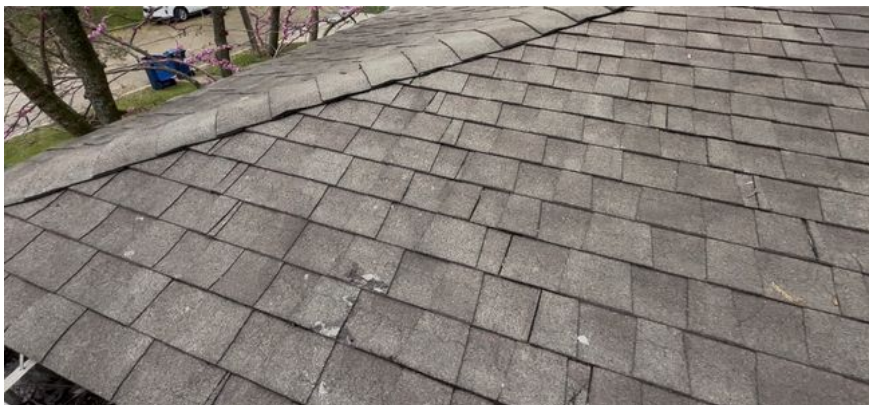
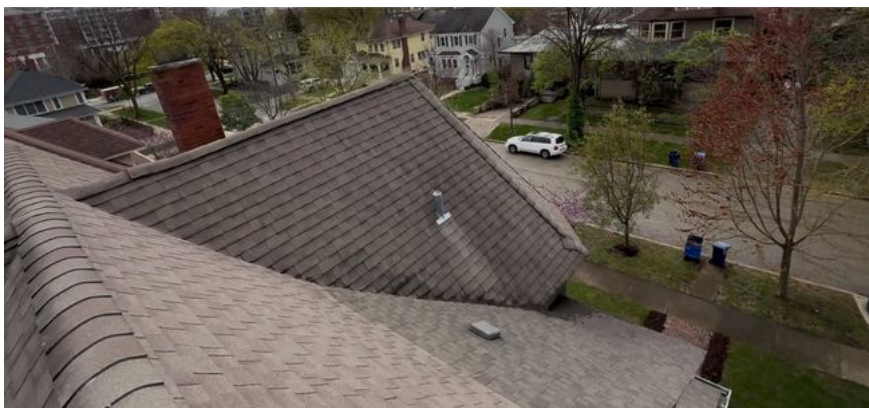
Comment 28

The roof is estimated to be between 15 and 20 years old. It appears that portions of the roof have been previously repaired. Some damage noted on the lower sections of the roof along the first floor entryway, this may shorten the service life of the roofing shingles. The edges of the shingles are damaged along the lowest course of each roommate, roofing section.

Some defects noted in the inspection report. It is recommended that a licensed roofing contractor make repairs and evaluate the remaining service life of the roof.

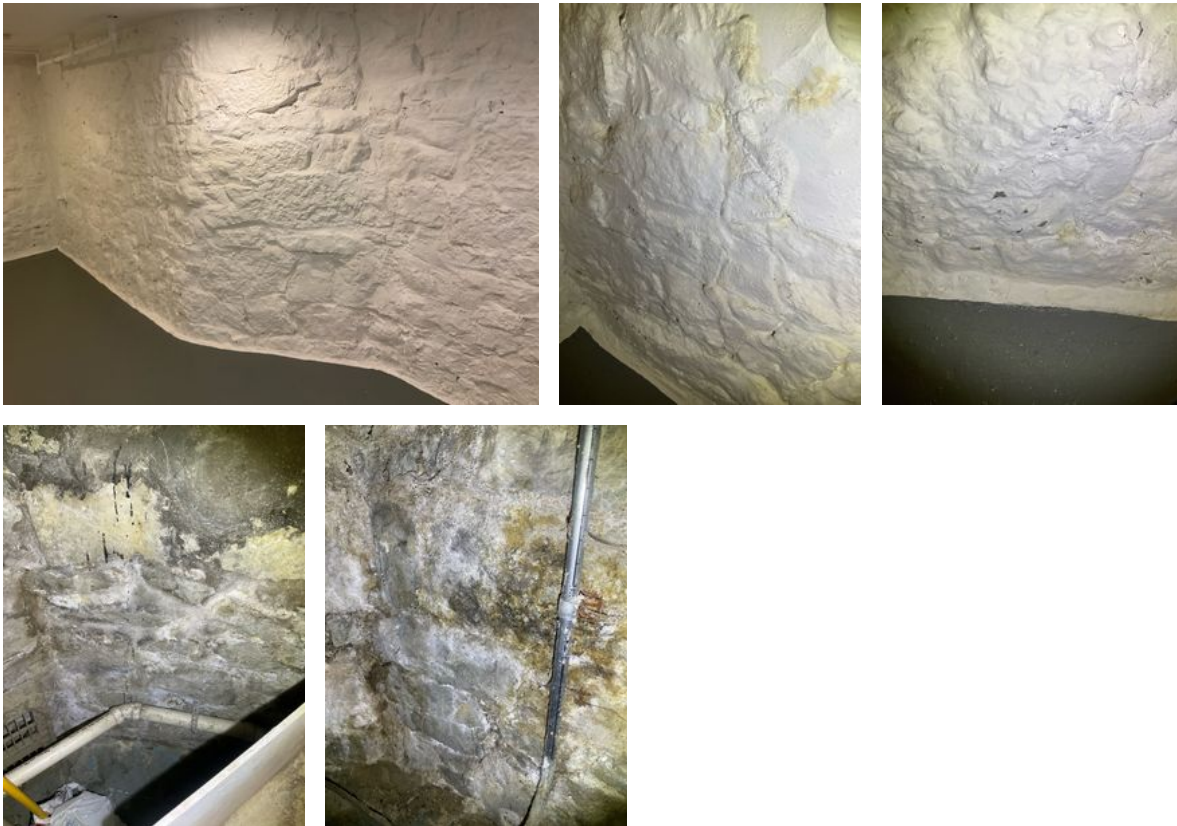
Comment 33

The homes primary foundation is stone. Stone foundations are prone to allowing moisture penetration which is evident from staining and efflorescence (white powdery substance). Recommend monitoring the exposed foundation walls for signs of loose or missing mortar which should be repaired. Recommend monitoring the exterior for any moisture pooling along the homes foundation, this can lead to seepage. Recommend keeping all drainage running away from the home to prevent moisture seepage.

Minor seepage noted along the front wall of the home near the main water shut off valve.

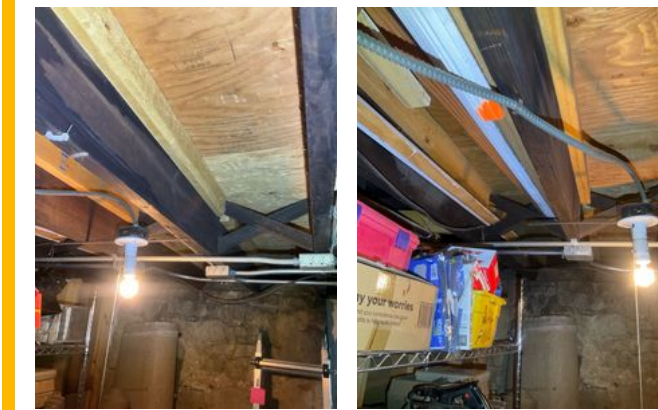
Areas of the flooring structure below the dining room have been previously repaired and the floor leveled. This is common in older homes, the nailing pattern on the installed 2 x 4 supporting joist appears to be sufficient. Recommend requesting any building permits or inspection reports from previous construction from the current owner.

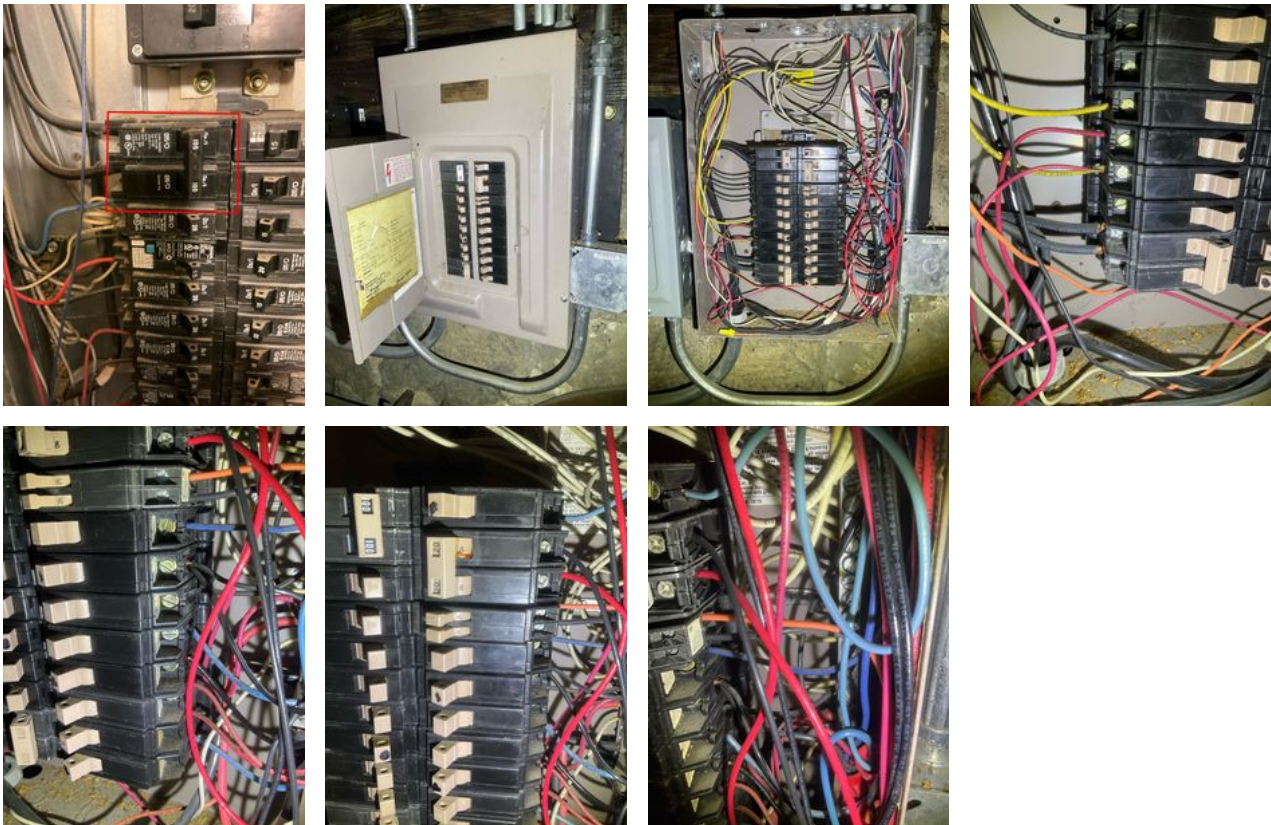
Comment 43

Recommend repair of the double taps and evaluation of the double breaker by a licensed electrician. The service panel may require an upgrade.

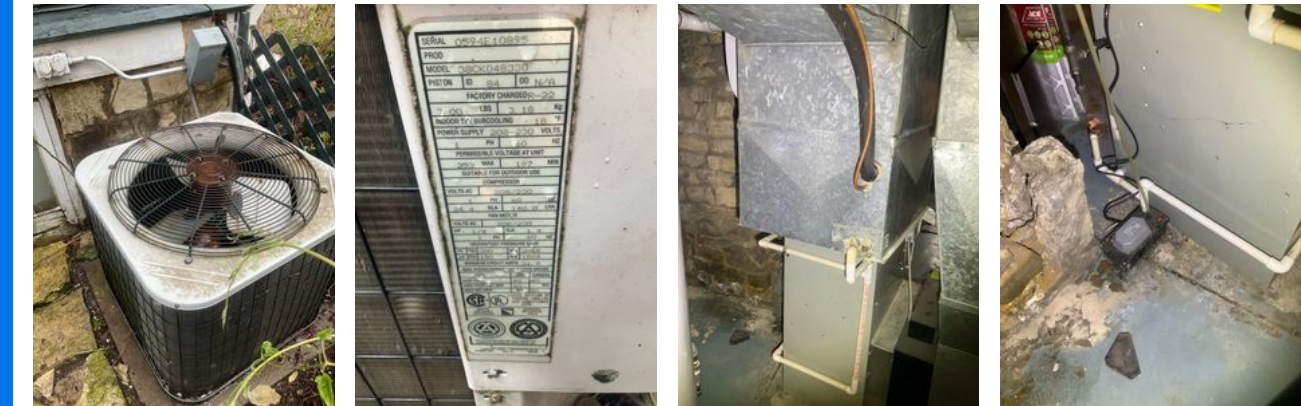
Comment 47

The system uses R-22 refrigerant which has been phased out and has limited availability. The cost of the refrigerant is high and replacement of the AC condenser and coil may be more cost effective than recharging the unit every few years.

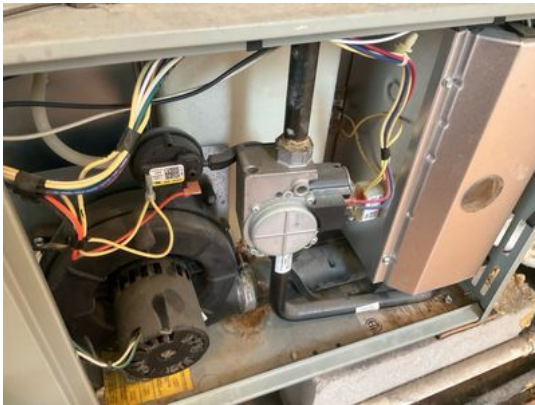
The furnace is dirty on the interior. Recommend having the furnace cleaned and serviced by a professional HVAC technician.

Furnaces over 10 years old should be checked, cleaned and serviced yearly by a licensed contractor.

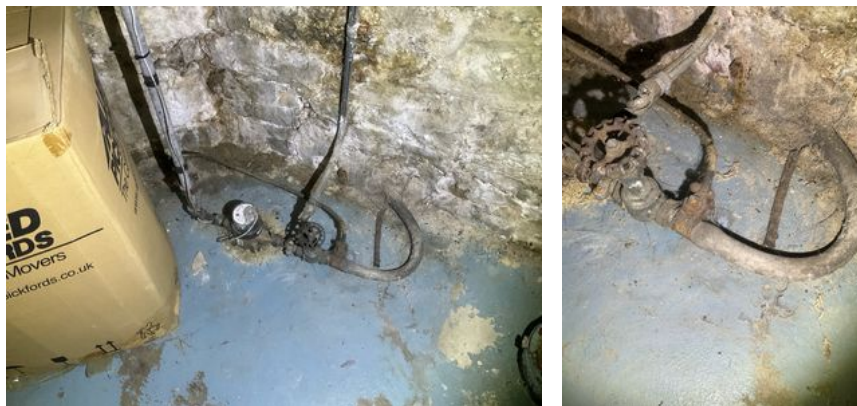
Comment 57 Information

The water supply line entering the home from outside appears to be made of lead. These pipes are common in the area and sometimes cause elevated levels of lead contamination in water levels. If levels test high the pipe can be coated, replaced or a filtration system put in place to remove contaminants. Recommend testing the water quality for lead content.

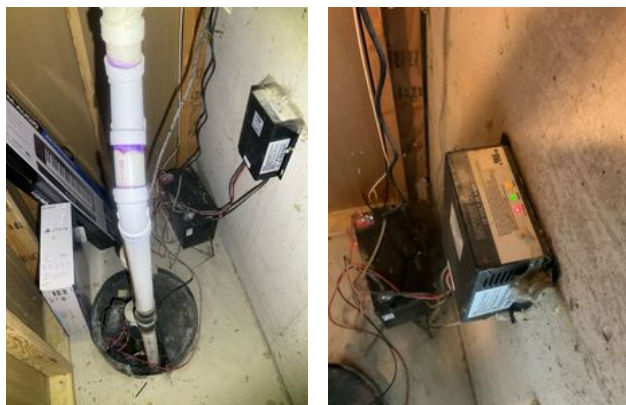
Sump pump with battery back up system located in the basement and ejecting along the rear of the home. Sump pump is most likely connected to a perimeter drain along the interior of the finished basement area. The full extent of the drainage system could not be determined. Recommend consulting a plumber or contractor specializing in waterproofing to determine full extent of the drainage system.

Recommend checking the battery back up system monthly to make sure the batteries are charging.

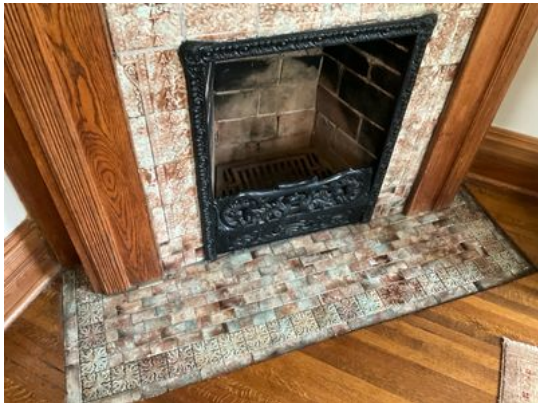
Comment 62

Tiles along the hearth along the floor appear to be loose. Recommend mo, the tiles may need to be re secured.

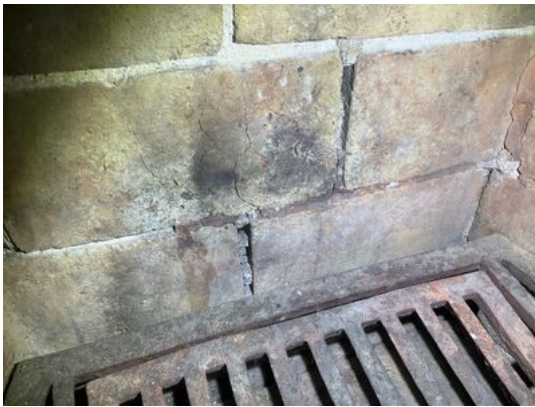
The full condition of the chimney flue is not available, the entire chimney was not visible during the inspection. Further evaluation of the chimney by a professional chimney contractor or chimney sweep can determine the condition of the chimney flue.

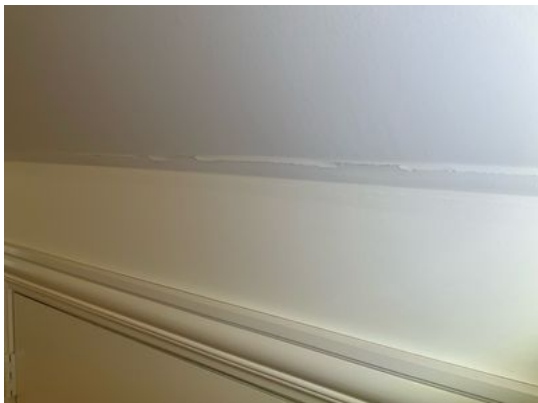
Comment 69
Deficiency

Drywall tape separating/cracking, this is common and can be repaired.

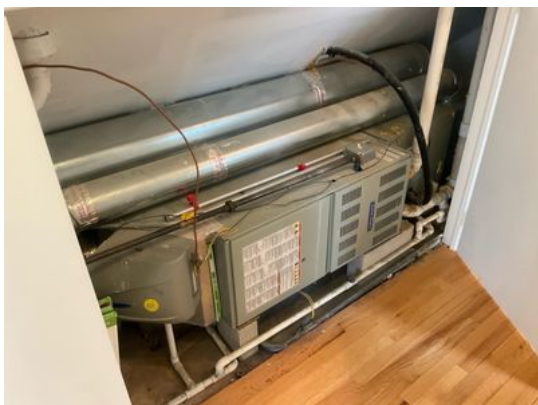
Furnace is located in a closet for a room that is correctly used as a bedroom. It is not recommended that a furnace pull its combustion air from a bedroom or be placed in a bedroom due to a fire hazard and the potential for toxic fumes to emit from the furnace.

Recommend further evaluation and repair by a licensed contractor.

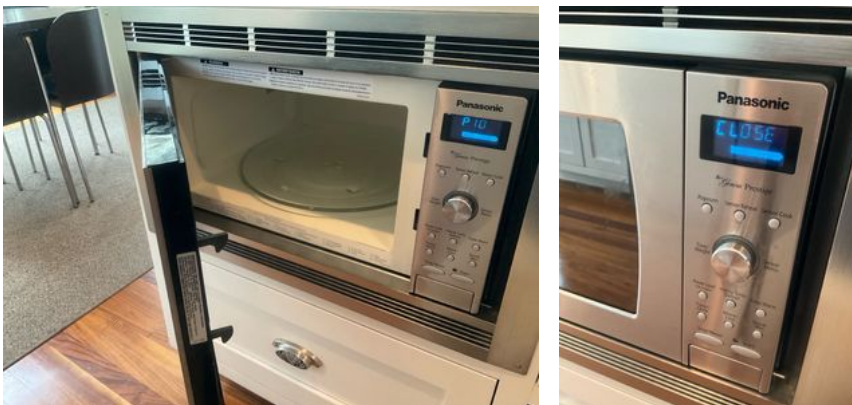
Comment 76

The microwave door sticks when opening. The microwave won't run as it is showing an error that the door is not closed. Recommend repair or replacement of the microwave.

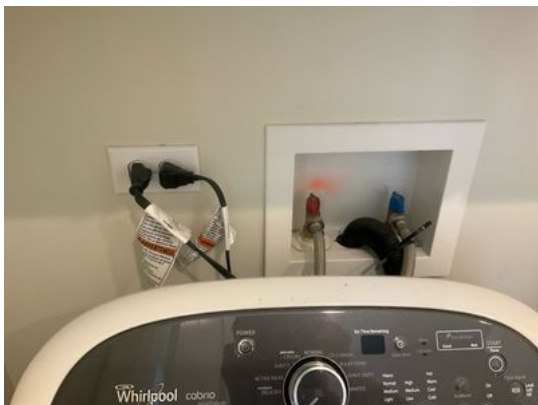
Comment 100

Non GFCI protected outlets in laundry room. Recommend adding GFCI outlets within 6' of any water source.

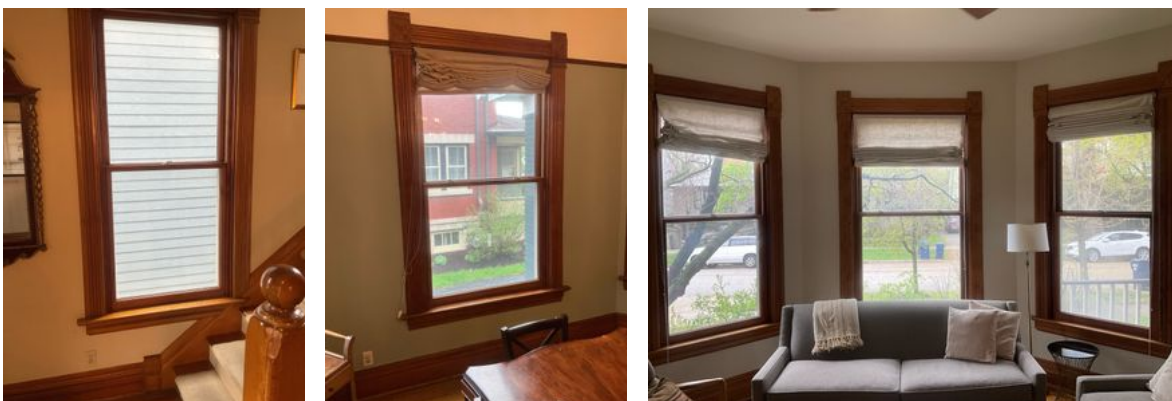
Entryway, Living Room & Dining Room

The lower window sashes in the entryway, living room (3 windows) and the dining room do not stay open and fall closed. The window must be propped open. Recommend repair by a licensed contractor.

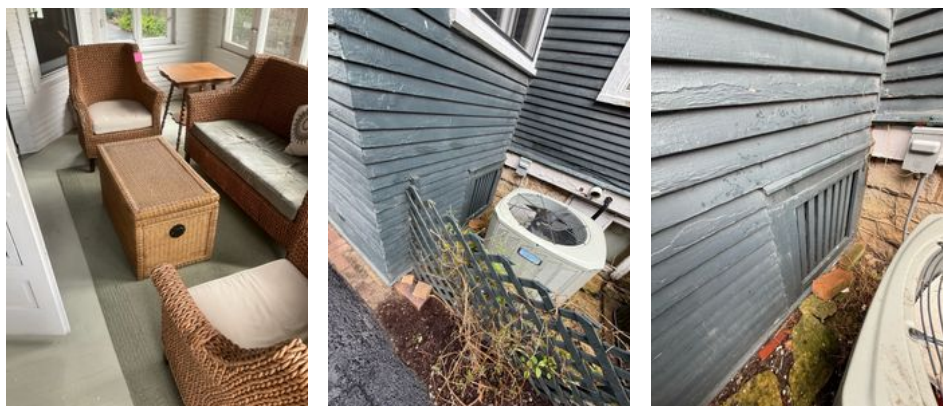
Porch

Movement noted in the enclosed porches flooring. The crawlspace under the porch was not fully accessible, the hatch was painted shut and not accessible. The flooring structure may require repairs. Recommend further evaluation by a licensed contractor.

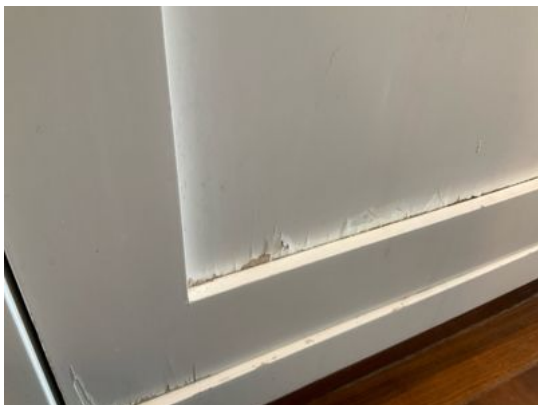
Kitchen & Sitting Area

Small areas of loose and peeling paint noted across the kitchen cabinets.

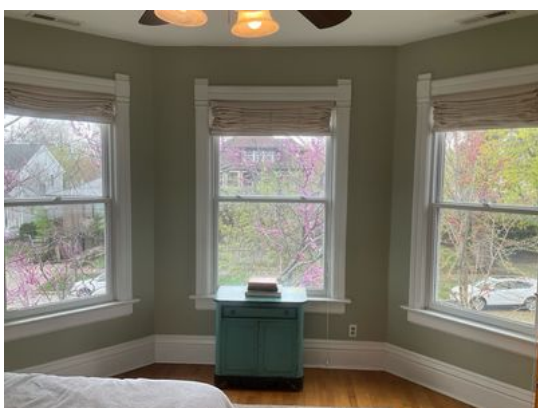
Bedrooms: Bedroom #2 (Front En-suite)

The lower window sashes (3) do not stay open and fall closed. The windows must be propped open. Recommend repair by a licensed contractor.

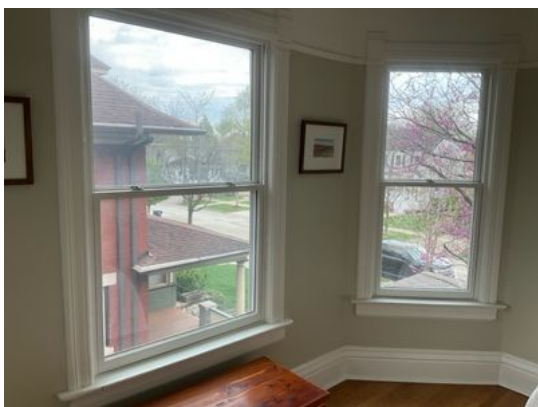
Bedrooms: Bedroom #3

The lower window sashes (2) do not stay open and fall closed. The windows must be propped open. Recommend repair by a licensed contractor.
