# INSPECTION REPORT

For the Property at:  
**202 SAMARITAN AVENUE**  
ASHLAND, OH 44805

Inspection Date: Wednesday, November 27, 2024

RE: Report No. 3858  
202 Samaritan Avenue  
Ashland, OH  
44805

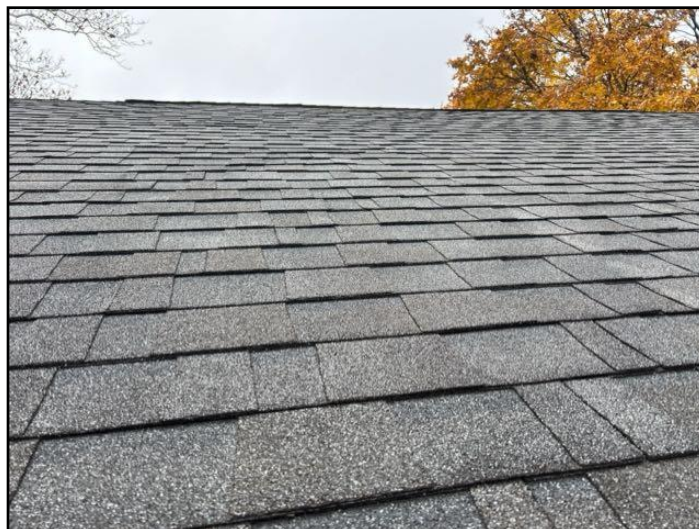
**1. Condition:** • The roof appeared to be in good condition at the time of inspection.

1. The roof appeared to be in good condition a...

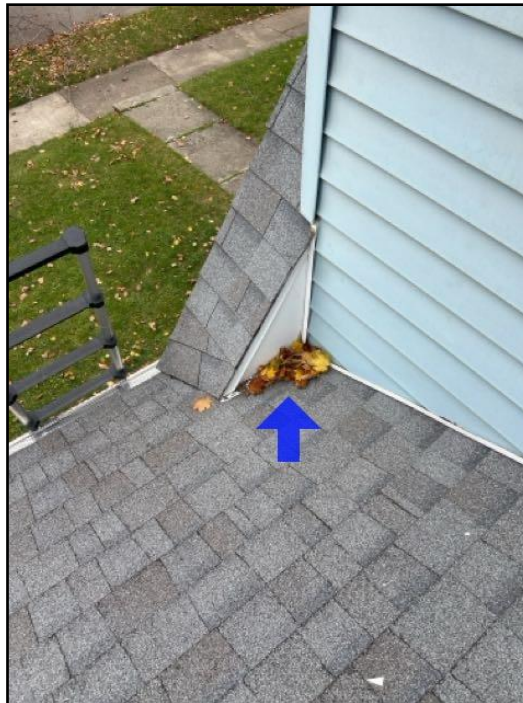
2.

**2. Condition:** • Vulnerable area for water ponding. Install flashing diversion as needed.

**Location:** Right Front

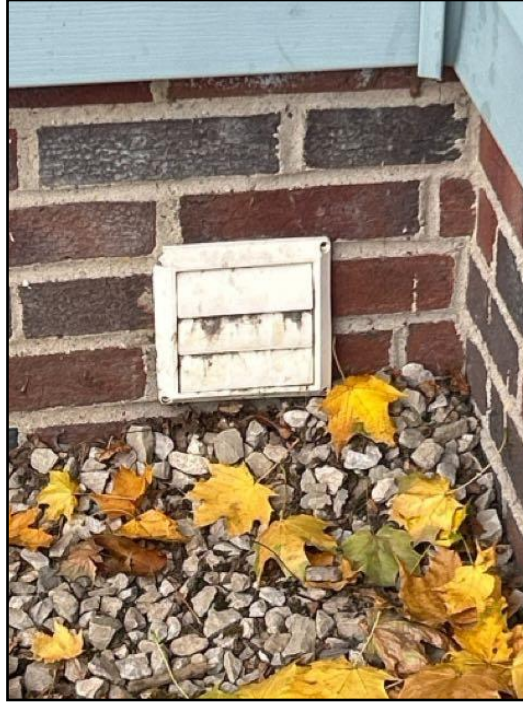
**4. Condition:** • Vent close to grade. This could easily be covered by snow in the winter months. Relocate if desired.

**Location:** Rear

*3. Vent close to grade. This could easily be...*

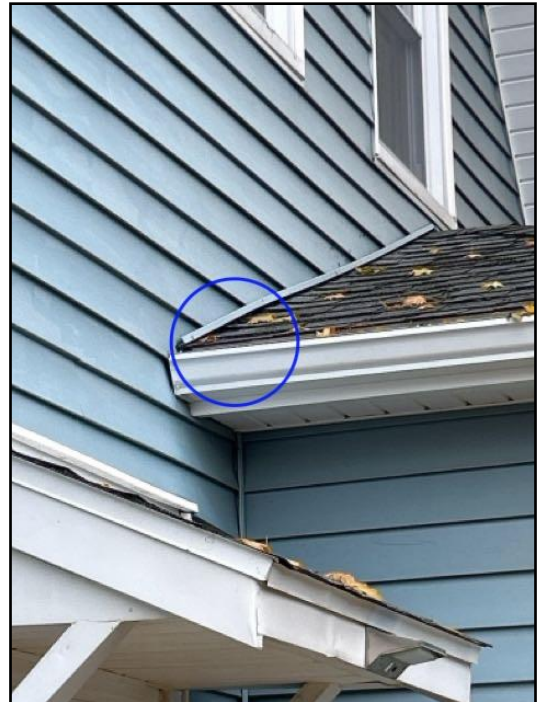
**6. Condition:** • Monitor for overflowing water and install splash guards as needed

5. Monitor for overflowing water and install...

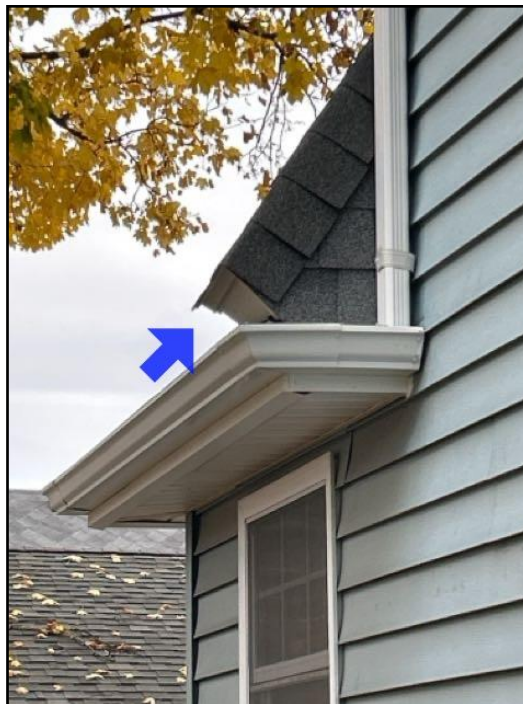
6.

**7. Condition:** • No gutter system at the left rear. Water likely overflows at this area.

**Task:** Repair as needed

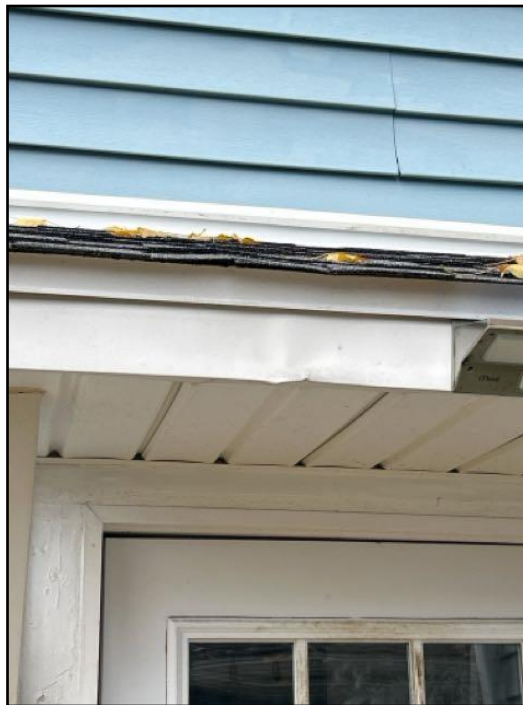
11.

10. **Condition:** • Dents/damage

**Location:** Rear

**Task:** Repair as desired

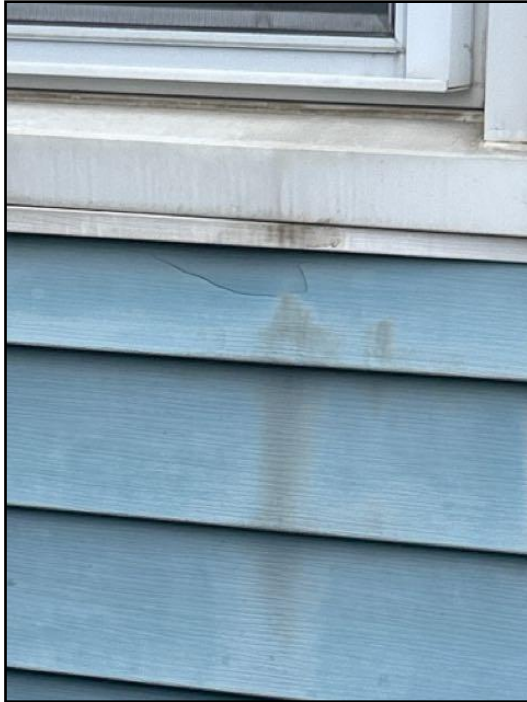
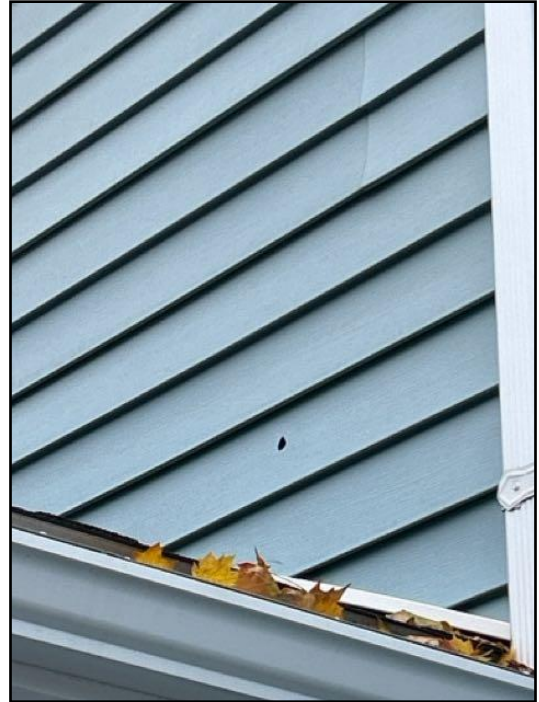
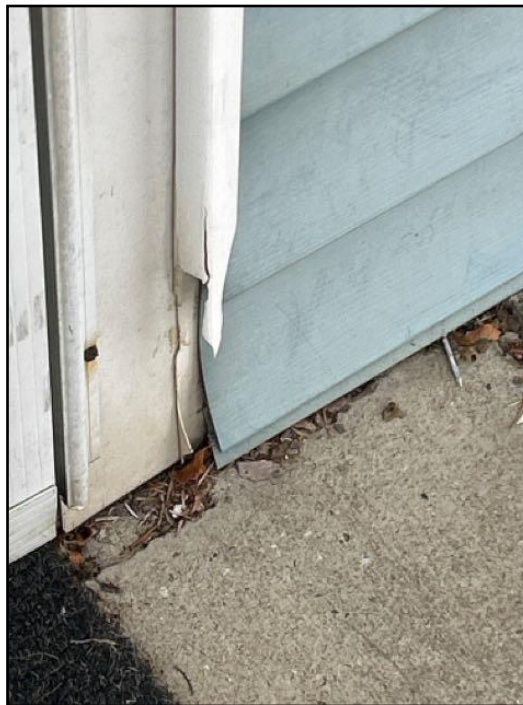
**12. Condition:** • Typical mechanical damage noted in areas. Repair or replace sections as needed.

12. Typical mechanical damage noted in areas....

13. Typical mechanical damage noted in areas....

14. Typical mechanical damage noted in areas....

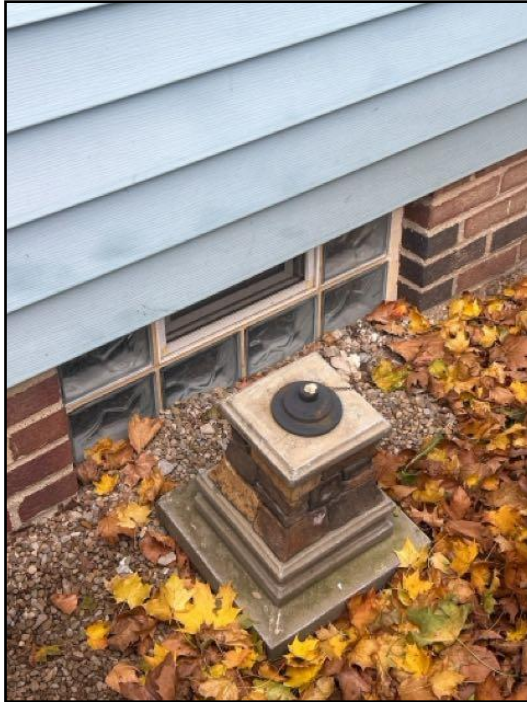
**13. Condition:** • Too close to grade. This is a vulnerable area for water intrusion. Re-grade.

**Location:** Rear and Left Side

**15.** Too close to grade. This is a vulnerable...

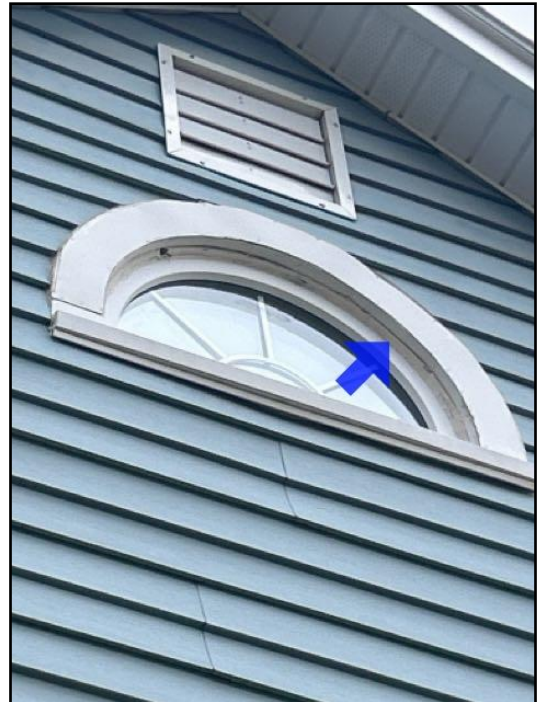
**14. Condition:** • Paint and caulking needed on window(s).

18. Paint and caulking needed on window(s).

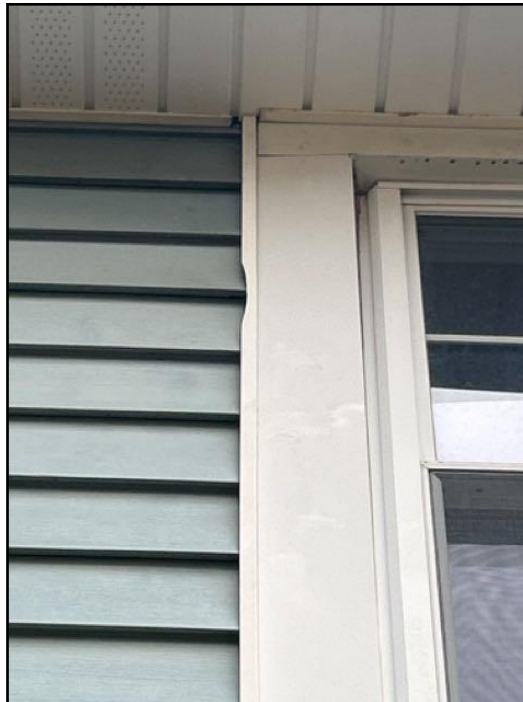
19.

15. **Condition:** • Minor damage

**Location:** Left Rear

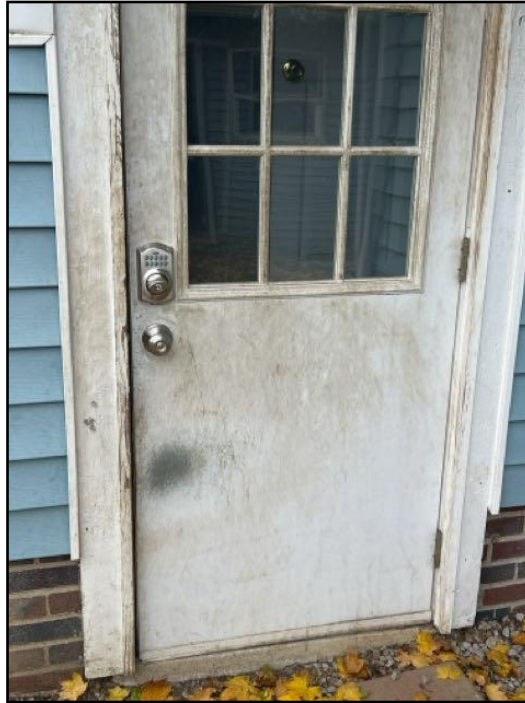
**17. Condition:** • Paint needed on exterior door trim. Paint to prevent damage from rain and pests.

Animal damage on door and trim

**Location:** Rear

**20.** Paint needed on exterior door trim. Paint t...

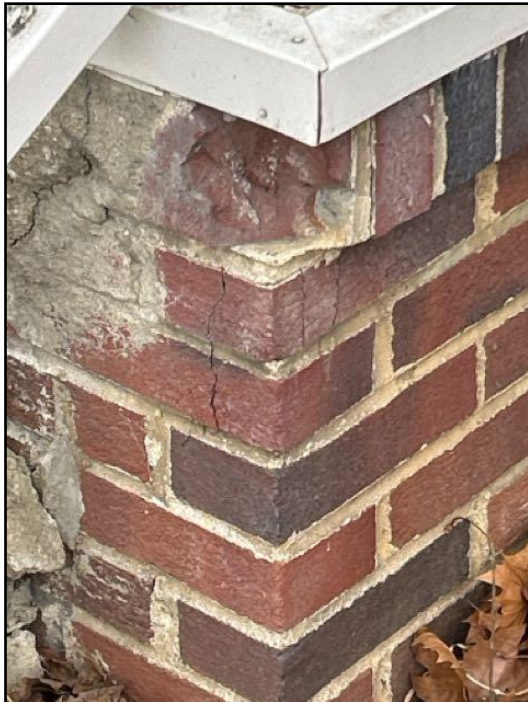
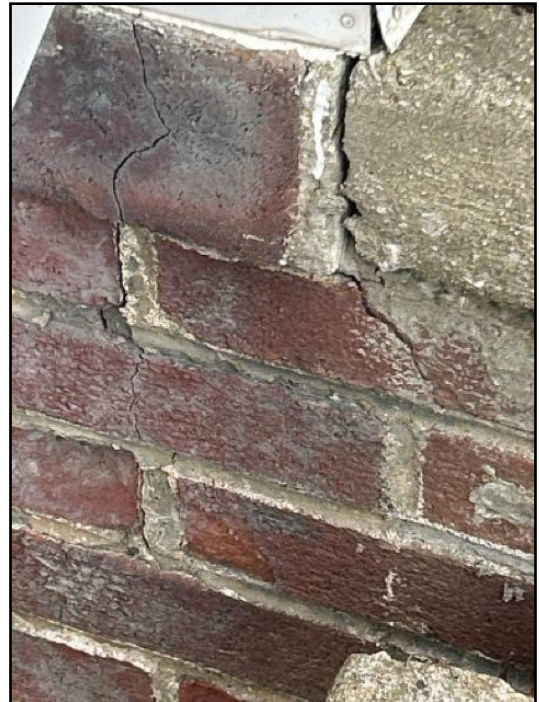
**18. Condition:** • Damaged/cracked

21. Damaged/cracked

22. Damaged/cracked

**Task:** Repair

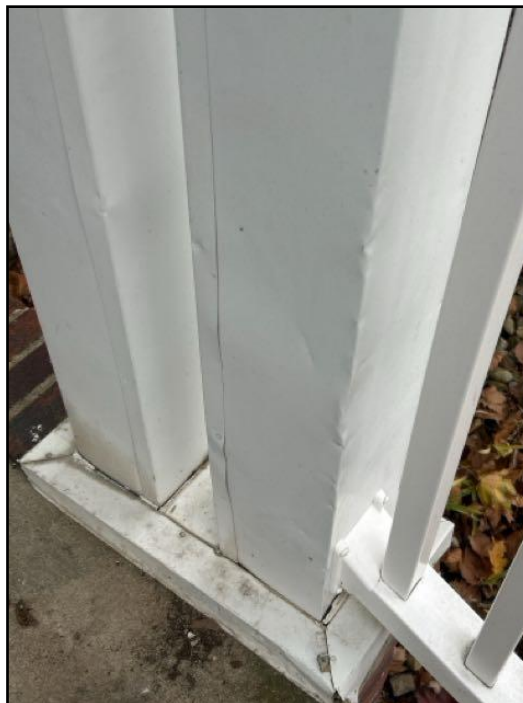
23.

19. Condition: • Typical mechanical damage. Repair as needed.

Location: Front Porche

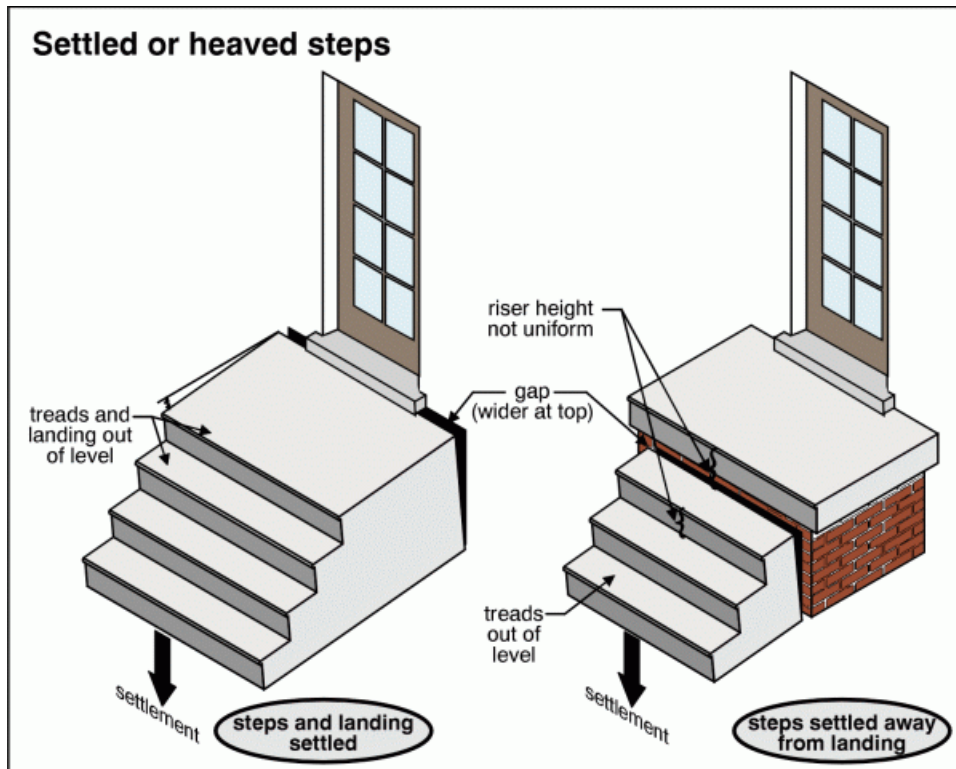
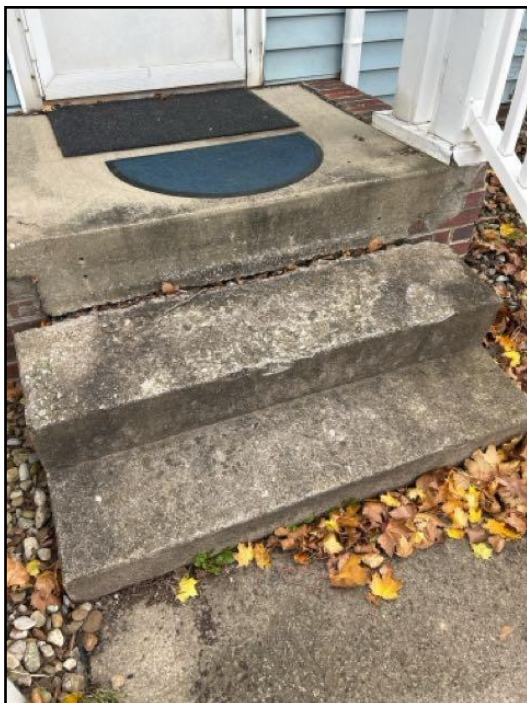
20. Condition: • [Steps or landings settling or heaving](#)

Implication(s): Weakened structure | Trip or fall hazard

Location: Front

24. Steps or landings settling or heaving

Task: Repair

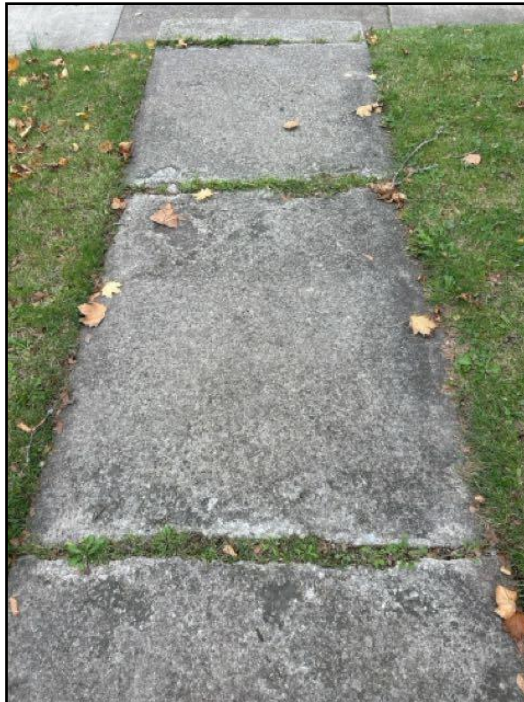
- 24. Condition:** • Cracked or damaged surfaces. Repair or replace as needed.

**Implication(s):** Trip or fall hazard

**Location:** Front

**26.** *Cracked or damaged surfaces. Repair or...*

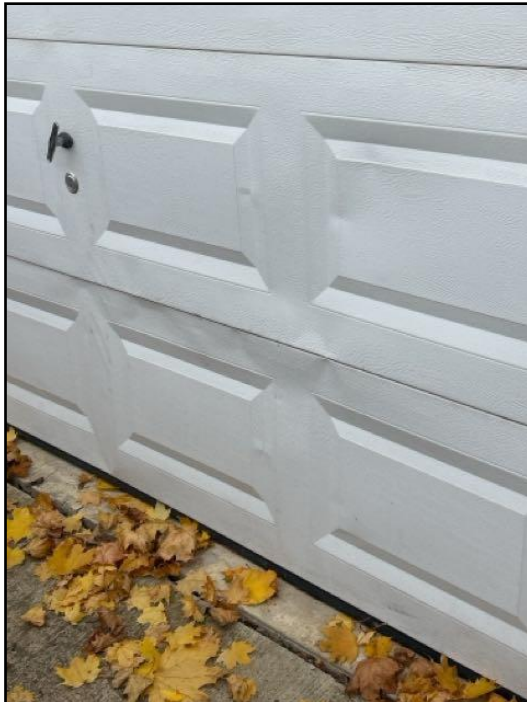
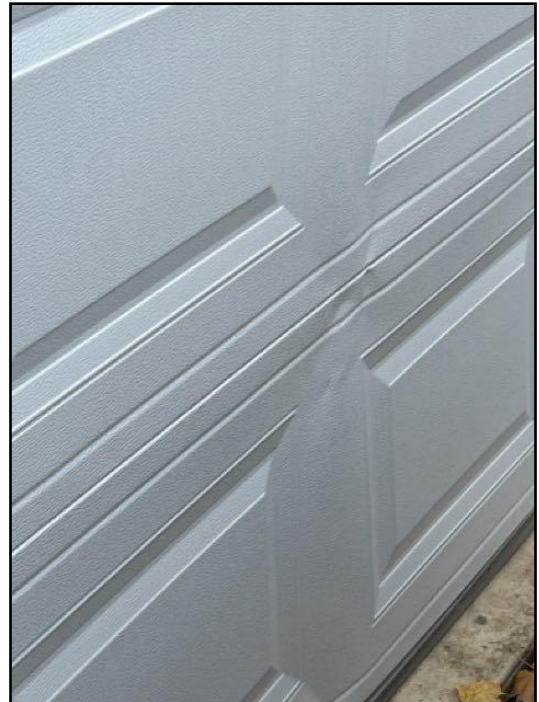
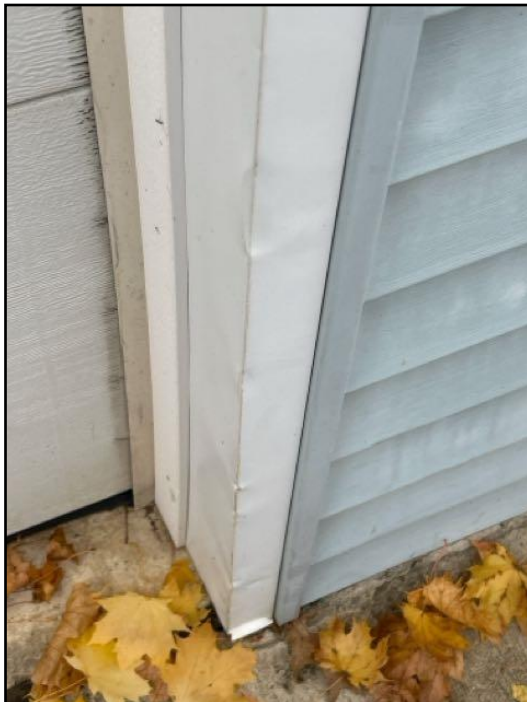
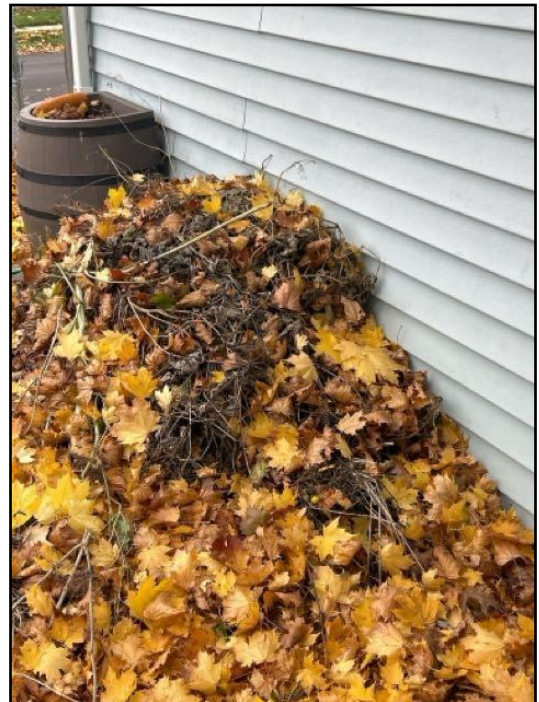
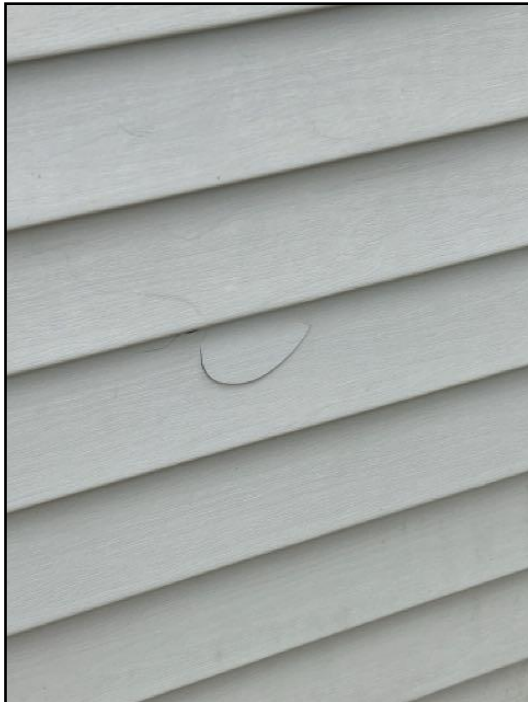
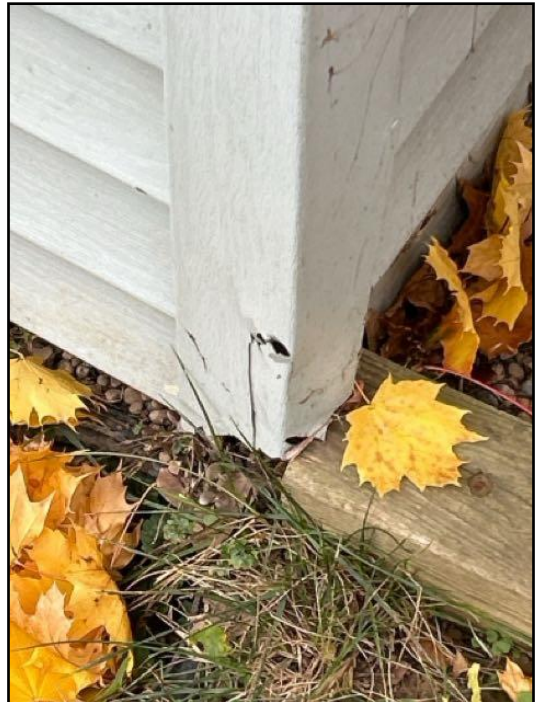
**26. Condition:** • The following are defects that were found on the detached garage. Repair or replace listed items as needed or desired.

- Mechanical damage on doors and trim
- Remove debris from exterior walls
- Typical mechanical damage on siding
- Siding too close to grade in areas
- Large trees next to structure
- Minor damage on screen
- Paint needed on man door trim
- Storage blocked the left side garage sensor. The right side door was unplugged.
- Possible water intrusion
- Storage limited the inspection

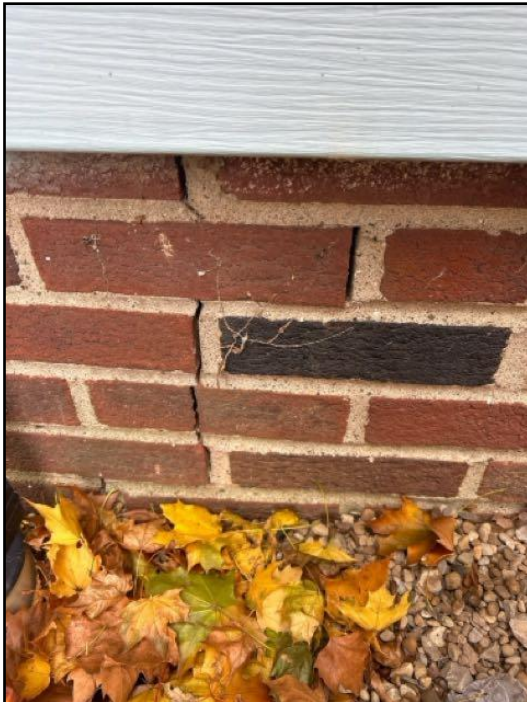
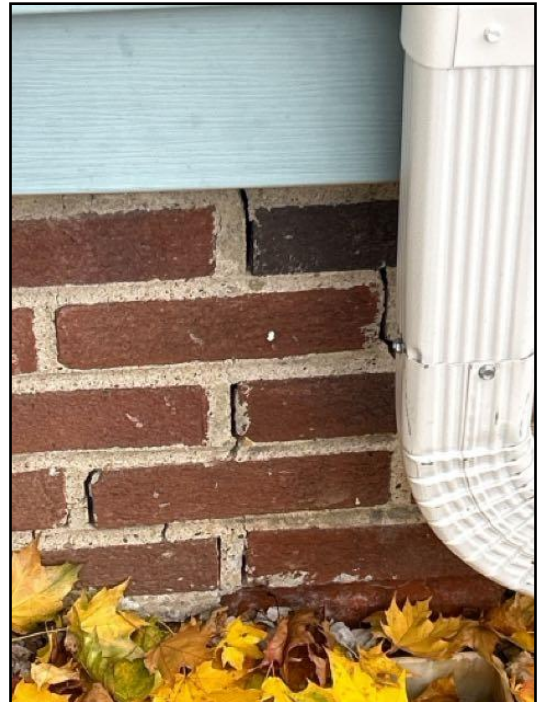
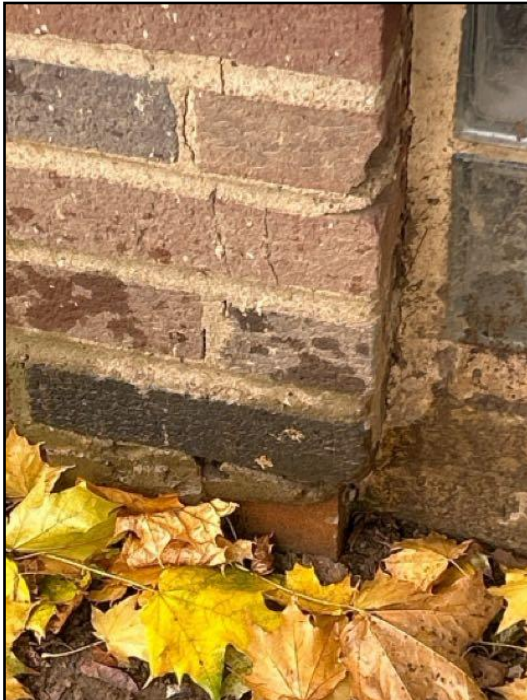
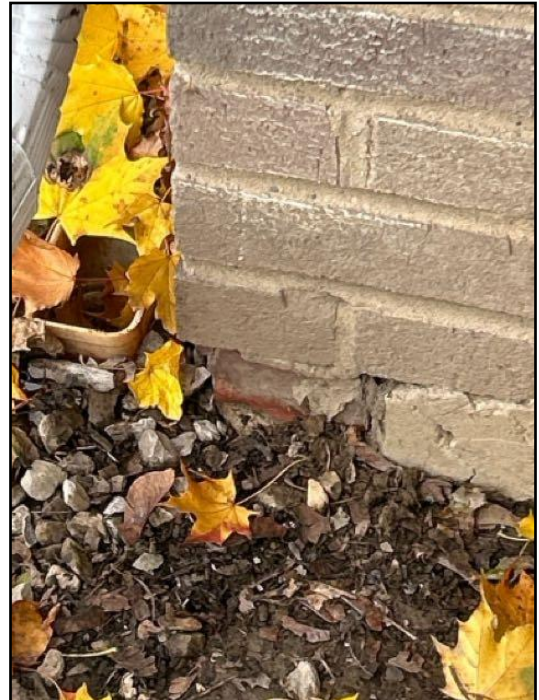
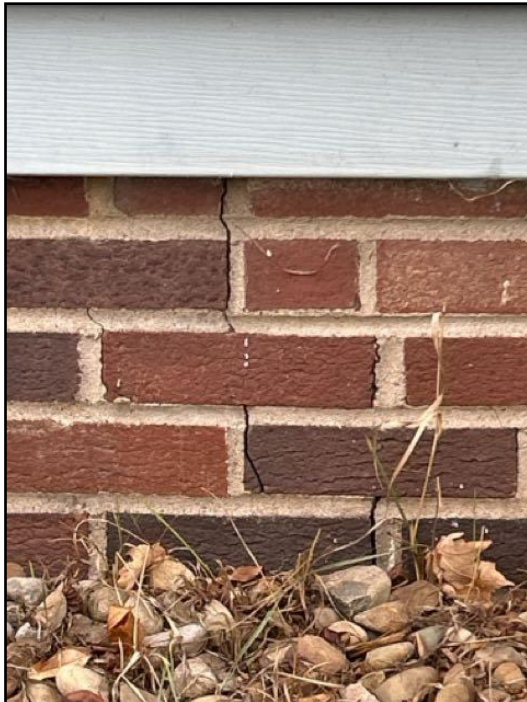
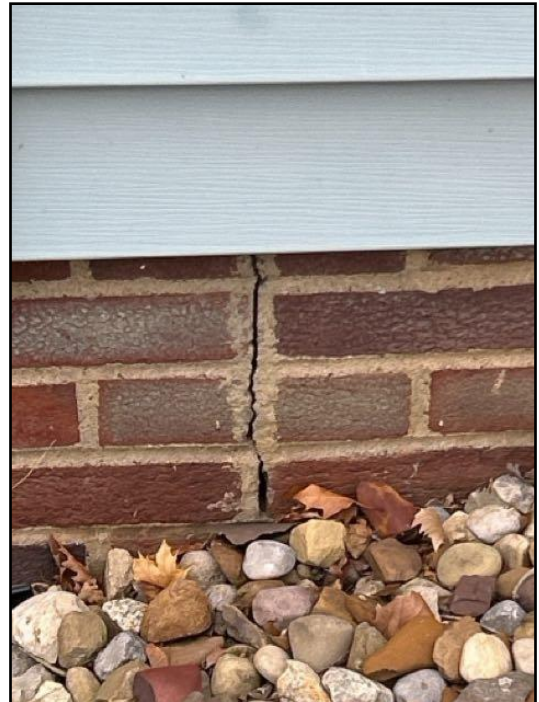
**27. Condition:** • Crack(s) noted on the basement foundation. Monitor for worsening cracking and repair as needed. If cracks widen overtime we recommend further evaluation by a licensed contractor. Seal crack(s) as needed to prevent water from entering the space.

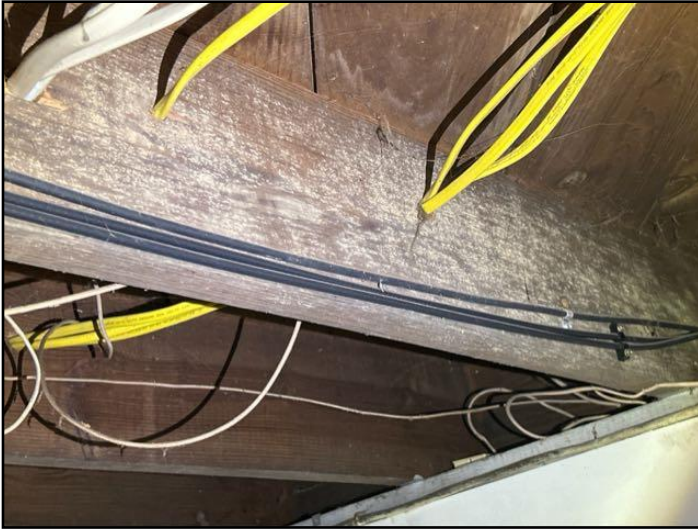
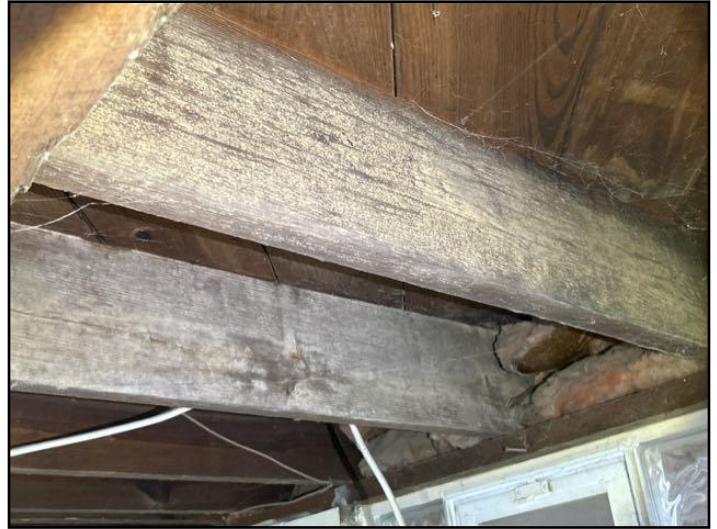
28. **Condition:** • Possible microbial growth noted on the floor joists. Recommend cleaning or further testing to verify.

46. Possible microbial growth noted on the floo...

47. Possible microbial growth noted on the floo...

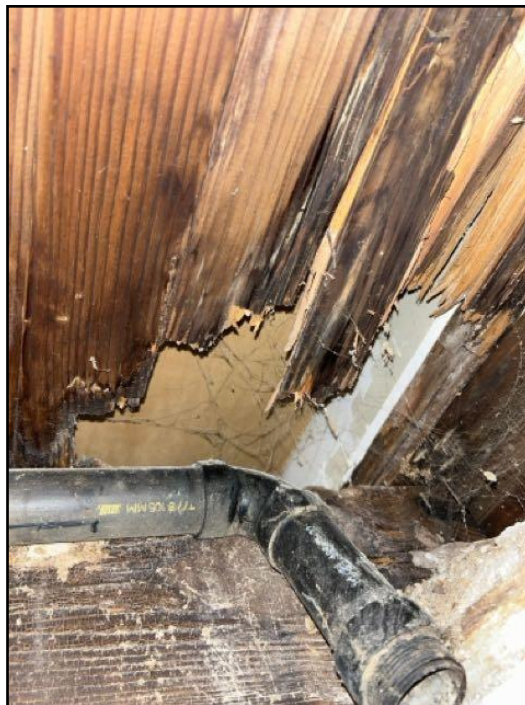
48.

**29. Condition:** • Old sink was removed. Repair floor as needed.

**Location:** Basement

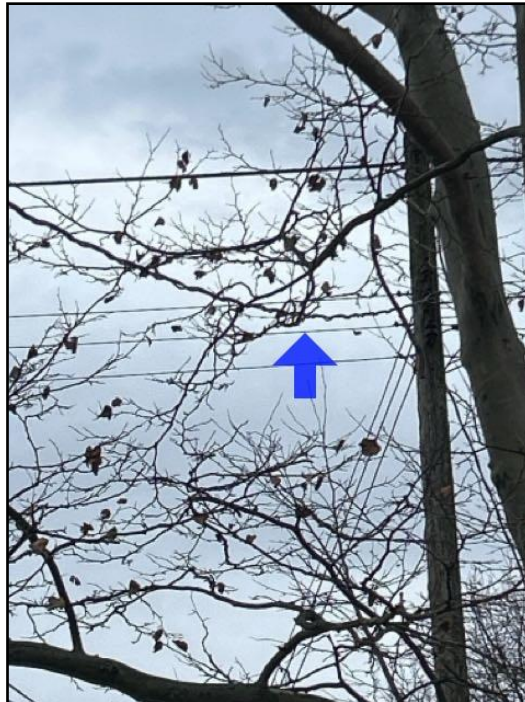
**31. Condition:** • The service wire is in contact with tree branches. Recommend trimming or removing the tree so that high winds don't damage the service line. Also, this is dangerous if a child is climbing the tree and doesn't see the wire.

50. The service wire is in contact with tree...

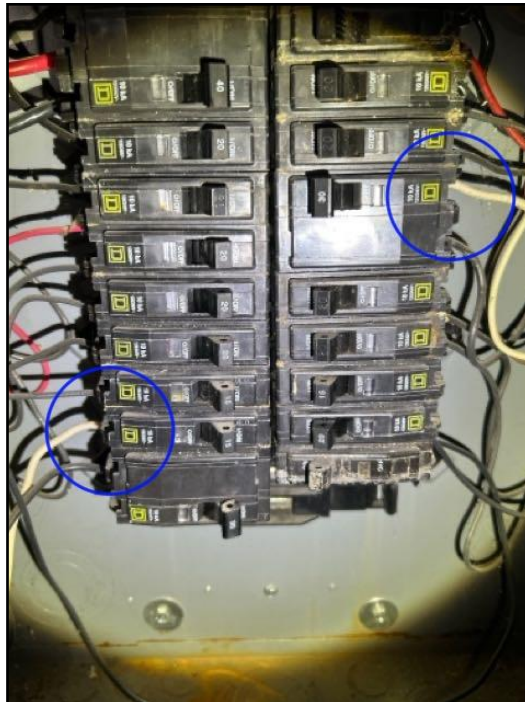
32. **Condition:** • Neutrals going into breakers should be marked with black tape showing that the wire is hot

51. Neutrals going into breakers should be...

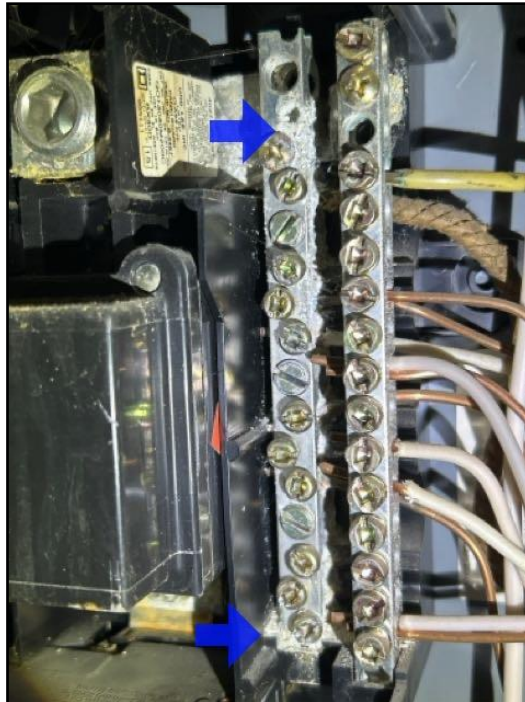
33. **Condition:** • Corrosion noted. Recommend further review by a licensed electrician.

52. Corrosion noted. Recommend further review b...

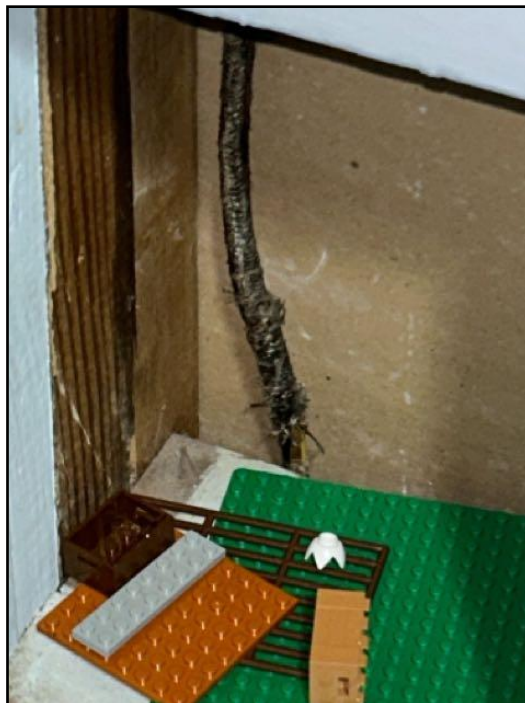
34. **Condition:** • Spliced/damaged wires. Replace or install proper junction box for safety.

**Location:** Rear Bedroom

53. Spliced/damaged wires. Replace or install...

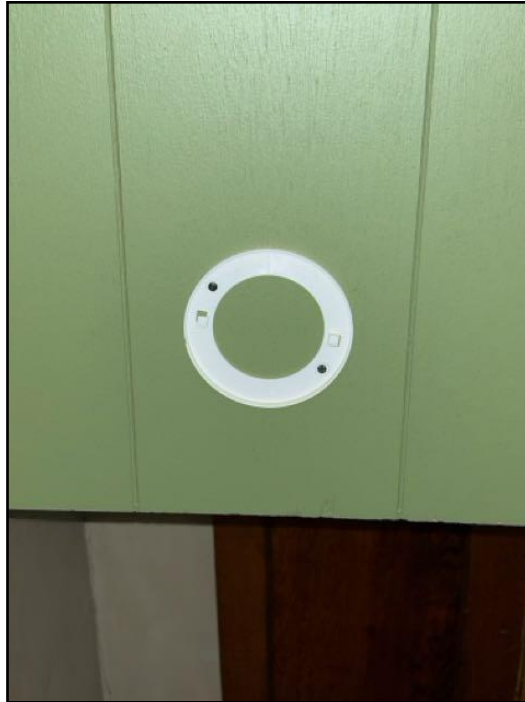
**35. Condition:** • Missing

**Location:** Attic

**54. Missing**

**Task:** Install

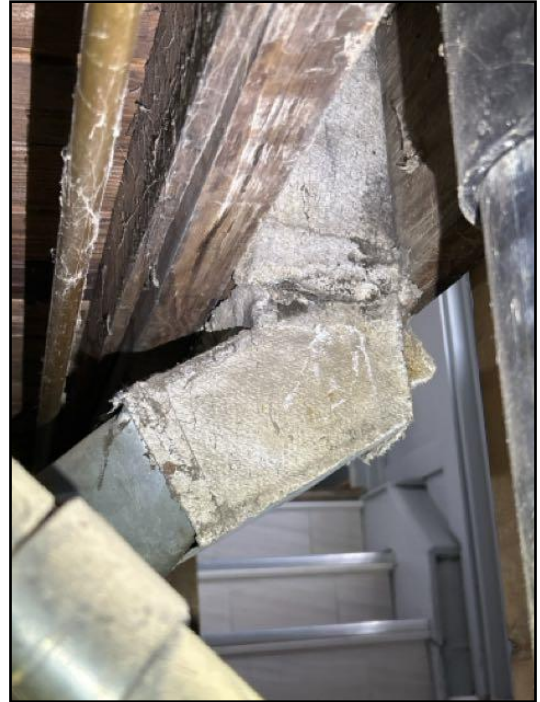
**40. Condition:** • The white tape covering some of the joints in the ductwork may be asbestos. This was commonly used at the time the home/property was built. Only laboratory testing can determine the presence of asbestos. If the tape is in good condition the EPA recommends doing nothing. If it is slightly damaged, we recommend covering with furnace tape.

57. The white tape covering some of the joints...

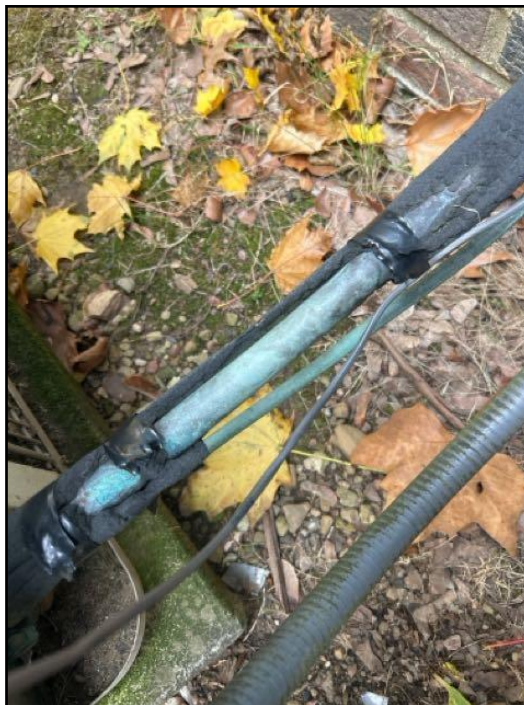
**44. Condition:** • Damaged Insulation on the refrigerant line. Recommend repairing or replacing the insulation.

**59.** *Damaged Insulation on the refrigerant line....*

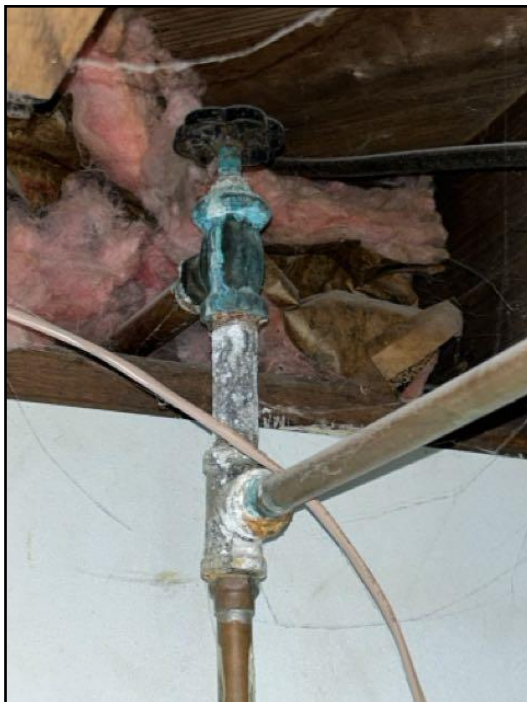
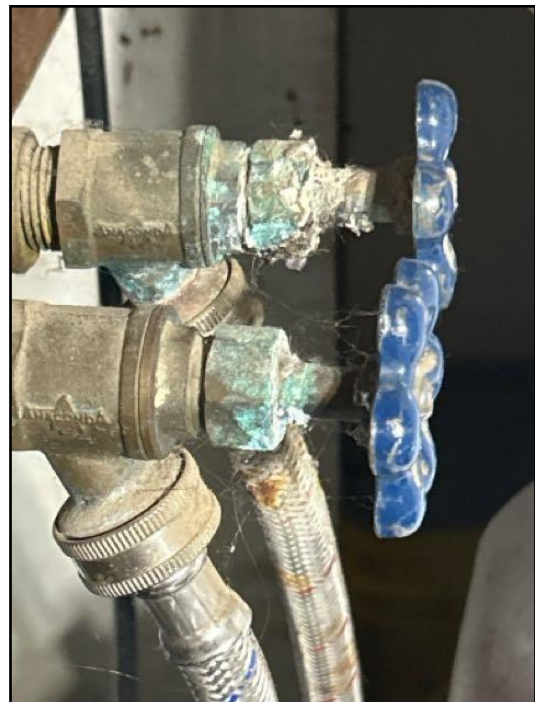
**45. Condition:** • Corrosion/Calcium buildup noted on some supply lines. Monitor for leaks and repair/replace as needed.

**Location:** Basement

61. Corrosion/Calcium buildup noted on some...

62. Corrosion/Calcium buildup noted on some...

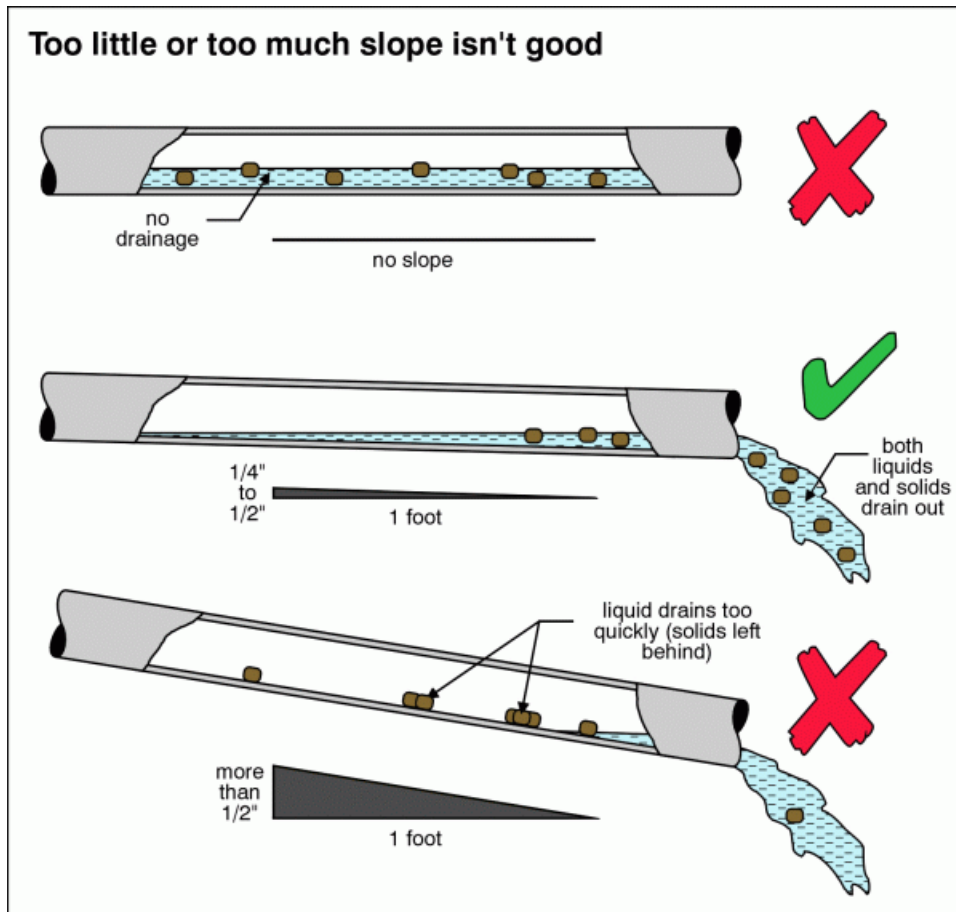
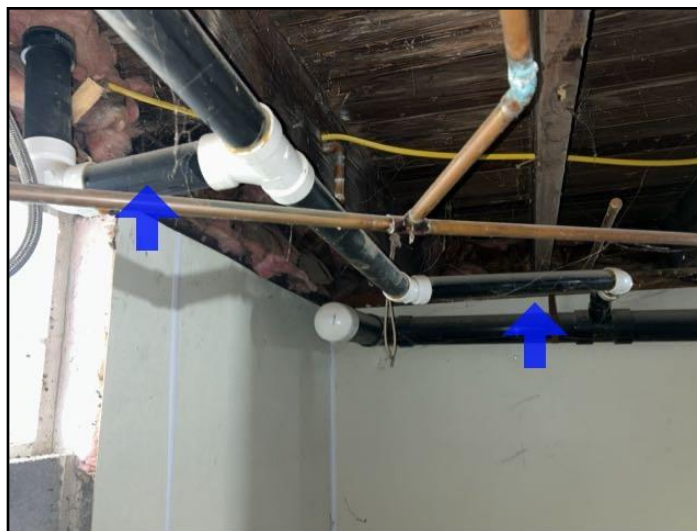
47. Condition: • [Poor slope](#)

Implication(s): Sewage entering the building

63. Poor slope

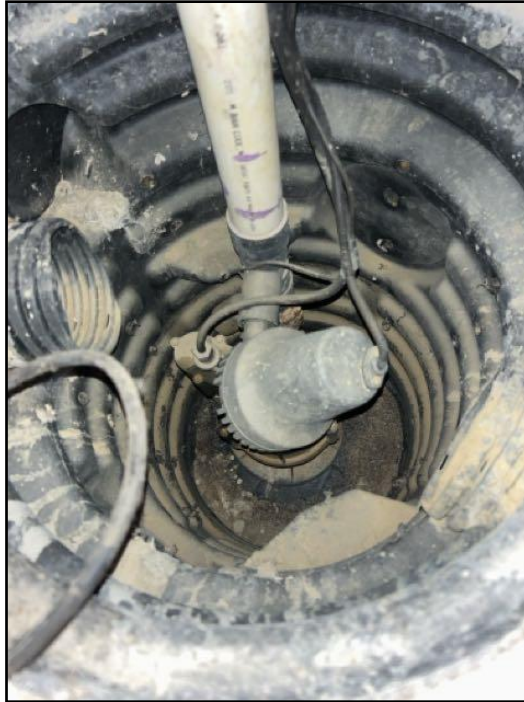
64.

**48. Condition:** • The sump pit was dry. This may be due to having the basement waterproofed. The pump was operational. Not having any water in the pit could damage the pump. Make repairs as needed.

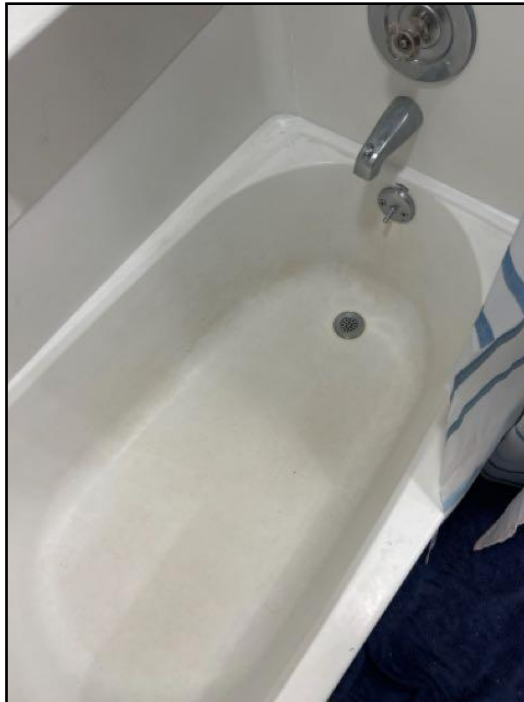
67. Surface defects. Clean or replace as needed.

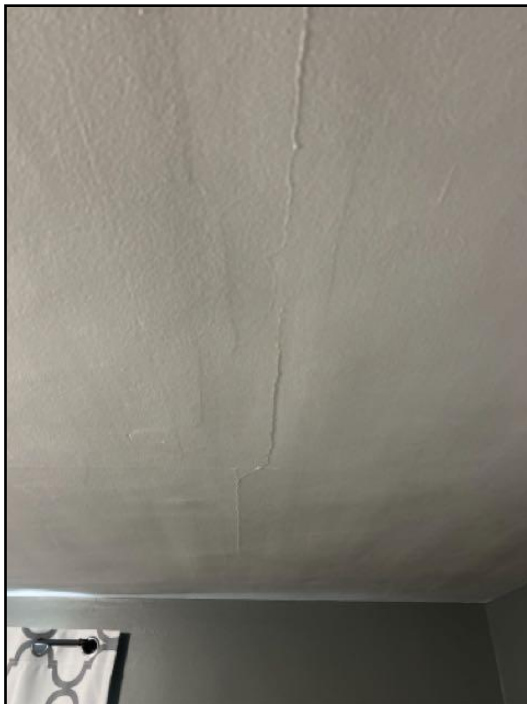
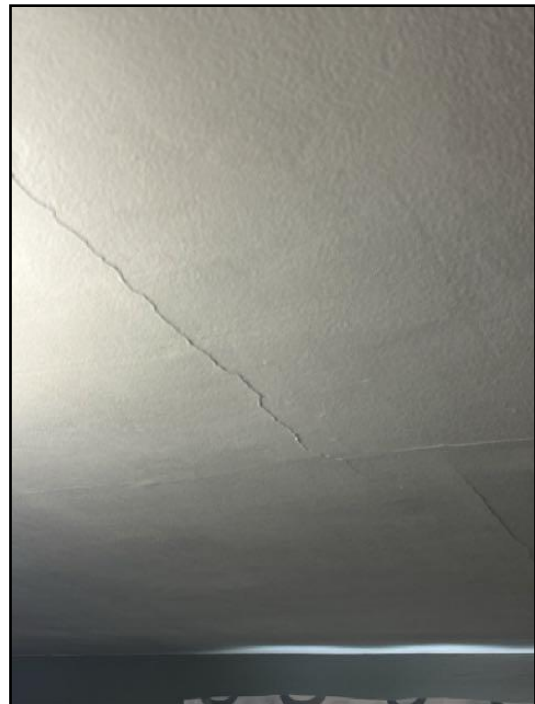
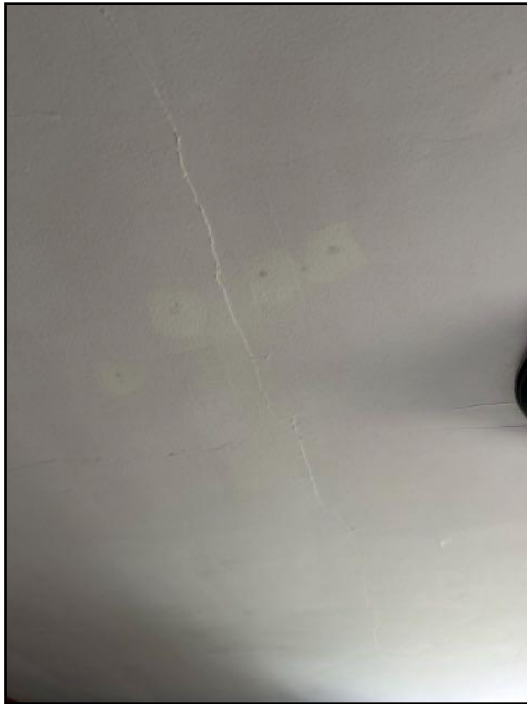
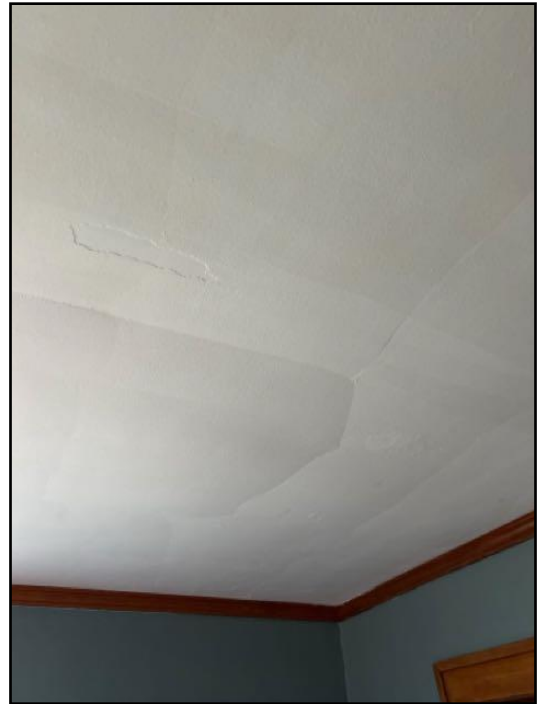
**53. Condition:** • Cracked areas. Prior repairs noted. Monitor for future cracking and repair as needed. If cracks worsen overtime we recommend further review and repair by a licensed contractor.

**Location:** Areas Throughout

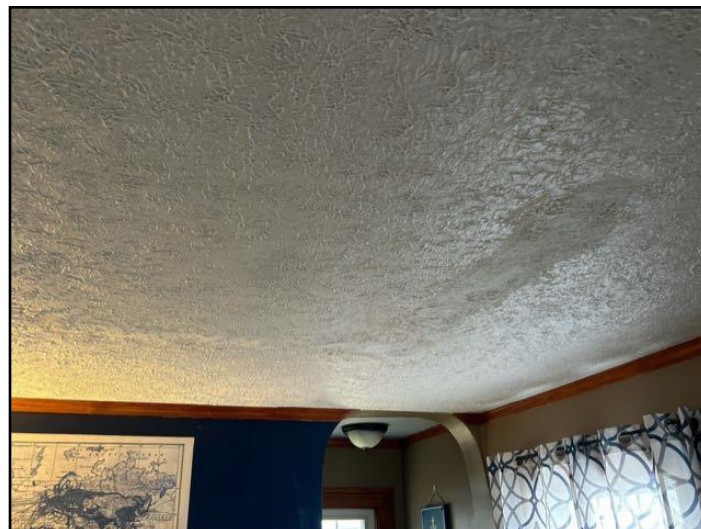
**54. Condition:** • Prior repair/patch noted. This area tested dry with the moisture meter at the time of the inspection. Ask sellers what was repaired in this area and make further repairs as needed.

**Location:** Front Living Room

72. Prior repair/patch noted. This area tested...

**Task:** Repair as needed

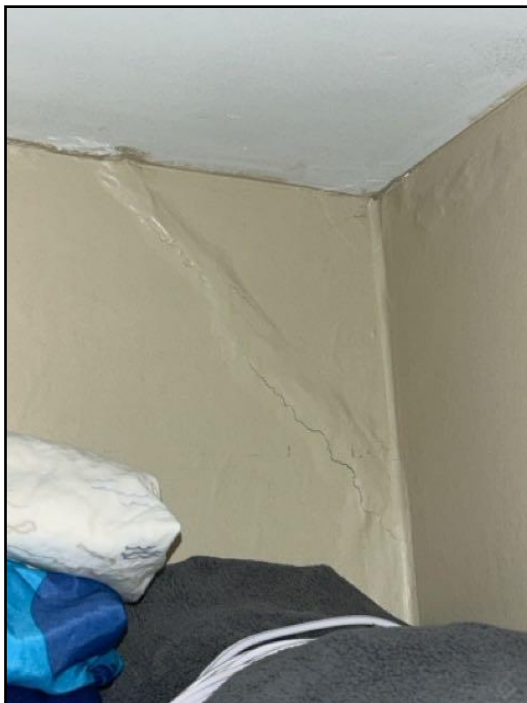
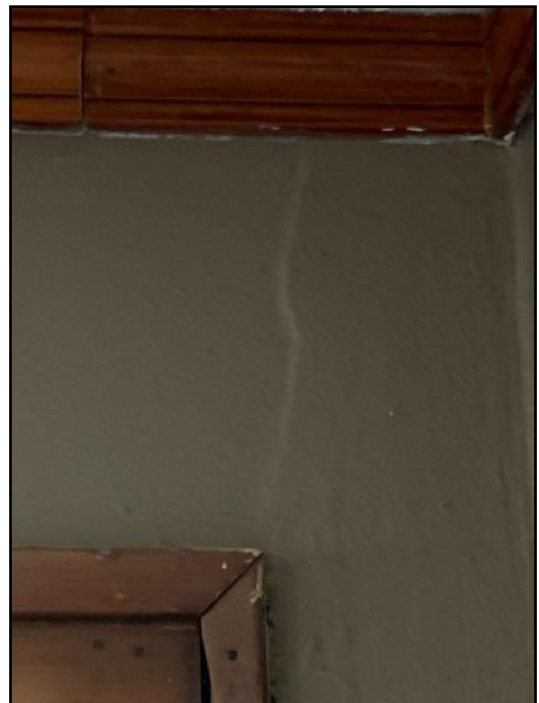
**56. Condition:** • Cracked/damaged in areas. Monitor for future cracking and repair as needed. If cracks worsen overtime we recommend further review and repair by a licensed contractor.

75. Cracked/damaged in areas. Monitor for futur...

76. Cracked/damaged in areas. Monitor for futur...

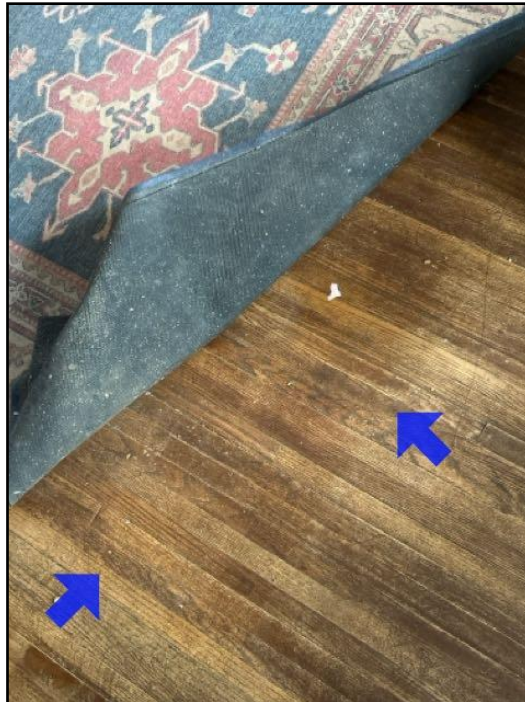
78. Ghosting noted on the floor. Repair area as...
