# INSPECTION REPORT

For the Property at:  
**202 SAMARITAN AVENUE**  
ASHLAND, OH 44805

Inspection Date: Wednesday, November 27, 2024

RE: Report No. 3858  
202 Samaritan Avenue  
Ashland, OH  
44805

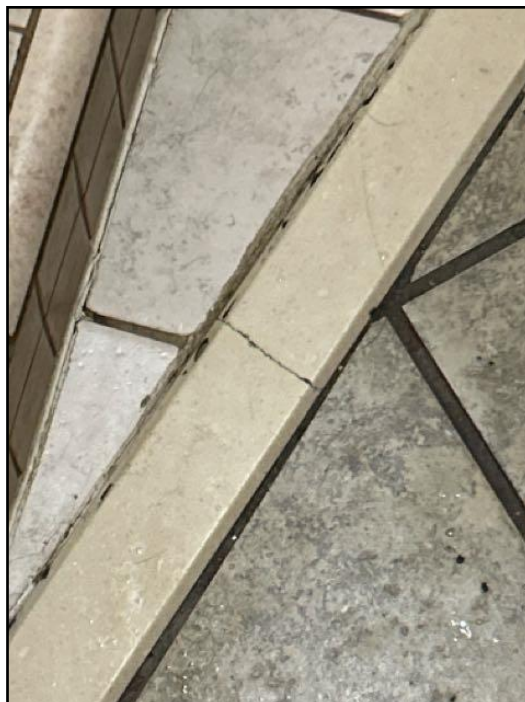
Location: Main Floor Bathroom

79. Tiles cracked

Task: Replace as desired

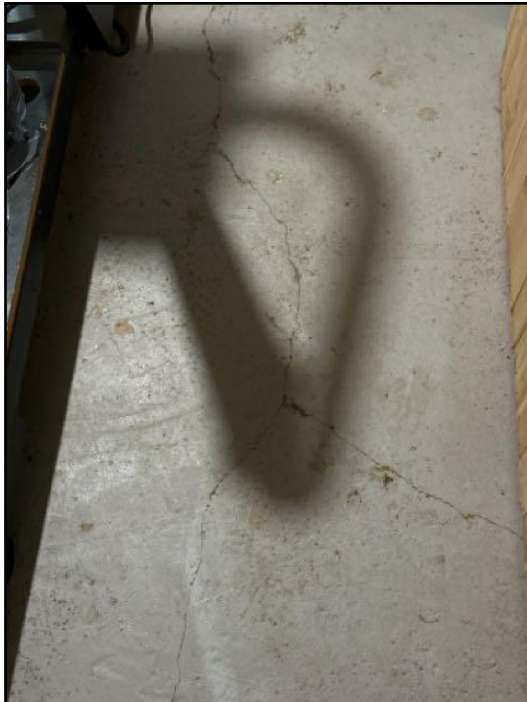
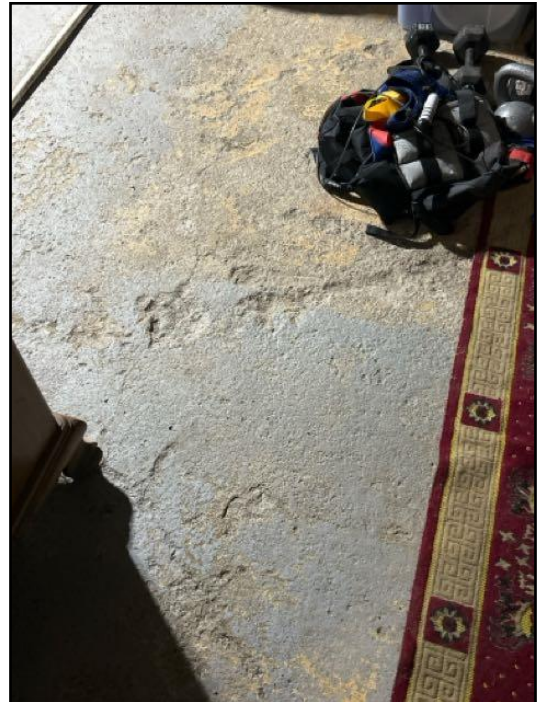
**64. Condition:** • The basement floor is cracked in areas. Monitor for future cracking and water intrusion and make repairs as needed.

Spalling also noted

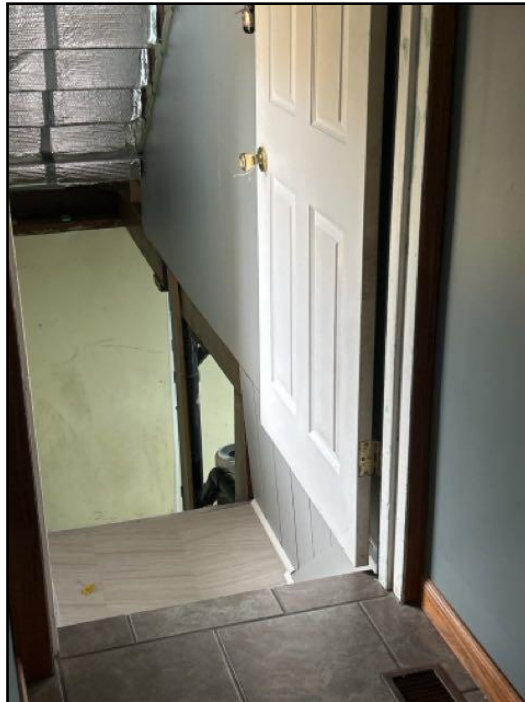
**65. Condition:** • The door to the basement swings over the stairs. Anyone opening the door from the basement will have to step backwards down the stairs to allow room for the door to swing open. They could lose their balance and fall. Recommend hinging the door from the other side.

82. The door to the basement swings over the...

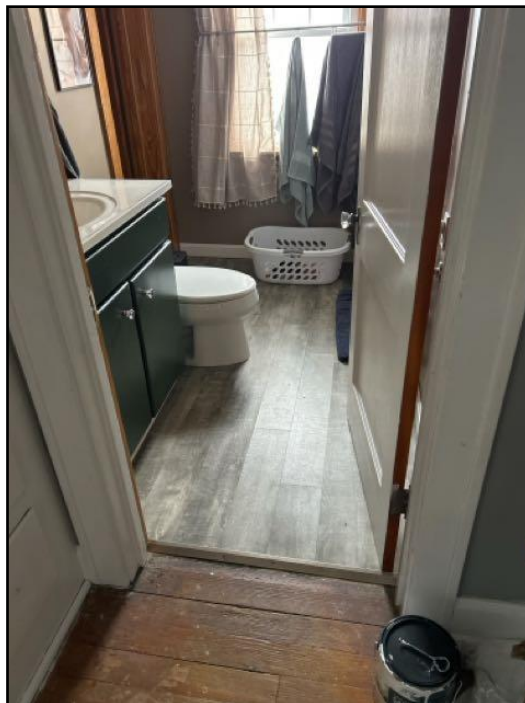
83.

**66. Condition:** • Poor fit. The door rubs the floor. The door does not properly latch/lock.

**Location:** Upstairs Bathroom Door

**Task:** Repair

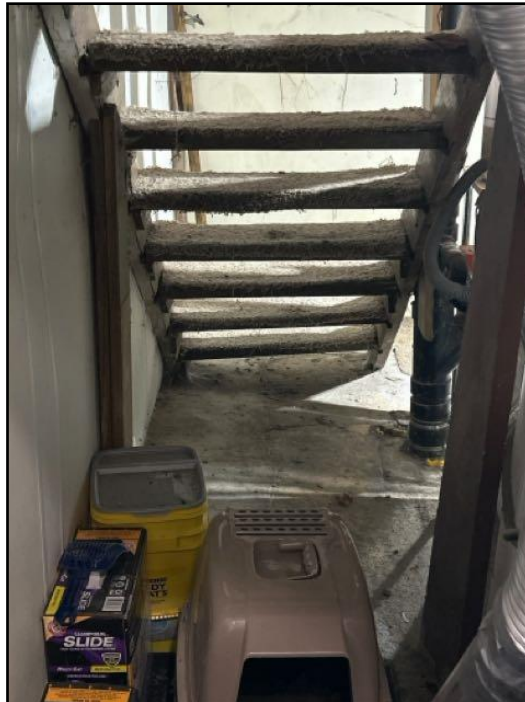
**Location:** Basement steps

85. Damage/out of level

**Task:** Repair as needed

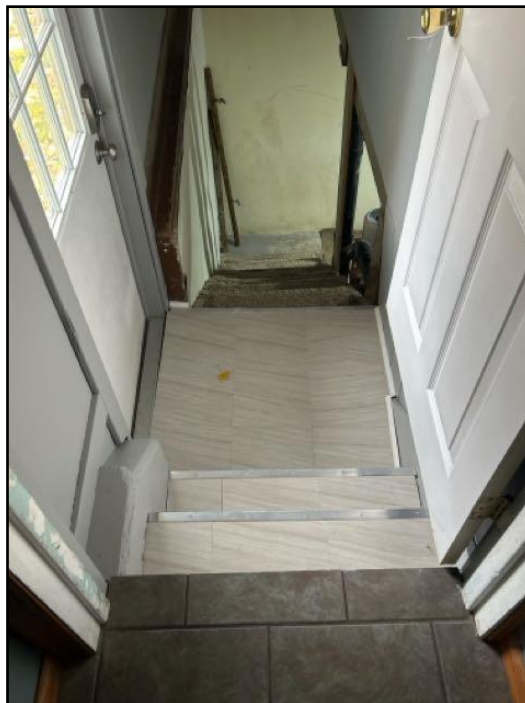
**70. Condition:** • Recommend installing handrails for safety.

**Location:** Basement

86. Recommend installing handrails for safety.

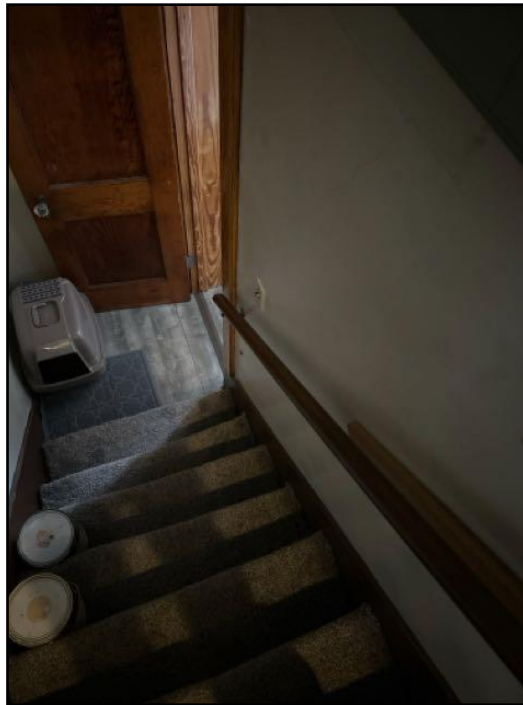
Implication(s): Fall hazard

Location: Attic

87. Loose

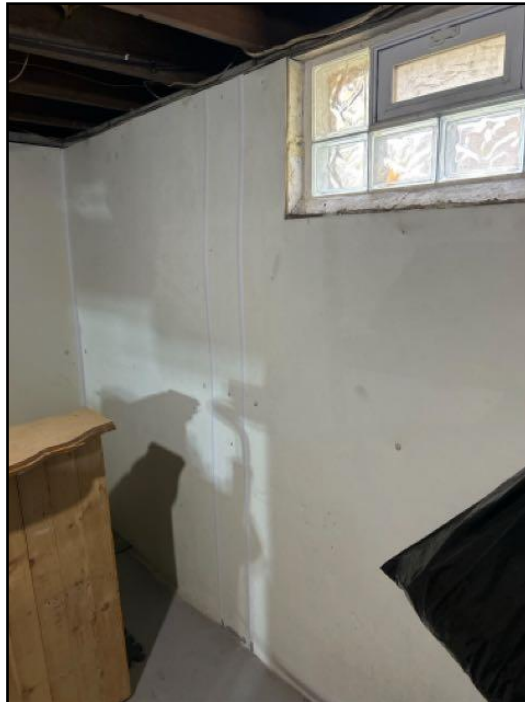
88. Prior B-Dry type repair noted along the...

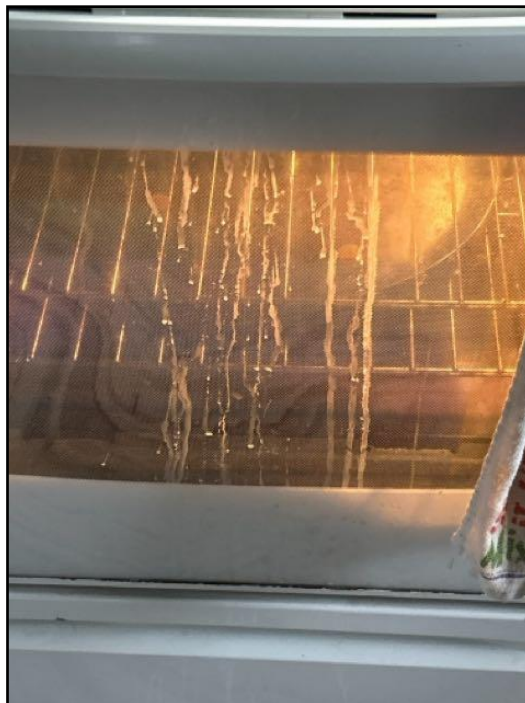
89.

73. **Condition:** • Stains between glass

**Task:** Clean
