CONDITION REPORT AND OPINION OF VALUE FOR INSURANCE WALNUT 24 th July 2017

nb Walnut

Carried out by the undersigned and is a statement of the factual condition of the vessel as seen at the time of the survey. As stated in the body of the Report, the subject vessel was a 56ft narrow boat age 1974.

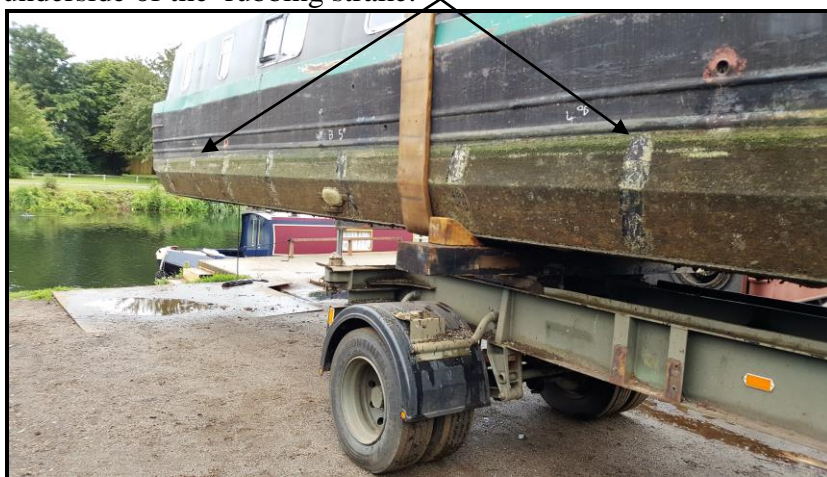
The vessel was then subjected, where practical, to an ultrasonic thickness examination in accordance with the Code of Practice published by the International Institute for Marine Surveying. Selected points at 1 m spacing in a grid pattern over the sides, along the wind and water strake and under the bottom in areas where the maximum corrosion and especially where the maximum shear forces and bending moments may be expected and such as were reasonably accessible were chosen such that a ring of readings was formed. These were then cleaned of dirt and the thickness measured ultrasonically using a Tritex through paint ultrasonic multi echo gauge. During the taking of the readings, the instrument's calibration was rechecked a number of times to ensure that it had maintained its validity and accuracy. Overplated to underside of the rubbing strake.

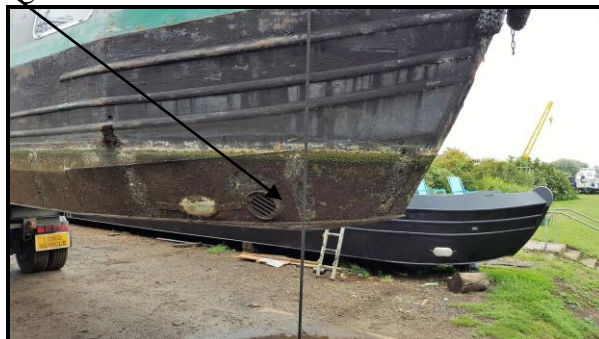
Bow thruster not working.

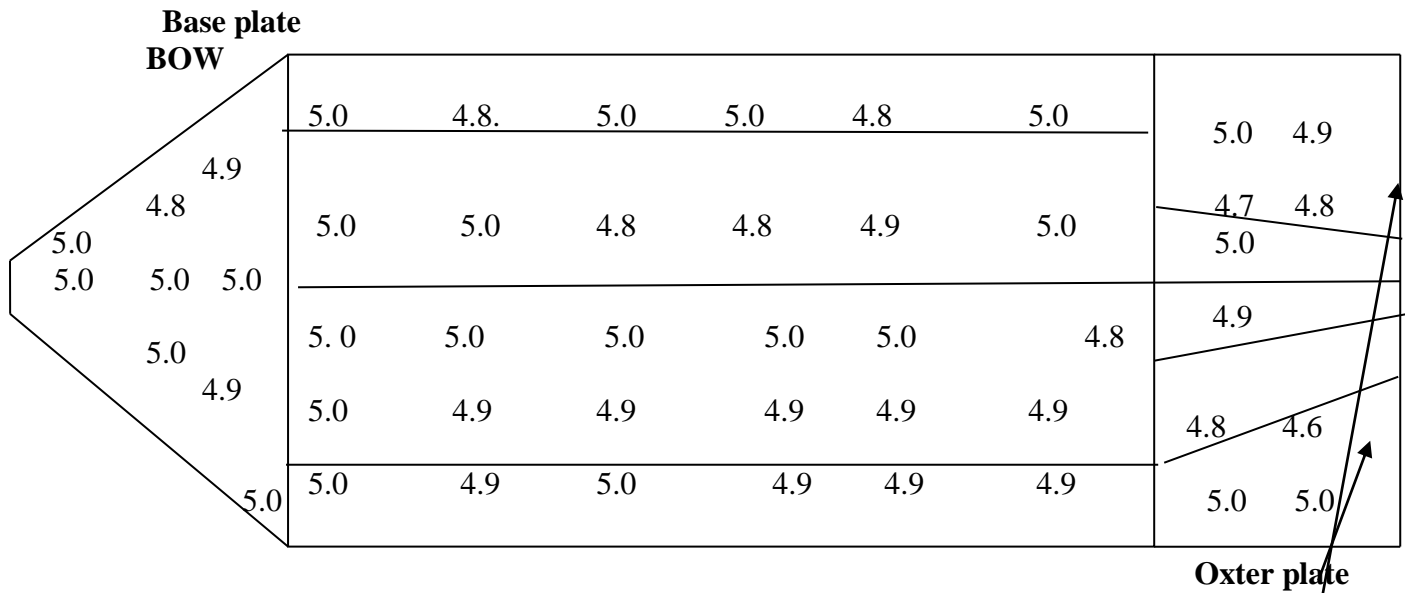
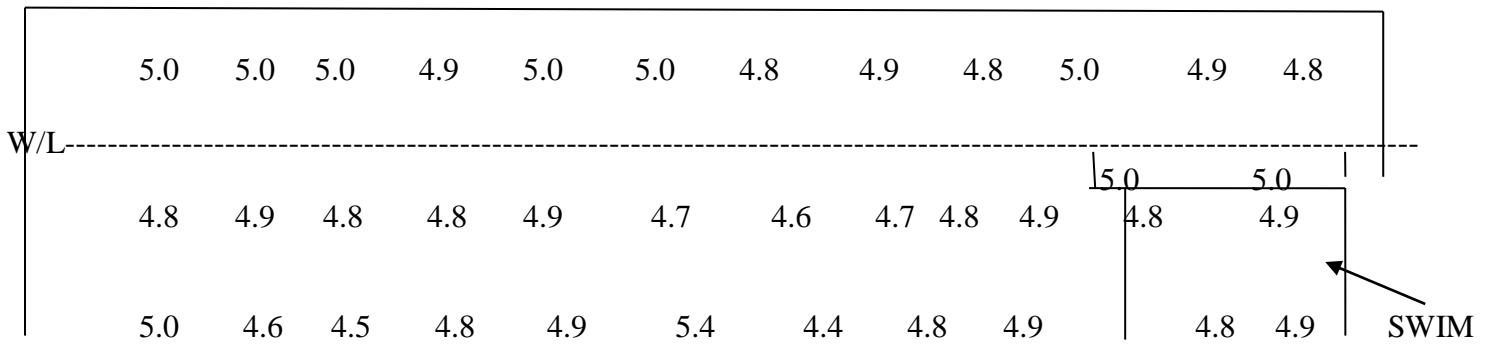
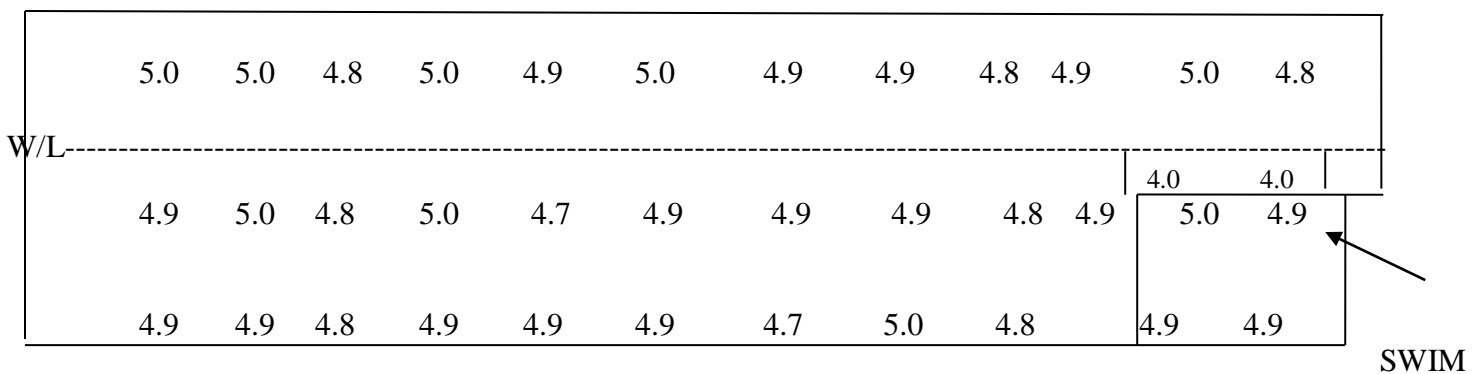
ULTRASONIC TEST RESULTS

The boat has been overplated to above the waterline in 5mm. There are scattered pits of 0.4mm.-no action. Weed hatch is 6mm all sides with 0.5 pits-no action.

Transom and side shell 4.0/5.0 mm as built above overplate.

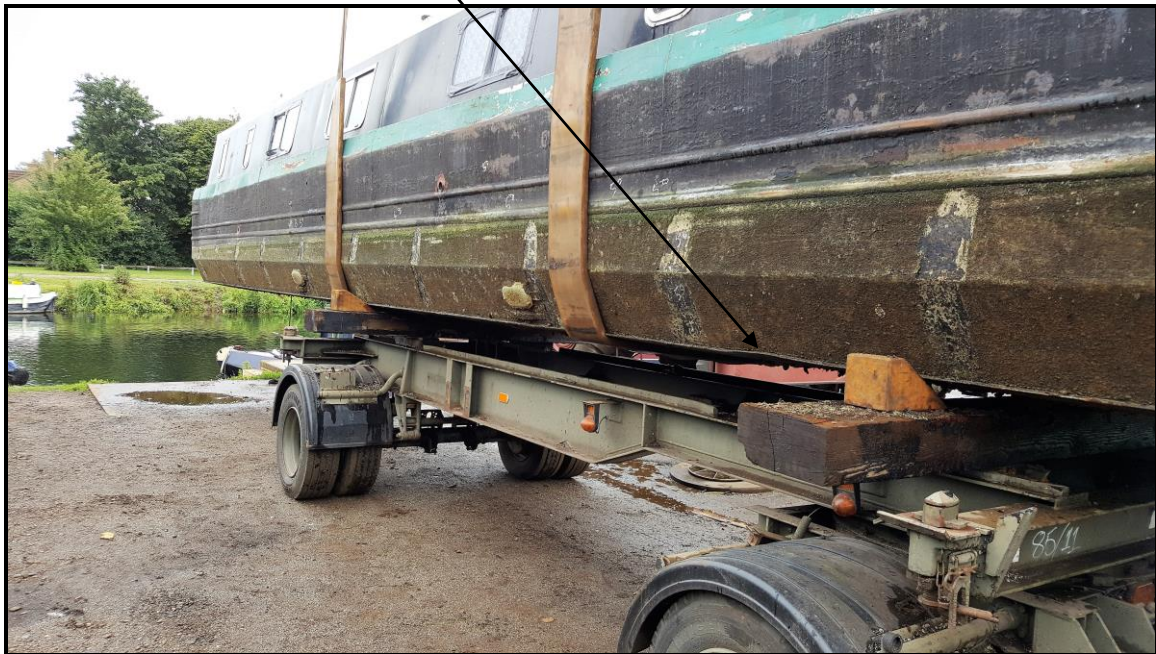
Wear plate approx. 20 mm wide in good condition apart from 2 areas that are damaged
By lifting with chains.

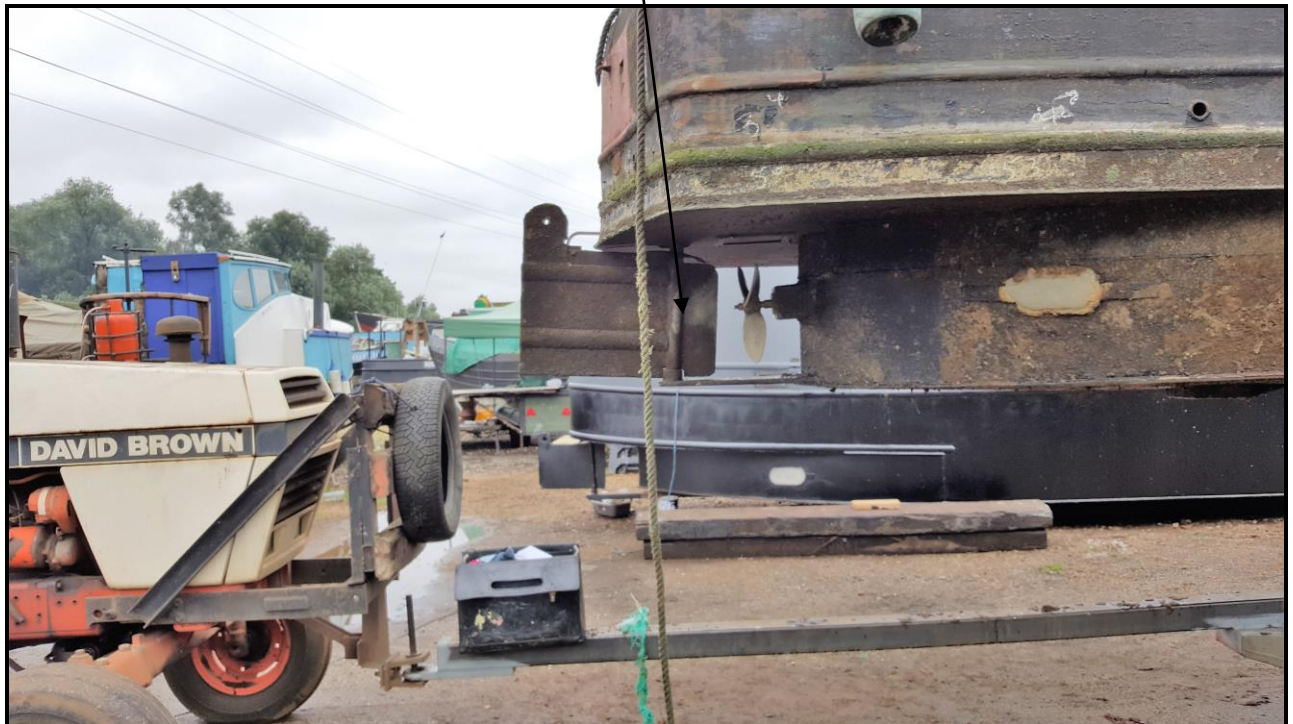
The rudder was of the single semi-balanced single plate type, constructed of mild steel with the blade fastened to the stock. Rudder stock is bent-monitor.
