**103 WOOD LANE
PILSALL
WS3 5DZ**

29TH OF OCTOBER 2025

Instructions were received on the 13th of October 2025 to undertake a snagging report of the property at 103 Wood Lane, Pilsall WS3 5DZ

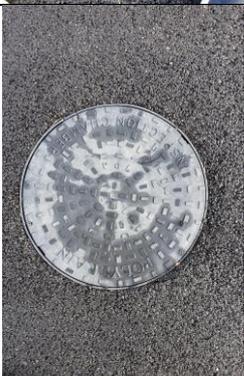
<p>There is damage to the drain cover.</p>

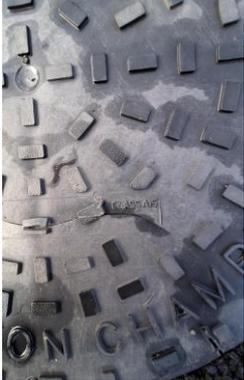
<p>The drain cover is not classified for a driveway. It's an A15, which is for pedestrian routes only.</p> <p>This inspection cover will need to be replaced with a metal cover and surround.</p>

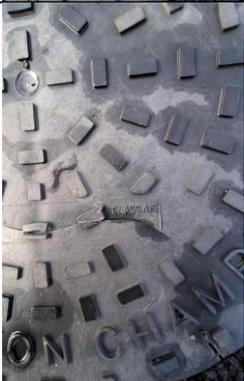
<p>This drain is full of tarmac.</p>

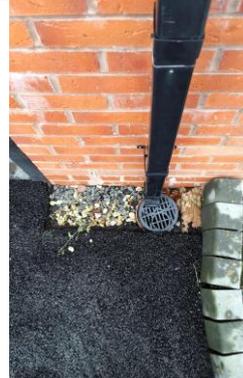
The downpipe is insecure and is missing fixings at the bottom

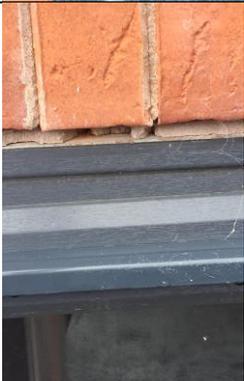
<p>There is damage to the left-hand window in various places.</p>

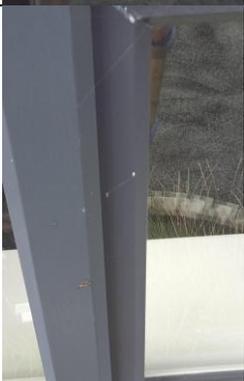
<p>There is damage to the left-hand windowsill.</p>

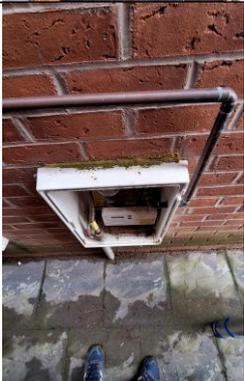
<p>A brick has been taken out to add an earth cable to the gas pipe, and it has been foamed back in. This needs to be taken out and properly pointed in with cement.</p>

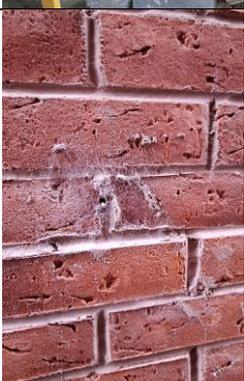
<p>Using foam around a waste pipe is not acceptable. The brick needs to be taken out and replaced, and then this pipe needs to be cemented in properly.</p>

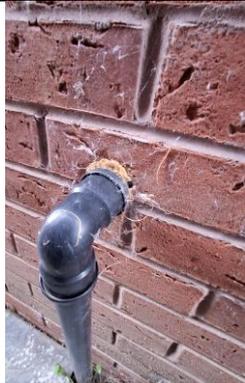
<p>Using foam for a gas pipe is not acceptable. The pipe needs to be sleeved through the wall and then cemented in</p>

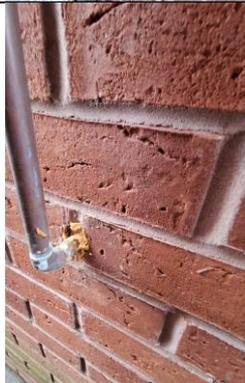
<p>Using foam on a boiler blow-off is not acceptable. This brick will need to be taken out and replaced with the pipe drilled through and properly cemented in</p>

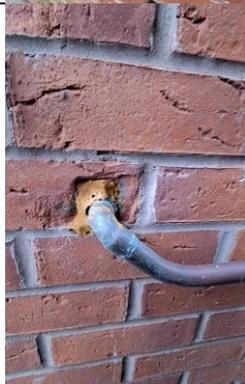
<p>Using foam around gas pipes is not acceptable. You have sleeved the gas pipe through the wall and then filled it with foam. You have also destroyed the brick.</p>

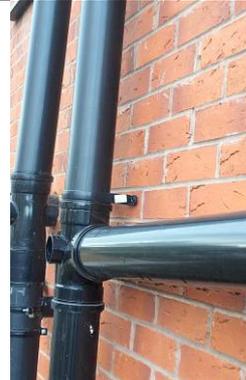
Using foam around SVP waste pipes is not acceptable; this needs to be cemented in properly.

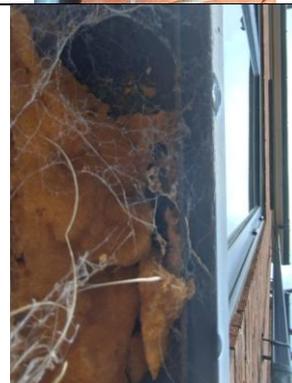
There's damage to the bi-fold doors in various locations.

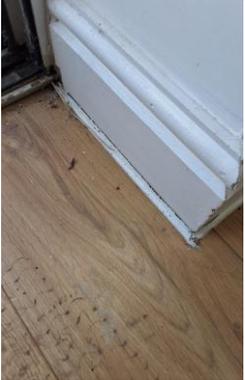
<p>The mastic seal is missing from the front door.</p>

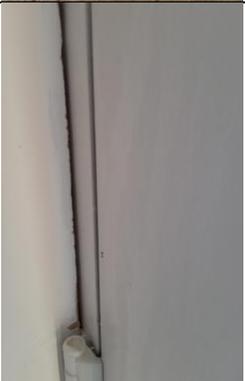
<p>The gap by the front door in the plasterboard is excessive, and there is no mastic seal.</p>

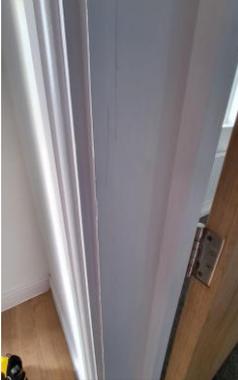
<p>The living room door frame is damaged.</p>

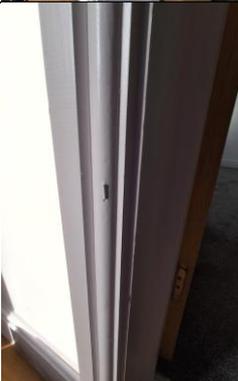
<p>There is damage to the skirting on the left-hand side of the door.</p>

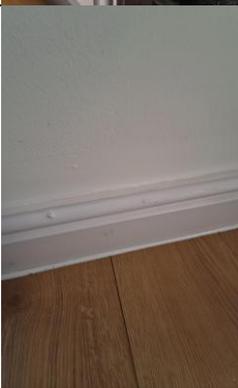
<p>The wood flooring has been cut too short, and the gap has been filled with silicon.</p>

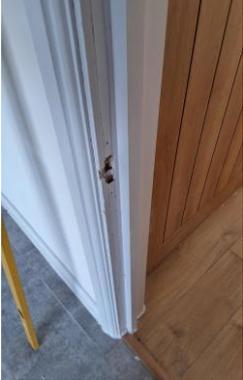
<p>There is damage to the door.</p>

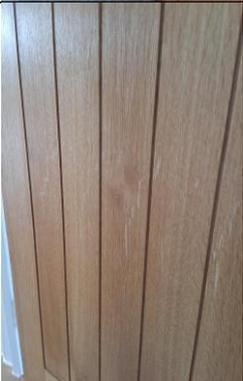
<p>The door margins are wrong.</p>

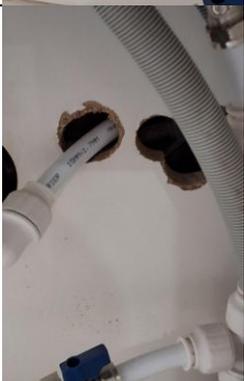
<p>There is damage to the left-hand side of the kitchen sink base unit.</p>

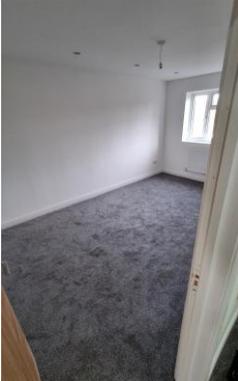
<p>The door keep is missing.</p>

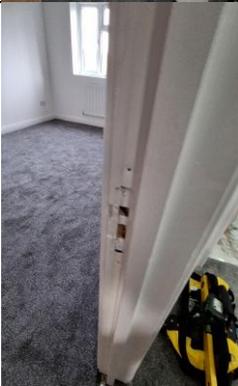
<p>The wrong intumescent seals have been installed in this door frame, and they have been nailed in.</p>

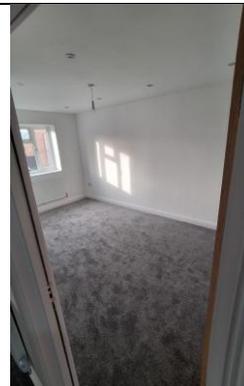
Intumescent strips are missing

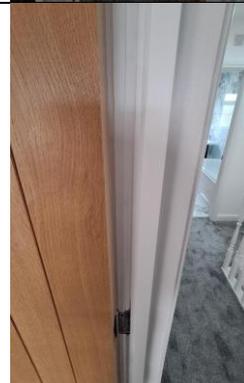
Decoration is required to the skirting on the right-hand side and underneath the radiator.

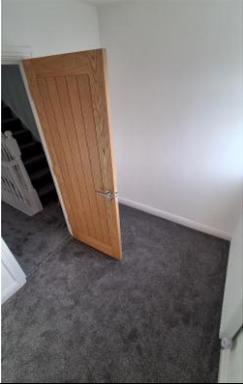
<p>The door keep is missing.</p>

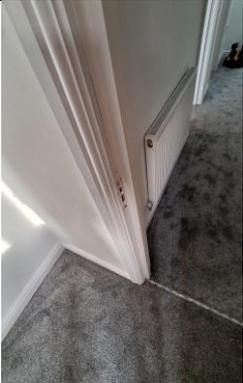
<p>The radiator is loose.</p>

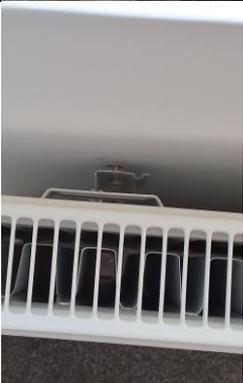
<p>The radiator pipes are visible underneath the radiator.</p>

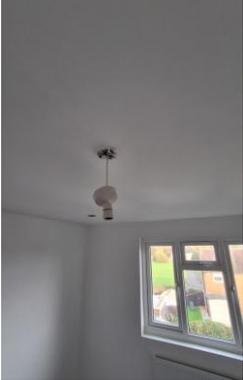
<p>The light switch is hanging off and very unsafe.</p>

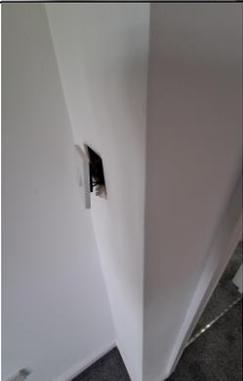
<p>All the sockets are covered with tape " Do not use" Get a qualified electrician to sign off on this property. I advise an independent electrician</p>

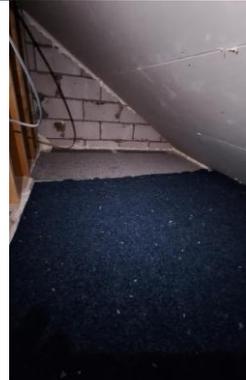
The door into the eaves is loose.

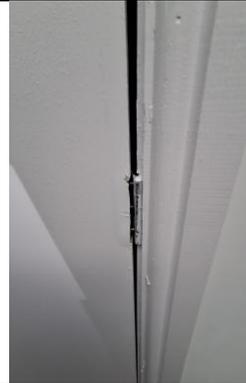
Decoration is required

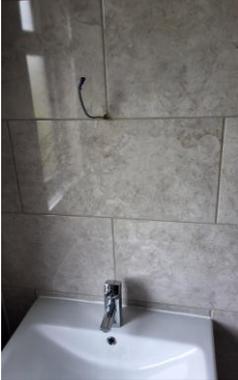
<p>There was no water at all in the hand basin.</p>

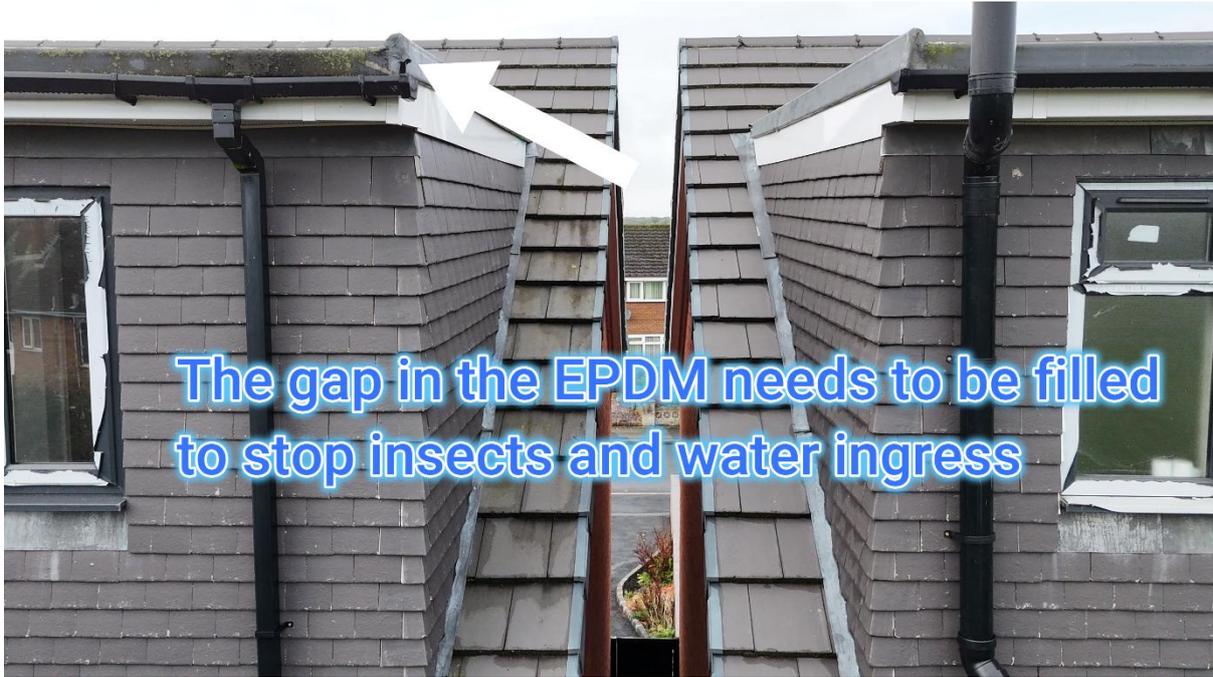
The gap in the EPDM needs to be filled to stop insects and water ingress

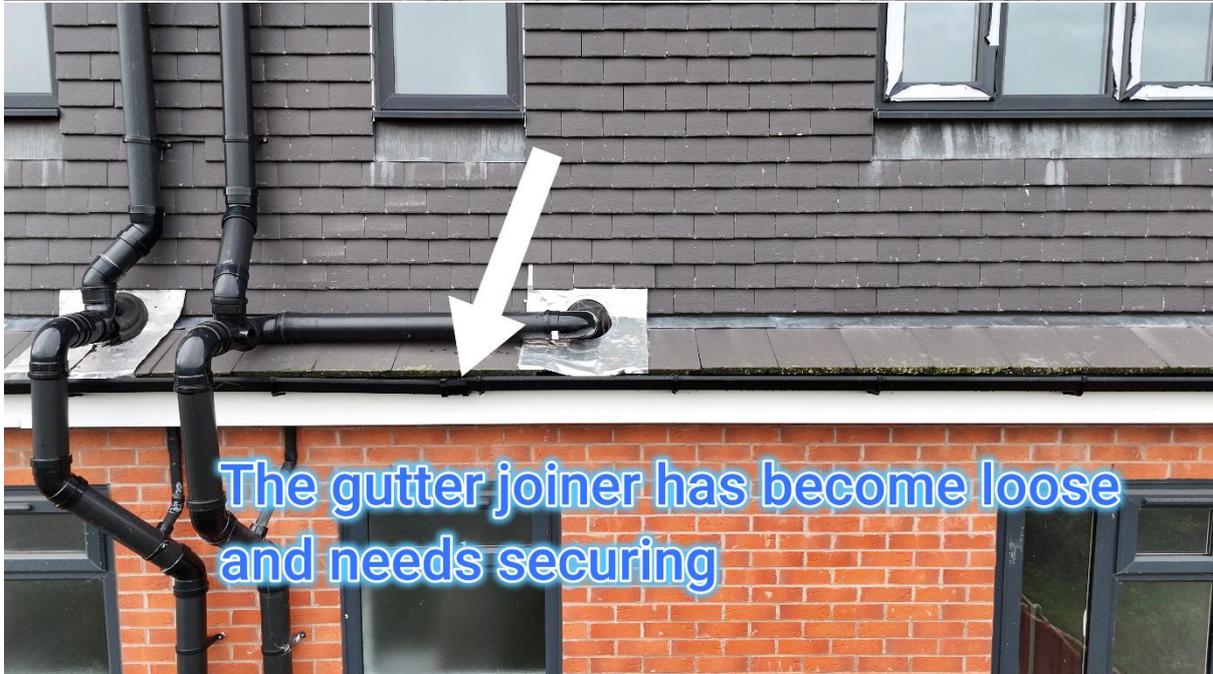
The gutter joiner has become loose and needs securing

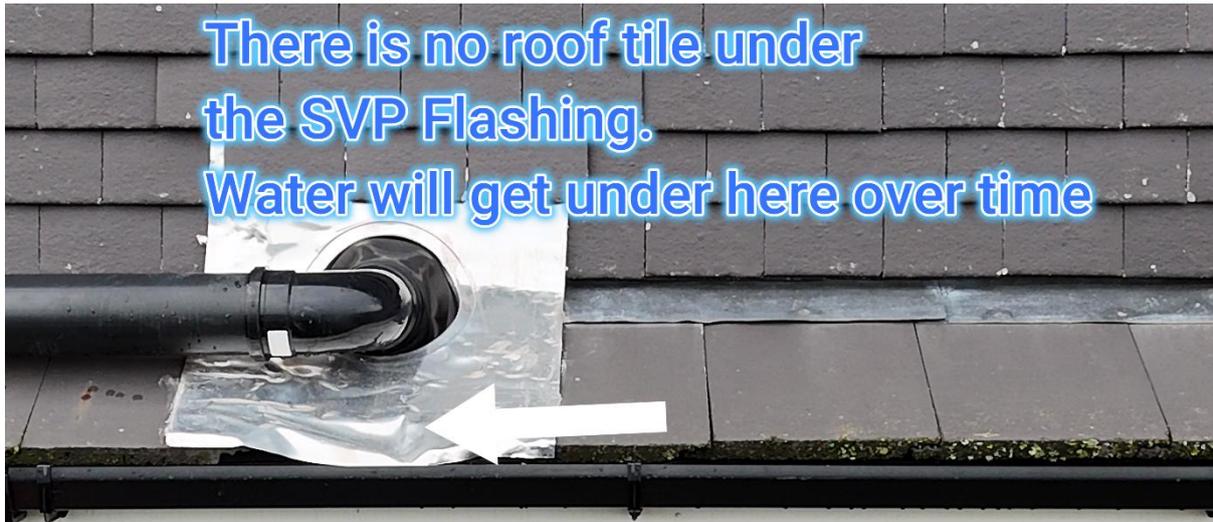
There is no roof tile under the SVP Flashing.
Water will get under here over time

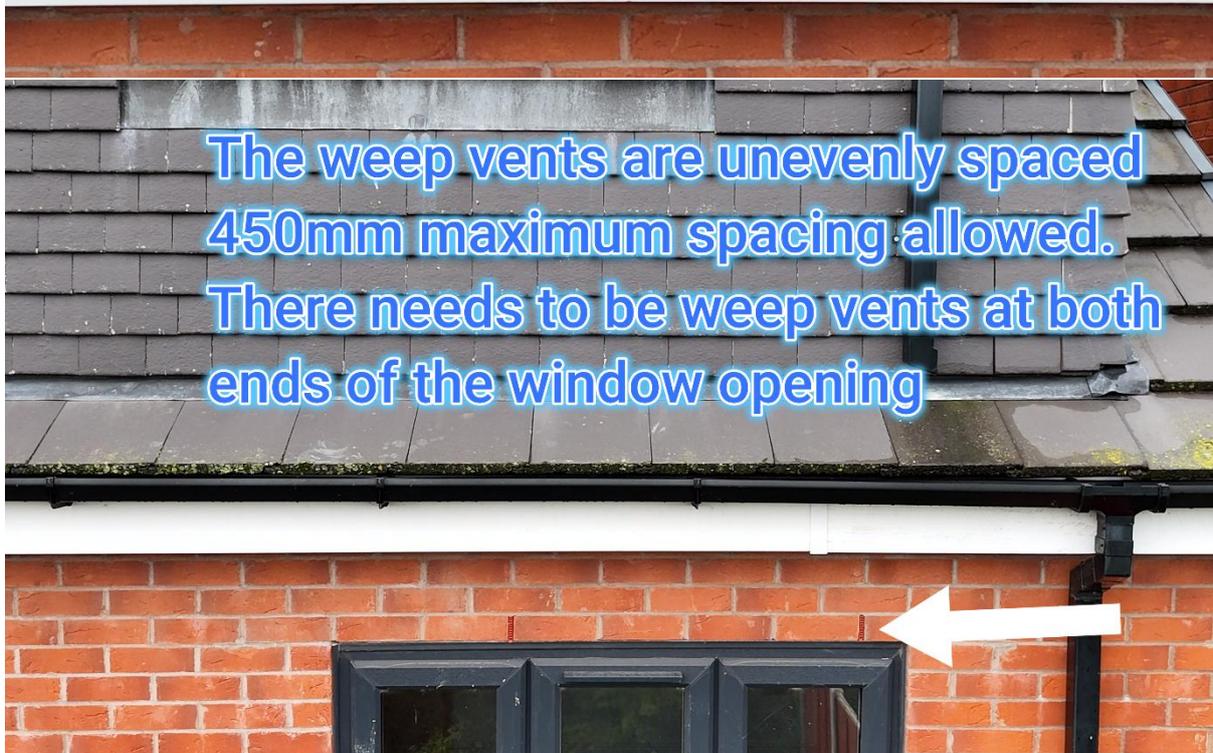
The weep vents are unevenly spaced
450mm maximum spacing allowed.
There needs to be weep vents at both
ends of the window opening

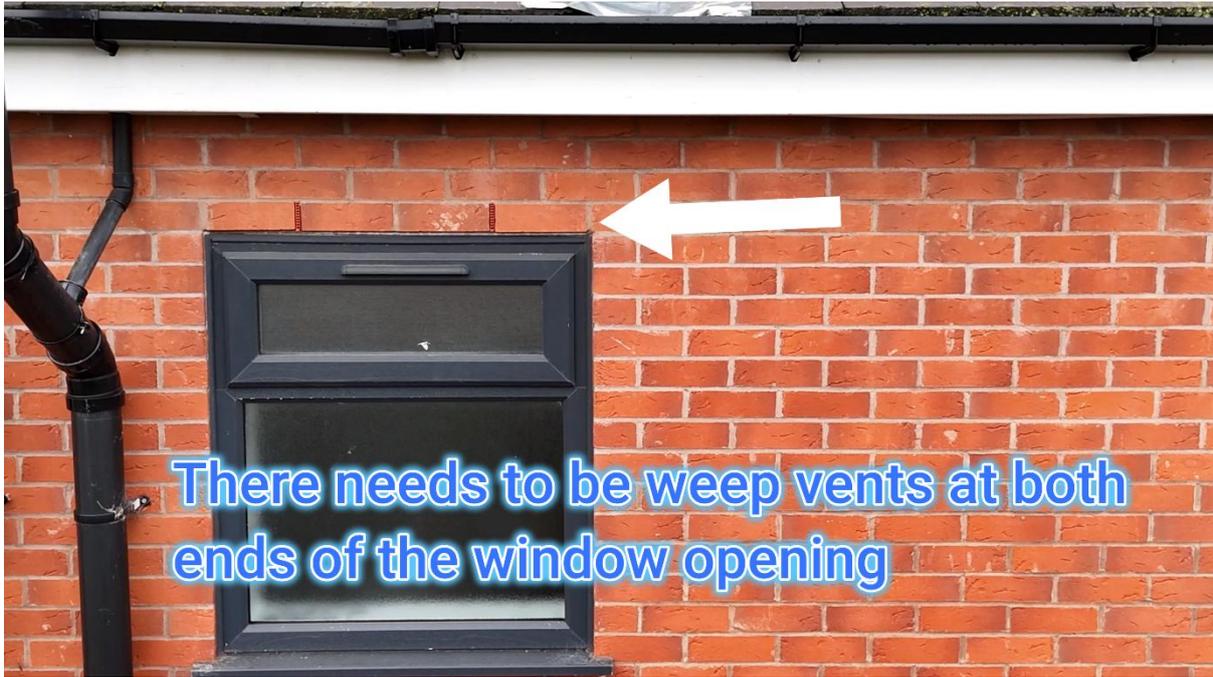
There needs to be weep vents at both ends of the window opening

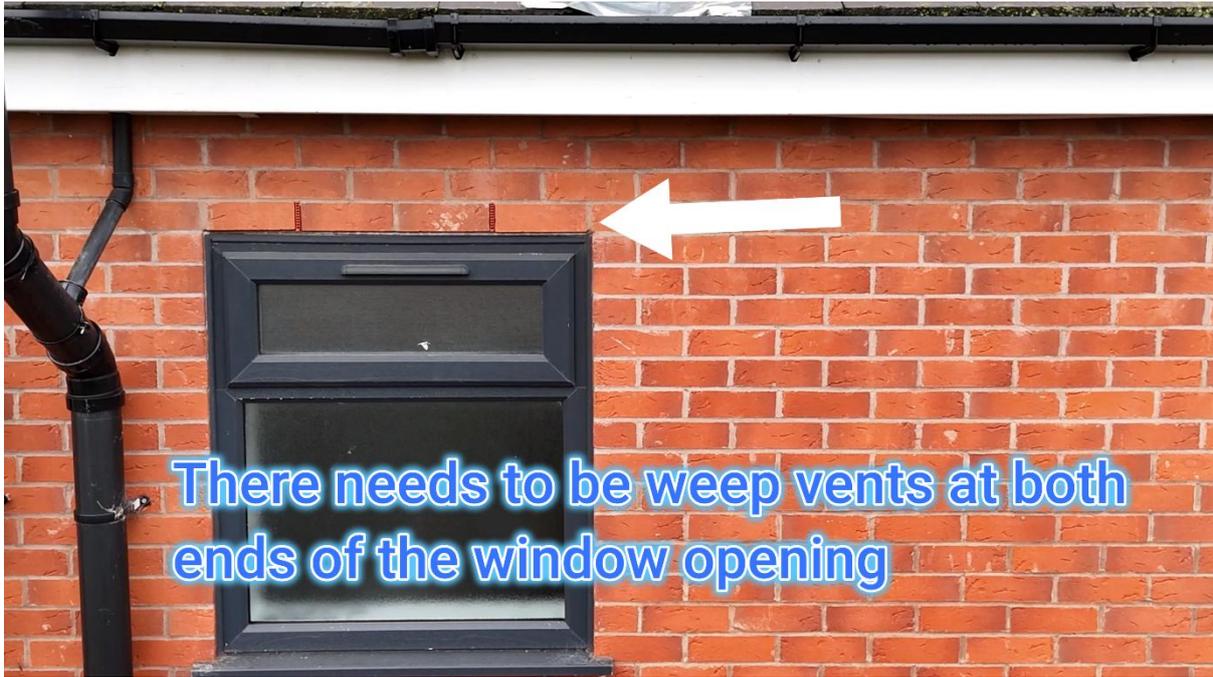
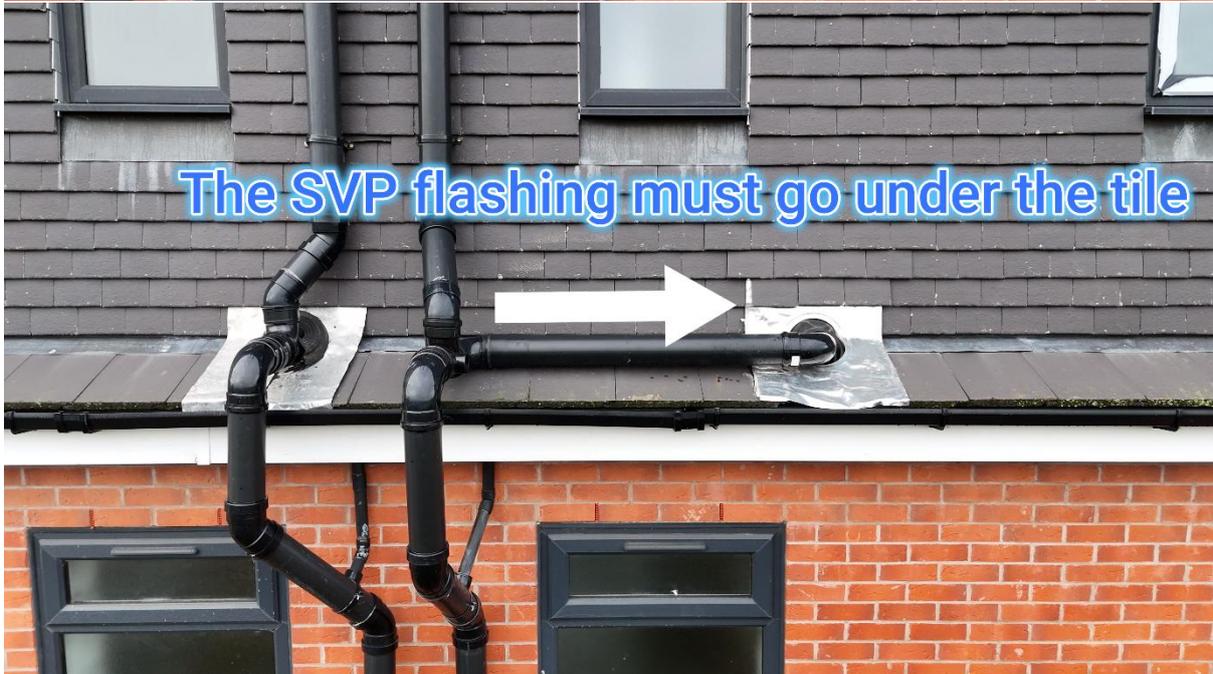
The weep vents are unevenly spaced
450mm maximum spacing is allowed.
There needs to be weep vents at both
ends of the window opening
