PROFESSIONAL
SNAGGING
SURVEYS

LAUREN HOUSE

25TH JANUARY 2025

Instruction was received on 20th January 2025 to undertake a snagging report of the property at Lauren House, Example Rd, GL20 7GG. The survey was carried out on 25th January 2025.

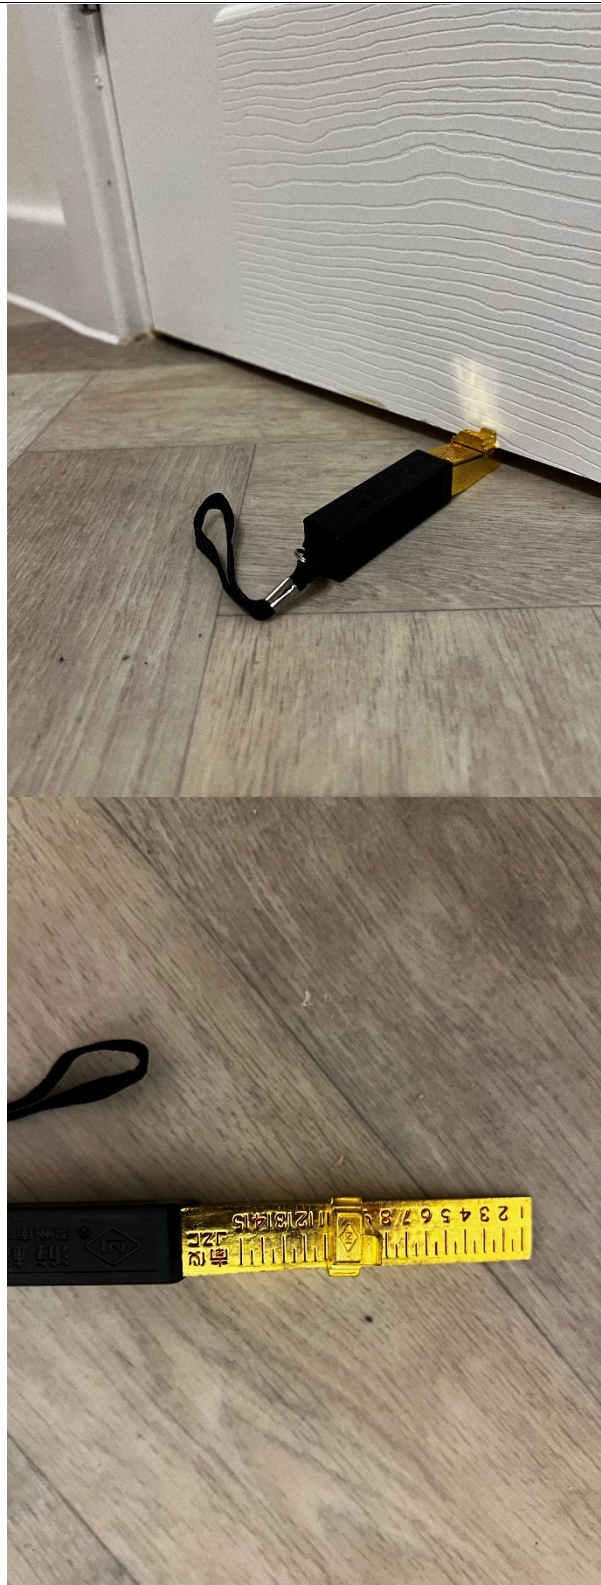
The fire door into the front room has a gap of 15mm which is 5mm over the allowed gap for a fire door.

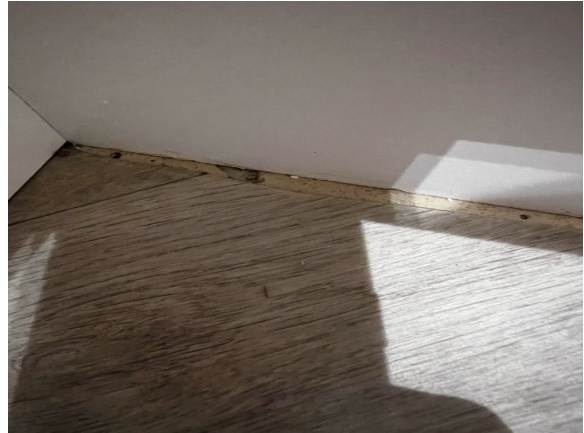
The flooring in the kitchen has been cut too short and is visible and will need to be replaced

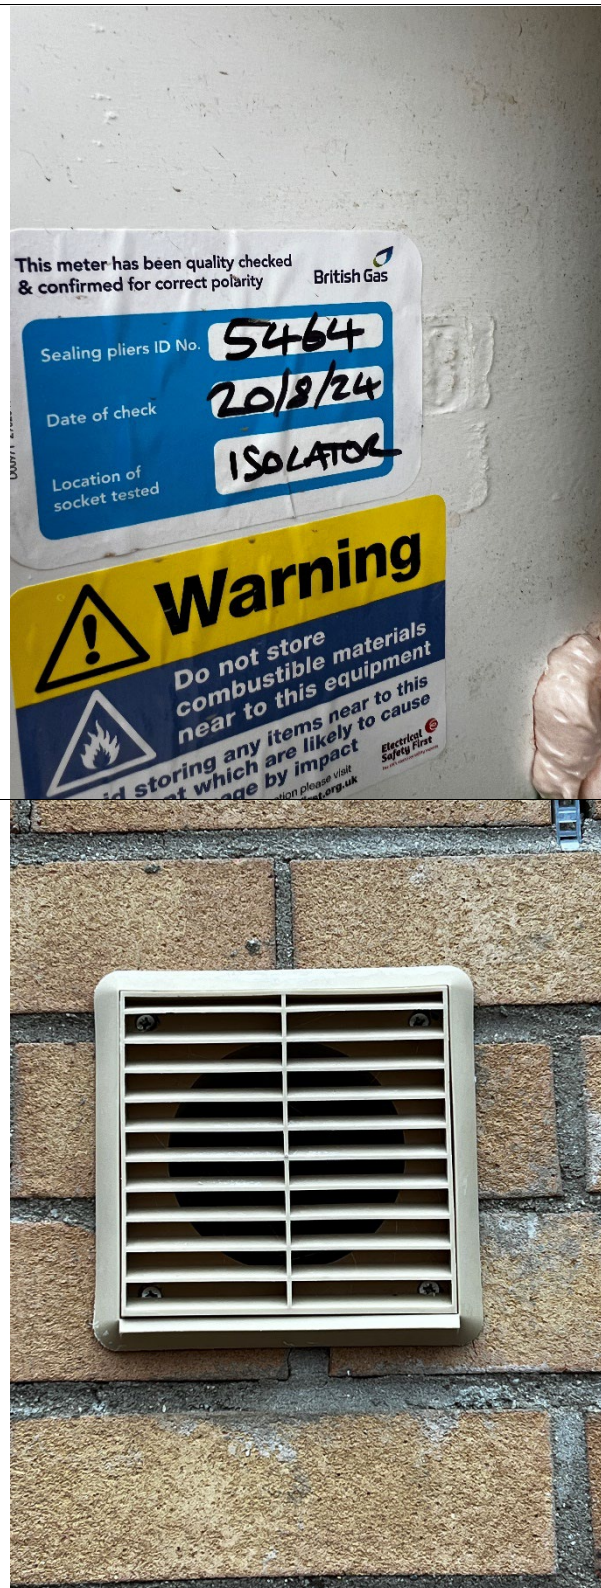
Vents require wind protection to be installed to stop wind ingress throughout the property

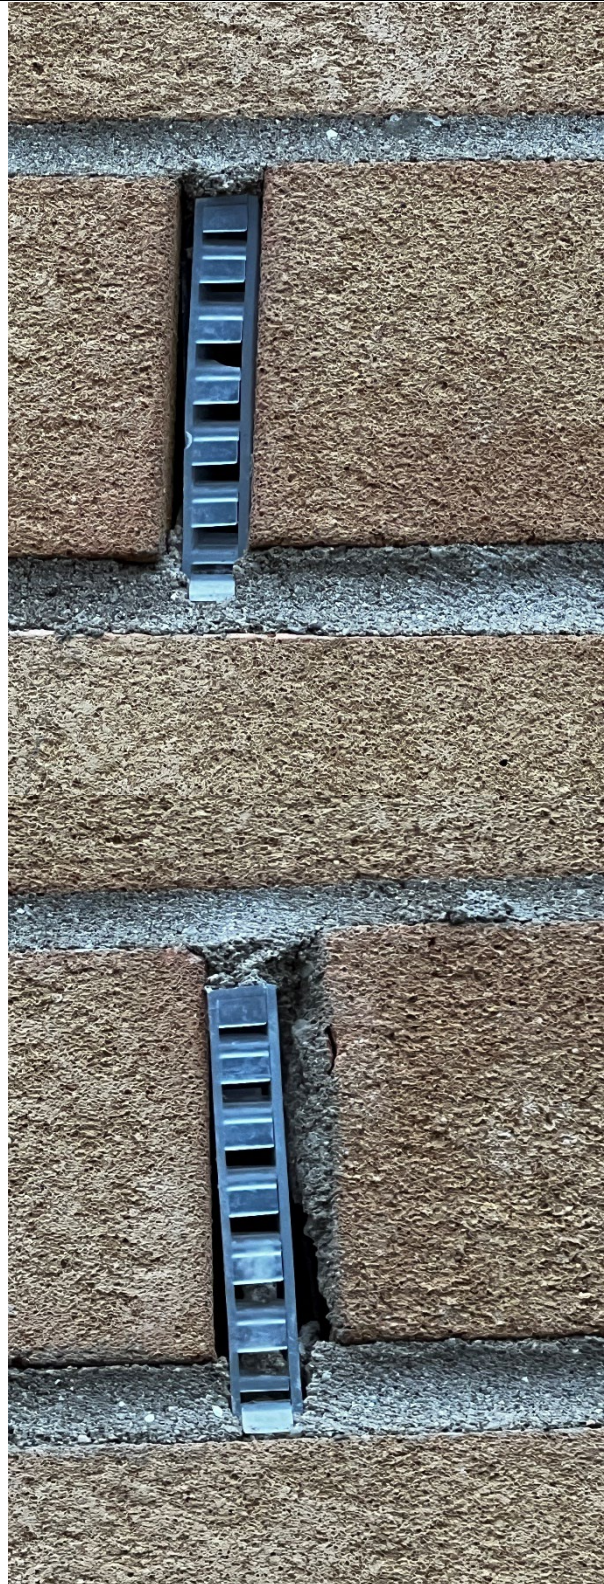
All weep vents need to be properly pointed in.

This is an issue throughout the property.

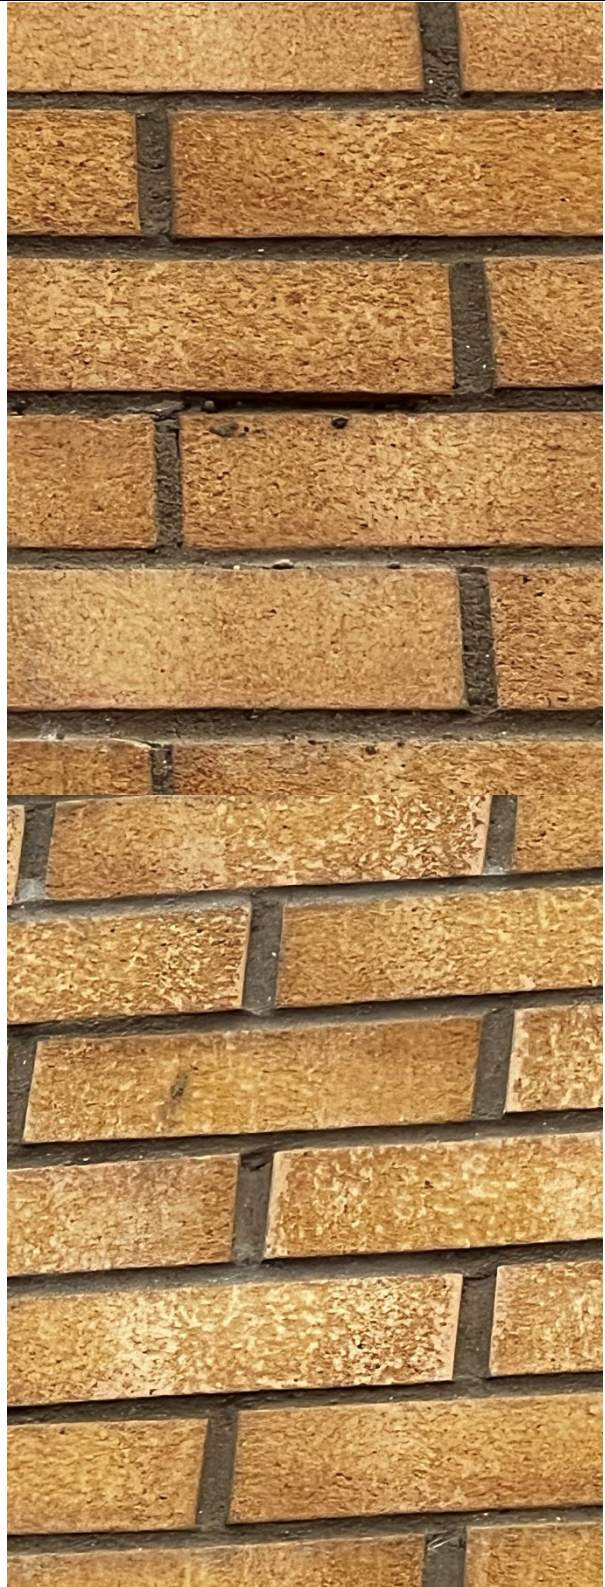
Pointing required

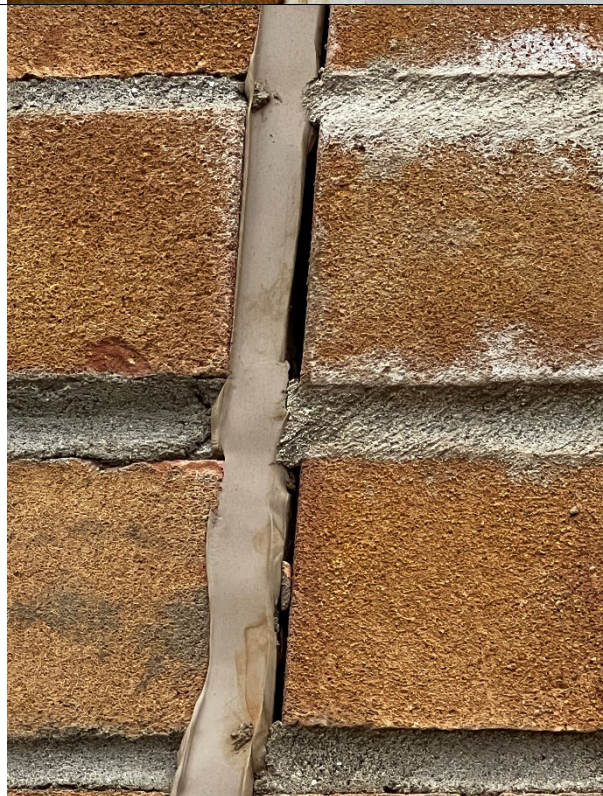
Movement joint needs attention

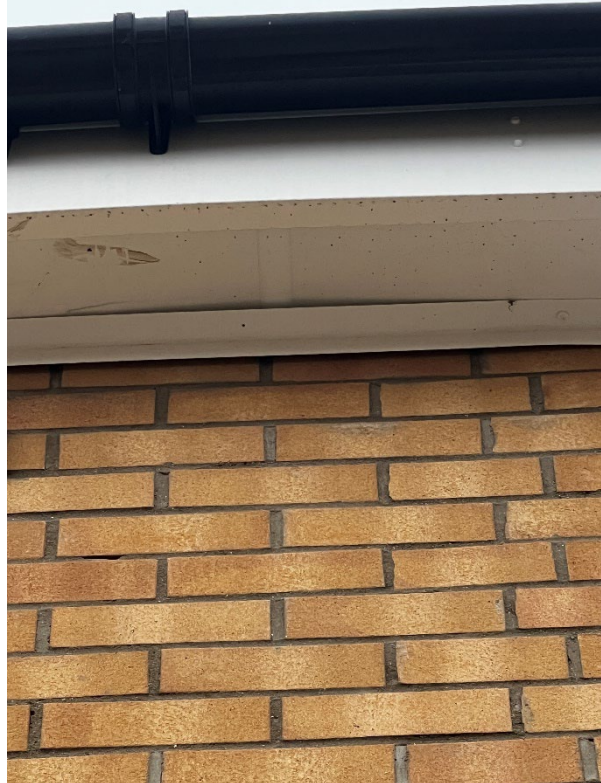
The trim onto the soffit is loose and needs properly fixing back all around the property

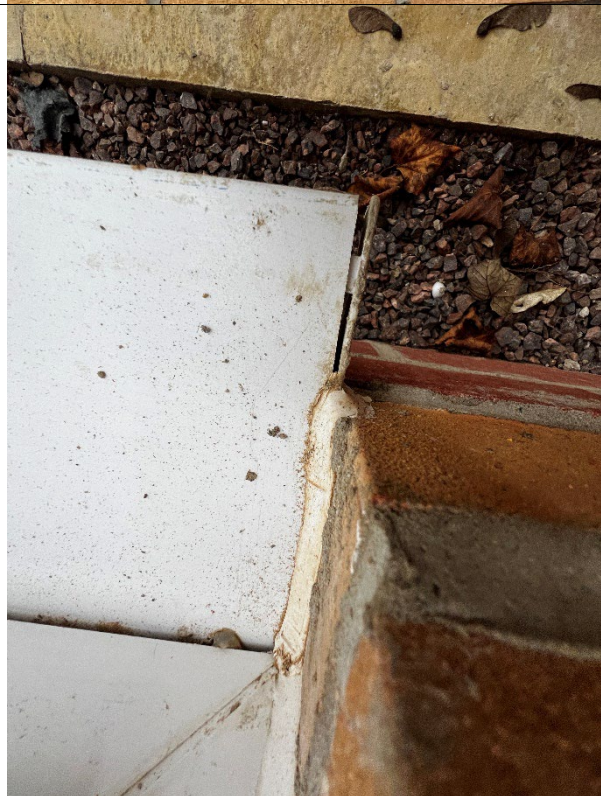
The window sill cover end caps are all loose and need to be glued/fixed into position

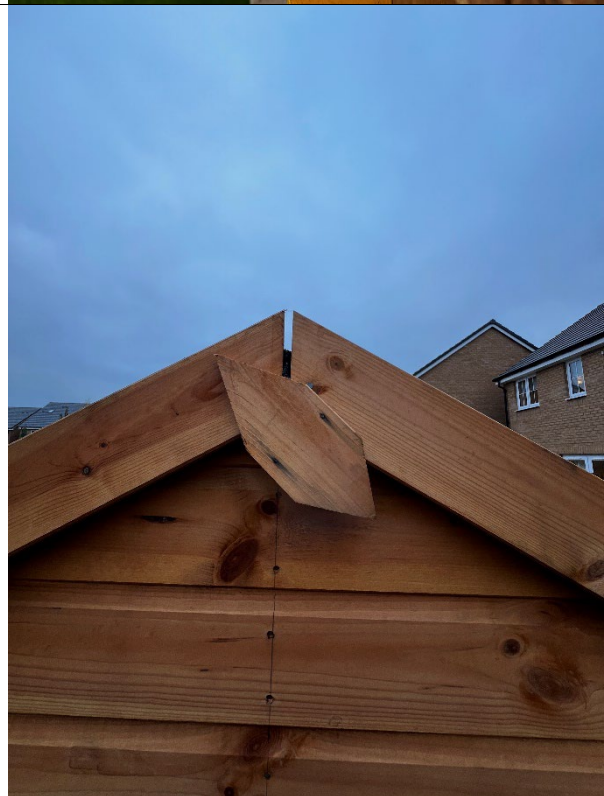
The shed needs attention

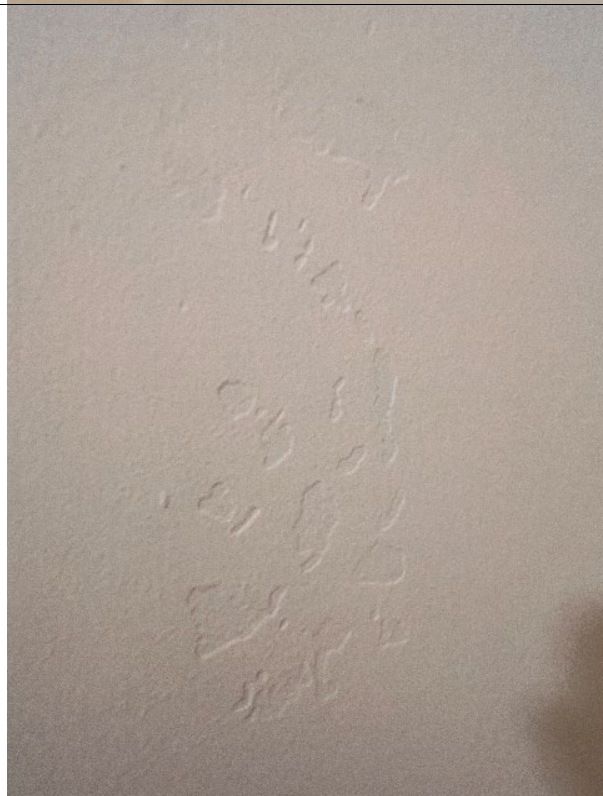
More decoration required within
this area

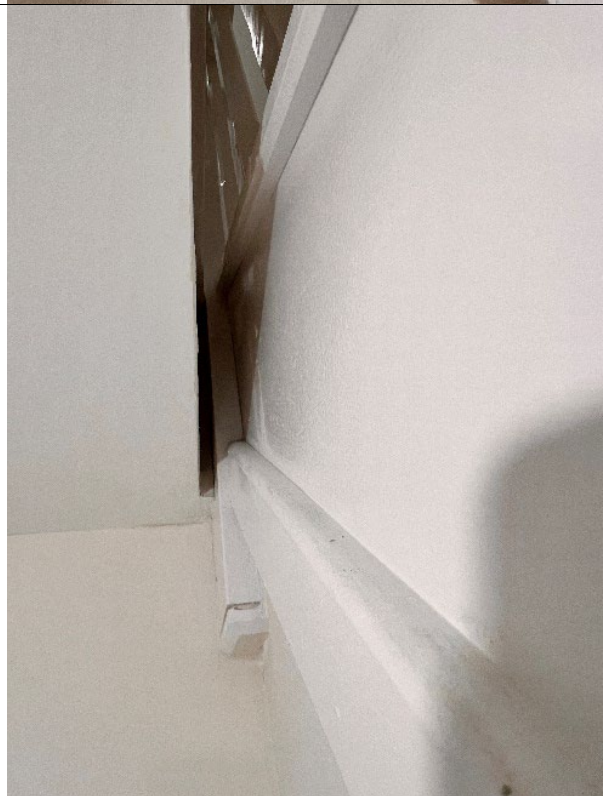
Decoration required throughout this area

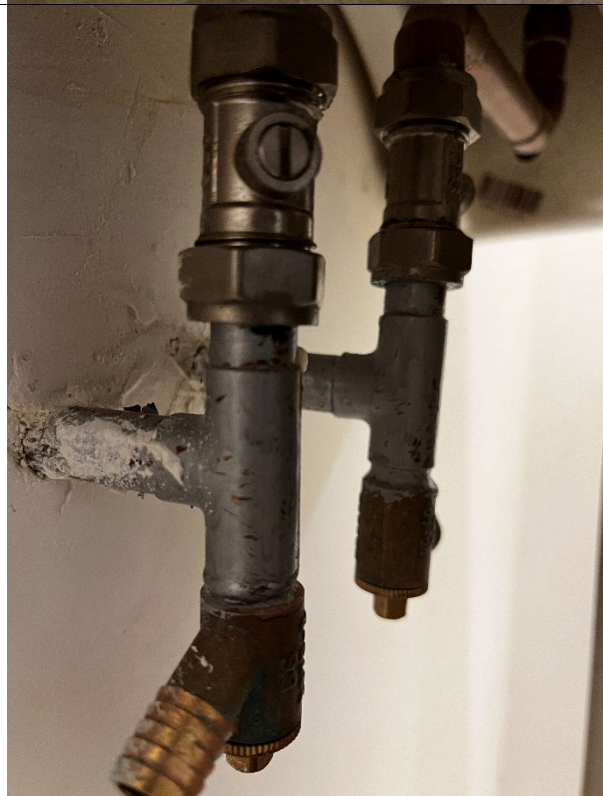
Decoration required

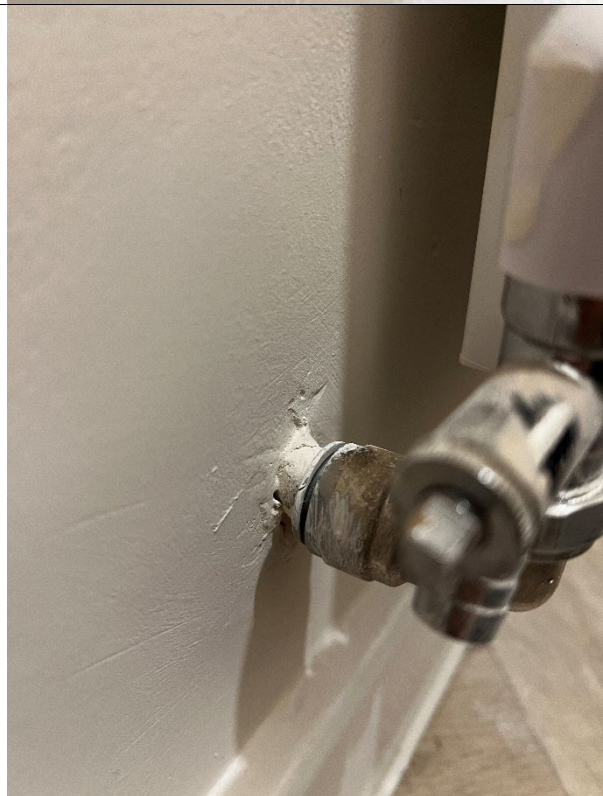
More decoration is required

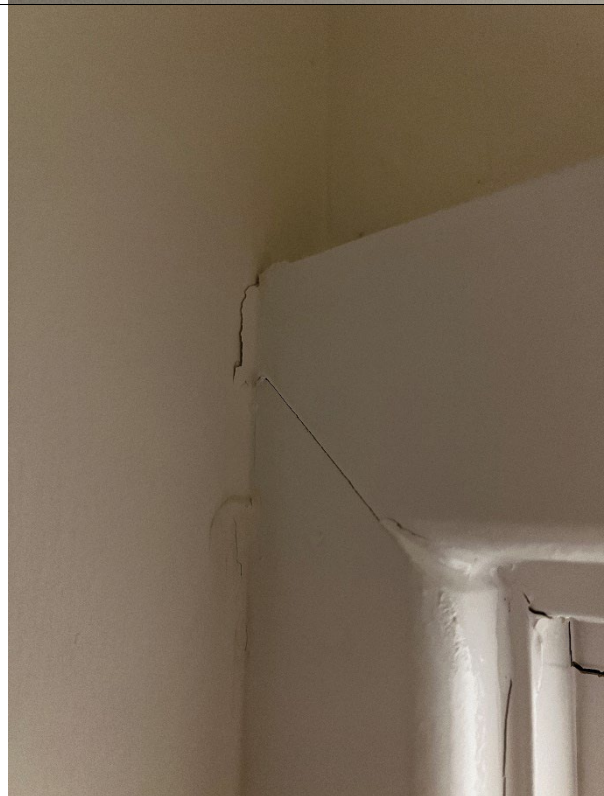
Decoration required to architrave
and wall connection and paint
required to the top of the
architrave

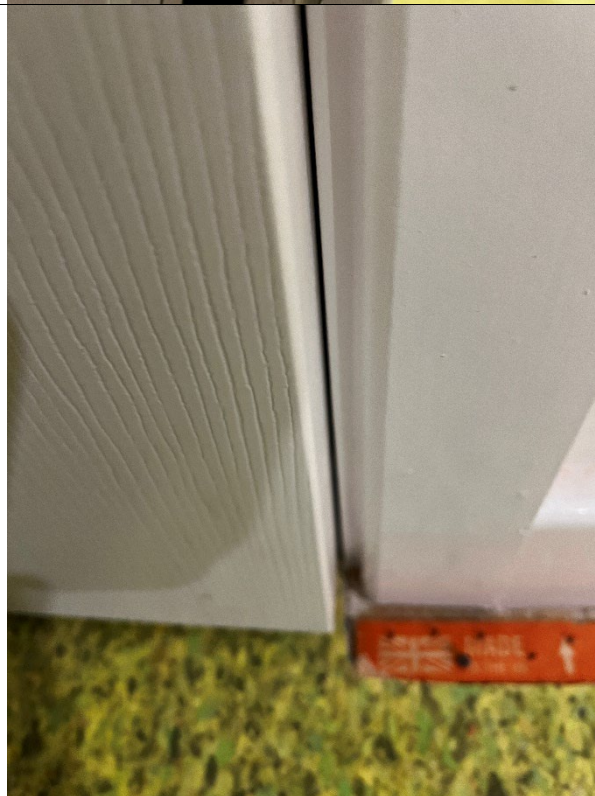
Door binding at the bottom,
needs adjusting

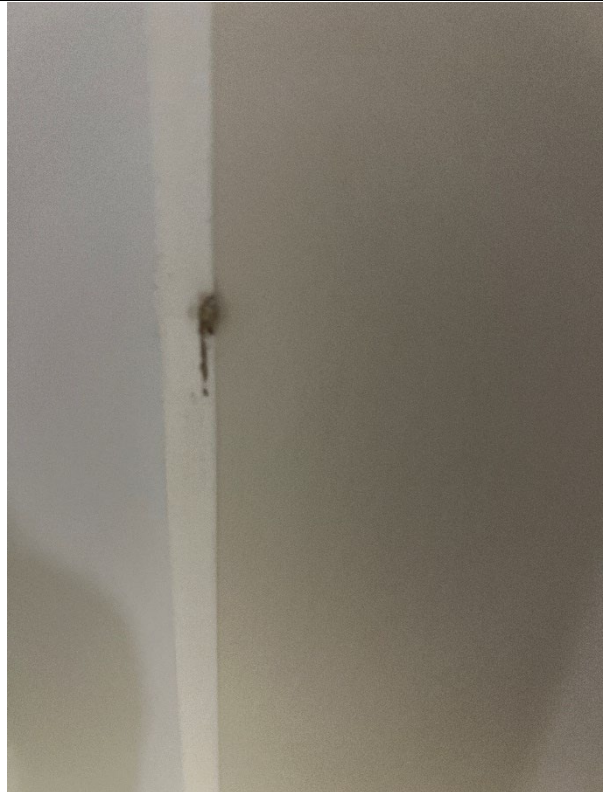
Damage to the corner need decoration

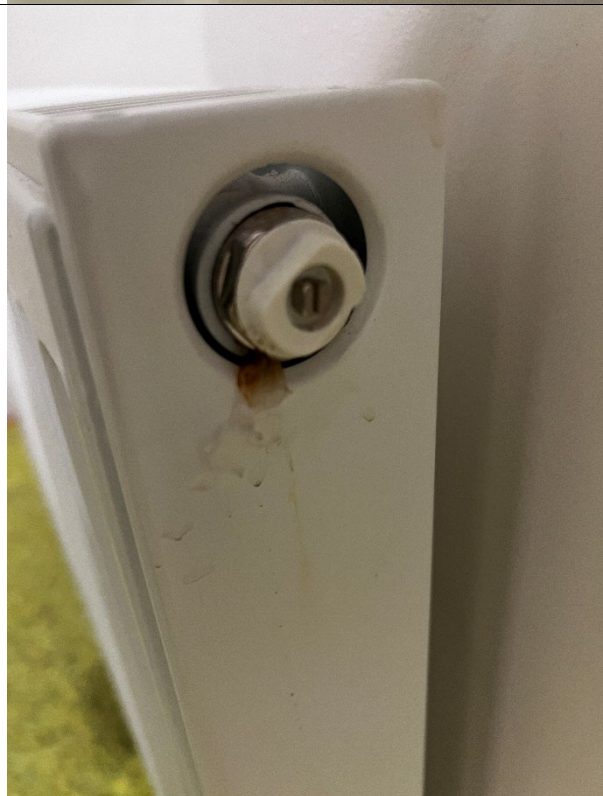
Radiator bleed valve needs cleaning and checking for leaks

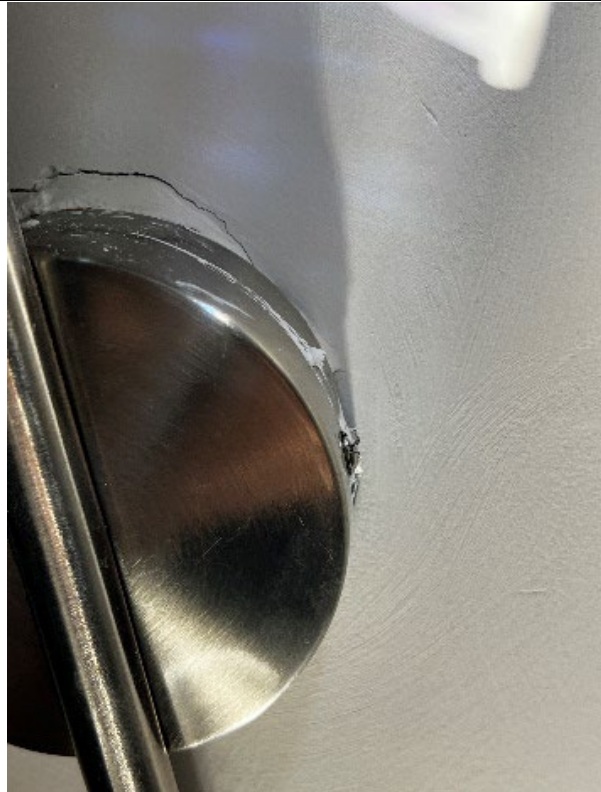
Decoration around the light pendant need's decoration.

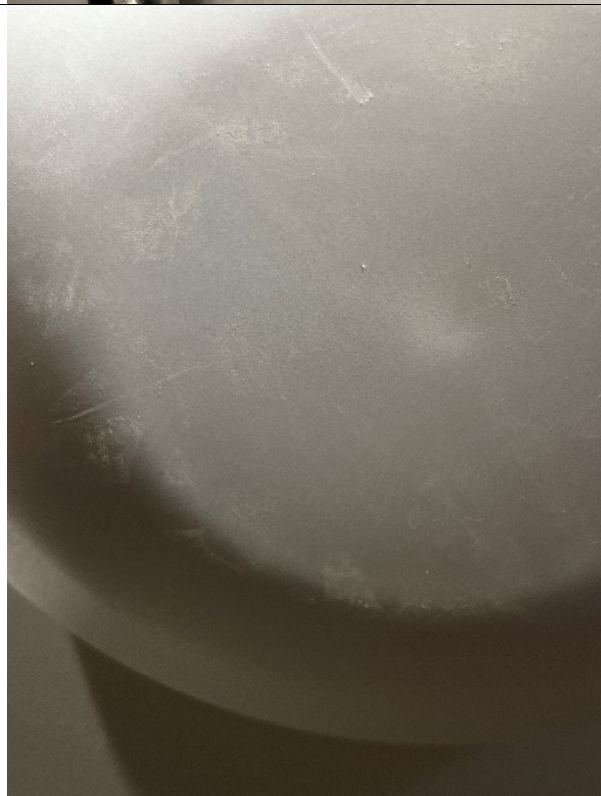
The external fan cover is scratched and dirty, this will need to be replaced.

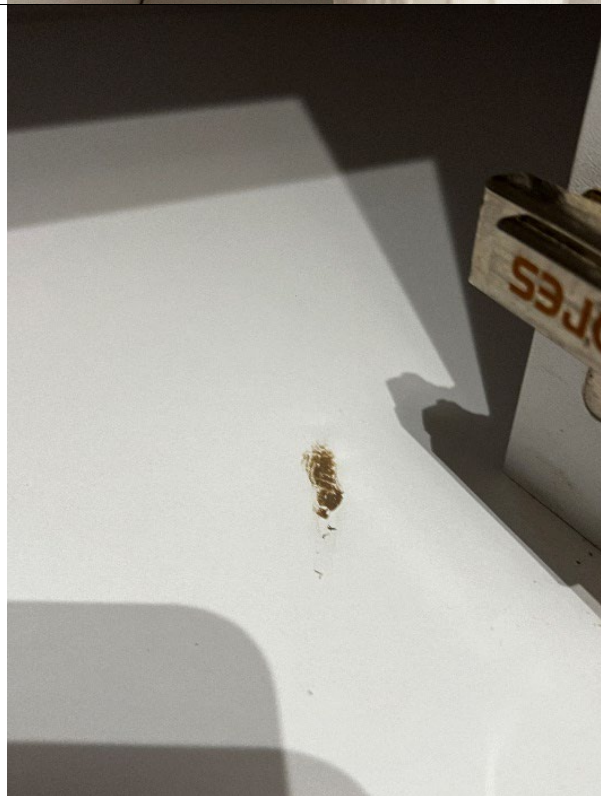
Burns to the base unit floor, this
will need to be fixed via a magic
man or a new base unit installed

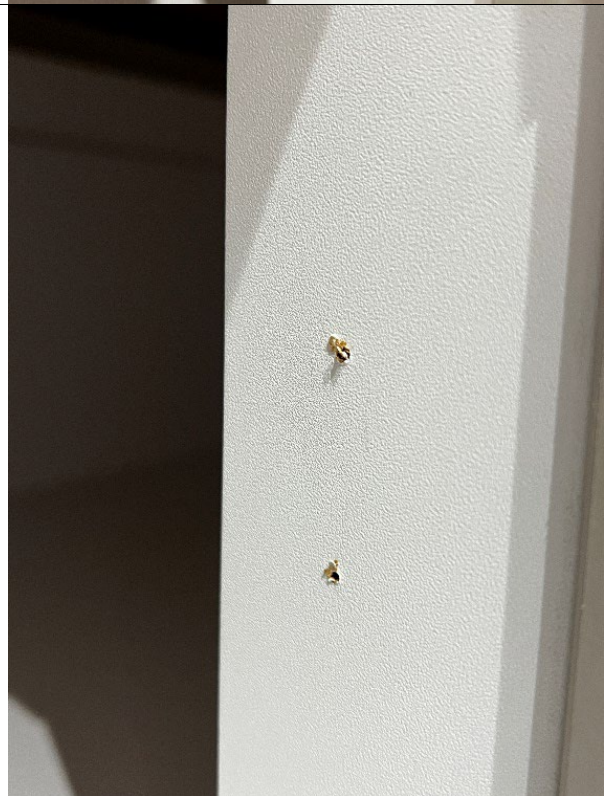
Holes in the base unit reveals needs to be addressed

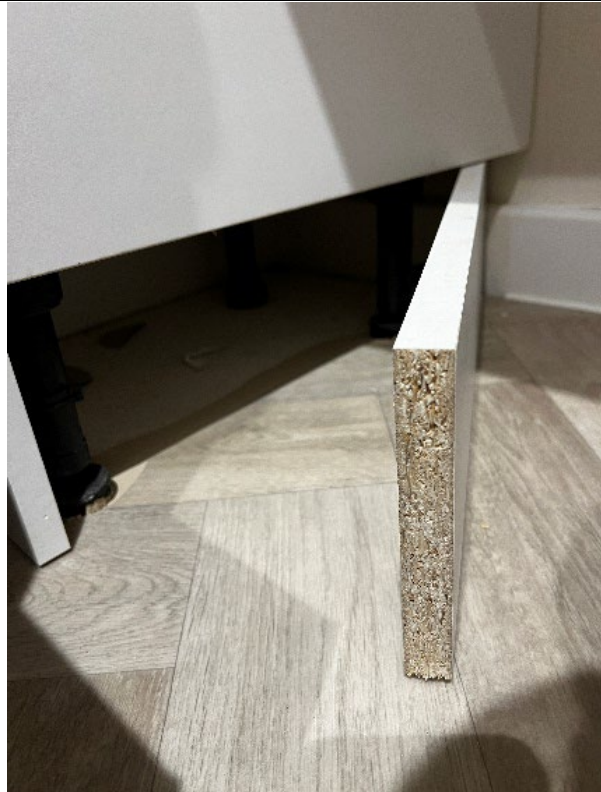
The plinth isn't properly fitted and missing clips to hold it securely in place

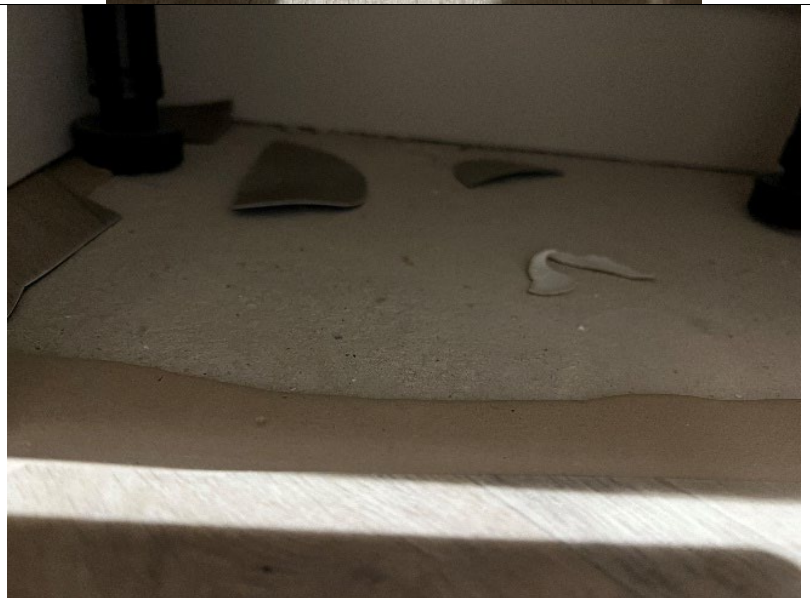
Rubbish left under the kitchen base units needs to be cleaned out

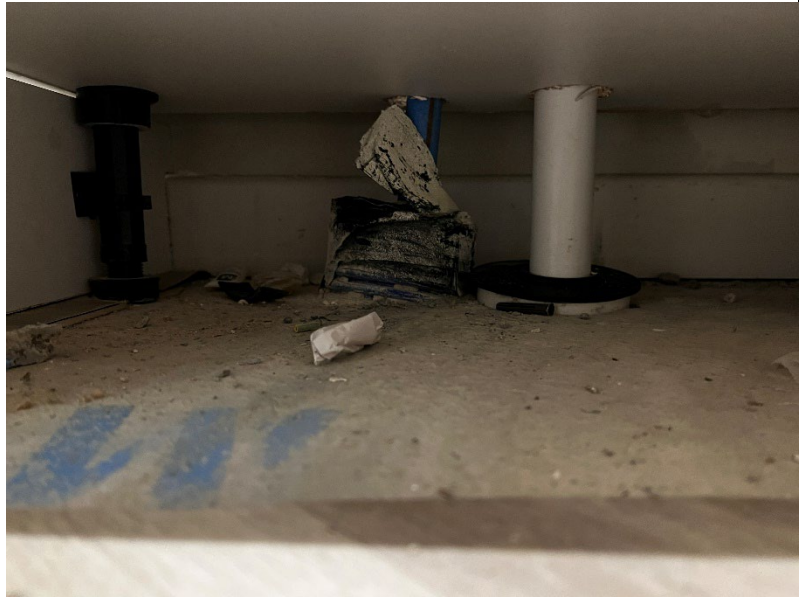
As above

Also, the water pipe needs
sealing to stop air ingress

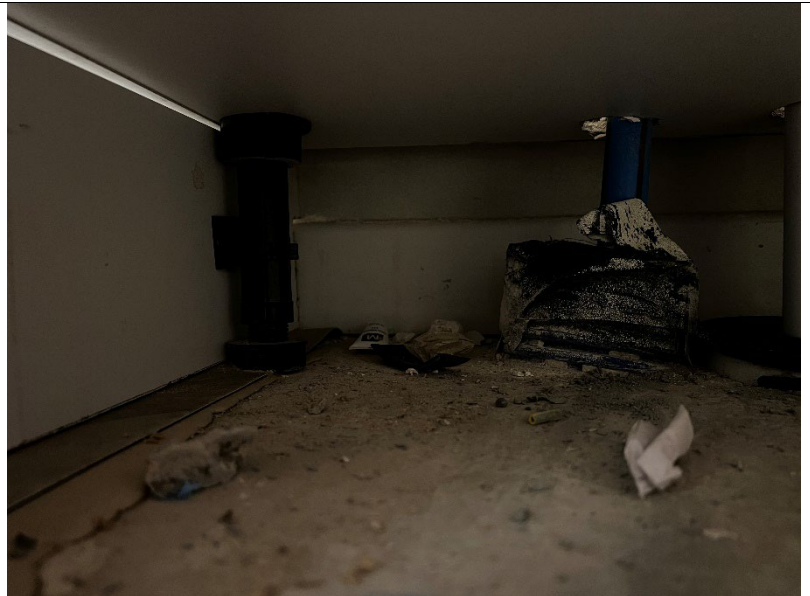
Debris under the kitchen base
units needs cleaning out

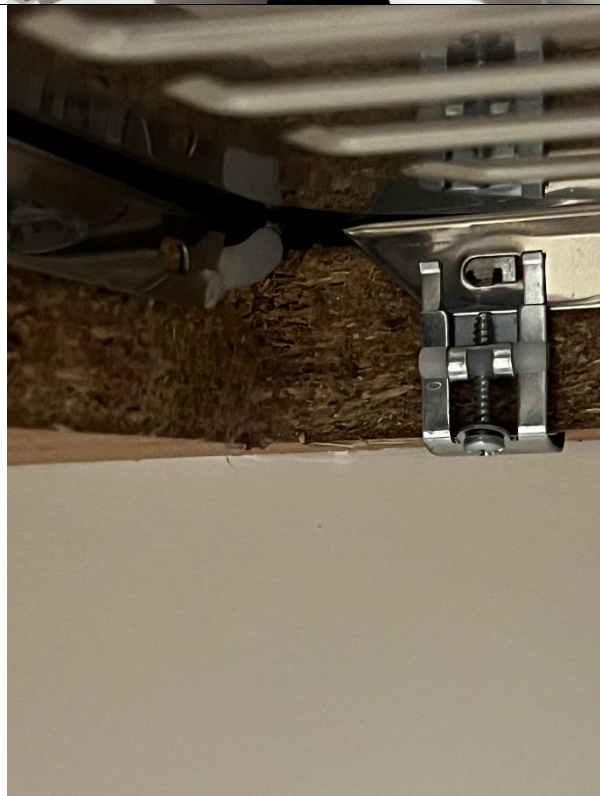
No silicon is visible to the kitchen sink cut out; this needs to be applied to stop water destroying the worktop over time

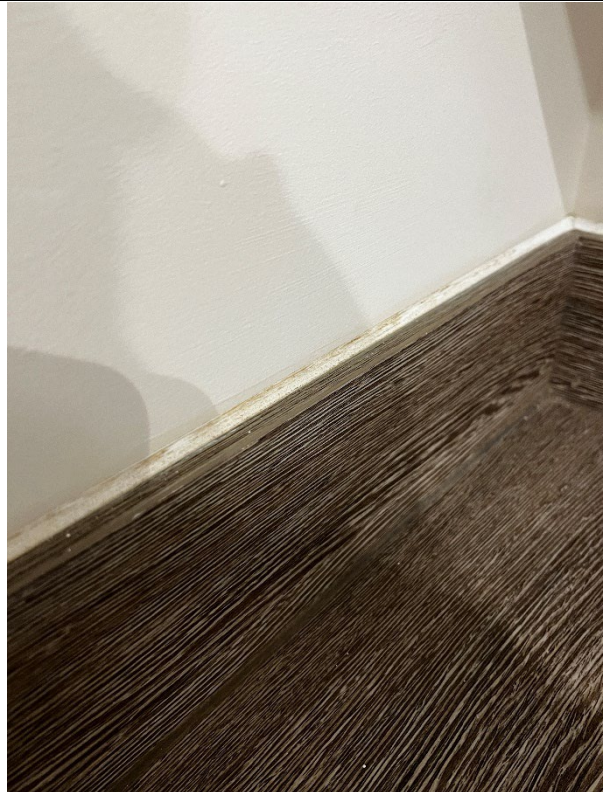
The silicon seal on the splashback is dirty and needs to be replaced

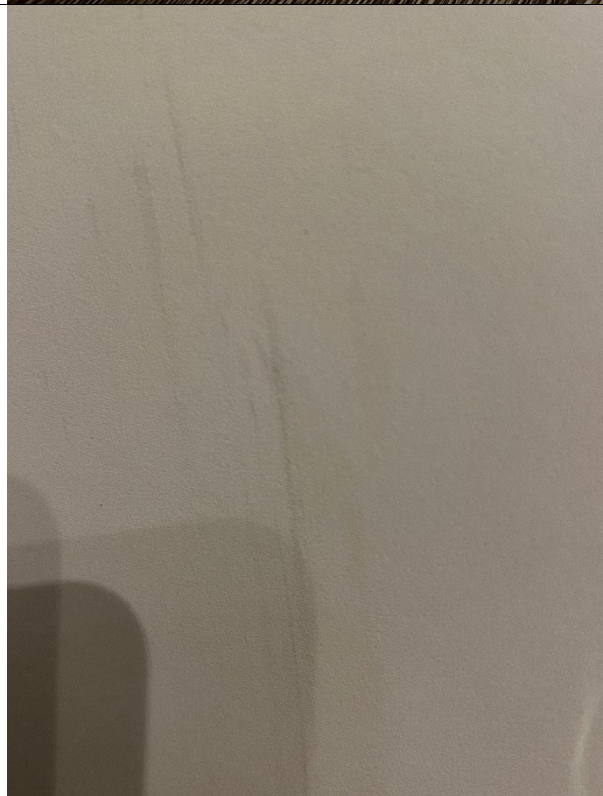
Marks on wall need to be decorated

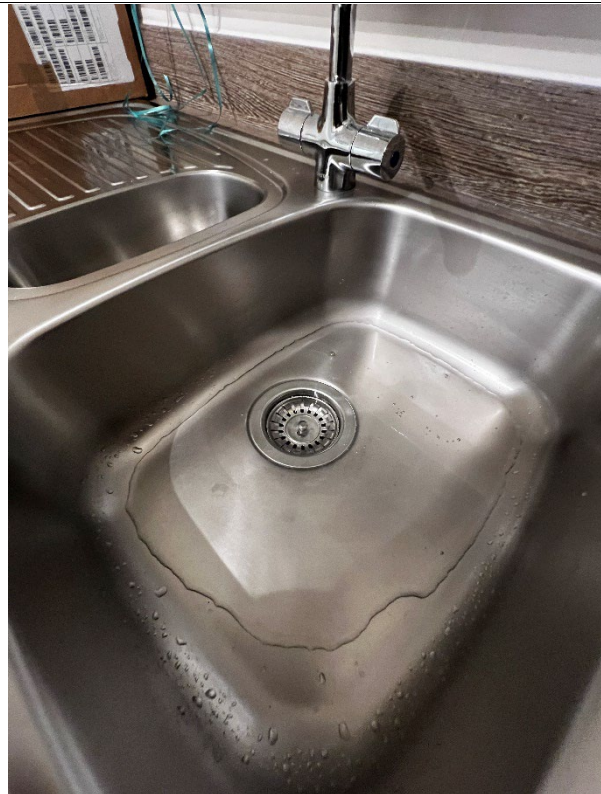
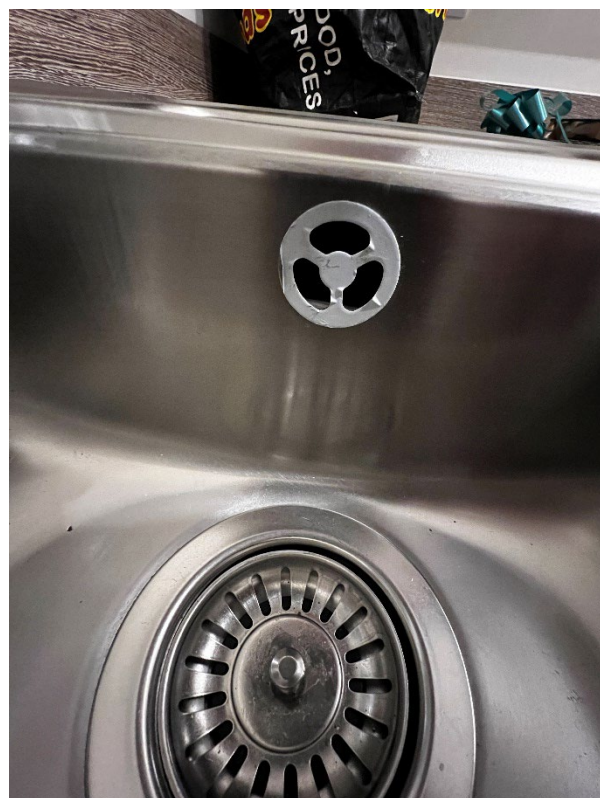
The sink hasn't got an overflow ,
and the protective cover is still
on the 1.5 bowl as shown below
on the photo

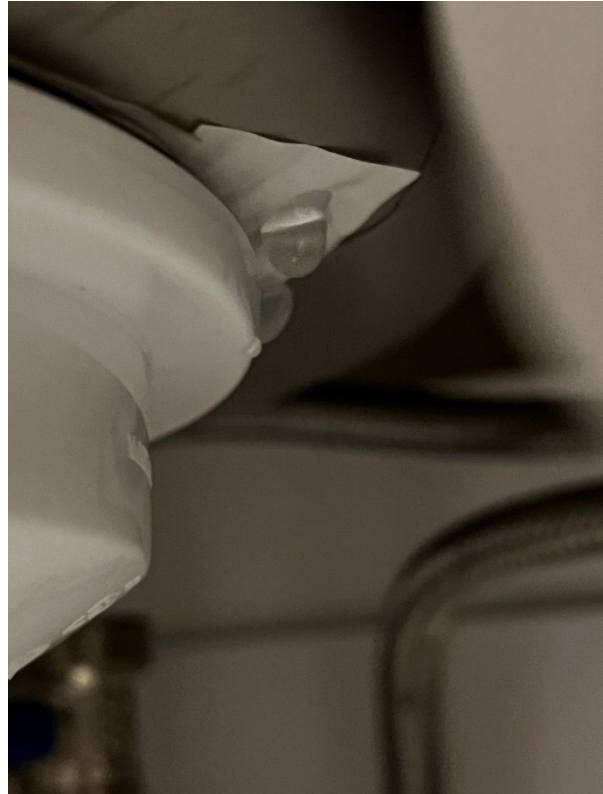
The sink has a leak from the sink waste, this needs to be fixed.

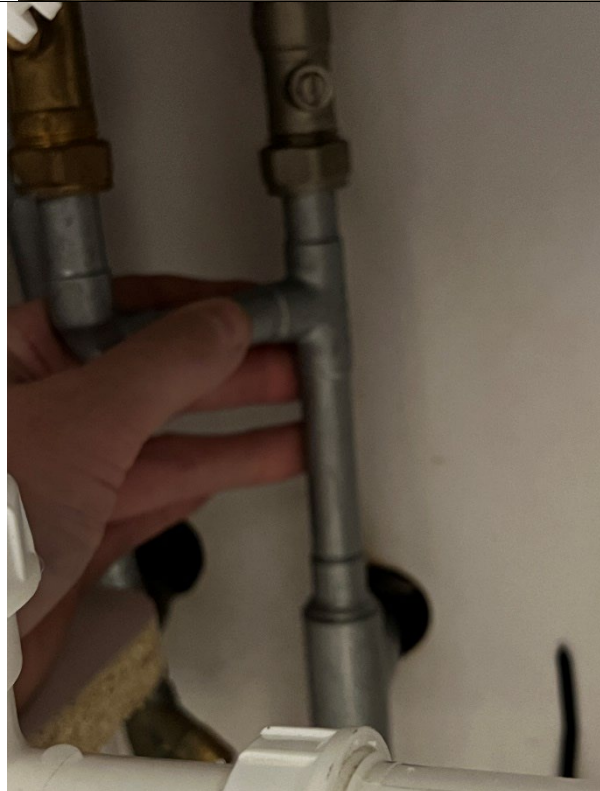
Pipes loose and will need clipping to secure

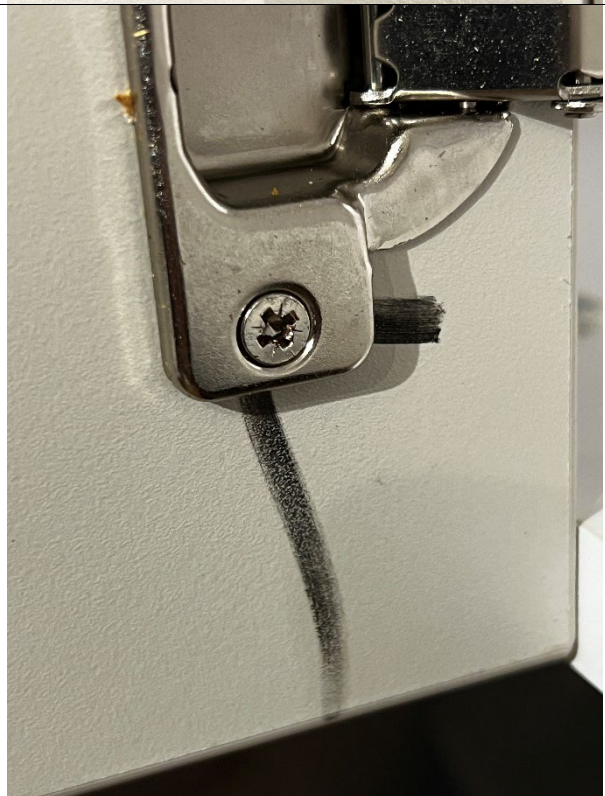
Marks on wall unit doors will need cleaning off

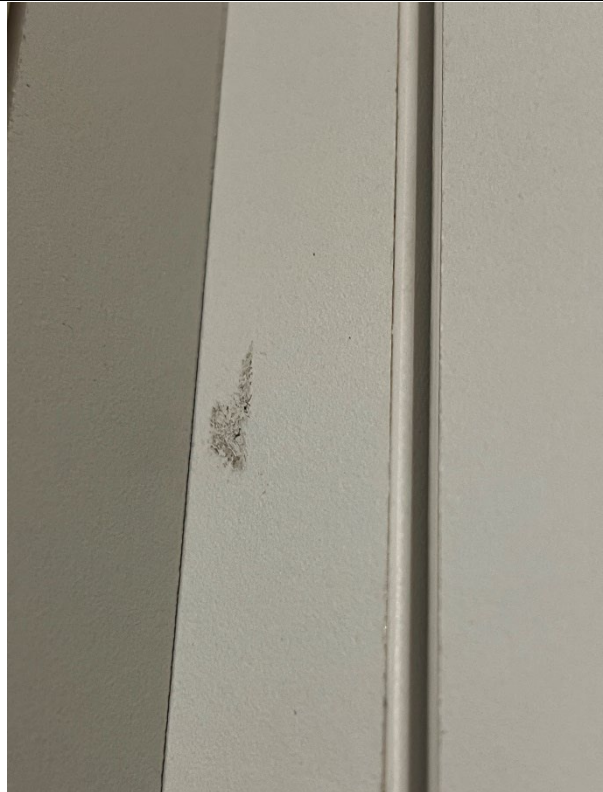
More damage to walls that need decoration

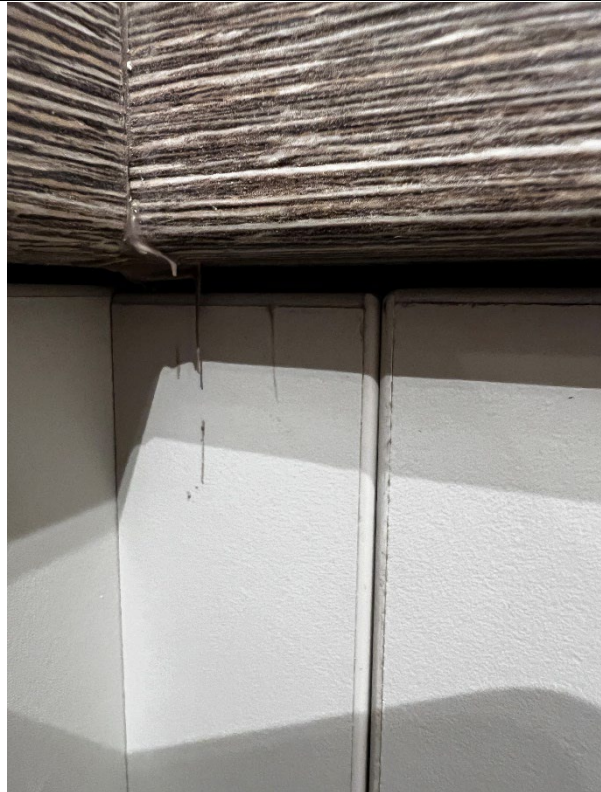
Various marks on the kitchen
base units needs to be fixed

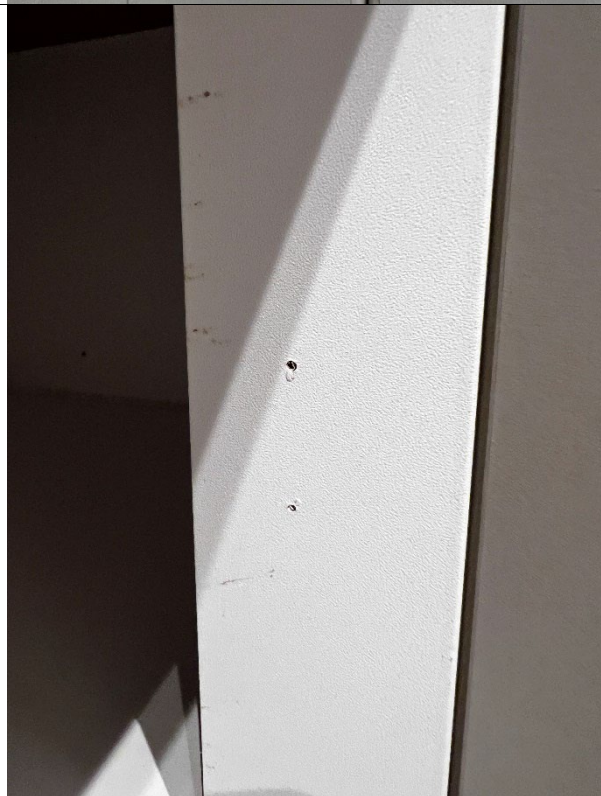
More damage to base unit
reveals needs fixing

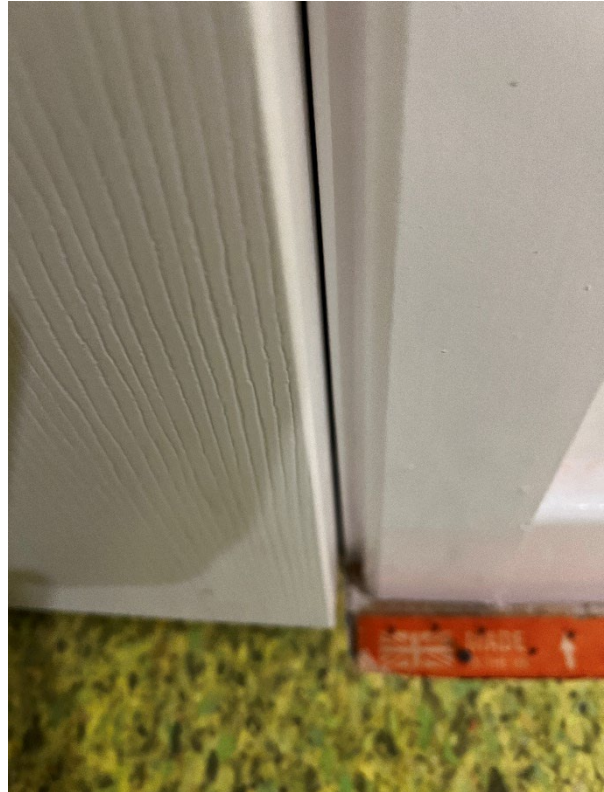
Door binding at the bottom,
needs adjusting

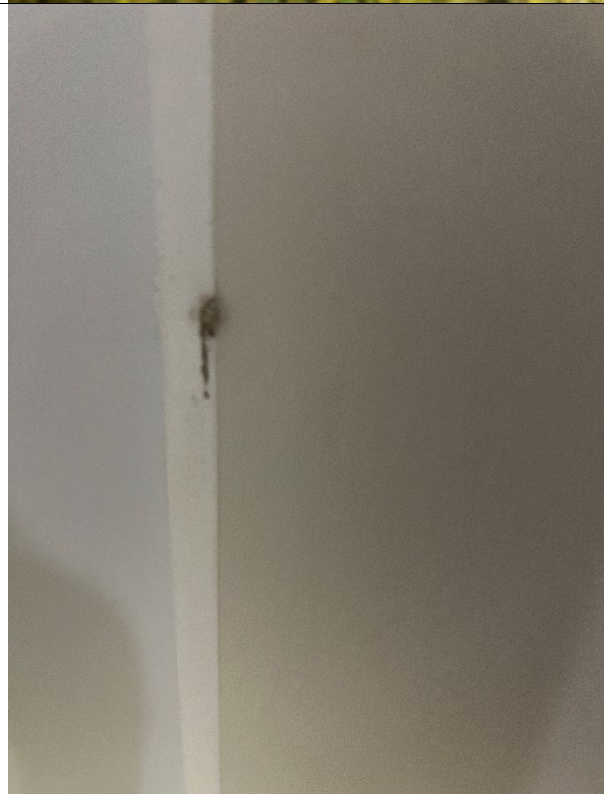
Damage to the corner need
decoration

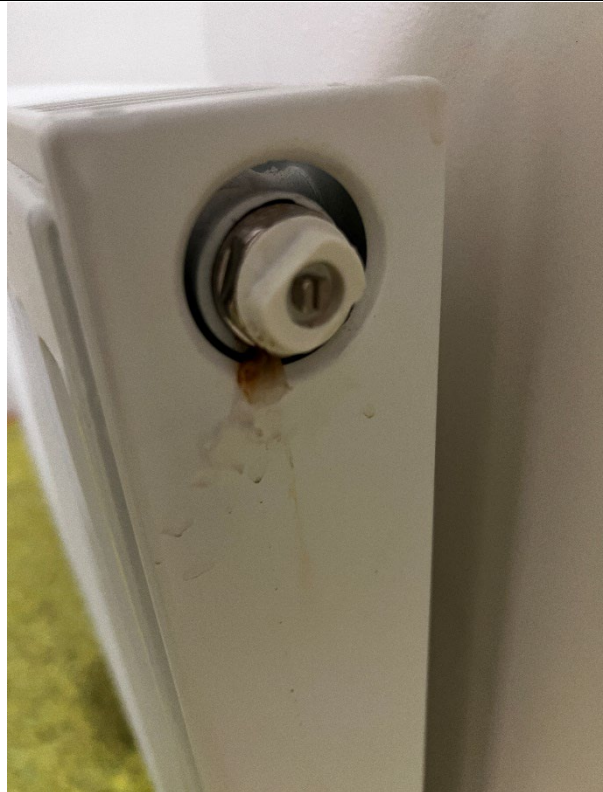
Radiator bleed valve needs
cleaning and checking for leaks

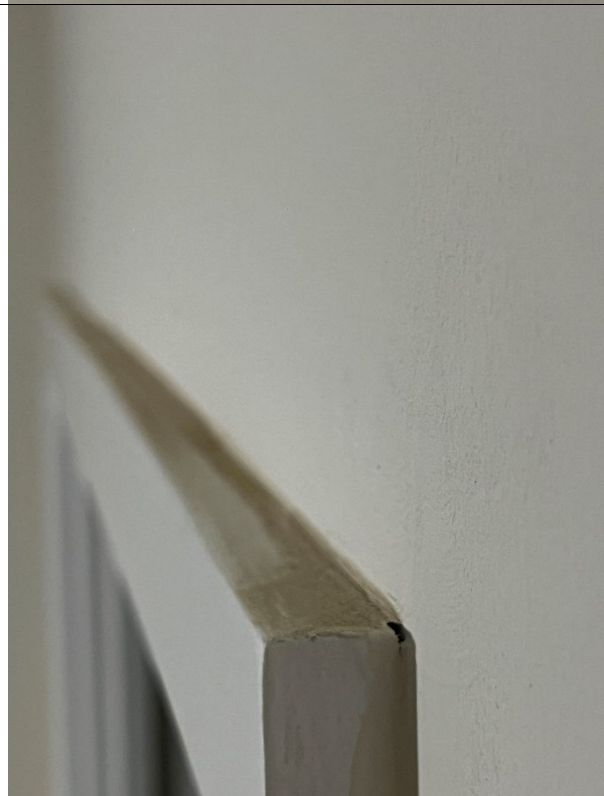
The top of the architrave needs decoration , this is throughout the whole house!

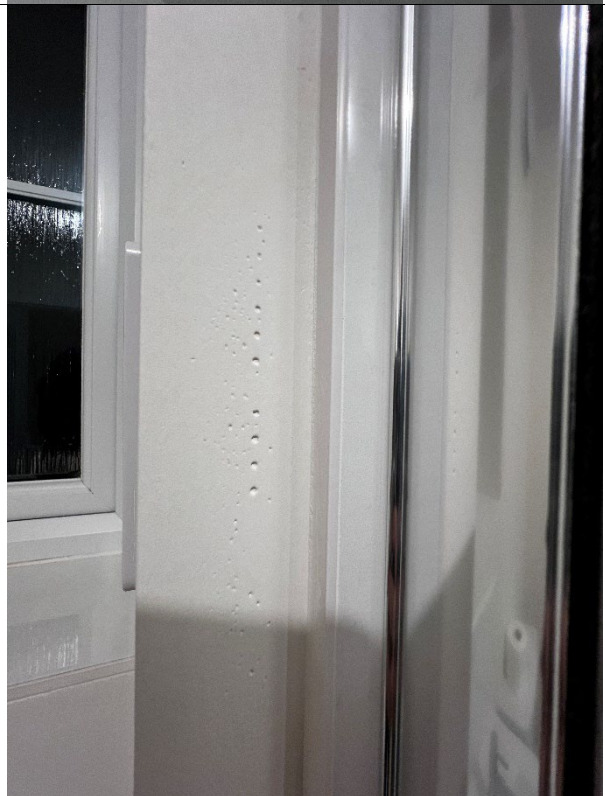
Decoration required by the shower

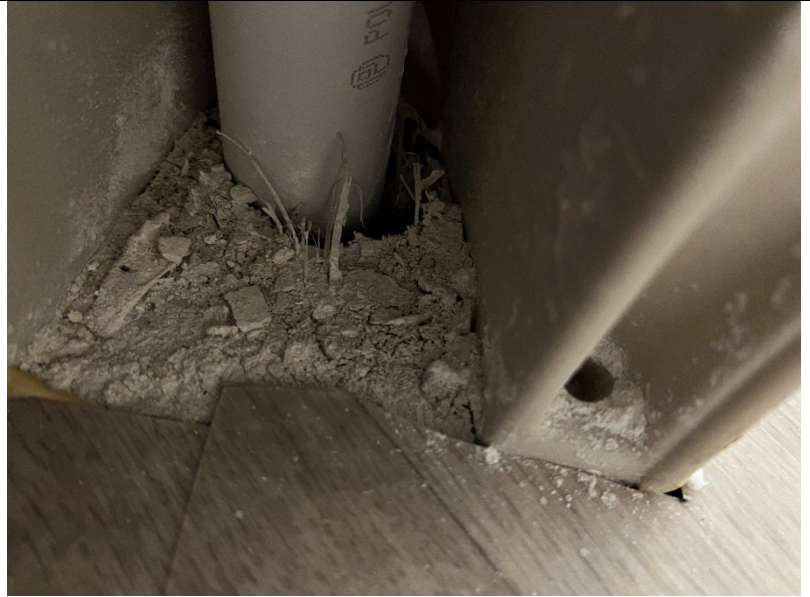
Has this house been cleaned?
This is appalling!

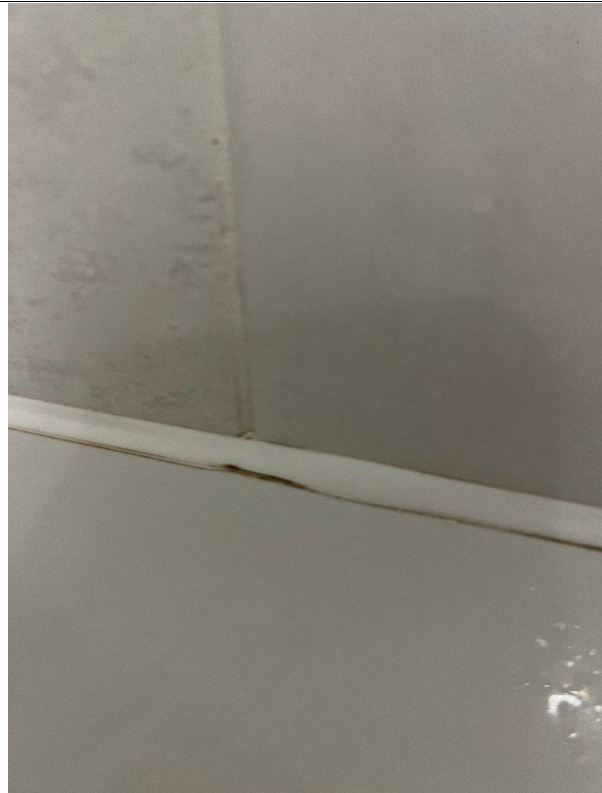
Silicon to bath needs replacing
with fresh silicon that isn't
stained and fitted incorrectly
