PROFESSIONAL
SNAGGING
SURVEYS

LAUREN HOUSE

25TH JANUARY 2025

Instruction was received on 20th January 2025 to undertake a snagging report of the property at Lauren House, Example Rd, GL20 7GG. The survey was carried out on 25th January 2025.

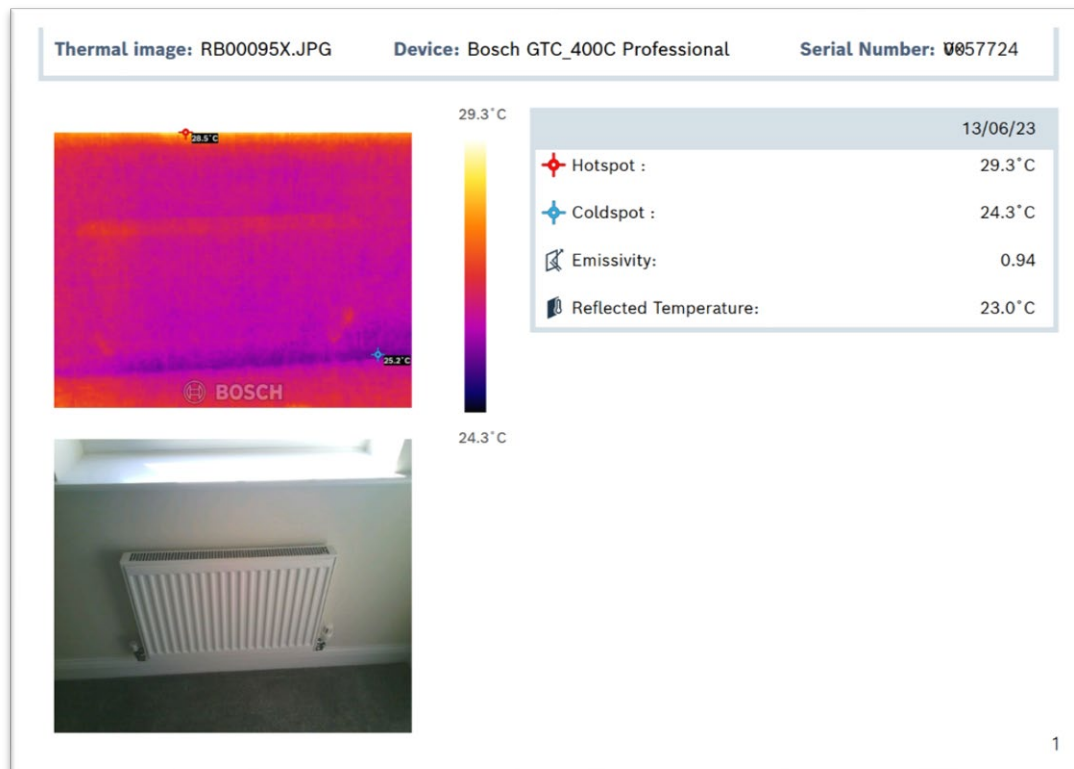
Image shows radiator not working

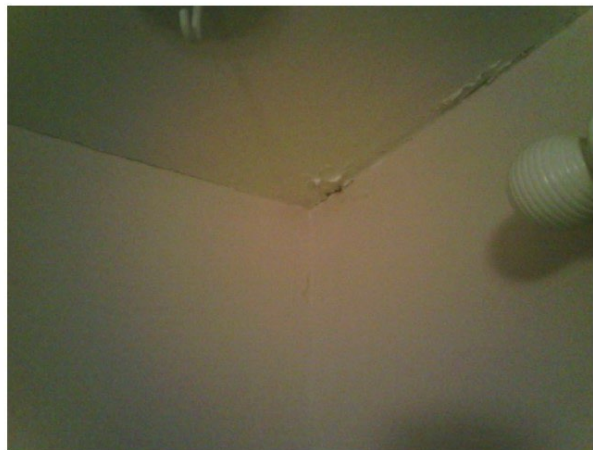
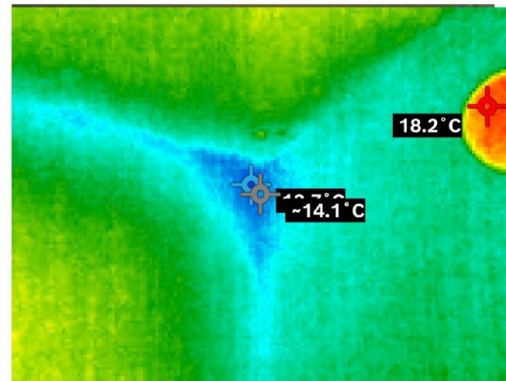
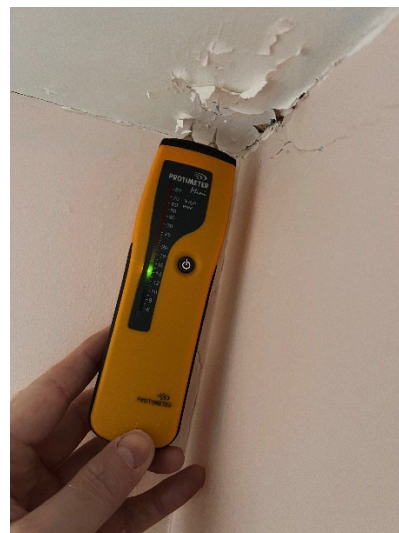
Client reporting cold spot in top corner of bedroom. Top image shows area overview, second image shows thermal image of cold spot. Third image shows the moisture meter not picking up any moisture. Insulation issue.

18.4°C

13.4°C

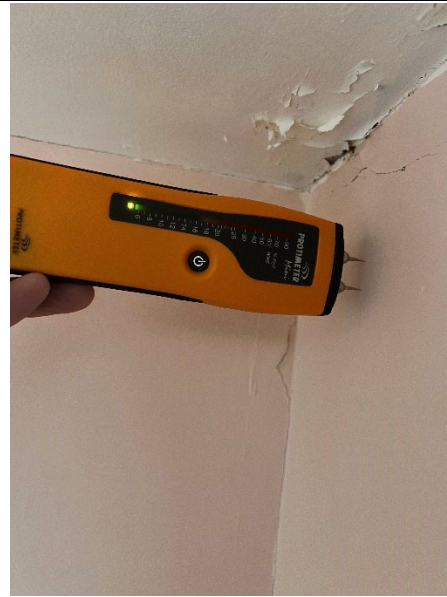
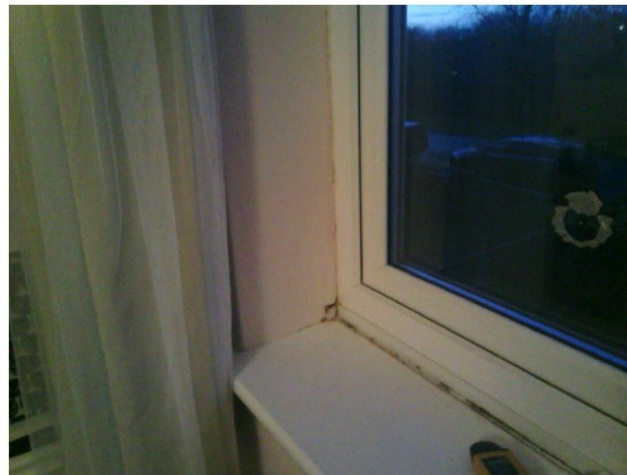
First image shows overview of internal window surround. Second image shows thermal image of cold spot. Third image shows the moisture meter picking up moisture. External seals need replacing.

19.5°C

9.7°C
