## Understanding of Grade 91 DMW Failures

Gang Zhou <sup>a</sup>, Jeff Henry <sup>a</sup>, Xu Tong <sup>b</sup>, Song Ming <sup>b</sup>, and Li Yi <sup>b</sup>

### Abstract

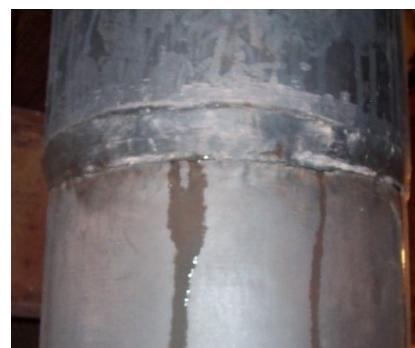
Since 2008, numbers of Grade 91 DMW joints have failed prematurely in service, with service lives less than 16,000 hours being reported in some cases [1-7]. The failures have included Grade 91 DMW joints in main-steam piping, superheat outlet header leads, steam outlet piping, steamline flowmeters, superheat header lugs and superheat tube attachments. Figure 1 shows an example of a Grade 91 DMW failure in main steam piping.

Figure 1. Shown is a failed Grade 91-TP321H DMW in a section of main-steam piping, with water leaking from a through-wall crack at the dissimilar metal interface [1].

The typical macrostructural features of a Grade 91 DMW failure involved a non-ductile cracking on Grade 91 side of the joint with no obvious branching, and the crack can be seen to closely follow the contour of the weld bead pattern as shown (Figure 1). In cases where the weld has not completely separated, the cracking typically is dominant on one side of the joint, with the damage concentrated within an arc of approximately 180°.

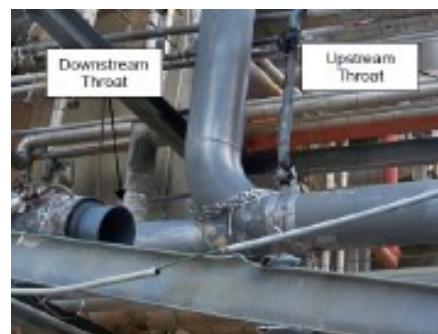
As indicated in Figure 2, the failure of Grade 91 DMW joints, especially the DMWs in thick-walled components, can cause significant damage to the power plant and, more importantly, can jeopardize the welfare of plant workers. It is for this reason that efforts to understand the damage mechanism or mechanisms involved and to identify the principal factors that reduce the lives of these joints are important in serving as the basis for improvements in the design, manufacture, maintenance and operation of these joints.

Figure 2. Shown is a steam flowmeter that failed at a Grade 91-TP316H DMW [2].

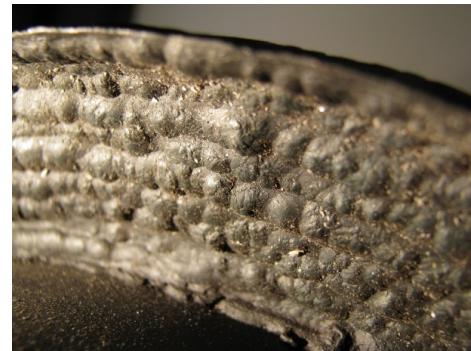
In cases where the cracking is completely through-wall, the fracture surfaces frequently exhibit the characteristic “bead profile” appearance documented in Figure 3, which is a feature that was commonly observed in the failed SH/RH tubing DMW joints that occurred in such large numbers beginning in the late 1960s. This unique fracture appearance is characteristic of damage that occurs when cracking propagates preferentially through a relatively narrow zone of material that closely follows the dissimilar metal weld interface on the ferritic side of the joint.

Figure 3. Shown is the typical appearance of the fracture surface on a failed DMWs in which the profile of the individual weld beads is evident [2].

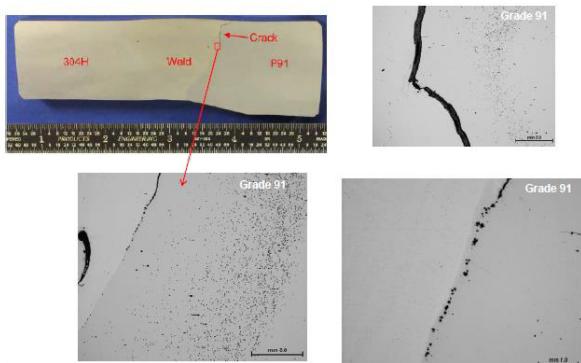
In general, the damage in Grade 91 DMW joints initiates at or near the OD surface and progresses toward the ID surface of the joint. However, in some failures it has been found that the damage has initiated at or near the ID surface, at or near mid-wall of the joint, as documented in Figures 4, 5 and 6, or simultaneously at several locations through the thickness of the joint. In the majority of cases, creep cavities have been detected immediately ahead of the crack tip along Grade 91 interface.

Figure 4. Shown are typical microstructural features of OD-initiated damage in a Grade 91 DMW, unetched [9].

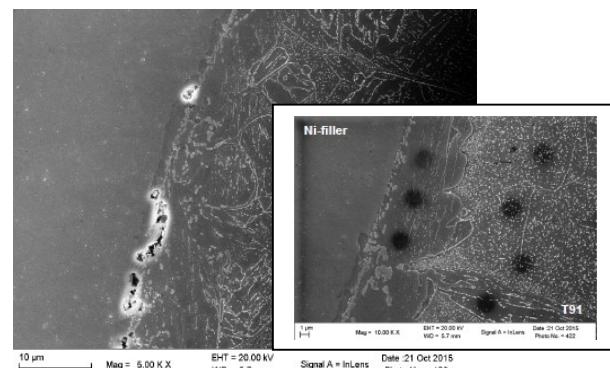
Figure 5. Shown is a typical view of the interface of a Grade 91 DMW as observed in the SEM, Vilellas [9].

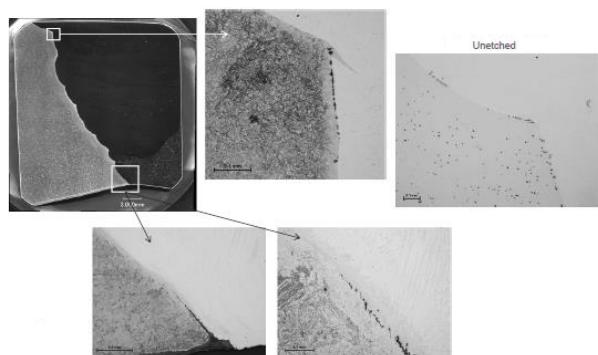
Figure 6. Shown are typical microstructural features of damage at the mid-wall and ID locations in a Grade 91 DMW, Vilellas [ 9].

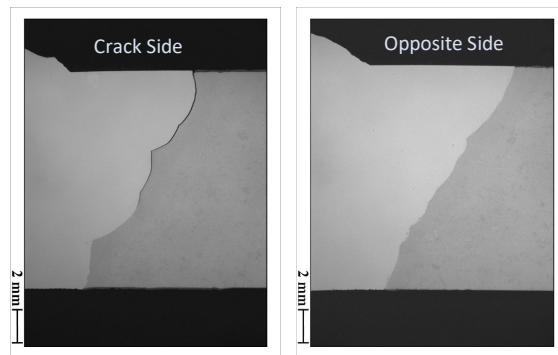
In addition, in the majority of cases the damage is concentrated on one side of the joint. Often, on the side of the joint opposite the visible crack, no damage is found at all, as shown in Figure 7. This suggests that in many of these failures the influence of a bending moment is a significant factor in the damage process, with the bending moment occurring either due to thermal or mechanical effects that in many cases are related to the system design and the joint location.

Figure 7. Shown is the typical damage distribution around Grade 91 DMW joint, Velillas [ 8].

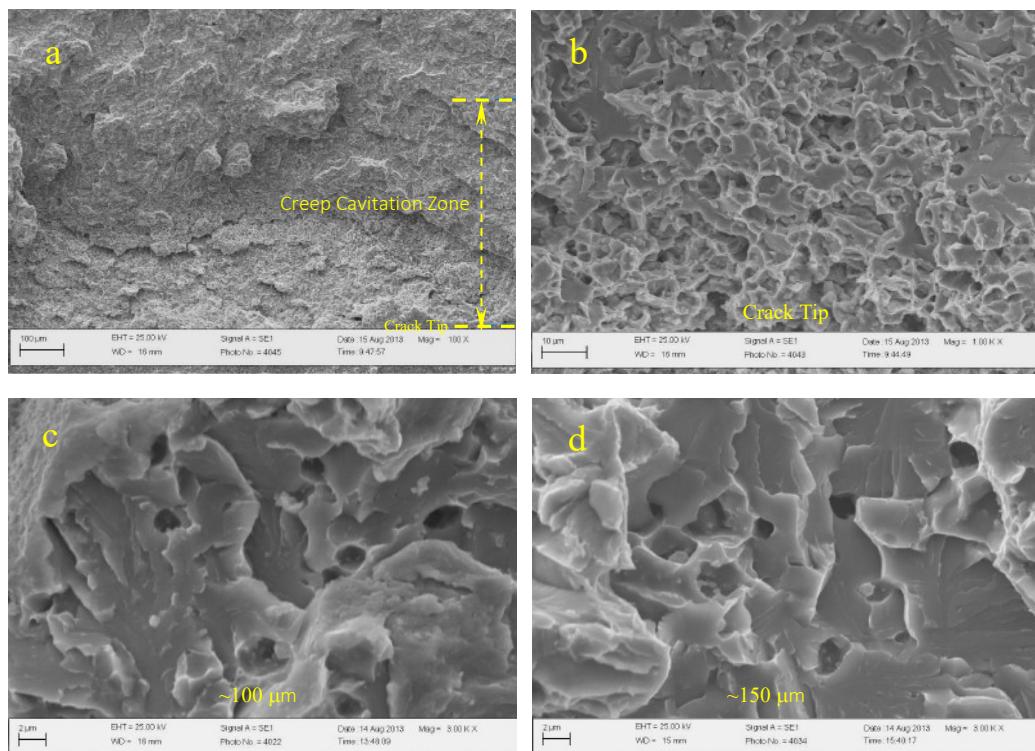
Figure 8. Shown are typical SEM fractographic features of creep cavity distribution ahead of crack tips in Grade 91 DMW joints; a) overall view of examined area, b) creep cavities at crack tip, c) creep cavities at ~100 μm ahead of crack tip and d) creep cavities at ~150 μm ahead of crack tip (6).

Figure 8 shows a typical example of creep cavitation in the damage zone ahead of a crack tip. Based on the current available data, the creep cavitation zone in front of the crack tip ranges in extent from approximately 20 – 100  $\mu\text{m}$  for P91 butt weld-type DMWs and up to  $\sim 400 \mu\text{m}$  in T91 attachment DMWs. The creep damage in front of the crack tip governs subsequent crack propagation behavior. The size of the cavitation zone depends on the nature of the loading (axial tension, bending, tensile hold period, cyclic frequency and so on), which is significantly affected by the system design and unit operation. This is why the cavitation zone is often more extensive in the T91 attachments since a severe bending load can develop with a stress concentration through the root of the fillet DMW joints when the attachment couples are jammed or bound.

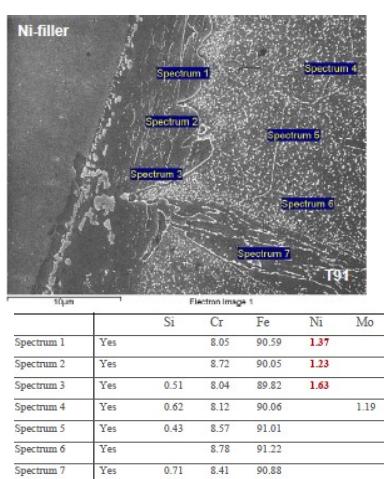
The chemical characteristics of Grade 91 failures can be examined using energy dispersive spectrometer (EDS) analysis on both metallographic and fractographic specimens with spot and line-scan modes. Figure 9 reveals an example of EDS analysis results obtained from a metallographic specimen and Figure 10 shows an example of EDS analysis results obtained from a fractographic specimen. As shown, the chemical features of the damage zone along Grade 91 interface consists of Grade 91 base metal with a “small” amount of nickel. In addition, an EDS line-scan across the Grade 91 interface is also presented in Figure 11, which reveals an identical pattern of Ni distribution. This suggests that the damage occurs in the unmixed zone (UNZ) of the DMW joint.

Figure 9. Shown is the EDS results on a metallographic specimen [9].

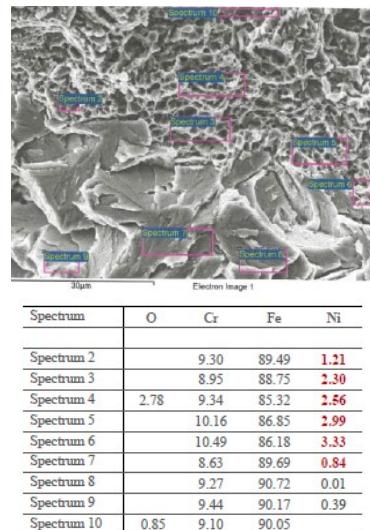
Figure 10. Shown is the EDS results on a fractographic specimen [8].

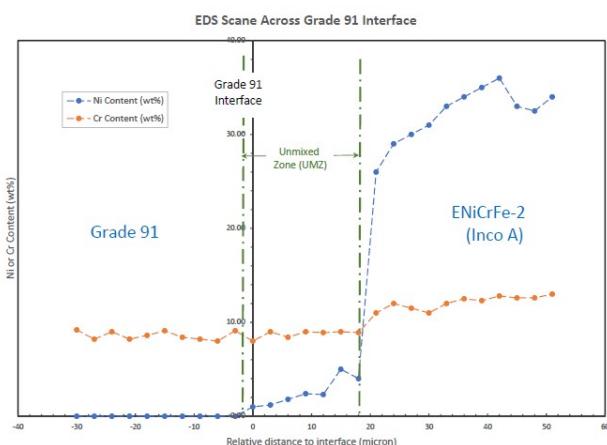
Figure 11. Shown is an EDS line scan across a Grade 91 DMW interface (6)

The EDS results demonstrate that Ni content in the UMZ can be as high as 4 wt% and that the UMZ can be up to 20  $\mu\text{m}$  in width. The significance of these compositional changes along the Grade 91 interface relative to the performance of the DMW is twofold: first, with increasing Ni content, the lower critical transformation temperature ( $A_{c1}$ ) of the UMZ is significantly reduced and probably to levels below the PWHT temperature – i.e., 730 - 775°C (1350 - 1425°F). This means that the UMZ will undergo a partial phase transformation during PWHT, which will result in the creation of a severely “creep-weakened” zone of material along Grade 91 interface. This, in turn, will result in the development of a significant creep strength mismatch along the Grade 91 interface. Previous research (10) has demonstrated that intercritical overheating during PWHT of any Grade 91 material will significantly degrade the creep properties of Grade 91, as shown in Figure 12.

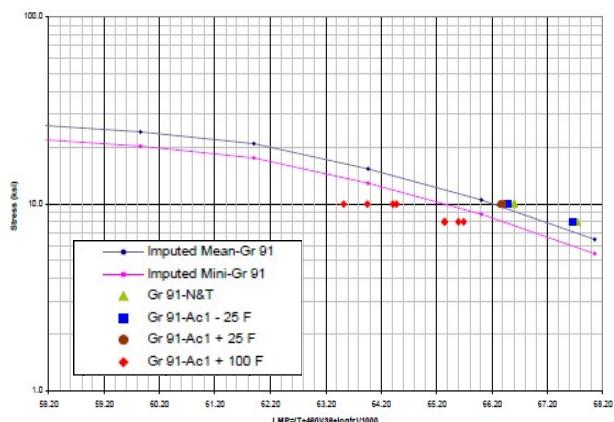
Figure 12. Shown are the effects of intercritical heating on the creep properties of Grade 91 (10)

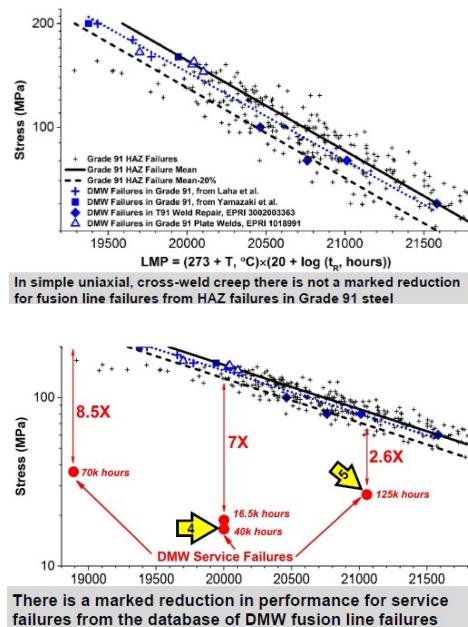
Figure 15 shows a review of uniaxial creep test results for Grade 91 DMWs carried out by EPRI (25). As can be seen, damage and failures have occurred only in the Type IV region of the joint, which does not mirror the interface damage observed in the in-service failures. The service failures that have occurred so far suggest that a stress level 2.6 to 8X higher than the calculated axial stress from steam pressure alone is necessary for creep-dominated interfacial damage to occur. There is sufficient evidence suggesting that bending load in a cyclic mode is a necessary stress condition for development of Grade 91 DMW interface damage mode.

Figure 15. Uniaxial creep testing of Grade 91 DMW in comparison with actual service failure (25)

Also, a substantial work has been done in comprehending and modeling the stress state responsible for Grade 91 DMW failures. From the design standpoint, considerable amount of work has been made to locate Grade 91 DMW joints in a low stress and no bending condition where Grade 91 DMW joints can be easily inspected and replaced.
