Service Experiences with Cracking in T23 Weldments

Jeff Henry ^a, Gang Zhou ^a. Song Ming ^b, Xu Tong ^b and Li Yi ^b

^a ATC-Combustion Engineering Solutions, USA

^b Chinese Special Equipment Inspection & Research Institute, China

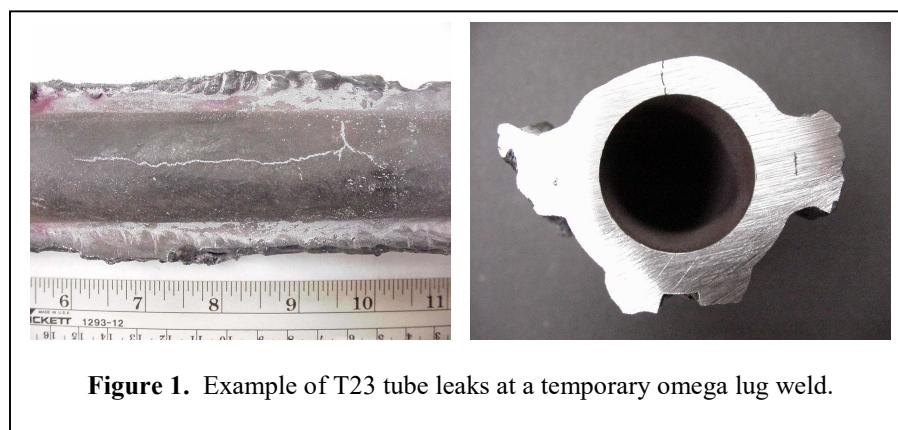
Figure 1. Example of T23 tube leaks at a temporary omega lug weld.

erection lug weld; the through-wall crack can be seen on the transverse cross-section of the tube. These lugs had been installed temporarily in the shop to assist in the alignment of the furnace wall panels prior to the final assembly welding of the panels. Once the panels were installed, the lugs were removed from the tubes at

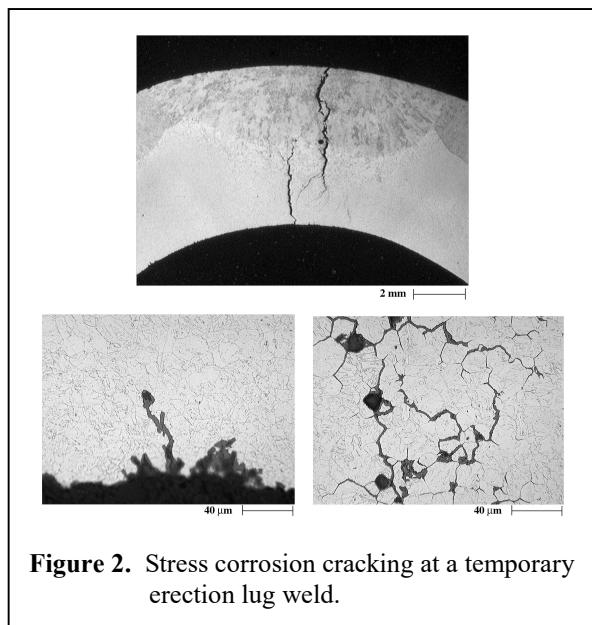
A detailed review of the procedures used during both manufacturing and erection of the boiler uncovered several practices that contributed to the stress corrosion cracking problem. First, during the removal of the erection lugs, the grinding had not been controlled, so that on a number of the tubes extensive weld repair was necessary to repair local grinding damage to the tube wall. In several cases the weld repair

extended completely through the wall of the tube. There was no pre-heat or post-weld heat treatment (PWHT) applied in the course of making the weld repairs, and hardness in the weld Heat-Affected Zones was measured to be as high as 370HV. With regard to the girth butt welds, similar welding practice had been followed in making these welds (i.e., no pre-heat and no PWHT), and hardness levels in the HAZ were

Figure 2. Stress corrosion cracking at a temporary erection lug weld.

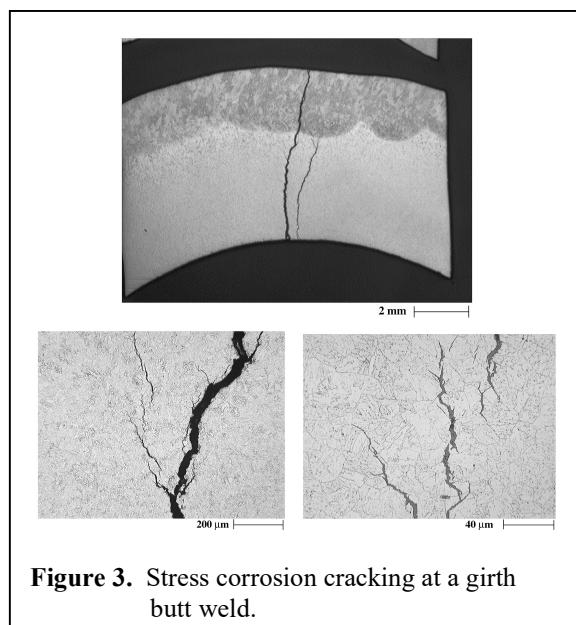
Figure 3. Stress corrosion cracking at a girth butt weld.

comparable to those measured in the weld repair HAZ. With regard to the leak in the bent tube at the nose arch, it was found that in this case a small area of the tube wall had been re-austenitized by torch heating to facilitate minor adjustments to the alignment of the tube in the panel. Hardness within this locally re-austenitized region was measured to be approximately 325HV.

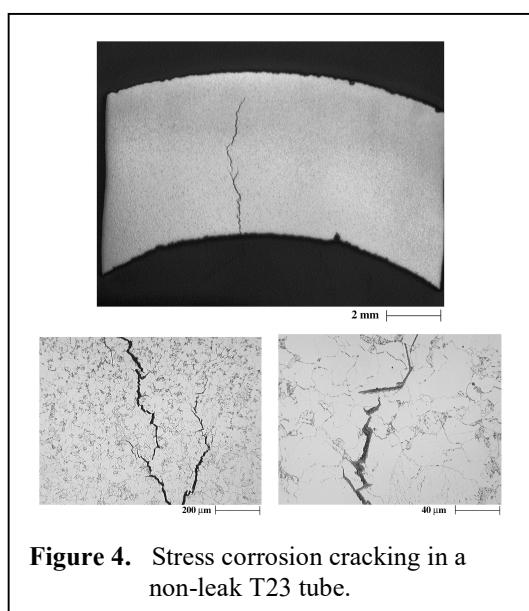
Destructive analysis of the failed tubing established that the leaks in rear wall tubing were the result of caustic-induced stress corrosion cracking (SCC), with the cracks exhibiting the transgranular/intergranular branched fracture path characteristic of this type of damage. All cracks had initiated on the inside surface of the tube. Evidence of the SCC was found on both the furnace side and the backside ID surface of the tubing. Figures 2 and 3 record typical macrostructural and microstructural features of the SCC as it appeared at the temporary erection lugs and at girth butt welds. An examination of other tubes in the same area that had not leaked confirmed the presence of SCC attack in a number of these tubes, as well, with cracks of sufficient depth in some to insure imminent failure of the tube, as shown in Figure 4.

Figure 4. Stress corrosion cracking in a non-leak T23 tube.

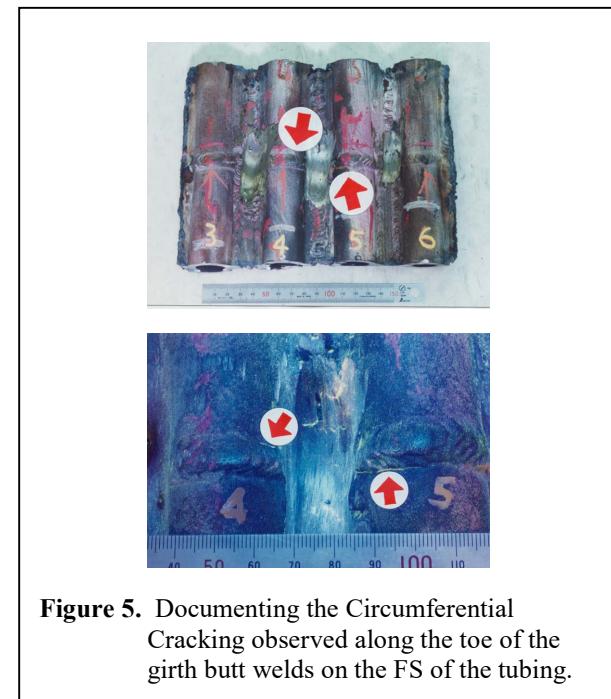
During a unit restart of the same boiler, several tube leaks were detected in field butt welds at the same elevation on the furnace rear wall. The leaks were traced to circumferential cracks at the toe of the weld on the furnace side of the assembly, as indicated in Figure 5. The tubing material SA213, T23 with dimensions of 1.375" OD x 0.220" MWT.

Metallographic examination revealed that the cracks had initiated in and propagated through the coarse-grained region of the HAZ and exhibited a fracture morphology that differed markedly from the caustic stress-corrosion cracking observed at other locations on the rear wall of the furnace. In particular, the cracks at these leak sites proved to be predominantly transgranular, with substantially different branching characteristics. The maximum HAZ hardness was measured to be at the level of 370HV. The distinctive microstructural features of the cracking, and the localized nature of the damage in an area where the welds were highly restrained by large welded attachments, suggested that this damage was the result of hydrogen-induced or "cold" cracking. (Access to sample material, unfortunately, has been limited, so that documentation of the cracking cannot be provided at this time. However, all pertinent information related to this damage, including the welding procedures, the component configuration, and the microstructural features of the damage were reviewed by materials engineers representing the operator, the tubing supplier, and the boiler manufacturer, all of whom agreed in the diagnosis of "cold" cracking).

Figure 5. Documenting the Circumferential Cracking observed along the toe of the girth butt welds on the FS of the tubing.

With regard to the issue of pre-heat of T23 tubing material, it has been claimed by suppliers that for tubing the T23 alloy can be welded without either pre-heat or postweld heat treatment. This claim likely is true when welding conditions are properly controlled during fabrication and when the degree of restraint on the joint is relatively low. However, any deviation from conditions of proper control (e.g. wet rods, poor gas shielding, etc.) may render the material susceptible to "cold" cracking in the absence of pre-heat, depending on the degree of restraint. The basis for this susceptibility is a level of hardness in excess of 350 HV that may be achieved with some heats of the T23 material, even when the carbon and alloy contents are near or only slightly above mid-range for the alloy. It is for this reason that the application of the ASME Boiler Code requirement for the pre-heating of welds made in T23 tubing at a minimum temperature of 300°F, or the postweld heat treating at a minimum temperature of 1250°F is prudent in certain applications.

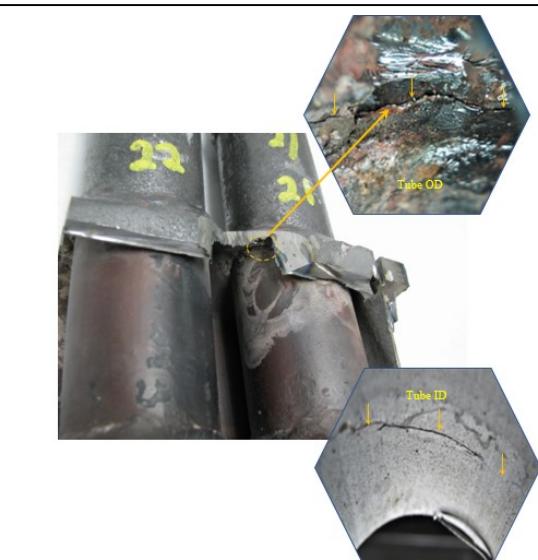
During the normal operation of a CFB boiler, a tube leak occurred in high crown-seal area of the superheat wingwall assembly. The leak was traced to the root of the high crown-seal weld on the furnace side of the assembly, as indicated in Figure 6. The tubing material SA213, T23 with dimensions of 1.75" OD x 0.165" MWT. Metallographic examination revealed that the cracks had initiated in and propagated through the coarse-grained region of the HAZ (CGHAZ) as documented in Figure 7. In addition to the intergranular cracking, extensive cavitated grain boundaries were also observed in the CGHAZ. The maximum weld deposit hardness was measured to be at the level of 300HV, indicating that either the welds had not been post-weld heat treated or that the temperature used for the PWHT was relatively low. SEM fractographic examination exhibited the intergranular fracture with cavitated grain boundary facets as exhibited in Figure 8. The distinctive microstructural features of the cracking, and the localized nature of the damage in an area where the welds were highly restrained by high crown-seal structure, suggested that this damage was the result of the reheat cracking.

Figure 6. Documenting the cracking observed along the root of the high crown-seal weld.

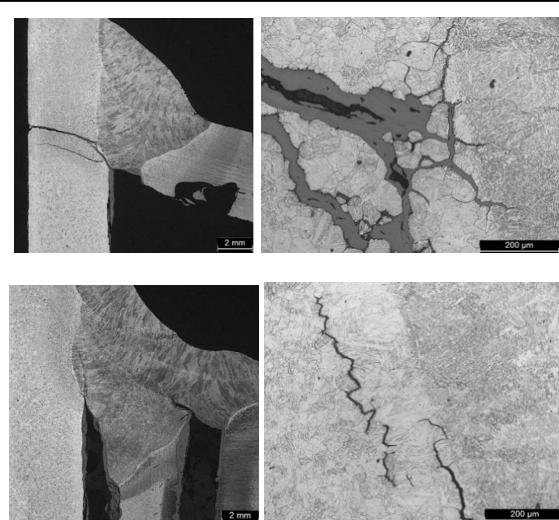
Figure 7. Documenting the metallographic features of cracking in the CGHAZ of crown-seal weld.

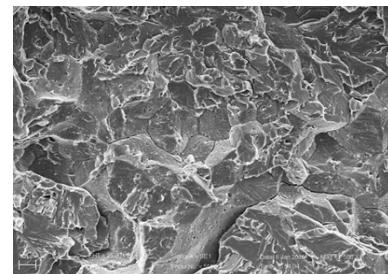
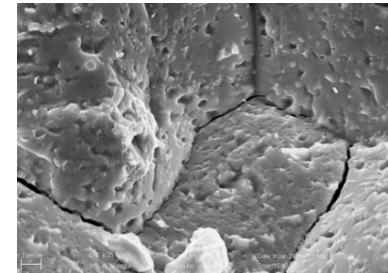
Figure 8. Documenting the SEM fractographic features of cracking in the CGHAZ of crown-seal weld.
