***EXPERIENCE WITH GRADE 91
MATERIAL IN BOILER & HRSG
APPLICATIONS***

Dr. Gang Zhou

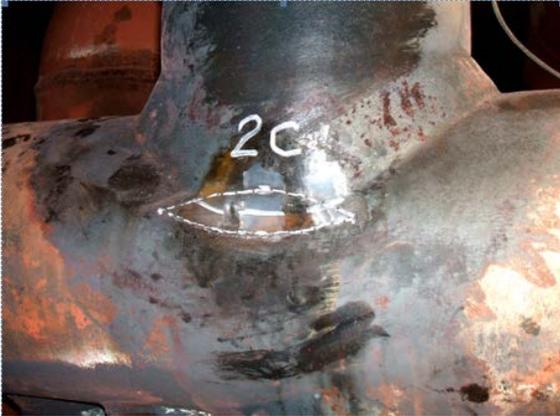
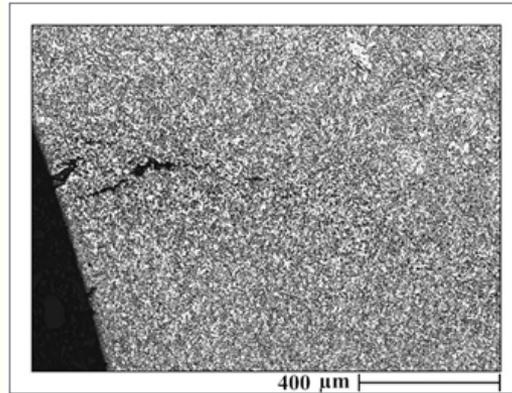
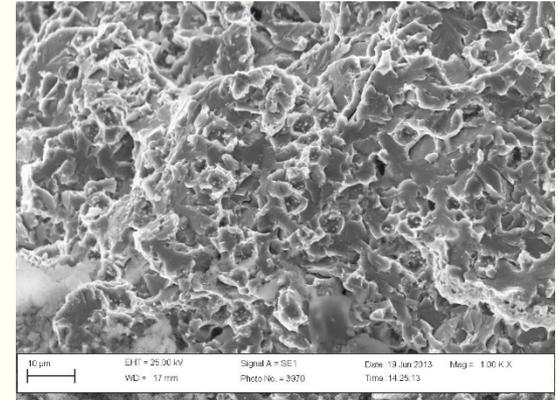
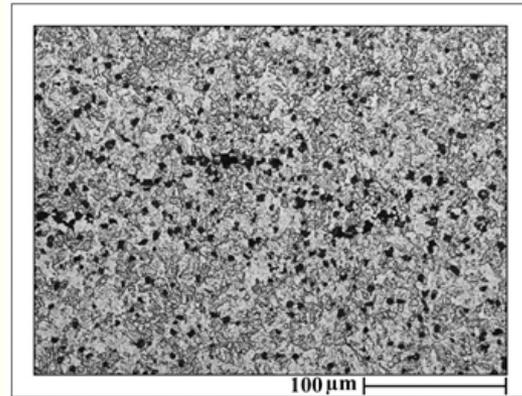
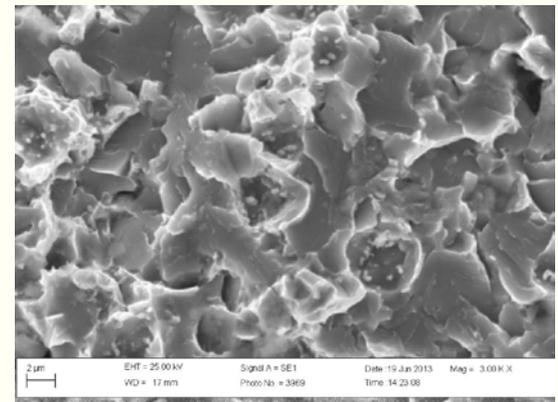
Case Study 1: Cracking in Type IV and Creep Damage in Base Metal

- P91 main steam manifold saddle joint.
- ASME SA-335, P91, 4" NPS x Sch.120.
- 27,000 hrs in service.
- Cracking found in FGHAZ of joint at saddle point

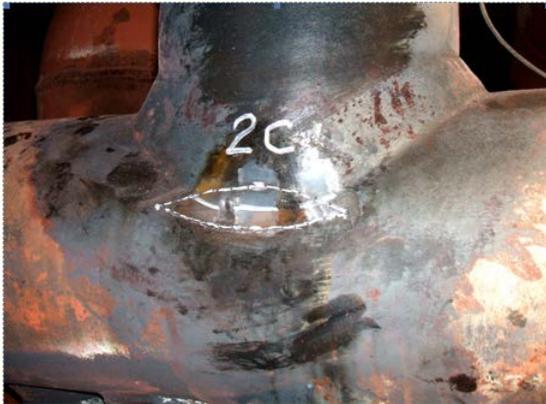
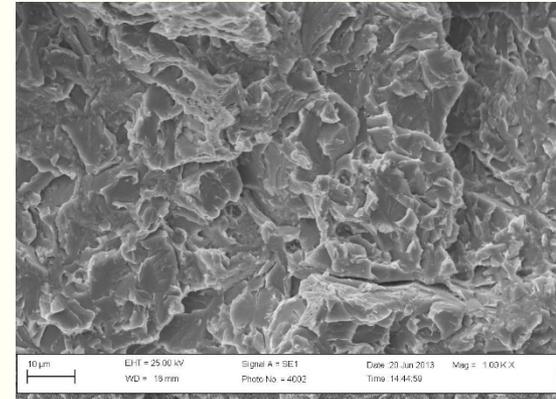
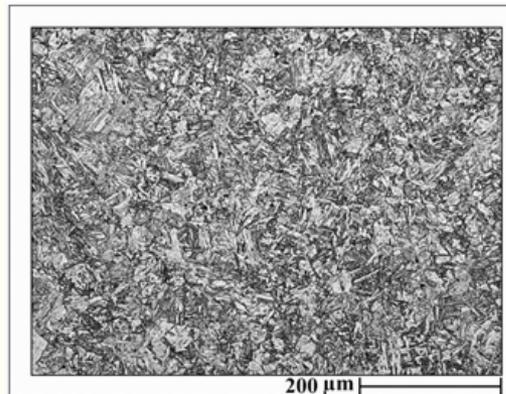
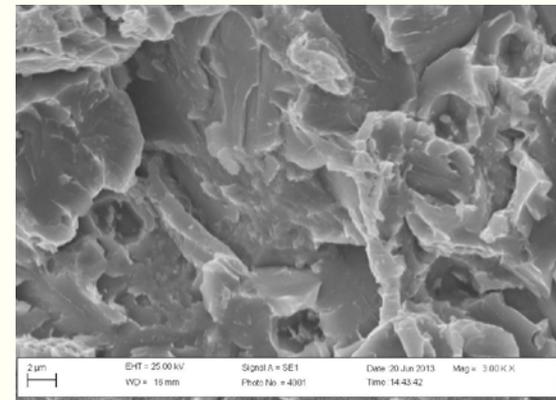
Case Study 1: Cracking in Type IV and Creep Damage in Base Metal

- P91 main steam manifold saddle joint.
- ASME SA-335, P91, 4" NPS x Sch.120.
- 27,000 hrs in service.
- Creep Damage in BM with uncharacteristic microstructure – ultra-fine mixed with ultra-coarse grains

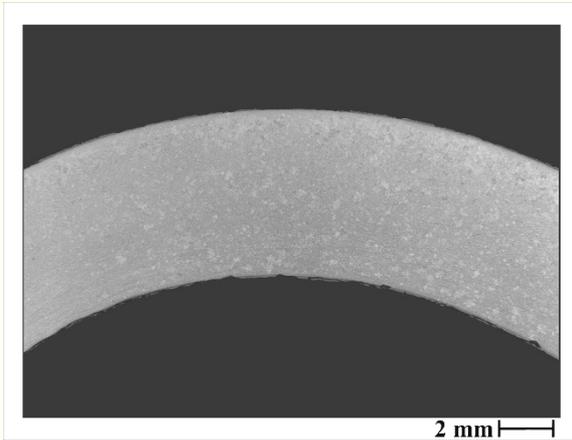
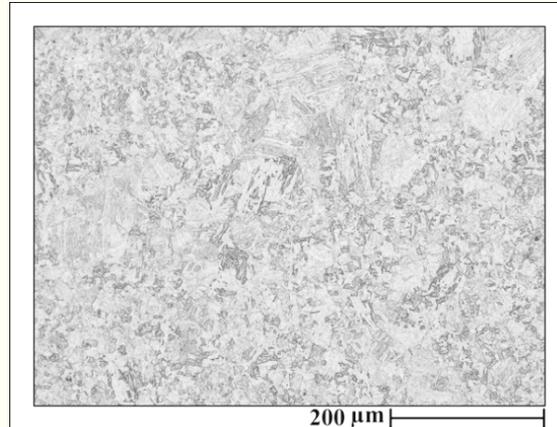
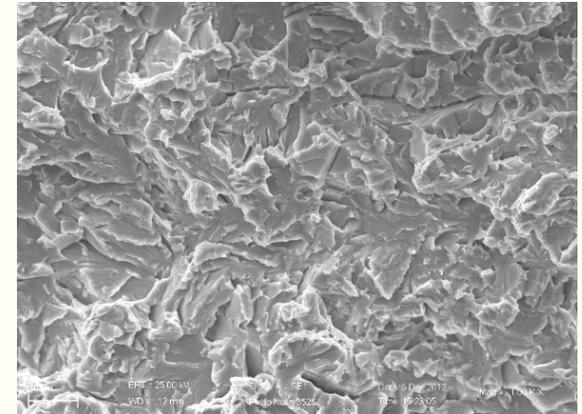
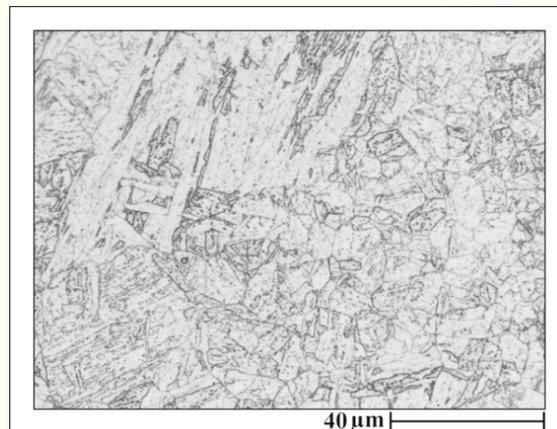
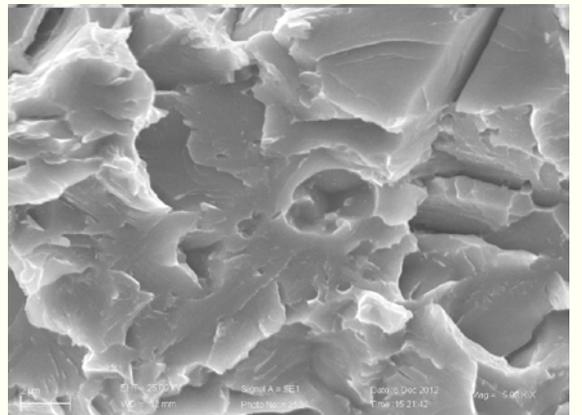
Case Study 2: Abnormal Microstructure and creep damage in T91 Final Superheater Tube

- T91 final SH tubing.
- ASME SA-213, T91, 1.75" OD x 0.225" MWT.
- 23,000 hrs in service.
- SH assemblies suffered multiple failure. This is a unfailed tube.

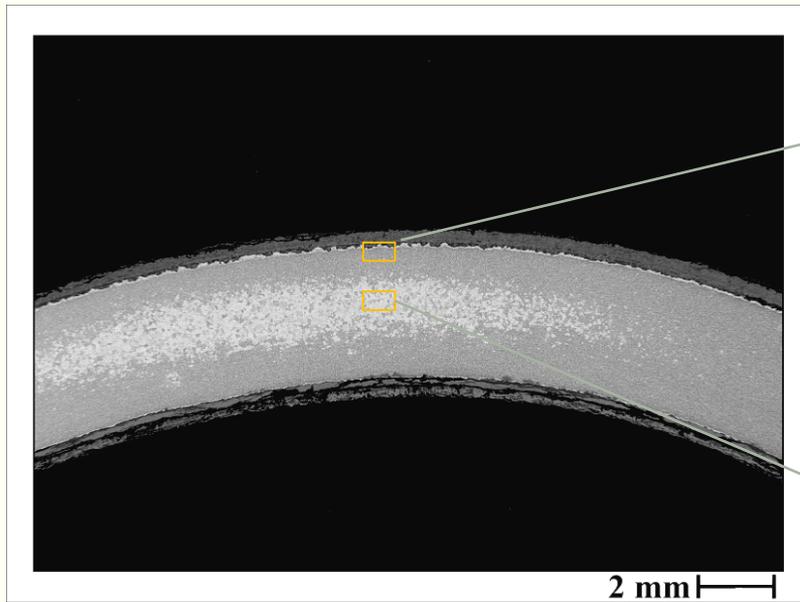
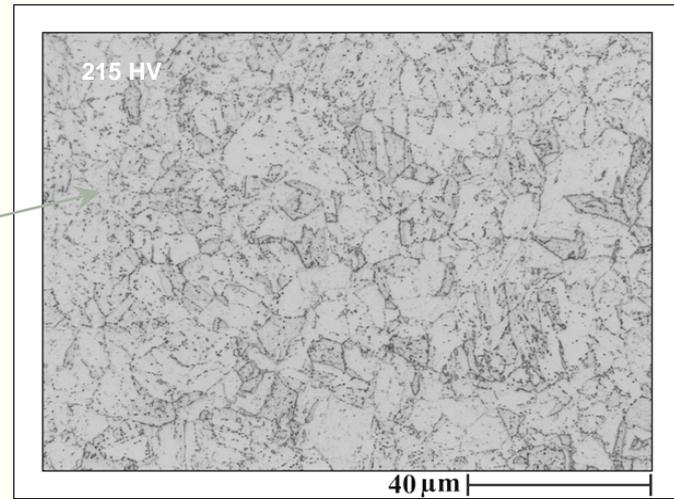
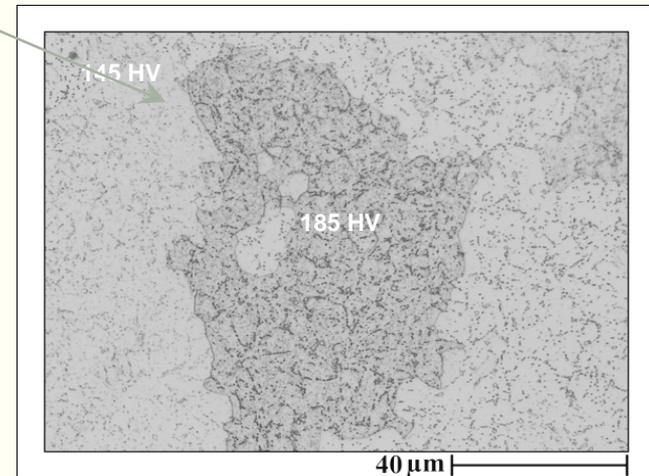
Case Study 3: Abnormal Microstructure in T91 Final Reheater Tube

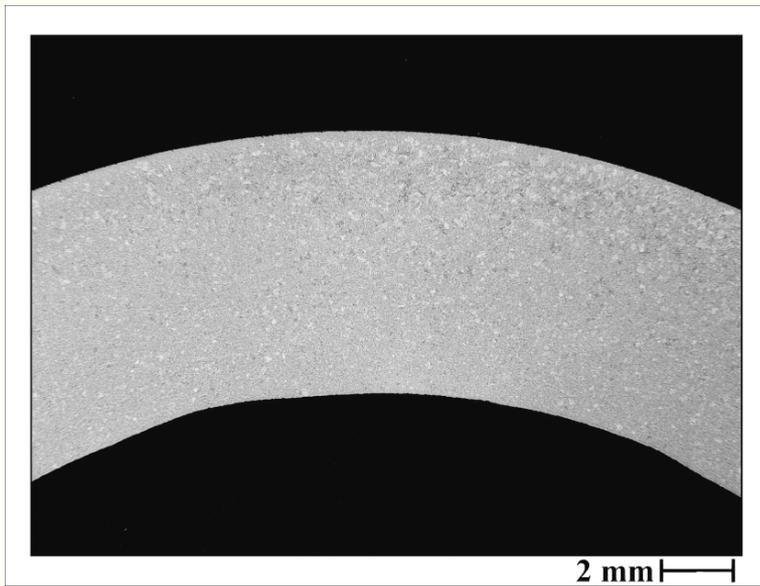
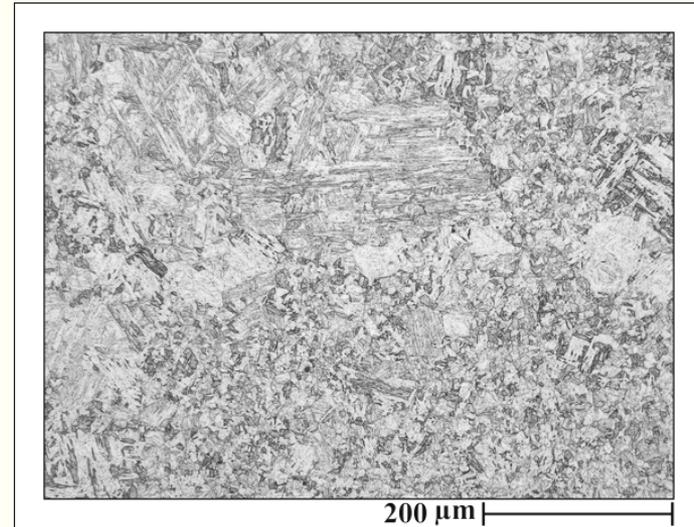
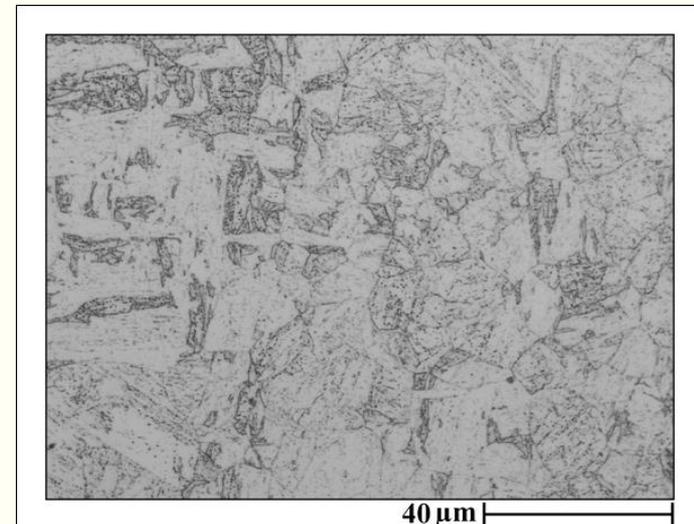
Case Study 4: Abnormal Microstructure in New T91 tubing

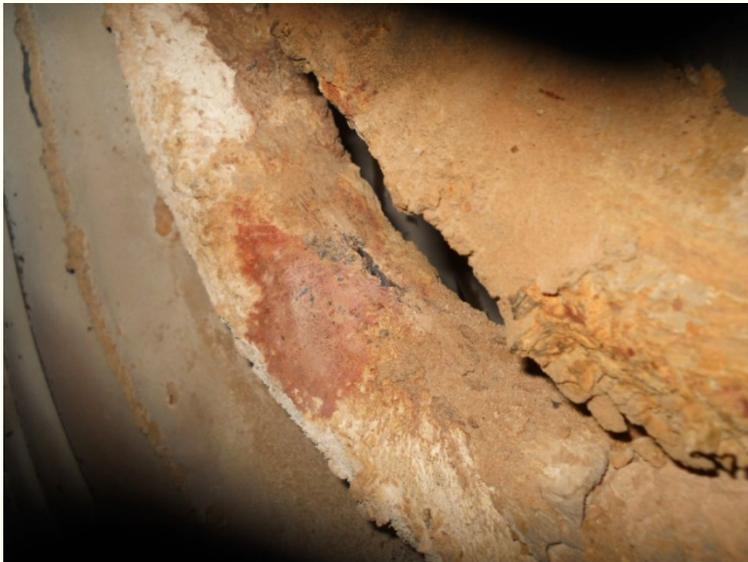
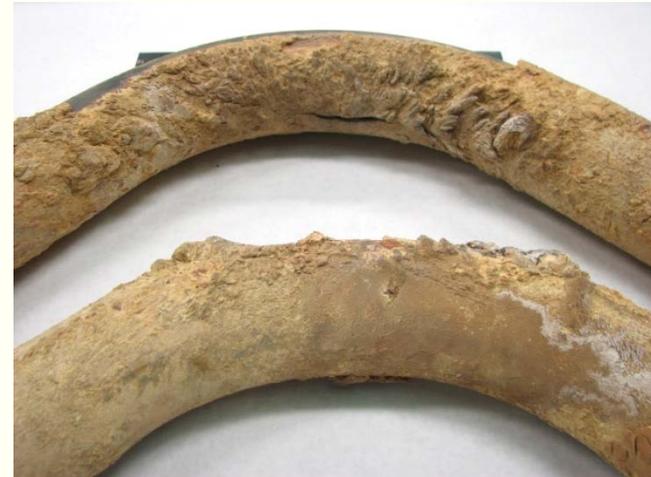
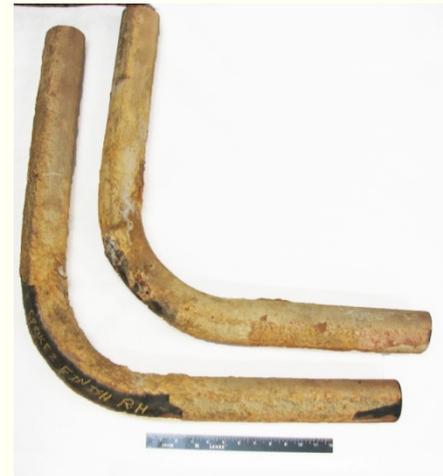
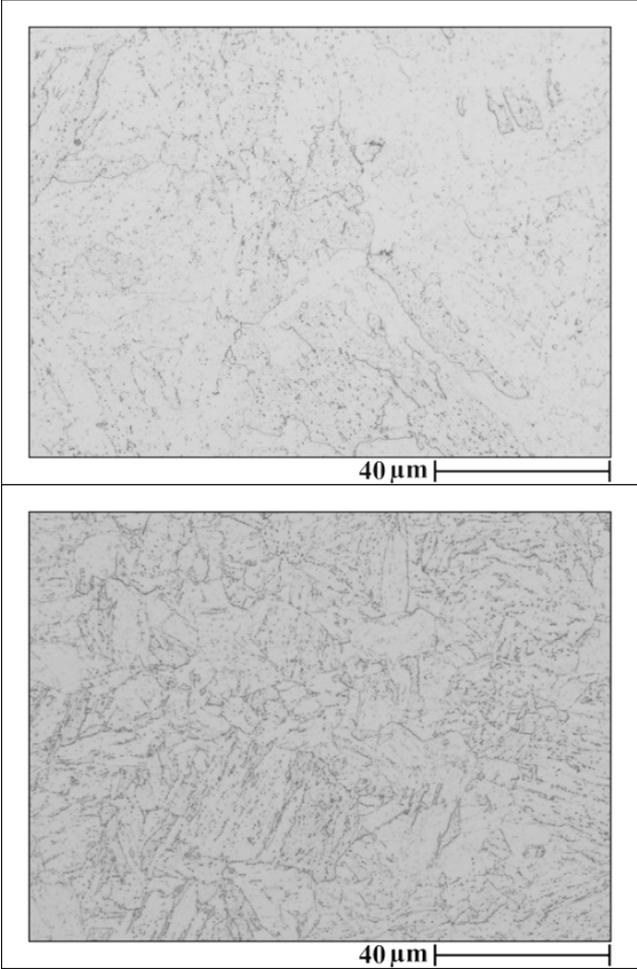
Case Study 5: T91 Reheater Tube

- Multiple Failures on the intrados of the front bend after ~17,000 hrs in service.
- ASME SA-213, T91, 2.75" OD x 0.150" MWT.

Sample	Location		Average	Range	
				Min.	Max.
RH-7	Bend (Micros A & B)	Crack Center (intrados)	149 (78)	135	164
		Crack End (Intrados)	172 (85)	155	184
		Extrados	218 (95)	216	219
	Straight (Micro C)	Front Side	217 (95)	216	217
		Back Side	203 (92)	201	206
RH-8	Bend (Micro D)	Intrados	176 (86)	158	192
		Extrados	216 (94)	209	223
	Straight (Micro E)	Front Side	214 (94)	209	217
		Back Side	208 (93)	203	211

Conclusion: Torch-Heating Intrados of Bend in Manufacture

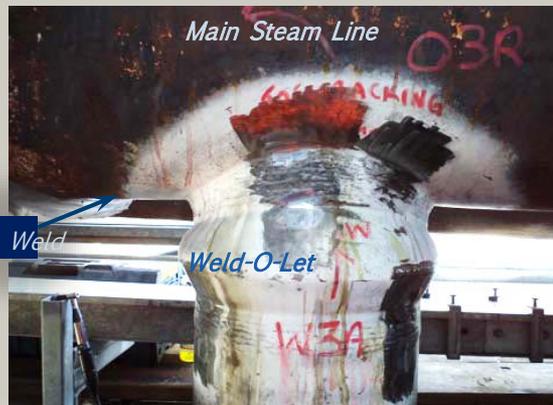
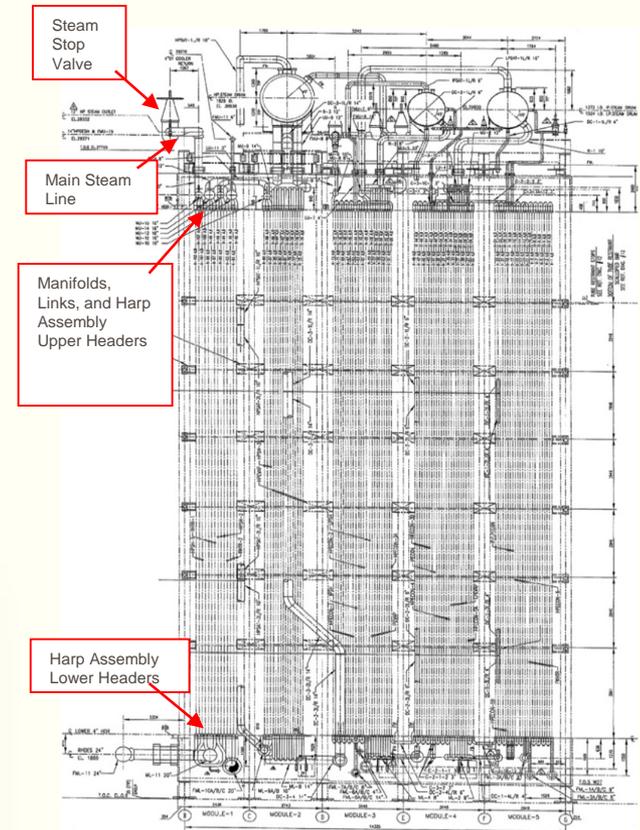
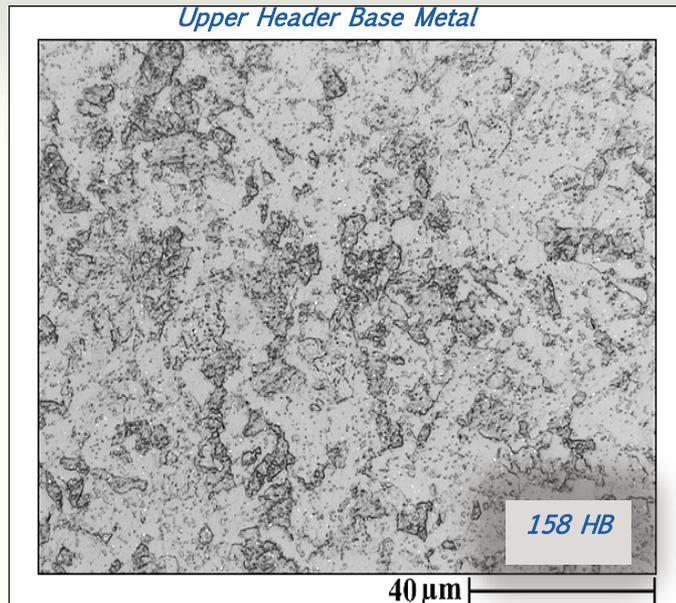
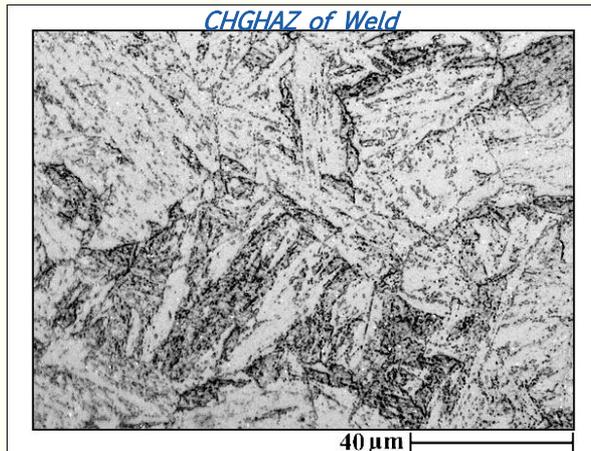
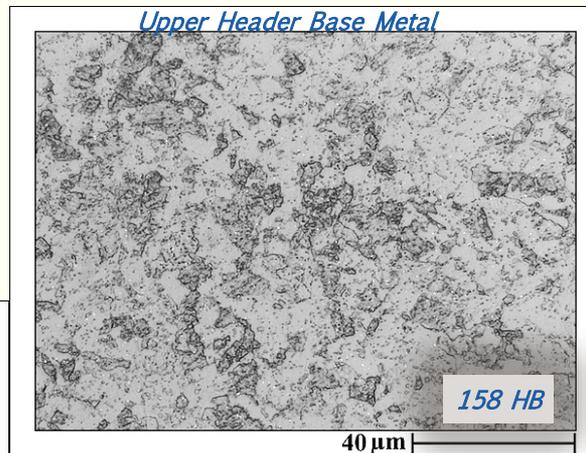
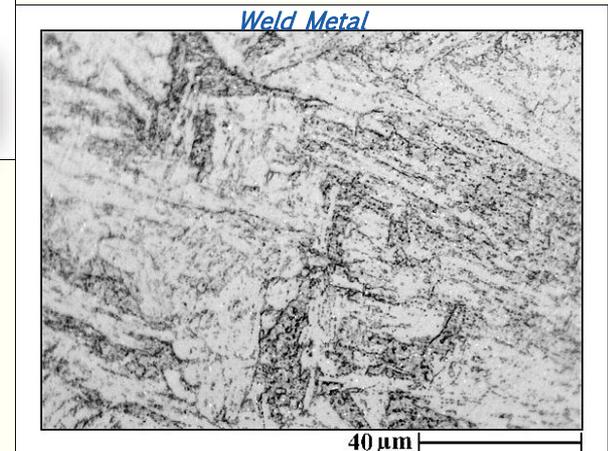
- Issue was started with a crack at the toe of a connection weld between the main steam line and the superheater.
- Extensive NDE inspection be made from Main steam, manifolds and harp assembly upper and lower headers.
- BM: ASME SA-335, P91 & ~27,000 hrs in service.
- Low hardness values (as low as 158 HB) were found in HTSH upper and lower headers.
- Replica examination revealed 1) a fine-grained uncharacteristic microstructure in HTSH upper & lower headers & 2) possible creep damage in Type IV zone of many welds in HTSH.
- Suspected overheating during low-load operation with GT exhaust-gas temperature up to 650°C.
- Question about over-tempering during manufacture & installation.

- Was the low hardness in upper & lower headers of harp assemblies the result of overheating?
- Did accumulated-temper effect in manufacture & installation play any role?
- The MTR data of the original pipe appears to be normal. Could it be possible that this was the original piping condition? If so, how did the original piping have this condition?

- The condition of the CGHAZ and weld metal appears to be normal with no sign of any overheating and consistent with a normal Gr. 91 weld.
- The fine-grained ferrite structure with moderately spheroidized precipitates are likely consistent with improper-normalizing practice and a slow-cooling rate.
- It is recommended:
 - Investigate the details of the heat-treatment in the pipe mill.
 - Remove the sample(s) for destructive examination.
 - Determine the creep properties of the low-hardness pipe.
 - Design-review to determine whether Gr. 22 fits the design criteria for lower header.
 - Discuss the recommendations above with customer.

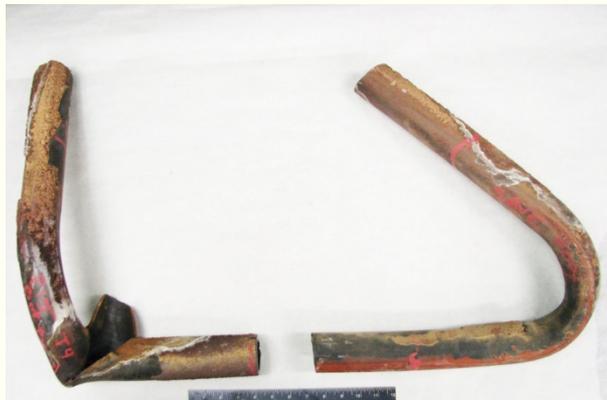
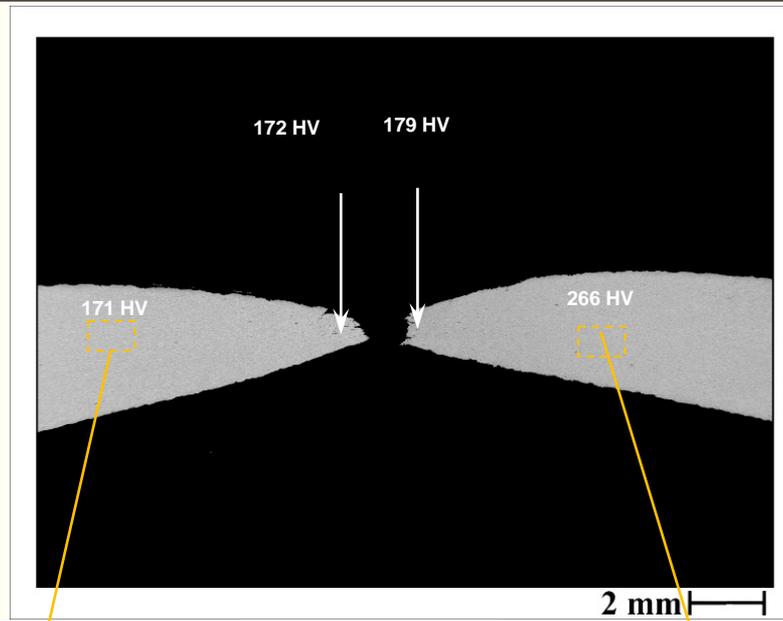
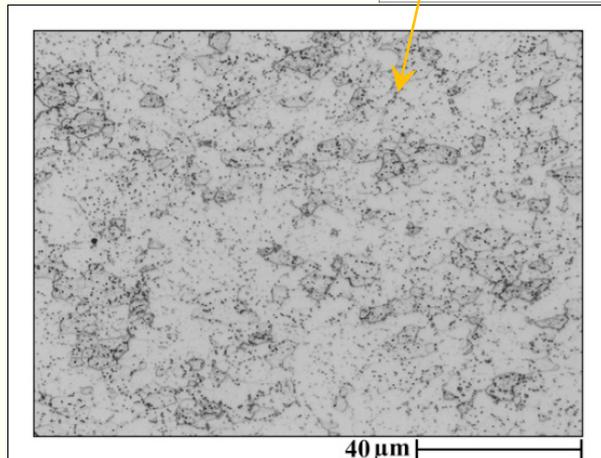
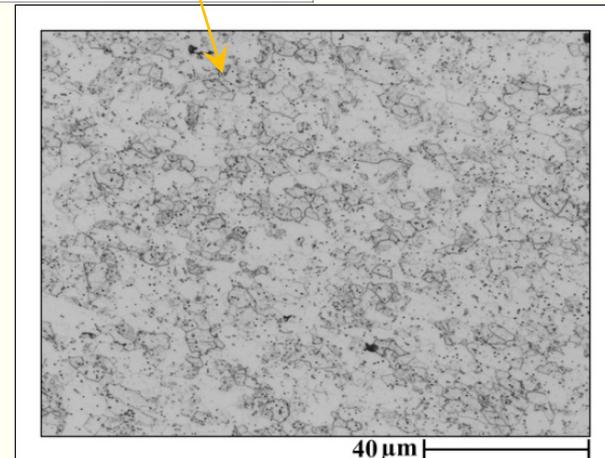
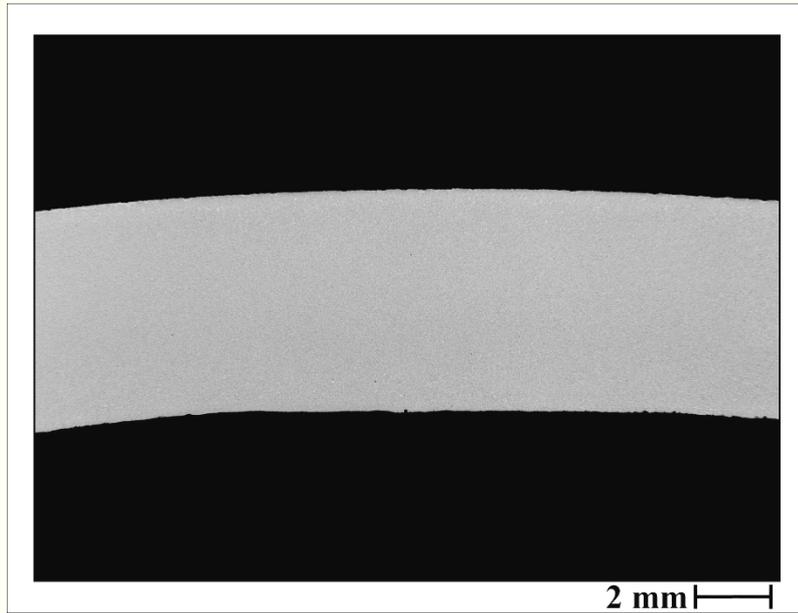
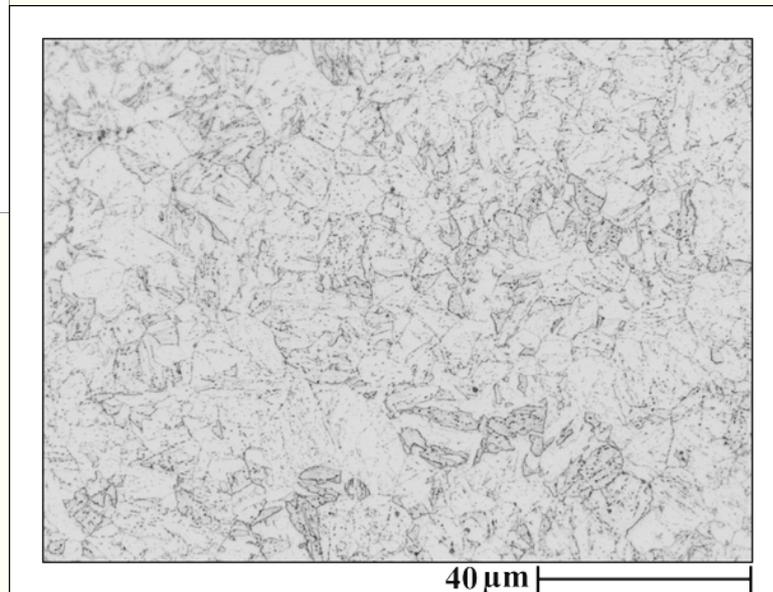
- A front bend in finishing superheater assemblies failed after over 20,000 hrs service.
- ASME SA-213, T91, 2.25” OD x 0.240” MWT.
- Failure caused severe damage to the entire loop.

Conclusions: The bends had been improperly heated during manufacture.

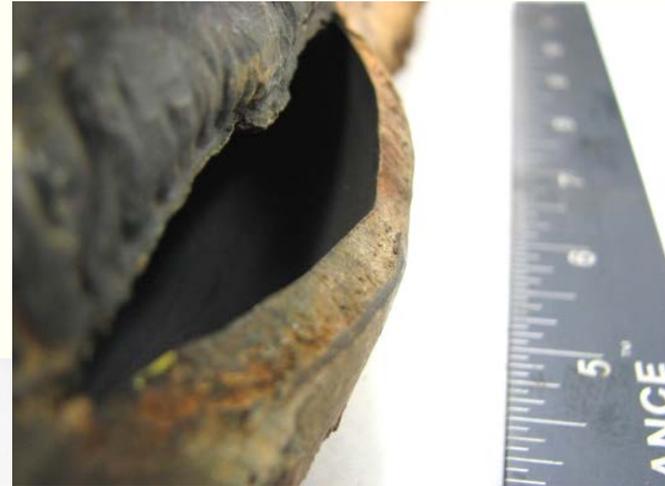
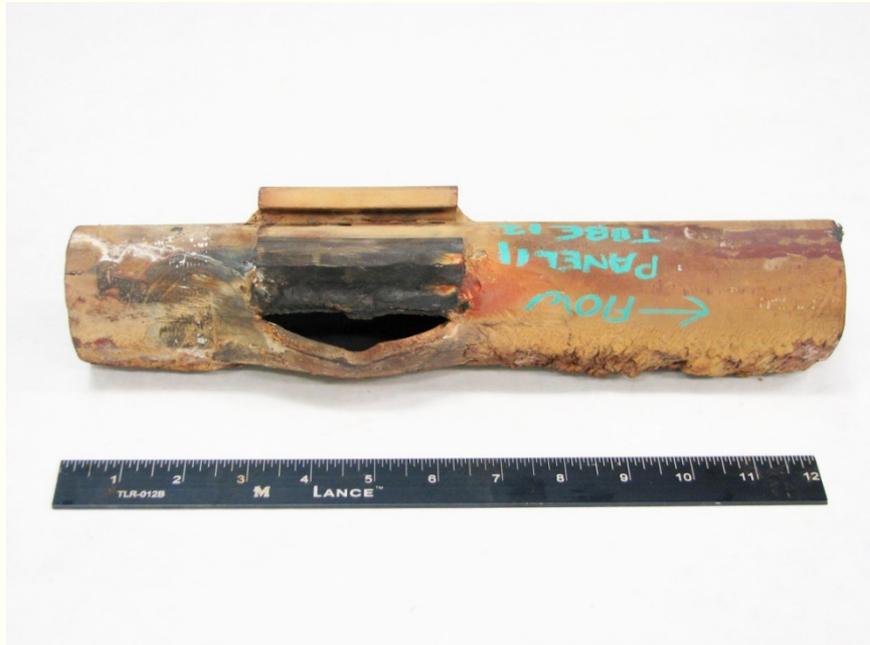
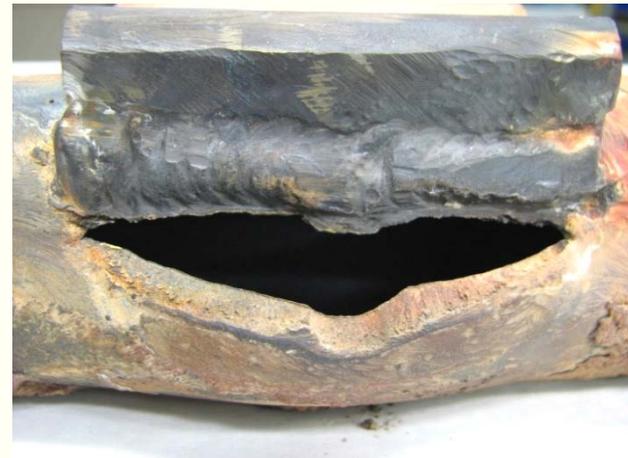
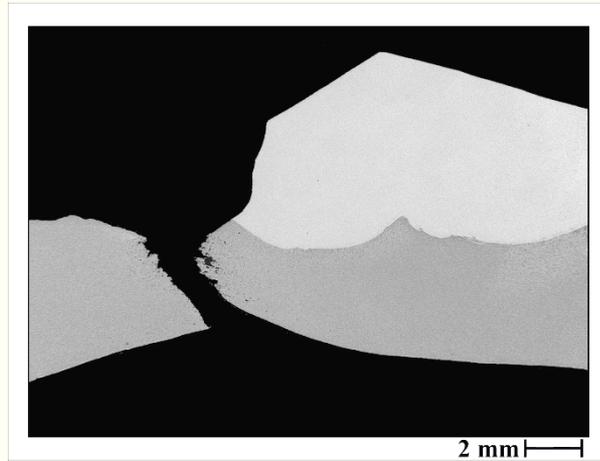
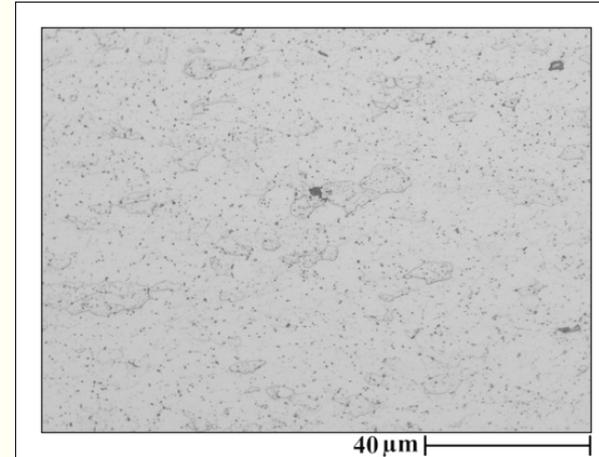
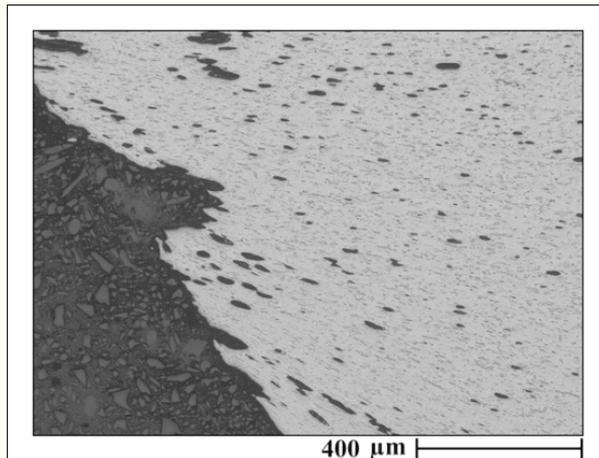
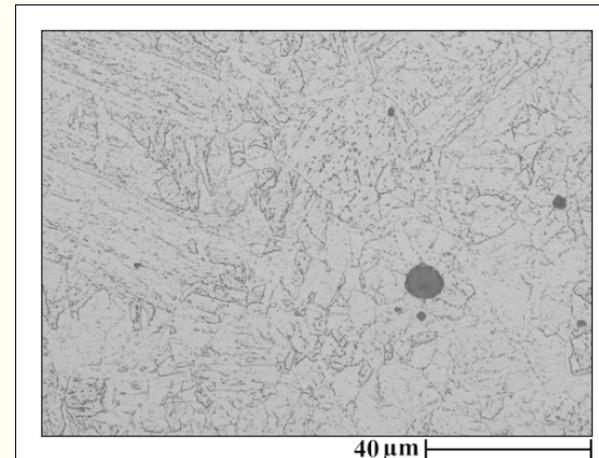
- Over 800 lugs failed after 23,000 hrs service and weld repaired
- A T91 FSH tube failed when the unit was back on-line.
- ASME SA-213, T91, 2.25" OD x 0.240" MWT.
- Repair Procedure: B9 build-up and ENiCrFe-2 (Inco-Weld® A)

Conclusion: The failure along the toe of the repair weld was the result of stress rupture that occurred in the low-temperature region (slight over A_{C1}) of the base metal heat-affected zone (HAZ) associated with the weld repair

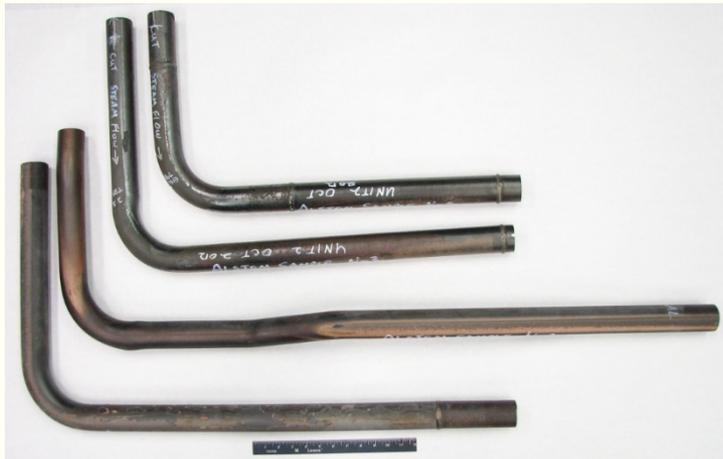
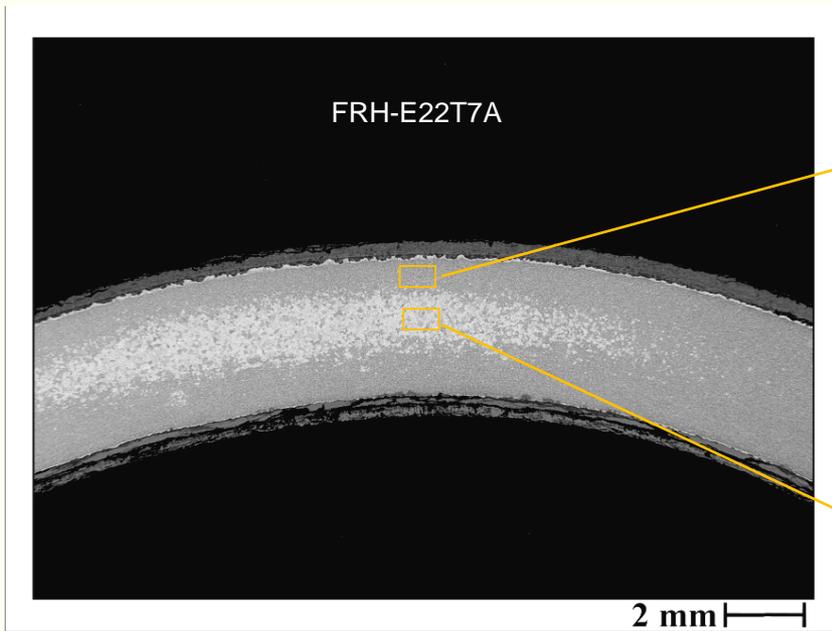
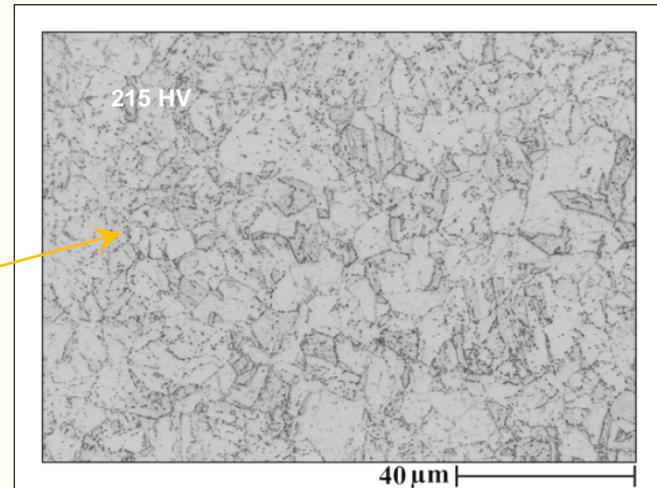
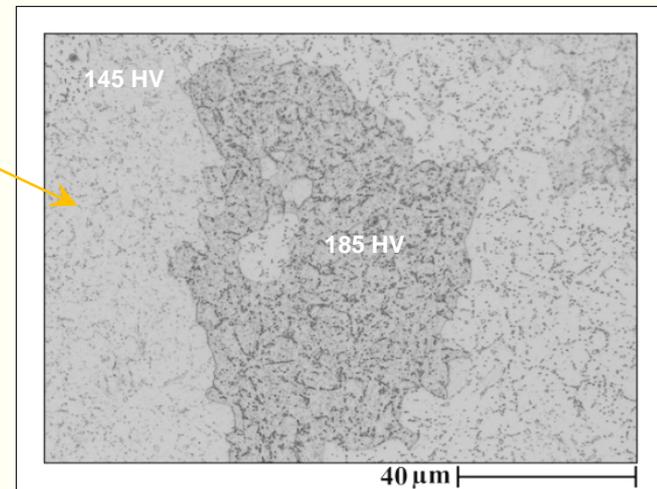
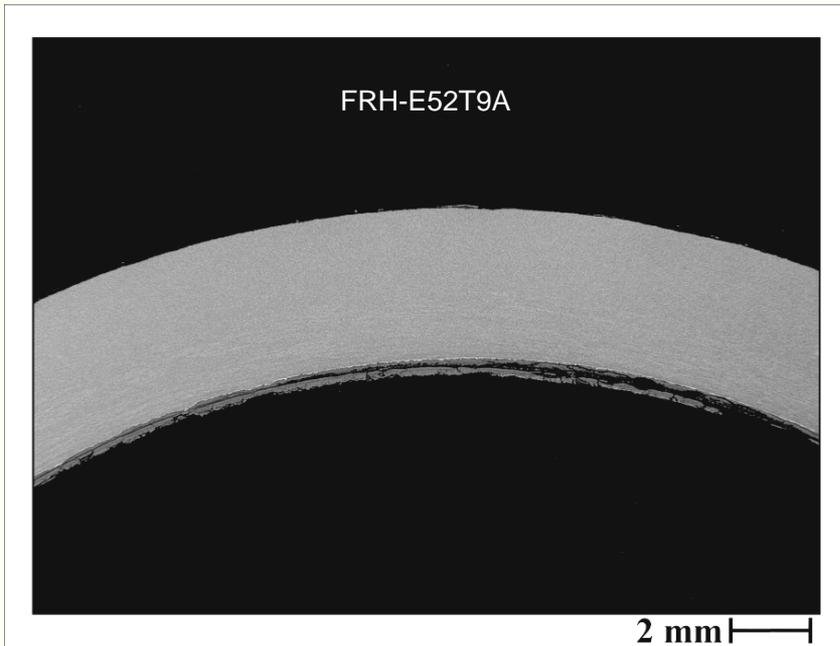
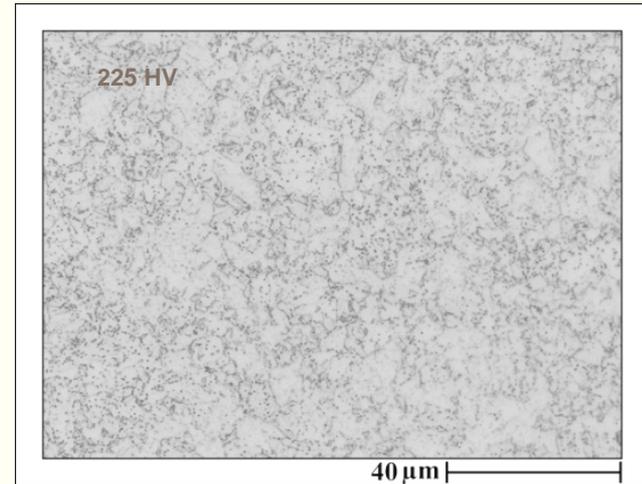
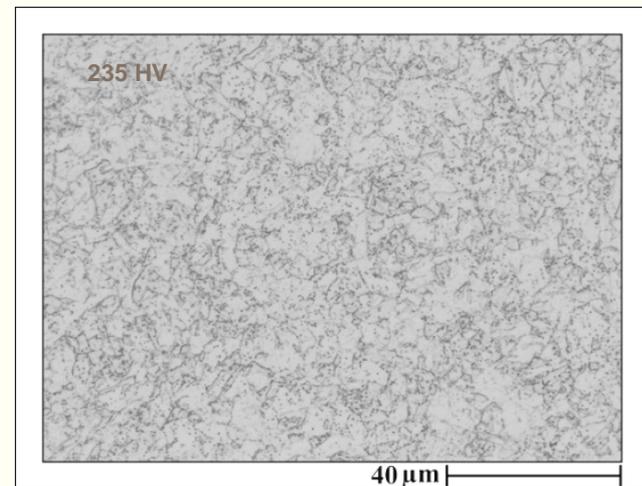
- Five failures in final reheater bends
- ASME SA-213, T91, 2.0" OD x 0.150" MWT.
- Suspect that T91 bends were not improperly manufactured.

Bend was improperly heated during manufacture

Conclusion: Bend was improperly tempered during manufacture with tempering temperature > A_{C1}

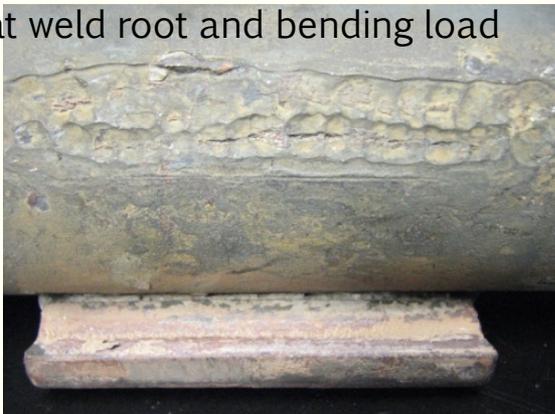
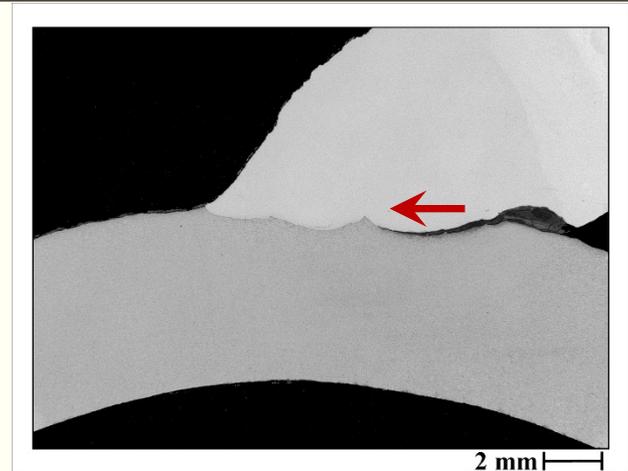
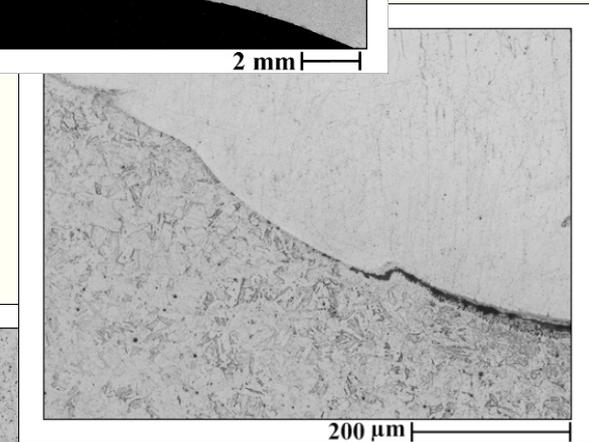
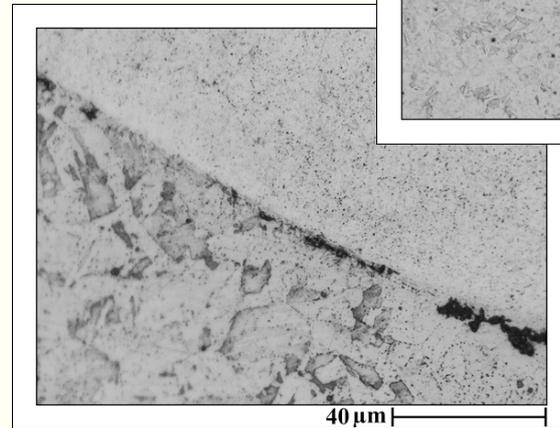
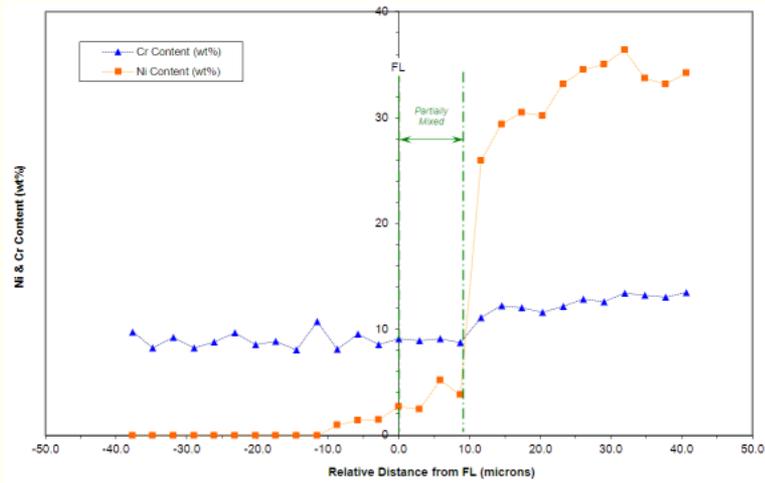
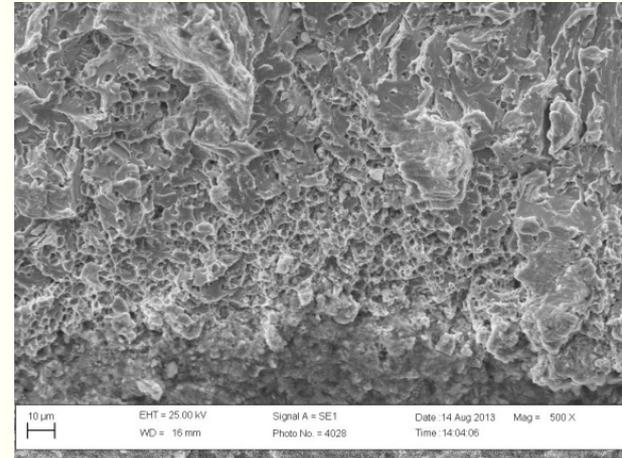
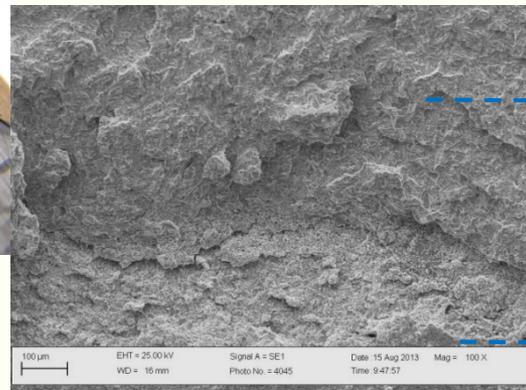
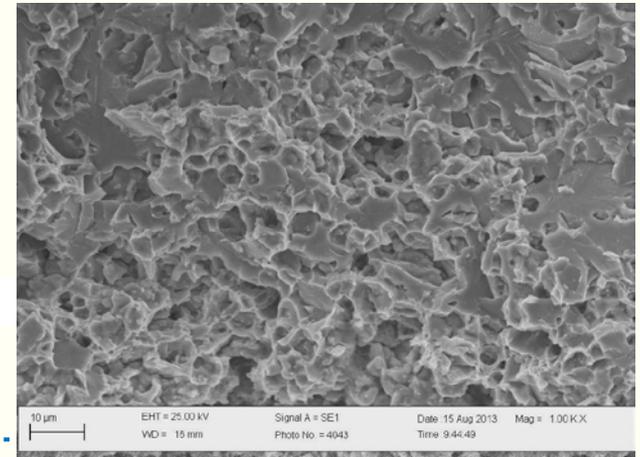
- More than 800 attachment welds failed after 23,000 hrs in service
- BM: SA-213, T91
- Lug: ASTM A297, Grade HH
- Filler Metal: ENiCrFe-2 (Inco-Weld® A)
- Cracking was an intergranular fracture along the partially mixed zone on the weld metal side
- 100-150 microns deep creep cavitated zone in front of the crack tip
- Up to 5%Ni in the partially mixed zone
 - Significantly lower Ac1
 - PWHT temperature over Ac1 of the partially mixed zone
 - A creep weak zone after PWHT
- Notch at weld root and bending load

~400 μ m
Crack Tip

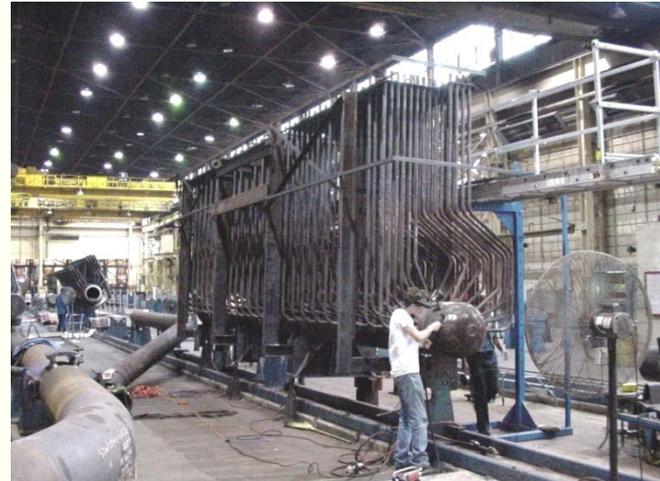
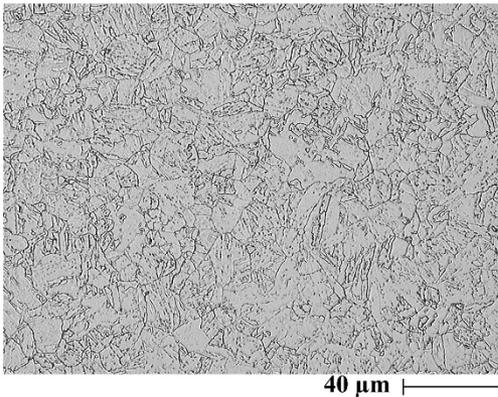
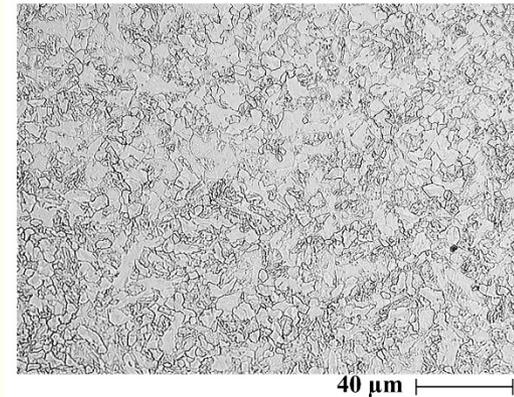
Hardness Measurements after PWHT revealed ~150 HV.

Effect of PWHT Temperature > A_{C1}

HARDNESS VALUES-HV* (Equotip)					
Sample	Location	0°	90°	180°	270°
Header Body	North**	214	216	218	224
	South**	213	213	210	208
Girth Weld	North	258	267	280	274
	South	227	241	229	230
Hemi-Head	North	135	137	160	141
	South	168	176	175	172

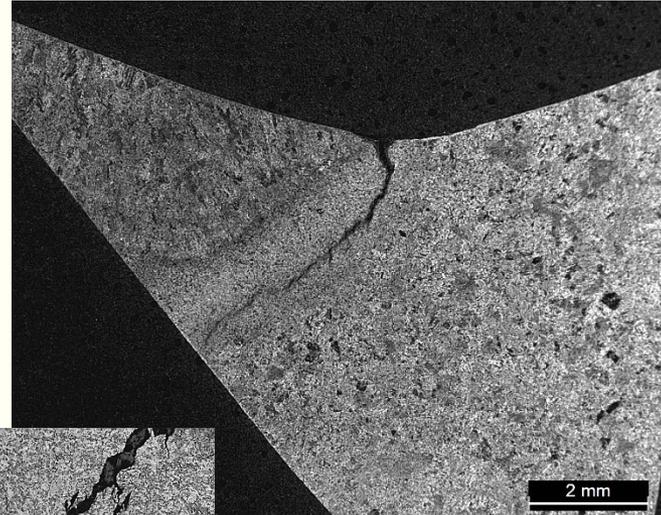
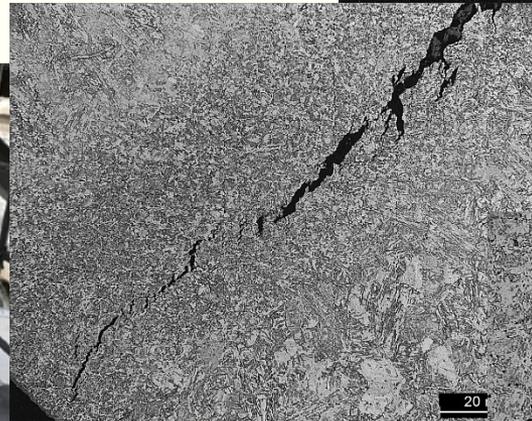
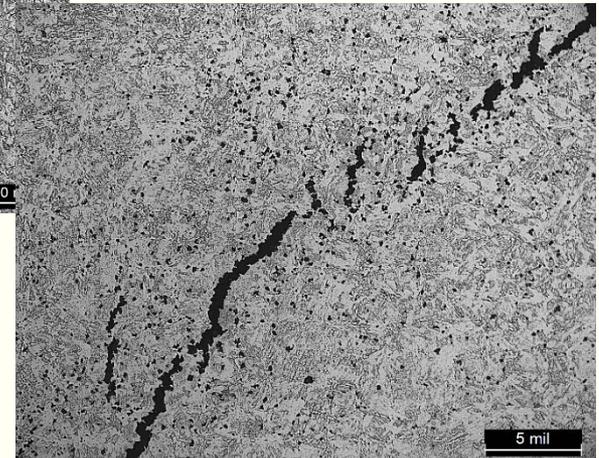
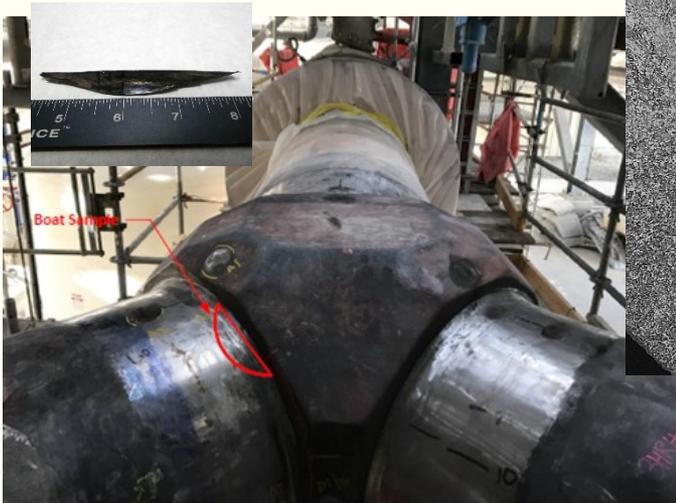
Case Study 12: Type IV Damage in P91 Girth Weld

- 20" OD Sch. 40 ASME SA335 P91
- Design temperature: 1067°F
 - Design pressure: 450 psig
- ~70,000 hrs in service
- Primary cracks were located from about 9:00 to 12:00 on the crotch side of the wye block
