METALLURGICAL REPORT

EXAMINATION OF MAIN STEAM SUPPORTING LUG

**CES PROJECT-17J197
PO-TBD**

**CES
ENGINEERING SOLUTIONS
200 COMPRESS STREET
CHATTANOOGA, TENNESSEE 37405**

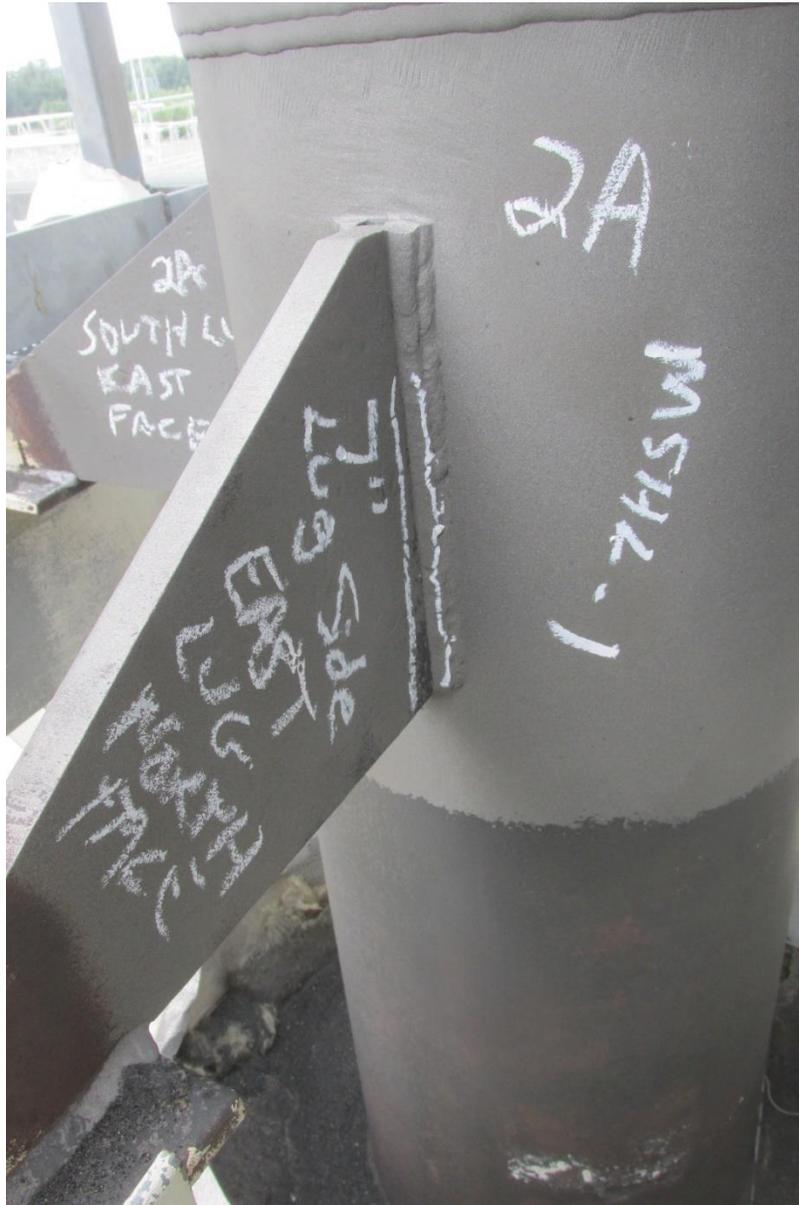
A portion of a support lug ([REDACTED]) that had been welded to main steamline piping for [REDACTED] was removed from service and submitted to CES-Engineering Solutions for metallurgical analysis. It was reported that the sample had been removed because a 7" long indication had been detected along the attachment weld in the east lug, as shown by the area marked in white in Figure 1. No information was provided regarding the non-destructive test method used to find the indication.

Figure 1. Shown is the north side of the east support lug [REDACTED], with the approximate location of the indication detected during a non-destructive inspection outlined in white.

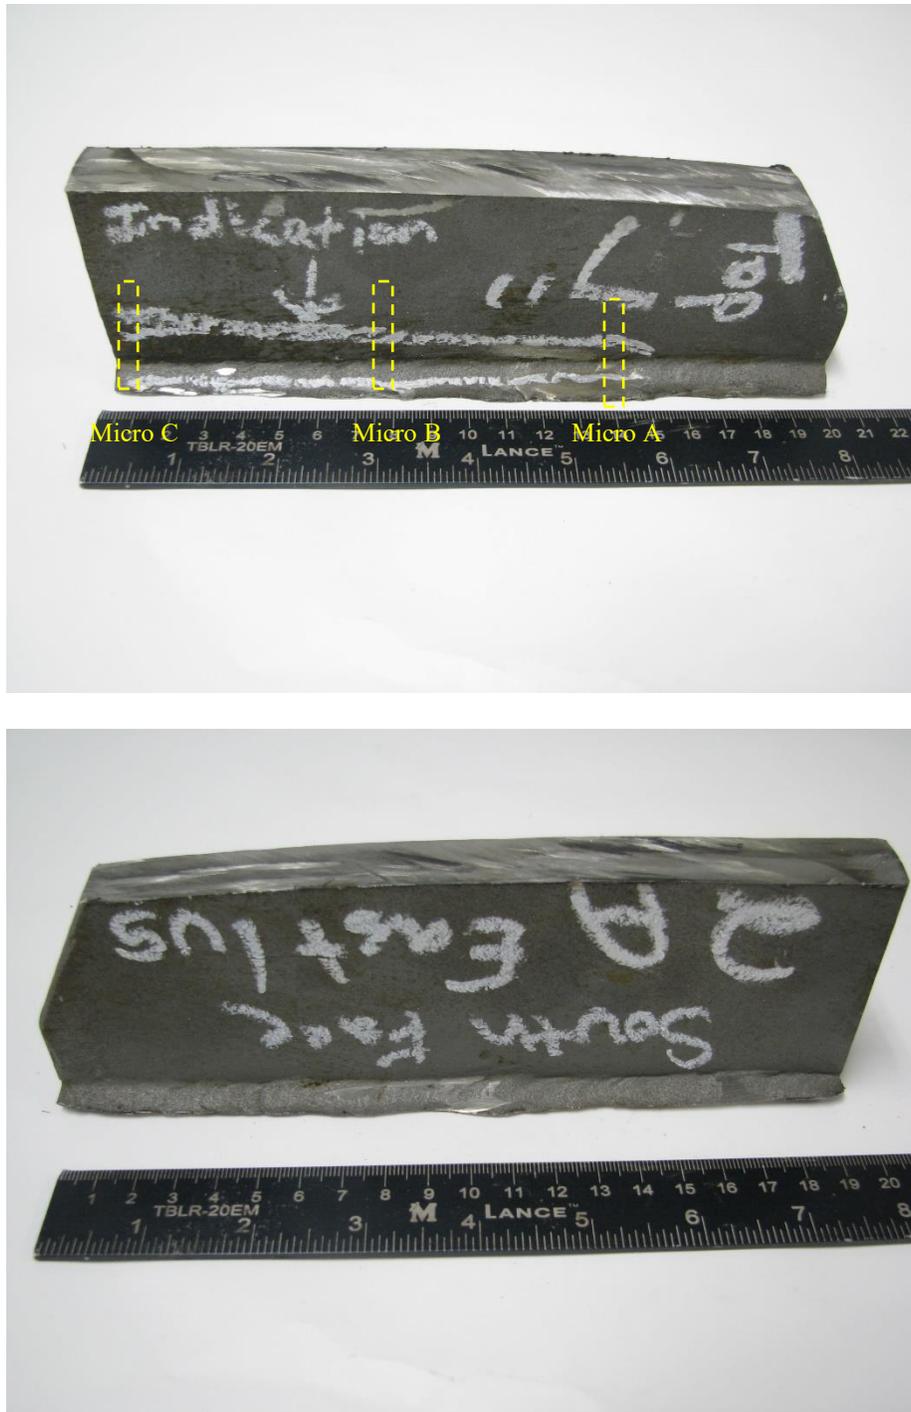
The sample was examined with the aid of a low magnification stereomicroscope in order to characterize the general features of the lug and the weld area, and to identify any visible damage or structural anomalies that might have been related to the indication. Of particular interest was the area at the bottom half of the North side of the lug where a portion of the weld had been circled in white to designate the suspected location of the indication (see Figures 1 and 2).

Three metallographic specimens were removed transverse to the North side attachment weld, one from near the top of the marked area on the weld, a second from the approximate mid-point of the marked area and a third from the bottom of the marked area, as indicated in the top photograph in Figure 2. These specimens were polished and etched so that the macrostructural and microstructural features of the weld deposit, the weld Heat-Affected Zone (HAZ) and the lug, itself, could be evaluated in detail using light microscopy.

Figure 2. Shown are the general features of the lug sample in the as-received condition; the approximate locations from which the metallographic specimens were removed also is indicated in the top photo.

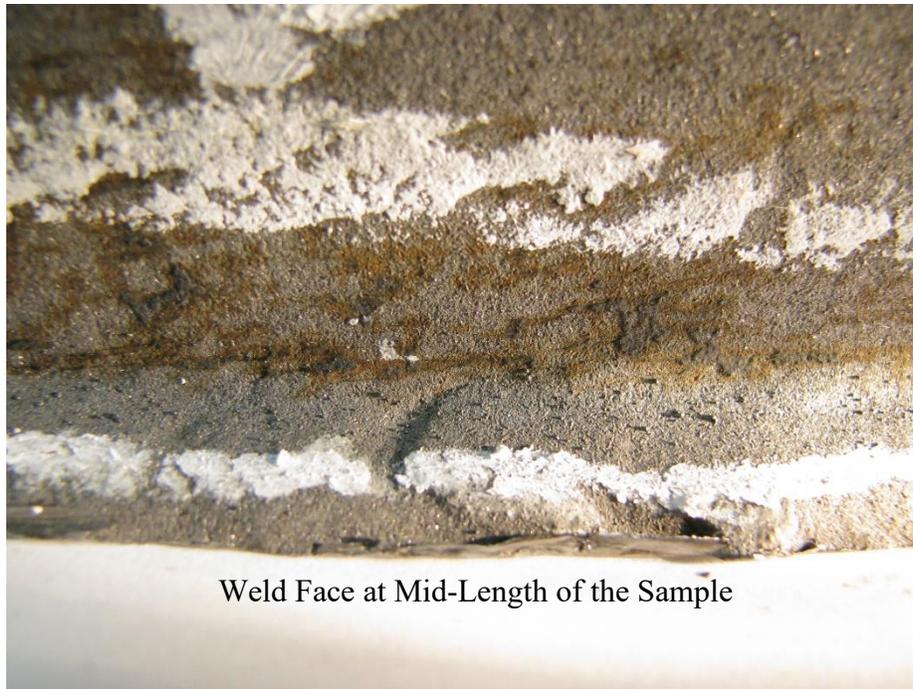
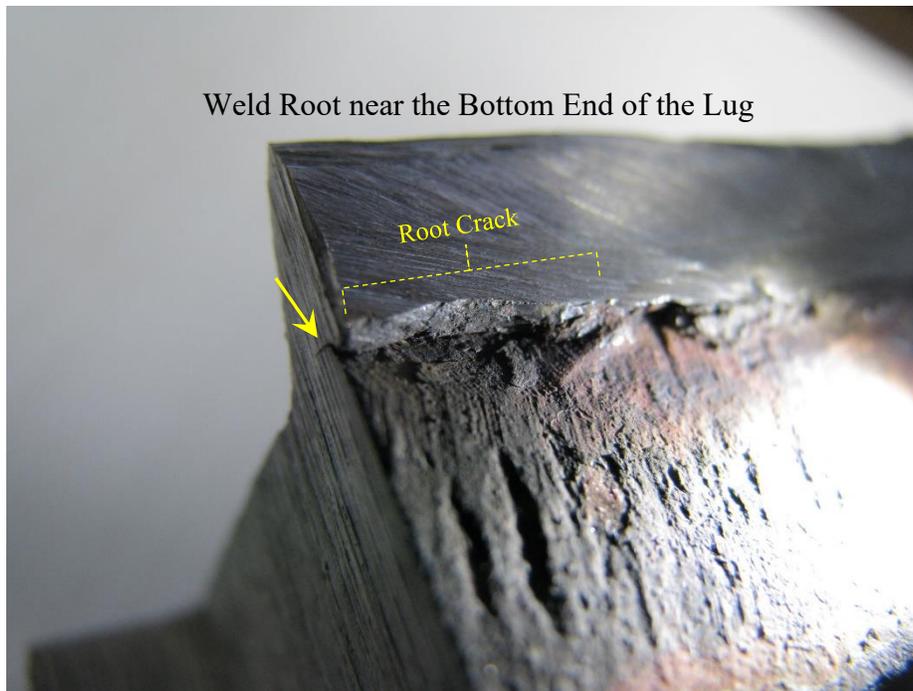
As shown in Figure 3, evidence of oxide-fatigue notching was observed on the weld face along the entire length of the marked area. On the root side of the weld, a crack was observed at the bottom end of the lug on the same side of the lug where the indication was reported to have been detected (North side); the visible crack extended approximately 18 mm (0.71”) from the bottom end of the lug.

Figure 3. Shown are close-up views of the lug sample on the face-side (top photo) and root-side (bottom photo) of the weld.

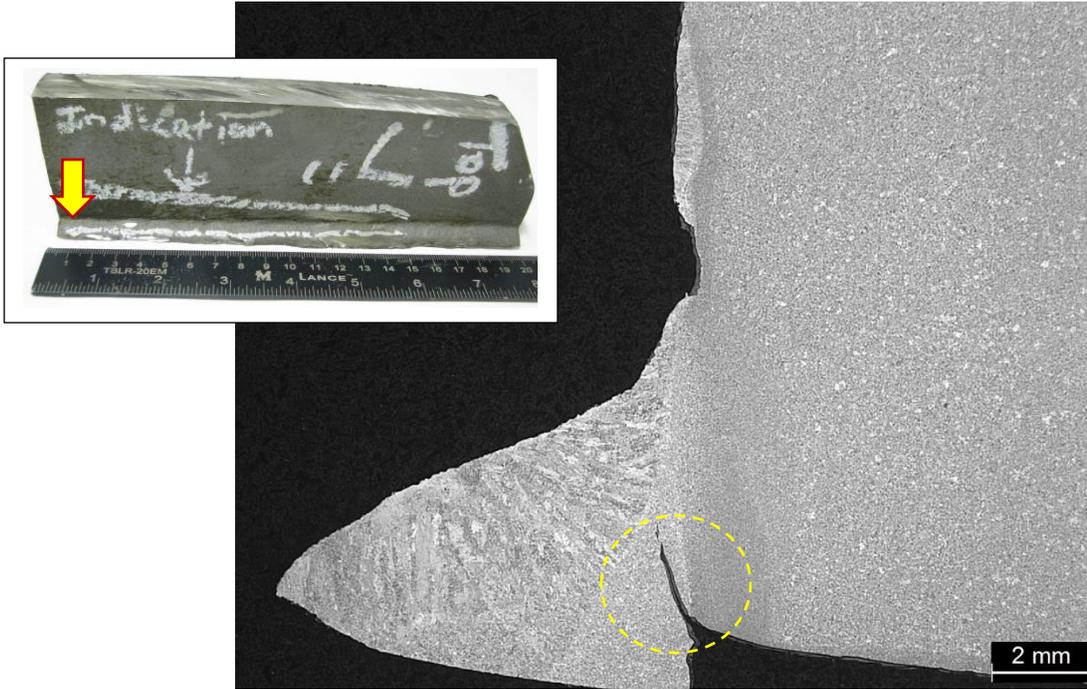
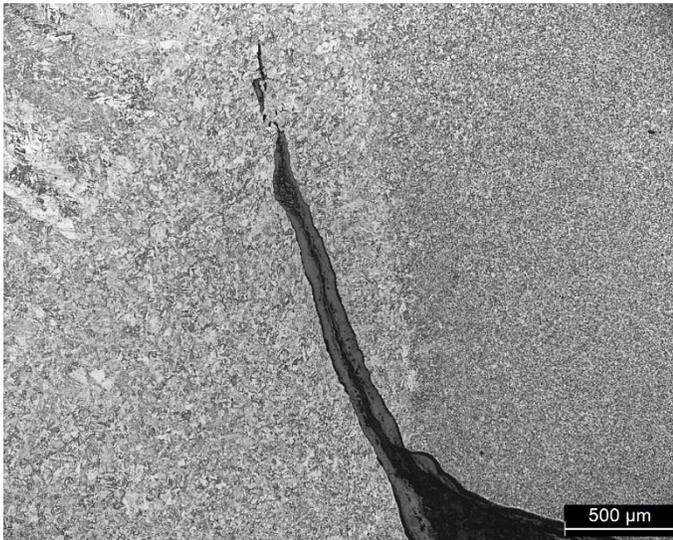
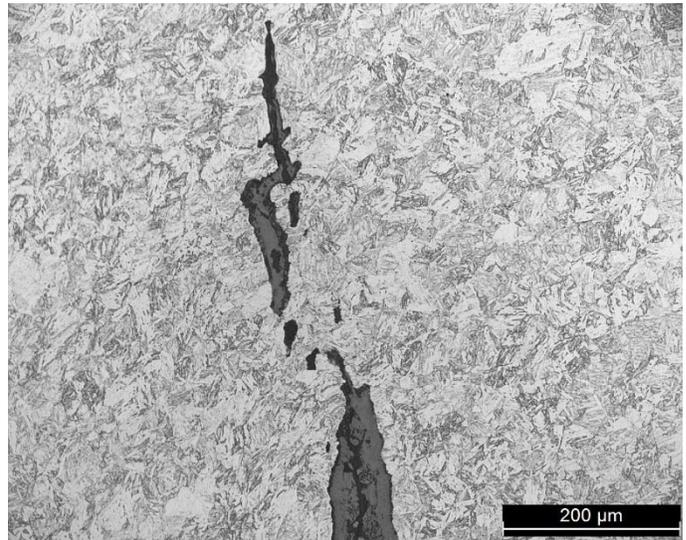
*Bottom End of Lug
Indication-Side of
the Weld*

The destructive examination of the lug sample revealed that a crack had initiated from the root of the attachment weld and was propagating through the weld. The crack was approximately 2.4 mm (0.94") deep within a weld deposit that was approximately 5.2 mm (0.20") thick at the crack location. The crack was located near the bottom end of the lug and extended upwards approximately 18 mm (0.71"). The majority of the fracture surface was covered by a layer of high temperature oxide, so that the original features of the fracture could not be examined in sufficient detail to determine the cause of the initial cracking. The remaining features at the crack tip were indicative of a single transgranular crack that had propagated by fatigue. Shallow oxide-fatigue notches with a depth not exceeding 0.15 mm (0.006") were observed on the weld face along the entire length of the marked area.

Although there was not sufficient evidence to state with certainty why the crack at the root of the attachment weld first developed, it is likely that the cracking initiated during the original welding of the lug, possibly as a “cold” crack, and that the subsequent fatigue propagation occurred in response to the presence of that crack.

Examination of the specimen taken from the bottom end of the marked area revealed a crack that extended 2.4 mm (0.94”) into the 5.2 mm (0.20”) thick weld deposit, as shown in Figure 4. The majority of the crack length was covered by a relatively thick layer of high temperature scale, which obscured the original microstructural features of the crack. Near the crack tip, the visible features of the fracture were consistent with a single transgranular crack that had propagated by fatigue. In front of the crack tip, highly localized early-stage creep damage – i.e., cavitation - was found in the weld metal, as documented in Figure 5. In addition, a few shallow oxide-fatigue notches were observed on the weld face, as shown in Figure 6.

Figure 4. Shown are the features of the crack that was found to have initiated from the root of the weld. The crack depth is approximately 2.4 mm, while the total thickness of the weld metal at this location is approximately 5mm.

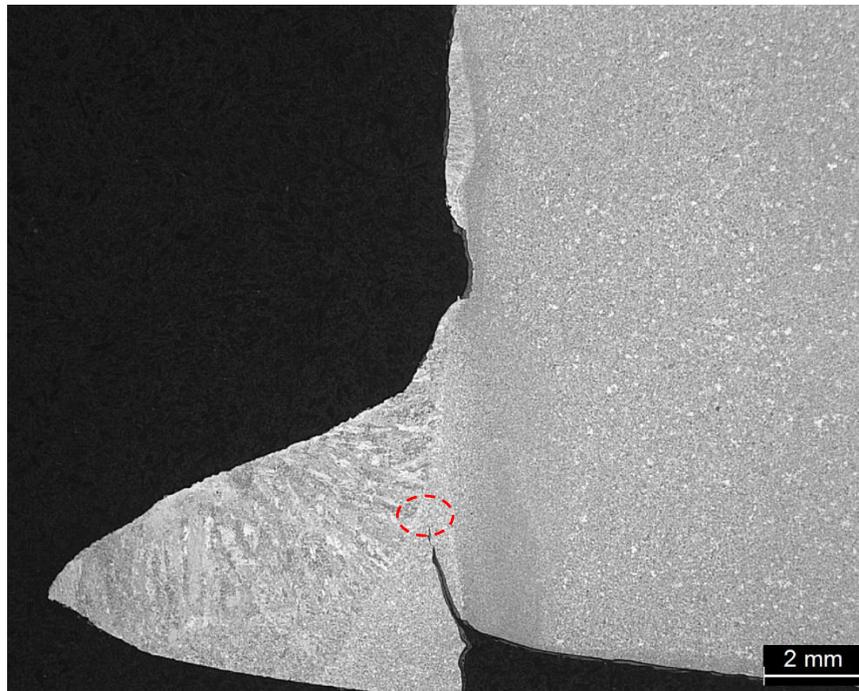
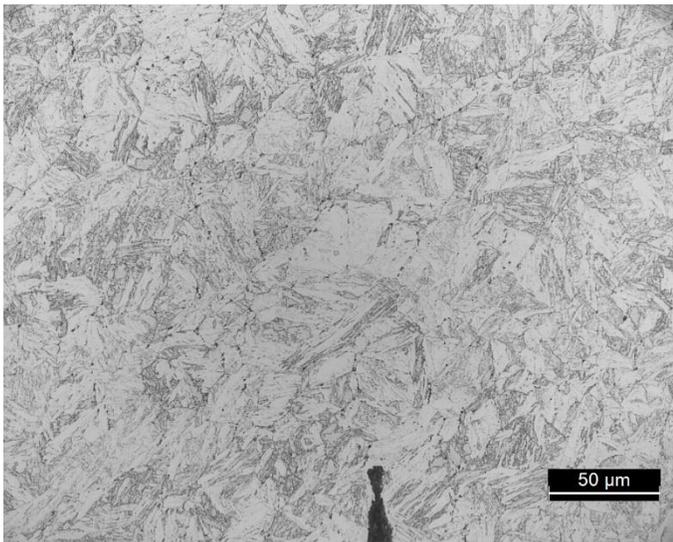
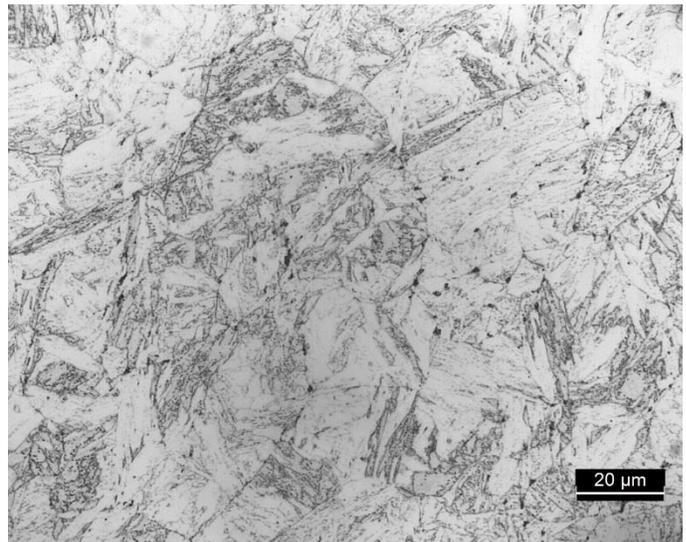
*Bottom End of Lug
Indication-Side of
the Weld*

Examination of the weld metal in front of the crack tip uncovered highly localized early-stage creep cavitation (stage 2 – isolated cavities) due to the stress-concentration effect at the crack tip. Examination of the remainder of the sample showed that the metallurgical condition of the lug and the weld were normal, with no signs of additional cracking or any significant service-induced distress.

Figure 5. Shown are the features of the weld metal near the crack tip, with evidence of early-stage creep cavitation (Stage 2 – isolated cavities) visible near the crack tip.

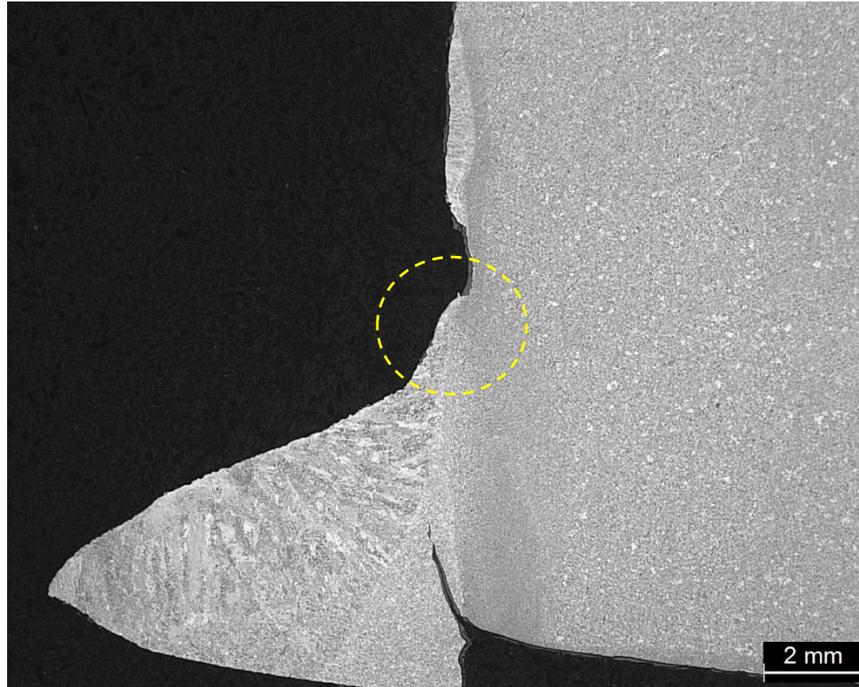
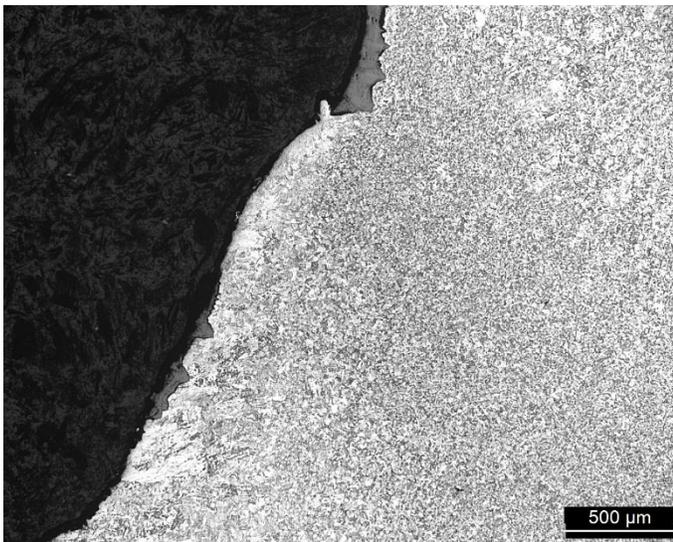
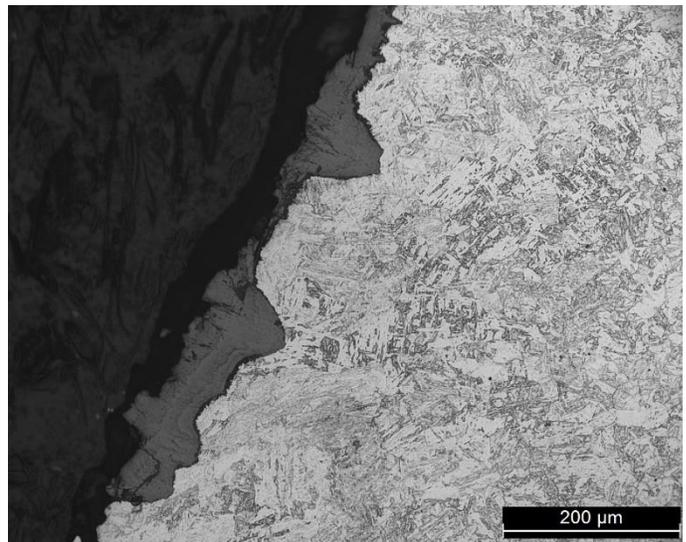
*Bottom End of Lug
Indication-Side of
the Weld*

Figure 6. Showing the features of the oxide-fatigue notches on the face of the weld.

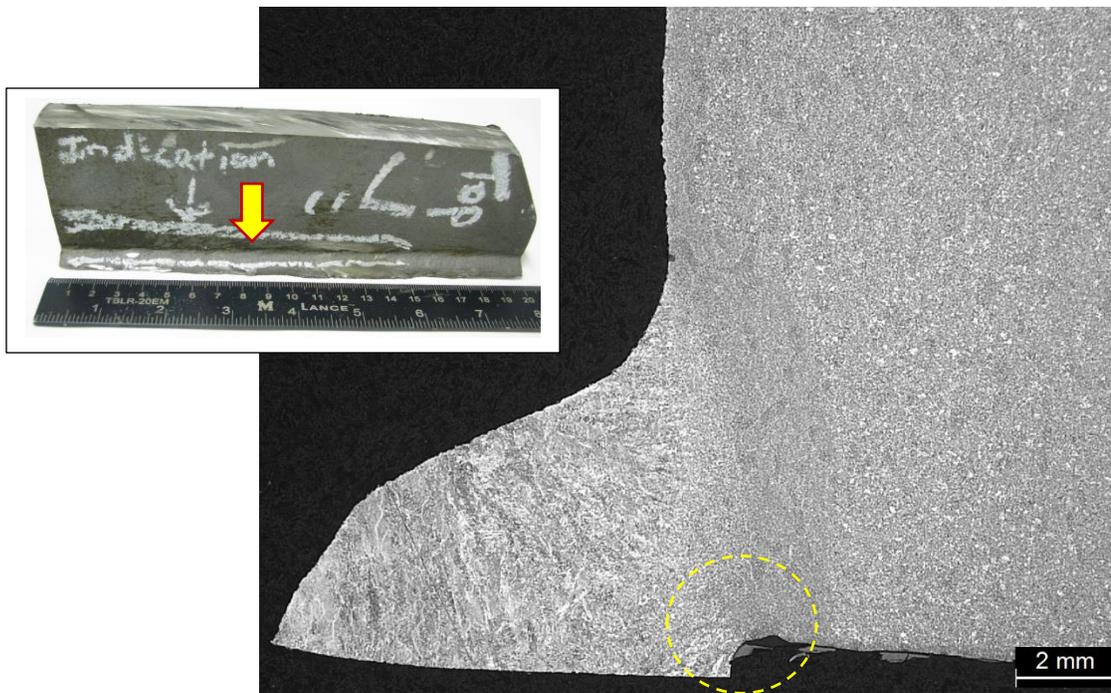
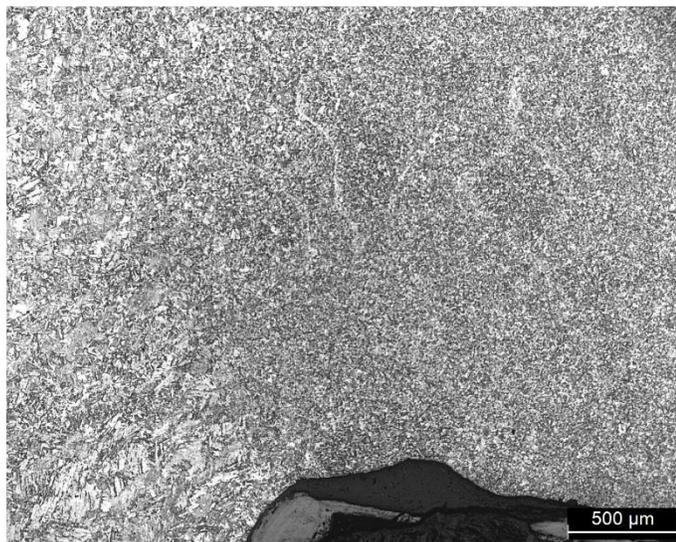
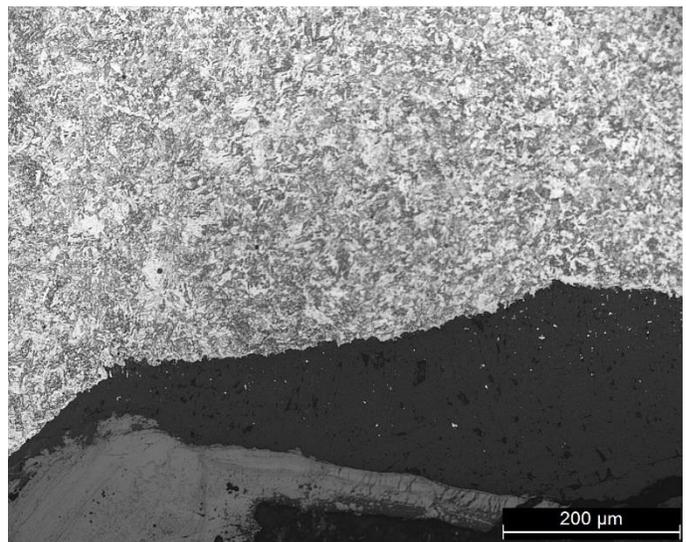
*Mid-Length of
Marked Area
Indication-Side of
the Weld*

Examination of the specimens from the middle and top of the marked area at the weld revealed no signs of cracking from either the root or the face of the weld, as documented in Figures 7 and 9. On the weld face, a few shallow oxide-fatigue notches were observed, as shown in Figure 8 and 10.

Figure 7. Shown are the features of the root of the weld at the mid-length of the marked area, with no sign of any crackling.

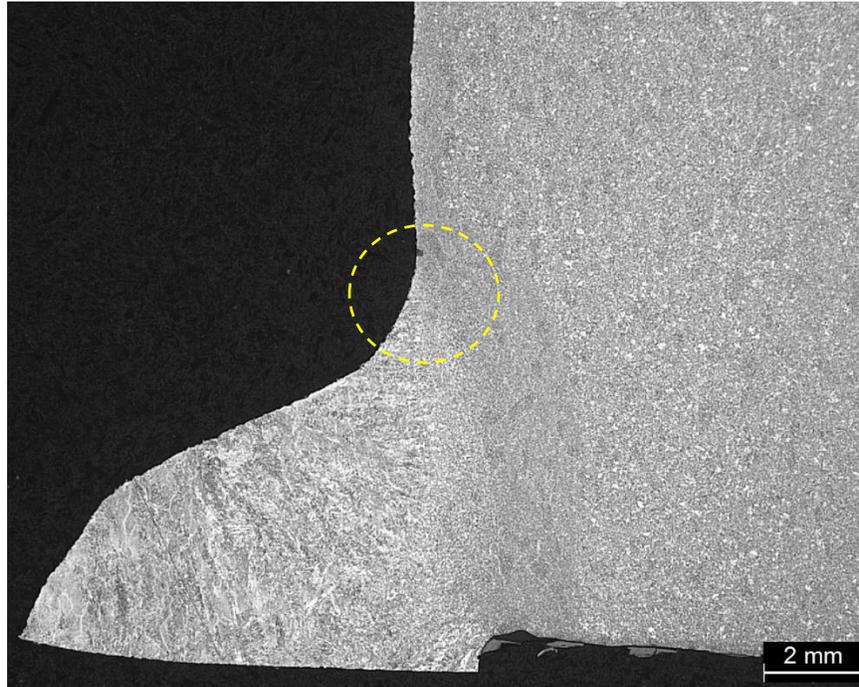
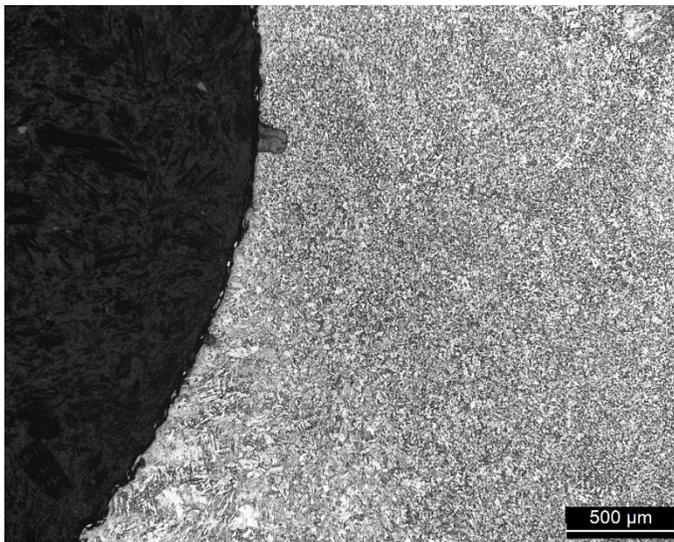
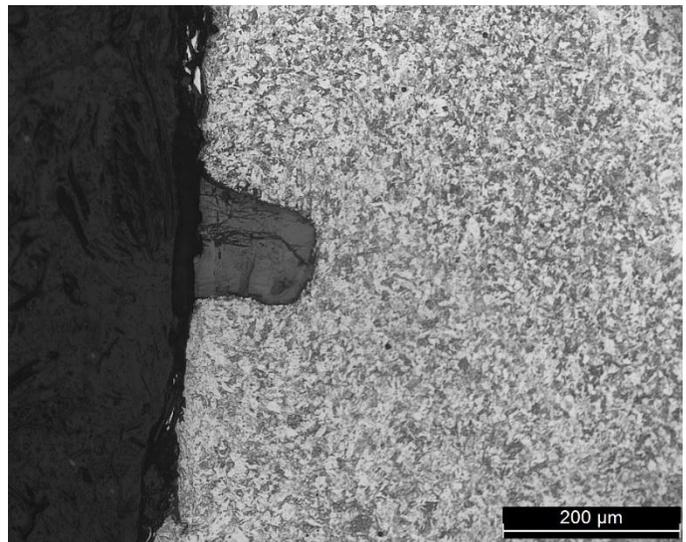
*Mid-Length of
Marked Area
Indication-Side of
the Weld*

Figure 8. Shown are the features of oxide-fatigue notches on the face of the weld at the mid-length of the marked area.

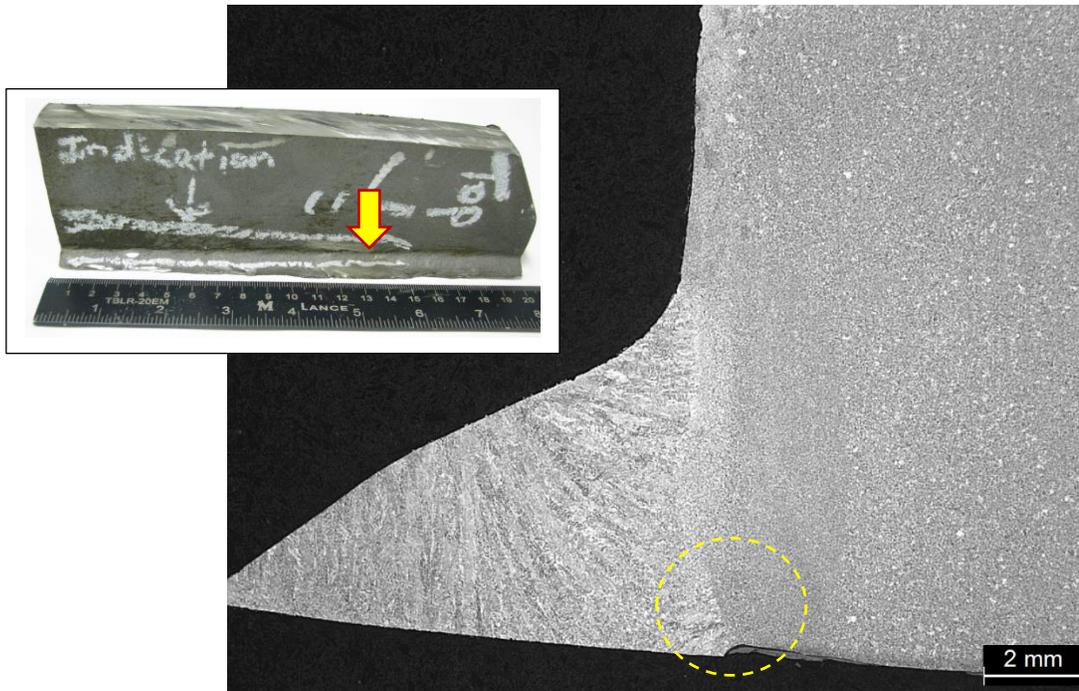
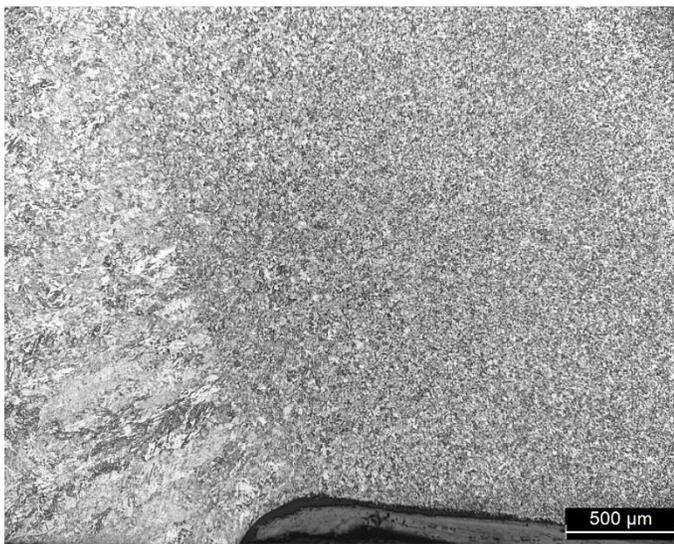
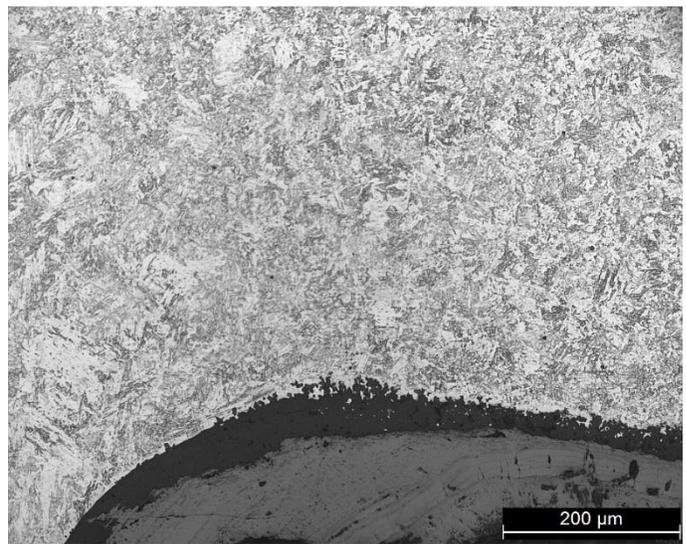
*Top End of
Marked Area
Indication-Side of
the Weld*

Figure 9. Shown are the features of the root of the weld at the top end of the marked area, with no sign of any crackling.

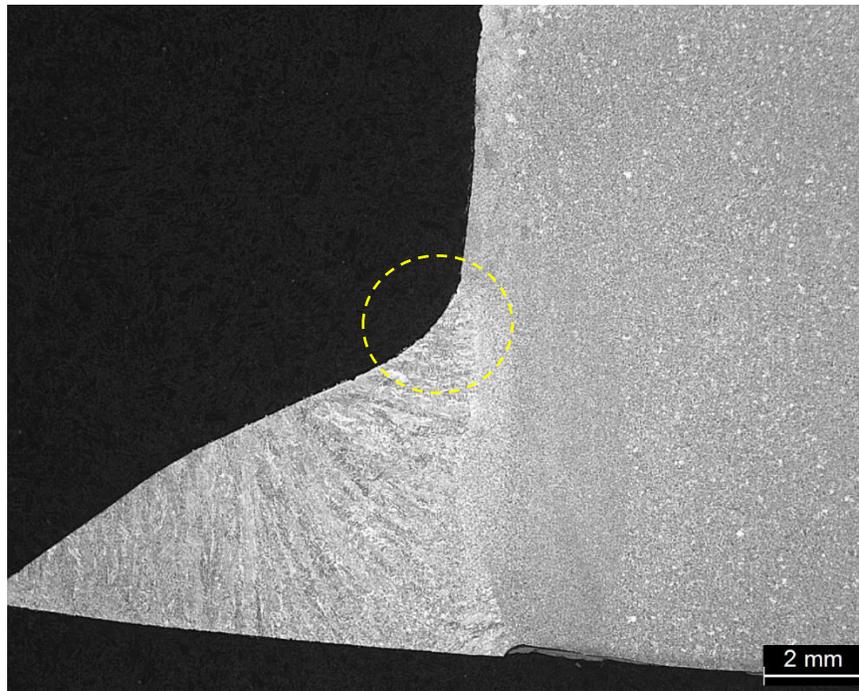
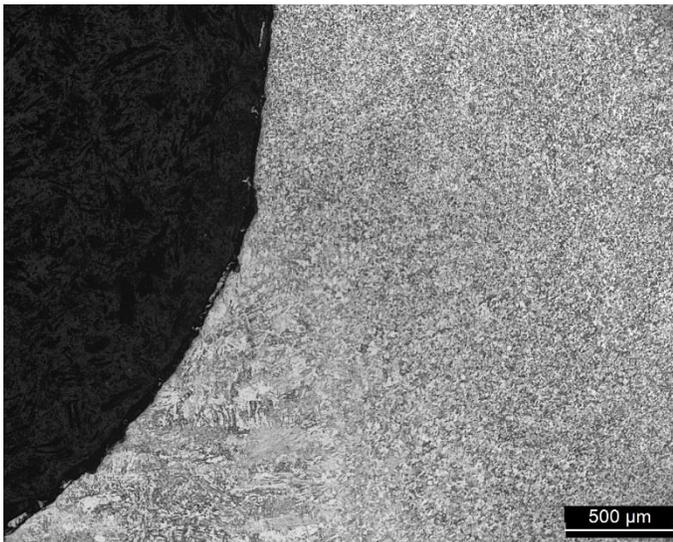
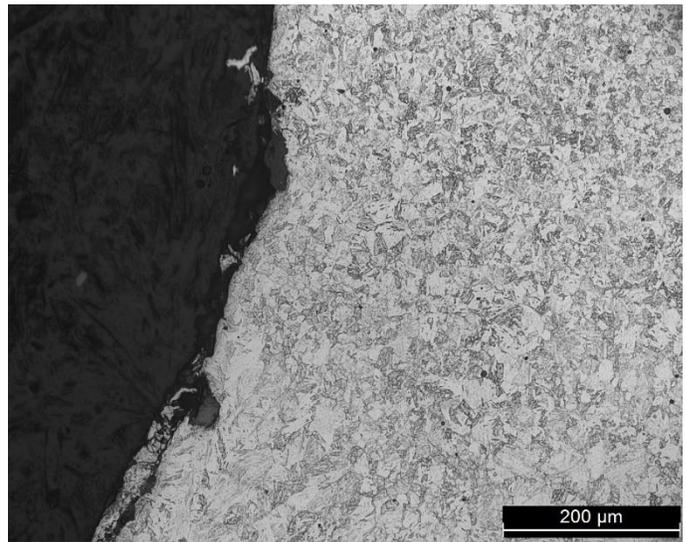
*Top End of
Marked Area
Indication-Side of
the Weld*

Figure 10. Shown are the features of the oxide notches on the face of the weld at the top end of the marked area.

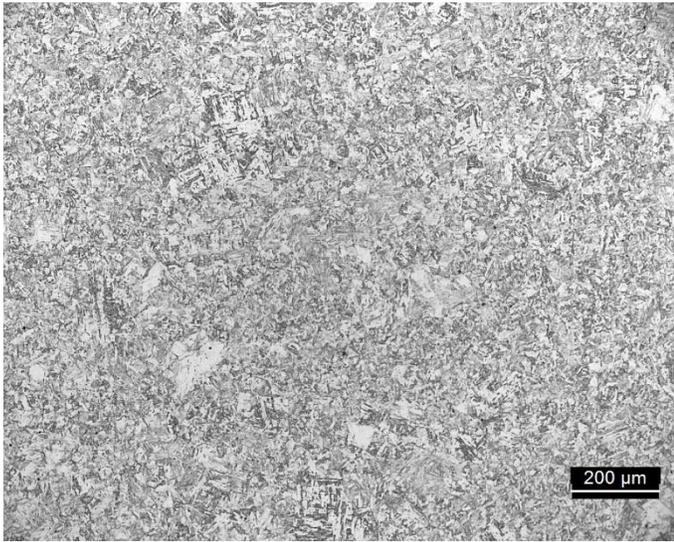
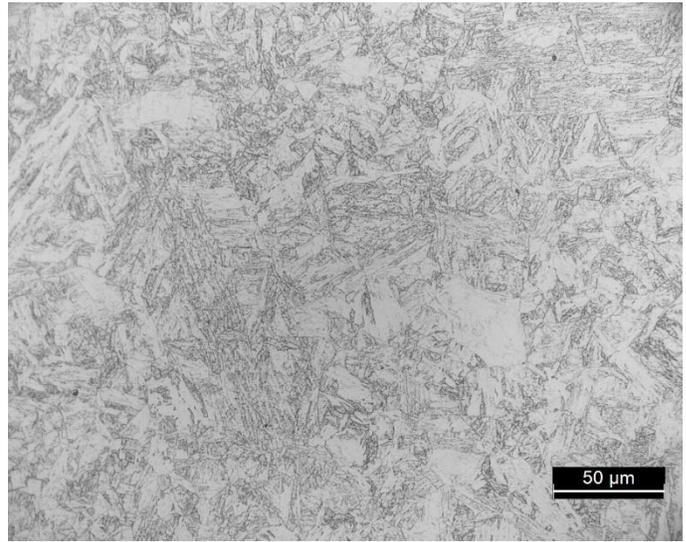
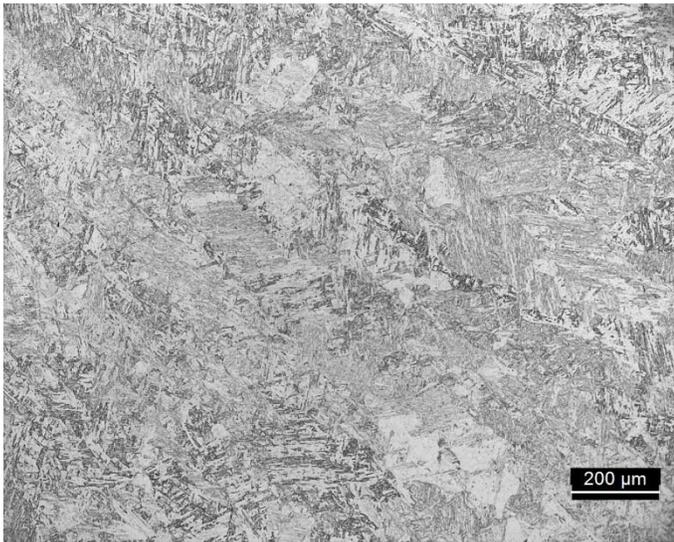
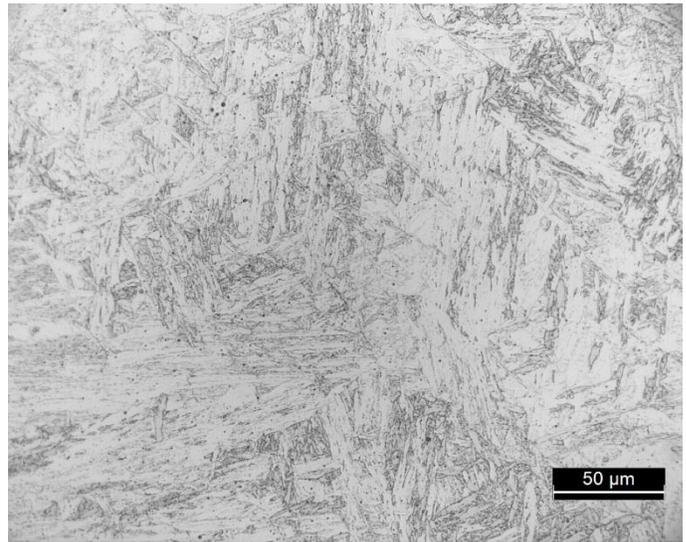
Examination of the lug body and the weld, itself, uncovered no evidence of any discontinuities or other structural anomalies that could have contributed to the onset of the cracking. The typical metallurgical condition of the lug and the weld were found to be normal, with no signs of any significant service-induced distress. The typical microstructural condition of the lug base metal and the weld metal are documented in Figure 11.

Figure 11. Shown are typical microstructural features of the base metal and the weld metal in the main steam lug sample.
