METALLURGICAL REPORT

EXAMINATION OF A BOILER CIRCULATION PUMP SHAFT

ATC PROJECT-18B071

Examination of a Failed Boiler Circulation Pump Shaft

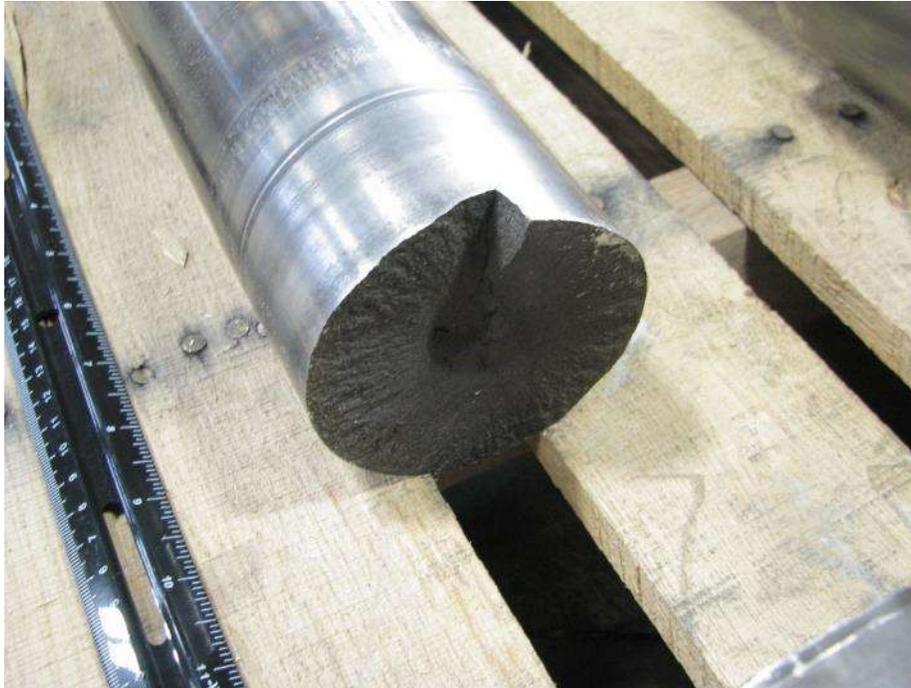
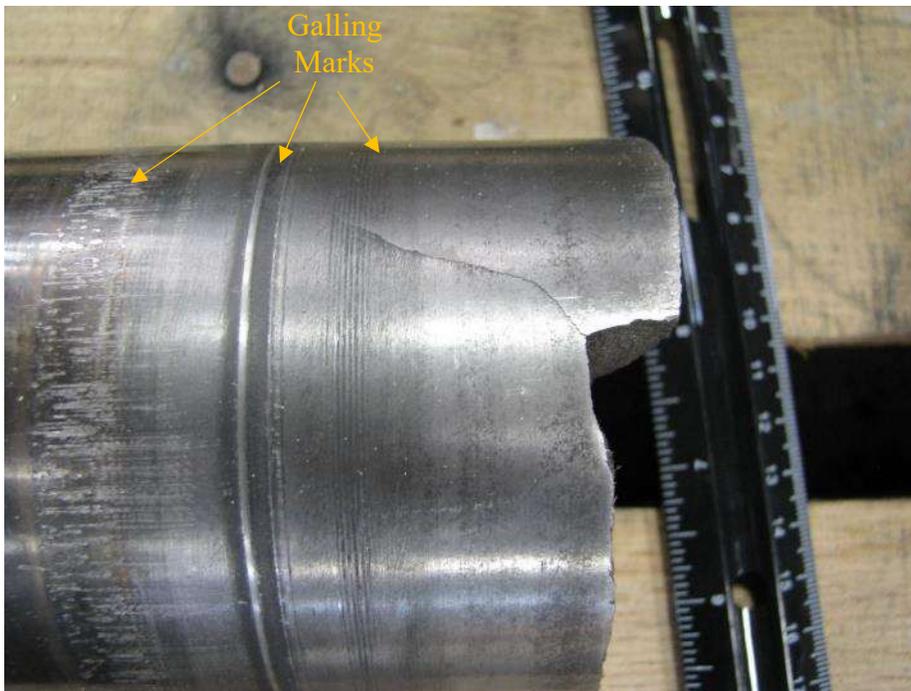
Figure 2. Documenting the general features of the primary fracture that had occurred in the boiler circulation pump shaft.

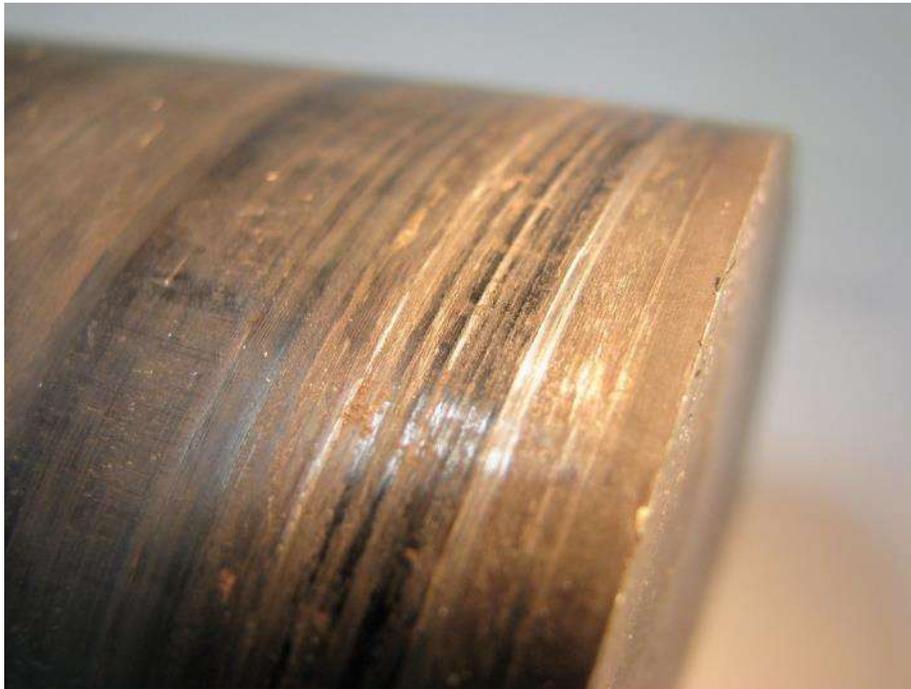
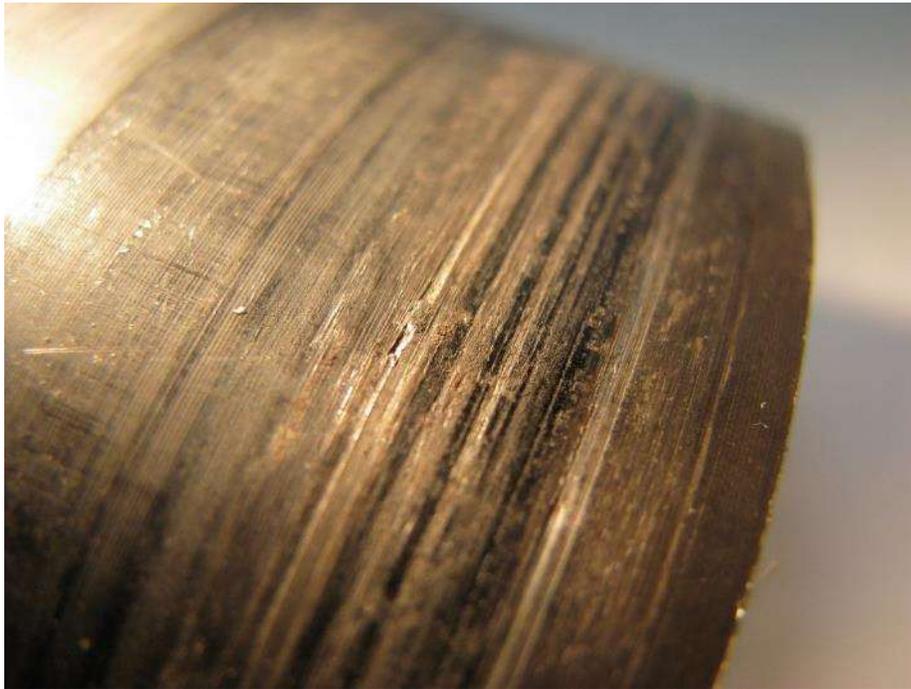
With respect to the contacting surfaces between the sleeve and the shaft and the sleeve and the bushing, the visual examination revealed evidence of severe wear damage and gouging on all contacting surfaces. The conditions of the internal surface of the sleeve and the surface of the shaft where they were in contact are documented in Figures 3 and 4. The pattern of damage observed on these two surfaces was consistent with each other, supporting the conclusion that the damage was a direct result of contact between the surfaces. The conditions of the external surface of the sleeve and the internal surface of the bushing are represented in Figures 5 and 6. As was true with the inner sleeve and shaft surfaces, the pattern of the damage observed on the outer sleeve and inner bushing surfaces was consistent between the two surfaces; this, again, supports the conclusion that the damage observed occurred as the result of contact between those surfaces.

Figure 3. Showing the surface scoring visible on the shaft surface near the fracture.

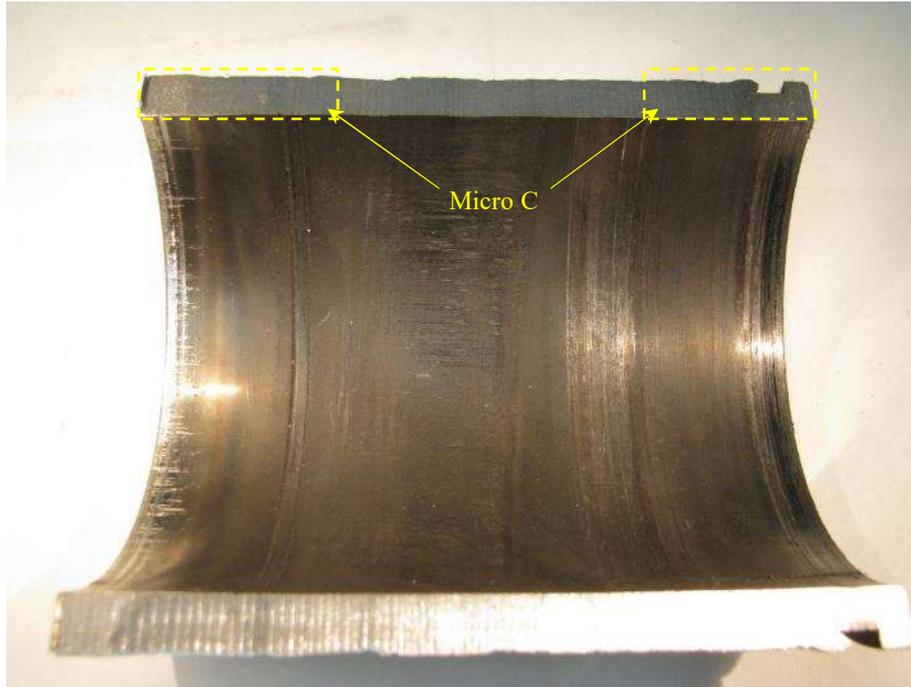
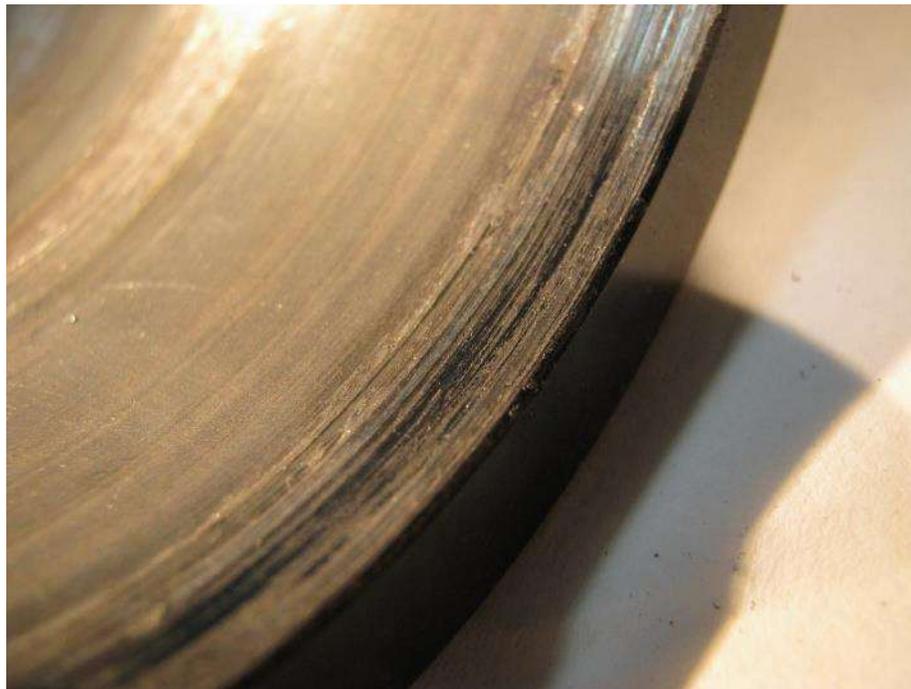
Figure 4. Showing the surface scoring and gall marks visible on the internal surface of the sleeve where it was in contact with the shaft surface.

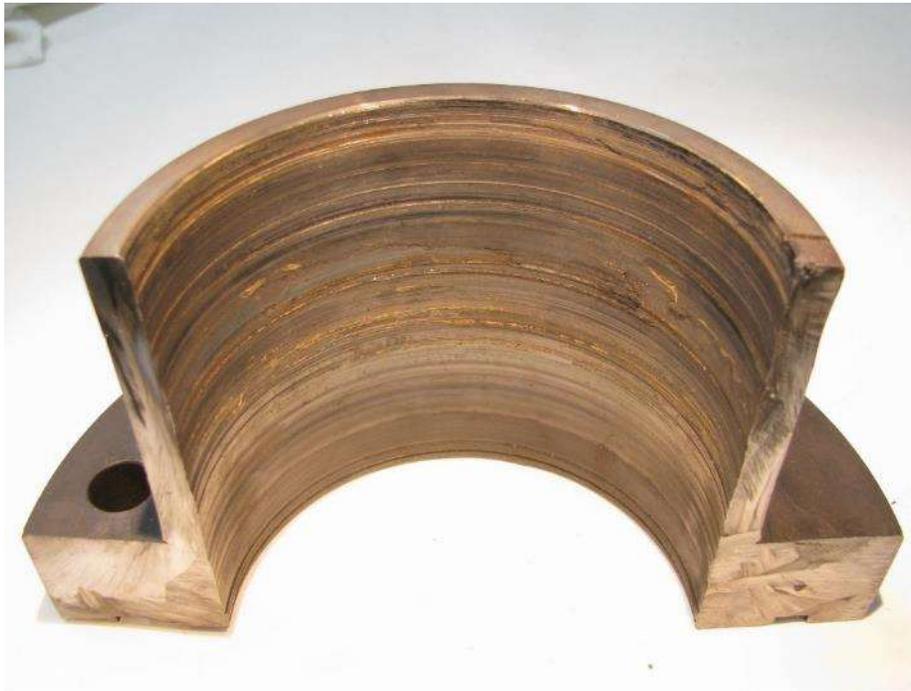
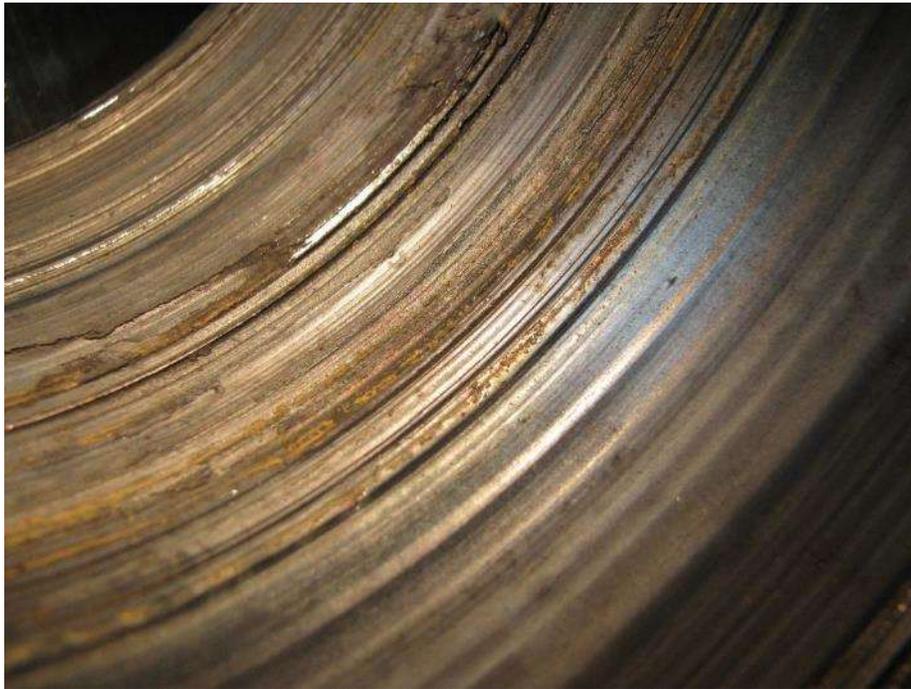
Figure 5. Showing score marks and deep gouges that were visible on the internal surface of the bushing where it was in contact with the outer surface of the sleeve.

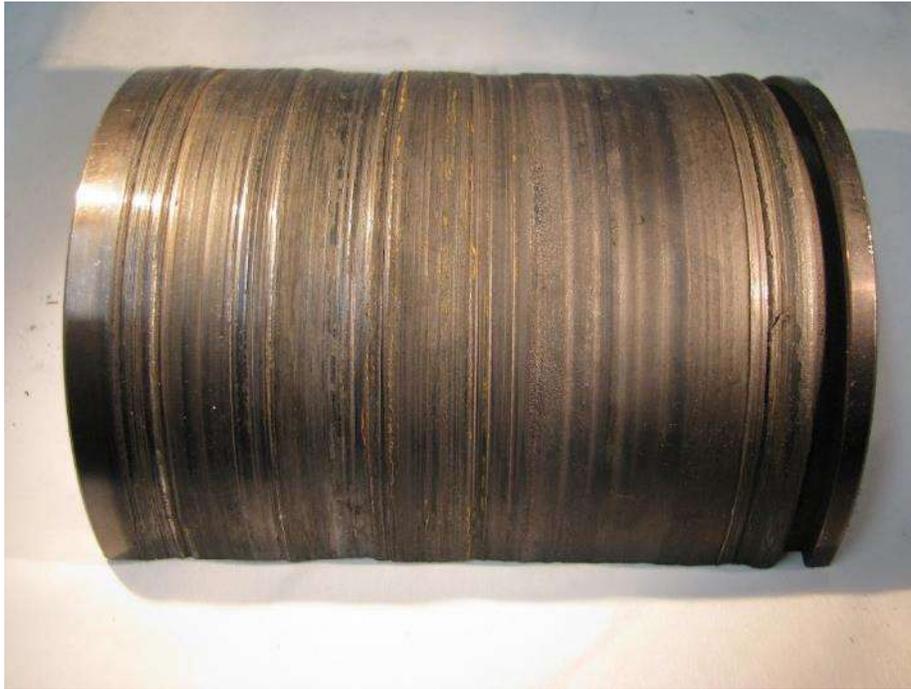
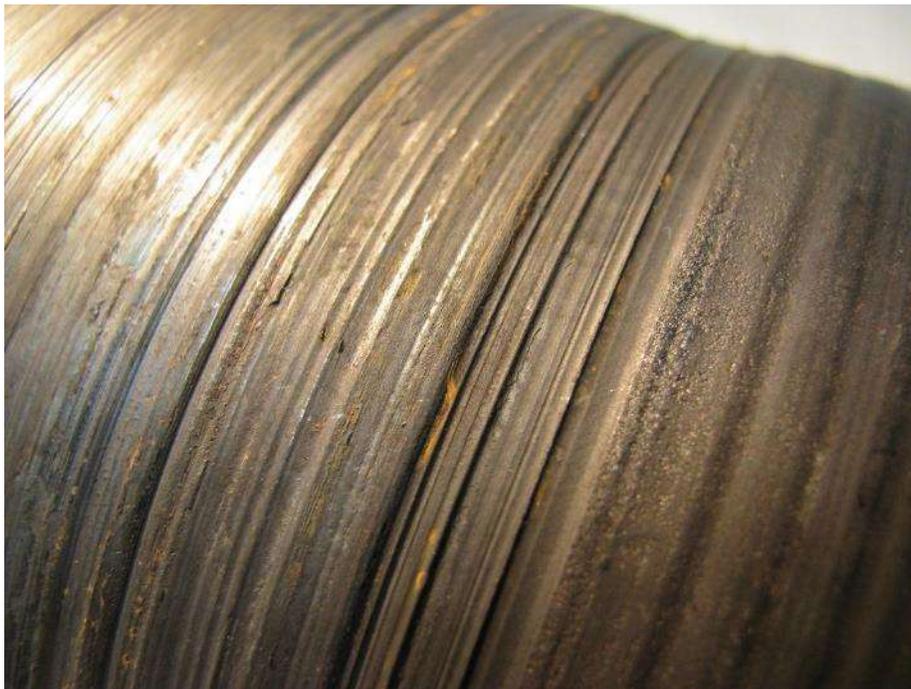
Figure 4. Documenting score marks and deep gouges visible on the external surface of the sleeve where it was in contact with the internal surface of the bushing.

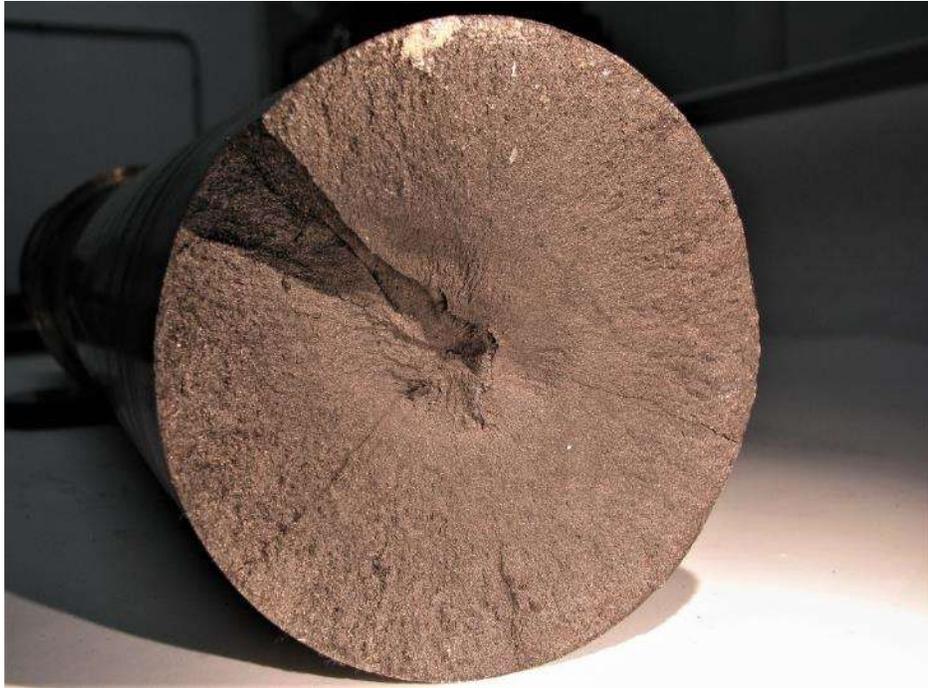
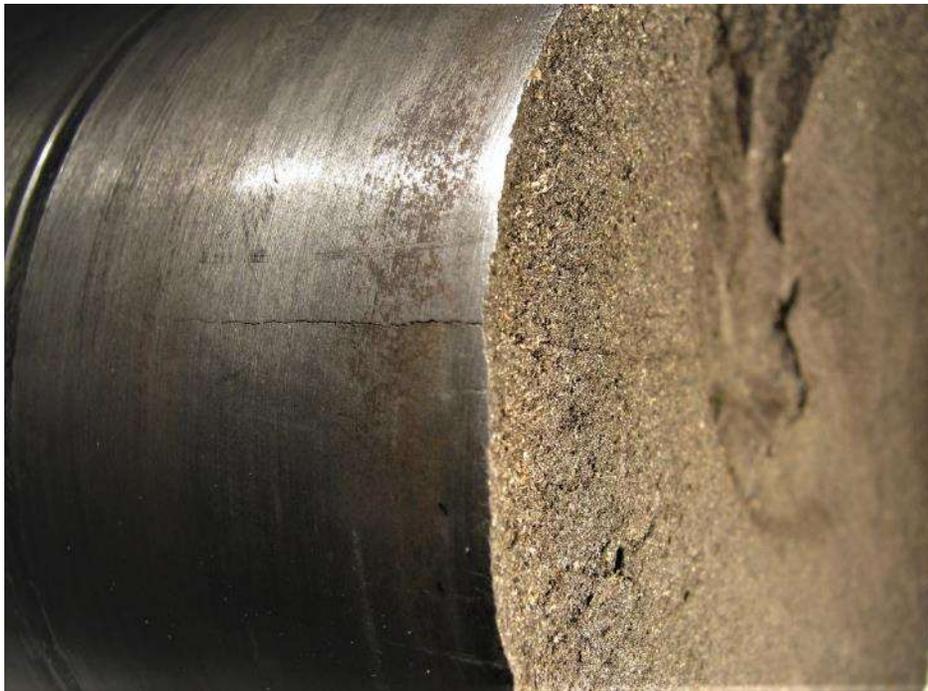
Figure 5. Documenting the general appearance of the primary circumferential fracture in the shaft and showing one of the secondary axial cracks that straddled the primary fracture. Both the axial and circumferential fractures were non-ductile in character.

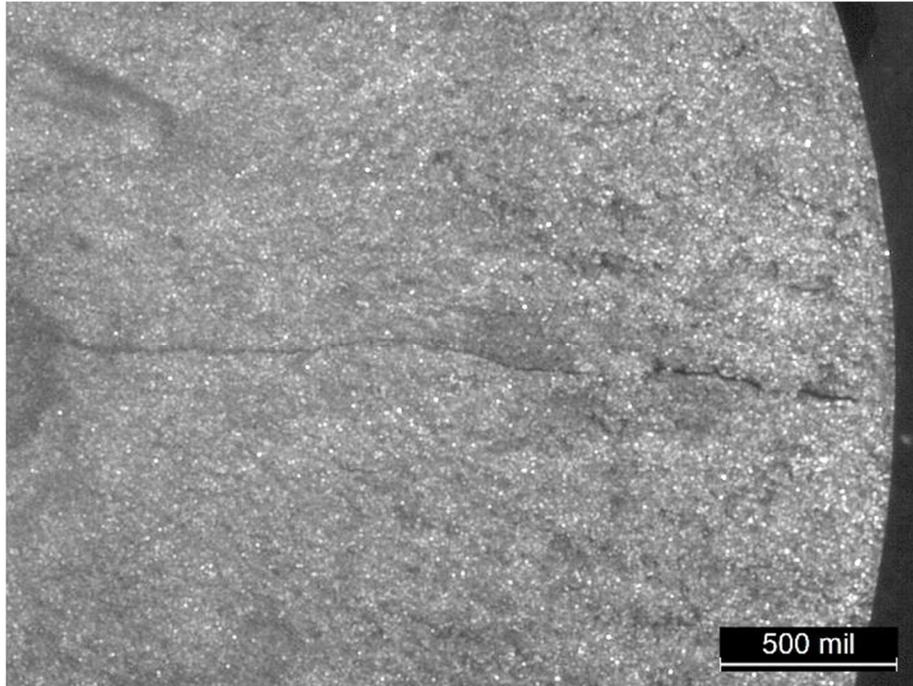
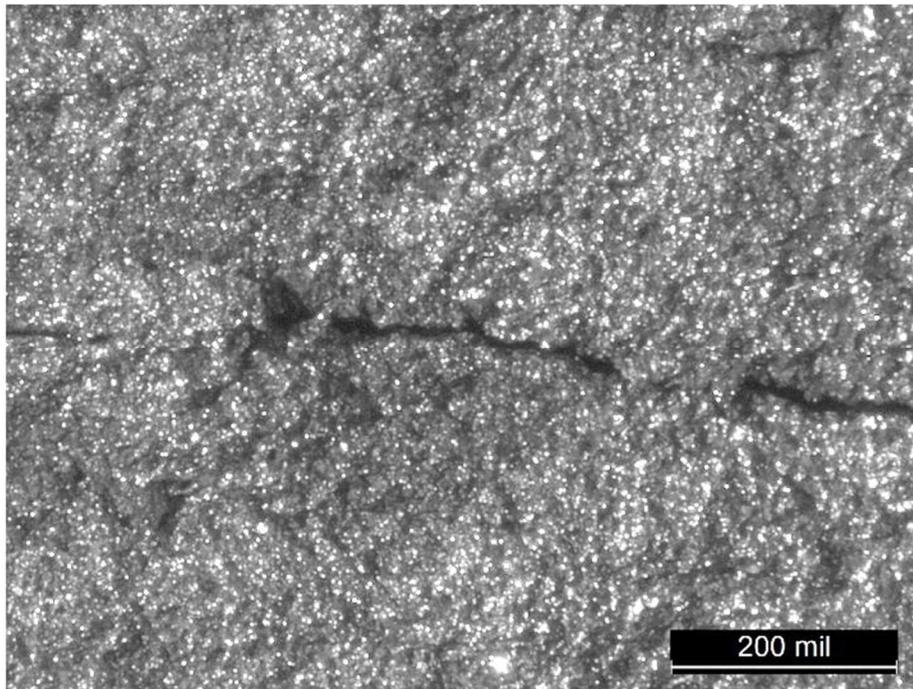
Figure 6. The features of the primary fracture at the edge of the pump shaft are shown here at higher magnifications; the fracture appearance was consistent with an intergranular-dominated fracture.

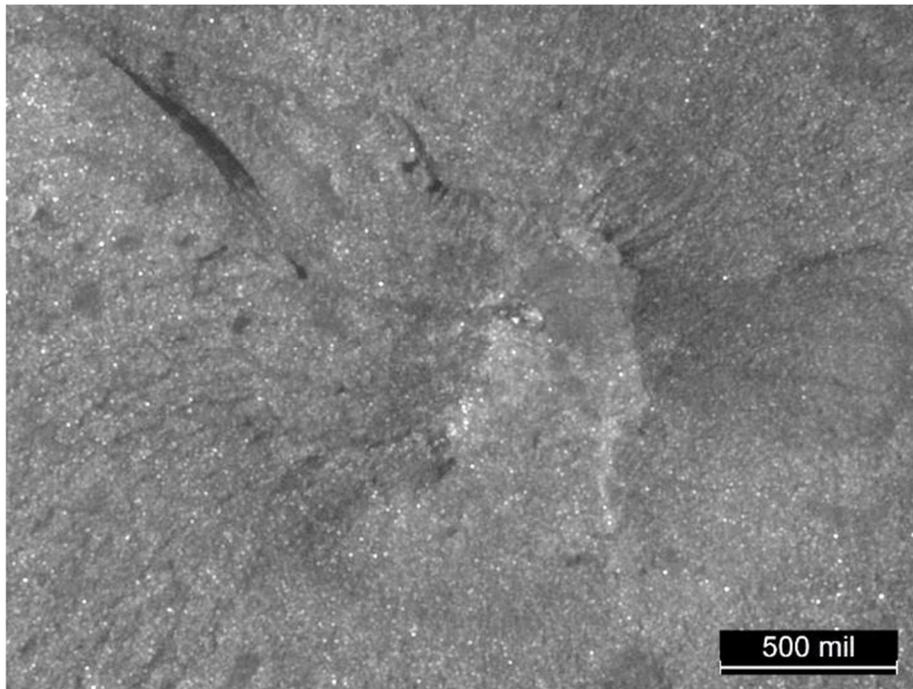
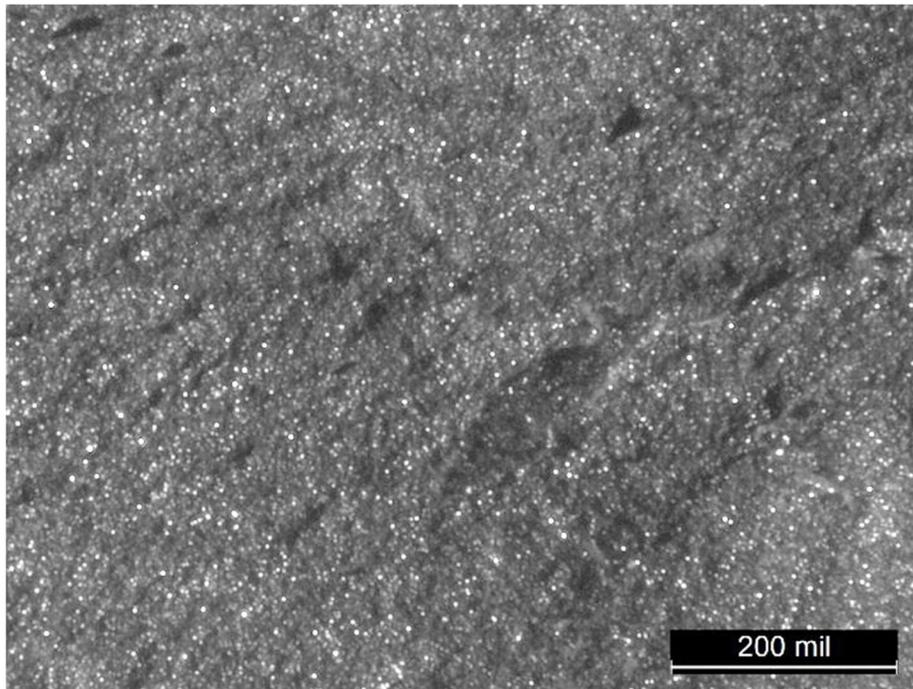
Figure 7. The features of the primary fracture at the center of the shaft are shown here at higher magnifications; the fracture appeared to be predominantly intergranular at this location, as well.

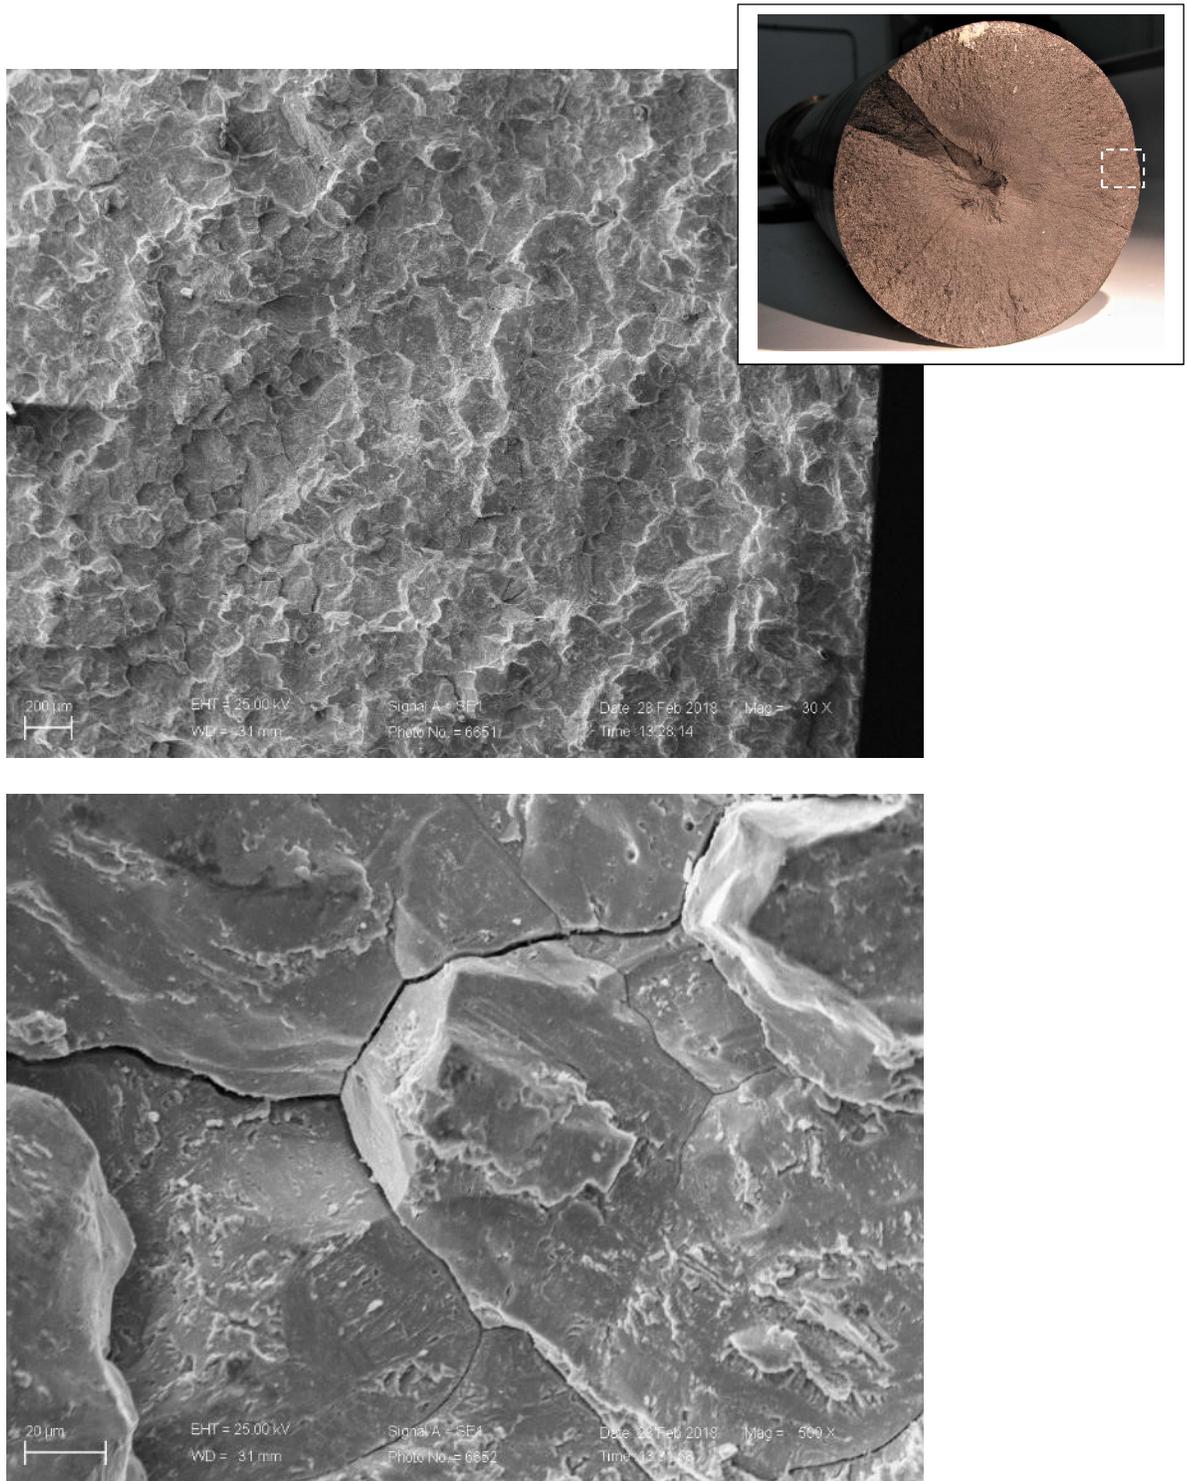
Figure 8. SEM micrographs confirming the intergranular nature of the fracture at the edge of the pump shaft.

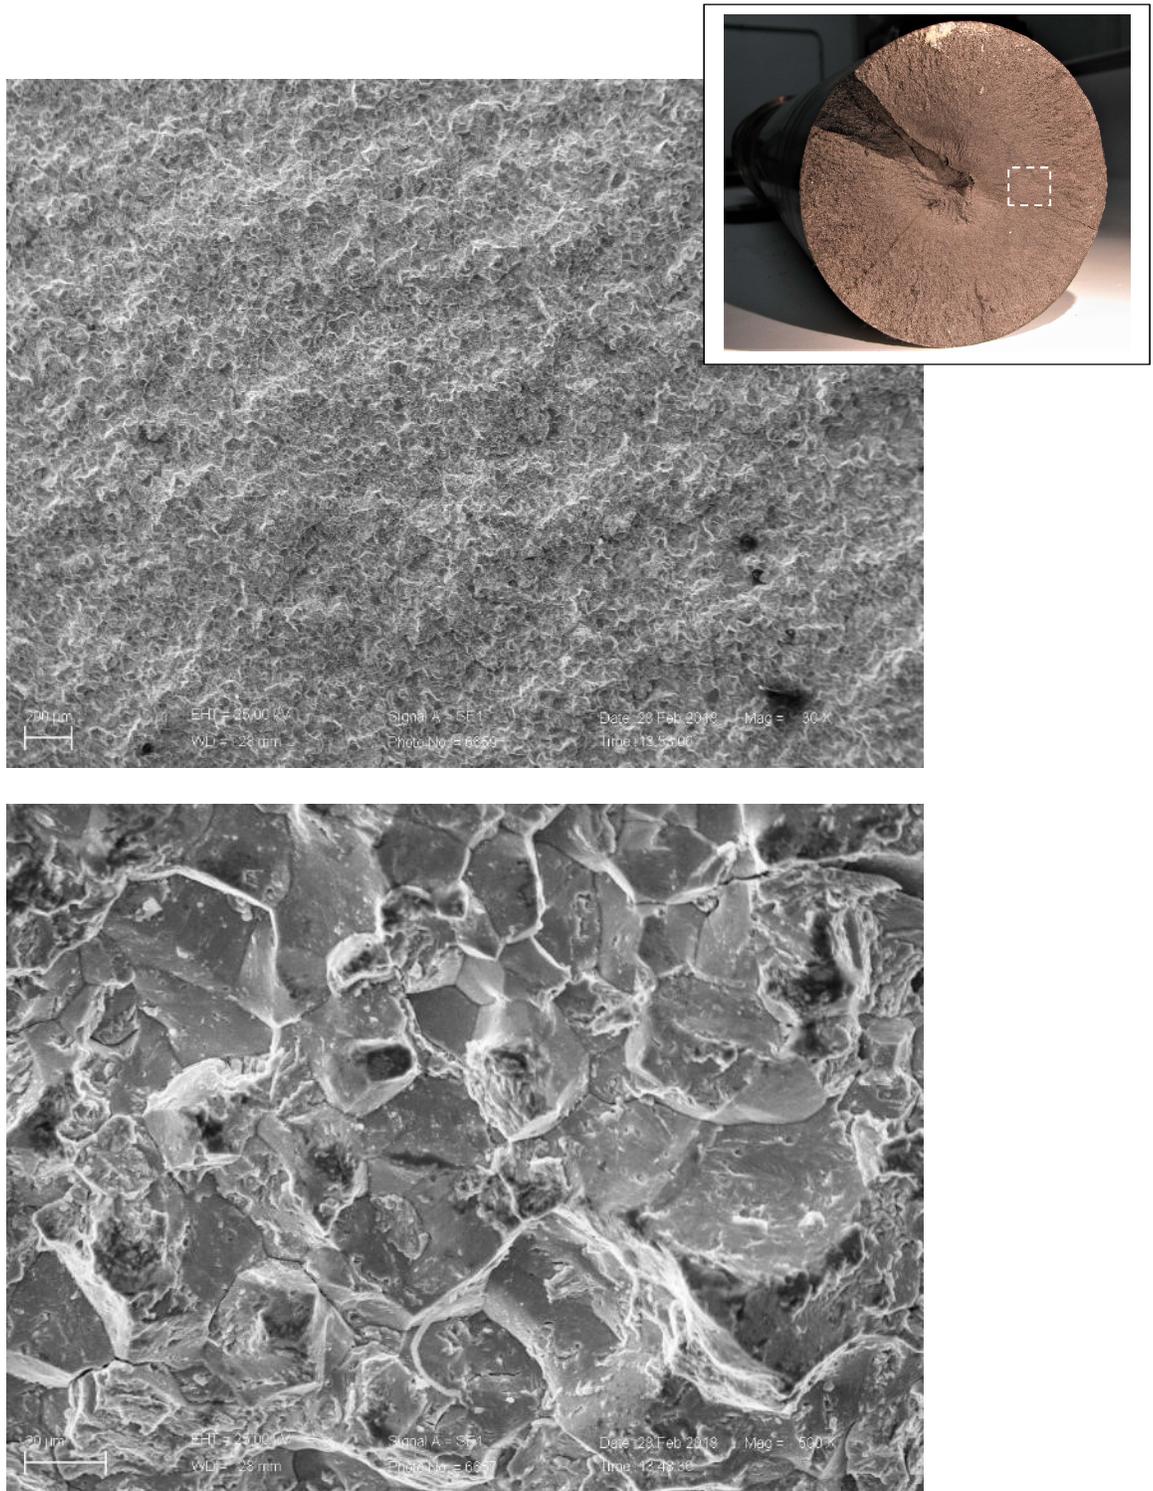
Figure 9. SEM micrographs confirming the intergranular nature of the fracture at the 0.5 radius location of the shaft.

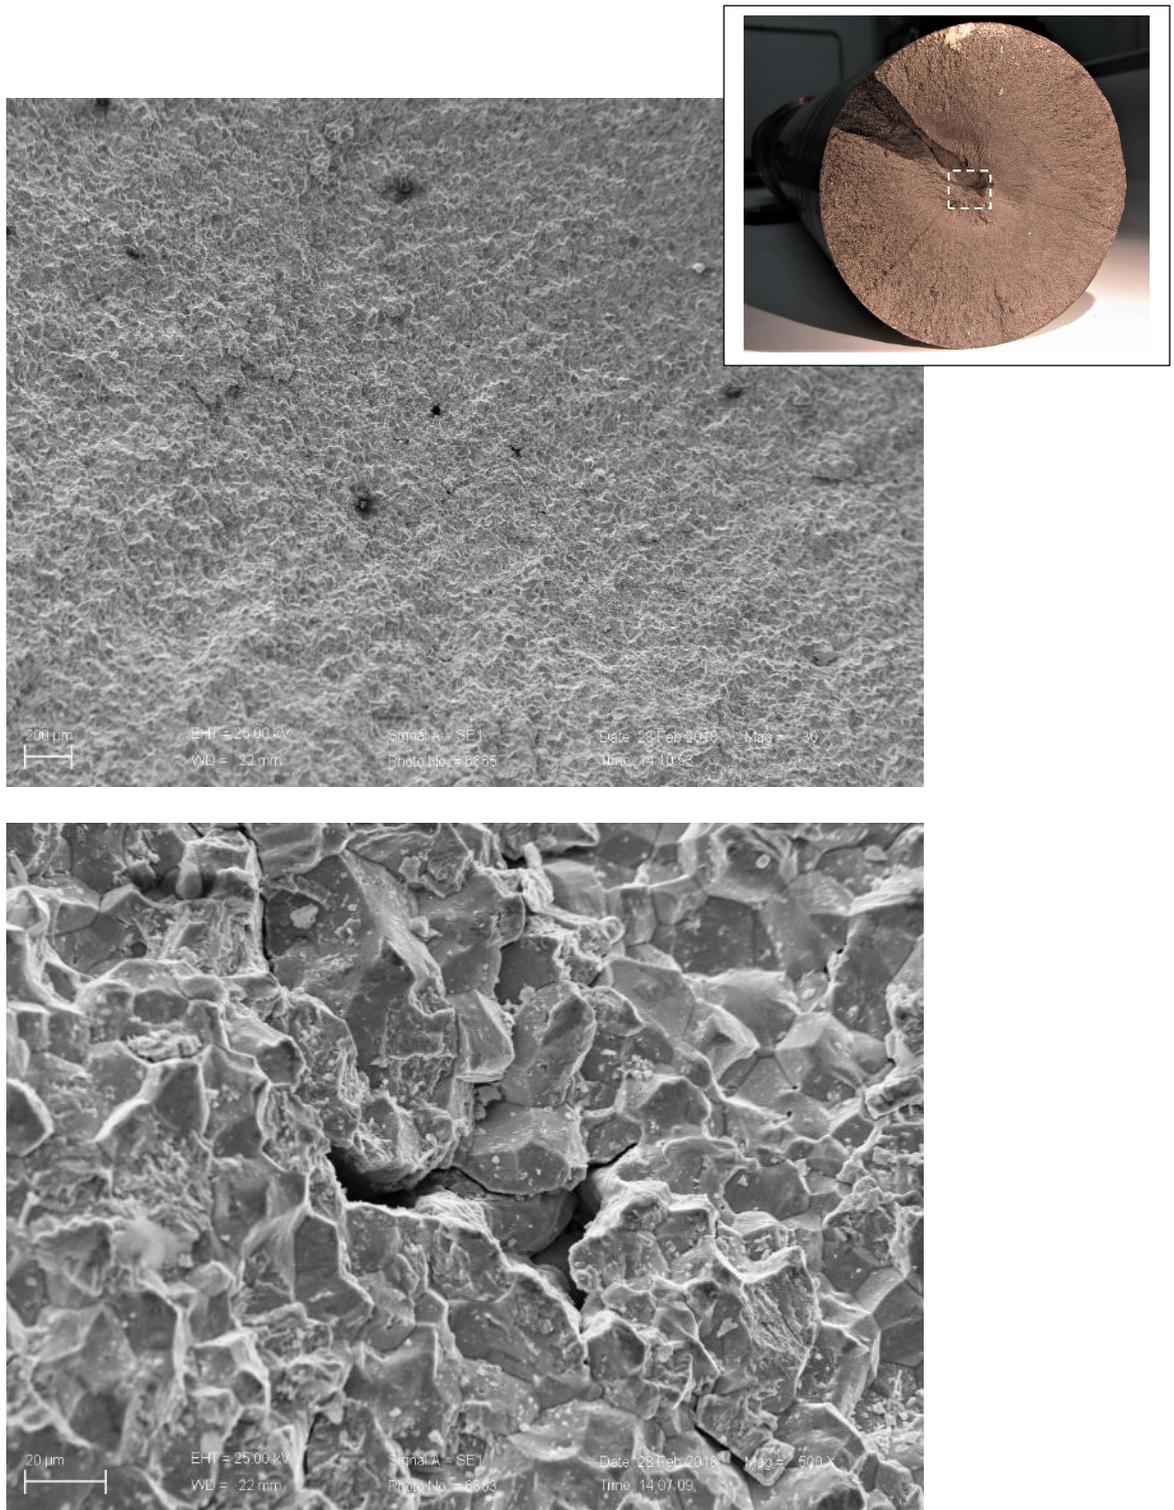
Figure 10. SEM micrographs confirming the intergranular nature of the fracture at the center of the shaft.

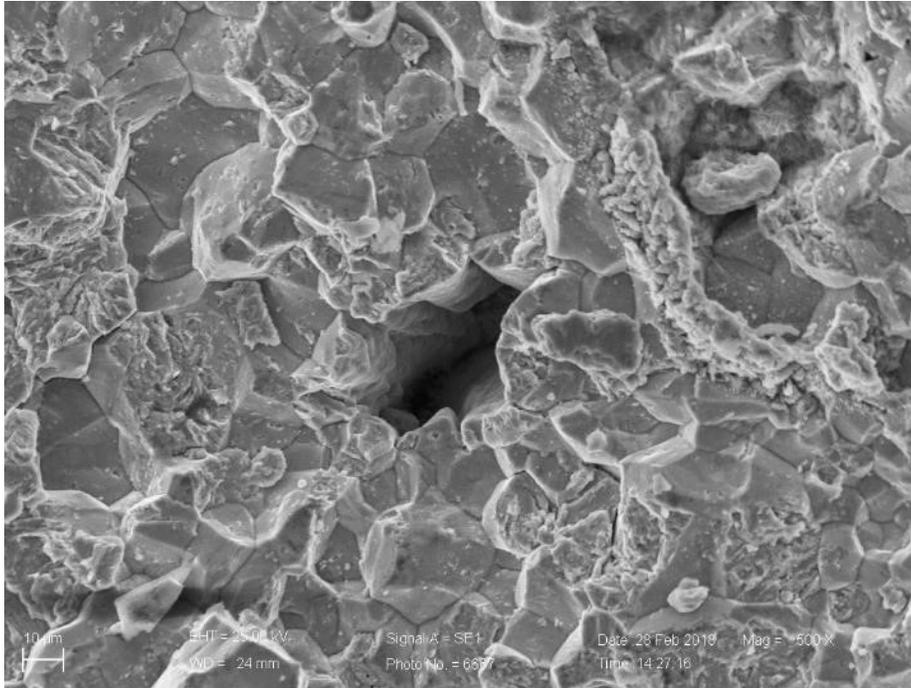
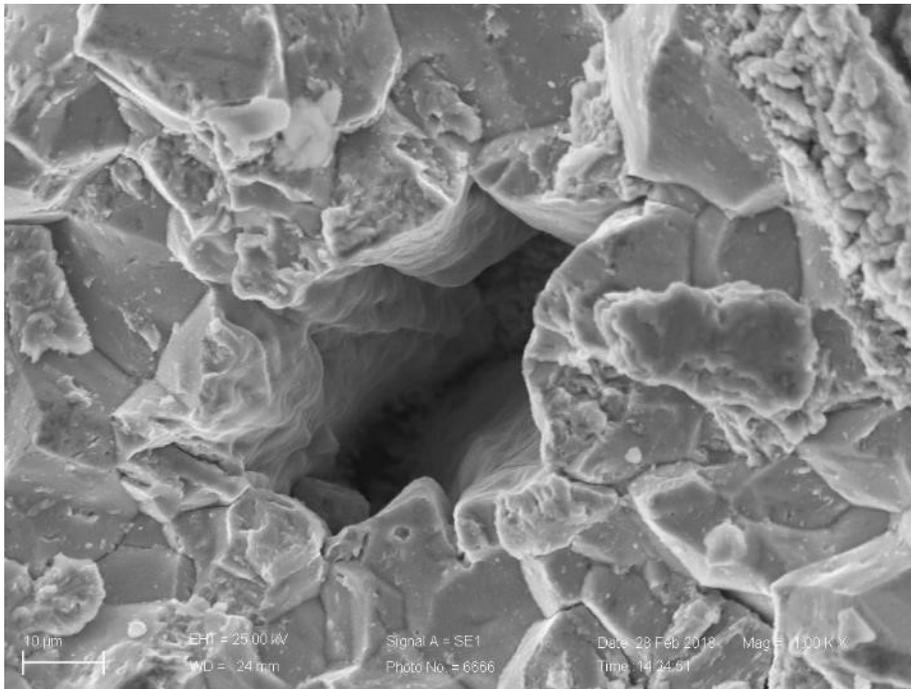
Figure 11. Illustrating solidification shrinkage voids detected in the center area of the shaft, a remnant of casting-type defects that were present in the ingot from which the shaft was produced.

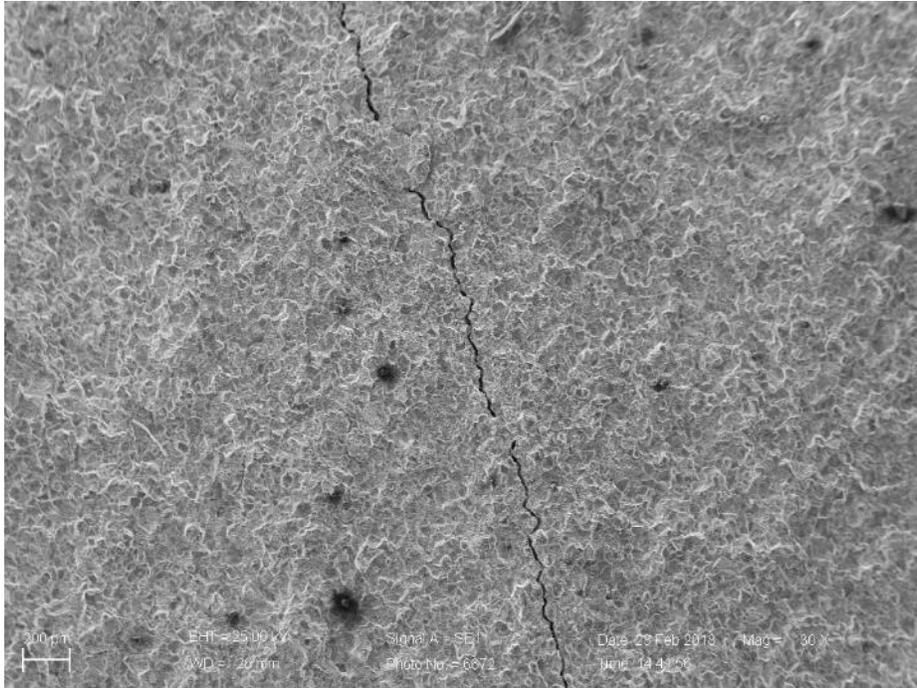
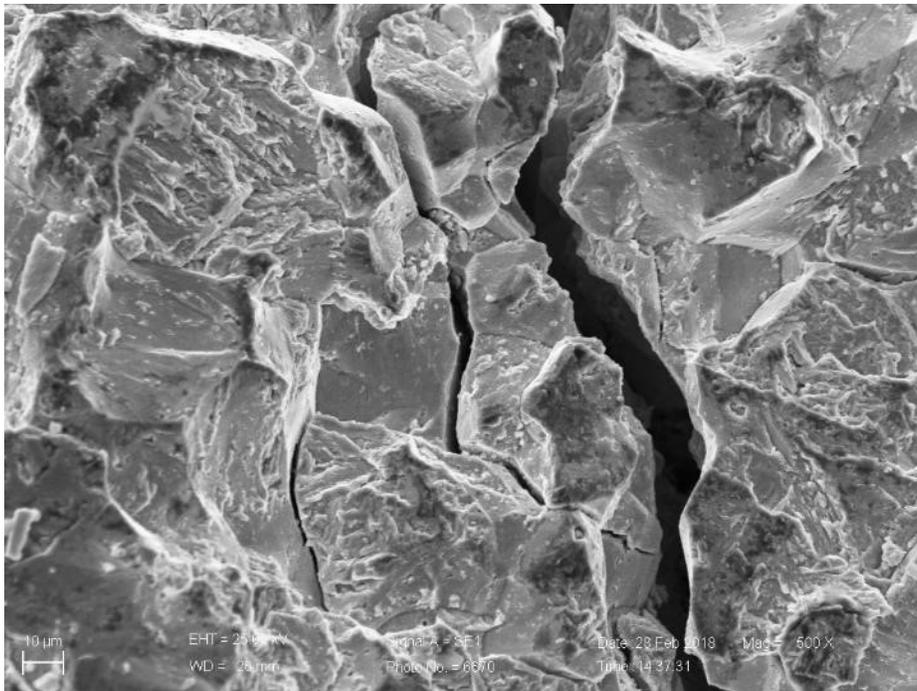
Separate examination of the axial cracks showed that these cracks also were intergranular in nature, as documented in Figure 14.

Figure 12. SEM micrographs presenting “typical” features of one of the axial cracks that had formed in the shaft during the failure event.

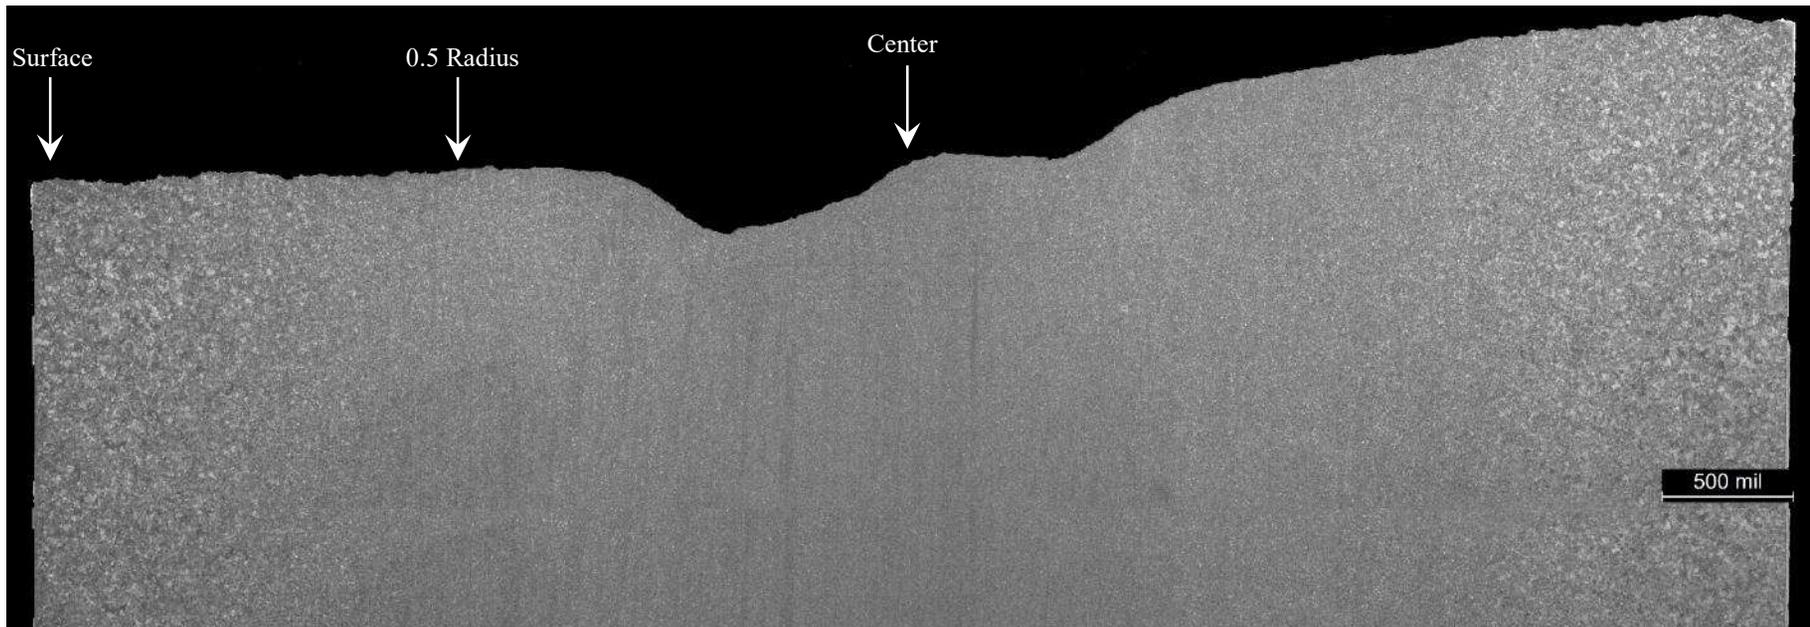
Figure 13. Shown are the macroscopic features of the entire cross-section of the shaft, with the evidence of ingotism in the center portion and coarse-grained structure near the outside surface.

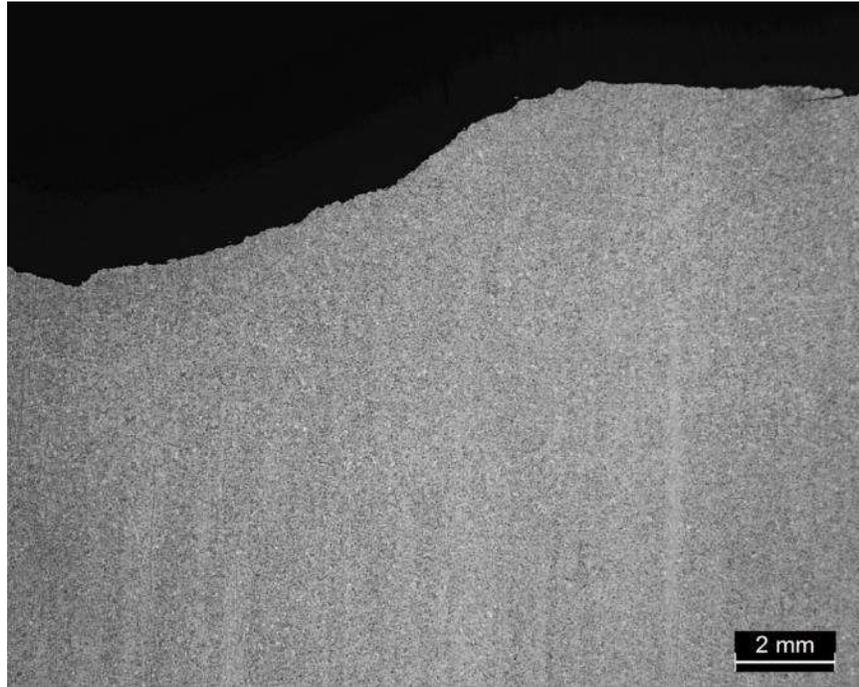
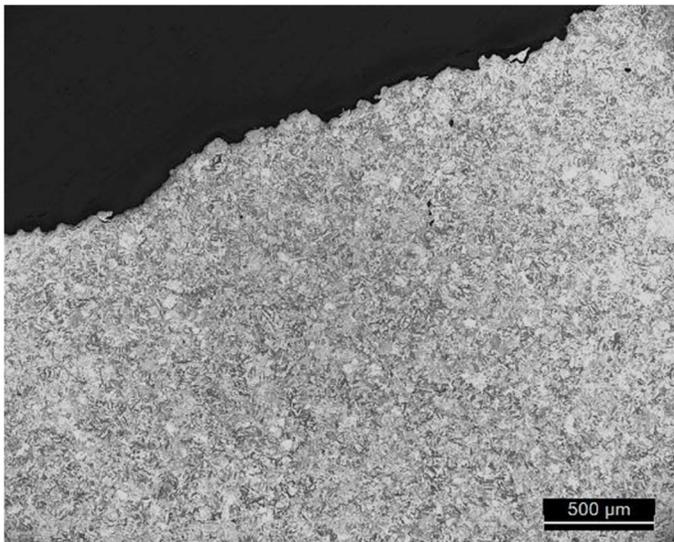
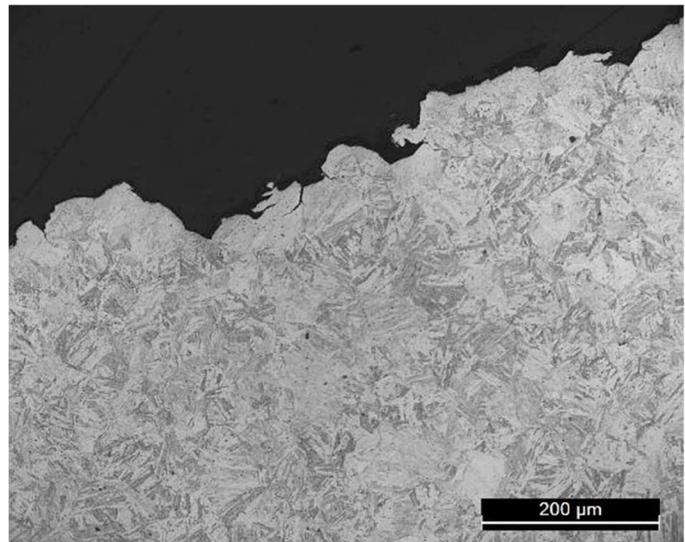
*Center Portion of
Shaft*

Figure 14. Documenting typical features of the fracture at the center of the shaft, consistent with intergranular-dominated fracture.

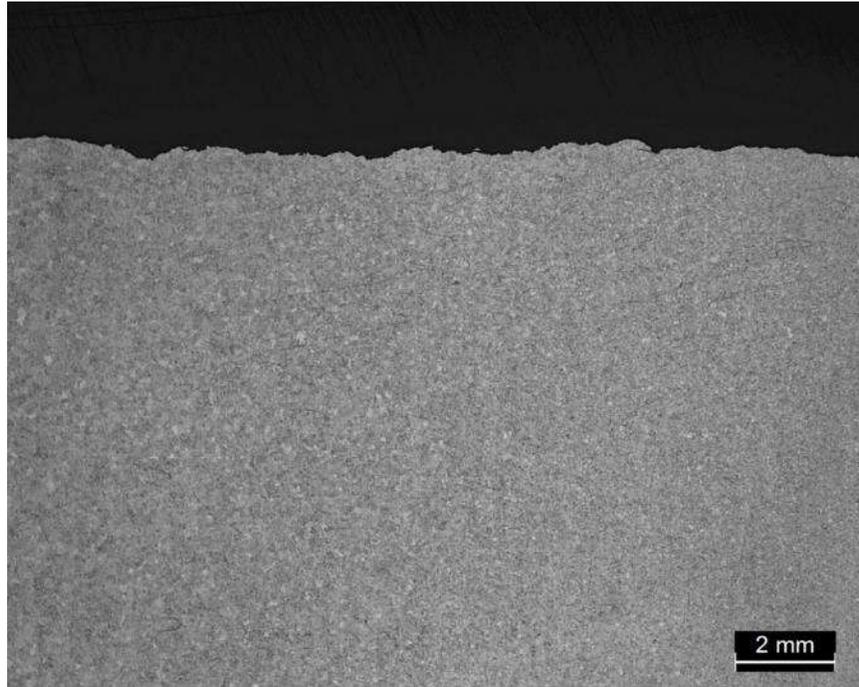
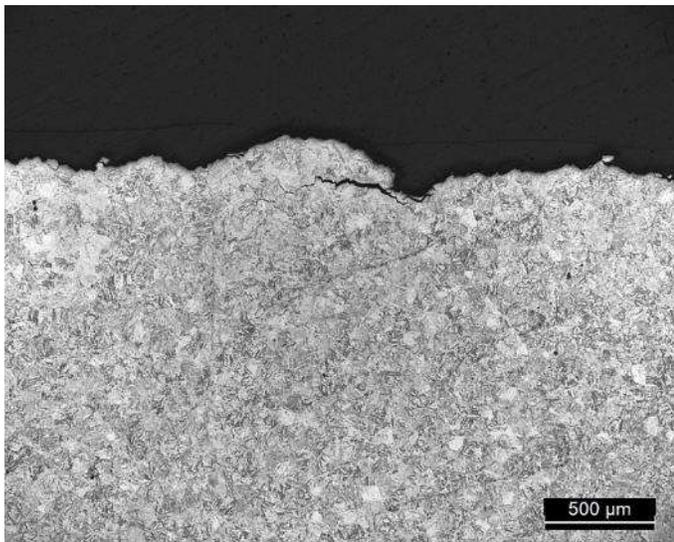
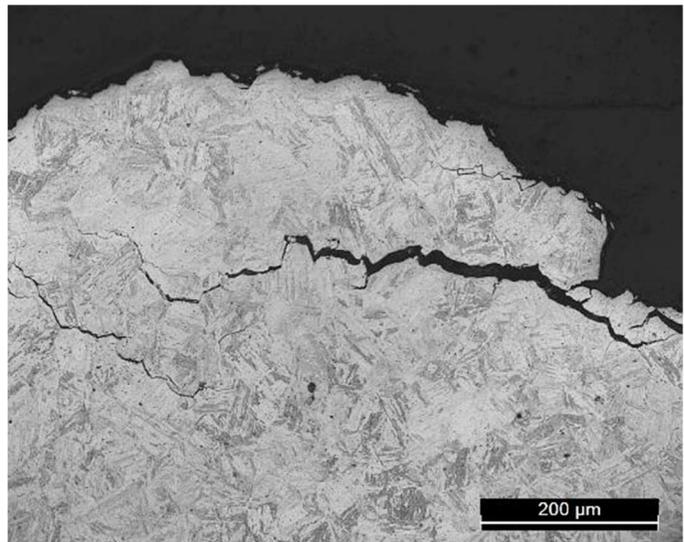
*0.5 Radius of
Shaft*

Figure 15. Showing typical features of the fracture at the 0.5 radius location on the shaft, with evidence of intergranular-dominated fracture.
