METALLURGICAL REPORT

EXAMINATION OF A BOILER CIRCULATION PUMP SHAFT

ATC PROJECT-18B071

Examination of a Failed Boiler Circulation Pump Shaft

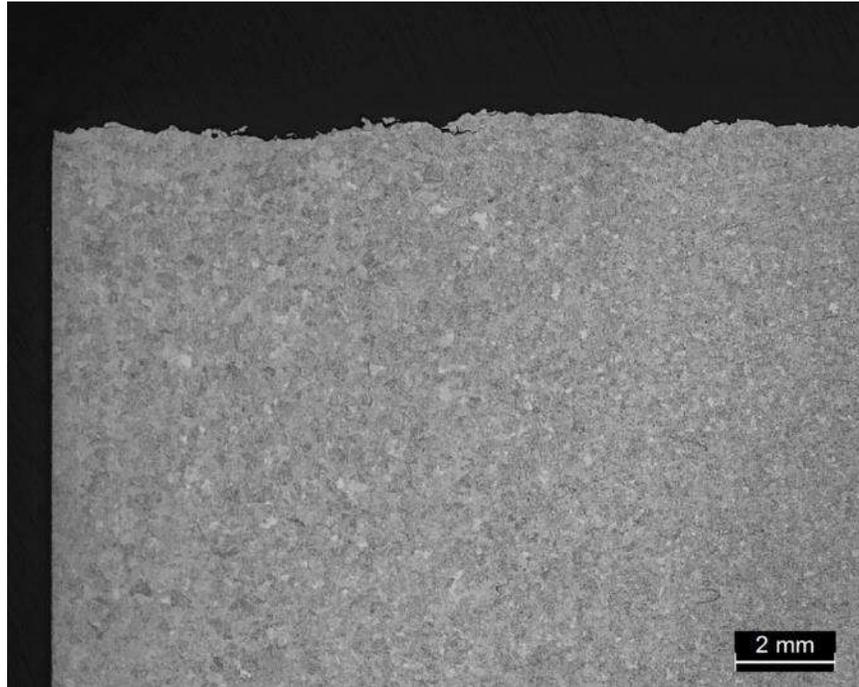
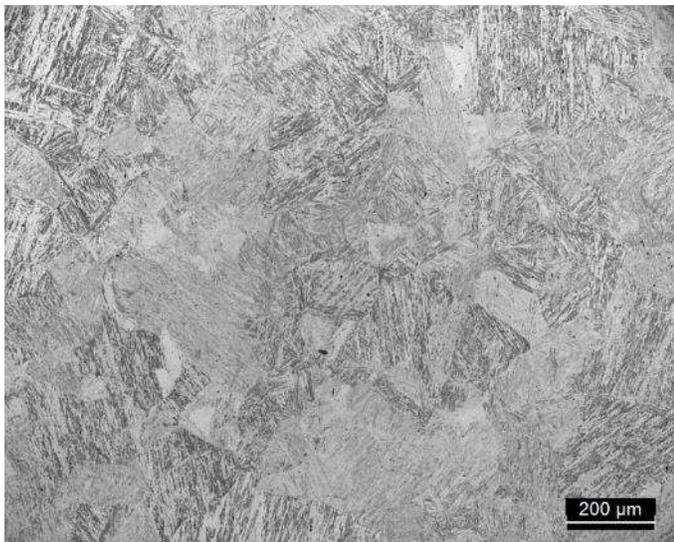
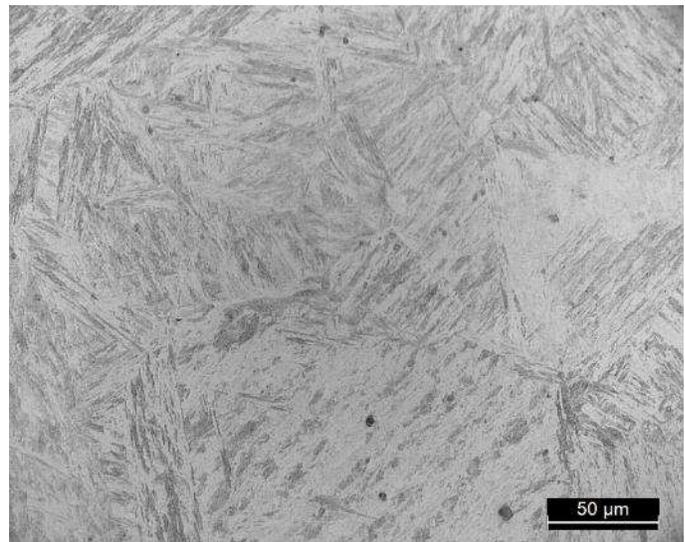
*Surface of Shaft
at fracture*

Figure 16. Showing typical features of the shaft microstructure near the outer surface of the shaft in an overheated layer containing a severely coarsened grain structure.

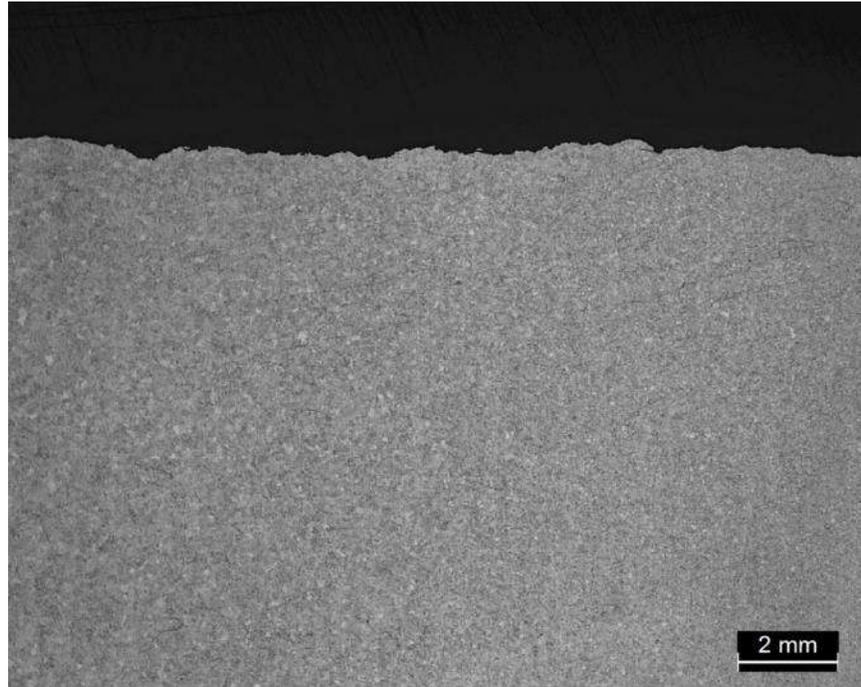
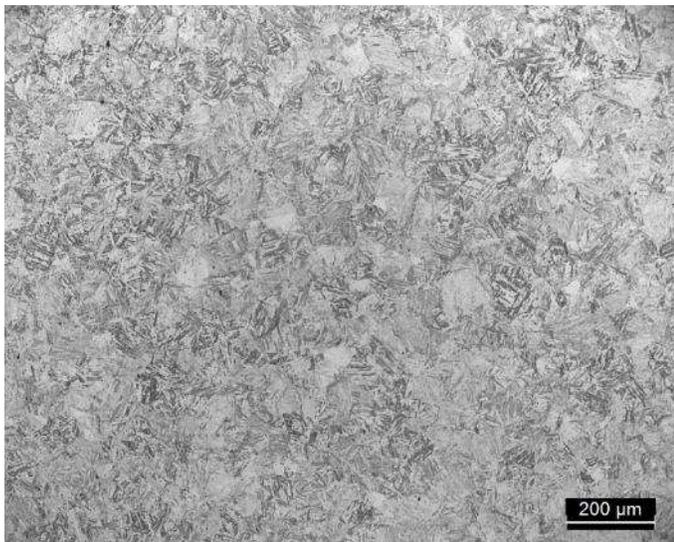
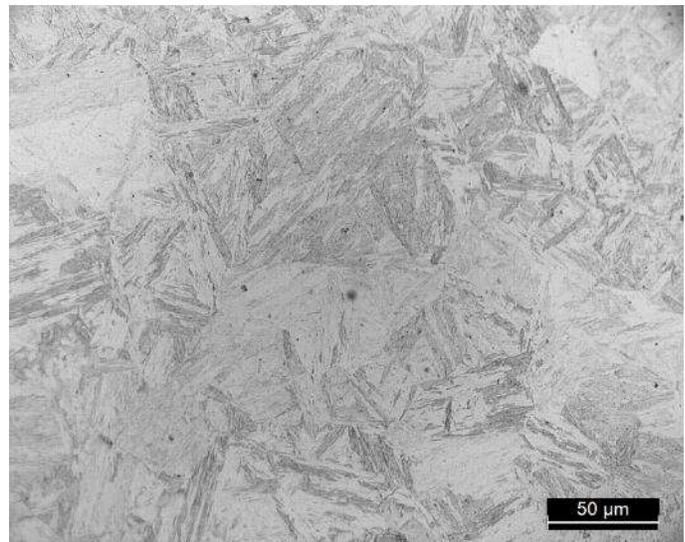
*0.5 Radius of
Shaft at fracture*

Figure 17. Showing typical features of the shaft microstructure at the 0.5 radius location on the shaft, where the structure shows a more “normal” fine-grained appearance.

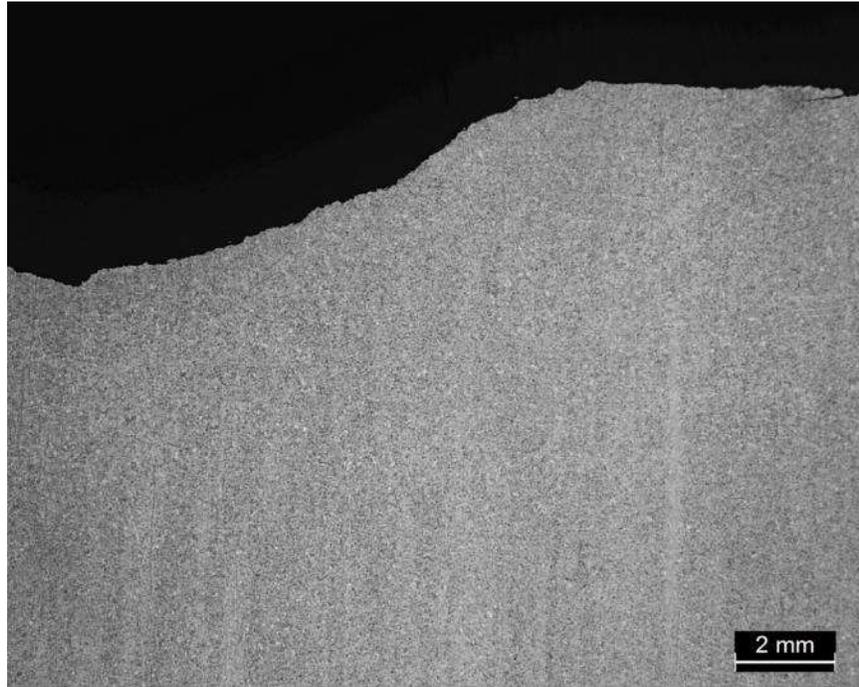
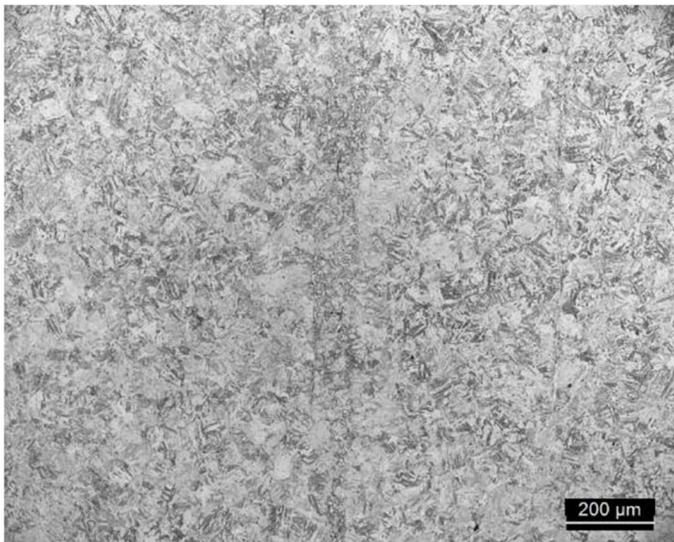
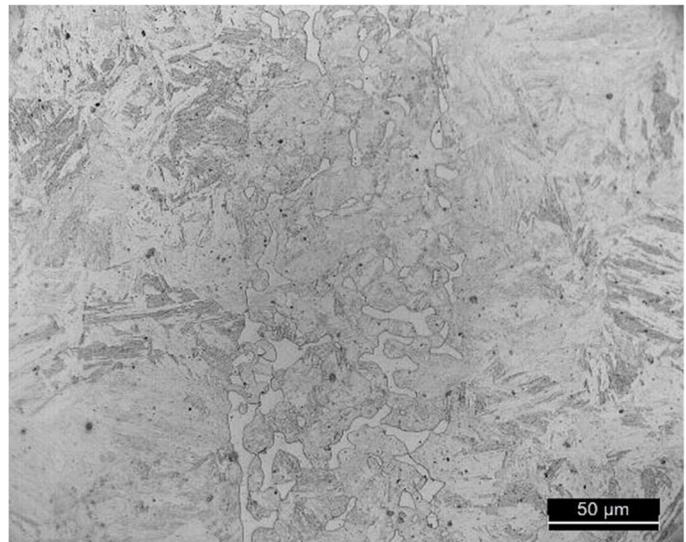
*Center of Shaft
at fracture*

Figure 18. Showing typical features of the shaft microstructure at the core (center) of the shaft, with evidence of the effects of ingotism and ferrite bands.

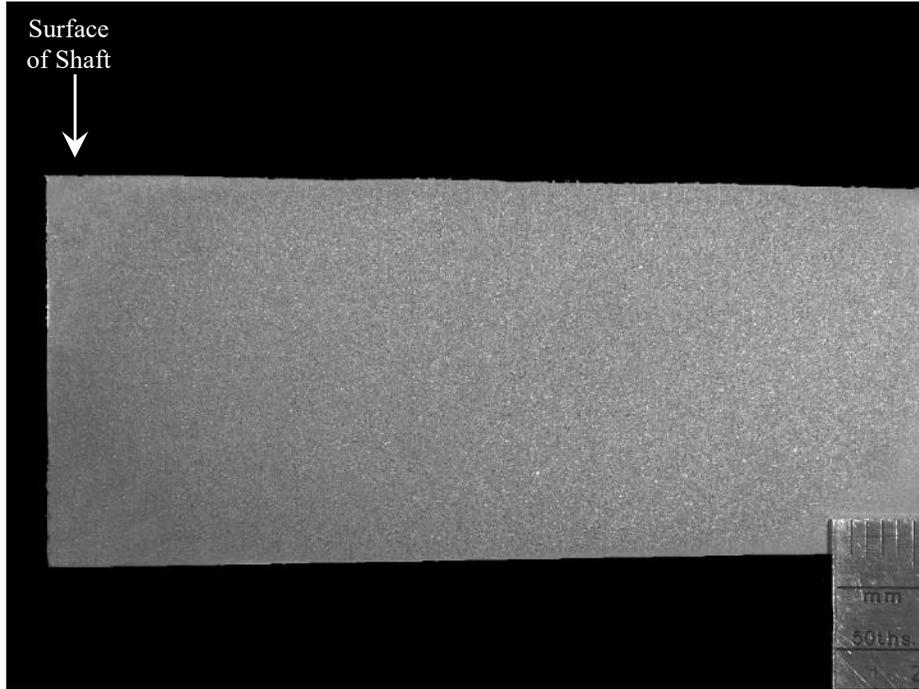
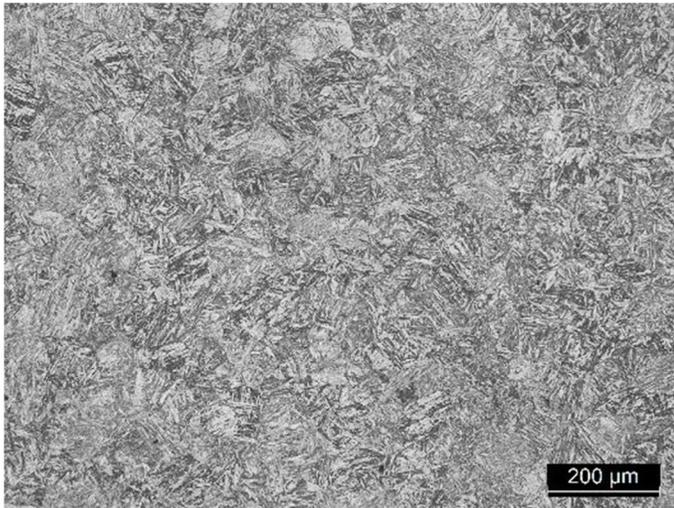
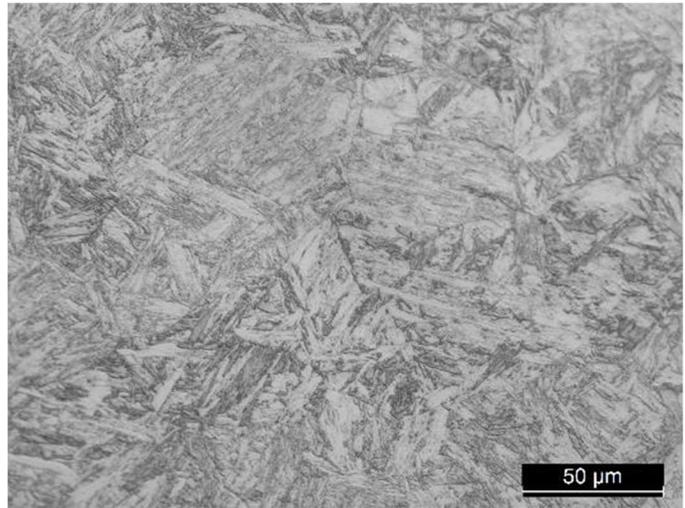
*Surface of Shaft
at Opposite End
of Fracture*

Figure 19. Showing typical features of the shaft microstructure near the surface of the shaft at a location well away from the failure area; note the relatively fine-grained structure.

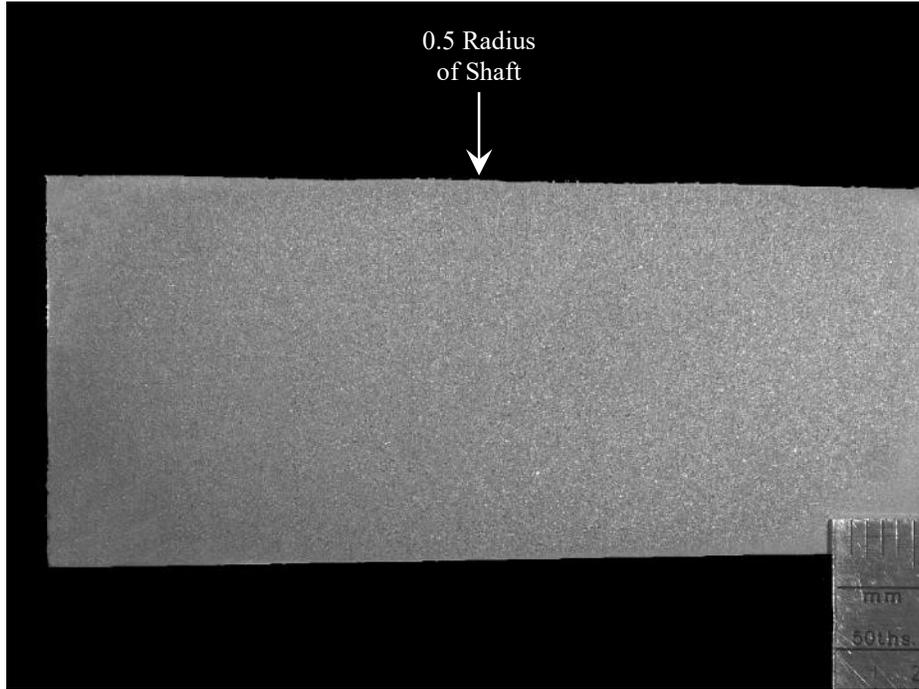
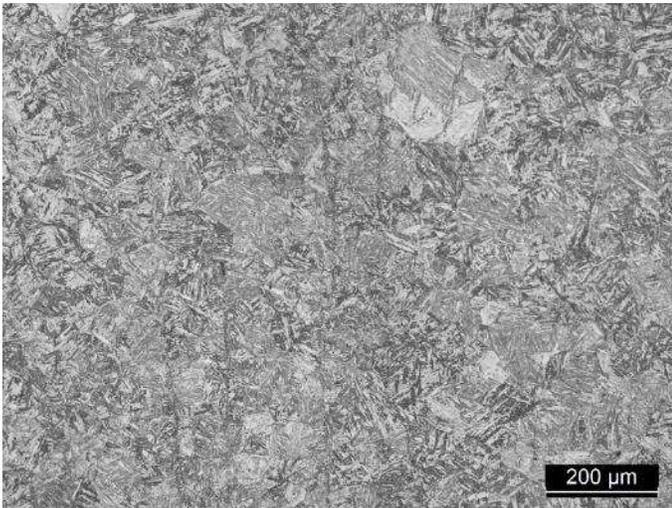
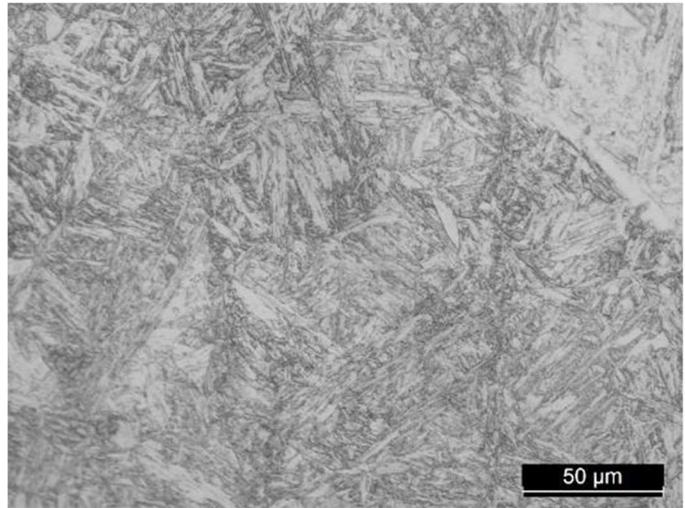
*0.5 Radius of
Shaft at Opposite
End of Fracture*

Figure 20. Showing typical features of the shaft microstructure at the 0.5 radius of the shaft at a location well away from the failure area.

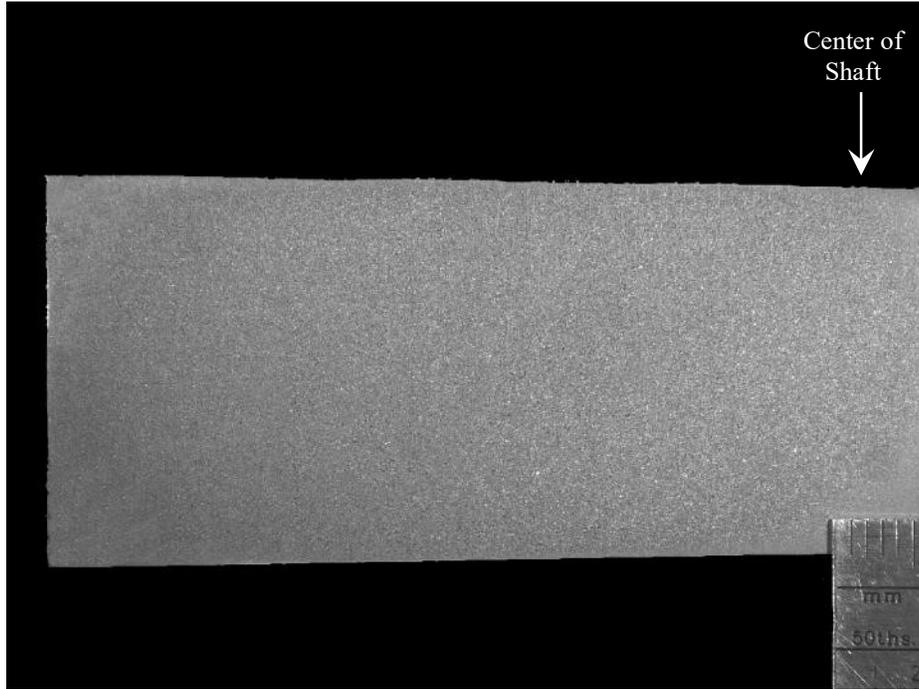
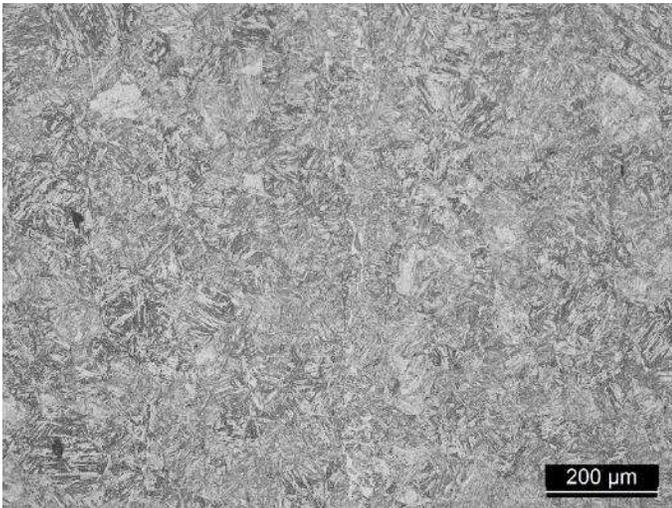
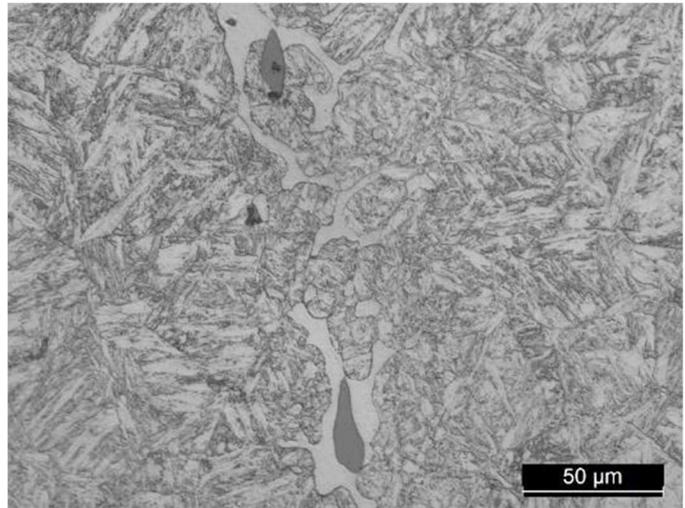
*Center of Shaft at
Opposite End of
Fracture*

Figure 21. Showing typical features of the shaft microstructure at the core (center) of the shaft at a location well away from the failure area, with evidence of the effects of ingotism and ferrite bands.

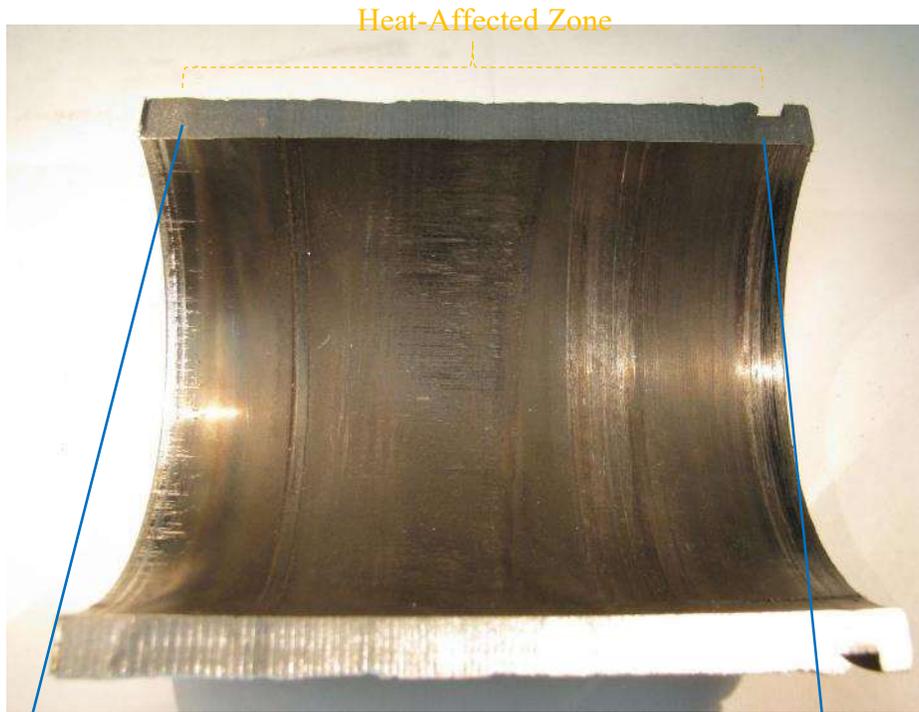
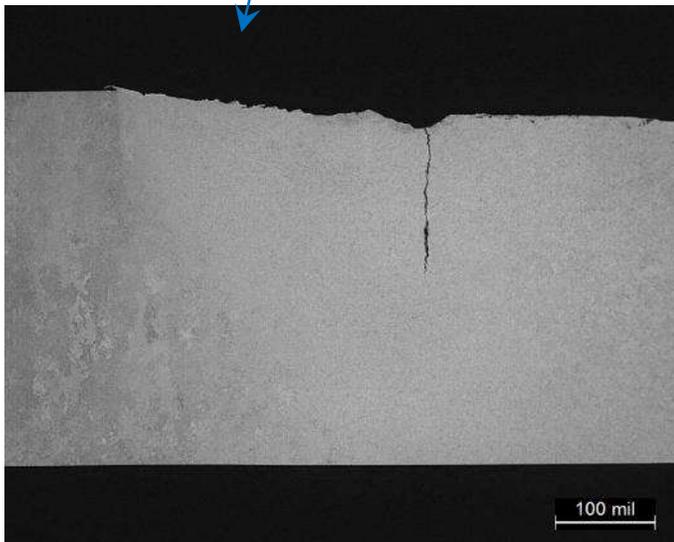
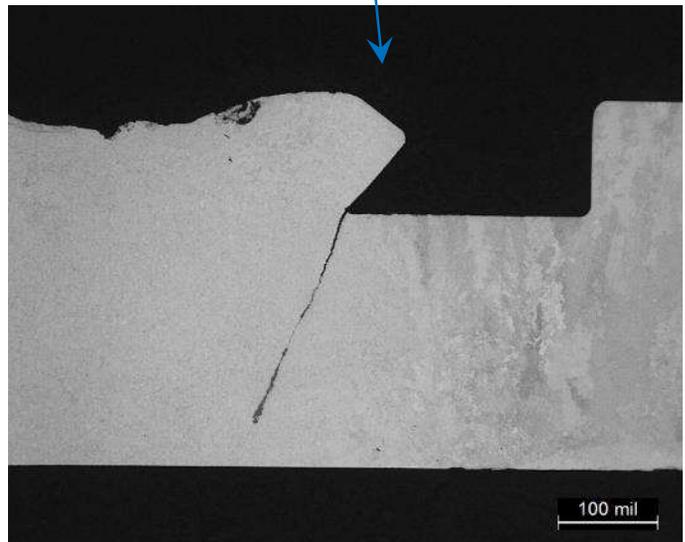
Overheating
zones in
Sleeve

Figure 22. Documenting the evidence of a pronounced heat-affected zone (HAZ) in the sleeve; this HAZ extended almost the entire length (>85%) of the sleeve. Note the cracking that had occurred in the sleeve within the overheated region.

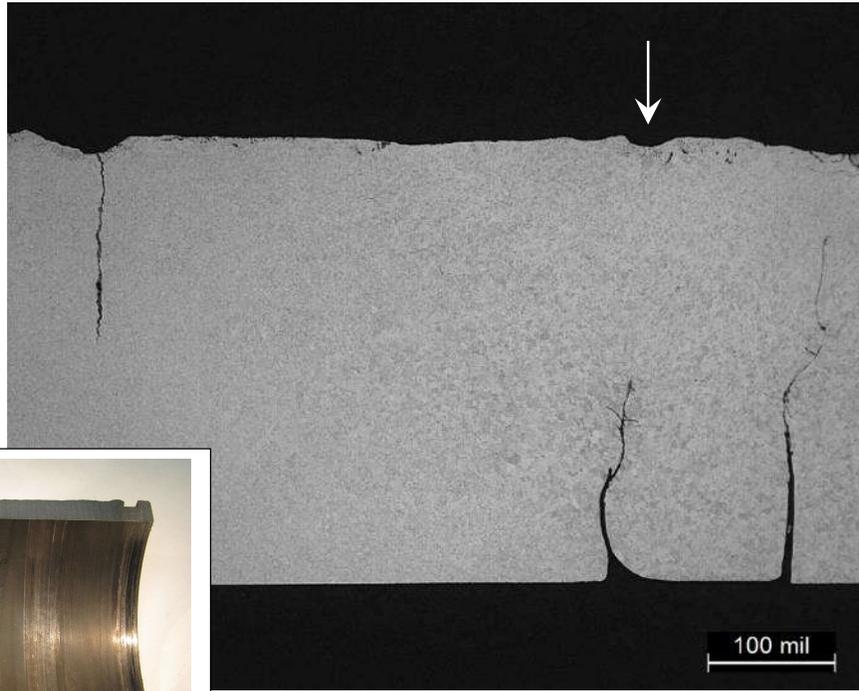
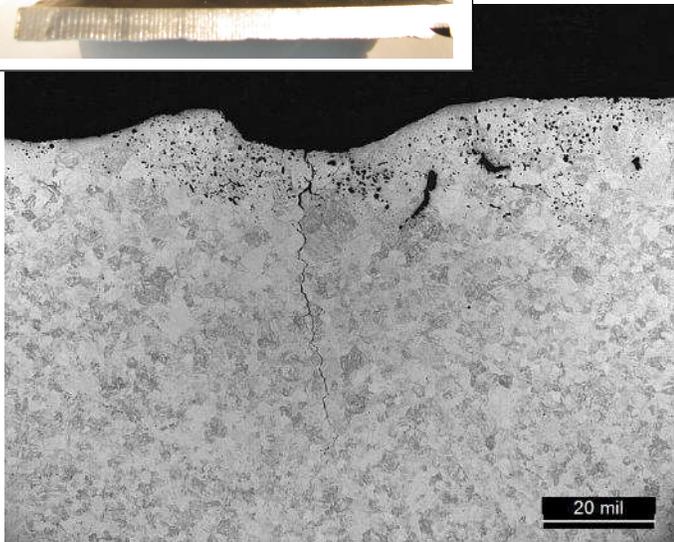
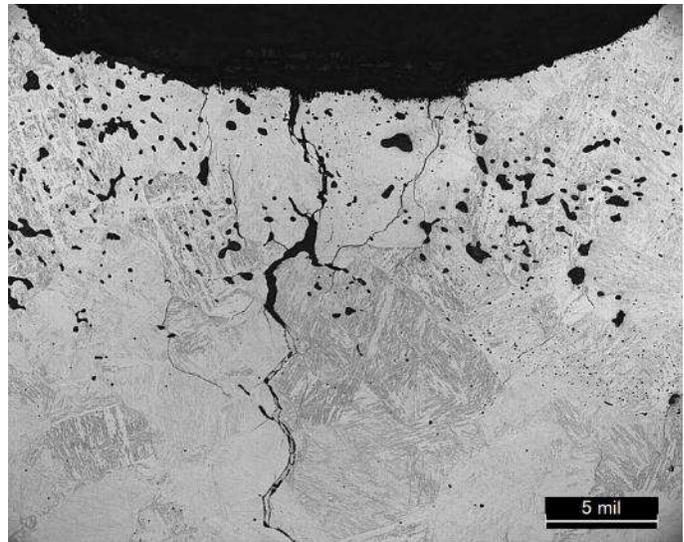
OD Surface
Sleeve

Figure 23. Showing typical features of the structure of the sleeve material at the OD surface, with evidence of partial melting and re-austenitization of the structure, together with significant levels of through-thickness cracking.

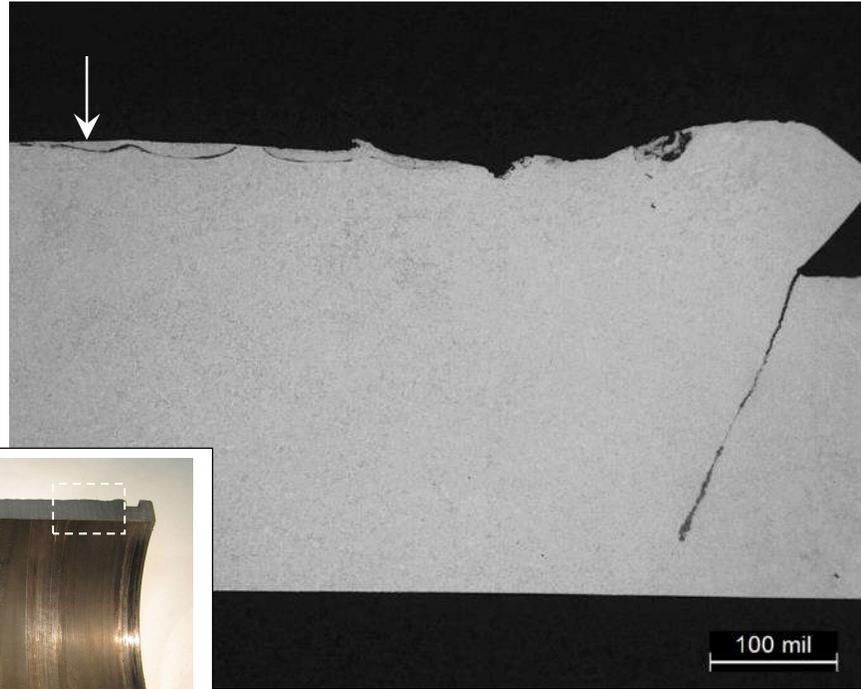
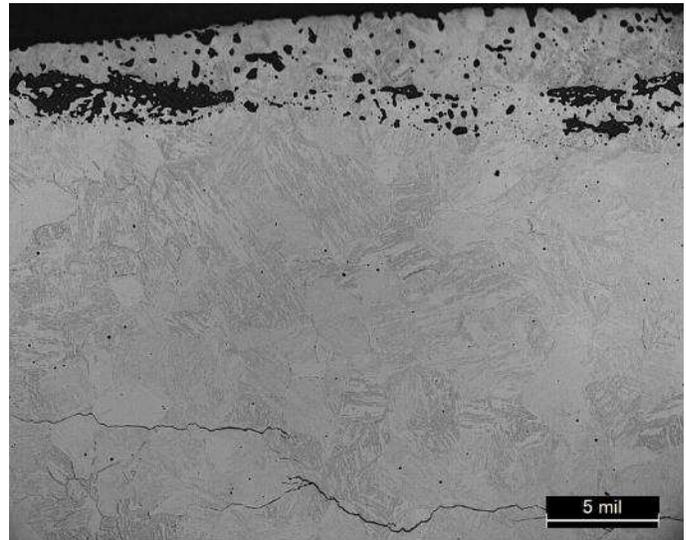
OD Surface
Sleeve

Figure 24. Showing typical features of the structure of sleeve at the outer surface, with evidence of partial melting and re-austenitization of the structure, as well as significant levels of axial cracking.

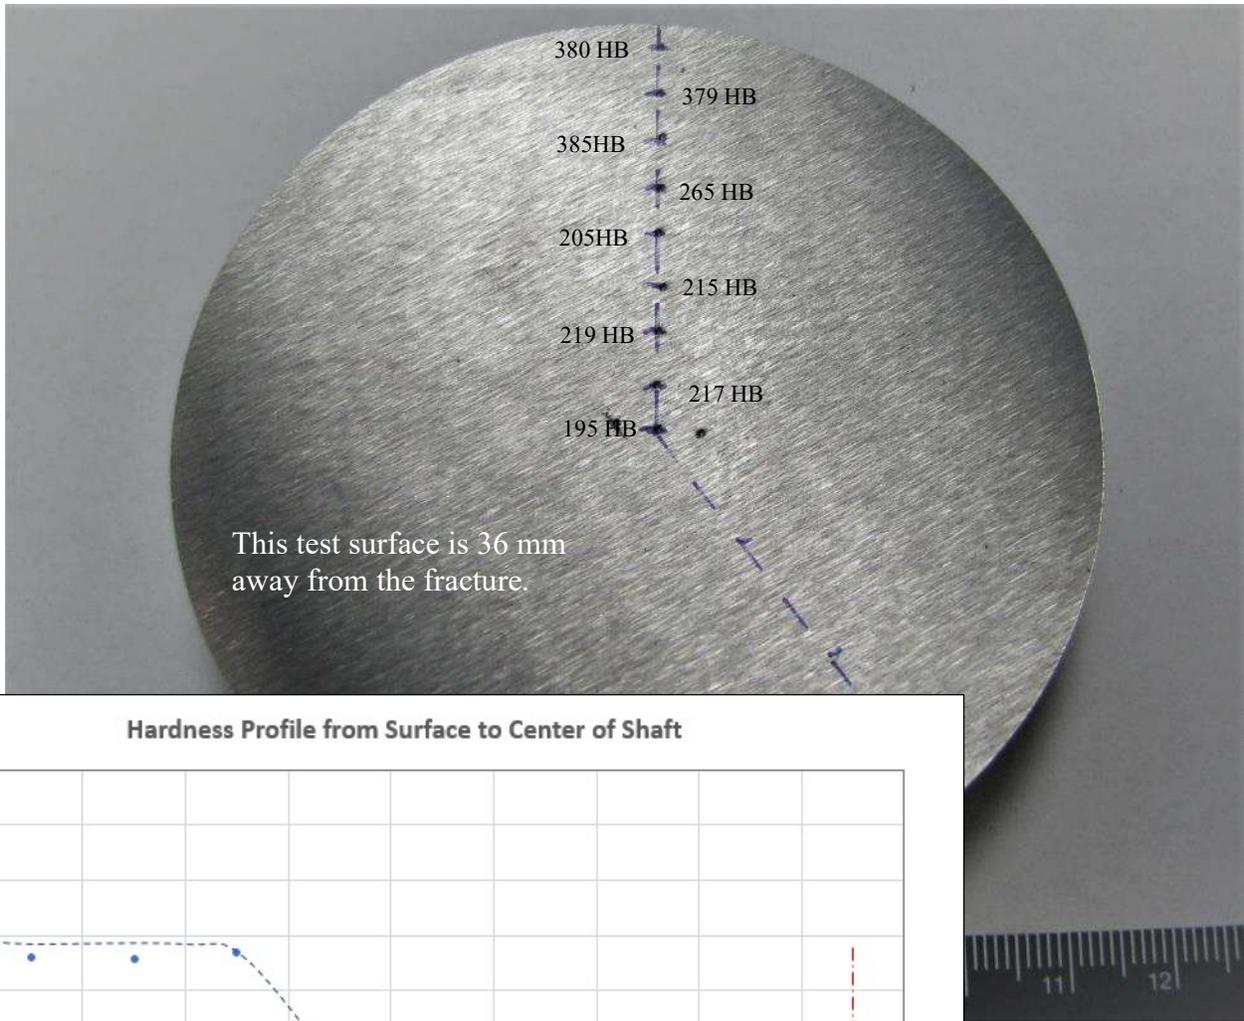
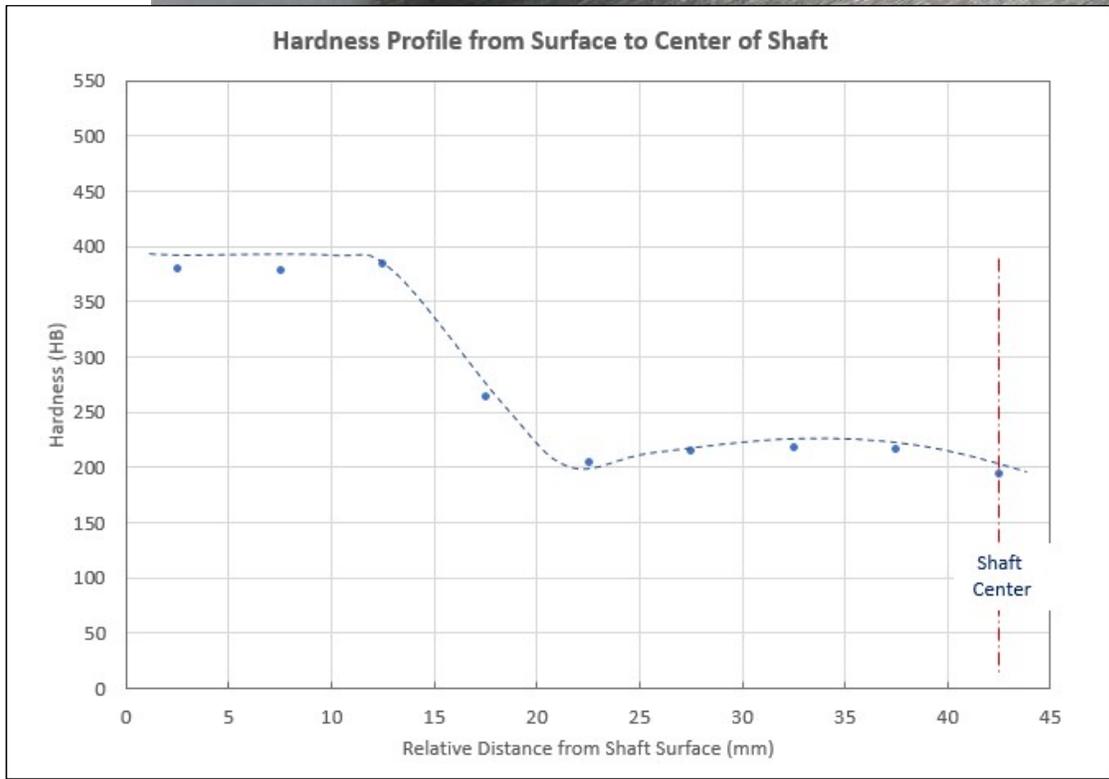
The hardness profile across the radius of the shaft was determined using a Rockwell Hardness Tester in the C-scale range. The test results are shown in Figure 27. As can be seen, the surface layer had hardness values in excess of 380HB while the hardness at the center of the shaft was as low as 195HB. This hardness profile reflects damage at the outer edges of the overheated region where a large temperature variation existed between the surface (>1600°F) and the center (1400°F)

of the shaft. At the shaft surface, the material was heated well above 1600°F to form untempered martensite while at the shaft center the maximum temperature achieved was in the range of 1400°F, resulting in an over-tempered martensitic structure.

Figure 25. Showing a hardness profile produced through the thickness of the shaft (the distance from the surface to the 1st indentation is 2.5 mm and the distances between all other indentations is 5 mm). The hardness values were measured using the Rockwell C scale and these were converted to standard Brinell values.

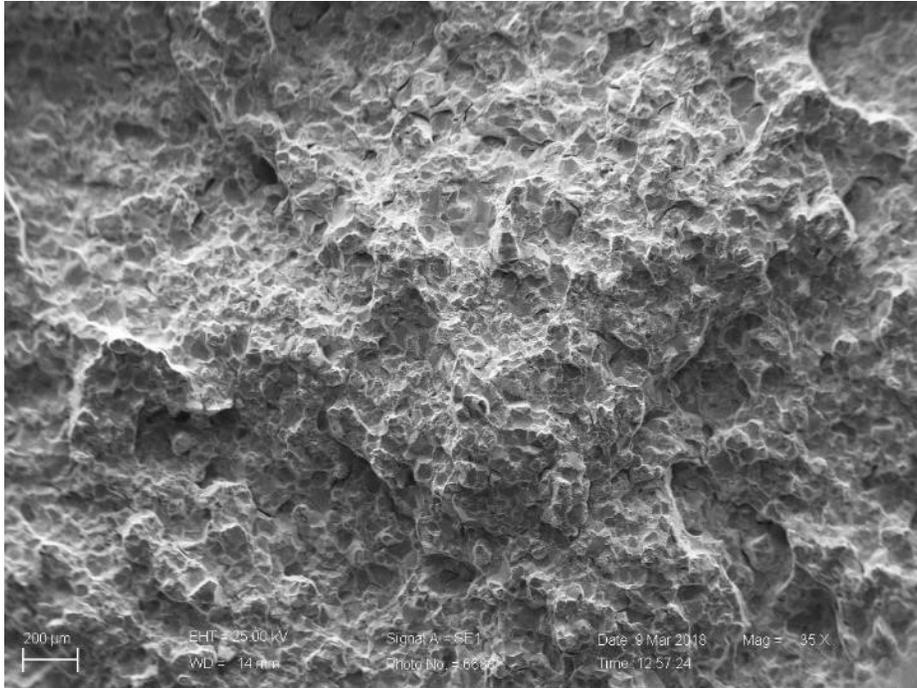
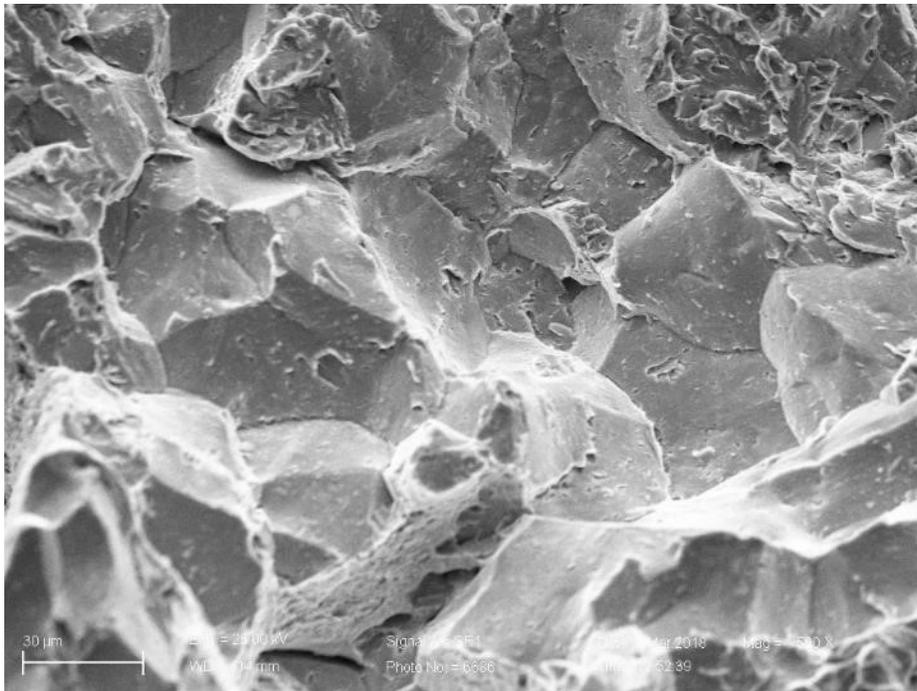
Figure 26. Shown are SEM images of typical fracture features taken from CVN specimen O1, highlighting the intergranular nature of the fracture.

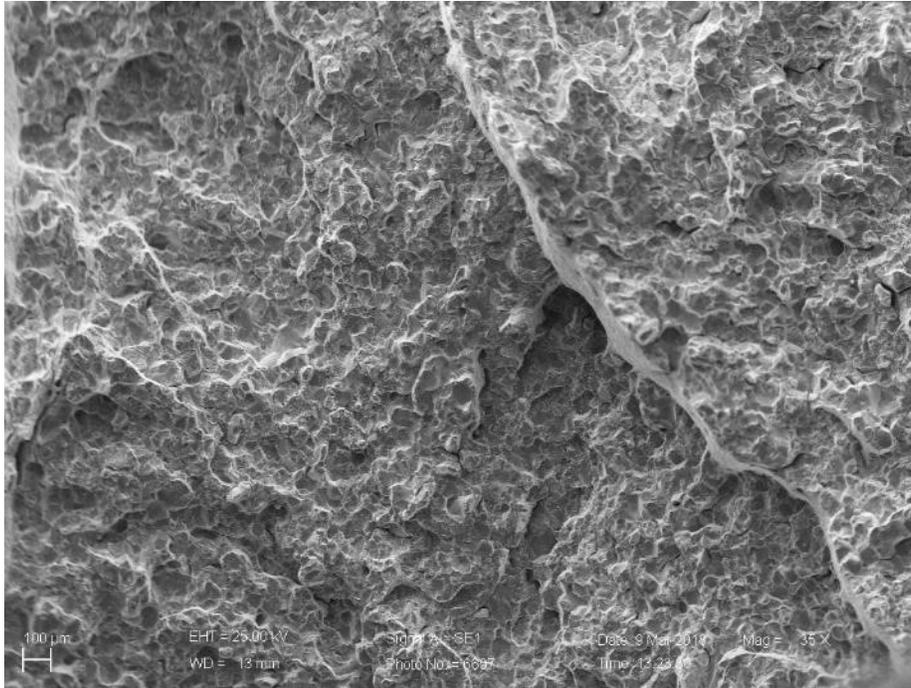
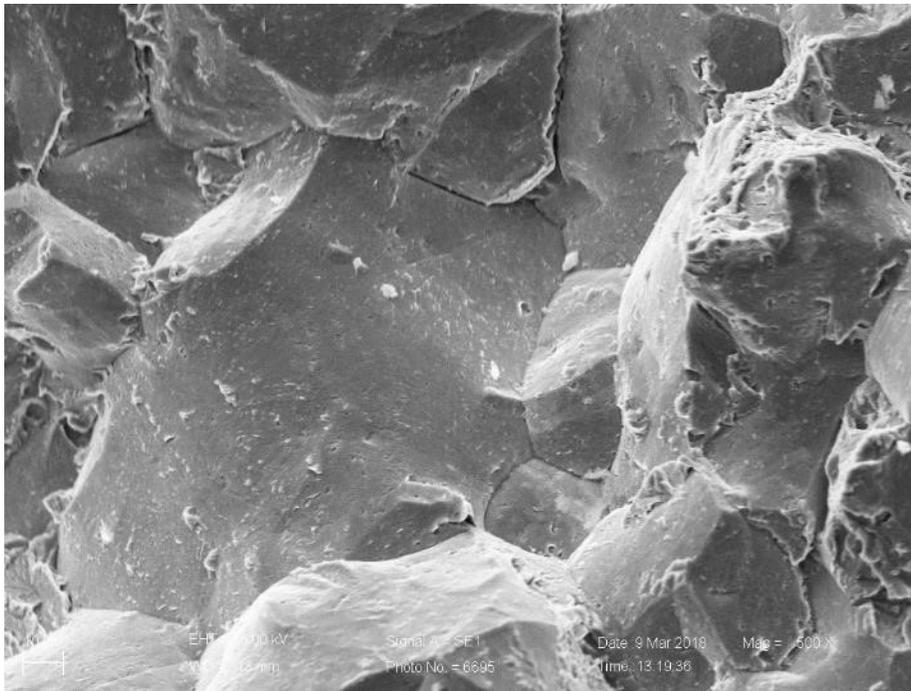
Figure 27. Shown are SEM images of typical fracture features taken from CVN specimen O3, highlighting the intergranular nature of the fracture.

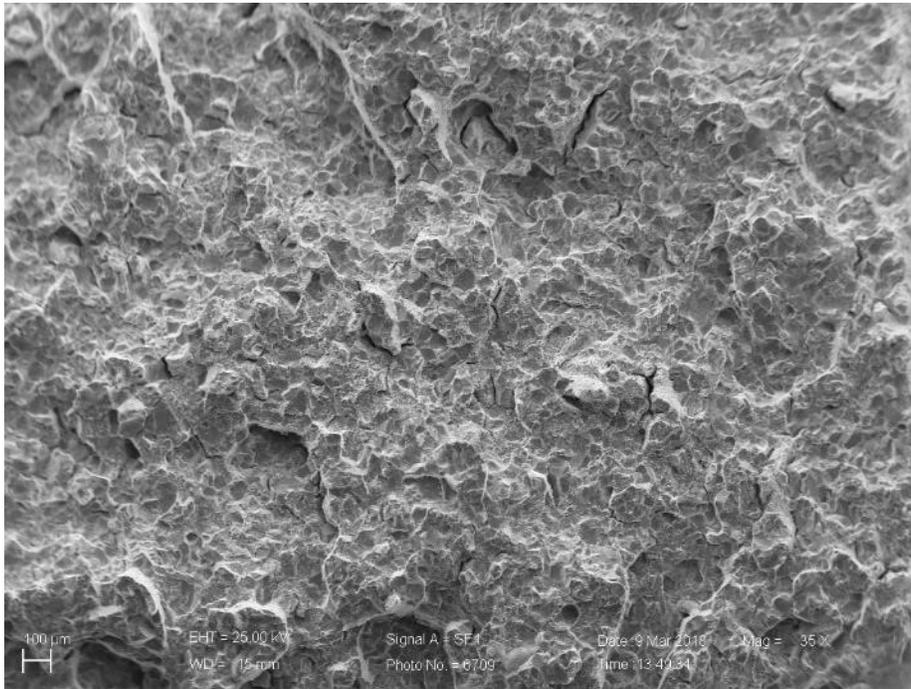
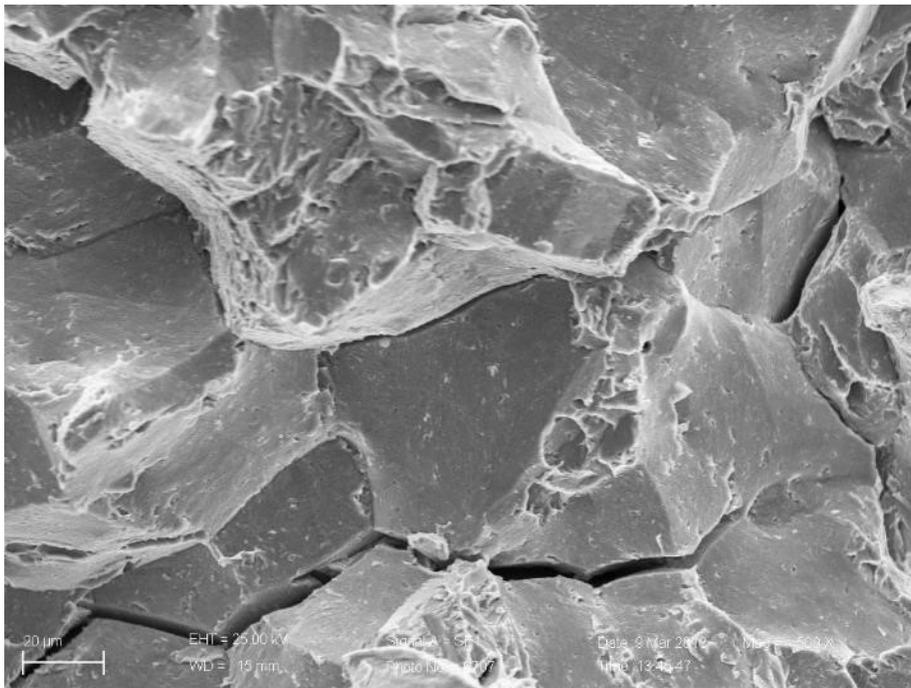
Figure 28. Shown are SEM images of typical fracture features taken from CVN specimen F1, highlighting the intergranular nature of the fracture.

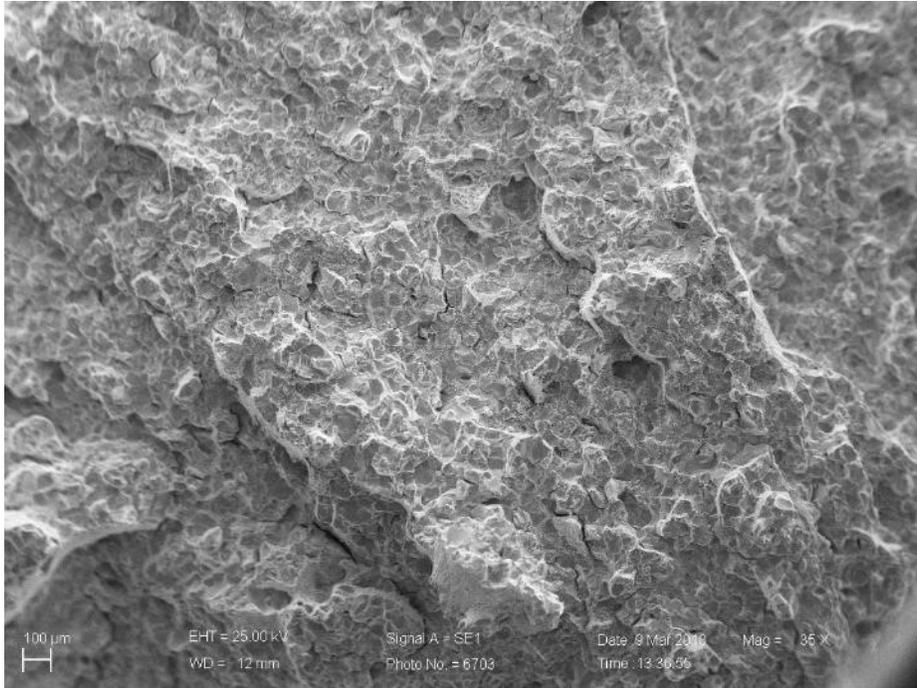
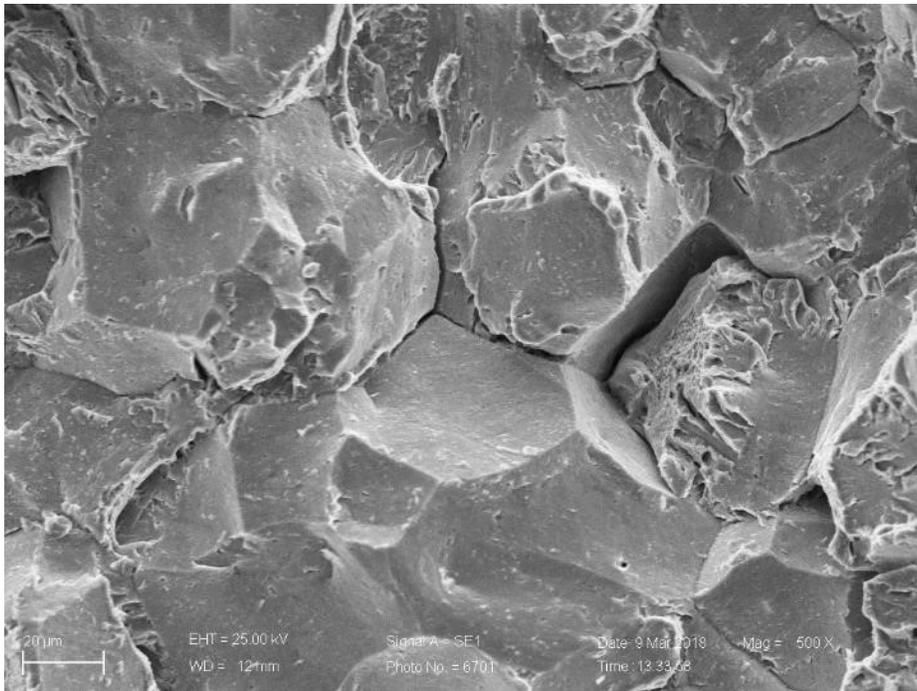
Figure 29. Shown are SEM images of typical fracture features taken from CVN specimen F3, highlighting the intergranular nature of the fracture.
