Jolly Roger

2020 Formula F330-CBR

MARINE SURVEY

Inspection Performed on: 4/10/2025

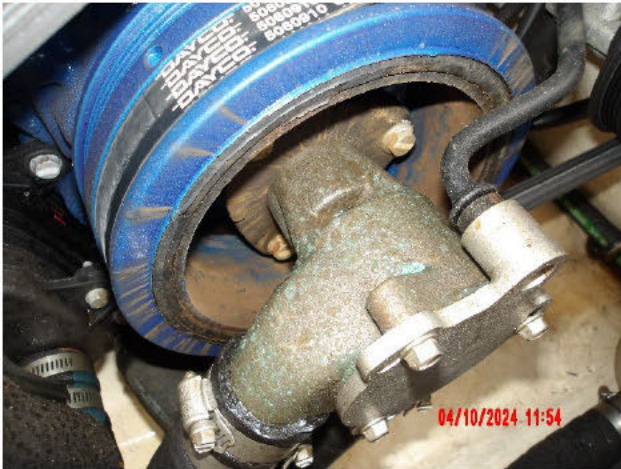
Leaking was sighted at the starboard engine's raw water pump. The amount leaking increased from ~3 drips a minute to a near-constant stream at the time of haulout. Seller informed. Increased corrosion was noted near the pump and pulley. It is recommended to investigate further and repair or replace. Clean corrosion as needed.

<p>2. Leaking was sighted at the starboard engine's raw water pump. Increased corrosion is present at the pulley and the pump.</p>	<p>It is recommended to investigate further and repair/replace as needed. Clean corrosion as needed.</p>

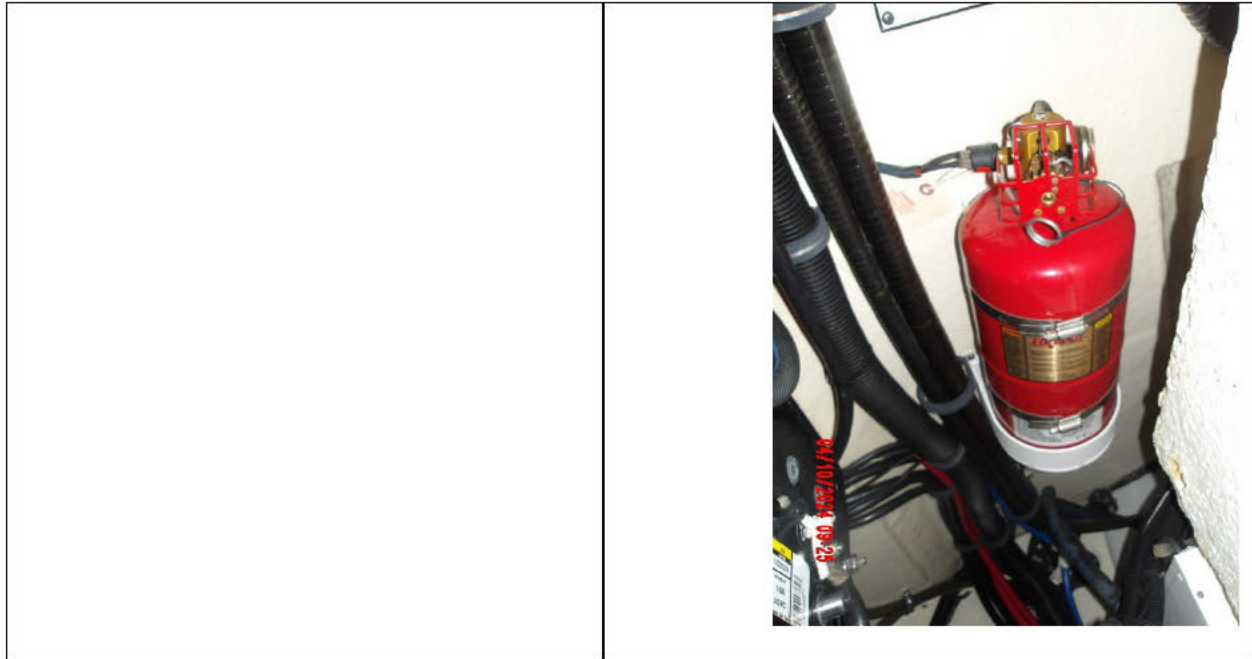
No current inspection tag was found on the canister.

<p>5. No current inspection tag was found on the fixed fire system's canister.</p>	<p>Consult a fire specialist and properly inspect per</p> <p>ABYC A-4.</p>

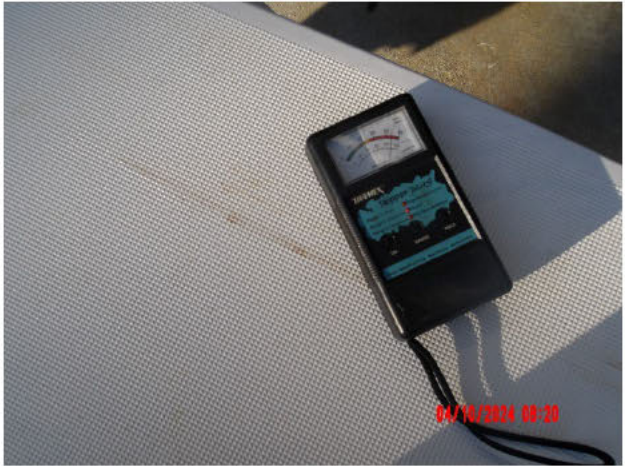
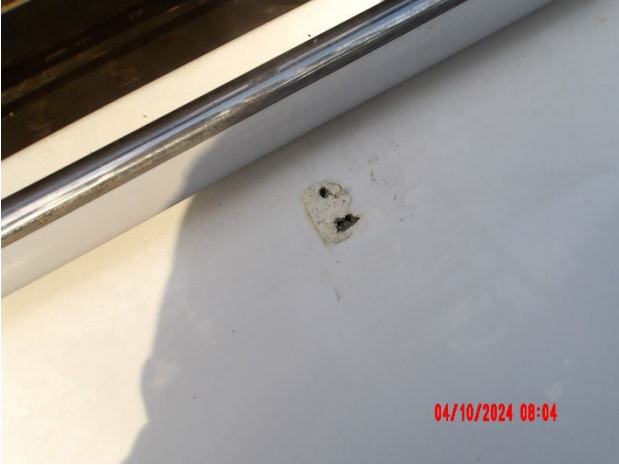
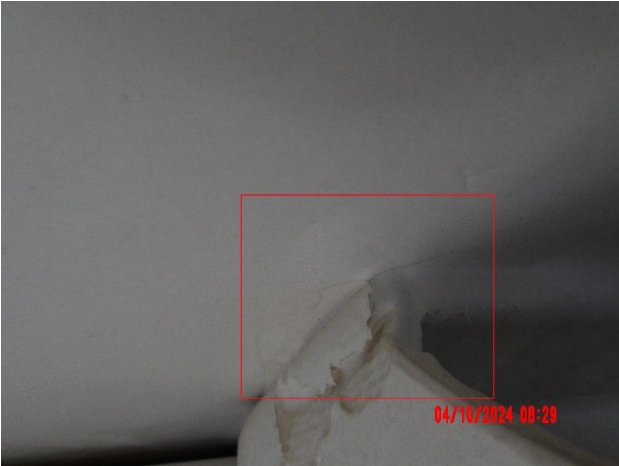
A mechanically fastened/molded swim platform was found installed, with a drop-down platform present. The drop-down platform showed elevated conductivity readings with historical hardware holes present. Stress cracking was found in the molded mounts of the swim platform; these mounts are for the drop-down platform, which was viewed from below. Please note that no abnormal percussions were found. Filling hardware holes and monitoring stress cracking / moisture readings is recommended.

[B] SECOND PRIORITY/FINDINGS NEEDING TIMELY ATTENTION	
FINDING	RECOMMENDATION
<p>1. The drop-down platform showed elevated conductivity* readings with historical hardware holes** present.</p> <p>Stress cracking*** was found in the molded mounts of the swim platform / drop-down platform connection point.</p> <p>Please note that no abnormal percussions were found.</p>	<p>Fill hardware holes and monitor stress cracking / moisture readings.</p> <p style="text-align: right;">*</p> <div style="text-align: center;">

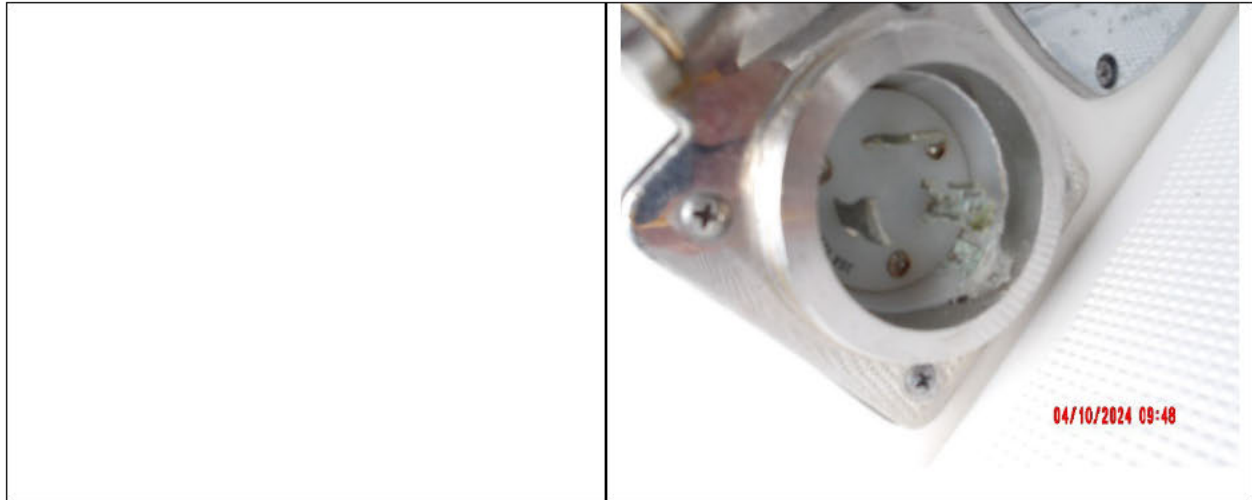
2. The head's faucet did not turn off appropriately.	Investigate further and repair or replace as needed.
3. No amps were displayed at the battery charger when the unit was powered on.	Investigate further and repair or replace as needed.
4. Corrosion was sighted at the prongs of the shore power inlet.	Investigate further and clean corrosion off or replace as needed.

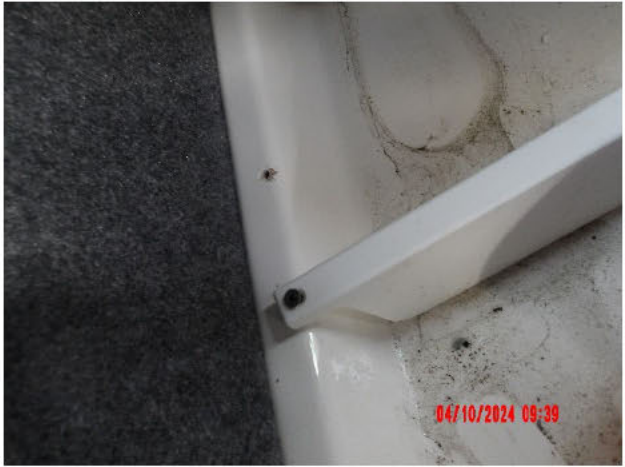
[C] SURVEYOR'S GENERAL FINDINGS, NOTES, AND OBSERVATIONS	
FINDING	RECOMMENDATION
1. Coolant was found below the max fill line on the Starboard engine. Coolant was found above the max fill line on the port engine.	Confirm the appropriate amount of coolant and adjust as needed.
2. Molding was found detached in the locker forward of the cockpit's sink.	Refasten the molding. <div style="text-align: right;">
