1 **Historic Weaverville Colored School Assessment Report**

7 The Preservation Society of Asheville and Buncombe County assessed the major visible
8 components of the Weaverville Colored School and documented their existing conditions on
9 April 17, 2023. Based on the information compiled through the assessment, prioritized treatment
10 recommendations were developed to help with the long-term care of the building.
11

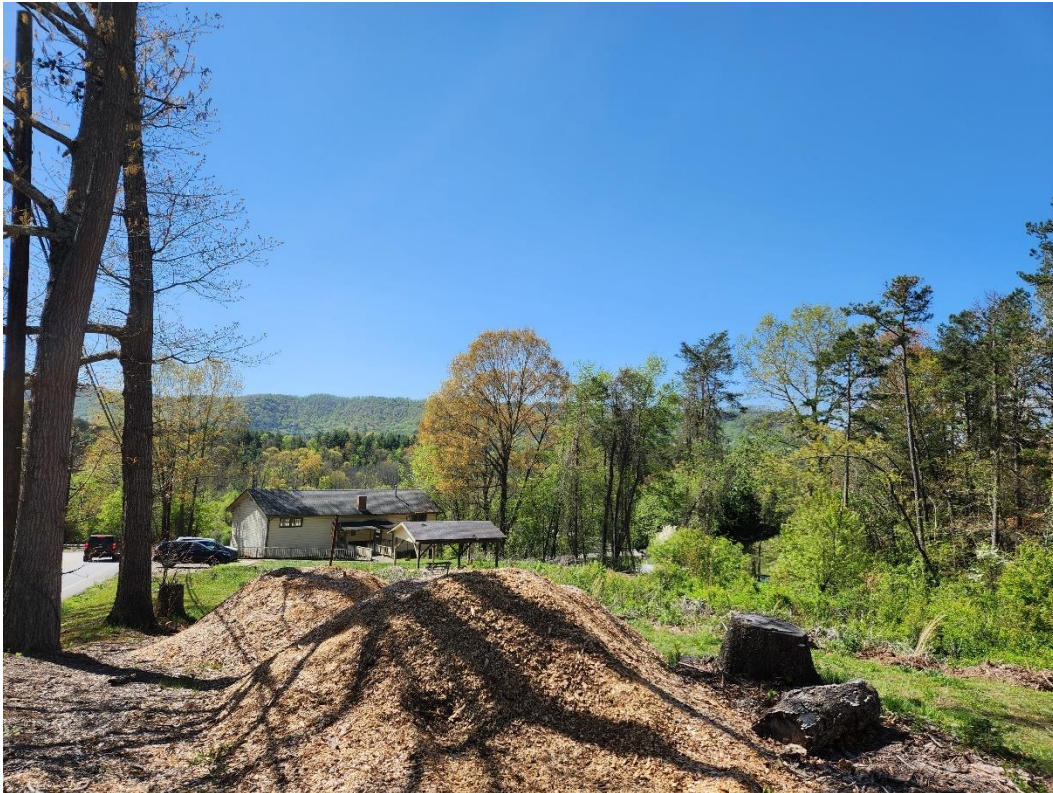
17
18 There are concrete sidewalks leading from the parking lot to the building, which are in good
19 condition. Along the edges of the sidewalks, there are wood railings. However, some of the
20 balustrades on the wood railings are missing, and there is minor wood rot. The paint is also
21 loose and delaminating.

23
24 Figure 1. View of the historic Weaverville Colored School looking southeast from Little Mount Zion Baptist
25 Church. (PSABC 2023)

- 36
- 37 ● Seal around all pipes and conduit, which penetrates the exterior wall with backer rod and
38 sealant.
- 39
- 40 ● Repair wood railings at the front porch and sidewalks as required and install missing
41 balustrades. Prep, prime, and paint all sides of the wood railings.

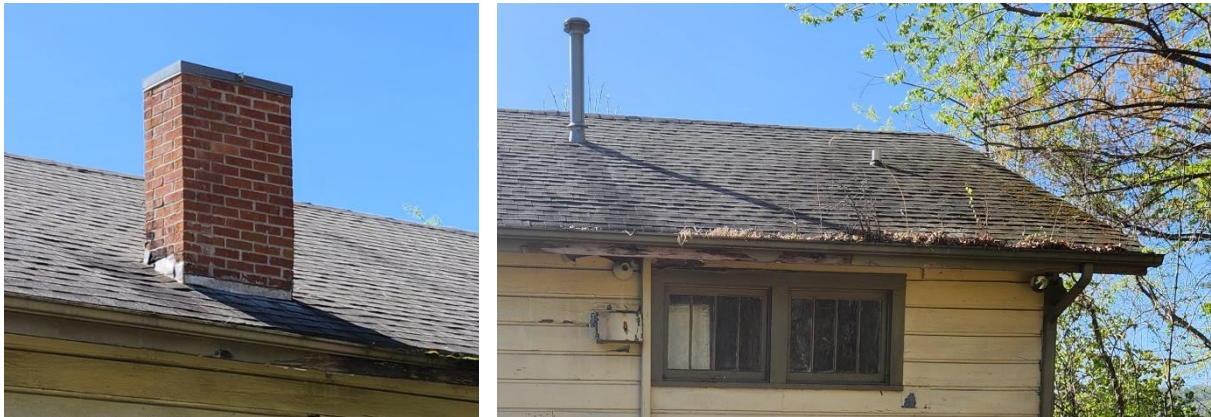
4
5 The chimney was assessed from grade, but it appears in good condition with no open mortar
6 joints or deteriorated bricks. However, the flashing along the base of the chimney is not properly
7 installed to meet current industry standards. The flashing should be stepped, and
8 counterflashed into the mortar joints. Without the proper flashing, water can infiltrate the roof
9 structure and the building.

10
11 There are existing K-style gutters installed along the northwest and southeast elevation of the
12 building and along the low edge of the porch's shed roof. There are rectangular-shaped
13 downspouts at each of the corners of the building and the north corner of the porch. The gutters
14 are very full of leaves and debris, which prevents water from draining properly. It is also
15 assumed that the downspouts are also full. The gutters are not sloping towards the downspouts,
16 causing water to sit in the gutters and/or run over the edge of the gutters. This can lead to water
17 infiltration in the building. The metal that forms the gutters and downspouts is also showing
18 signs of deterioration, and the downspouts are damaged and dented in several locations.

20
21 Figures 4 and 5. Left: View of the brick chimney. Right: View of the leaves and debris in the gutter along
22 the northwest elevation. (PSABC 2023)

- 19
- 20
- 21 • Clean all gutters and downspouts to remove all debris. Repair downspouts to ensure
22 that they properly drain. Repair gutters to raise the low points in the gutter to drain water
23 toward the downspouts. Test all gutters and downspouts to ensure that they are not
24 leaking. Patch damaged areas with butyl tape, as required.
25
- 26 • Remove the significantly deteriorated wood siding on the northwest elevation (front) of
27 the building. Inspect the structure behind the siding and repair as required. Resecure
28 roof flashing as required to create a watertight transition between the roof and the wall.
29 Install new exterior grade wood board that exactly matches the wood species, size, and
30 profile of the existing tongue and groove siding. Prep, prime, and paint the new siding
31 piece.
32
- 33 • Remove all vegetation from the exterior surface of the building.
34

- 12 • Remove the existing roof down to the sheathing. Replace and repair the sheathing as
13 required. Install new waterproof underlayment and new ice and water shield along the
14 roof edges and ridge cap. Install new asphalt shingle roof. The color of the new shingles
15 is to match the existing. Install new flashing throughout the roof with new step flashing
16 and cricket at the chimney.
17

- 18 • When the roof is replaced, remove existing gutters and downspouts and install new
19 gutters and downspouts that are appropriately sized for the roof. The gutters and
20 downspouts can be replaced in-kind with new K-style gutters and rectangular-shaped
21 downspouts. Historically, they would have been half-round gutters and round
22 downspouts. These could also be options for the new gutters and downspouts. Repair
23 existing wood soffit as required. Prep, prime, and paint the soffit and associate trim prior
24 to installing the new gutters and downspouts.
25

- 26 • Investigate if the brick chimney is used for venting any equipment. If it is no longer used,
27 install a pre-finished metal cap on the brick chimney to prevent moisture infiltration, as
28 well as to prevent heat loss. Provide a drip edge and a sloped top to promote water
29 drainage and install it per the Sheet Metal and Air Conditioning Contractors' National
30 Association (SMACNA) guidelines.
31

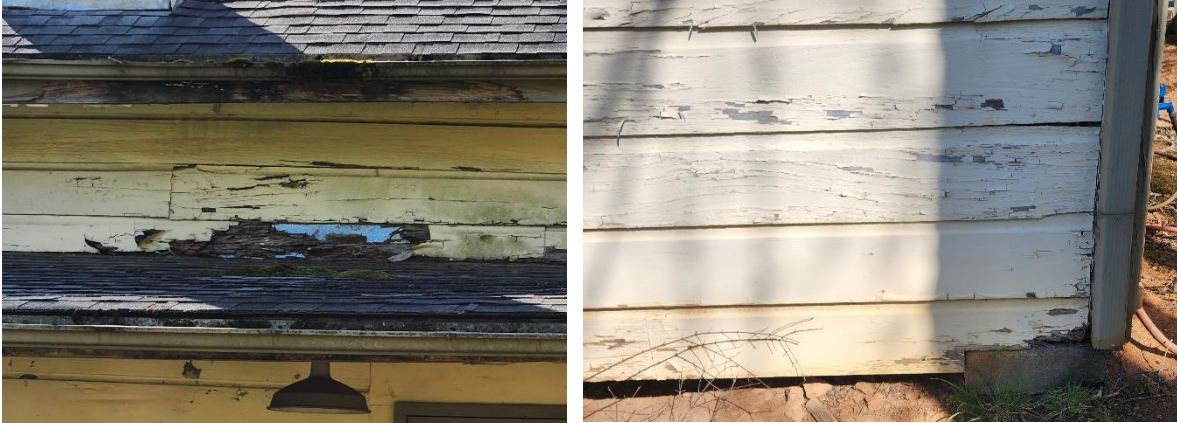
24 The tongue and groove wood siding is in fair to good condition. There is one location on the
25 northwest elevation (front) with significant wood rot and deterioration. In this location, the wood
26 is so deteriorated that the wood is gone leaving the wall open and exposing the shed roof
27 flashing. This could lead to a potential water leak. There are a few locations throughout the
28 remainder of the building with minor wood rot and deterioration. A few sections of wood siding
29 and trim are also loose, which could potentially fall.

31 The painted finish on the tongue and groove wood siding is in poor condition. There is a
32 significant amount of loose and delaminating paint on the exterior of the building. There is a
33 potential that lead-based paint could be present due to the age of the building. In addition, the
34 loose and delaminating paint could be a life safety issue as the paint particles could easily
35 become air born or be tracked into other buildings and houses.

1
2 Figures 6 and 7. Left: View of the significant wood rot and deterioration in the tongue and groove siding
3 on the northwest elevation. Right: View of the typical condition of the tongue and groove siding.
4 (PSABC 2023)
5

- 32 • Restore exterior wood siding and trim.
 - 33 ○ Remove all loose and delaminated paint on the exterior of the building with a
34 chemical paint remover specifically designed for wood substrates or other
35 methods that meet the Lead-Based Paint Hazard Management Programs for
36 Renovation, Repair, and Painting (RRP) because it is assumed that lead-based
37 paint is present in the building. Testing should be completed to confirm its
38 presence.

- 39 ○ Resecure all loose sections of wood siding and trim.
 - 40 ○ Repair or replace wood siding and trim with wood rot and damage.
 - 41 ■ In locations with minor wood rot and damage, repair wood with wood
42 epoxy.

- 43 ■ In locations with significant wood rot or damage, remove the damaged
44 and deteriorated wood. Inspect the structure behind the siding and repair
45 as required. Install new exterior grade tongue and groove wood board

- 1 that exactly matches the wood species, size, and profile of the existing
2 siding.
- 3 ○ Prep, prime, and paint the entire exterior of the building.
- 4

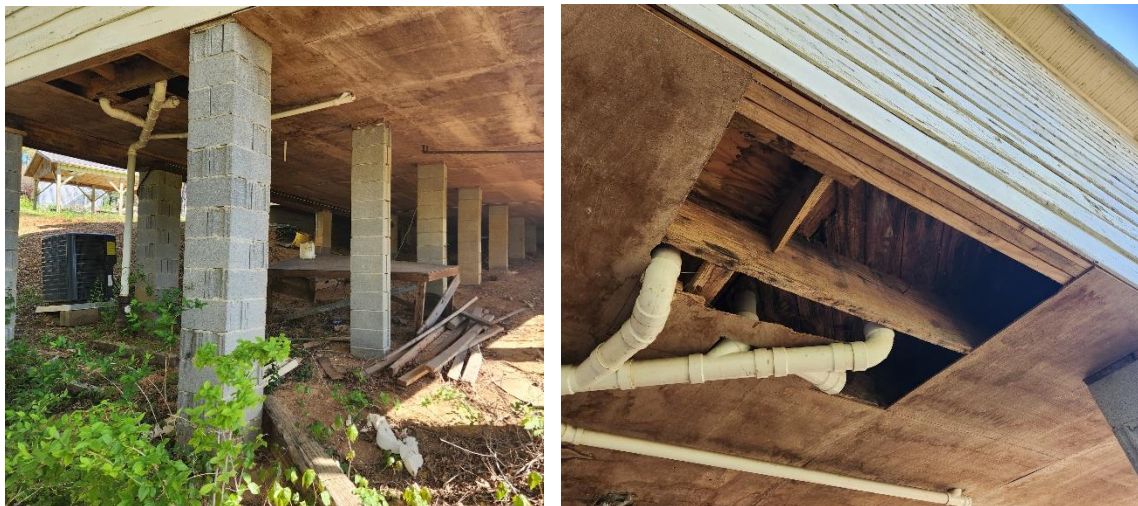
13 The foundation for the building is a combination of a concrete masonry unit (CMU) wall
14 foundation and CMU pier foundation. The CMU piers and foundation appear to be stable, but
15 there are several locations where the mortar joints are open, or the mortar is completely
16 missing. Mortar is integral to tying the CMU together to create a stable foundation.
17

18 On the underside of the floor structure on the southwest end of the building, there is a large hole
19 in the sheathing. It appears the hole was made to install or repair piping. The hole can allow
20 insects, pests, and animals into the floor structure and potentially into the building.
21

22
23 Figures 8 and 9. Left: View of the CMU piers. Right: View of the hole in the sheathing on the underside of
24 the floor structure. (PSABC 2023)

- 5 ● Square off the hole in the sheathing enclosing the underside of the floor structure on the
6 southwest end of the building. Ensure the new opening is from the center of a floor joist
7 to the center of the floor joist to allow for the new sheathing to be securely fastened.
8 Install new exterior grade plywood within the opening and properly seal the joint with
9 sealant.

- 10
- 11 ● The CMU piers supporting the building appear to be stable, but a structural engineer
12 should be hired to review their condition and be repaired as required.

- 13
- 14 ● Repoint CMU piers and foundation.
- 15
- 16 ● Restore all original wood windows. If it is desired not to have the windows operable,
17 consider fixing the windows in place. To protect the original wood windows, wood storm
18 windows could be installed on the exterior of the windows. The storm windows should be
19 visually unobtrusive with a frame that is smaller than the original wood windows and the
20 meeting rail matching the location of the meeting rail on the original window. Replacing
21 the original windows would damage the character of the building and potentially prevent
22 it from being listed in the National Register of Historic Places, so this option should NOT
23 be explored.

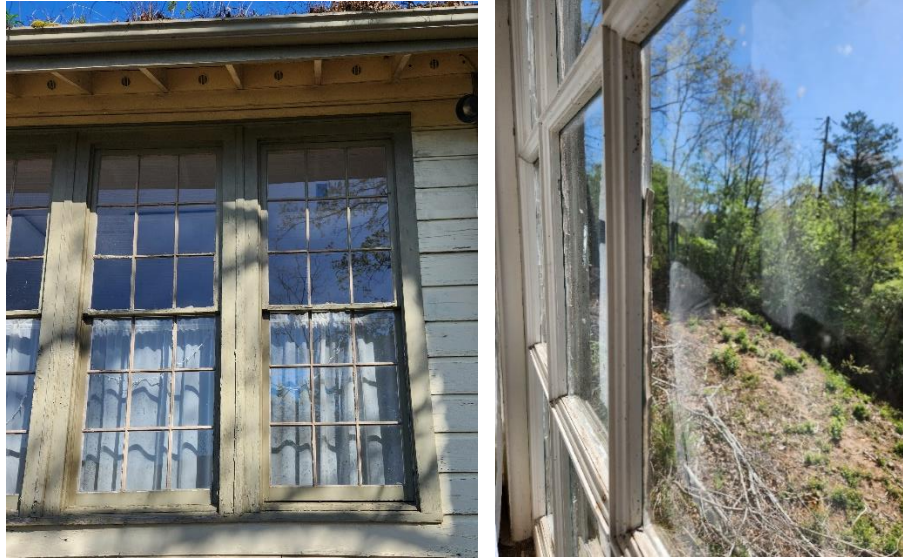
1 All of the original wood windows are still in place in the building and are in fair condition. The
2 glazing putty on all of the windows is cracked and missing in several locations. The glazing putty
3 helps hold the glass in place and prevents air infiltration through the window. The paint on the
4 interior and exterior of the window frames and trim is loose and delaminating, and there are a
5 few locations with minor wood rot and deterioration. The windows have been fixed in place with
6 screws to prevent people from opening the windows.

8
9 Figures 10 and 11. Left: View of the large original wood hung windows. Right: Detail view of the muntins
10 and the deteriorated glazing putty. (PSABC 2023)

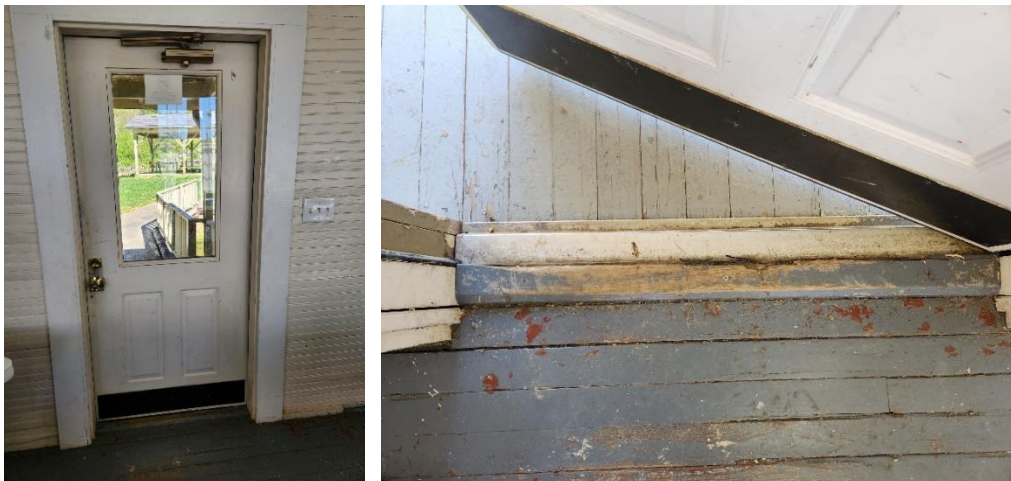
11
12 The two exterior doors are metal, non-original, with a window in the upper panel and two
13 rectangular panels in the lower half. The finish on the doors is scratched, worn, and generally
14 dirty. Weatherstripping is missing or damaged on the bottom of both doors, which can allow air
15 and water to infiltrate the building under the door. The doorknobs on both doors do not meet
16 accessibility requirements because they require a person to tightly grasp and twist the wrist to
17 operate. The wood sill on the northeast door is damaged and starting to deteriorate.

19
20 Figures 12 and 13. Left: View of the large original wood hung windows. Right: Detail view of the muntins
21 and the deteriorated glazing putty. (PSABC 2023)

- 24
- 25 ● Exterior Doors
- 26 ○ Prep, prime, and paint the interior and exterior of the doors.
- 27 ○ Remove existing doorknobs and install new levers that meet accessibility
28 requirements on both exterior doors.

- 29 ○ Install sweeps and weatherstripping at the bottom of both exterior doors.
- 30 ○ Repair the damaged and deteriorated wood sill on the northeast exterior door.

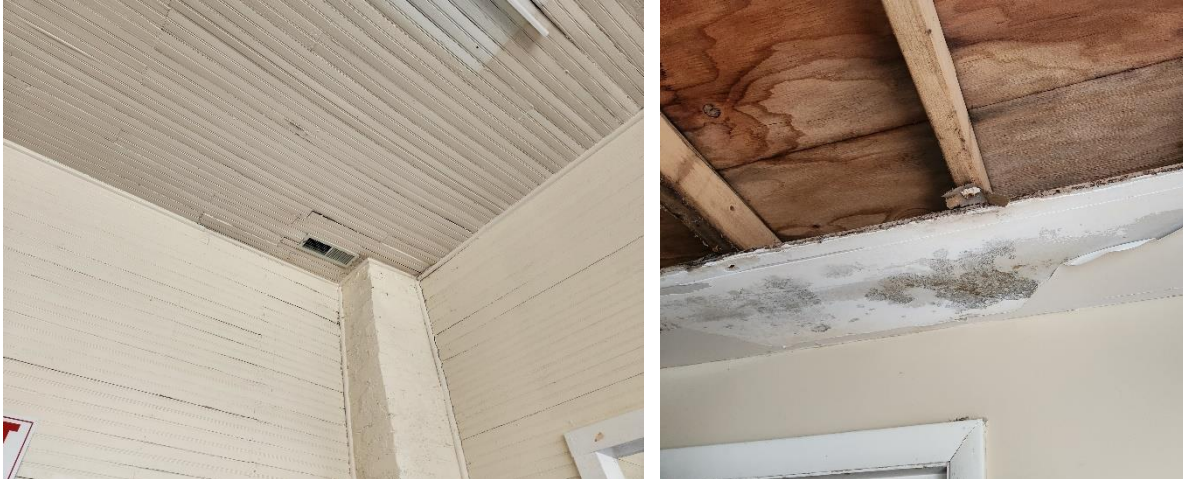
The beadboard ceilings and walls are in fair to good condition. There are a few small holes through the beadboard from where electrical and other building systems have been installed, and there is some minor damage from typical wear and tear. A few sections of the beadboard are loose, which could potentially fall. The paint finish on the beadboard is loose and delaminating. Similar to the exterior, there is a potential that lead-based paint could be present due to the age of the building.

The non-original drywall ceilings and walls are in fair to good condition. There is one location in the corridor by the restrooms where a section of the drywall has previously been removed. It appears it was removed to abate mold or remove water-damaged drywall. There is still some mold remaining on the drywall surrounding the hole. It is unknown if there is still an active water leak.

1
2 Figures 15 and 16. Left: View of the typical condition of the beadboard ceilings and walls. Right: Detail
3 view of the mold surrounding the hole in the drywall ceiling of the corridor by the restrooms.
4 (PSABC 2023)
5

- 4
- 5 • Repair the holes and damaged sections in the wood beadboard walls and ceilings as
- 6 required.
- 7
- 8 • Secure loose sections of the wood beadboard walls and ceilings.

- 16 repainted or refinished and stained.
- 17
- 18 • Remove sections of drywall with mold from the ceiling of the corridor by the restrooms.
- 19 Inspect the ceiling structure for the presence of additional mold. Treat as required. Install

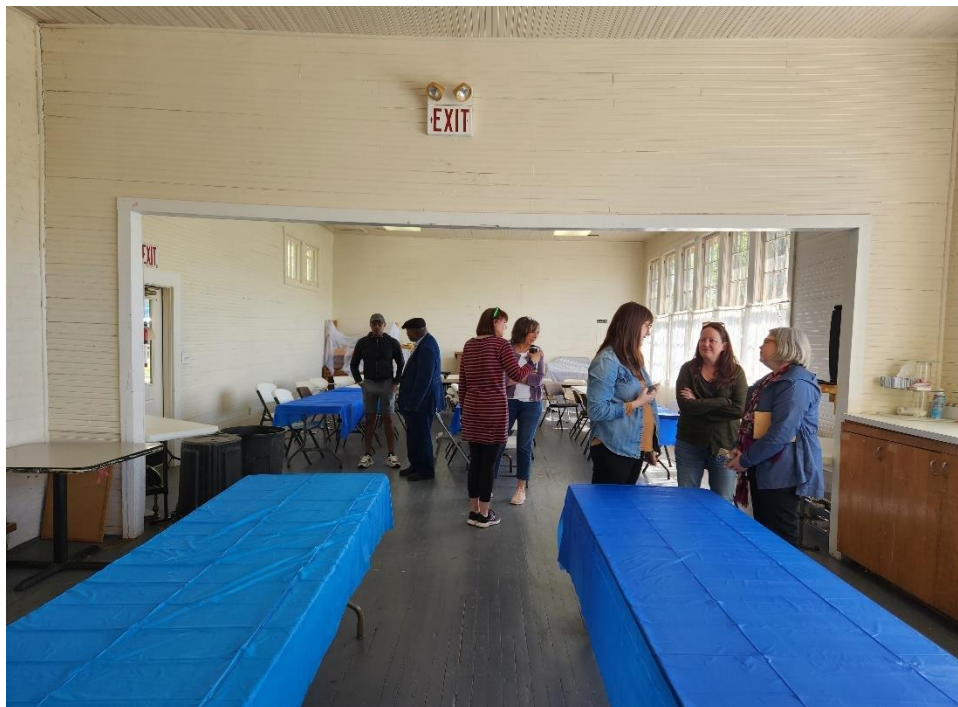
10 The header for the wall opening between the two rooms appears to be sagging. It is unknown if
11 this is a sign of active movement in the header, previous settlement, or inadequate structural
12 support capacity of the wood header members. Additional investigation is required to determine
13 the cause of the sagging and what repairs are required.
14

15
16 Figure 17. View looking northeast at the wall opening between the two rooms. Note, the sag at the
17 header. (PSABC 2023)

- 36 • Monitor the sagging at the header for the wall opening between the two rooms to see if
37 there is ongoing movement. If the header appears to be moving, shore the opening until
38 the header can be reviewed by a structural engineer and repaired.
39
40
41
42
43
44
45

- 2 • The header at the wall opening between the two rooms appears to be sagging. A
- 3 structural engineer should be hired to review the header and repair as required.

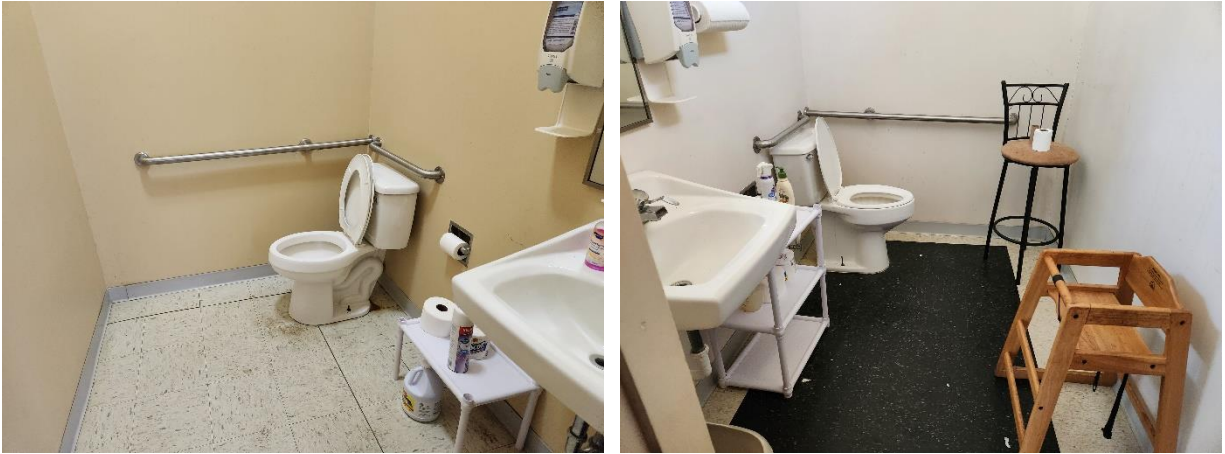
1 The two non-original restrooms are in good condition. When they were constructed, it appears
2 that they were designed to meet accessibility requirements. However, there are a few current
3 requirements that have not been met. The piping under both sinks is exposed, which could
4 potentially cause someone harm. There are currently horizontal grab bars installed, but the
5 restrooms are missing vertical grab bars. The restrooms and the corridors outside the restrooms
6 are full of shelves and storage items, which are impeding the required clearances at the toilets
7 and the maneuvering clearances at the restroom doors.
8

9
10 Figures 18 and 19. Views of the two restrooms within the historic Weaverville School.
11 (PSABC 2023)
12

- 1 ○ Remove shelves and storage items from within the restroom to create the
 2 required accessible clearance next to the toilet. Reference the diagram below for
 3 required clearances.
 4

- 8 ○ Remove shelves and storage items from outside the restrooms in the corridor to
 9 create required accessibility maneuvering clearances at each of the restroom
 10 doors.
 11

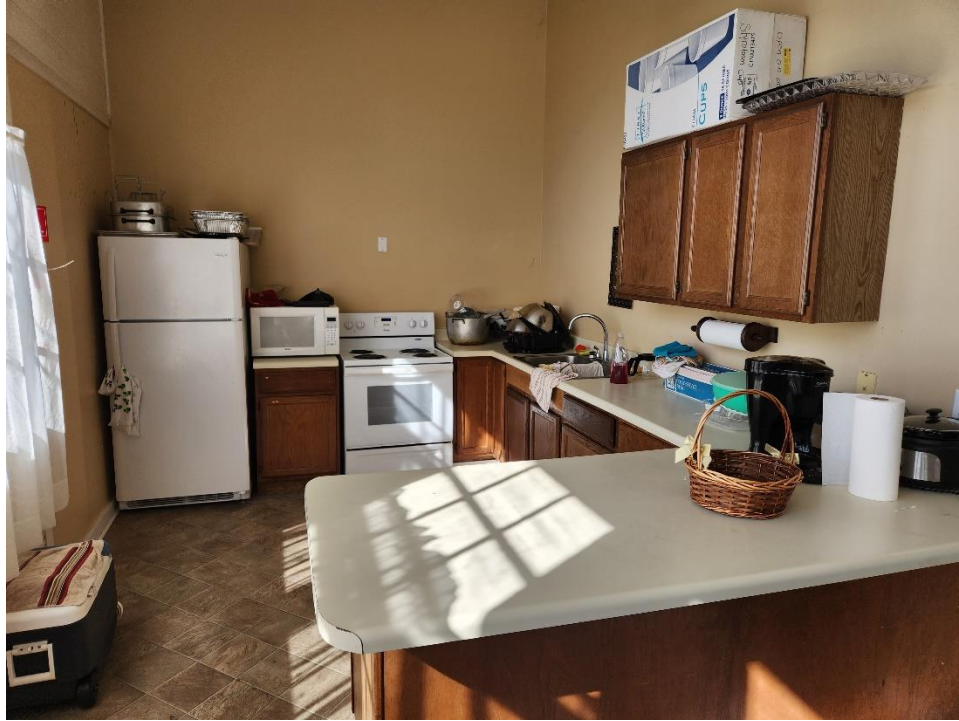
13 The non-original kitchen and the countertop along the southeast wall show signs of typical wear
14 and tear. They also do not meet accessibility requirements. The countertops are too tall, and
15 there is not the required toe space under the sink. In addition, there currently is not a hood
16 above the stove, which is required by the North Carolina International Mechanical Code. The
17 Mechanical Code classifies this kitchen as commercial, so a hood with a fire suppression
18 system and a grease filter are required.
19

Figure 20. View looking southwest into the Kitchen area. (PSABC 2023)
