**PHASE 1 - Milestone Inspection**

Inspection Firm or Individual Name: RAY ENGINEERING, INC.

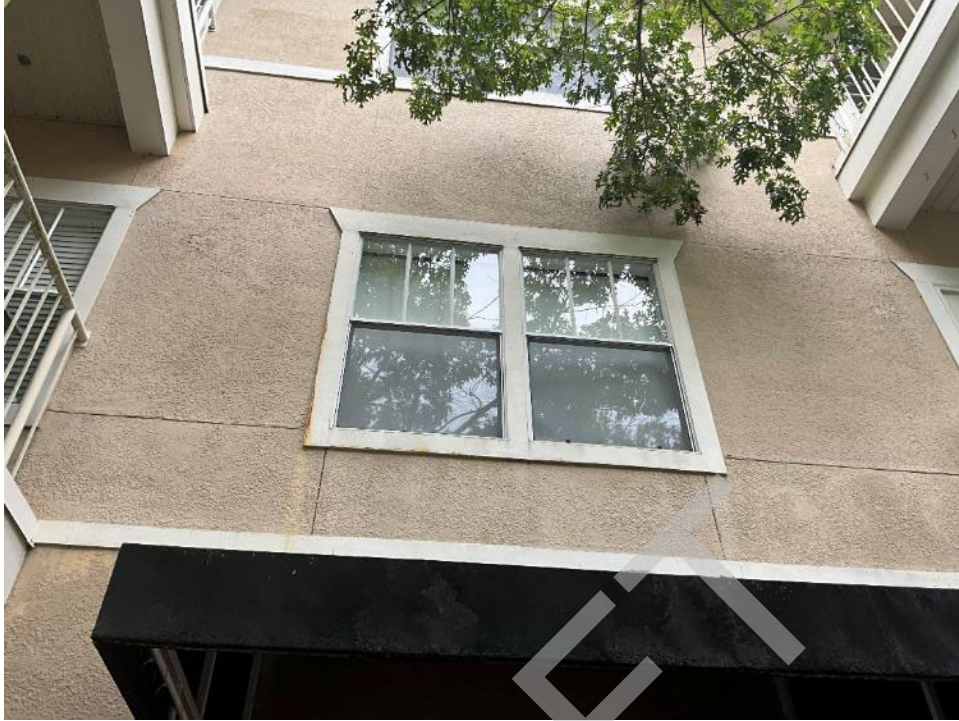
7. View of staining along the finish around the windows.

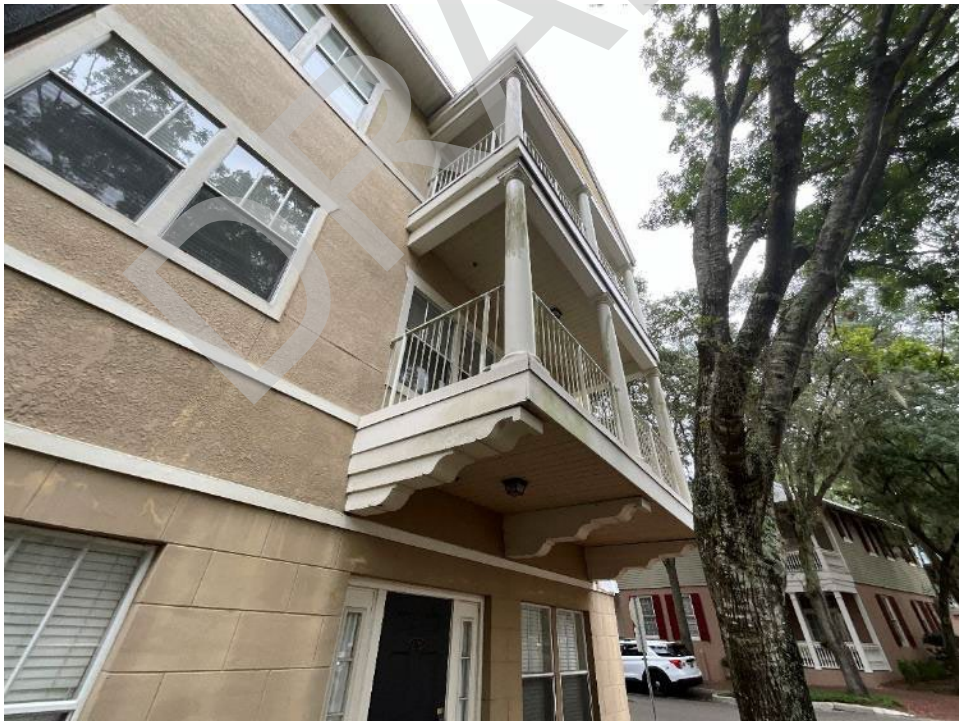
8. View of staining observed along the walls, columns, and beams of the balconies of all buildings.

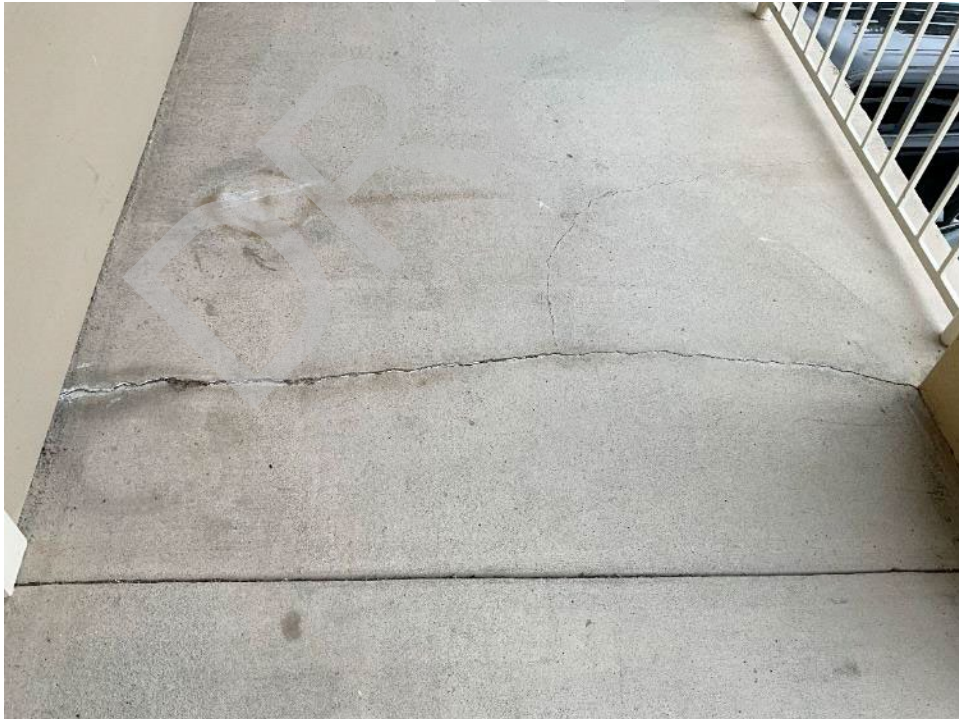
12. View of cracks in the breezeways of the building.

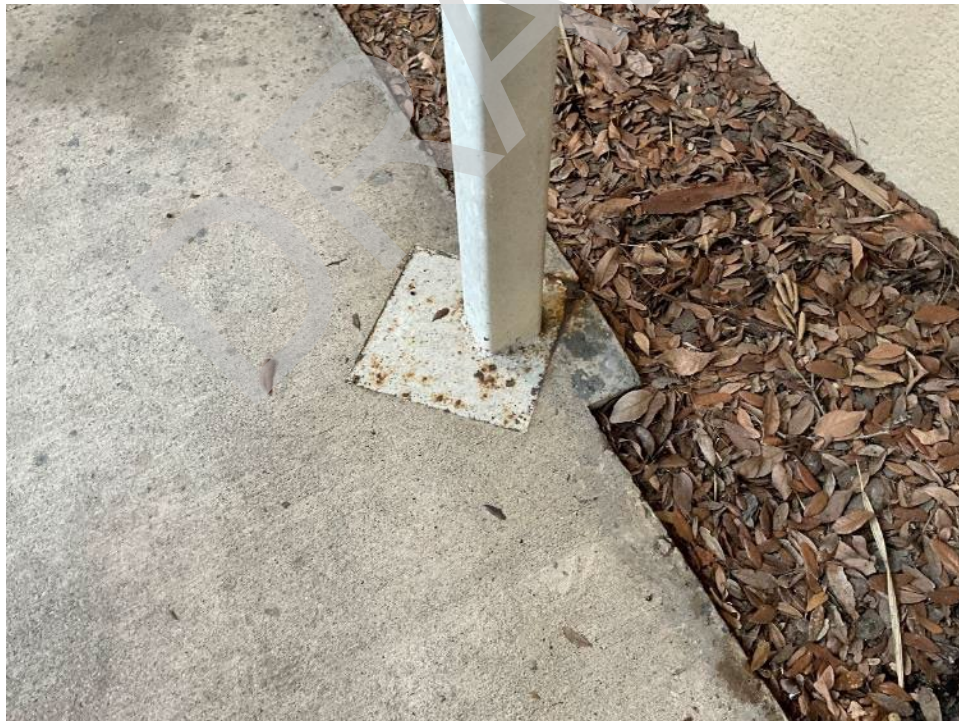
18. View of corrosion observed at the base of the metal columns along the rear of Building A.

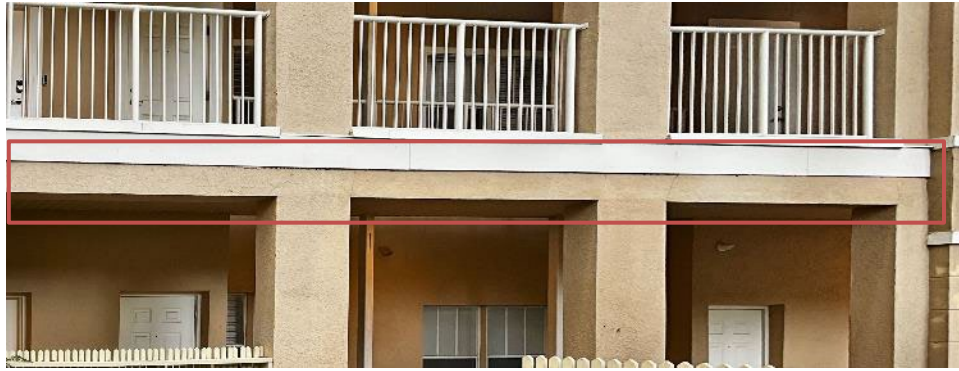
**19. View of cracked section of beam below the Building A breezeway. The paint and stucco will need to be removed to expose the beam for Phase II.**

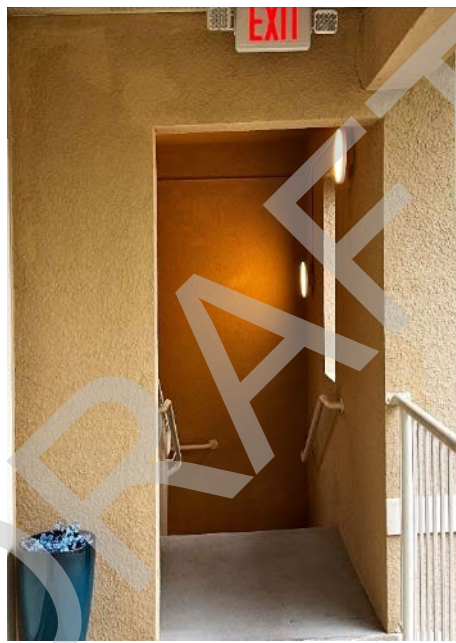
**20. View of cracked section of wall next to unit A303. The paint and stucco will need to be removed to expose the wall for Phase II.**

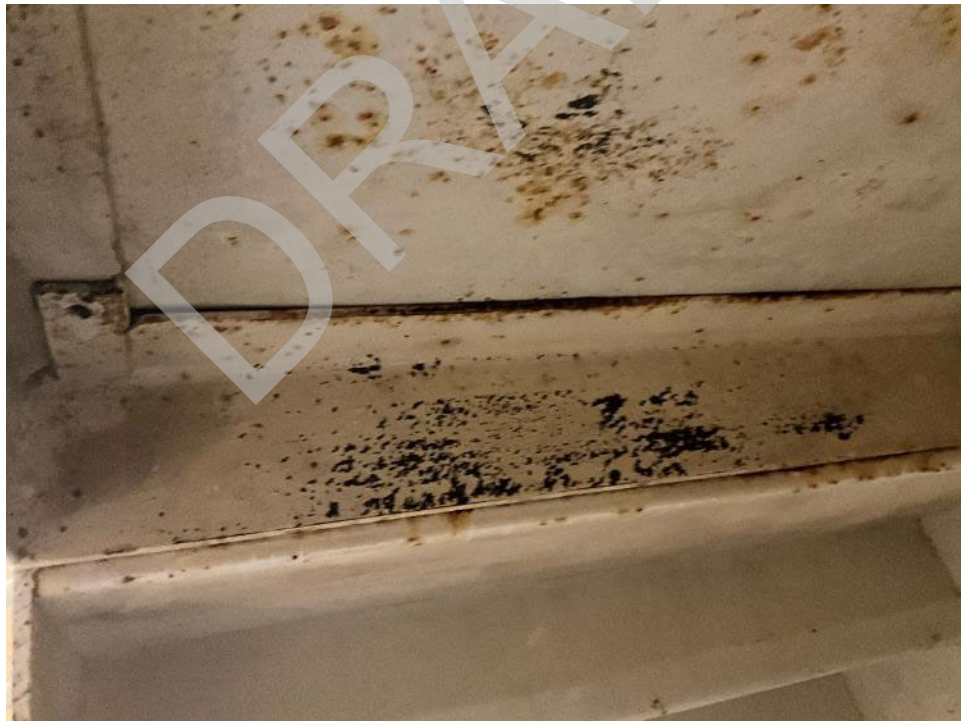
22. View of corrosion below the metal stairs.

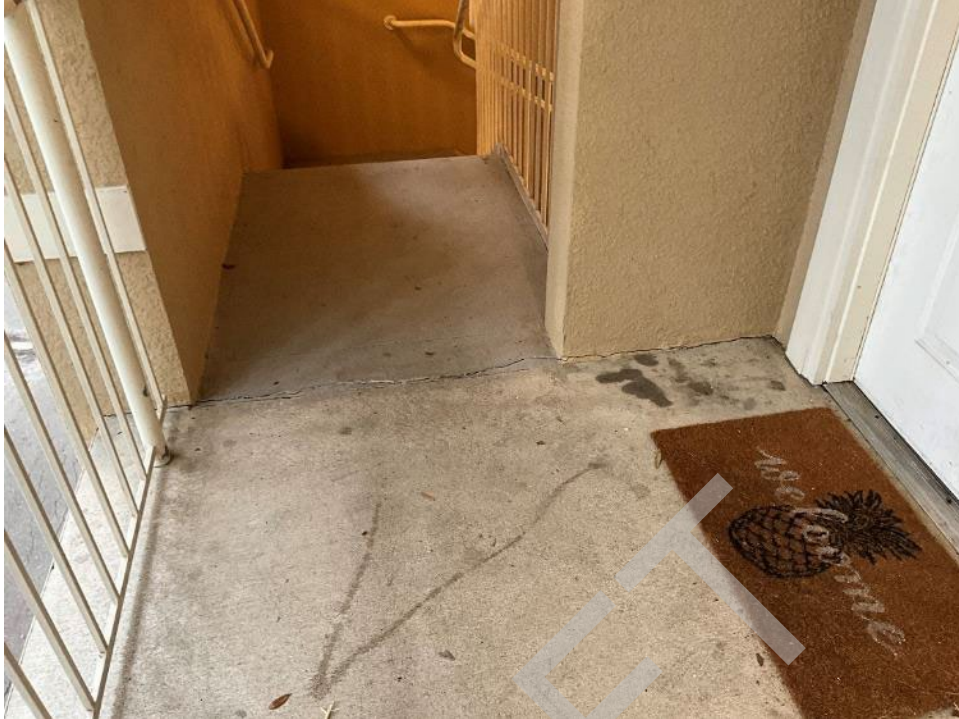
25. View of cracking along wall and breezeway slab flooring that extends through the floor slab.

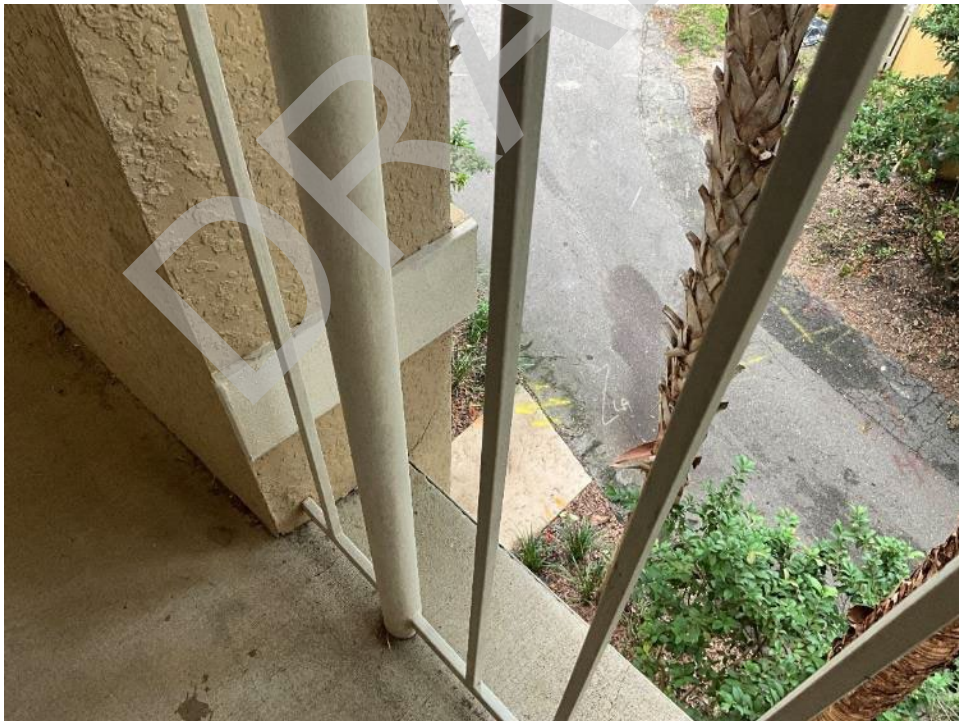
26. View of cracking in the column next to the third level breezeway.

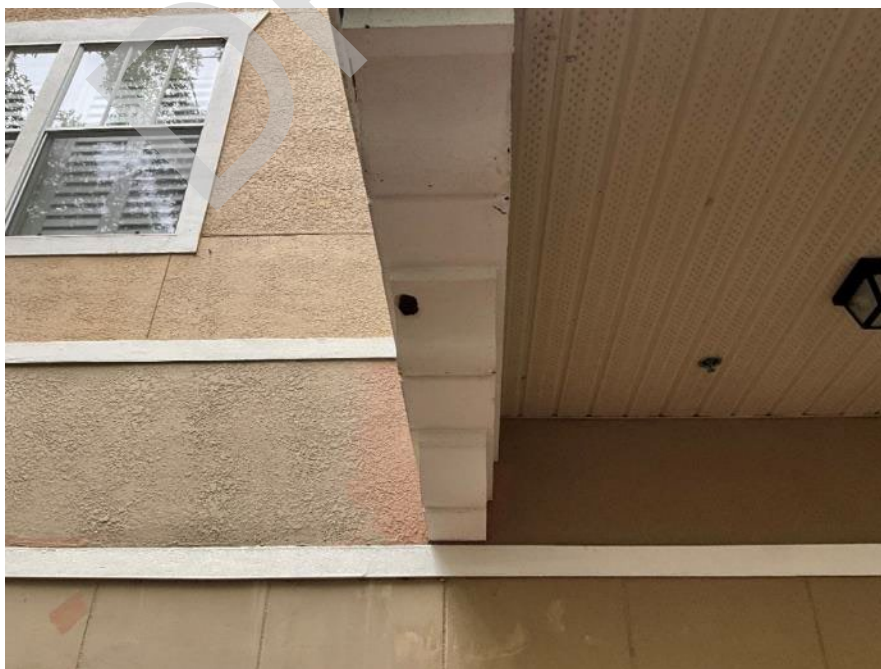
**28. View of spalling in decorative beam below balcony above unit B101.**

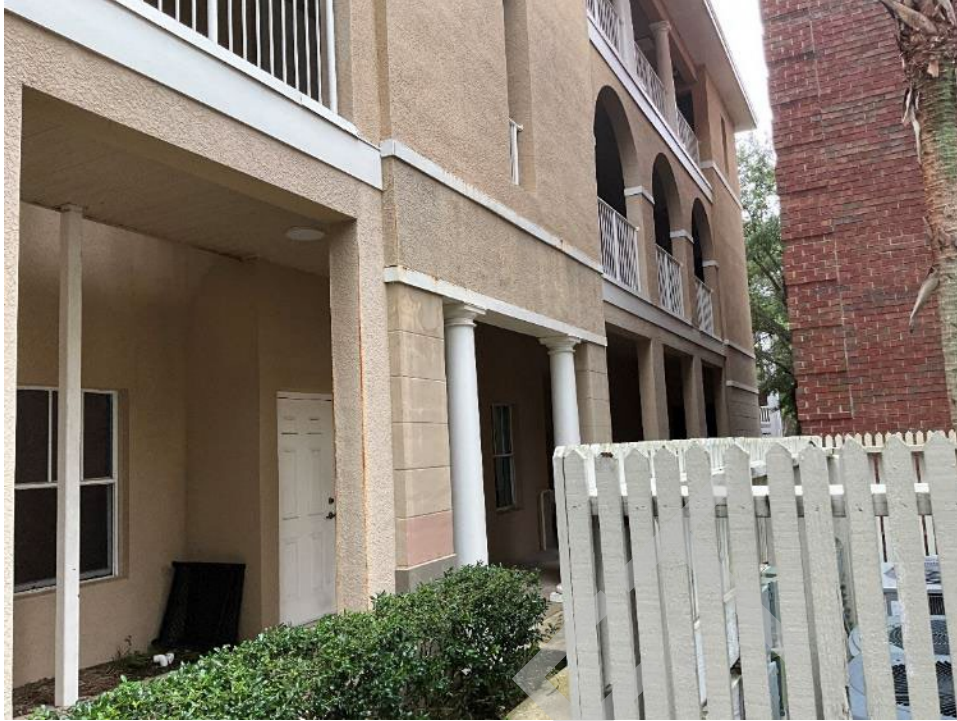
31. View of corrosion along edges of column in rear elevation.

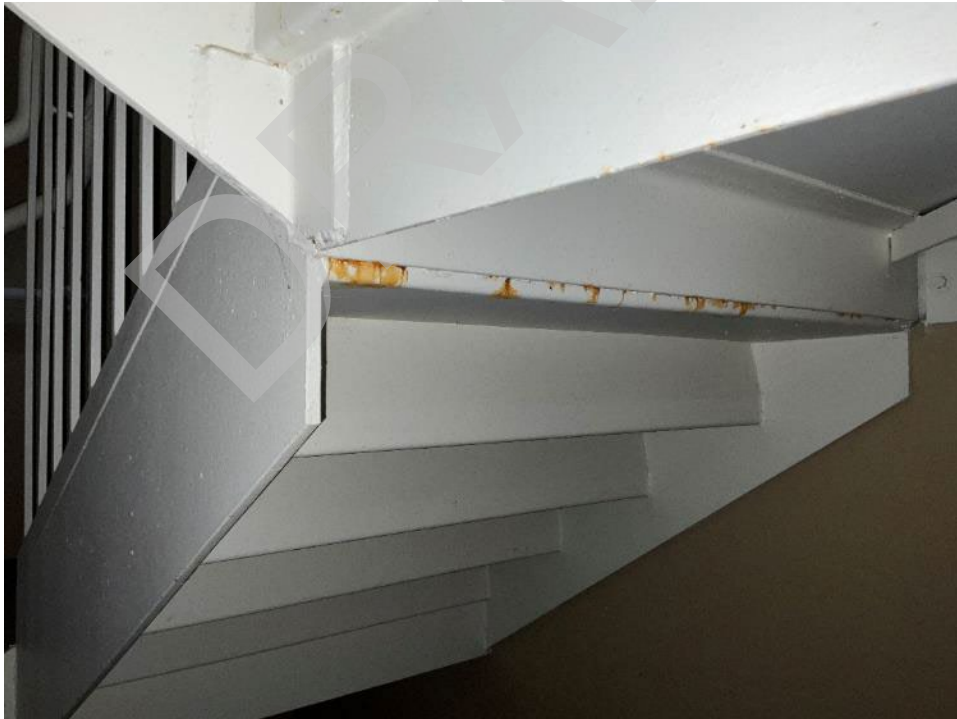
32. View of corrosion under stairs in stairwell.

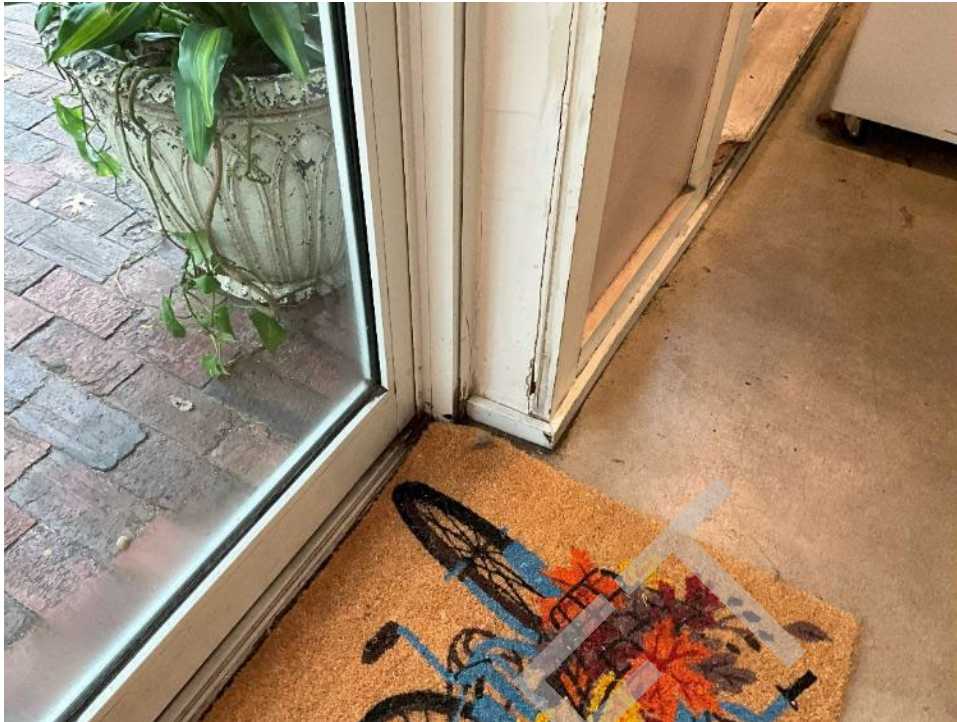
37. View of cracking along the finish around the entry door to suite B-102

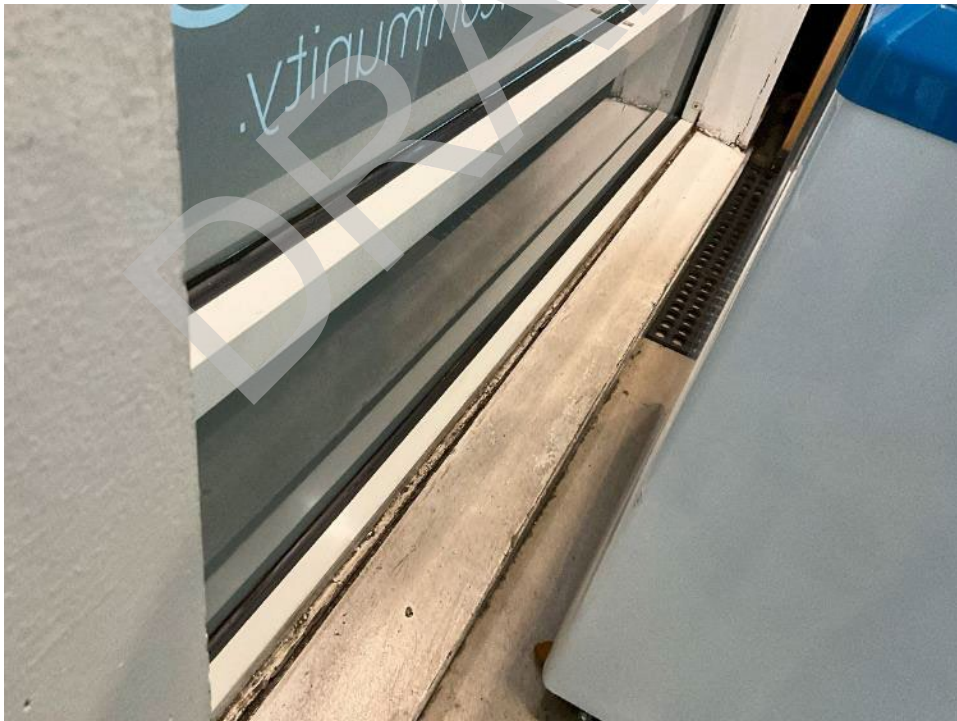
38. View of cracking along the interface between the window and the sill in suite B-102.

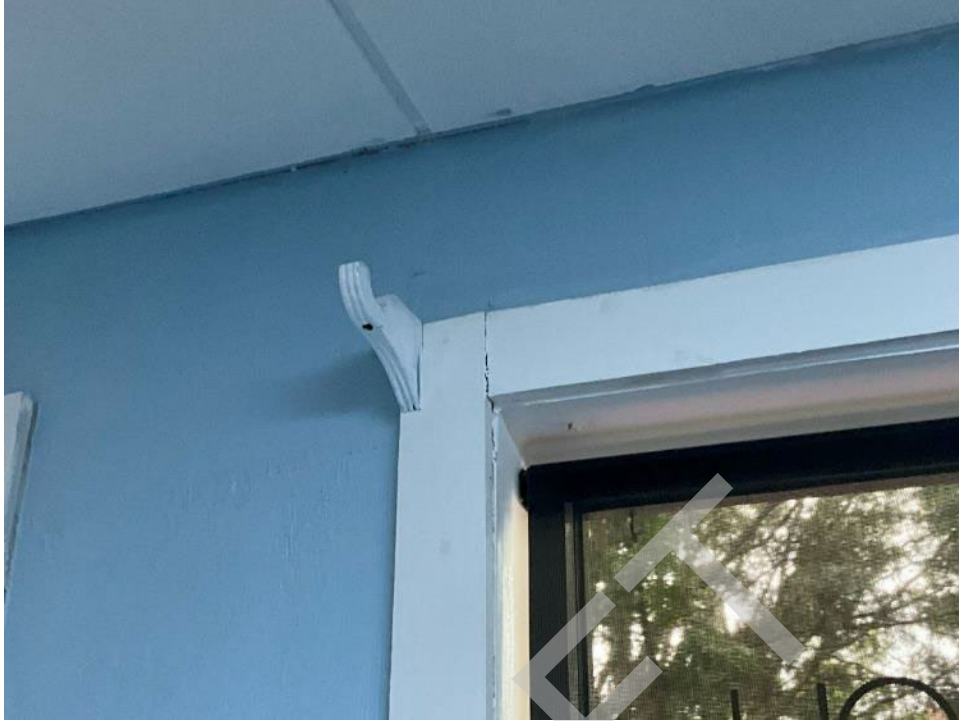
41. View of crack in the finish around a window in suite B-103.

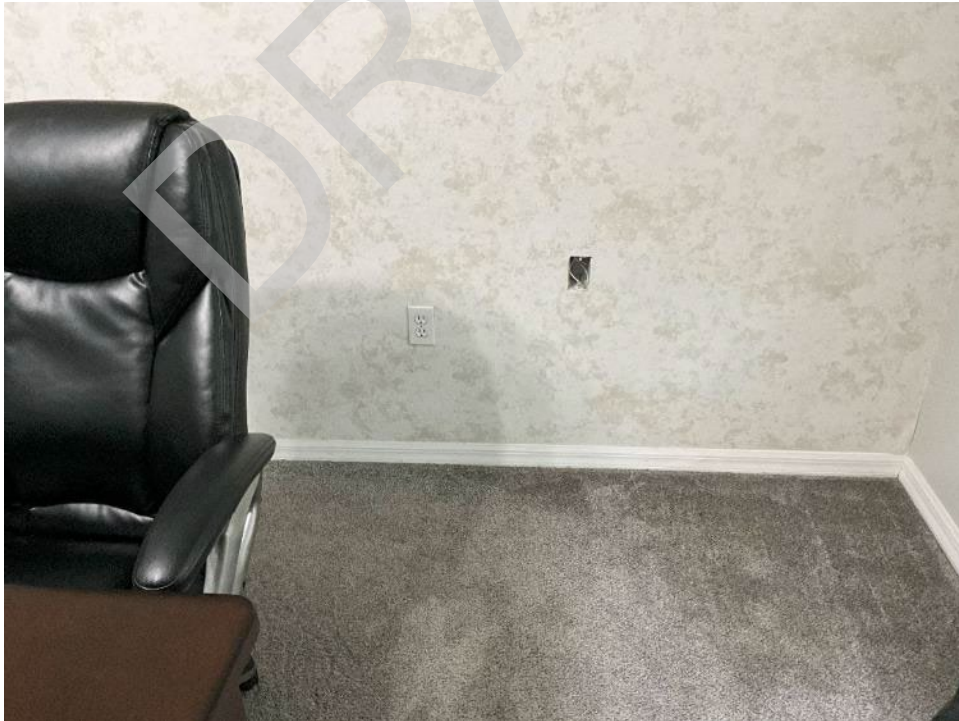
42. View of open electrical receptical in unit C101.

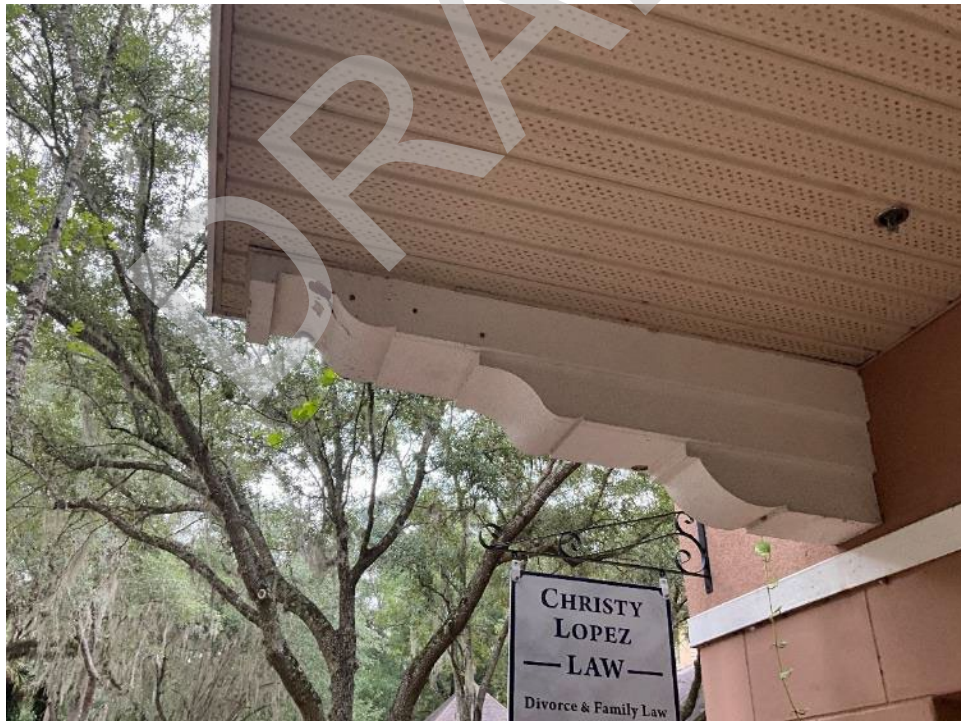
44. View of holes and cracks in the finish for the beams above unit C101.

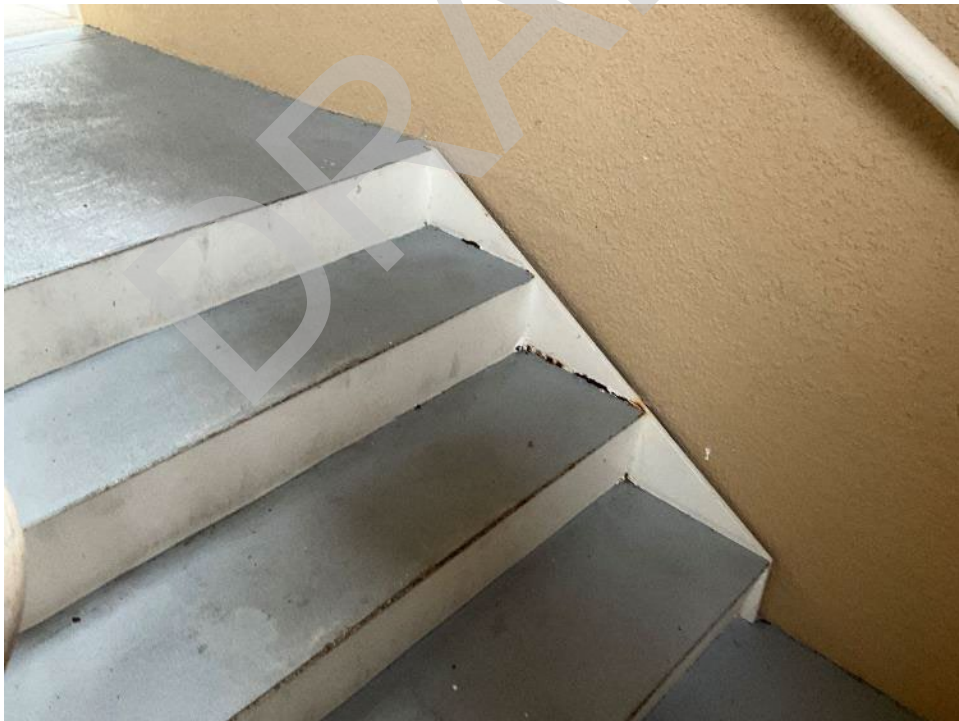
48. View of corrosion along the stairs.

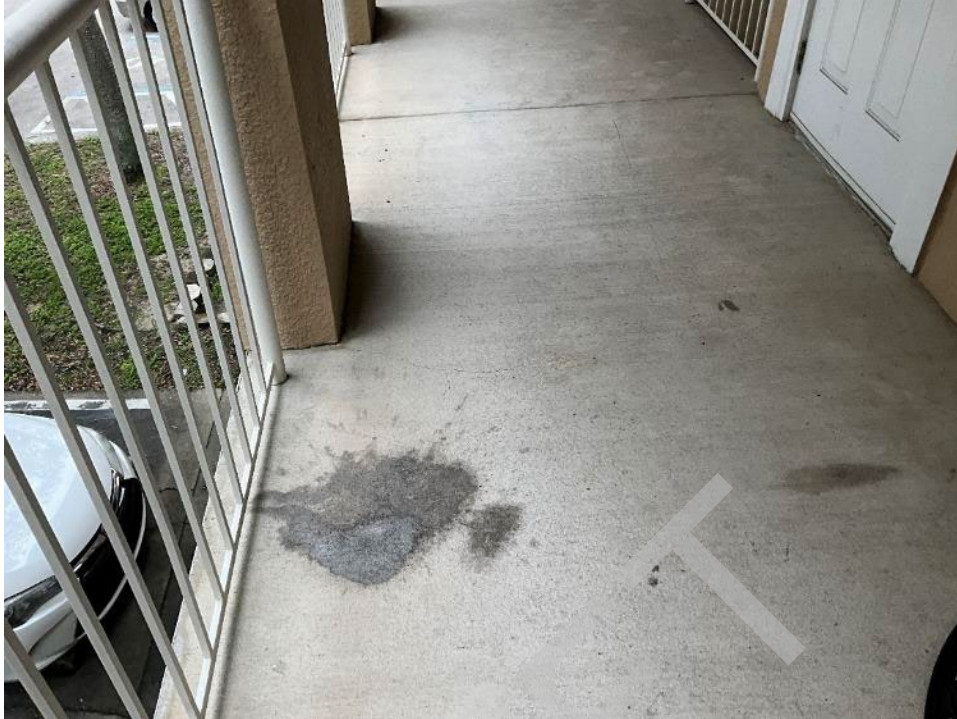
51. View of staining along the breezeway floor in front of unit C201.

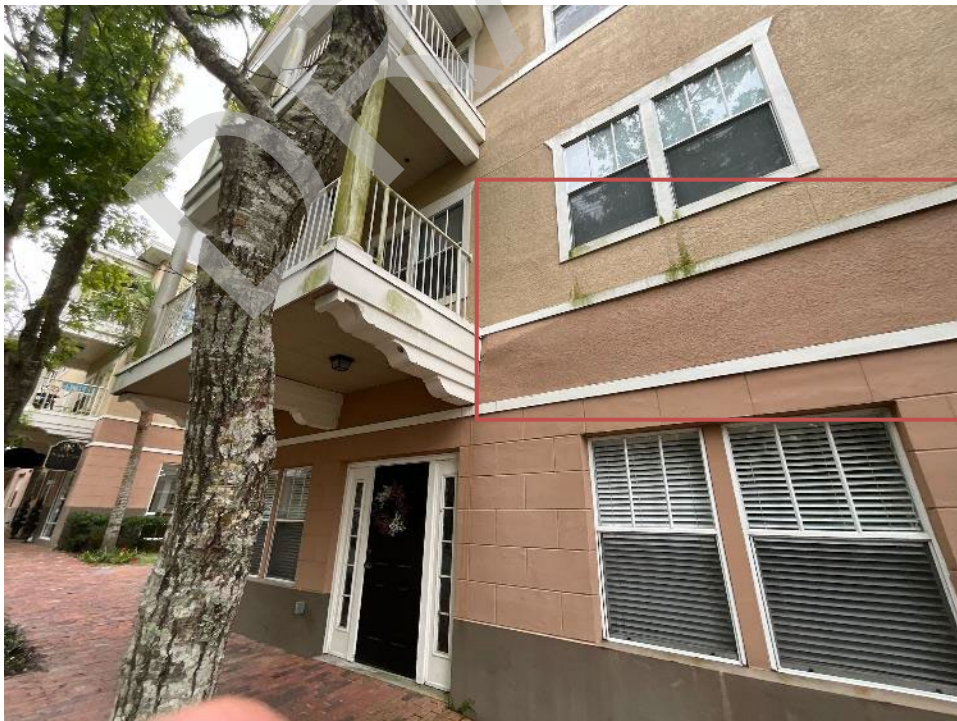
**52. View of cracked section of wall next to unit D201 balcony. The paint and stucco will need to be removed to expose the wall for Phase II.**

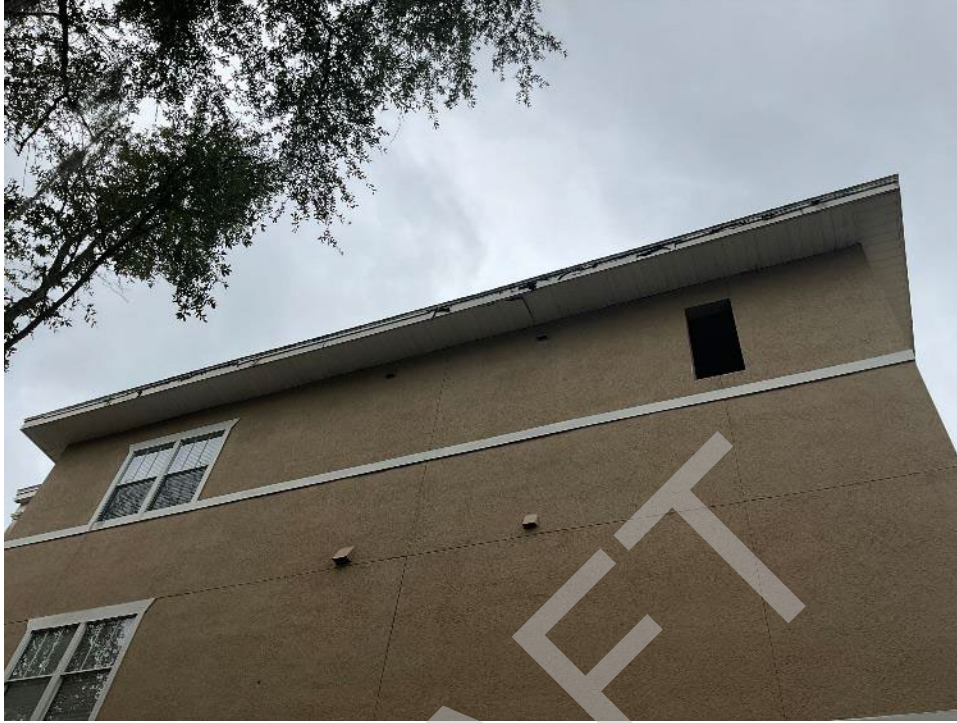
**53. View of cracked section along the west elevation fascia. The fascia will need to be removed to expose the trusses for Phase II.**

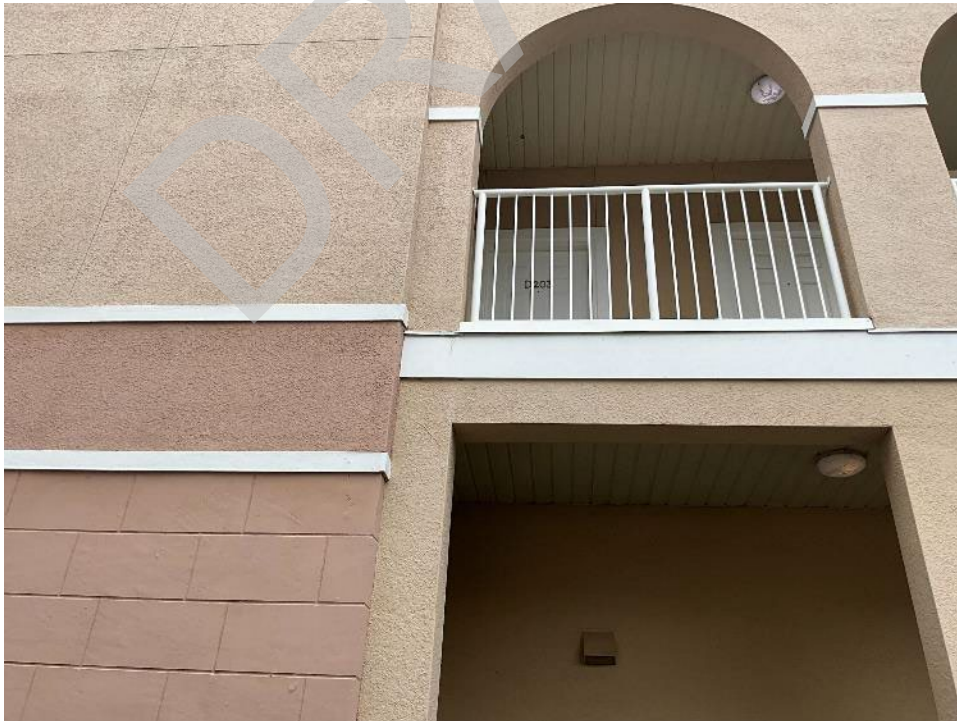
**54. View of cracked section along the exterior column near D203. The stucco will need to be removed to expose the column for Phase II.**

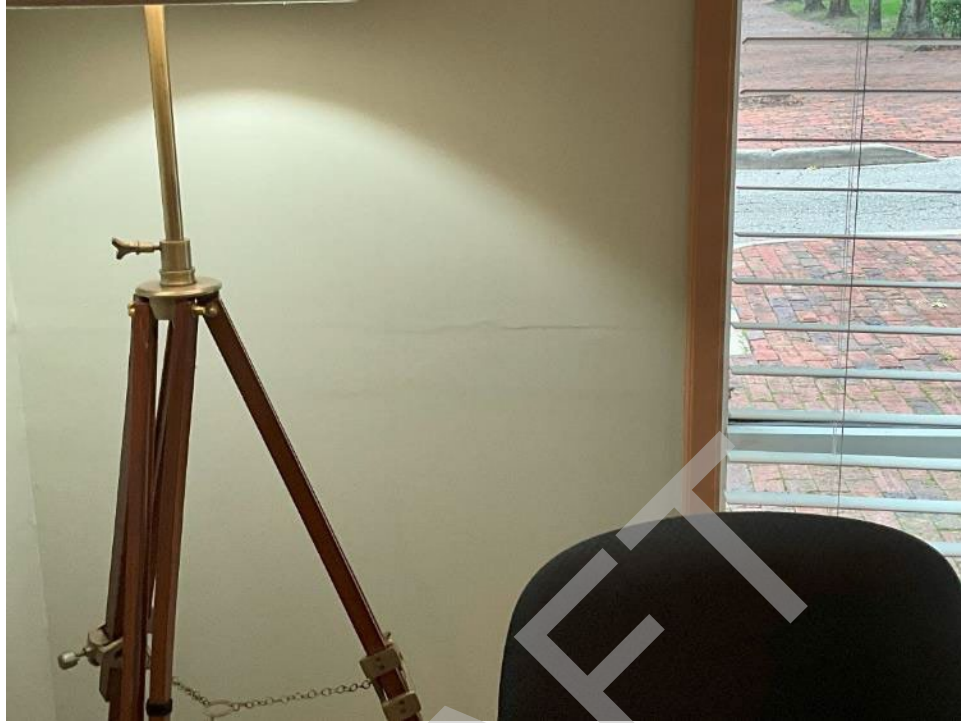
55. View of crack observed in the finish of the exterior wall of suite D-102.

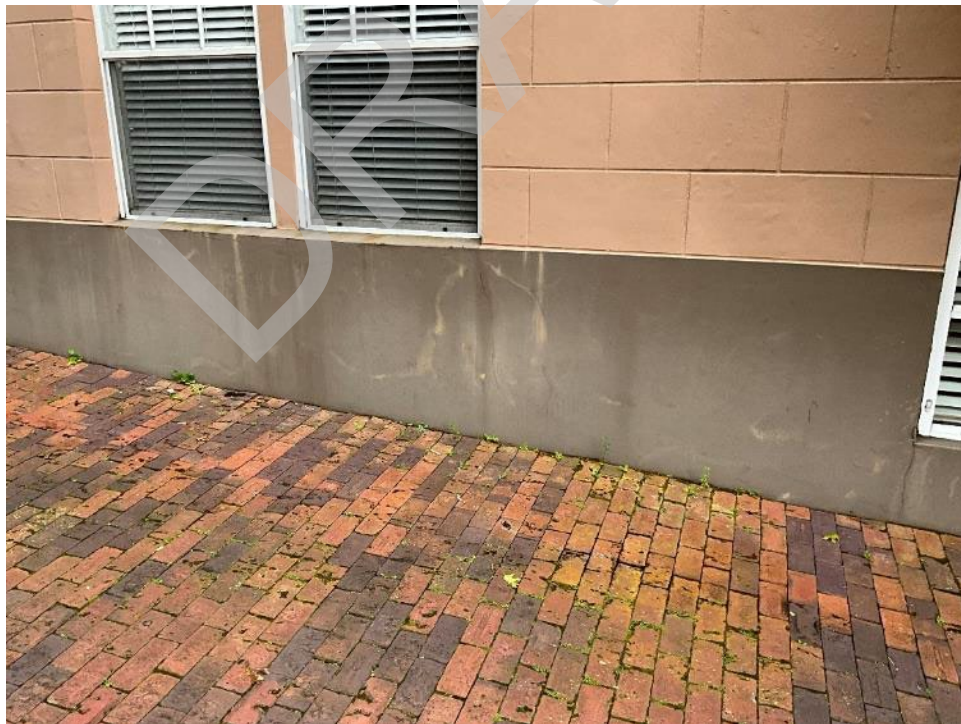
56. View of staining and cracking along the base of the walls around the building.

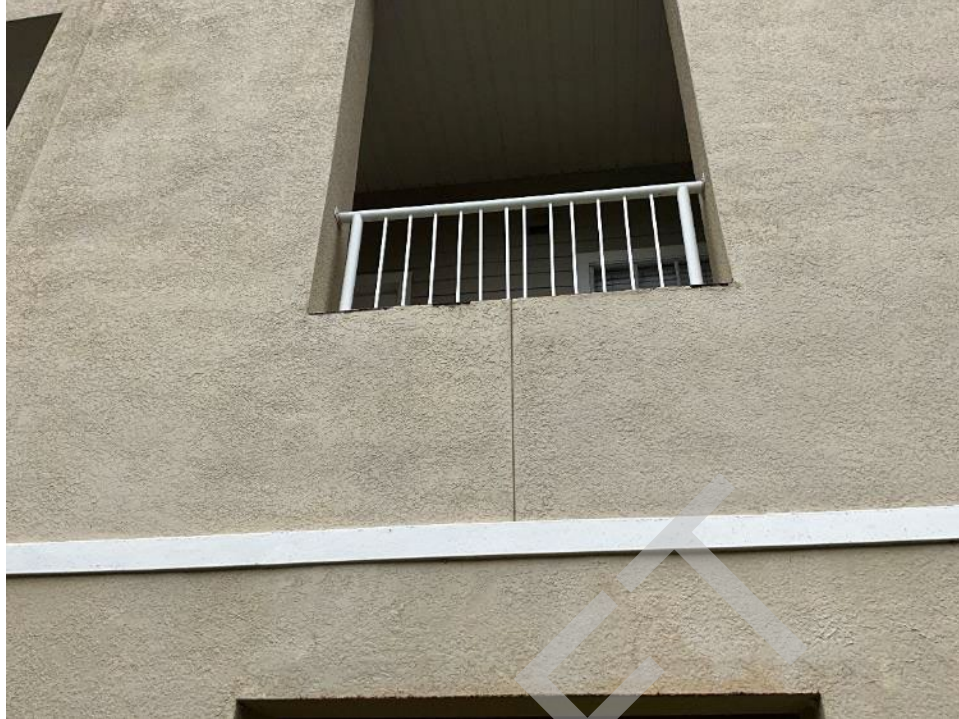
63. View of corrosion around the railing alcoves around the building.

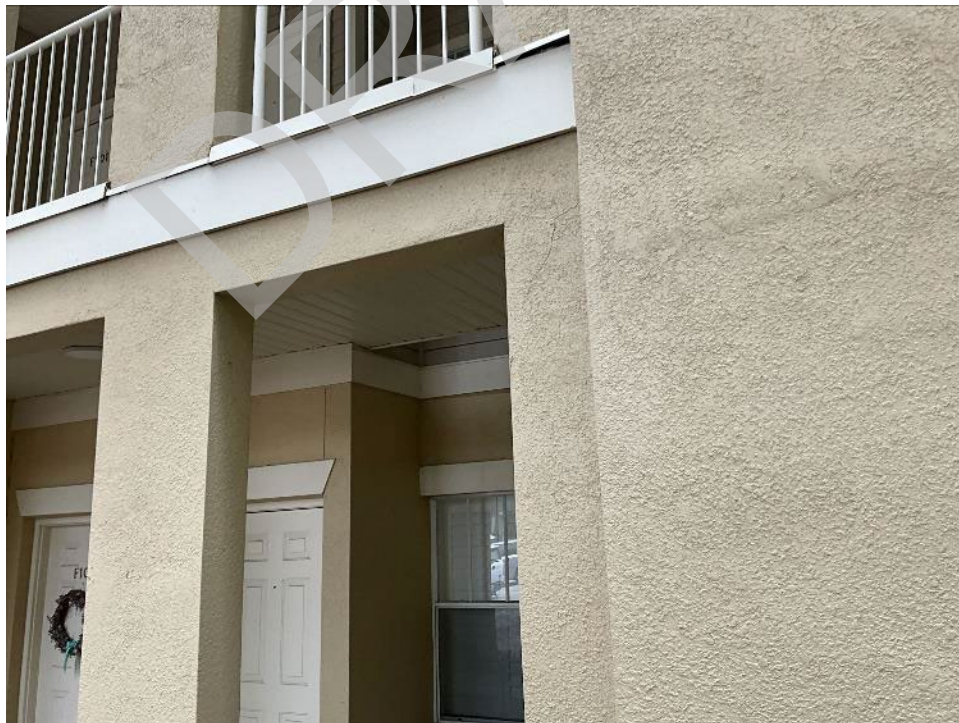
**64. View of cracked section along the exterior column near F103. The stucco will need to be removed to expose the column for Phase II.**

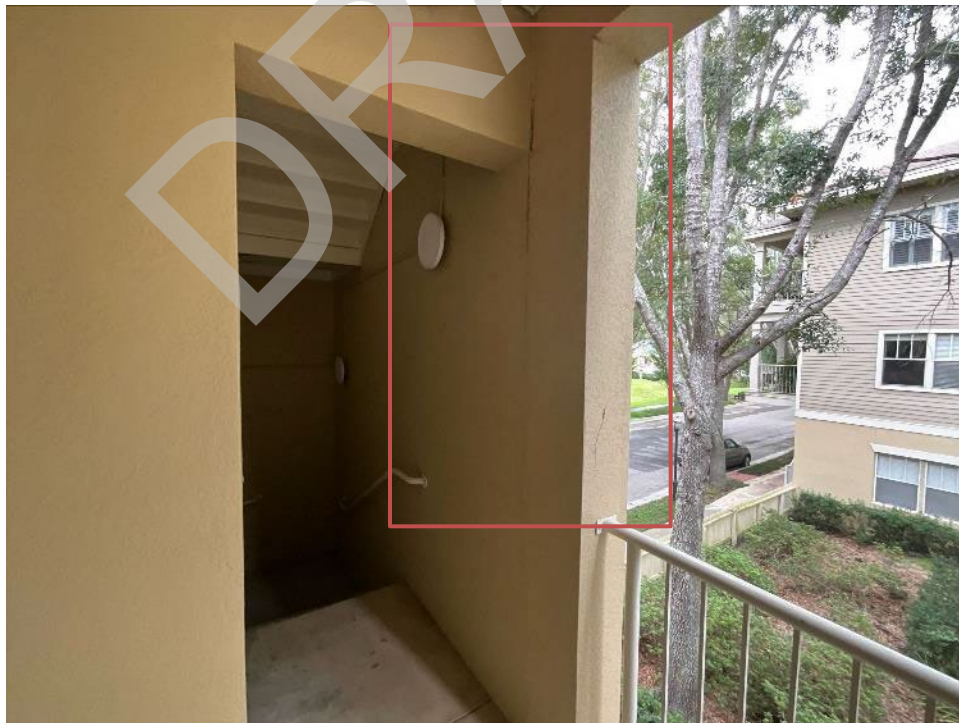
**66. View of cracked section along the wall and beam near unit F203. The stucco will need to be removed to expose the interface for Phase II.**

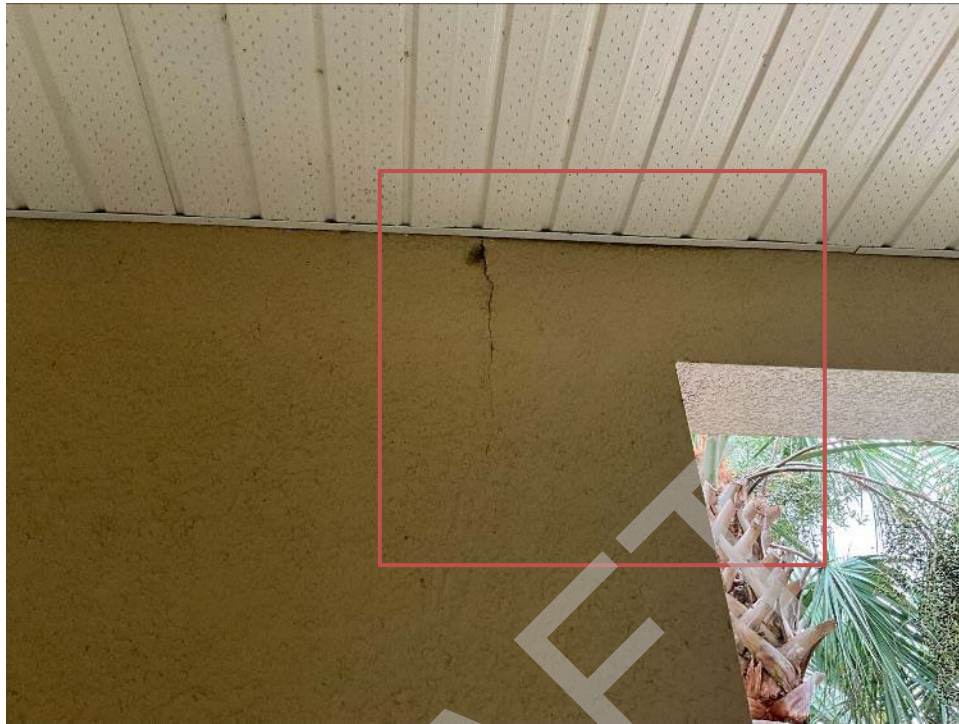
**67. View of cracked section along the wall between units F201 and F202. The stucco will need to be removed to expose the column for Phase II.**

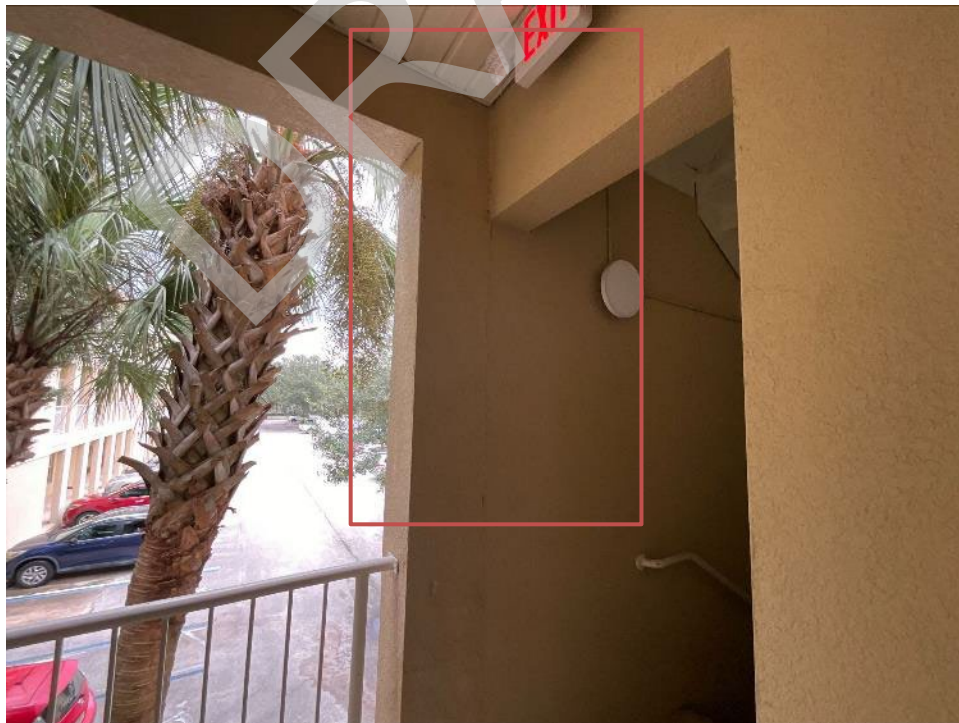
**68. View of cracked section along the wall and beam near unit F201. The stucco will need to be removed to expose the interface for Phase II.**

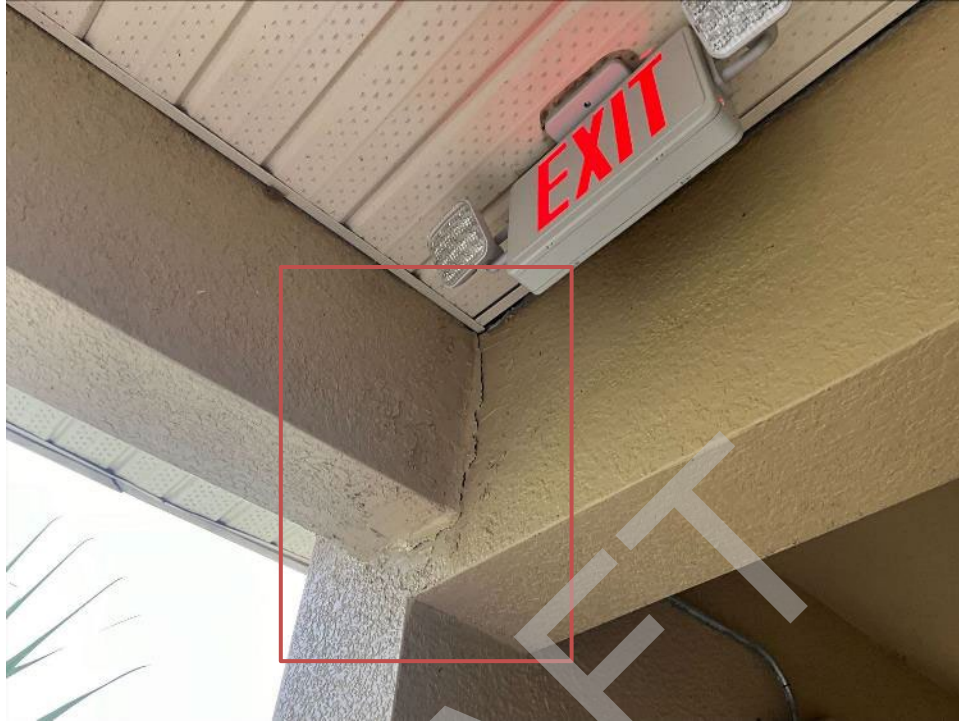
**69. View of cracked section along the beam to wall interface near unit F301. The stucco will need to be removed to expose the interface for Phase II.**

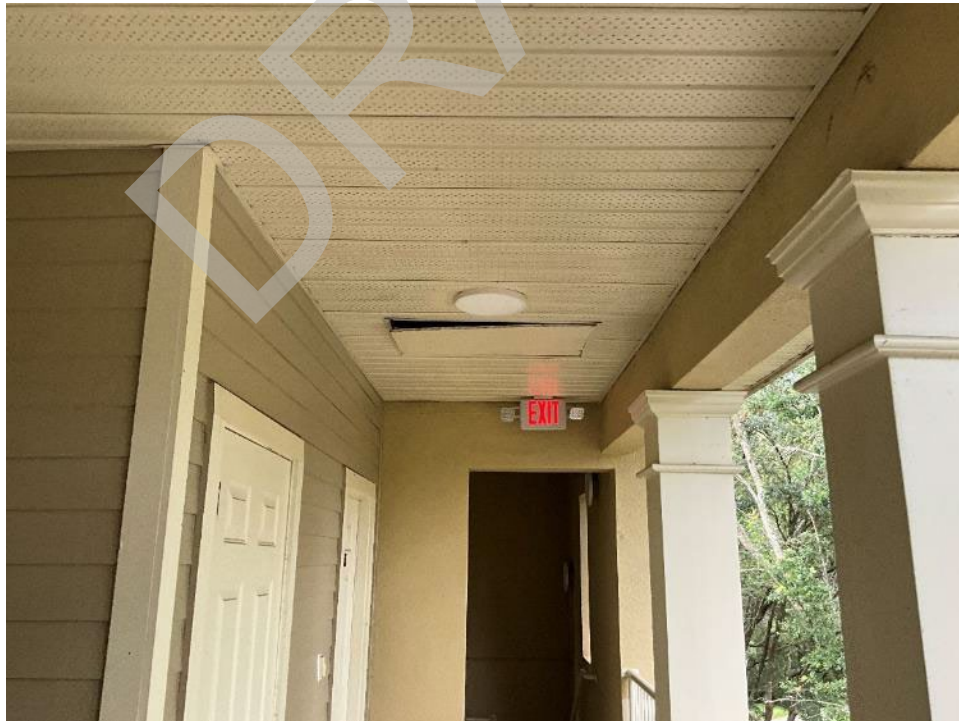
**70. View of an opening that is observed to be left open.**

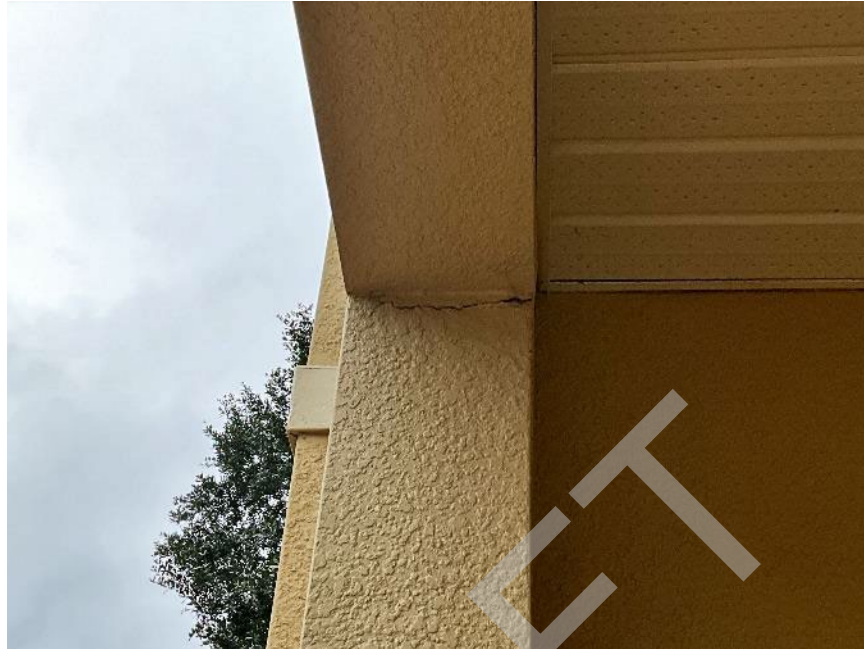
**71. View of cracked section along the beam to column interface near unit G104. The stucco will need to be removed to expose the interface for Phase II.**

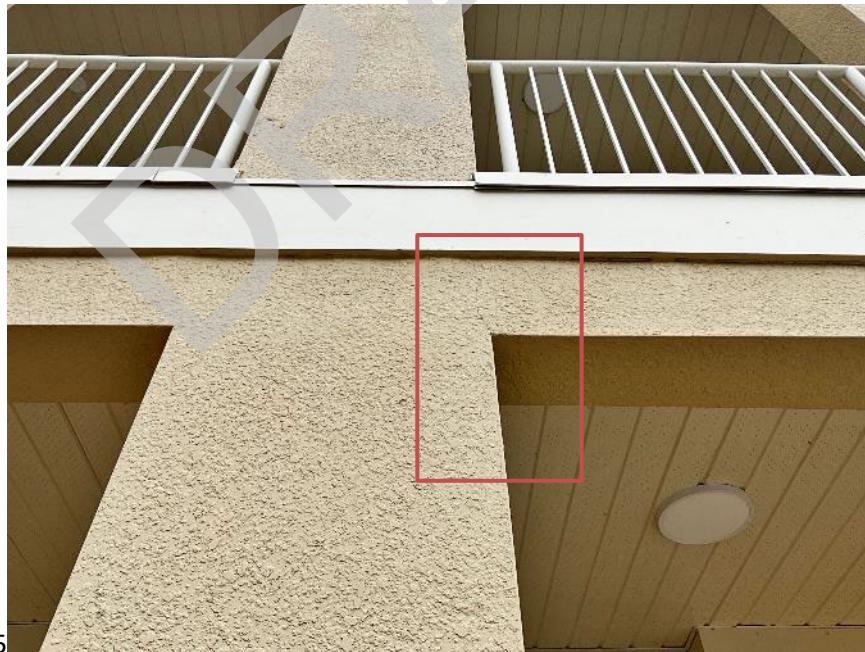
**72. View of cracked section that runs along each side of the beam to column interface near units G102 and G104. The stucco will need to be removed to expose the interface for Phase II.**
