**PHASE 1 - Milestone Inspection**

Inspection Firm or Individual Name: RAY ENGINEERING, INC.

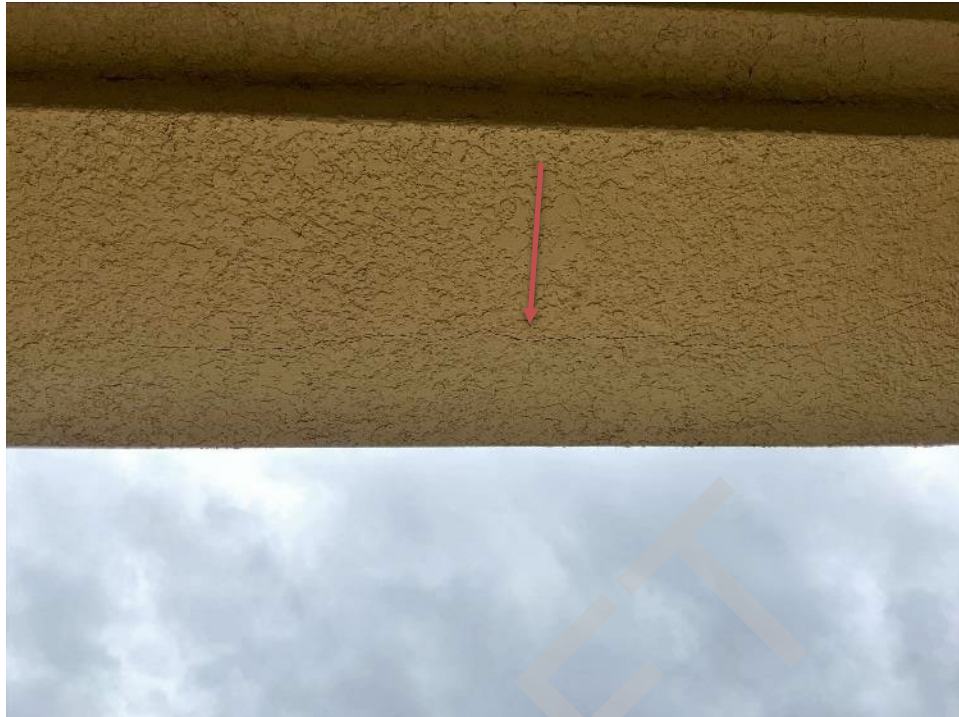
**73. View of cracked section along the bottom of the beam near units G302 and G303. The stucco will need to be removed to expose the beam for Phase II.**

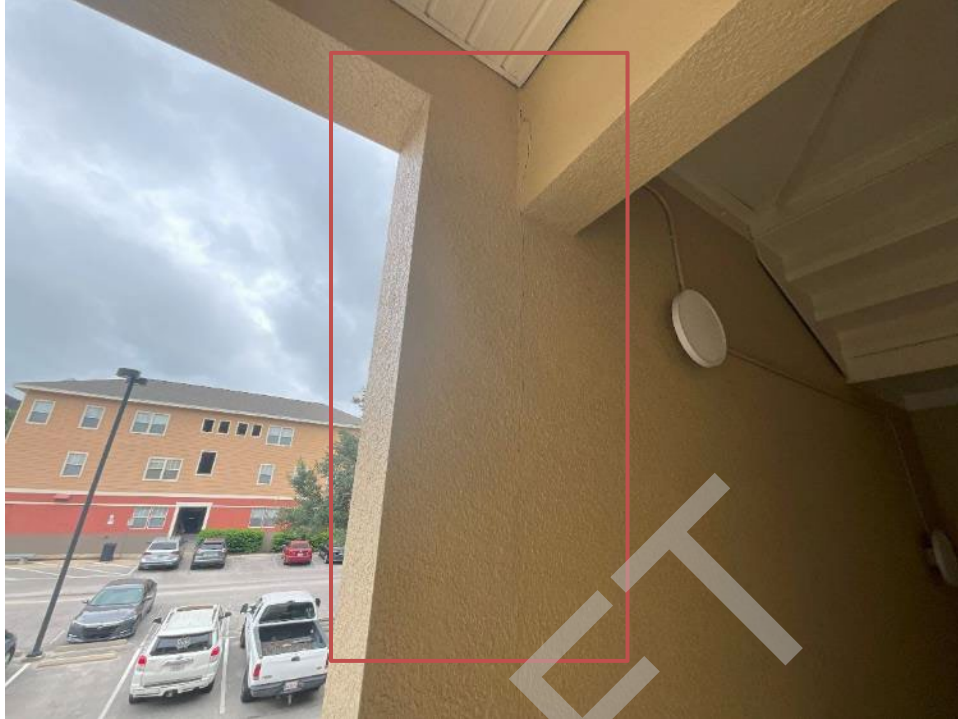
**75. View of cracked section along the wall near unit G204. The stucco will need to be removed to expose the wall for Phase II.**

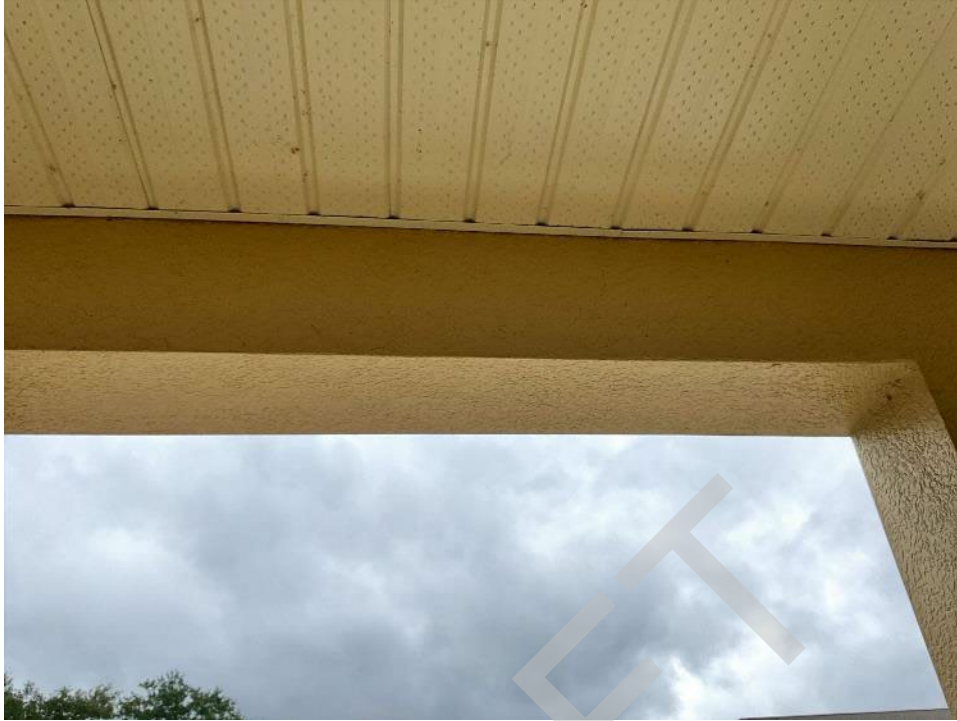
**77. View of cracked section along the beam near unit G201. The stucco will need to be removed to expose the beam for Phase II.**

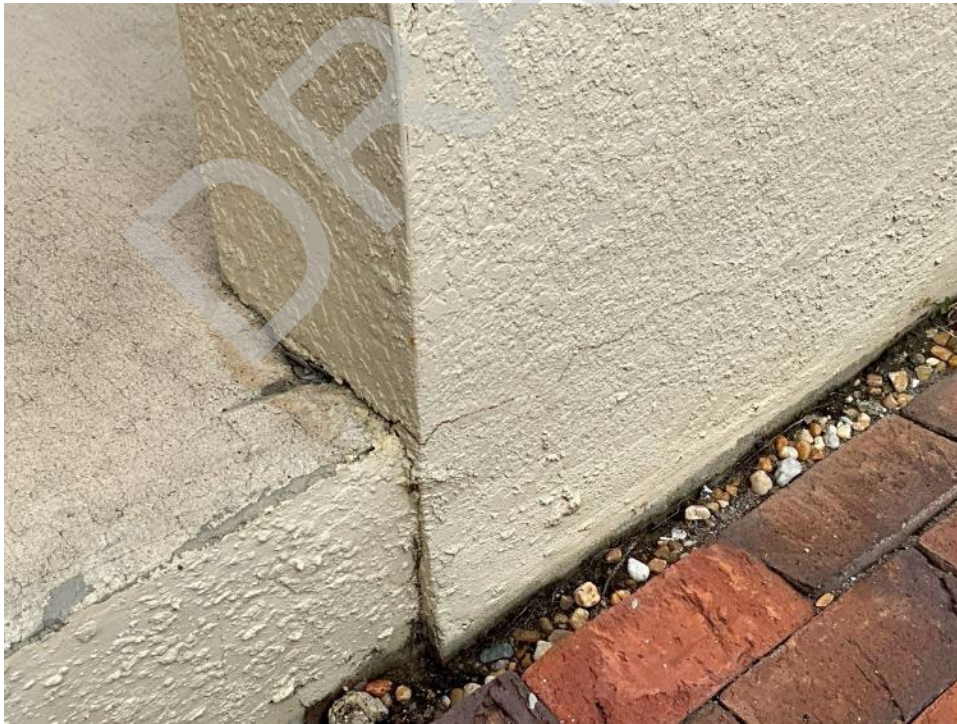
78. View of crack in bottom of the column in front of unit G104.

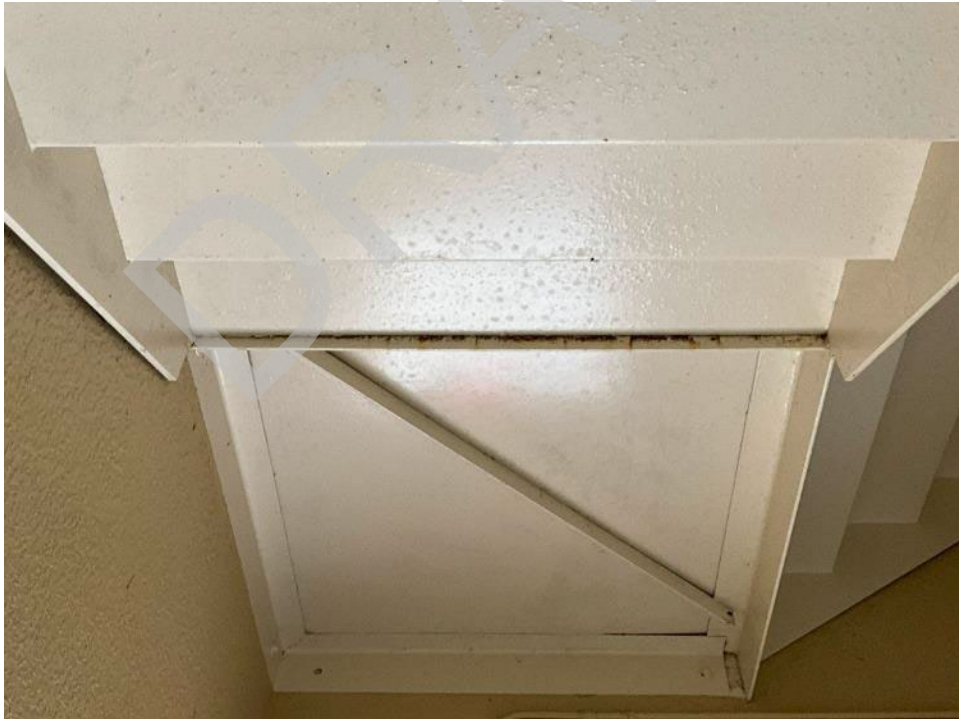
84. View of minor corrosion under the metal stairs.

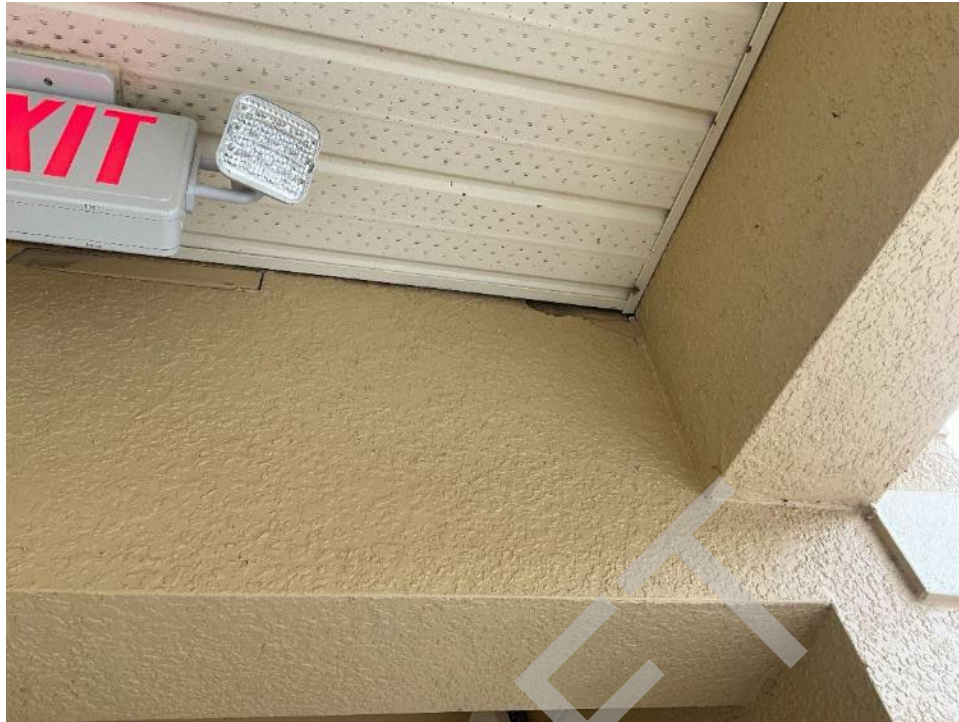
85. View of finish cracking in the beam near the stairwell.

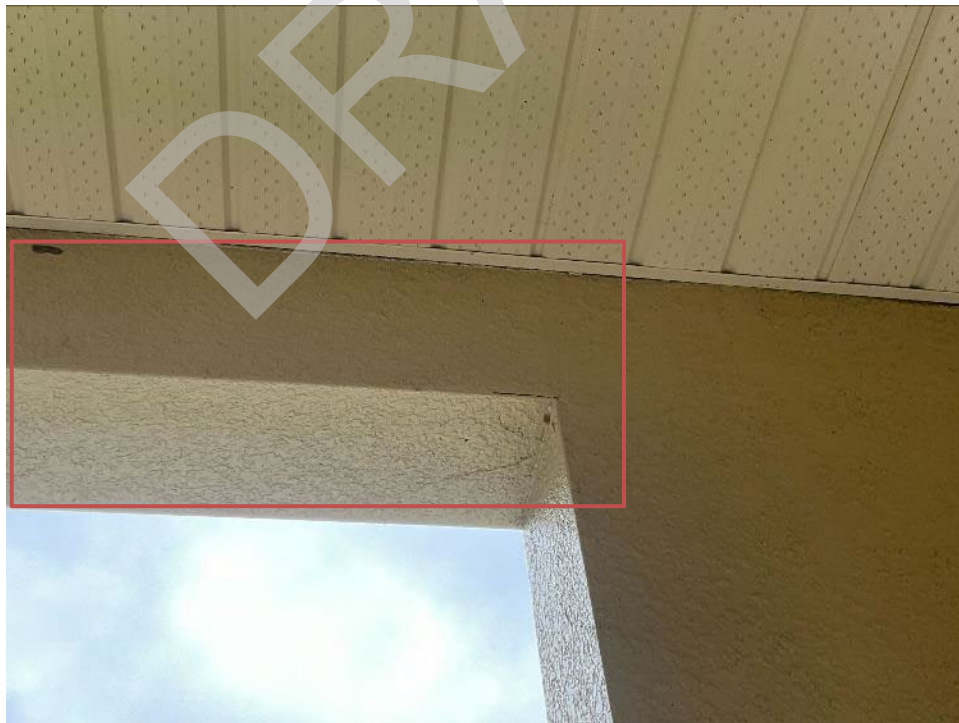
**86. View of cracked section along the beam near unit H102. Cracks are observed along all faces of the beam. The stucco will need to be removed to expose the beam for Phase II.**

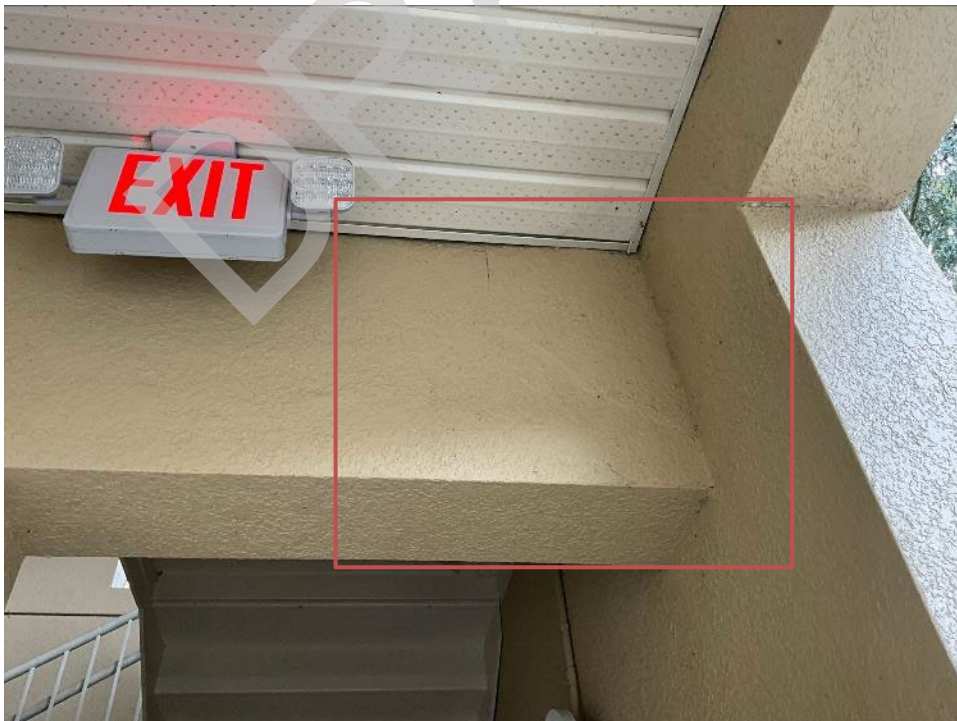
**88. View of cracked section along the beam near unit H201. The stucco will need to be removed to expose the beam for Phase II.**

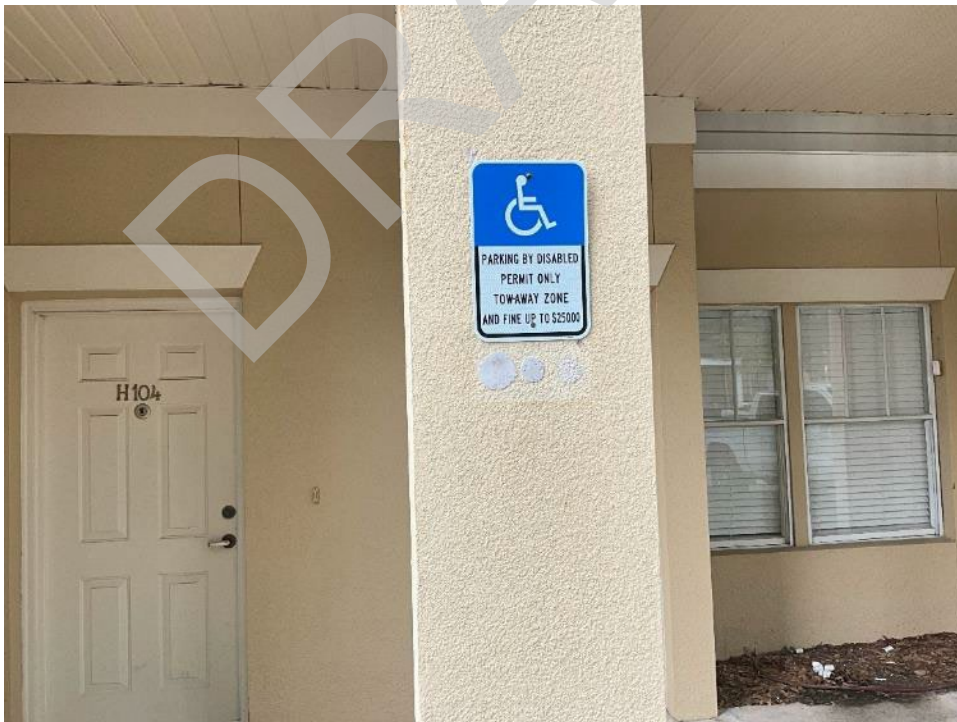
90. View of unrepaired column section unit H104.

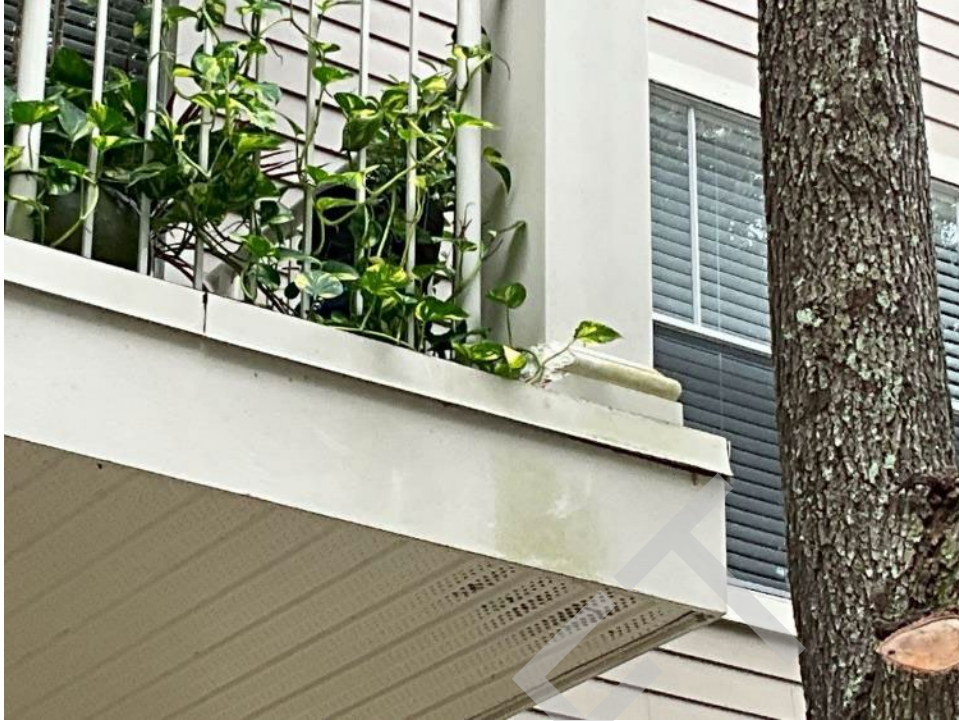
93. View of missing section of bottom of column in balcony near unit H201.

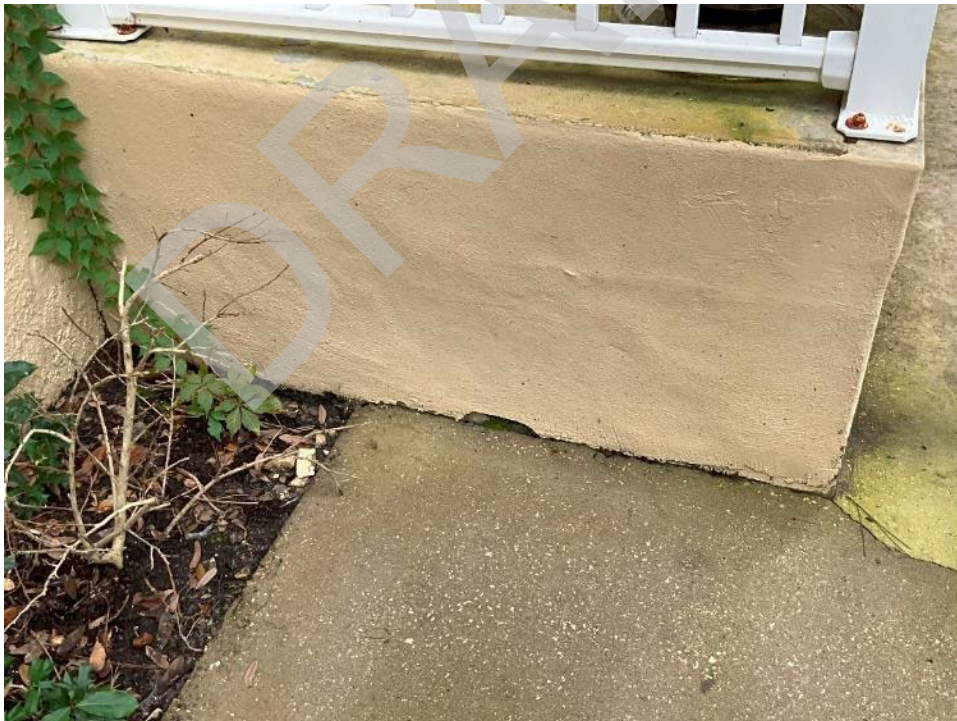
96. View of spalled section and minor bulging along the concrete stairs of unit H104.

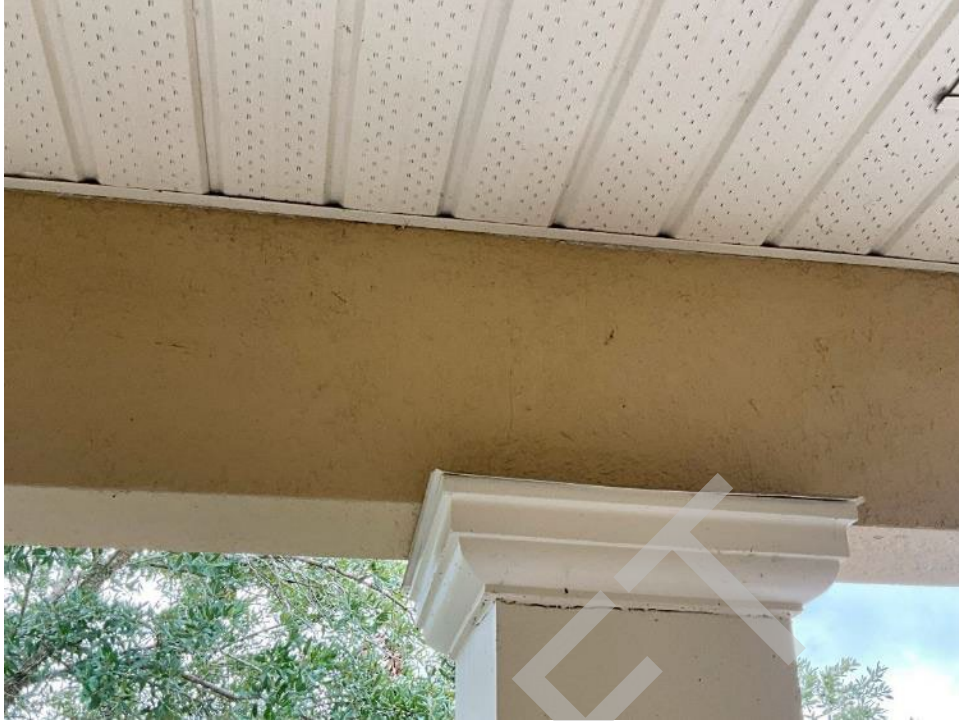
99. View of cracks in the interface of the column top and the column.

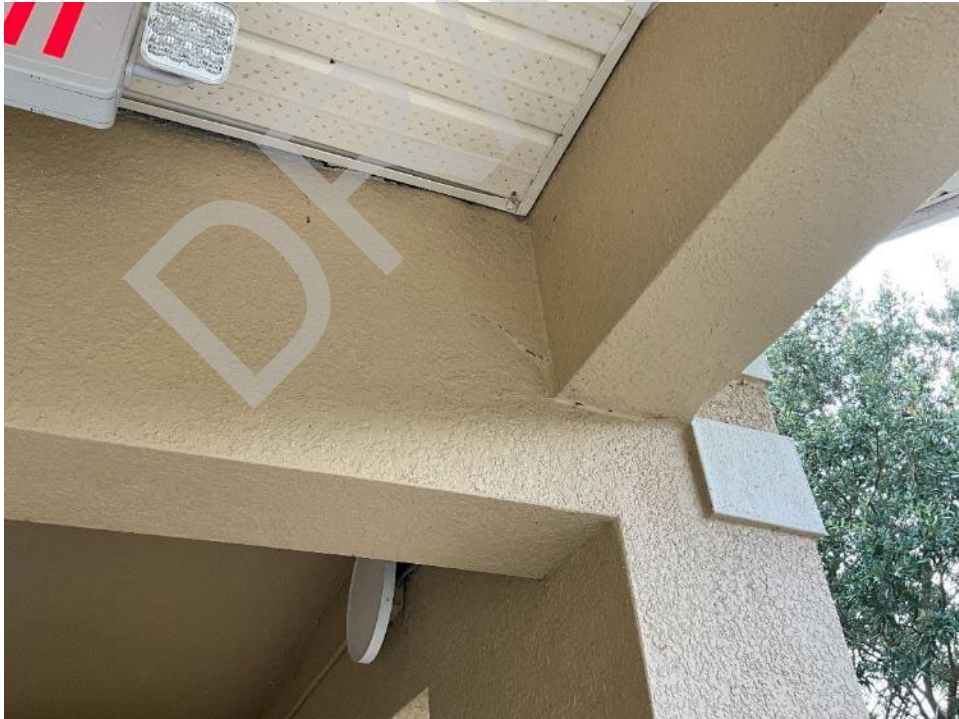
100. View of finish cracking in the beam near the stairwell and unit H301.

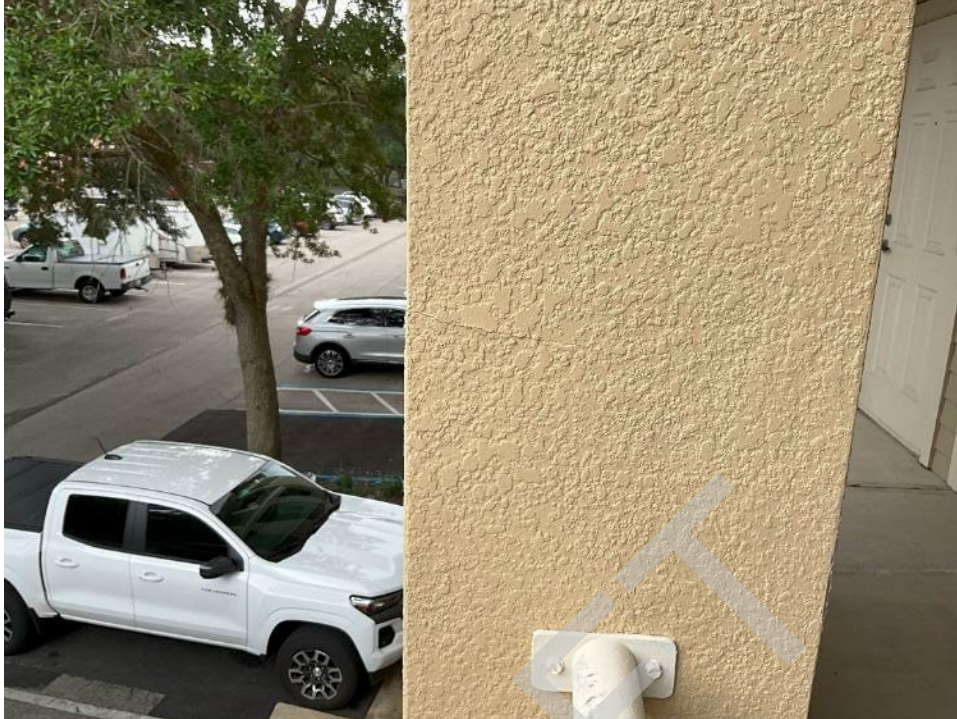
101. View of finish cracking in the column near the stairwell and unit H201.

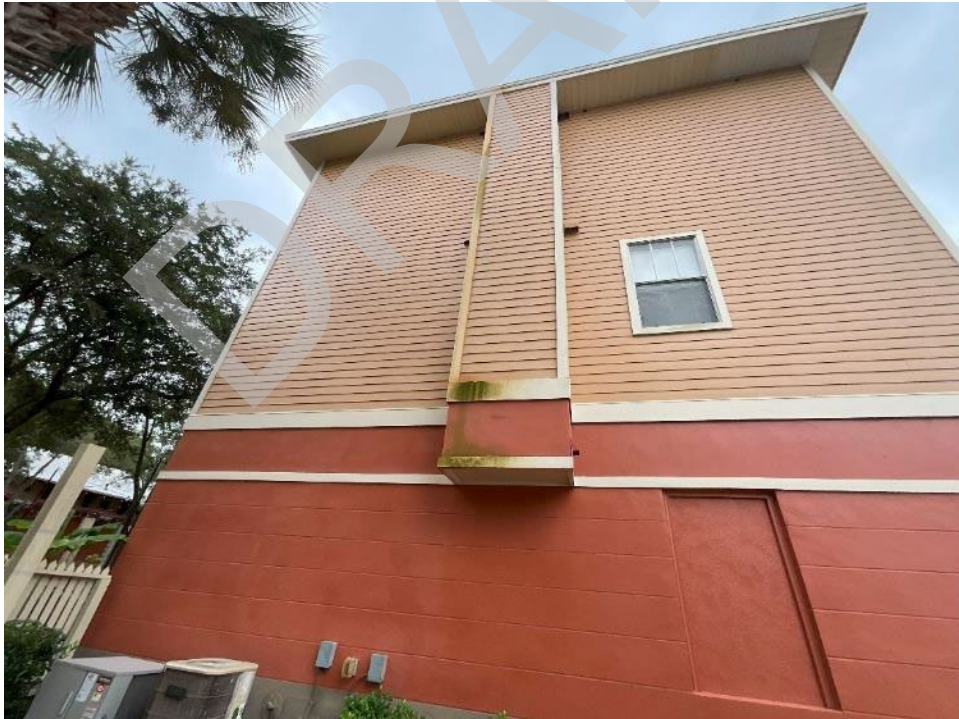
104. View of staining along a ventilation stack.

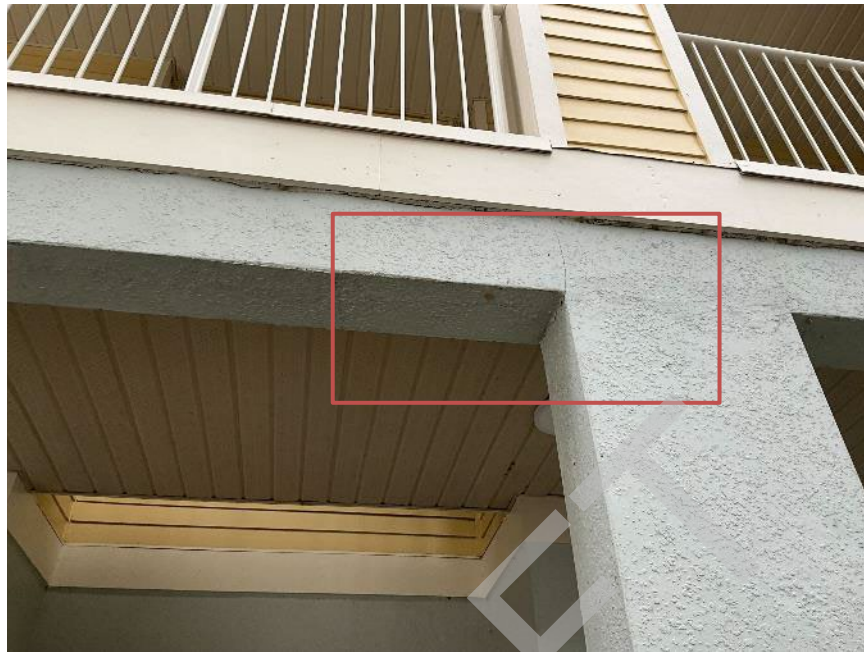
105. **View of cracked section on both sides of the beam to wall interface near unit J201. The stucco will need to be removed to expose the interface for Phase II.**

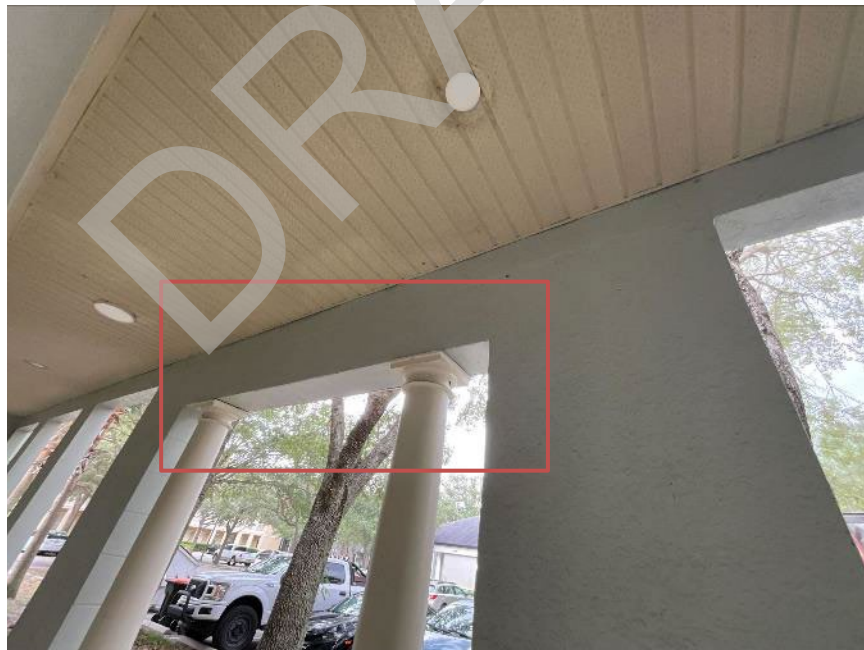
106. **View of section observed with bulging and cracking along the first level beam along the rear elevation. The stucco will need to be removed to expose the interface for Phase II.**

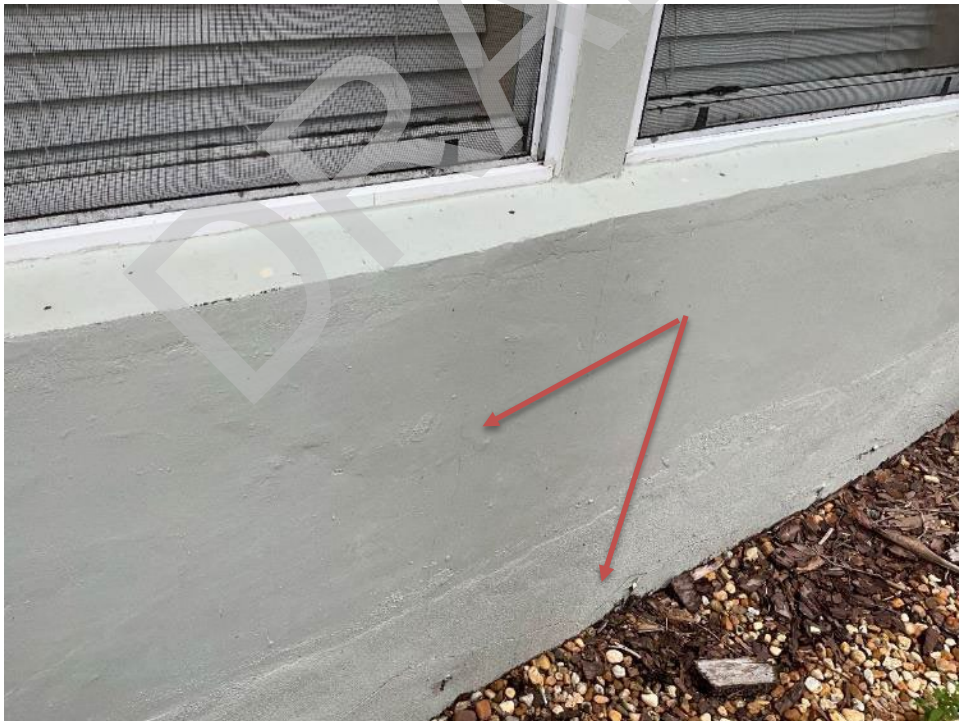
108. View of cracking in the base of the walls.

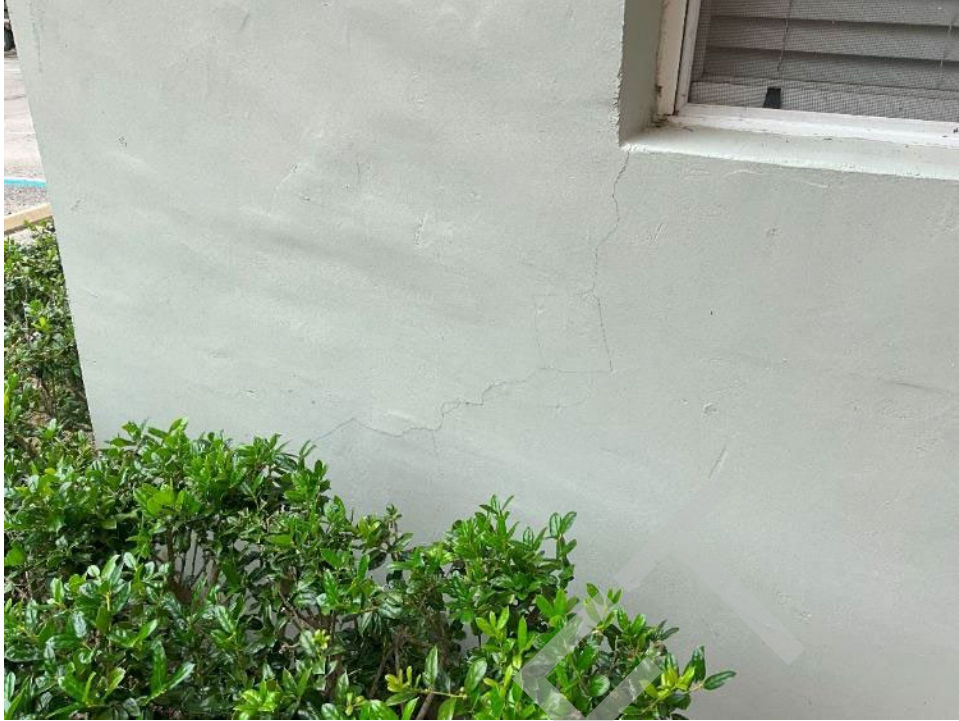
109. View of crack running from the corner of the window to the bottom of the wall.

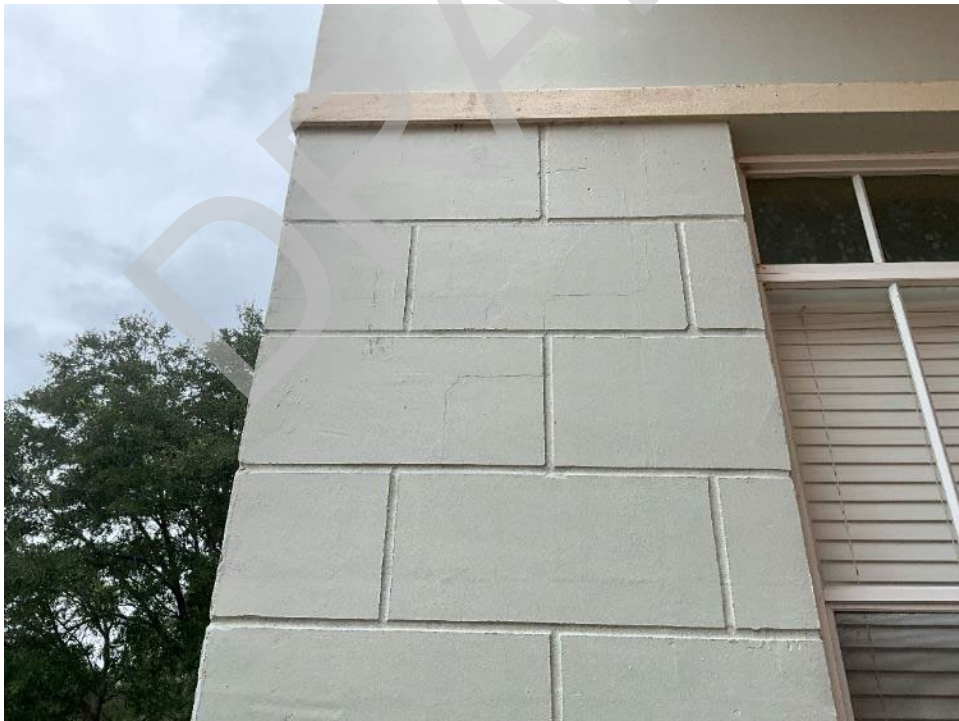
110. View of stair-step crack in the wall near the window.

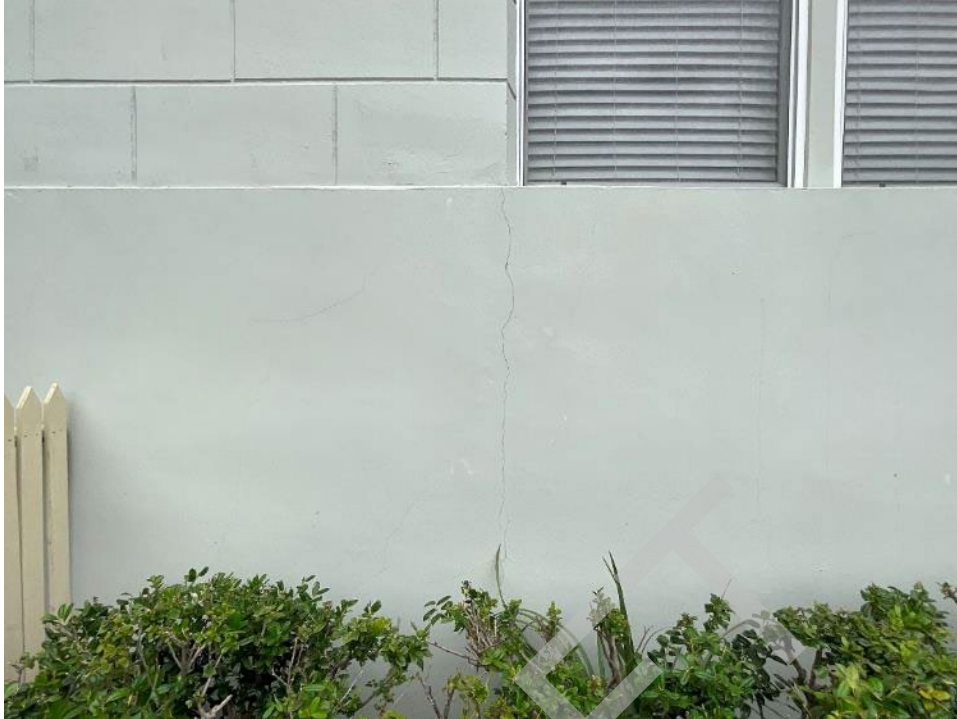
111. View of vertical cracking observed around the base of the wall.

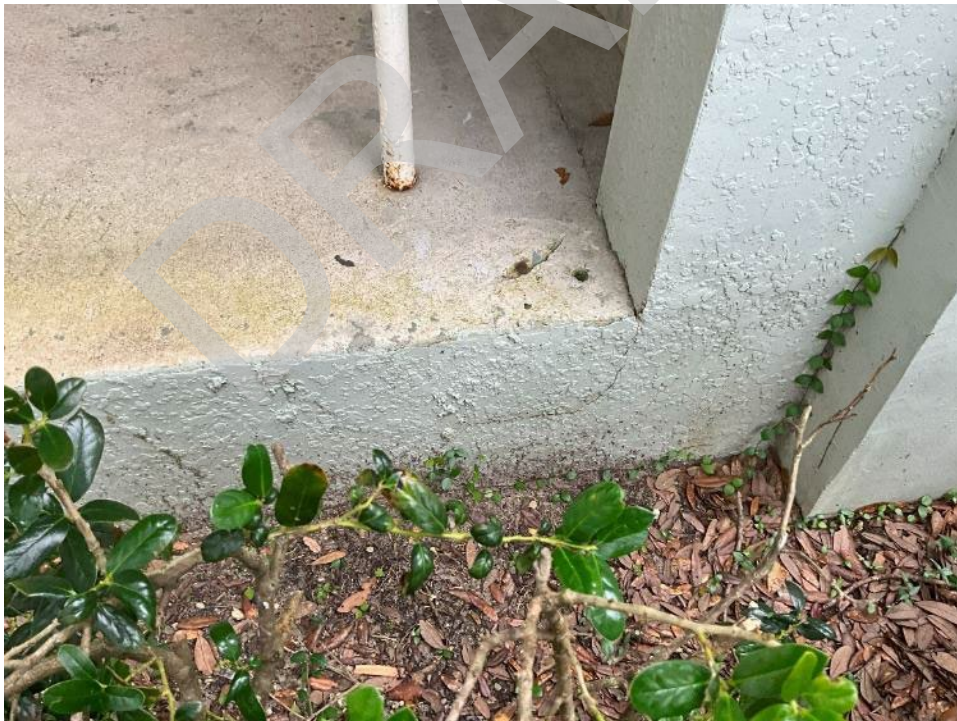
112. View of cracking in the stucco in front of the bottom slab.

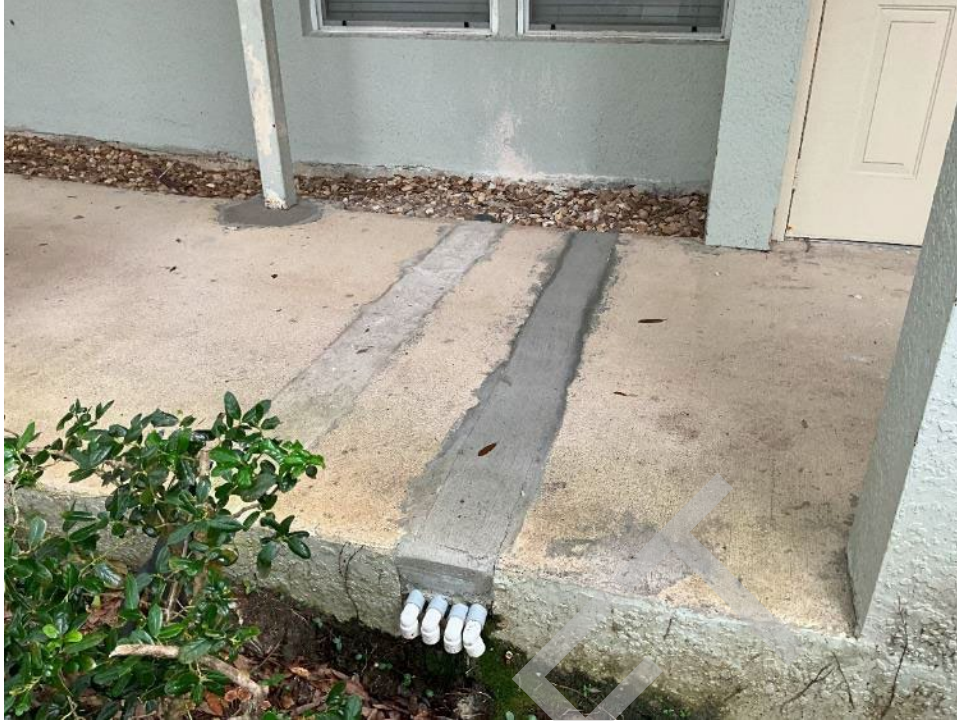
113. View of repaired slab.

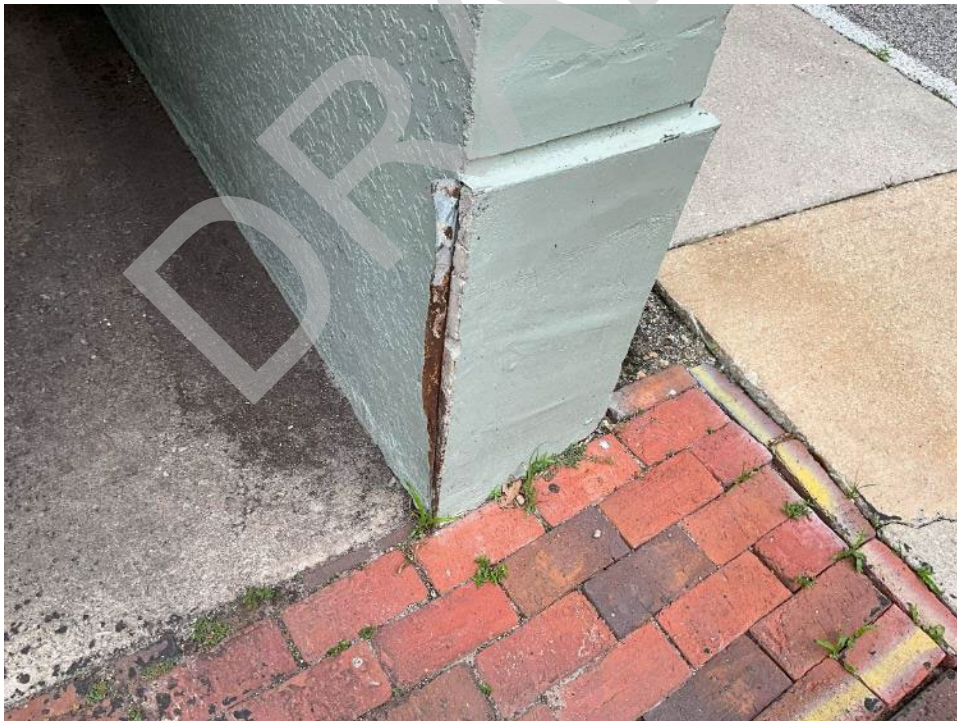
114. View of corroded edge of wall base.

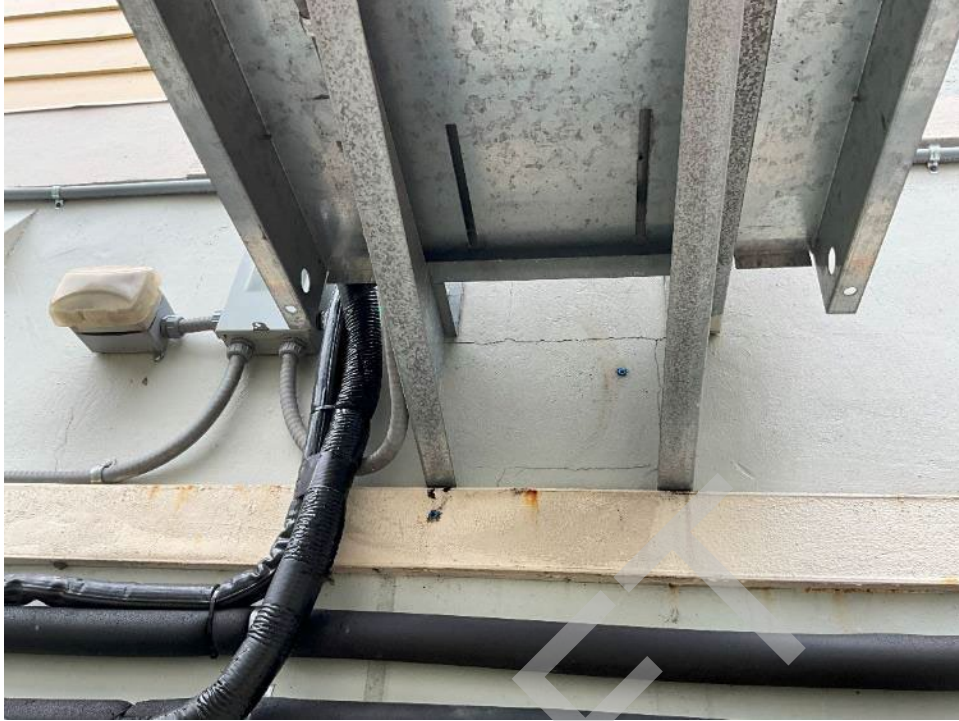
115. View of cracked wall behind AC stand.

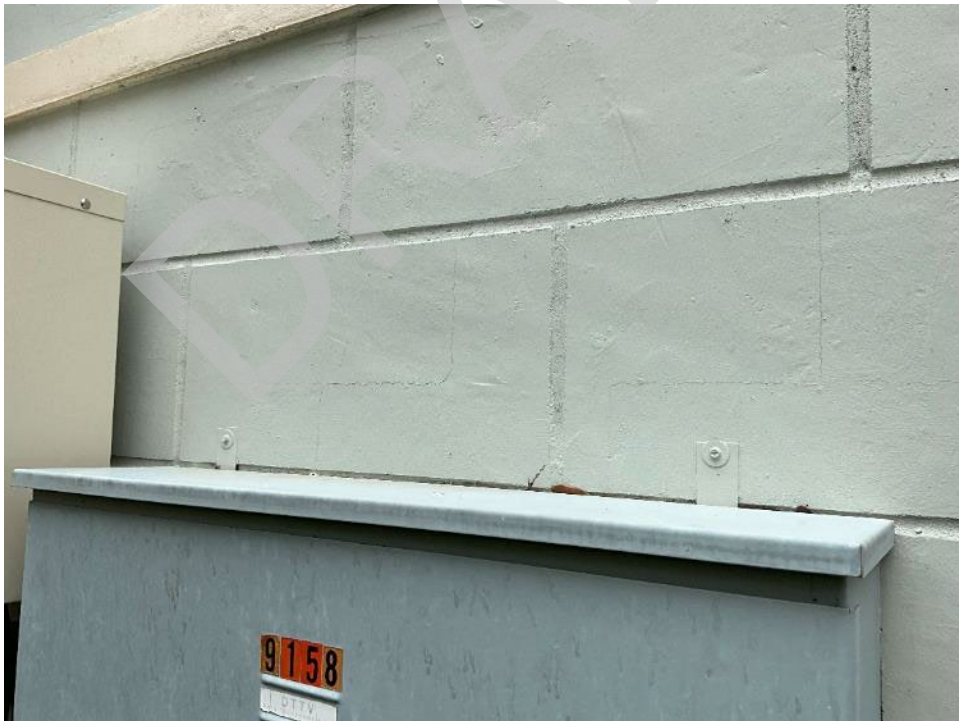
116. View of stair-step cracks along north wall.

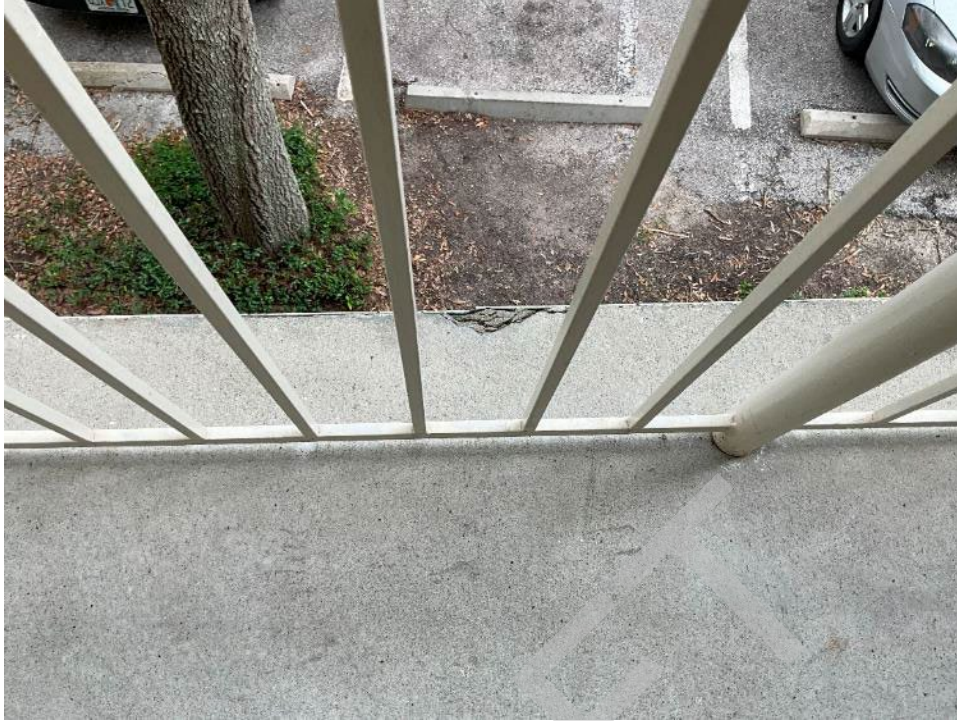
117. View of crack in the edge of the second level breezeway floor.

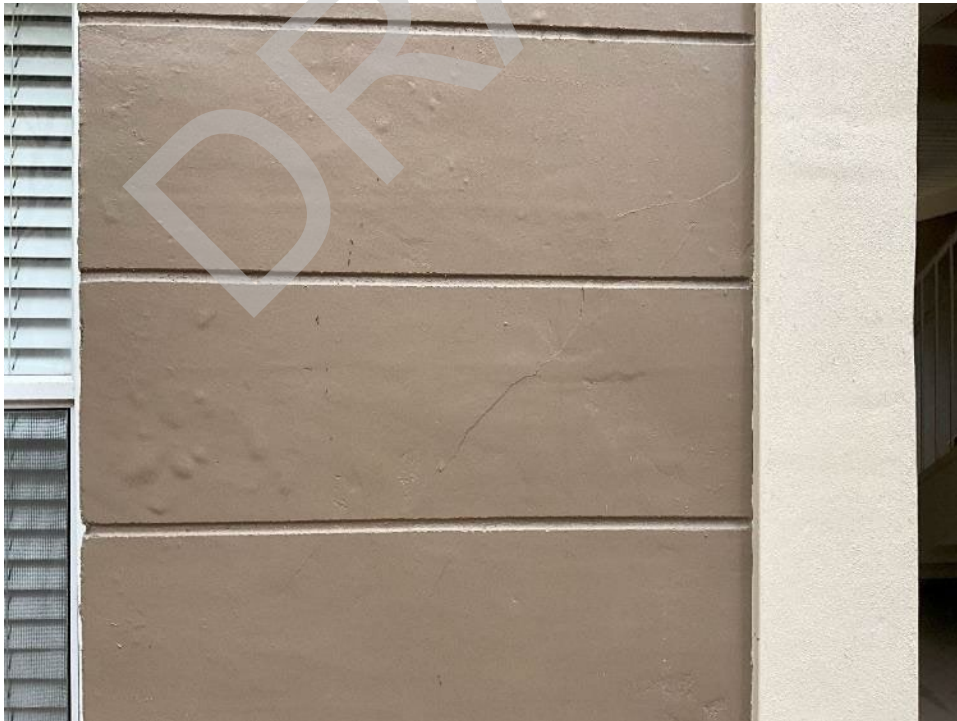
118. View of paint bubbling and finish cracks in multiple areas around the building.

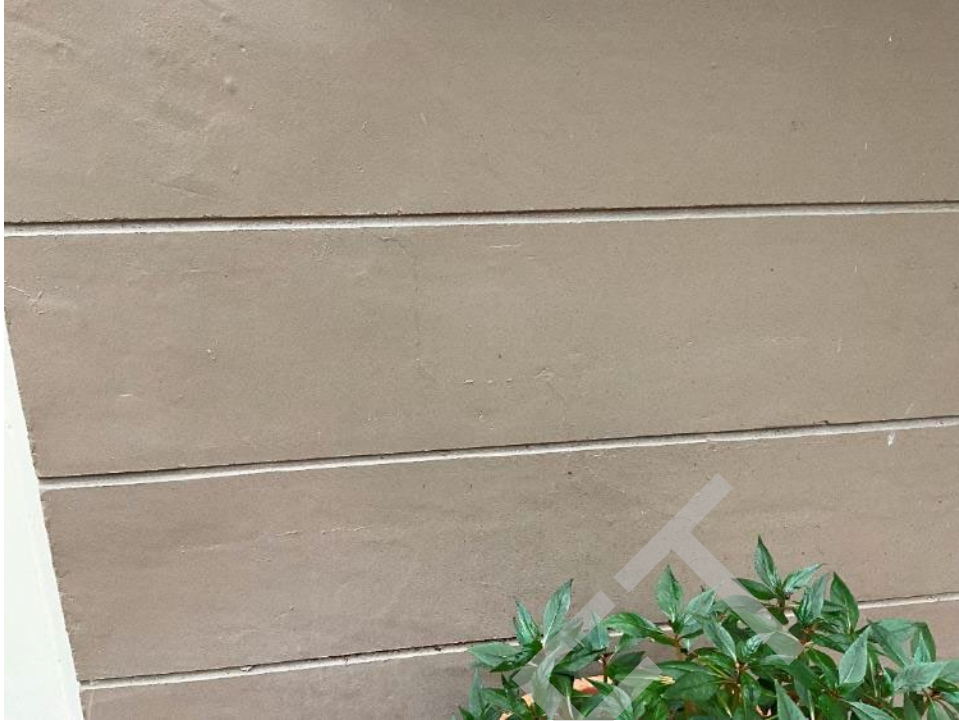
119. View of stair-step crack observed in multiple areas around the building.

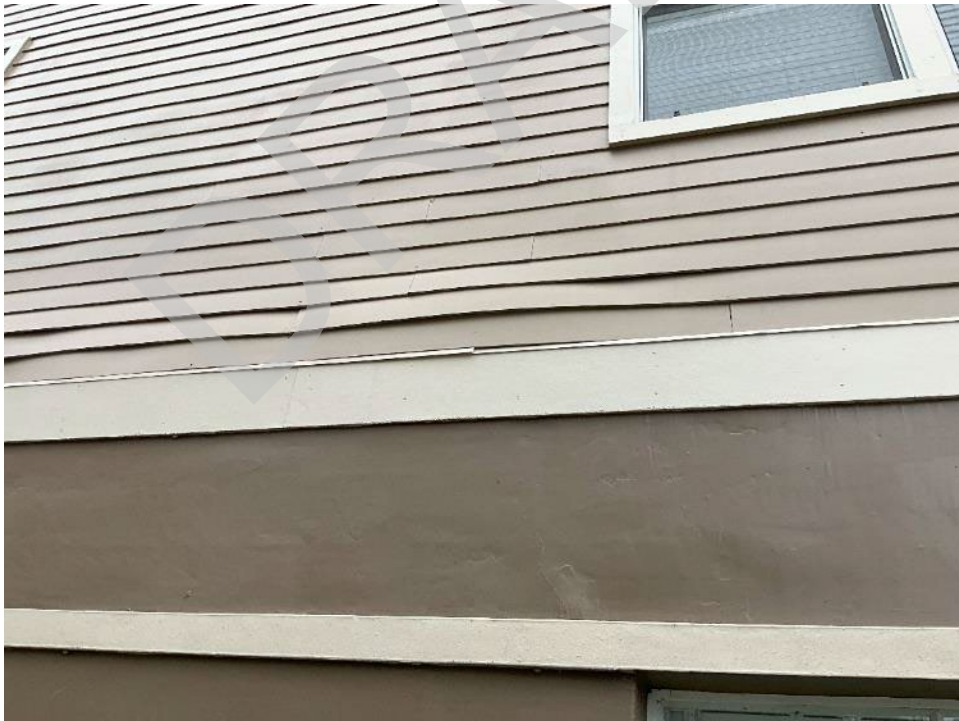
120. View of bulging under the siding around the building.

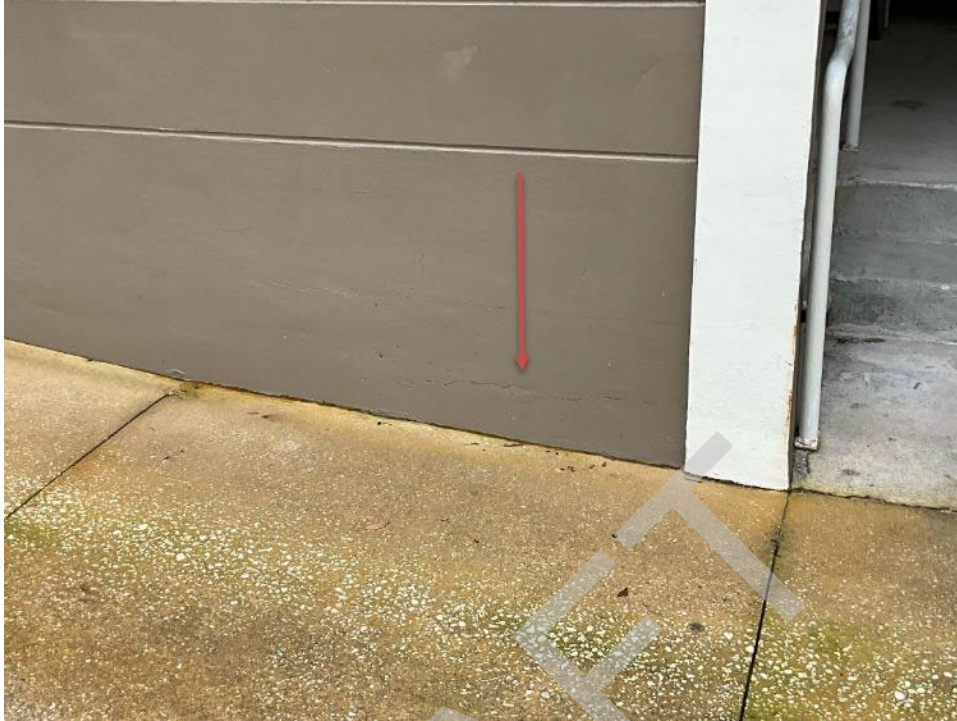
123. View of horizontal crack at the base of the wall next to the opening on the west elevation.

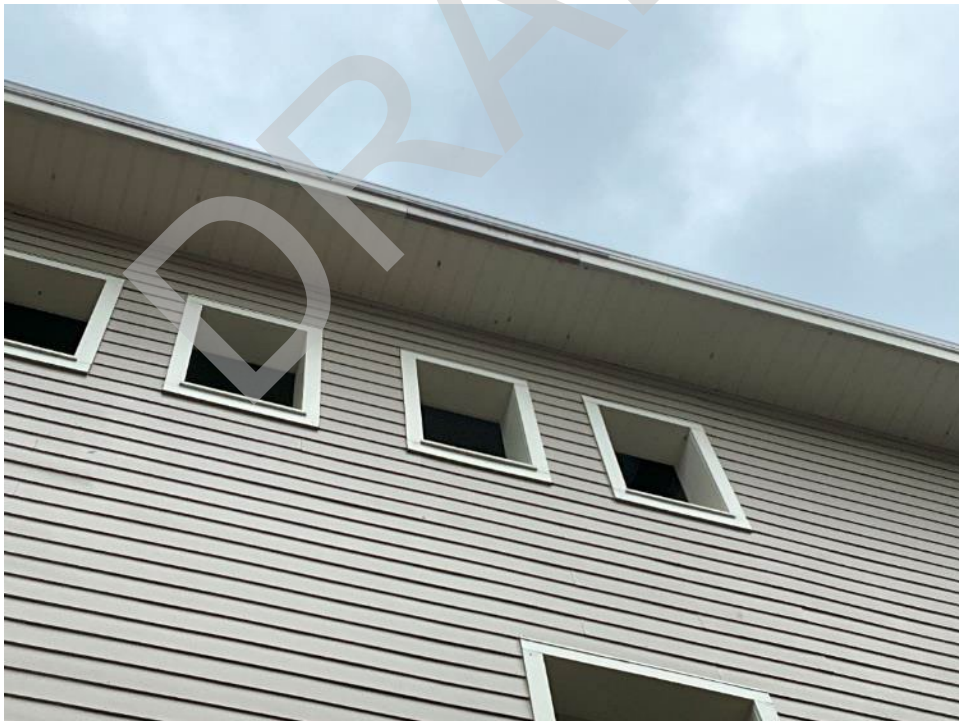
126. View of missing piece of the finish on the fascia along the east elevation.

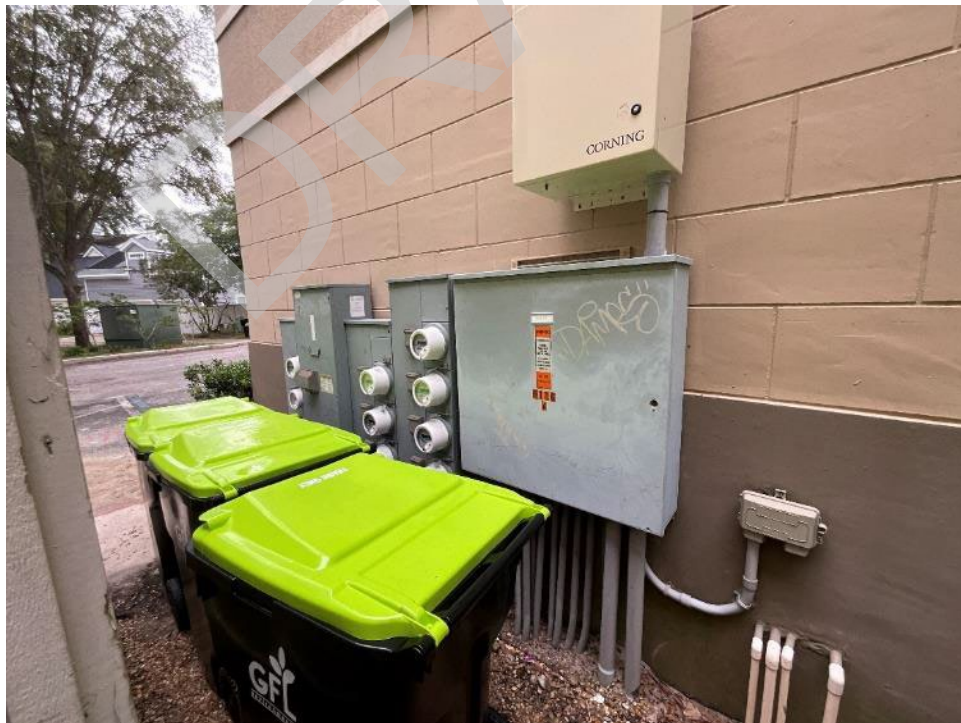
128. View of typical electrical meters.
