VILLAGE AT HAILE CONDOS

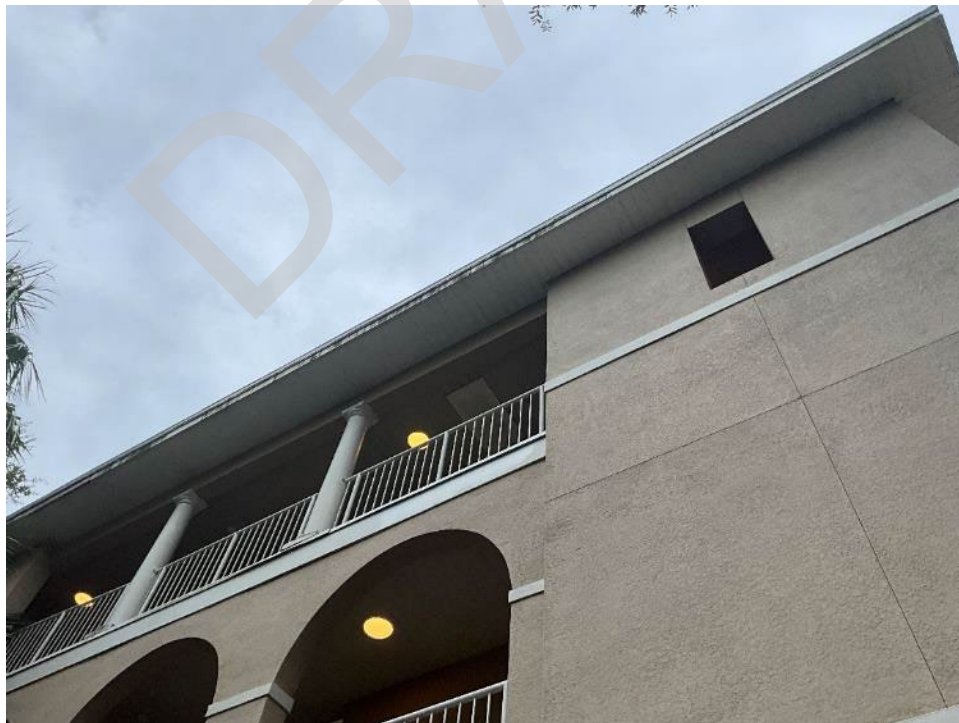
6. View of staining around the fascias of each building.

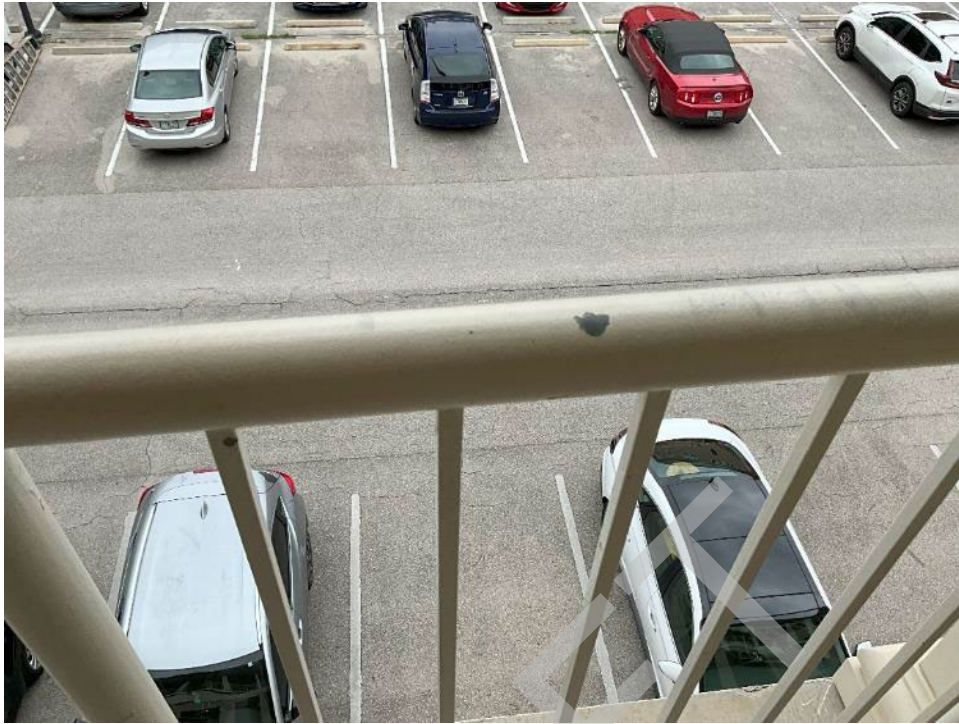
9. View of paint delamination along the breezeway railing at each building.

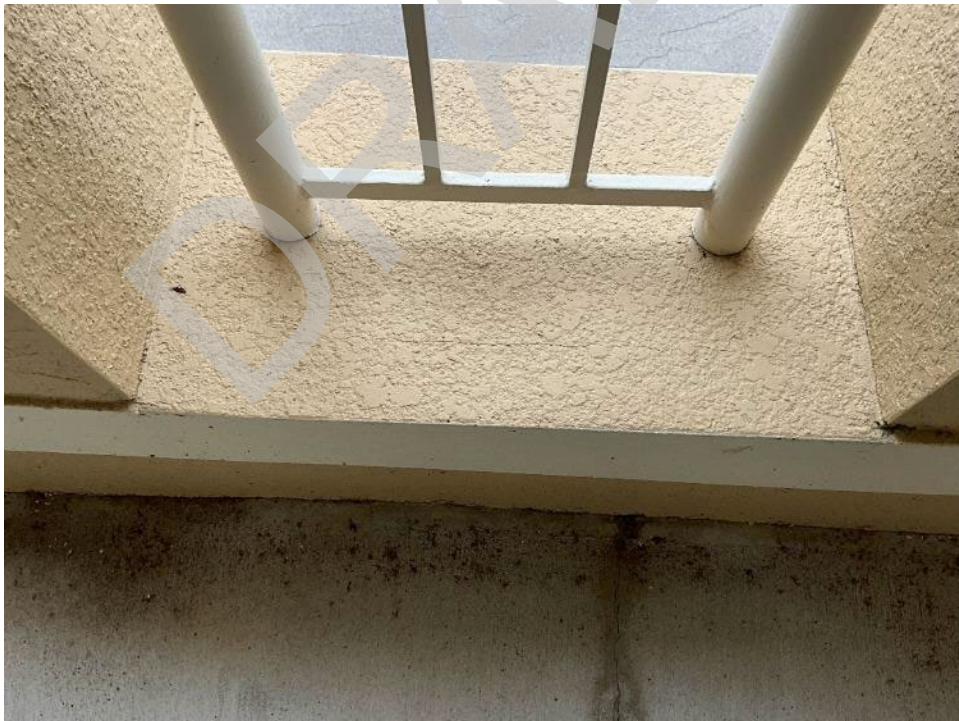
10. View of cracking underneath the railing alcoves at each building.

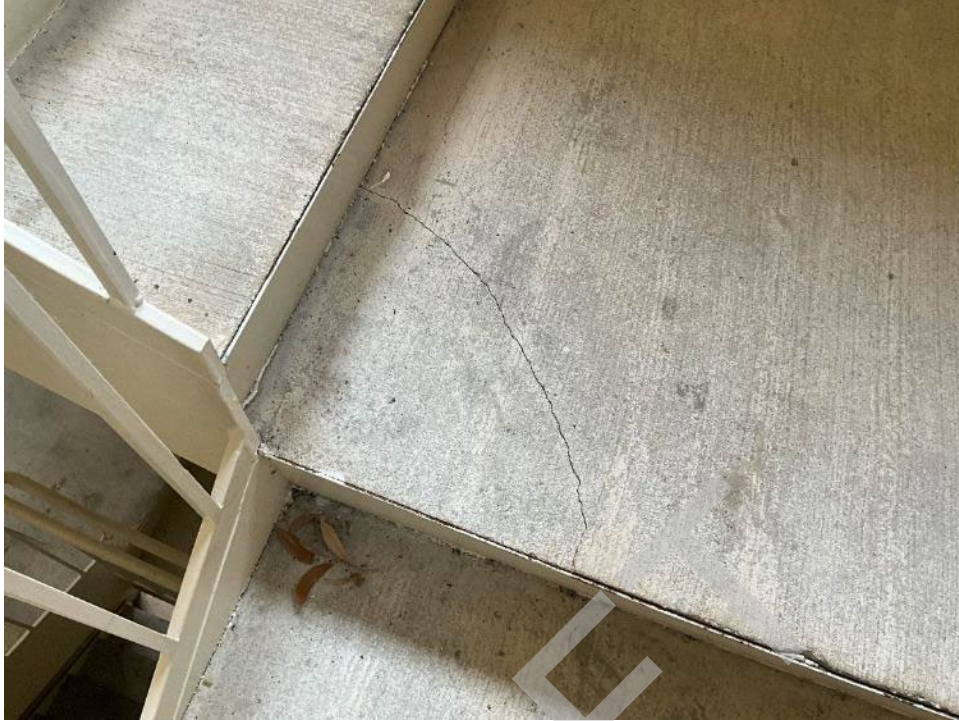
11. View of cracking in the concrete topping in the stairwells.

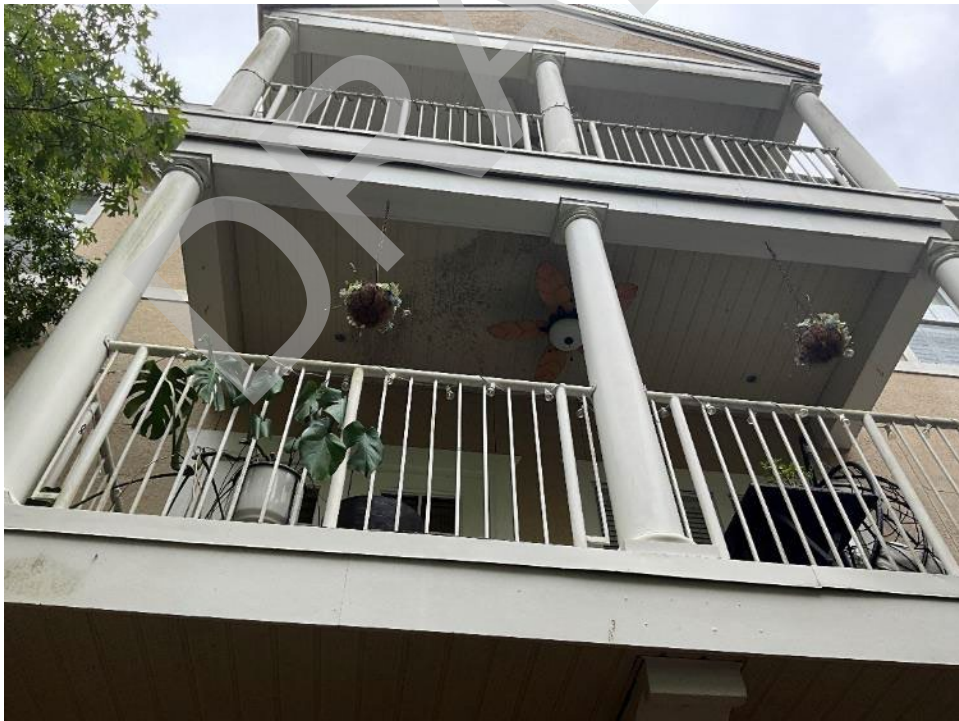
16. View of staining observed on the ceiling of a balcony of Building A.

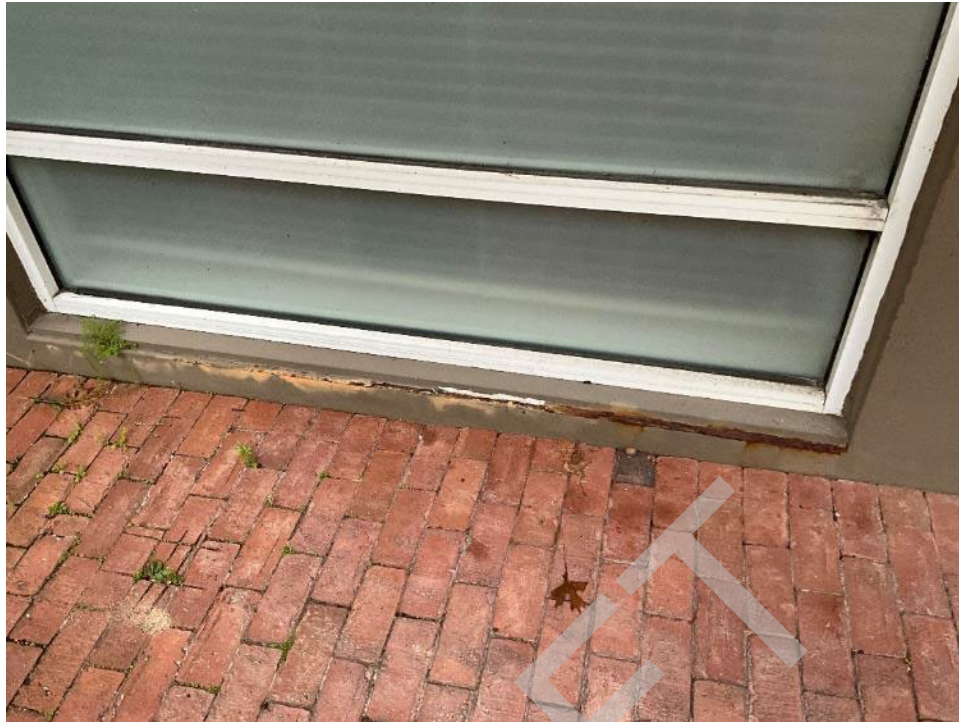
17. View of staining and corrosion along the base of the window of Suite A-103.

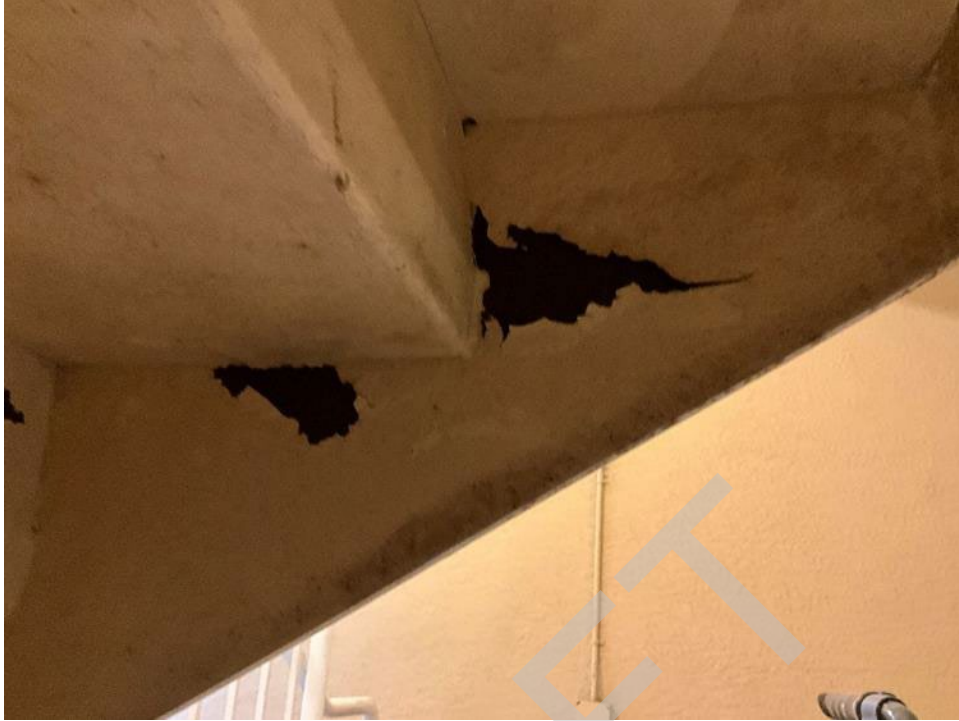
21. View of paint delamination along the stairwells.

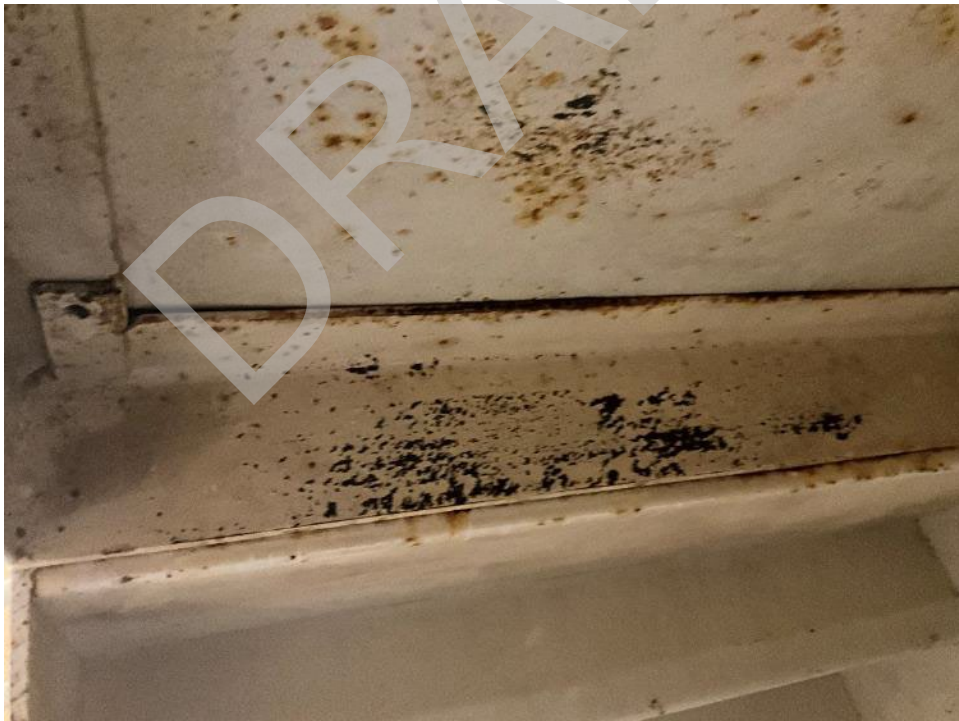
22. View of corrosion below the metal stairs.

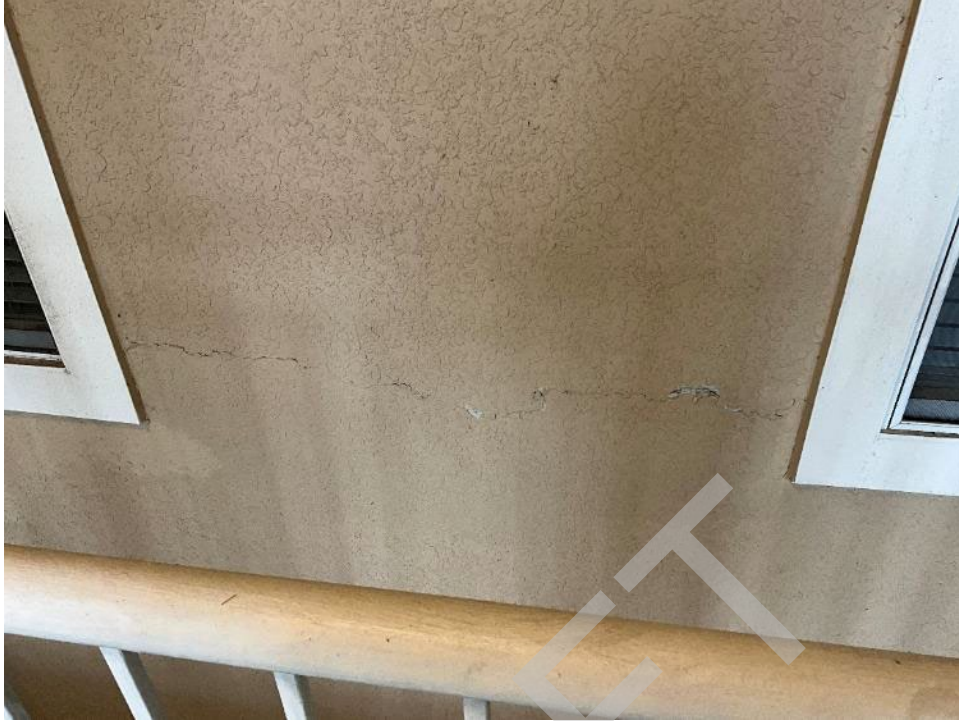
23. View of horizontal cracking between windows on the second level.

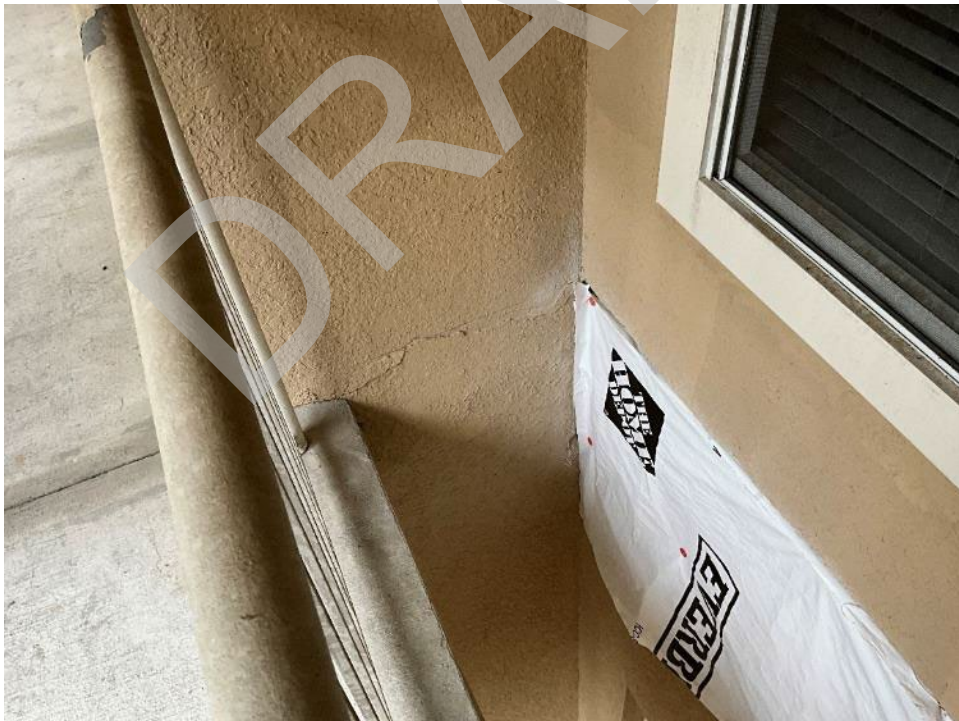
24. View of horizontal cracking between the breezeway slab and the wall.

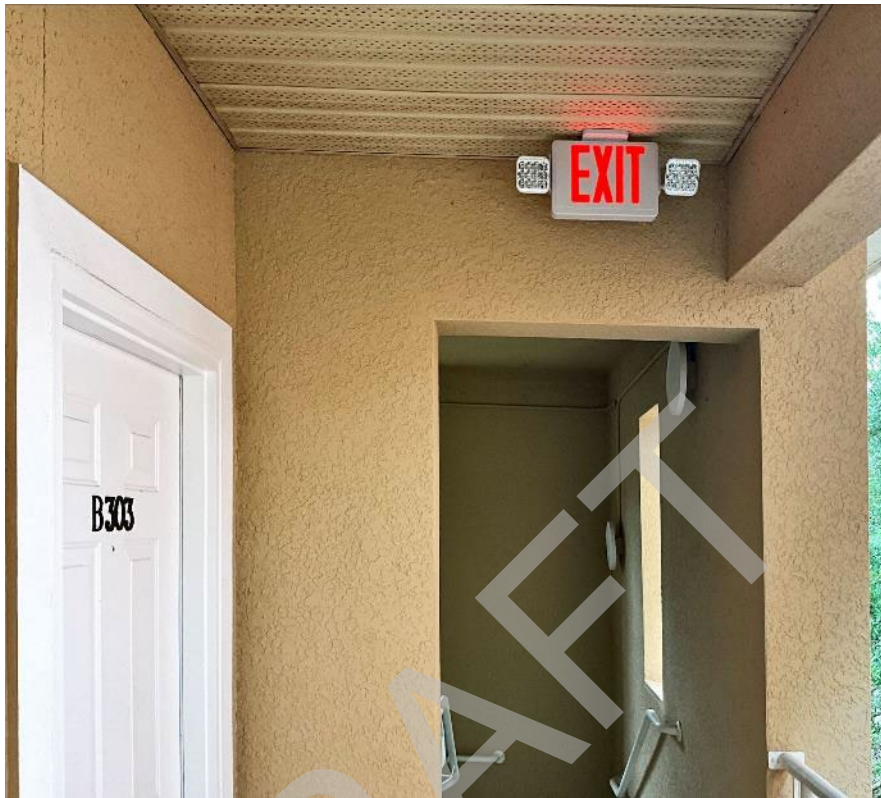
27. View of cracked section of wall next to unit B303. The paint and stucco will need to be removed to expose the wall for Phase II.

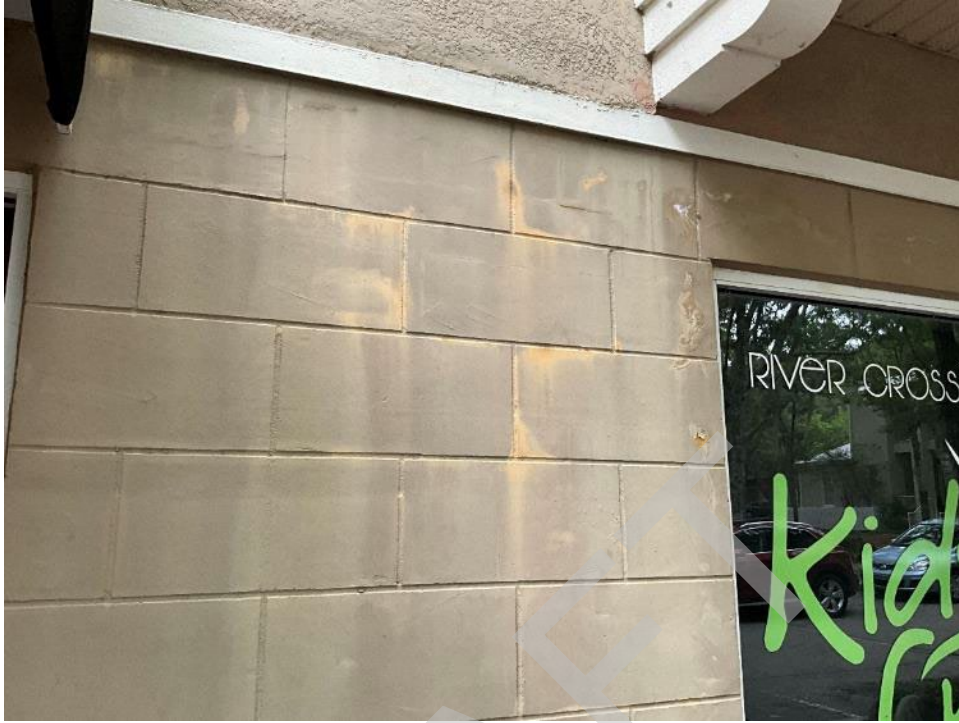
29. View of staining along the walls of the building.

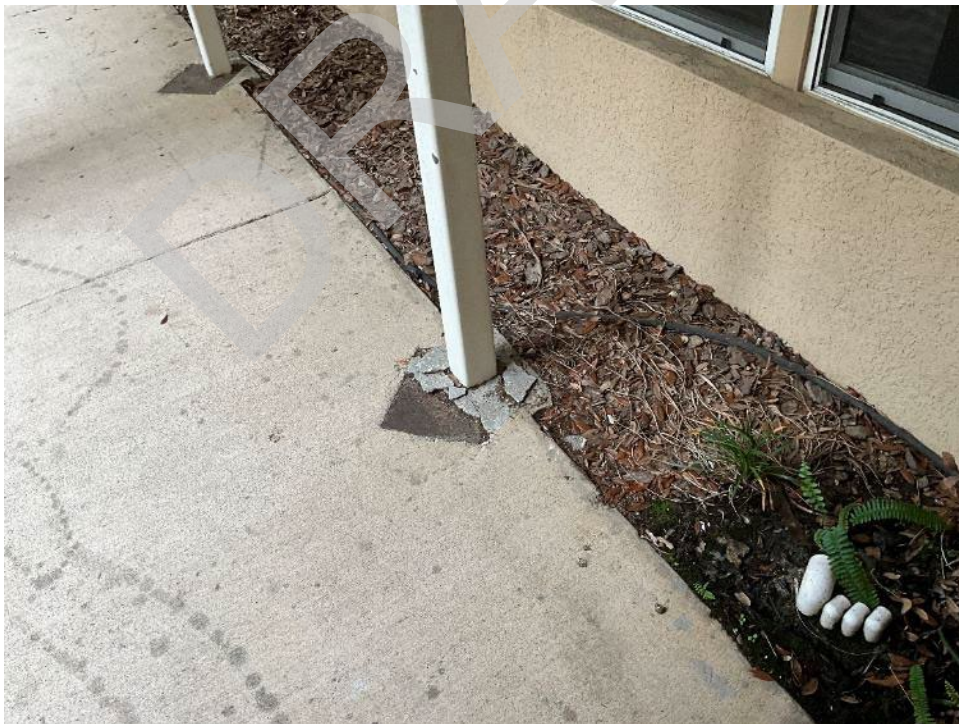
30. View of spalled concrete above steel column base plate at rear elevation.

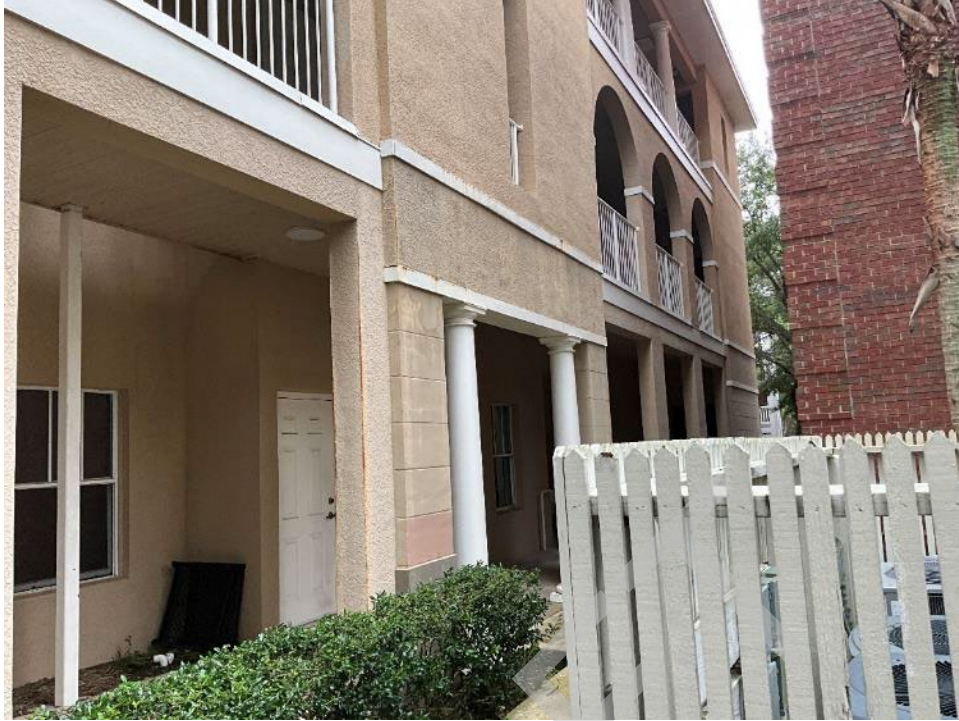
31. View of corrosion along edges of column in rear elevation.

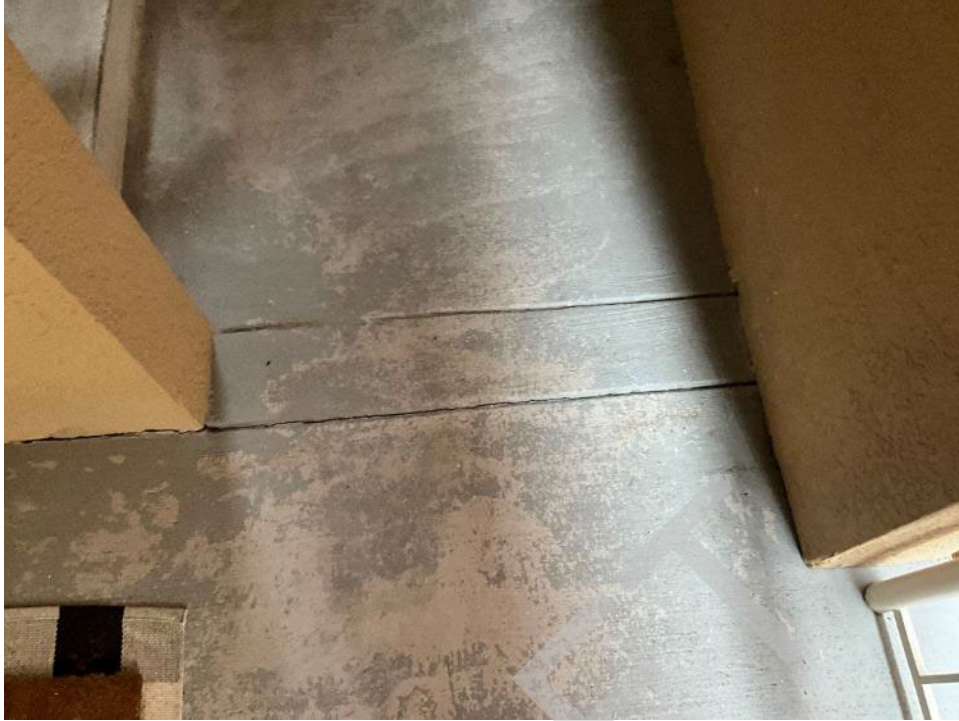
33. View of cracking along control joint and delamination along the breezeway floors.

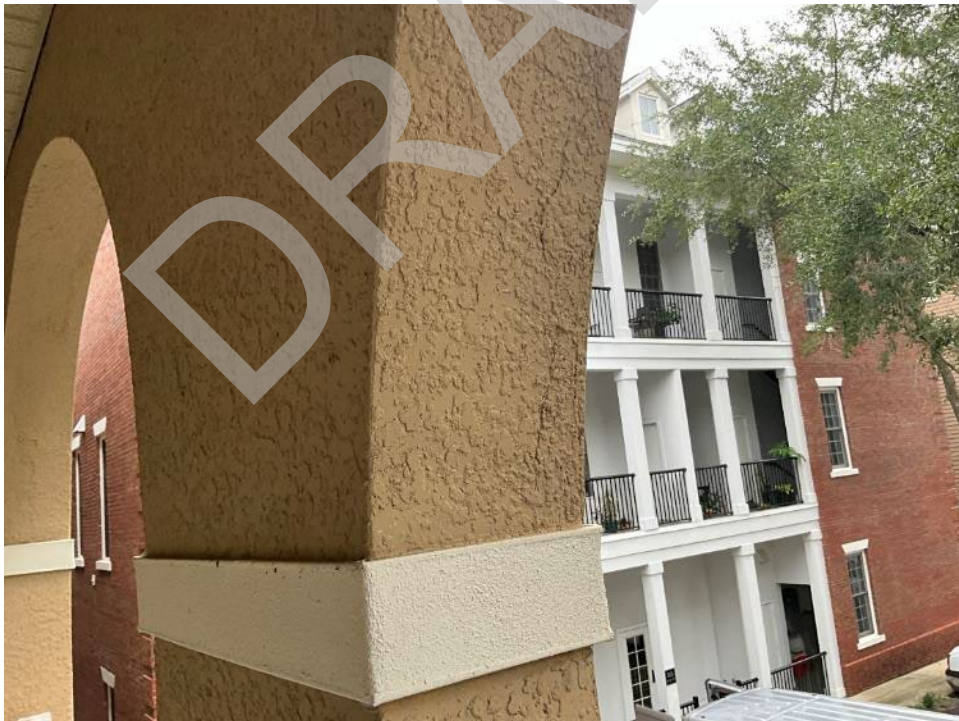
34. View of finish cracking along column near unit B201.

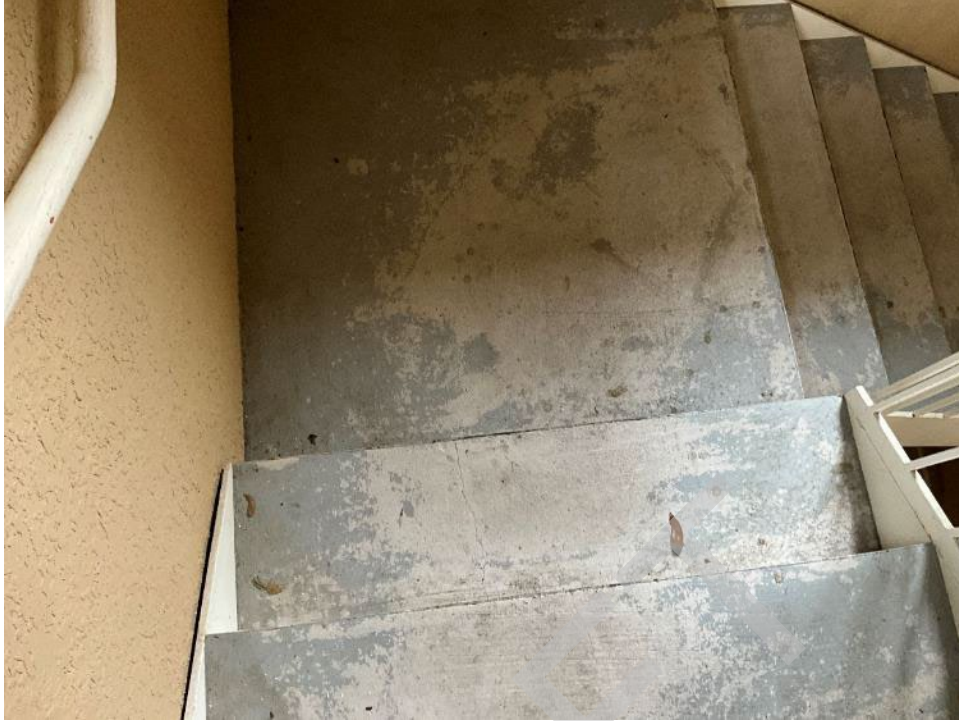
35. View of delamination on the concrete topping along the stairs.

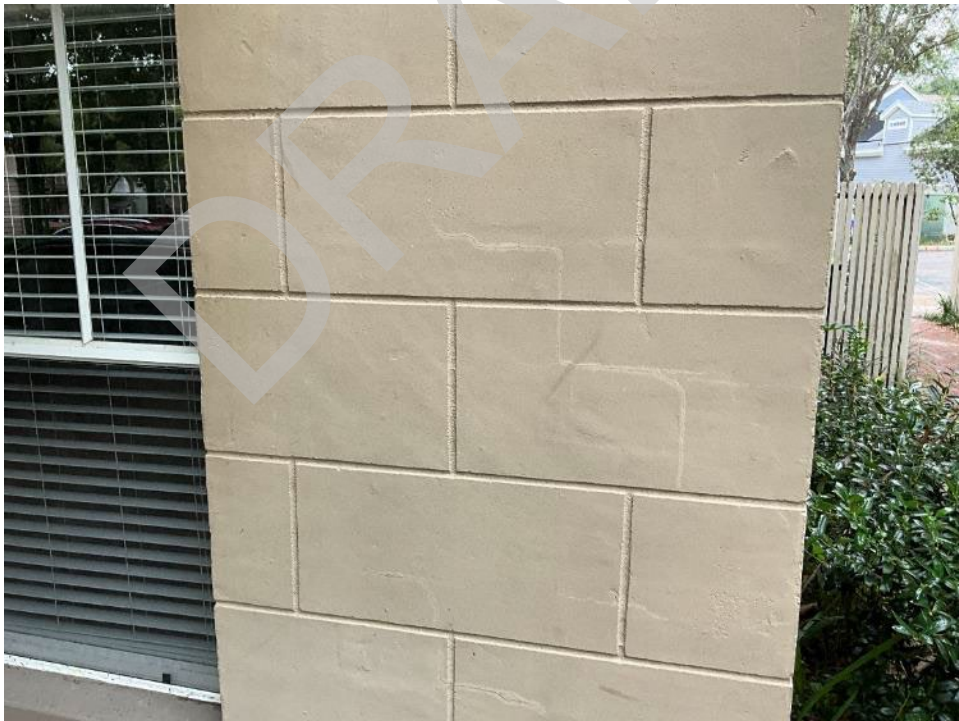
36. View of stair step cracking on the exterior wall.

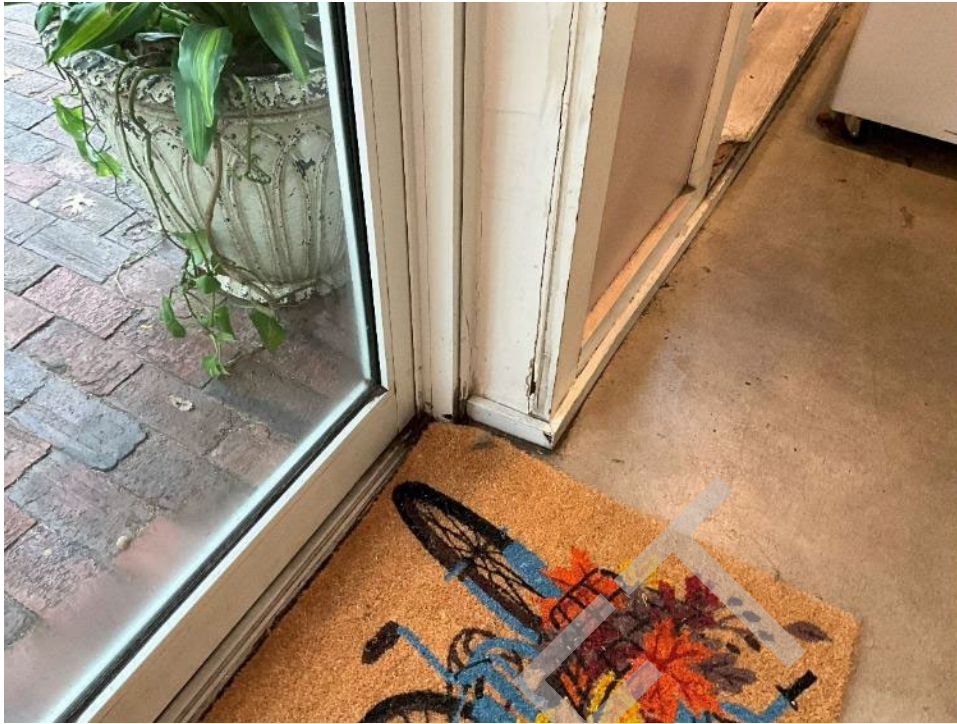
37. View of cracking along the finish around the entry door to suite B-102

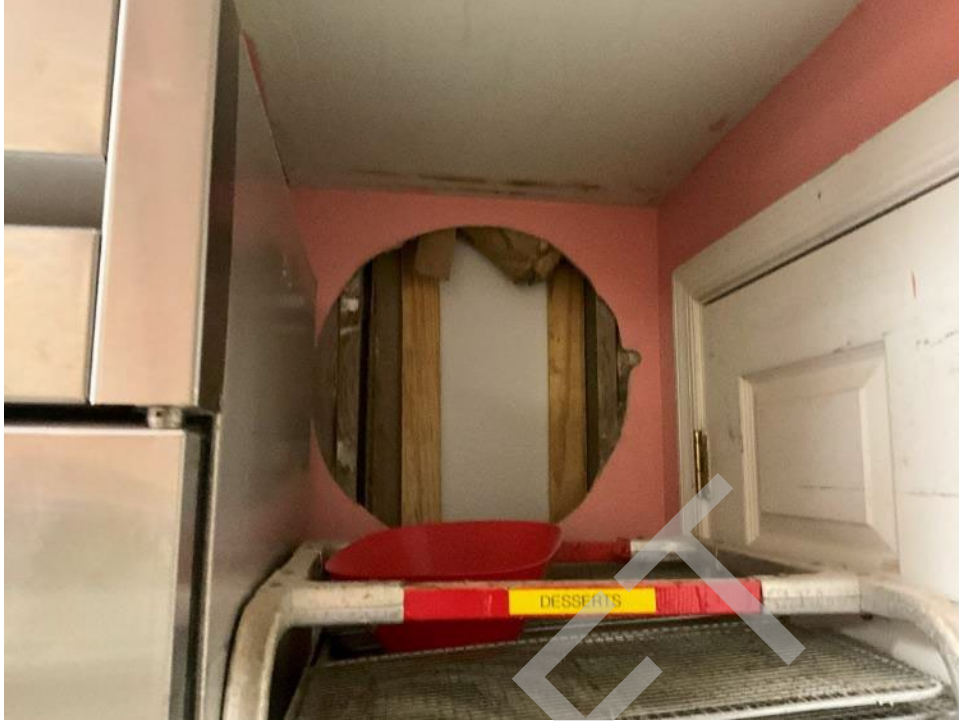
39. View of unrepaired walls in suite B-102.

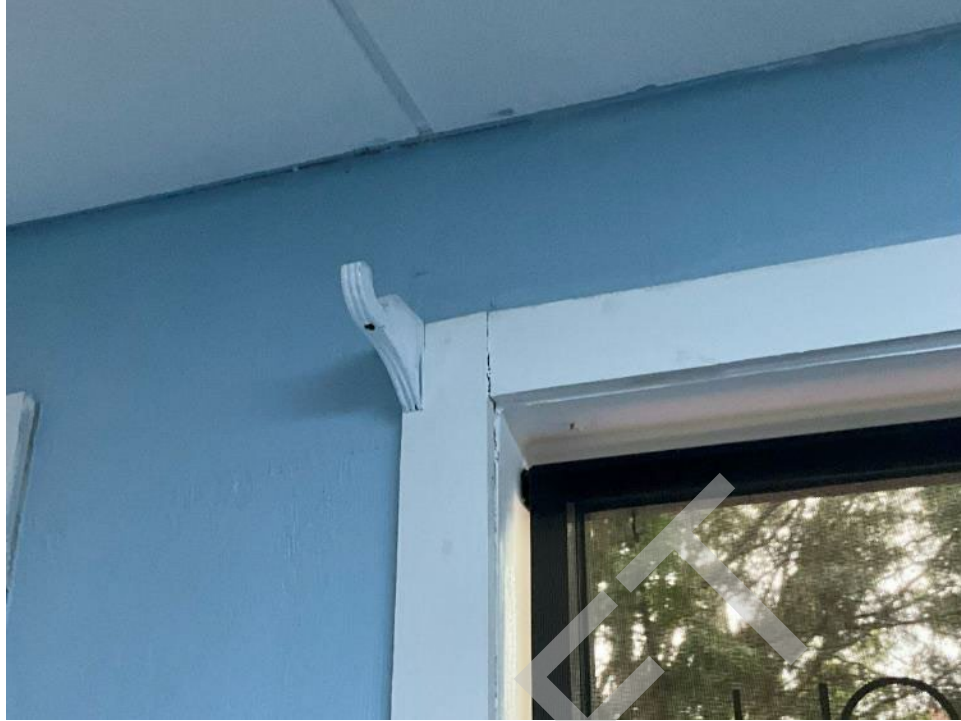
41. View of crack in the finish around a window in suite B-103.

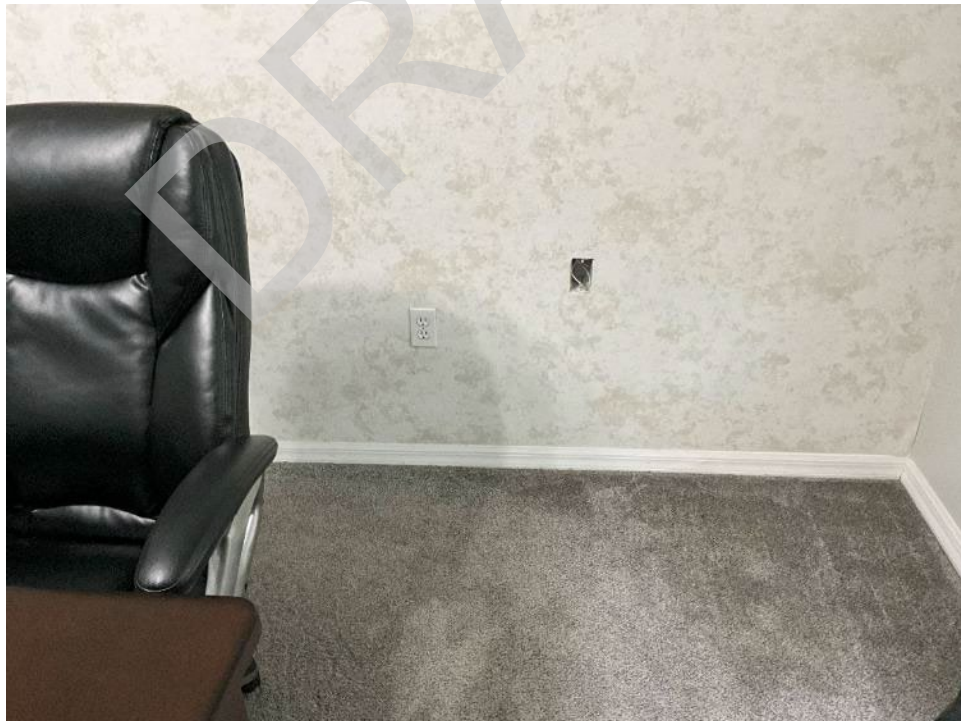
42. View of open electrical receptical in unit C101.

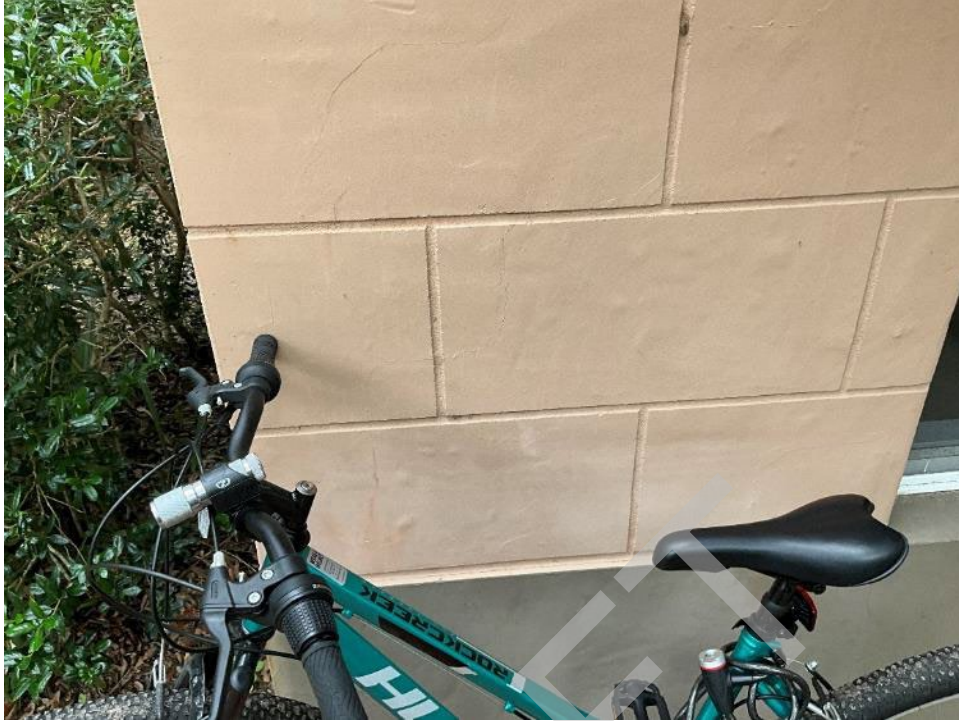
45. View of stair-step cracks in the wall finish.

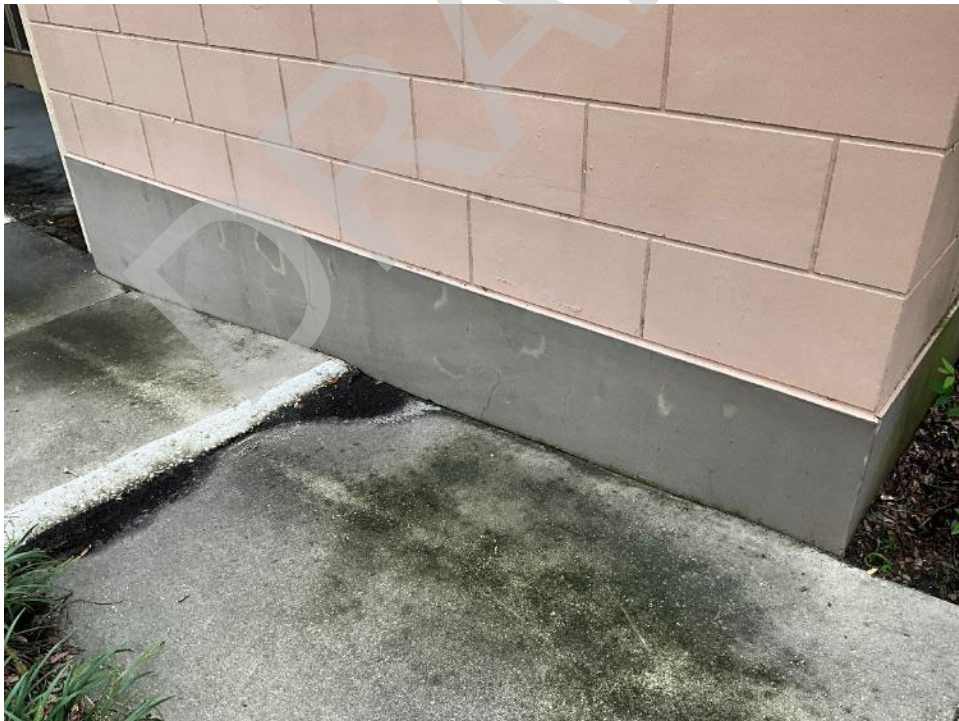
46. View of staining and cracking around the foundation of the building.

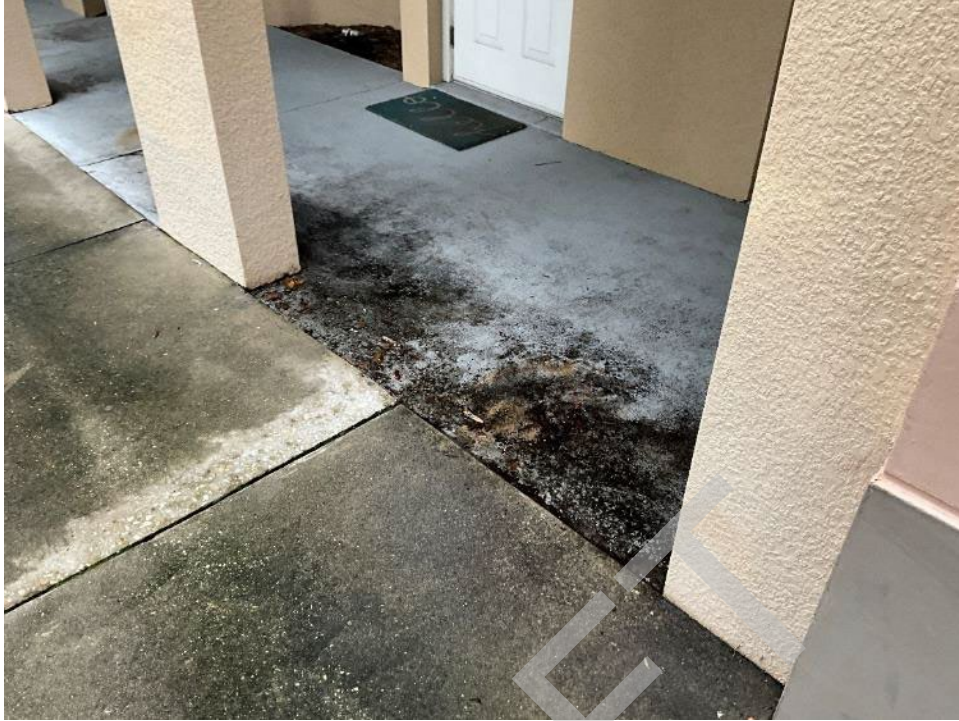
47. View of major staining along the first level slab.

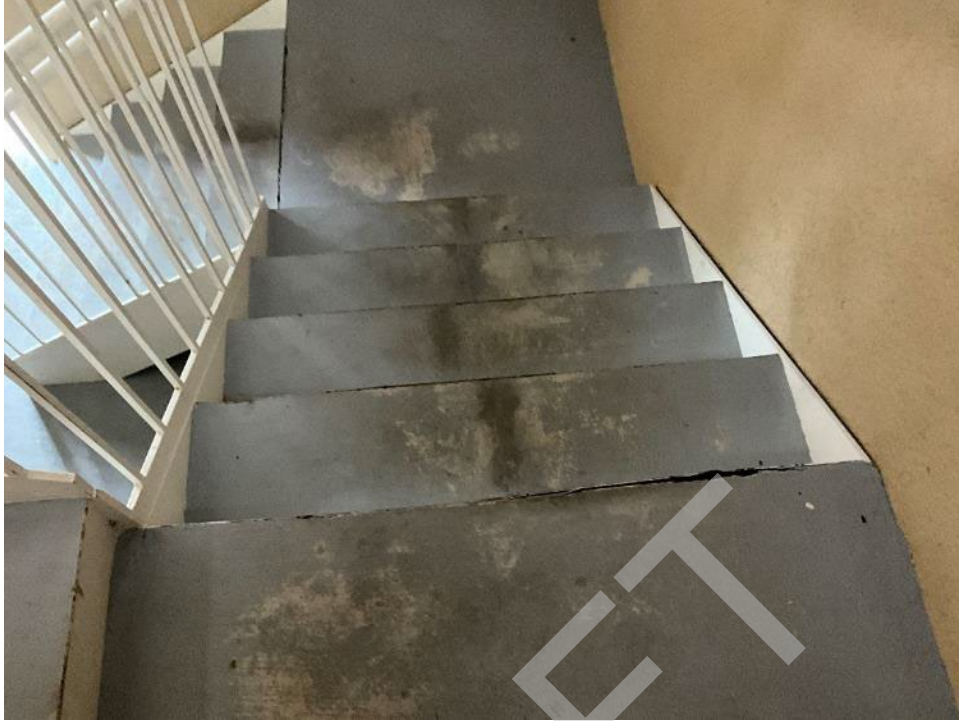
49. View of paint delamination along the stairs.

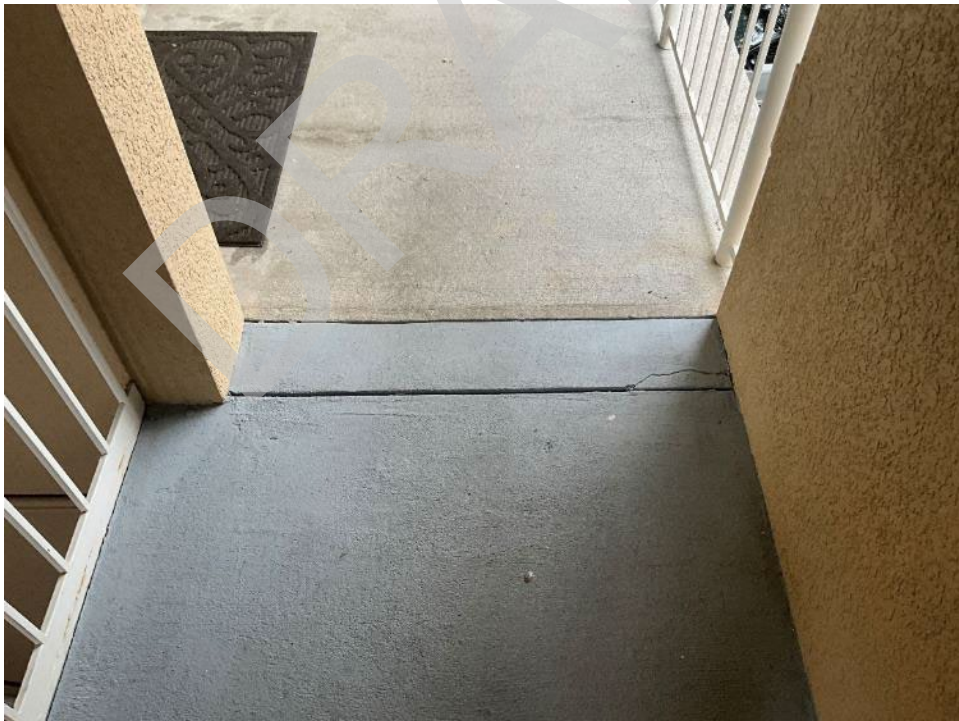
50. View of cracking around the control joint.

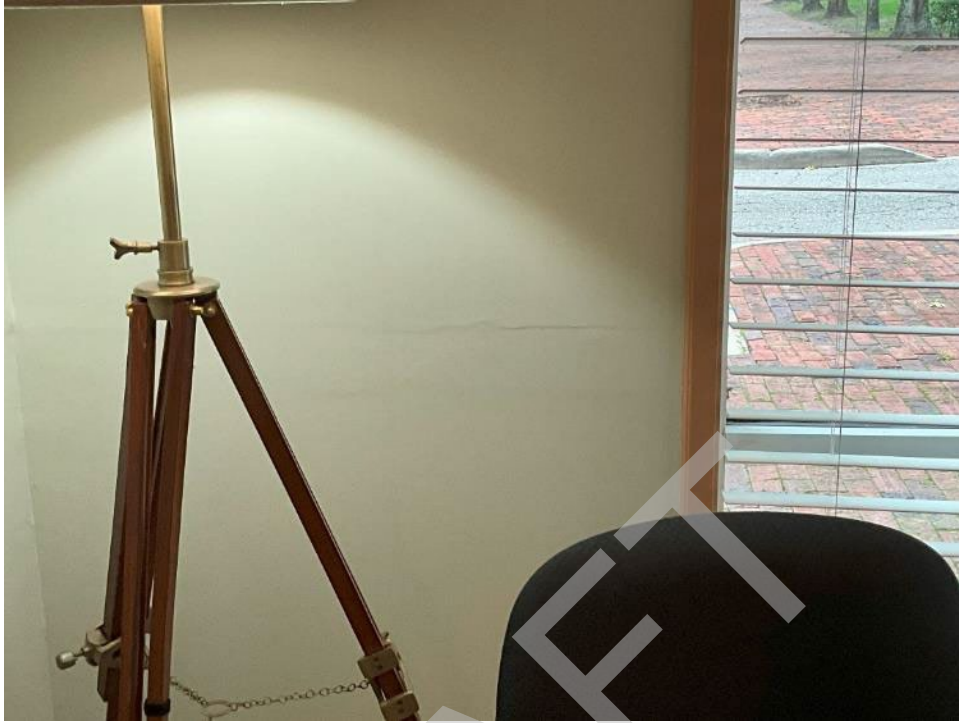
55. View of crack observed in the finish of the exterior wall of suite D-102.

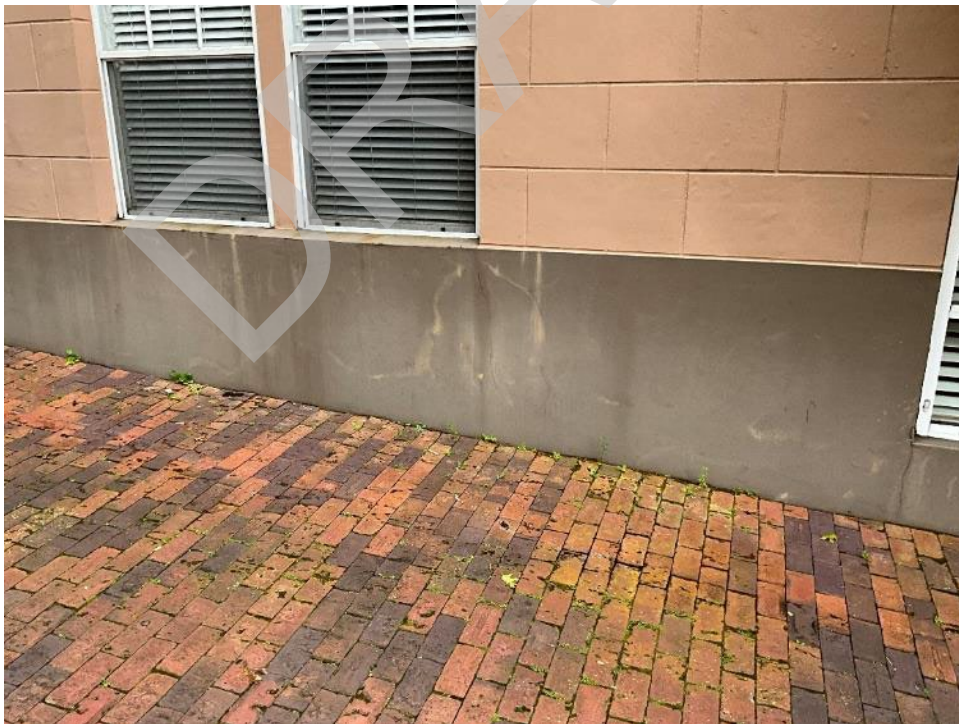
56. View of staining and cracking along the base of the walls around the building.

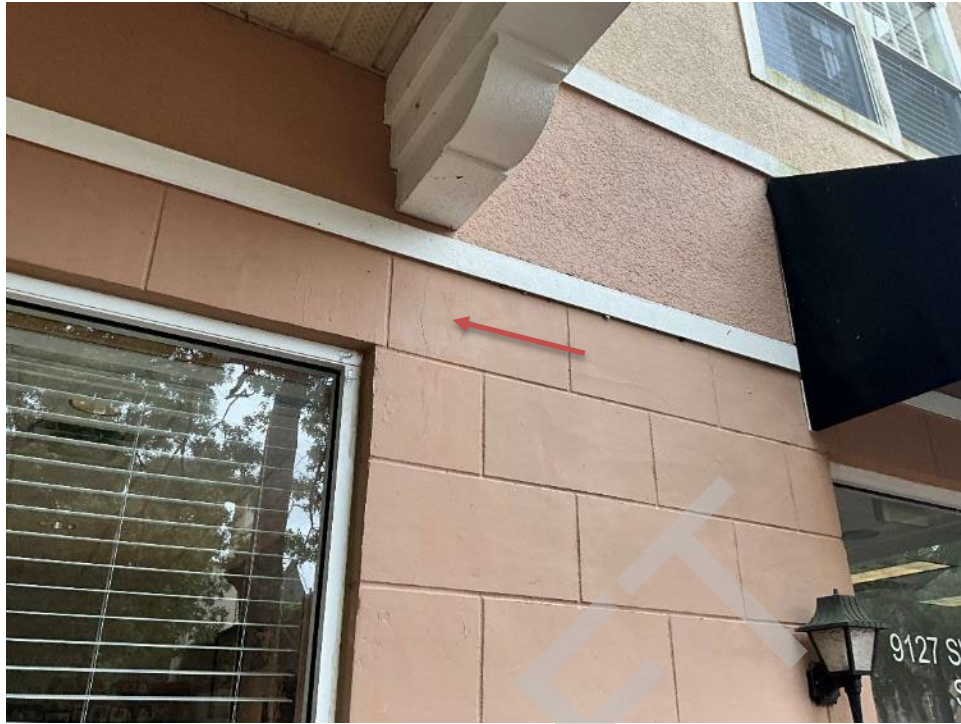
57. View of minor vertical crack in the wall near the window to unit D-102.

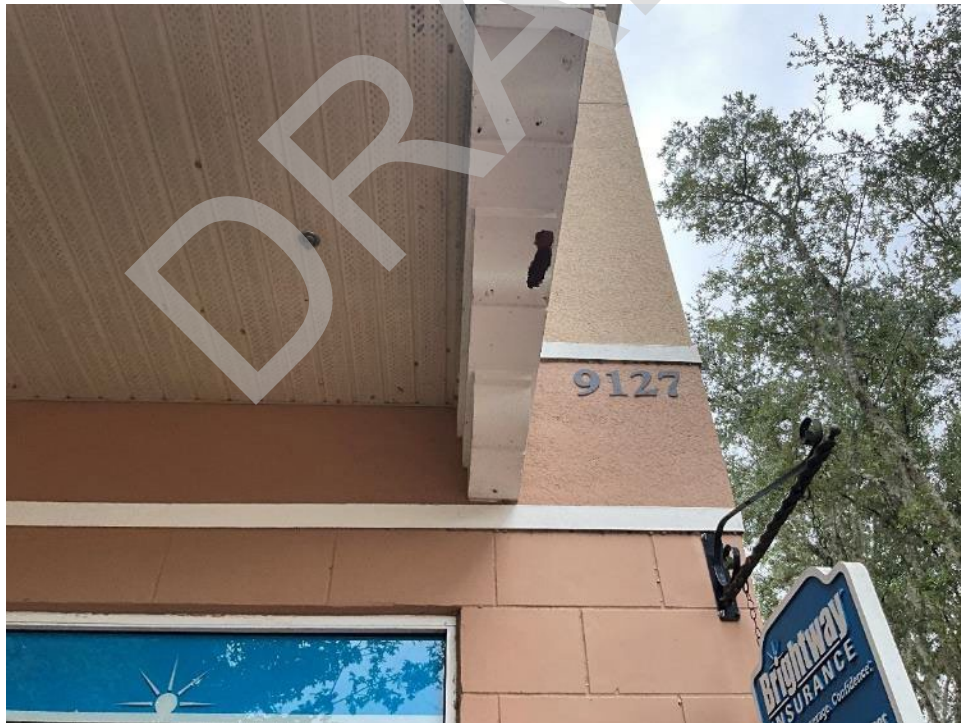
58. View of cracking and holes in the finish of the beams above unit D-103.

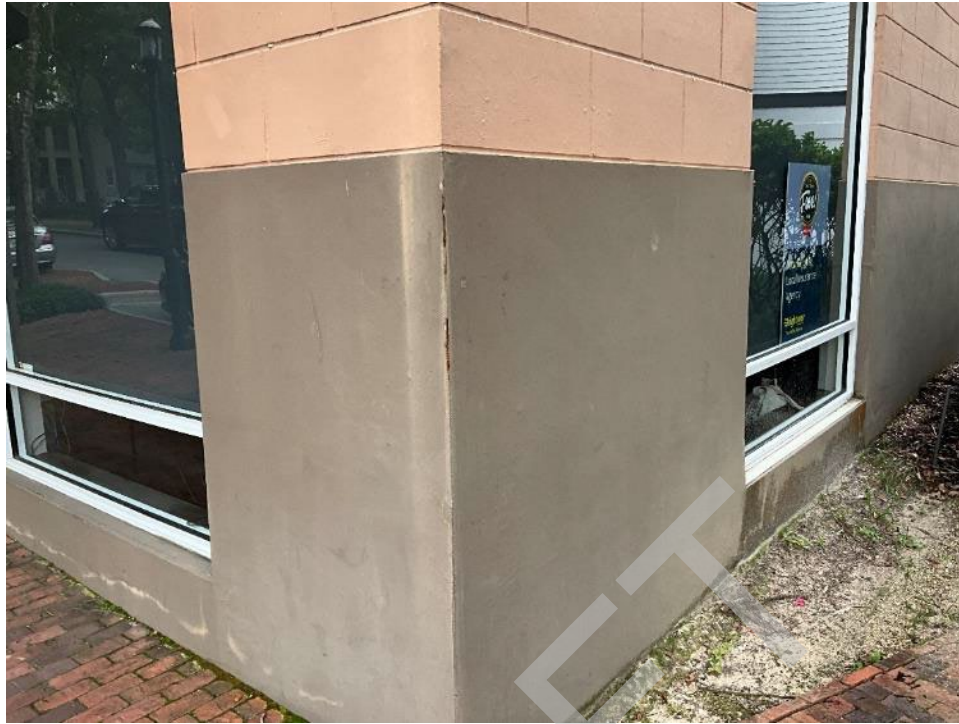
59. View of corrosion at the corners of the building.
