VILLAGE AT HAILE CONDOS

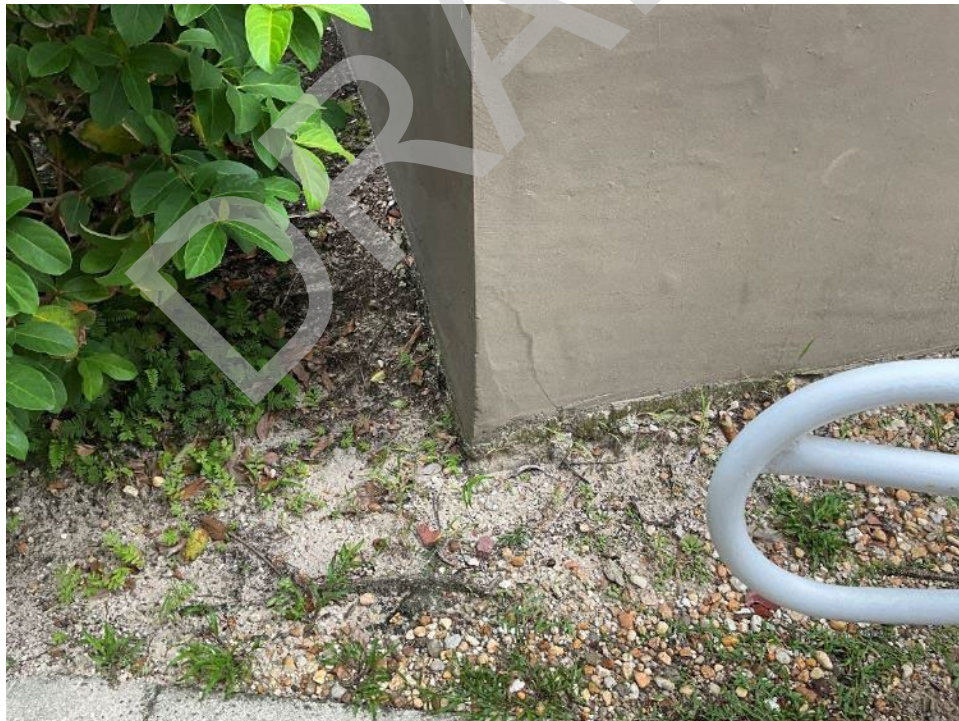
60. View of cracking at a corner of the building.

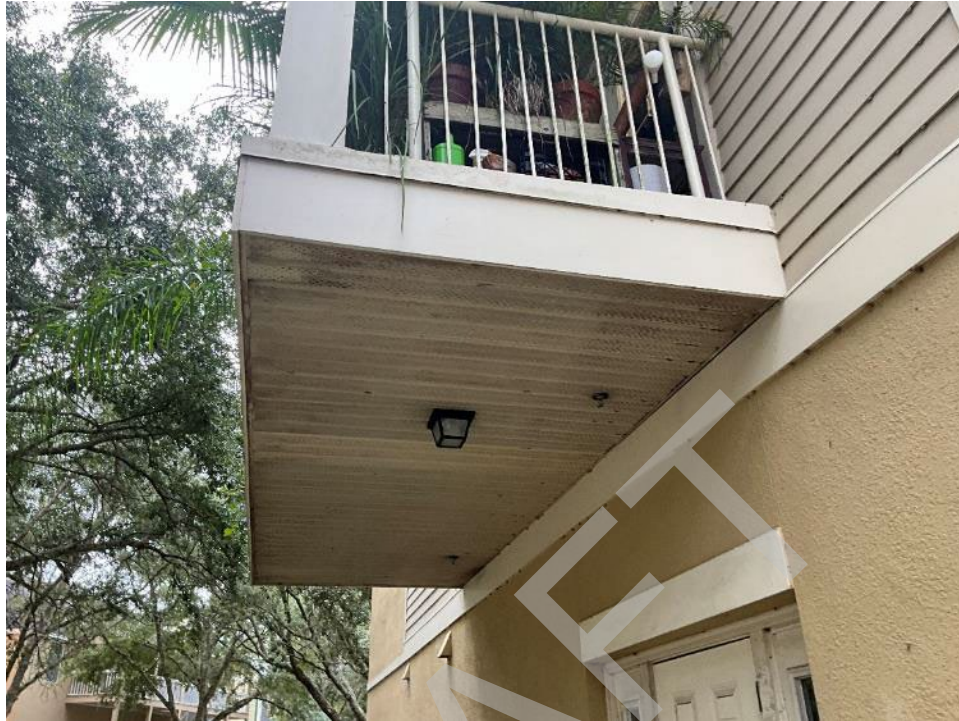
61. View of staining under the balconies.

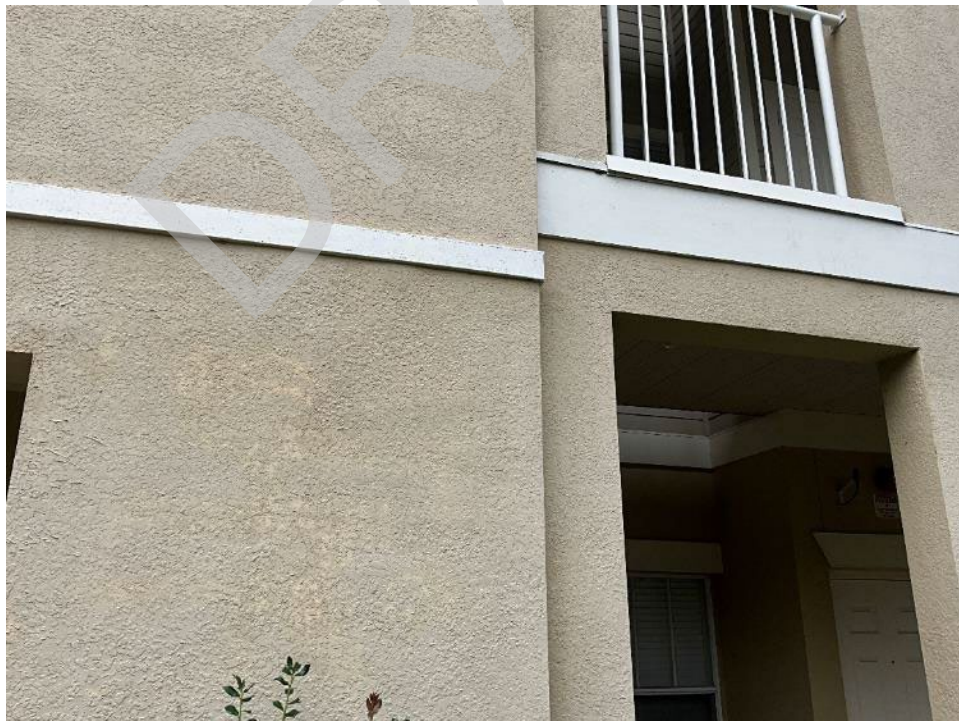
62. View of paint delamination along the walls around the building.

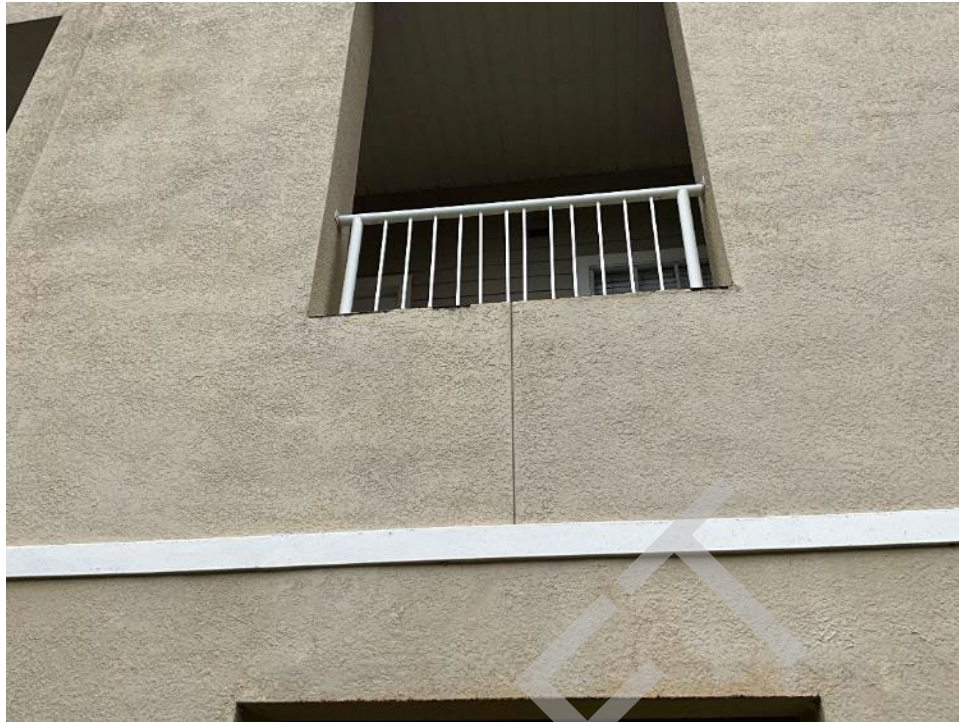
63. View of corrosion around the railing alcoves around the building.

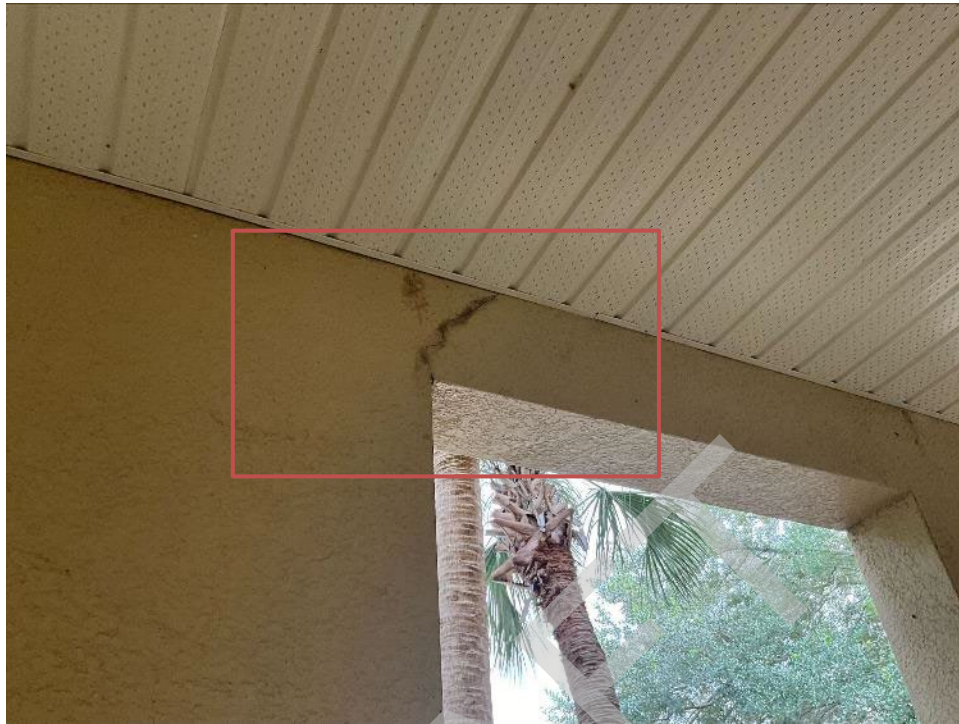
65. View of cracked section along the wall and beam near unit F101. The stucco will need to be removed to expose the interface for Phase II.

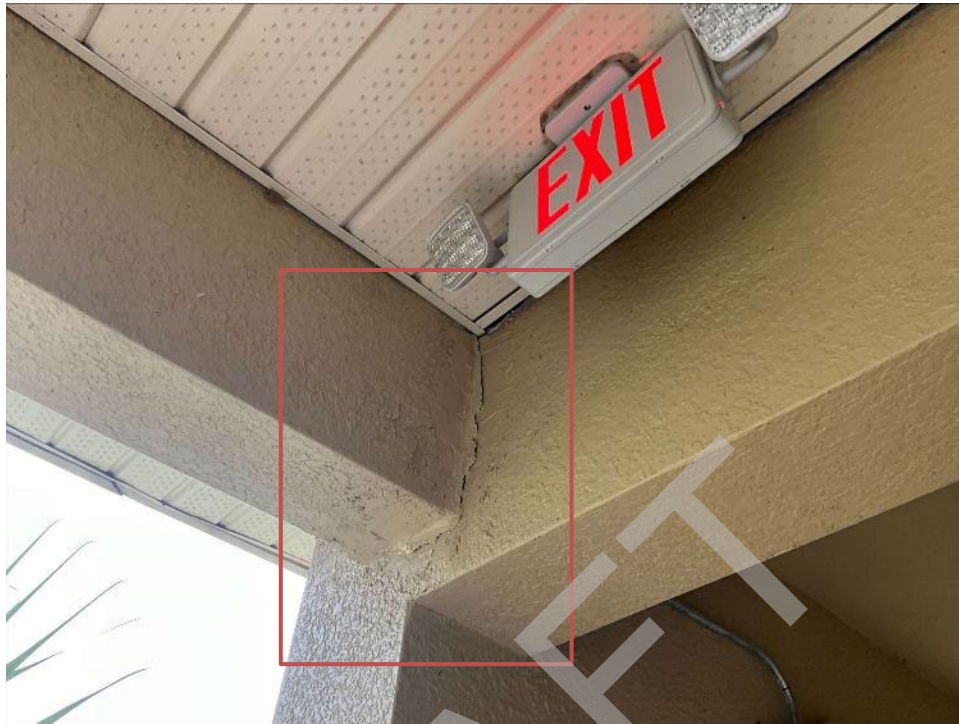
69. View of cracked section along the beam to wall interface near unit F301. The stucco will need to be removed to expose the interface for Phase II.

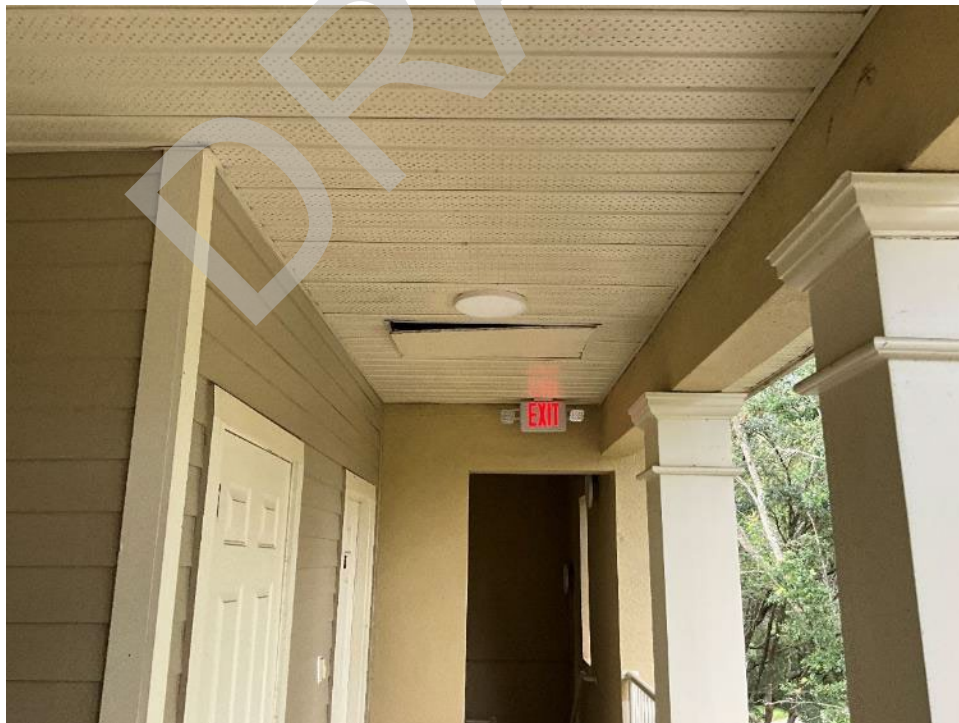
70. View of an opening that is observed to be left open.

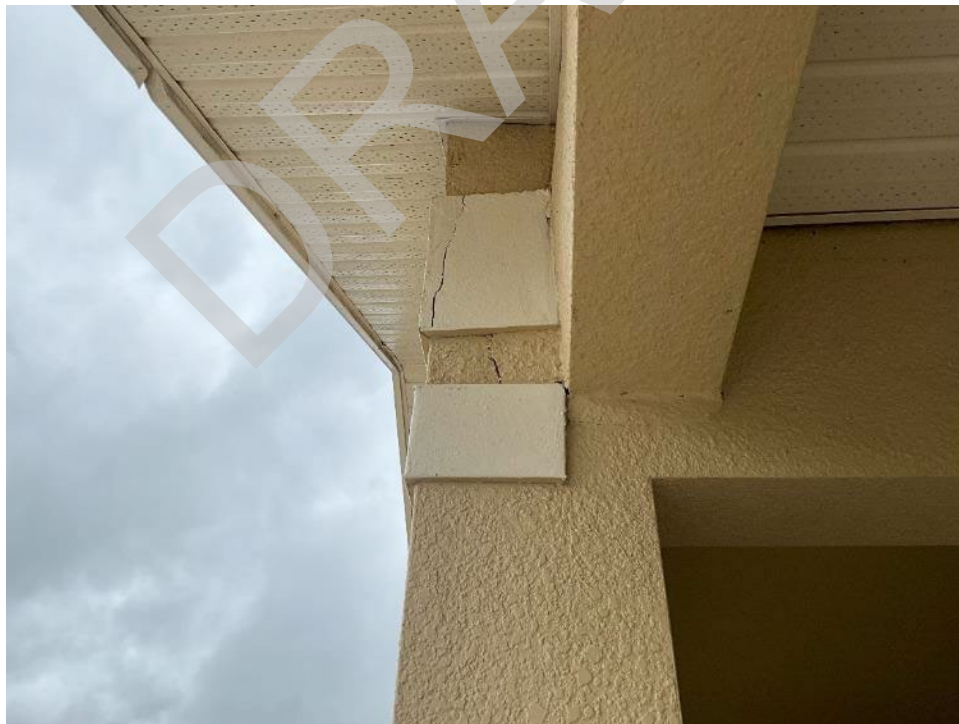
74. View of cracked sections along the beam and wall near unit G304. The stucco will need to be removed to expose this area for Phase II.

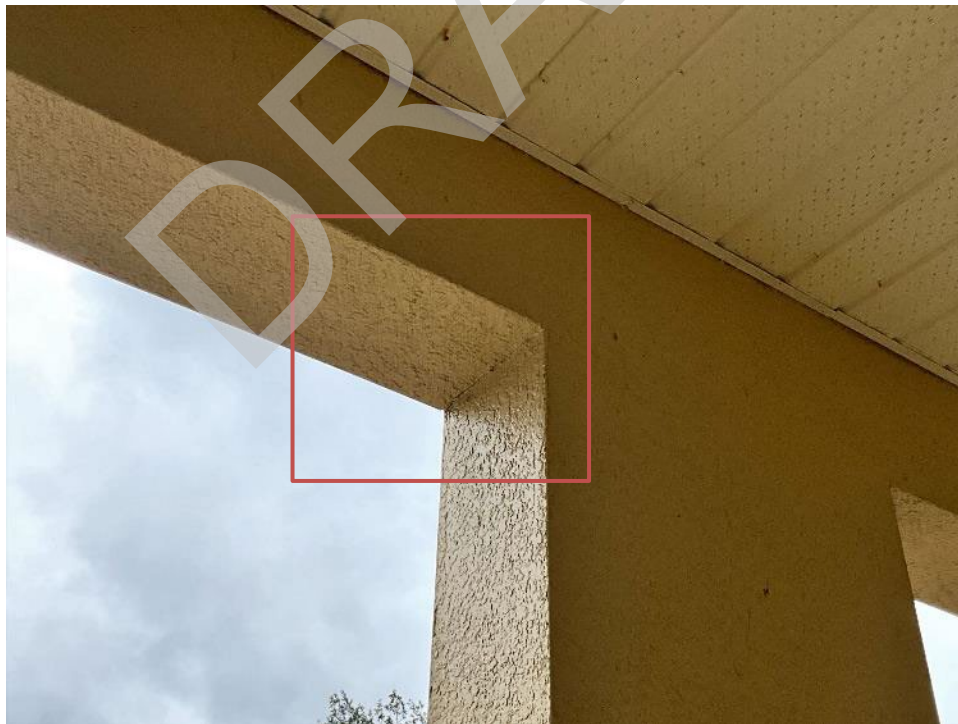
76. View of cracked section along both sides of the beam to column interface near unit G204. The stucco will need to be removed to expose the interface for Phase II.

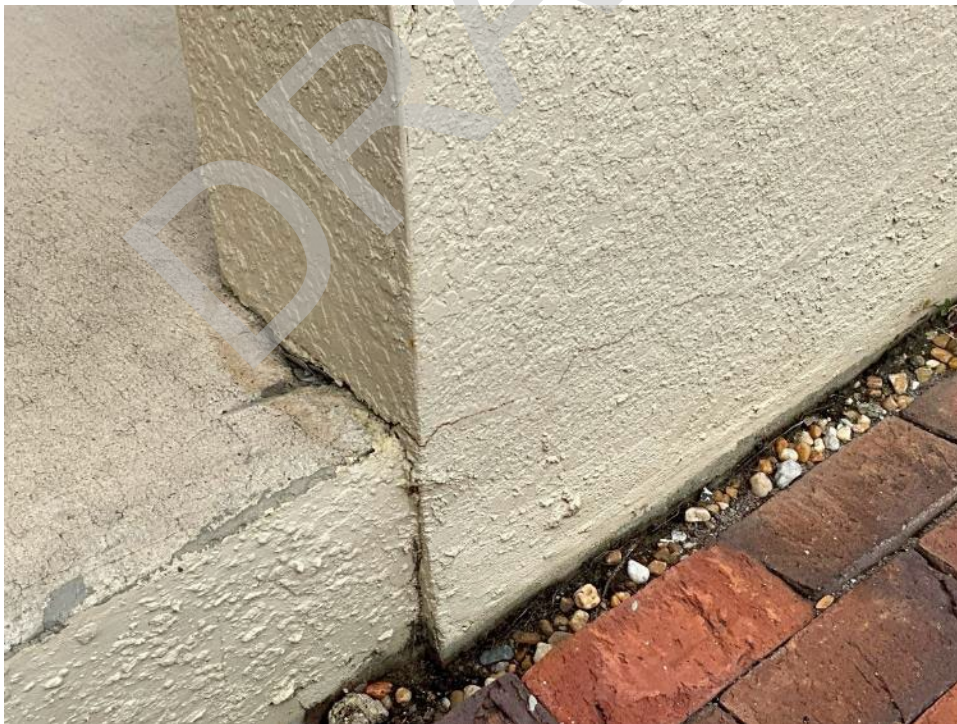
78. View of crack in bottom of the column in front of unit G104.

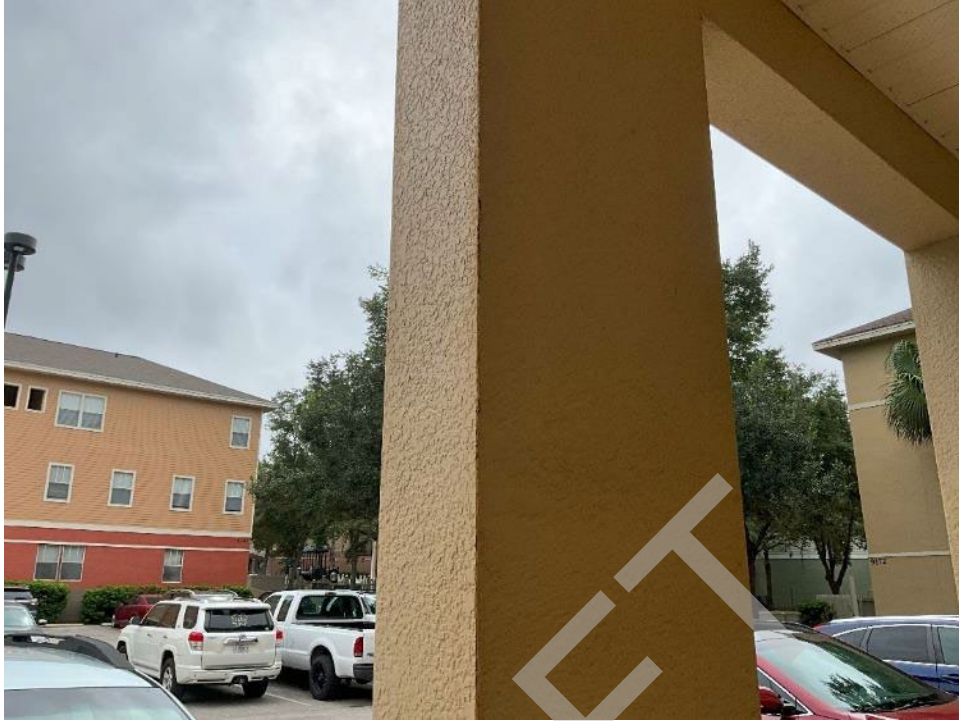
79. View of corrosion in the corner of a column on the first level.

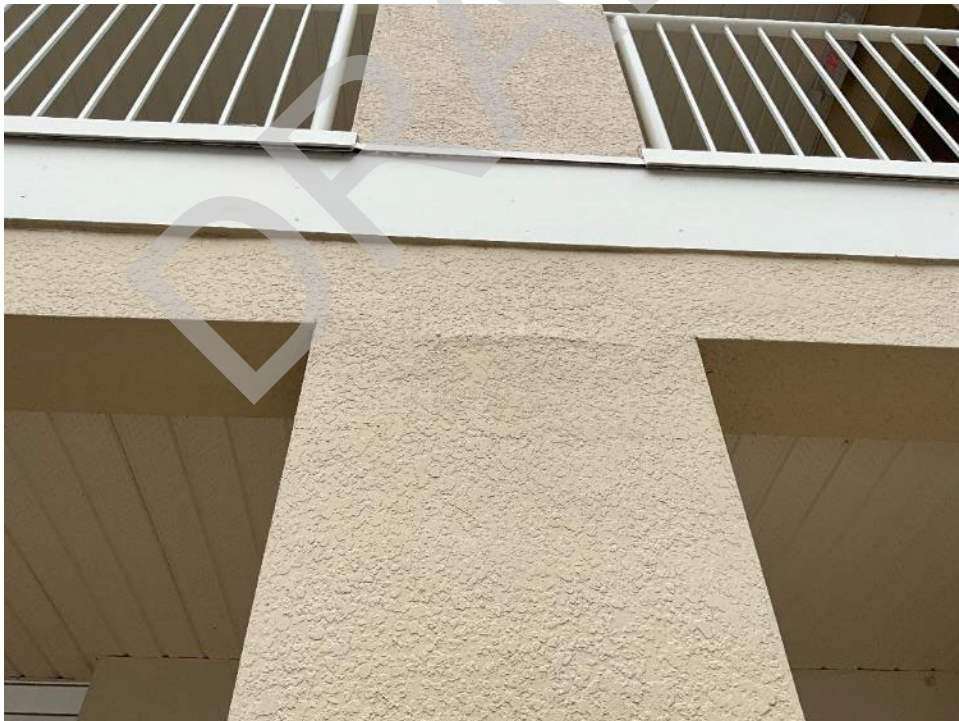
80. View of bulging on the front of a first level column.

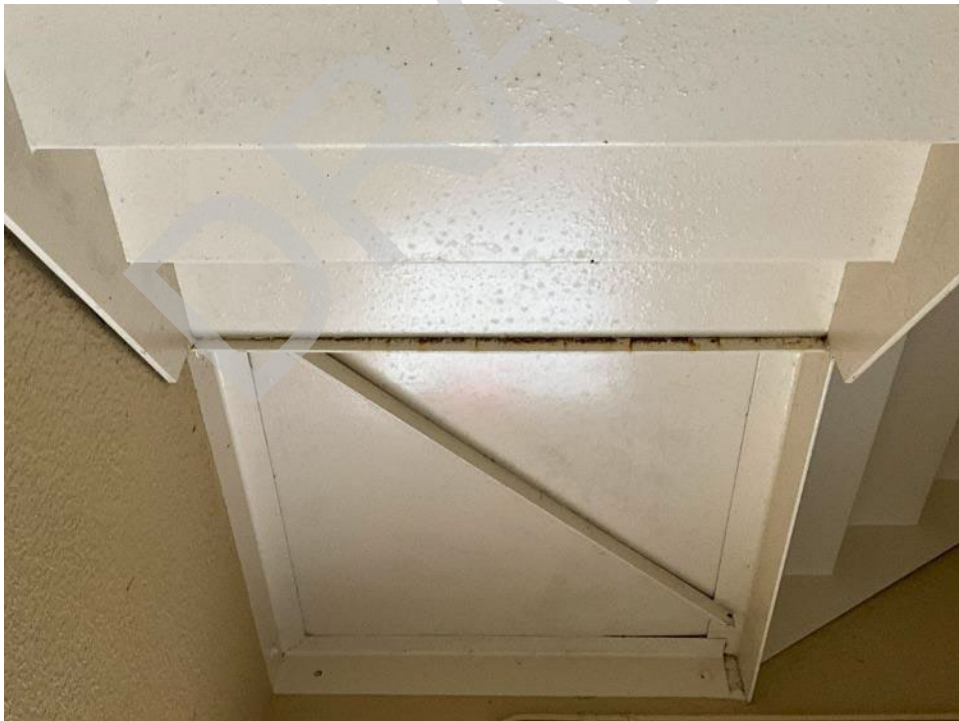
84. View of minor corrosion under the metal stairs.

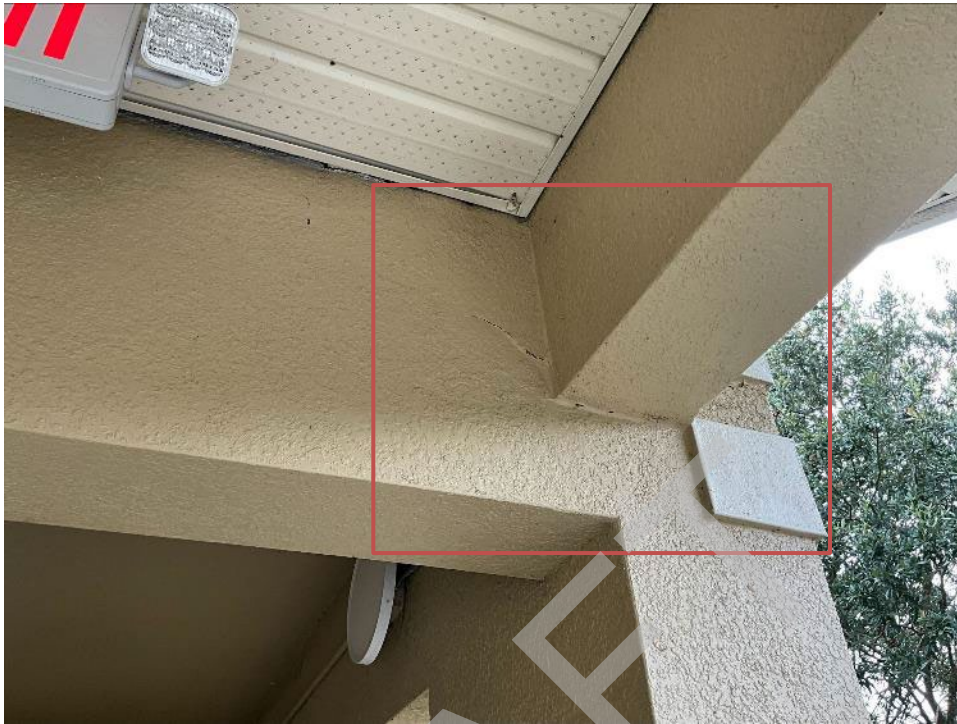
87. View of cracked section along the beam to beam interface near unit H301. The stucco will need to be removed to expose the interface for Phase II.

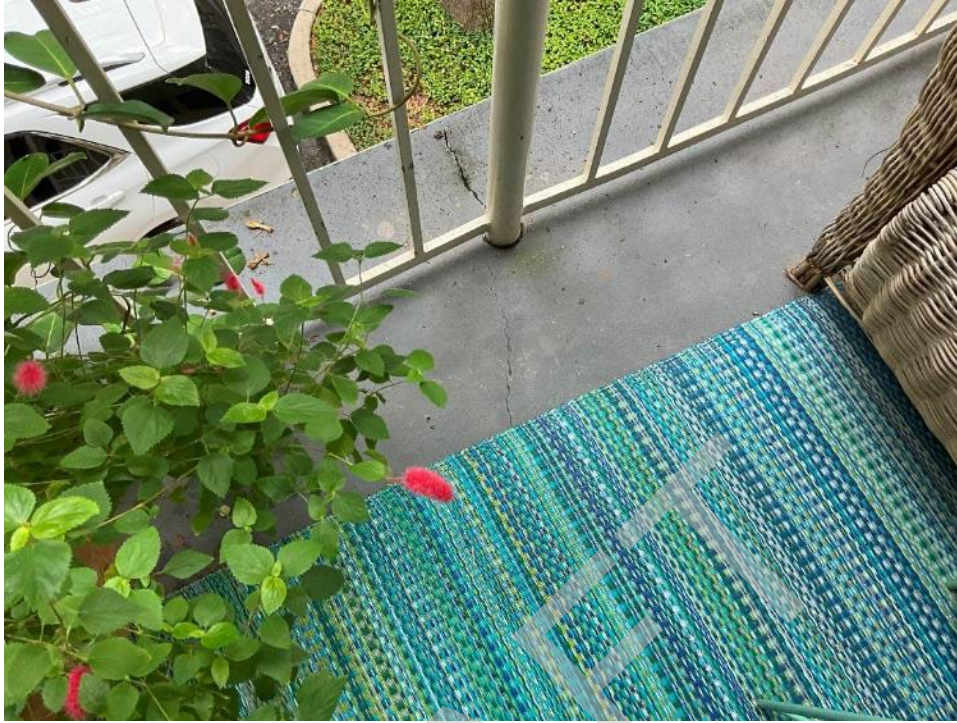
89. View of a crack in the balcony of unit H201.

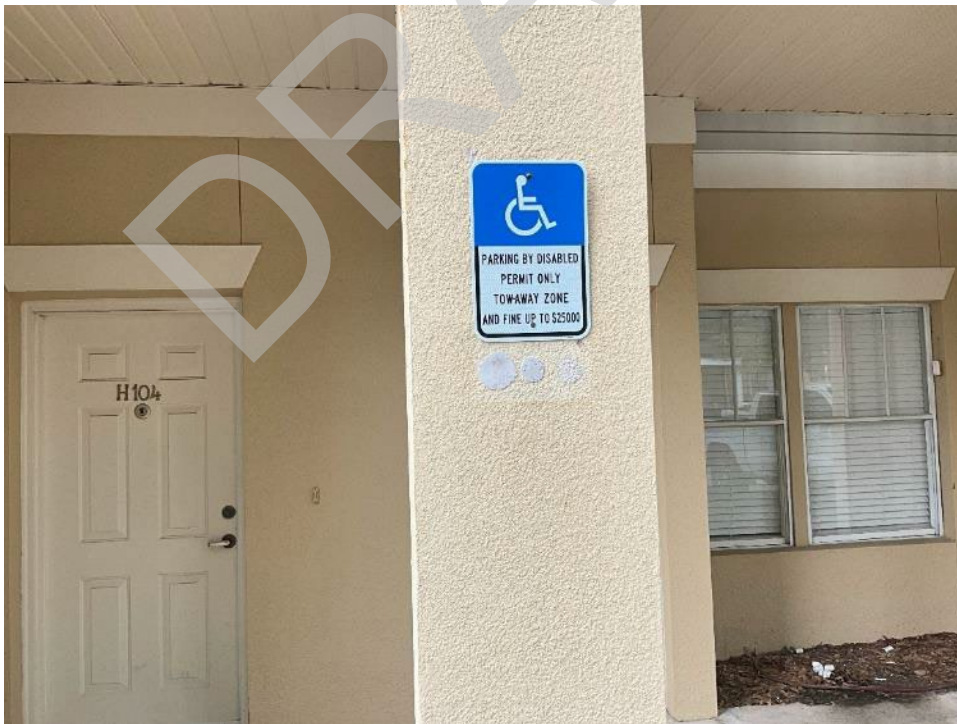
90. View of unrepaired column section unit H104.

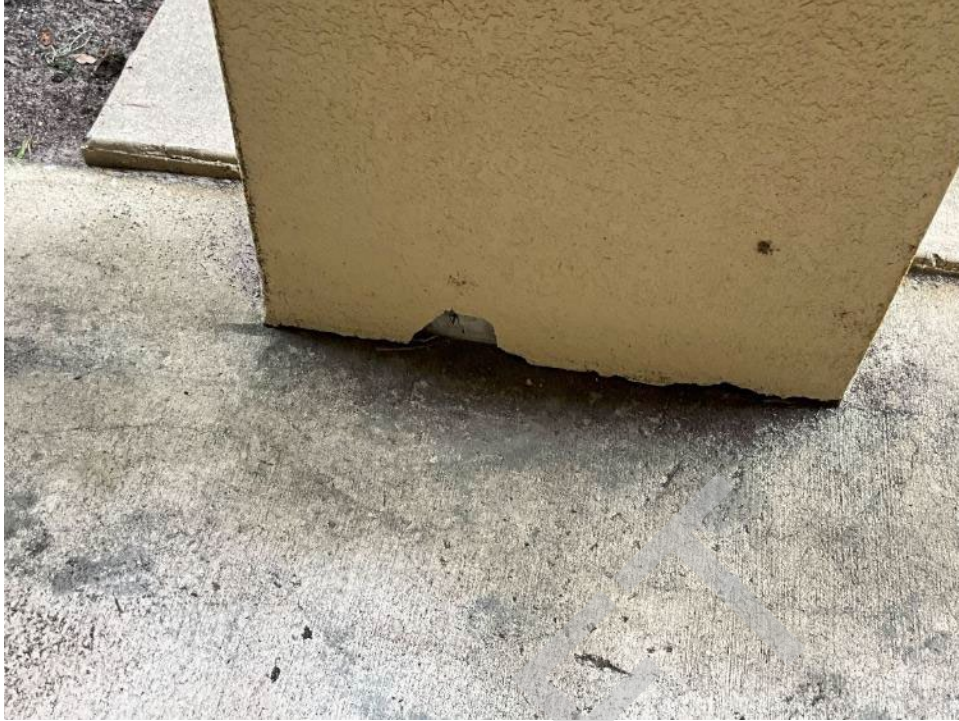
91. View of missing section of stucco at the bottom of a column near unit H104.

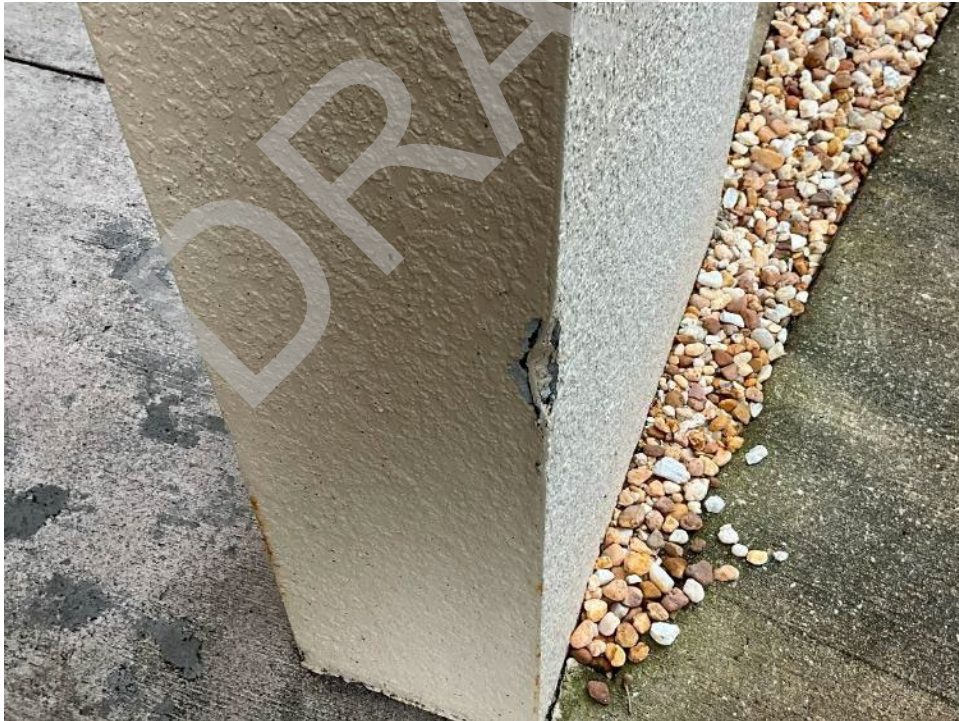
92. View of spalled concrete column near unit H103.

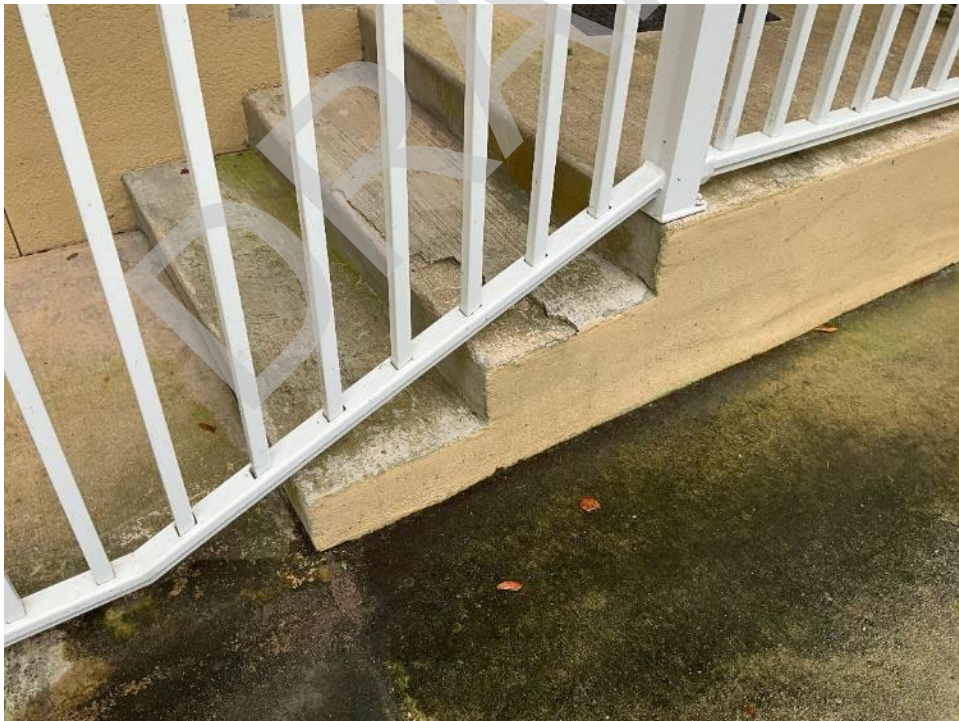
94. View of spalled section of concrete stairs.

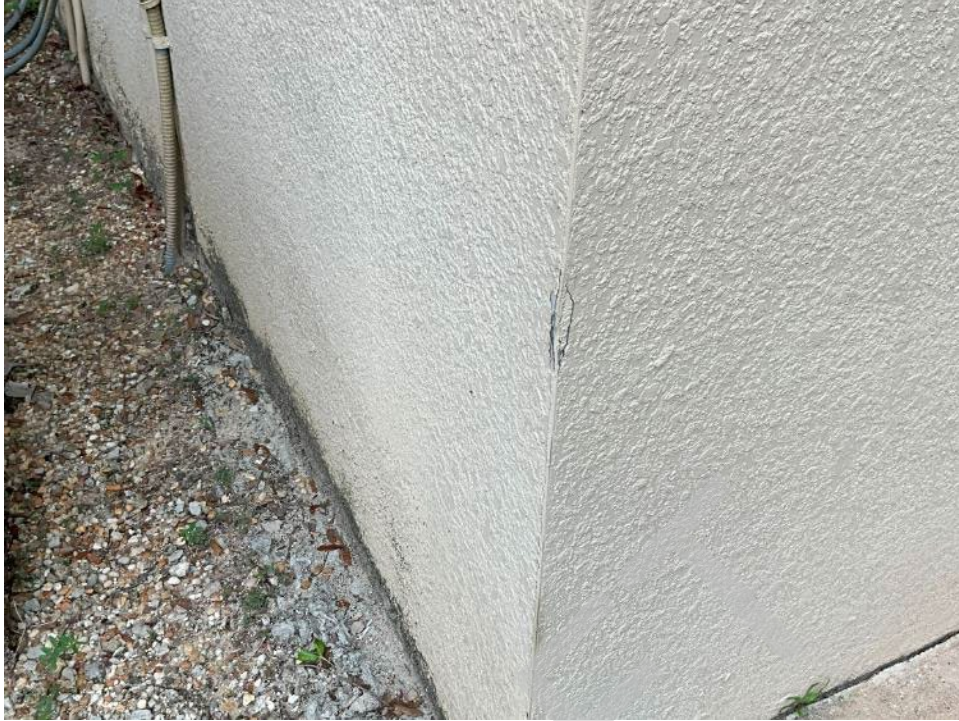
97. View of spalling at the corner of the building.

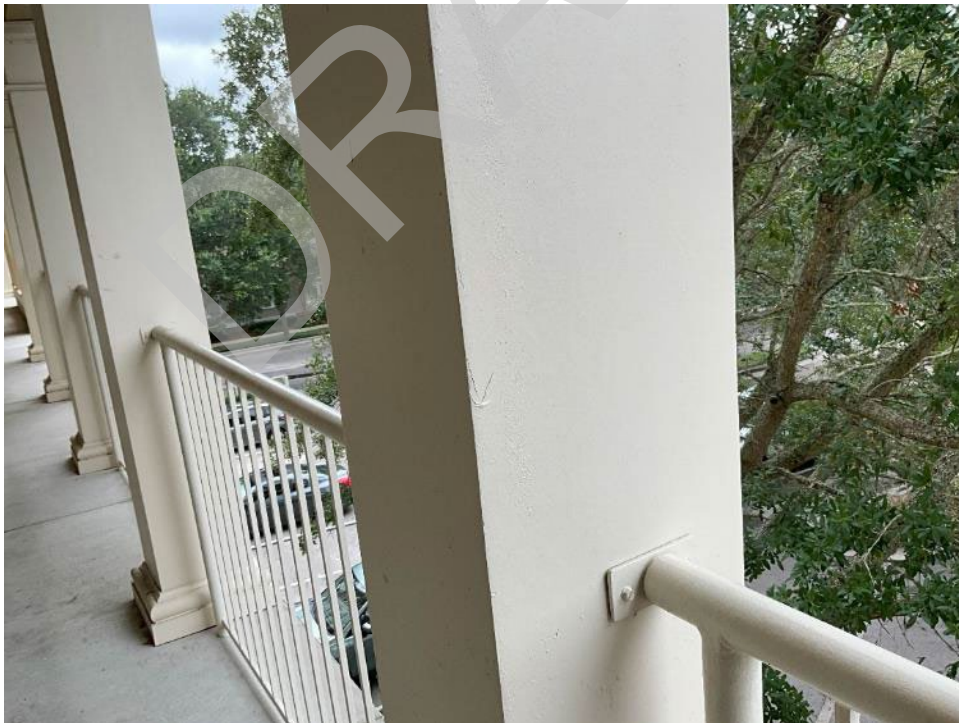
98. View of bubbling in the paint in the column near unit H304.

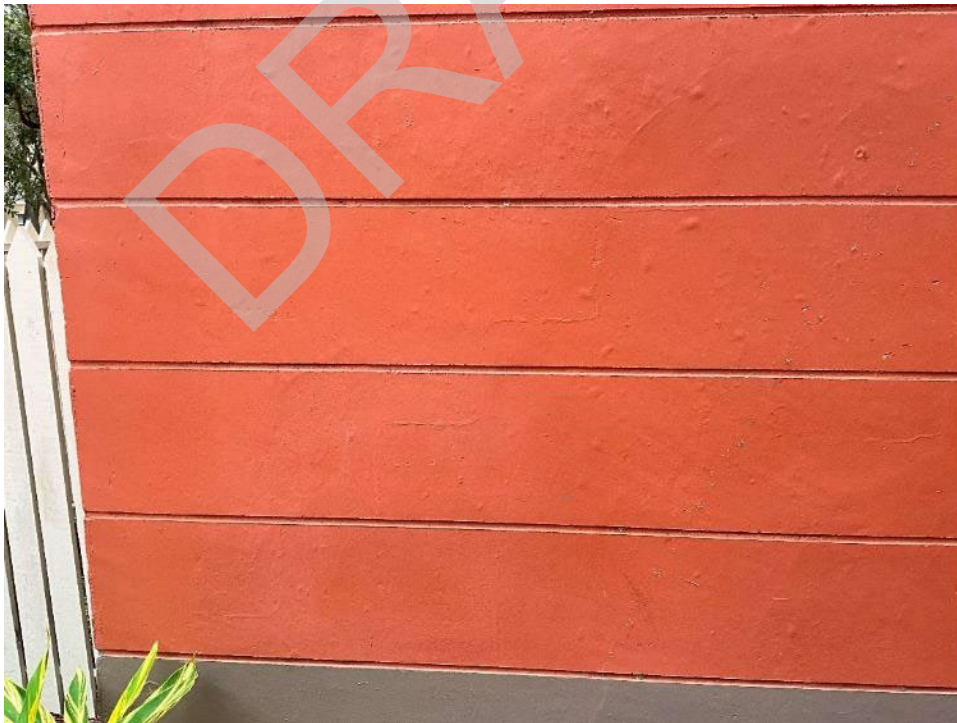
102. View of stair-step cracking observed in multiple walls around the building.

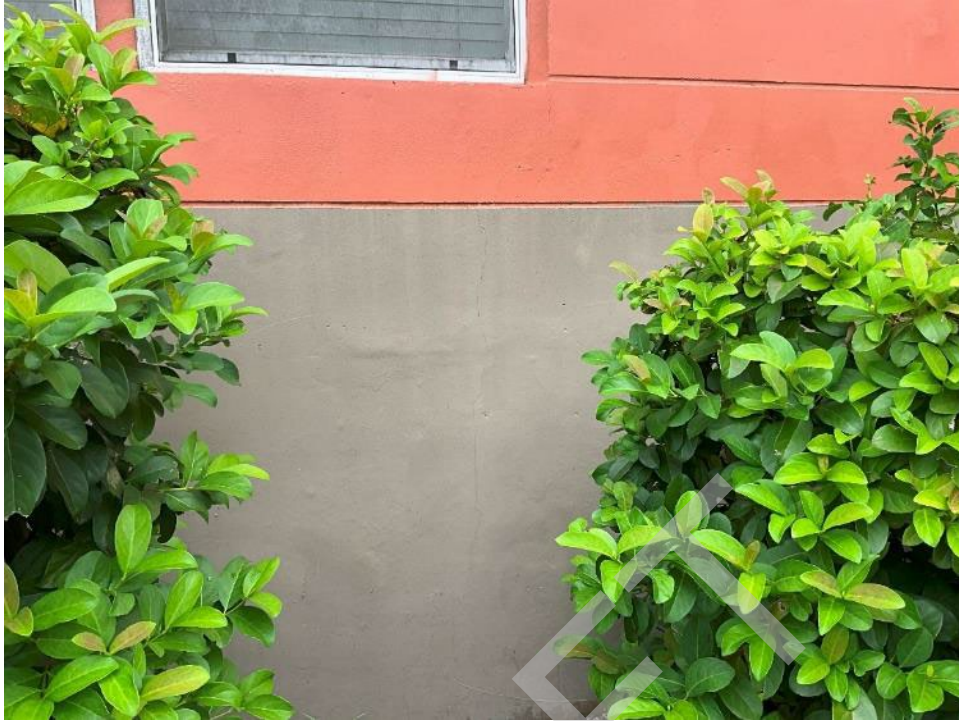
103. View of vertical cracking in base of walls.

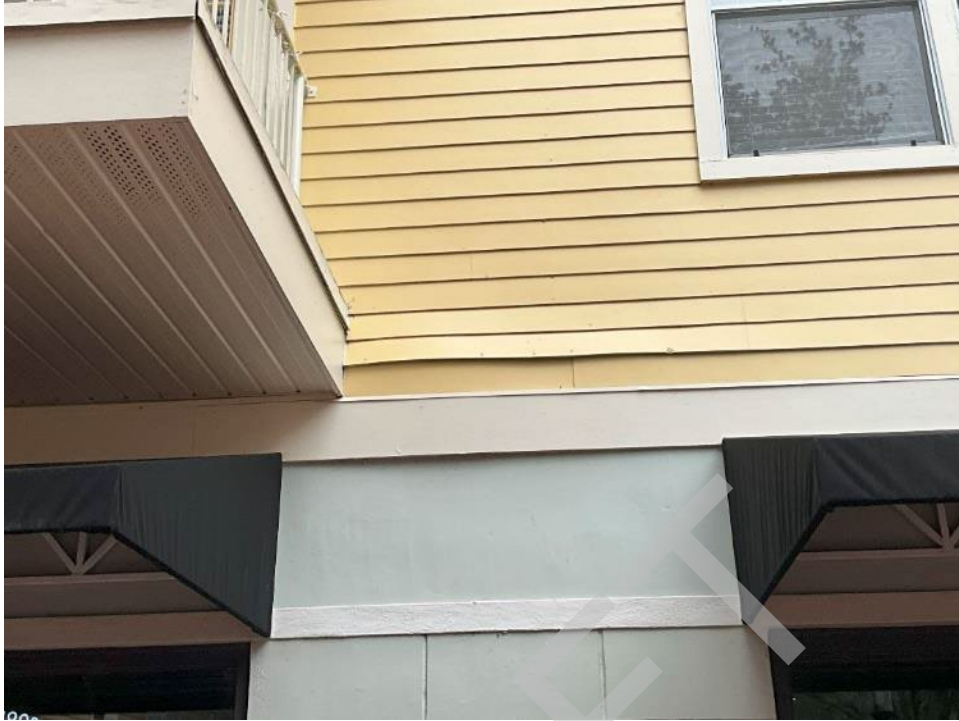
107. View of bulging siding observed around the building.

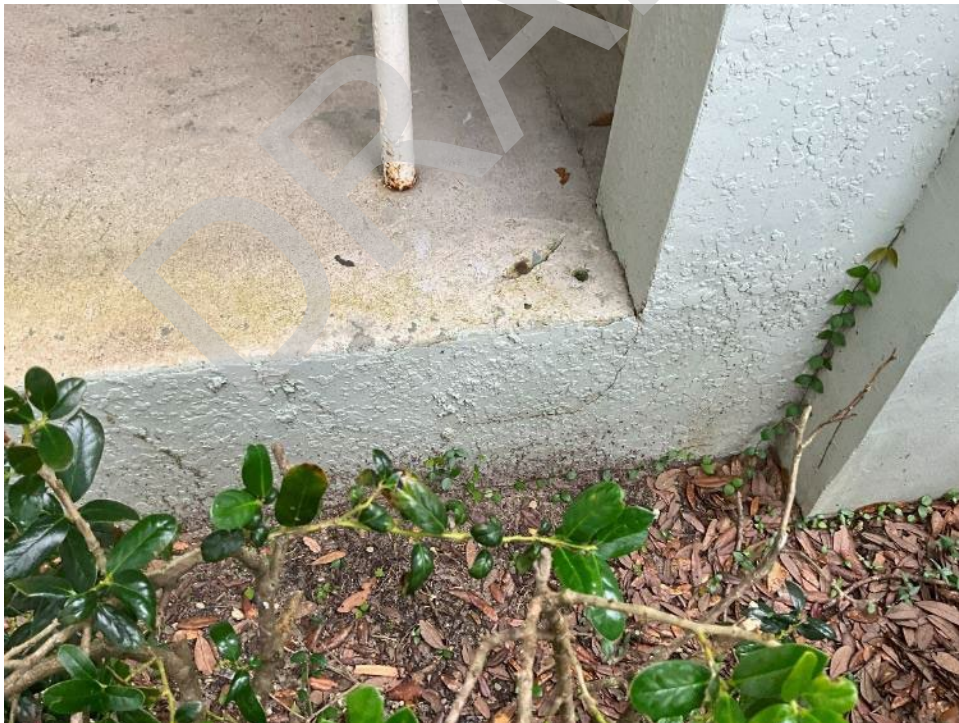
112. View of cracking in the stucco in front of the bottom slab.

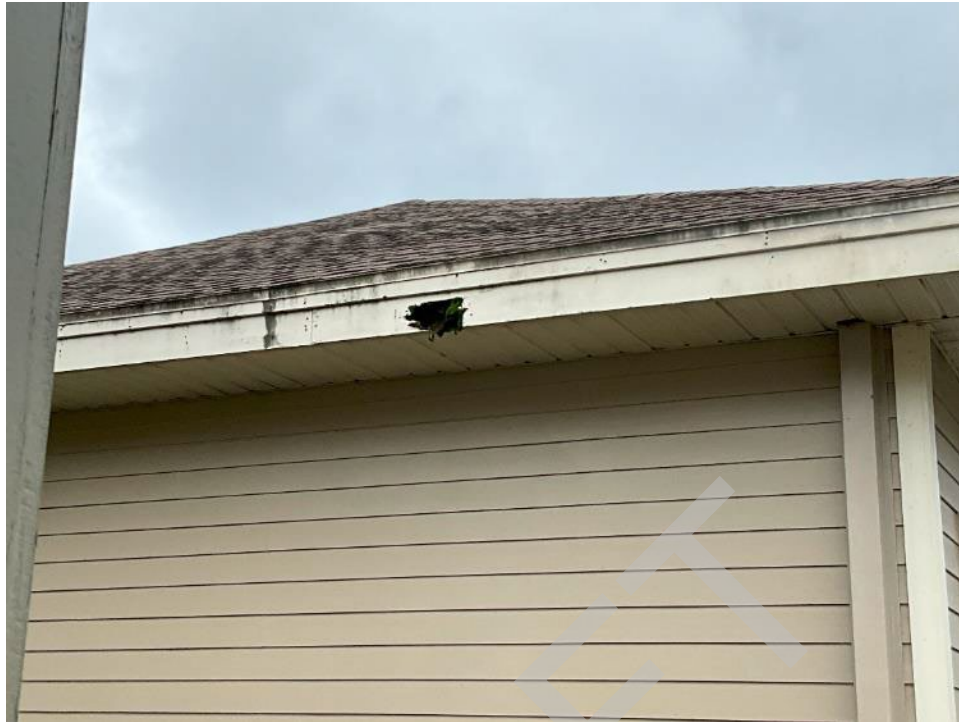
121. View of missing area in the fascia with vegetation growth located on the west side of the roof. The fascia will need to be removed to expose the trusses for Phase II.

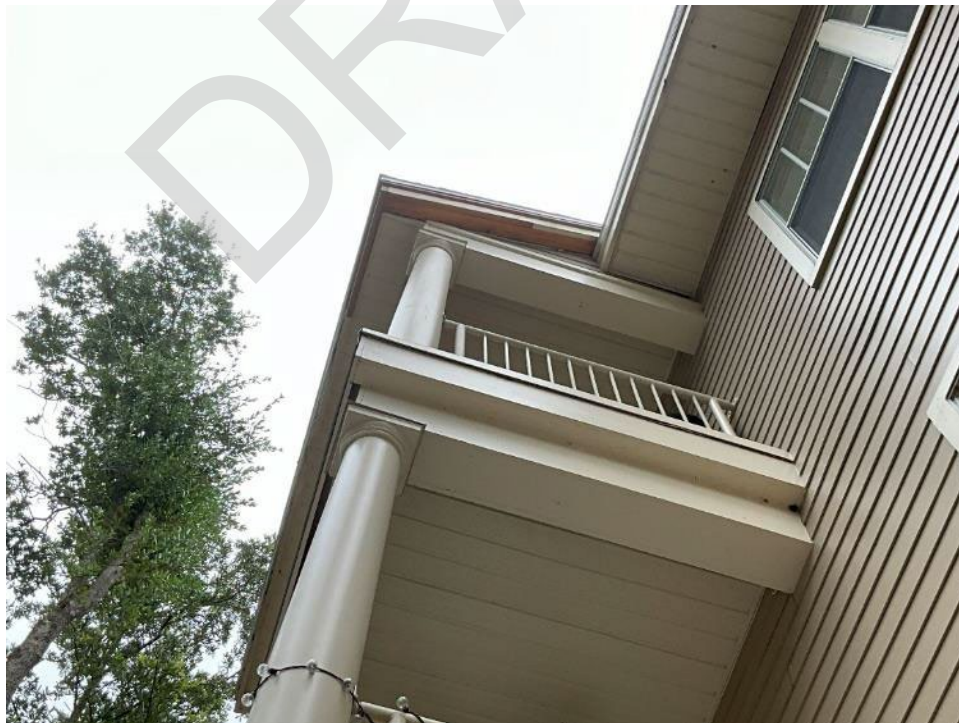
122. View of missing soffit material at the roof of a balcony on the west elevation.

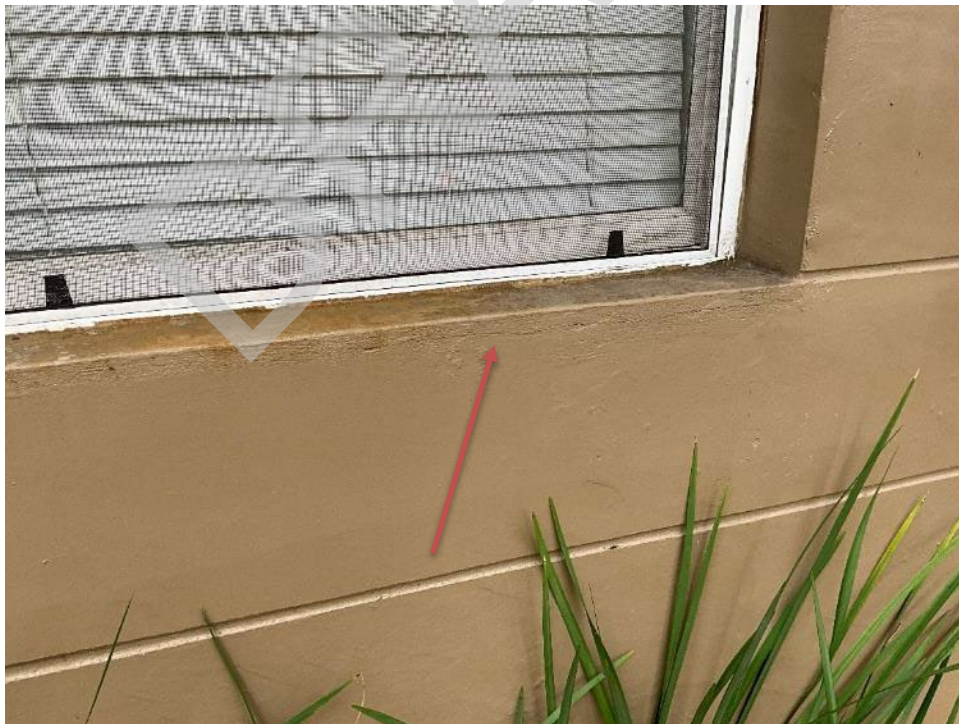
124. View of cracking under a window-sill.

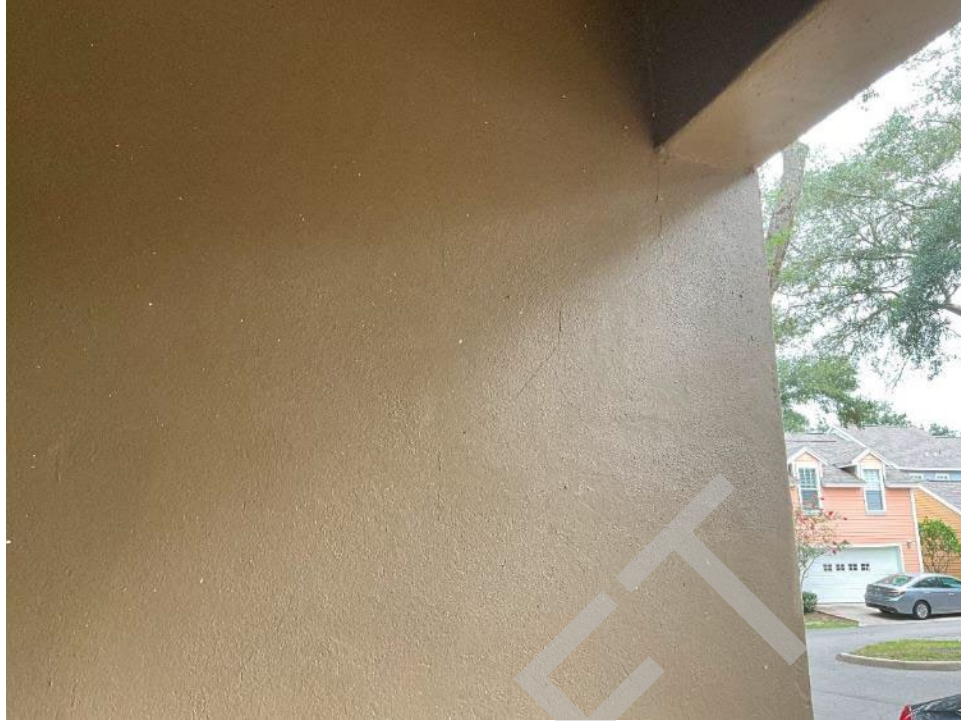
127. View of crack in the finish along the interior breezeway.
