001240125-0005457.00 | Attachment A

Village at Haile Condominiums Milestone Phase II –Site Photographs

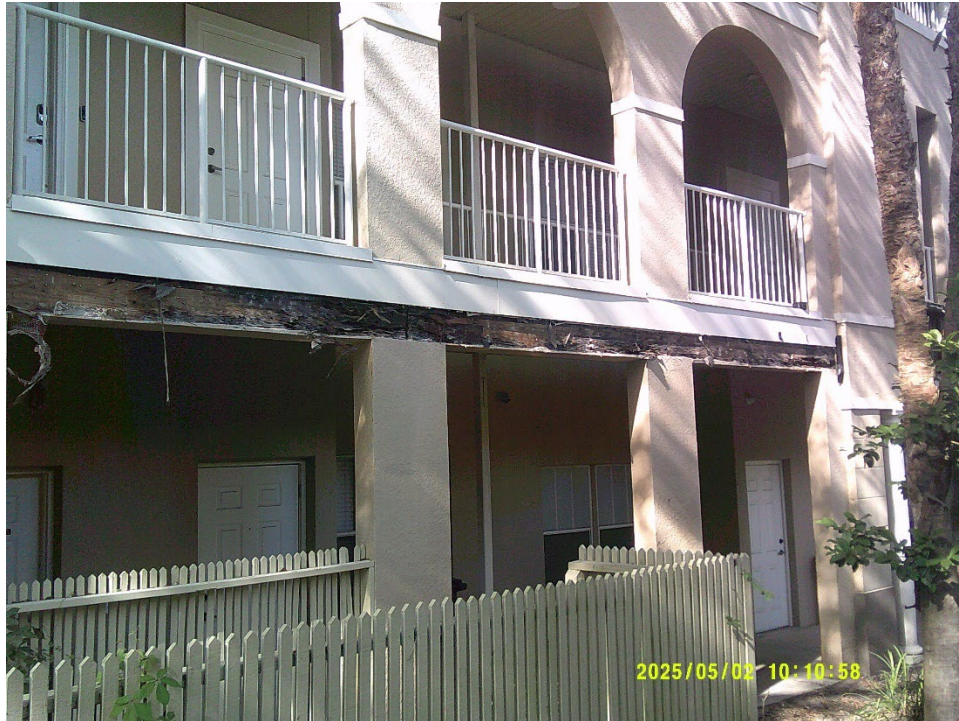
1. View of the exposed compromised beam at A101-A02 (refer to photograph 19 in the phase 1 report)

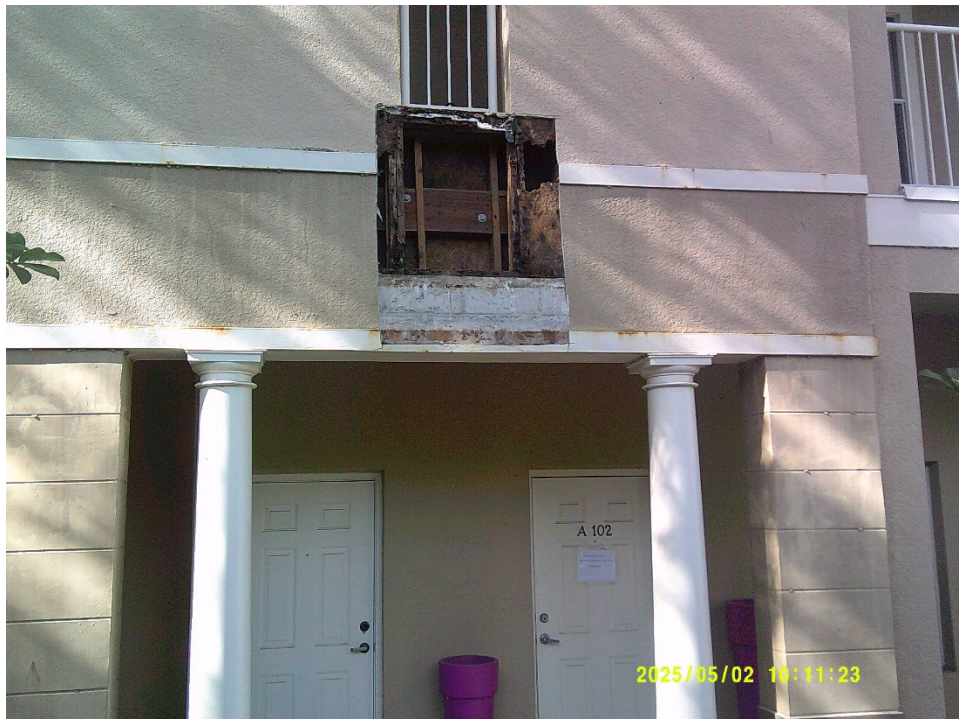
2. Additional area exposed during the phase 2 process, indicating water-damaged studs and OSB sheathing.

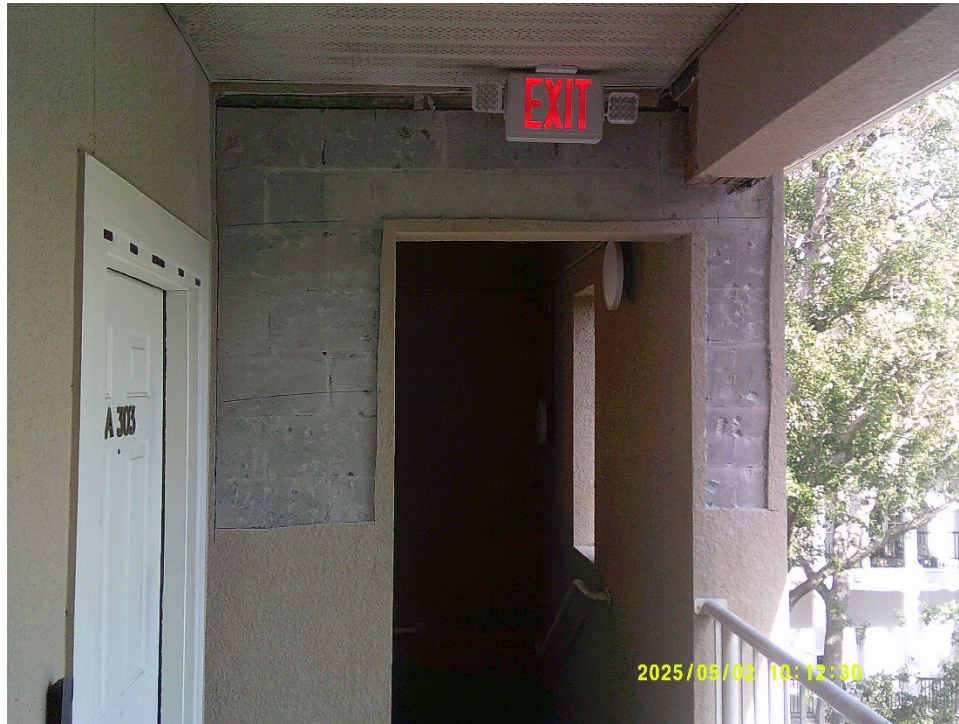
3. View of the exposed area observed at the stair entry in the breezeways. This specific photograph is at A303 (refer to photographs 20, 27, 66, 68, 69, 71, 75, 87, and 88 in the phase 1 report)

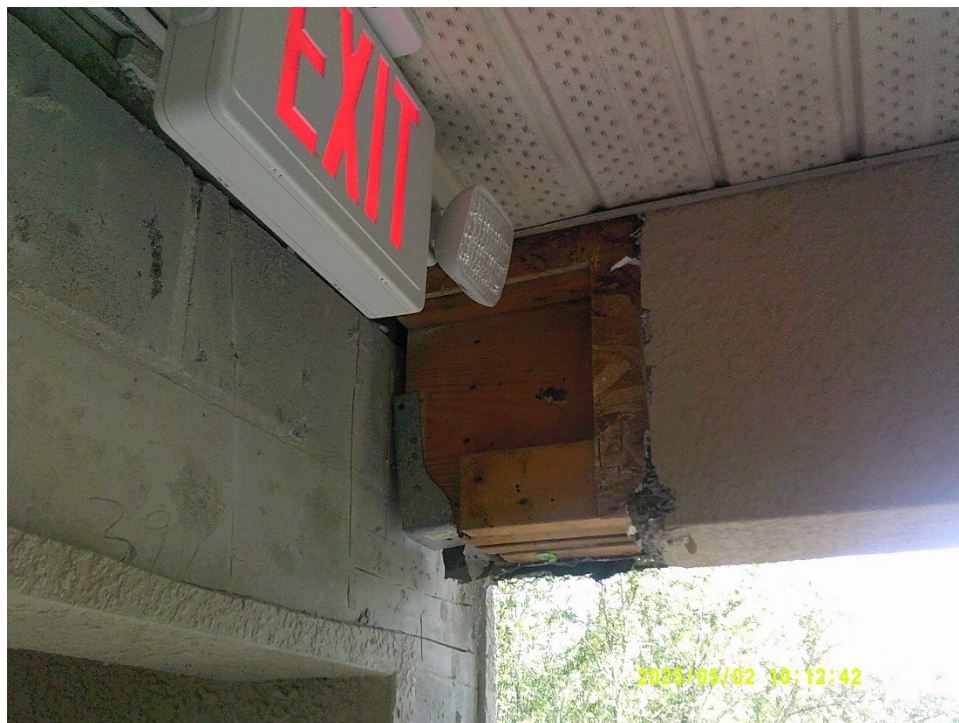
4. Additional photo of the wood beam to CMU wall connection in the previous photograph.

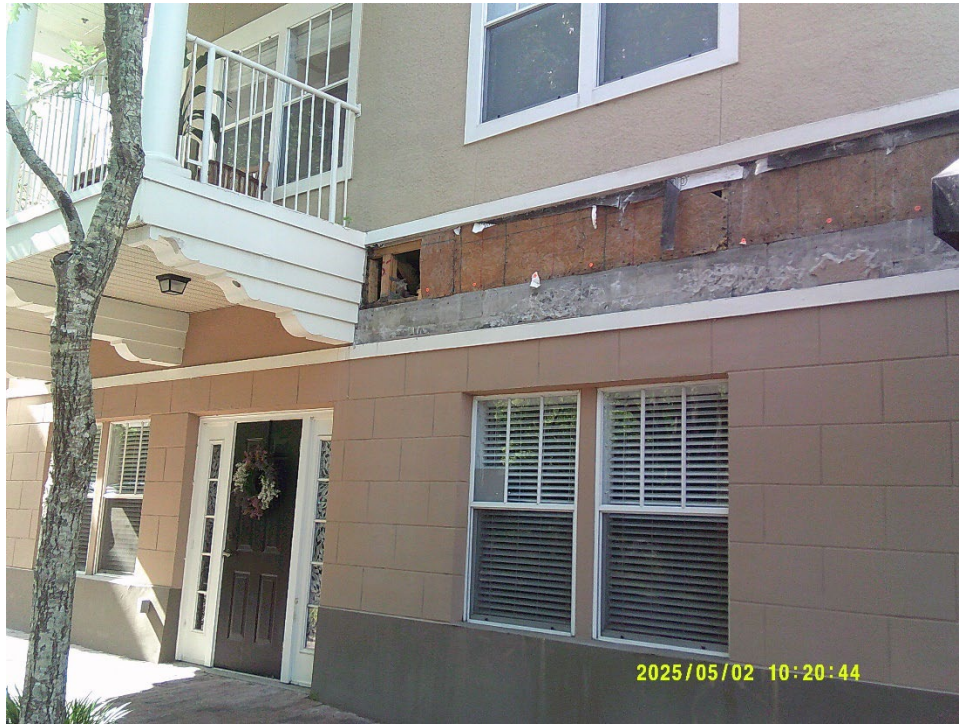
5. View of the exposed section at Building D. (Refer to photograph 52 in the phase 1 report)

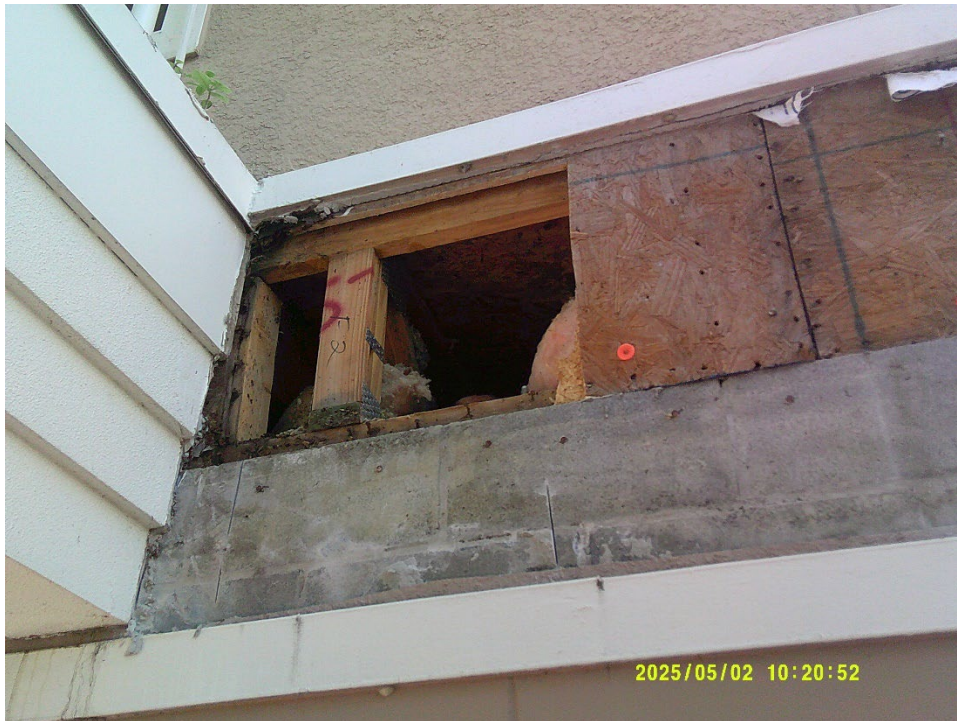
6. Close-up of the exposed area in the previous photograph. (Refer to photograph 52 in the phase 1 report).

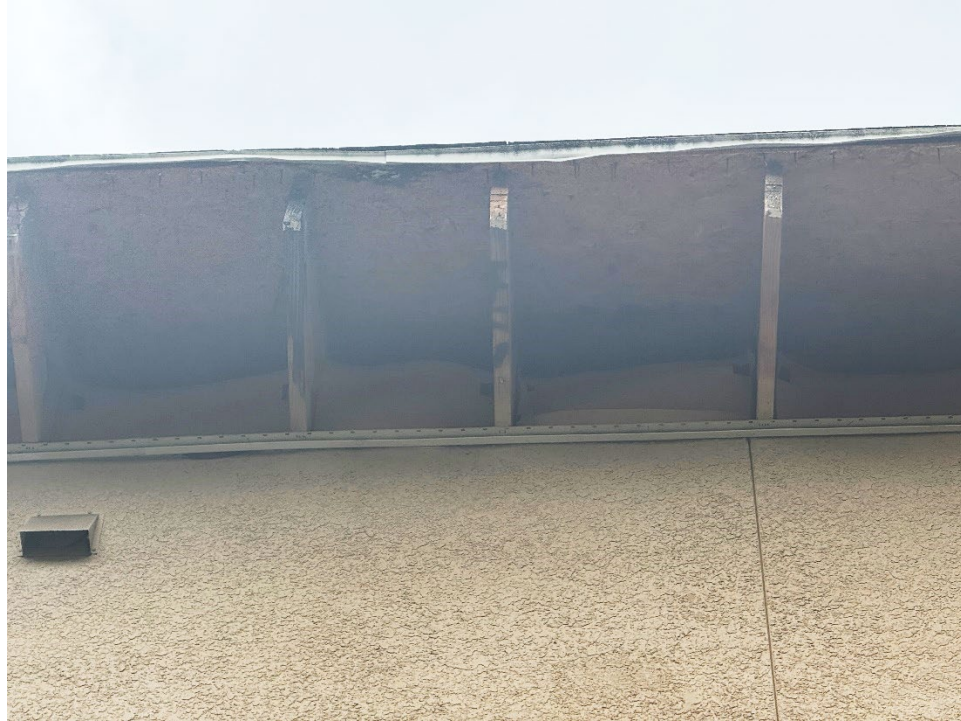
6. View of the minor water damage at the end of a wood truss at Building D. (Refer to photograph 53 in the phase 1 report.)

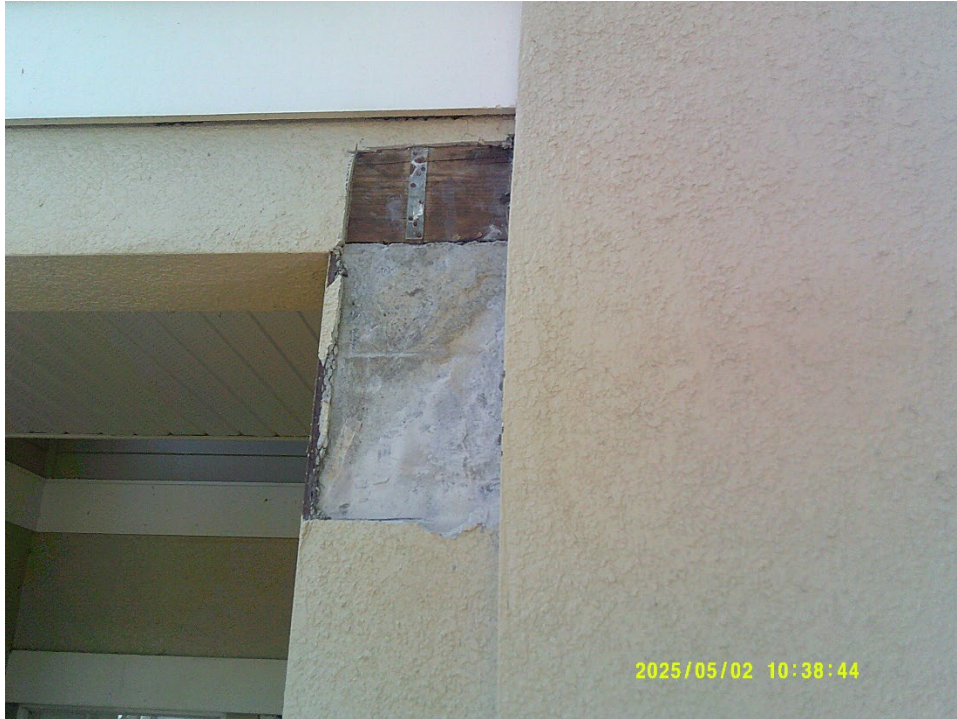
7. Close-up of the exposed area at Unit F103. (Refer to photograph 64 in the phase 1 report).

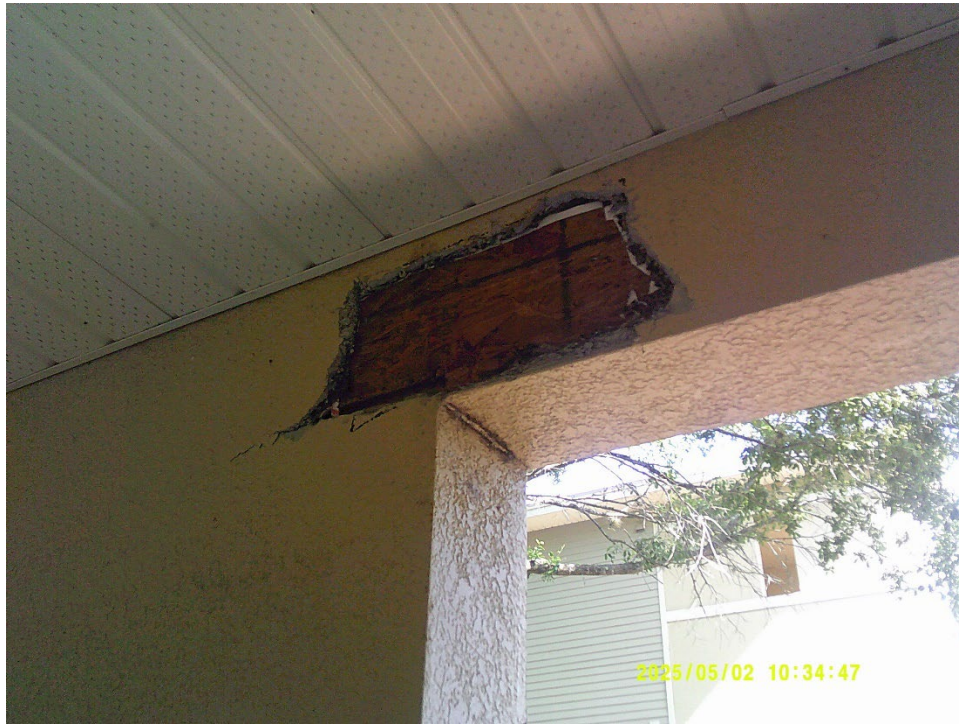
8. Close-up of the exposed area at Unit F101. (refer to photograph 65 in the phase 1 report)

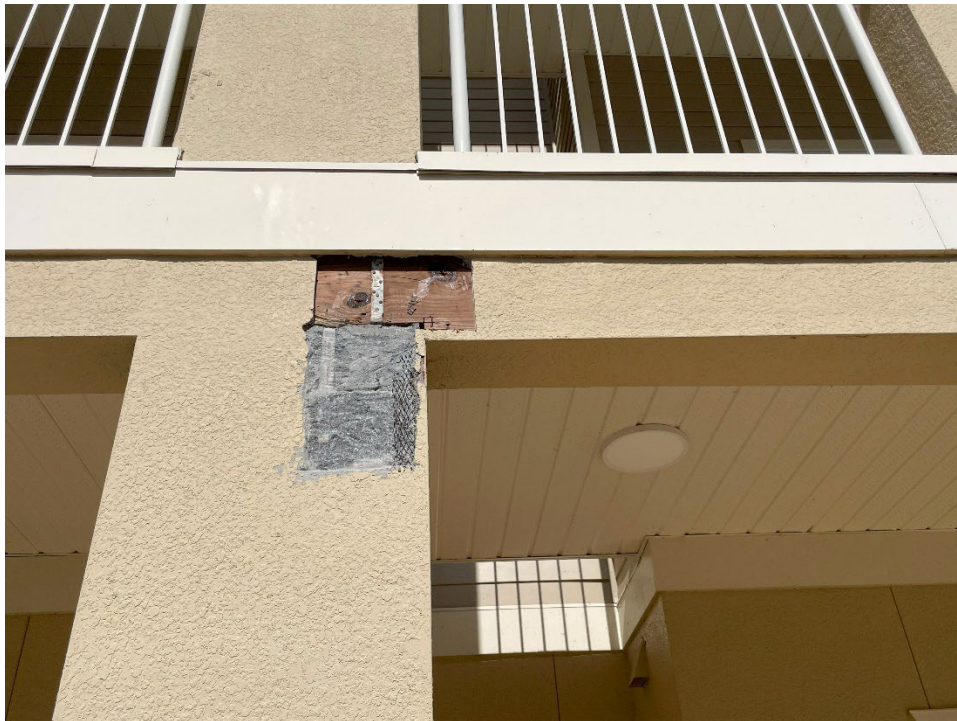
9. Close up of the exposed area near units G102 and G104. (Refer to photograph 72 in phase 1 report).

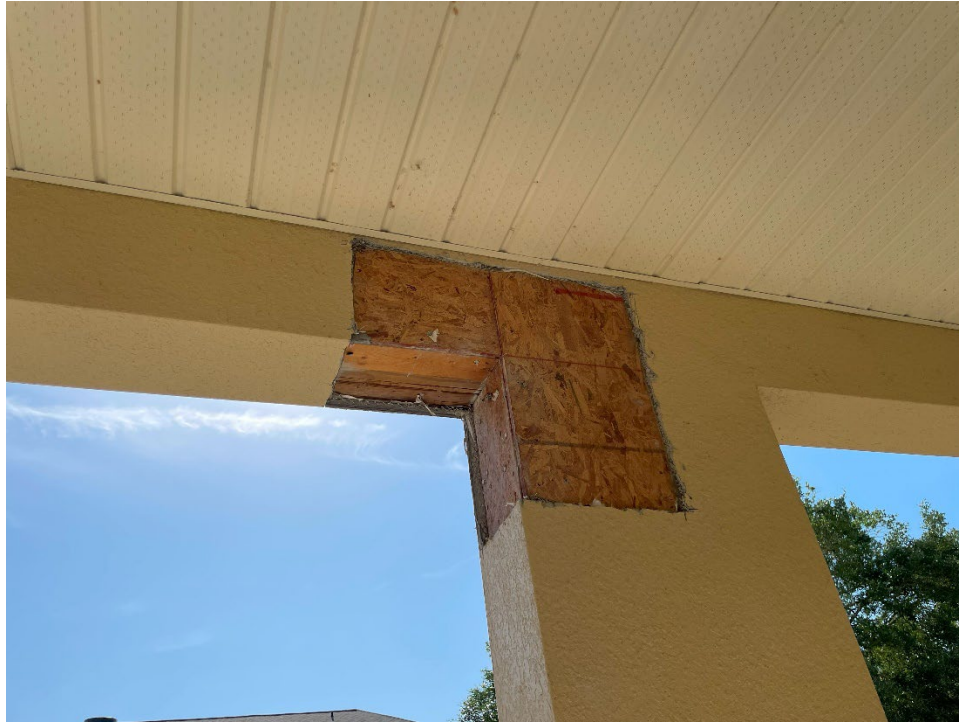
9. Close-up of the exposed area at Unit G204. (refer to photograph 76 in phase 1 report)

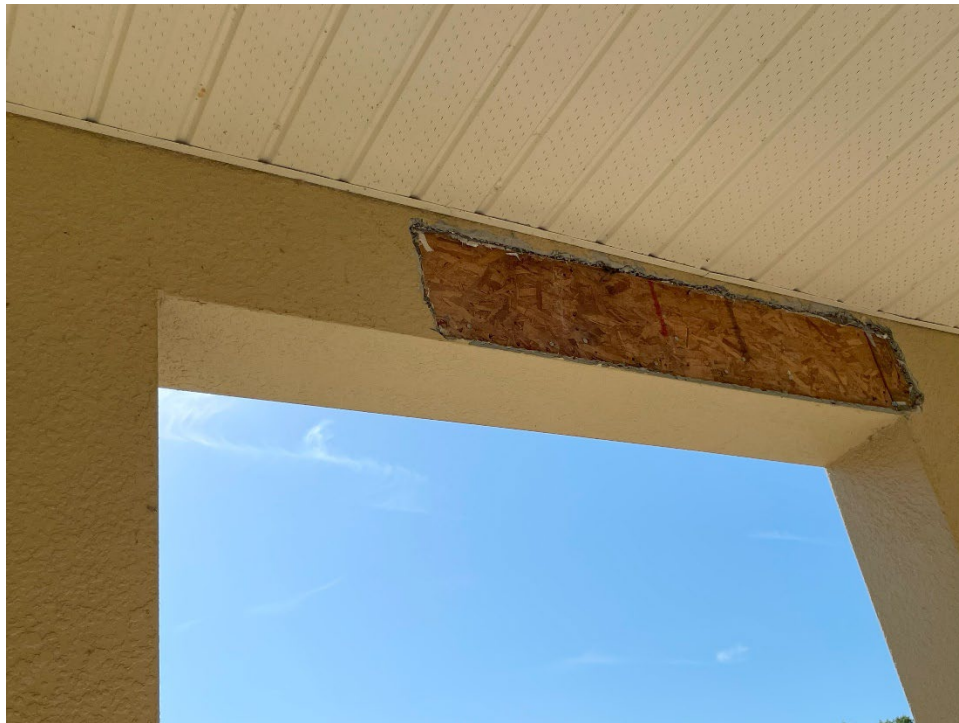
10. Close-up of the exposed area at Unit G201. (refer to photograph 77 in phase 1 report)

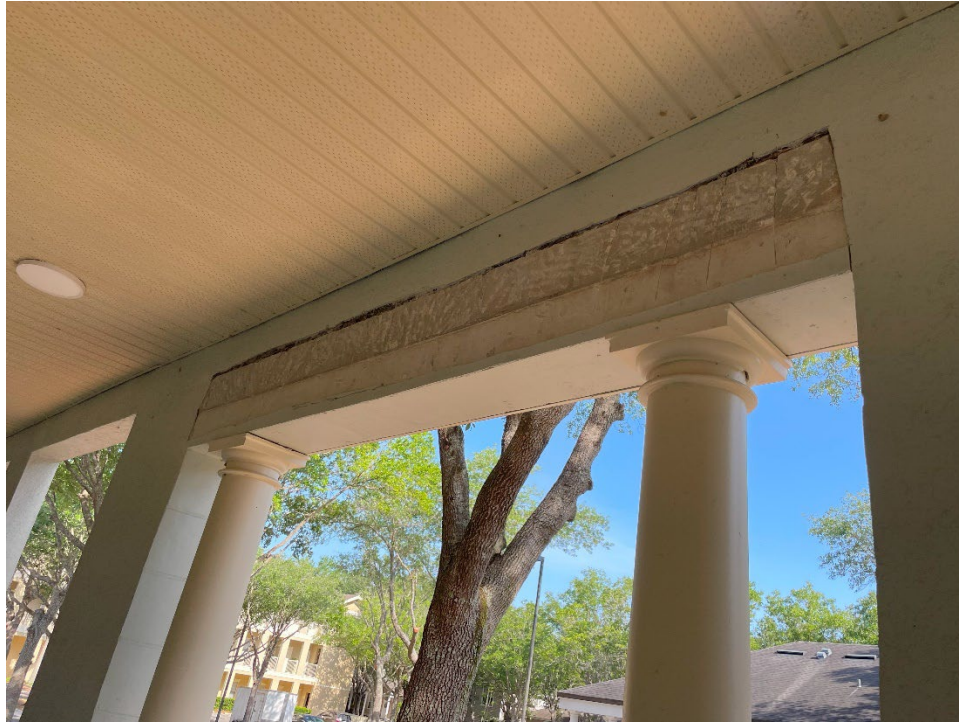
11. Close up of the exposed area at Unit F101. (refer to photograph 65 in phase 1 report)

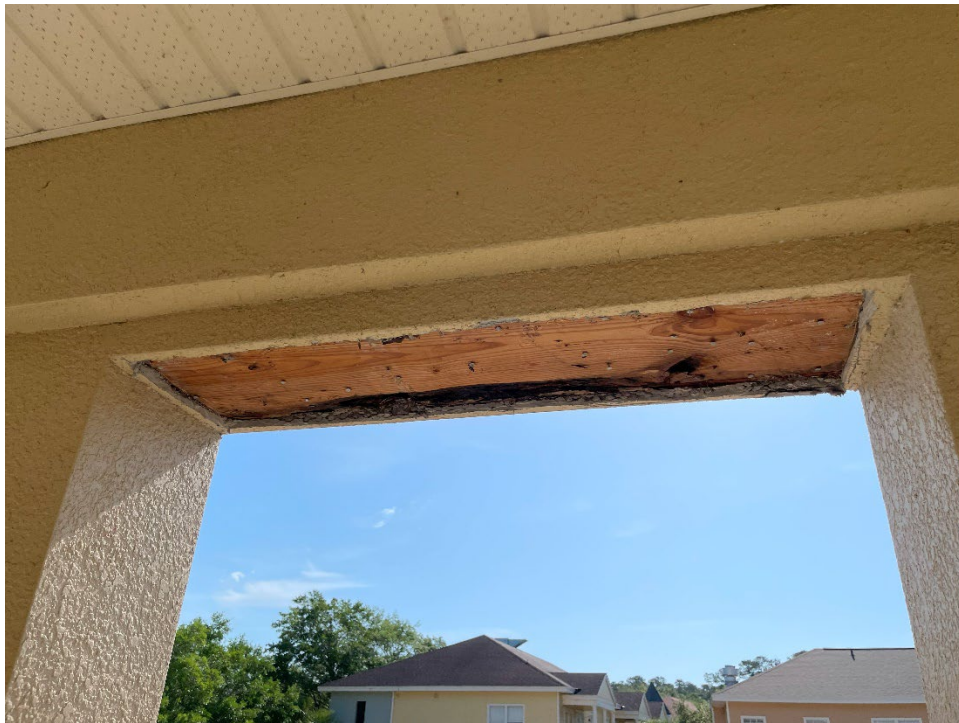
12. View of water-damaged sheathing at G302 and G303 . (refer to photograph 73 in phase 1 report).

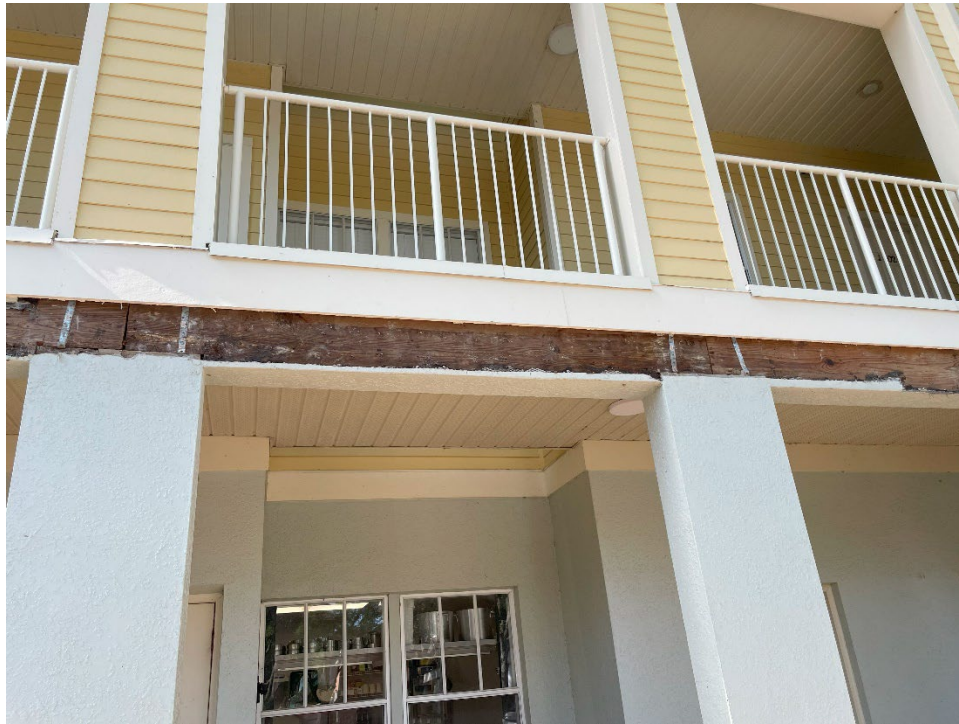
13. Close up of the exposed area at Unit J201. (refer to photograph 105 in phase 1 report)

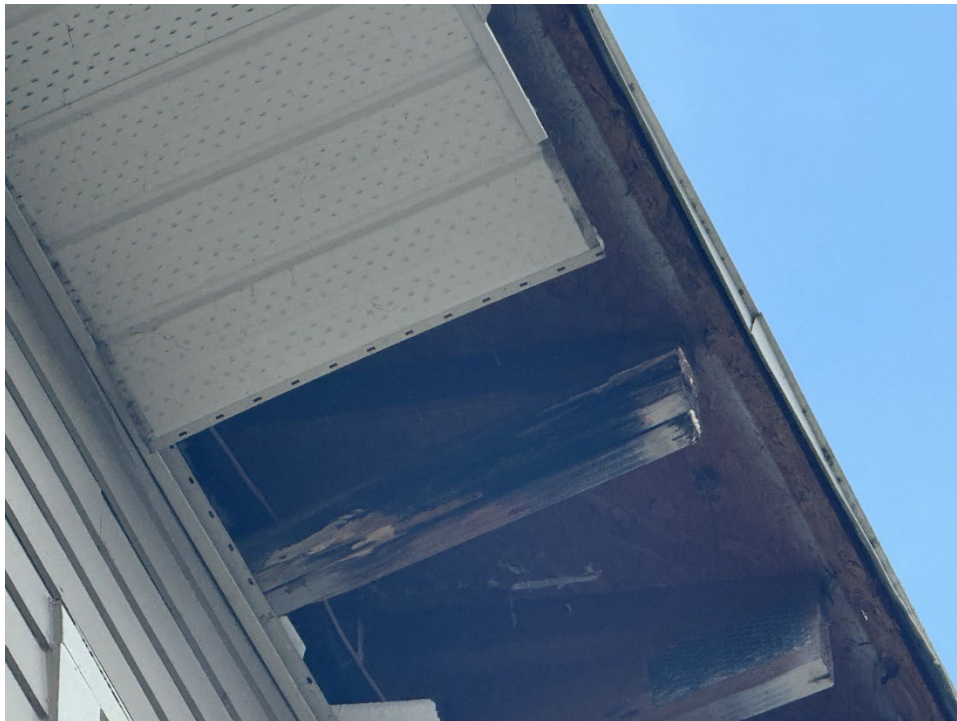
14. An additional soffit was exposed at Building K, which indicated a water damaged truss.
