# VILLAGE AT HAILE CONDOMINIUM – DESTRUCTIVE TESTING SUMMARY

July 17, 2026

**SUBJECT: Destructive Testing Summary and Recommendations**

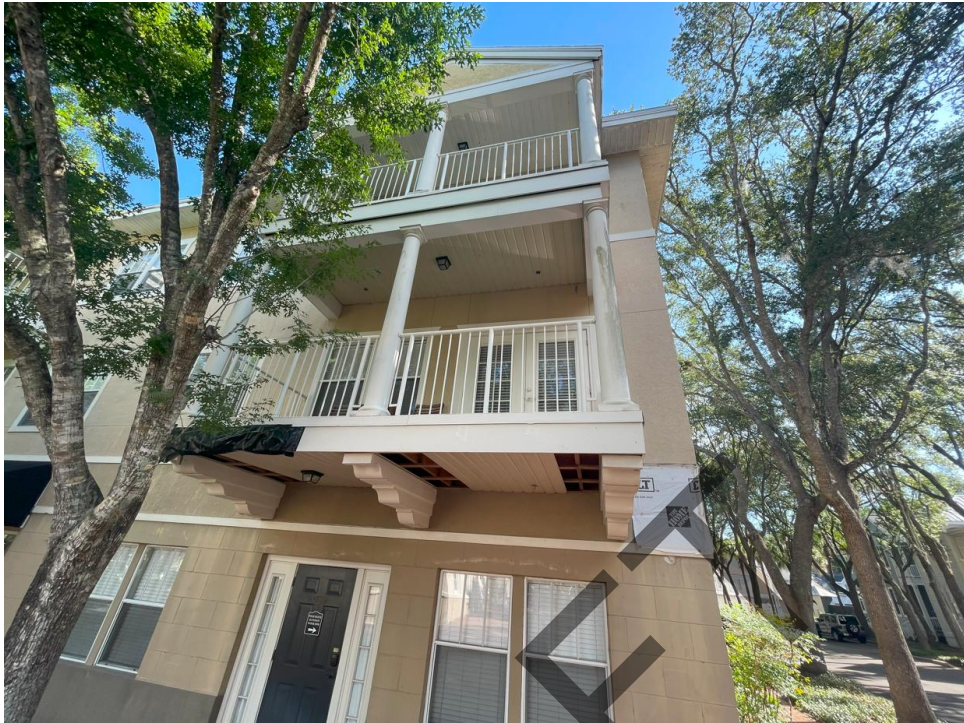
Typical DT at the balconies consisted of removing soffit materials and, in some cases, cutting and removing the perimeter trim to expose the underlying wood framing. More extensive DT was performed at the balcony of Unit A-201 (**Photograph 1**). This testing included removal of a decorative foam support below the balcony and cutting an opening in the bottom of the balcony column to expose internal components. Based on the destructive testing performed, the following observations were made:

Photograph 1: View of the balcony at Unit A-201. This is a typical balcony configuration.

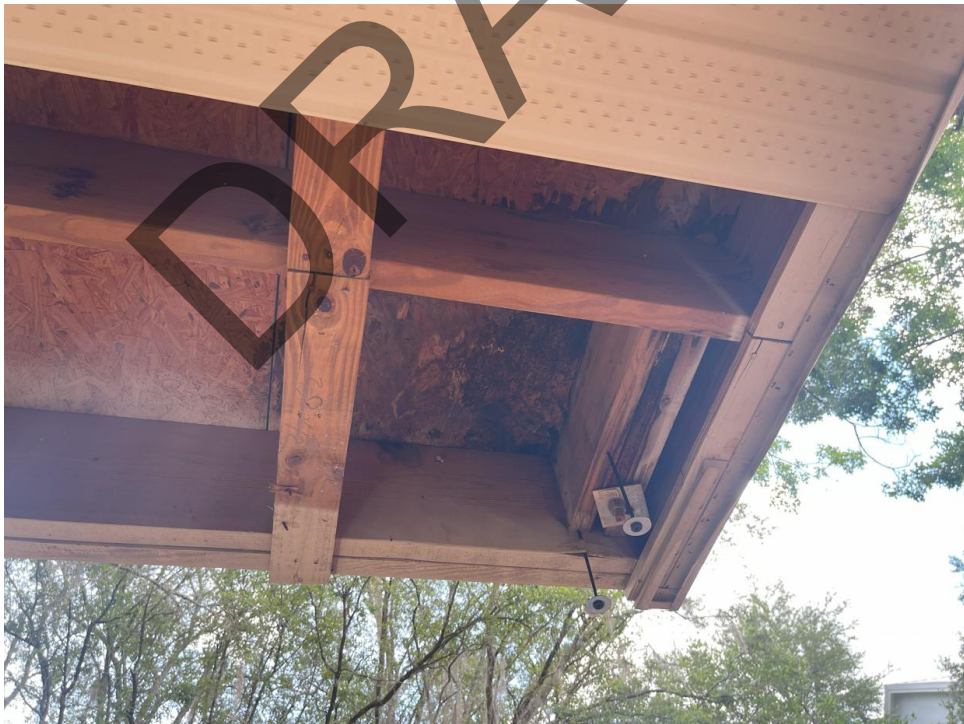
- Deteriorated oriented strand board (OSB) sheathing was observed beneath the balconies, particularly at locations below the columns, at all tested locations (**Photograph 2**).
- A threaded rod was observed extending through the interior of the balcony column at Unit A-201 (**Photograph 3**). A nut and bearing plate were observed at the base of the threaded rod. Corrosion was observed on the threaded rod at some locations. In addition, some connections did not appear to be properly torqued. This is called a Hurri-bolt system and acts as lateral and uplift reinforcement in the structure.

The extent of similar conditions at untested locations should be verified during repair implementation and may differ from the representative conditions observed during destructive testing. Deteriorated OSB sheathing was observed beneath the balcony columns at all tested locations. The observed deterioration is consistent with prolonged moisture exposure and may affect the serviceability of the balcony assembly. Cracking was also observed in the concrete balcony slabs at several locations.

Photograph 2: View of deteriorated oriented strand board (OSB) sheathing below the balcony at Unit A-201.

NV5 recommends submitting proposals to develop balcony restoration drawings that address damaged OSB subfloor sheathing, water infiltration, and deficient Hurri-Bolt connections. This restoration protocol will be implemented as a multi-phase project, with the most severe conditions addressed first and the remaining conditions phased based on severity. The most severe conditions

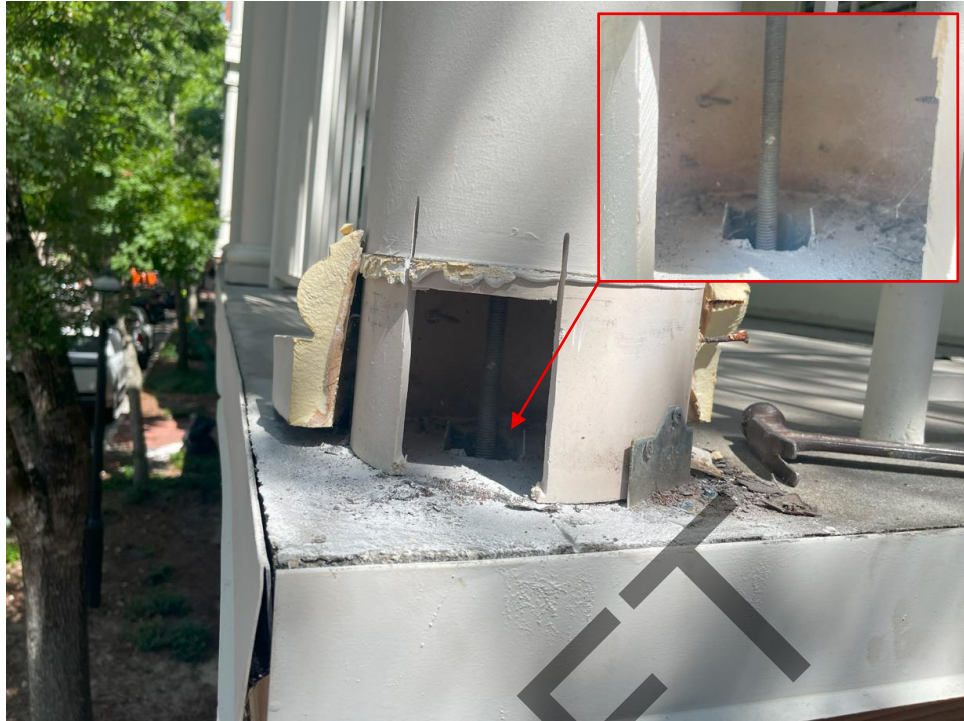
The Hurri-Bolt threaded rod assembly was observed within the balcony column system and consists of a threaded rod extending vertically through the column enclosure with a bearing plate and nut at the base of the rod. Portions of the exposed rod exhibited corrosion at some locations, and some connections appeared loose. The threaded rod was observed extending upward toward the roof structure; however, the upper connection could not be fully evaluated during the destructive testing because structural wood framing obstructed the view. The observed corrosion and improperly torqued connections may reduce the uplift and lateral load resistance provided by the system at these balcony locations. As such, the observed configuration warrants further evaluation to confirm the intended load path and structural function of the threaded rod system.

Photograph 3: View of the interior of the balcony column at Unit A-201. A threaded rod was observed extending through the column.

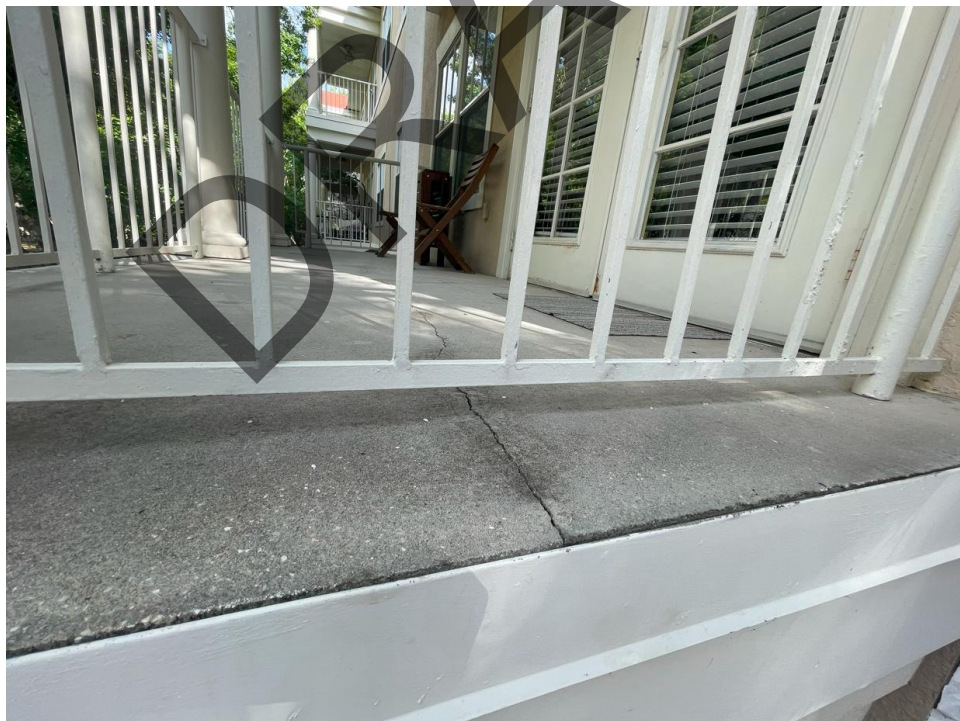
- Cracking was observed in the concrete balcony slabs at several locations (**Photograph 4**).
- Wood balcony joists cantilevered from the building and were oriented parallel to the floor trusses. At some locations, gaps were observed between the balcony joists and adjacent floor trusses (**Photographs 5 through 7**).
- Cripple stud wood blocking was observed between the balcony joists and the top of the CMU wall, where it appeared to function as a load-bearing member (**Photograph 8**).

Photograph 4: View of cracking observed in the concrete balcony slab at Unit A-201.

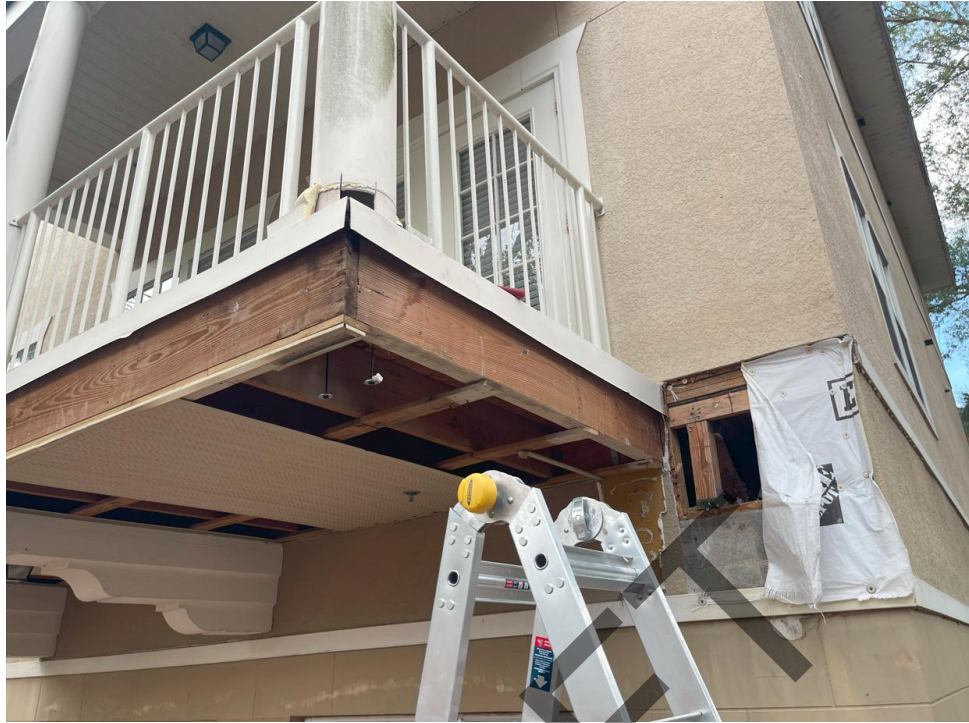
Photograph 5: View of the exposed wood framing at the balcony of Unit A-201 and the exposed wood floor trusses between the first and second floors.

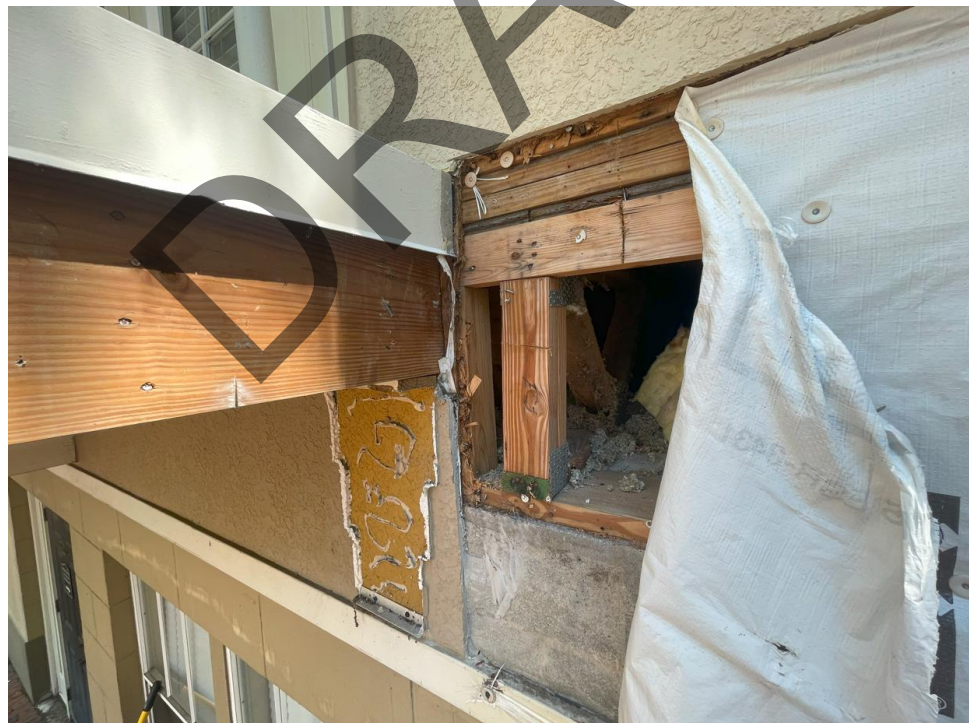
Photograph 6: View of the exposed wood framing at the balcony of Unit A-201 and the exposed wood floor trusses between the first and second floors.

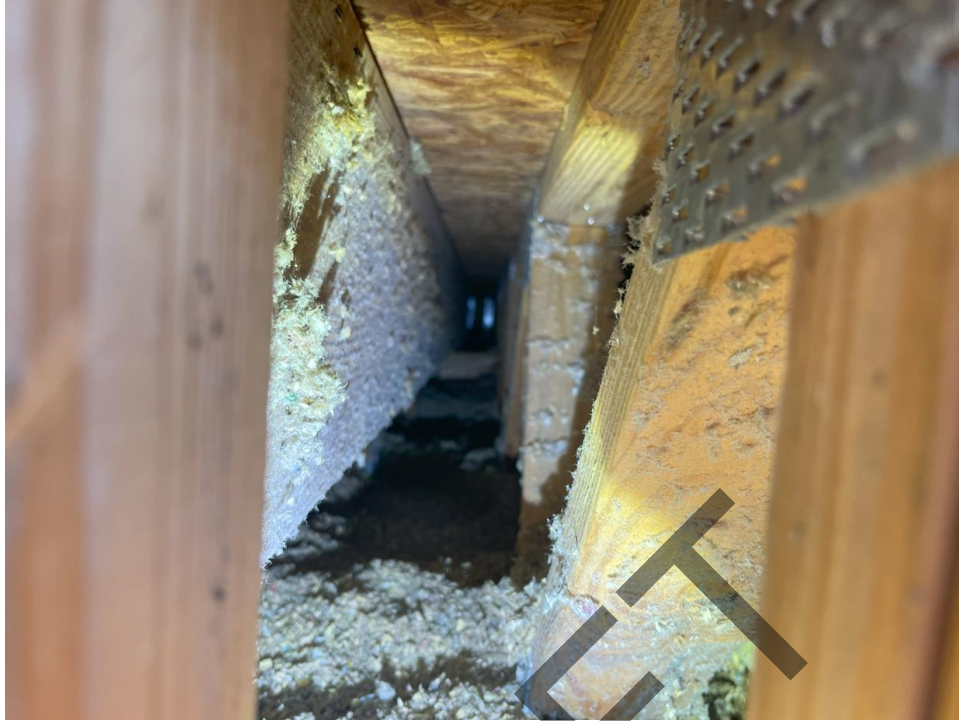
Photograph 7: View of an approximately 3- to 4-inch gap between the balcony joist and the floor truss between the first and second floors at Unit A-201.

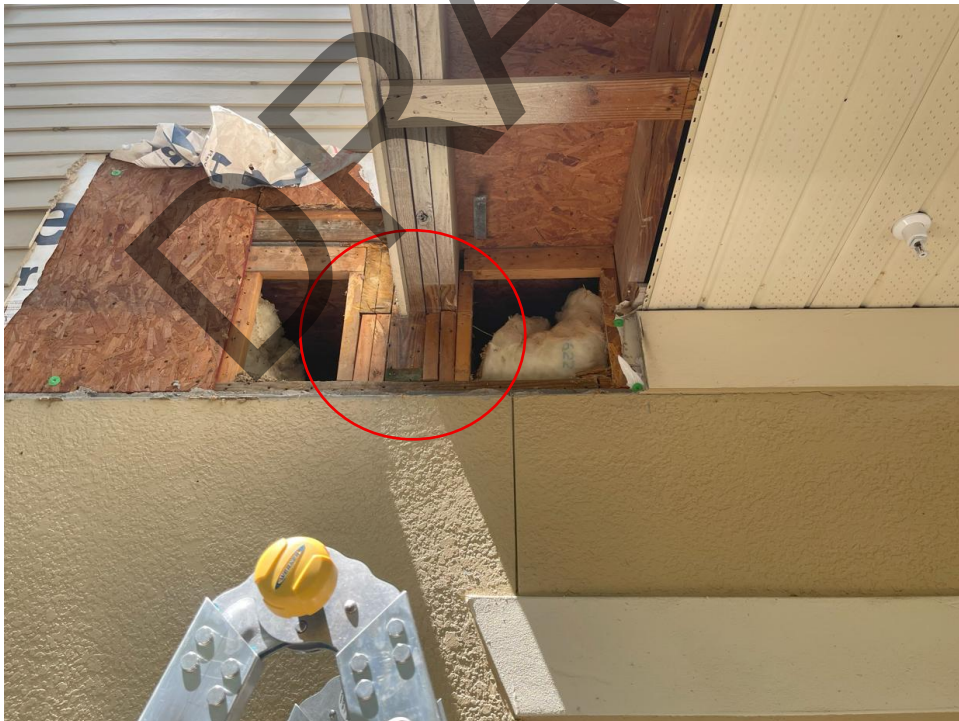
Two cripple studs were observed between the balcony framing and the CMU wall. Based on our observations, these members appear to have been field-installed and do not appear to be part of an engineered load path. Therefore, we recommend installing a 4x4 column anchored to the CMU wall with a hurricane tie connection at the beam.

Photograph 8: View of wood blocking between the balcony joists and the CMU wall at the balcony of Unit F-202.

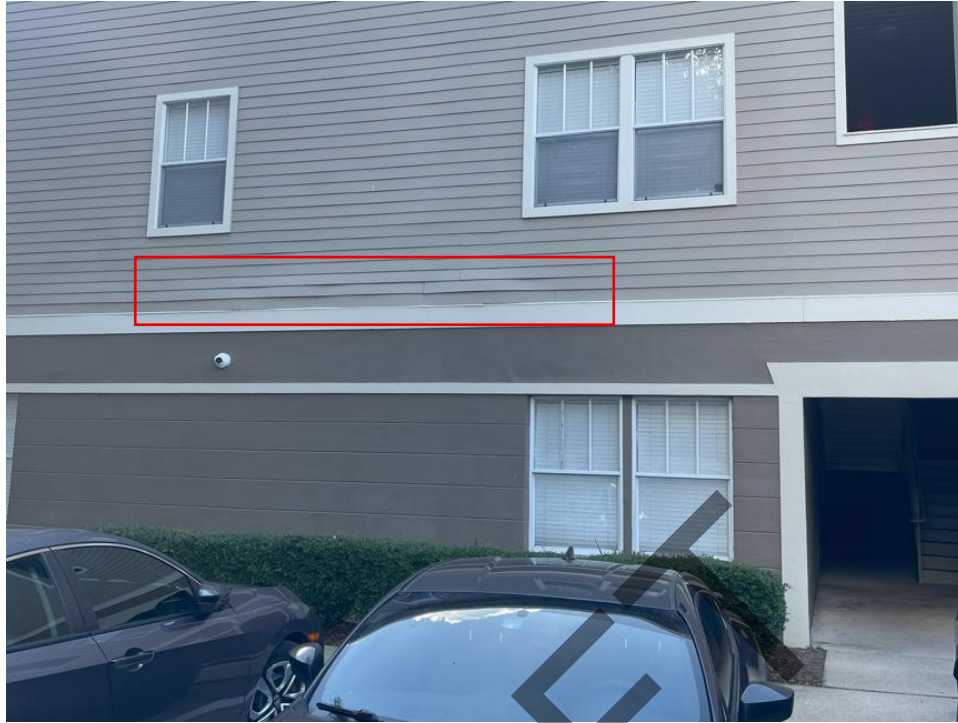
Typical DT at locations exhibiting bulging exterior siding (**Photograph 9**) consisted of cutting and removing portions of the siding and associated OSB wall sheathing. Observations at the selected locations revealed the following:

The extent of similar conditions at untested locations should be verified during repair implementation and may differ from the representative conditions observed during destructive testing. Based on the observations, the bulging exterior siding appears to be associated with deformation of the underlying OSB wall sheathing. Moisture exposure, in conjunction with improperly installed or missing fasteners, may have contributed to the warping and displacement of the wall sheathing.

Photograph 9: View of bulging siding observed along the west elevation of Building K.

NV5 recommends submitting proposals to develop shear wall sheathing restoration drawings that address the extent of damaged or warped wall sheathing requiring replacement. Areas containing warped, swollen, or otherwise deteriorated OSB wall sheathing should be removed and replaced in kind with proper fastening in accordance with applicable building code and manufacturer requirements. At locations adjacent to balconies, replacement of affected wall sheathing should be accompanied by evaluation and repair of potential water intrusion pathways. Additional flashing should be installed at balcony interfaces, as necessary, to direct water away from the exterior wall assembly. Following repairs, an appropriate water-resistive barrier shall be installed over the wall sheathing, and the exterior siding shall be restored to match the existing construction. All shear wall sheathing deficiencies identified as part of the Milestone Project shall be repaired prior to project

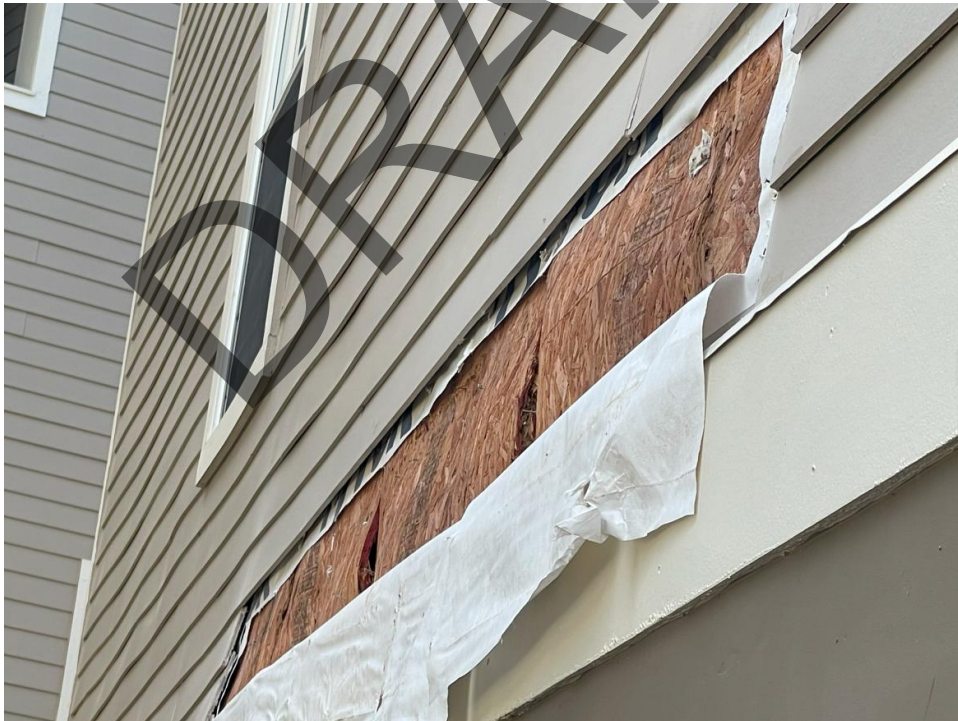
- Warped OSB wall sheathing was observed at all tested locations (**Photograph 10**).
- Staining was observed on wood framing and sheathing components at several locations (**Photograph 11**). The more severe staining was generally observed adjacent to balconies.
- Missing fasteners were observed at several locations between the OSB wall sheathing and wall framing (**Photograph 12**).
- Several locations exhibited overdriven fasteners that had penetrated through the OSB wall sheathing (**Photograph 13**).

Photograph 10: View of warped oriented strand board (OSB) sheathing along the west elevation of Building K.

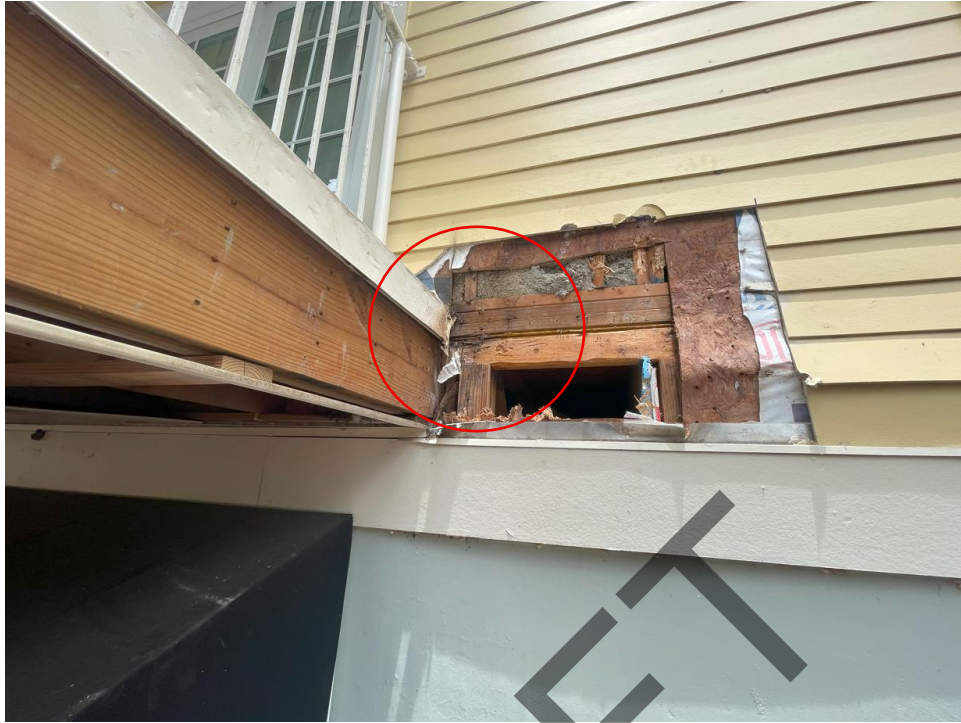
Photograph 11: View of stained wall framing observed to the east of the balcony at Unit J-202.

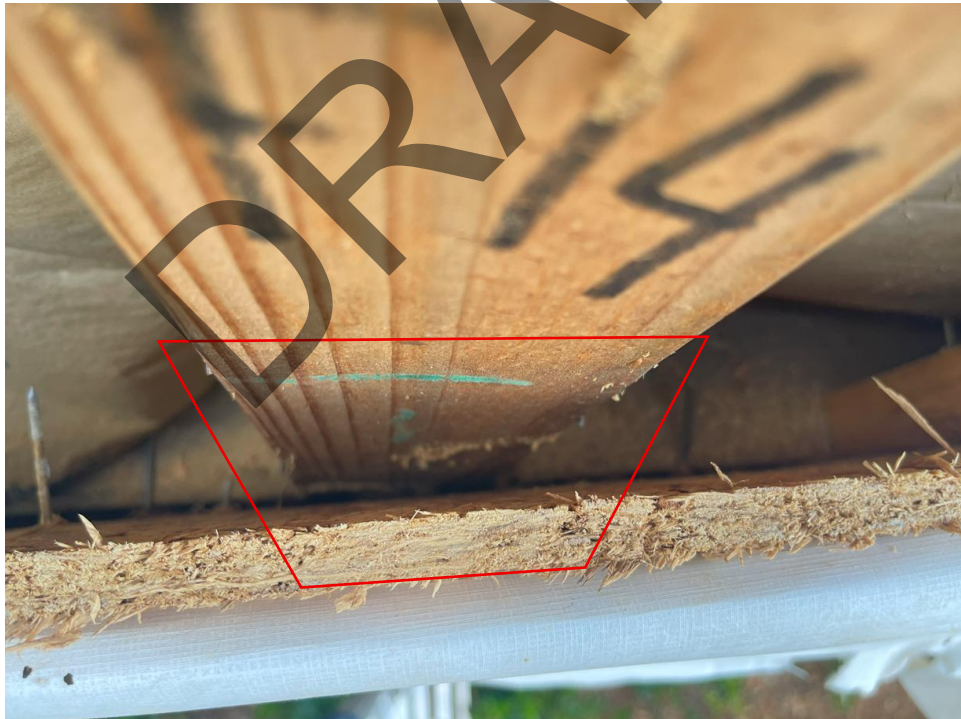
Photograph 12: View of missing fasteners between the OSB sheathing and wood framing along the west elevation of Building K.

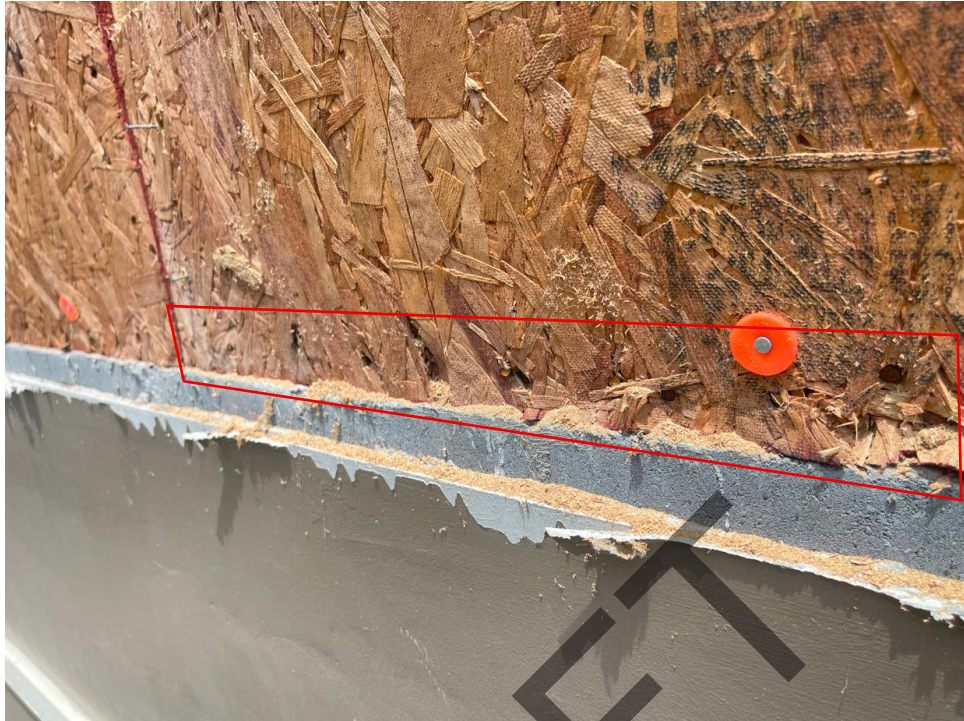
Photograph 13: View of overdriven fasteners between the OSB sheathing and wood framing along the west elevation of Building K.
