VILLAGE AT HAILE CONDOMINIUM – DESTRUCTIVE TESTING SUMMARY

January 30, 2026

SUBJECT: Destructive Testing Summary and Recommendations

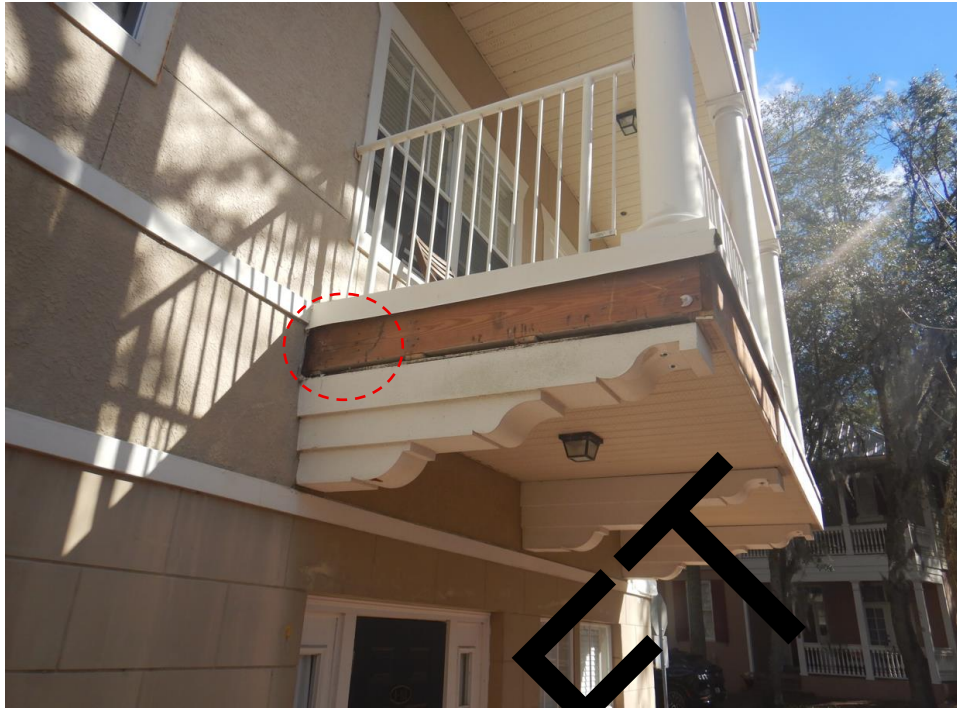
Photograph 1: View of a portion of stained fascia board along the east balcony along the second floor balcony of Building A.

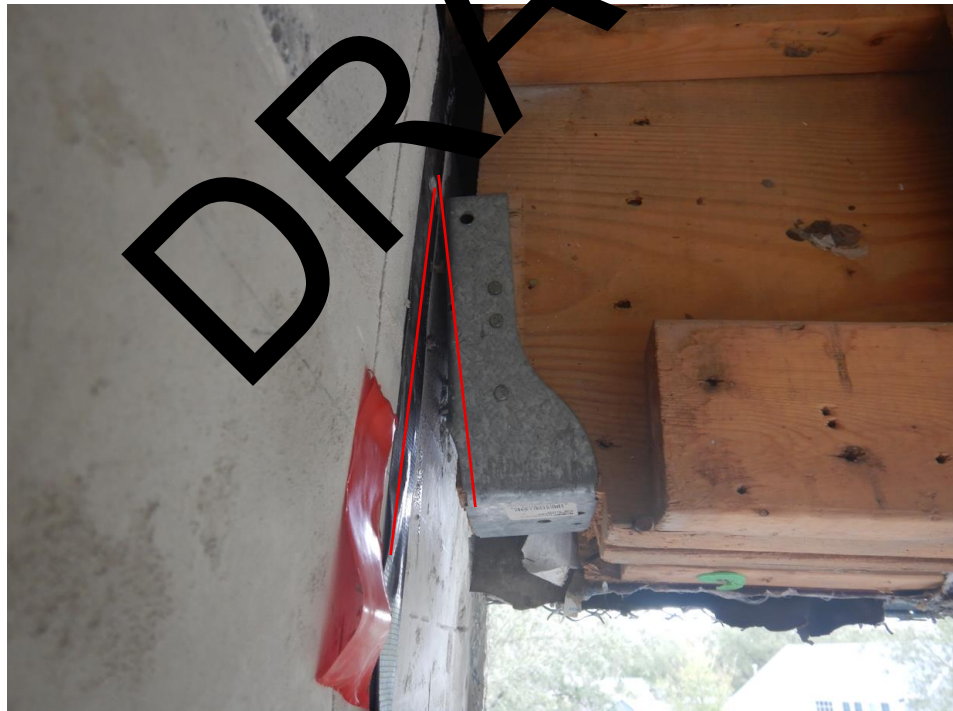
Due to consistent findings across multiple buildings, several uninvestigated locations were assumed to exhibit similar conditions to those previously observed. The primary structural concern involves the breezeway beam connections to the concrete masonry unit (CMU) walls. At the first-floor breezeway level, the beams were observed bearing directly on the CMU wall and/or columns and were secured with a metal strap resembling a hurricane tie typically used in wood-framed roof truss systems (**Photograph 3**). At the second-floor breezeway level, the beams did not appear to have any direct connection to the CMU wall; instead, each beam was observed bearing on a small section of wood framing (**Photograph 4**). At the third-floor breezeway level, the beams were supported by USP face-mount joist hangers, installed with nails at the beam interface and anchor screws into the CMU wall. In several instances, the beams were pulling away from the wall, resulting in measurable separation between the hanger assembly and the CMU substrate (**Photograph 2**).

Photograph 2: View of separation between the north breezeway beam and CMU block on the third floor of Building A.

NV5 recommends installing temporary shoring at all locations where the existing beam-to-wall connections present a structural concern (**Attachment C – Shoring Locations**). Additional shoring will also be required at locations below these elevated concern areas to ensure proper load transfer to the ground level and to prevent unintended overloading of intermediate building components. We further recommend that a properly engineered, permanent connection be designed and installed at these locations to prevent any additional structural movement. In addition, NV5 recommends expanding the destructive testing scope to confirm whether similar conditions exist throughout all buildings. These measures will help mitigate further damage and support timely and effective resolution of the issue.

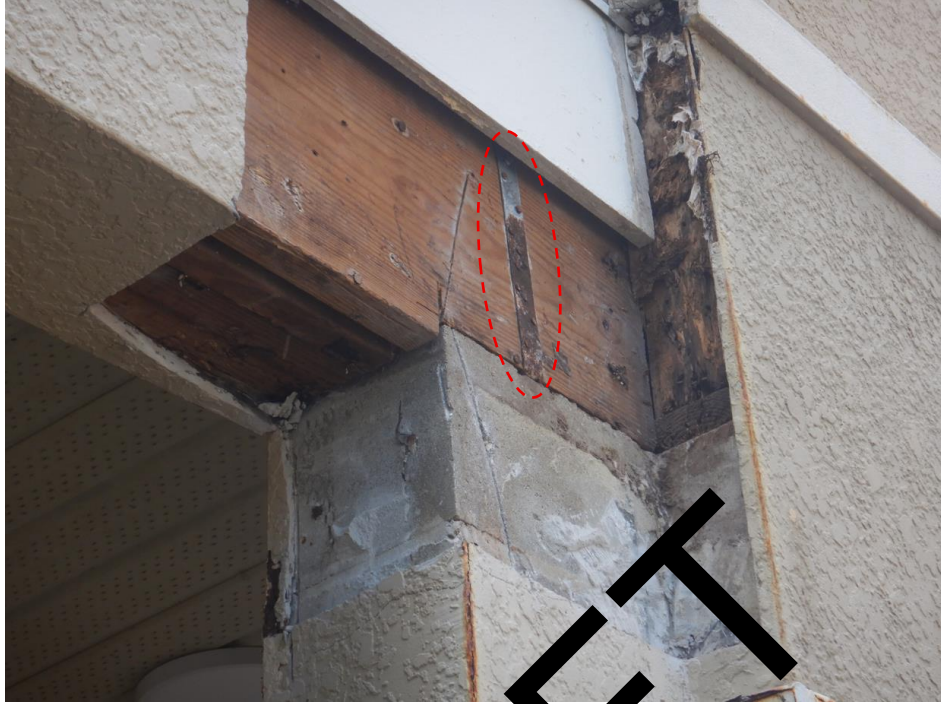
Photograph 3: View of a strap connection between the south breezeway beam and the CMU column on the first floor of Building B.

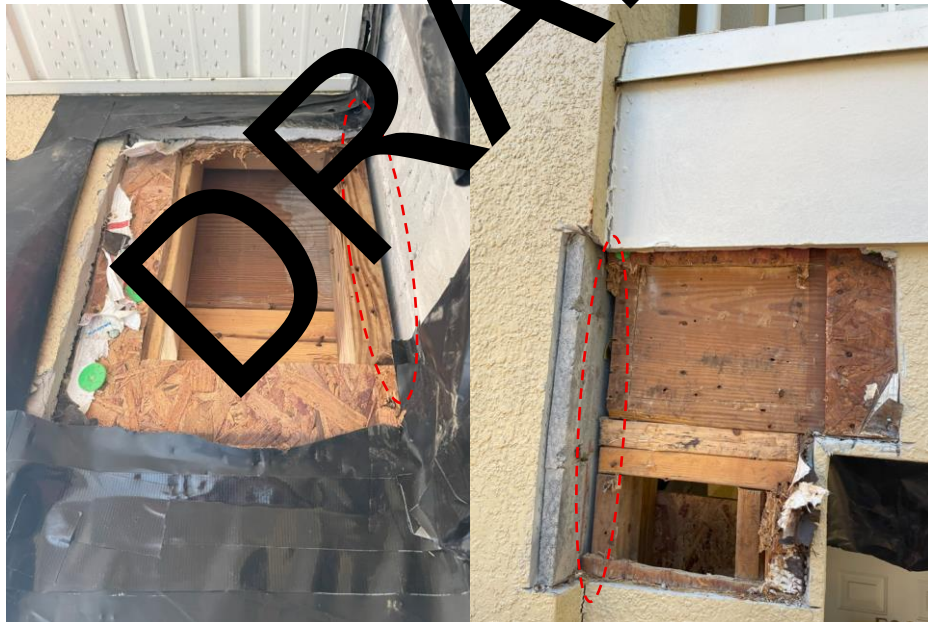
Photograph 4: View of no connection between the east breezeway beam and the CMU block on the second floor of Building F.

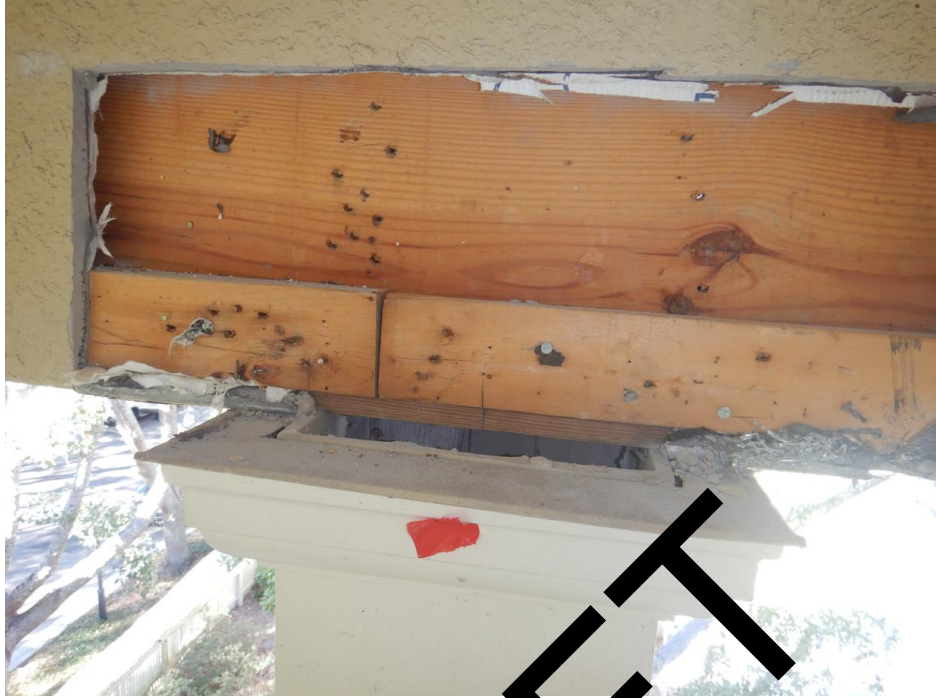
Photograph 5: View of a hollow column below the west breezeway beam on the third floor of Building F.

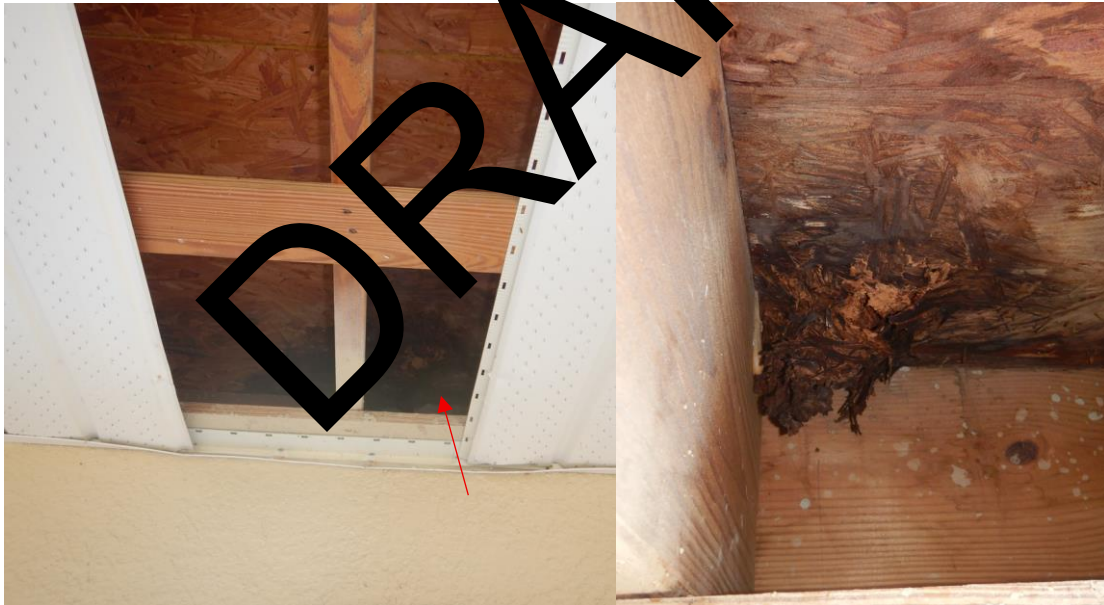
Photograph 6: View of stained and deteriorated wood decking above the north breezeway on the first floor of Building G.

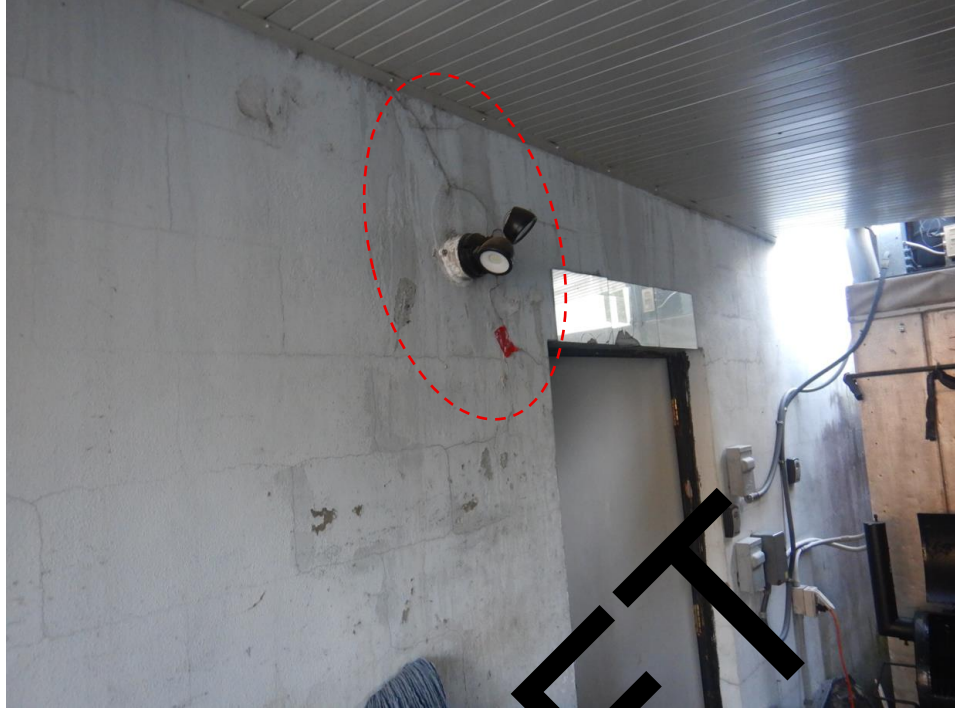
Photograph 7: View of cracked exterior wall finish along the south wall of Building I.

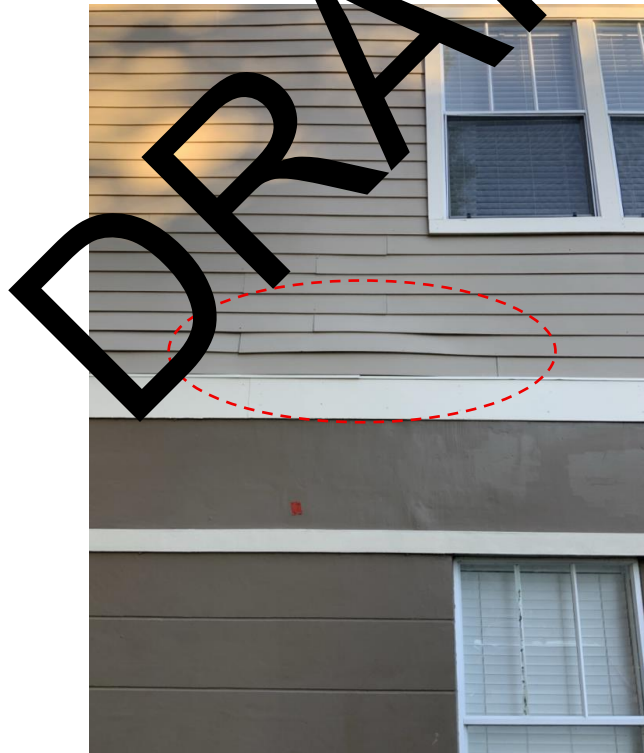
Photograph 8: View of bulging siding along the west elevation of Building K.

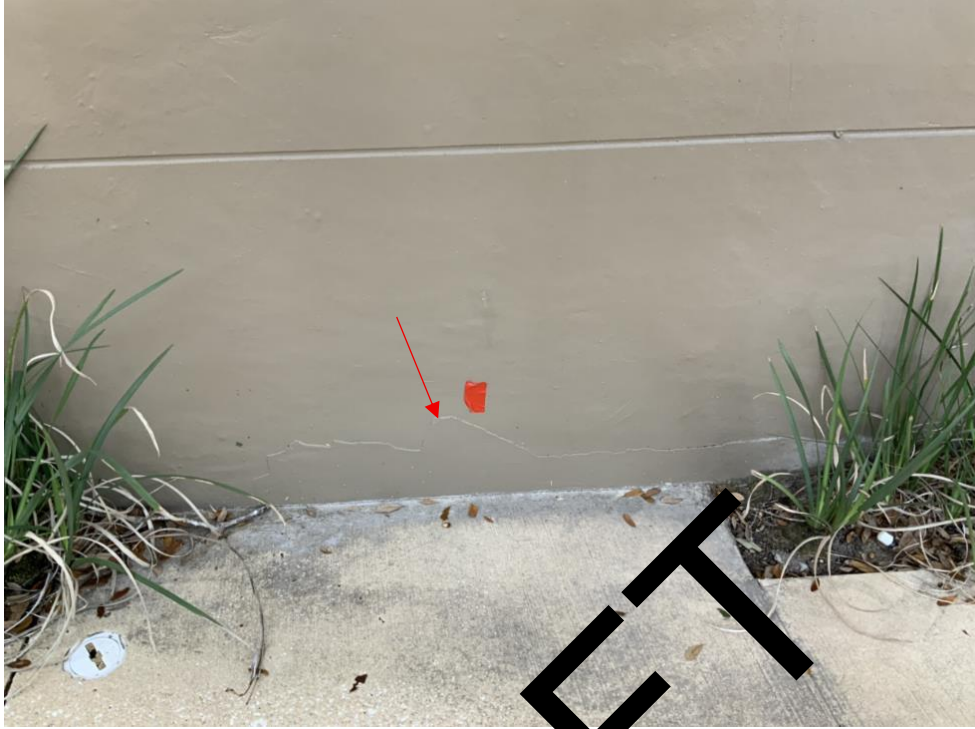
Photograph 9: View of a portion of cracked exterior wall finish along the north elevation of Building L.

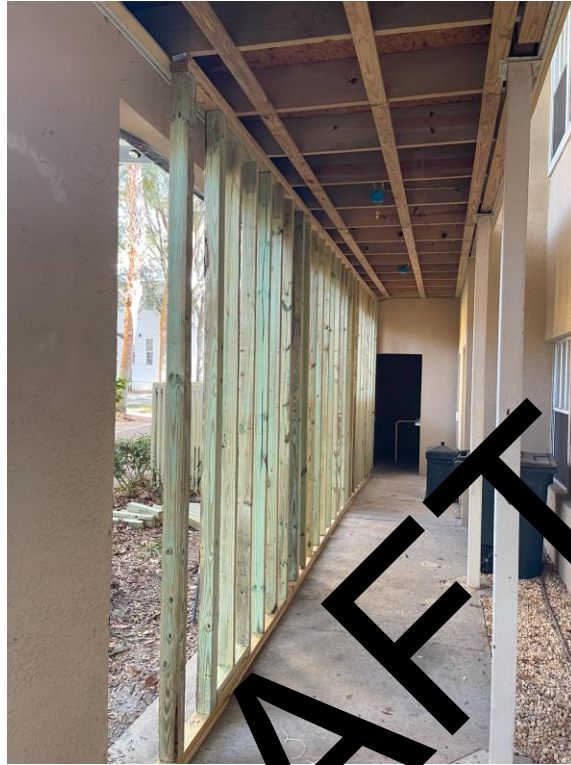
Shoring 1: View of a portion of completed shoring along the north elevation of Building A.
