# VILLAGE AT HAILE CONDOMINIUM – DESTRUCTIVE TESTING SUMMARY

January 30, 2026

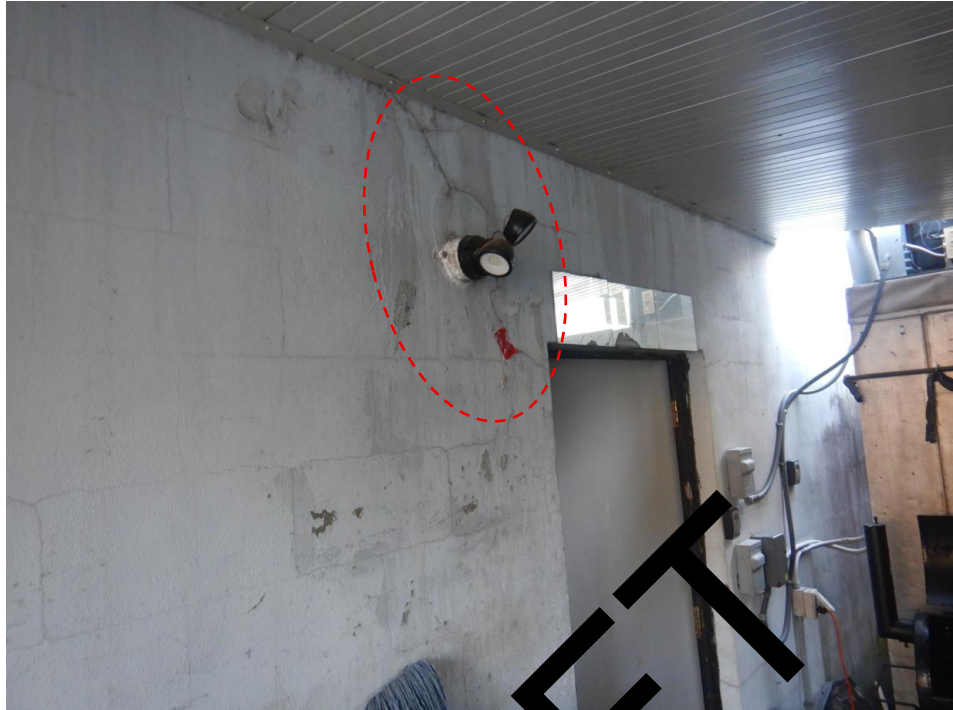
Photograph 7: View of cracked exterior wall finish along the south wall of Building I.

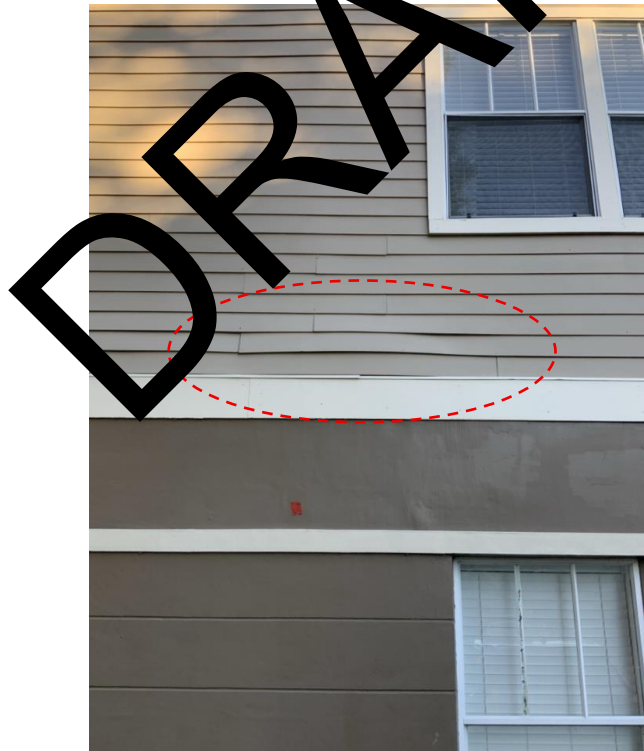
Photograph 8: View of bulging siding along the west elevation of Building K.
