Your Inspection Report

123 Home Pro Blvd
Harrisburg, PA 17104

INSPECTION DATE:
Friday, September 1, 2023

Home Pro Inspectors LLC
153 Crooked Hill Road
Hummelstown, PA 17036

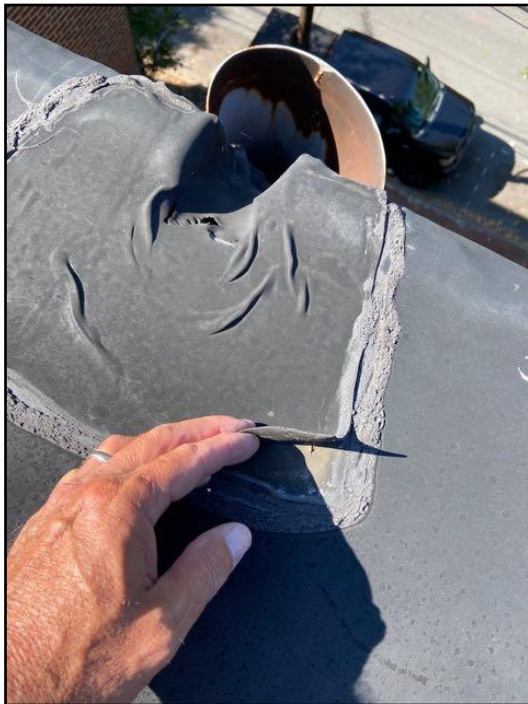
Condition: • Openings at seams or flashings

There are quite a few open seams and holes in the rubber roof. It does appear to be at the end of its life. I would recommend replacing the rubber roof and resealing around all of the metal flashing and roofing.

Implication(s): Chance of water damage to structure, finishes and contents

Lifting seams

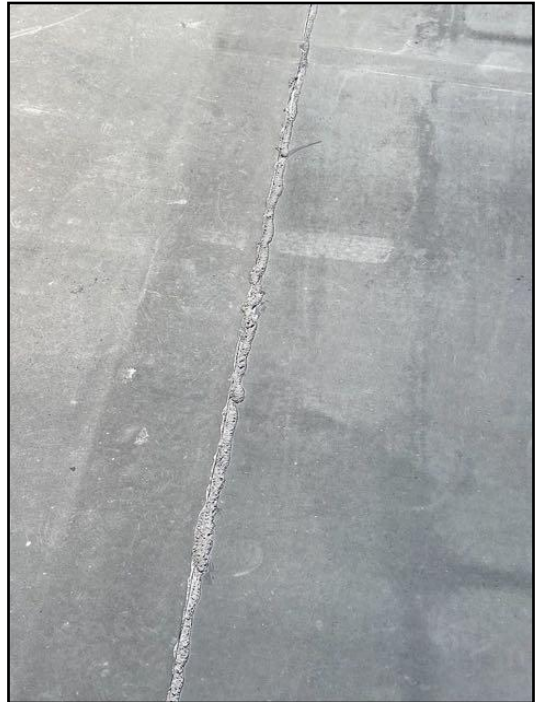
Loose seams

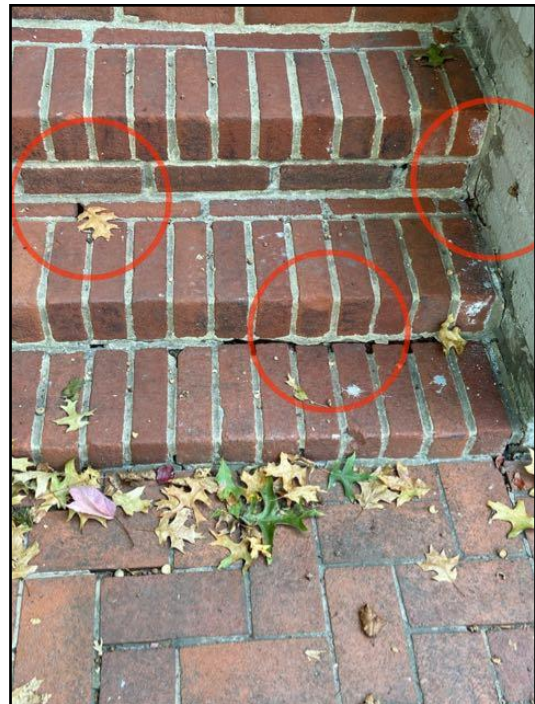
Condition: • There are a few locations outside where the mortar is loose or missing. Mortar only has a lifespan of 50 years. This can allow water to seep in and freeze causing additional damage to the facade. I would recommend having a mason come out to chisel out the old worn out mortar and replace it.

Mortar loss

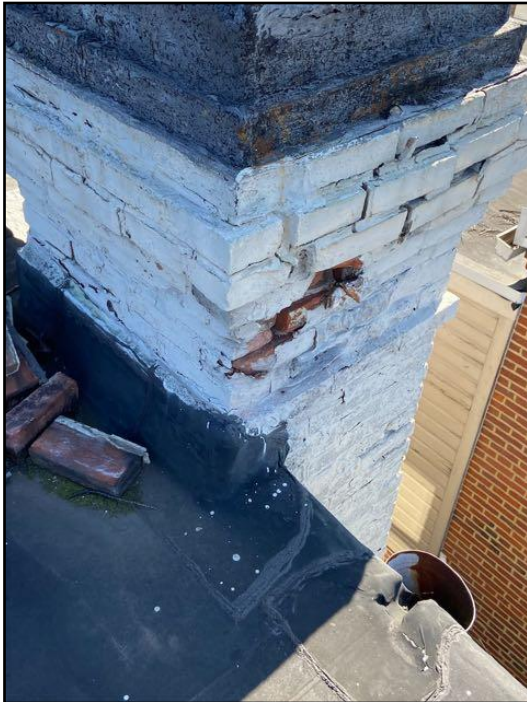
Condition: • The crown on the top of the chimney is cracked/missing. This will allow water to seep in between the terra cotta sleeve and the block.

Missing brick

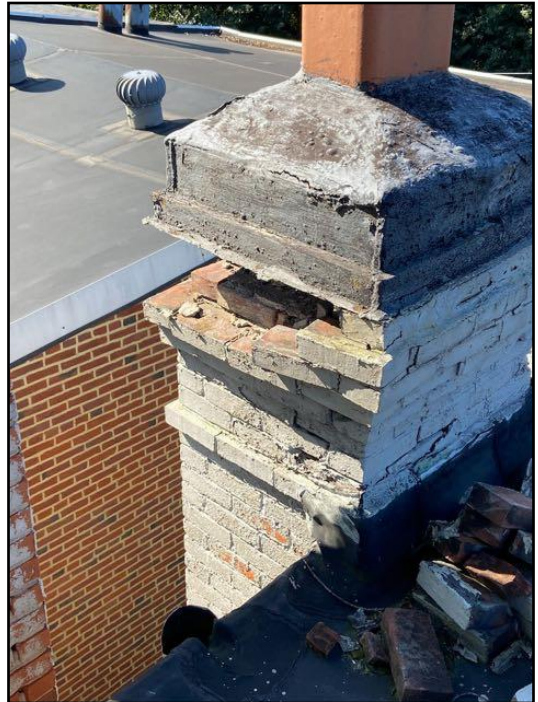
Missing brick

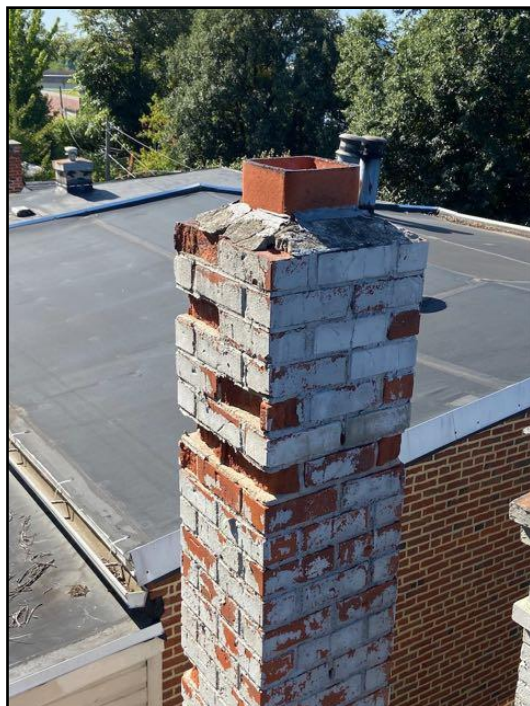
Missing brick

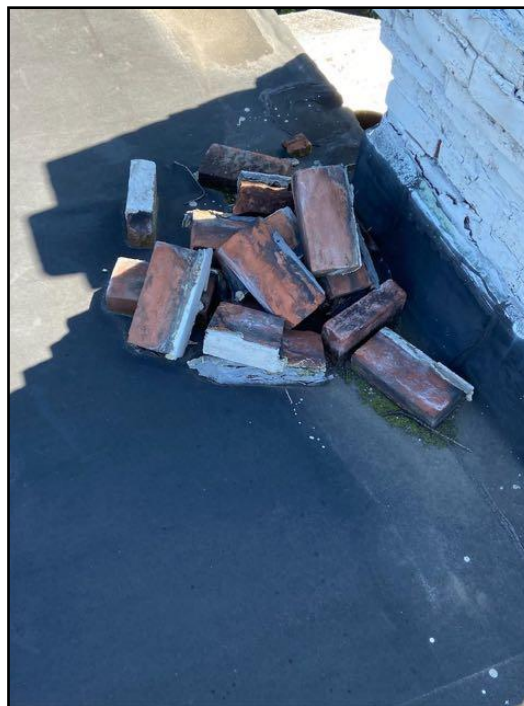
Found brick

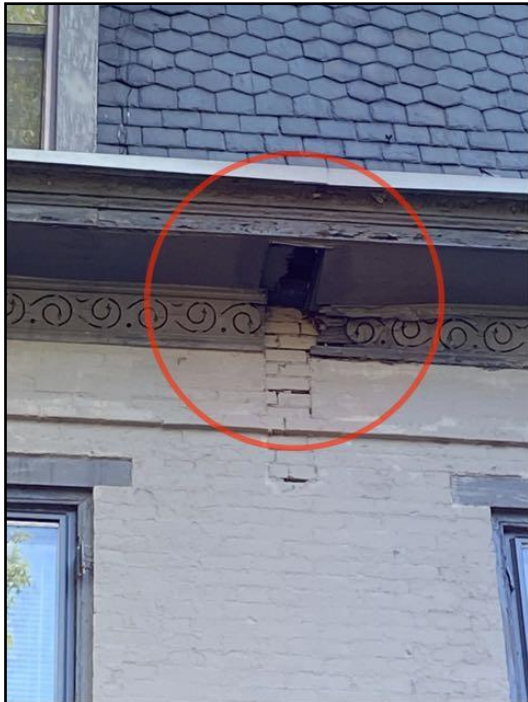
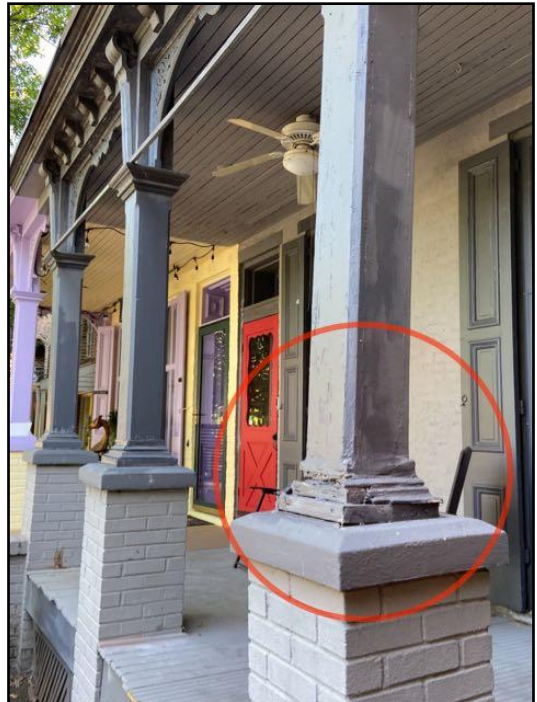
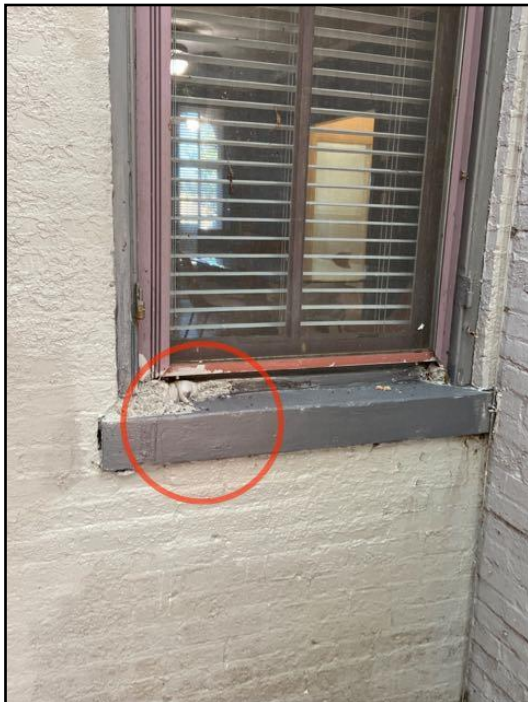
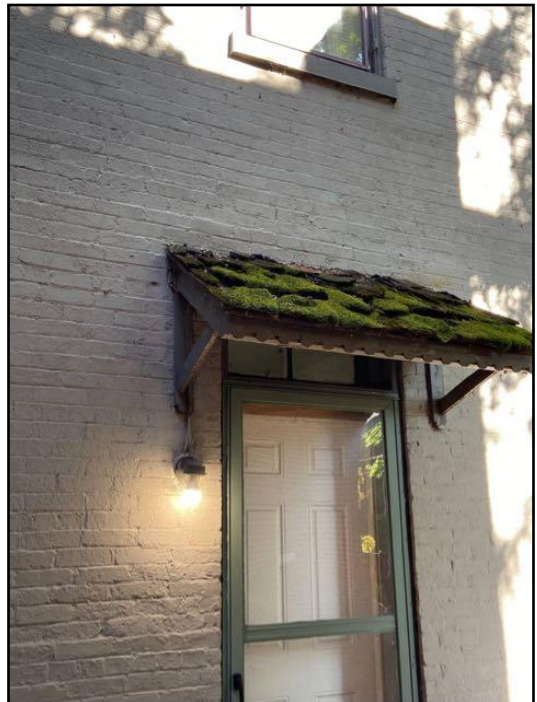
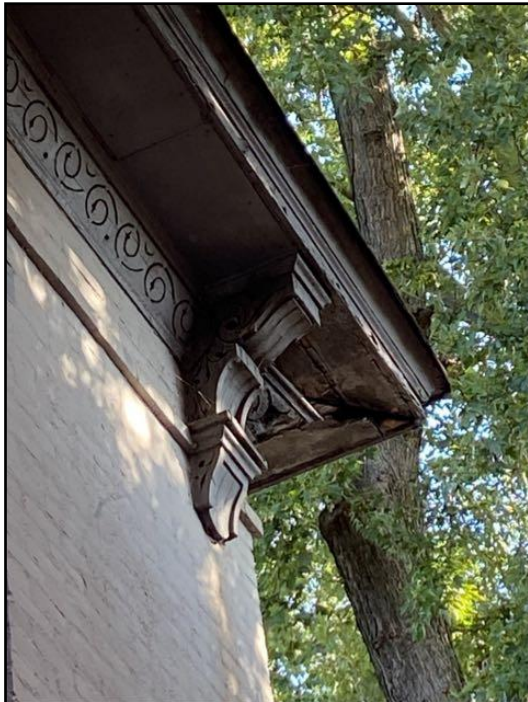
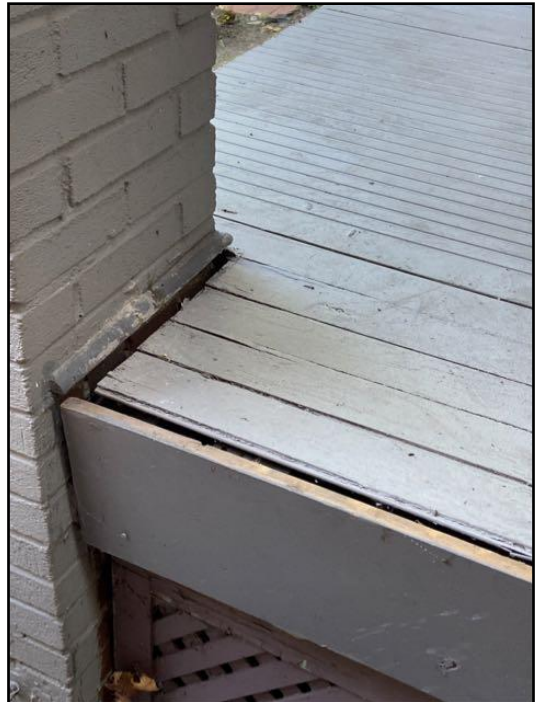
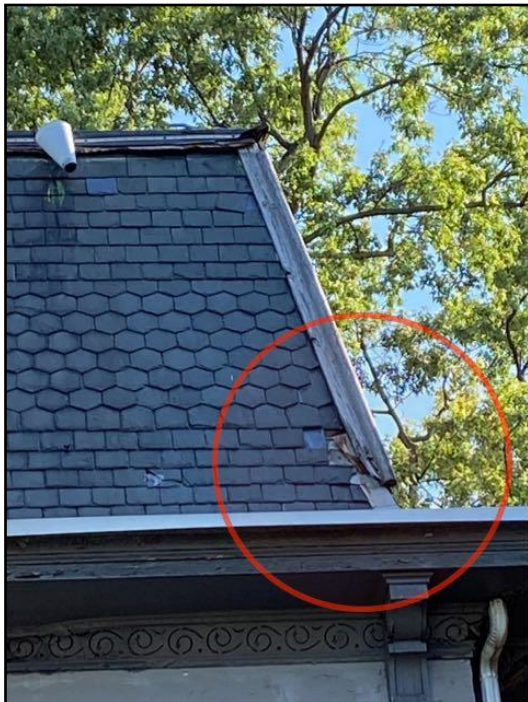
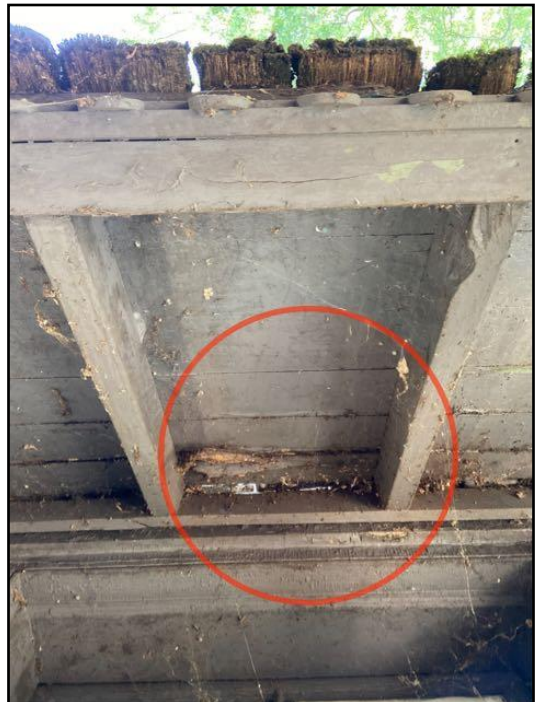
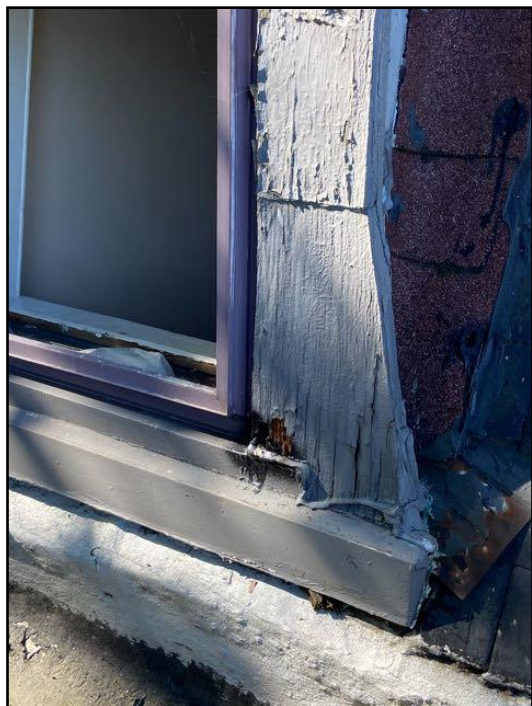
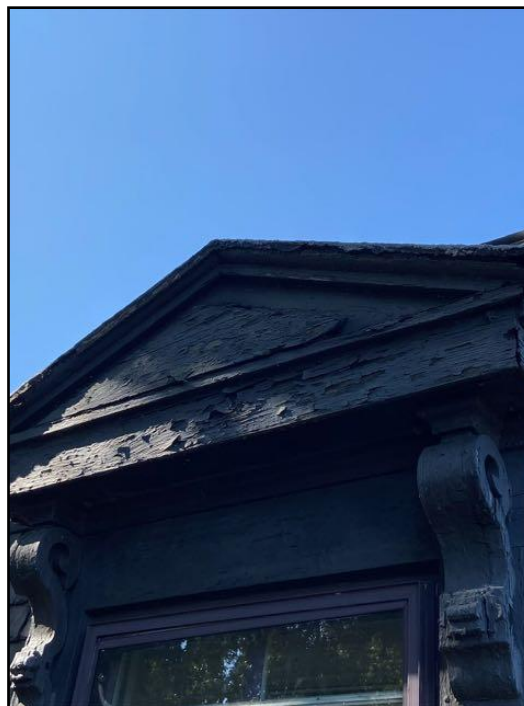
There is rotted wood on the outside of the home in numerous locations. There is some rotted trim up in the front of the home near the roof top. There is missing and rotted trim at the fascia and soffit. The front porch is a bit rotted. Some of the boards are coming up. The columns are a little rotted and need attention. There are some issues with the windowsills on the outside that are also rotted as well as the little overhang in the back. I would recommend going around the outside and replace all of your rotted wood.

Implication(s): Material deterioration | Chance of water damage to structure, finishes and contents

Rot

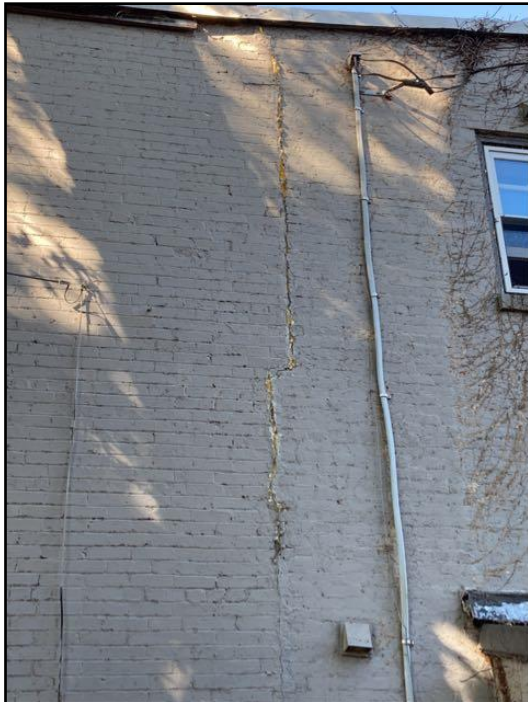
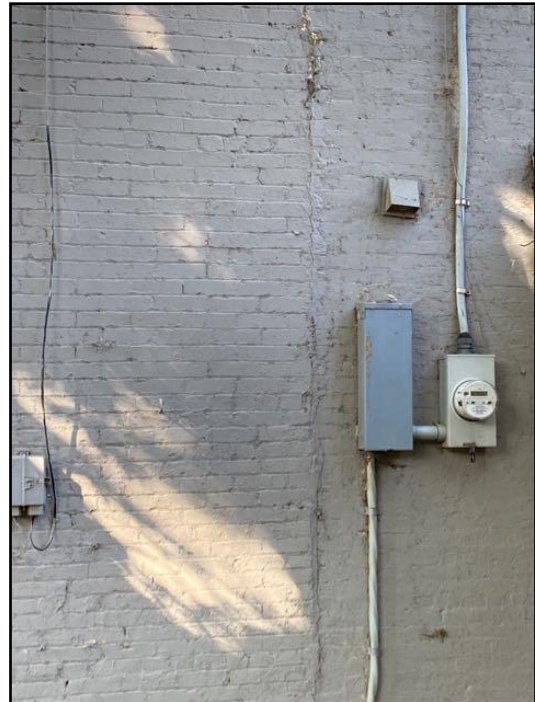
There's a crack down the brick in the back of the property. Currently they had filled it with expansion foam and painted over top. You may want to keep an eye on this area for any additional movement. This home is in the flood plane and is most likely old damage from a past flood. You may want to remove the expansion foam and mortar it properly. If you do notice any additional movement, you will need to contact a structural engineer.

Implication(s): Chance of movement | Weakened structure | Chance of water entering building

Cracked

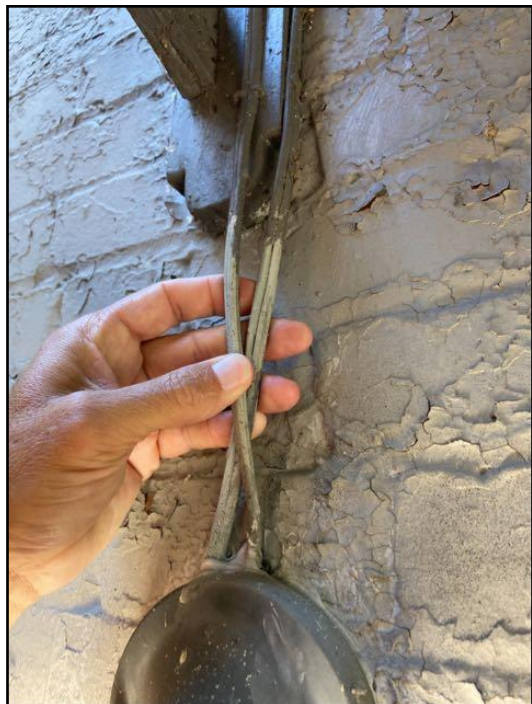
Currently, they are using lamp wire to wire up the back patio light. I would highly recommend changing this out with a UV rated permanent outdoor wire.

Implication(s): Electric shock | Fire hazard

Wrong type

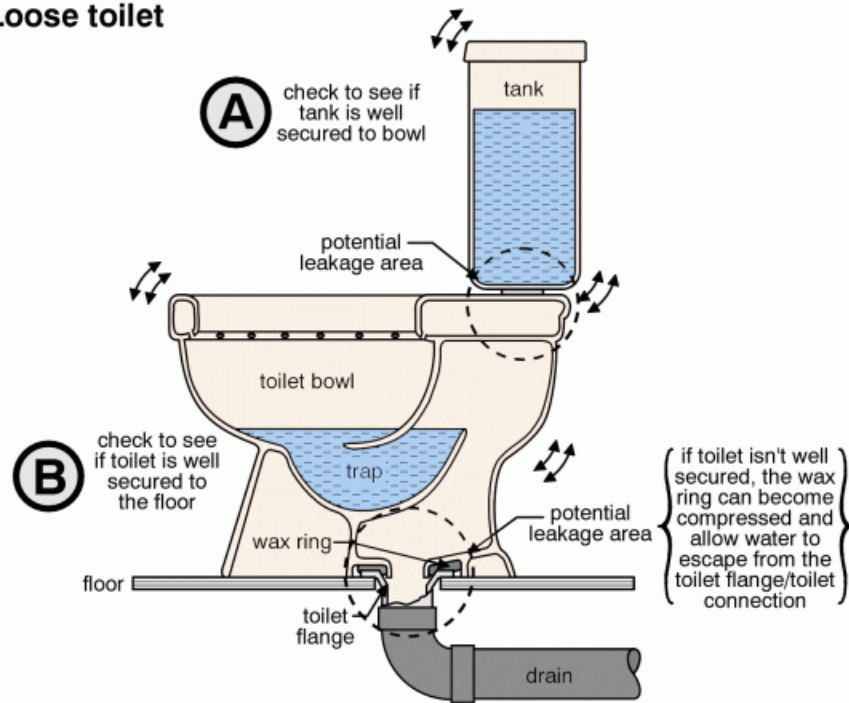
Condition: • You have a toilet that is loose and shifting back and forth.. This can allow minor leaking to begin around the wax flange causing damage to the subfloor.

No leaks were found below the toilet with a thermal camera. I would recommend tightening the toilet down.

Loose toilet

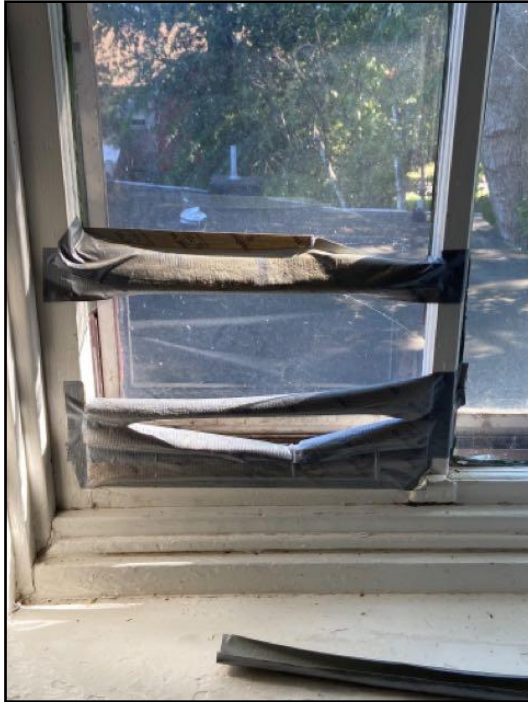
There are a few broken windows in the home. Some of the windows in the home would not open. You may want to go around replace any pieces of broken glass and make sure all the windows open and close and lock.

Broken

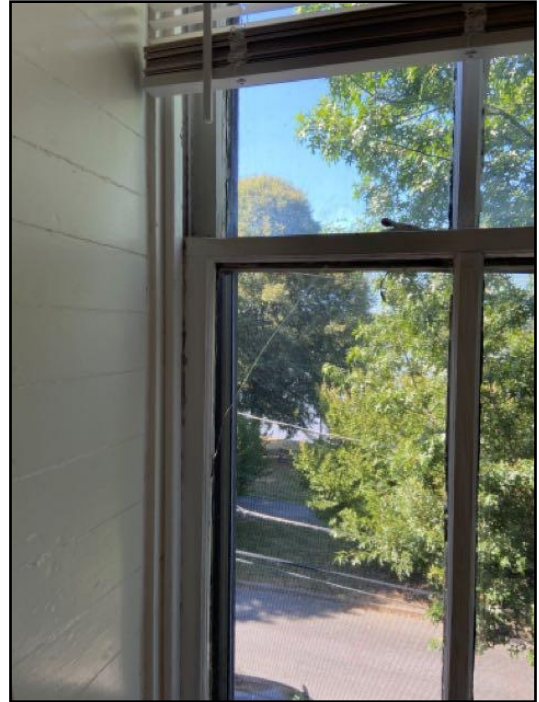
Cracked

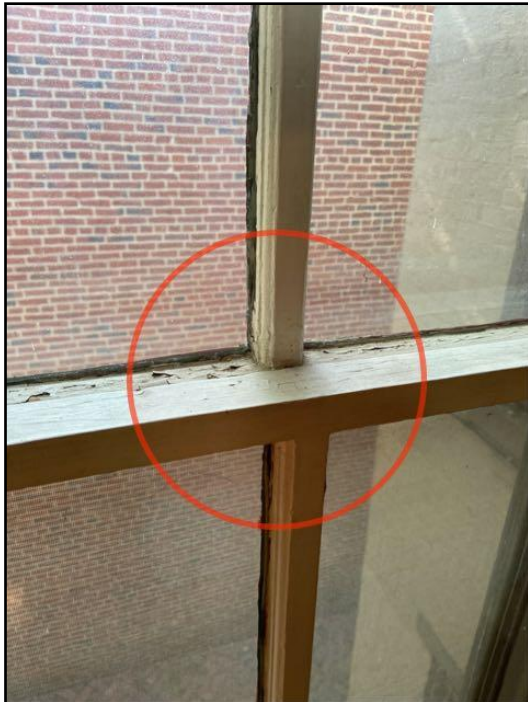
Missing hardware

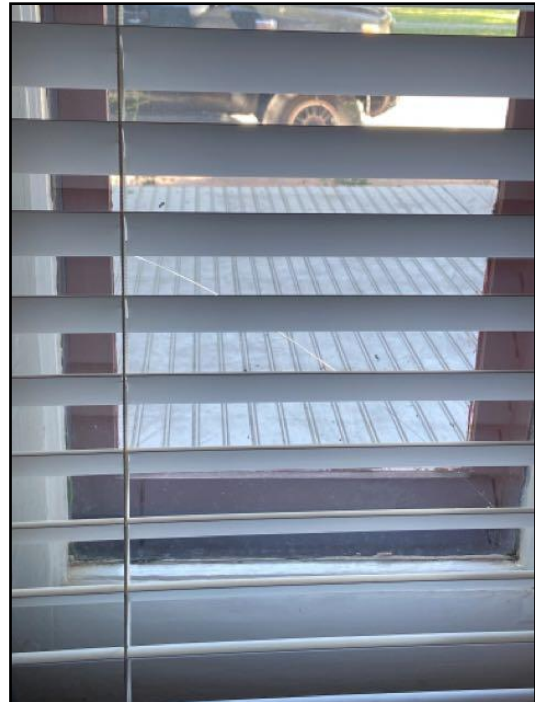
Cracked

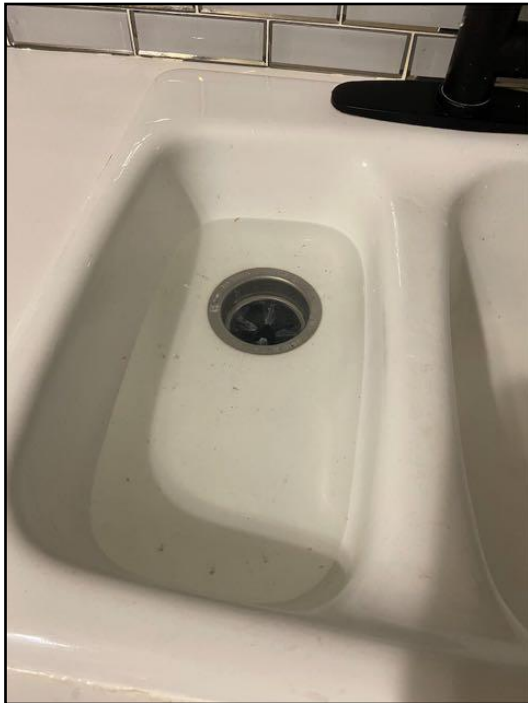
Condition: • When the dishwasher is draining, it is filling up the sink on the left-hand side. Most likely the garbage disposal is clogged.

Sink backing up

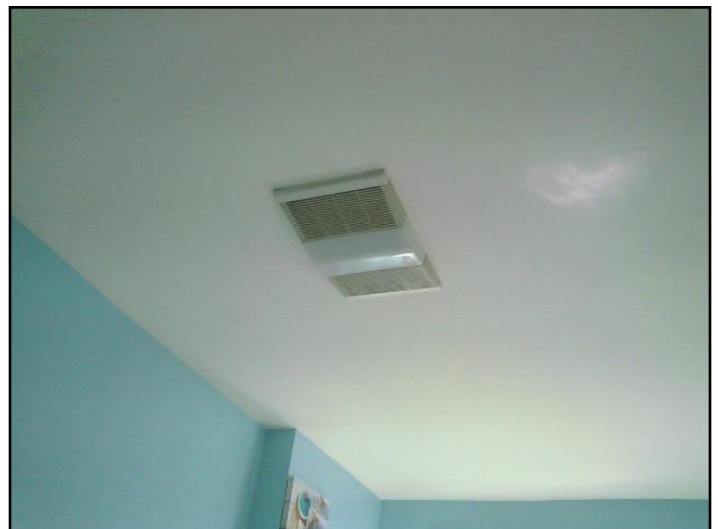
- **NO ACTIVE LEAKS WERE OBSERVED AT THE TIME OF THIS THERMAL SCAN.**

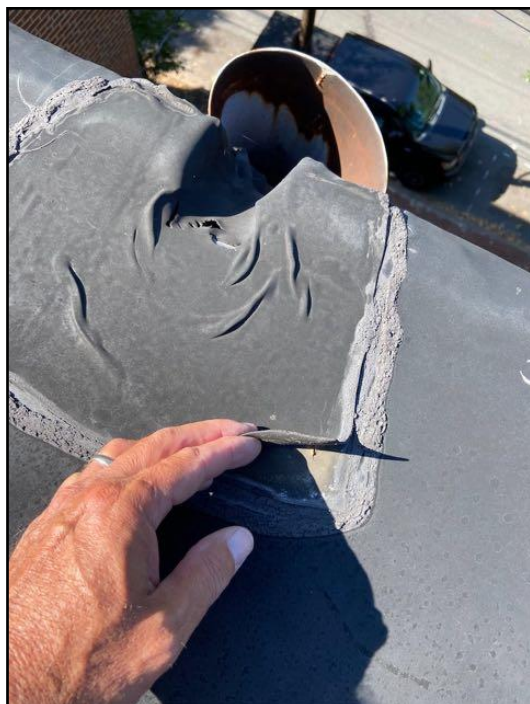
Condition: • Openings at seams or flashings

There are quite a few open seams and holes in the rubber roof. It does appear to be at the end of its life. I would recommend replacing the rubber roof and resealing around all of the metal flashing and roofing.

Lifting seams

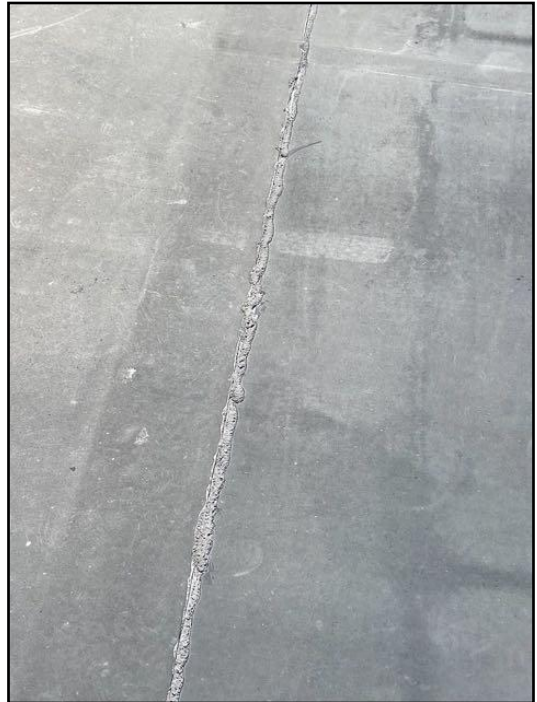
Loose seams

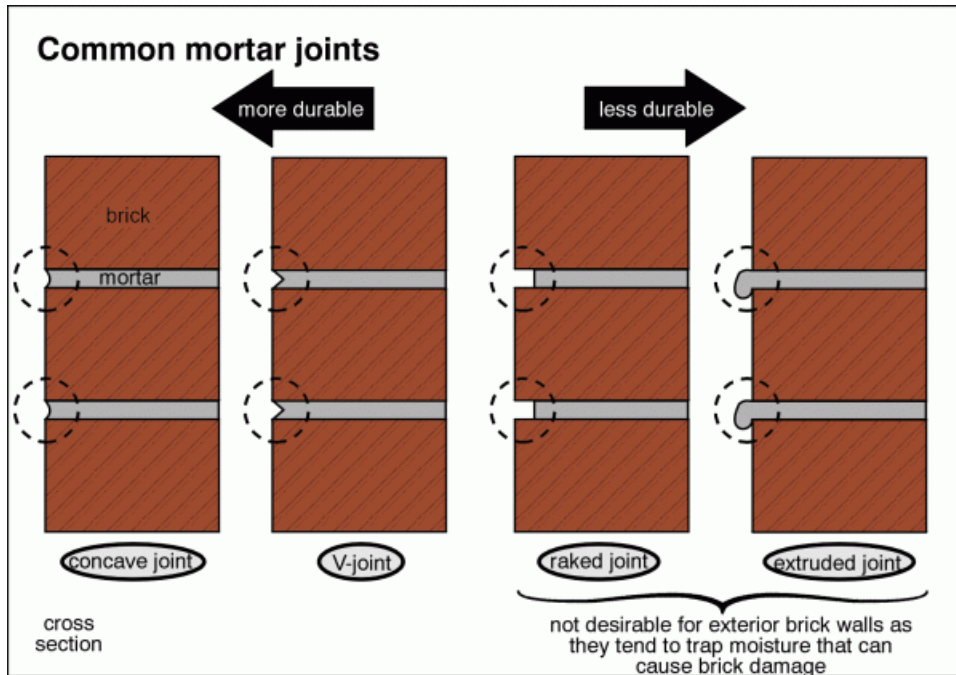
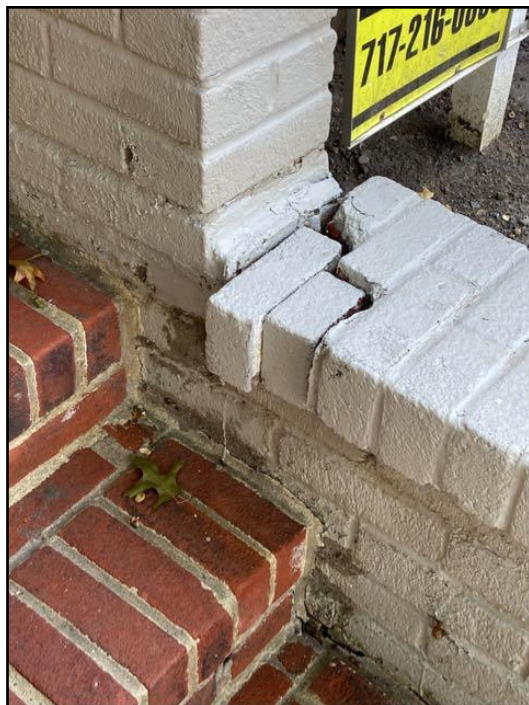
Condition: • There are a few locations outside where the mortar is loose or missing. Mortar only has a lifespan of 50 years. This can allow water to seep in and freeze causing additional damage to the facade. I would recommend having a mason come out to chisel out the old worn out mortar and replace it.

Mortar loss

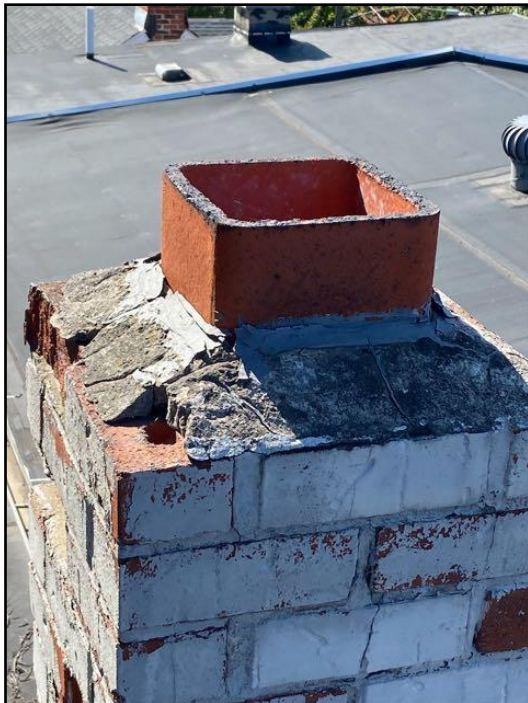
Condition: • The crown on the top of the chimney is cracked/missing. This will allow water to seep in between the terra cotta sleeve and the block.

Bad crown

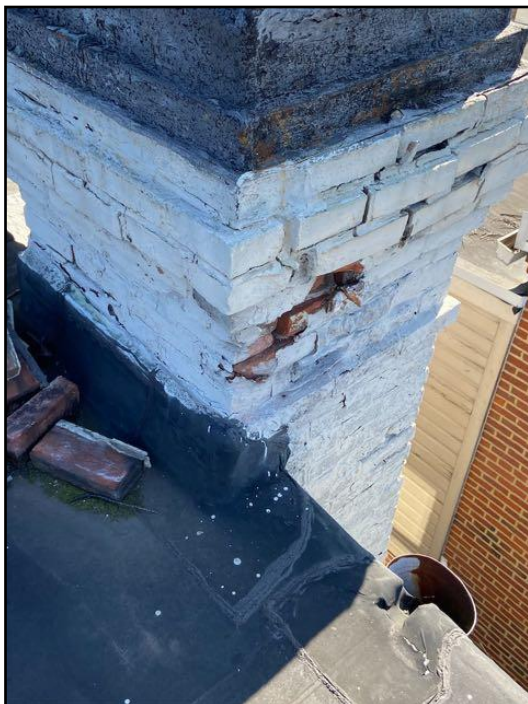
Missing brick

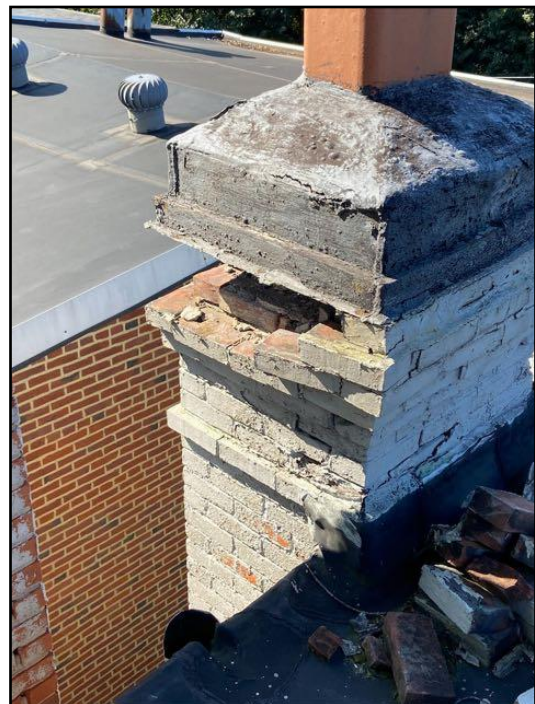
Missing brick

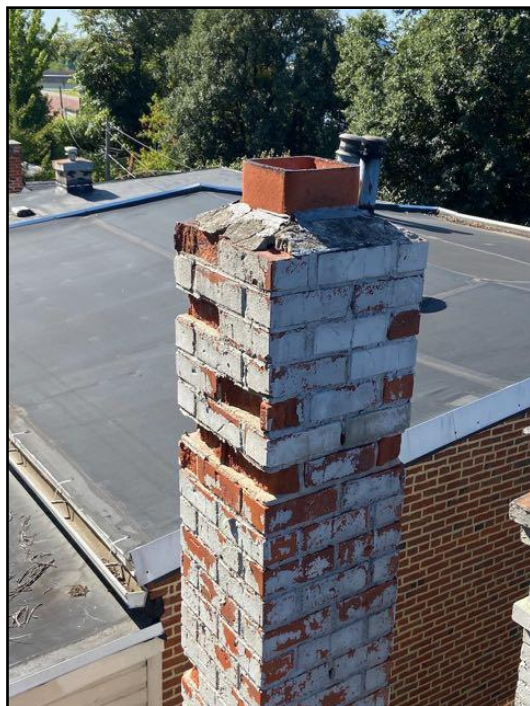
Missing brick

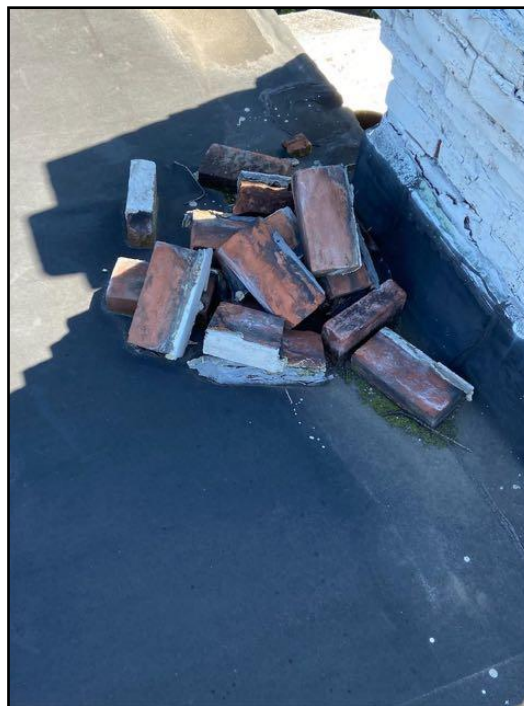
Found brick

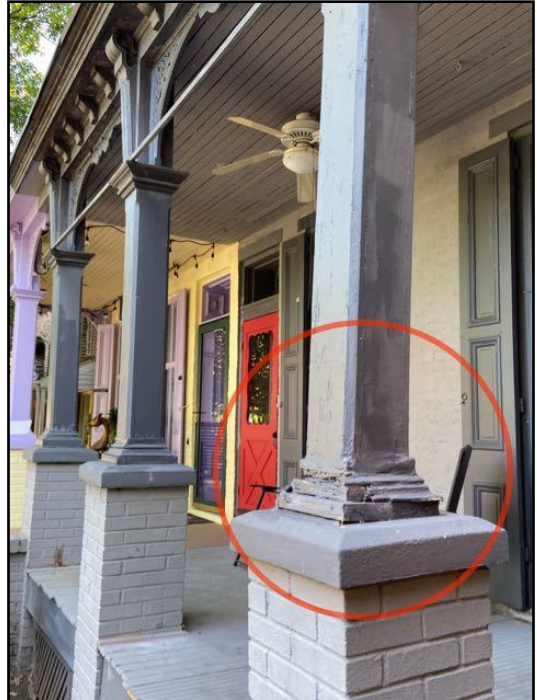
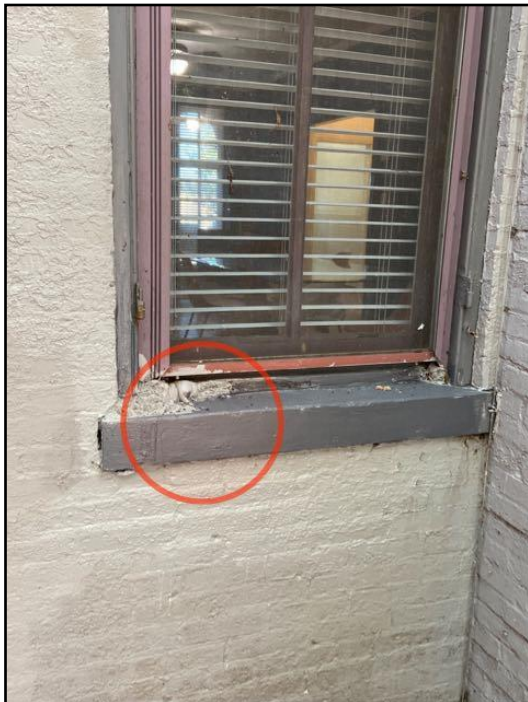
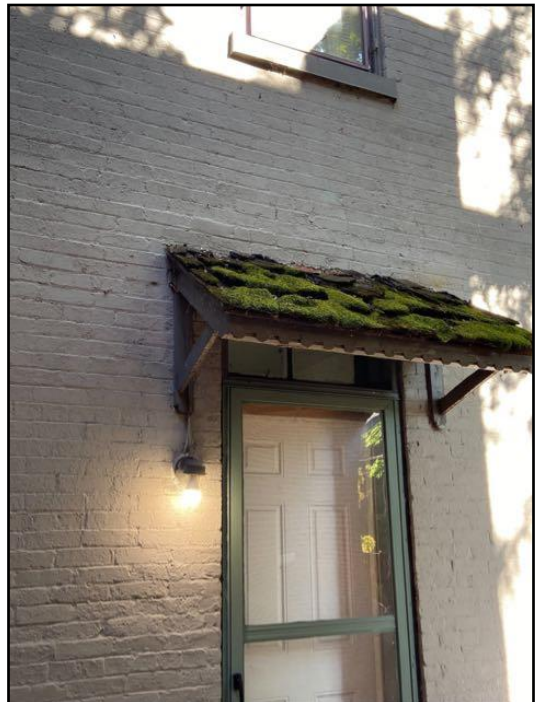
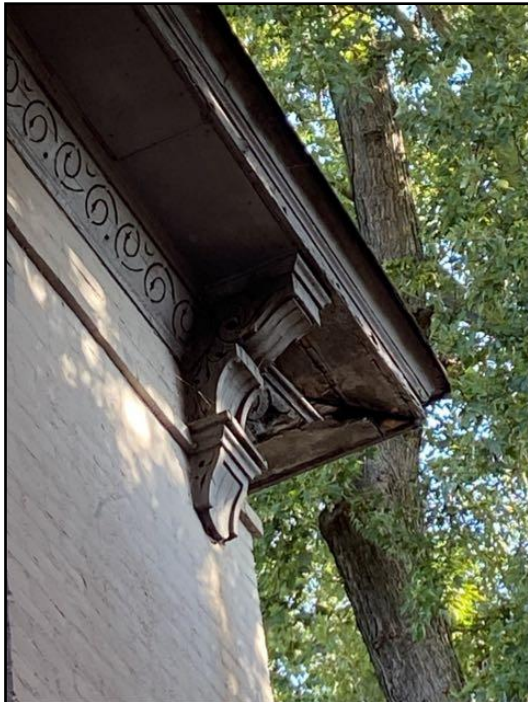
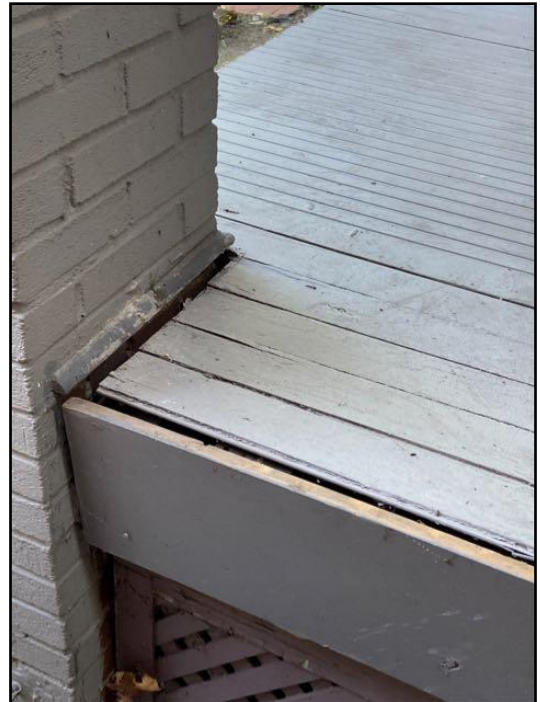
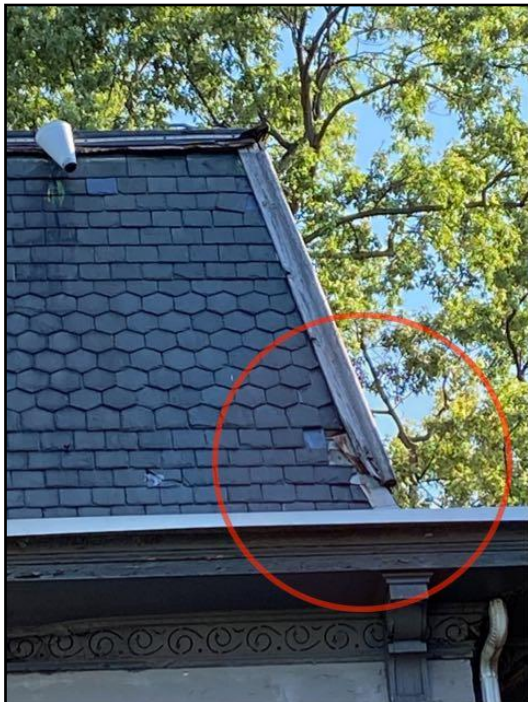
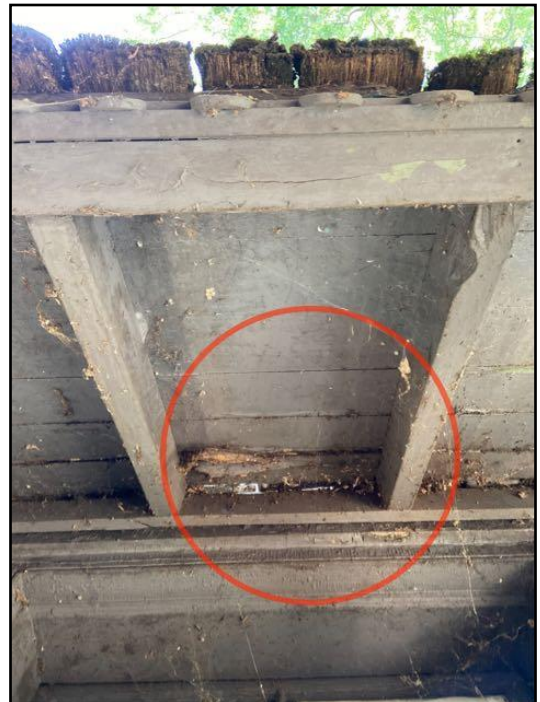
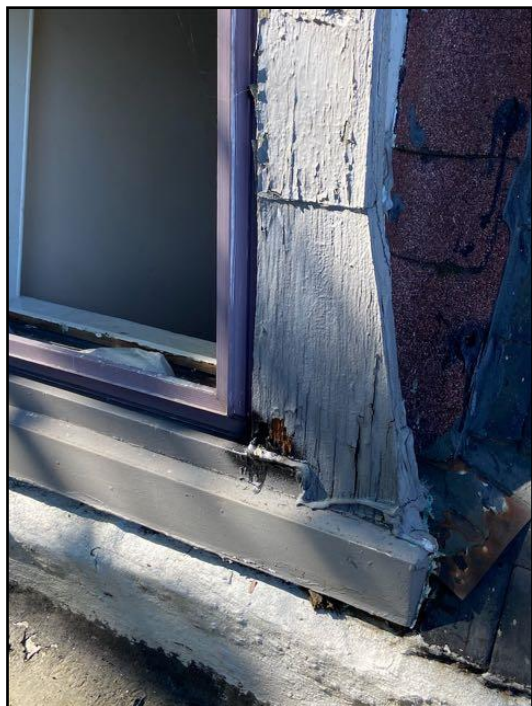
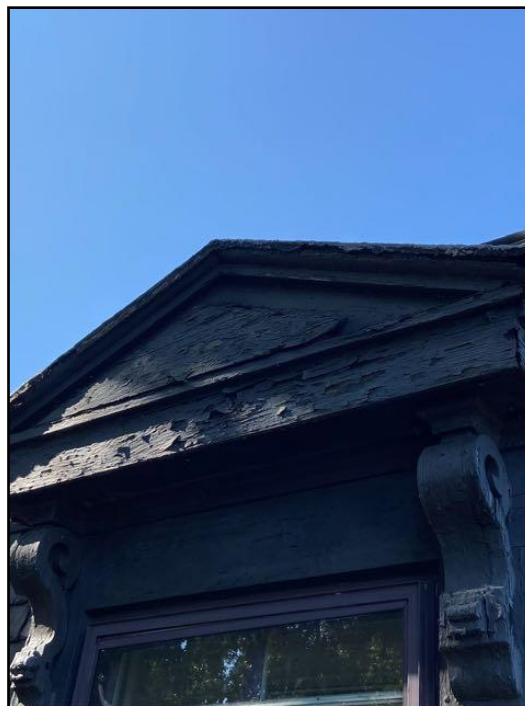
There is rotted wood on the outside of the home in numerous locations. There is some rotted trim up in the front of the home near the roof top. There is missing and rotted trim at the fascia and soffit. The front porch is a bit rotted. Some of the boards are coming up. The columns are a little rotted and need attention. There are some issues with the windowsills on the outside that are also rotted as well as the little overhang in the back. I would recommend going around the outside and replace all of your rotted wood.

Rot

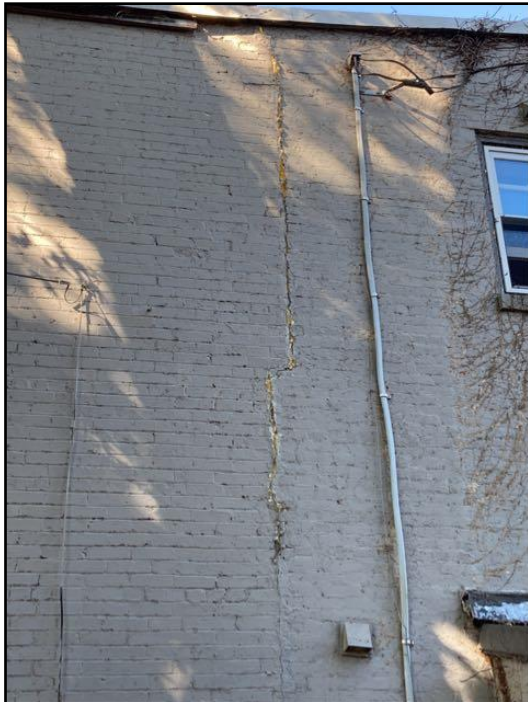
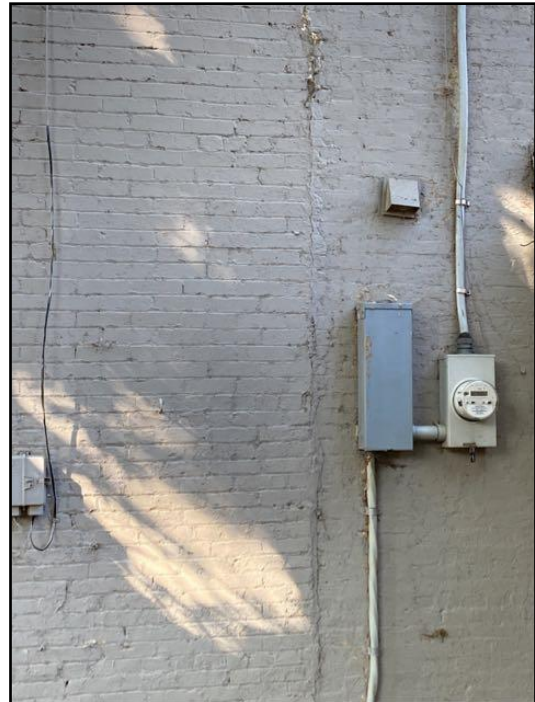
There's a crack down the brick in the back of the property. Currently they had filled it with expansion foam and painted over top. You may want to keep an eye on this area for any additional movement. This home is in the flood plane and is most likely old damage from a past flood. You may want to remove the expansion foam and mortar it properly. If you do notice any additional movement, you will need to contact a structural engineer.

Cracked

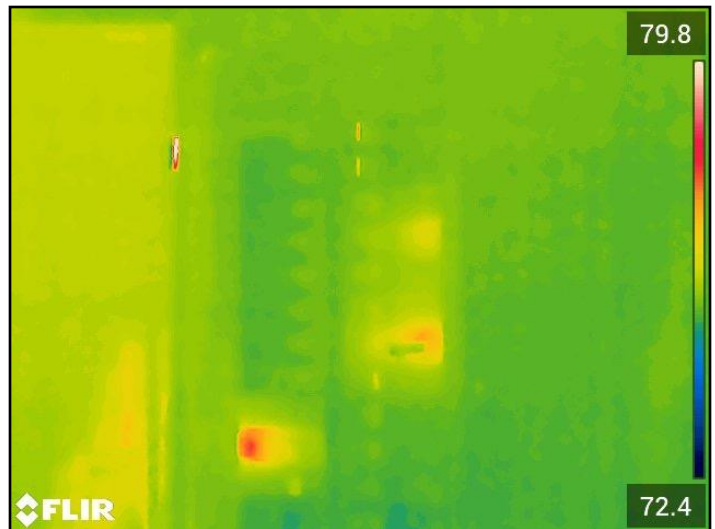
- **NO OVERHEATED CIRCUITS WERE OBSERVED AT THE TIME OF THIS THERMAL SCAN.**

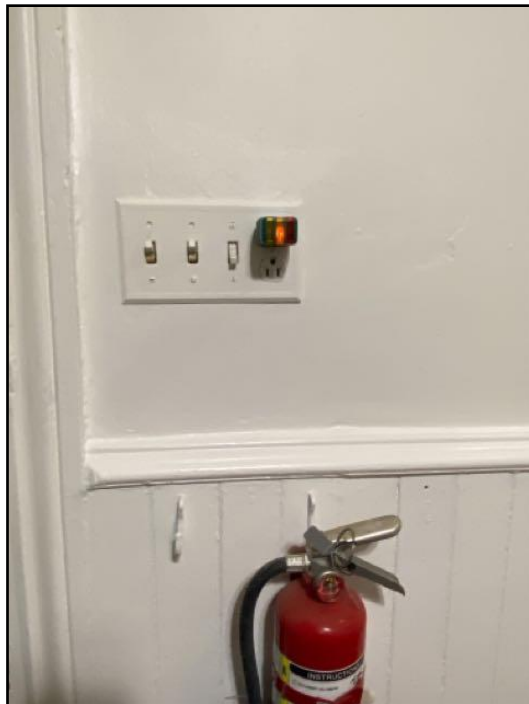
Condition: • There are ungrounded outlets in the home. I would recommend hooking the ground wire back up or replacing the outlets with two prong receptacles.

Ungrounded

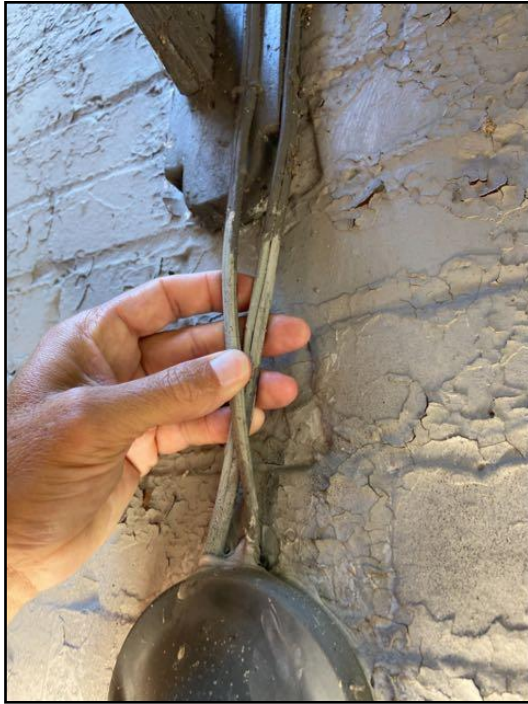
Currently, they are using lamp wire to wire up the back patio light. I would highly recommend changing this out with a UV rated permanent outdoor wire.

Implication(s): Electric shock | Fire hazard

Wrong type

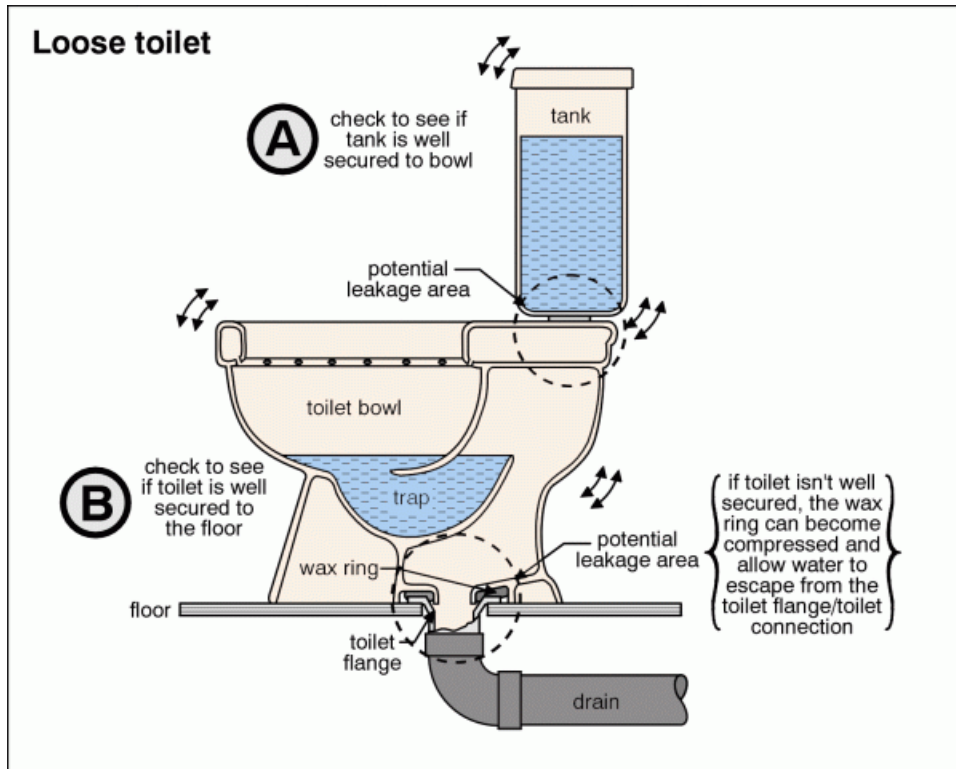
Condition: • You have a toilet that is loose and shifting back and forth.. This can allow minor leaking to begin around the wax flange causing damage to the subfloor.

No leaks were found below the toilet with a thermal camera. I would recommend tightening the toilet down.

Loose toilet

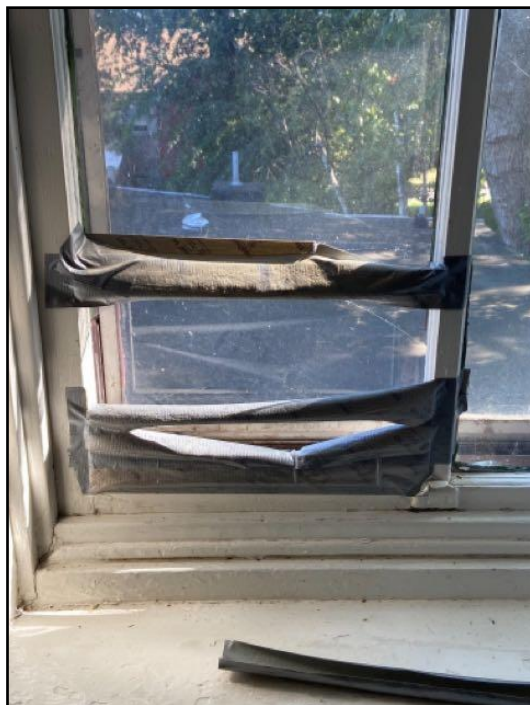
There are a few broken windows in the home. Some of the windows in the home would not open. You may want to go around replace any pieces of broken glass and make sure all the windows open and close and lock.

Broken

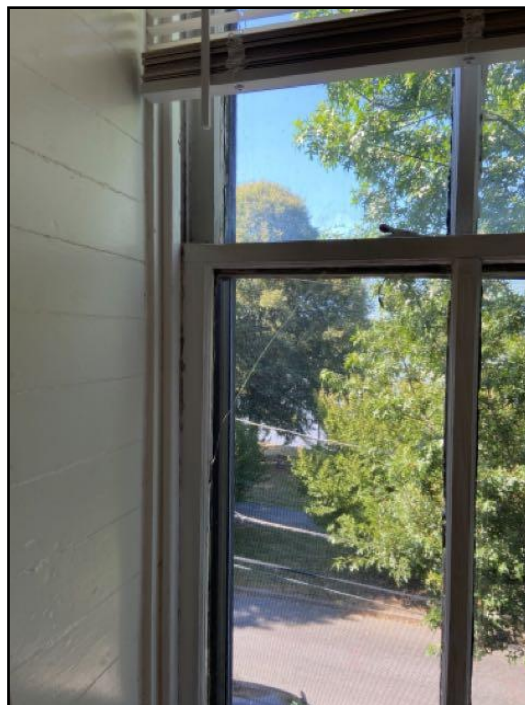
Cracked

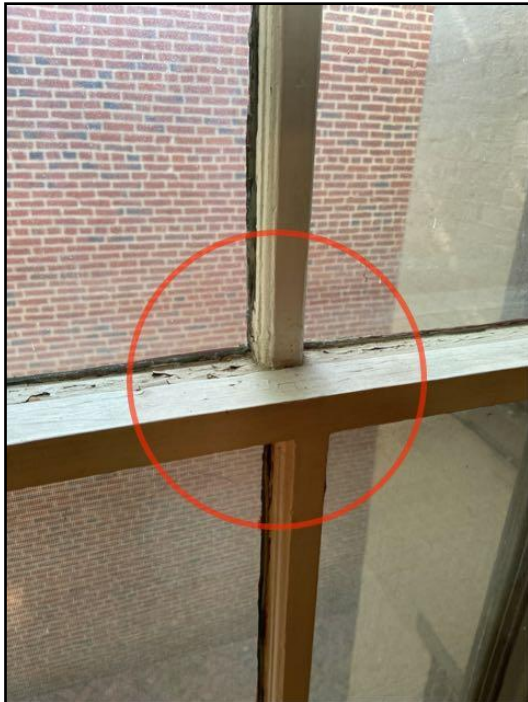
Missing hardware

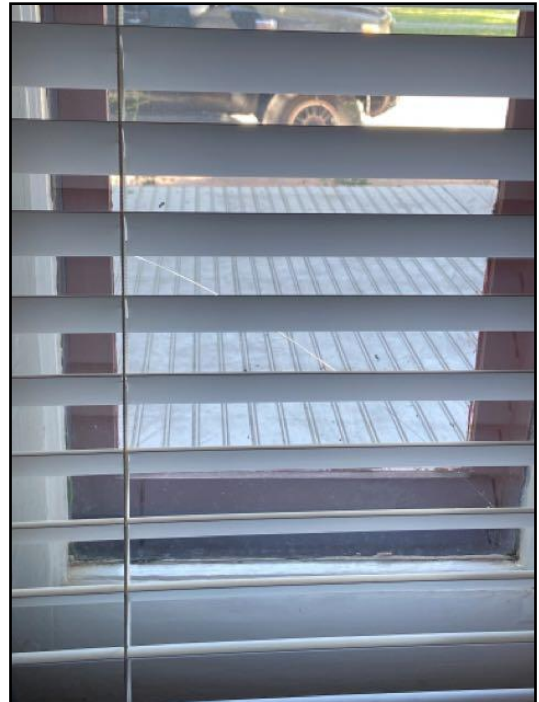
Cracked
