Your Inspection Report

123 Home Pro Blvd
Harrisburg, PA 17104

INSPECTION DATE:
Friday, September 1, 2023

Home Pro Inspectors LLC
153 Crooked Hill Road
Hummelstown, PA 17036

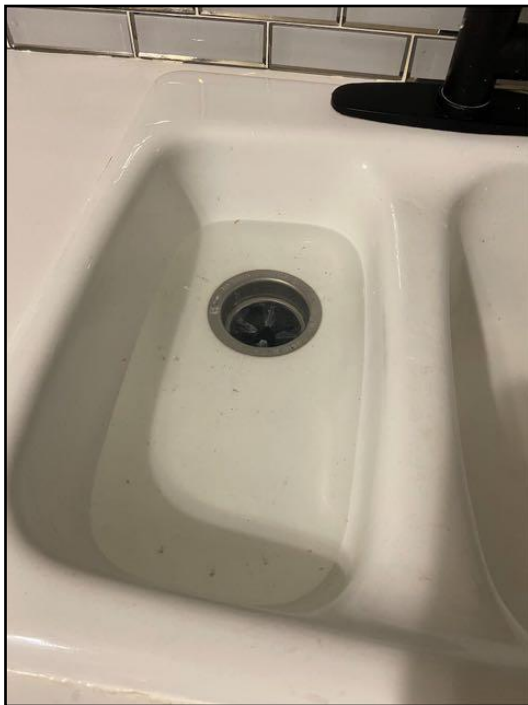
Condition: • When the dishwasher is draining, it is filling up the sink on the left-hand side. Most likely the garbage disposal is clogged.

Sink backing up
