# Your Inspection Report

PREPARED FOR:
JANE SMITH

INSPECTION DATE: Monday, July 18, 2022

Report No. 2938, v.0 For inspection at: 123 Sample Road Hummelstown, PA 17036 on: Monday, July 18, 2022

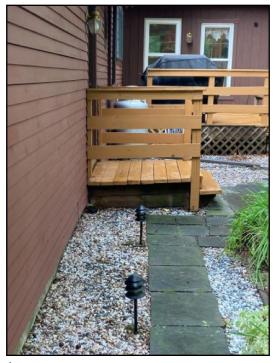
1

**Condition:** • The small side porch leading to the laundry room is slopeing towards the house. This can allow water to run toward the home every time it rains and help rot the wood siding. You may want to replace this little porch and make sure everything is sloping away from the home.

**1. Condition:** • The small side porch leading to the laundry room is slopeing towards the house. This can allow water to run toward the home every time it rains and help rot the wood siding. You may want to replace this little porch and make sure everything is sloping away from the home.

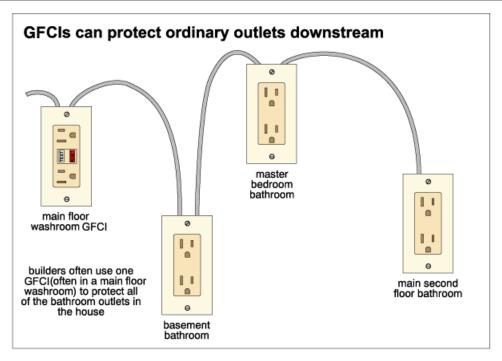
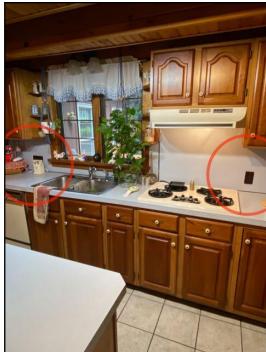
2.

**Condition:** • After 1975 it was required to have GFCI protected outlets within 6 feet of water. There are receptacles that you may want to replace with GFCI receptacles.

The receptacles in the kitchen within 6 feet of the sink should be GFCI protected.

**2. Condition:** • After 1975 it was required to have GFCI protected outlets within 6 feet of water. There are receptacles that you may want to replace with GFCI receptacles.

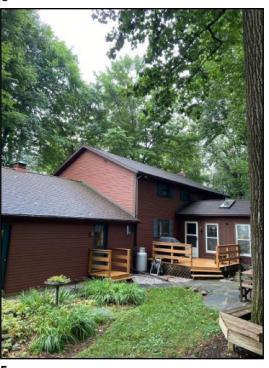
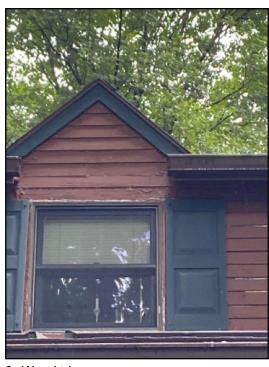
6. Wood trim

Some of the wood trim is going to need addressed. You may want to replace the soft wood trim around the property as needed.

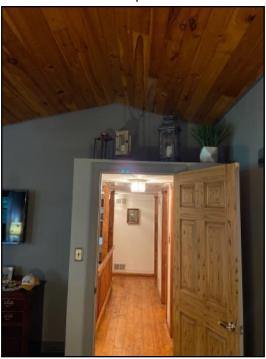
10.

• There was no access to the attic space. I was unable to inspect this area.

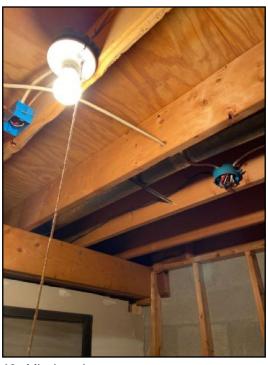
13. Missing plates

**Type and number of outlets (receptacles):** • <u>Grounded - typical</u> • There are a few missing cover plates that you may want to put on. • Before moving all your furniture into the home I would recommend going around and tightening up any loose switches, receptacles and replace missing cover plates throughout.

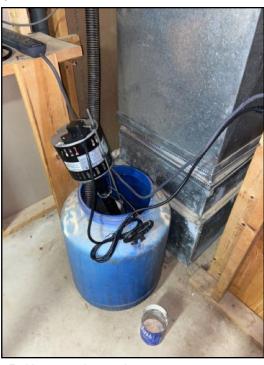
Currently they're using a sump pump and plastic barrel as a condensate pump for excess moisture created by the heat pump. Currently, it is working.

15. Homemade condensate pump

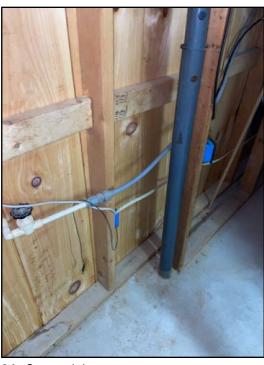
24. Quest piping

Supply piping in building: • Copper • CPVC (Chlorinated PolyVinylChloride) • Polybutylene aka Quest piping is a discontinued piping in homes that was known to leak at the older compression connectors. In the early 90s they decided to use crimp rings at all splice points to prevent leaks. Currently there are no visible leaks or issues. I would recommend making sure you have leaking pipe coverage with your homeowners insurance..

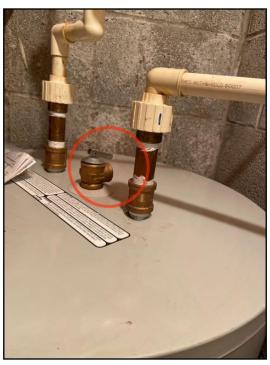
26. Missing discharge tube

Water heater type: • Conventional • Tank • Owned • There is no discharge tube on the pressure relief valve on the hot water heater. To prevent the possibility of it discharging hot water on to passer byers you may want to add one. It is a 3/4" threaded pipe that should angle down within 8" of the floor.

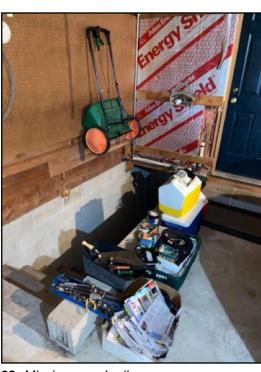
28. Missing guard rail

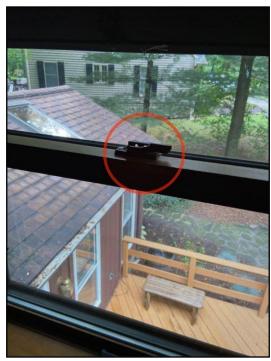
The window hardware needs adjusted in some of the windows upstairs.

30. Hardware adjustment needed
