Hacienda Inspectors  
18551 E. Carriage Way  
Queen Creek, AZ 85142  
Looking in to a house  
and finding your home

# Building Inspection Report

1234 Sample Report Age 2009  
Gilbert, AZ 85296

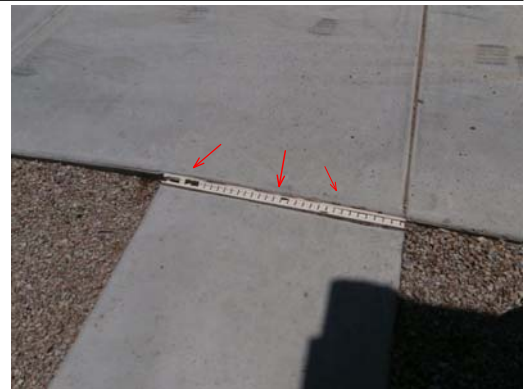
1. Walks: Concrete Broken drain trough causing a trip hazard, A qualified technician or contractor is recommended to re-evaluate, repair/ replace as needed

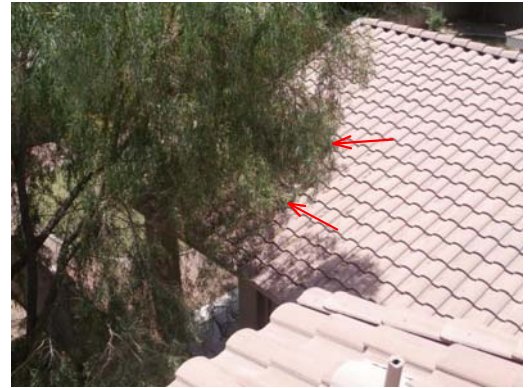
2. Vegetation: Shrubs, Trees Tree limbs over hang the neighbors roof and should be cut back (neighbor came over & requested this), A qualified technician or contractor is recommended to re-evaluate, repair/ replace as needed

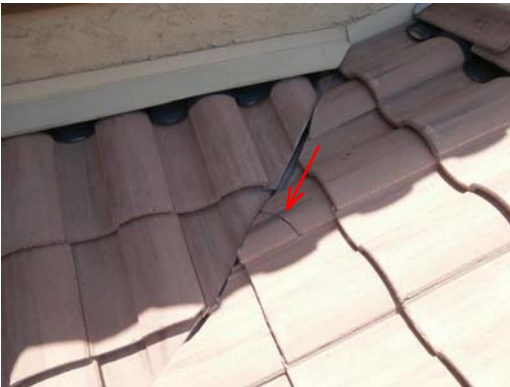
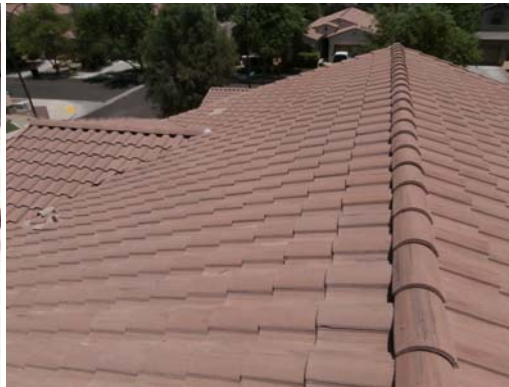
3. House & Garage Roof Surface Material: Concrete tile Loose, damaged or missing tiles or shingles, A qualified technician or contractor is recommended to re-evaluate, repair/ replace as needed

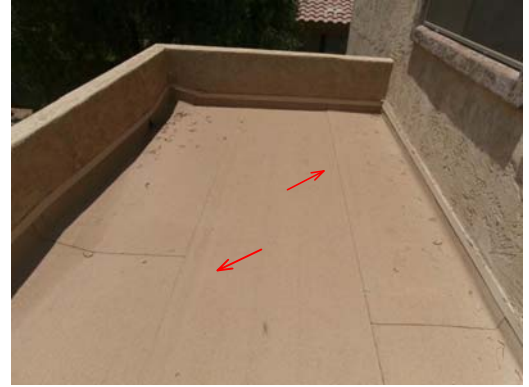
4. Patio Roof Surface Material: Rolled roof material [Maintain roof material on a regular basis, Consult a qualified roofer](#)

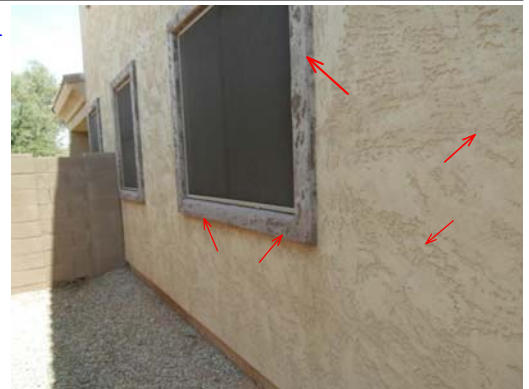
5. Building exterior Exterior Surface Type: Stucco [Areas of siding need painting, A qualified technician or contractor is recommended to re-evaluate, repair/ replace as needed](#)

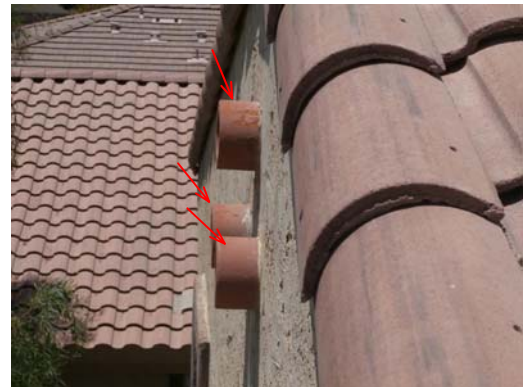
6. Trim: Styrofoam, Wood, Stucco [Areas of trim, fascia or soffit need painting &/ or refinishing, A qualified technician or contractor is recommended to re-evaluate, repair/ replace as needed](#)

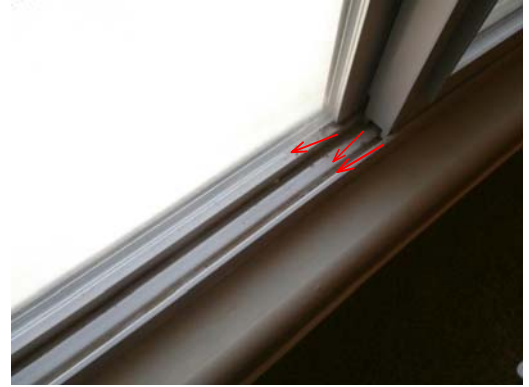
8. Windows: Vinyl- double pane There is dirt infiltration on some or all of the window sills, A qualified technician or contractor is recommended to re-evaluate, repair/ replace as needed

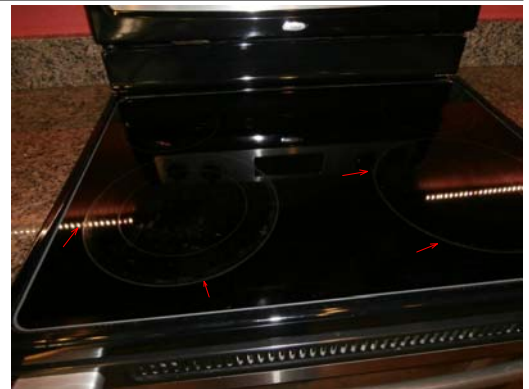
9. 1st Floor, Southwest Kitchen Cooking Appliances: XXX Scratched &/or dirty glass on cooktop, A qualified technician or contractor is recommended to re-evaluate, repair/ replace as needed

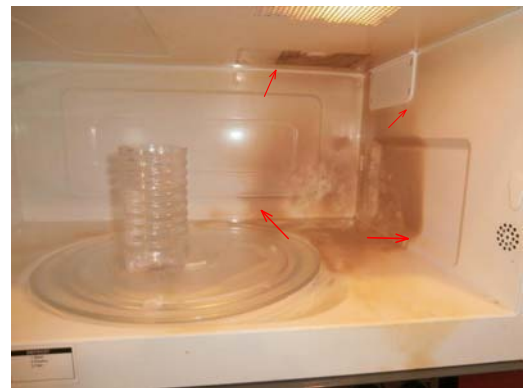
10. 1st Floor, Southwest Kitchen Dishwasher drain looped high under cabinet? No The dishwasher drain hose should be looped high to the bottom of the counter top to help prevent backflow of contaminated water into the dishwasher, A qualified technician or contractor is recommended to re-evaluate, repair/ replace as needed
11. 1st Floor, Southwest Kitchen Microwave: XXX Evidence of a past microwave fire, A qualified technician or contractor is recommended to re-evaluate, repair/ replace as needed

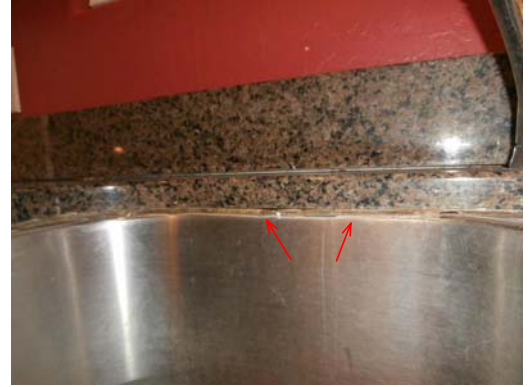
12. 1st Floor, Southwest Kitchen Sink: Stainless Steel **Caulking needed around sink, A qualified technician or contractor is recommended to re-evaluate, repair/ replace as needed**

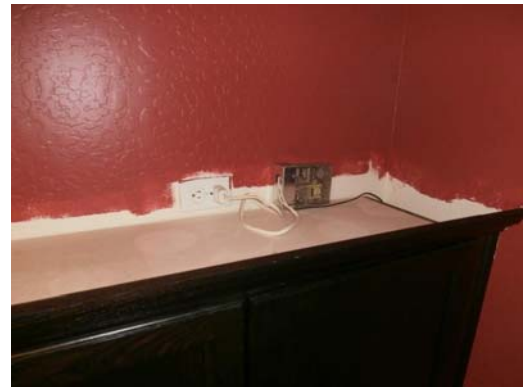
13. 1st Floor, Southwest Kitchen Electrical: 110 VAC lighting & GFCI outlet circuits **FYI- low voltage transformer on top of cabinets for under cabinet lighting, A bulb or bulbs are not functional, or are missing, replace as needed**

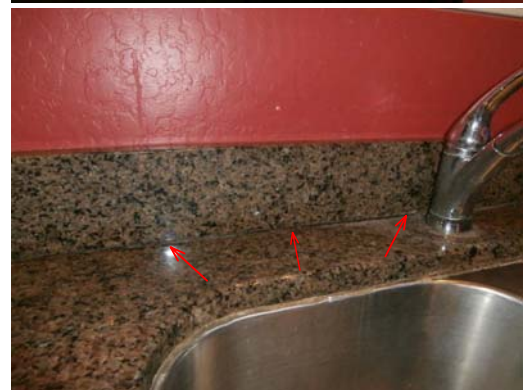
14. 1st Floor, Southwest Kitchen Counter Tops: Granite **Loose, cracked or missing caulk or grout, needs caulking/ grouting, A qualified technician or contractor is recommended to re-evaluate, repair/ replace as needed**

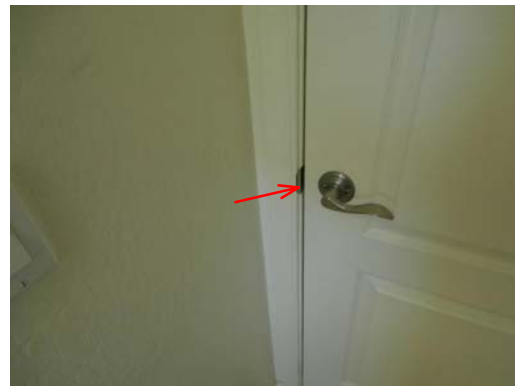
16. 2nd Floor, North Laundry Room/Area Doors: Hollow wood Lockset(s) not latching, A qualified technician or contractor is recommended to re-evaluate, repair/ replace as needed

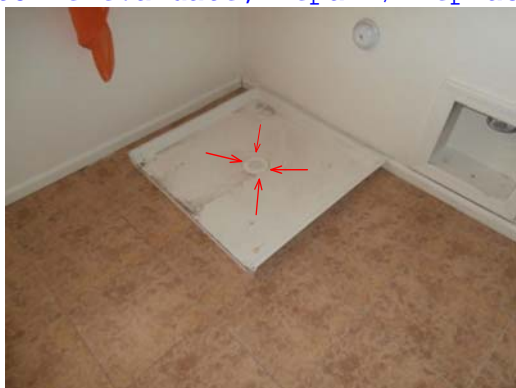
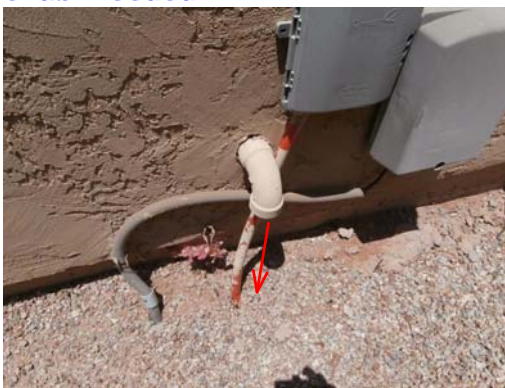
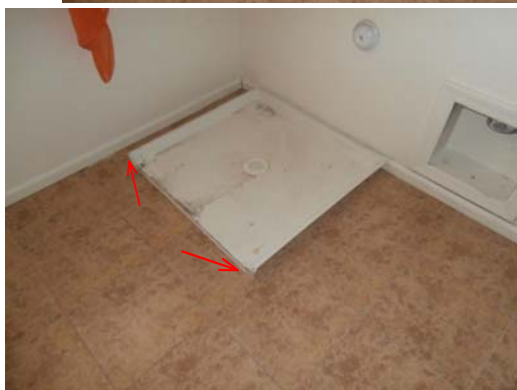
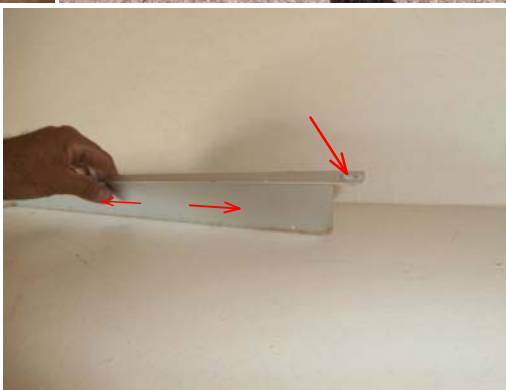
17. 2nd Floor, North Laundry Room/Area Floor Drain: Washing machine drain pan Washing machine drain pan missing front edge plate screws, A qualified technician or contractor is recommended to re-evaluate, repair/ replace as needed

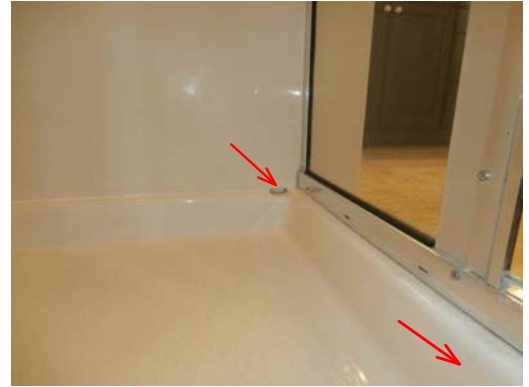
18. Master bath, 2nd floor Bathroom Shower/Surround: Fiberglass pan, Cultured marble surround **Open holes in the top edge of the shower pan where the shower enclosure walls intersect, Recommend caulking/ re-caulking, A qualified technician or contractor is recommended to re-evaluate, repair/ replace as needed**

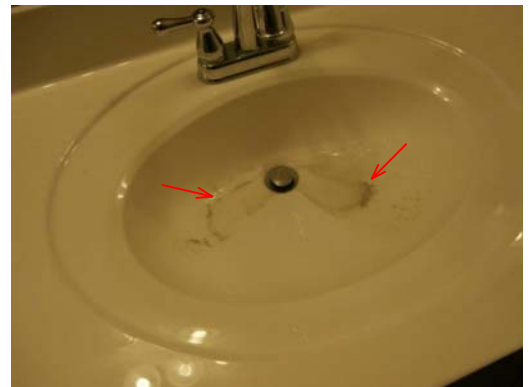
19. Main hall bath, 2nd floor Bathroom Sink/Basin: Cultured marble **Mystery substance in right hand sink needs cleaning, A qualified technician or contractor is recommended to re-evaluate, repair/ replace as needed**

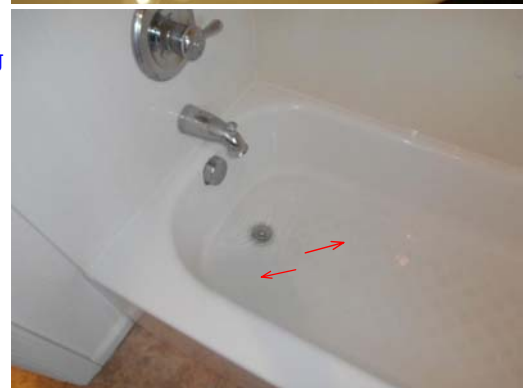
20. Main hall bath, 2nd floor Bathroom Faucets/Traps: Two handle sink faucet(s) & ABS trap(s), Single handle tub/shower faucet **Slow draining noted at bathtub -further review/repair, A qualified technician or contractor is recommended to re-evaluate, repair/ replace as needed**

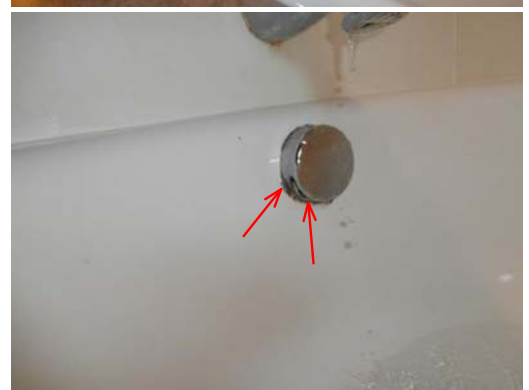
21. Main hall bath, 2nd floor Bathroom Tub/Surround: Porcelain on steel tub, Cultured marble surround **Substance at tub overflow needs cleaning, A qualified technician or contractor is recommended to re-evaluate, repair/ replace as needed**

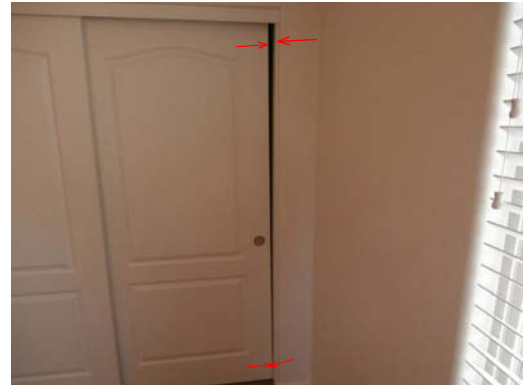
25. Northwest, 2nd Floor Bedroom Doors: Hollow wood **Align/adjust closet doors, A qualified technician or contractor is recommended to re-evaluate, repair/ replace as needed**

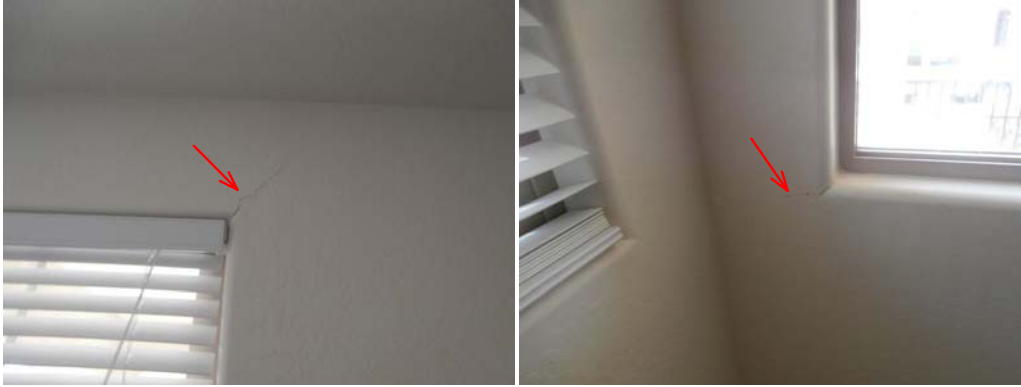
27. Hallway, Entry, & stairway Living Space Floor: Ceramic tile, Carpet **Squeaking/ creaking floor at top of stairway/ walkway, A qualified technician or contractor is recommended to re-evaluate, repair/ replace as needed**
28. Living Room, Dining Room Living Space Walls: Drywall **Cracks &/or nail pops present, patch as needed in the course of normal maintenance, A qualified technician or contractor is recommended to re-evaluate, repair/ replace as needed**

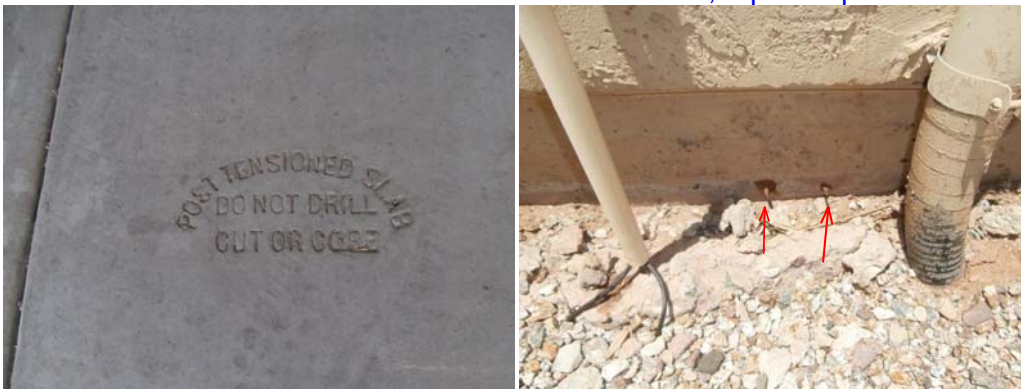
29. Foundation: Post tensioned concrete slab, Not visible Nails protruding from concrete, need removal, A qualified technician or contractor is recommended to re-evaluate, repair/ replace as needed

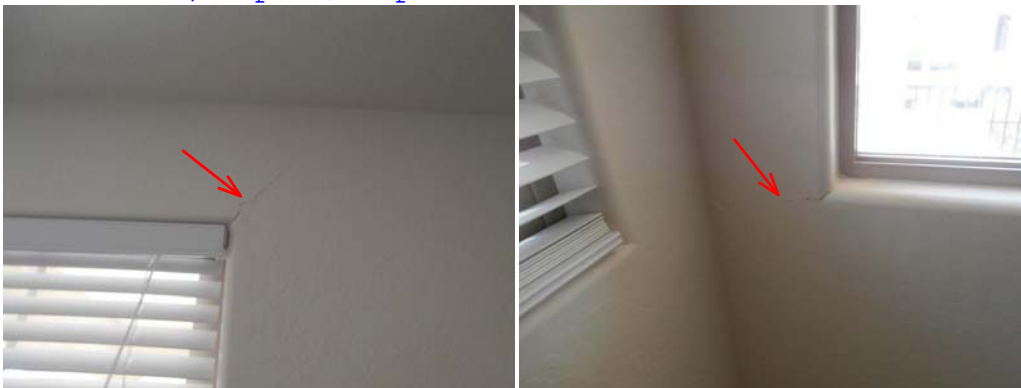
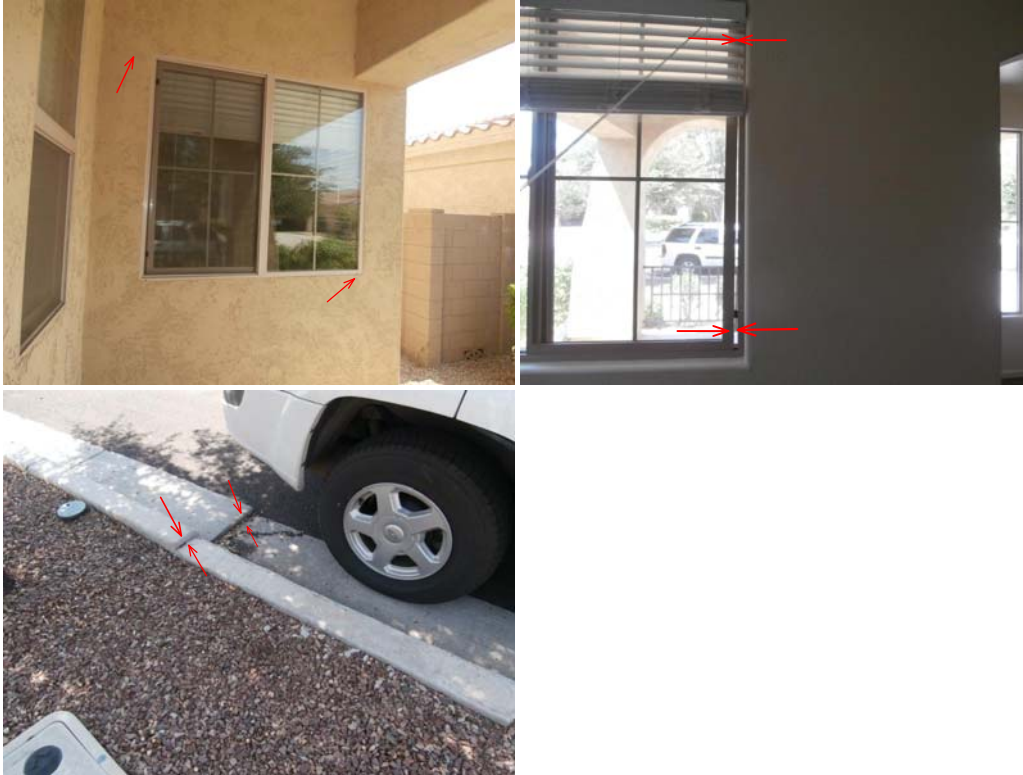
30. Differential Movement: Some shifting/ settling present Areas of cracking noted, Any concerns with the structural integrity of the building should be taken up with a qualified structural engineer, A qualified technician or contractor is recommended to re-evaluate, repair/ replace as needed

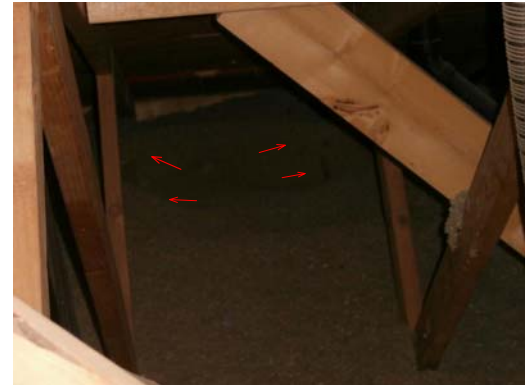
31. Laundry Room Attic Unable to Inspect: 25% Ductwork, Tight framing, Insulation, Any concerns with possible hidden attic conditions should be taken up with a qualified technician
32. Laundry Room Attic Insulation Depth: 7-8", 9-10" Insulation has "snow drifted " out of place, A qualified technician or contractor is recommended to re-evaluate, repair/ replace as needed

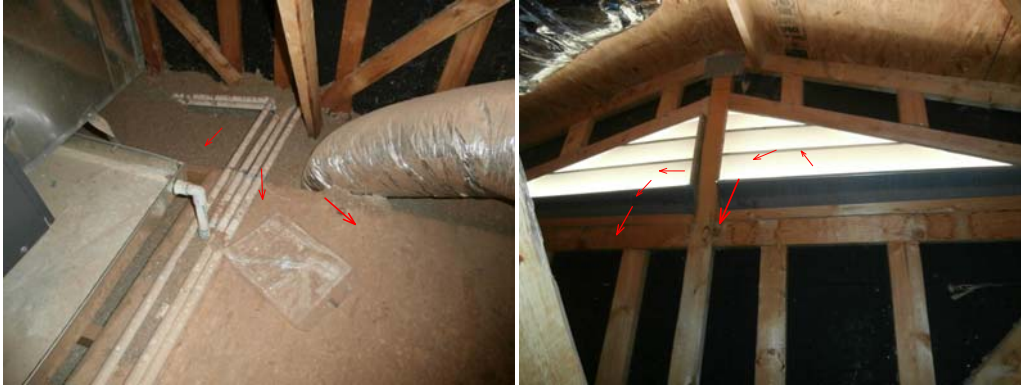
33. Laundry Room Attic Moisture Penetration: Previous water penetration noted Moisture staining &/ or damage present, A qualified technician or contractor is recommended to re-evaluate, repair/ replace as needed, Any concerns with moisture intrusion should be referred to a qualified remediation contractor

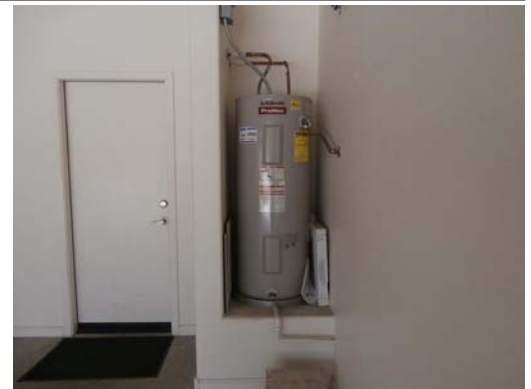
34. Garage Water Heater Water Heater Operation: Functional at time of inspection [We recommend keeping home warranty coverage on the water heater](#)

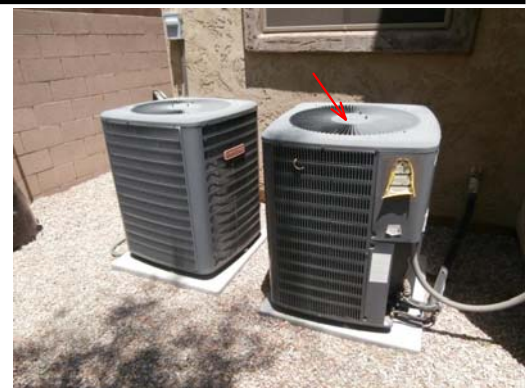
37. Southwest exterior, East unit AC System A/C System Operation: Appears serviceable [The A/C system\(s\) uses R-410-A refrigerant instead of the older R-22 refrigerant that is being phased out. Advise your A/C service provider of this fact when calling for service, Because of the 14 SEER mandate set forth by the Department of Energy, the unit is at a point where any major breakdown may be cause for replacement. We recommend obtaining & maintaining a home warranty that will cover the 14 SEER upgrade](#)

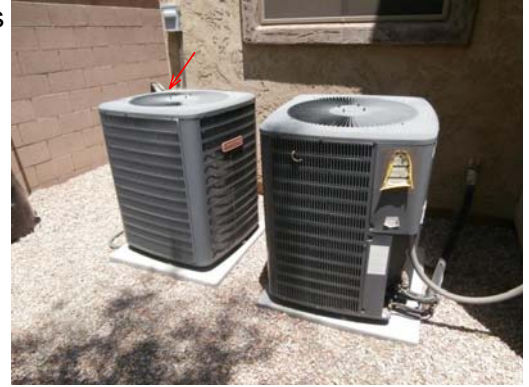
38. Southwest exterior, West unit AC System A/C System Operation: Appears serviceable The A/C system(s) uses R-410-A refrigerant instead of the older R-22 refrigerant that is being phased out. Advise your A/C service provider of this fact when calling for service, Because of the 14 SEER mandate set forth by the Department of Energy, the unit is at a point where any major breakdown may be cause for replacement. We recommend obtaining & maintaining a home warranty that will cover the 14 SEER upgrade

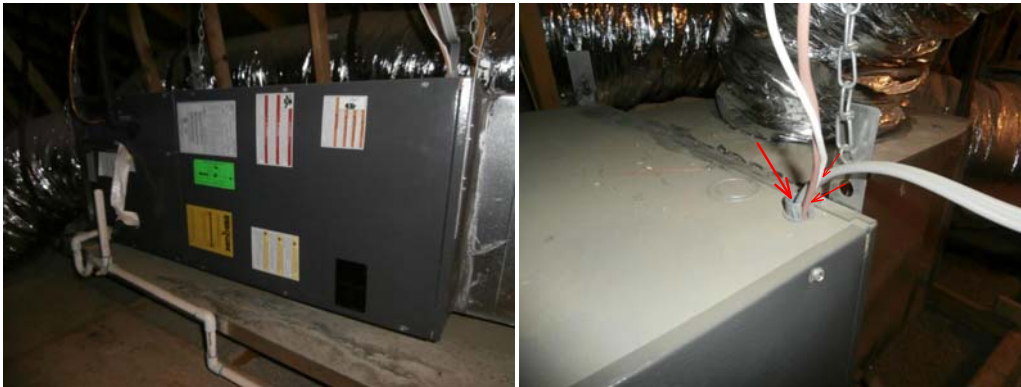
39. Attic, East Heating System Heating System Operation: Appears functional Due to the exterior temperature being over 65 degrees, the heat pump was tested in cooling mode only. The heating mode uses the same components in reverse cycle. Because of the 14 SEER mandate set forth by the Department of Energy, the unit is at a point where any major breakdown may be cause for replacement. We recommend obtaining & maintaining a home warranty that will cover the 14 SEER upgrade, Thermostat wire improperly run to unit/ run through same penetration as high voltage cable, A qualified technician or contractor is recommended to re-evaluate, repair/ replace as needed

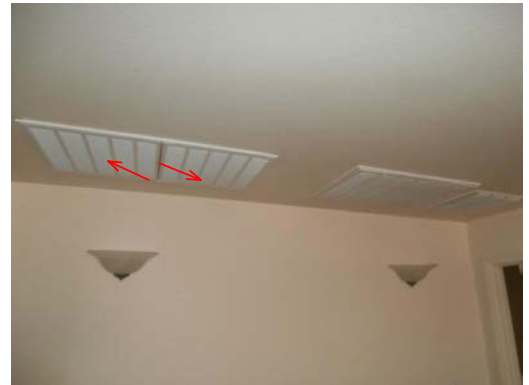
40. Attic, East Heating System Blower Fan/Filter: Direct drive, Disposable filter Clean/ replace filter on a regular basis

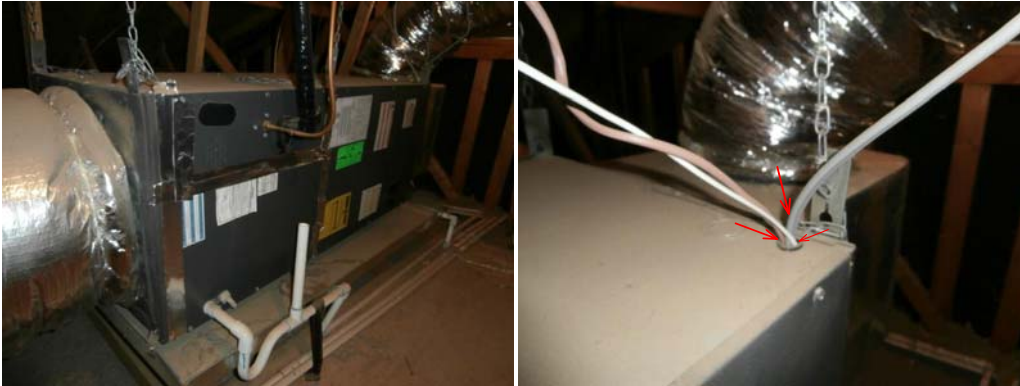
42. Attic, West Heating System Heating System Operation: Appears functional Due to the exterior temperature being over 65 degrees, the heat pump was tested in cooling mode only. The heating mode uses the same components in reverse cycle. Because of the 14 SEER mandate set forth by the Department of Energy, the unit is at a point where any major breakdown may be cause for replacement. We recommend obtaining & maintaining a home warranty that will cover the 14 SEER upgrade, Thermostat wire improperly run to unit/ run through same penetration as high voltage cable, A qualified technician or contractor is recommended to re-evaluate, repair/ replace as needed

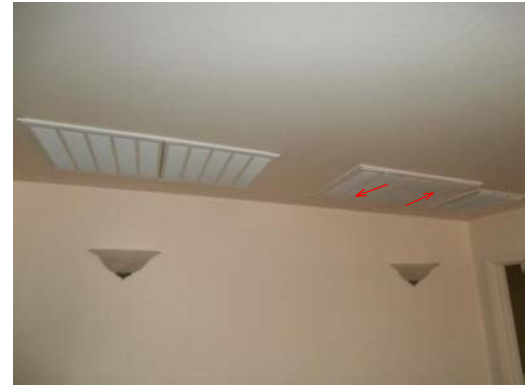
43. Attic, West Heating System Blower Fan/Filter: Direct drive, Disposable filter Clean/ replace filter on a regular basis

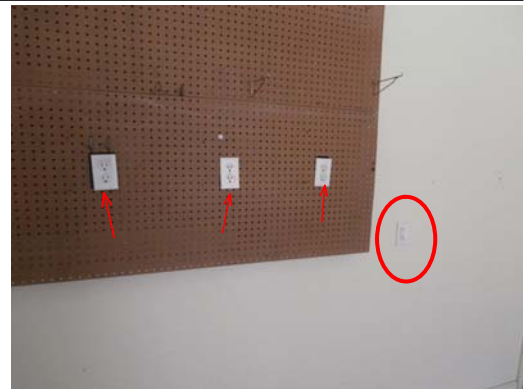
1. Northeast, Front Garage Electrical: 110 VAC lighting & GFCI outlet circuits  
Outlets on peg board not working, A qualified technician or contractor is recommended to re-evaluate, repair/ replace as needed

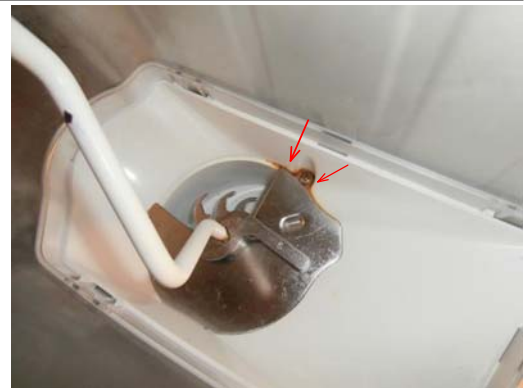
2. 1st Floor, Southwest Kitchen Refrigerator: XXX Rust in the icemaker/ icemaker chute, A qualified technician or contractor is recommended to re-evaluate, repair/ replace as needed, The icemaker was shut off & could not be inspected

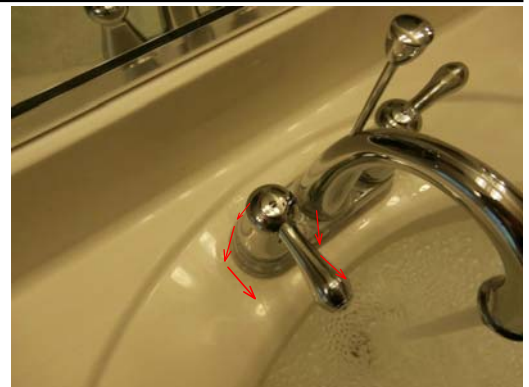
3. Master bath, 2nd floor Bathroom Faucets/Traps: Two handle sink faucet(s) & ABS trap(s), Single handle tub/shower faucet Leaking &/ or dripping right hand sink faucet, A qualified technician or contractor is recommended to re-evaluate, repair/ replace as needed

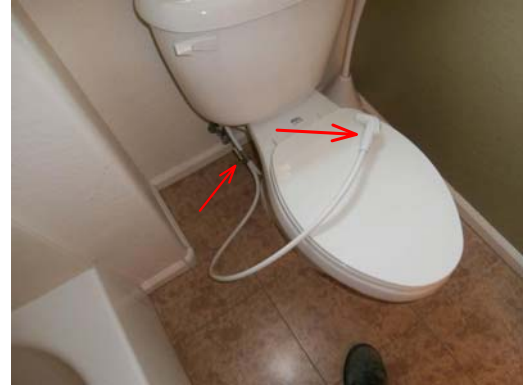
4. Main hall bath, 2nd floor Bathroom Toilets: Ceramic Recommend properly removing & capping makeshift bidet spray hose, A qualified technician or contractor is recommended to re-evaluate, repair/ replace as needed
