May 23, 2025

Subject: **Geotechnical Evaluation of Paver Roads**
Enclave at Lake Havasu (34.508809⁰, -114.251130⁰)
Lake Havasu City, Arizona 86406
CSET 81-142

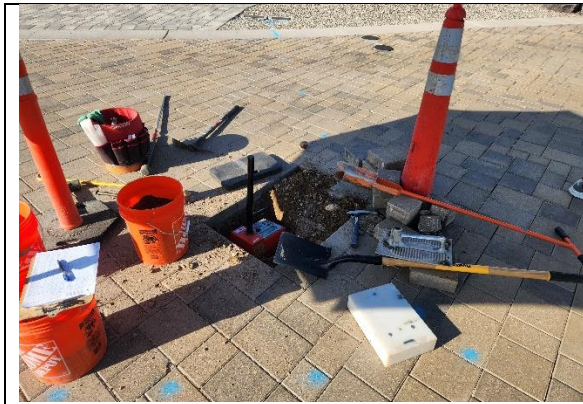
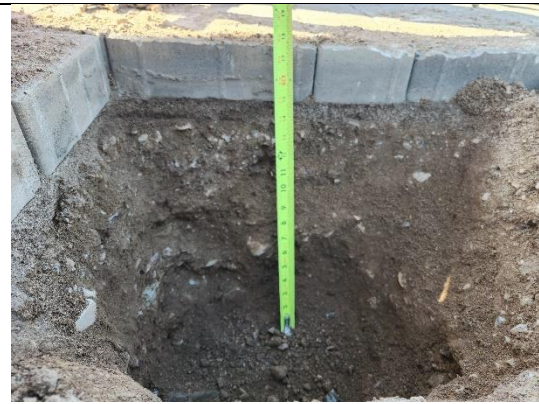
TP-1 - The subgrade is similar to the AB except the subgrade has rocks as large as three inches

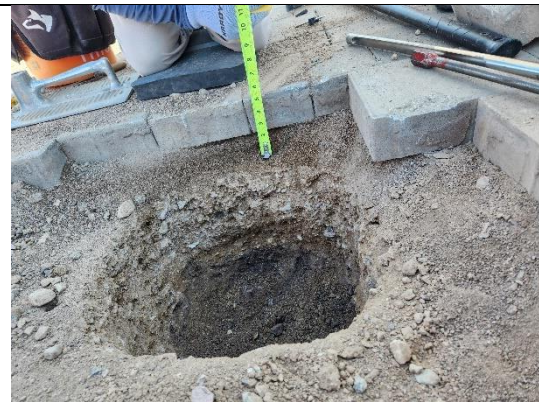
TP-3 The subgrade is different from all the other test locations. It is darker in color, has plasticity and more fines.

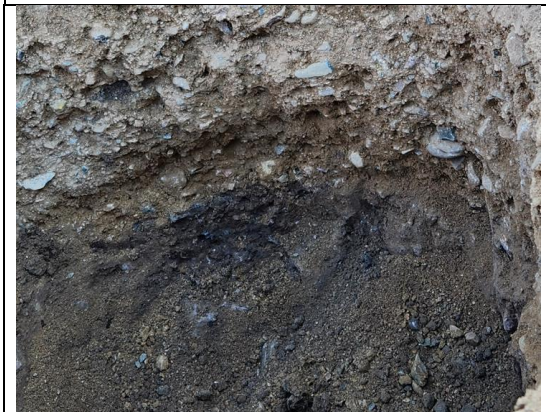
TP-3 A closer view of the subgrade soil

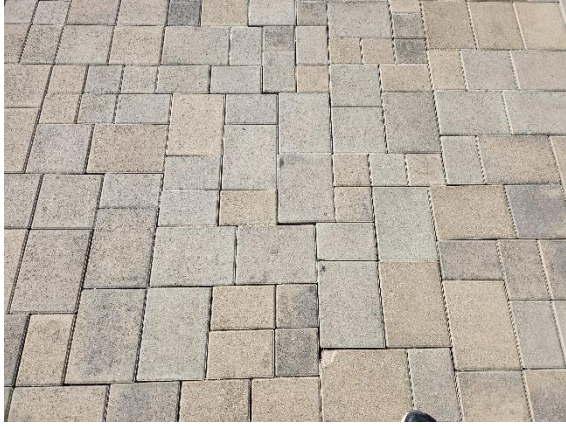
<p>Chipped pavers along the concrete ribbon</p>	<p>Gap between pavers</p>

<p>Gaps between pavers</p>	<p>Chipped pavers</p>

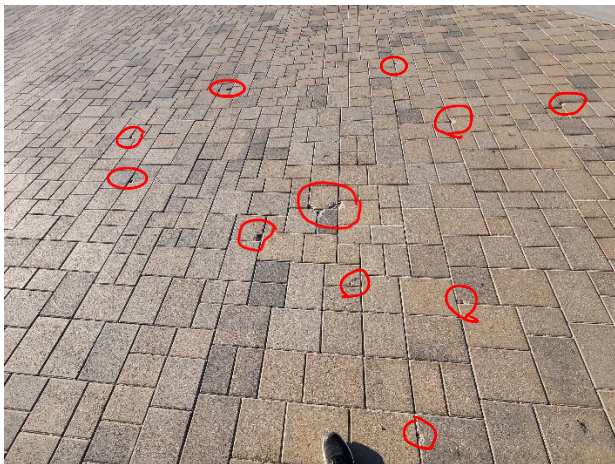
- B. **Chipped Pavers** - There are several chips at the corners of the pavers. There are a lot more chipped pavers on the western half of the Camino de la Enclave than the rest of the roadways. We suspect that a rock rests on the corners of the pavers where minor depression exist, and vehicle loads on top the rock causes the paver to chip. Chipped pavers are common along the concrete ribbon at driveway ramps to empty lots.

Chipped pavers are circled

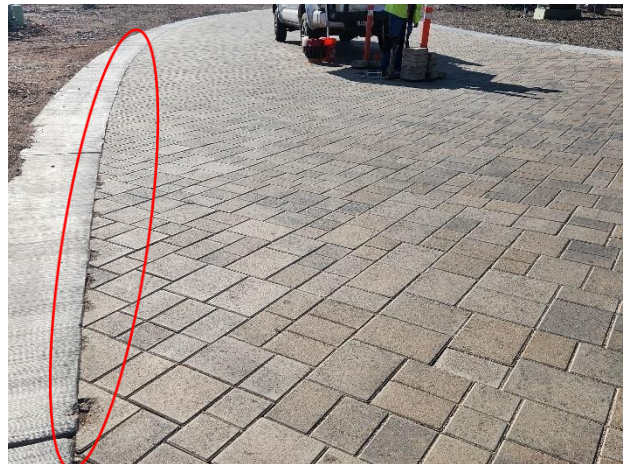
Chipped next to the concrete ribbon

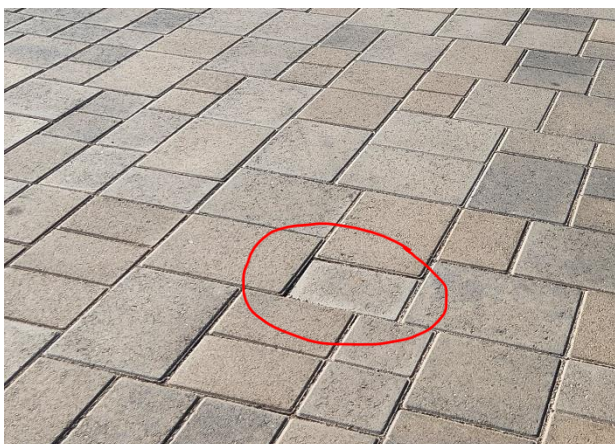
Note the slightly depressed paver. The Arizona Registrar of Contractors (AROC) states that there should be no more than 1/8" elevation difference between pavers.

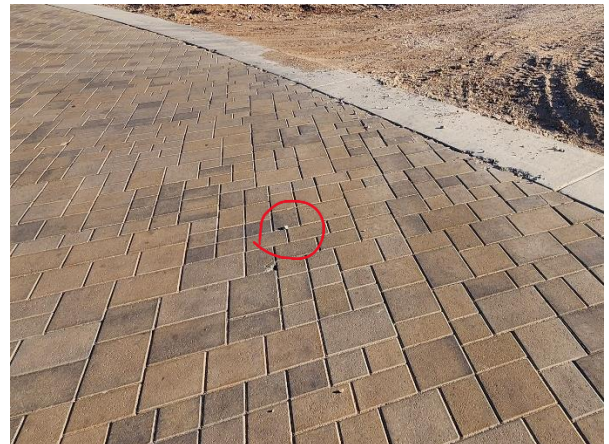
A rock at the corner of the pavers

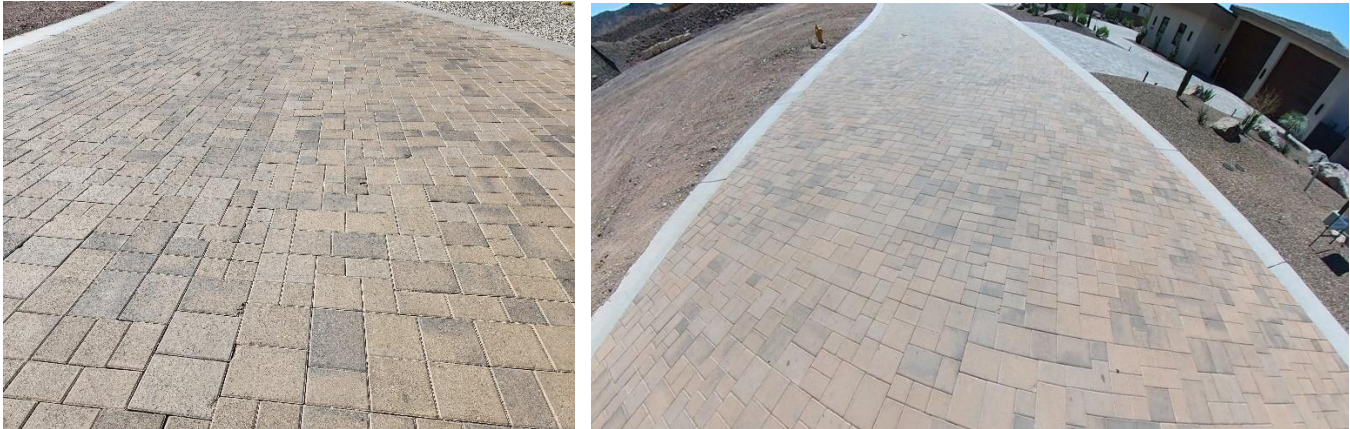
CSET noted in several areas that the installation of the pavers lacks the necessary interlocking pattern. The following photos show long linear joints between the pavers that lack the locking pattern. The right photo is a snapshot of a 360 video.

5. Long, linear paver joints due to lack of interlocking pavers were noted throughout. The lack of interlocking may lead to lateral and vertical movement of the pavers.

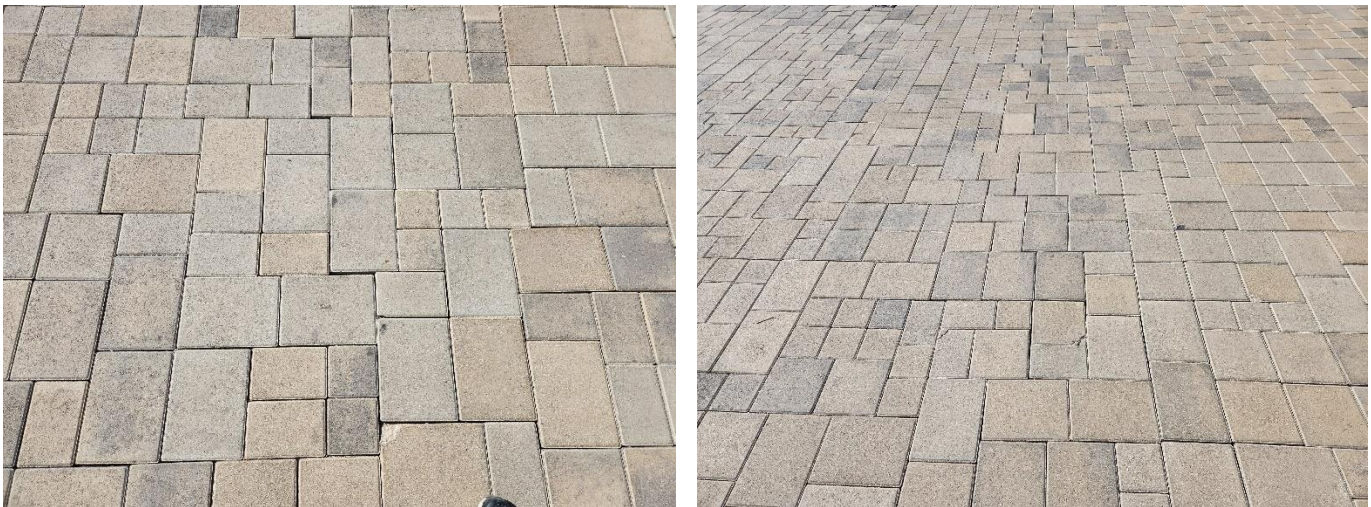
In addition to the long, linear joints, the joint width (gaps between the adjacent pavers) appears to be wider. AROC recommends the joint width should be between 1/16 and 3/16 inch.

6. The joint widths are found to be wider in some areas. They were either installed incorrectly or the pavers had shifted.
7. The thickness of the bedding sand is slightly more than ideal. Minor settlement of the sand can lead to depressed paver corners where rocks could get stuck and cause chipping of the pavers.
